**SCAT Area Transition Report for
B22**

Silvertip Pipeline Incident
Laurel, Montana

October 21, 2011

Our Ref.:
B0085883.1103

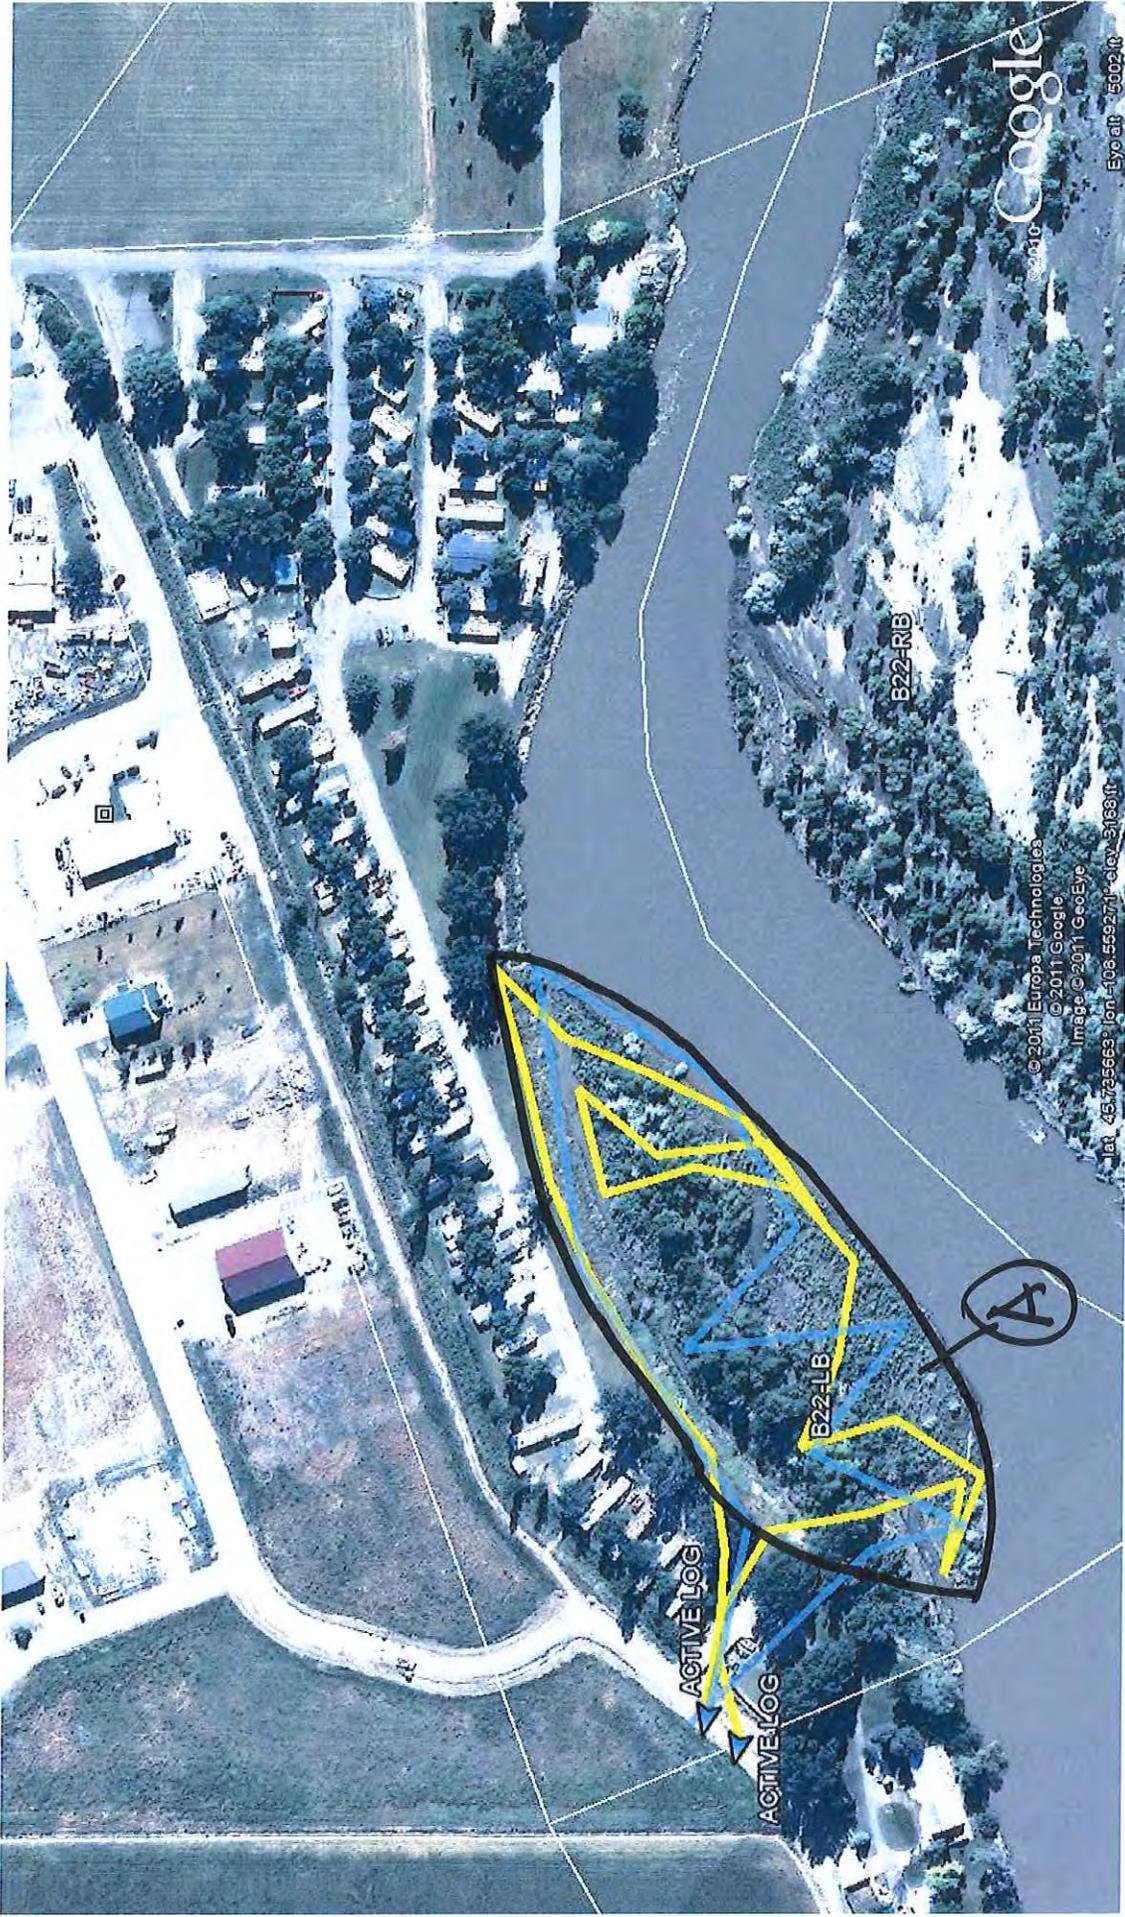
09/07/11
SCAT 4

ZONE A: NFT
