**SCAT Area Transition Report
for B41**

Silvertip Pipeline Incident
Laurel, Montana

October 26, 2011

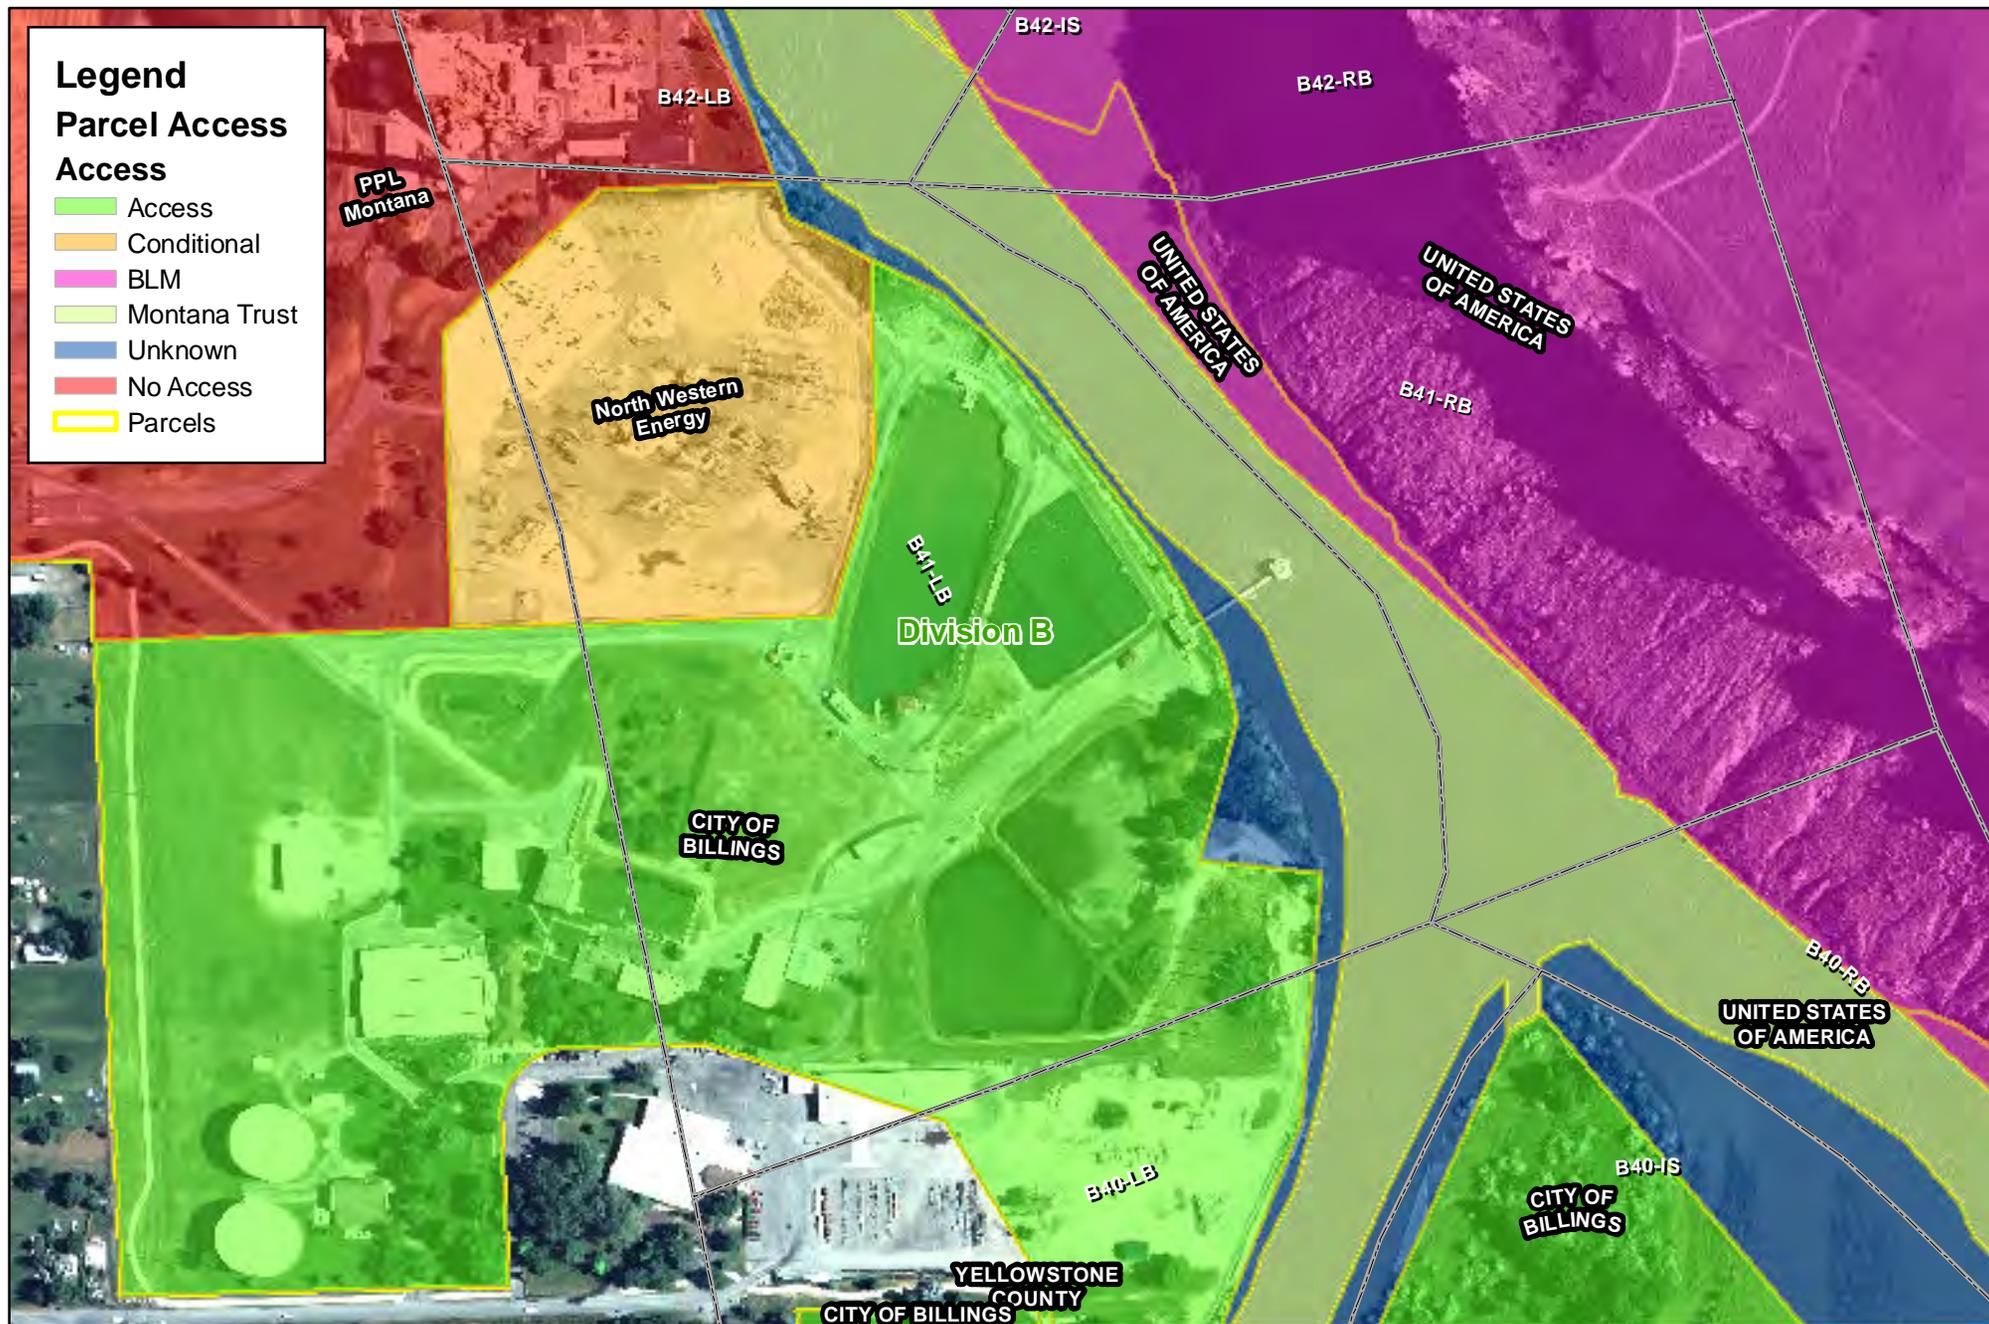
Figure 1 provides an aerial map of SCAT Area B41, along with the (a) SCAT Area boundary, (b) parcel boundaries and respective property owners, and (c) access constraints identified during the oil cleanup process. The acreage surveyed in Area B41 is 2.5. There was conditional access for a portion of the left bank in Area B41.

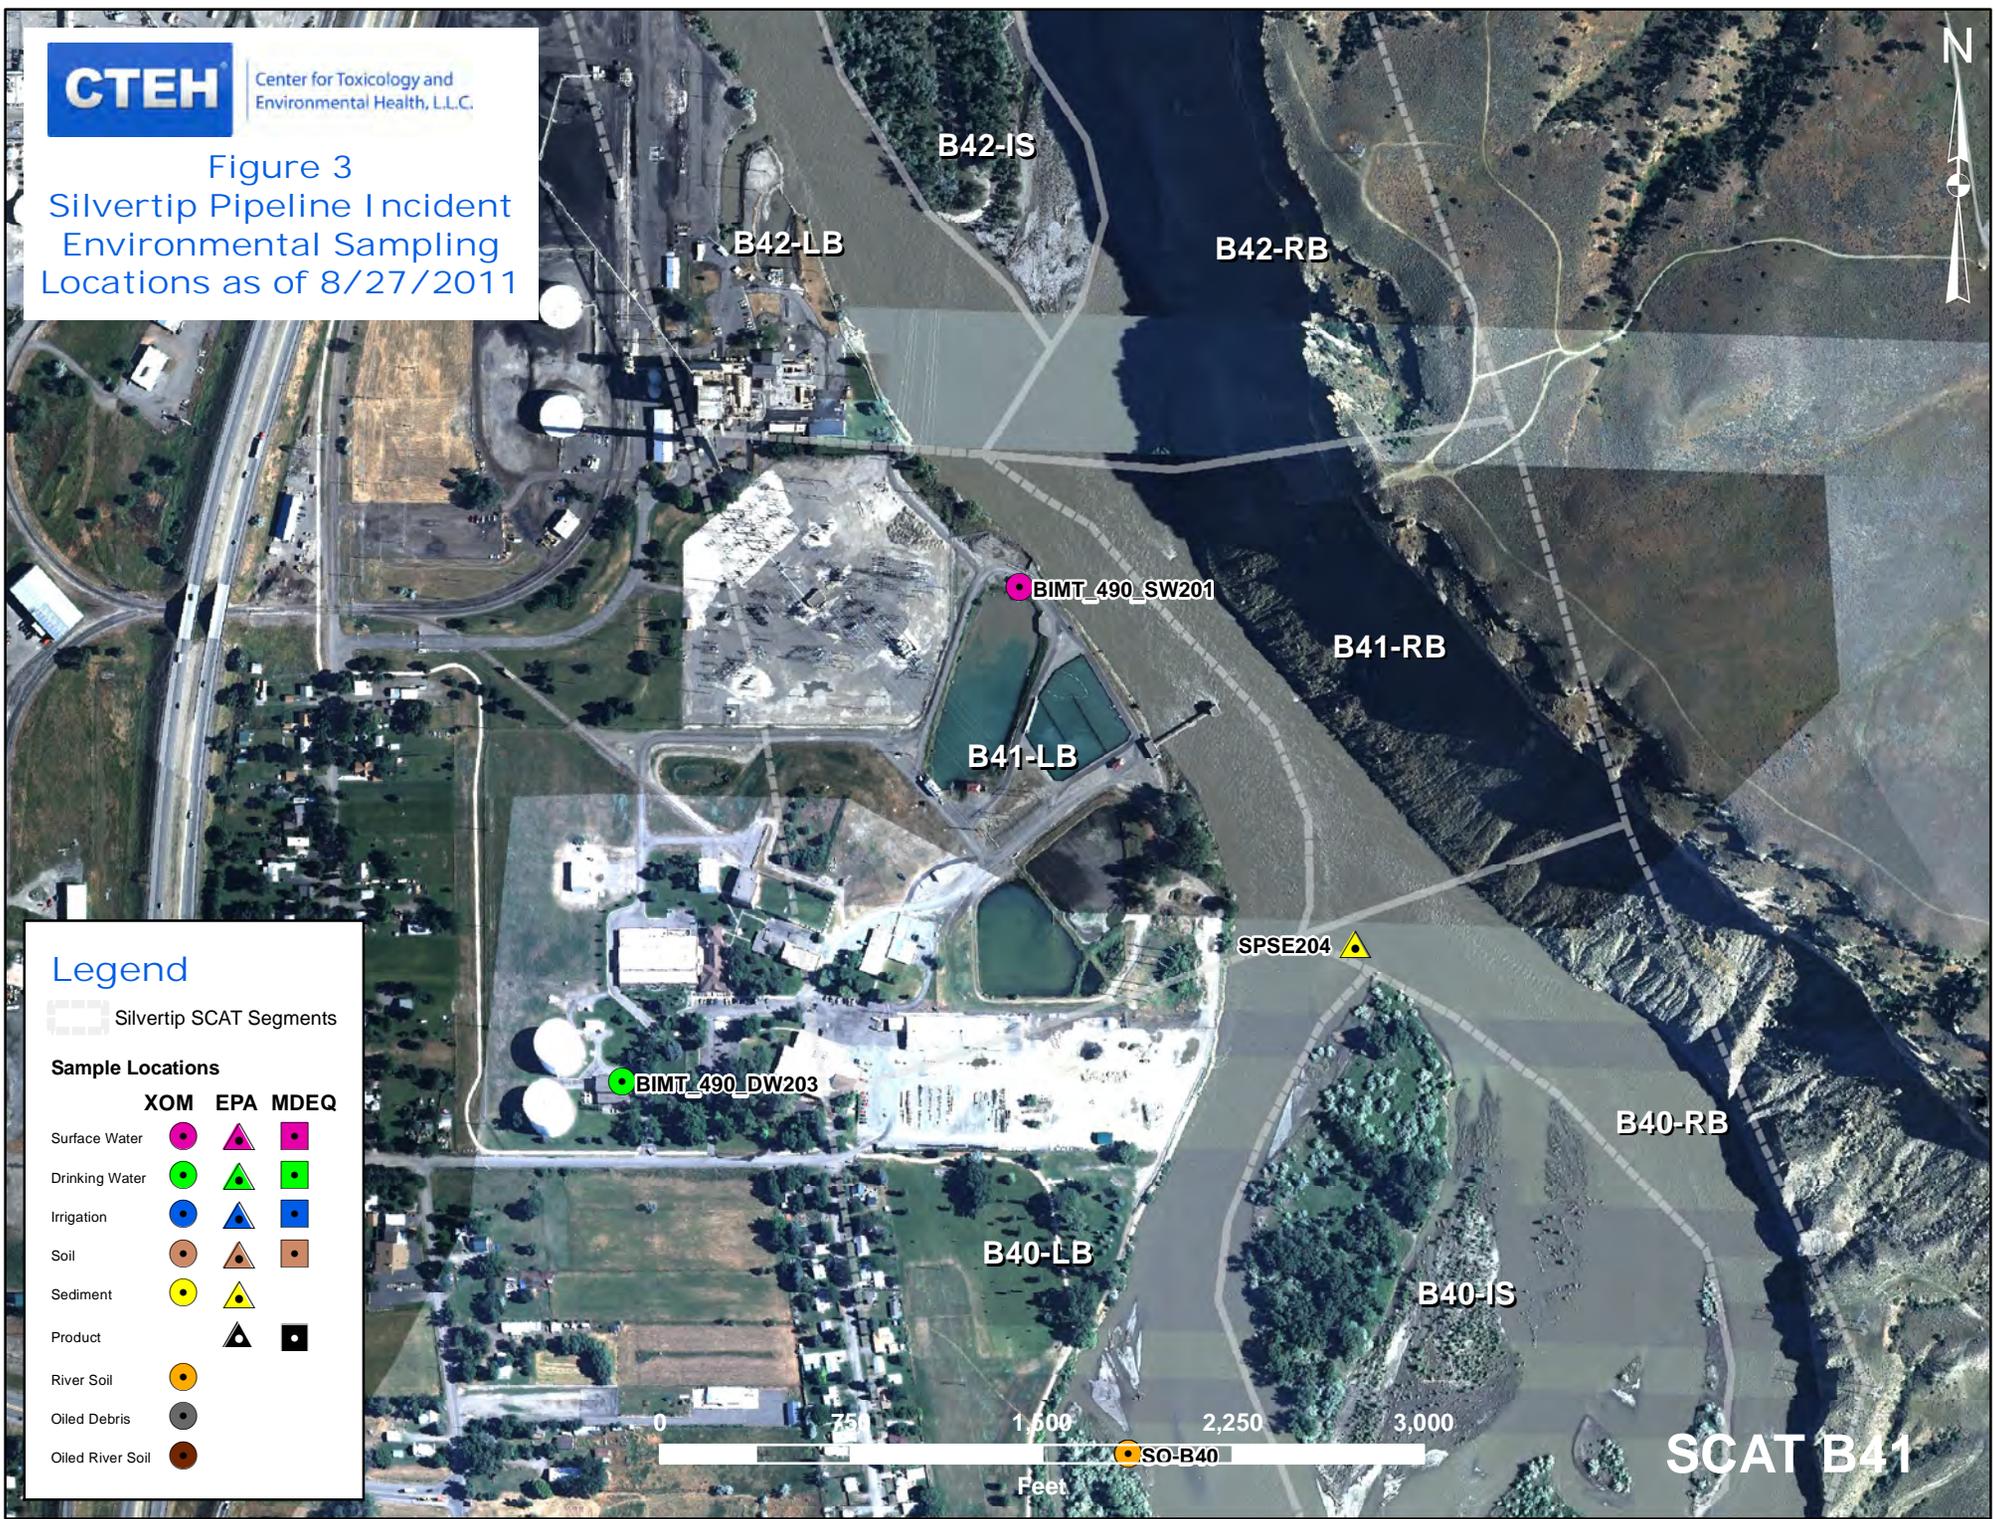
Figure 3
Silvertip Pipeline Incident
Environmental Sampling
Locations as of 8/27/2011

Table 1 (below) summarizes samples collected within Area B41. The analytical results for the samples collected can be accessed through a publicly accessible database on the United States Environmental Protection Agency's (USEPA's) website. The approximate locations of samples collected within Area B41 are provided on Figure 3.

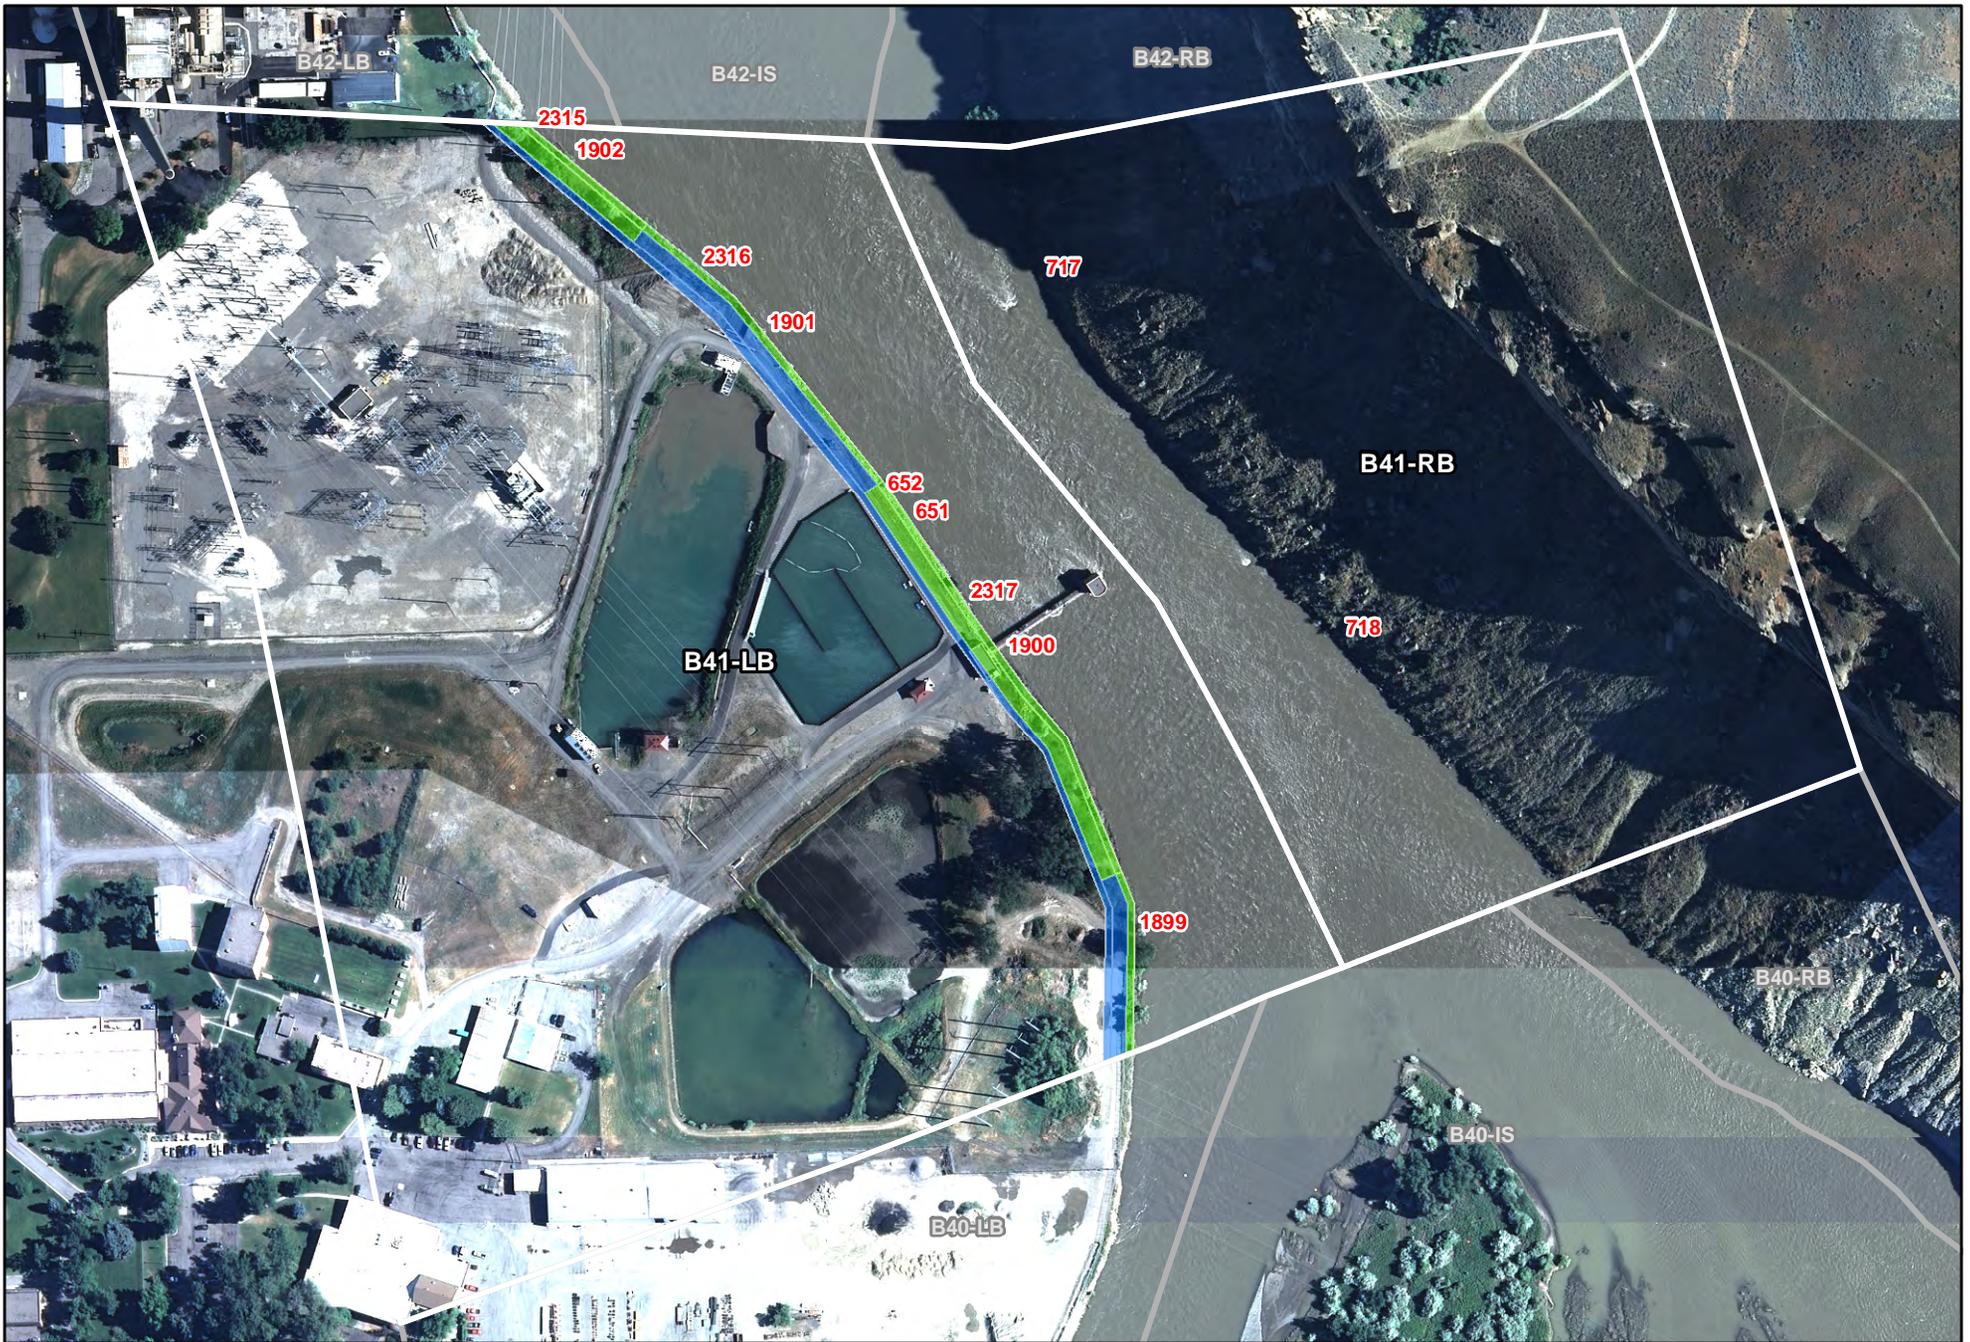
The SCAT teams used systematic evaluation criteria and treatment method tables approved by the National Oceanic and Atmospheric Administration to provide a standard approach for data collection and conducting field surveys. The forms and sketches from the initial SCAT surveys performed along the river bank (water edge) and floodplain within Area B41 are included in Appendix B. Figure 4 provides the maximum oiling zones observed by the SCAT team during the initial surveys of Area B41.

<p>9999 Oiling Zone ID Red Heavy Oiling Orange Moderate Oiling</p>	<p>Yellow Light Oiling Green Very Light Oiling Blue No Oil Observed</p>	<p>Figure 4 - Maximum SCAT Observations For SCAT Area: B41</p> <p>225 0 225 450

The SCAT team developed compiled treatment recommendations (CTRs) providing approved treatment methods (ATMs) for each oiling zone identified during the initial SCAT surveys ([CTR No. 32](#) and [CTR No. 33](#)).

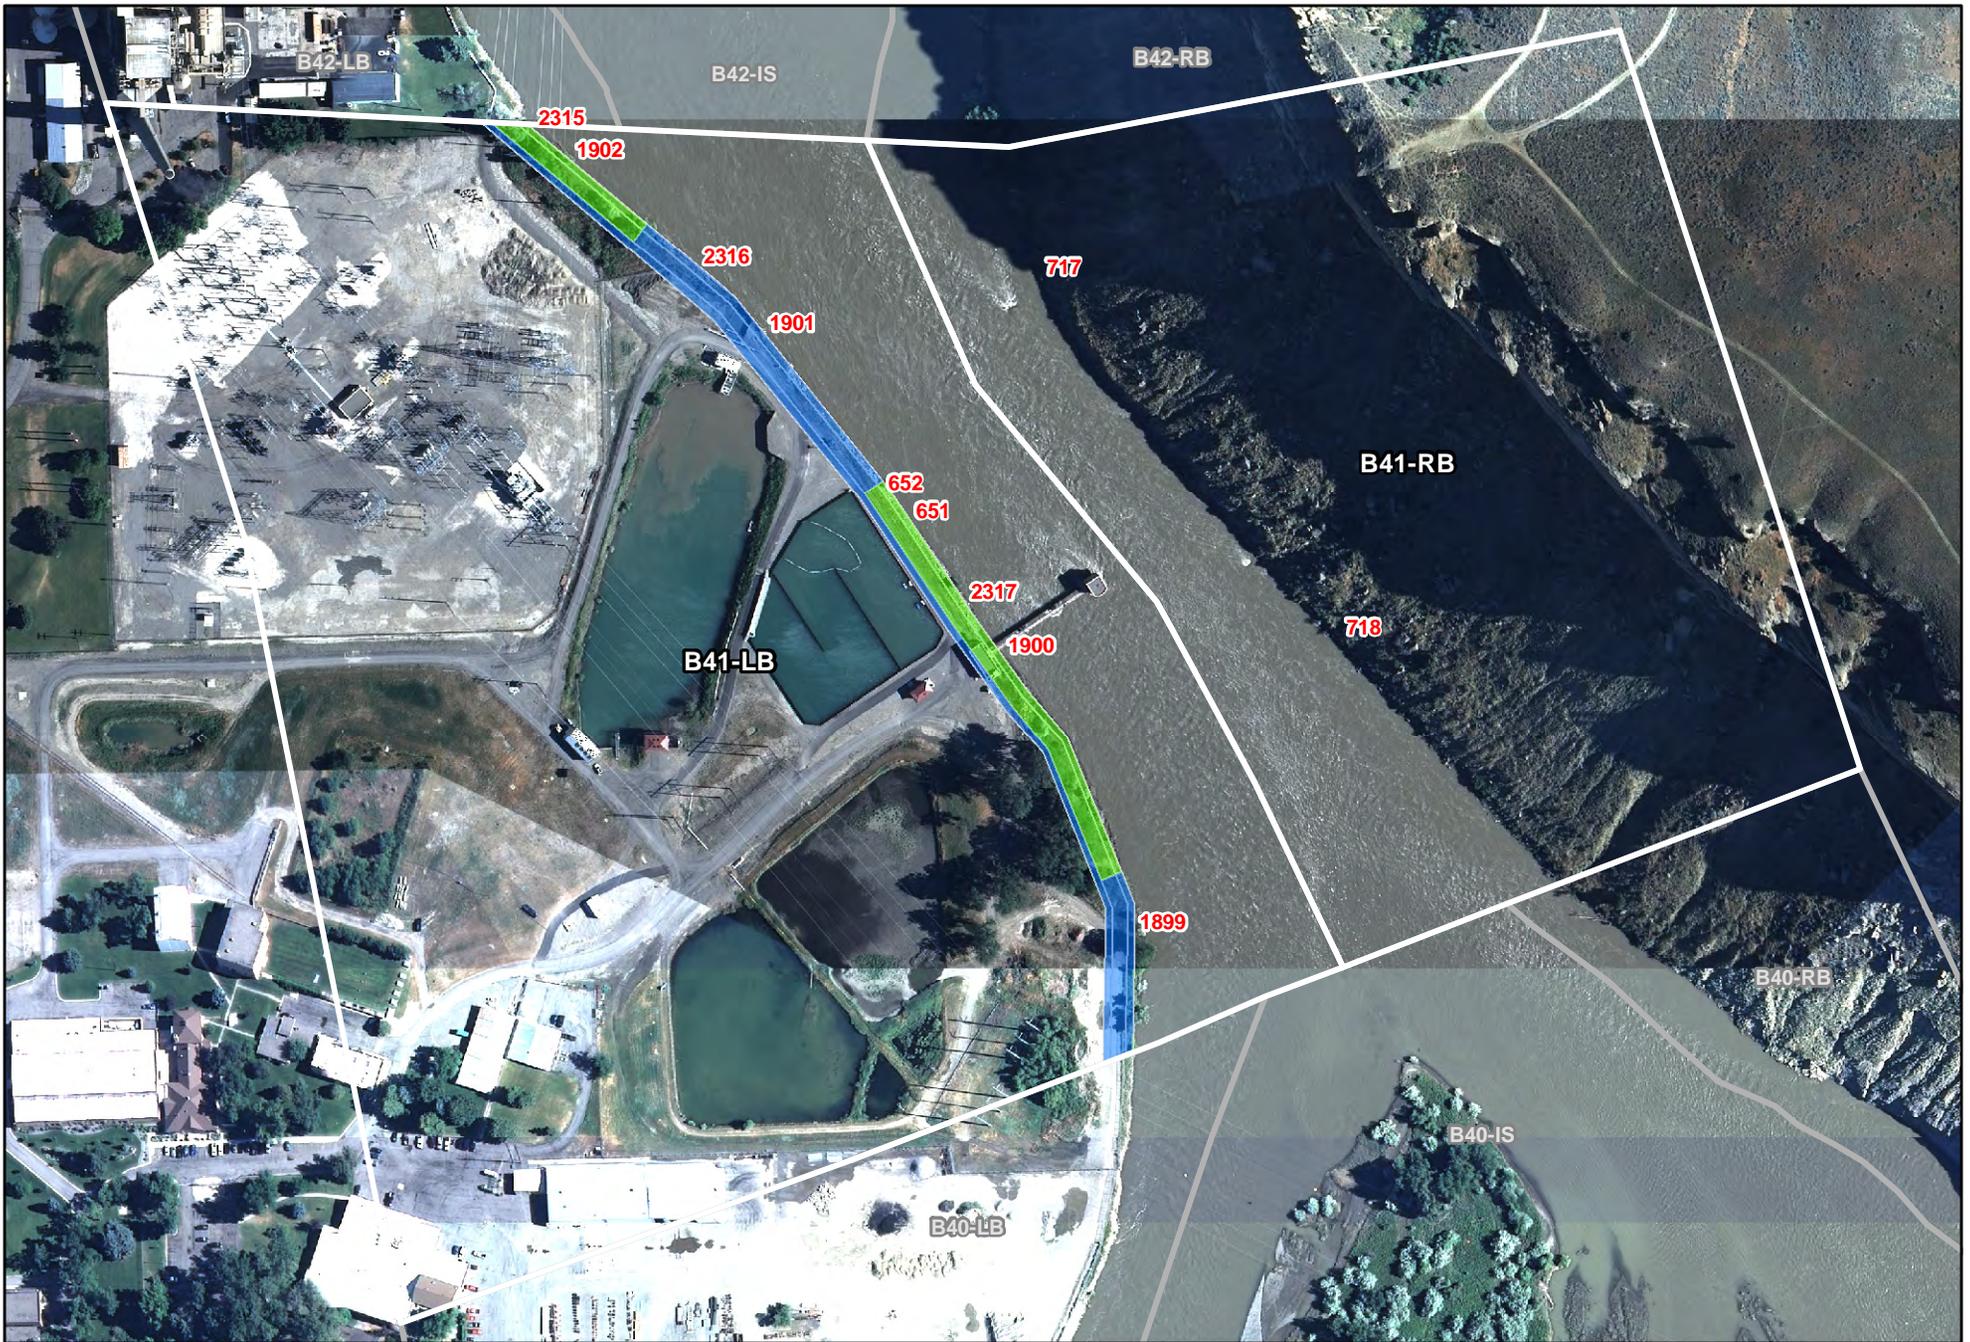
Figure 5 shows the oiling conditions within Area B41 following completion of oil removal activities. The SCAT team performed final surveys of the left bank within SCAT Area B41 to confirm the agreed-upon cleanup endpoints identified in the applicable CTRs had been achieved. The final SCAT survey documentation is presented in Appendix E.

<p>9999 Oiling Zone ID Red Heavy Oiling Orange Moderate Oiling</p>	<p>Yellow Light Oiling Green Very Light Oiling Blue No Oil Observed</p>	<p>Figure 5 - Final SCAT Observations For SCAT Area: B41</p>

Based on the initial SCAT boat survey performed on the right bank, an overbank survey is not required and therefore no further treatment is recommended. Based on the final SCAT surveys performed on the left bank within Area B41, no further treatment is recommended for this segment. SCAT Segment Sign-Off Forms are included as Appendix F.

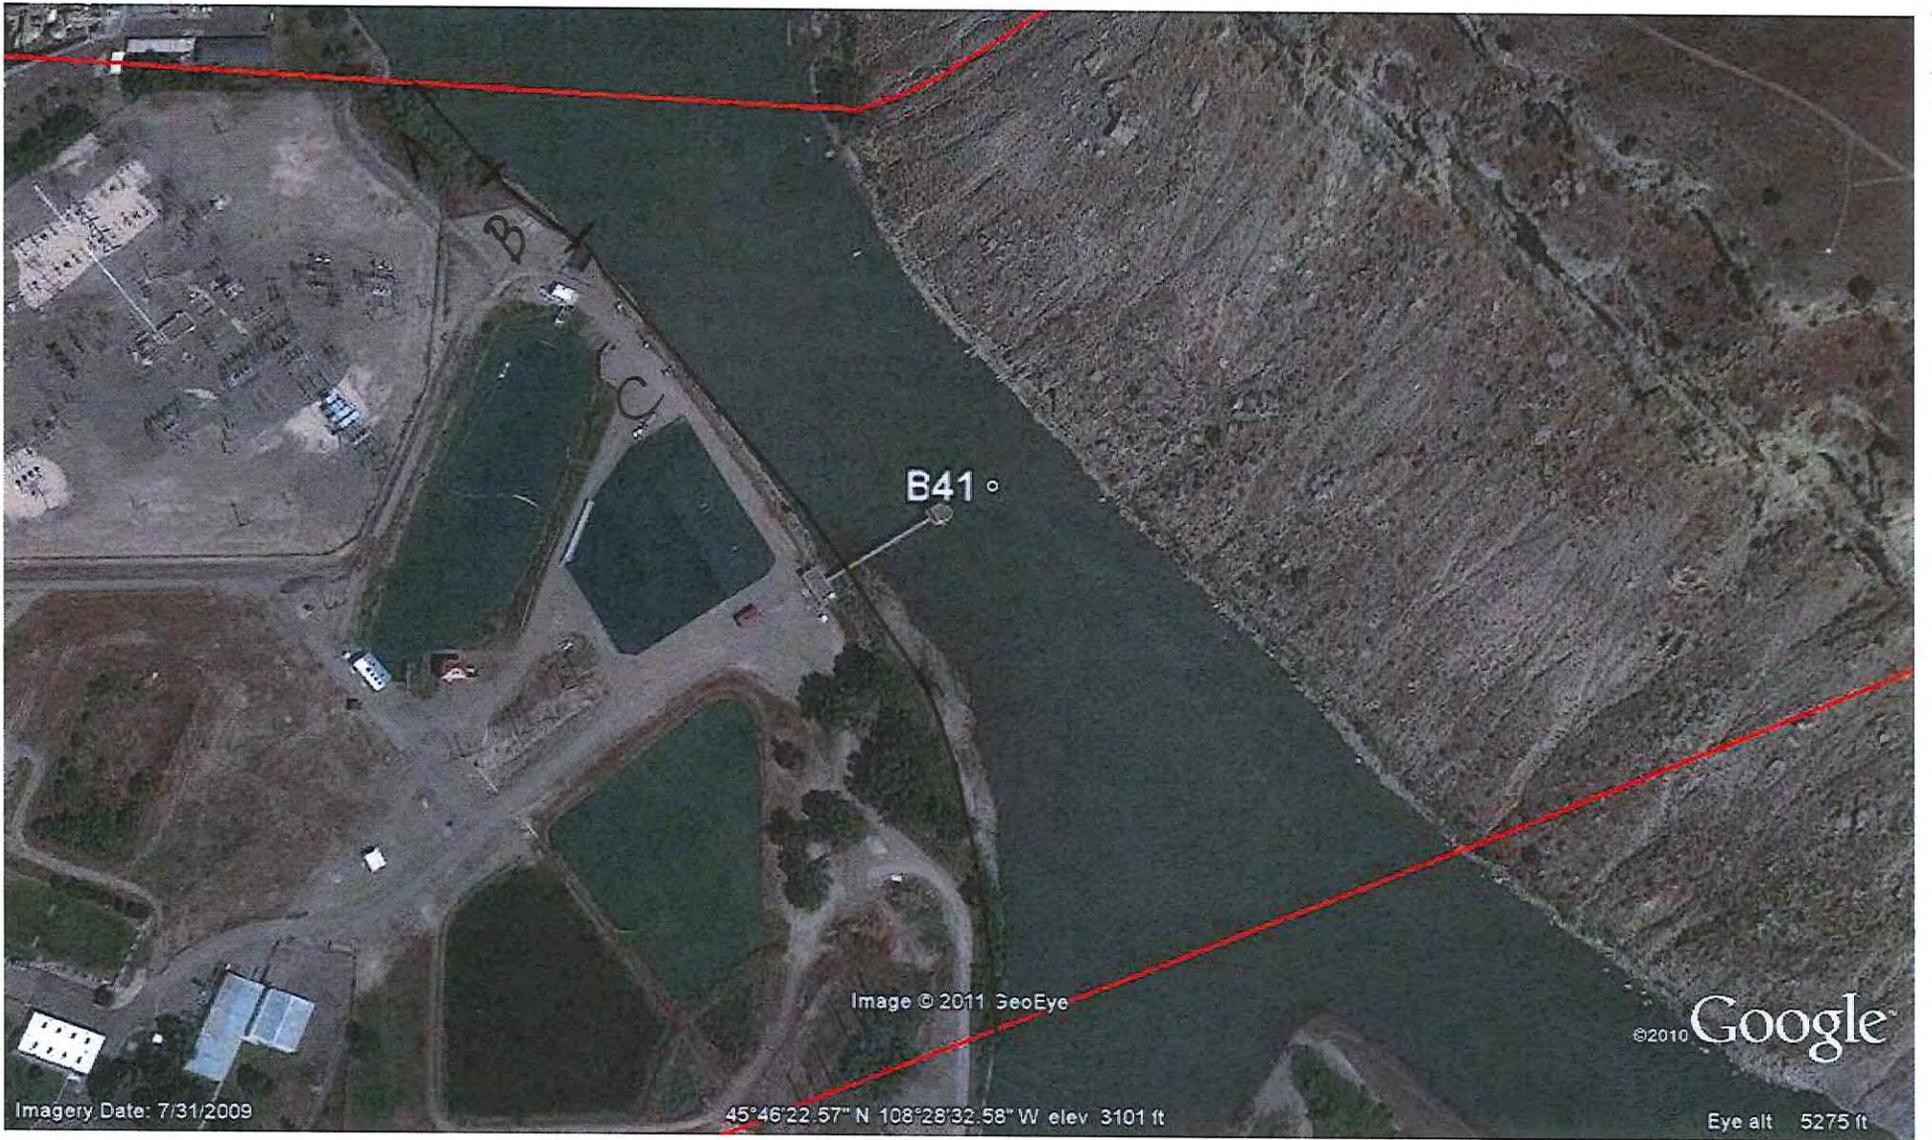
B41 °

Oil band heights: Zone B - 60cm

Treatment Recommendations:
 Zone A: No oil observed; no treatment required.
 Zone B: Cut & remove oil coated vegetation smaller than 1" diameter. Wipe larger oil coated vegetation.
 Zone C: No oil observed; no treatment required.

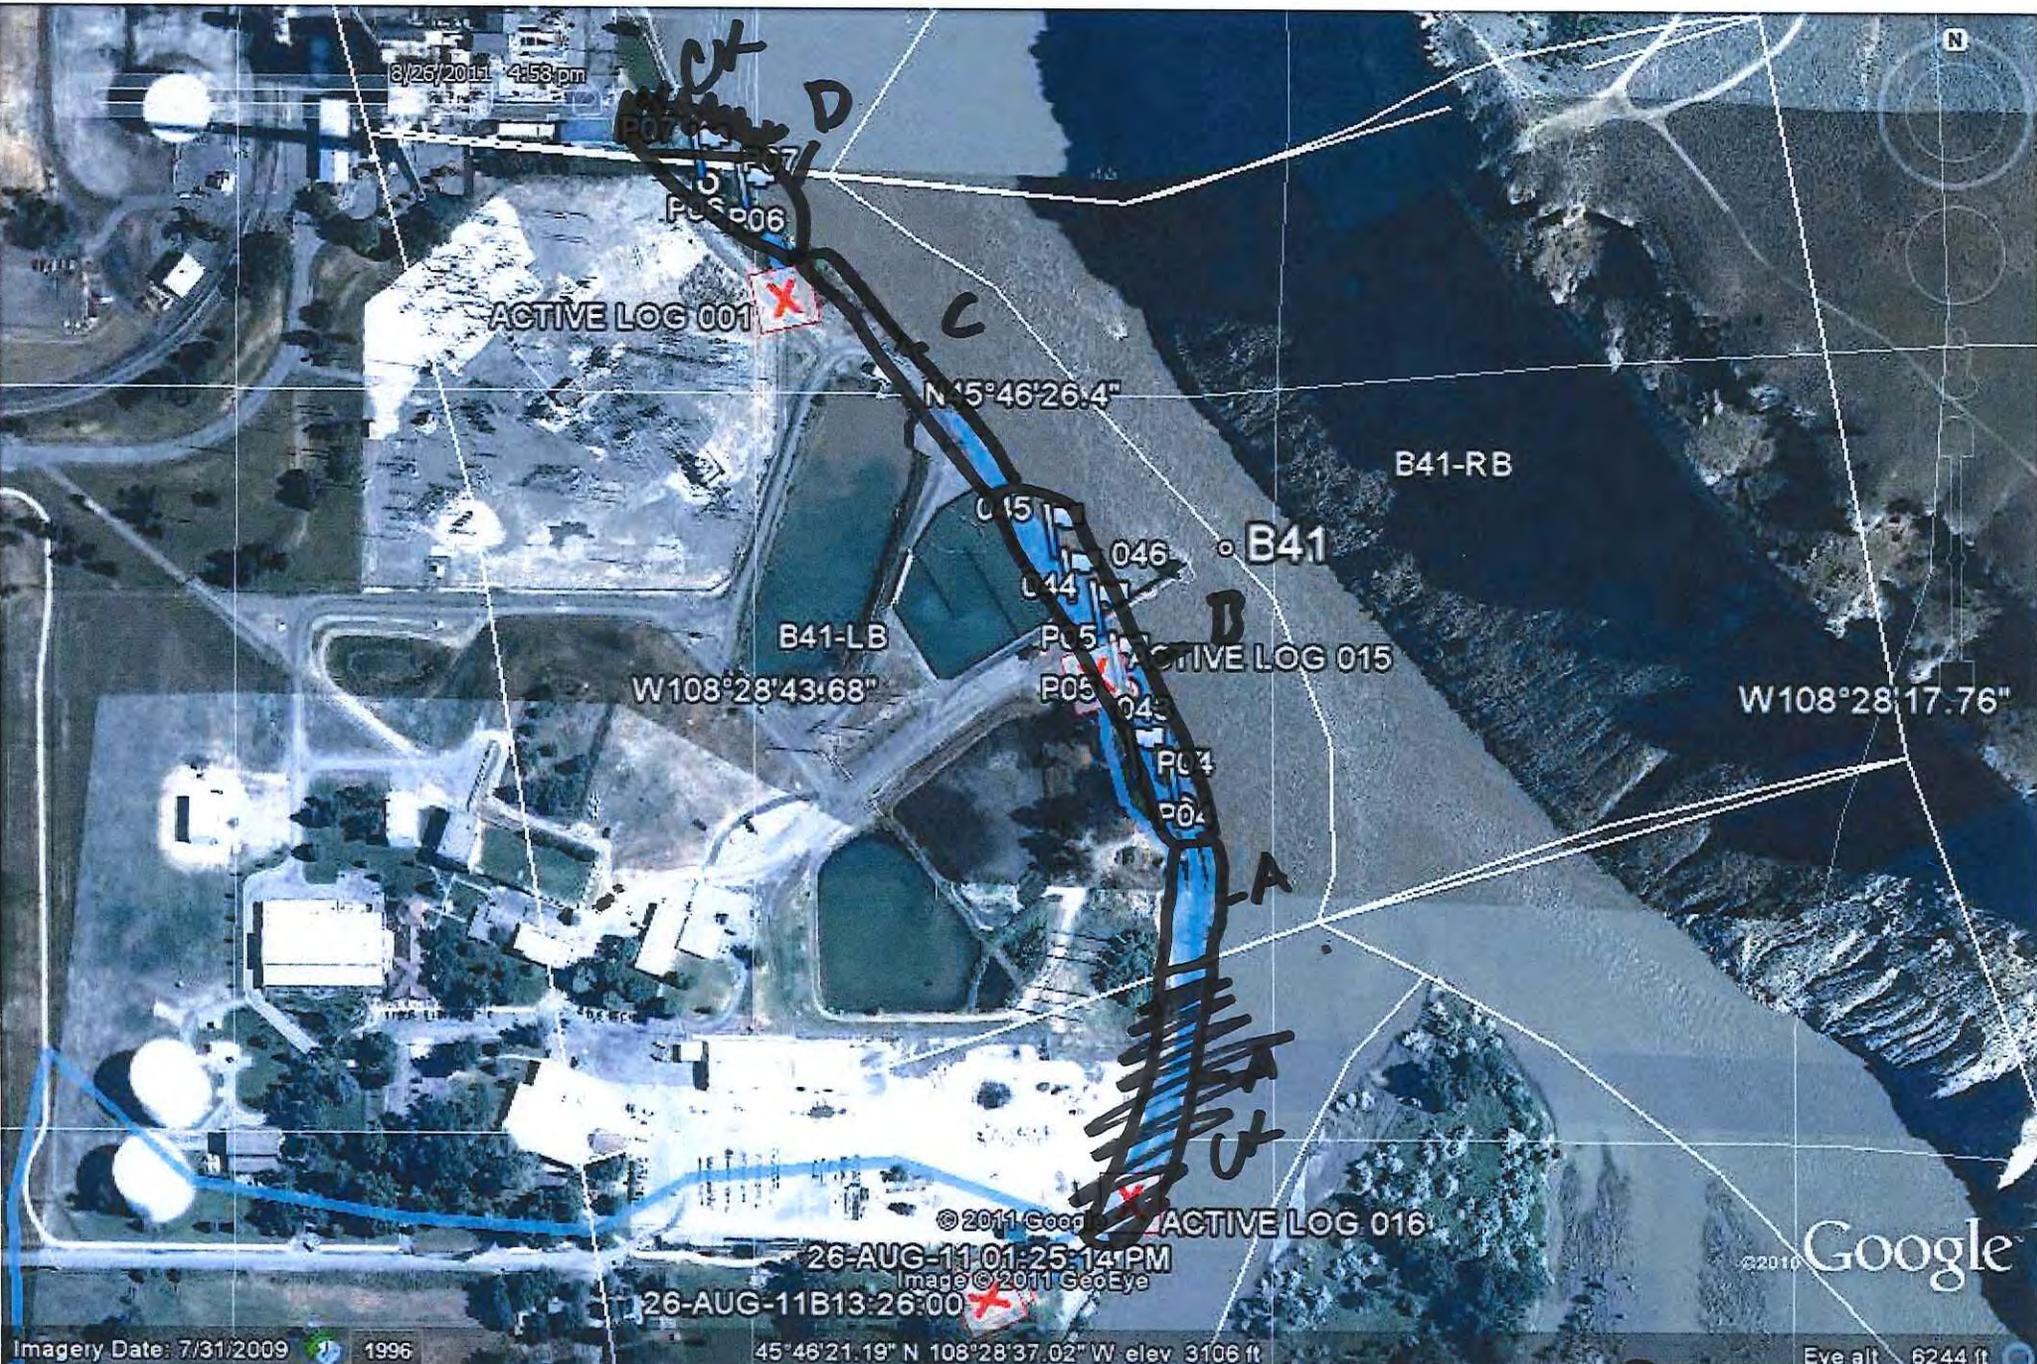
8-26-11 B41C B41-LB

Zone A+C No oil ~~observed~~ Observed
