**SCAT Area Transition Report  
for C19**

Silvertip Pipeline Incident  
Laurel, Montana

October 19, 2011

Prepared by:  
ARCADIS G&M of North Carolina, Inc.  
11000 Regency Parkway  
West Tower, Suite 205  
Cary, North Carolina 27518-8518  
Tel 919.469.1952  
Fax 919.469.5676

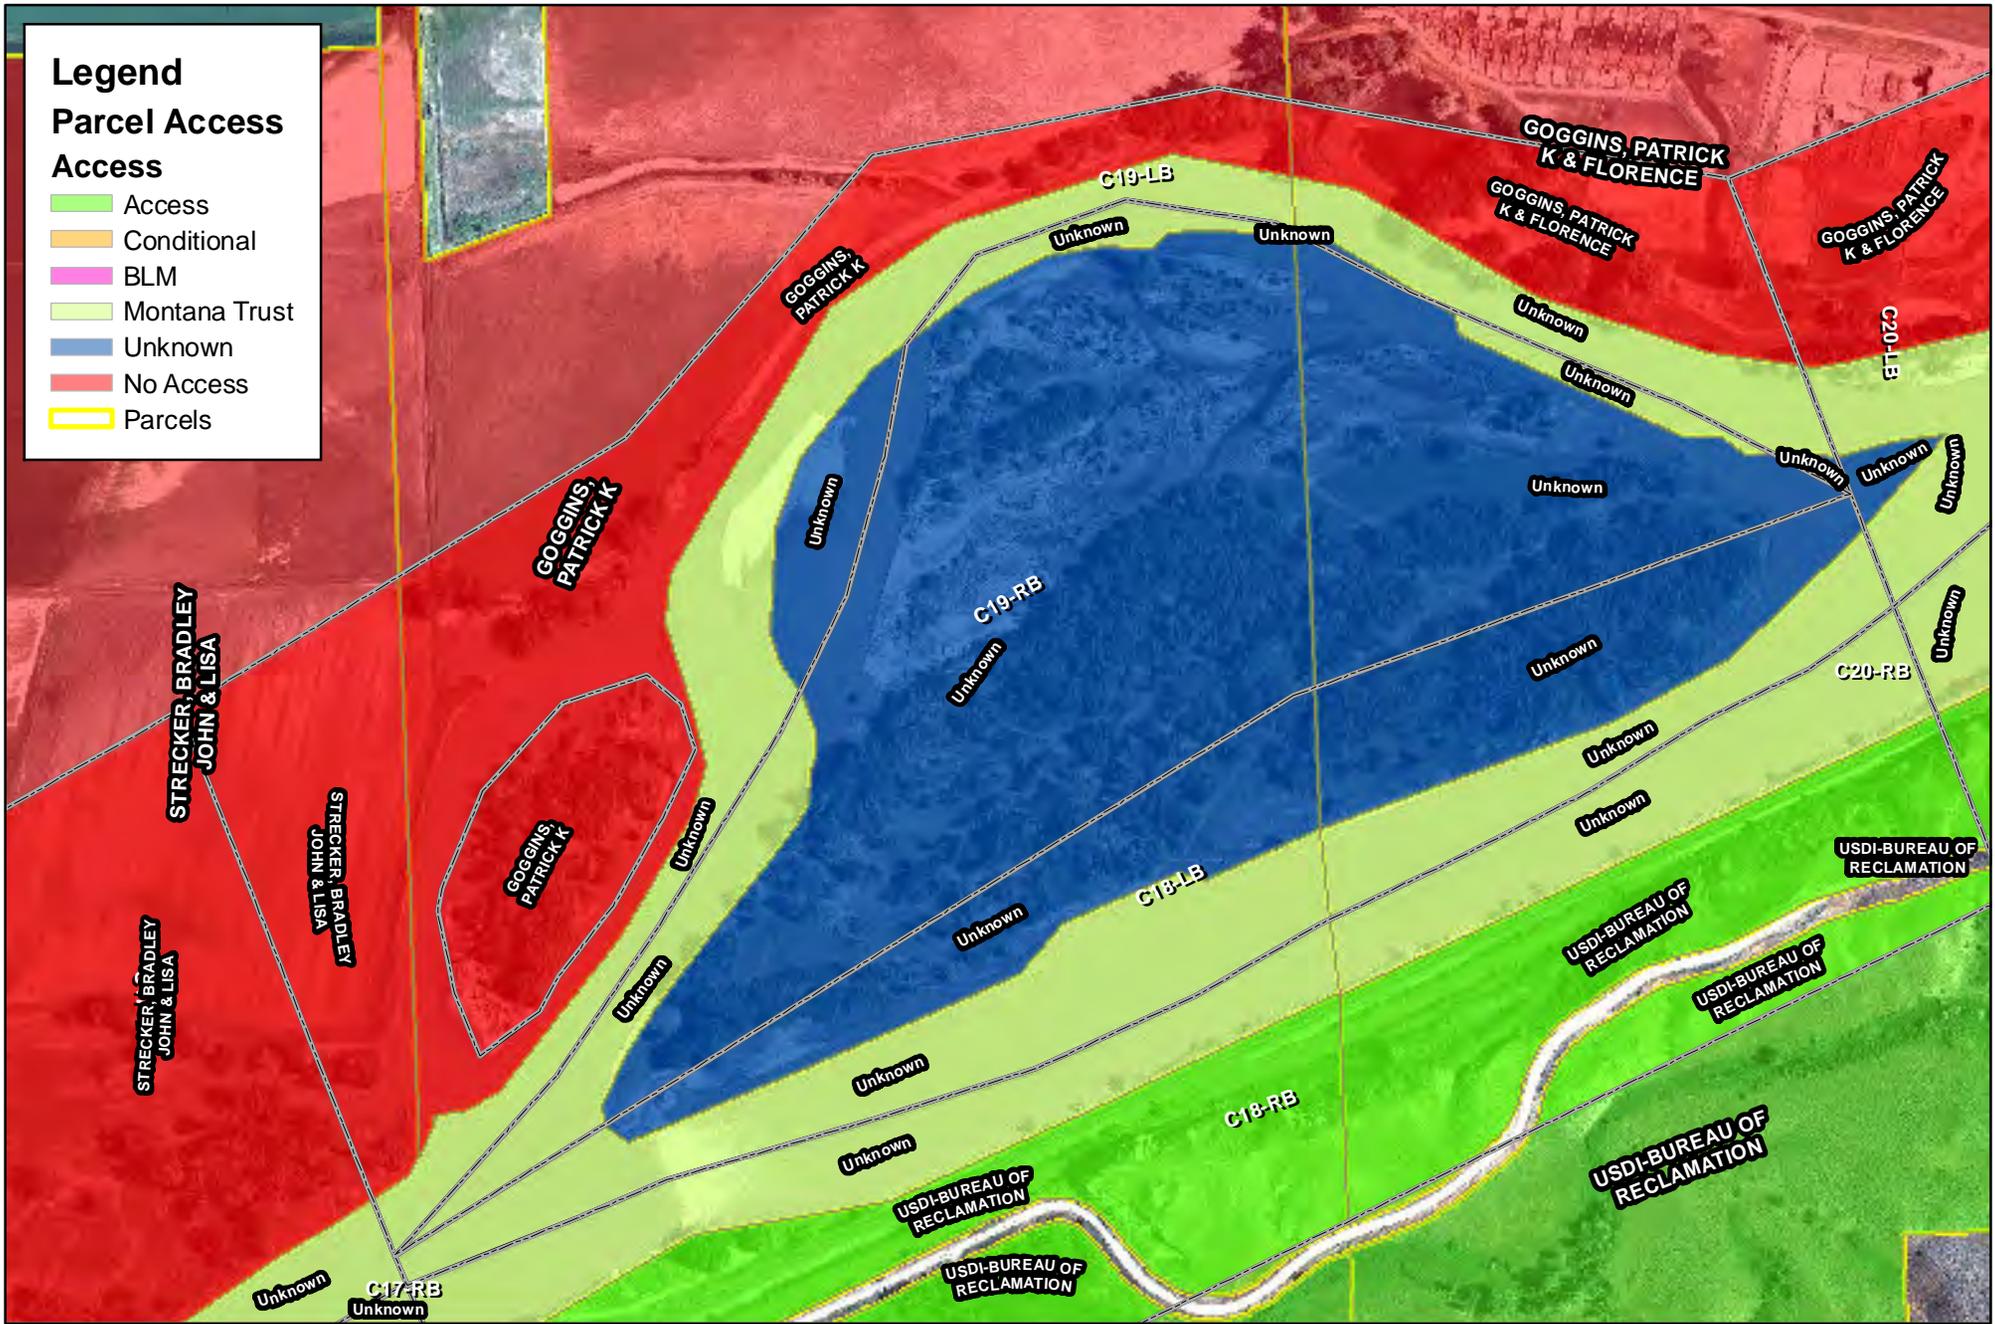
Figure 1 provides an aerial map of SCAT Area C19, along with the (a) SCAT Area boundary, (b) parcel boundaries and respective property owners, and (c) access constraints identified during the oil cleanup process. The acreage surveyed in Area C19 is 55.0. There was an access issue for the left bank but access was granted for SCAT, operations, and SCAT reassessments at scheduled times.

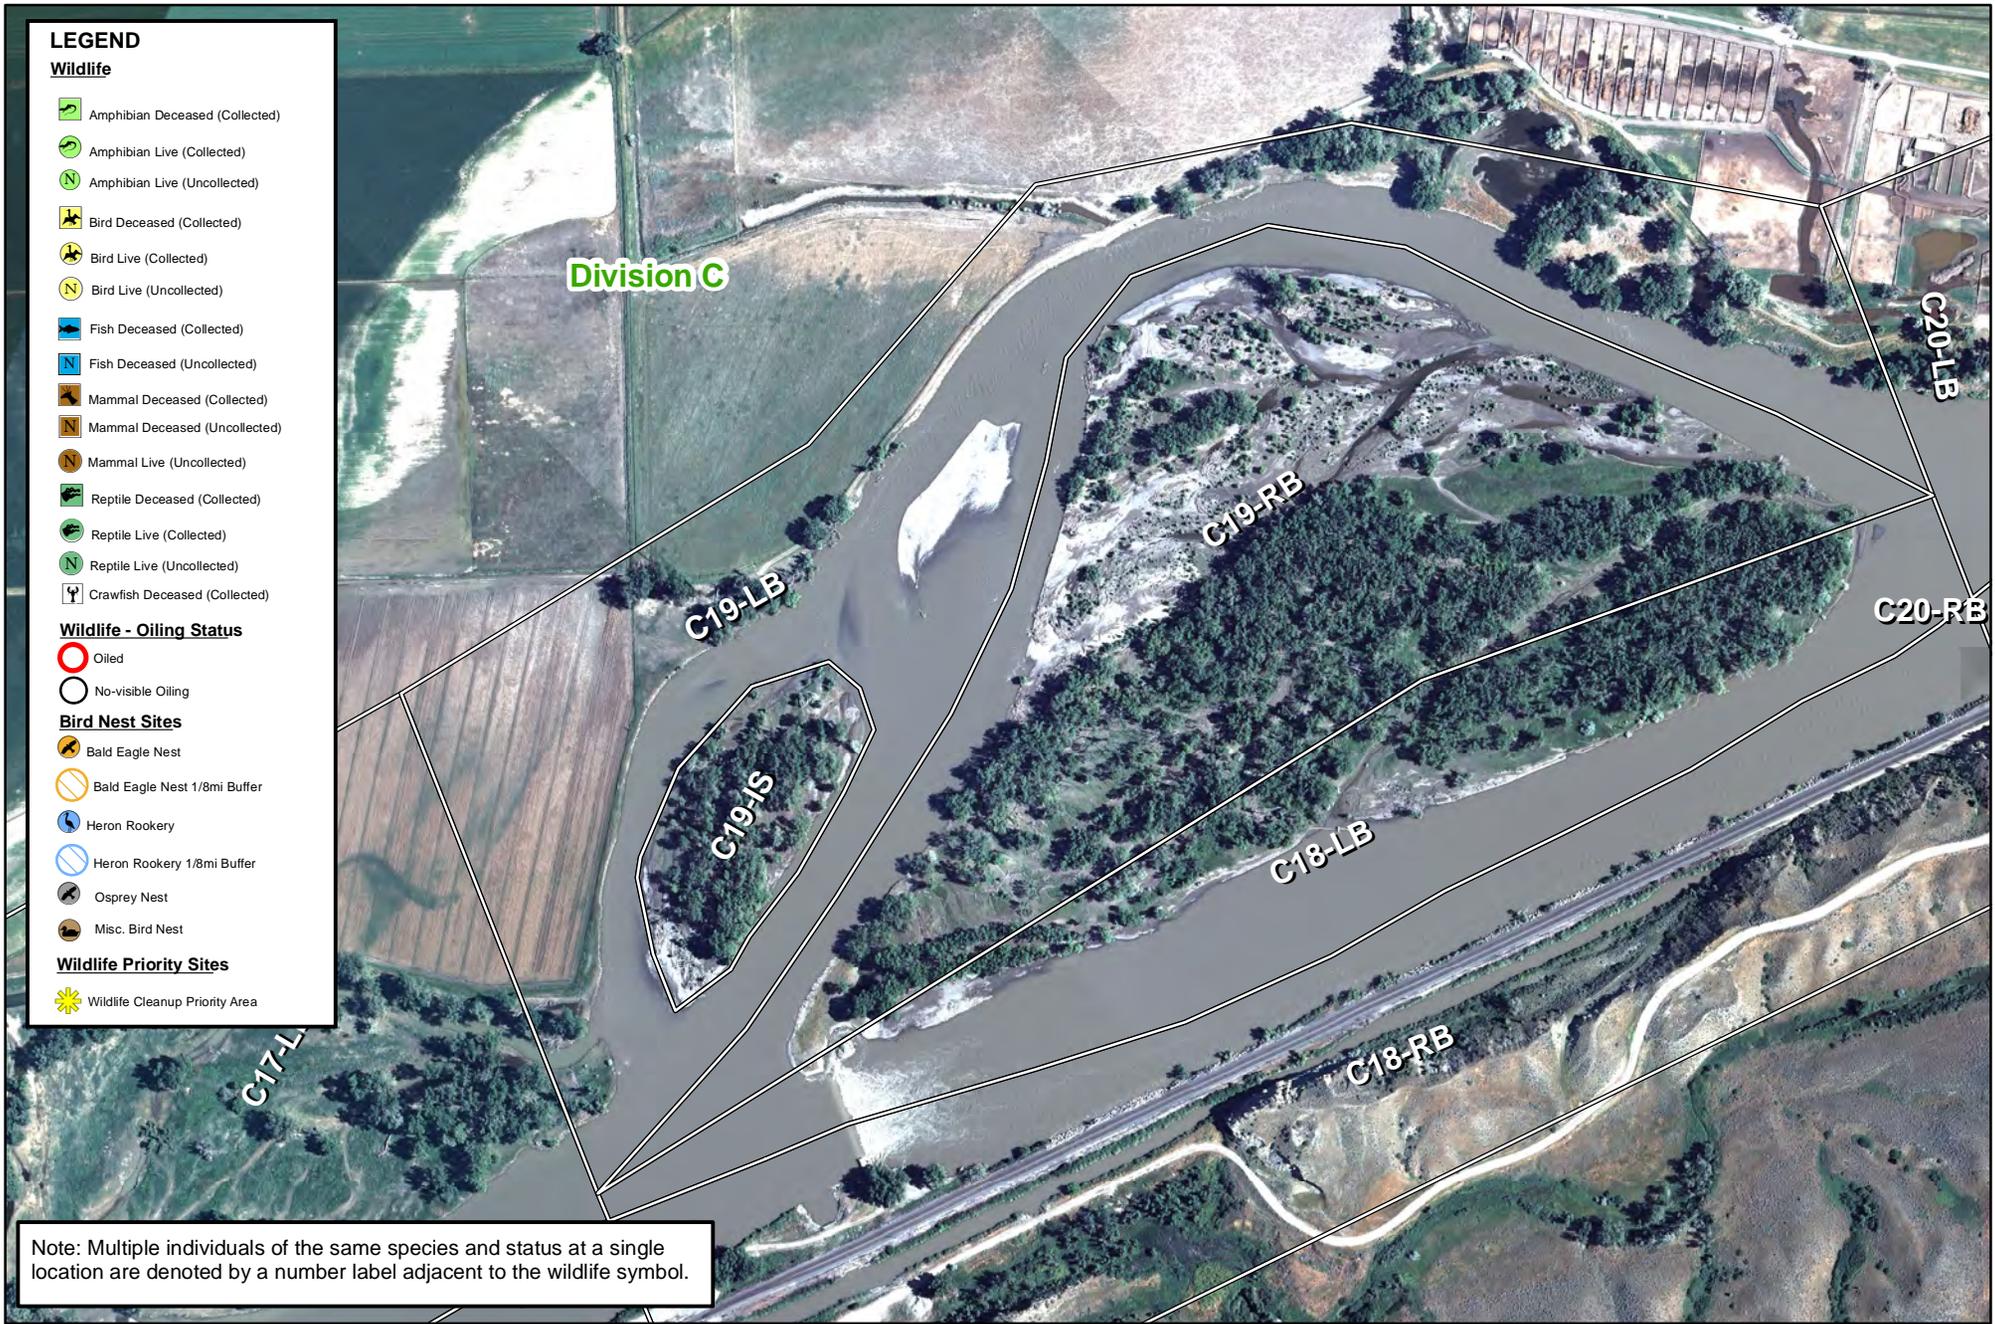
**Figure 2**  
**Wildlife Resources**

Figure 2 summarizes the natural resources identified in this segment. International Bird Rescue and Resource Advisors from U.S. Fish and Wildlife Service conducted limited inspections of Area C19 due to the low level of oiling in Division C. No oiled wildlife was observed or recovered. No Wildlife Priority Cleanup Areas were identified. No active migratory bird nests were identified in Area C19.

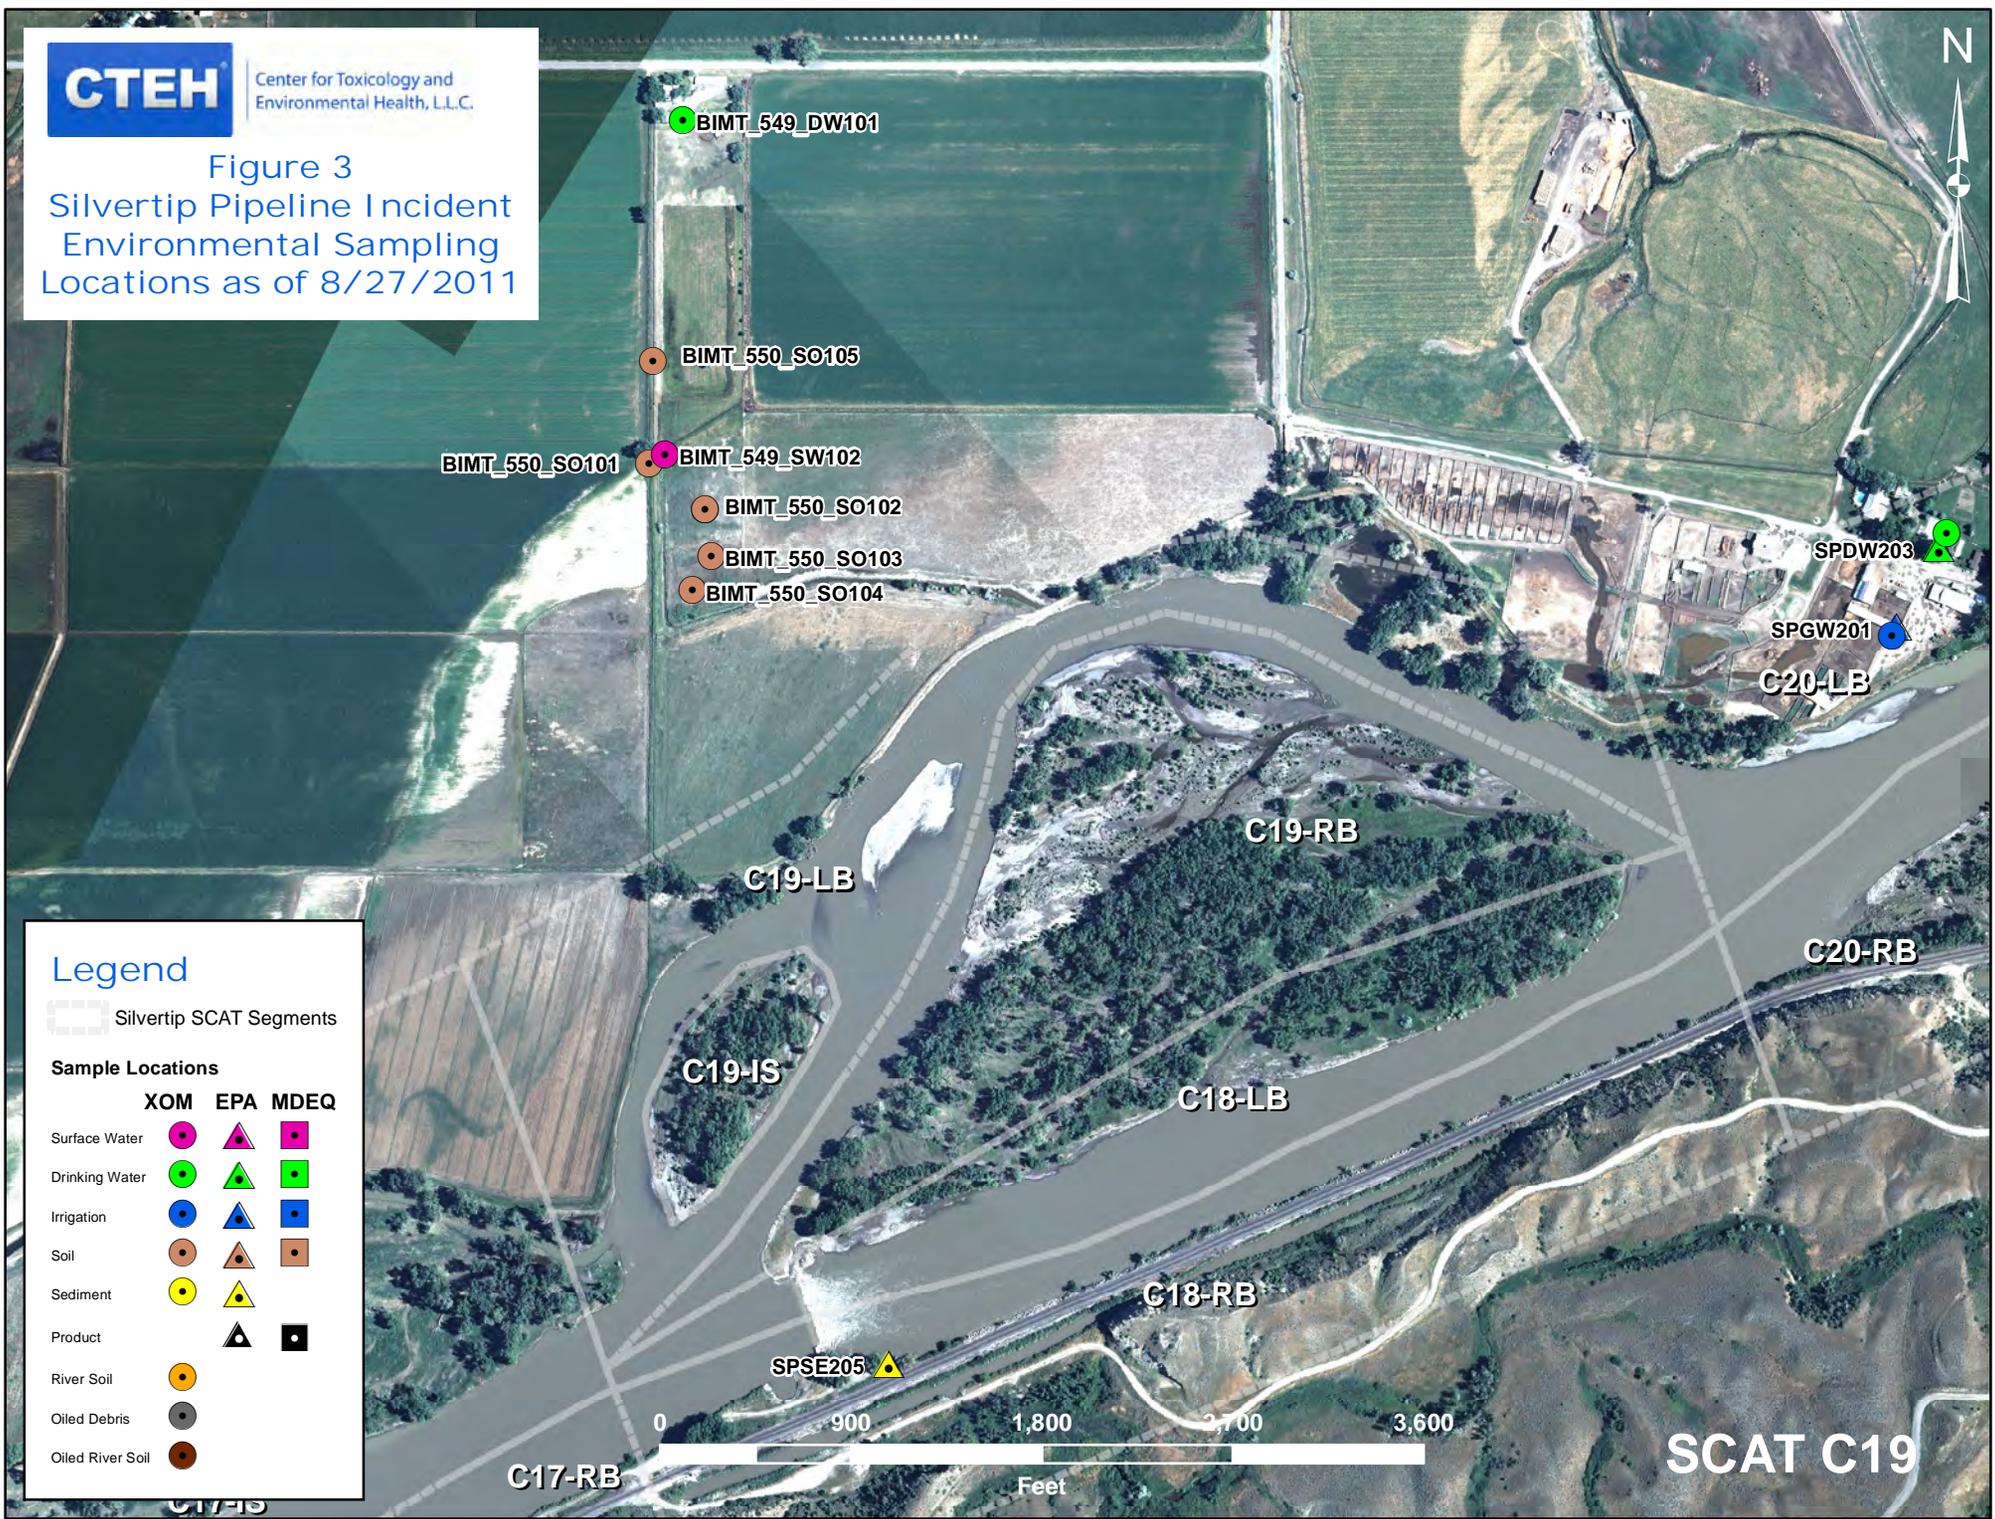
Figure 3  
Silvertip Pipeline Incident  
Environmental Sampling  
Locations as of 8/27/2011

Table 1 (below) summarizes samples collected within Area C19. The analytical results for the samples collected can be accessed through a publicly accessible database on the United States Environmental Protection Agency's (USEPA's) website. The approximate locations of samples collected within Area C19 are provided on Figure 3.

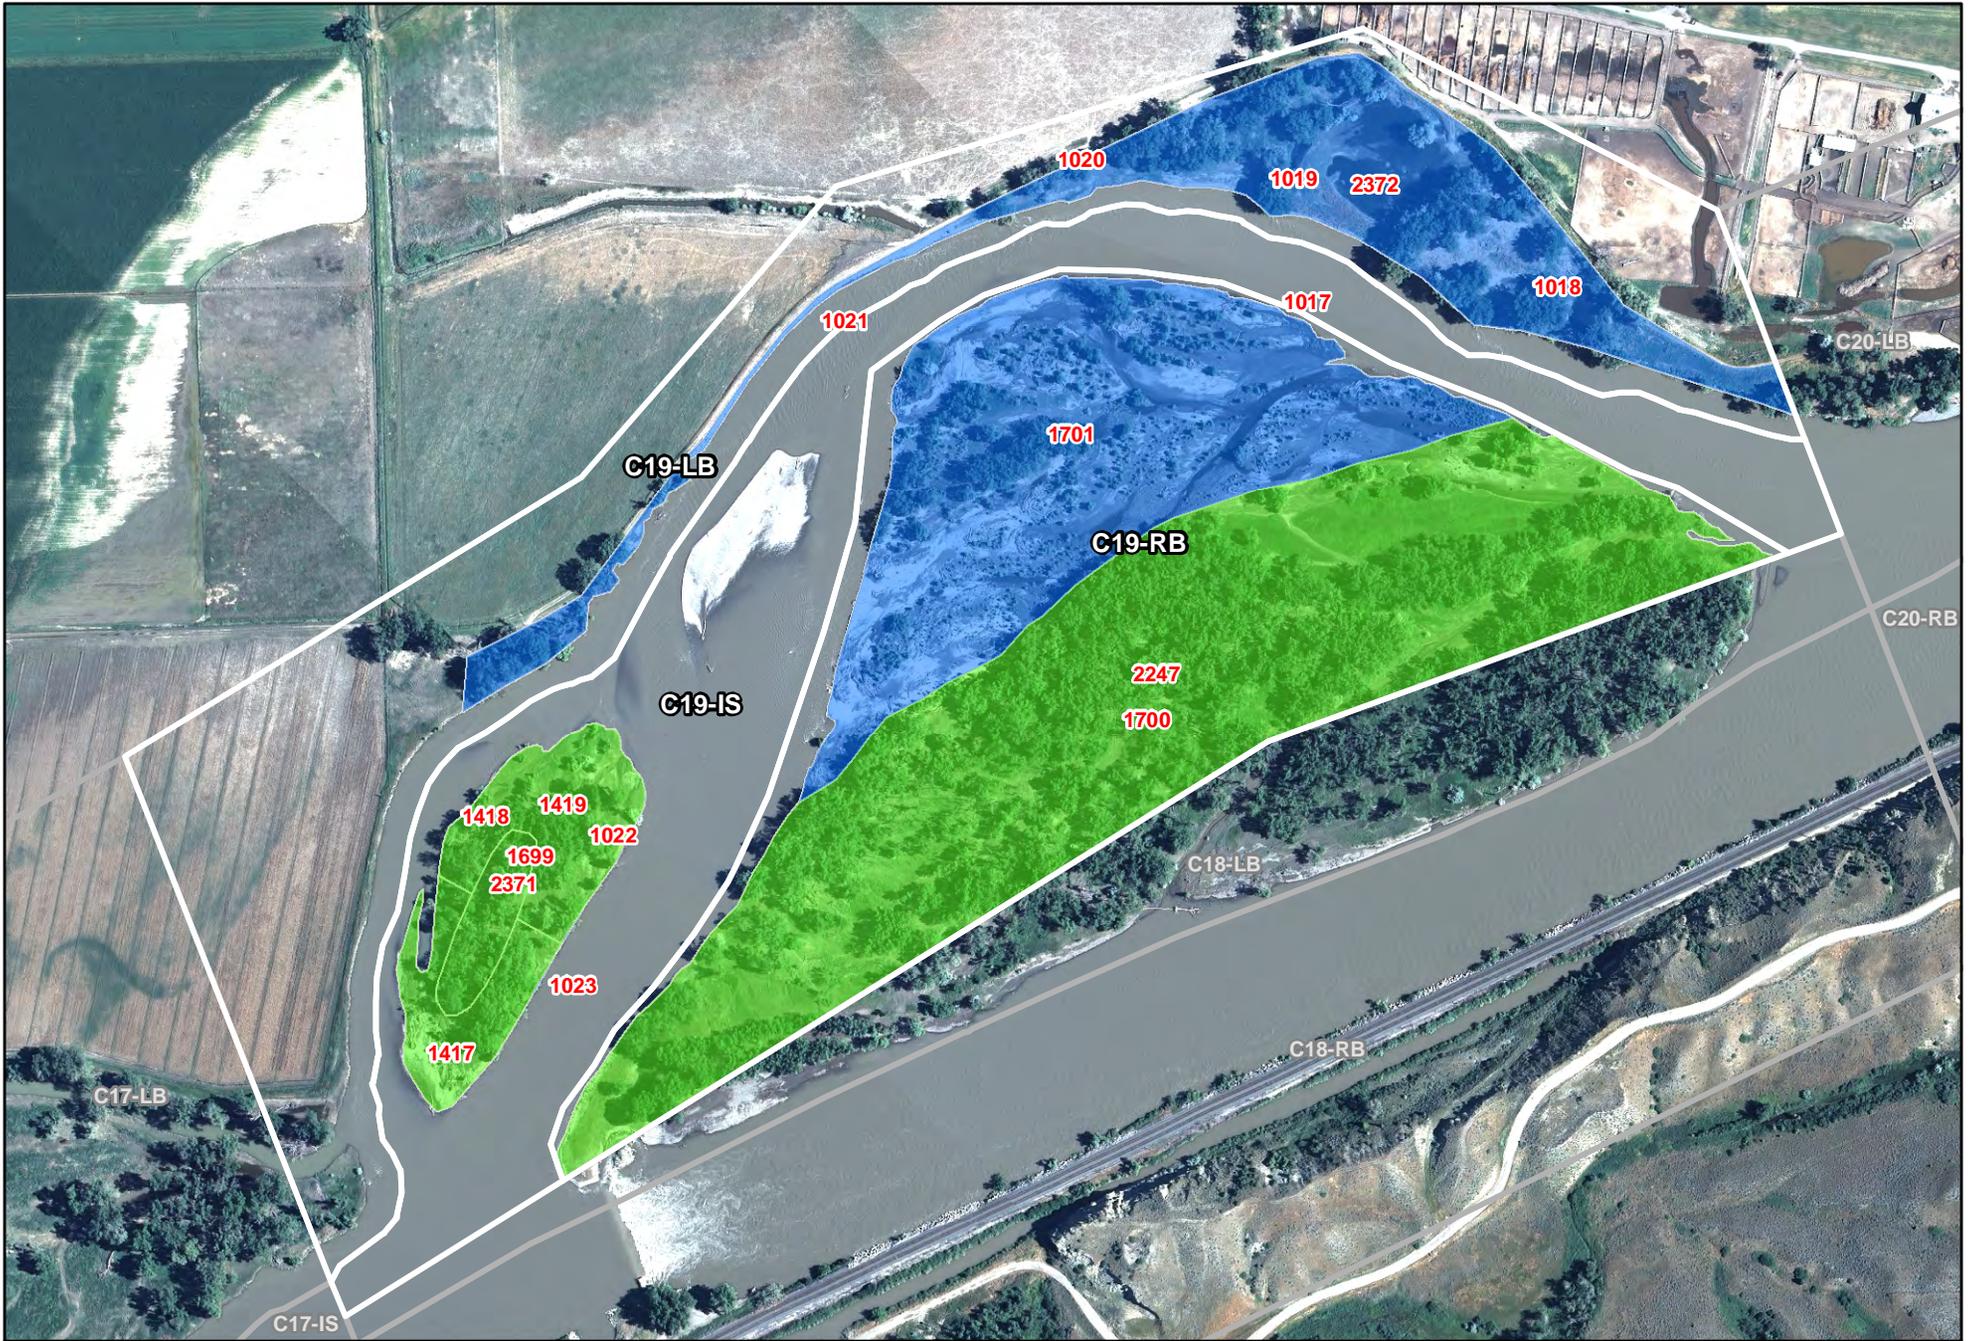
**Figure 4 - Maximum SCAT Observations For SCAT Area:**

The SCAT teams used systematic evaluation criteria and treatment method tables approved by the National Oceanic and Atmospheric Administration to provide a standard approach for data collection and conducting field surveys. The forms and sketches from the initial SCAT surveys performed along the river bank (water edge) and floodplain within Area C19 are included in Appendix B. Figure 4 provides the maximum oiling zones observed by the SCAT team during the initial surveys of Area C19.

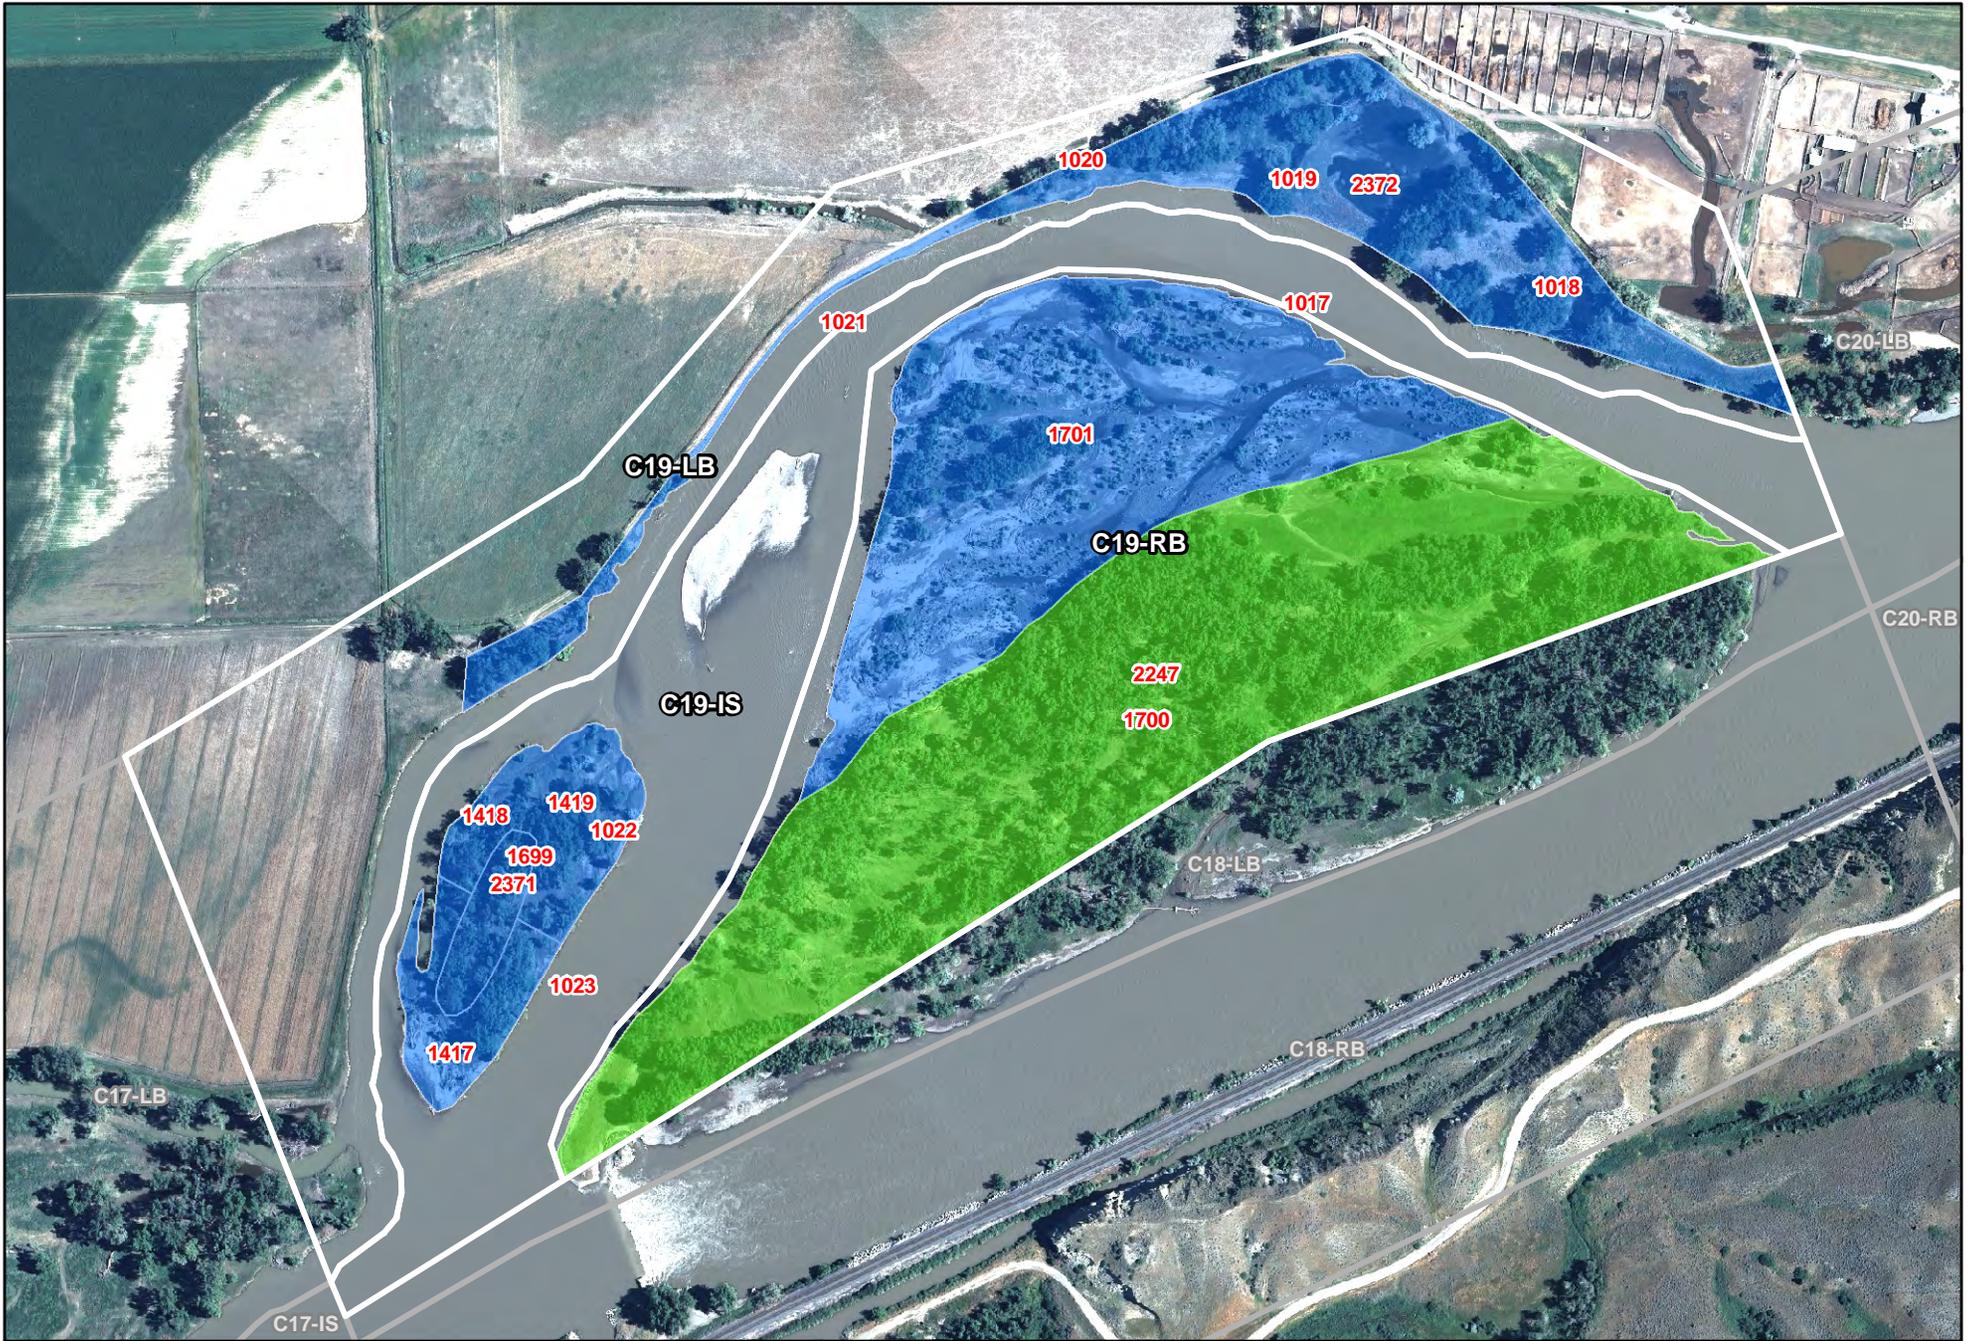
**Figure 5 - Final SCAT Observations  
For SCAT Area:**

Figure 5 shows the oiling conditions within Area C19 following completion of oil removal activities. The SCAT team performed final surveys of the island, left bank, and right bank within SCAT Area C19 to confirm the agreed-upon cleanup endpoints identified in the applicable CTRs had been achieved. The final SCAT survey documentation is presented in Appendix E.

Based on the final SCAT surveys performed on the island, left bank, and right bank within Area C19, no further treatment is recommended for these segments. SCAT Segment Sign-Off Forms are included as Appendix F.

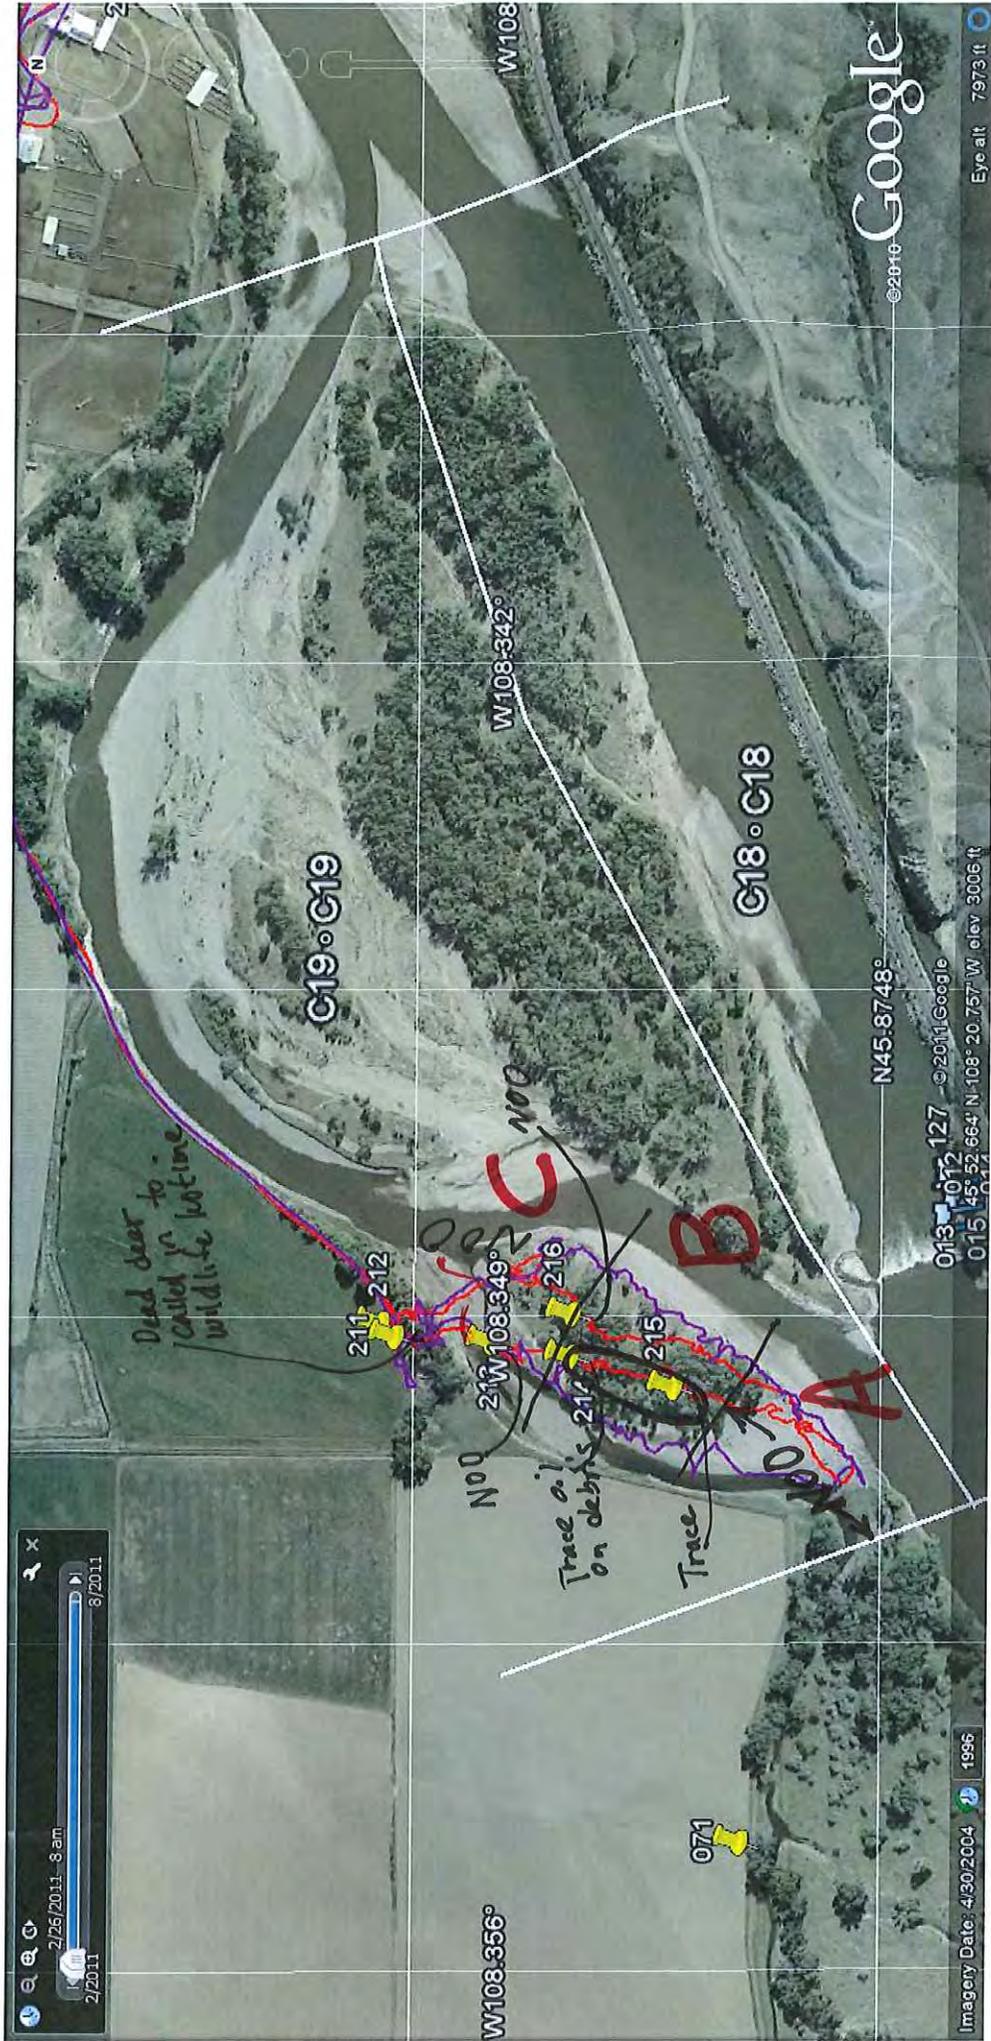
PARTIAL SURVEY  
C-19L

One dead five-point deer was present at the NE end of the surveyed zone.

Trace oiling on debris is transferable and is probably best addressed by using a small crew with UTVs to remove oiled debris.

A = N00 - 150m  
B = Vary length - 140m  
C = N00 - 160m.

450m Surveyed.

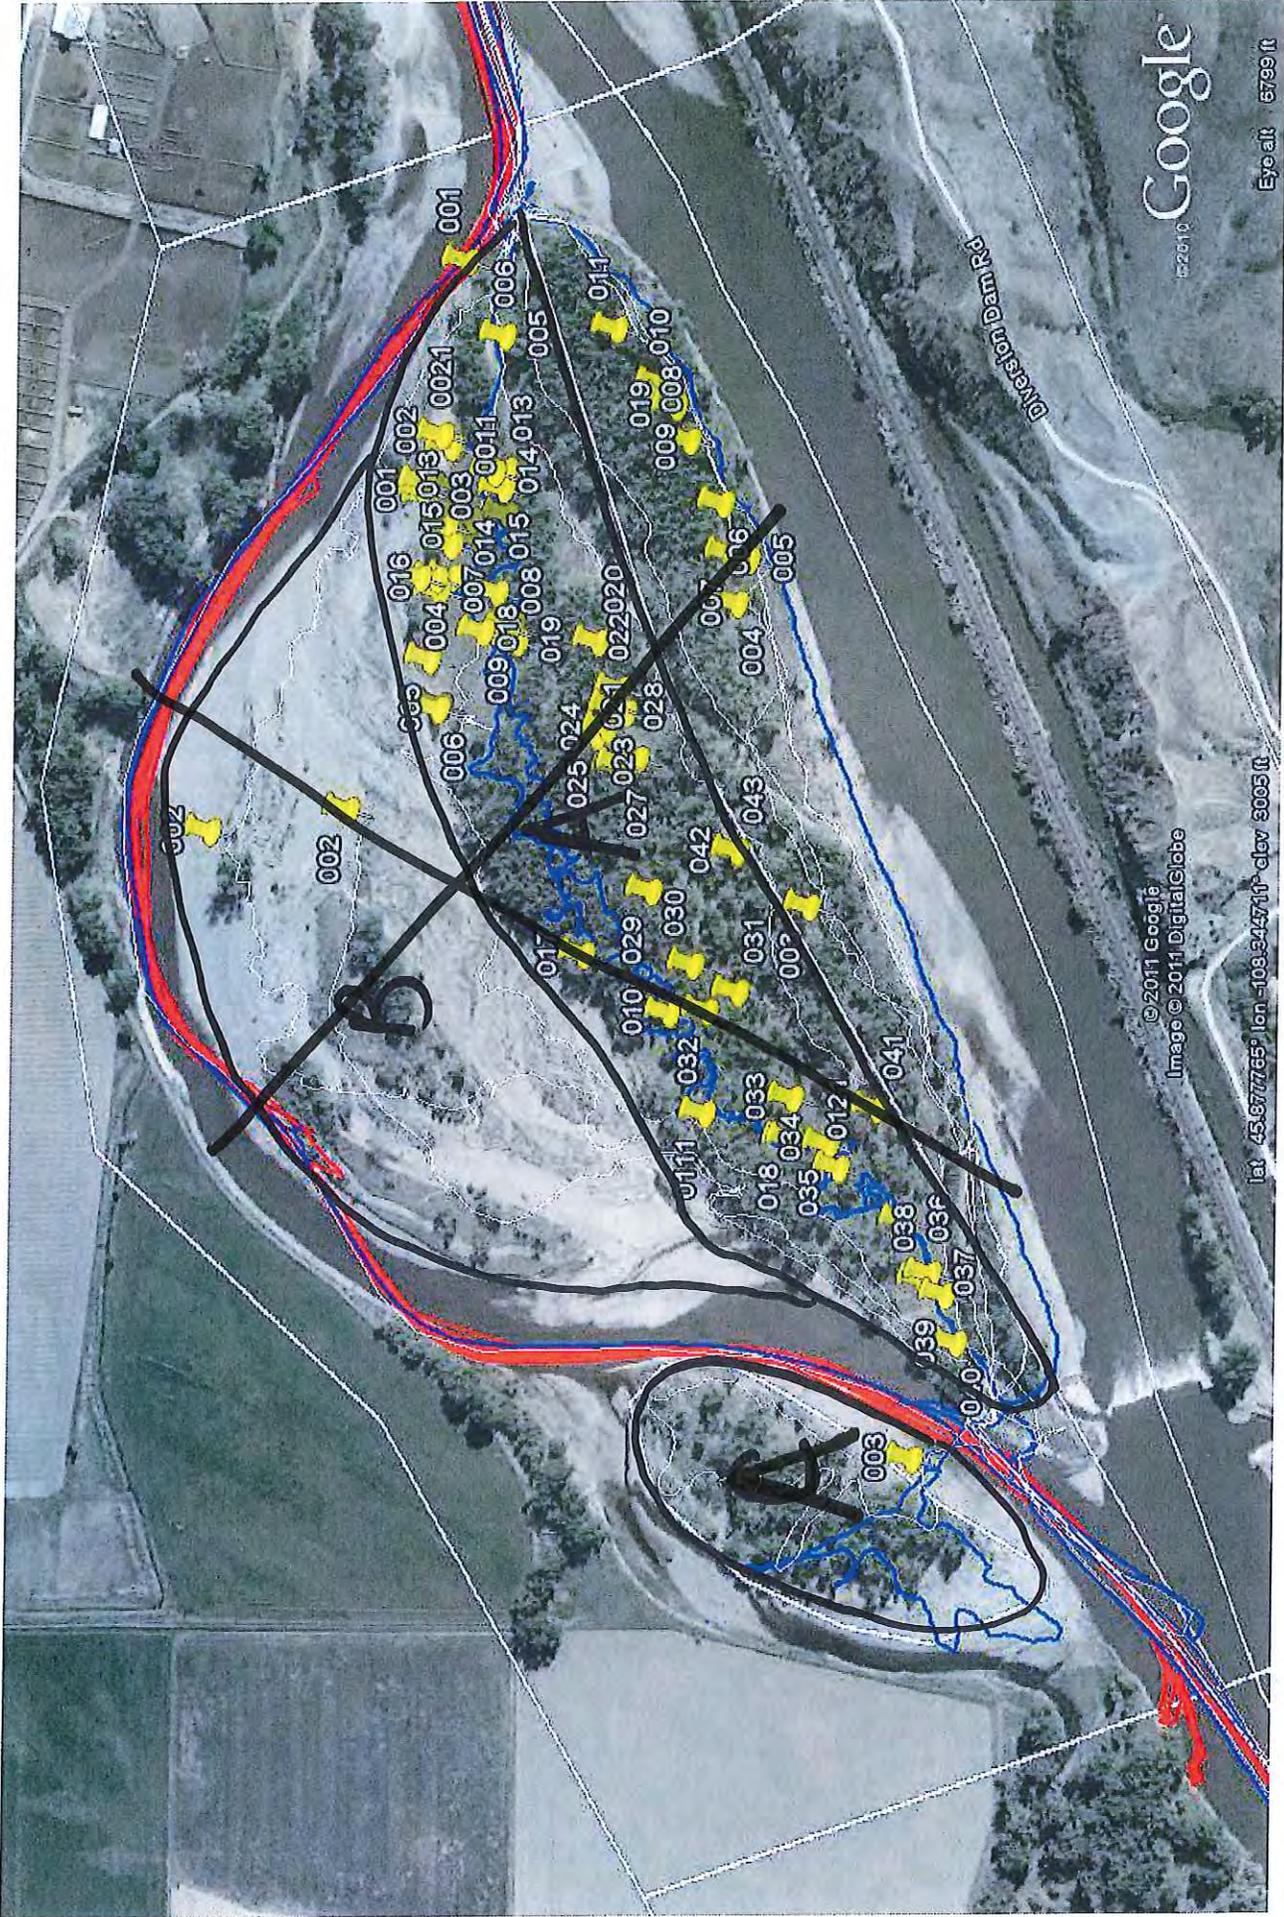
C19T  
TEAM 3+1  
19/08/11

Zone A. sporadic oiling on vegetation and debris, staining, tar coat, not easily transferable. ~~Hot shot crew recommended.~~ ~~approximate 3 bags anticipated to be generated.~~

Zone B. no oiling observed. NFT JB

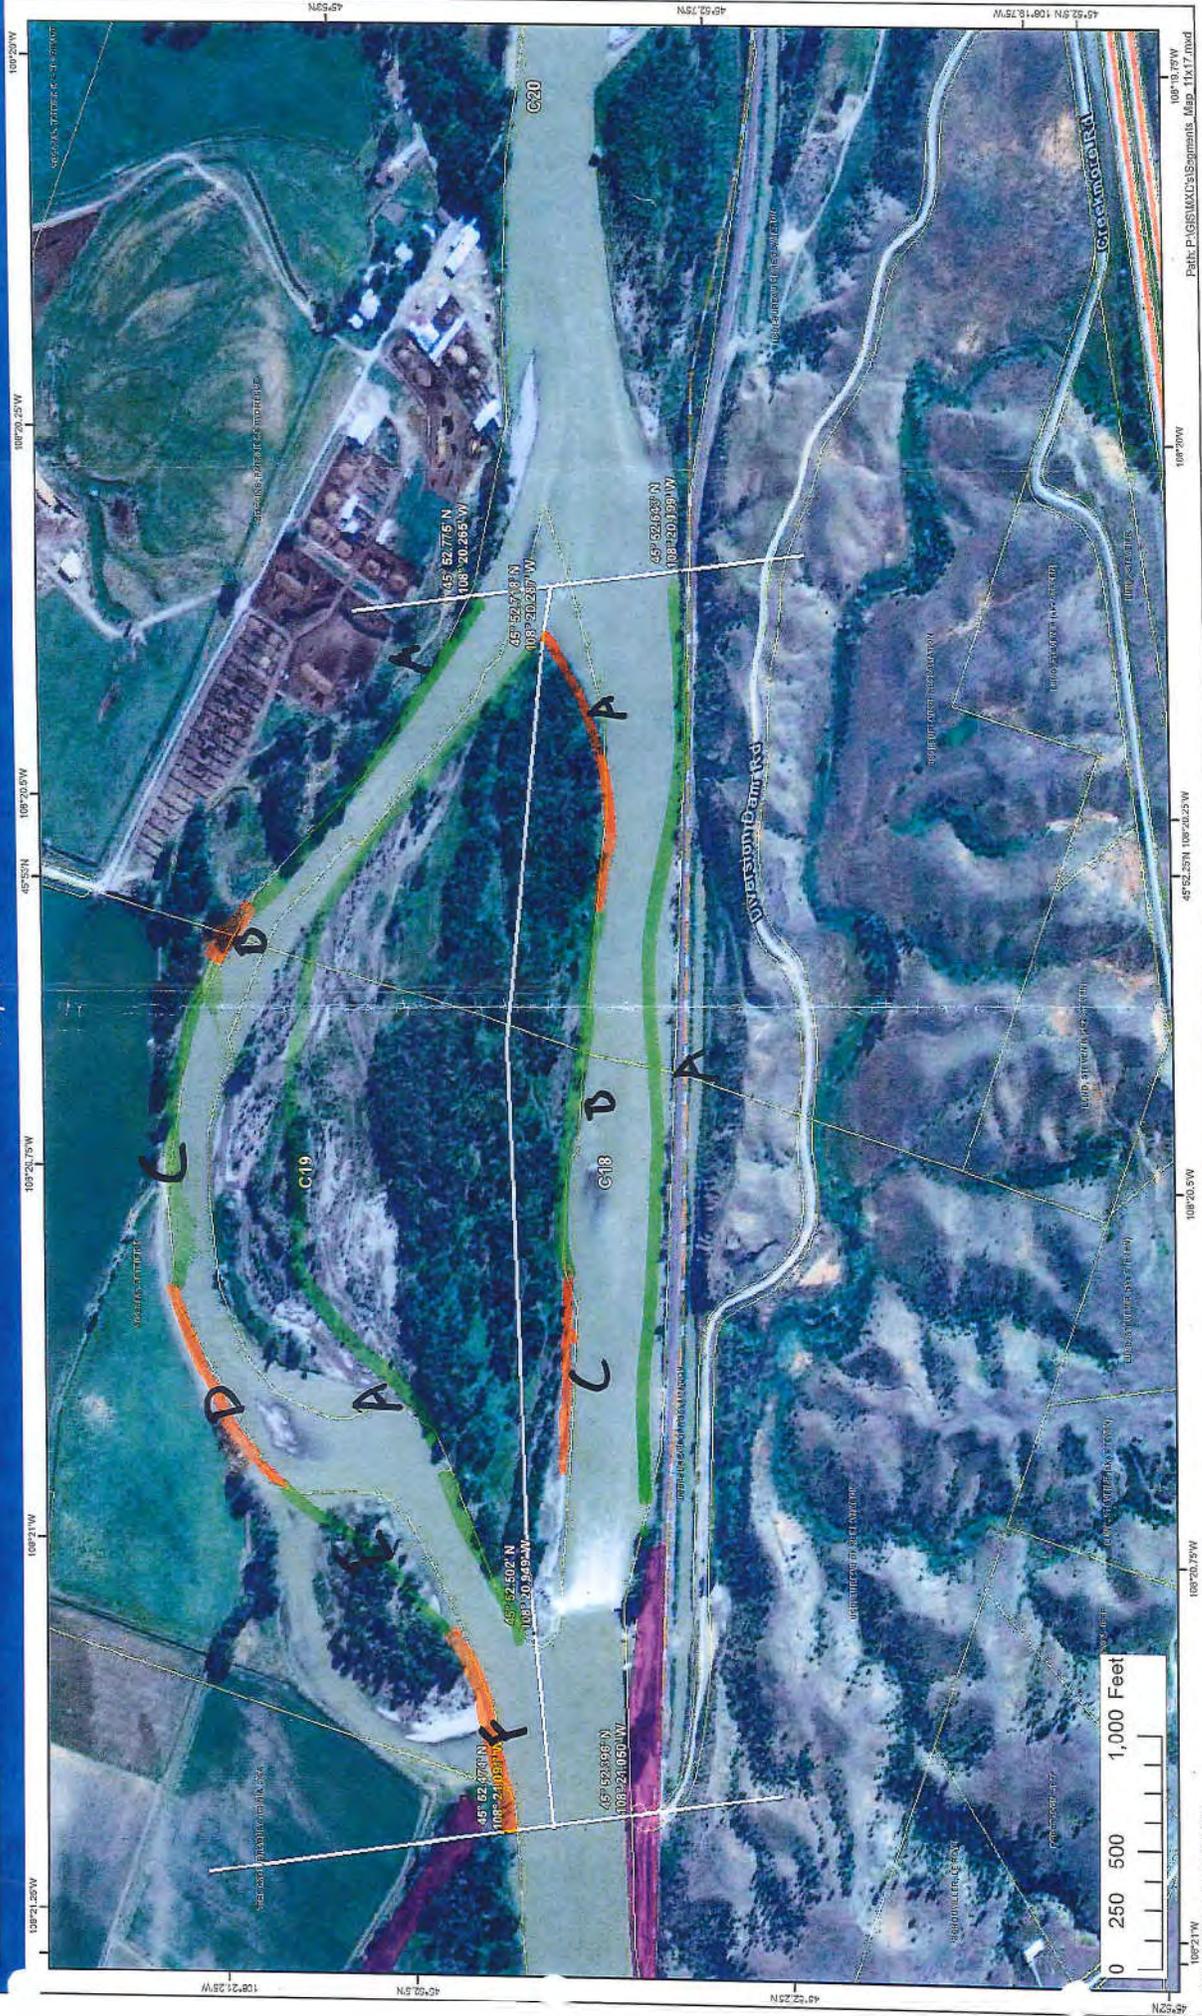
Zone B, D, + F have stained and coated veg (primarily grass)

Veg needs to be cut either treated and removed when applicable
