**SCAT Area Transition Report  
for C19**

Silvertip Pipeline Incident  
Laurel, Montana

October 19, 2011

Prepared by:  
ARCADIS G&M of North Carolina, Inc.  
11000 Regency Parkway  
West Tower, Suite 205  
Cary, North Carolina 27518-8518  
Tel 919.469.1952  
Fax 919.469.5676

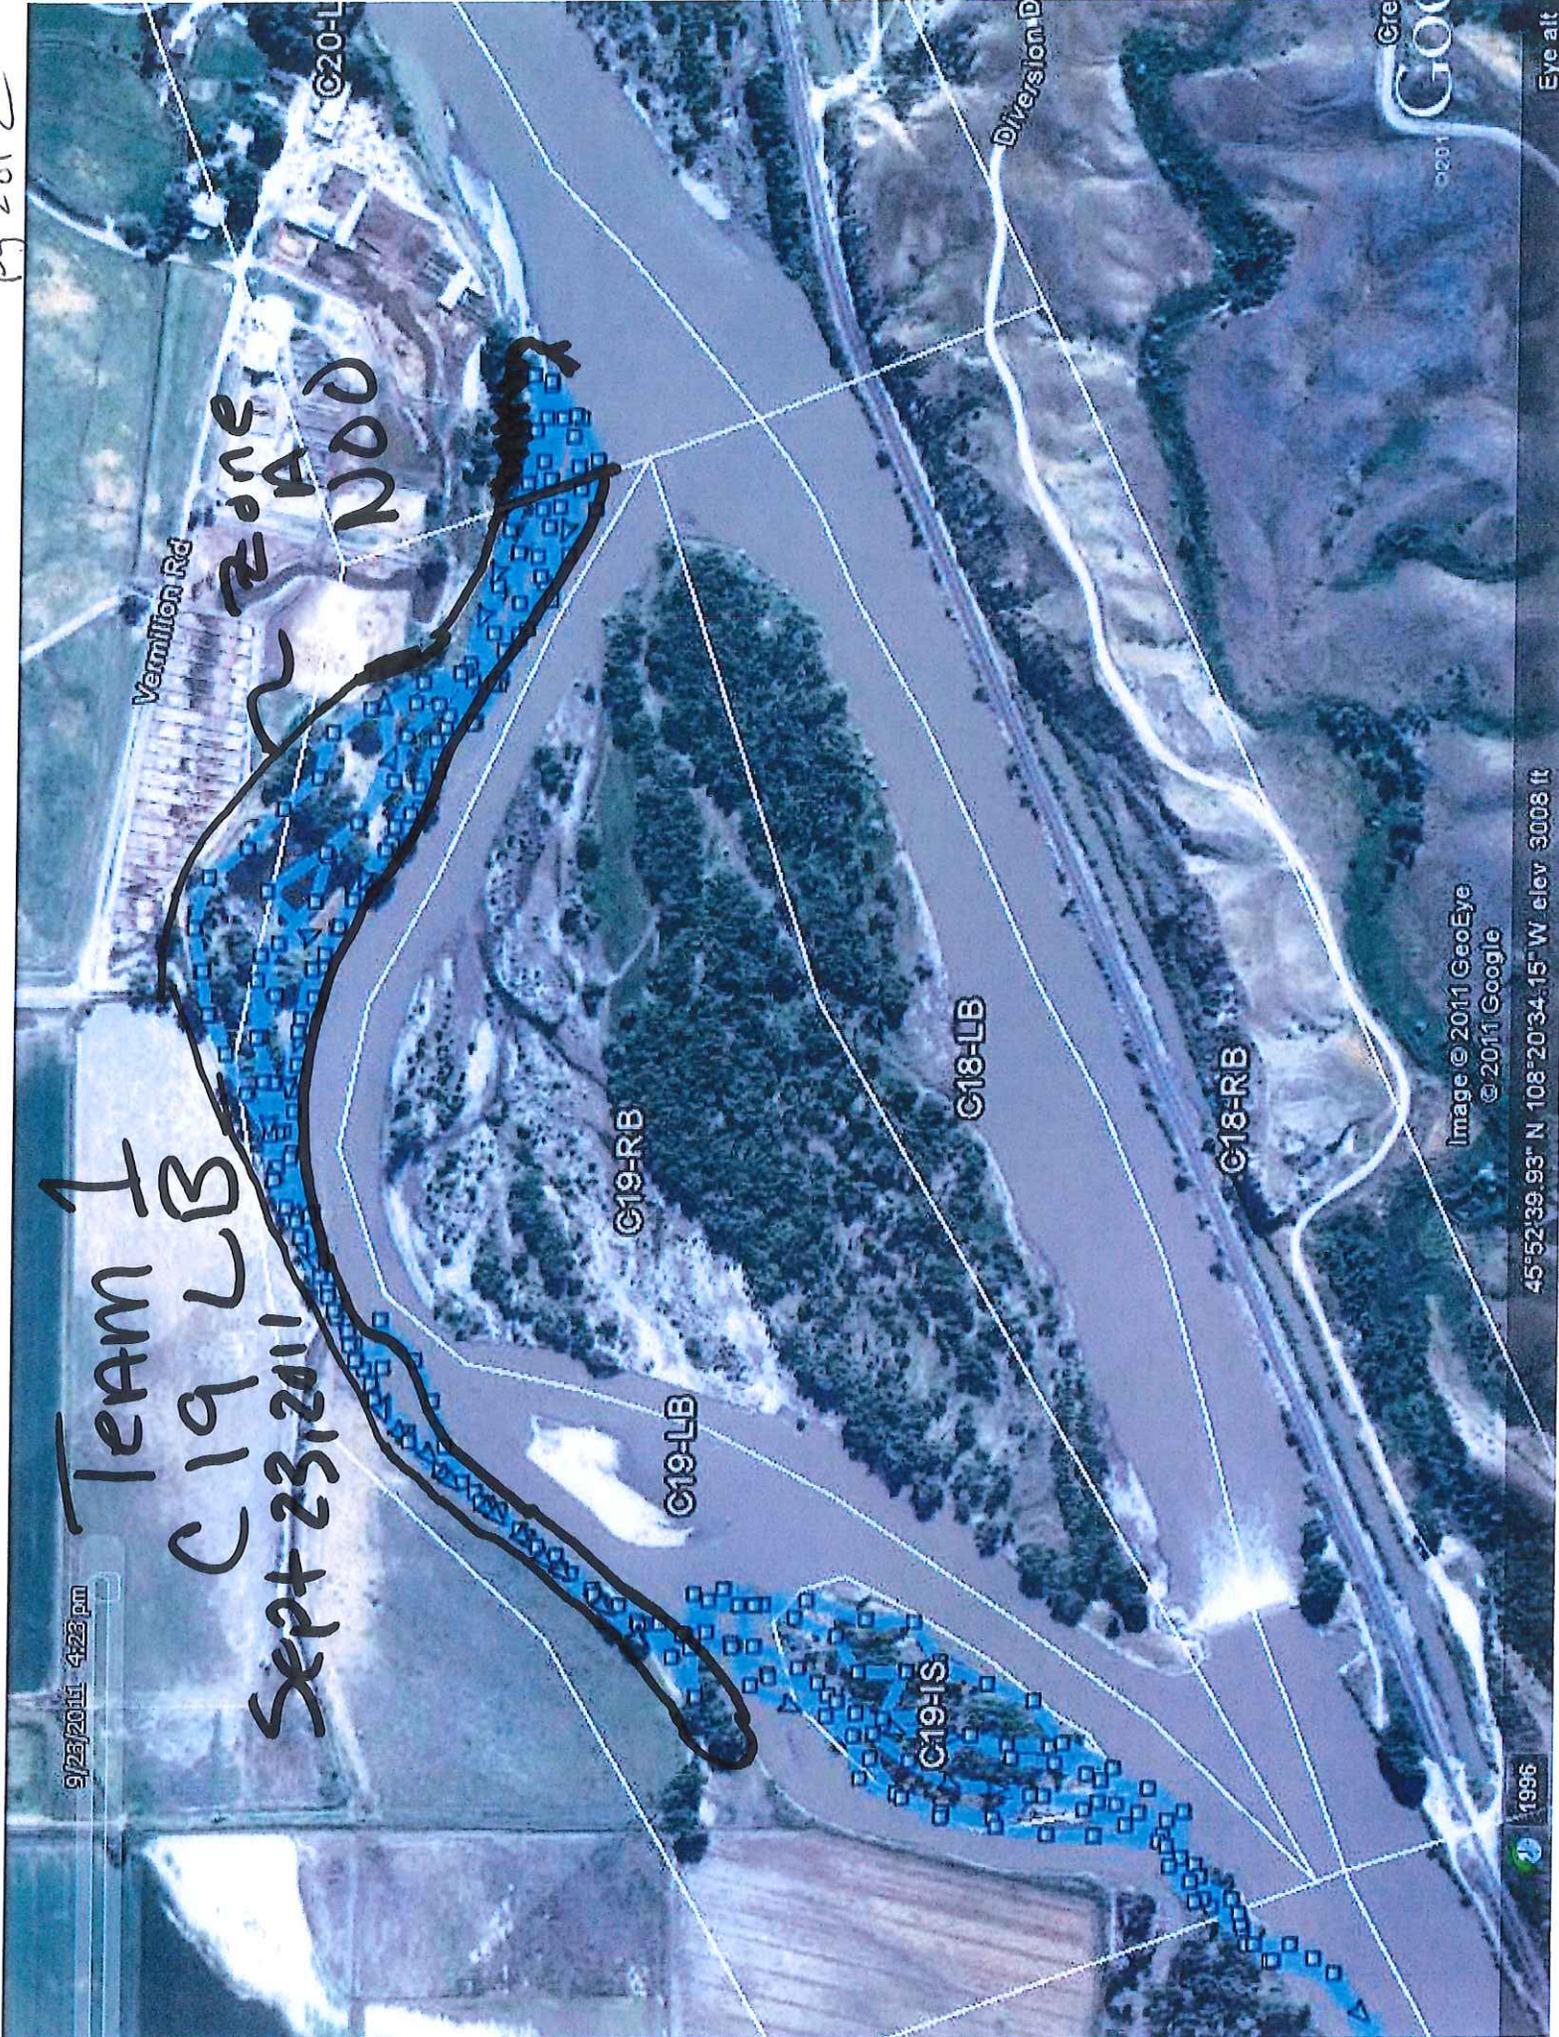
Team 1  
C19 LB  
Sept 23, 2011

zones  
NOD
