**SCAT Area Transition Report for  
C20**

Silvertip Pipeline Incident  
Laurel, Montana

October 25, 2011

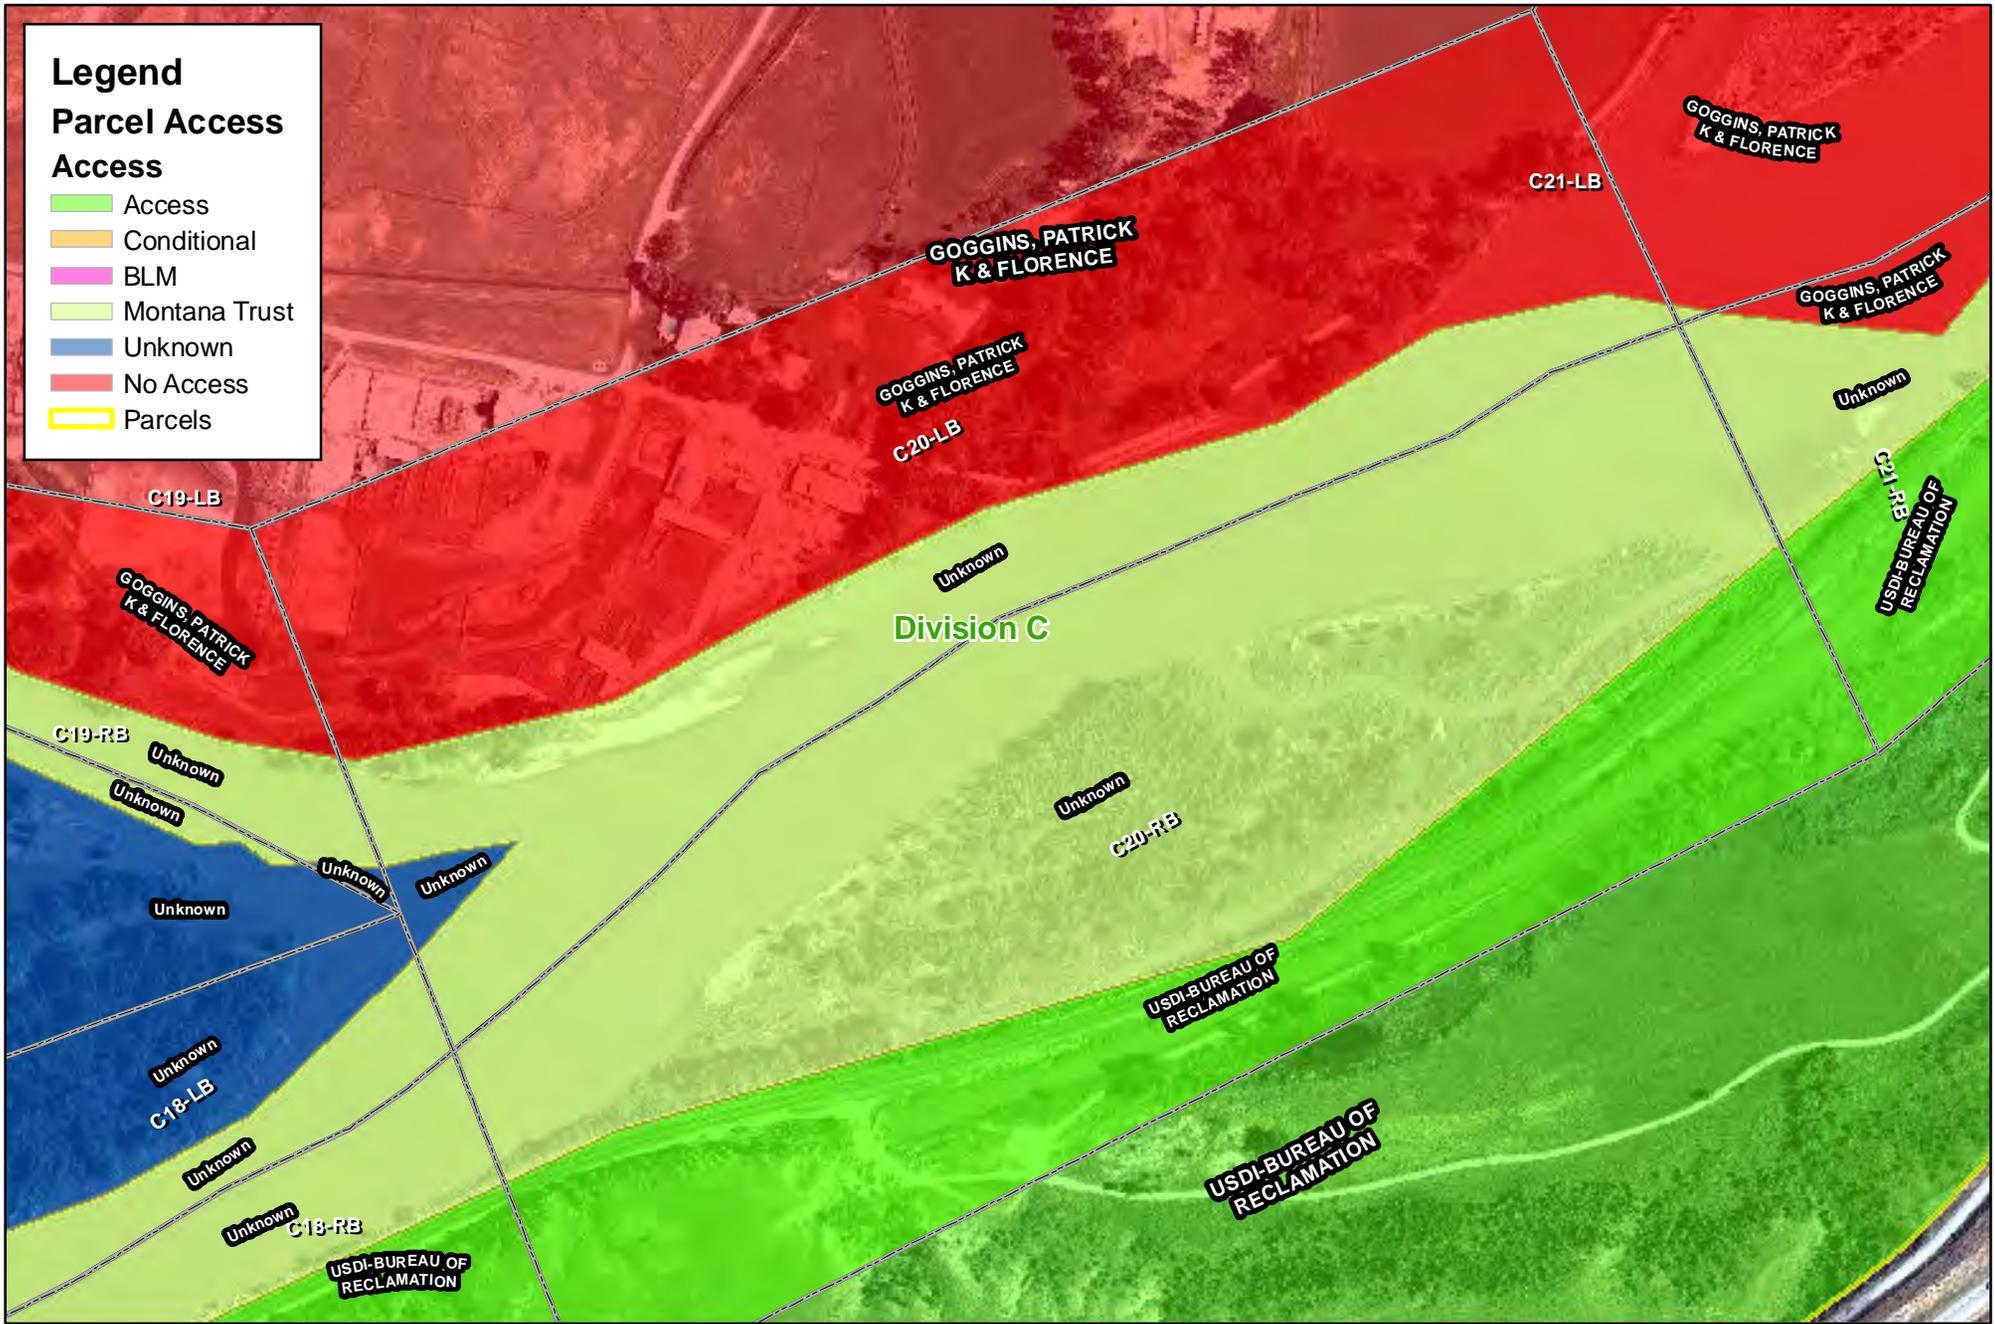
Figure 1 provides an aerial map of SCAT Area C20, along with the (a) SCAT Area boundary, (b) parcel boundaries and respective property owners, and (c) access constraints identified during the oil cleanup process. The acreage surveyed in Area C20 is 33.1. There were access issues for the left bank.

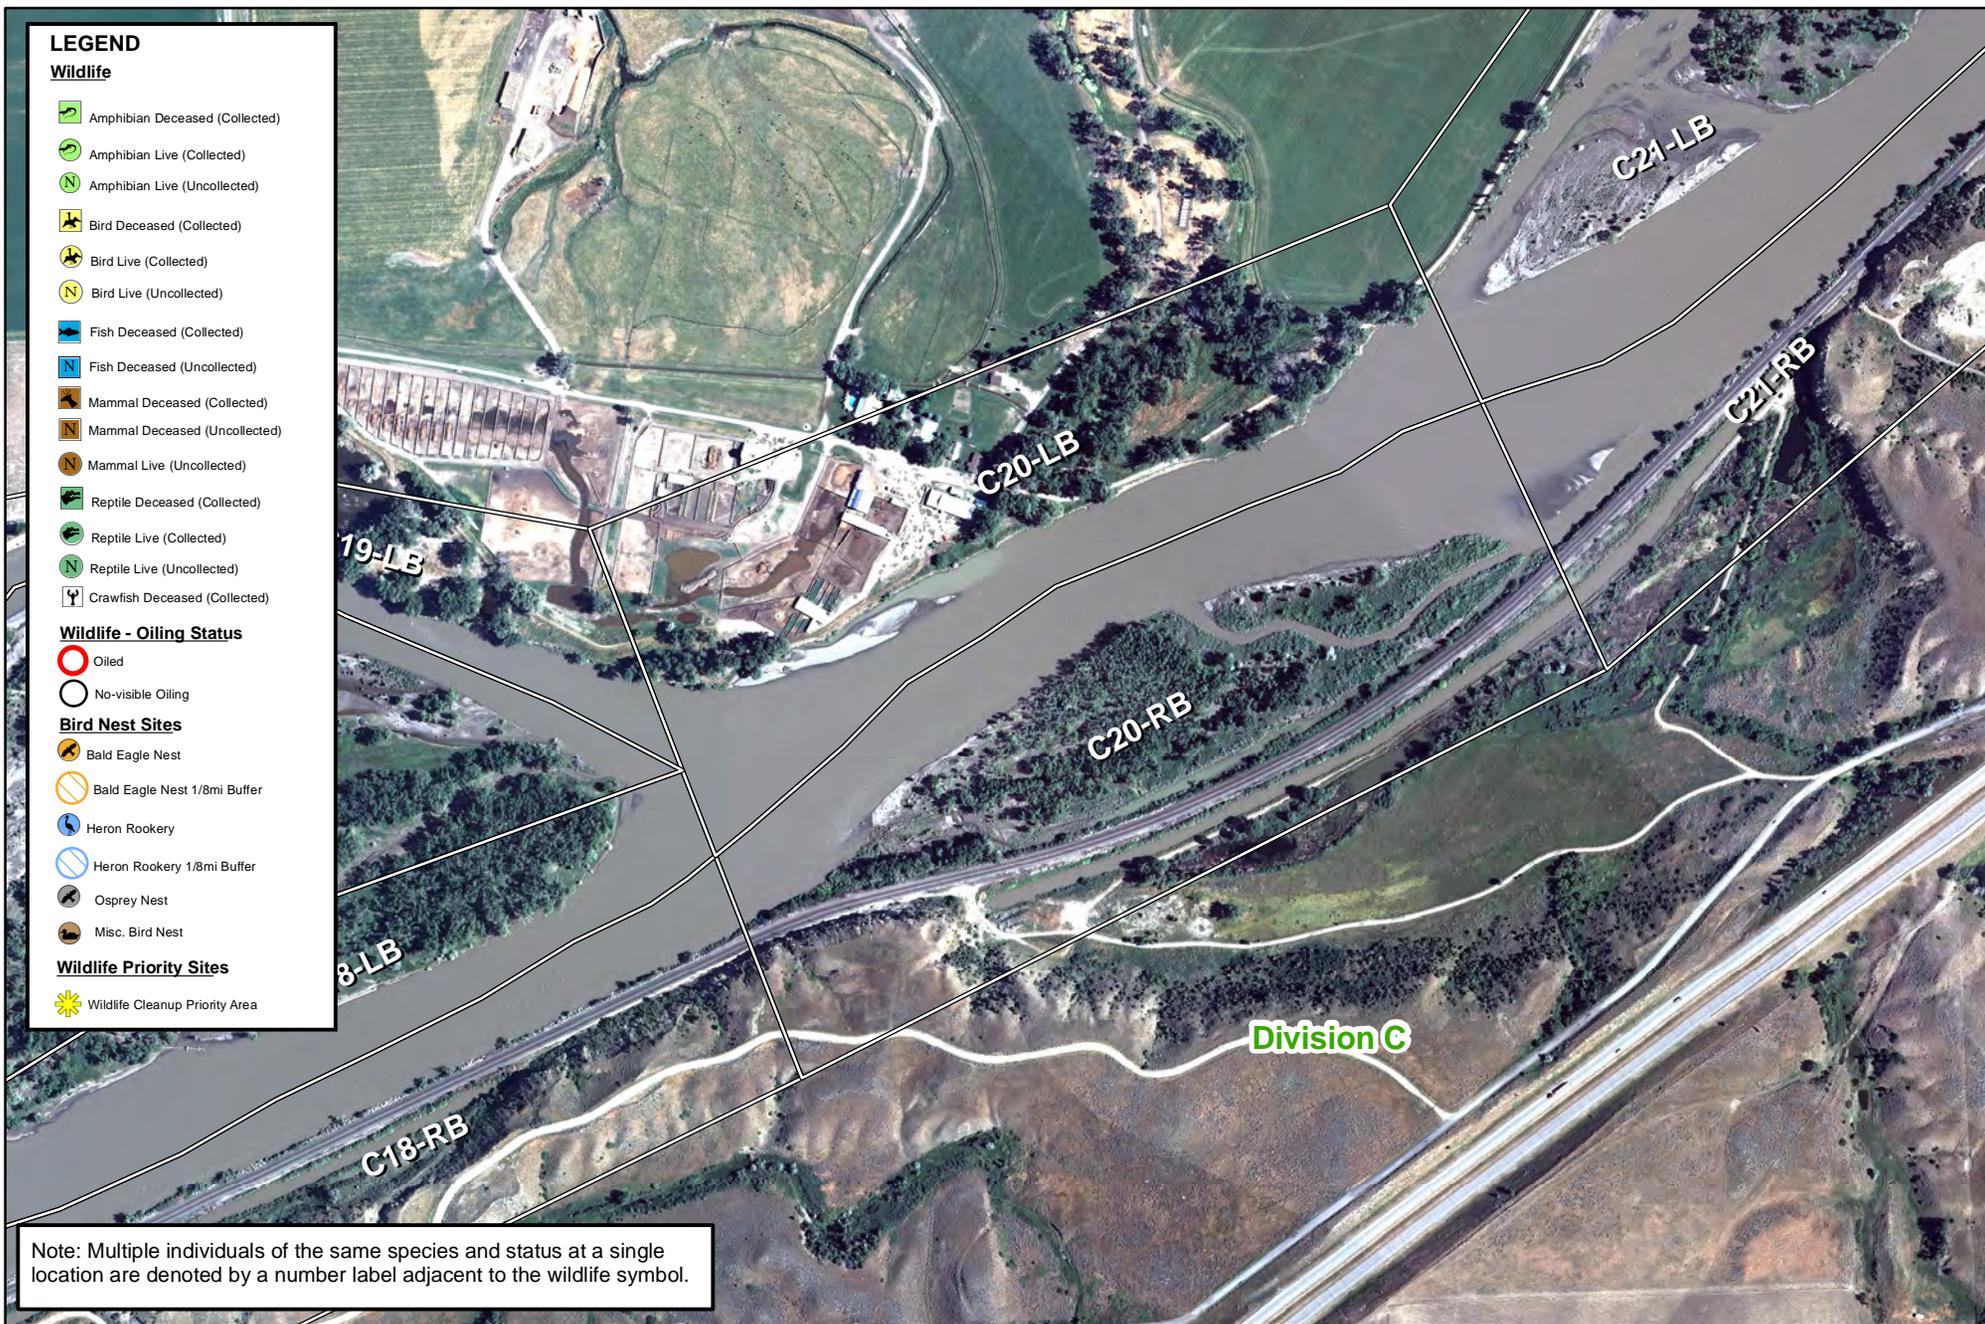
**Figure 2**  
**Wildlife Resources**

Figure 2 summarizes the natural resources identified in this segment. International Bird Rescue and Resource Advisors from U.S. Fish and Wildlife Service conducted limited inspections of Area C20 due to the low level of oiling in Division C. No oiled wildlife was observed or recovered. No Wildlife Priority Cleanup Areas were identified. No active migratory bird nests were identified in Area C20.

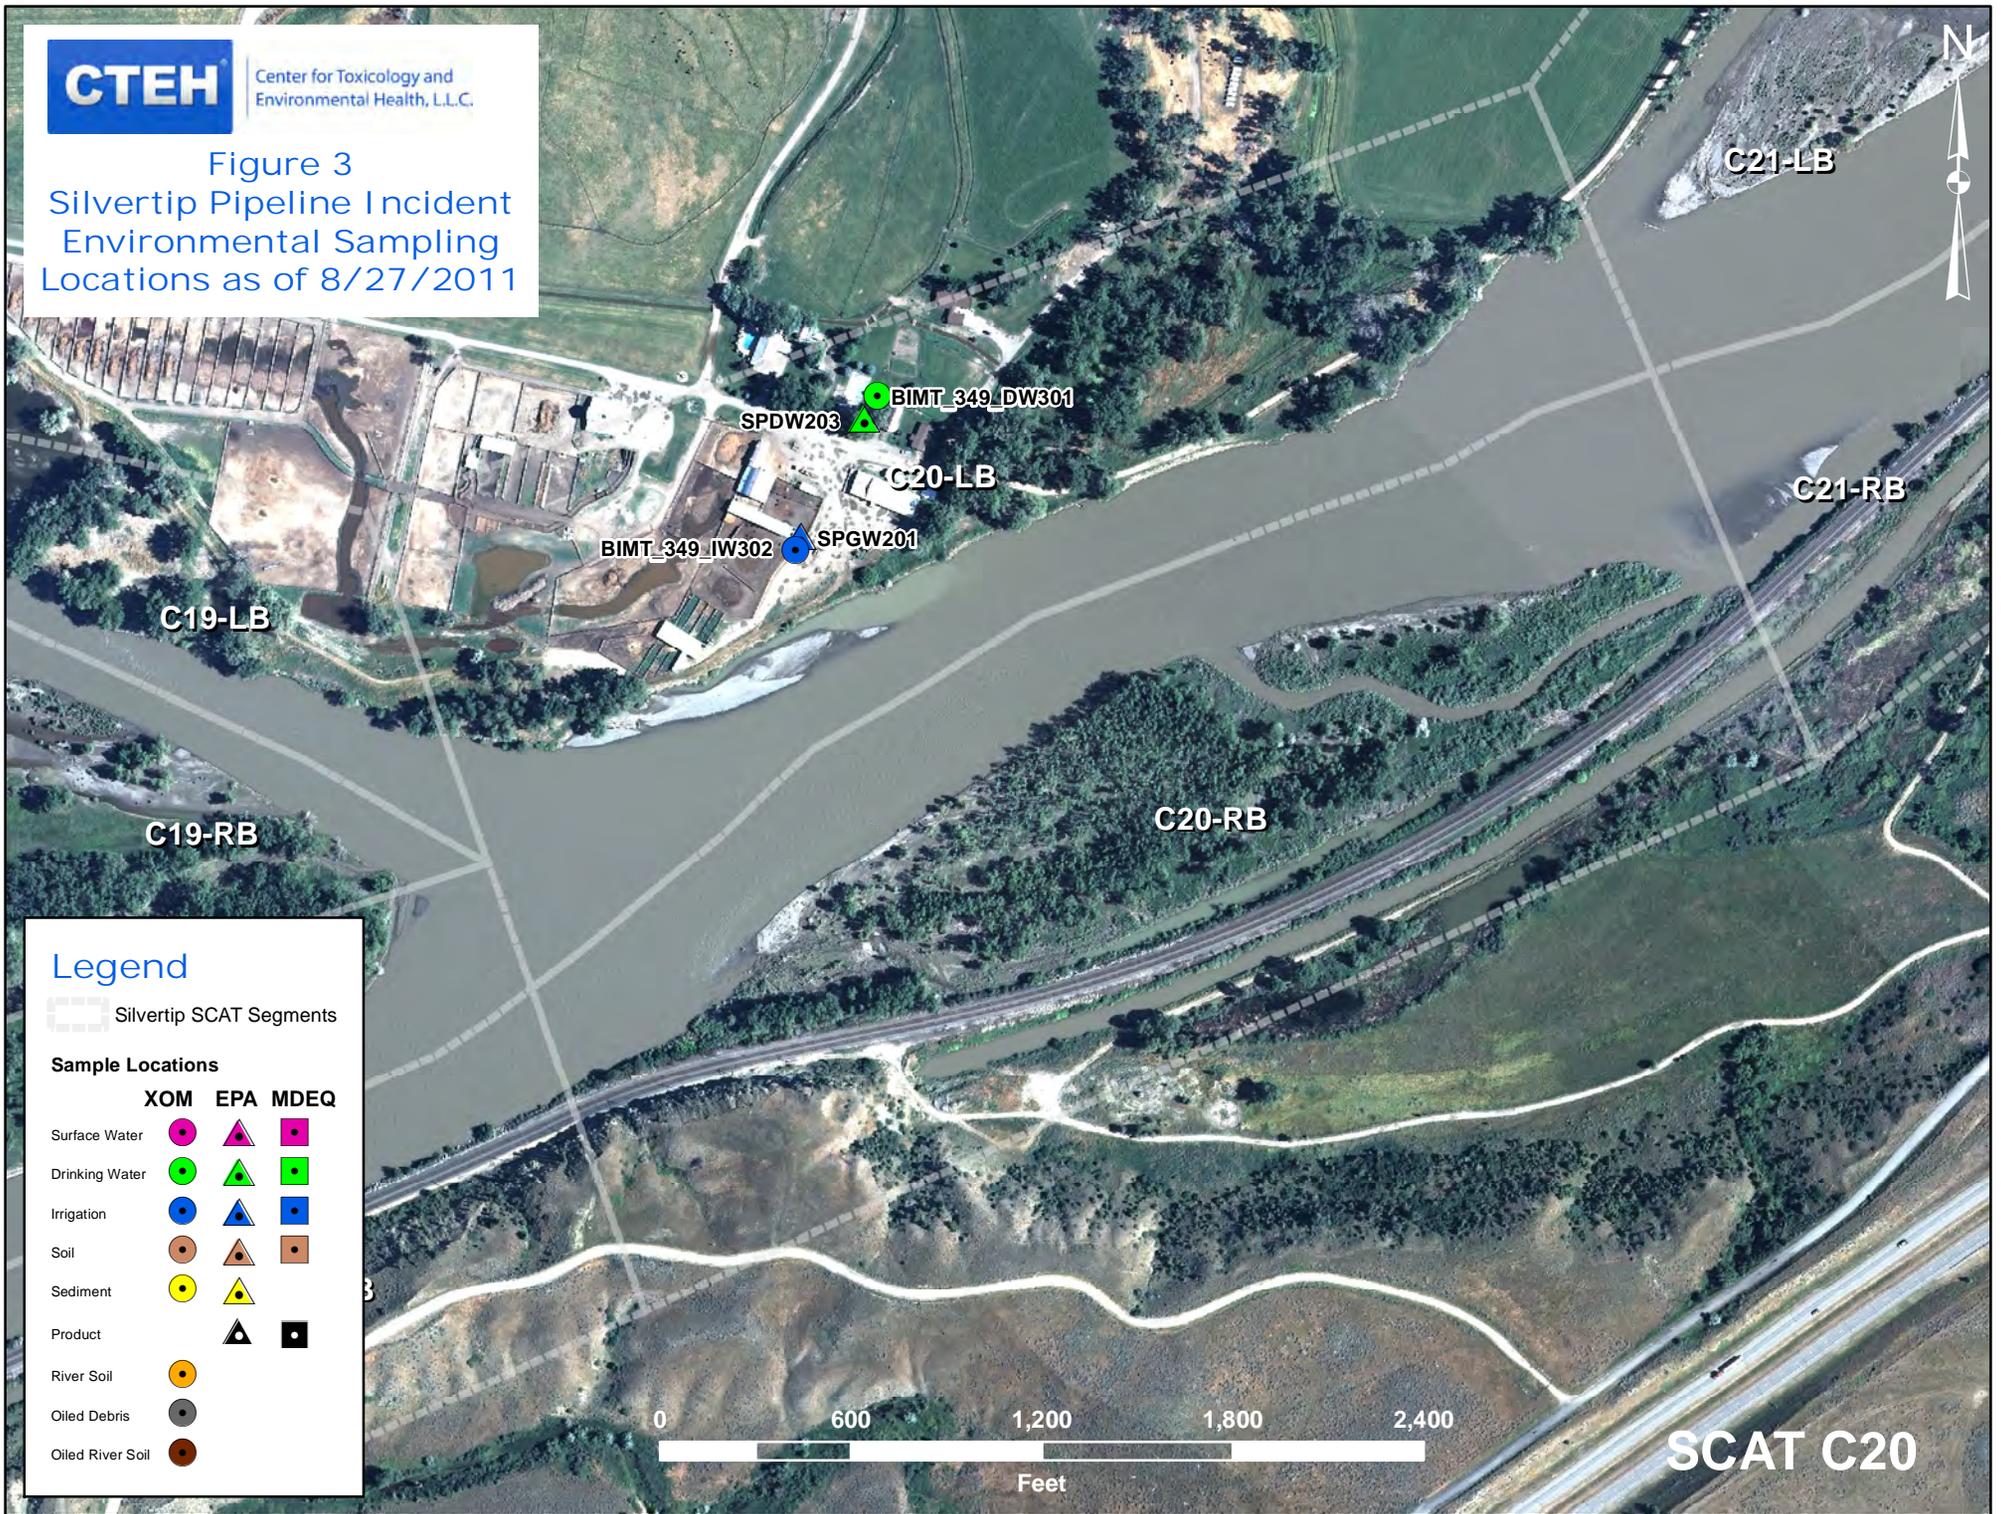
Figure 3  
Silvertip Pipeline Incident  
Environmental Sampling  
Locations as of 8/27/2011

Table 1 (below) summarizes samples collected within Area C20. The analytical results for the samples collected can be accessed through a publicly accessible database on the United States Environmental Protection Agency's (USEPA's) website. The approximate locations of samples collected within Area C20 are provided on Figure 3.

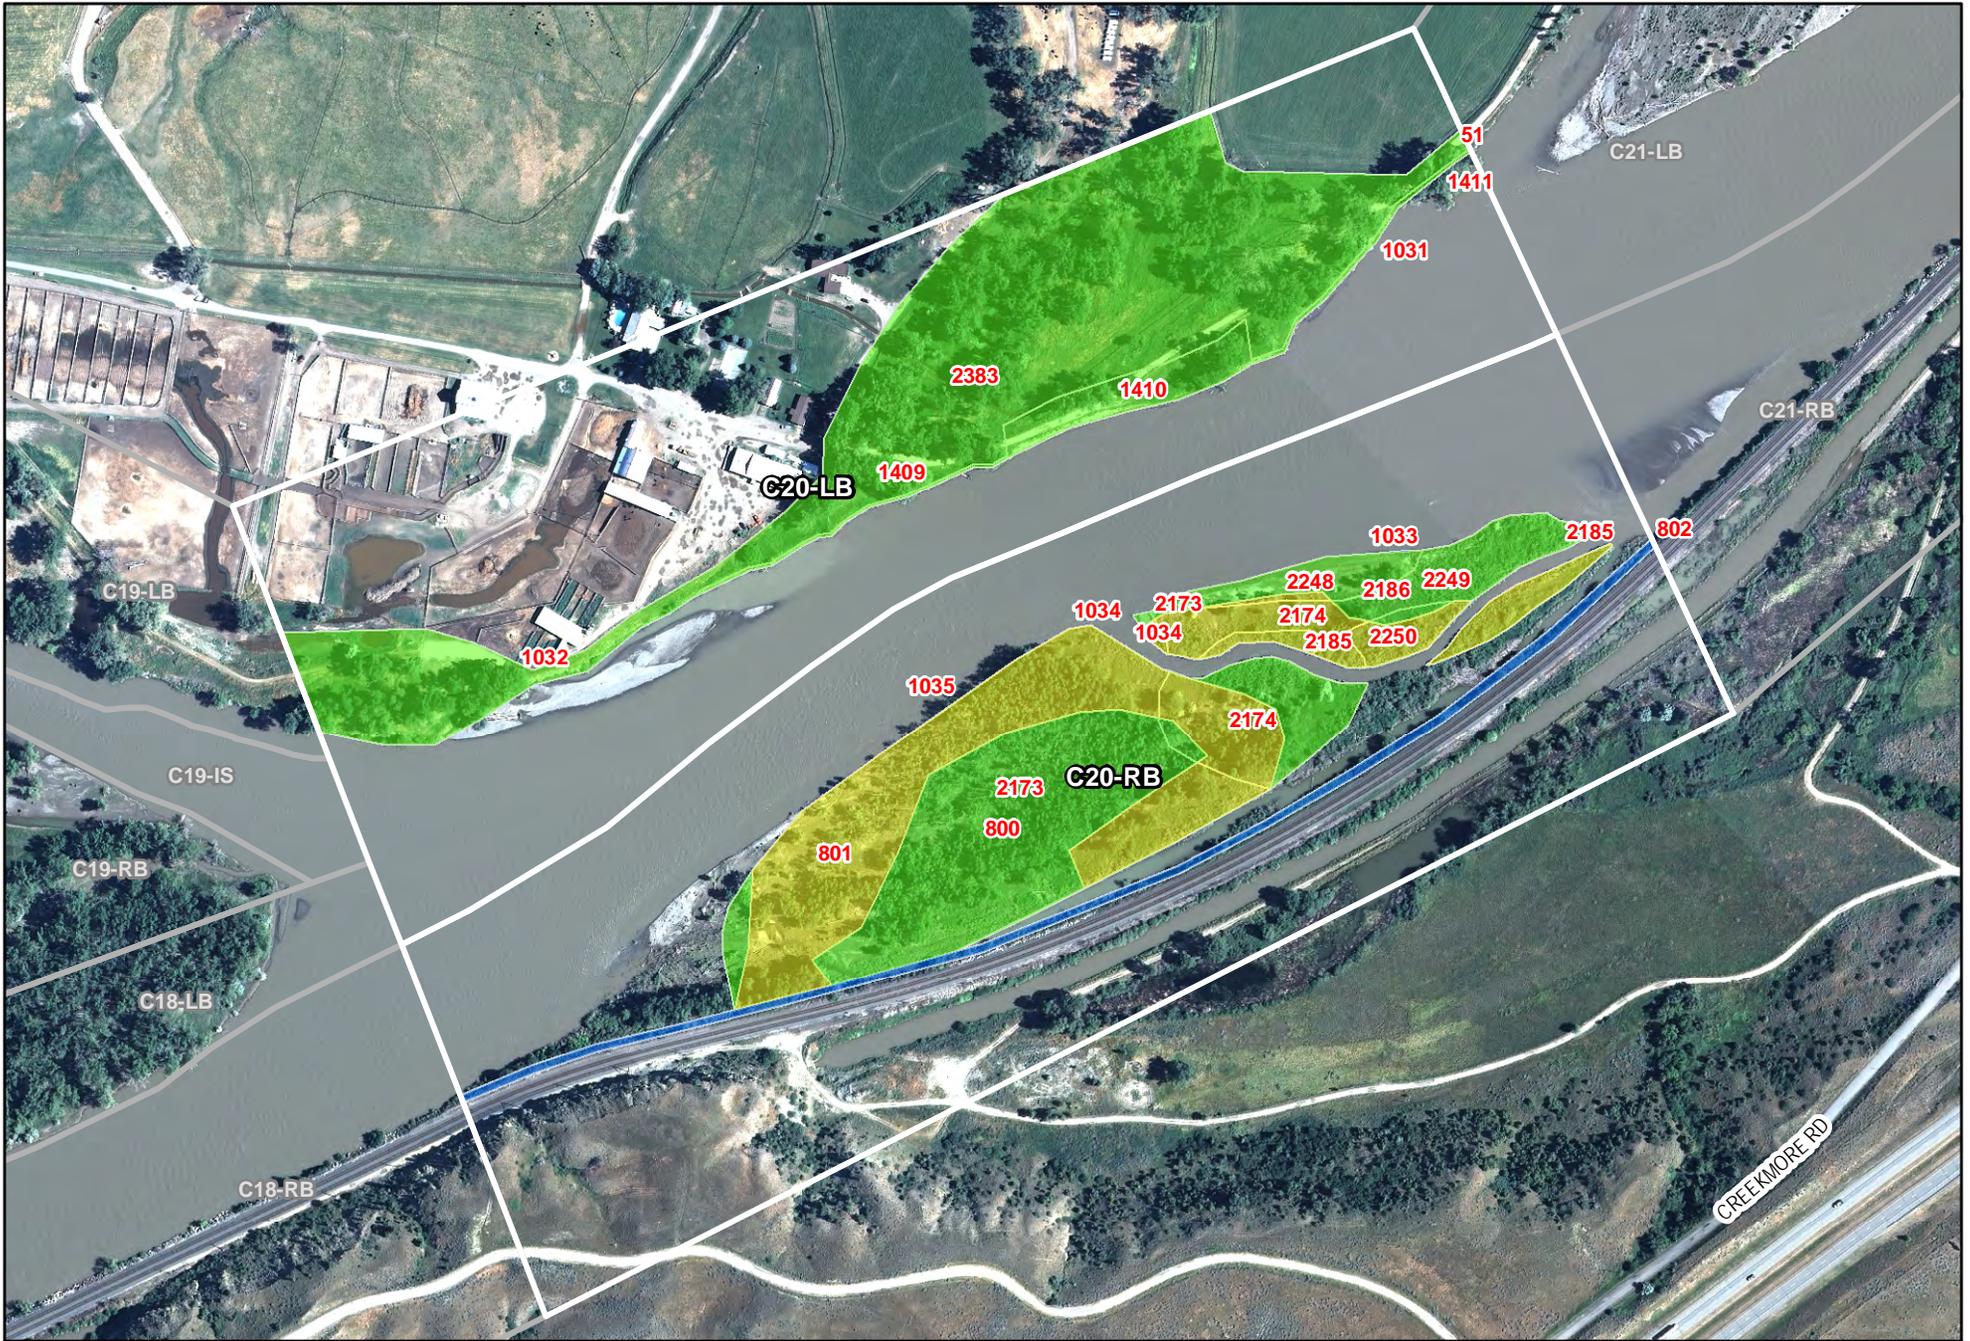
**Figure 4 - Maximum SCAT Observations For SCAT Area: C20**

The SCAT teams used systematic evaluation criteria and treatment method tables approved by the National Oceanic and Atmospheric Administration to provide a standard approach for data collection and conducting field surveys. The forms and sketches from the initial SCAT surveys performed along the river bank (water edge) and floodplain within Area C20 are included in Appendix B. Figure 4 provides the maximum oiling zones observed by the SCAT team during the initial surveys of Area C20.

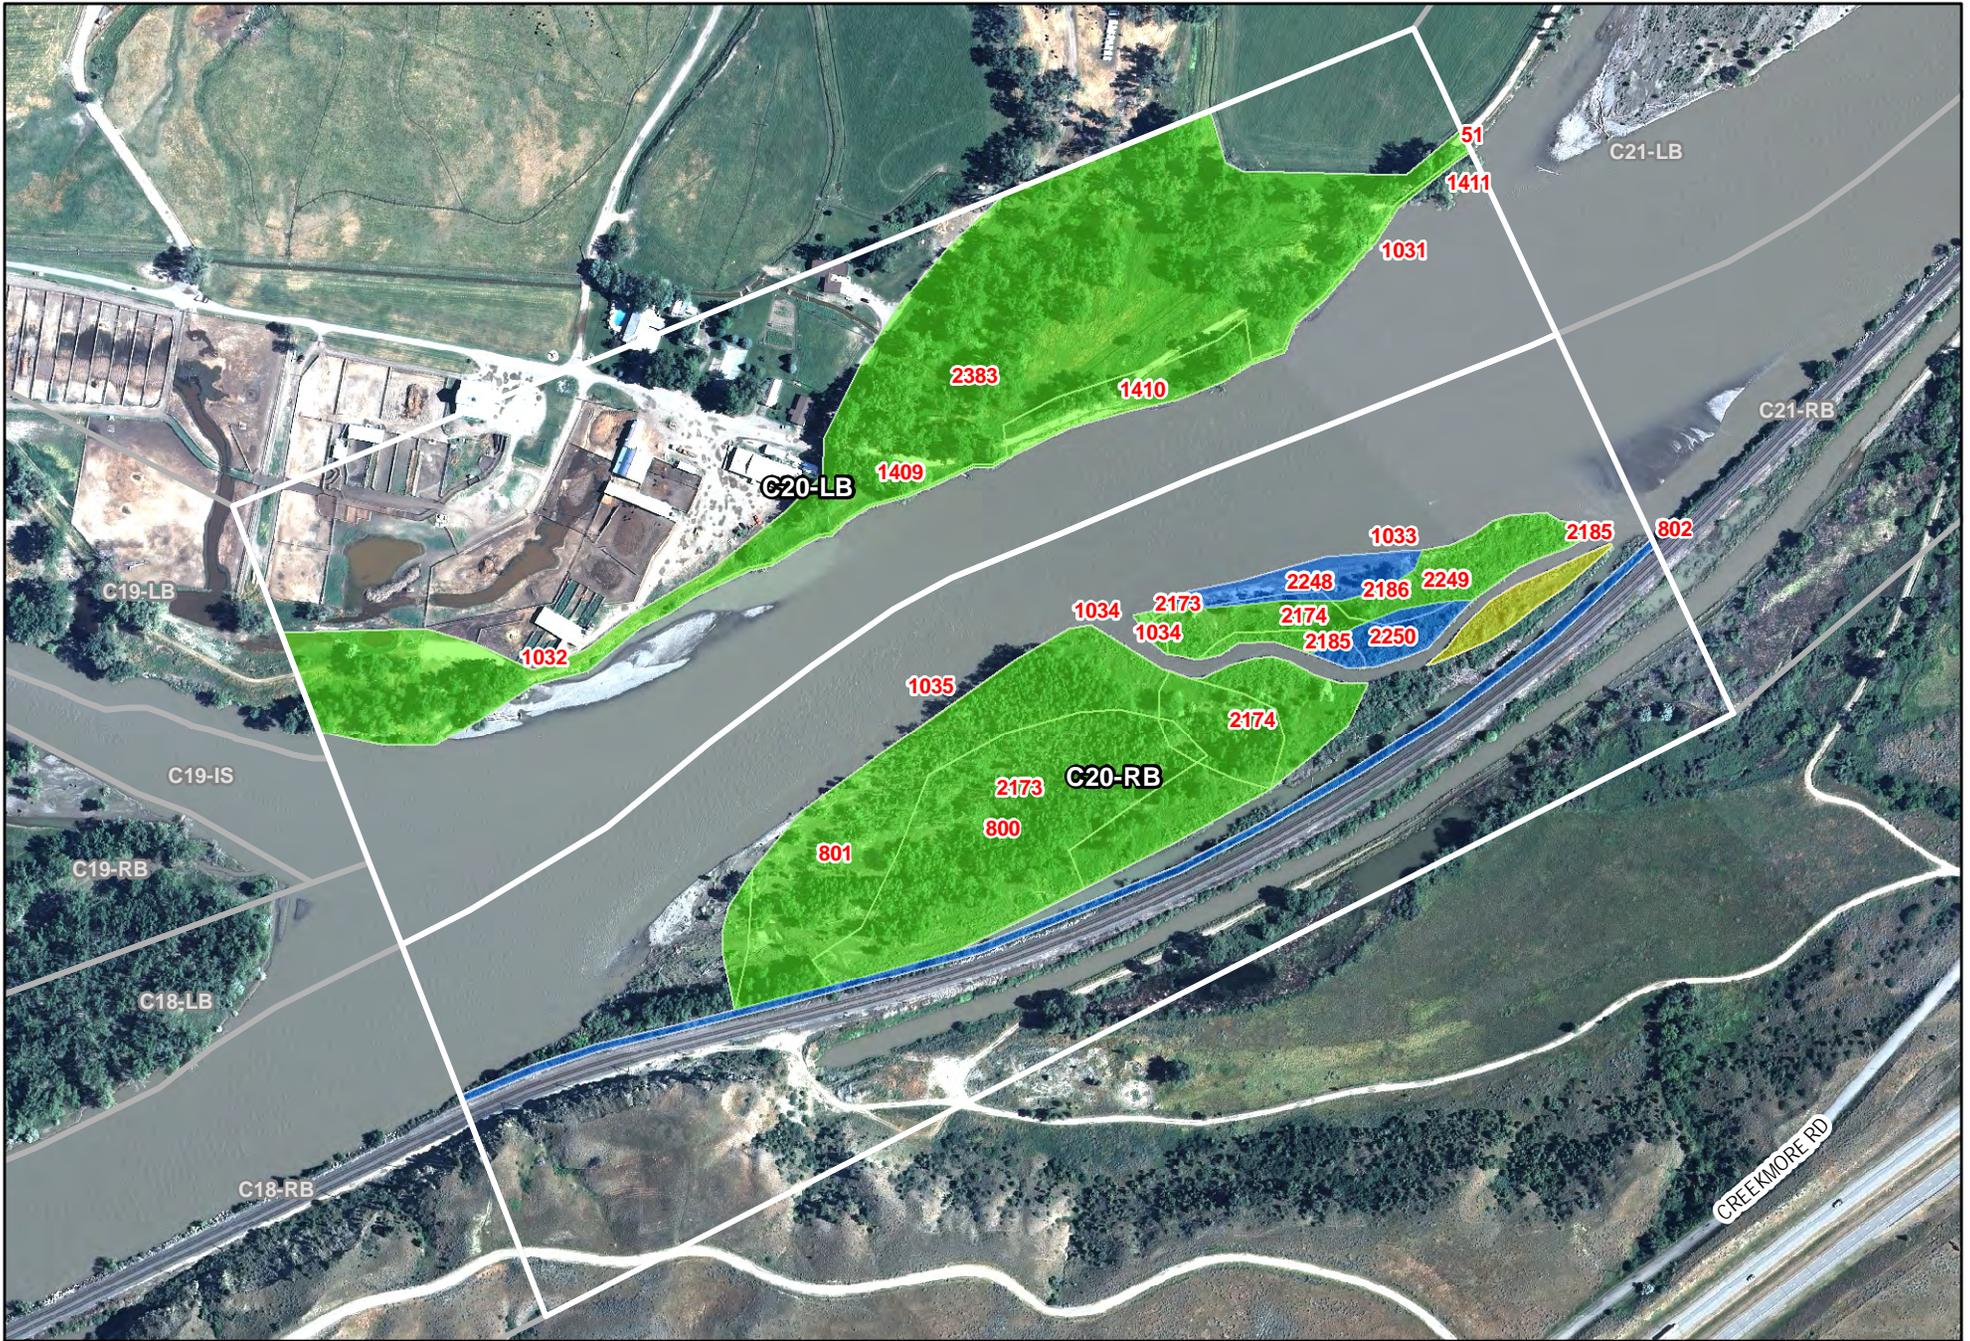
No Oil Observed</p>	<p><b>Figure 5 - Final SCAT Observations</b>  <b>For SCAT Area: C20</b></p> <p>0 320 640 Feet</p>

Figure 5 shows the oiling conditions within Area C20 following completion of oil removal activities. The SCAT team performed final surveys of the left and right banks within SCAT Area C20 to confirm the agreed-upon cleanup endpoints identified in the applicable CTRs had been achieved. The final SCAT survey documentation is presented in Appendix E.

Based on the final SCAT surveys performed on the left and right banks within Area C20, no further treatment is recommended for these segments. SCAT Segment Sign-Off Forms are included as Appendix F.

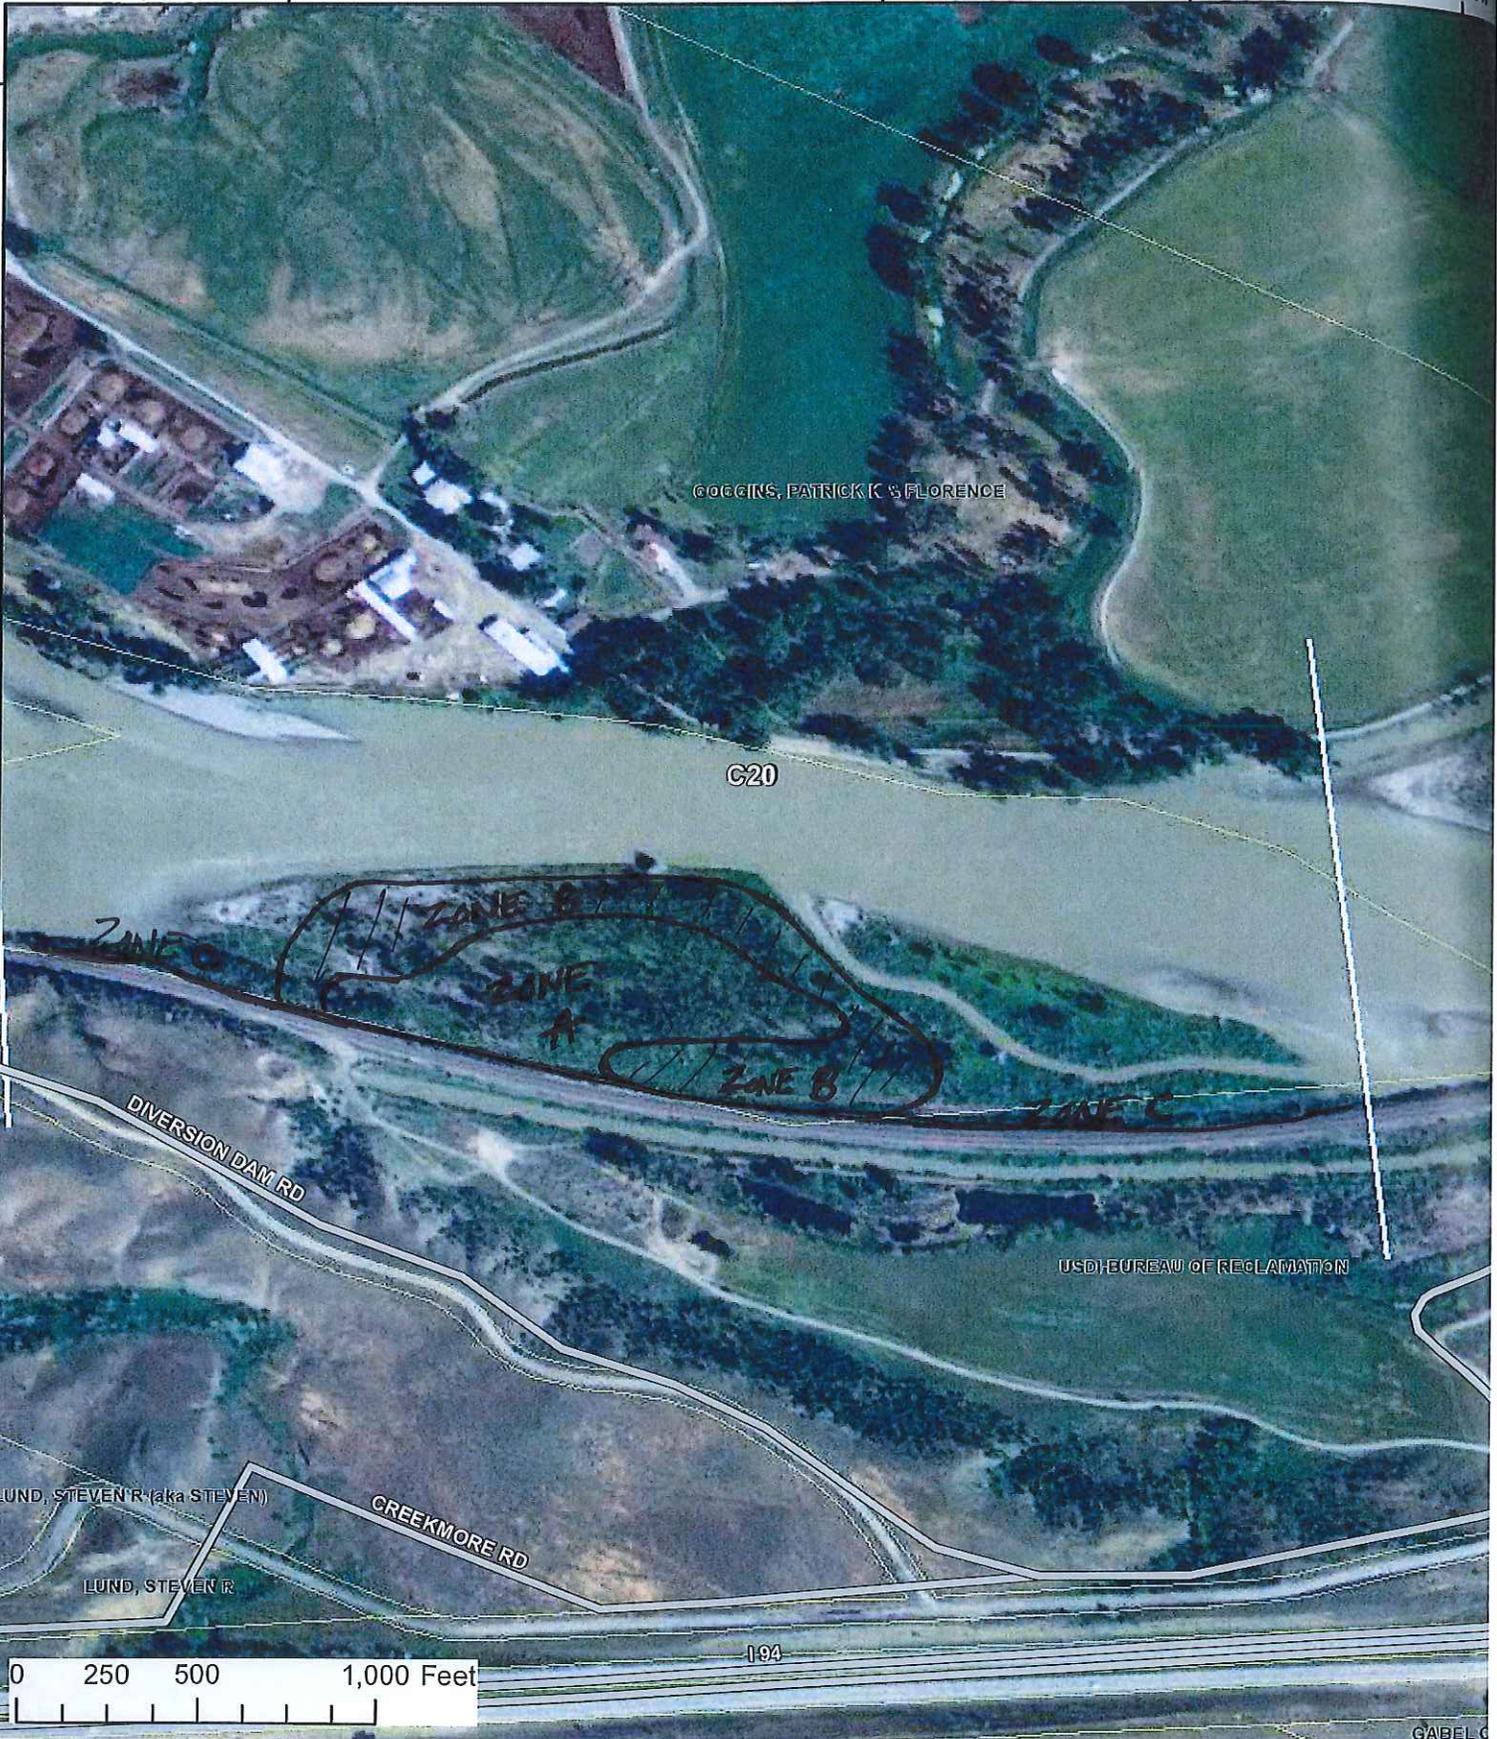
ZONE A: no oil observed  
recommendation:

ZONE B: isolated areas of oil coated veg and debris (flagged) and a 30x30m area of lightly oil stained (coated veg (banding))  
recommendations: cut/trim oiled veg, hand removal of oiled debris

ZONE C: no oil observed  
recommendations:

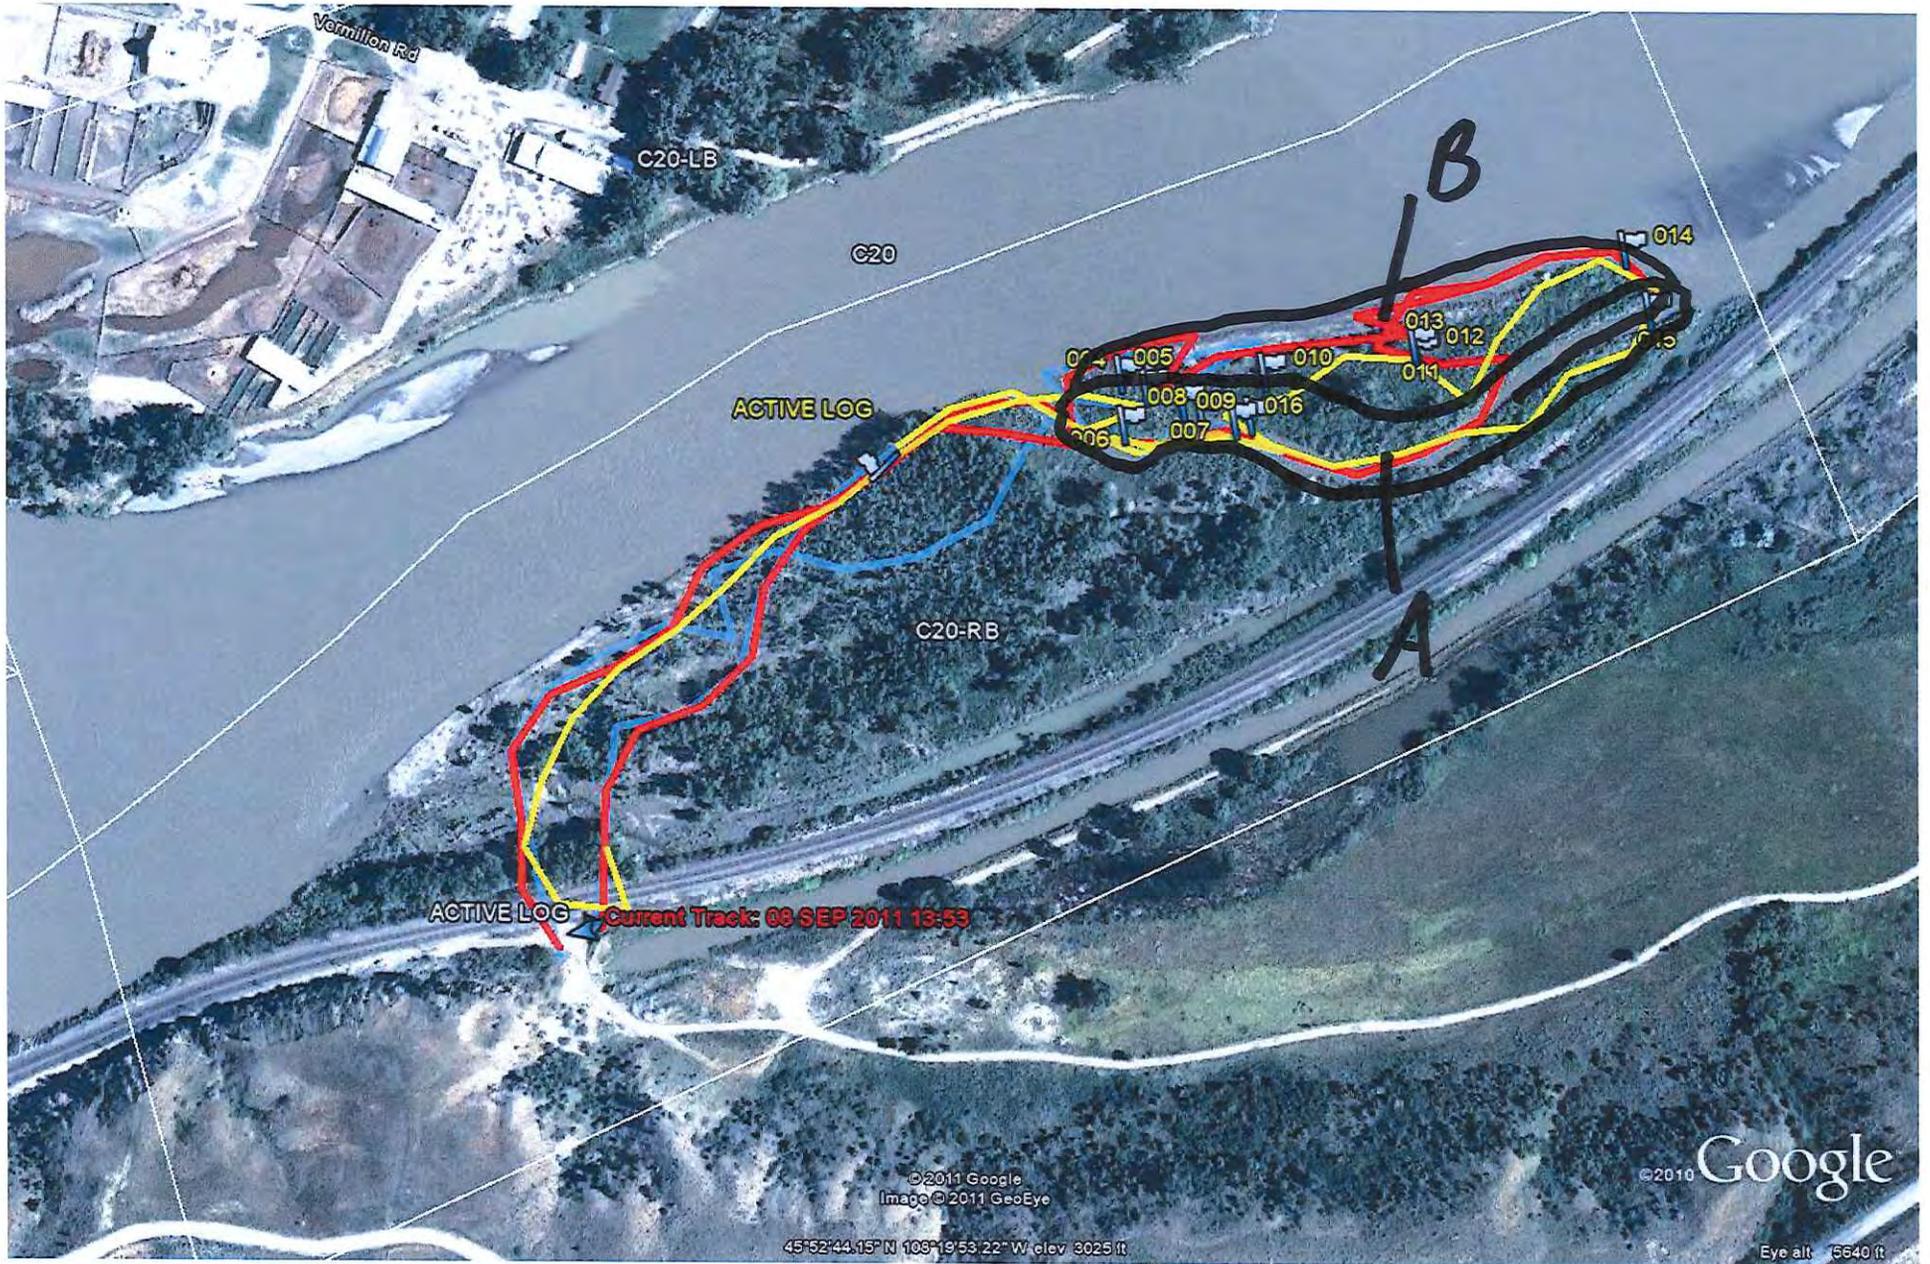
Zone A - Light oil coated and stain on willow branches along inside channel cut is transferable  
 Recommend 3 Hot Shot Crews for 1-2 days to cut and remove oil/willows/vegetation and debris, wipe down vegetation and apply dust fixative where possible  
 Estimate of 40-50 bags of oiled material for removal before ReSCAT can be done

Zone B - Very light oiling and stain on several spots. Remove oiled debris, cut vegetation and apply dust fixative where possible

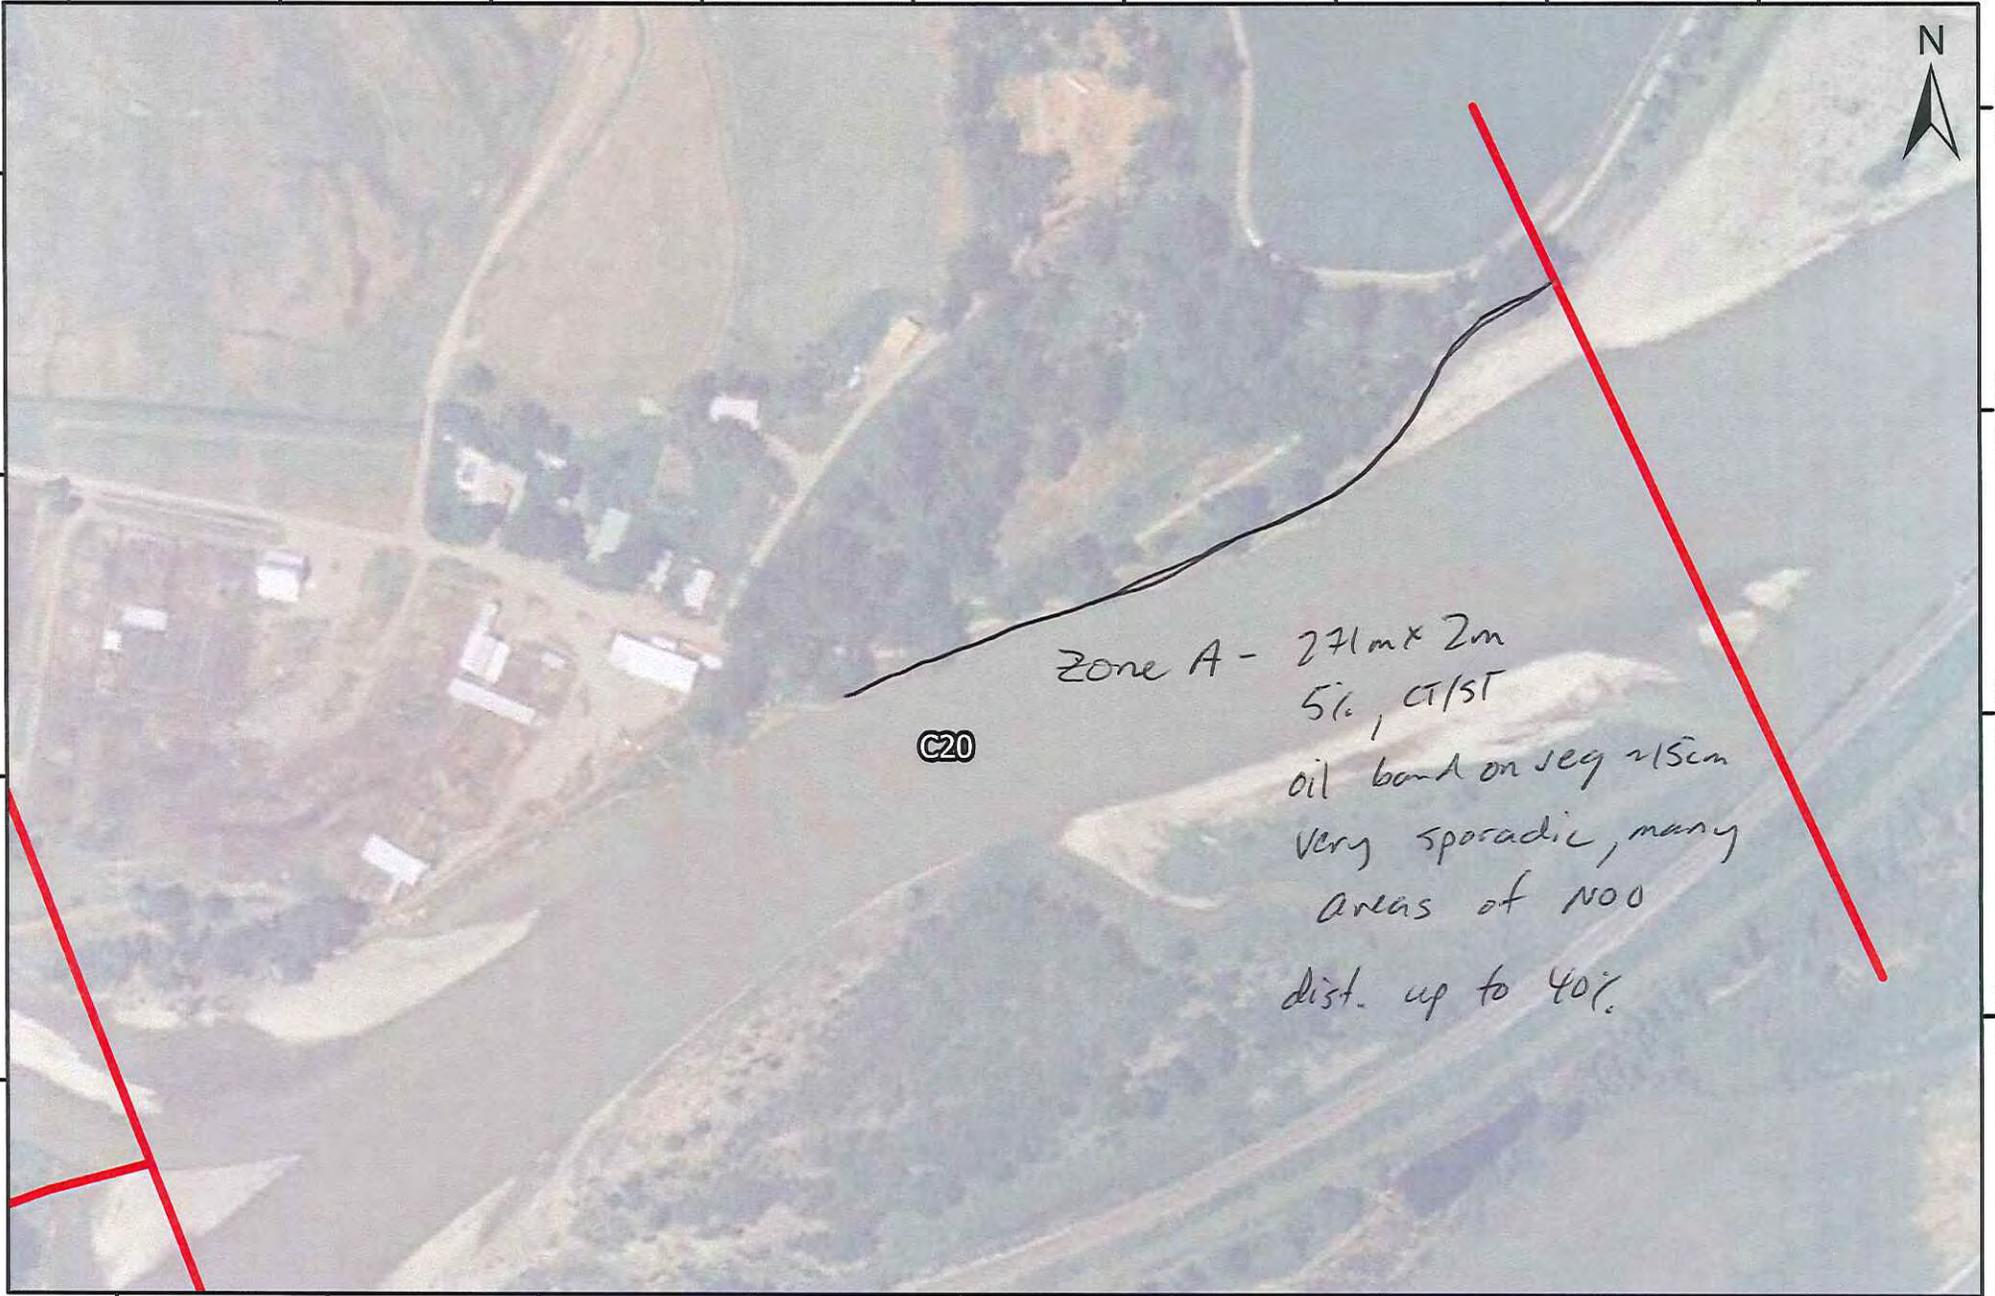
C20

Zone A - band of oil very sporadic, dist up to 40%, width up to 3m, some areas w/ no oil band ~15cm  
 No treatment recommended but on private property

Zone A - 271m x 2m  
5%, CI/ST  
oil band on seg ~15cm  
Very sporadic, many  
areas of NOO  
dist. up to 40%
