**SCAT Area Transition Report for  
C20**

Silvertip Pipeline Incident  
Laurel, Montana

October 25, 2011

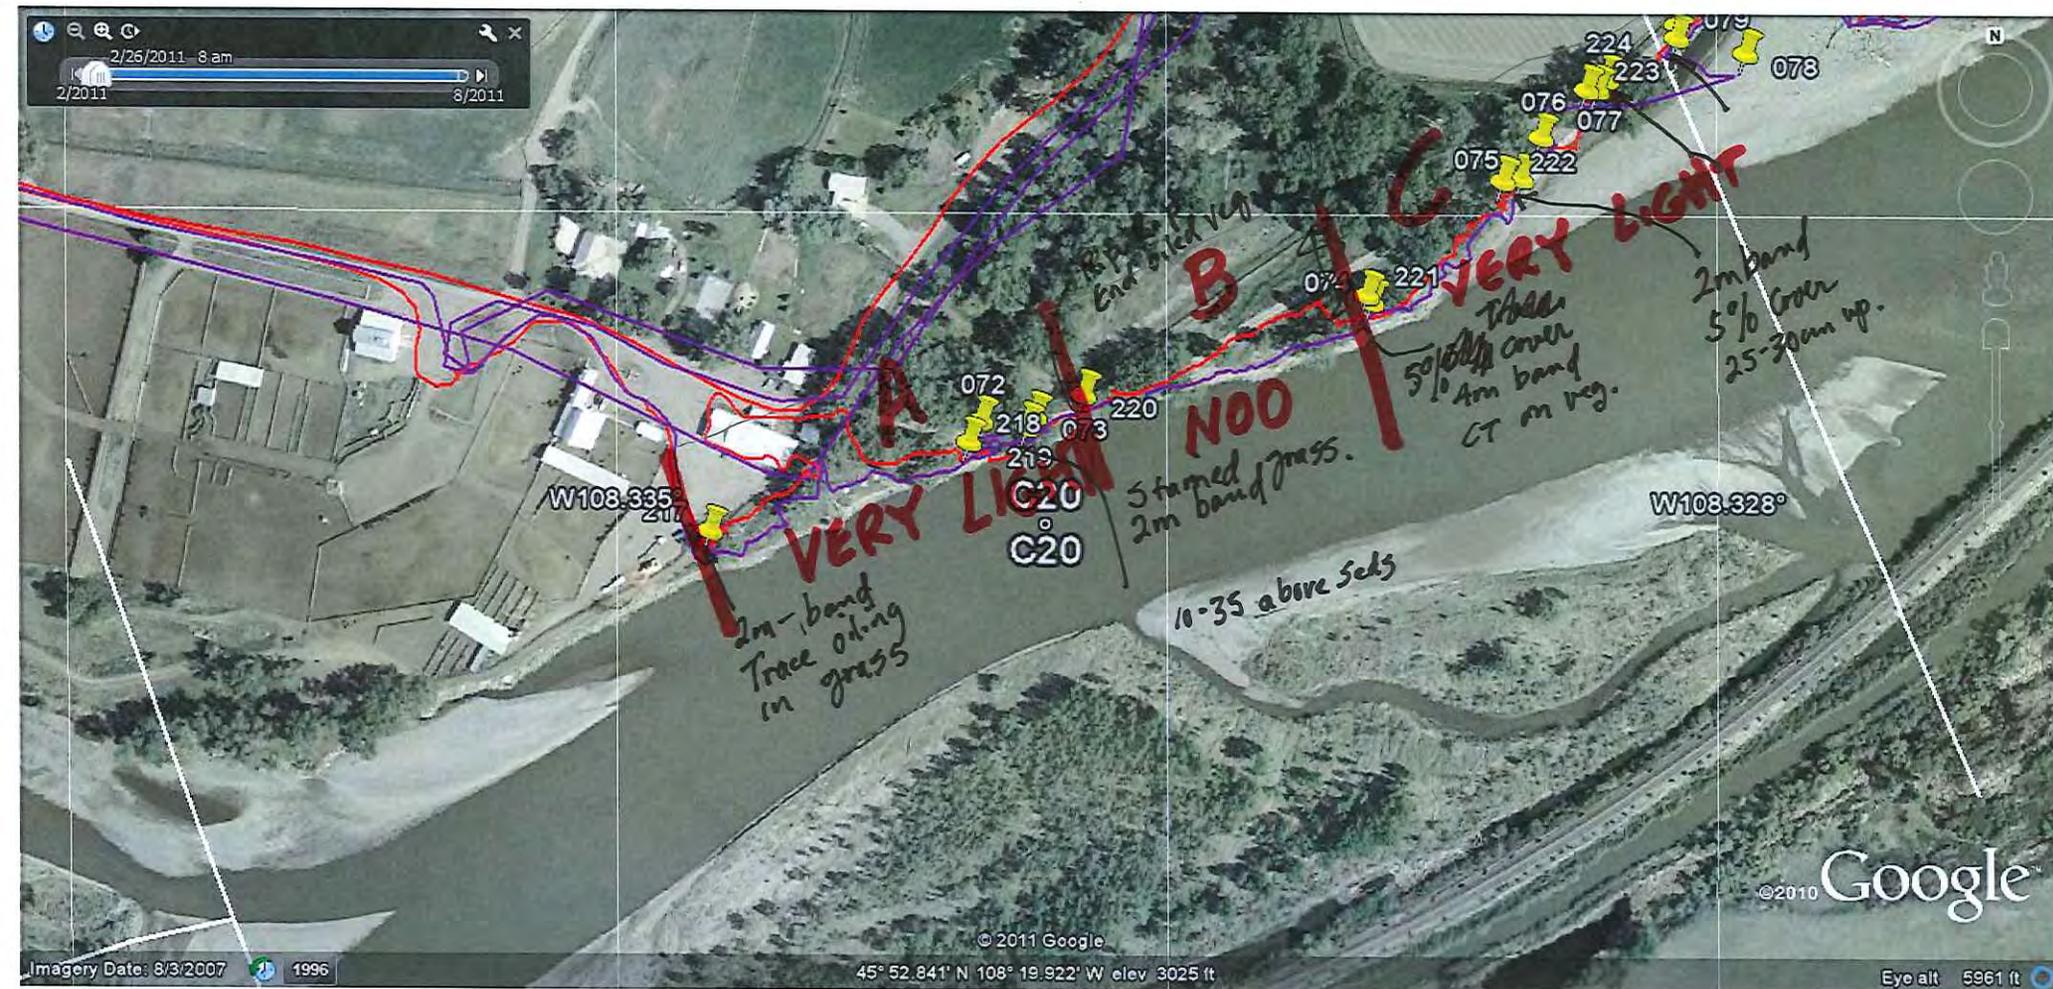
A = 205m Very Light  
B = 150m NOO  
C = 203m Very Light

Total = 540m

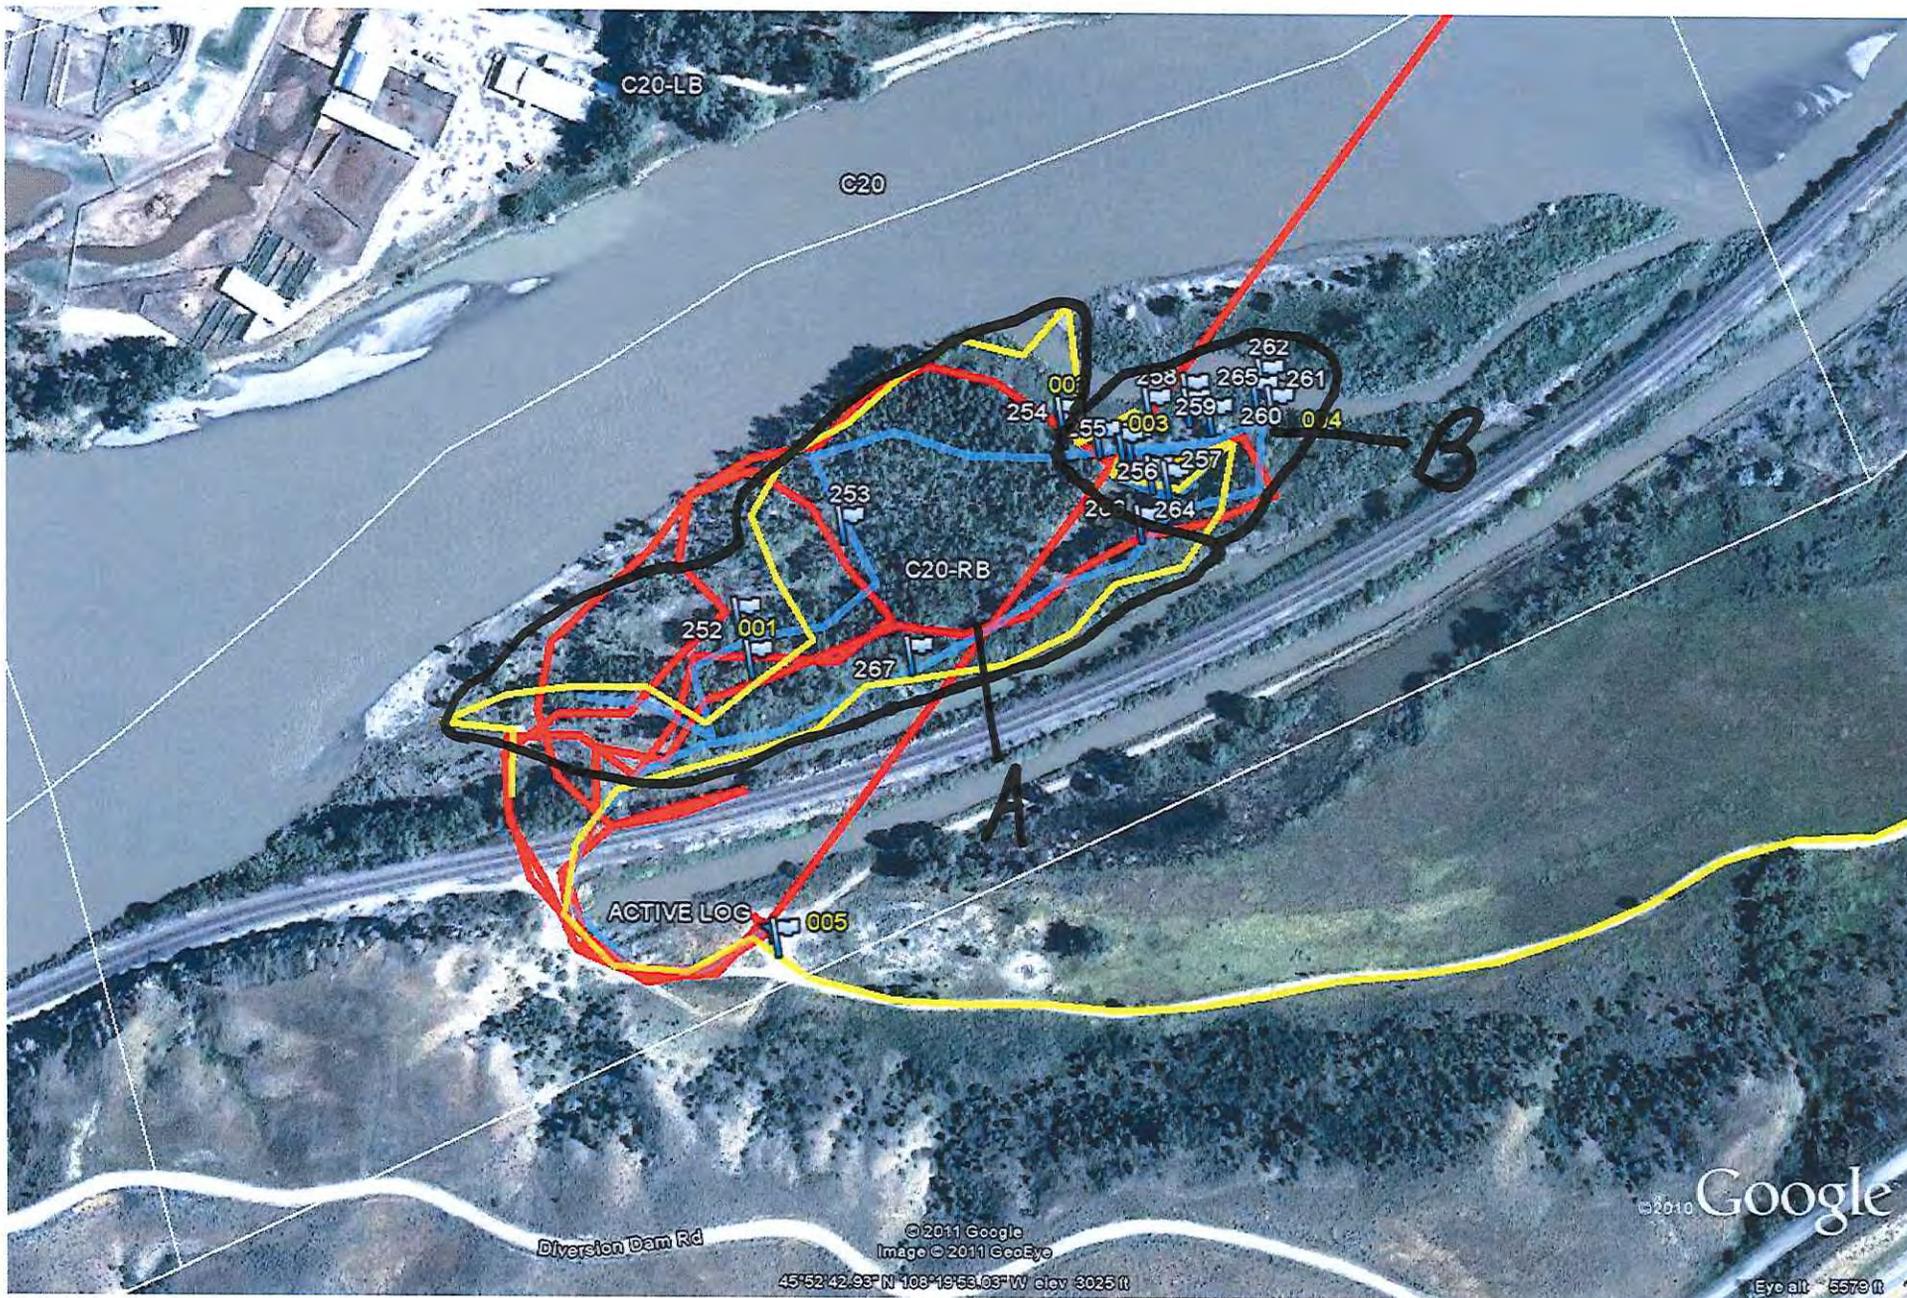
Team 3  
07/09/11  
C20RB

Zone A - Surface staining on some vegetation  
After Ops crew cleaned up the zone No Further Treatment Recommended

Zone B - Surface staining on grass and willow No Further Treatment Recommended

A-NFT  
B-NFT
