**SCAT Area Transition Report for
C40**

Silvertip Pipeline Incident
Laurel, Montana

October 20, 2011

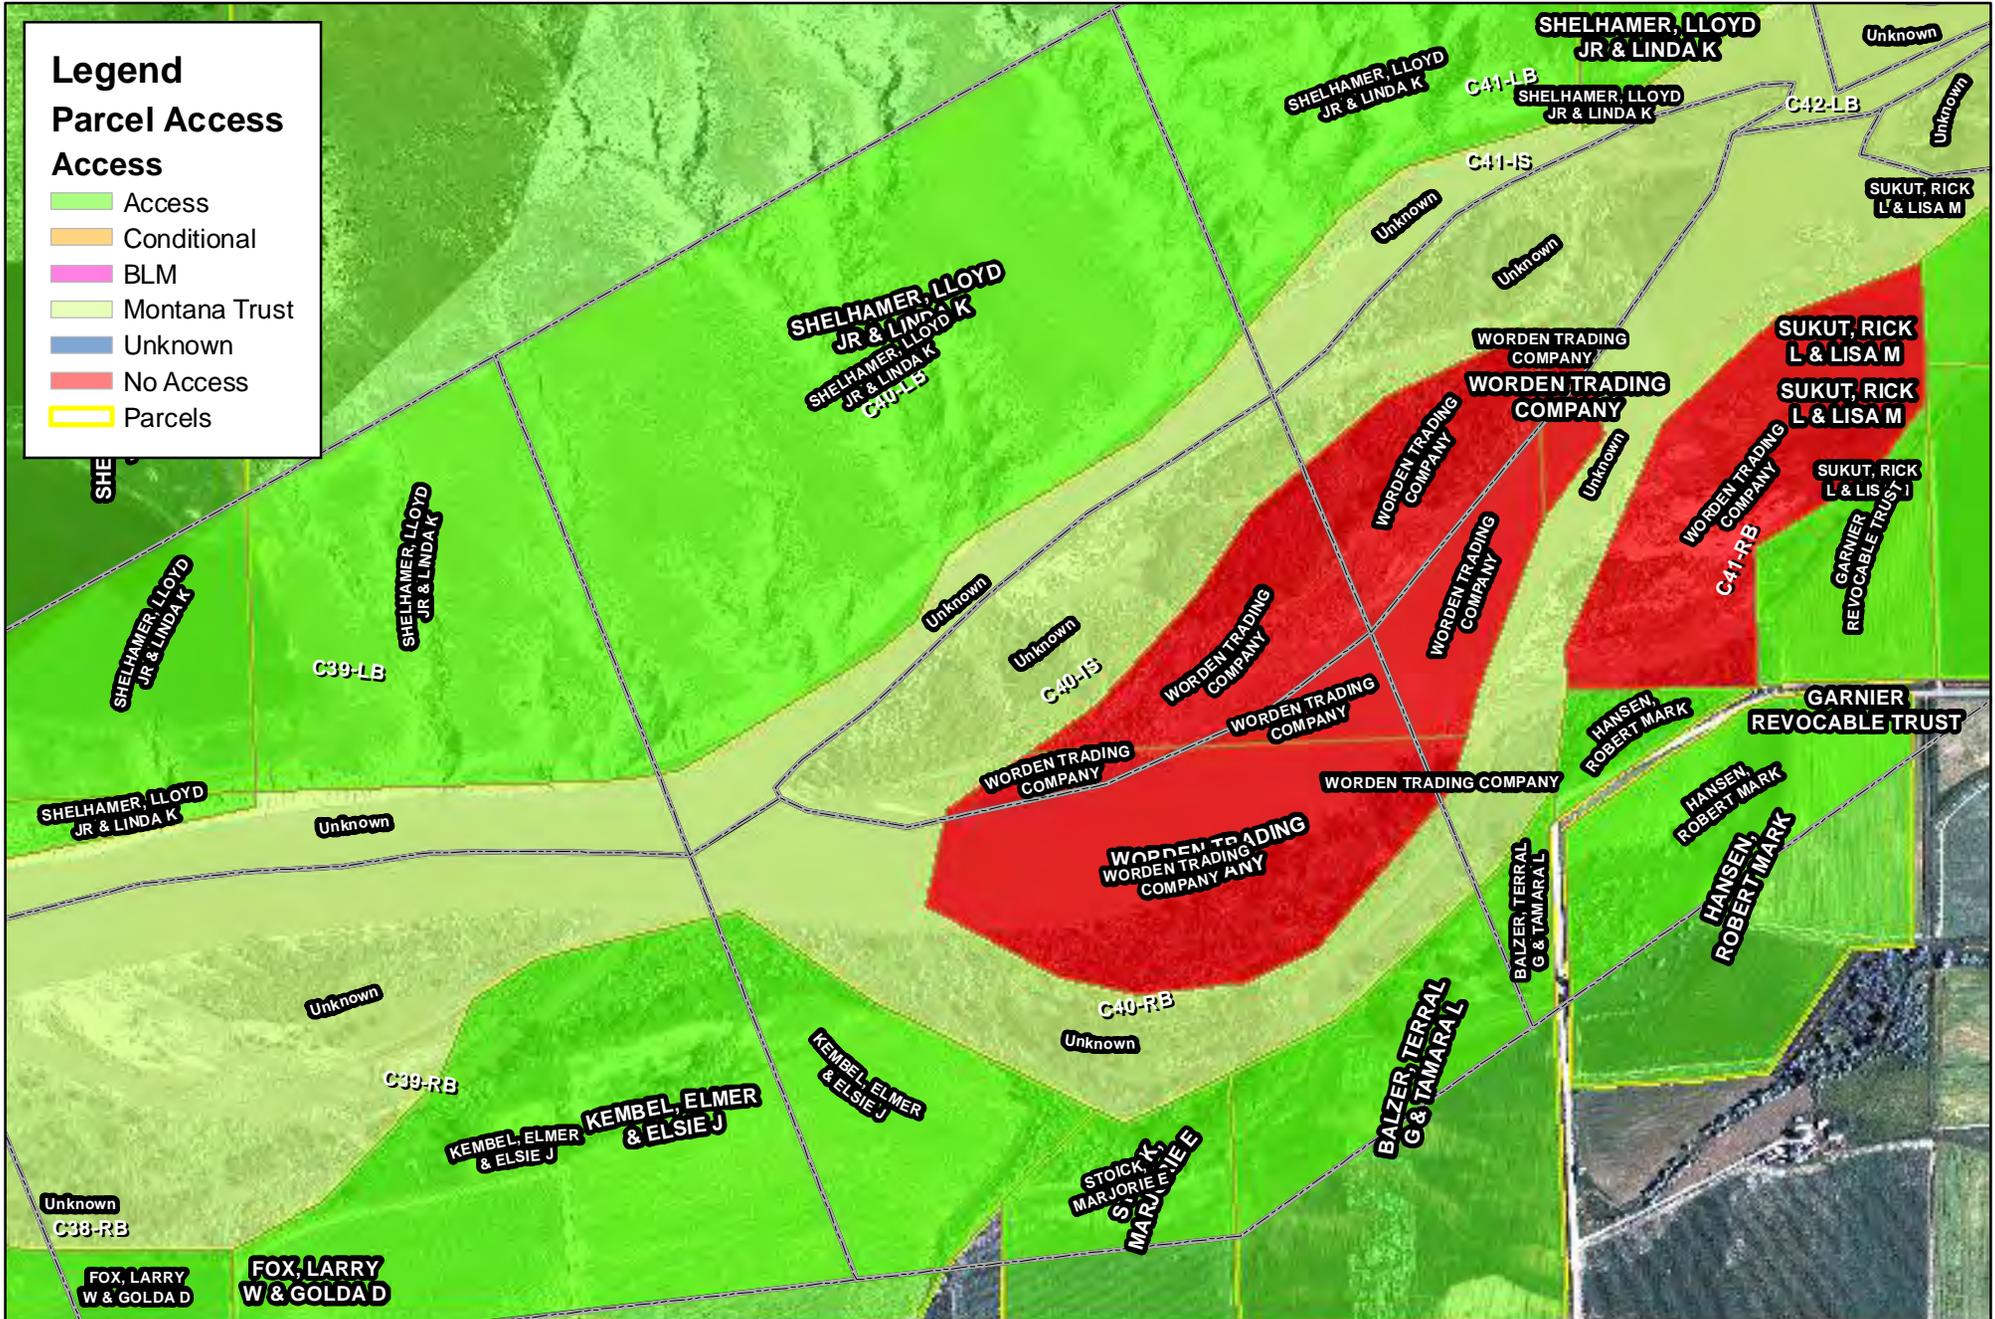
Figure 1 provides an aerial map of SCAT Area C40, along with the (a) SCAT Area boundary, (b) parcel boundaries and respective property owners, and (c) access constraints identified during the oil cleanup process. The acreage surveyed in Area C40 is 15.4. There were access issues for part of the island and right bank.

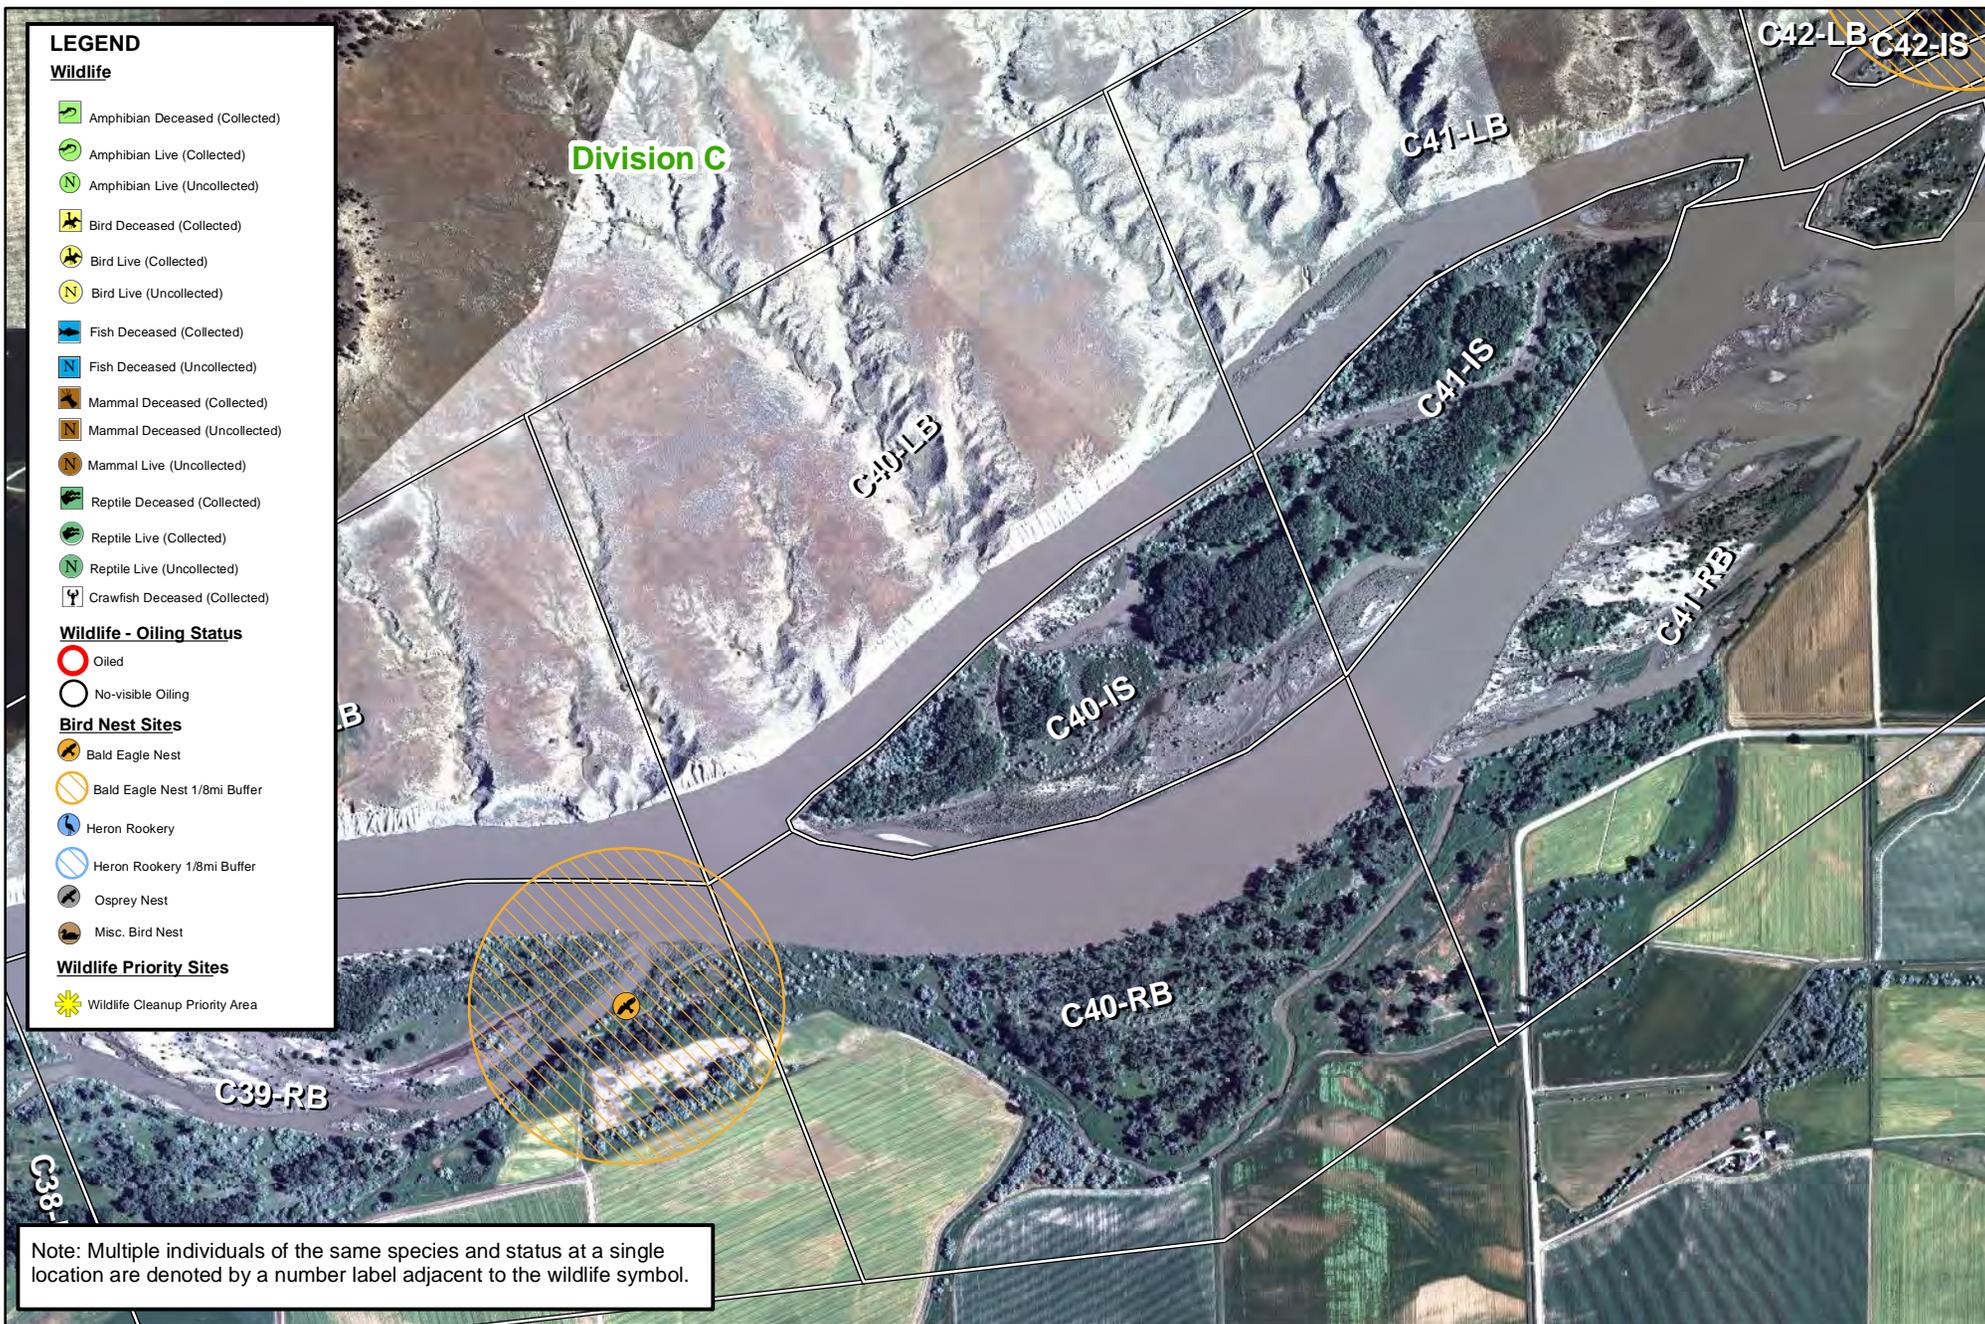
Figure 2
Wildlife Resources

Figure 2 summarizes the natural resources identified in this segment. International Bird Rescue and Resource Advisors from U.S. Fish and Wildlife Service conducted limited inspections of Area C40 due to the low level of oiling in Division C. No oiled wildlife was observed or recovered. No Wildlife Priority Cleanup Areas were identified. A portion of a bald eagle (*Haliaeetus leucocephalus*) nesting buffer zone extended into Area C40 and was provided to Operations to protect the nest.

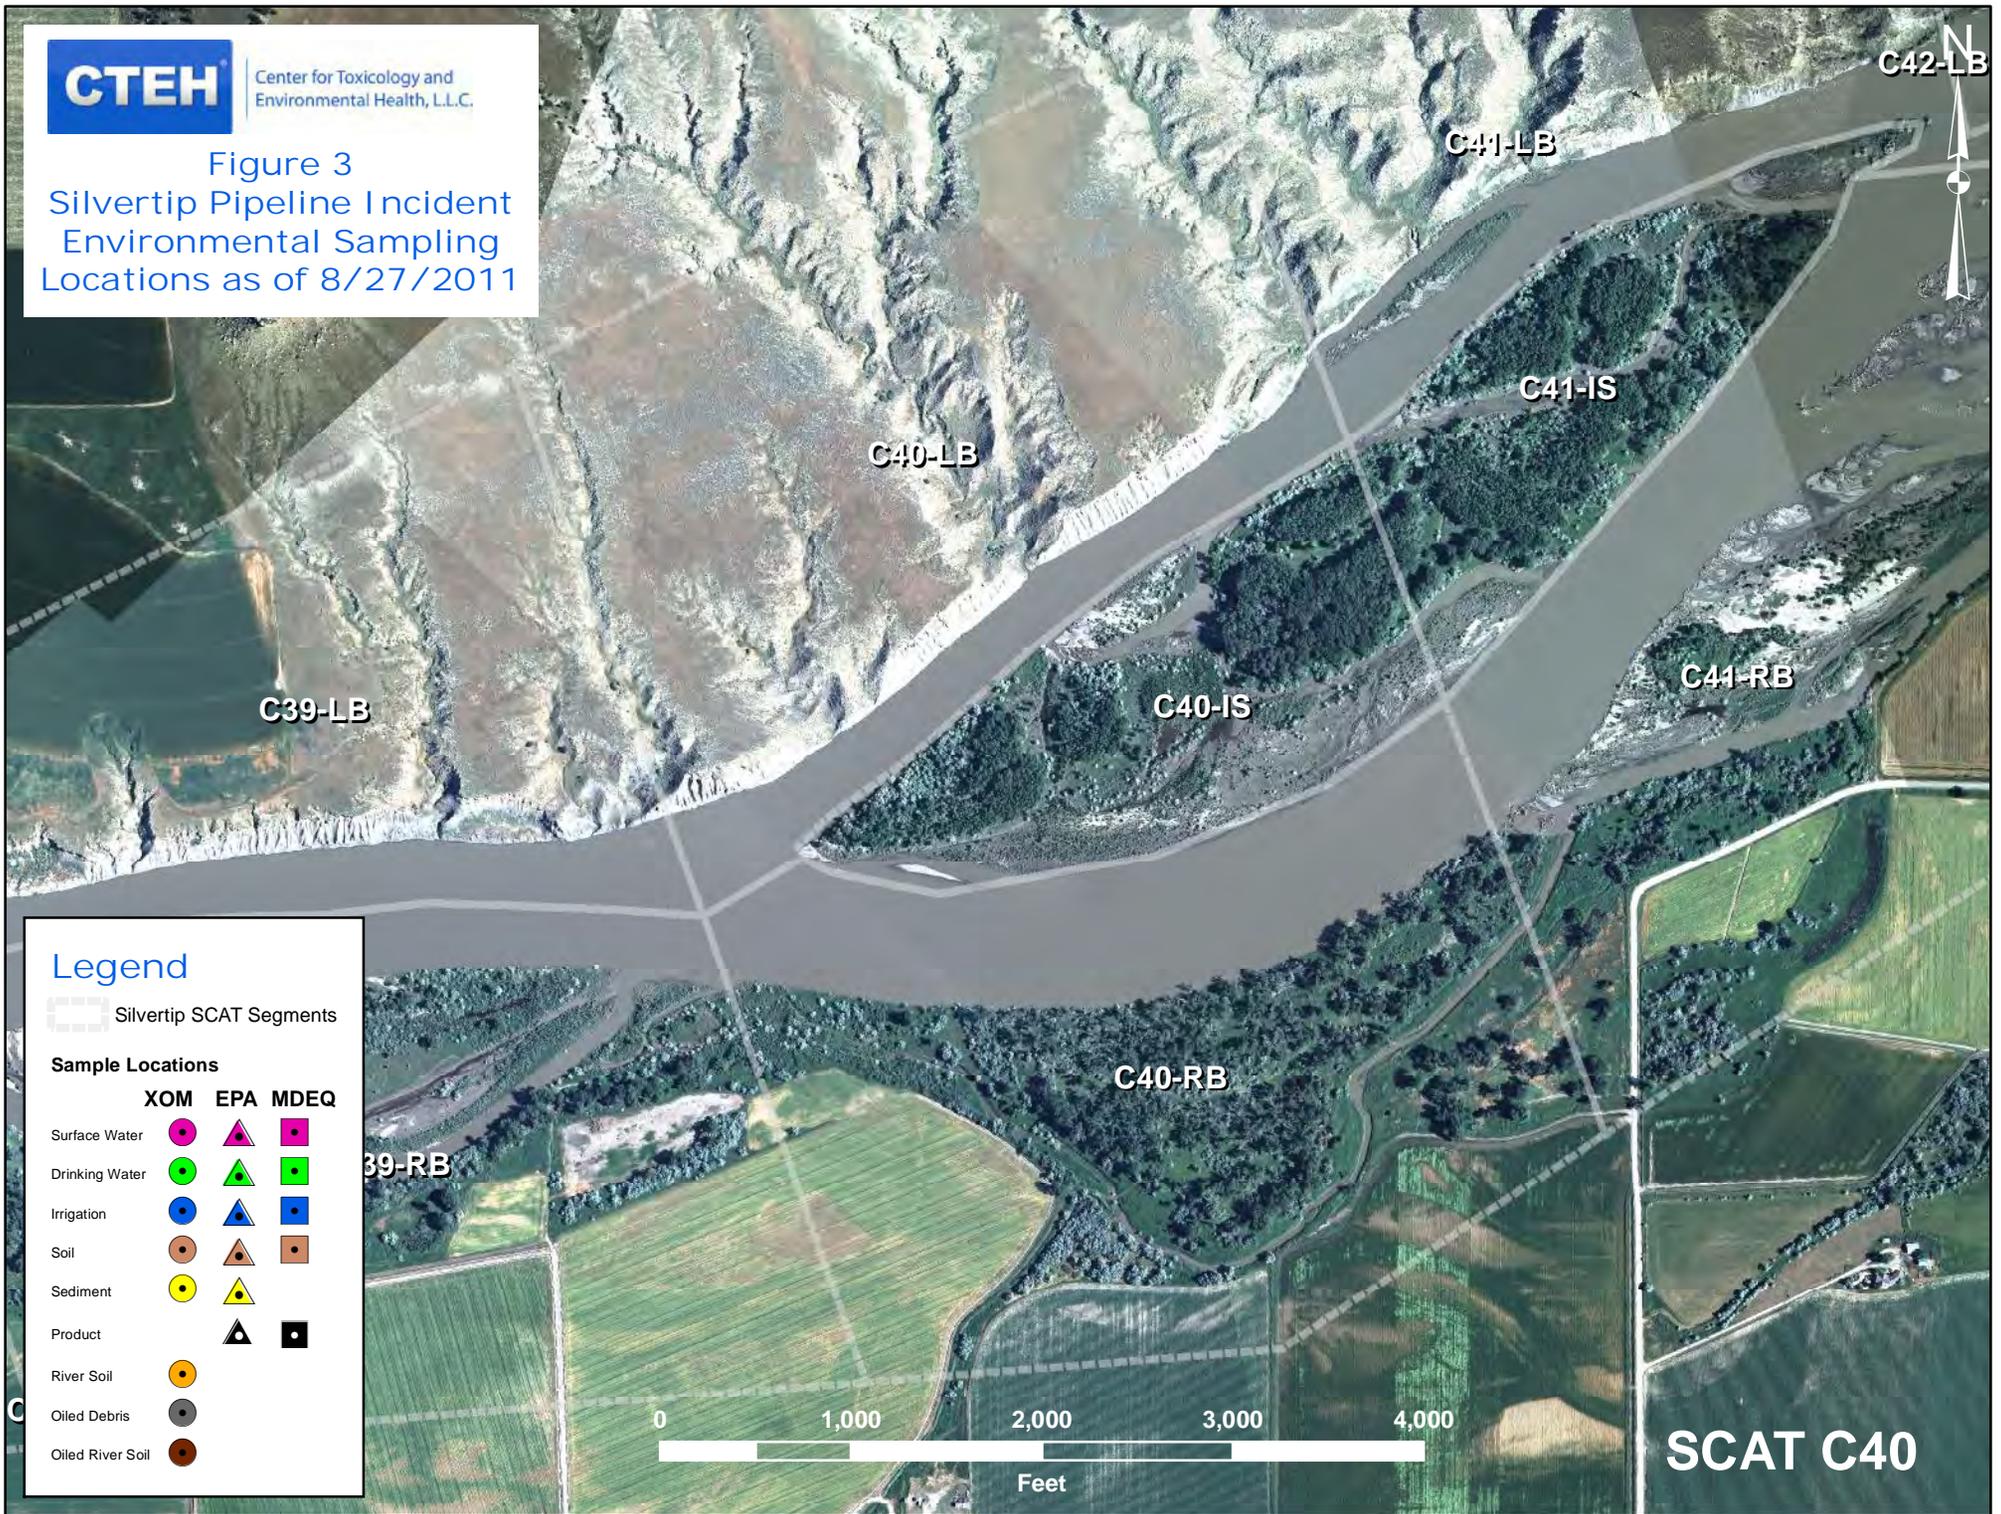
Figure 3
Silvertip Pipeline Incident
Environmental Sampling
Locations as of 8/27/2011

Table 1 (below) summarizes samples collected within Area C40. The analytical results for the samples collected can be accessed through a publicly accessible database on the United States Environmental Protection Agency's (USEPA's) website. The approximate locations of samples collected within Area C40 are provided on Figure 3. However, to date, no samples have been collected in this area.

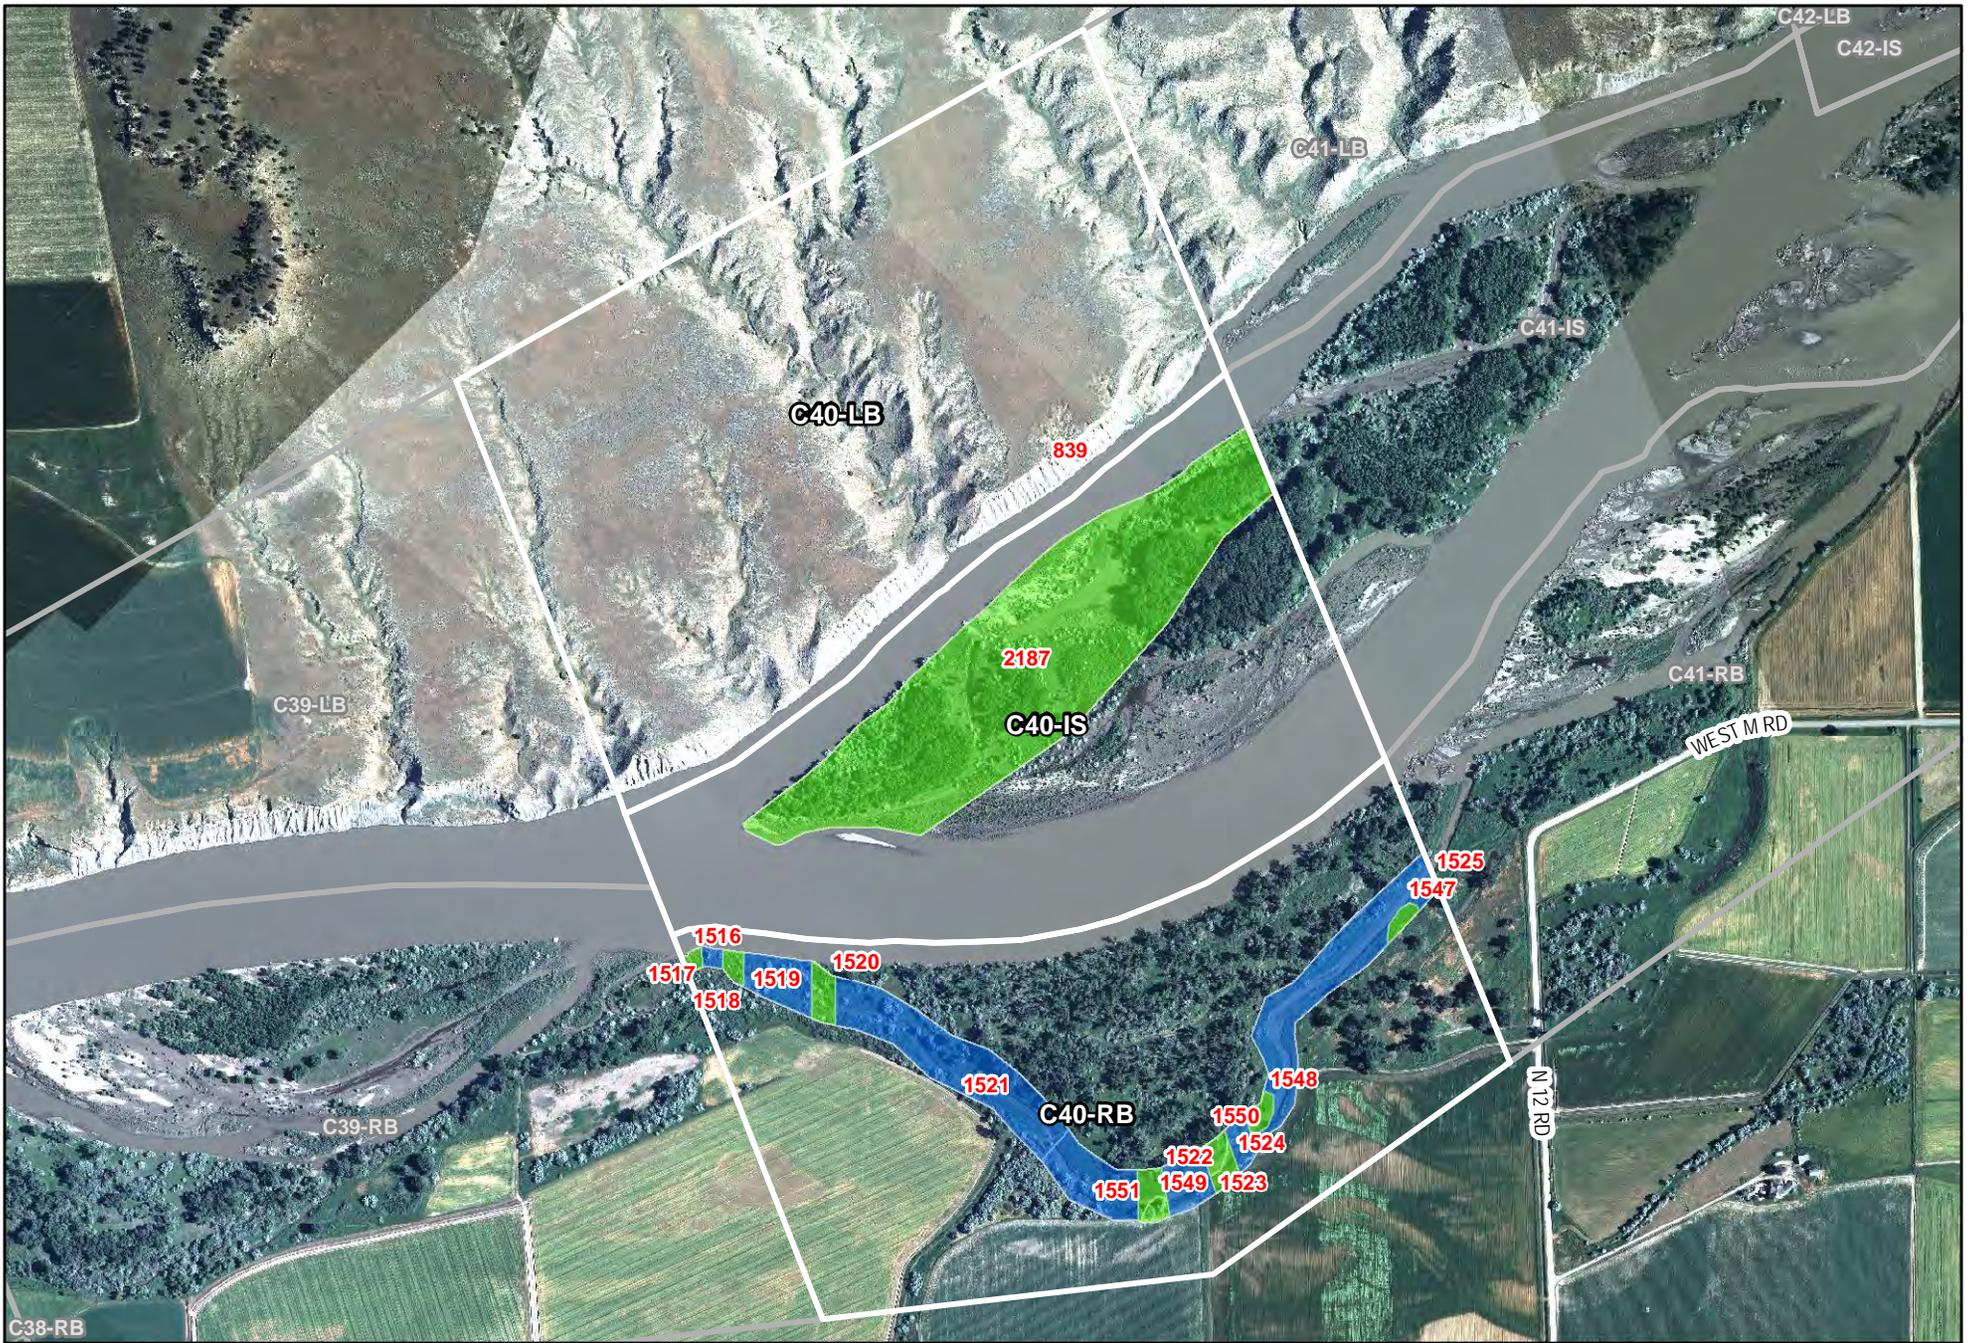
Figure 4 - Maximum SCAT Observations For SCAT Area:

The SCAT teams used systematic evaluation criteria and treatment method tables approved by the National Oceanic and Atmospheric Administration to provide a standard approach for data collection and conducting field surveys. The forms and sketches from the initial SCAT surveys performed along the river bank (water edge) and floodplain within Area C40 are included in Appendix B. Figure 4 provides the maximum oiling zones observed by the SCAT team during the initial surveys of Area C40.

Based on the initial SCAT survey performed within Area C40, only very light oiling was observed on a portion of the left and right banks and no oiling was observed in the remainder of Area C40. The very light oiling zones will be addressed through natural attenuation. Therefore, a PIST, POST, and final SCAT survey were not performed and a SCAT Segment Sign-Off Form is not necessary.

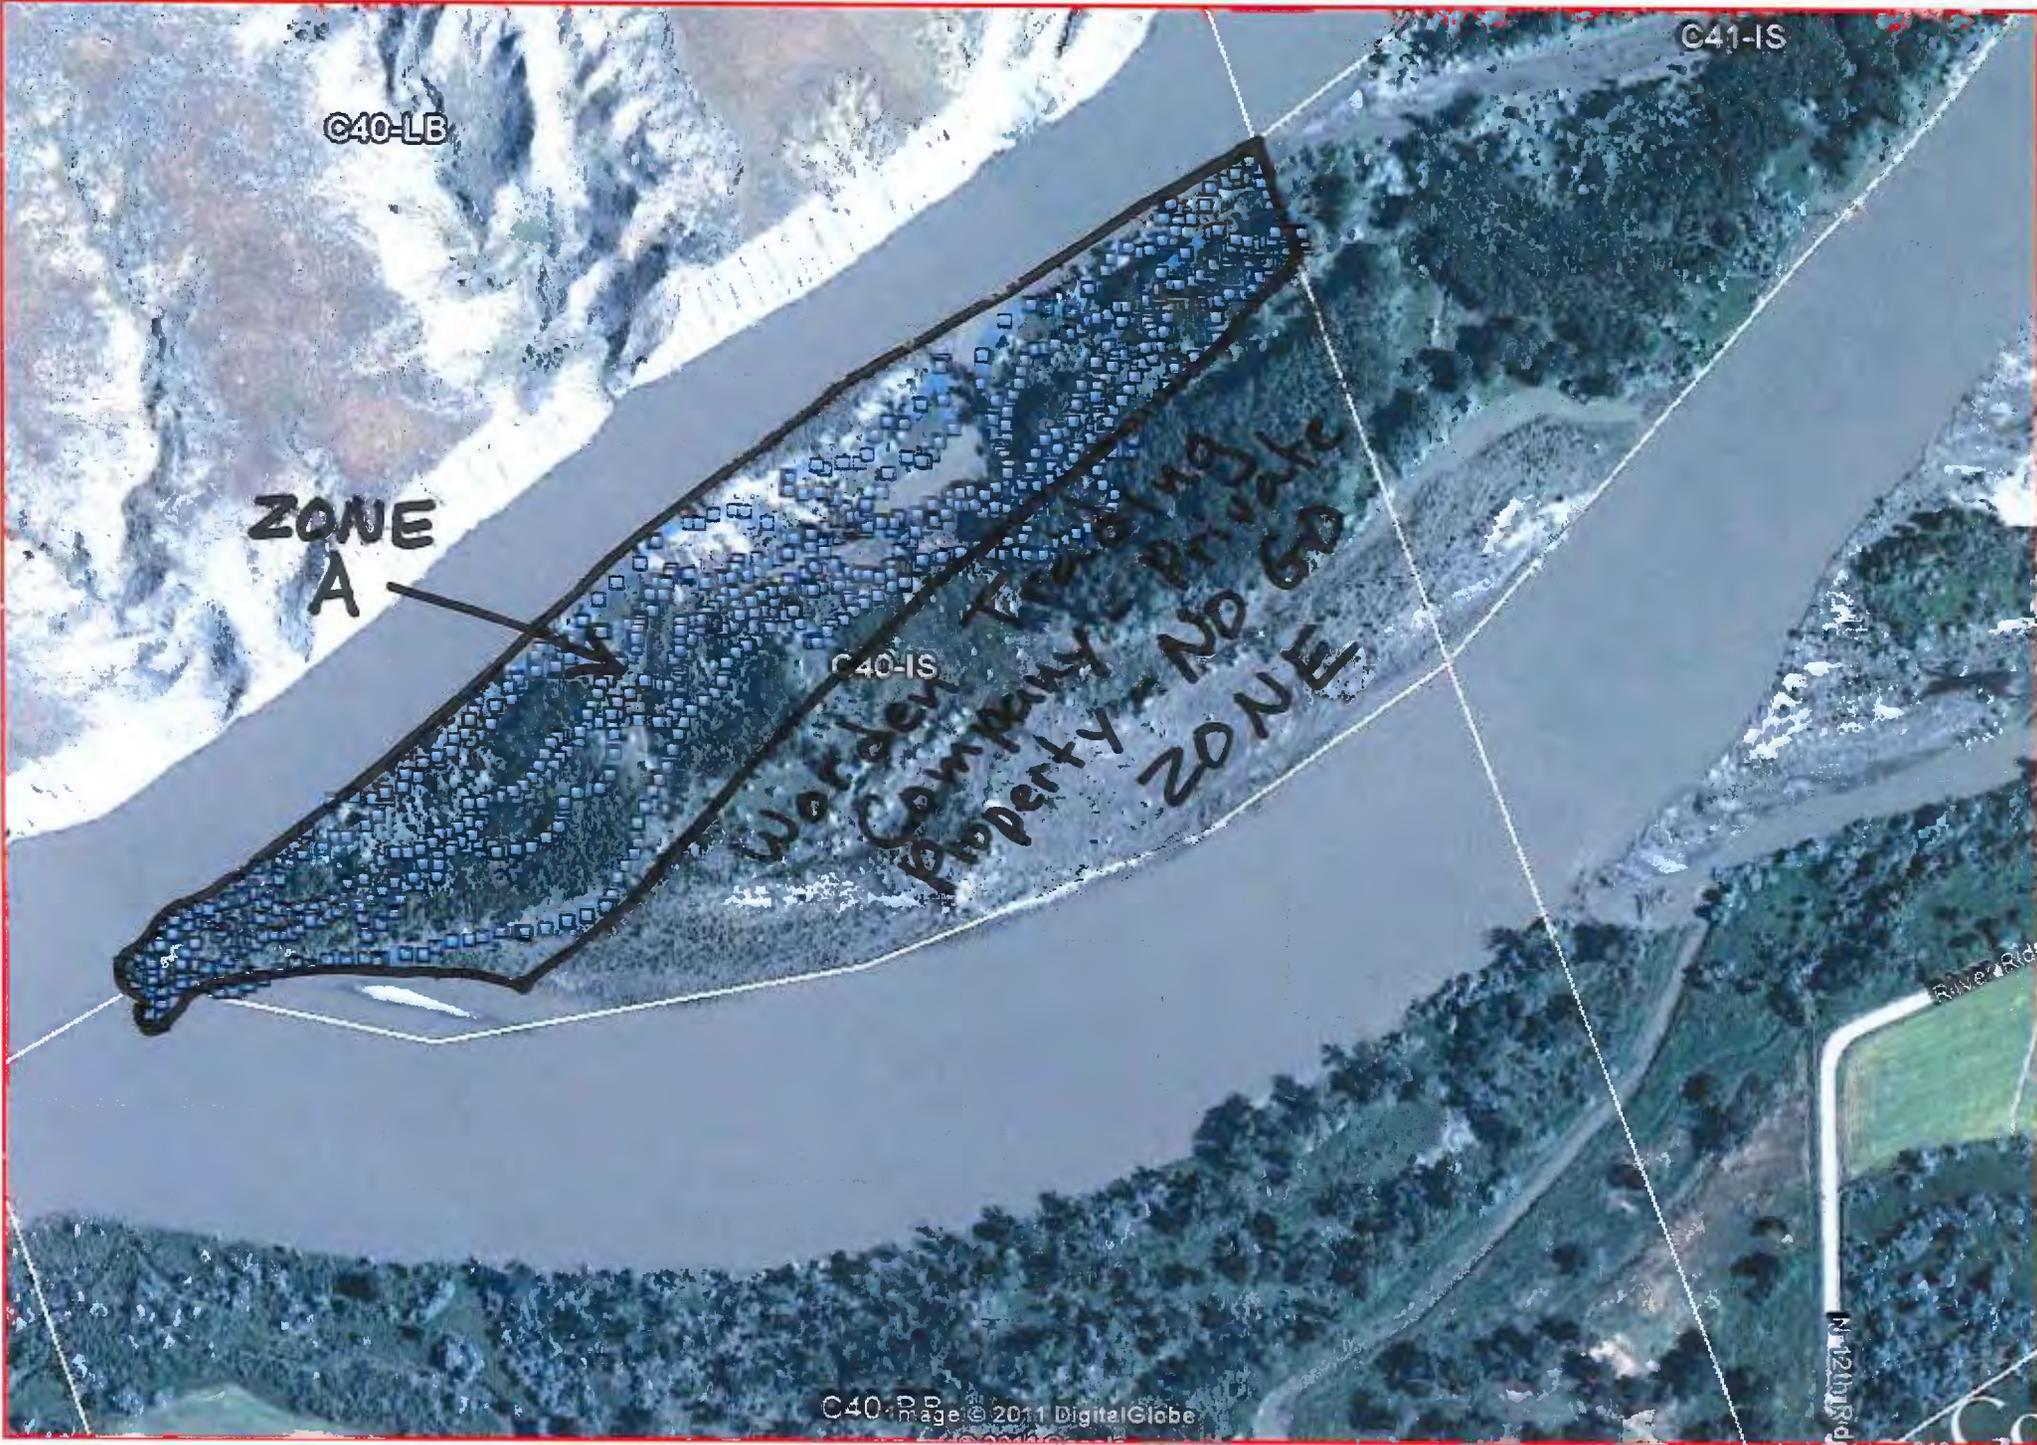
ZONE A: The product found and removed by the Hot Shot Team is far less than negligible trace in distribution (i.e. << 1/10,000 cover). All team members concur that the NEB is best achieved through Natural Attenuation

ZONE A = NFT

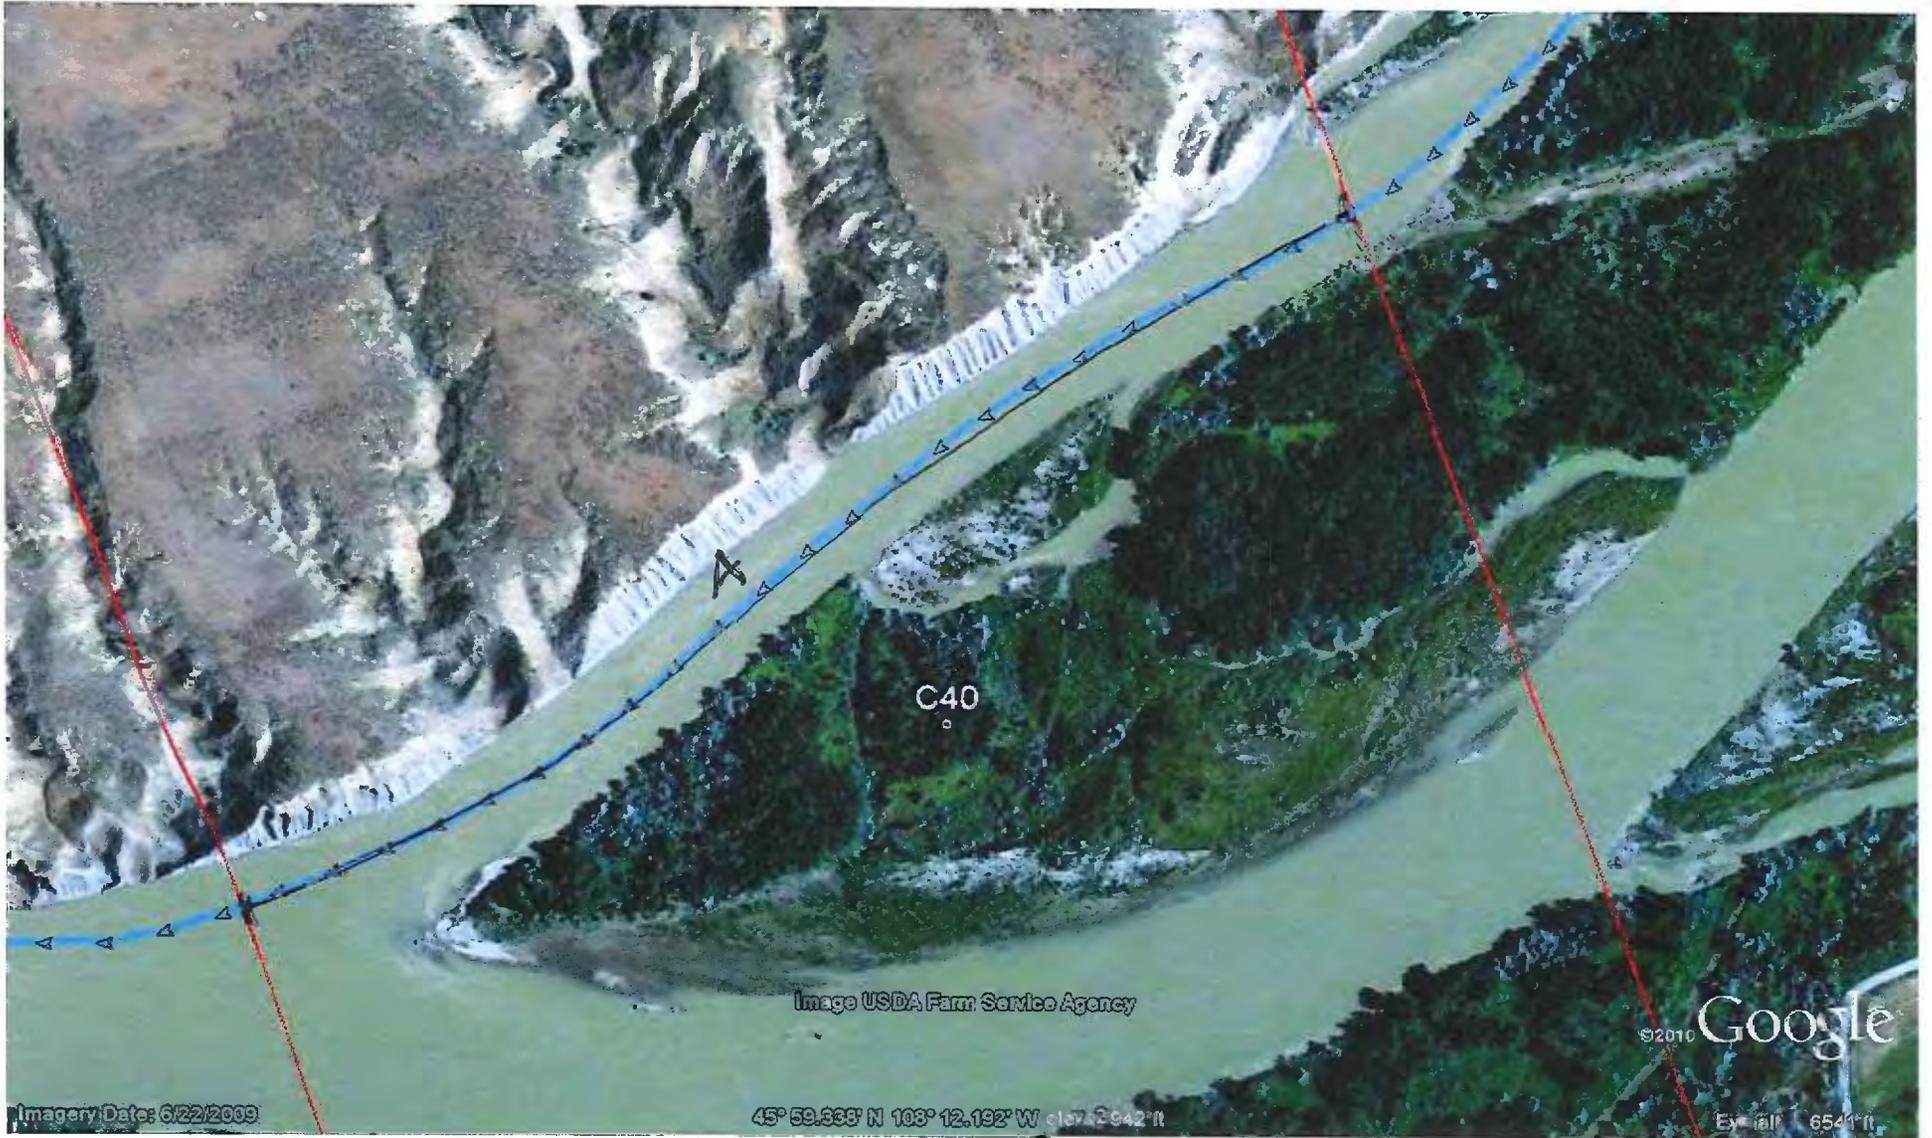
Zone A : No oil observed; no treatment required.

A = 216 + 656

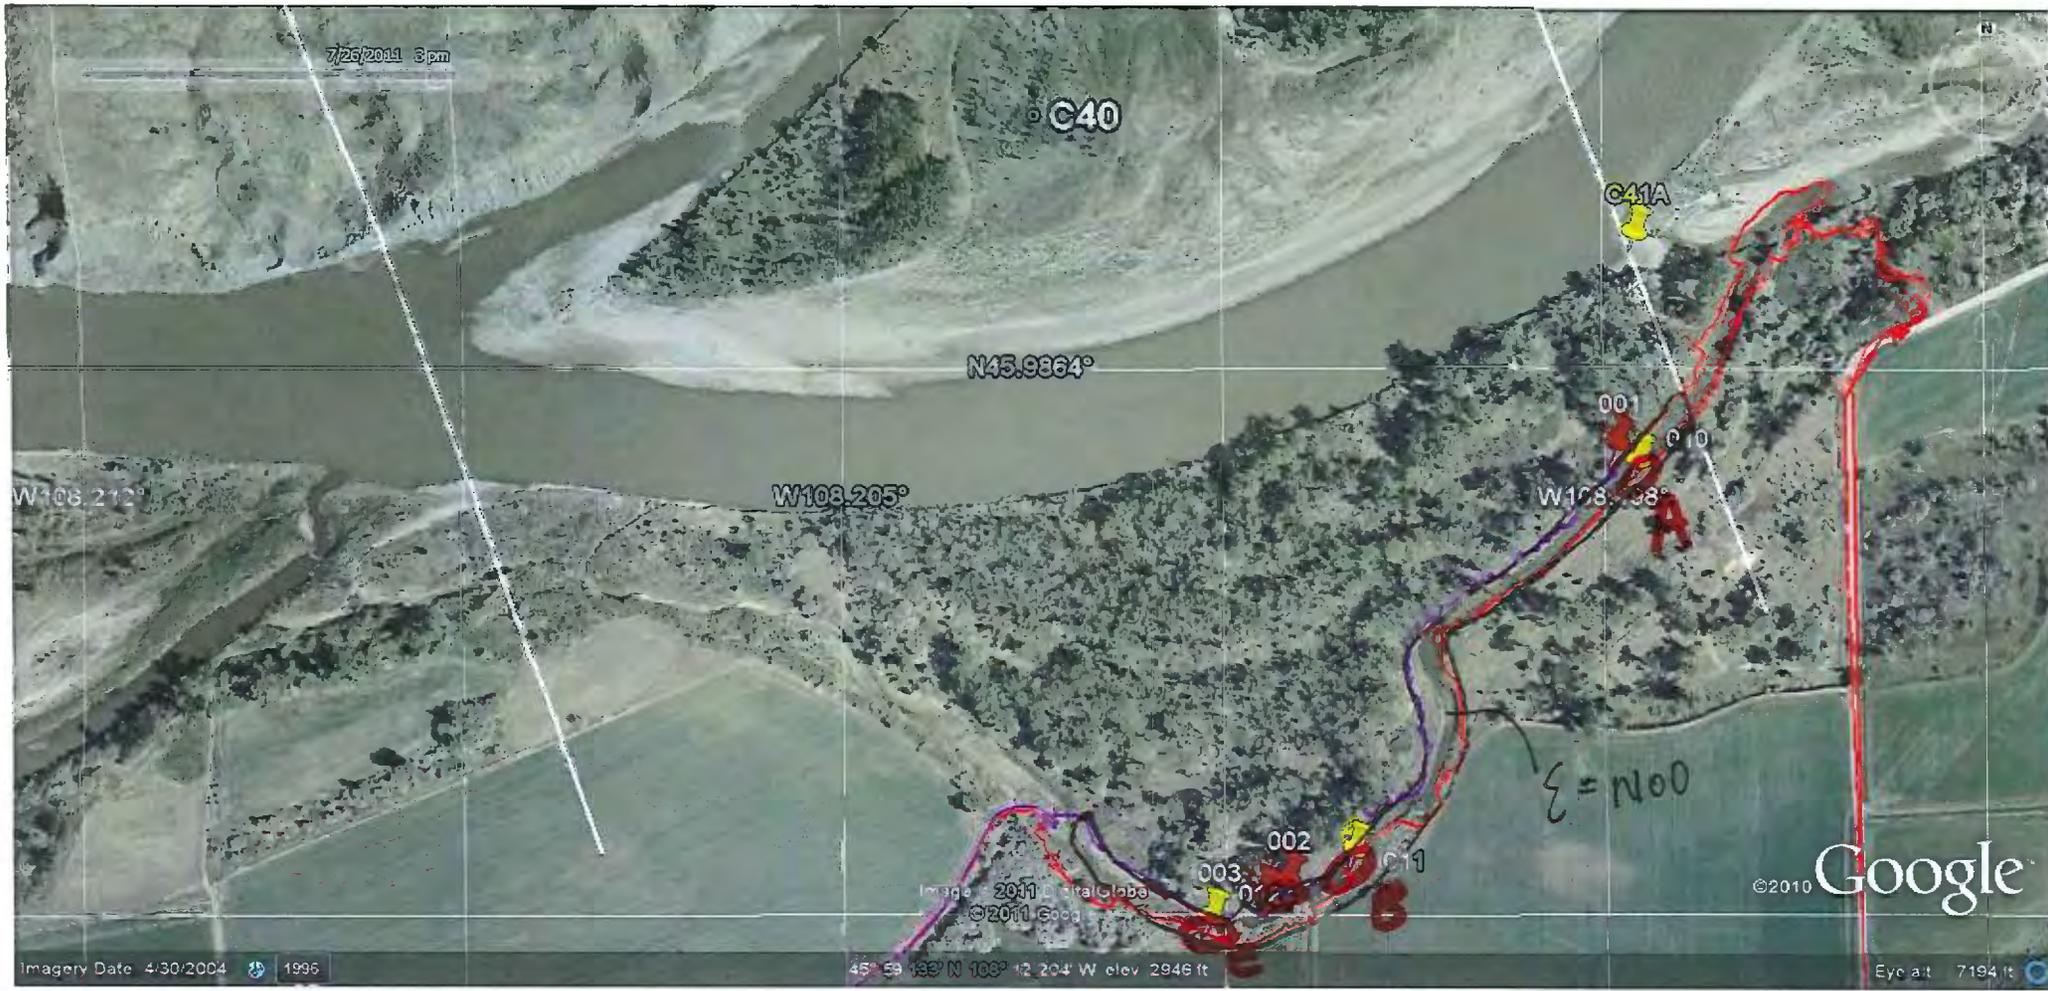
Segment C40 RB
 Team 3
 14 August 2011
 Partial Survey

Oiling in Zones A, B, C, and D is trace oiling on vegetation. The oiling is a tarry coat which is mostly non-transferable. Natural Attenuation or No Further Treatment is appropriate for the oiling in all four zones.

A = 1m x 5m	Stain on Vegetation	Very Light FI.	E = N00 (670m)
B = 1m x 3m	Stain on Vegetation	Very Light FI.	
C = 5m x 1m	Stain on Vegetation	Very Light FI.	
D = 5m x 1m	Stain on Vegetation	Very Light FI.
