REPORT OF INVESTIGATION
RED LODGE/BEARCREEK
SUBSIDENCE POTENTIAL STUDY

October 30, 1987

Subject: Report of Investigation Red Lodge/Bearcreek
Subsidence Potential Study
Project No. 87-3001.D

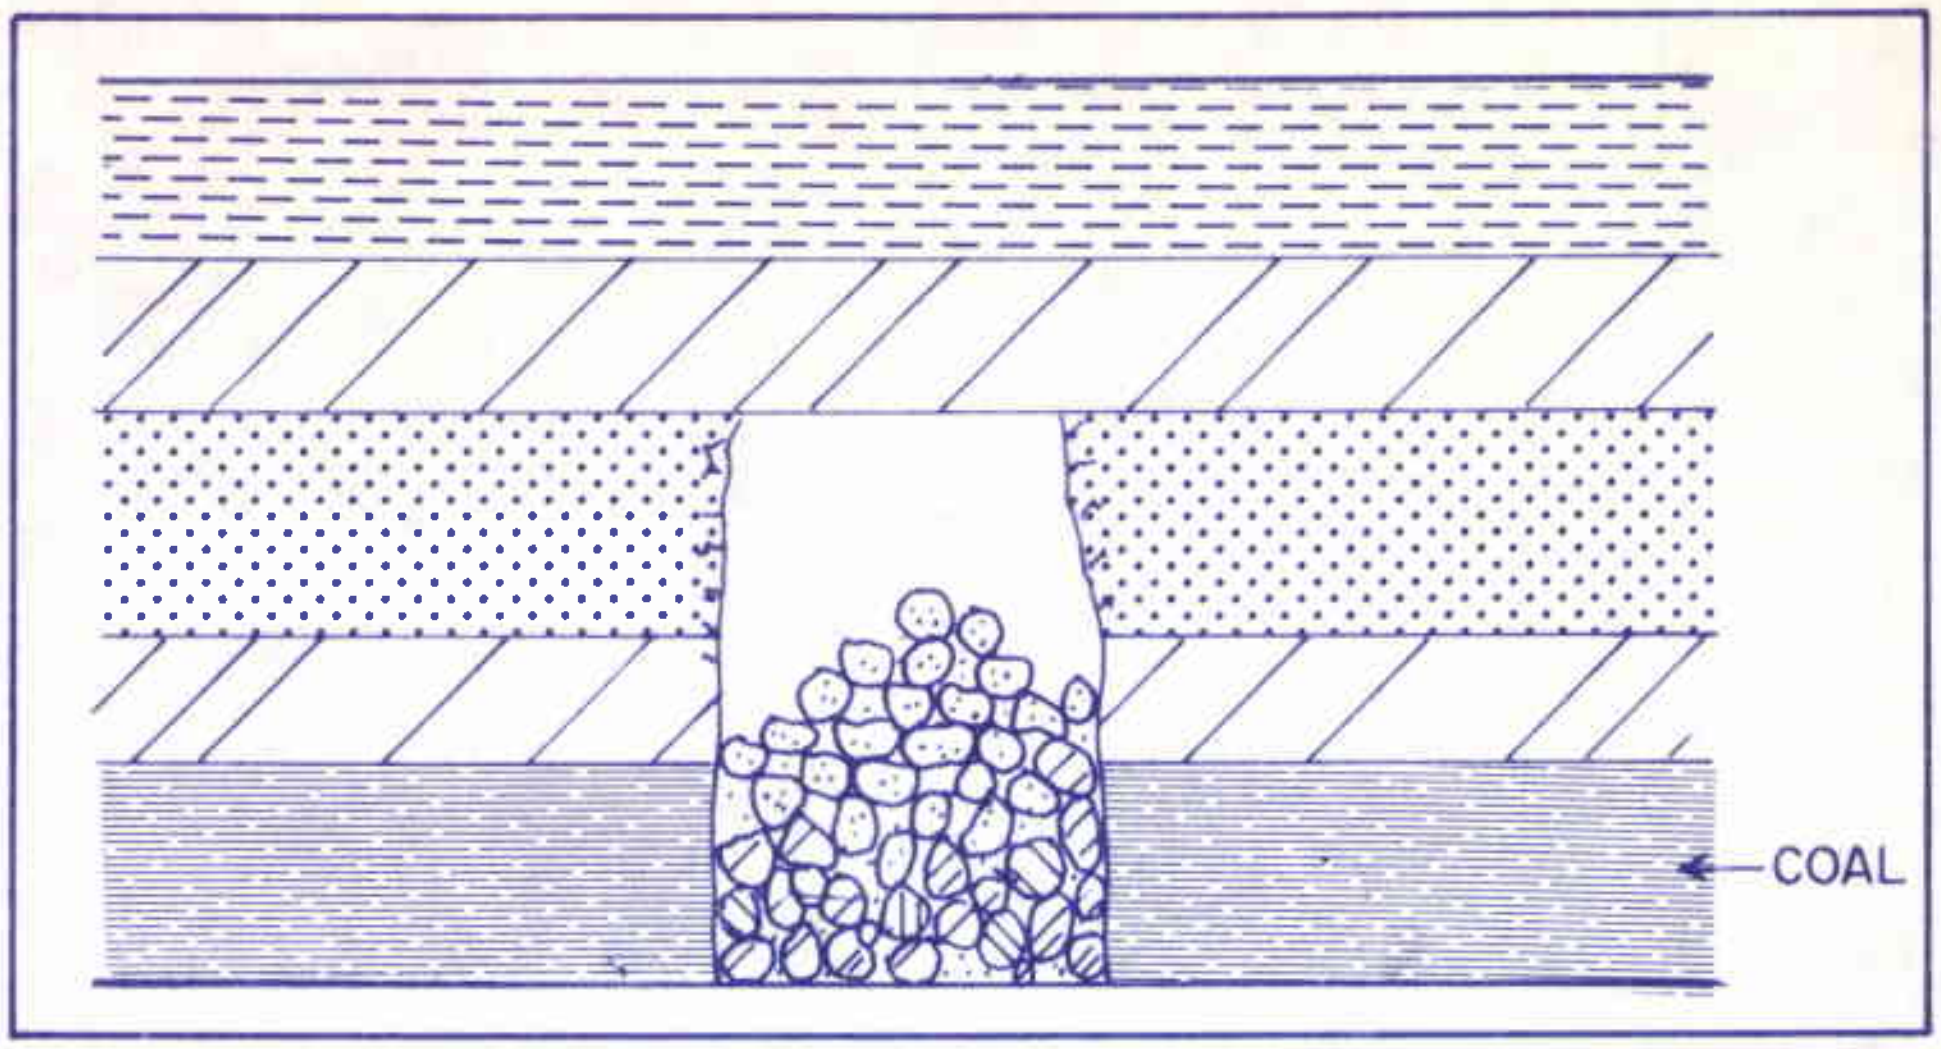
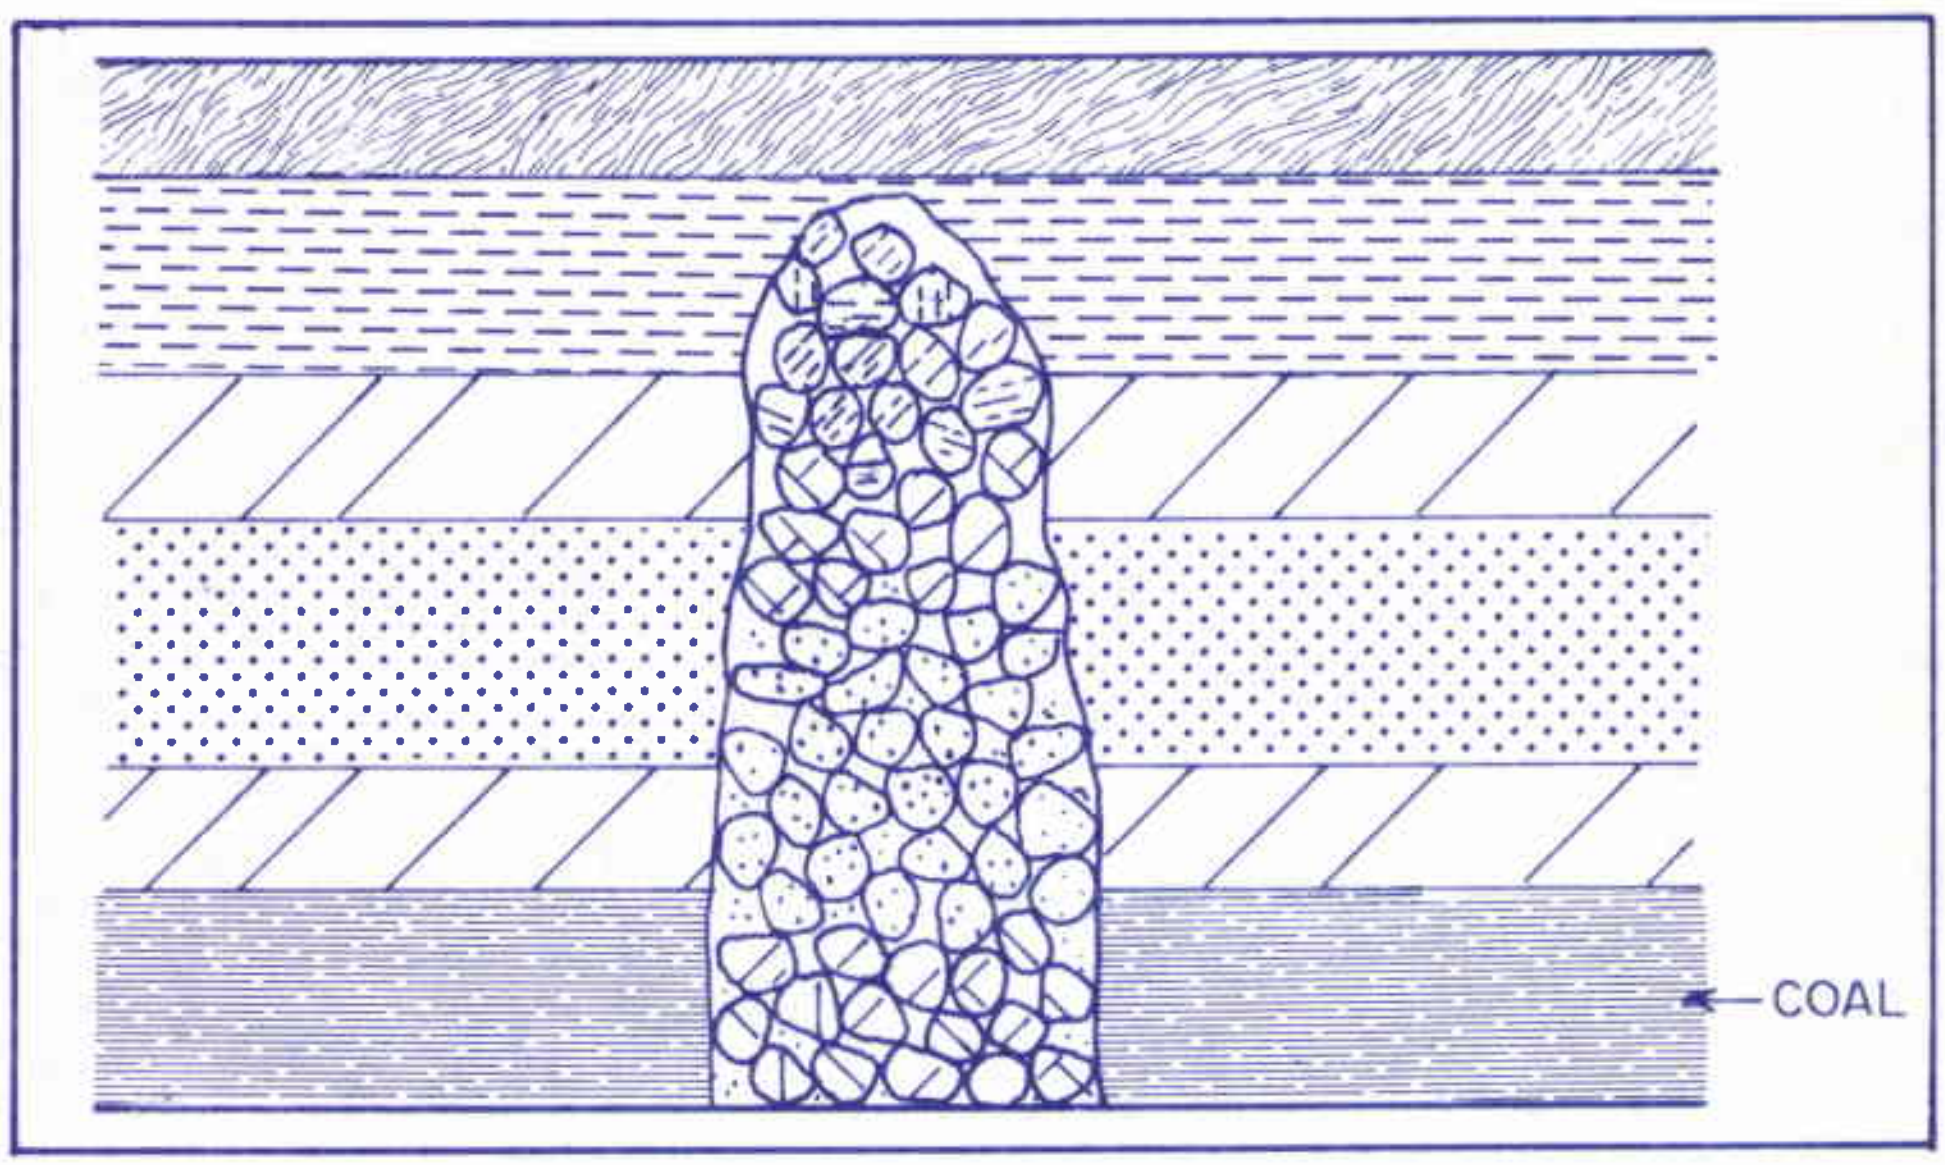
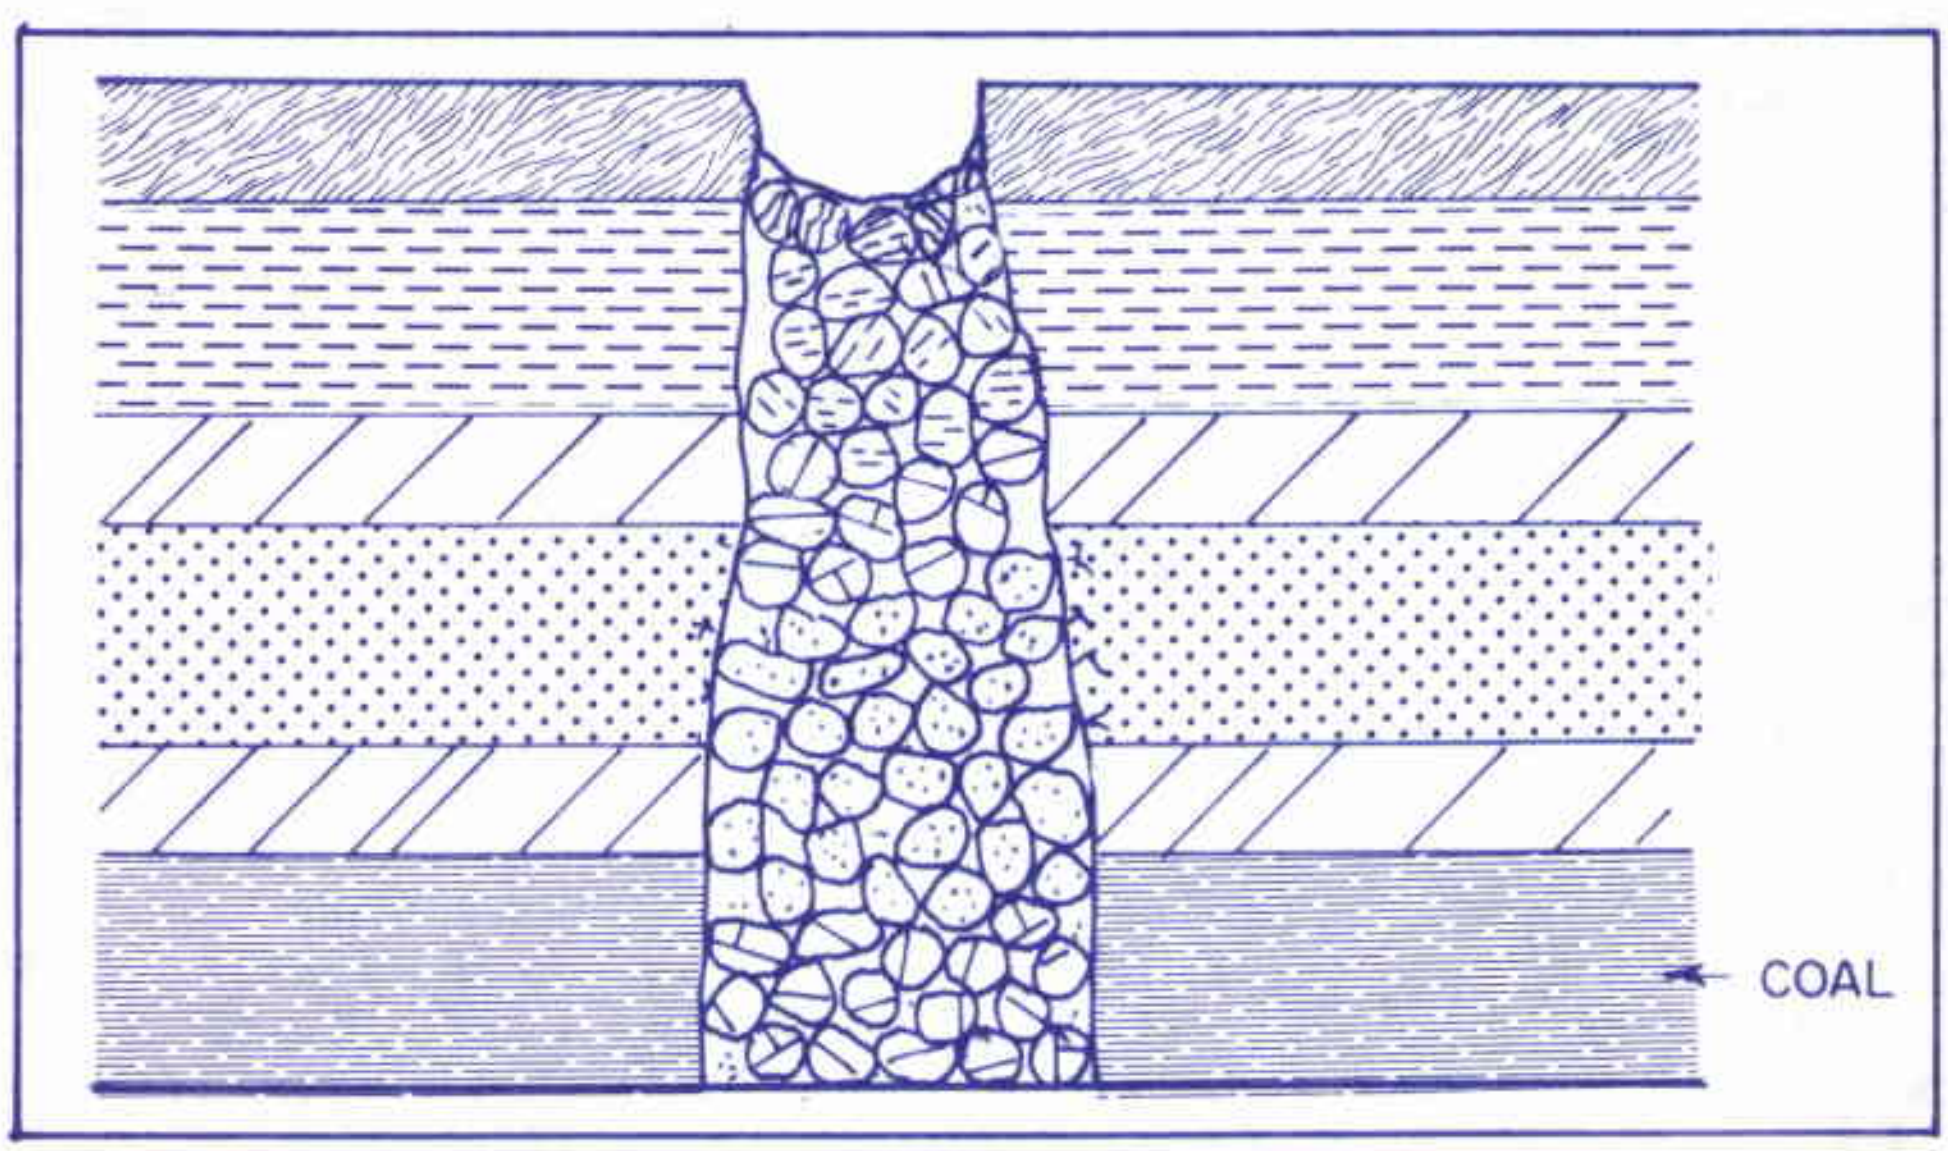
Figure 1 Chimney Subsidence Development

Figure 1 on page 9 shows the three outcomes of chimney subsidence; it can be arrested by a competent layer, by bulking or form a sinkhole at the surface. For this analysis it is assumed that caving will not be arrested by a competent layer; that is considered in the roof collapse discussion. As illustrated in Figure 1 the collapsed material contains voids and therefore occupies a greater volume than the intact material. Given a sufficient overburden thickness this bulking can effectively fill the void. Figure 2 presents heights of caving ratios for various void geometries and bulking factors. A bulking factor in the range of 0.2 has been inferred as an average value for western coal fields from observations by others(2 & 3). Using that value the maximum height of collapse for this mode is in the range of 5 to 15 times the mined seam thickness, for horizontal seams. For the case of a dipping seam it is possible for conical and elliptical chimneys to progress farther. Those two geometries involve limited areas rather than entire rooms. As a result a sloping floor allows material to initially roll away from the collapse location, so a larger area of the room fills with collapsed material before bulking can begin to fill the immediate chimney location. The additional volume of material cannot be easily quantified because it is a function of several variables including horizontal dimensions of the chimney, floor inclination, and location within the room. For the worst case conditions our calculation indicates the volume of additional material flowing out into an inclined room can be about twice that for a horizontal room. Consequently, for worst case conditions, it is possible for conical and elliptical chimneys having small horizontal dimensions to progress nearly twice as far as indicated by Figure 2. However, small chimneys are more prone to being arrested by a more competent layer and therefore rarely reach the surface.

Figure 1a. Caving Arrested by a Competent Stratum

Figure 1b. Arrested by Bulking of Roof Debris

Figure 1c. Formation of a Sinkhole at the Surface

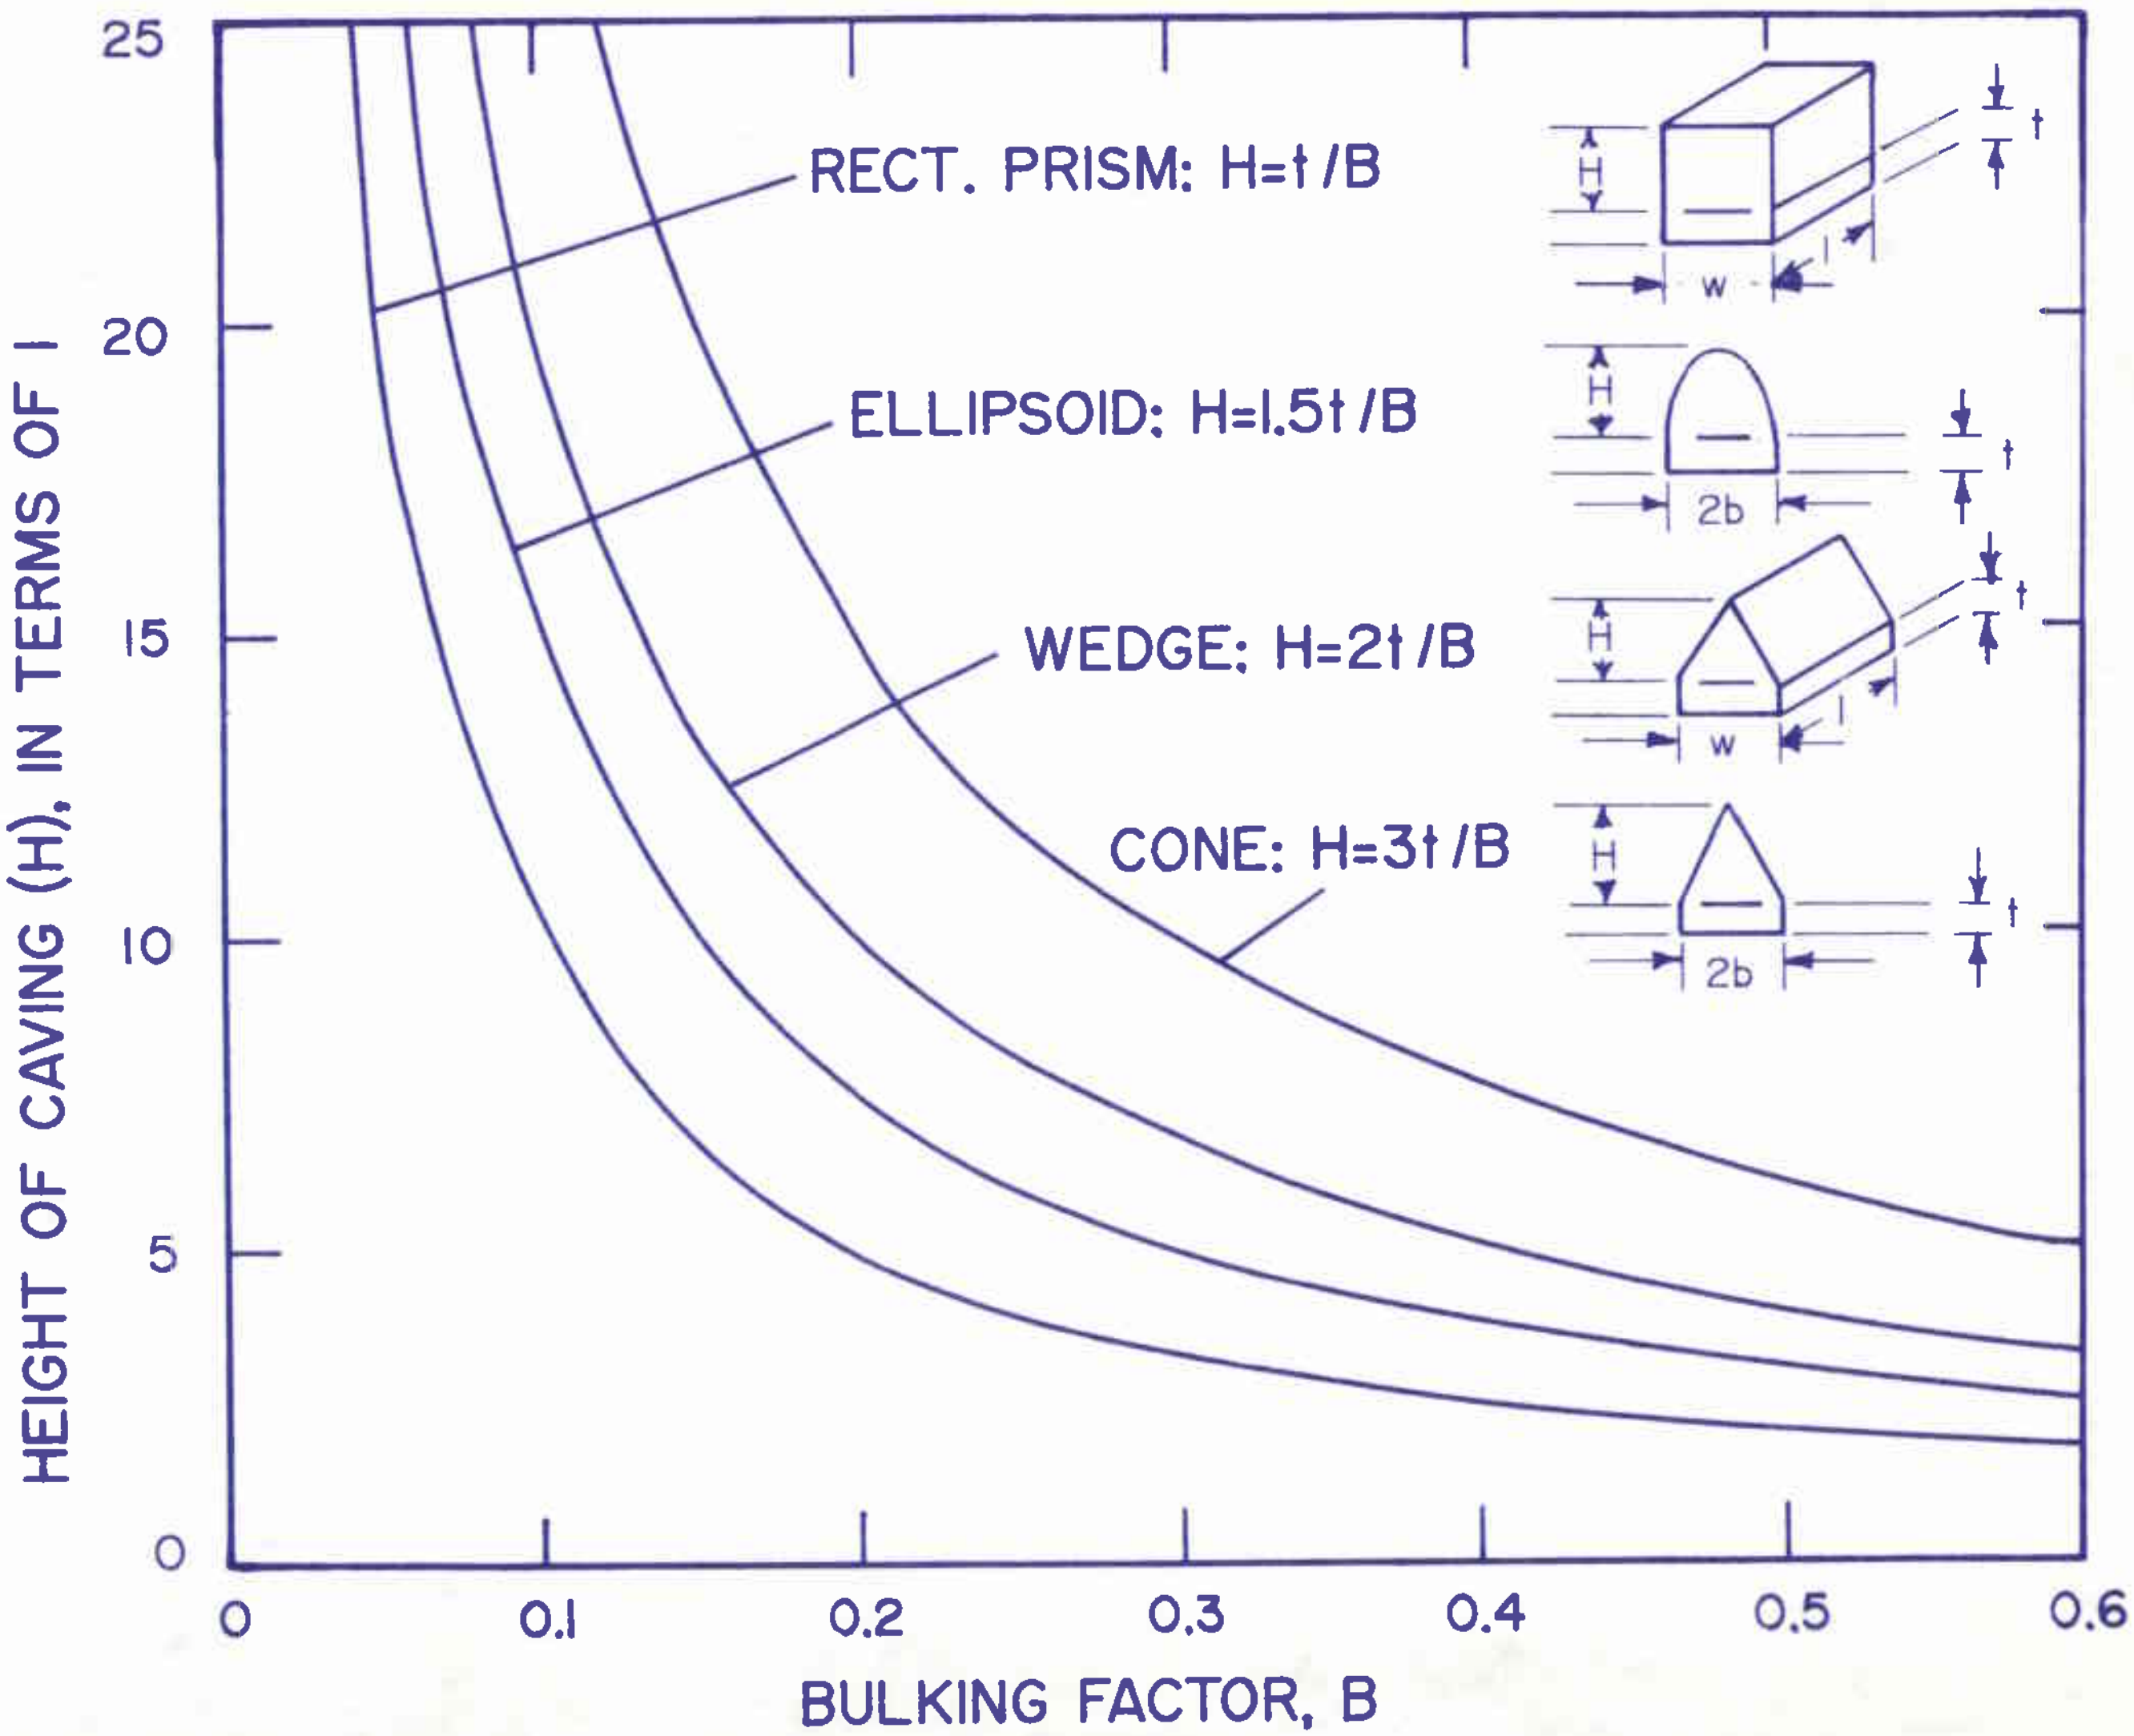
Figure 2 Maximum Height of Stoping

DH-2 was intentionally located where maps show extensive pillar robbing. For that area, we would expect the prism geometry of chimney subsidence to most accurately represent the height for collapse to progress. From the condition of the core and projected mine roof elevation, it appears the height of collapse was limited to 20 feet or less. Based on an average seam thickness of 5.5 feet, Figure 2. suggests a bulking factor in the range of 0.3 for that area.

In consideration of the conditions encountered in DH-2 and other borings, along with the special circumstances that could allow conical and elliptical chimneys to propagate farther than indicated by Figure 2, we selected the following criteria to assign subsidence potential:

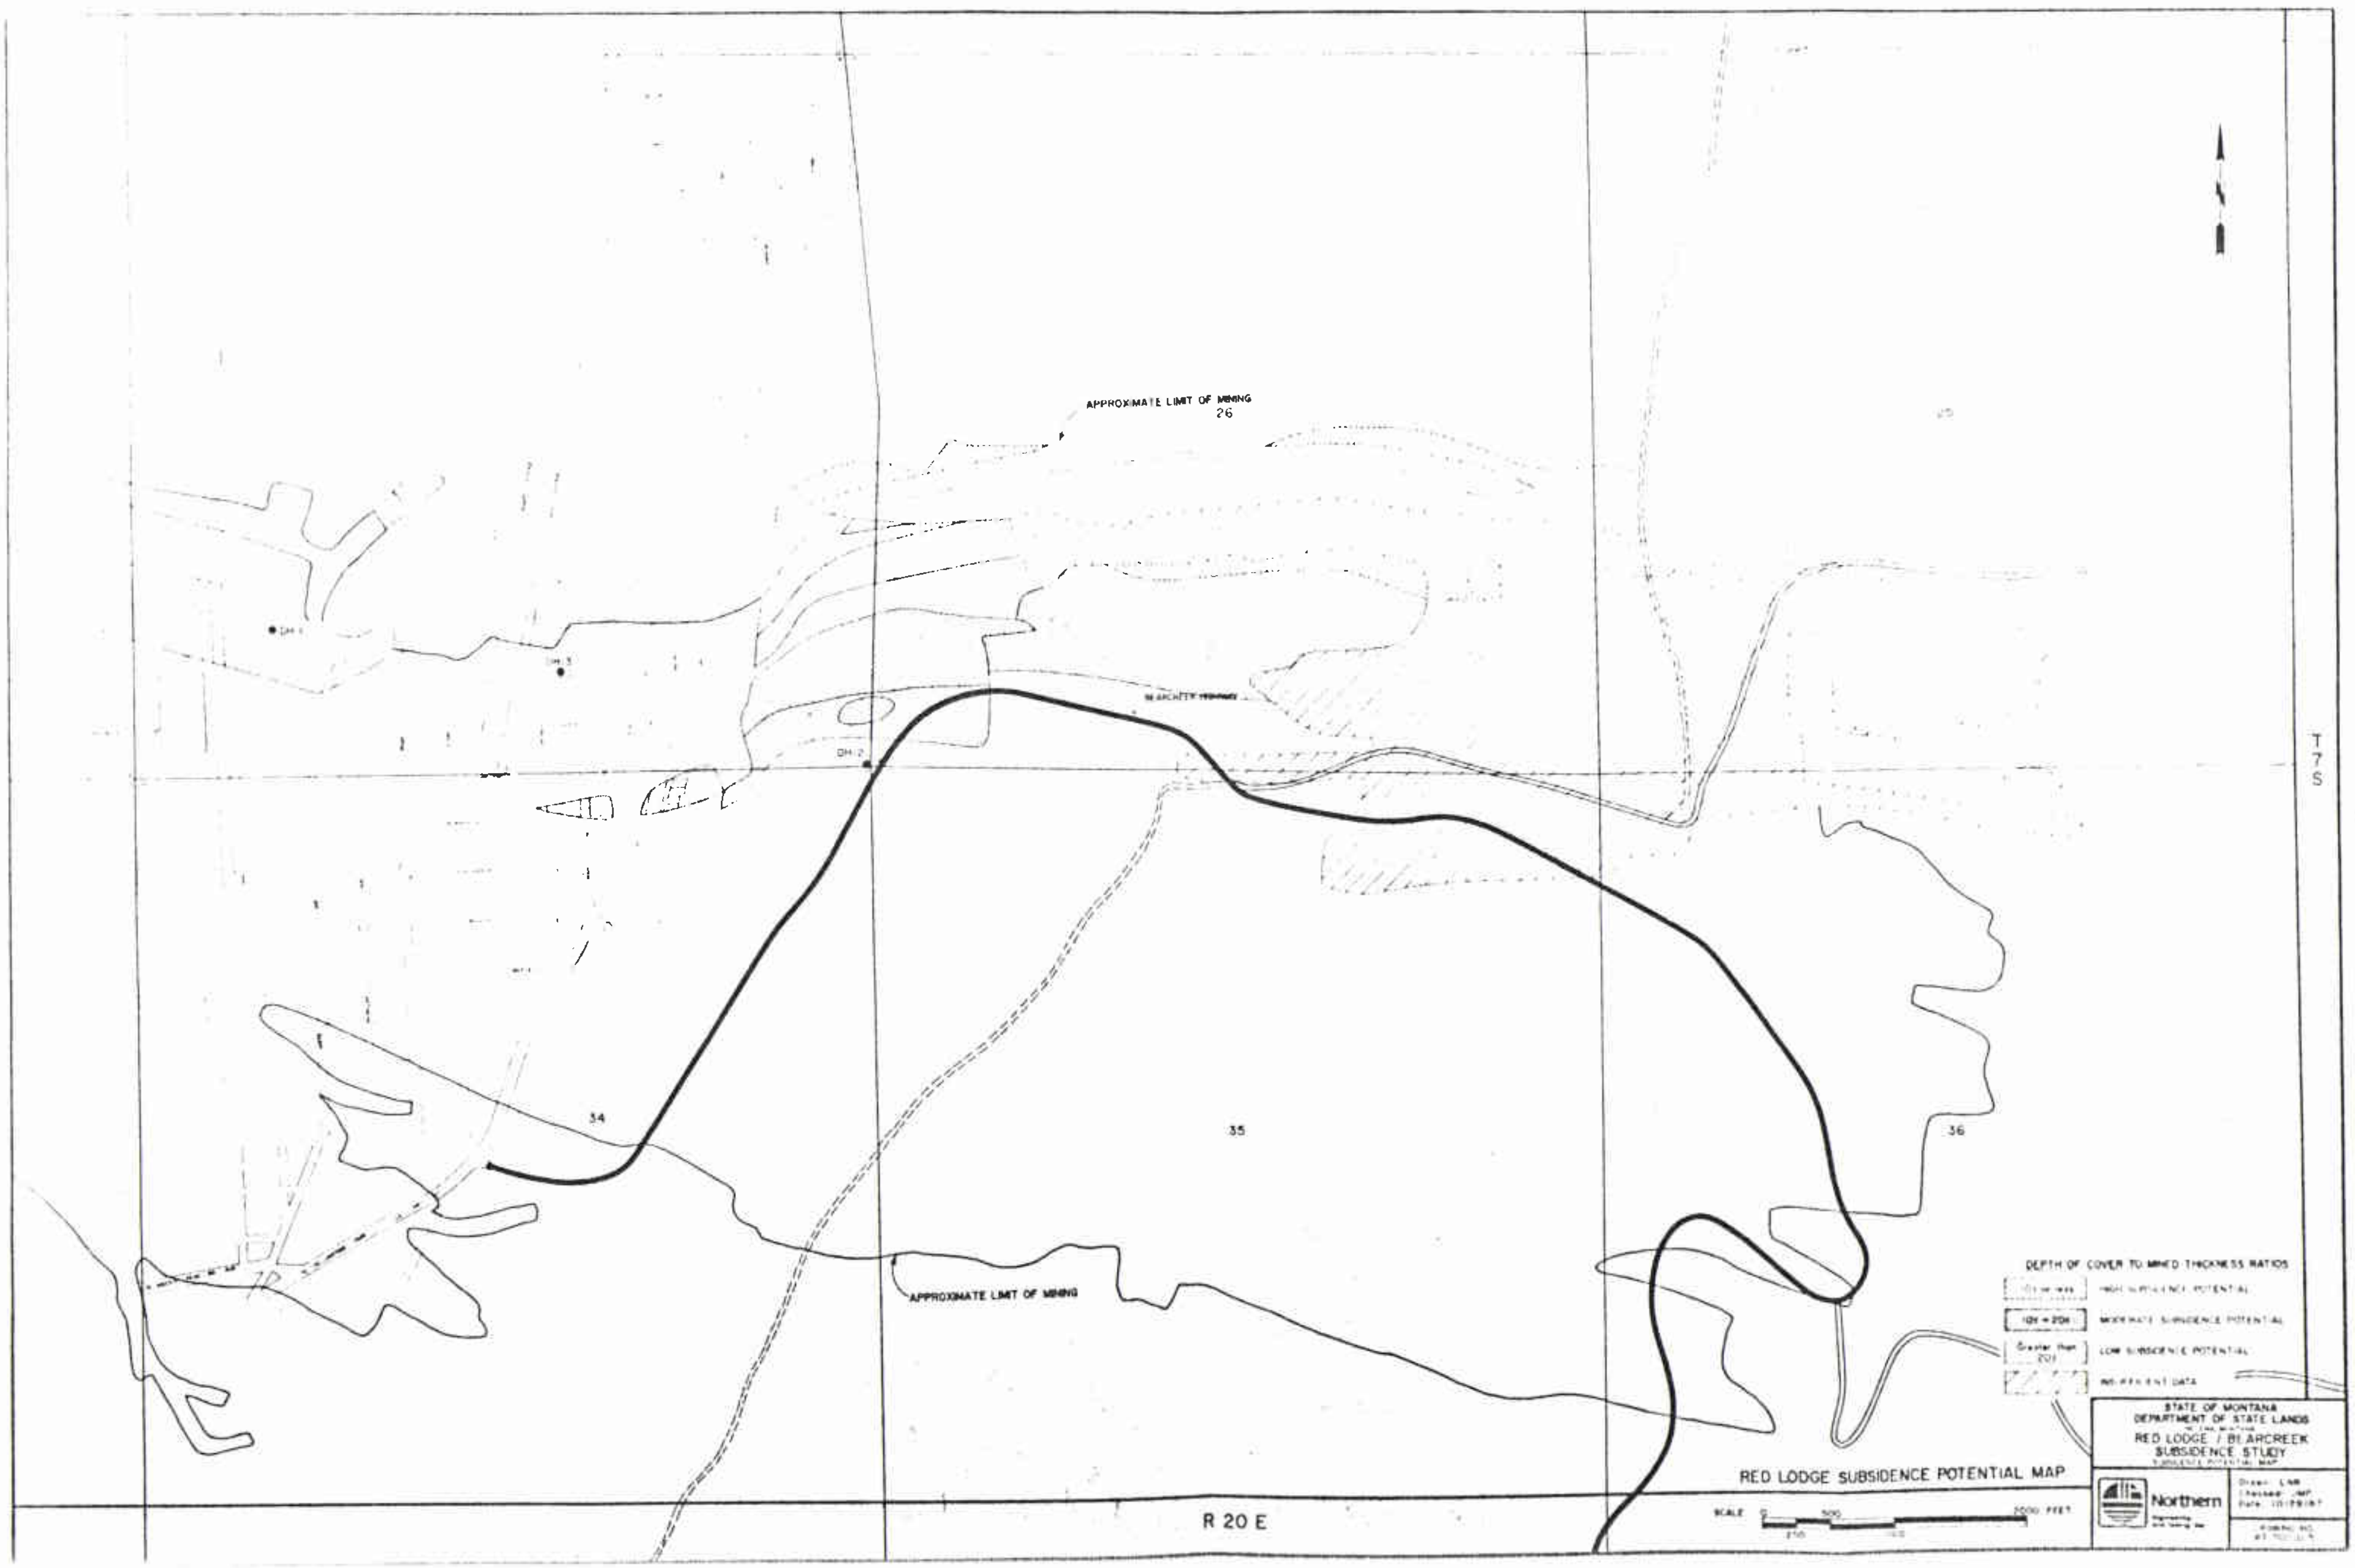
T 7 S
APPROXIMATE LIMIT OF MINING
26
DH-2
34
35
36
APPROXIMATE LIMIT OF MINING
DEPTH OF COVER TO MINED THICKNESS RATIOS
10t + 20t
MODERATE SUBSIDENCE POTENTIAL
Greater than 20t
LOW SUBSIDENCE POTENTIAL
INSUFFICIENT DATA
STATE OF MONTANA
DEPARTMENT OF STATE LANDS
RED LODGE / BEARCREEK
SUBSIDENCE STUDY
Northern
RED LODGE SUBSIDENCE POTENTIAL MAP
SCALE
2000 FEET
R 20 E

4. The potential for future subsidence is considered high only on the Bill Palmer property east of Red Lodge, near the west end of 10th Street, and above shallow adits in the Bearcreek area. It is predicted to consist of chimney subsidences similar to previous occurrences.

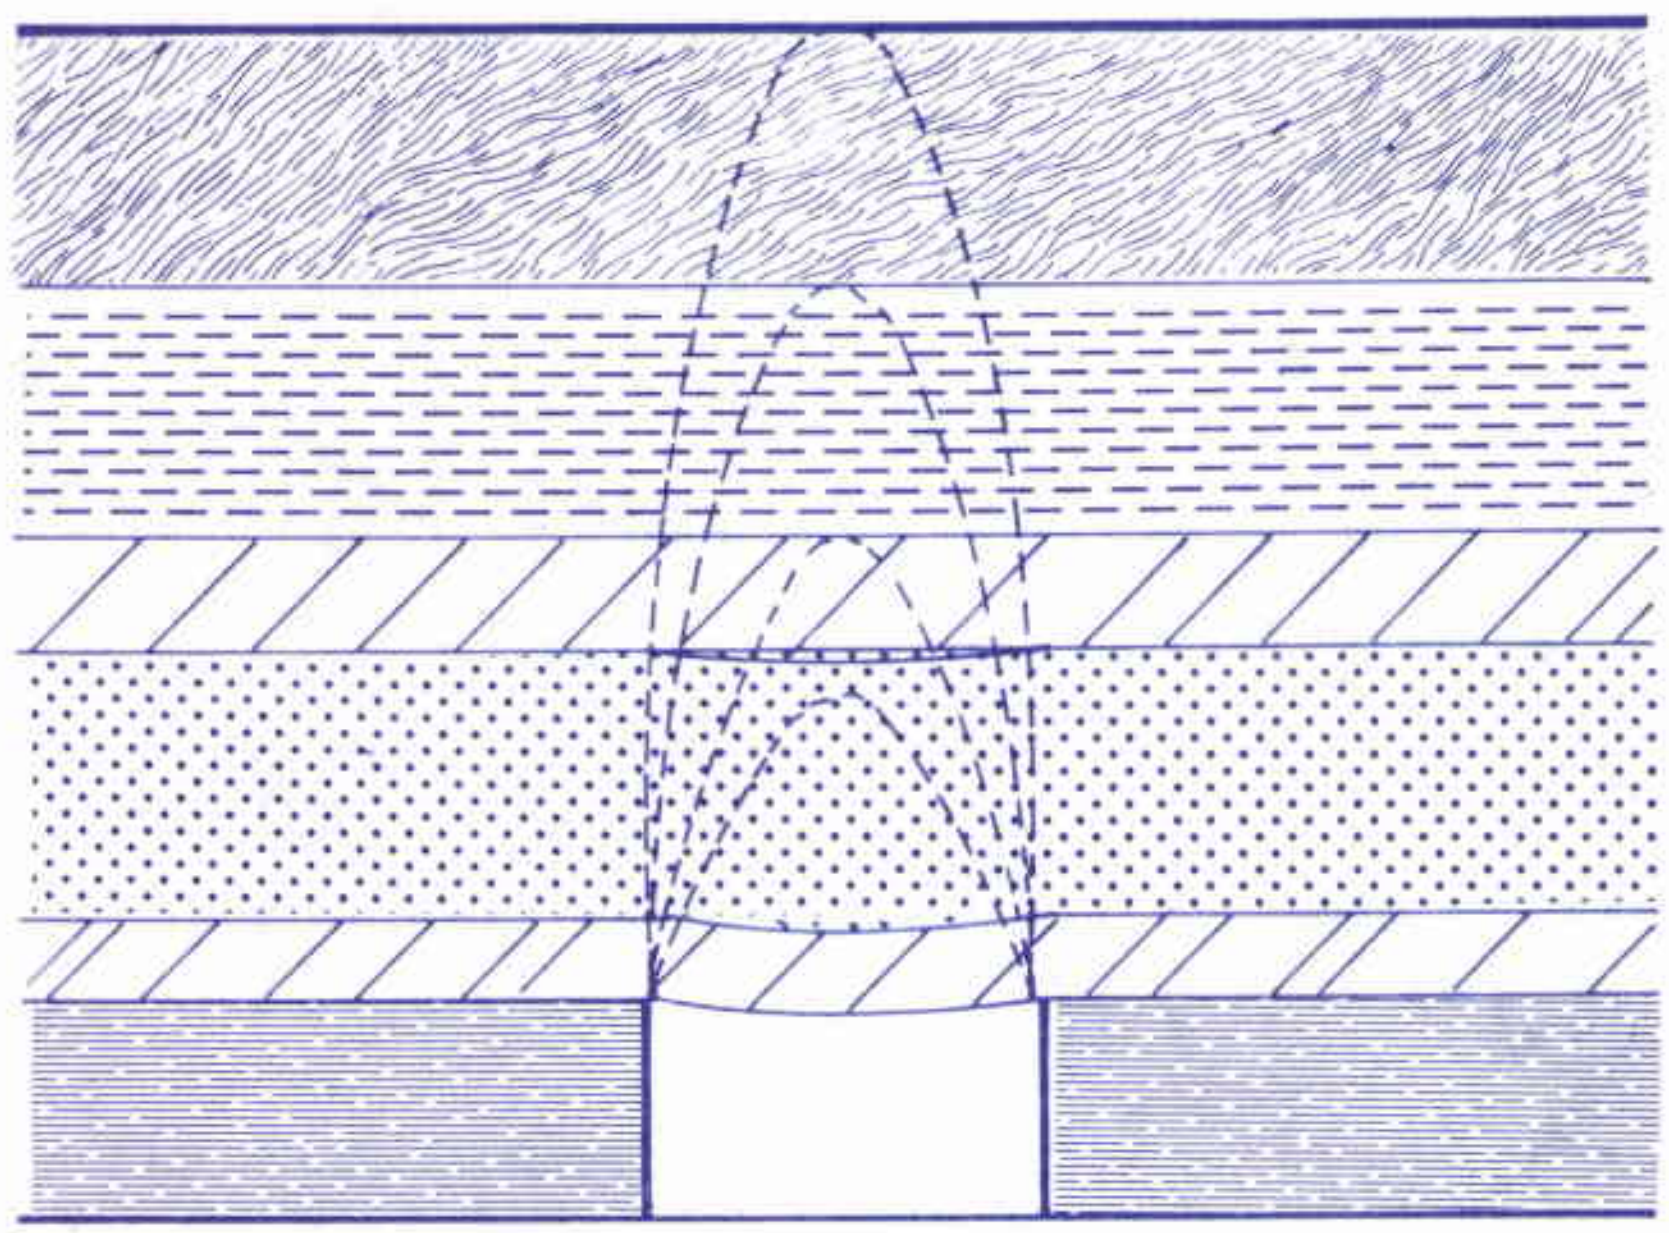
Figure 3 Deflection of the Roof Beams, Bed Separation, and Roof Stress Variation.

The mechanism of mine roof collapse is simply a large scale version of chimney subsidence. The concept of the theory is illustrated in Figure 3. The rock layers above the mine are analyzed as a series of beams. Beam thickness is dependent upon thickness of major rock types or bedding or discontinuity characteristics. Each beam is assigned a unit weight, tensile strength and elastic modulus. Initally calculations are made to estimate the deflection of each beam for determining if beams act independently or as composites. In a system of several beams both independent and composite beams can exist in the profile. A sample calculation is presented in Appendix B along with results of specific cases analyzed. Profiles at specific hole locations were modeled using three or four beams. The first beam consisted of the alluvium, having weight but contributing no strength. Subsequent beam dimensions and material properties were selected based upon the log of each hole and laboratory test results. The idealized profiles and material properties analyzed are presented in Figure 4.
