REPORT OF INVESTIGATION
RED LODGE/BEARCREEK
SUBSIDENCE POTENTIAL STUDY

October 30, 1987

Subject: Report of Investigation Red Lodge/Bearcreek
Subsidence Potential Study
Project No. 87-3001.D

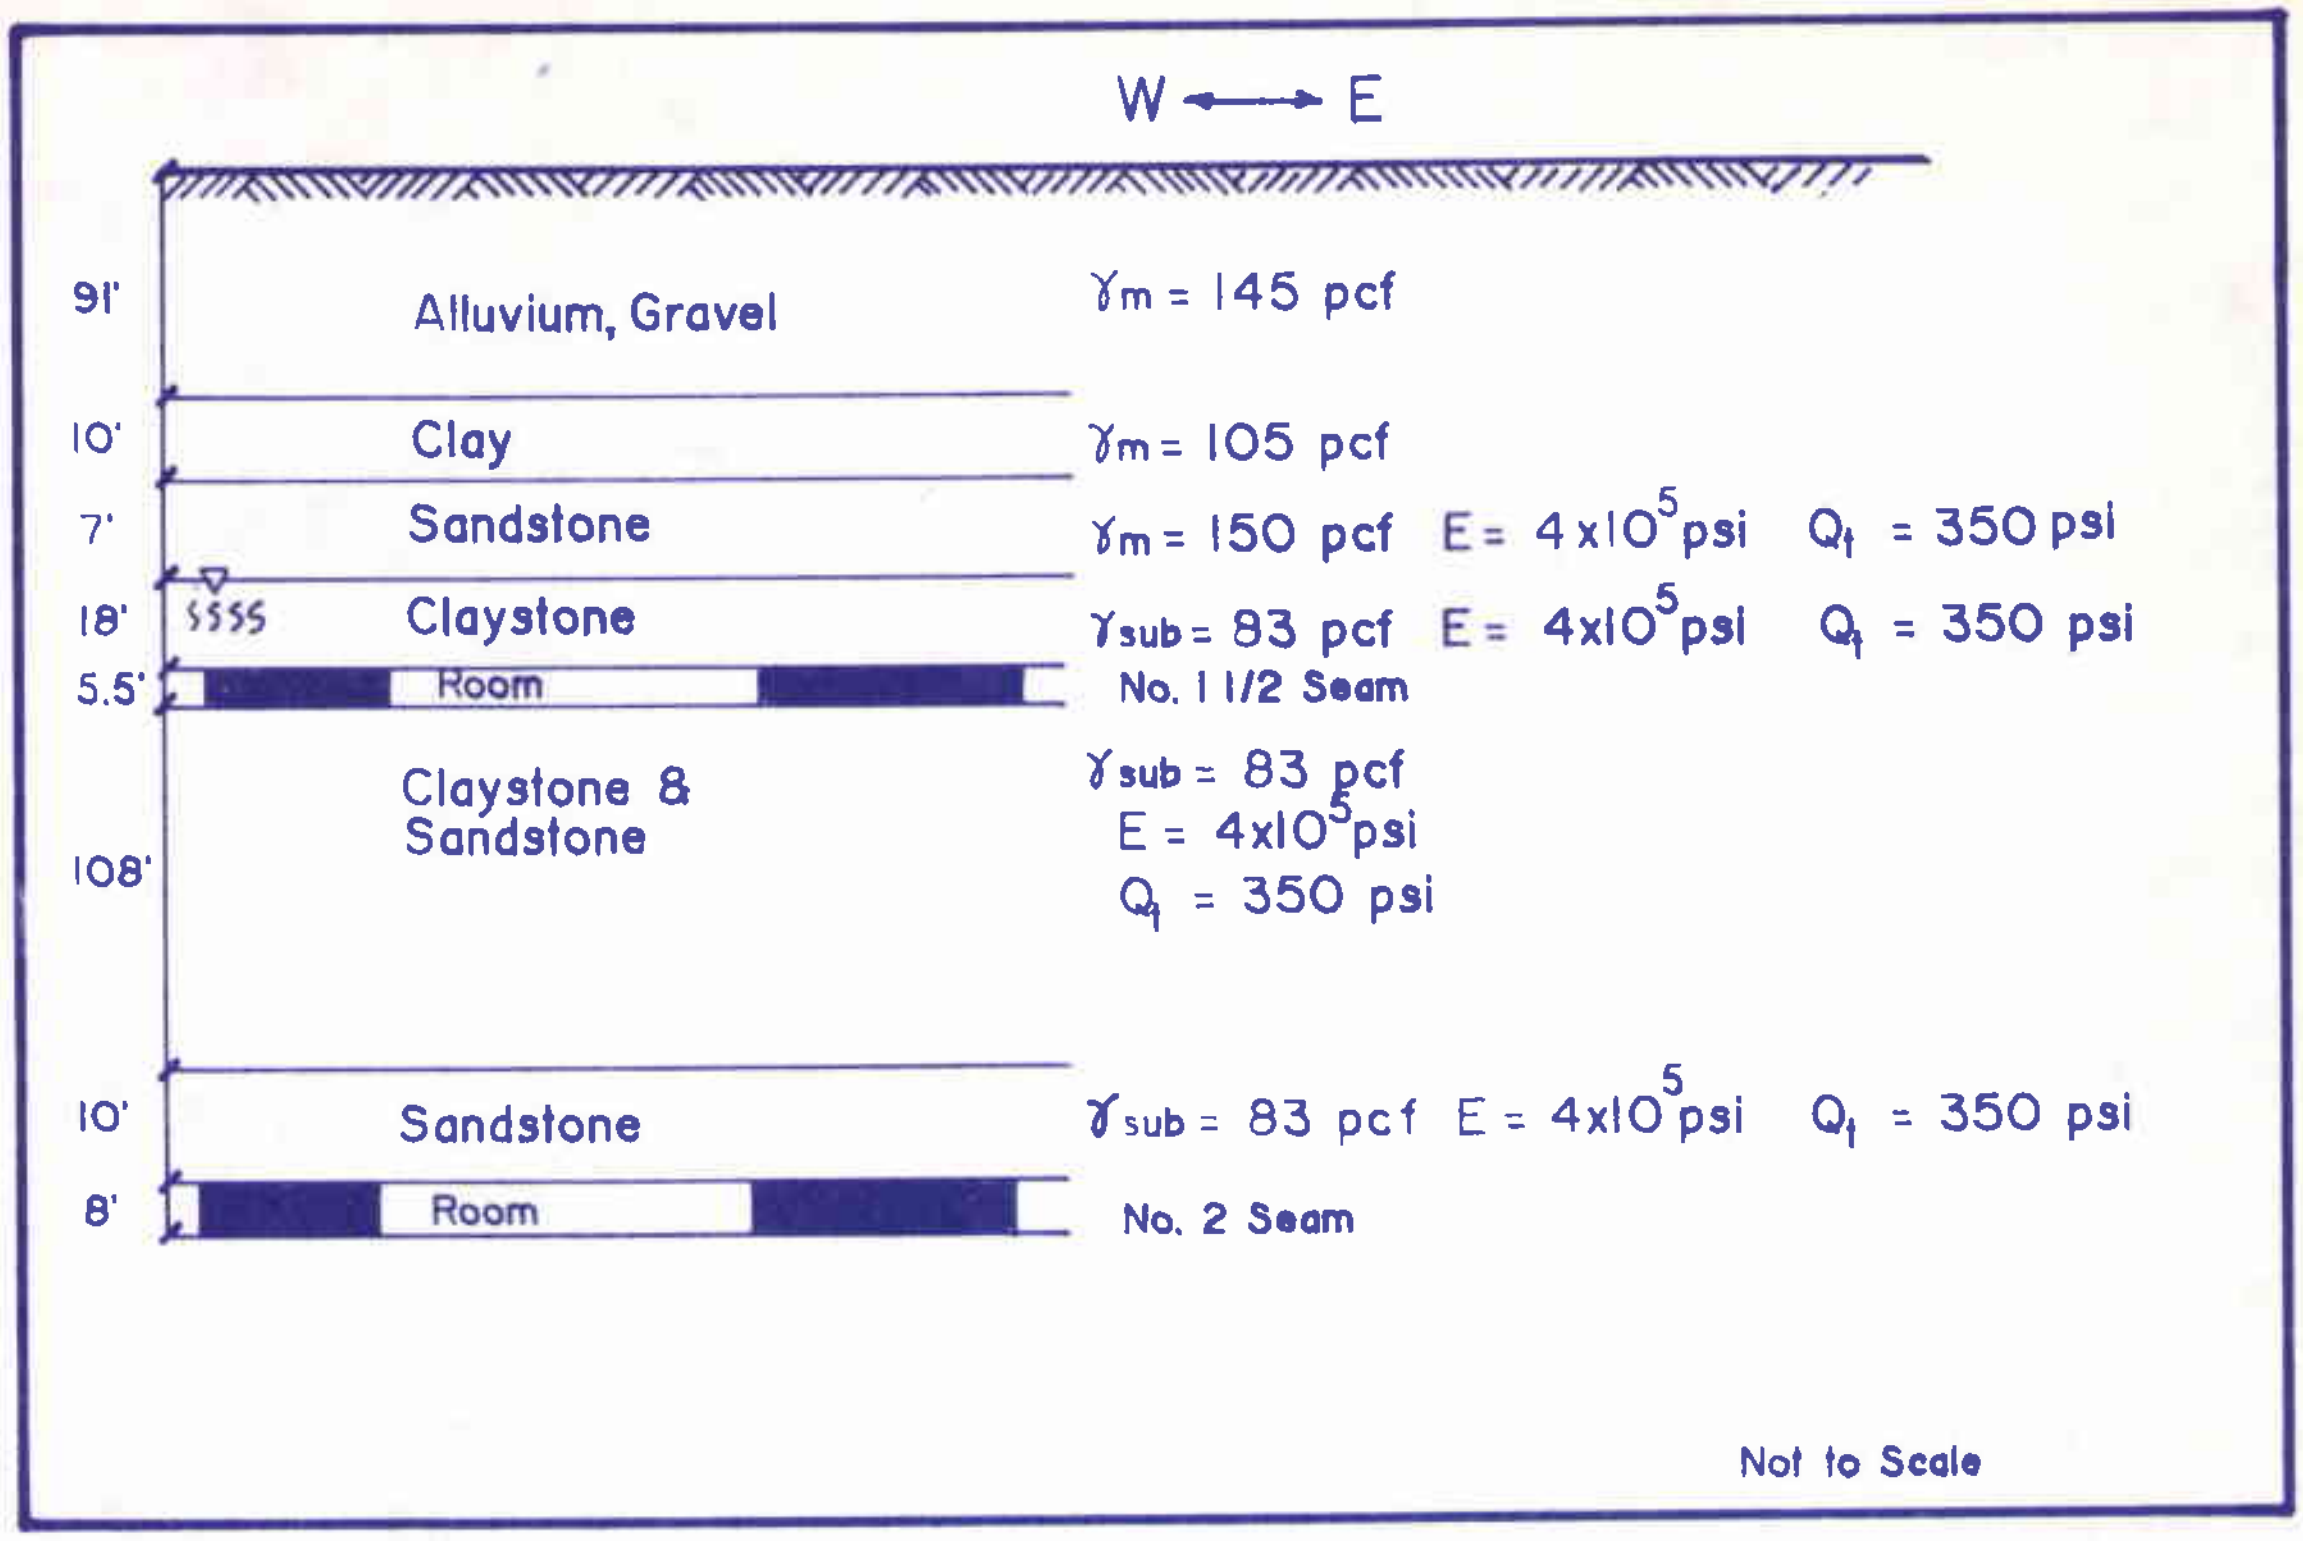
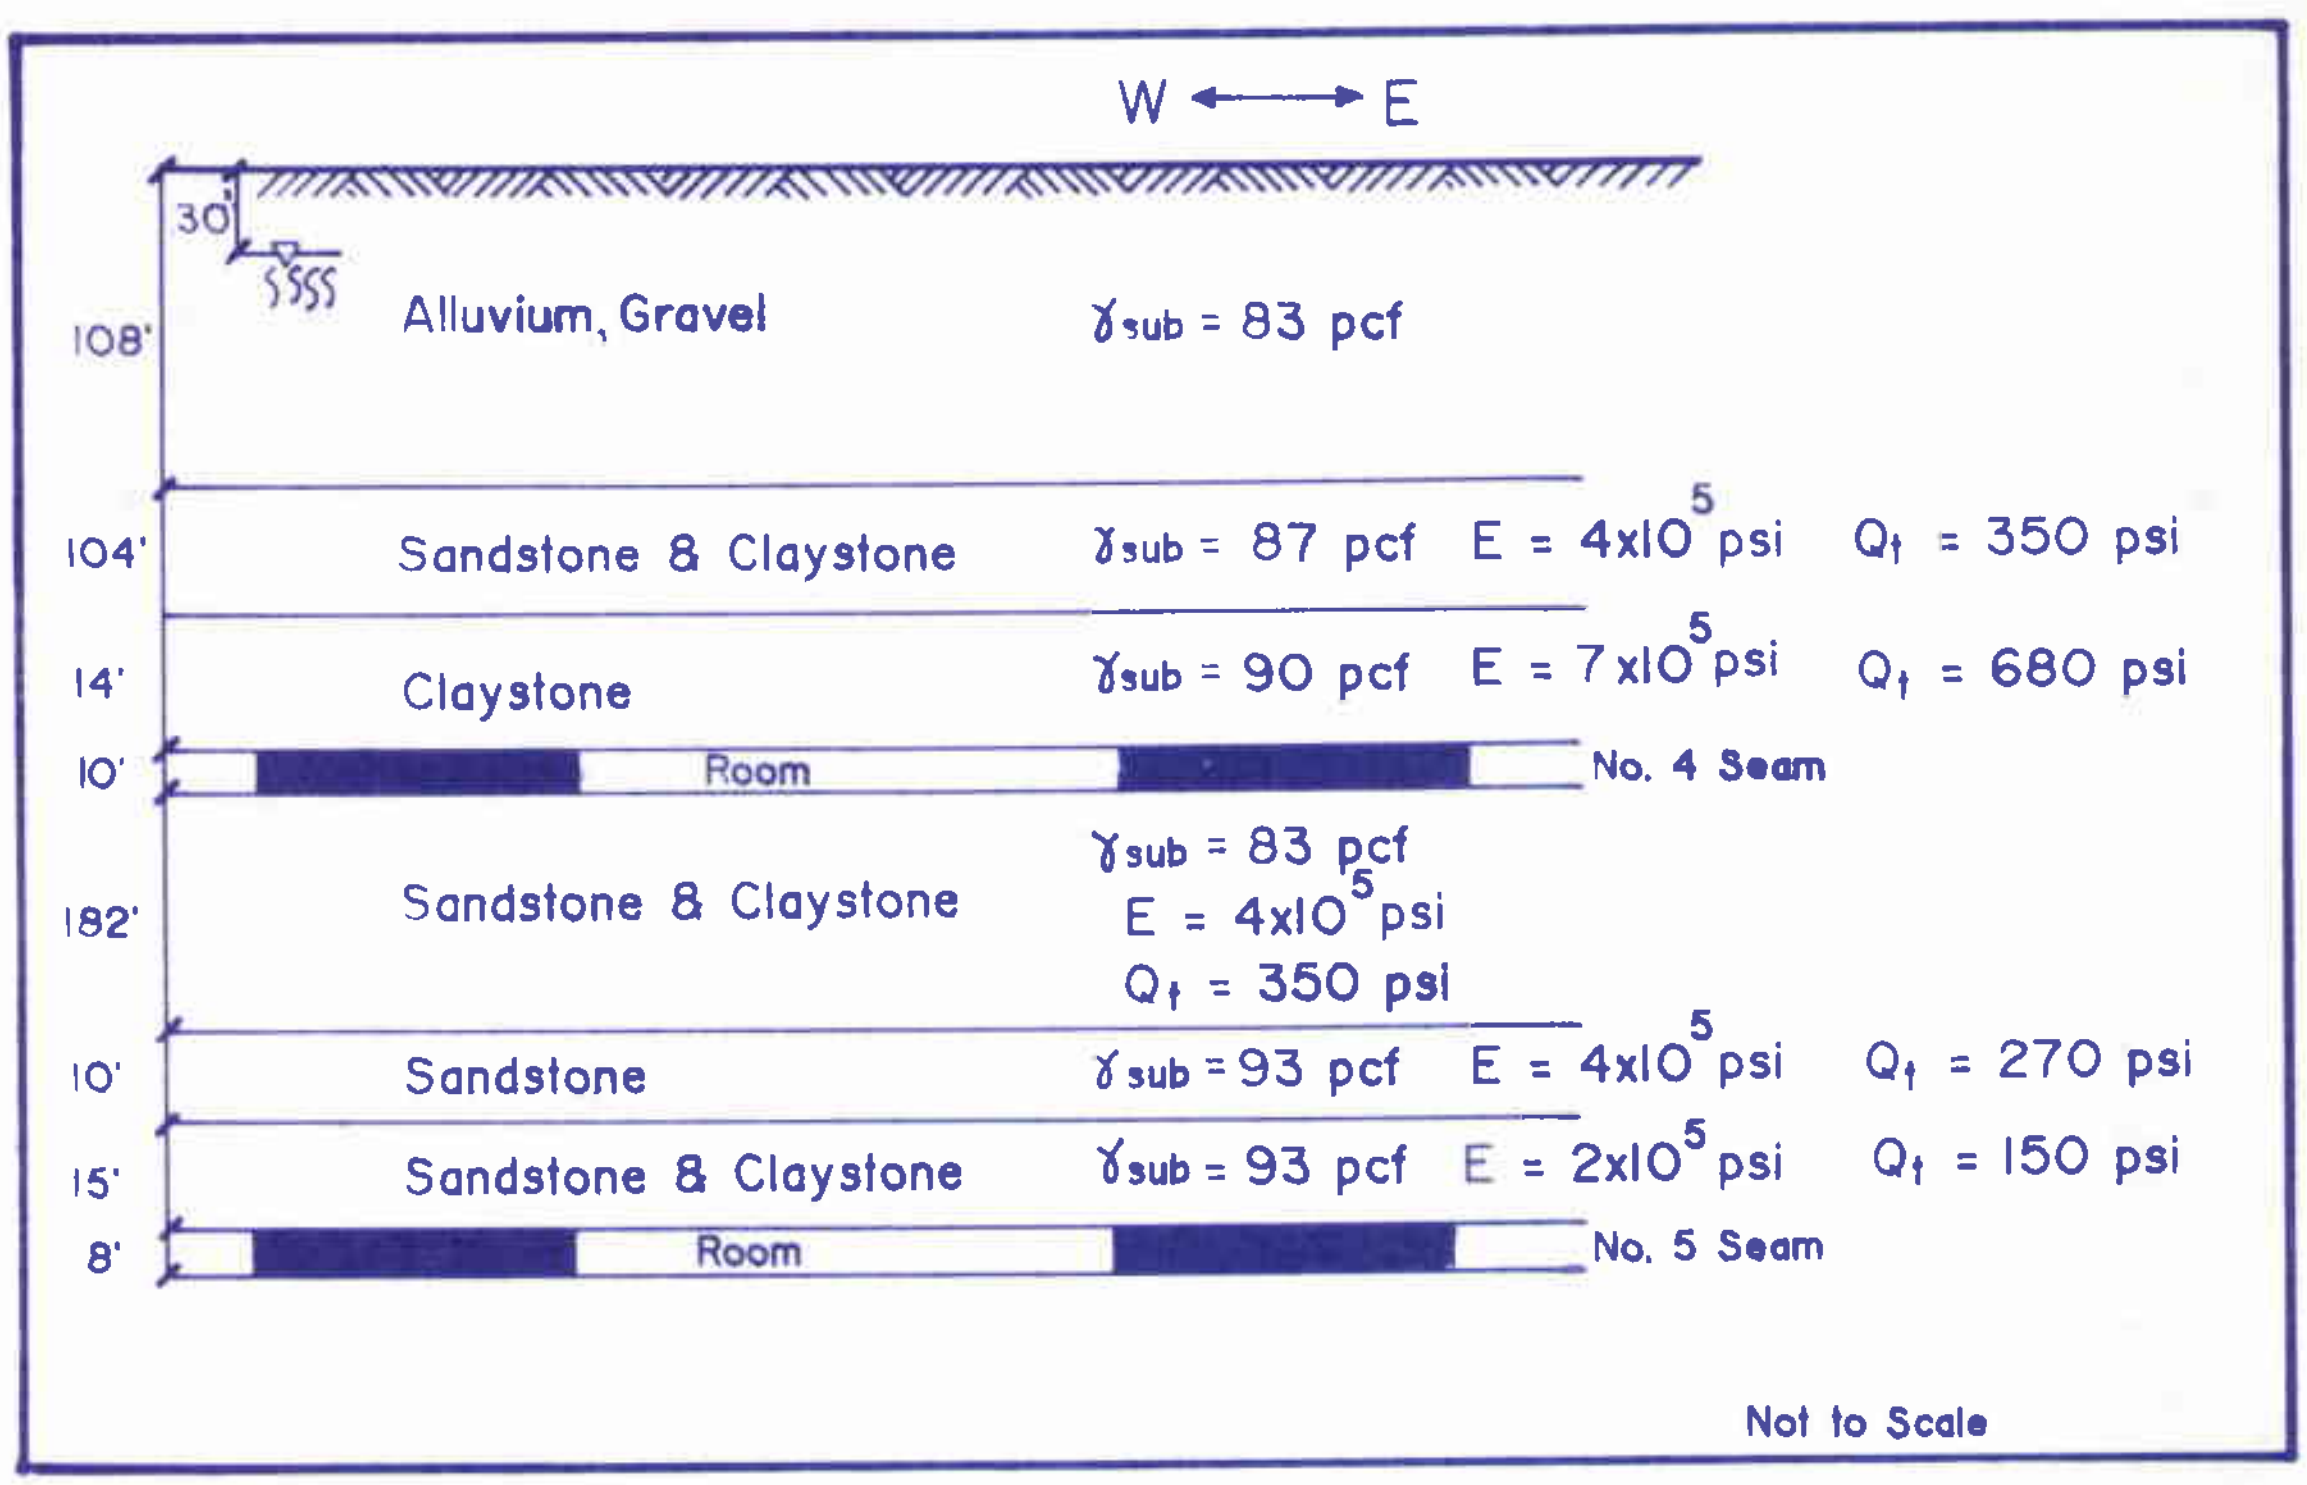
Figure 4 – Profiles for Roof Collapse Analysis

A determination of the minimum beam thickness required to span across rooms was made using a calculated safety factor of 1.5 as the limiting value. The value of 1.5 was selected as it allows a reasonable variation in material properties, and we believe those assigned to be slightly conservative. The following table presents the minimum lower beam thickness to provide a calculated safety factor greater than 1.5 for each of the cases illustrated in Figure 4.

* Note: The lower beam, 15 feet thick, was shown to fail. This thickness is in the second beam above the mined seam.

This table shows that massive roof collapse is not likely if bedding planes or discontinunities are farther apart than the minimum beam thickness. Our observations of the core indicates bedding planes and discontinuities are generally greater than 1 to 1.5 feet apart. As a result we would not predict massive roof collapse to be a common failure mode. The only analyzed location where the calculation predicted roof collapse was within the first 15 feet above the No. 5 Seam. That prediction appears to be reasonably consistent with conditions encountered in the borings.

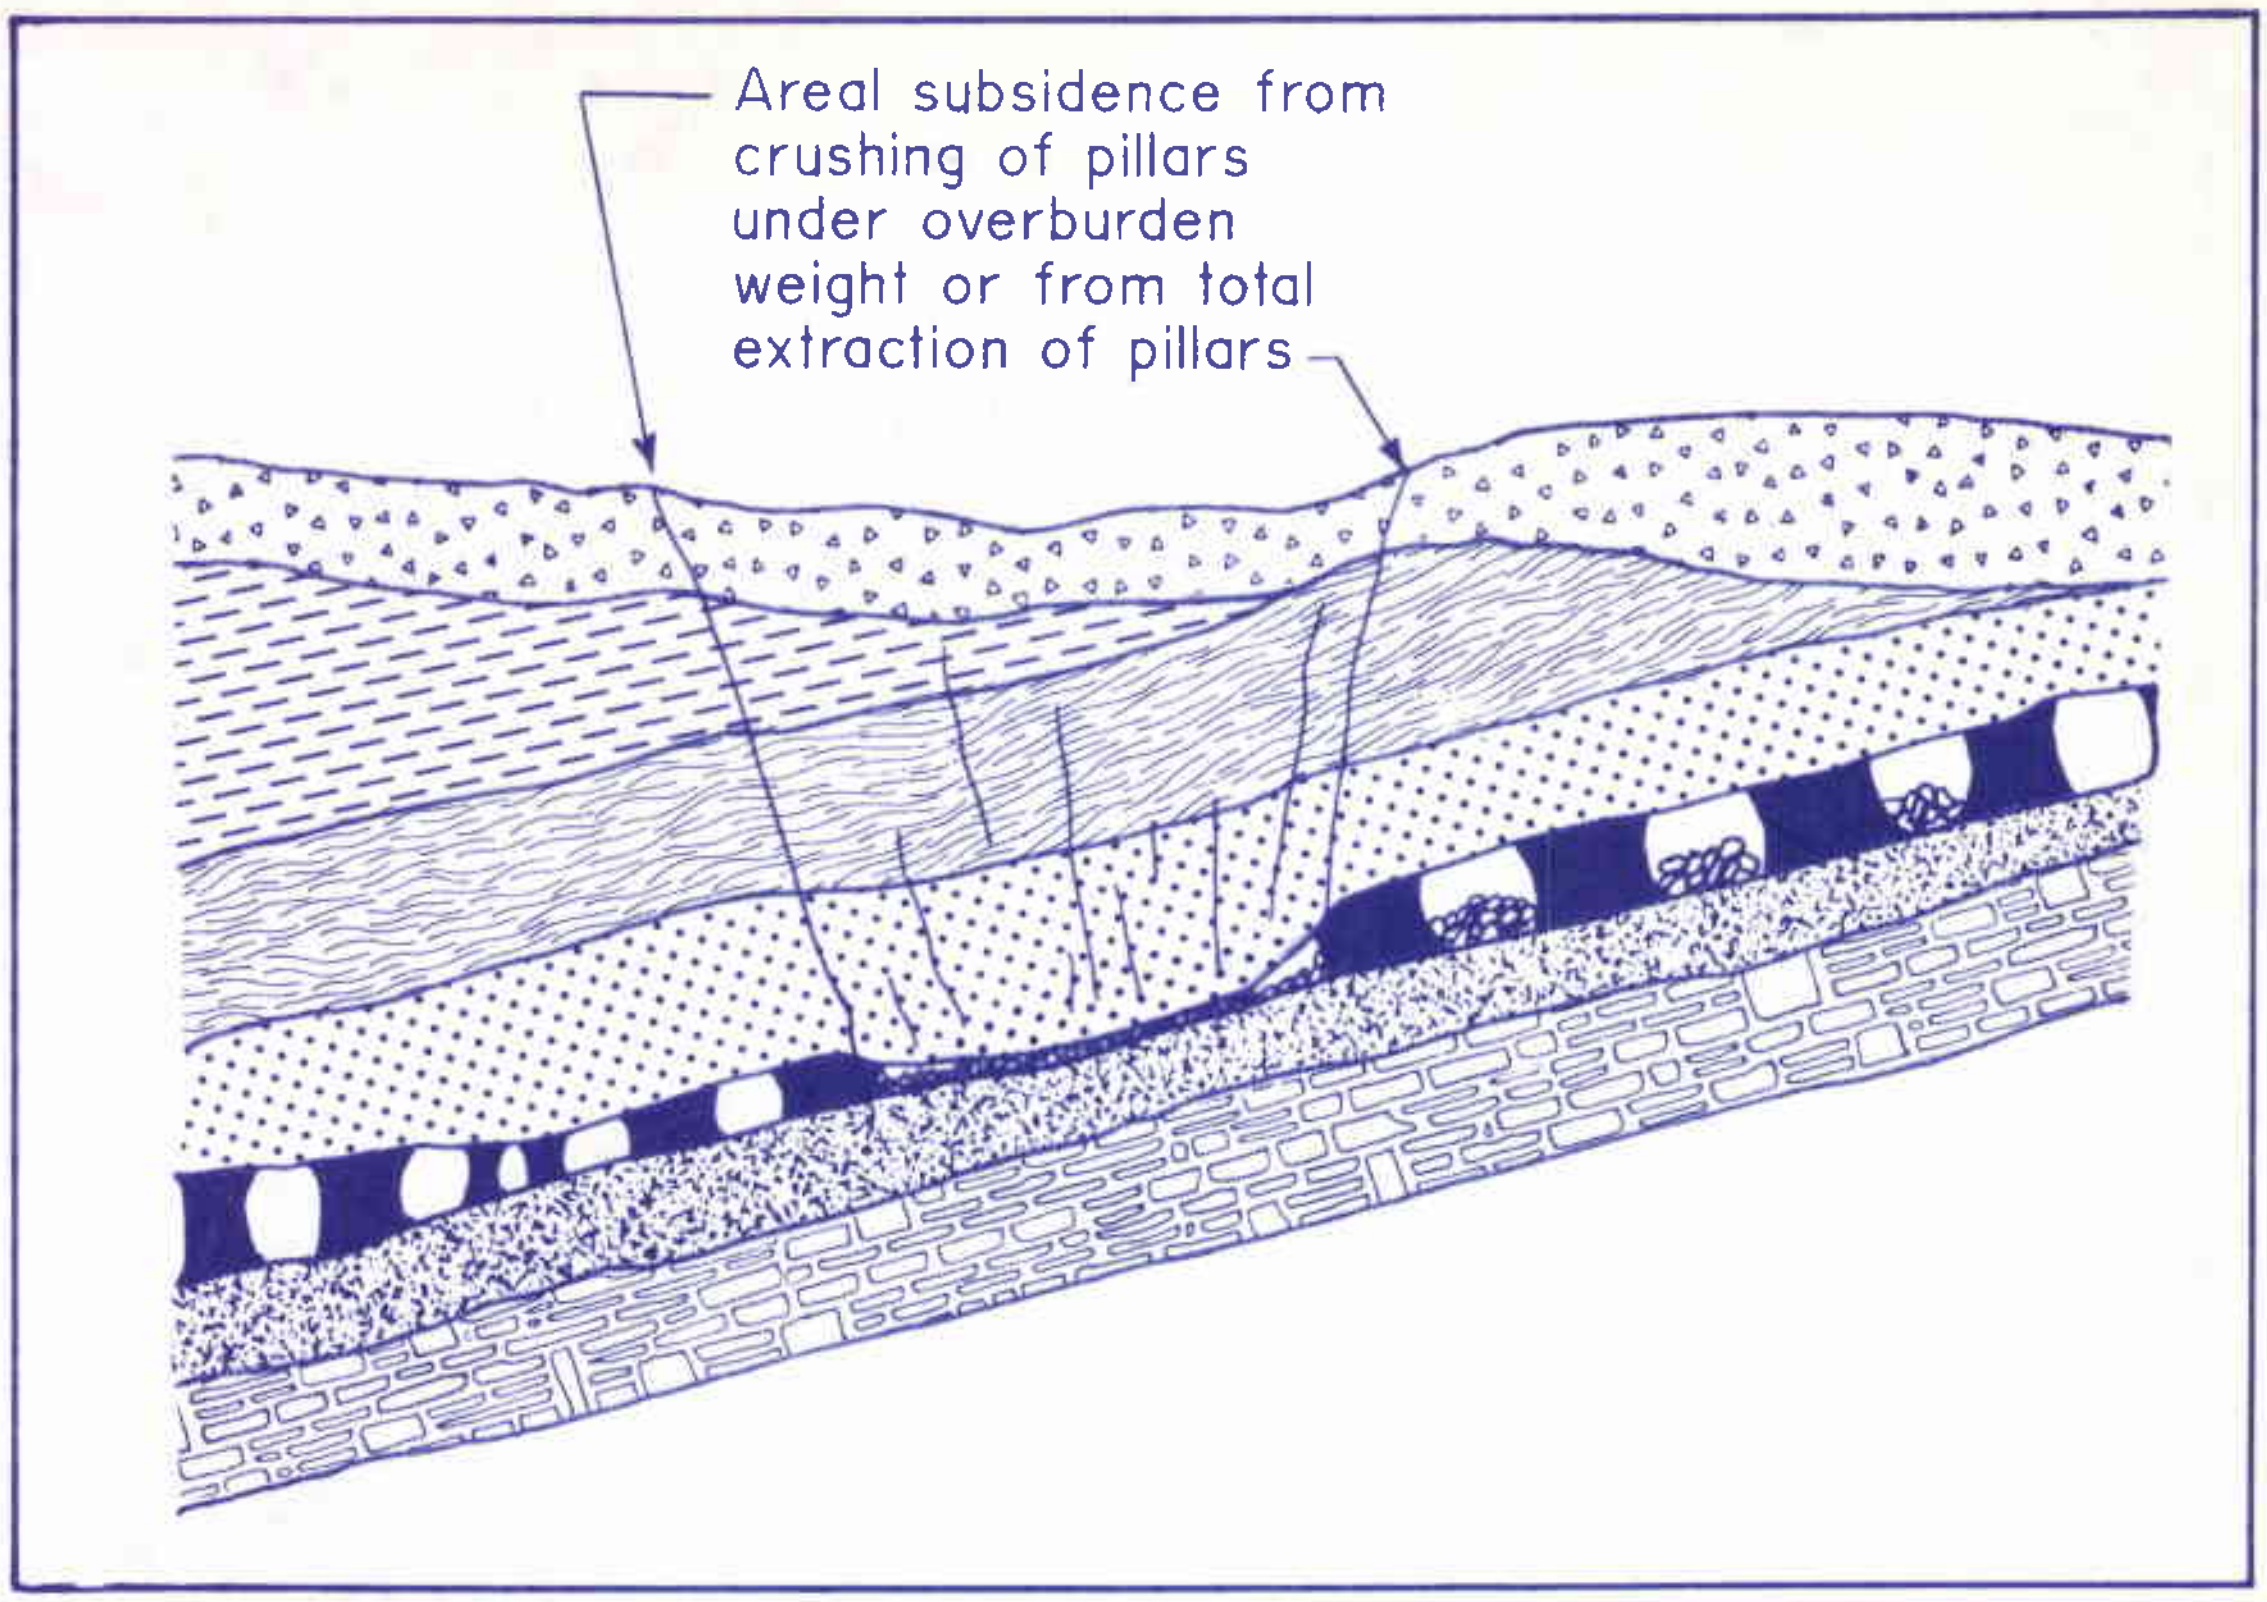
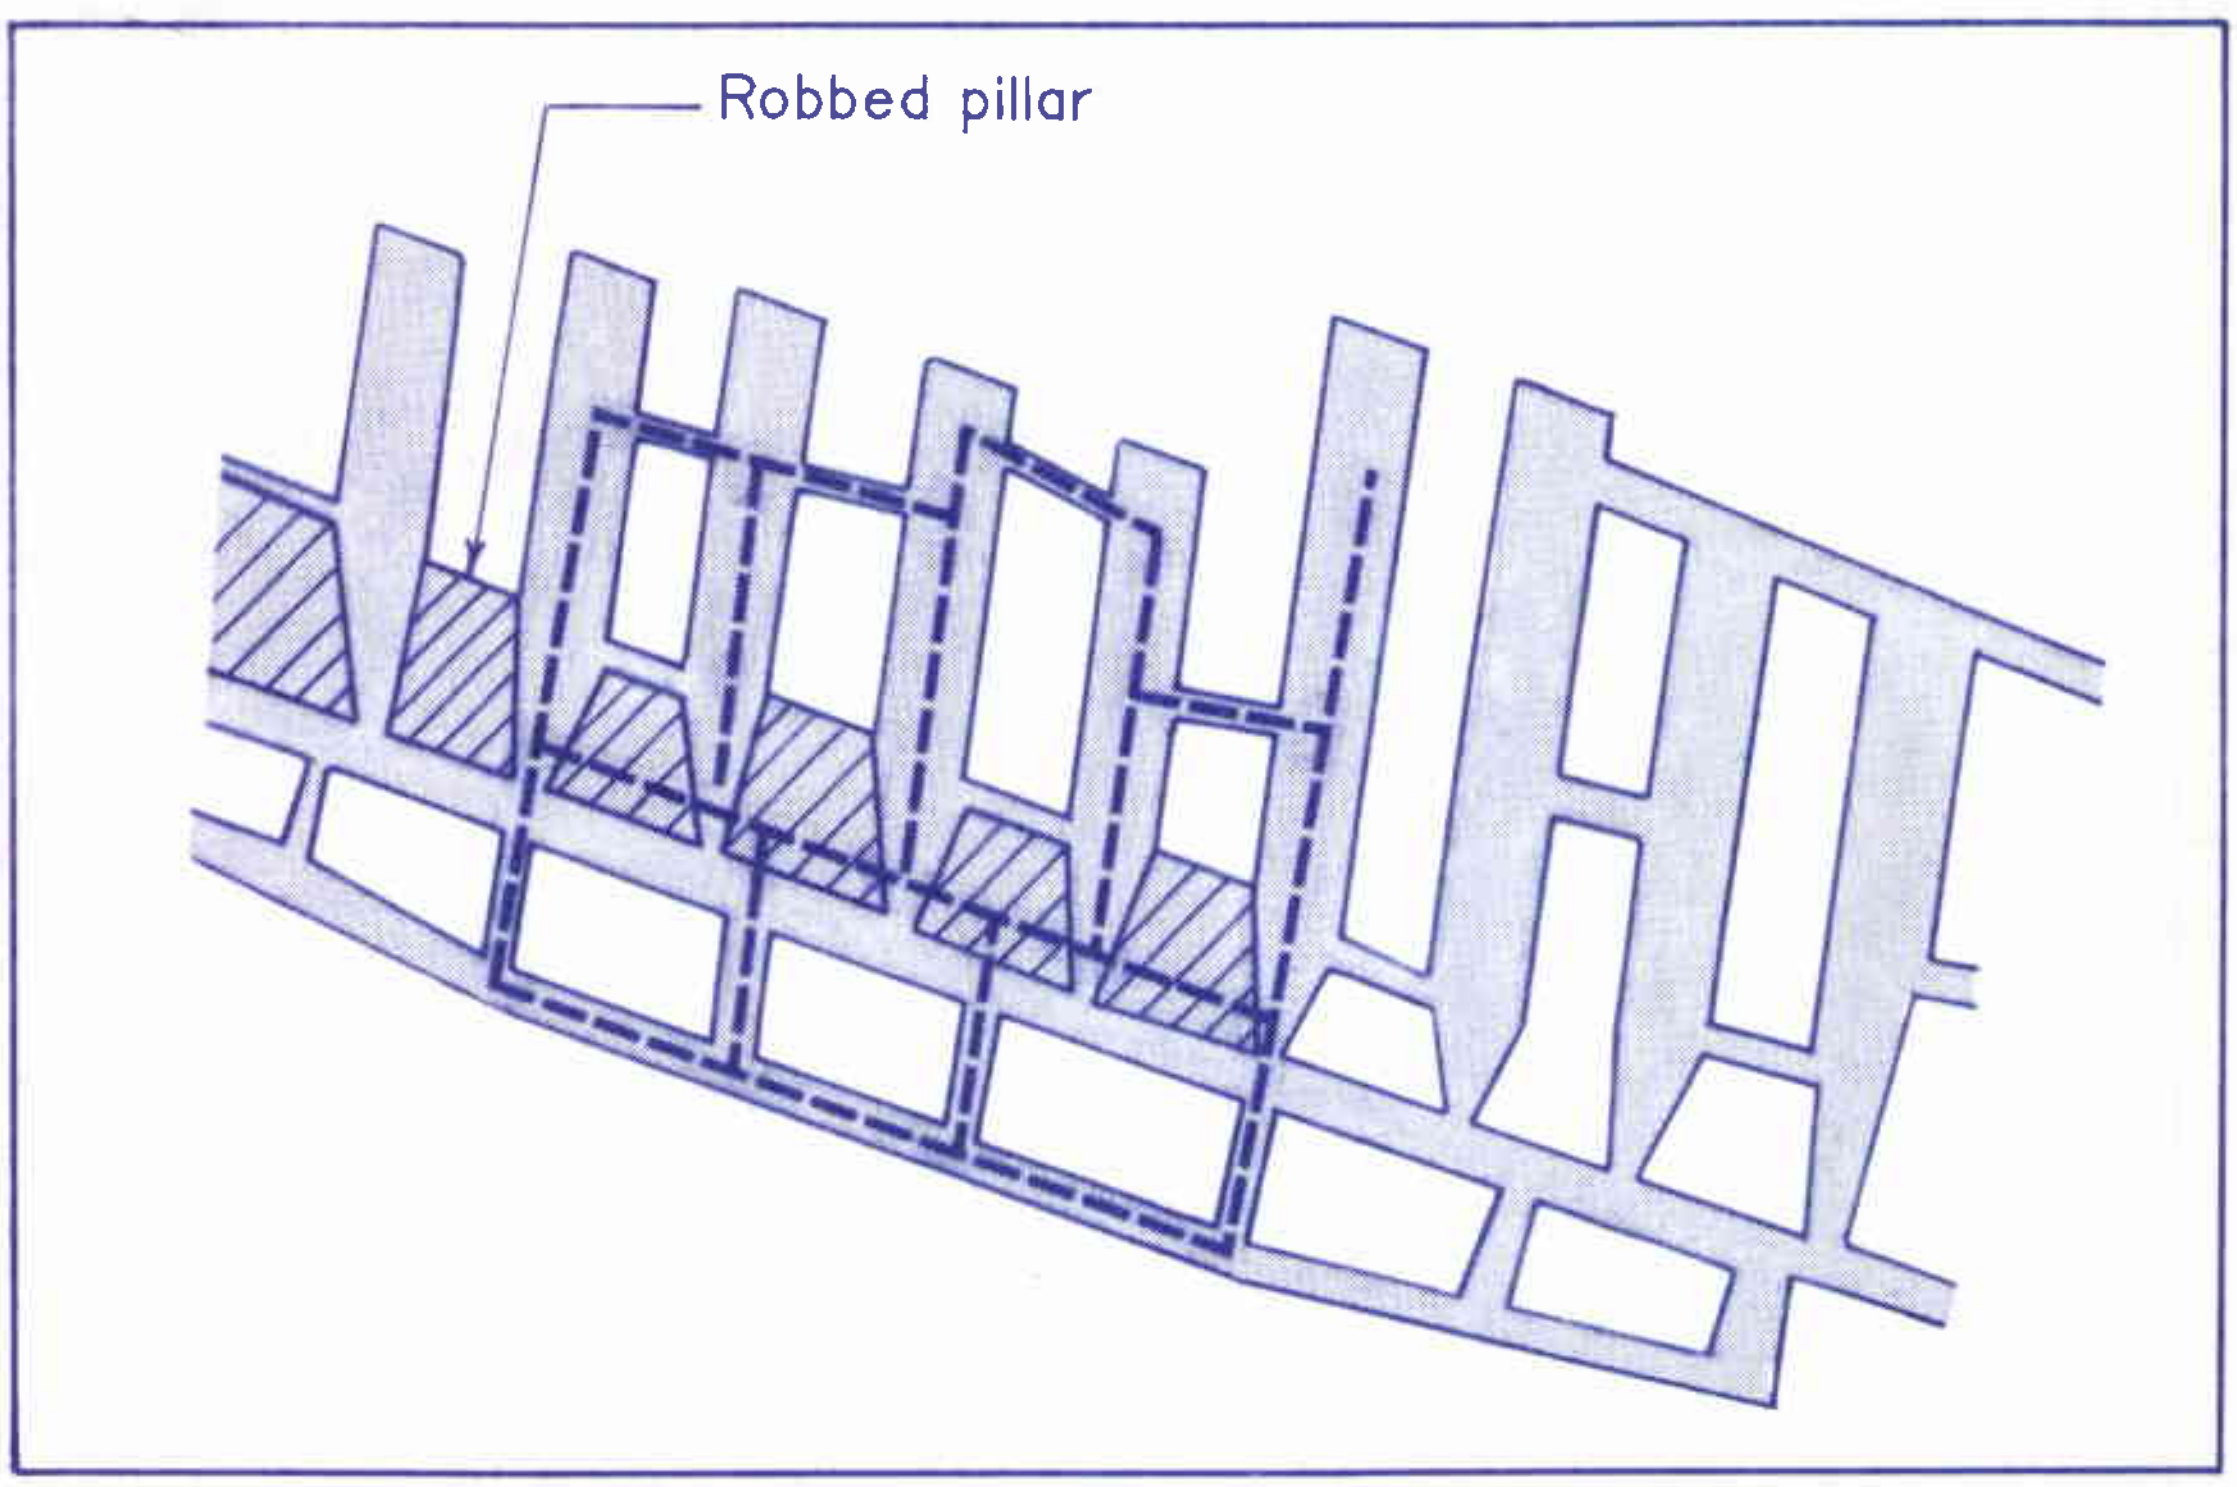
Figure 5 Pillar Crushing Failure Mode

Pillars crush when the overburden pressure exceeds the strength of the pillars. Once a pillar fails the overburden load it carried is either transferred to adjacent pillars, which may in turn fail, or the roof collapse mode of failure might occur. Figure 5 illustrates the concept of tributary areas for calculating loads supported by pillars.

The rock profiles analyzed were typical of DH-1 and 3. Room and pillar configurations were selected which appeared representative. The calculations generally yield safety factors in the range of 2 to 3 for the submerged condition. Predictably safety factors will decrease down dip, and in deeper seams. For the dewatered condition which existed during mining, pillar failures are often predicted. It is possible the laboratory tests under estimate the coal strength in those seams, or stress redistributions (temporary arching) influenced performance during mining. Observation of the mine maps do not normally show pillar sizes increasing at greater depths. The following table presents the approximate depths below which we would predict pillar crushing to occur for the submerged condition.
