REPORT OF INVESTIGATION
RED LODGE/BEARCREEK
SUBSIDENCE POTENTIAL STUDY

October 30, 1987

Subject: Report of Investigation Red Lodge/Bearcreek
Subsidence Potential Study
Project No. 87-3001.D

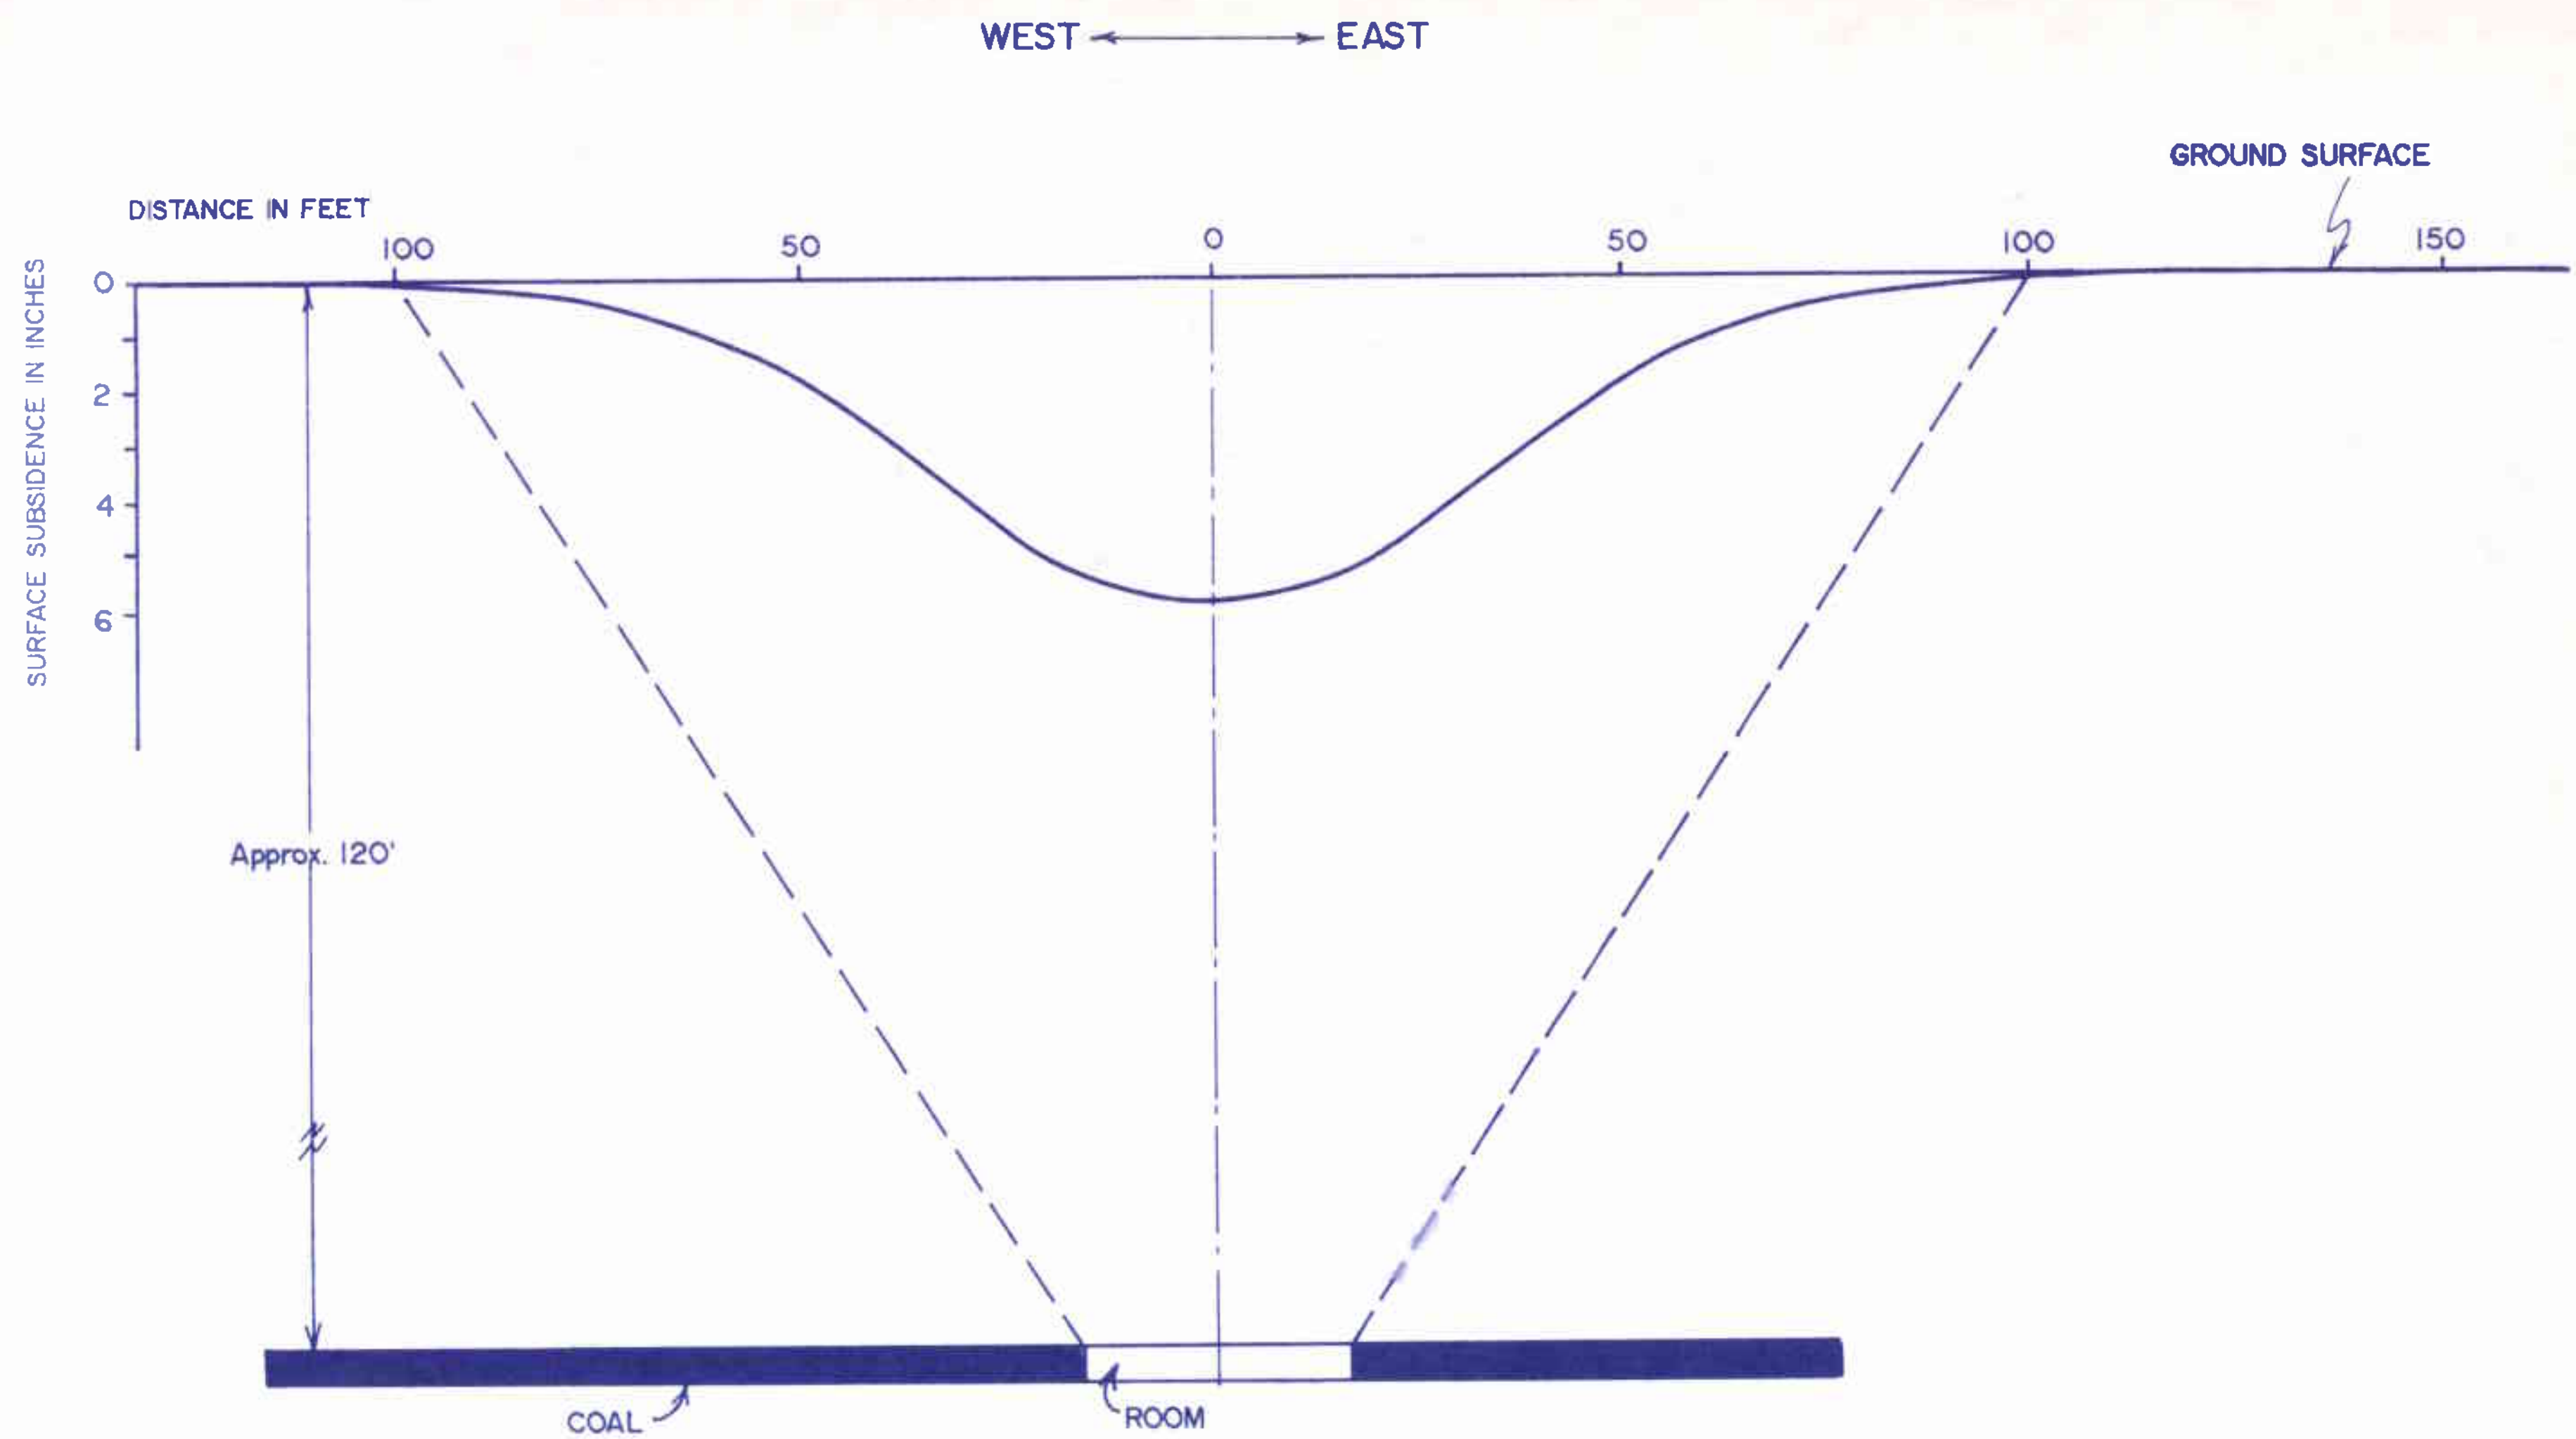
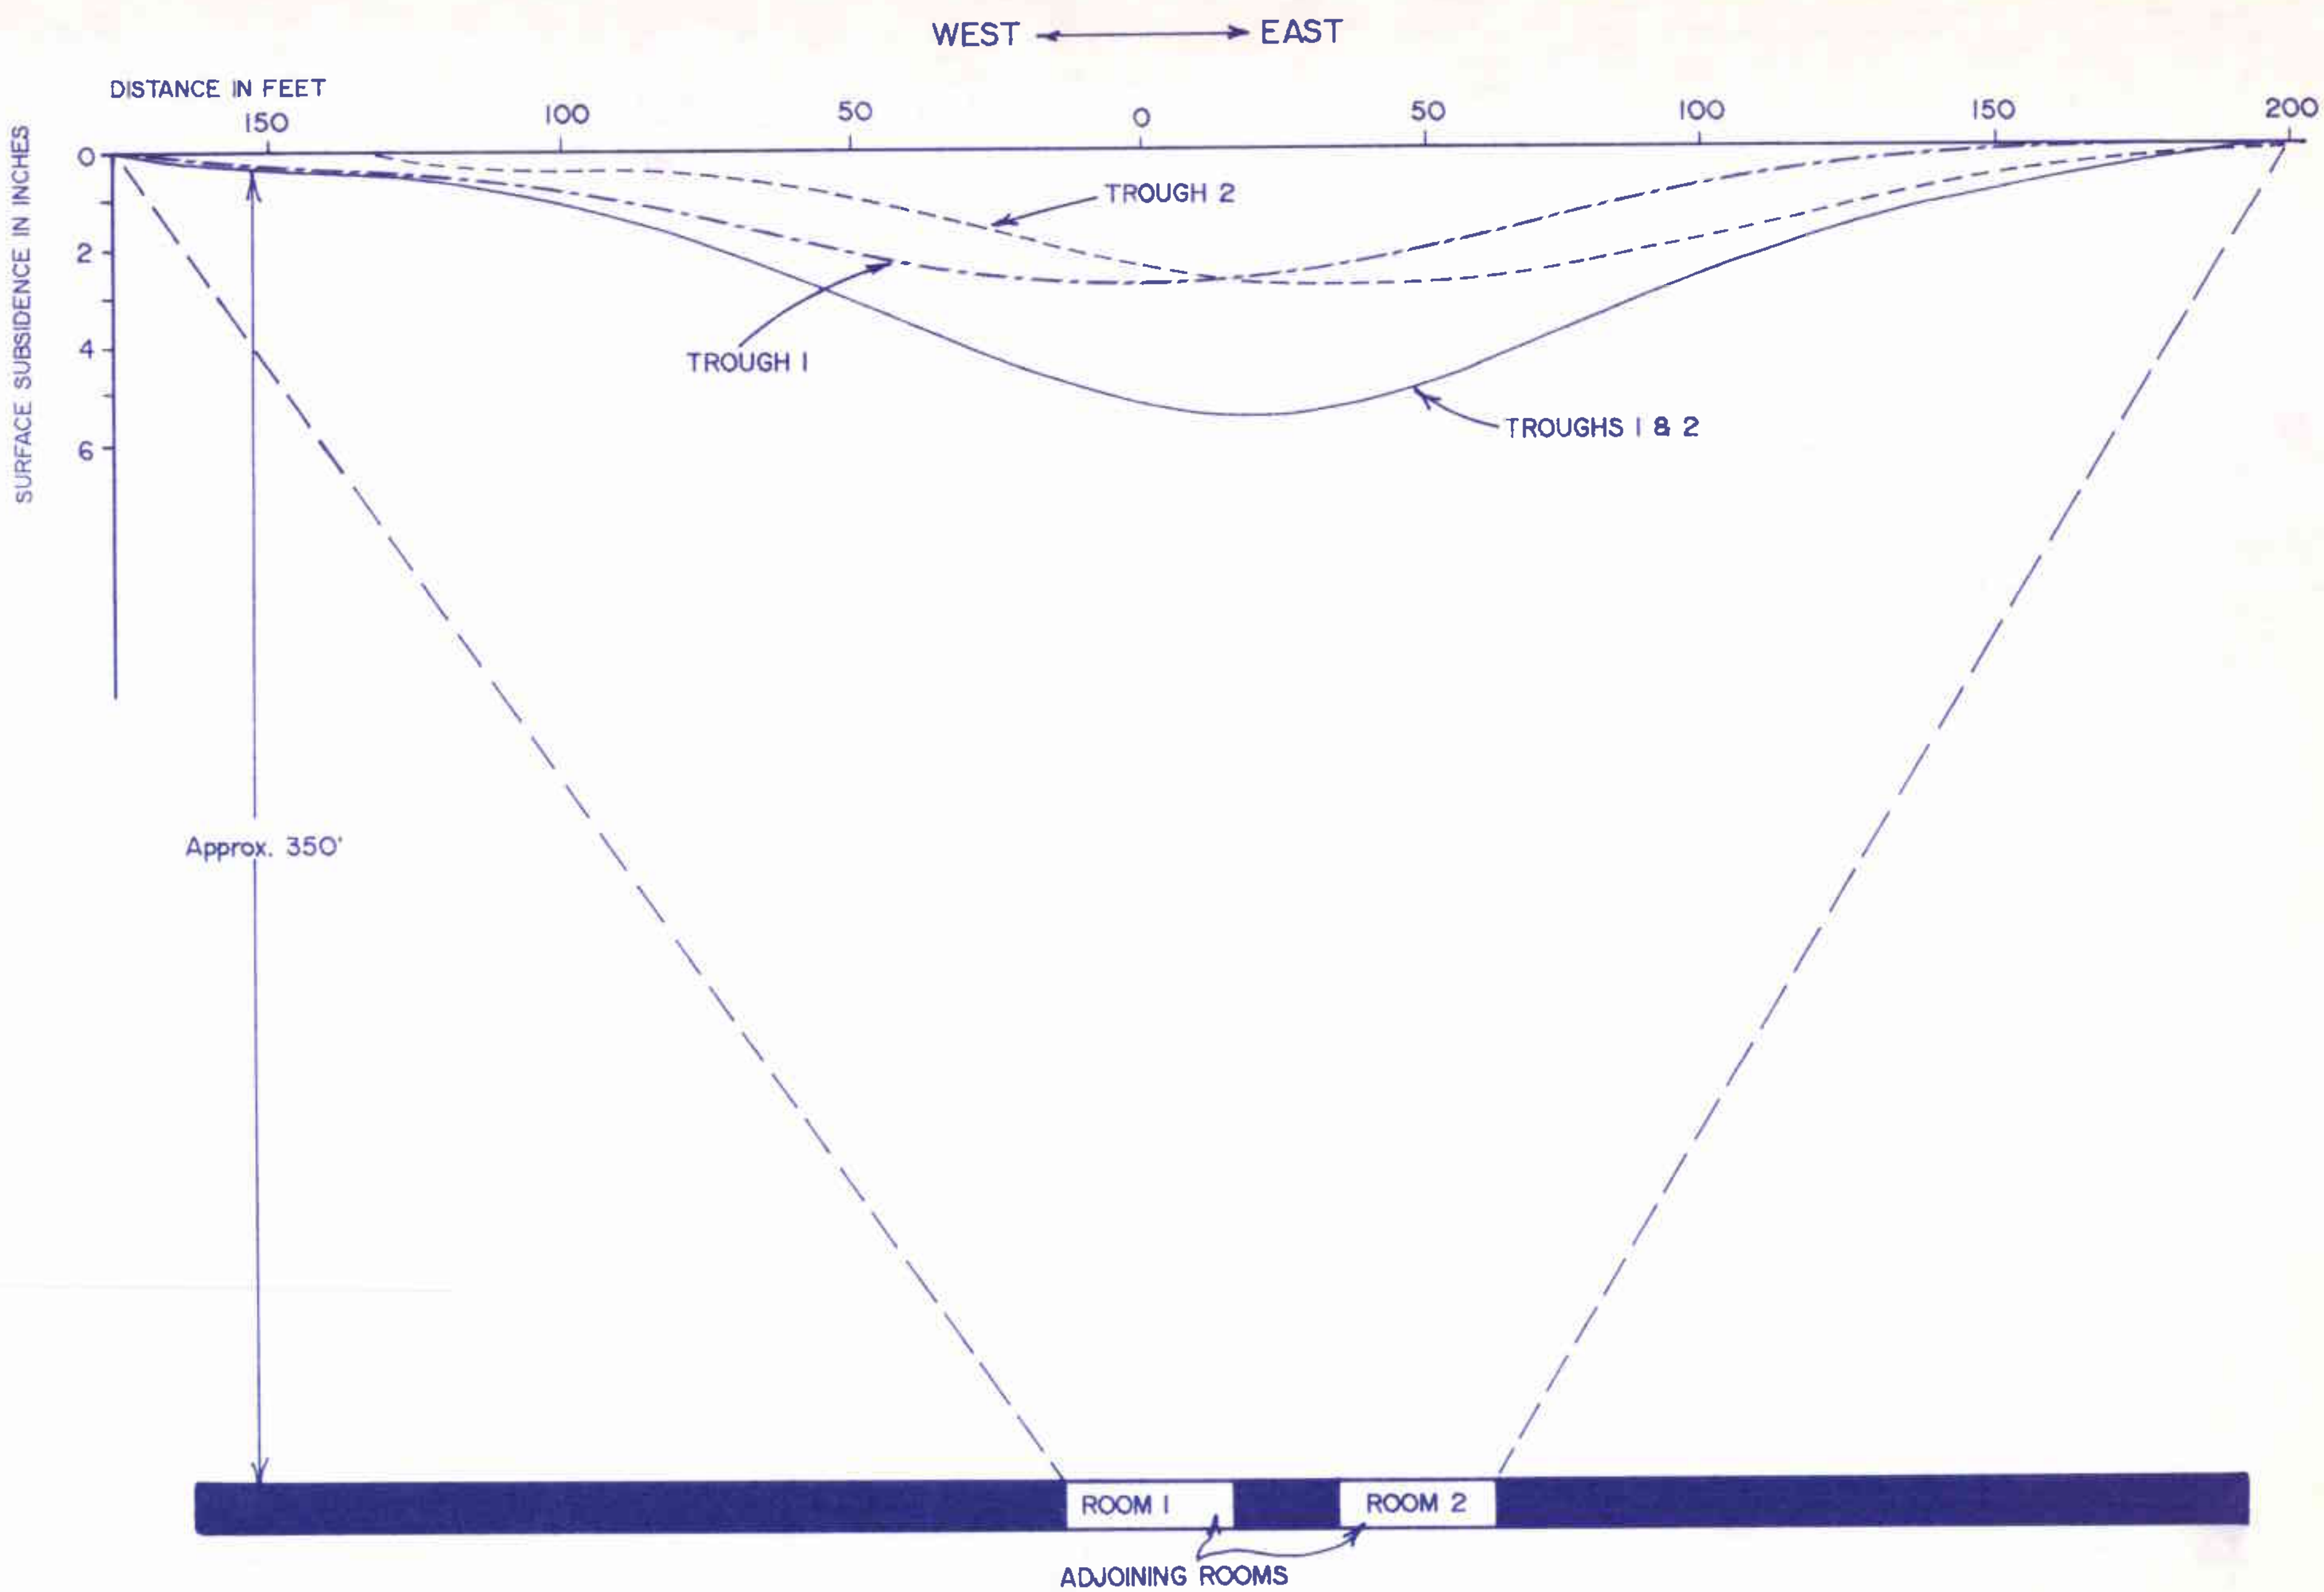
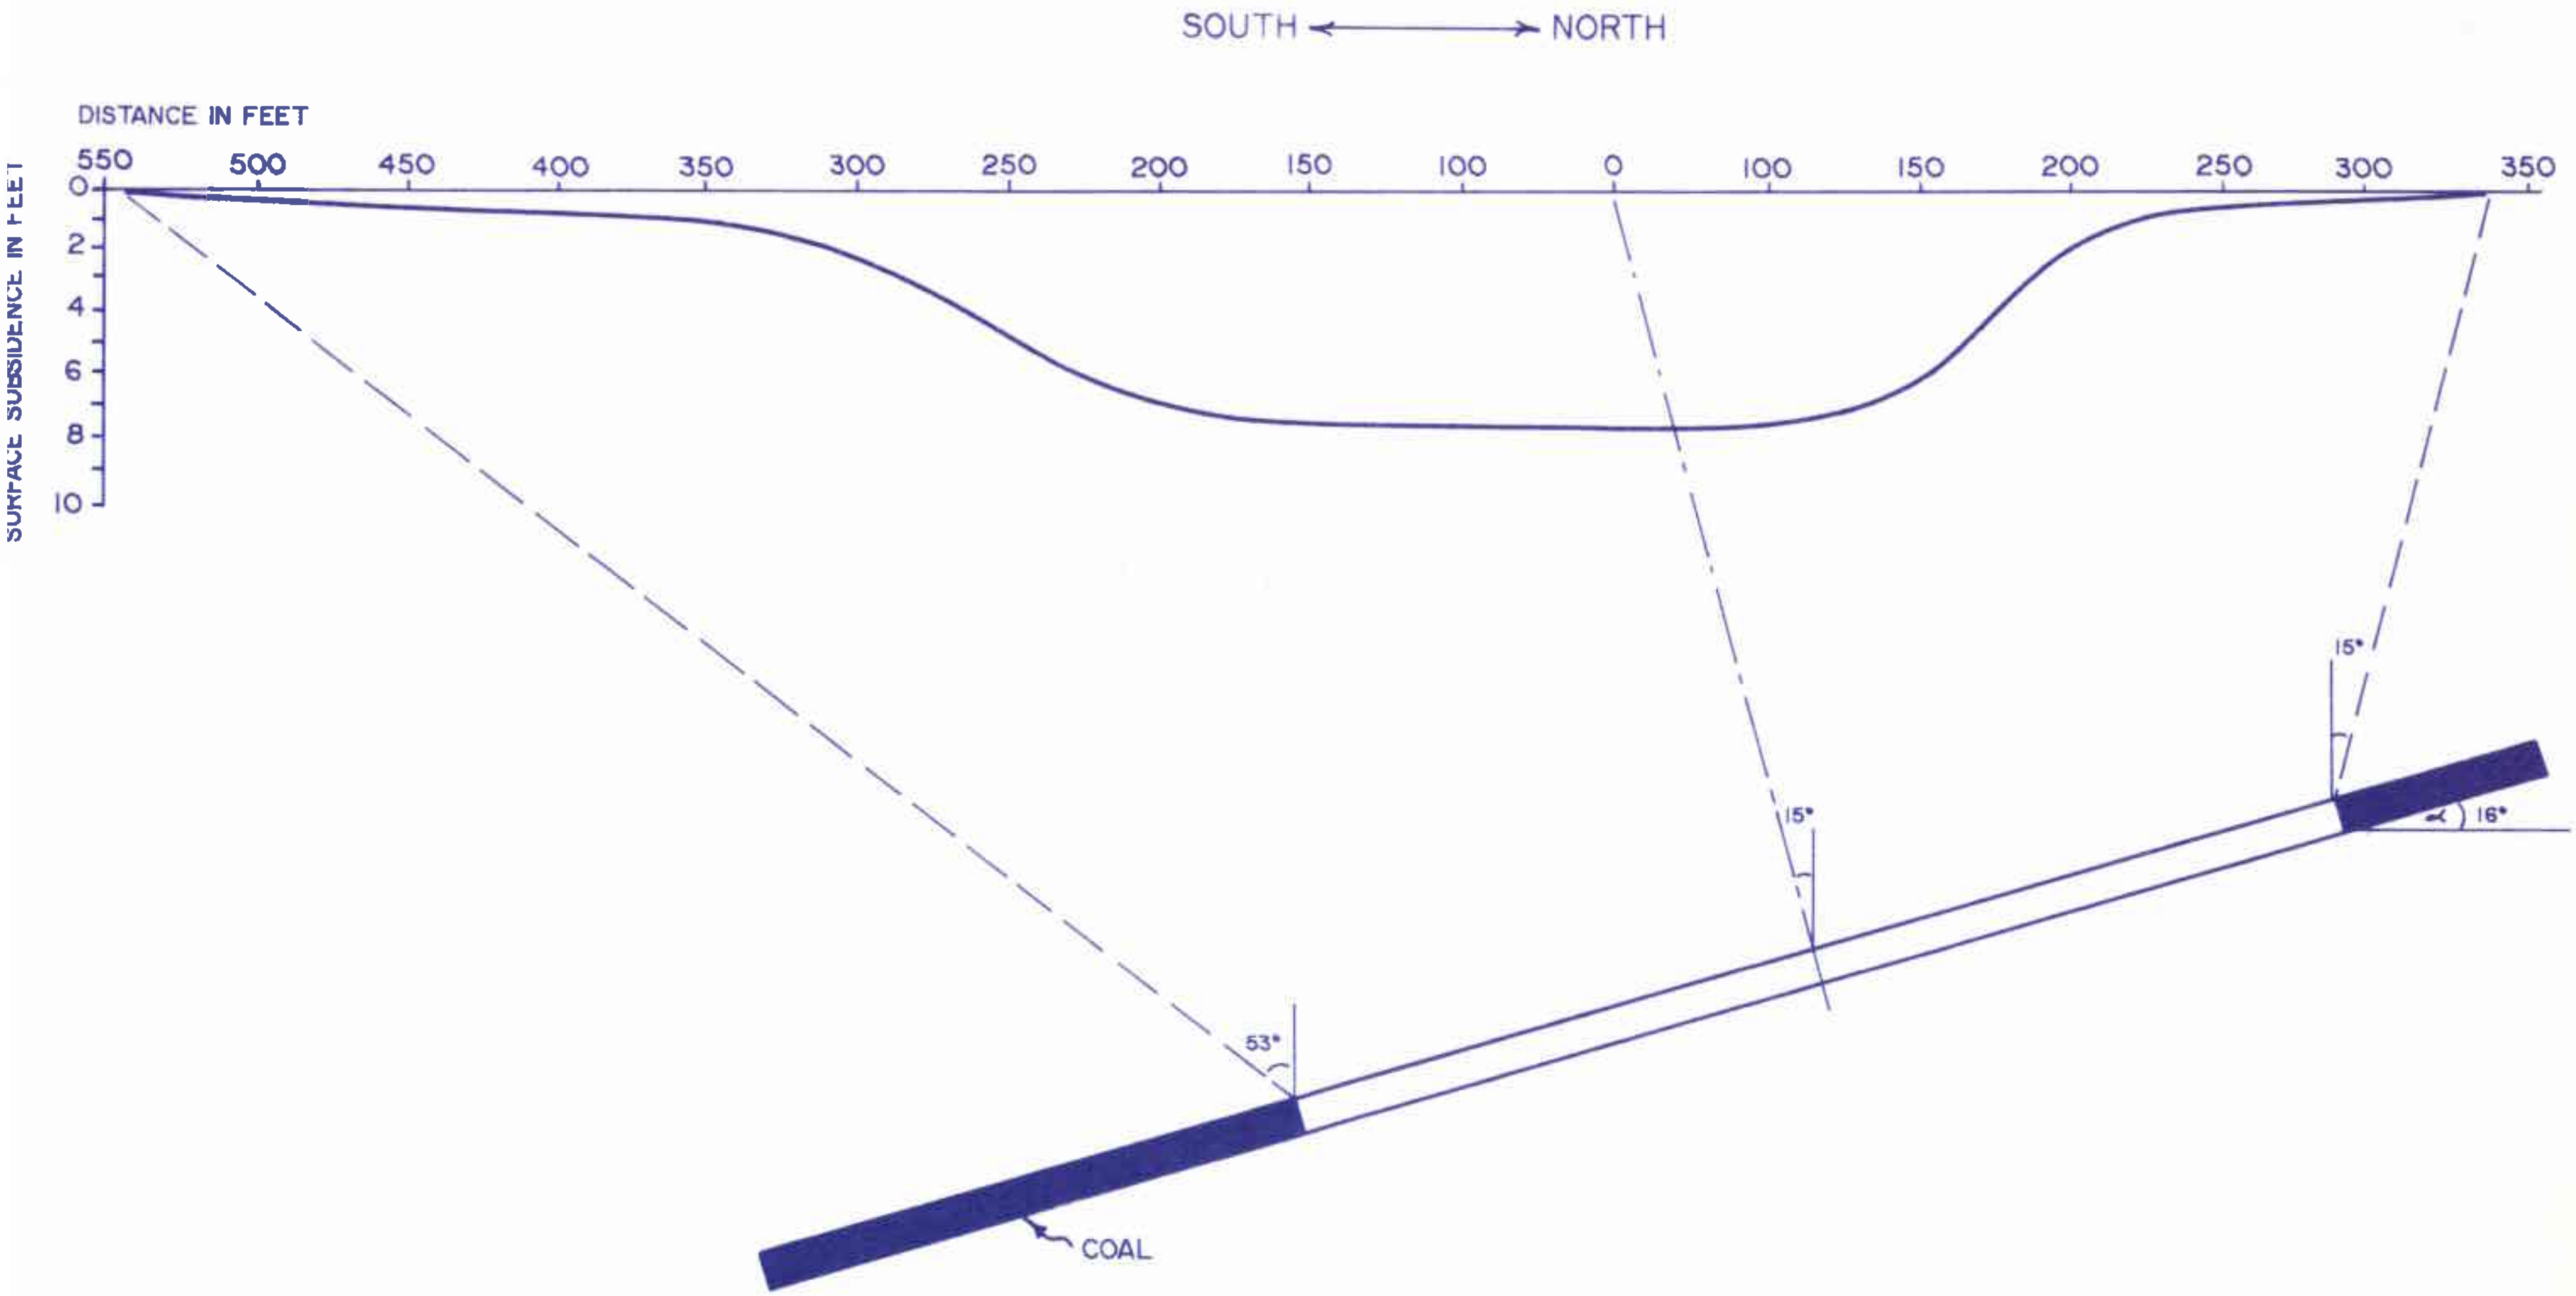
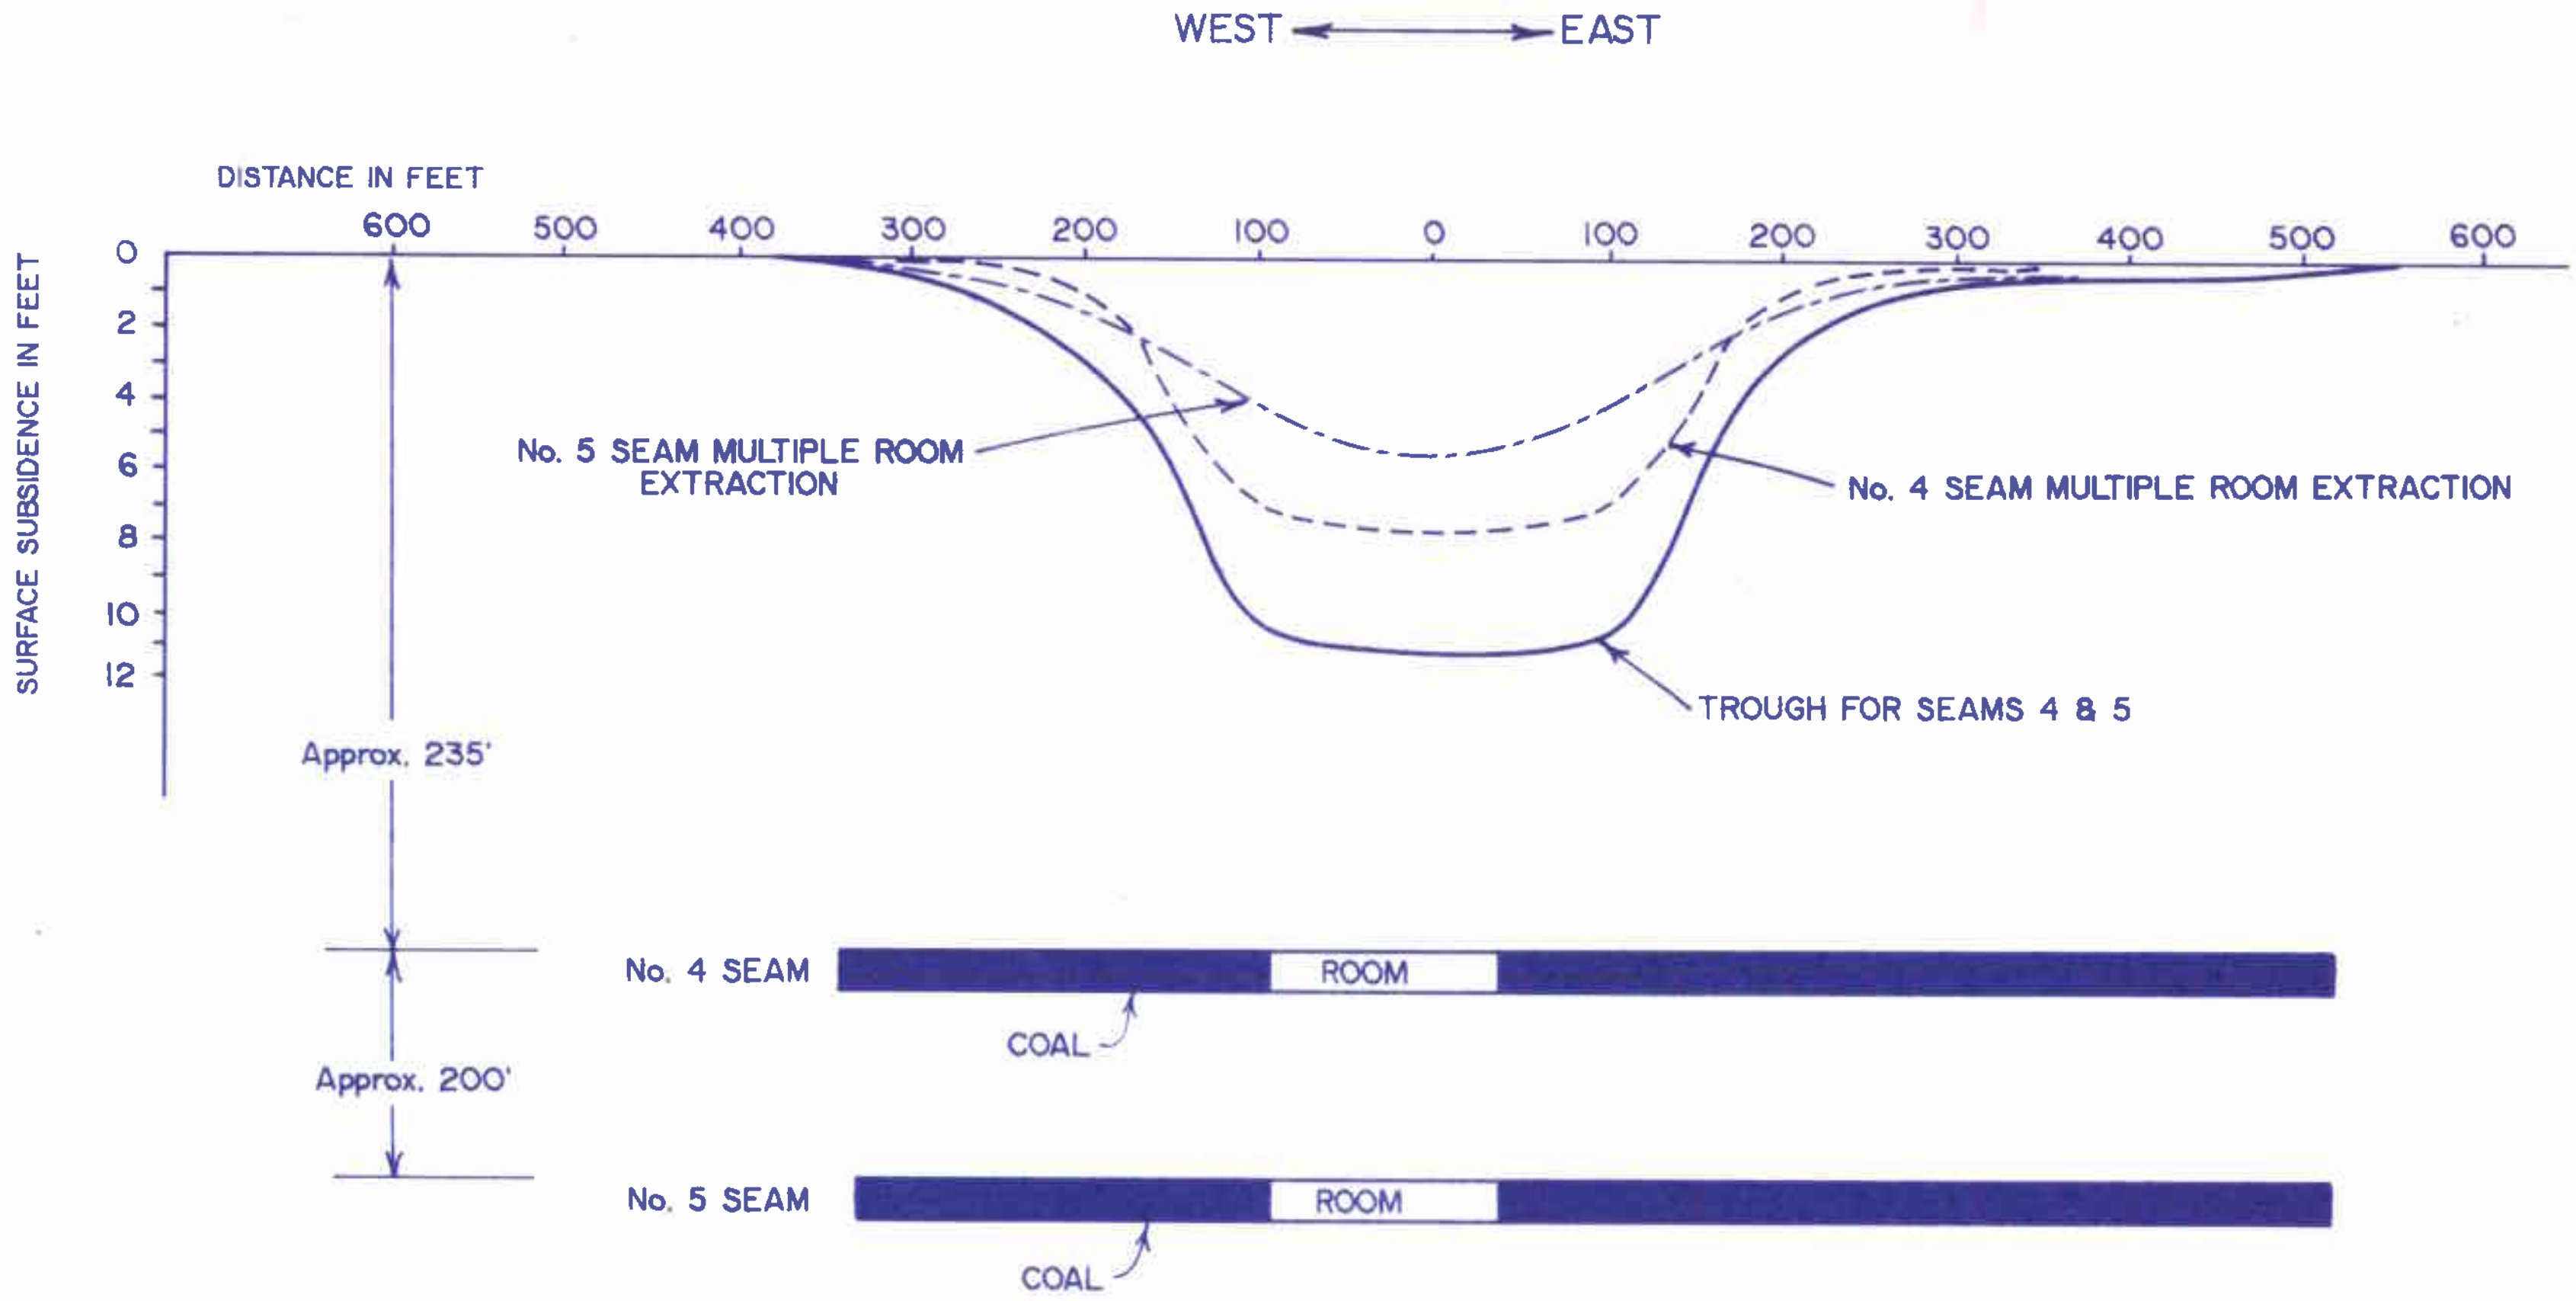
Figures 6 through 9 suggest that surface subsidence from a single room might only be in the range of a few inches, while multiple room and multiple seam subsidence is predicted to result in much greater surface subsidence. These figures are presented only for informational purposes. We are not aware of any previous subsidence features which can be represented by these constructions. Furthermore the condition of mine roofs and rooms observed in the borings present no indication which would lead us to believe the figures represent potential future surface subsidence. All indications suggest that bulking is preventing mine room failures from being expressed on the surface, except where chimneys have developed in high potential areas.

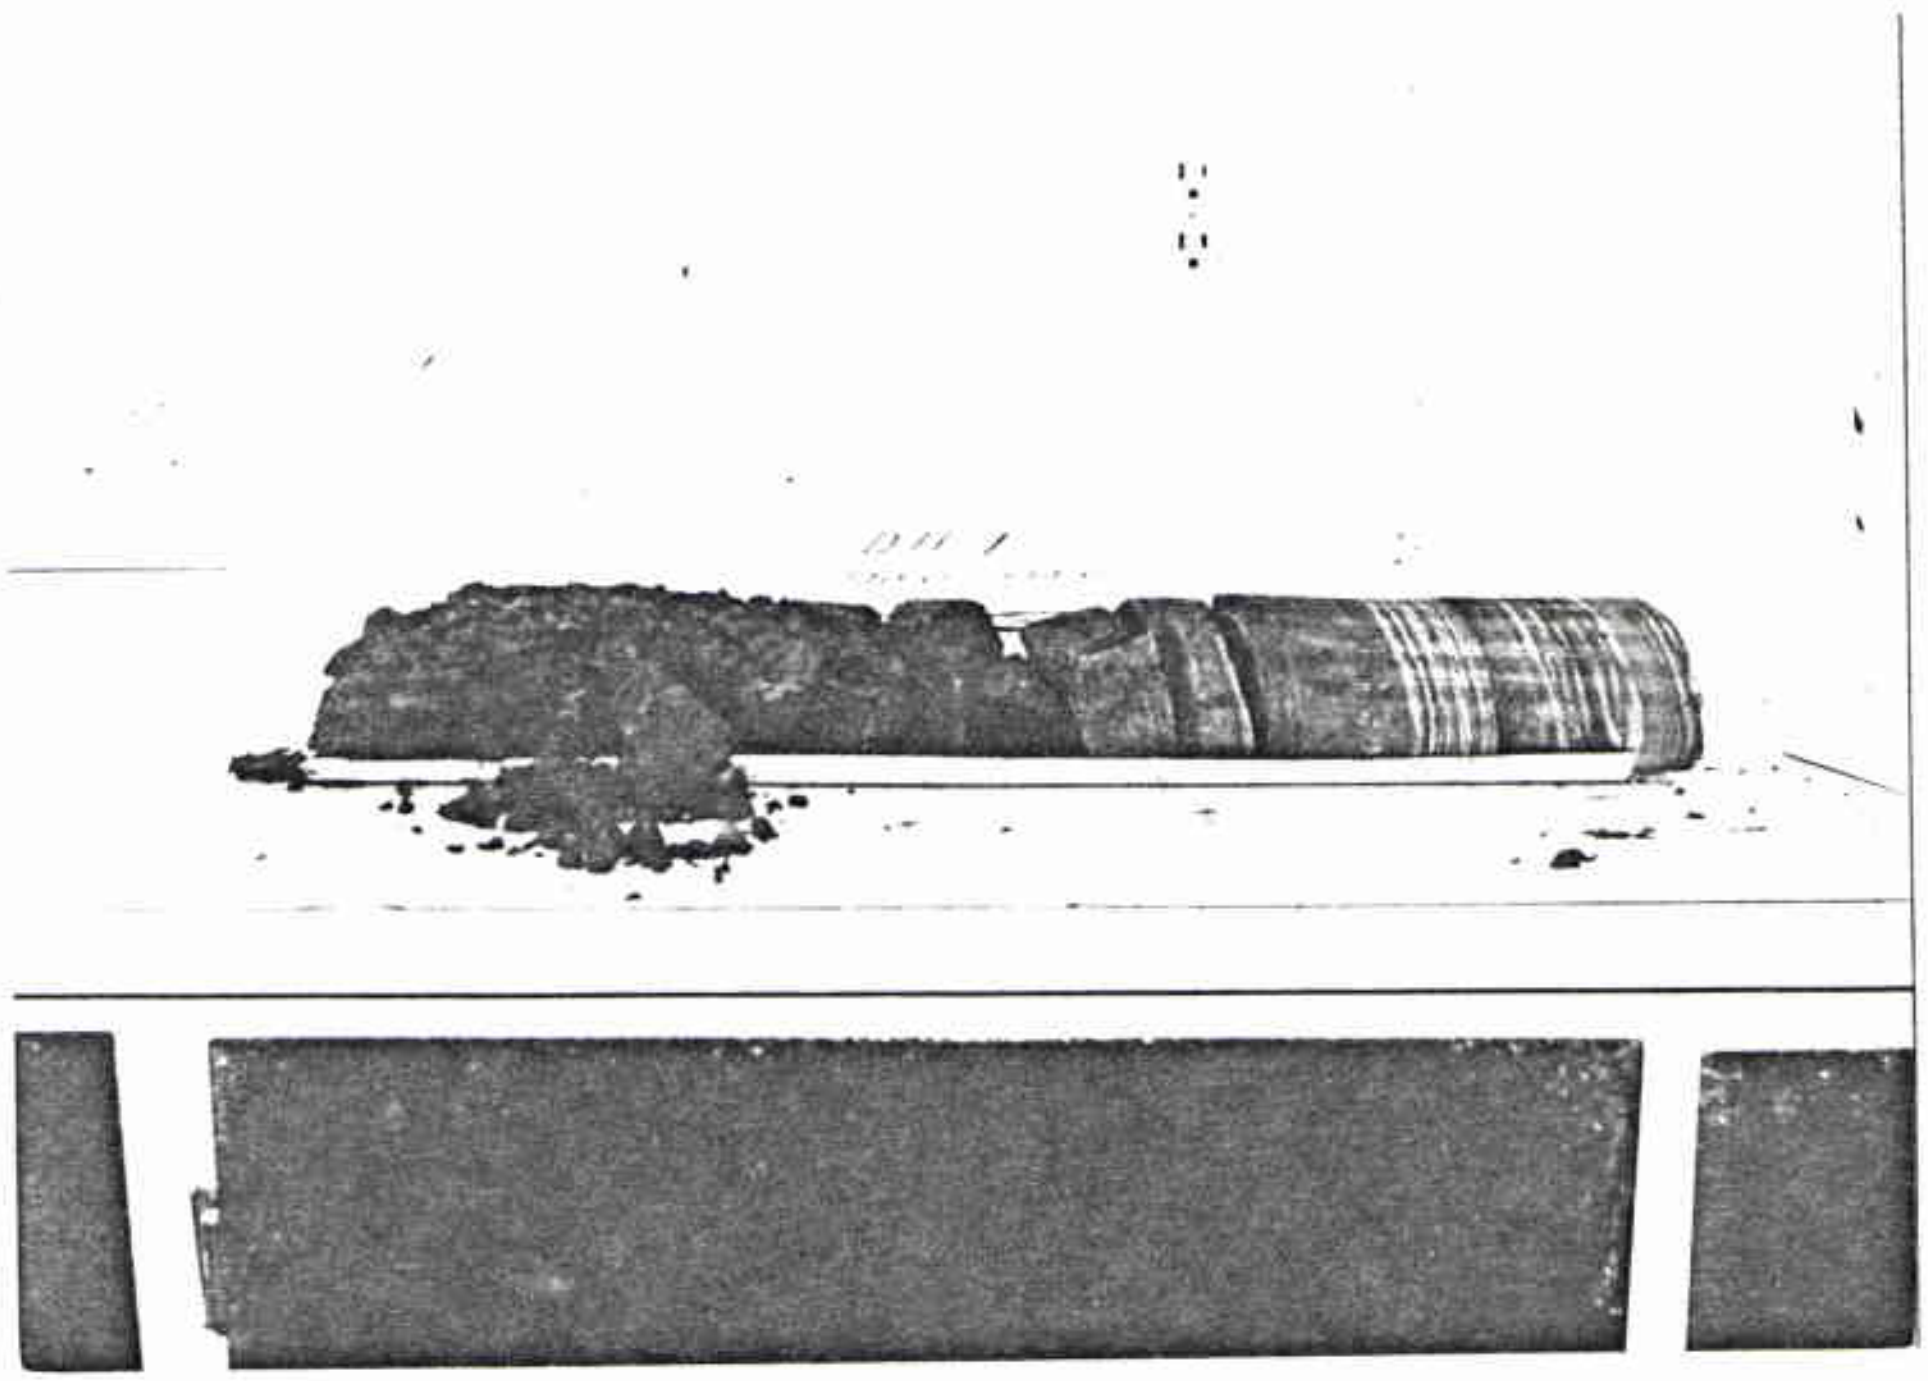
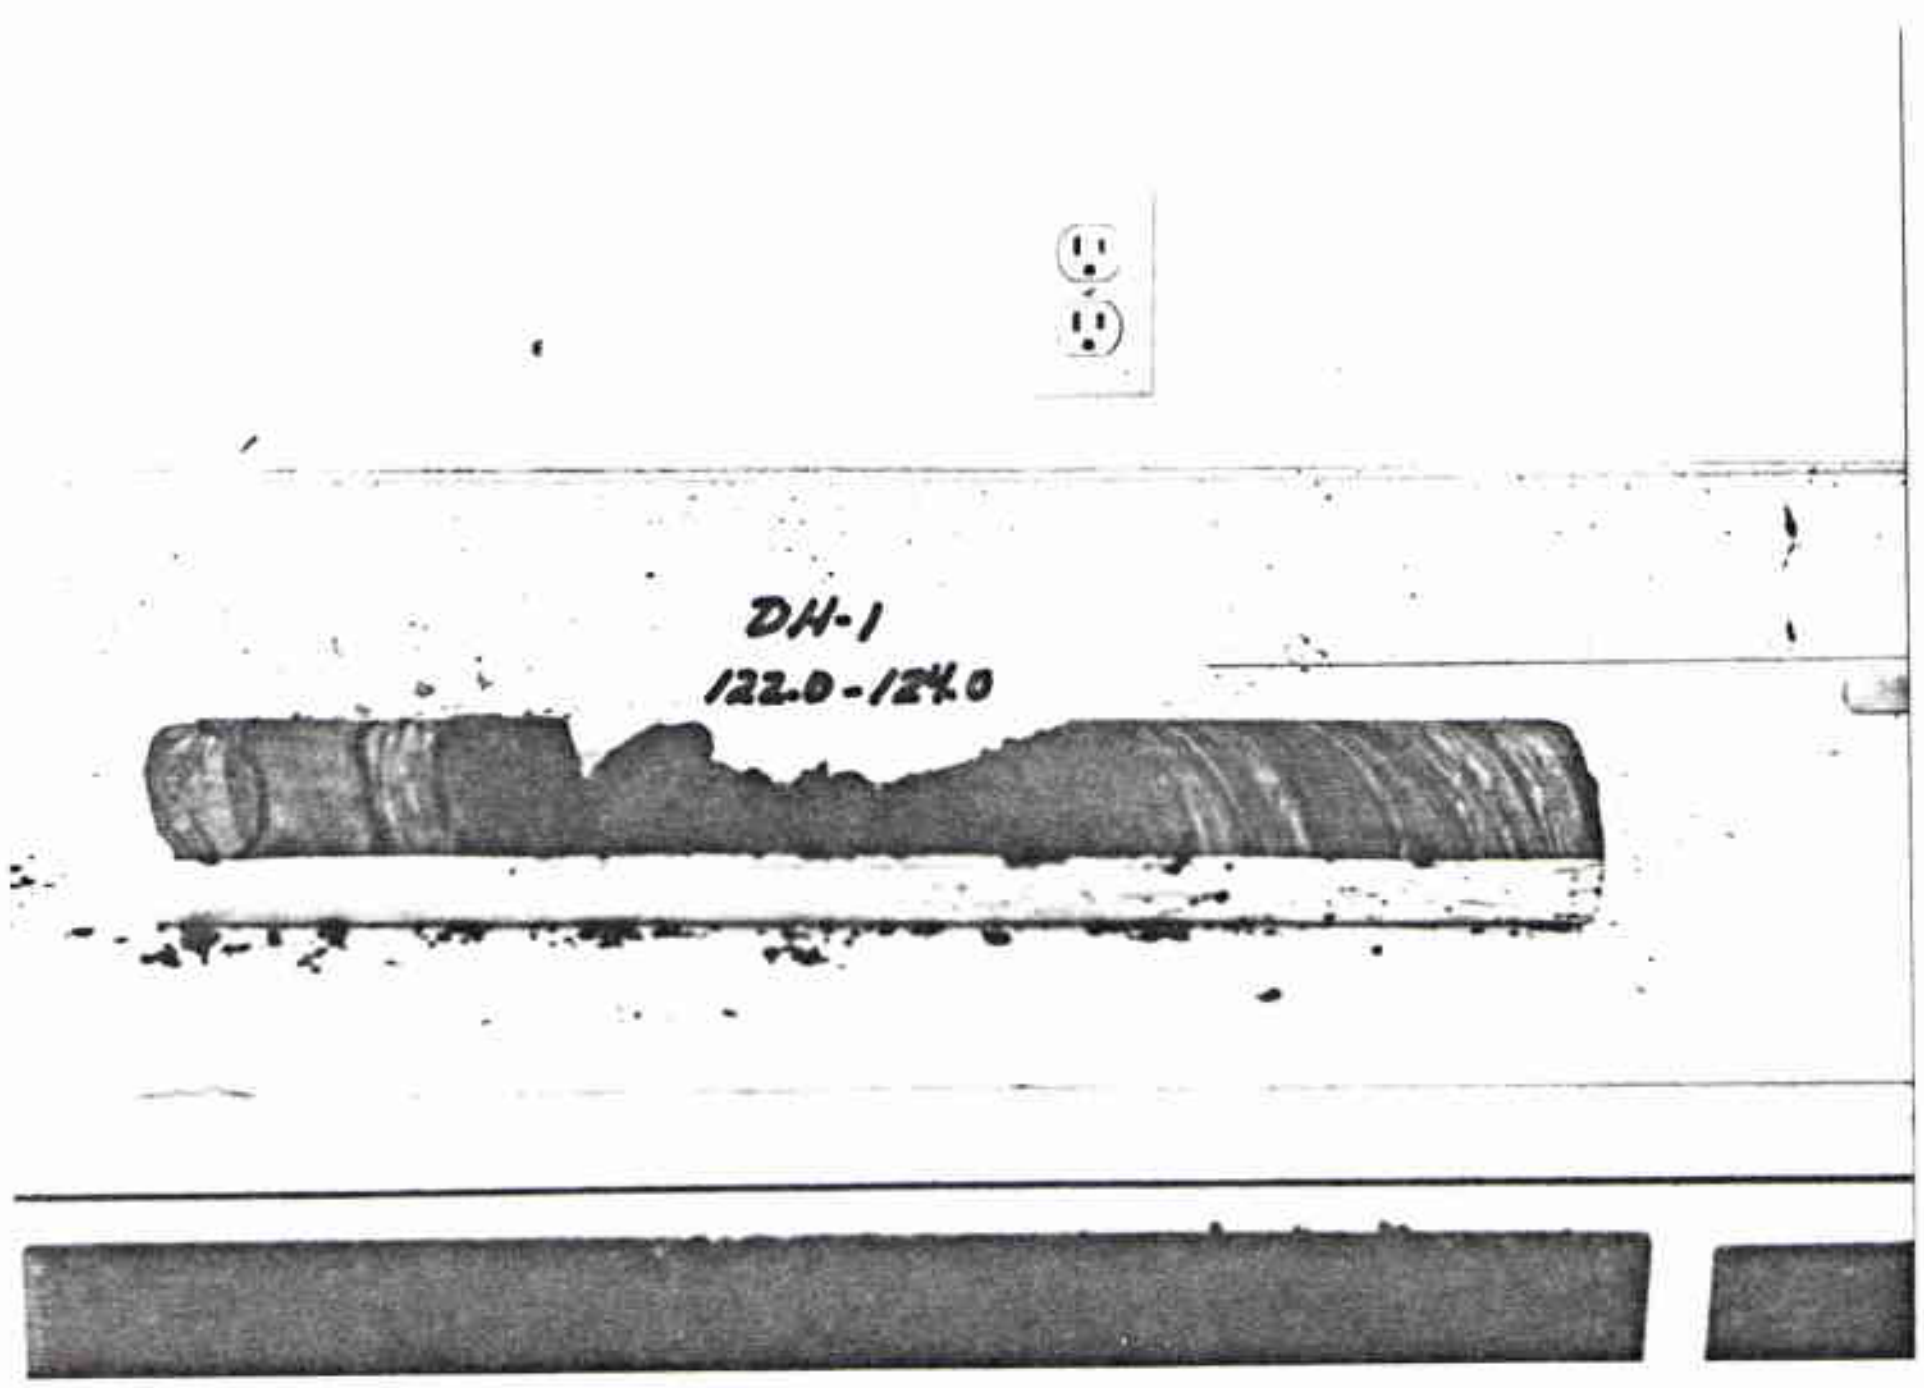
DH-1
122.0-124.0

At the airport, DH-1 intersected both the No. 1 1/2 and No. 2 Seams. While approaching the No. 1 1/2 Seam evidence of roof strain and possible collapse began to appear below 117.5 feet and continued down to the coal at 129 feet. The No. 1 1/2 Seam is between 129 and 134 feet; it is highly fractured. We interpret the zone between 117.5 to 129 to be fractures opened by roof collapse. The entire thickness of the coal was present, as shown by the video tape. This indicates a pillar rather than a room was intersected.

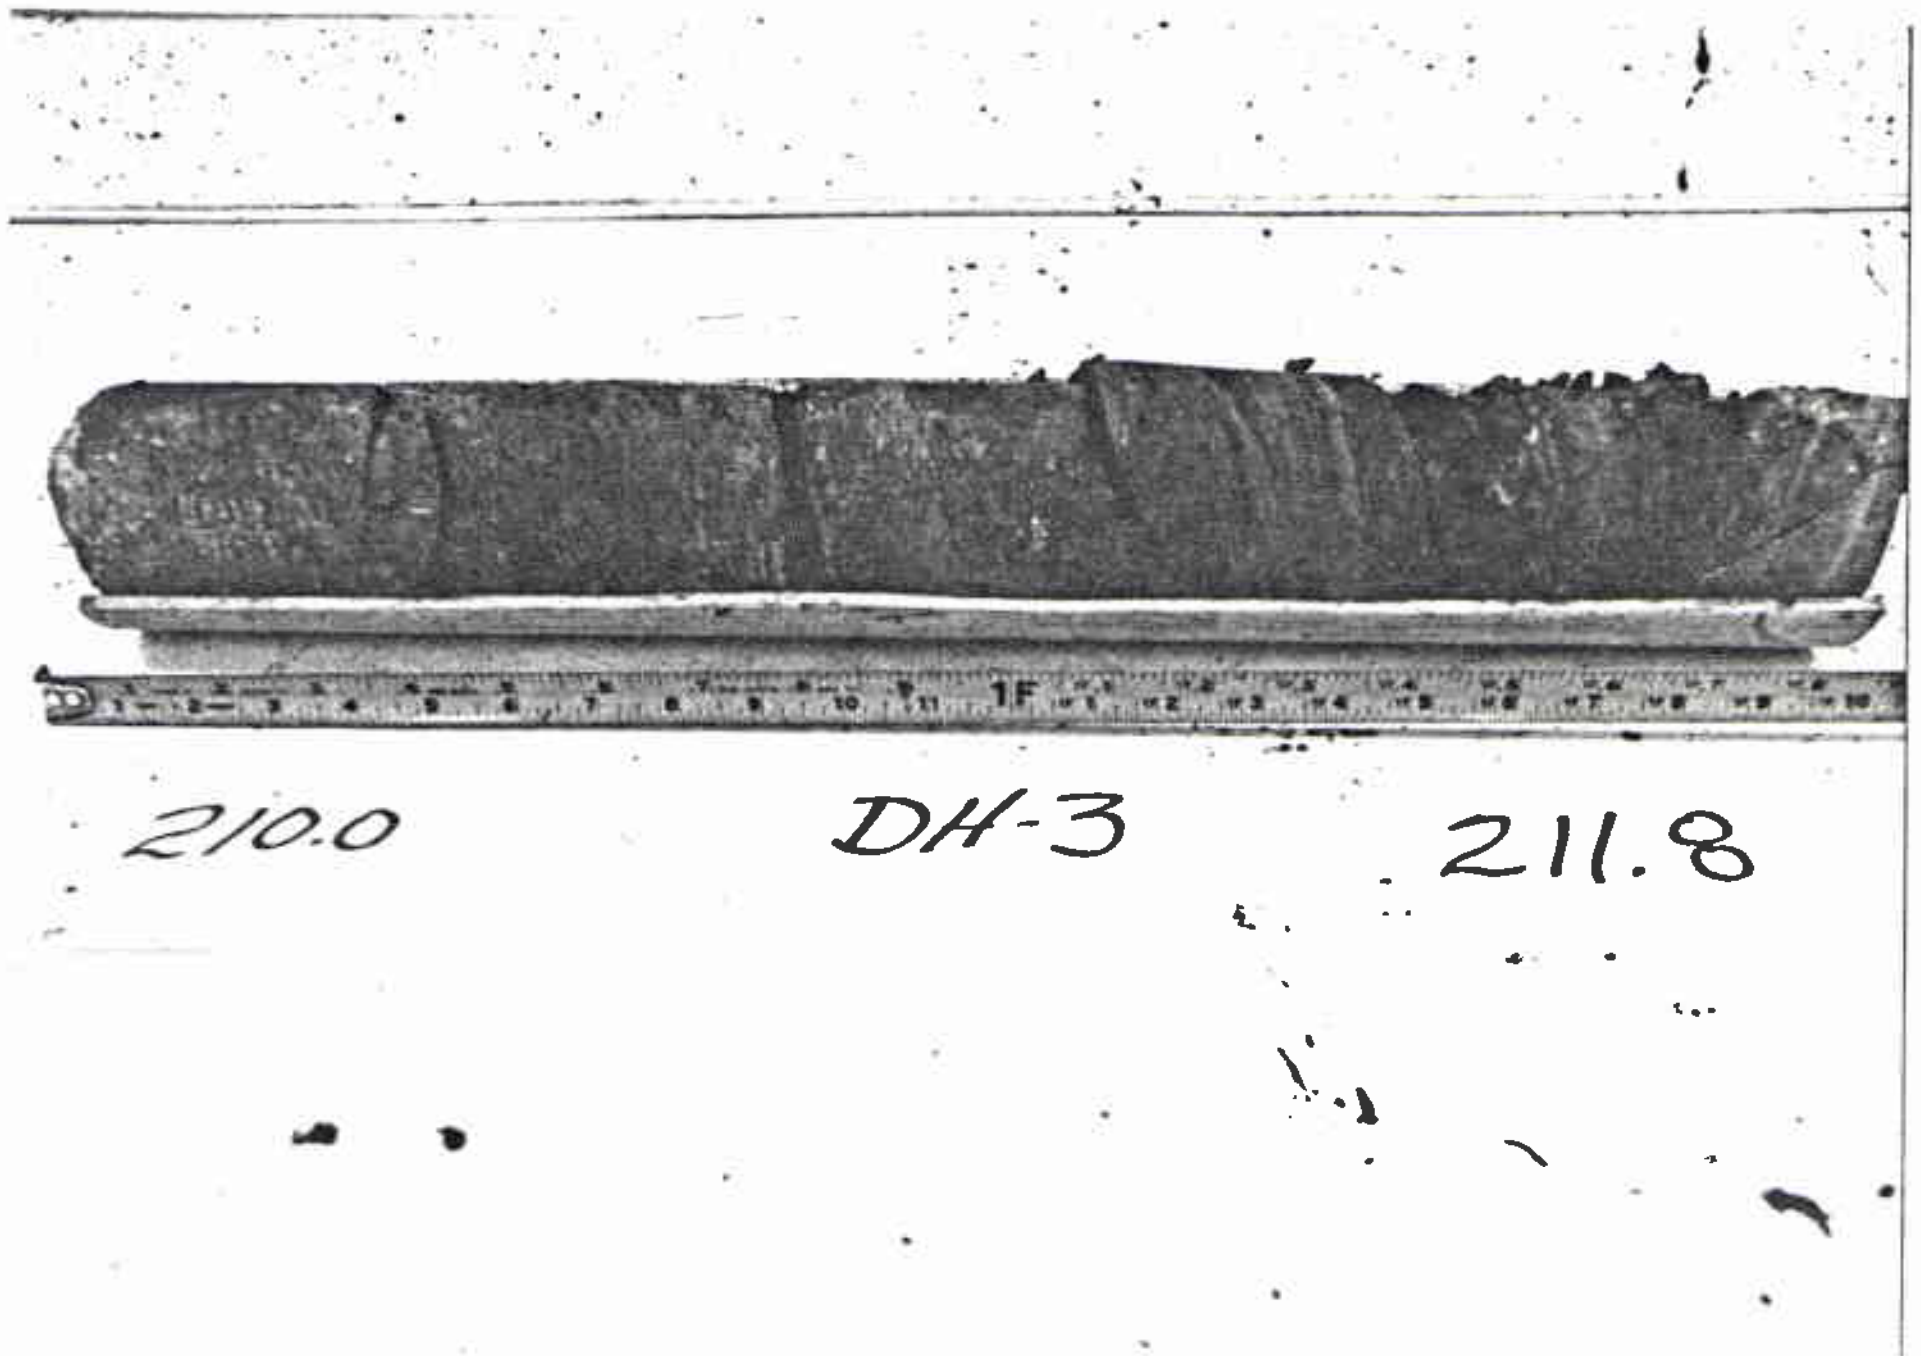
210.0
DH-3
211.8

On 14th Street, DH-3 encountered a pillar in the No. 4 Seam between about 228 and 237 feet. The core from that interval consists of highly fractured coal. The fracturing was so extensive that laboratory strength tests were not possible. Core recovery above the coal was good; about 95 percent with an RQD of 85 percent, indicating the roof to be relatively intact.
