REPORT OF INVESTIGATION
RED LODGE/BEARCREEK
SUBSIDENCE POTENTIAL STUDY

October 30, 1987

Subject: Report of Investigation Red Lodge/Bearcreek
Subsidence Potential Study
Project No. 87-3001.D

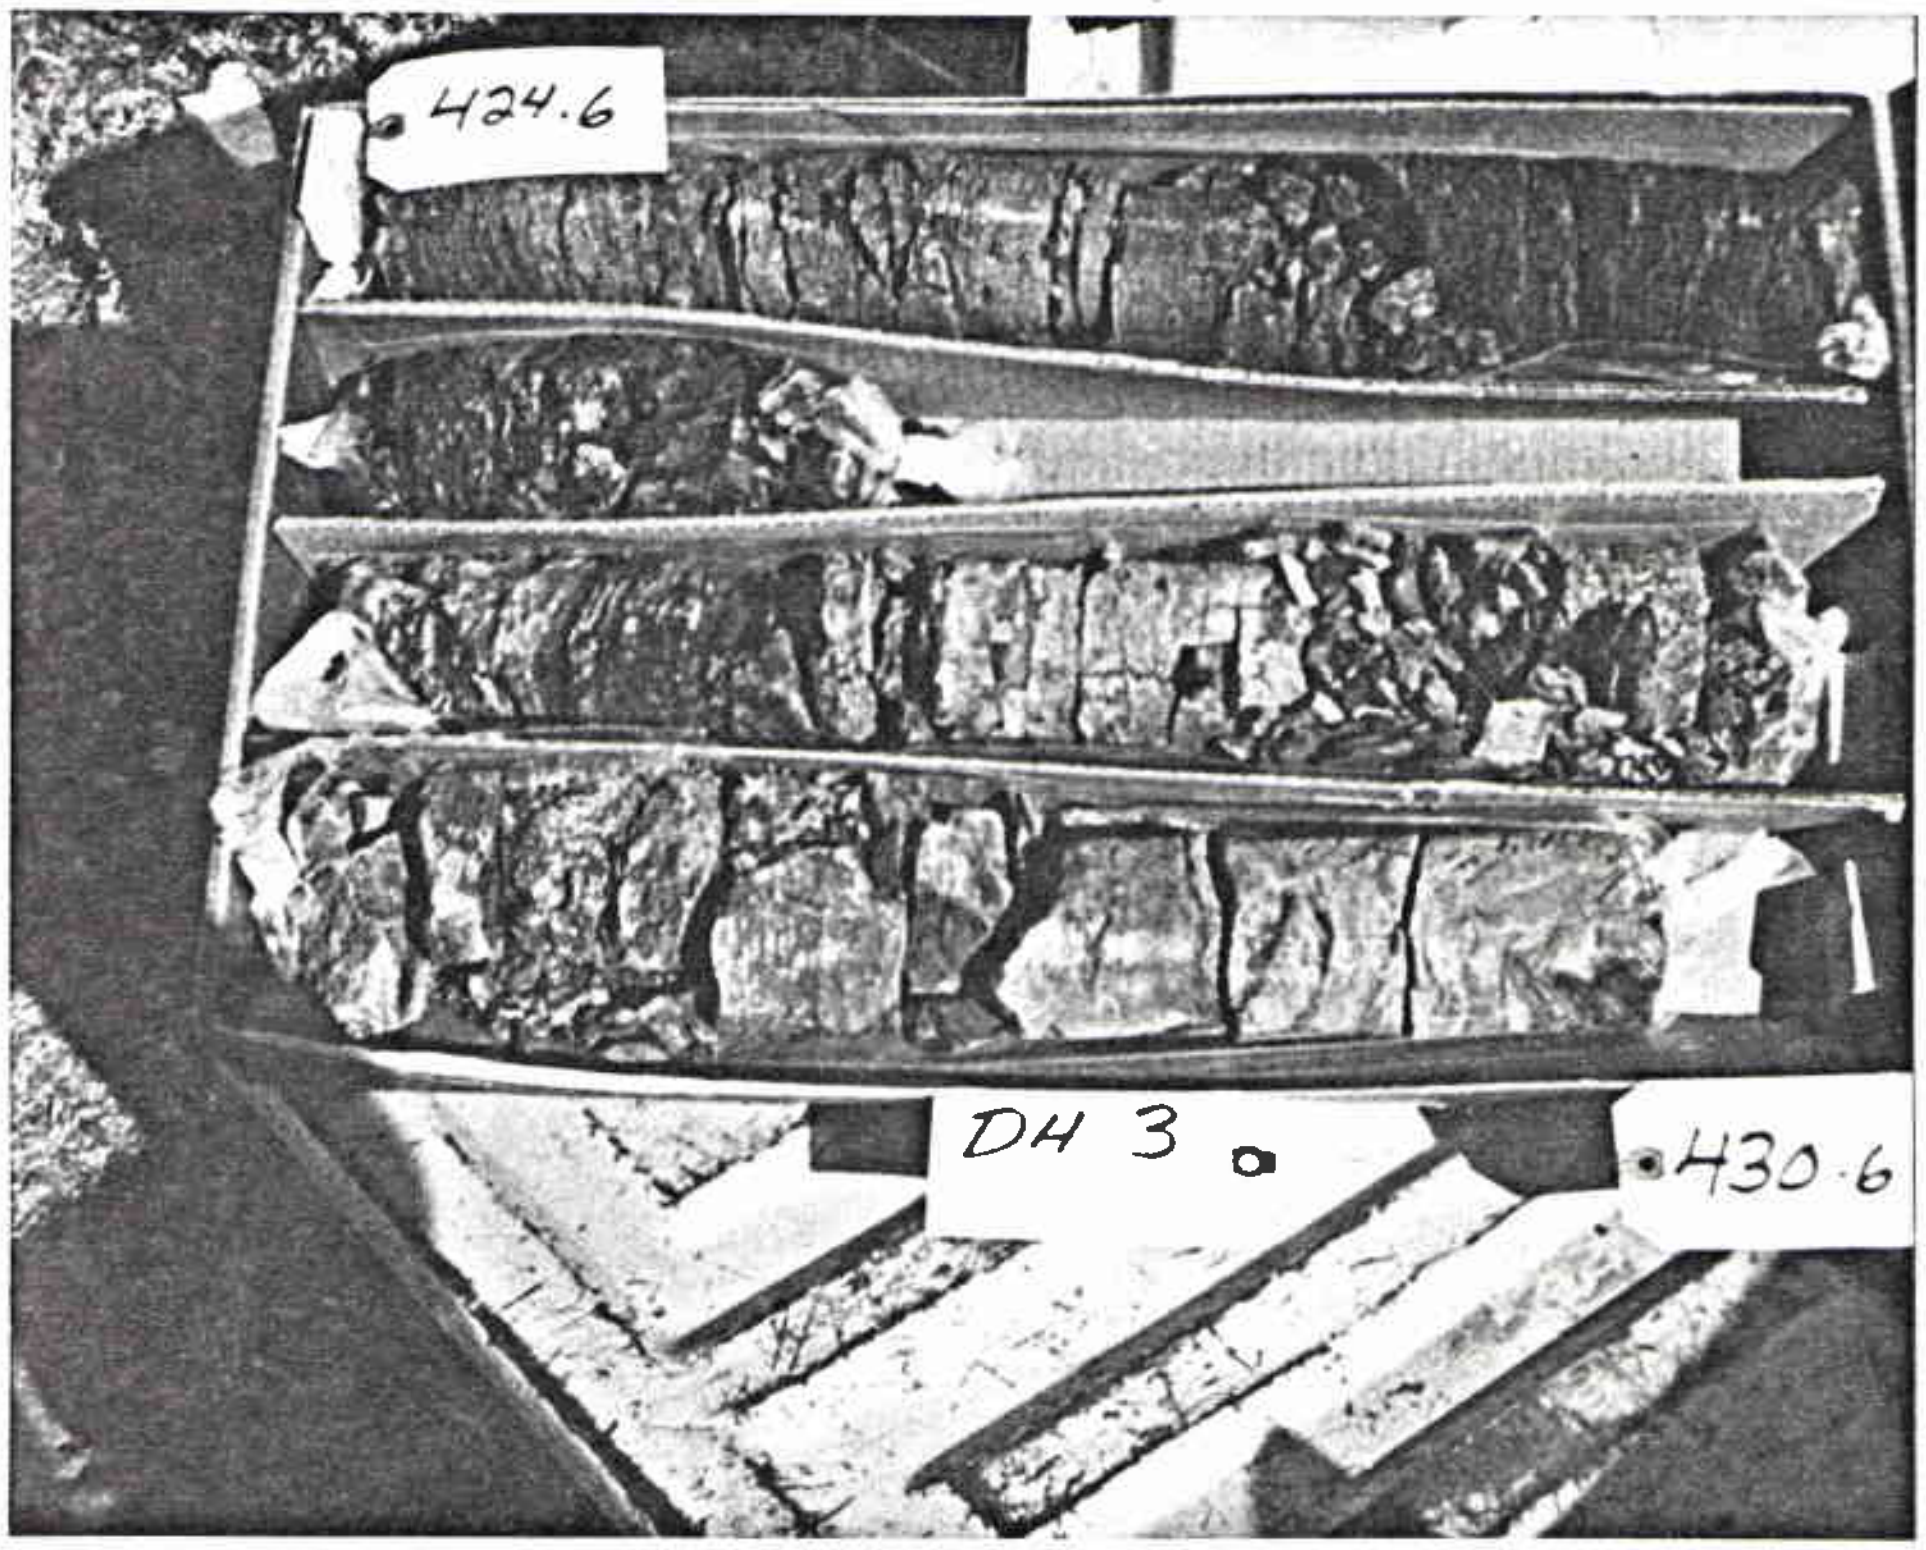
424.6
DH 3
430.6

The boring was continued down to intersect the No. 5 Seam near 435 feet. A distinct void was not encountered, but roof strain was evident in the core below 425 feet. Absence of coal in the core verifies that a former room was intersected. Since neither a distinct void nor a significant thickness of rubble was detected, we believe there has been roof-floor convergence, probably due to pillar crushing or punching. The roof strain noted in the core suggests pillar crushing or punching has caused the roof to sag. Borehole photography was not performed due to the camera's underwater depth limitation.

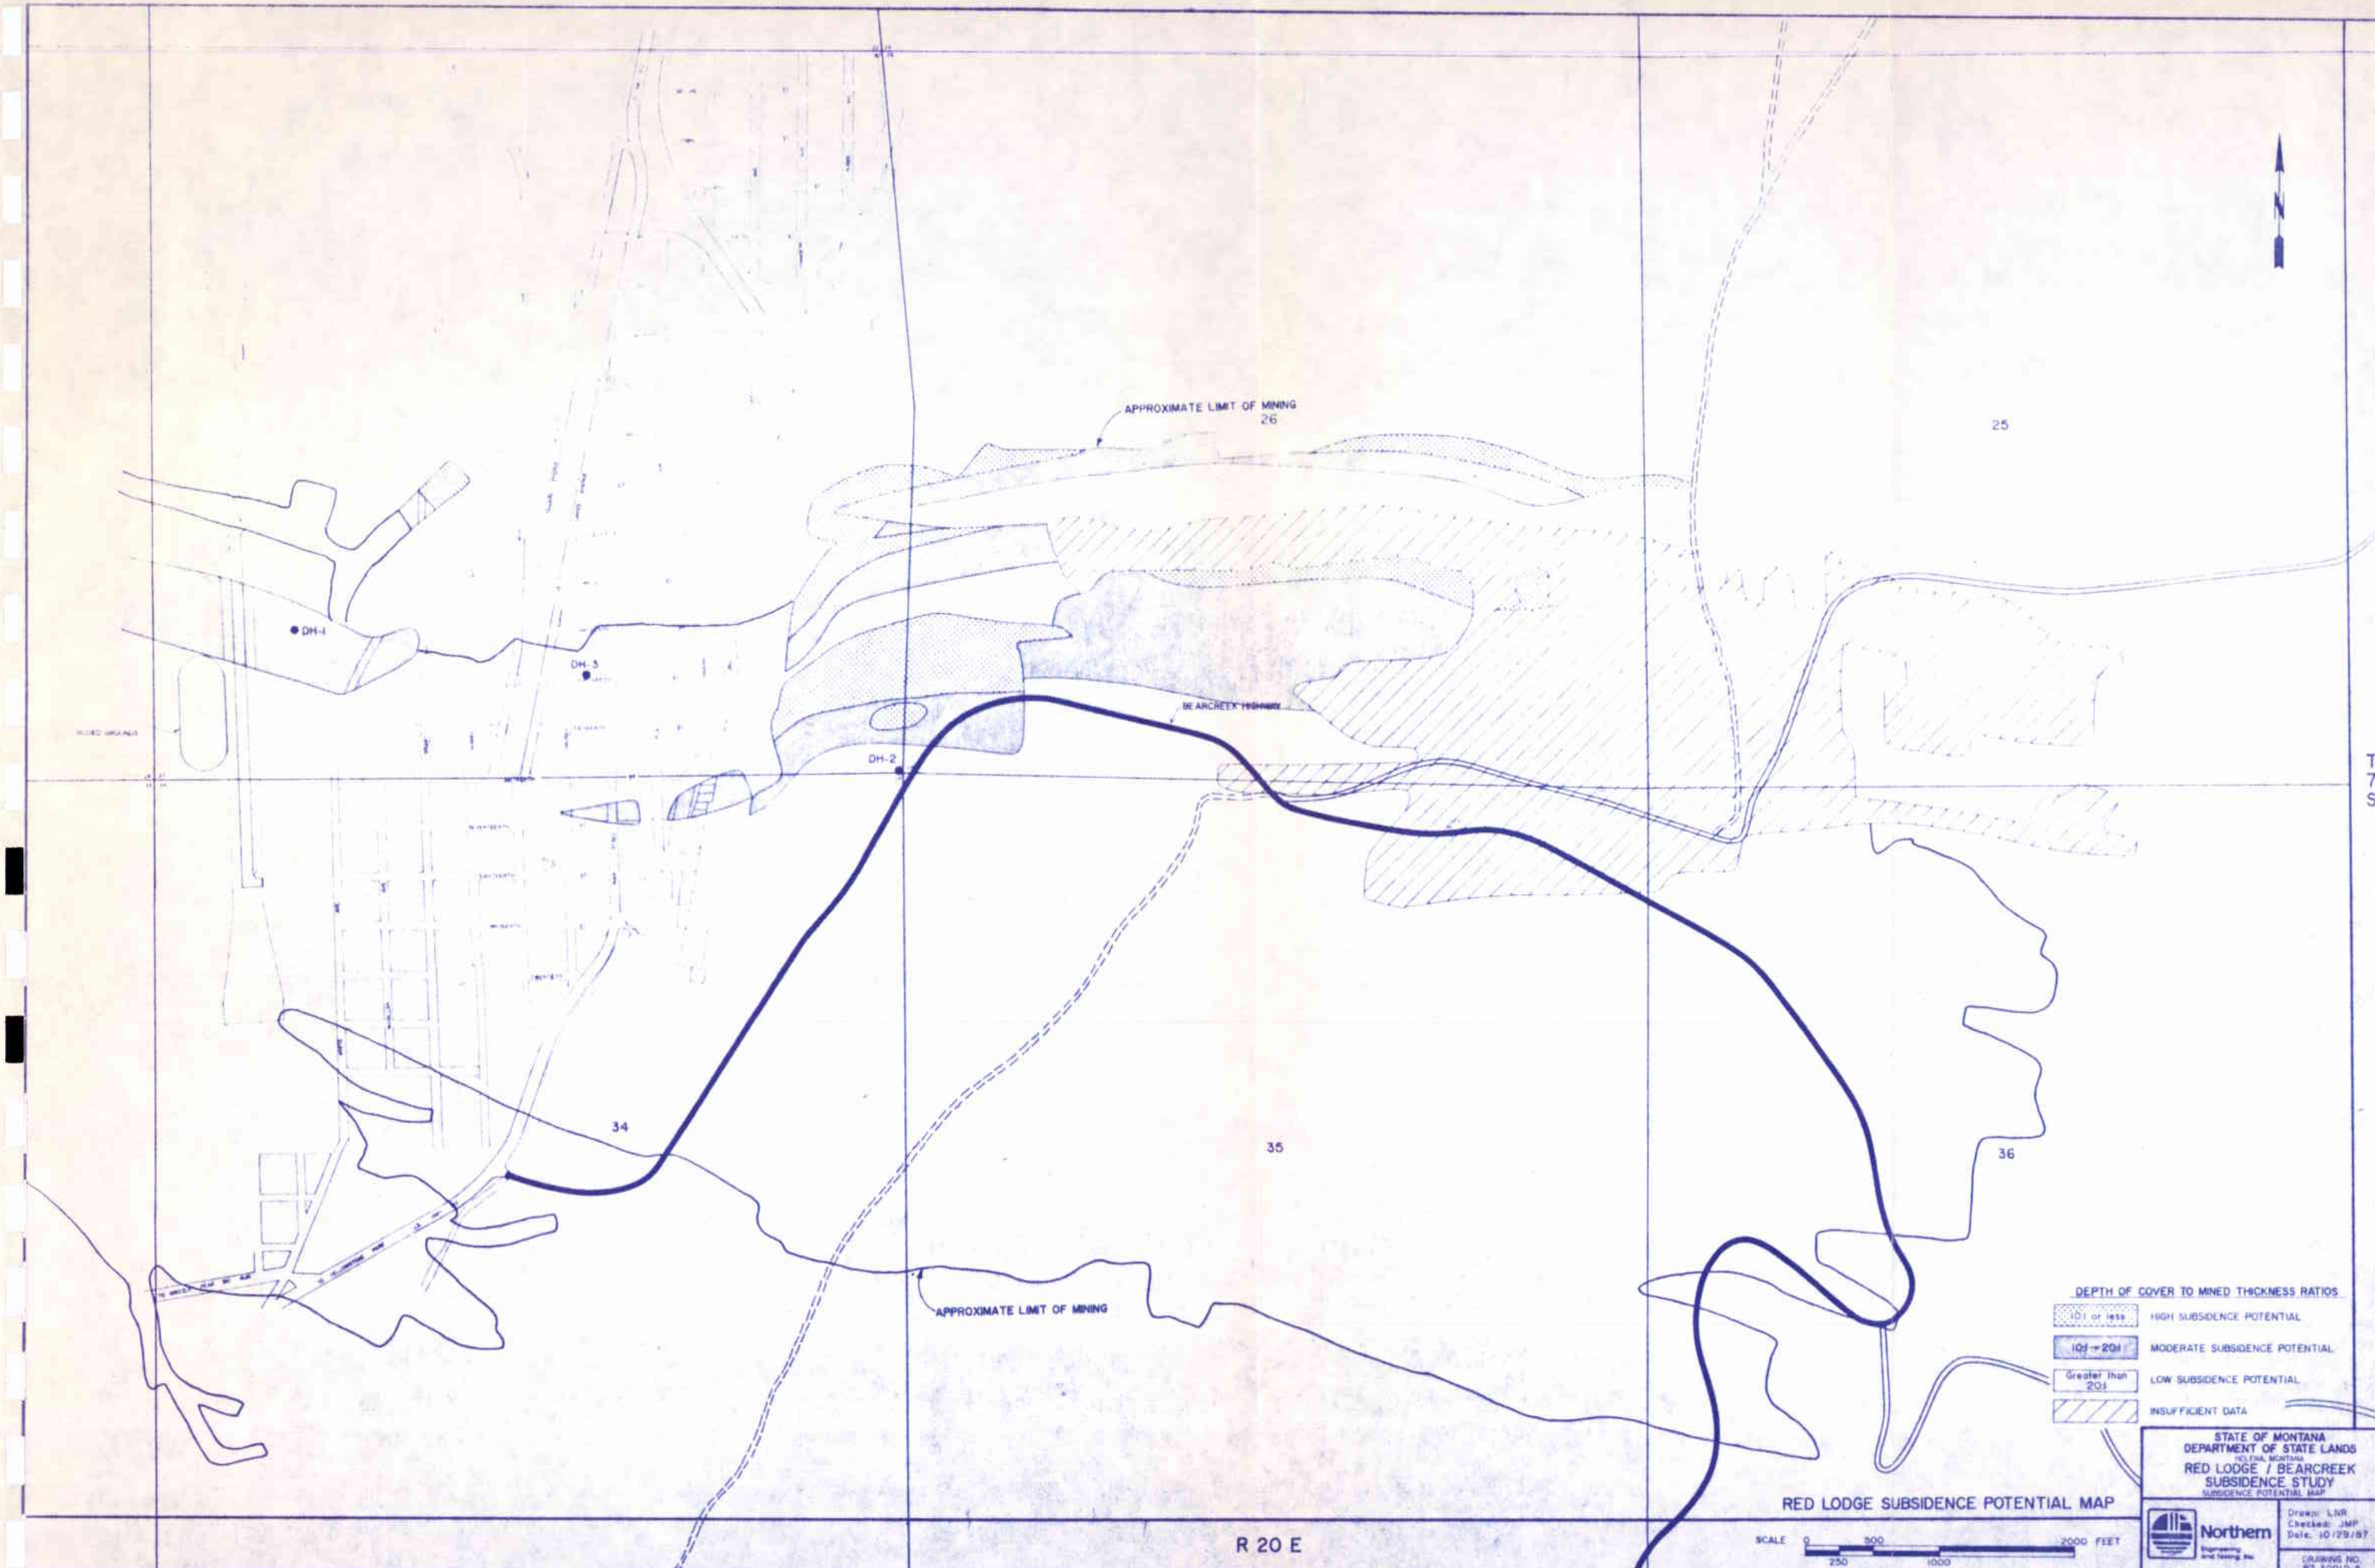
4. The potential for future subsidence is considered high only on the Bill Palmer property east of Red Lodge, near the west end of 10th Street, and above shallow adits in the Bearcreek area. It is predicted to consist of chimney subsidences similar to previous occurrences.

APPROXIMATE LIMIT OF MINING
26
25
DH-1
DH-3
DH-2
BEARCREEK HIGHWAY
T
7
S
34
35
36
APPROXIMATE LIMIT OF MINING
R 20 E
N
DEPTH OF COVER TO MINED THICKNESS RATIOS
10:1 or less — HIGH SUBSIDENCE POTENTIAL
10:1 → 20:1 — MODERATE SUBSIDENCE POTENTIAL
Greater than 20:1 — LOW SUBSIDENCE POTENTIAL
INSUFFICIENT DATA
RED LODGE SUBSIDENCE POTENTIAL MAP
SCALE 0 250 500 1000 2000 FEET
STATE OF MONTANA
DEPARTMENT OF STATE LANDS
HELENA, MONTANA
RED LODGE / BEARCREEK
SUBSIDENCE STUDY
SUBSIDENCE POTENTIAL MAP
Northern Engineering and Testing, Inc.
Drawn: LNR
Checked: JMP
Date: 10/29/87
DRAWING NO.
87-3001D-5
