# 2014 PERIODIC ENGINEER'S INSPECTION CASTLE ROCK RESERVOIR MAIN AND SADDLE DAMS COLSTRIP, MONTANA

**PPL MONTANA, LLC**  
Colstrip, Montana

**Hydrometrics, Inc.**  
Consulting Scientists and Engineers

SEPTEMBER 2014

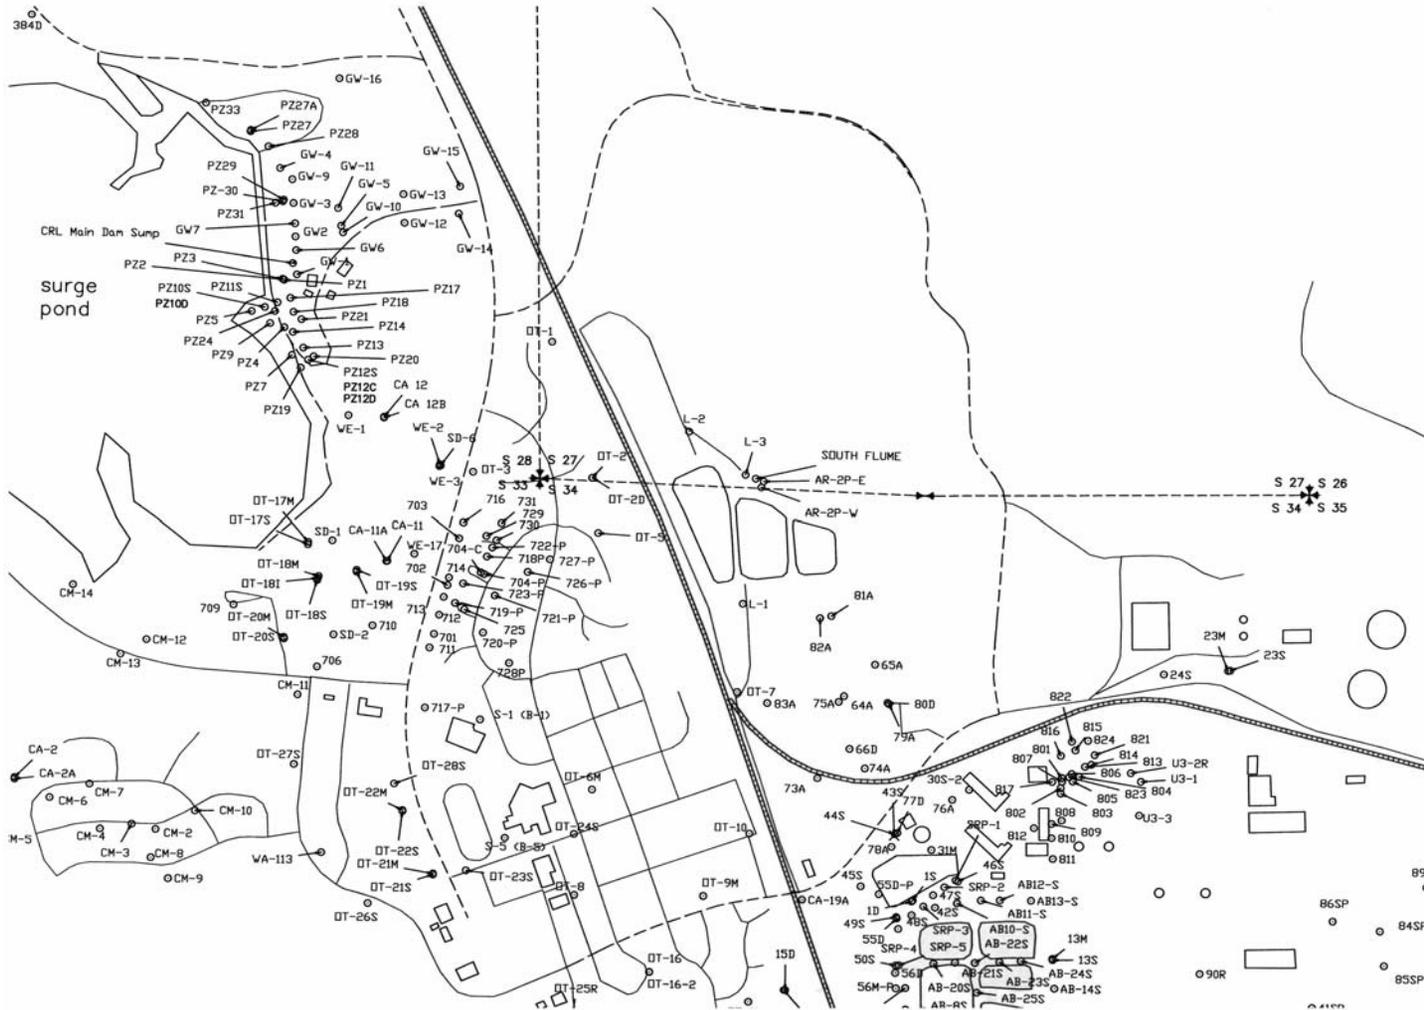
FIGURE 4-1. PIEZOMETERS NEAR THE CASTLE RESERVOIR

An engineering evaluation of the piezometer data available for the Main Dam was conducted. A map of the piezometers and seepage collection systems for the Castle Rock Dam are shown on Figure 4-1. Only piezometers installed on or near the Main Dam and which provided data useful in evaluating seepage in the embankment were analyzed. The list of useful piezometers, based on the analyses conducted in 2009, includes GW-2, GW-3, PZ-29, PZ-30, PZ31, and SURGE-09-1P (a vibrating wire piezometer installed in 2009 in the downstream shell just above the chimney drain (Womack, 2010)). The SURGE-09-1P piezometer has not detected groundwater since installation; the piezometer installation depth is approximately elevation 3222.7.

The seepage identified in the 1993 and 1999 inspection reports east of the Pumping Plant Building is still present but appeared to be similar to what was observed during the 1999 inspection, and less severe than the 1993 inspection. There is still an area of

standing water with marsh grass and cattails located just east of the dam access road, across from the Pumping Plant Building. This location is also shown on Figure 2<sup>1</sup>. The road material was moist but not muddy and there were no sand boils observed in the standing water. Installation of a trench drain to dry up the wet surface conditions and installation of either a surface water measuring device, such as a weir or flume, or a monitoring well to monitor future seepage are recommended at this location.”

Prior to the 2009 inspection, a perforated drainpipe surrounded by clean gravel was installed in the drainage trench east of the Pump Plant Building. Intercepted seepage is drained to a sump and pumped into the drain channel that runs along the downstream area below the dam and to the north of the Pump Plant Building. During the 2014 inspection, the drain system was operating and was in good working order. The seepage discharge was not measured.

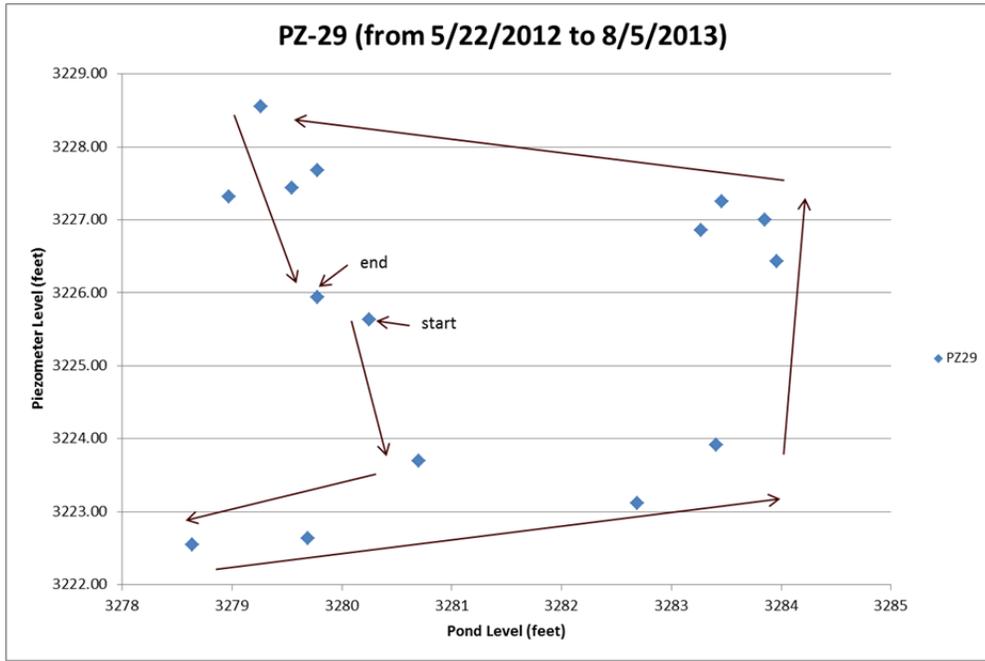
**FIGURE 4-3. RELATIONSHIP BETWEEN POOL LEVEL AND PIEZOMETER LEVELS FOR CASTLE ROCK MAIN DAM, PZ-29**

Figures 4-3, 4-4 and 4-5 show piezometer levels versus reservoir levels for piezometers PZ-29, GW-3 and GW-11. The data period for each figure spans from May 2012 to August 2013. Some general observations about Figures 4-3 through 4-5 are:

- Although each of the piezometers measures a different water level, all three react in a similar manner to changes in reservoir level. This consistency suggests that they are primarily being influenced by seepage from the reservoir and not some other source of groundwater that might influence one piezometer more than the others. The arrows on Figures 4-3 to 4-5 indicate the direction of data change over the 15 months represented.

We recommend that the surface seepage, which is collected from the interior drain and discharged along the downstream toe, should be measured and monitored along with corresponding pond levels and on the same schedule as the piezometers. The monitoring recommendations for both surface seepage and piezometers will provide effective methods for detecting signs of developing problems. By plotting seepage flow (or piezometer level) versus reservoir level, relationships can be derived which represent current normal seepage conditions and provides a basis for determining if future seepage flows suggest that problems may be developing as the embankment ages. Surface seepage monitoring is important because, unlike piezometers that only reflect seepage effects at one point in the dam, it provides a picture of how the entire dam is functioning. A good surface seepage monitoring program reduces the reliance on piezometer monitoring.

We recommend the following actions be taken before the next inspection in order to improve seepage monitoring for Castle Rock Dam:

1. Collect data from PZ-29, GW-3, GW-11 and SURGE-09-1P at the same time that pond levels are measured at intervals no longer than monthly and ideally twice a month for at least a year in order to establish a baseline for the piezometers' behaviors.
2. Install measurement devices to monitor the flow from the Main Dam's internal drain and from the interception ditch adjacent to the Pumping Plant Building. A recommended location for a measuring device is shown on Figure 2-2.

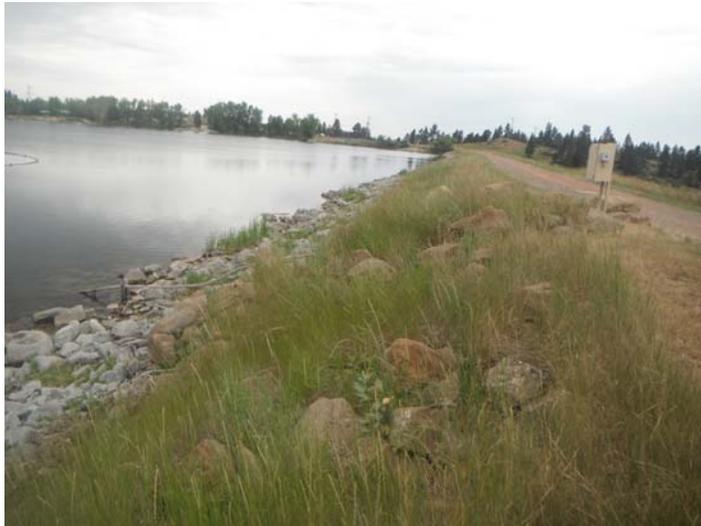
The upstream slope did not exhibit any signs of sliding, sloughing, escarpment, erosion, or unusual movement (Photos 3 and 6). The contact between the embankment and abutments was in good condition (Photo 4). Riprap slope protection was in good condition. Periodic monitoring of the riprap is recommended, with maintenance as needed. Scattered small willows and trees are growing within the riprap and need to be removed.

Photo 3. Castle Rock Surge Pond Main Dam, July 15, 2014.  
Upstream slope from right abutment.

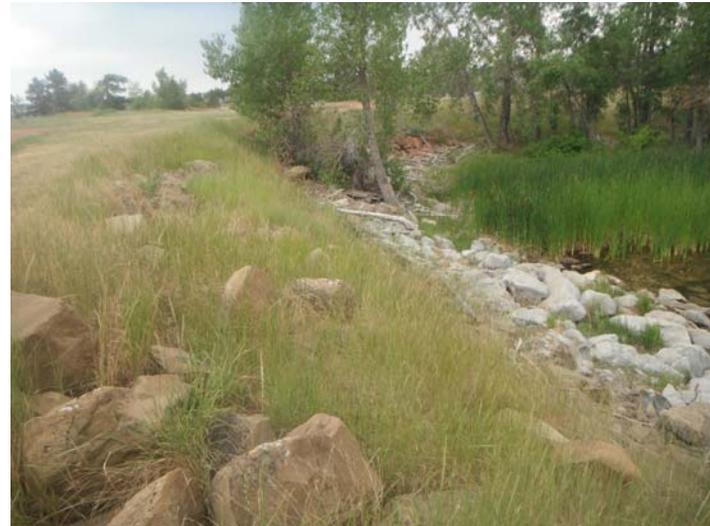
Photo 4. Castle Rock Surge Pond Main Dam, July 15, 2014.  
Upstream slope and right abutment area.

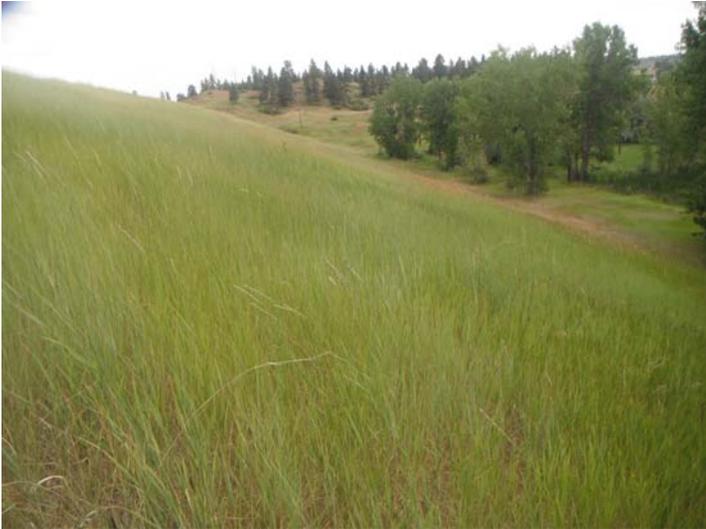
The downstream slope was in good condition with minor items identified that require attention. No signs of slope instability, wet areas, or seepage were observed. There was no erosion or unusual movement (Photos 5 and 9). The vegetative cover was good except for some scattered sagebrush growing near the crest. Some weeds were identified that should be controlled, and the weeds typically were present near identified rodent holes (Photos 12 and 13). It is not known if the rodent holes were active. We recommend backfilling rodent holes and monitoring to identify if rodents are present. PPL Montana reported that a rodent control program was enacted several years ago. A similar program will have to be used if rodents are still active. A large rodent or fox hole was found in the left downstream groin that needs to be backfilled and treated similar to the other rodent holes (Photo 14).

Photo 5. Castle Rock Surge Pond Main Dam, July 15, 2014.  
Downstream slope, mid-dam.

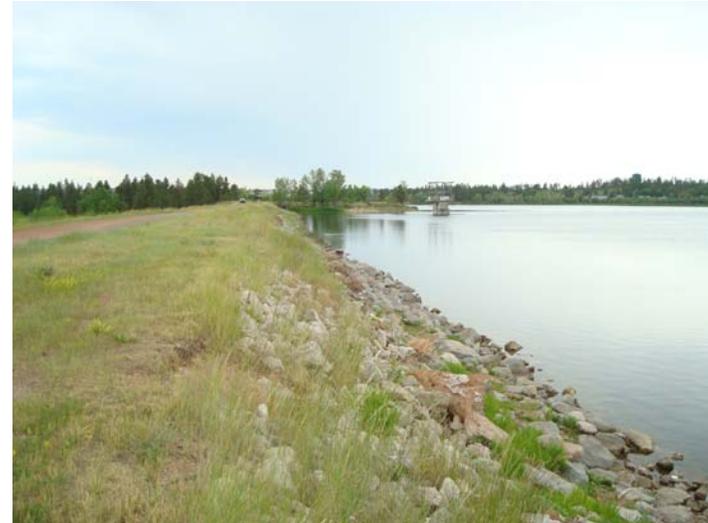
Photo 6. Castle Rock Surge Pond Main Dam, July 15, 2014.  
Upstream slope from left abutment.

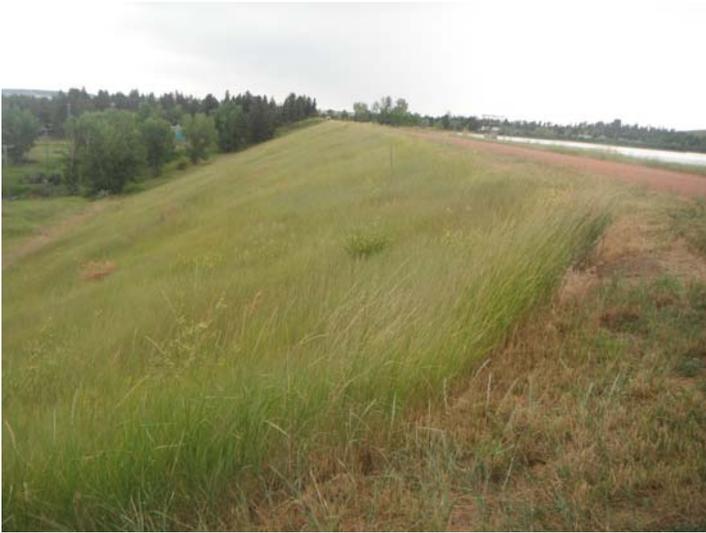
Photo 9. Castle Rock Surge Pond Main Dam, July 15, 2014.  
Crest and downstream slope from left abutment.

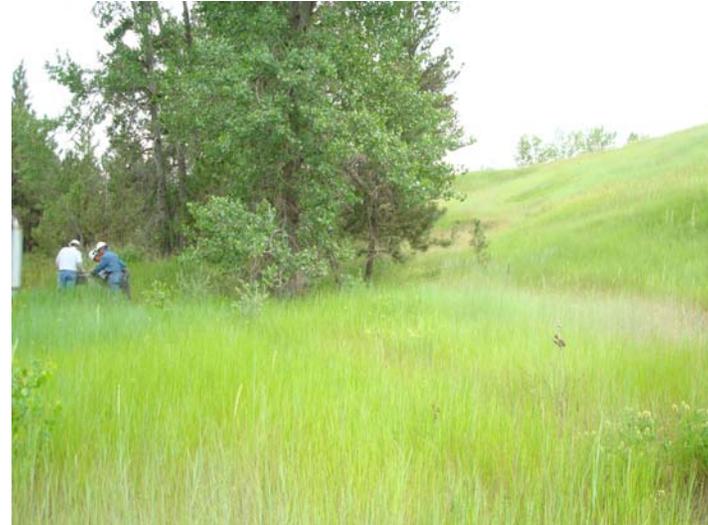
The downstream area of the Main Dam showed no signs of surface seepage except in the toe drain of the dam and in the interception trench near the Pumping Plant Building (Photos 17 through 22). Installation of a weir or other type of flow measuring device is recommended in the drainage channel in the center toe area (see Figure 2-3 for potential weir location). Once a measuring device is installed, flow in the trench should be monitored monthly, accompanied by corresponding reservoir water surface elevations.

Photo 18. Castle Rock Surge Pond Main Dam, July 15, 2014.  
Downstream toe area.

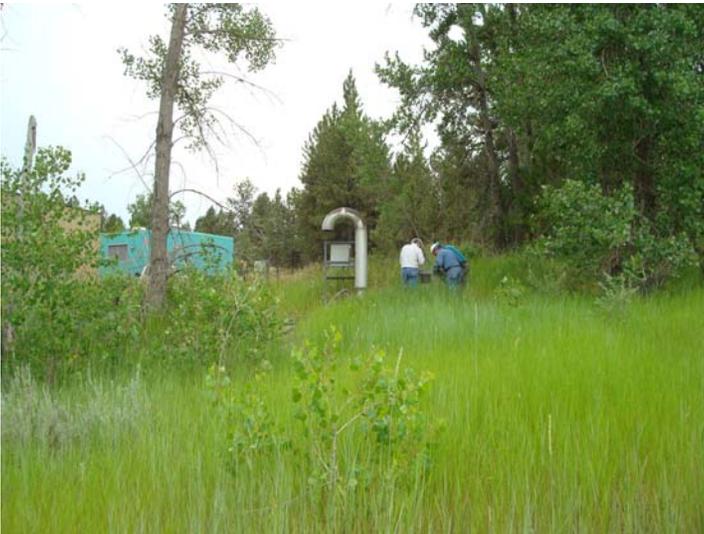
Photo 19. Castle Rock Surge Pond Main Dam, July 15, 2014.  
Seepage collection vault and access manhole to main outlet pipe.

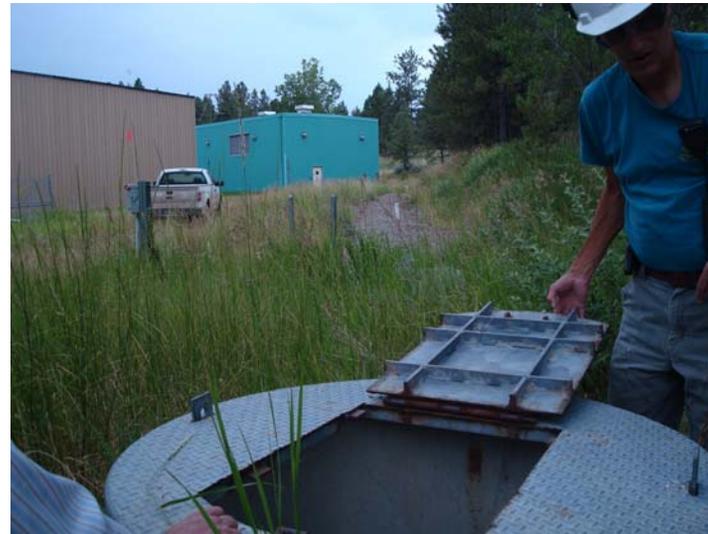
Photo 20. Castle Rock Surge Pond Main Dam, July 15, 2014.  
Manhole access to main outlet pipe leading from intake tower to pump plant.

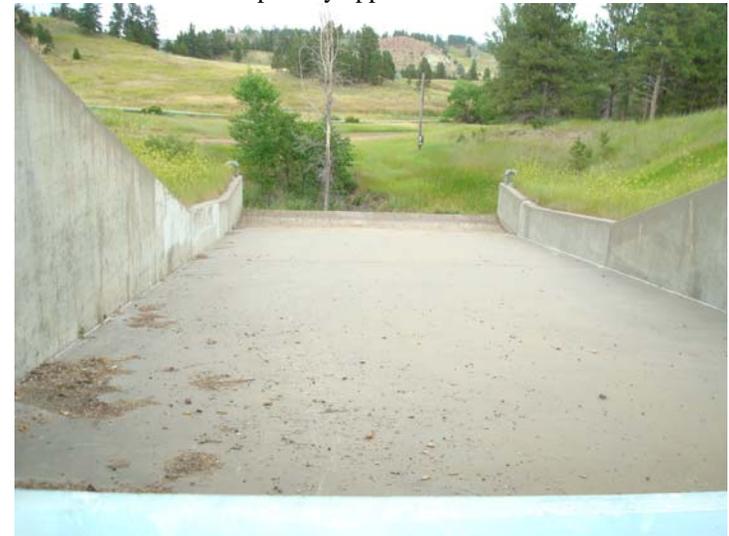
The spillway channel floor appears to be in good condition (Photos 28 and 33). There was no indication of displacement or unusual movement within the channel. The sidewalls appear to be in good condition except for spalling at the top of the right wall at a joint on the lower part of the spillway that needs repair (Photo 31). Some filler material is missing in the floor-wall joint on the left side near the flip bucket, which requires repair (Photo 35). The discharge area was in good condition with established vegetation.

Photo 28. Castle Rock Surge Pond Main Dam, July 15, 2014.  
Spillway concrete channel looking downstream.

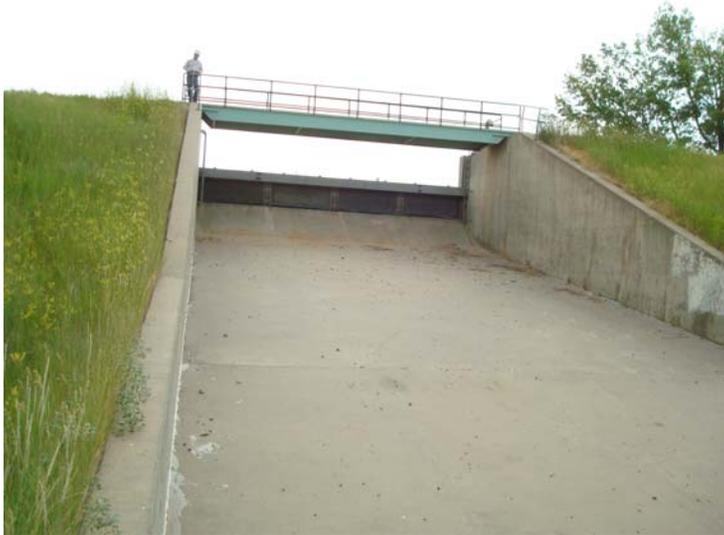
Photo 33. Castle Rock Surge Pond Main Dam, July 15, 2014.  
Looking upstream at spillway channel and walkway.

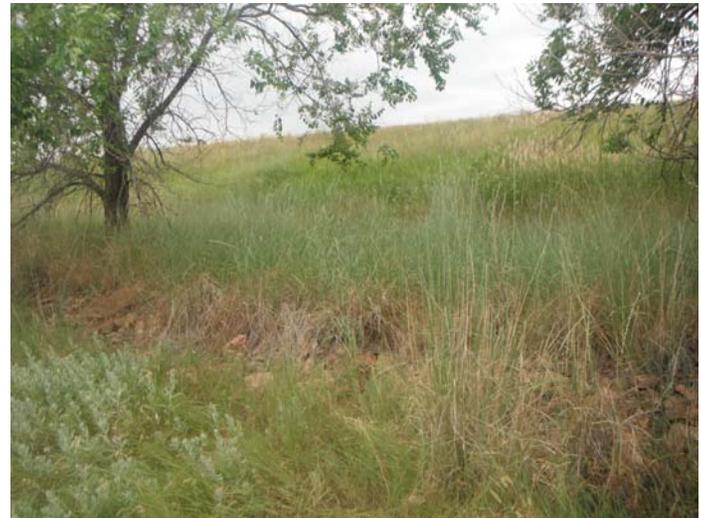
Inspection of the downstream area of Saddle Dam showed the area to be in good condition (Photo 40). The abutment and foundation showed no leakage, seepage, or evidence of instability. The Saddle Dam does not have a drainage system.

Photo 40. Castle Rock Surge Pond Saddle Dam, July 15, 2014.  
Downstream toe, mid-dam.

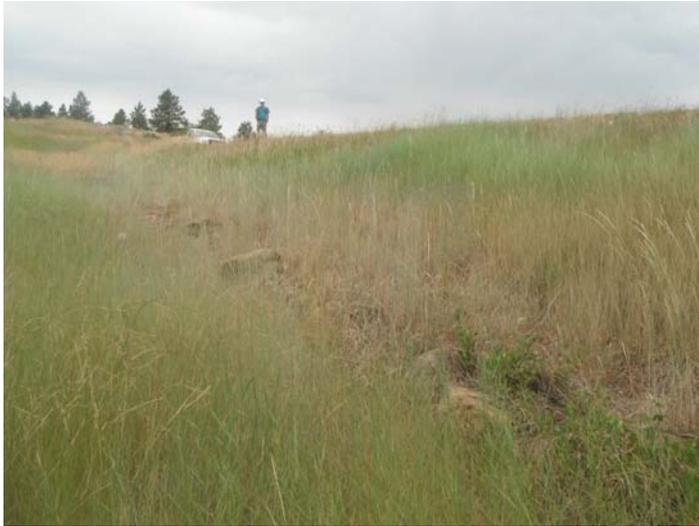
Photo 41. Castle Rock Surge Pond Saddle Dam, July 15, 2014.  
Downstream toe and slope, looking at right abutment.

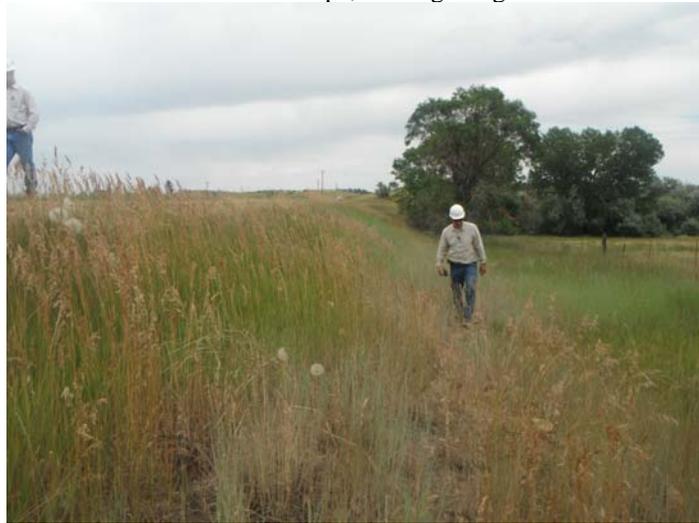
Photo 43. Castle Rock Surge Pond Saddle Dam, July 15, 2014.  
Downstream slope from right abutment.

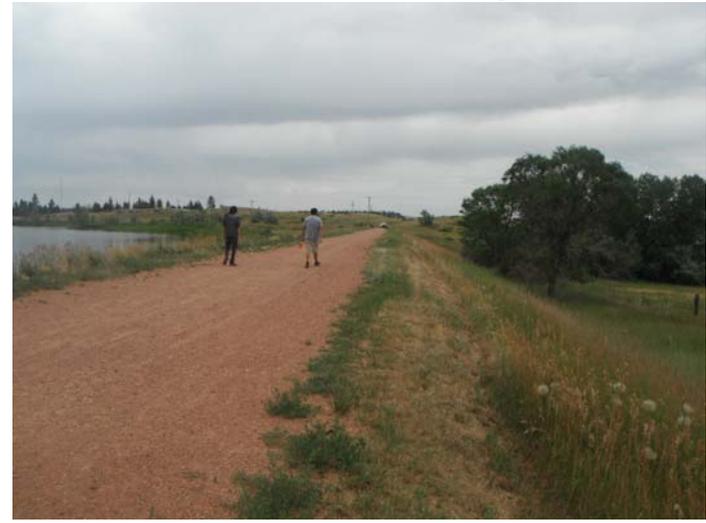
An elevation survey along the crest was not conducted during this inspection. Surveys conducted in 1988 and 1993 by Tetra Tech, Inc., dba Maxim Technologies, Inc. (Tetra Tech, 1988 and 1993) indicated no unusual settlement of the crest. During this inspection, no surface cracking, animal burrows, or low areas were evident along the crest. The horizontal alignment of the crest was good with no ruts or puddles evident. A bike/running path along the crest was in good condition and the vegetation cover on the shoulders was well established (Photo 44).

Photo 44. Castle Rock Surge Pond Saddle Dam, July 15, 2014.  
Crest and downstream slope from right abutment.
