2014 PERIODIC ENGINEER'S INSPECTION UNITS 1 & 2 STAGE II EVAPORATION POND (STEP) MAIN DAM COLSTRIP, MONTANA

PPL MONTANA, LLC
Colstrip, Montana

SEPTEMBER 2014

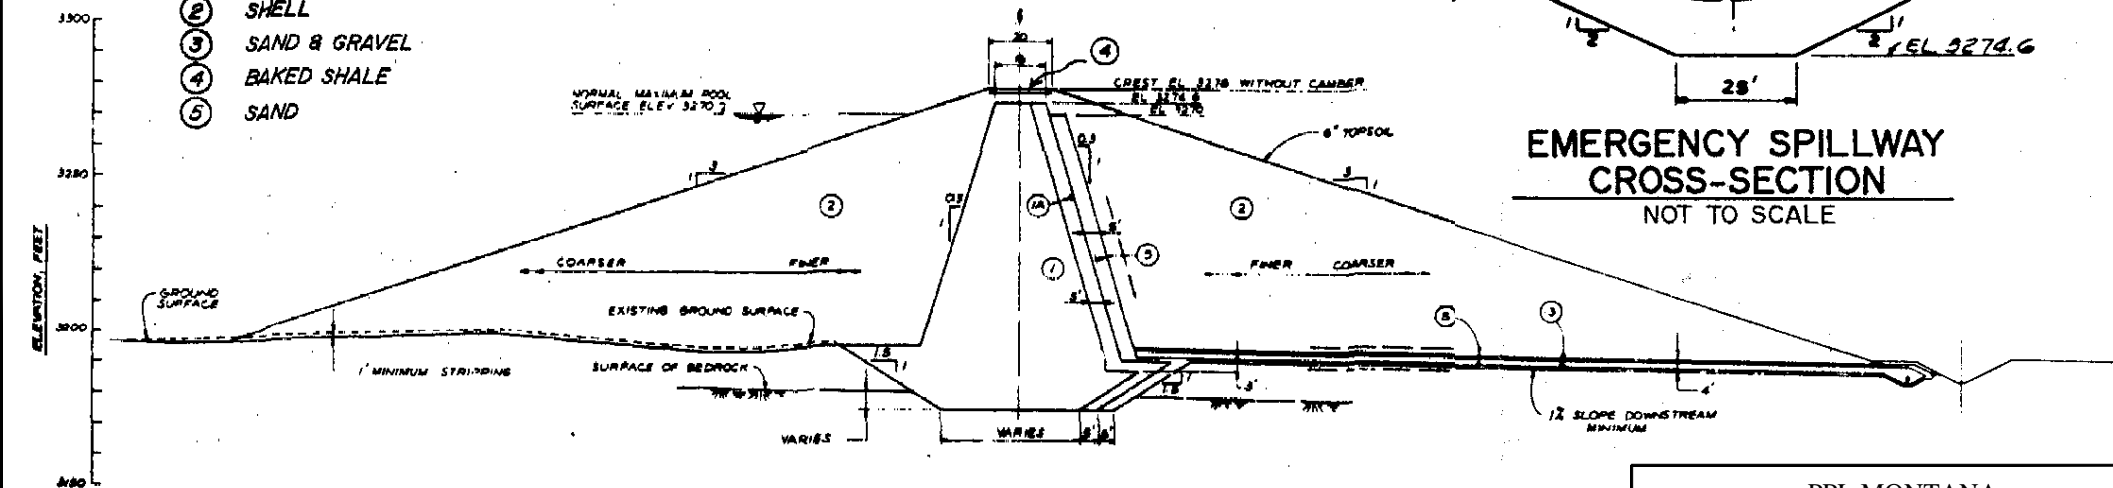
EMERGENCY SPILLWAY CROSS-SECTION

The spillway is an uncontrolled, unlined excavation through baked shale and weakly cemented bedrock. It is located about 200 feet north of the left abutment (Photo 12). A typical cross section of the spillway is shown on Figure 2-2. It has a bottom width of 36 feet and side slopes of 2:1, horizontal to vertical. The spillway would not be used unless Divider Dike C (see Figure 2-1) is overtopped or failed and enough water is stored in Area C (Figure 2-1) to flow into the spillway. Photo 13 is a view from the spillway crest back to Divider Dike C, looking across Area C.

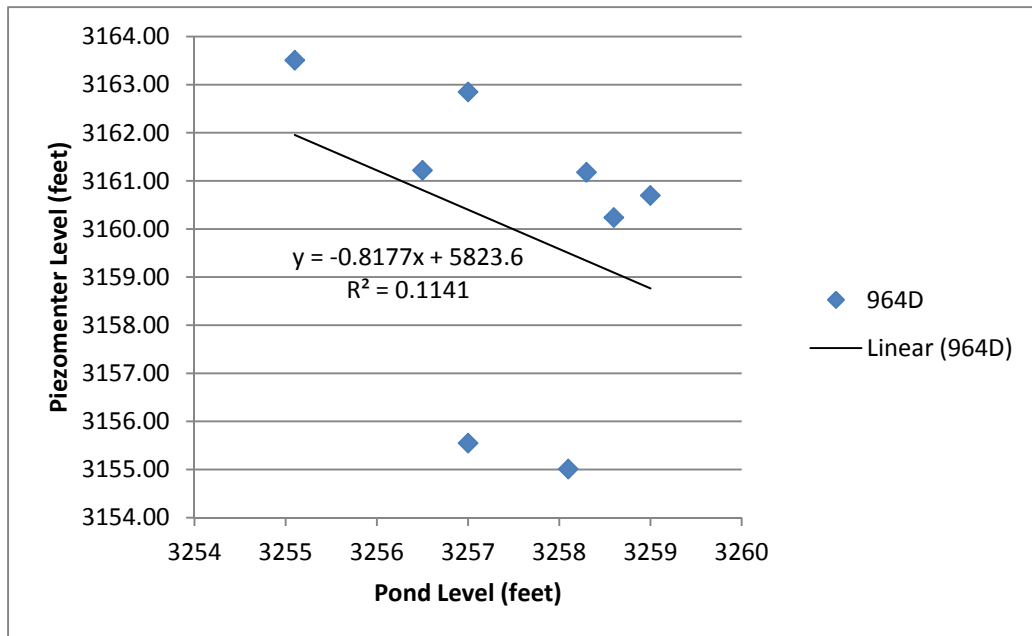
FIGURE 4-3. PIEZOMETER 694D LEVELS VS POND LEVELS

generally viewed as favorable because it suggests that the piezometers are not hydraulically connected to the pond and are not being influenced significantly by leakage or preferential seepage paths.

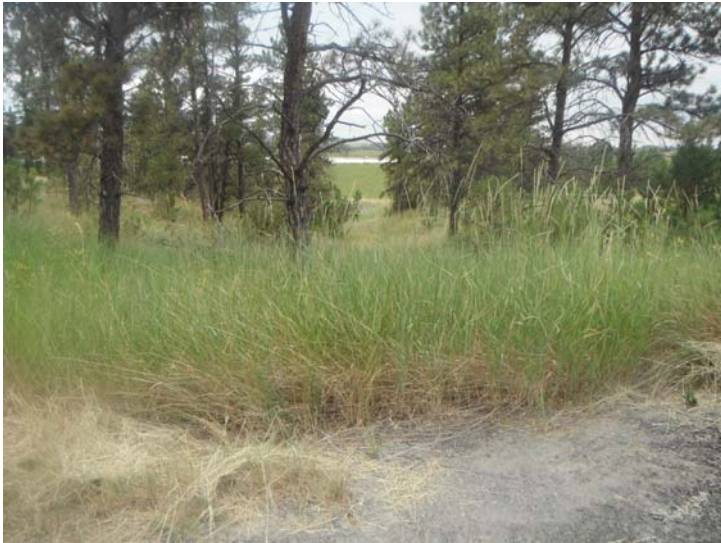
Photo 13. Units 1 & 2 STEP Main Dam, July 15, 2014.
Spillway, looking upstream.

There is no indication of displacement or unusual movement within the spillway channel. Erosion observed in 2009 on the spillway side slopes has been repaired and vegetation is established. The area should be monitored to determine if further erosion is taking place that requires attention. It is recommended to limit vehicle use in this area, especially during the wet season. The access road from the north side of the Main Dam forms the crest of the spillway. The downstream end of the spillway is steep (Photo 14) and the grade break between the spillway crest and the downstream area should be monitored for erosion and repaired if necessary.
