# Qualitative Rapid Assessment 2015-2017 Status Report

Milltown Reservoir / Clark Fork River NPL Site Clark Fork River Operable Unit, Reach A, Phase 1, Phase 2 and Phases 5 and 6

Qualitative Rapid Assessment, 2015-2017 Status Report Milltown Reservoir / Clark Fork River NPL Site Clark Fork River Operable Unit, Reach A

> > January, 2018

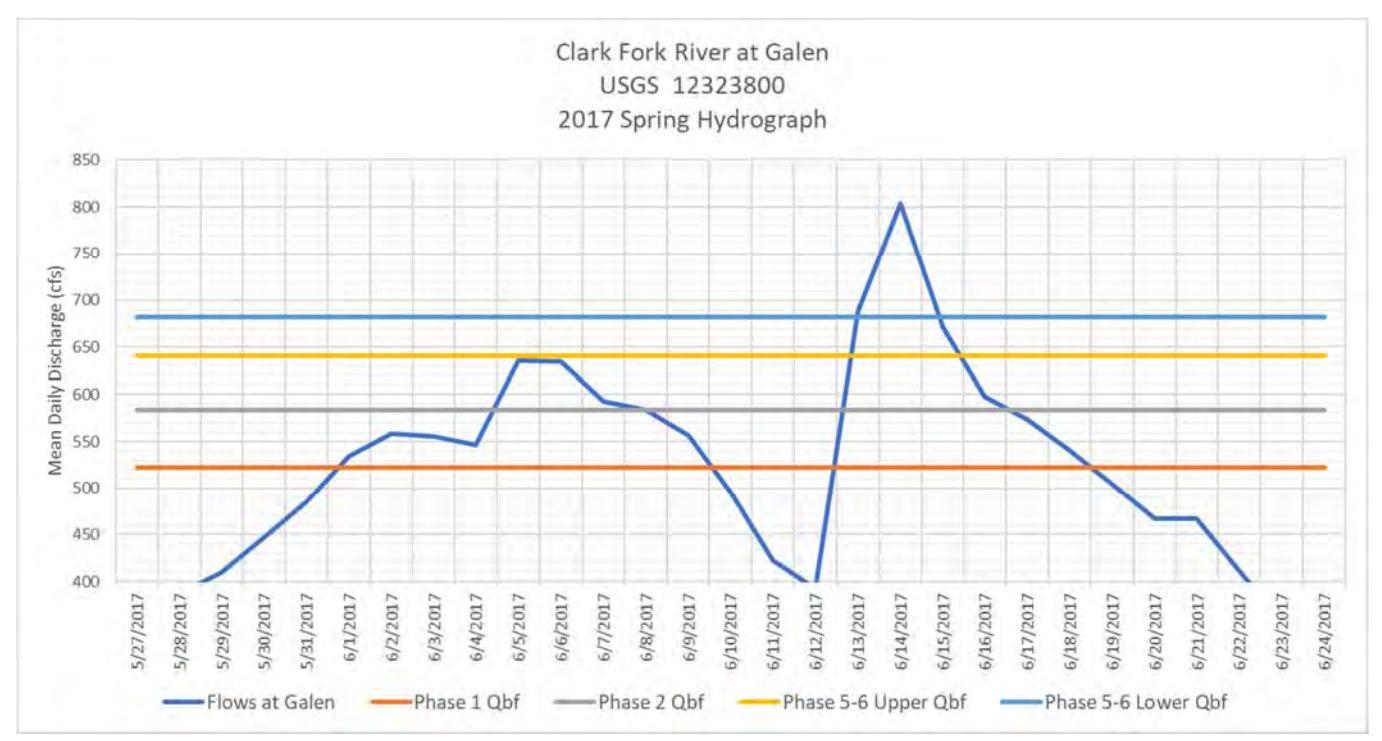
In mid-June of 2017, a 1.3-inch rainfall event (as measured at Deer Lodge) caused flows at the USGS Galen Gage (USGS 12323800) to exceed the design bankfull (2year return interval) flow for all phases evaluated in the QRA (Figure 1). The Galen Gage is considered an accurate representation of flows in Phases 1 and 2 because the gage is located at the Perkins Lane Bridge at the downstream end of Phase 2. Downstream of the Galen Gage, Lost Creek enters the Clark Fork River in Phase 3, Galen Creek enters the Clark Fork River in Phase 5 and Modesty Creek enters in Phase 6. The tributary contributions during the peak runoff in 2017 are unknown, although they are typically small during irrigation season and there is no evidence they were at flood stage during the Clark Fork River peak event. Discounting those potential inflows, both the amount and duration of June 2017 water overflowing onto the constructed floodplain decreases substantially in the downstream direction (Figure 2). This is consistent with 2017 QRA field observations and may have some implications for channel capacity design criteria in future phases.

Figure 1. Spring 2017 hydrograph at Galen (USGS 12323800) showing design bankfull flow (horizontal lines) for each Phase evaluated in QRA.

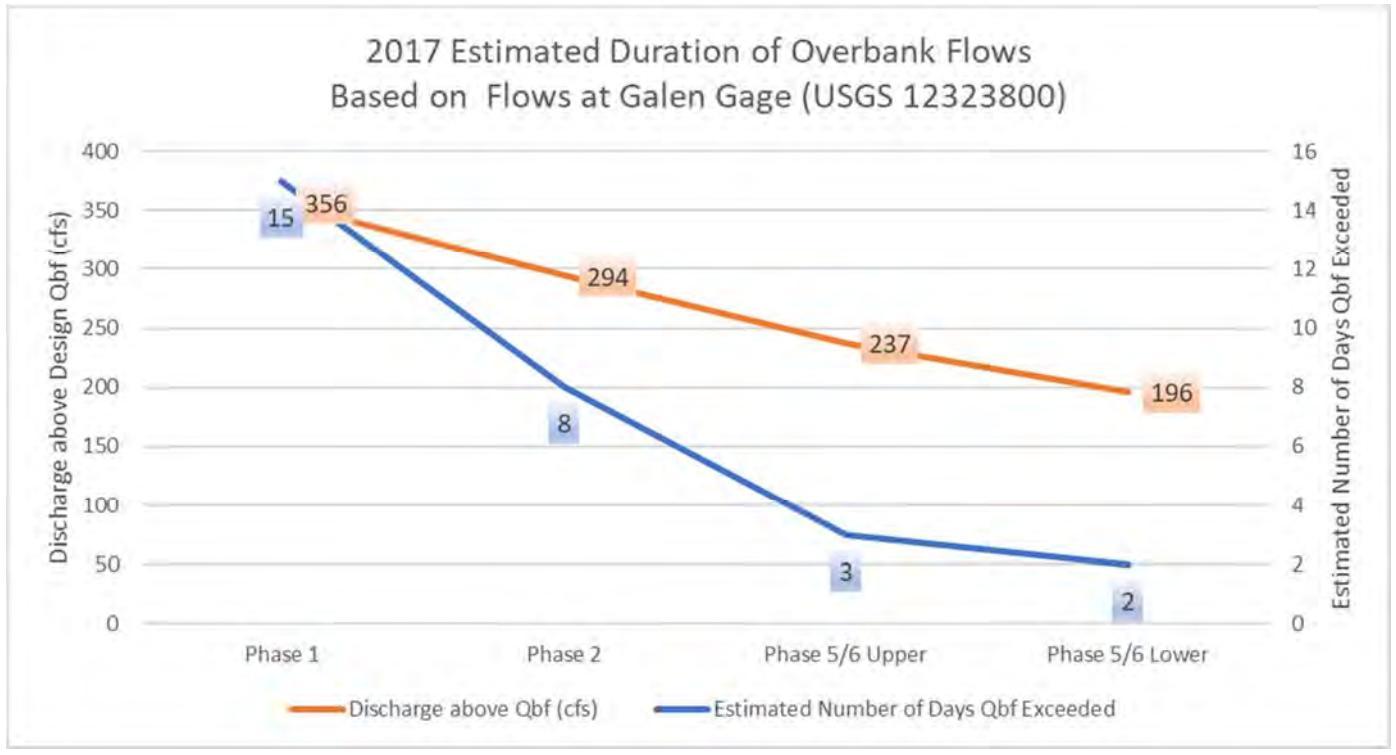
Figure 2. Estimated amount and duration of overbank flow in QRA phases during June 2017; estimates are based on Galen Gage record and do not include Lost Creek or Modesty Creek inflows.

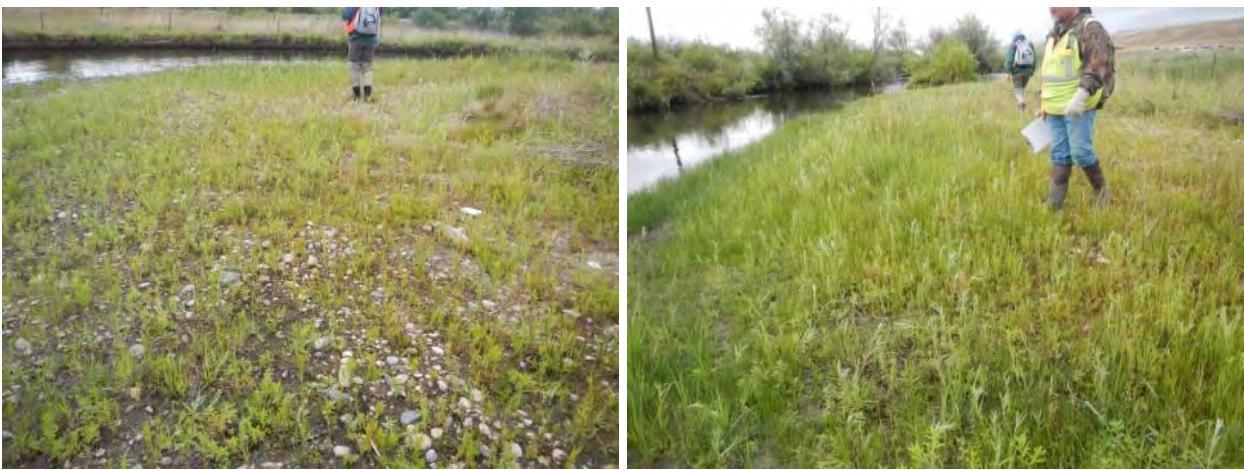
Channel stability trends identified by the QRA team in 2016 indicated that the channel was trending towards meeting project goals and objectives and performance target values. The QRA channel stability form indicated an overall rating of 3.6, which is within the 'Largely Stable' category and a slightly higher rating than the one assigned in 2015. The overall stability rating reflects mild aggradational conditions, based on observed fine sediment deposition within the channel, mostly on point bars. These deposits were

providing natural woody and non-woody vegetation colonization (Figure 6). There was no evidence of systemic coarse grained aggradation nor systemic degradation, and riffles showed good mobility and general gradation variability. Point bar morphologies showed smooth transitions to the channel (Figure 7) and bank erosion was generally concentrated on outside banks or high shear stress areas.

Figure 6. Fine sediment deposition and natural recruitment of woody and non-woody vegetation on point bars and floodplain surfaces.

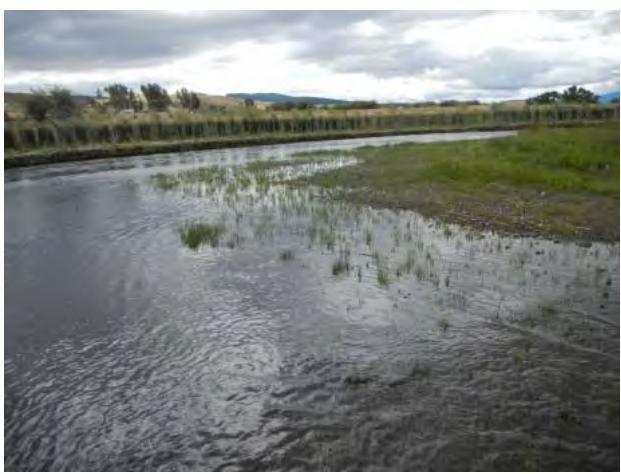
Figure 7. Point bar transition to main channel.

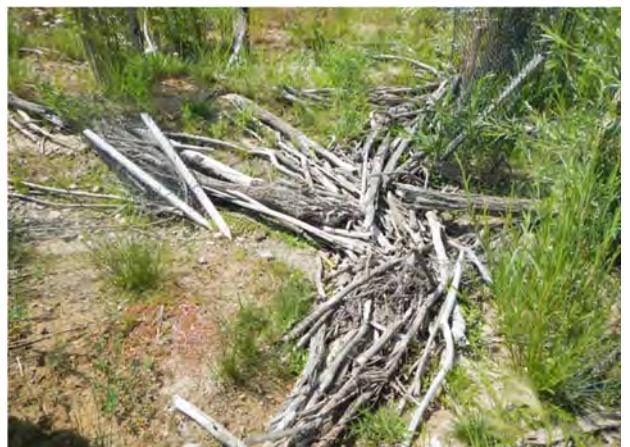
No flows had exceeded the design bankfull discharge since May 2014, and high water marks observed in July 2016 were low on point bars supporting the design objectives of minimal floodplain inundation under recent flow conditions. Remnant high water marks were still visible from the 2014 high flow event, mostly observed as floodplain deposits and reworking and stacking of coarse floodplain wood. Floodplain wood reworked during the 2014 event was observed to be oriented perpendicular to flow paths on the floodplain which helps disperse flow, prevent rilling and reduce the potential for headcut formation (Figure 9).

Figure 9. Floodplain wood that accumulated in 2014 high water flow paths, dispersing flows and reducing floodplain erosion.

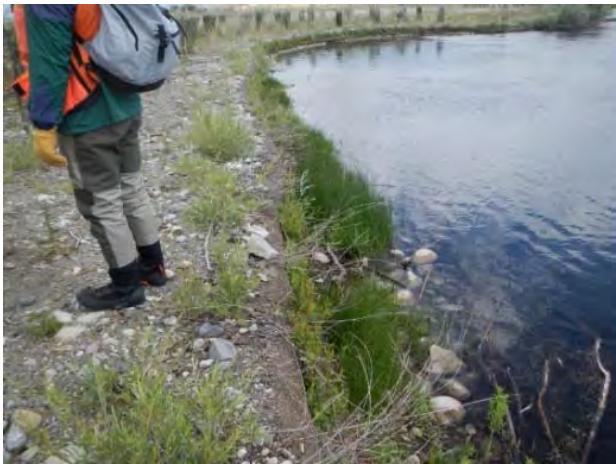
In 2016, extensive moss had developed on the coir logs still in the DVSL structures. This is likely from trapping of fine sediment in the logs and high moisture content. Fine sediment accumulations were observed in coir logs at several sites. Further, where a bench was present in front of the DVSL treatment, colonization by willows and wetland vegetation was observed (Figure 12). Building a narrow, 6-inch, bench in front of DVSL treatments promotes fine sediment accumulation and wetland plant/willow colonization along the channel in front of the bank treatment and should continue to be repeated in future designs where DVSL structures are built.

Figure 12. Colonization of wetland vegetation on toe material in front of DVSL LB-N-35.

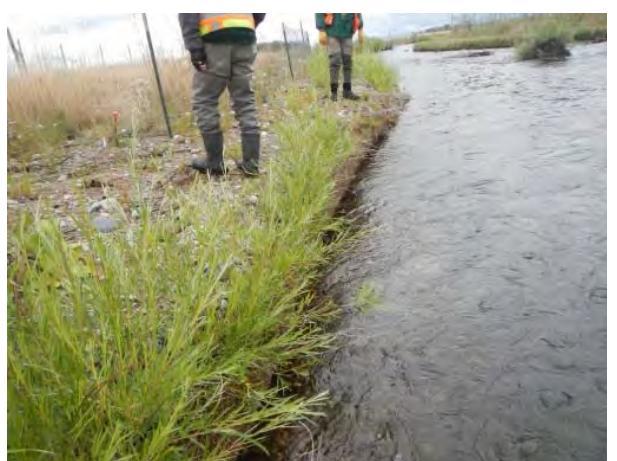
Willow growth in DVSL structures was more robust in 2016 compared to 2015. In 2015 it appeared that there was a high level of willow mortality in the bank treatments, but evidently there was substantial rebound in willow growth and vigor in the summer of 2016 (Figure 13). Beaver foraging was observed on willows in DVSL treatments in some areas.

Figure 13. Increased willow growth in DVSL structure LB-N-11.5.

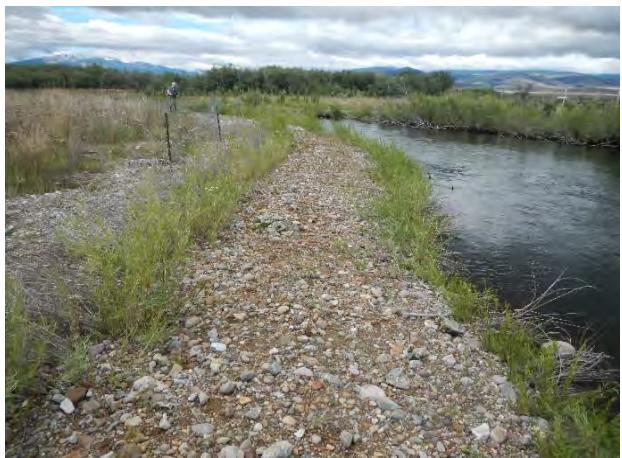
In 2016, all brush trench treatments had high willow survival and growth (Figure 14). In Phase 1, brush trenches were installed at the top edge of point bars, behind preserve vegetation (PV) banks, and at the back edge of alluvium placed behind DVSL banks.

Figure 14. Willow growth in brush trench behind DVSL (LB-N-27) (photo is looking downstream).

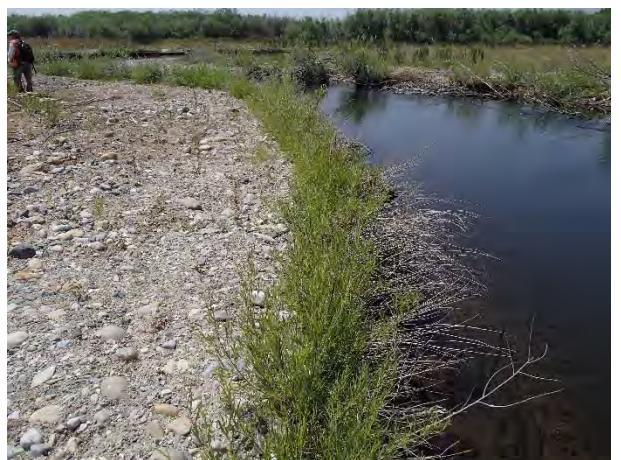
Figure 20. Re-growth of willows in 2015 that appeared to have died back in earlier observations.

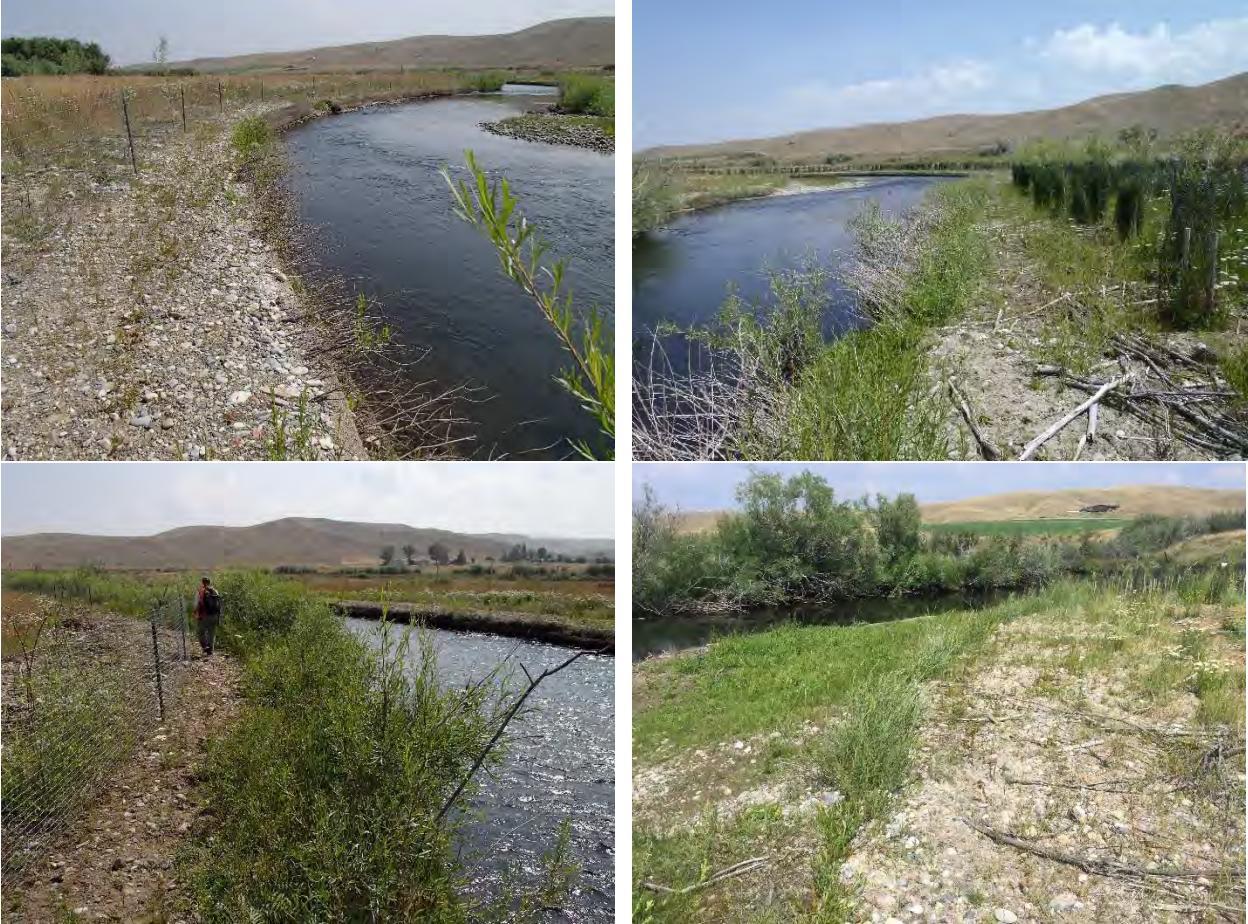
Brush trench (BT) structures mostly fell within Category 2 (10-40% cover) (18 of 27) and 6 banks were recorded as Category 1 (Figure 21). Brush trenches along the back edge of PV streambanks were often dominated by herbaceous vegetation and had less woody vegetation cover compared with other brush trench structures. Brush trenches placed behind DVSL structures and along the top edge of point bars had the highest cover of woody vegetation.

Figure 21. Top left photo of streambank treatment LB-N-7 (DVSL) Category 3 (<10%). Top right photo of streambank treatment RB-N-22 (PV) Category 2 (10 to 40%). Bottom left photo of streambank treatment LB-N-8 (PV) Category 1 (>40%). Bottom right photo of streambank RB-N-49 (BT) Category 2 (10 to 40%).

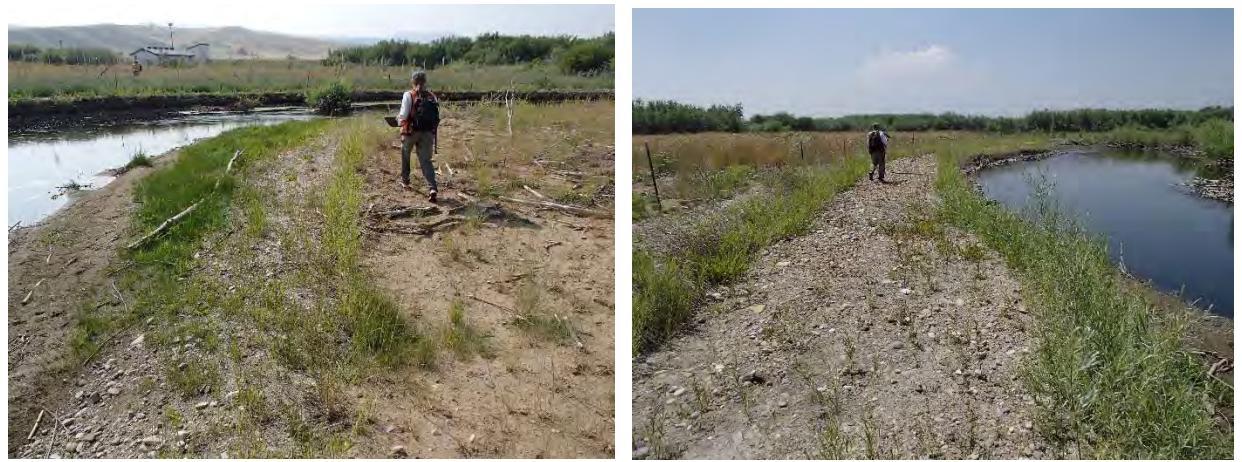
While not part of the QRA assessment, conditions on point bars were noted during the 2015 QRA. As of July 2015, almost all point bars had natural recruitment of woody species such as willow and black cottonwood. Survival and expansion of herbaceous wetland species on point bars was also observed and all had evidence of recent inundation such as fine sediment and woody debris accumulation (Figure 22).

Figure 22. Natural recruitment of herbaceous wetland vegetation on constructed point bar (left photo) and willows on placed alluvium behind a streambank structure (right photo).

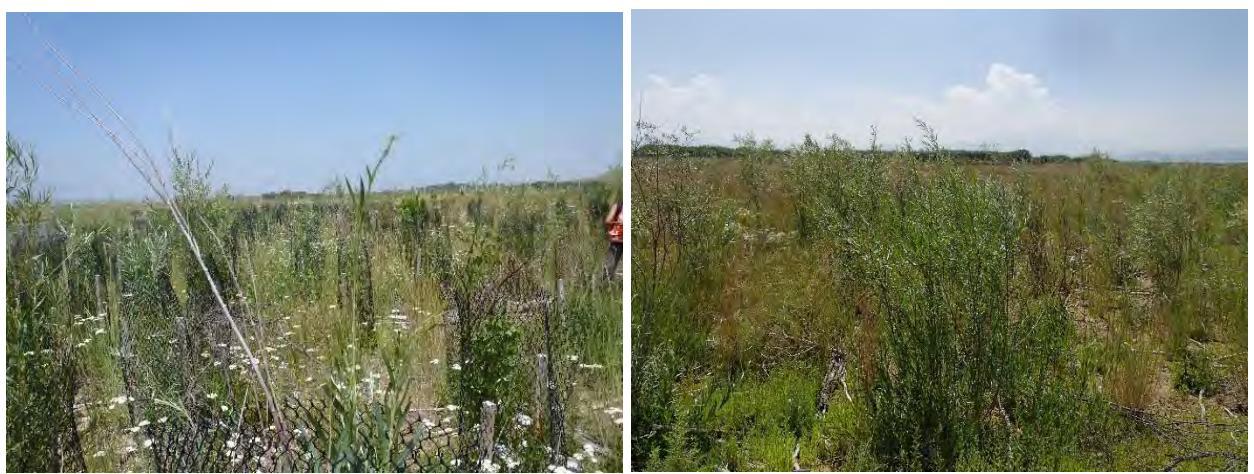
Figure 24. Survival plot OM16 (left photo) assigned to woody vegetation cover Category 2 (10 to 30% cover) and survival Category 1 (>80%). Survival plot SCS04A (right photo) assigned to woody vegetation cover Category 1 (>30% cover) and survival Category 1 (>80%).

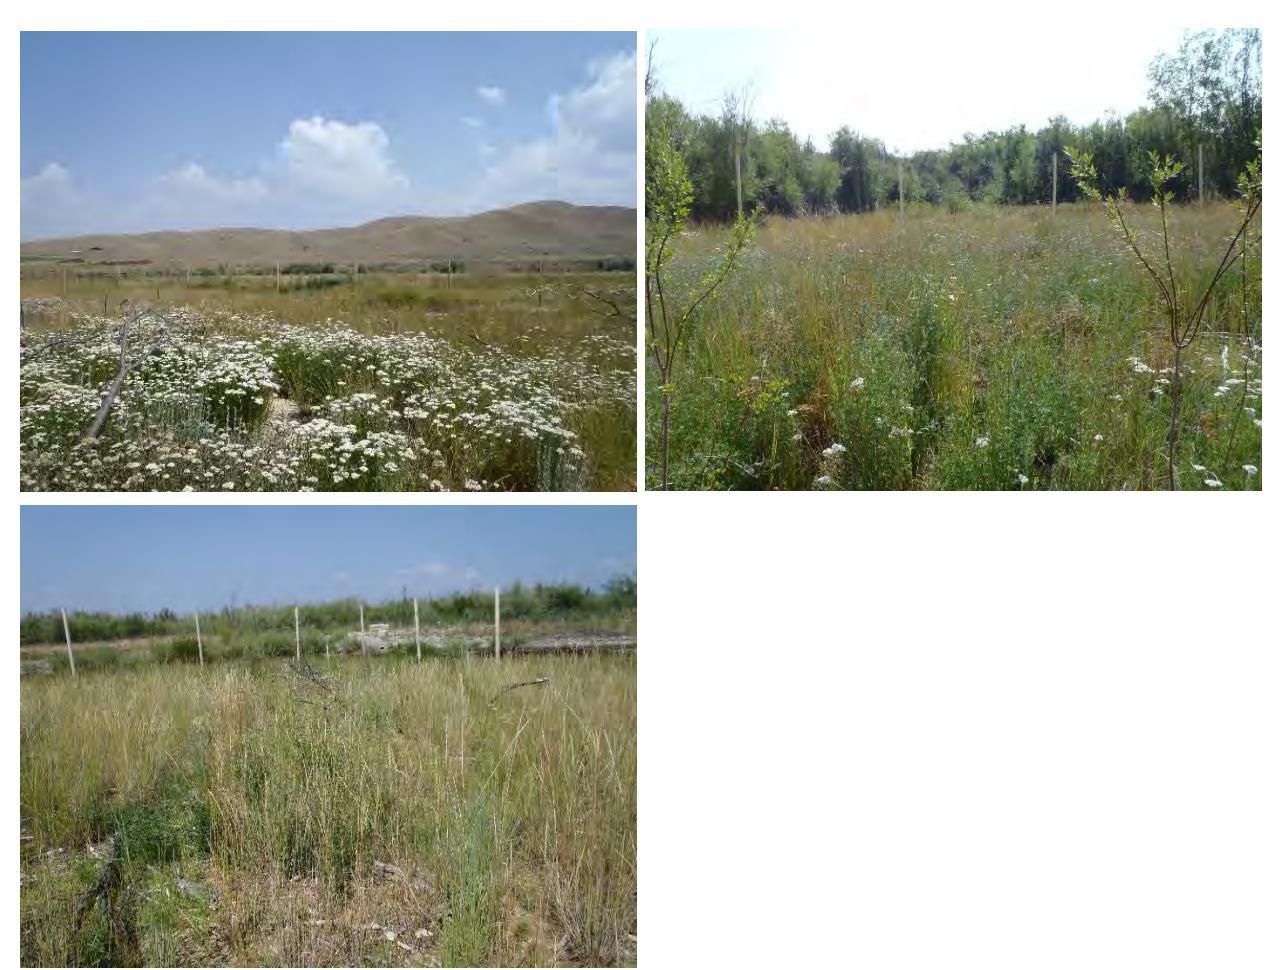
Figure 25. Top left photo is of floodplain transect 8 showing dominance by yarrow and assigned to Category 2 (50-80%). Top right photo is of floodplain transect 2 showing yarrow, alfalfa, and slender wheatgrass assigned to Category 1 (>80%). Bottom left photo is of floodplain transect 3 showing dominance by slender wheatgrass.

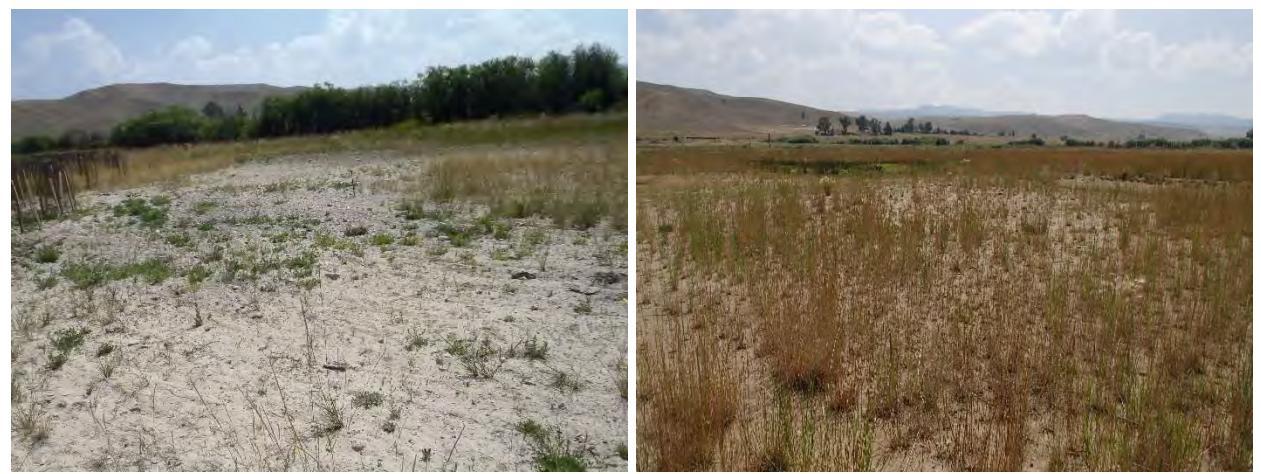
Figure 26. Floodplain areas with lower herbaceous cover along Transect 3 (photo left) and Transect 4 (photo right).

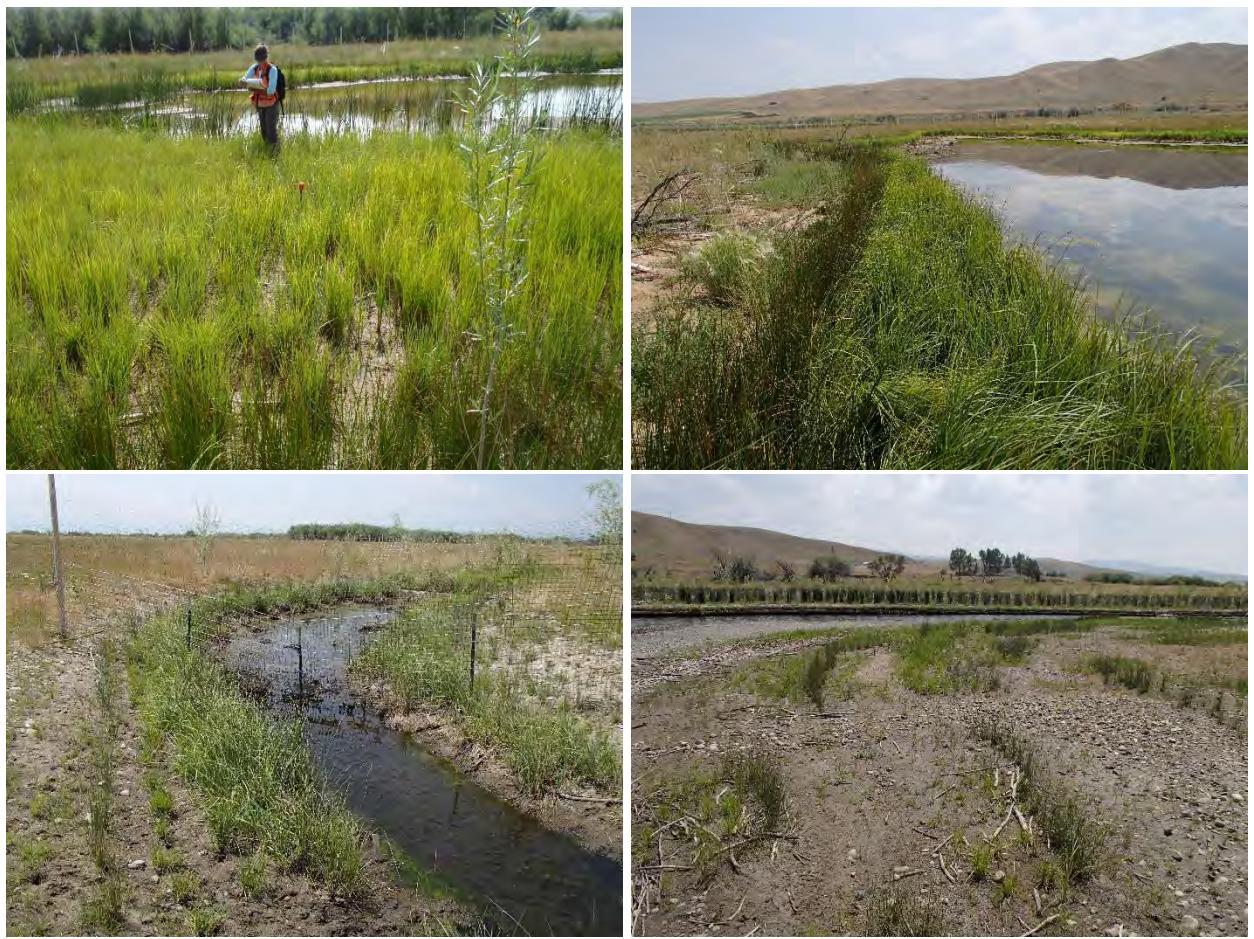
Herbaceous cover of wetland species, including sedges and rushes, was high in a concentrated area around the perimeter of the most wetlands (Figure 27). This concentrated development of zones is common in wetlands and relates to the hydrologic preference of wetland species. Natural colonization of cattails (*Typha latifolia*), bulrush (*Schoenoplectus* spp) and sedges (*Carex* spp) was also observed. Sedges were the primary herbaceous cover, but cover of mannagrass (*Glyceria* spp) (a native, seeded species) was also high in some wetlands. Redtop (*Agrostis gigantea*) was also a common, and sometimes dominant, species in wet areas.

Figure 27. Herbaceous cover of planted sedges in constructed wetland SW01 (top left photo); dense cover of sedges and bulrushes from pre-vegetated coir mats placed along constructed wetland SW05 (top right photo); expanding cover of pre-vegetated coir mats and planted herbaceous wetland plants along side channel SCS03 (bottom left photo); and good survival of herbaceous wetland plants planted on a constructed point bar (bottom right photo).

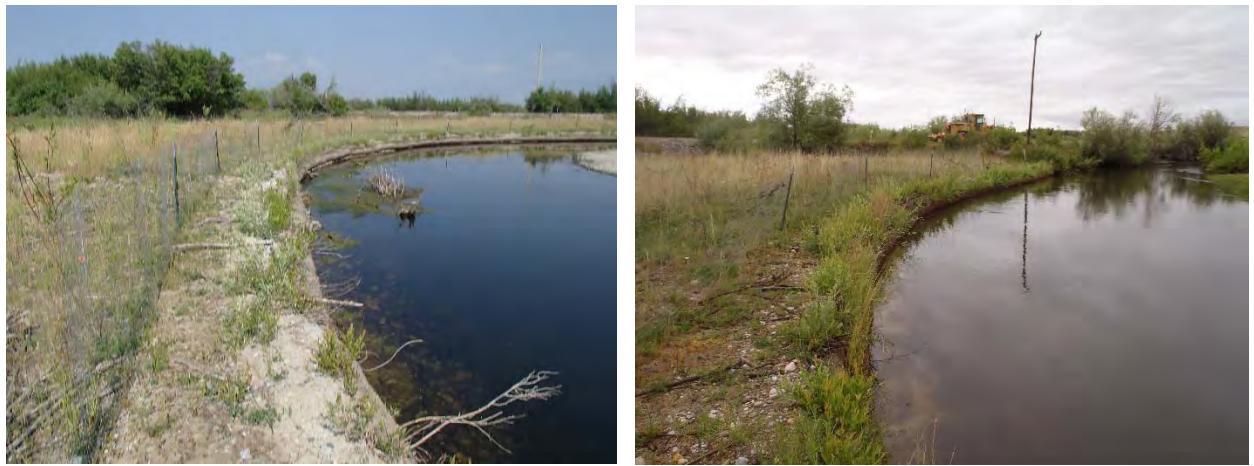
Figure 28. Typical increase in woody vegetation cover on DVSL structures between 2015 and 2016 (photo is of LB-S-07). Cover went from a Category 2- in 2015 to a Category 2 in 2016.

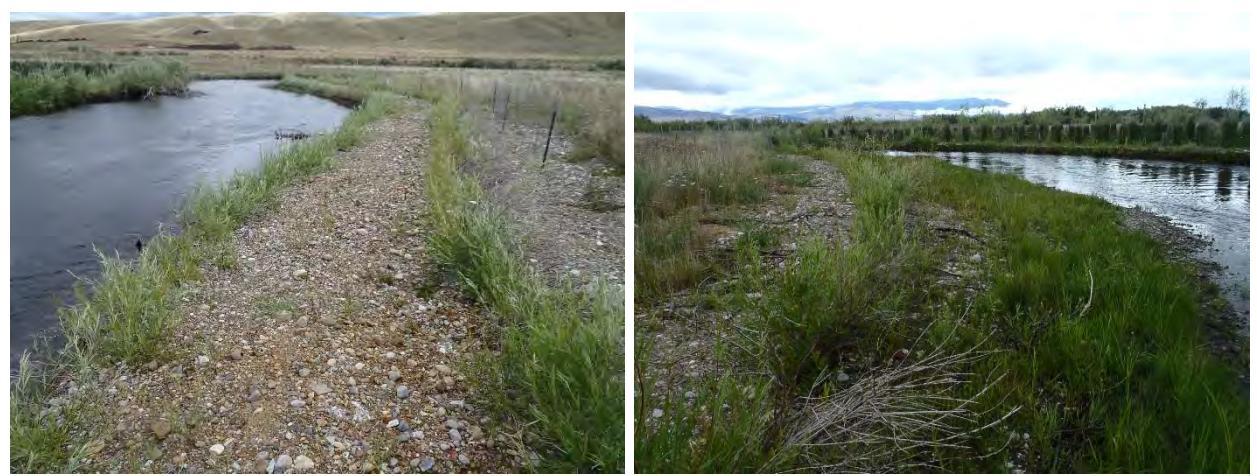
Figure 29. Left photo of streambank treatment LB-N-27/28 (DVSL) showing colonization of woody vegetation in alluvium placed in streambank. Right photo is of a constructed point bar with willow cover increasing in brush trench (LB-N-1) and herbaceous and woody vegetation colonization on fine sediments deposited on the point bar.

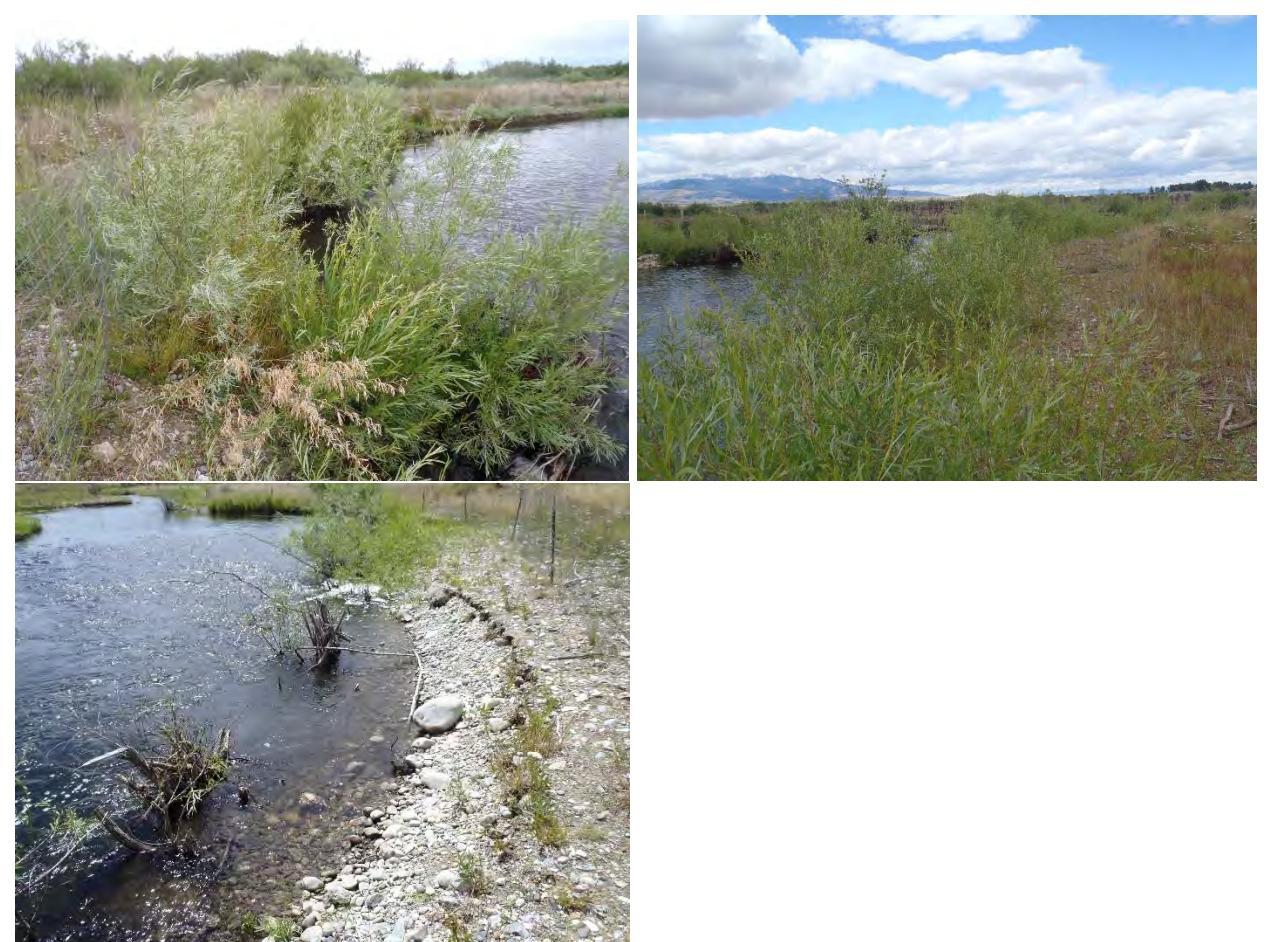
In 2016, preserve vegetation (PV) banks throughout Phase 1 had robust vegetation that is starting to expand out towards the floodplain (Figure 30). Little to no erosion or slumping of these banks was observed. One bank, LB-N-14-16 had localized erosion where willow cover was low (Figure 30).

Figure 30. Top photos are of preserve vegetation (PV) streambanks showing expansion of preserved willows into the floodplain (left photo is LB-N-3; right photo is RB-N-48). Right photo is of one of the few preserve banks where erosion had occurred (LB-N-14-16).

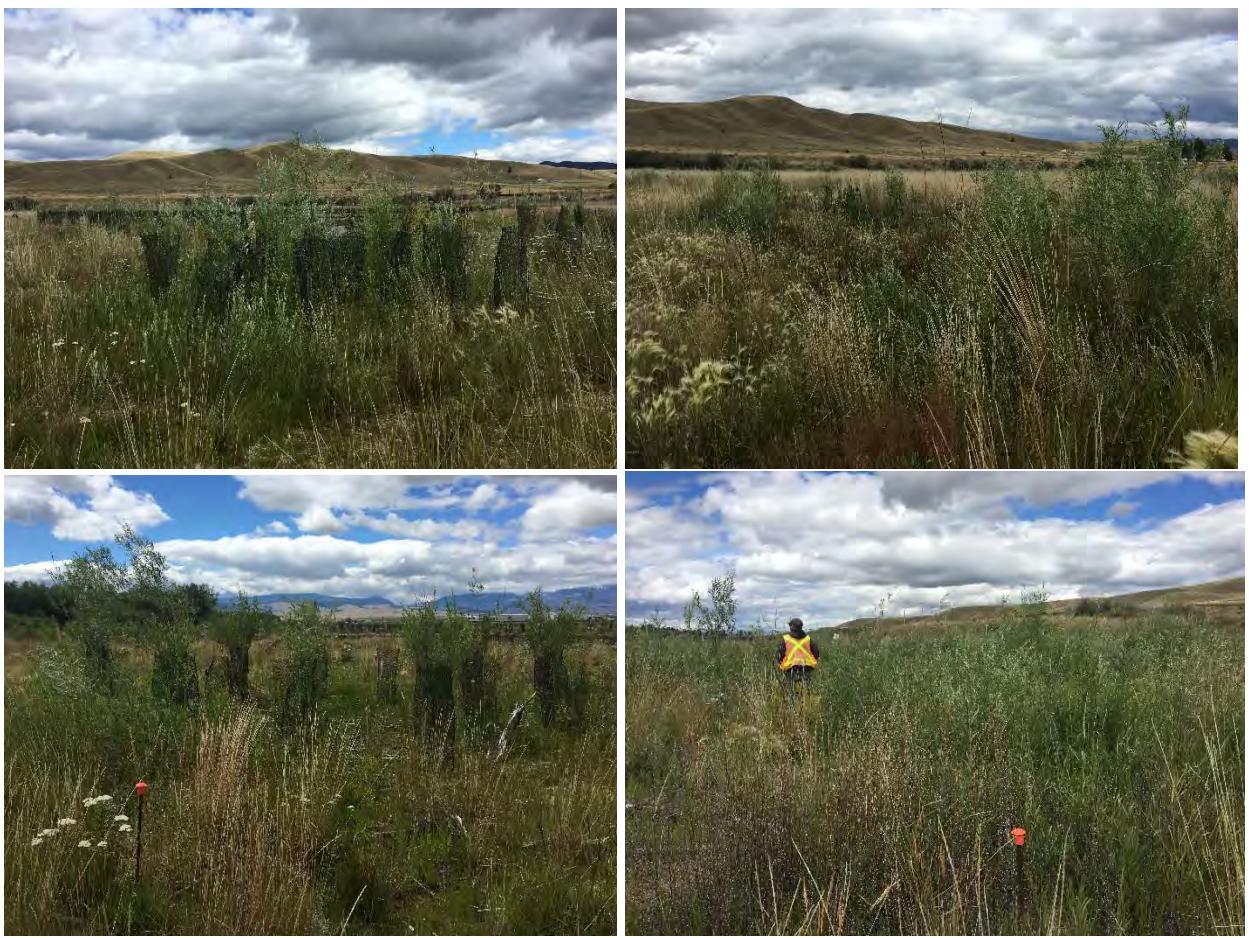
Survival of plants in the bottom of swale features continued to be poor due to prolonged standing water (Figure 33). The design criteria for these features continue to be adjusted to limit depth and duration of standing water. Survival in outer meander bank planting units was variable but high overall. Although survival increased slightly in the one meander core survival plot, overall survival appeared to have decreased in the meander core planting unit, with an increase in dead sandbar willows observed in 2016, likely due to a lower water table in these areas. Survival was highest in side channel planting units and shrub wetland planting units. Significant growth and expansion of willows has occurred in both of these areas and shrub wetland units (Figure 31). The two upland units, TS02 and TS07, have very poor survival.

Figure 31. Planted swale showing significant natural expansion of willows after inundation in 2014 high flows (photo top left is S063, photo top right is S088, photo bottom left is S092 and photo bottom right is SW11).

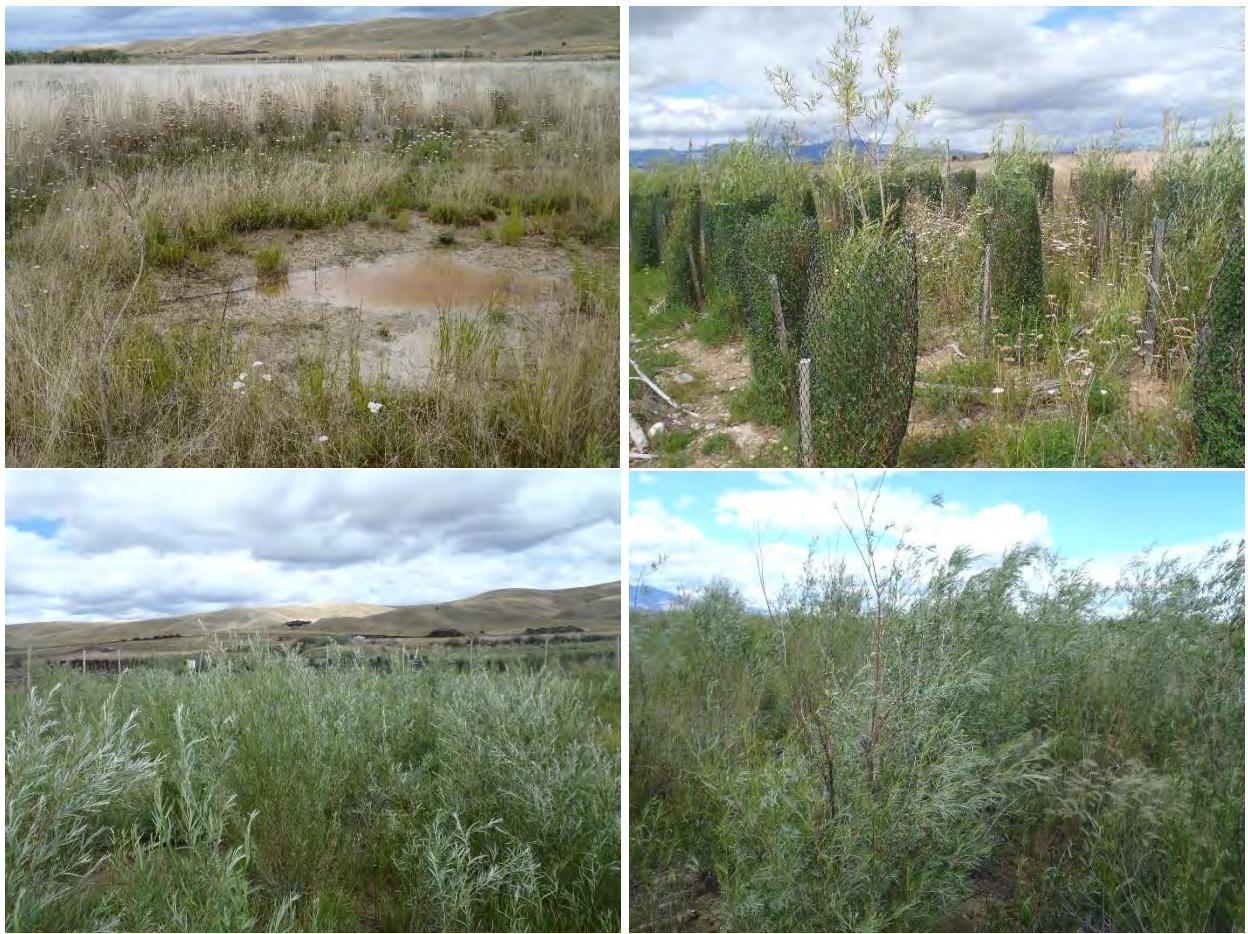
Figure 33. Planting Unit SO48 (swale) (top left photo) showing standing water late in the growing season. Planting unit OM13 (outer meander) (top right photo) showing high survival, but suppressed growth from browse protectors and alfalfa competition. Planting unit SCS04A (side channel) (bottom left photo) showing extensive cover of planted willows in the secondary channel wetland after browse by beaver. Planting unit SW09 (shrub wetland) (bottom right photo), located on the west side river at the downstream end of Phase 1 where woody cover is extensive.

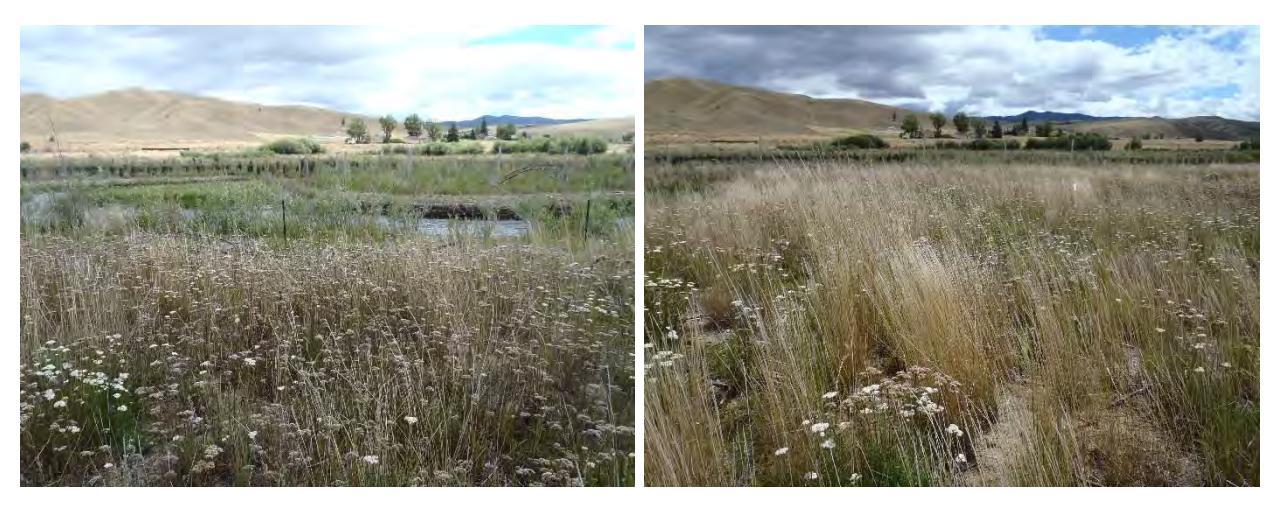
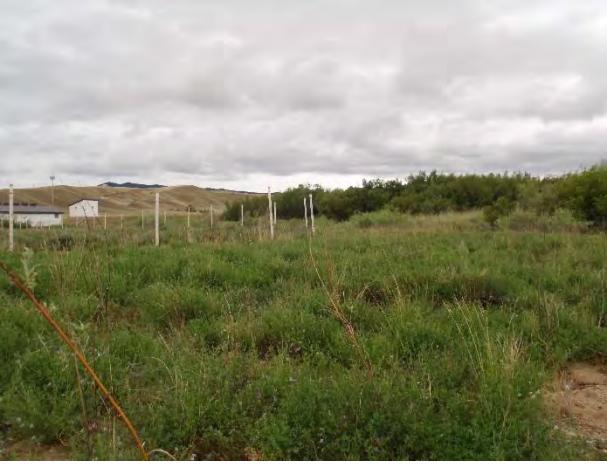
Figure 34. Top photos showing areas along floodplain transect #5 showing good yarrow and slender wheatgrass cover. Bottom photo showing dense cover of alfalfa upstream of the bridge.

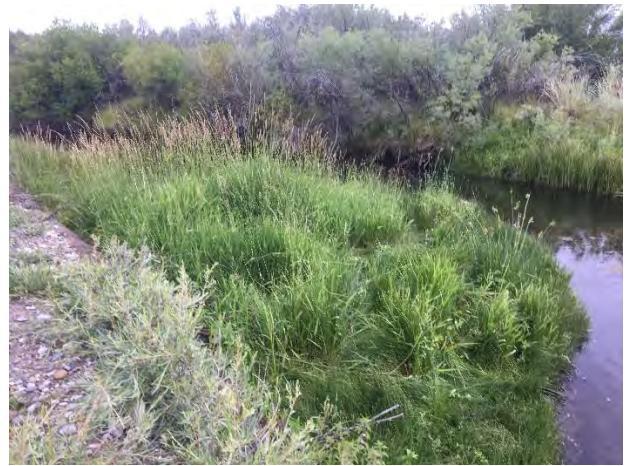
Figure 35. Reed canarygrass on preserved vegetated bar in Phase 1.

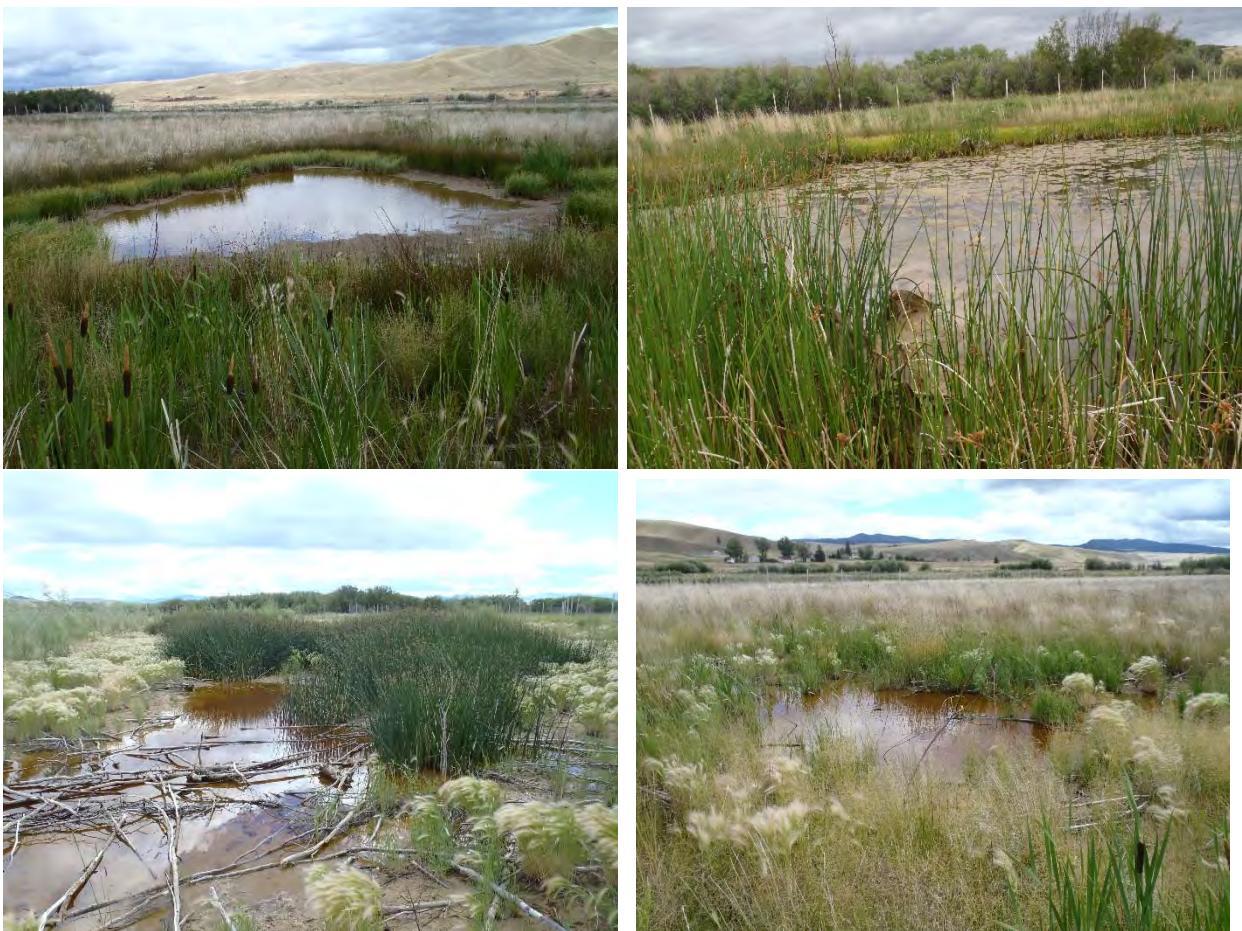
In addition to constructed wetlands, several swales are transitioning to emergent wetland or open water in the bottoms. These areas were not planted or seeded with emergent wetland species, but are being naturally colonized by cattail, sedges and wet grasses. Foxtail barley, a native perennial bunchgrass, (*Hordeum jubatum*) is also increasing in several wetlands and swales (Figure 36).

Figure 36. Top left photo of wetland on east side of river upstream of bridge. Top right photo of wetland on west side of river near Warm Springs water treatment ponds. Bottom left photo showing dense bulrush cover but also increased cover of meadow foxtail. Bottom right photo showing a swale with open water, cattails, redtop, and meadow foxtail.

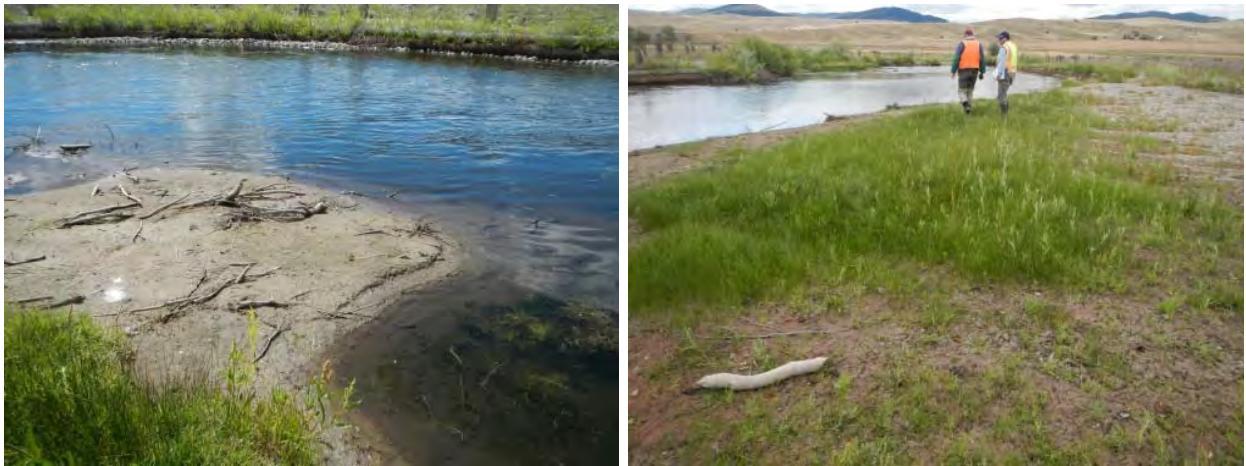
The QRA stability rating reflected mildly aggradational conditions in Phases 5 and 6 based on fine sediment deposition within the channel. Fine deposition consisted of discrete fine grained bar deposits in slack water areas that are up to several inches thick (Figure 37). Additional fine grained deposition was also observed on point bars and within brush matrix bank treatments. These deposits were providing conditions that support colonization by both woody and non-woody vegetation.

Figure 37. Left photo shows fine grained deposition in a slack water area along the channel and on a constructed point bar in right photo. Right photo also shows colonization of willows and herbaceous wetland vegetation.

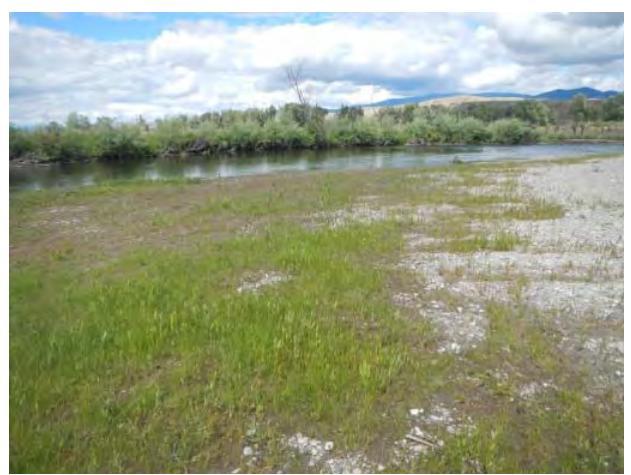
Floodplain connectivity was not evaluated due to a lack of overbank flows since construction. High water marks could be seen on point bars which supported the design criteria of minimal floodplain inundation under recent flow conditions. High water marks were indicated by fine sediment deposition and debris lines low on point bars (Figure 38).

Figure 38. Sediment deposition on point bar indicating high water line.

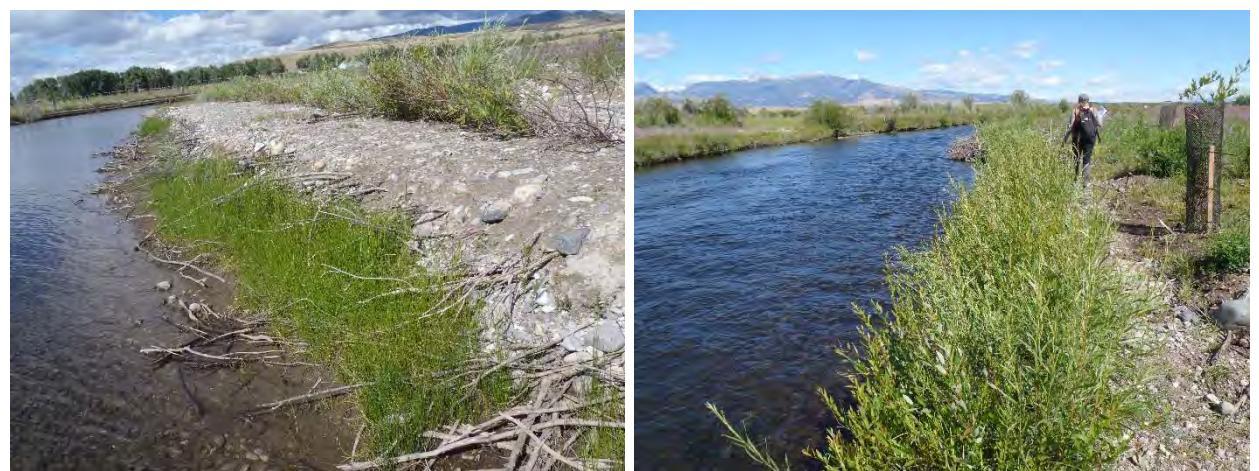
Survival of dormant willow cuttings installed in trenches at the back edge of brush matrix/gap treatments was high (Figure 42). Further, some of the brush used in the brush treatment had sprouted and grew, although this was only observed in a few locations. Much of the brush material used to build these banks sat on site for several months prior to use so it was not surprising that overall viability was low. Some localized scour/erosion of the alluvium placed in these banks was observed, particularly where woody brush cover is low. Fine sediment deposition was common at the toe of the brush matrix/gap treatments and both woody and herbaceous vegetation was observed growing in the deposited sediment (Figure 42).

Figure 42. Left photo is of brush matrix/gap treatment RB-6B showing recruitment of herbaceous wetland vegetation in fine sediment deposited within the placed brush. Right photo is of RB-35-DVSL with good growth of dormant willow cuttings.
