# Qualitative Rapid Assessment 2015-2017 Status Report

Milltown Reservoir / Clark Fork River NPL Site Clark Fork River Operable Unit, Reach A, Phase 1, Phase 2 and Phases 5 and 6

Qualitative Rapid Assessment, 2015-2017 Status Report Milltown Reservoir / Clark Fork River NPL Site Clark Fork River Operable Unit, Reach A

> > January, 2018

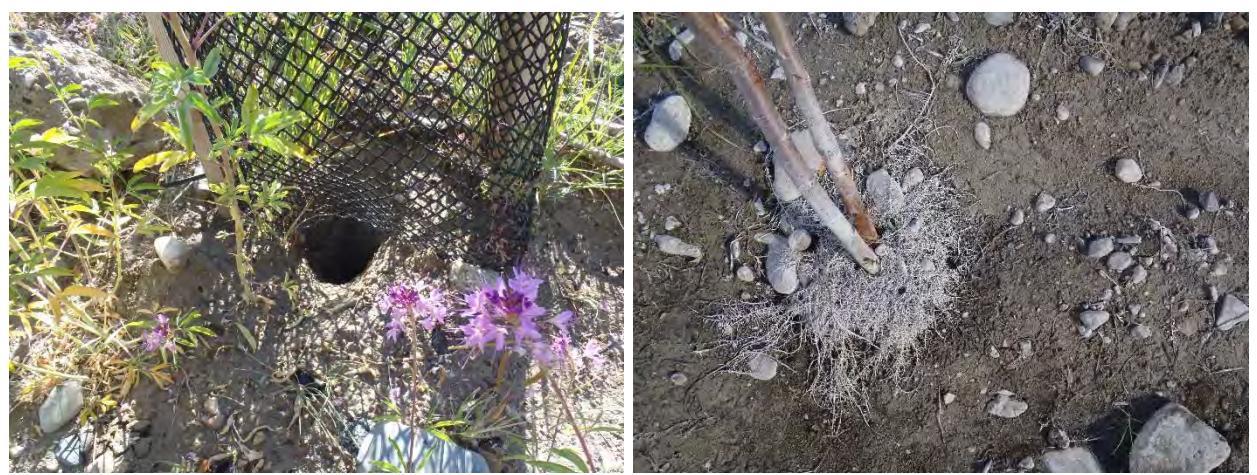
activity was sporadic and concentrated in a few areas. In these areas, beaver browse occurred within 15 feet of channel. Some plants had been completely up-rooted indicating browse occurred immediately after installation (Figure 44). Areas of high beaver activity were noted on QRA maps. In future phases, pre-construction beaver activity should be evaluated to identify where post-planting issues with beaver may arise. Deer browse was minimal in Phases 5 and 6 despite the wildlife exclusion not being complete at the time of the QRA. This may have been due to the on-going construction in this phase. Swales generally had low survival in the bottom due to the presence of standing water. In future phases, swale design criteria should be revised to reduce the potential for prolonged standing water (see criteria described for Phase 1).

Figure 44. Left photo of plant pulled out of the ground by beaver shortly after installation. Right photo of soil settling exposing roots and leading to desiccation of shrub stem.

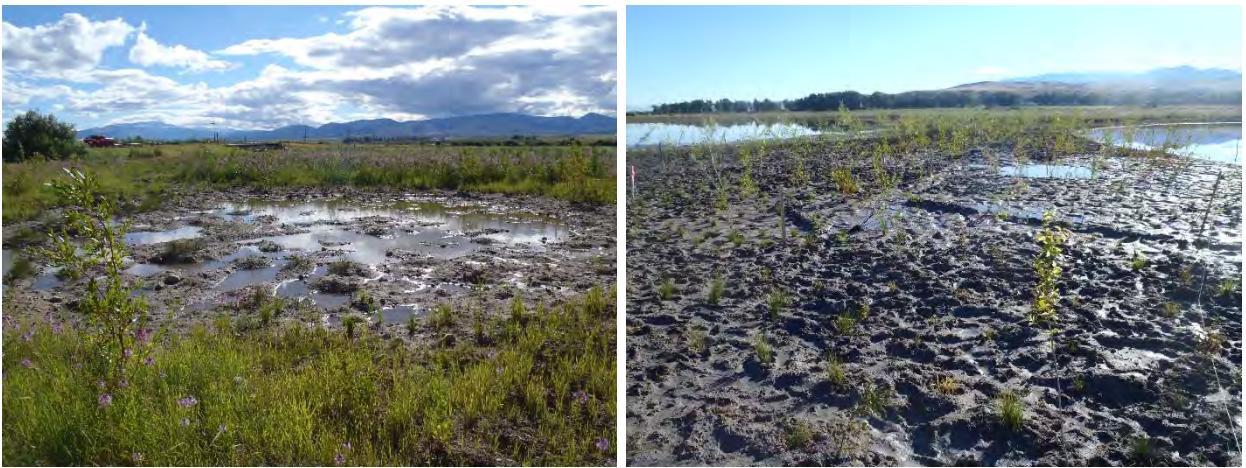
Wetlands in Phase 5 were developing as expected. All wetlands had perennial standing water in some portion of the wetland that maintained shallow depths late in the growing season (Figure 46). Some areas were being colonized naturally by cattails. Survival of planted wetland herbaceous plants was high. Wetland herbaceous plants had not expanded much since planting, but they typically expand rapidly during the second growing season after planting if hydrology is appropriate. In most Phase 5 wetlands, the emergent zone appears to be much smaller compared to Phase 1 wetlands. This may be due to the fact that wetlands are generally further from the channel and there are no major groundwater sources like Warm Springs Creek and Warm Springs Ponds like there is in Phase 1. Criteria used to design wetlands in future phases should continue to focus on maximizing the emergent wetland zone. Similar to swales, woody shrubs planted at a lower elevation in wetland features had lower survival.

Figure 46. Left photo of wetland SW01 on east side of channel and right photo of wetland planting unit SW04B, which is part of the Phase 5 borrow pond on the west side of the channel.

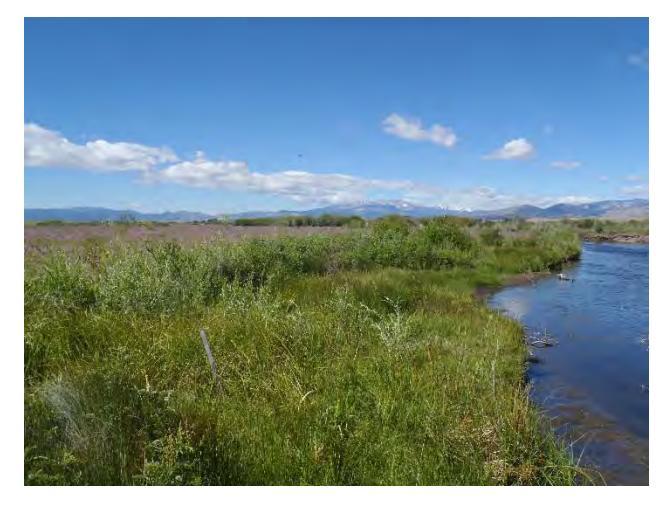
In Phases 5 and 6 several areas along the channel were preserved because they had diverse, native wetland vegetation. These areas were left in place to provide habitat and seed sources for colonization of constructed point bars. All of these preserved features continued to support diverse wetland vegetation in 2016 (Figure 47).

Figure 47. Preserved wetland vegetation along the channel in Phases 5 and 6 is expanding and colonizing constructed point bars downstream.

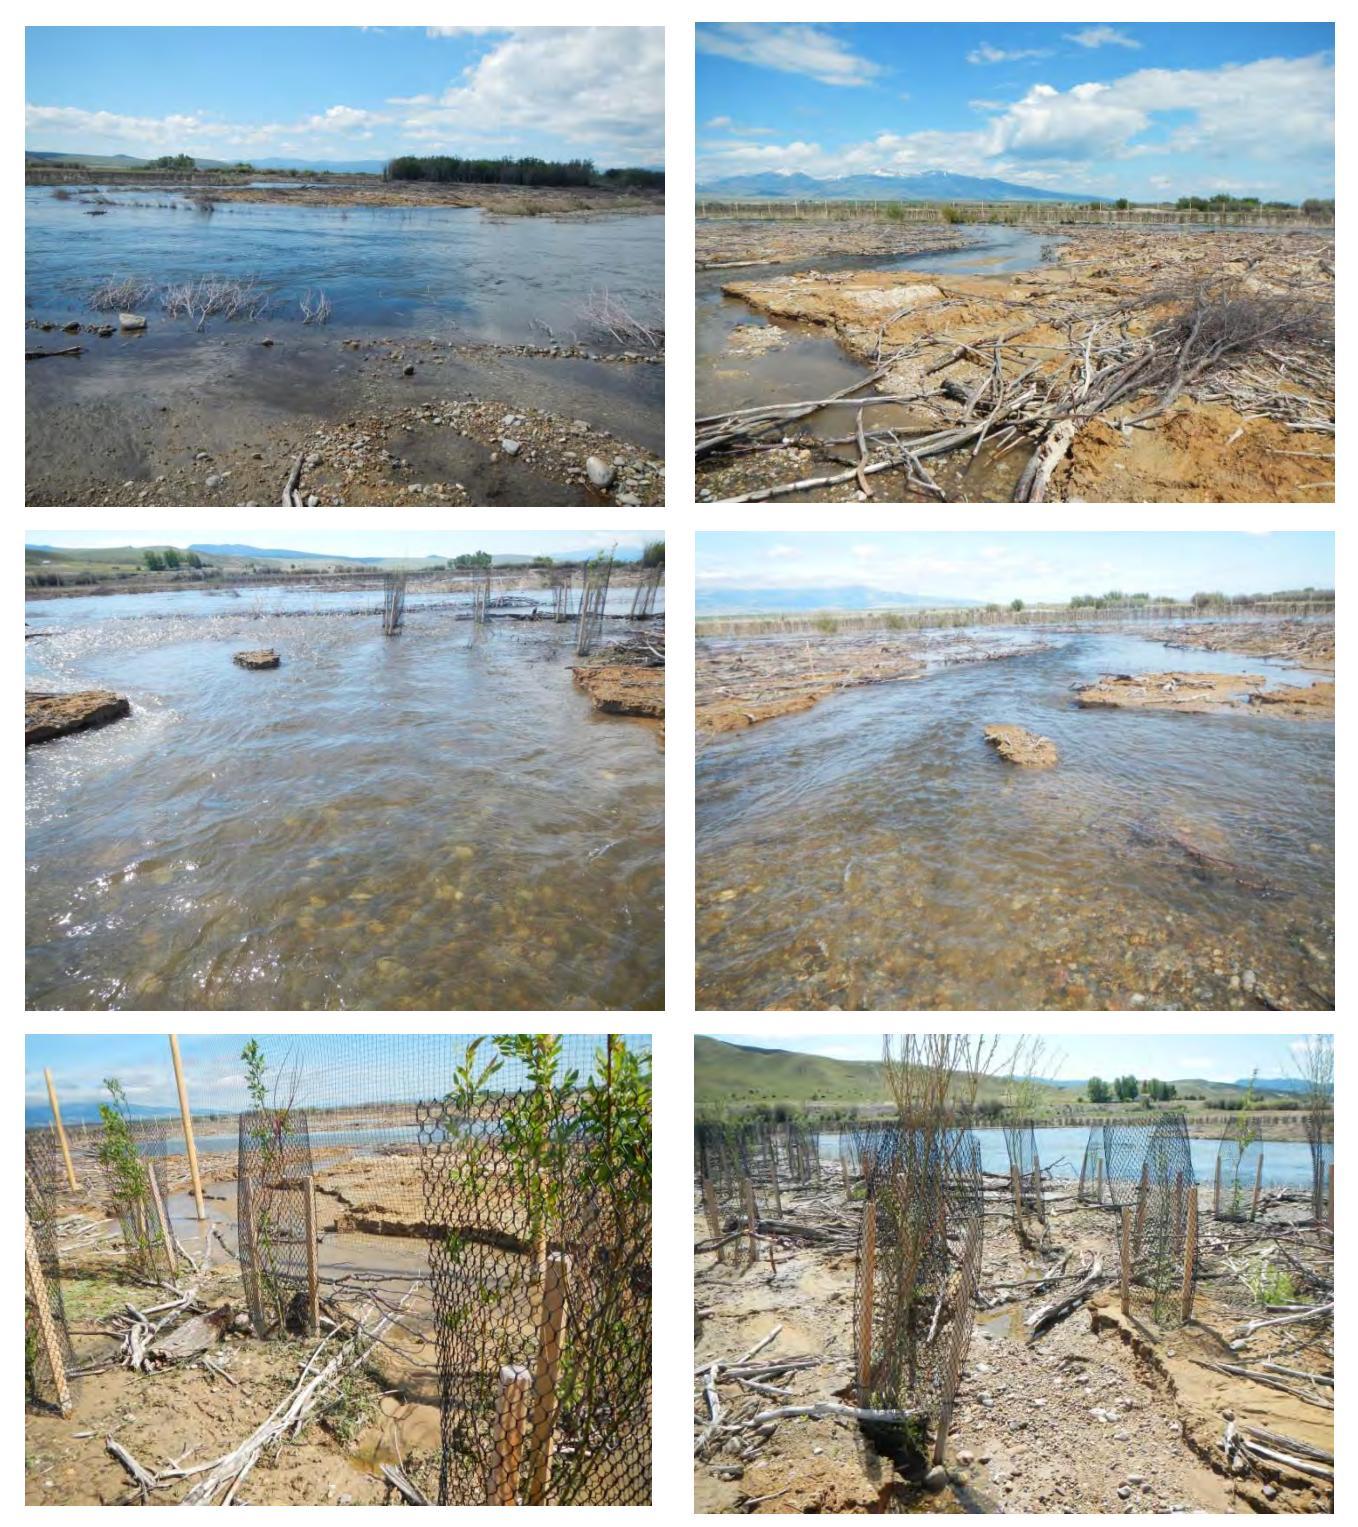
Photos 1-5. Overbank flows in May of 2014 showing overflow channel formation.

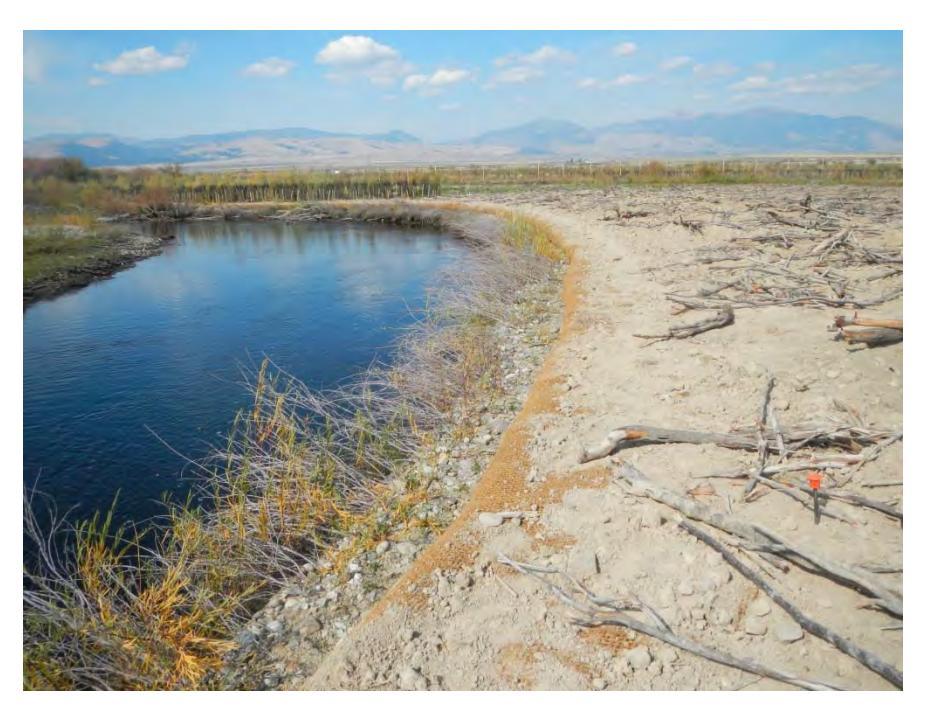
Photo 6. View downstream of bank and floodplain repairs at overflow site.

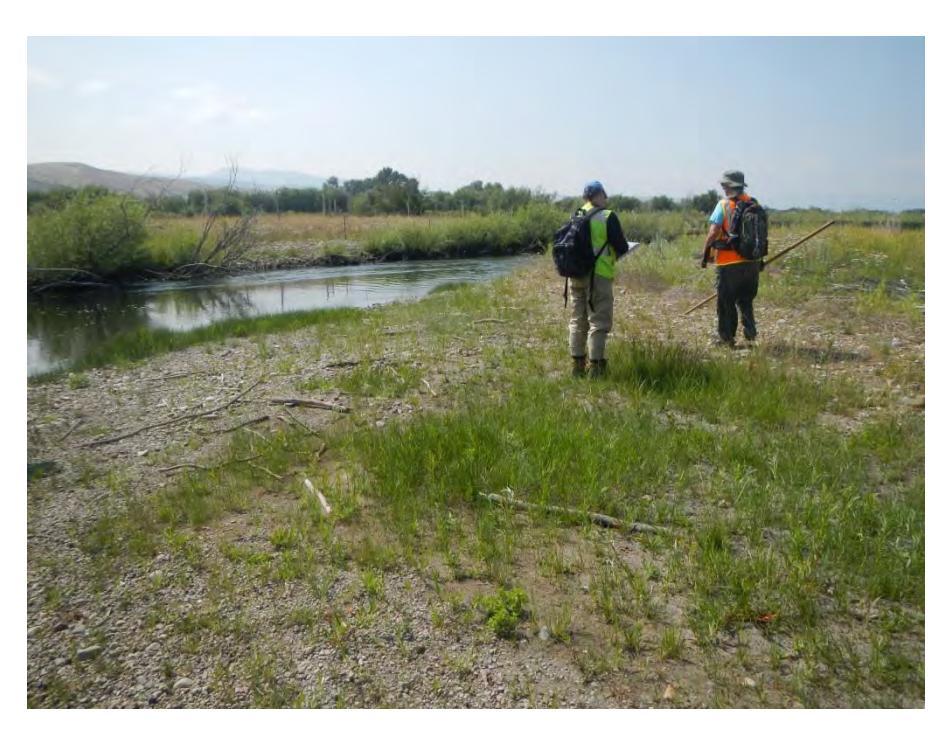
Photo 7. Point bar deposition and vegetation recruitment following 2014 high flows.

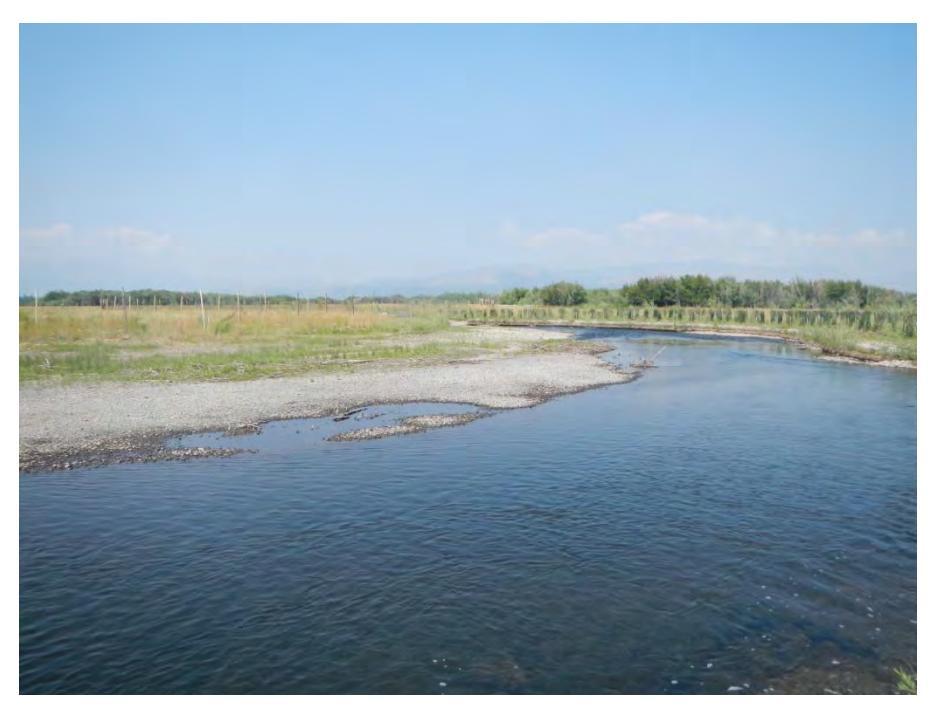
Photo 8. Point bar expansion following 2014 high flows.

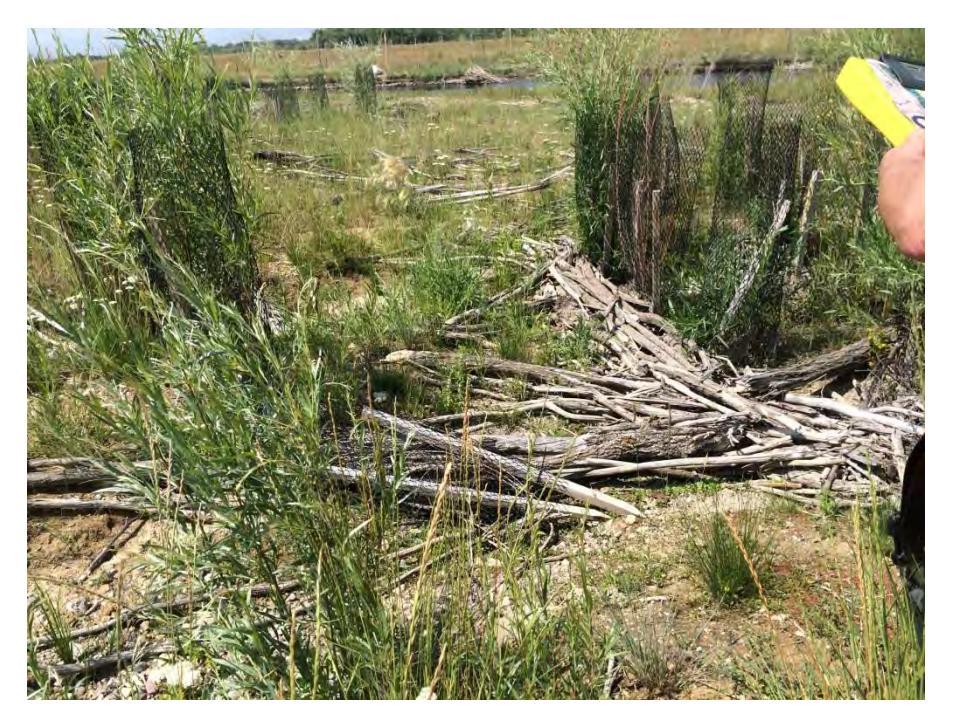
Photo 9. Large wood mobilization and concentration by 2014 high flows.

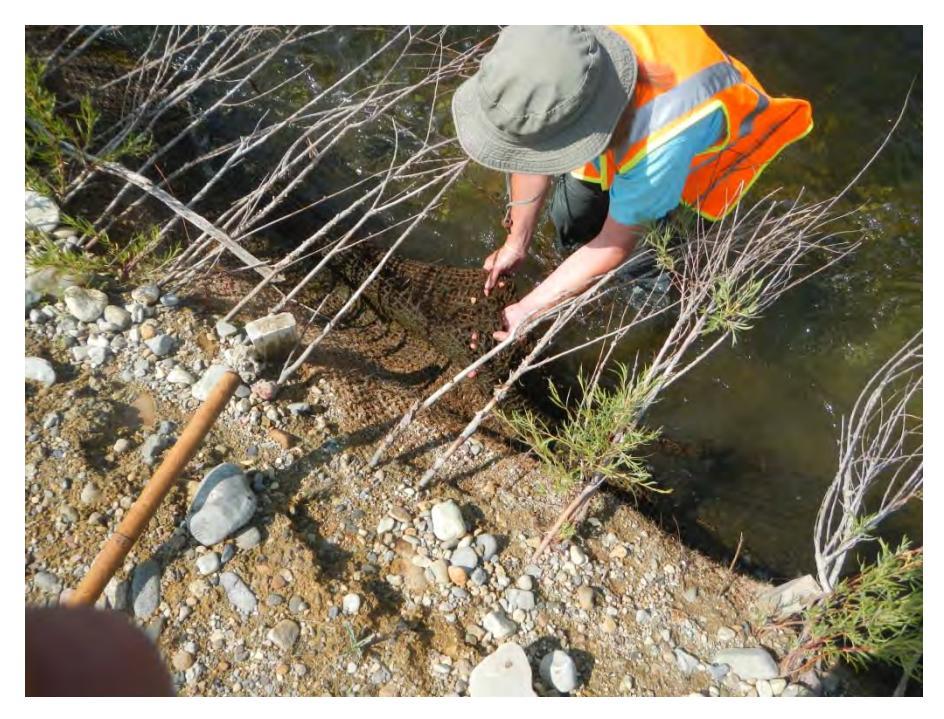
Photo 10. Torn fabric on slumping DVSL, Phase 1.

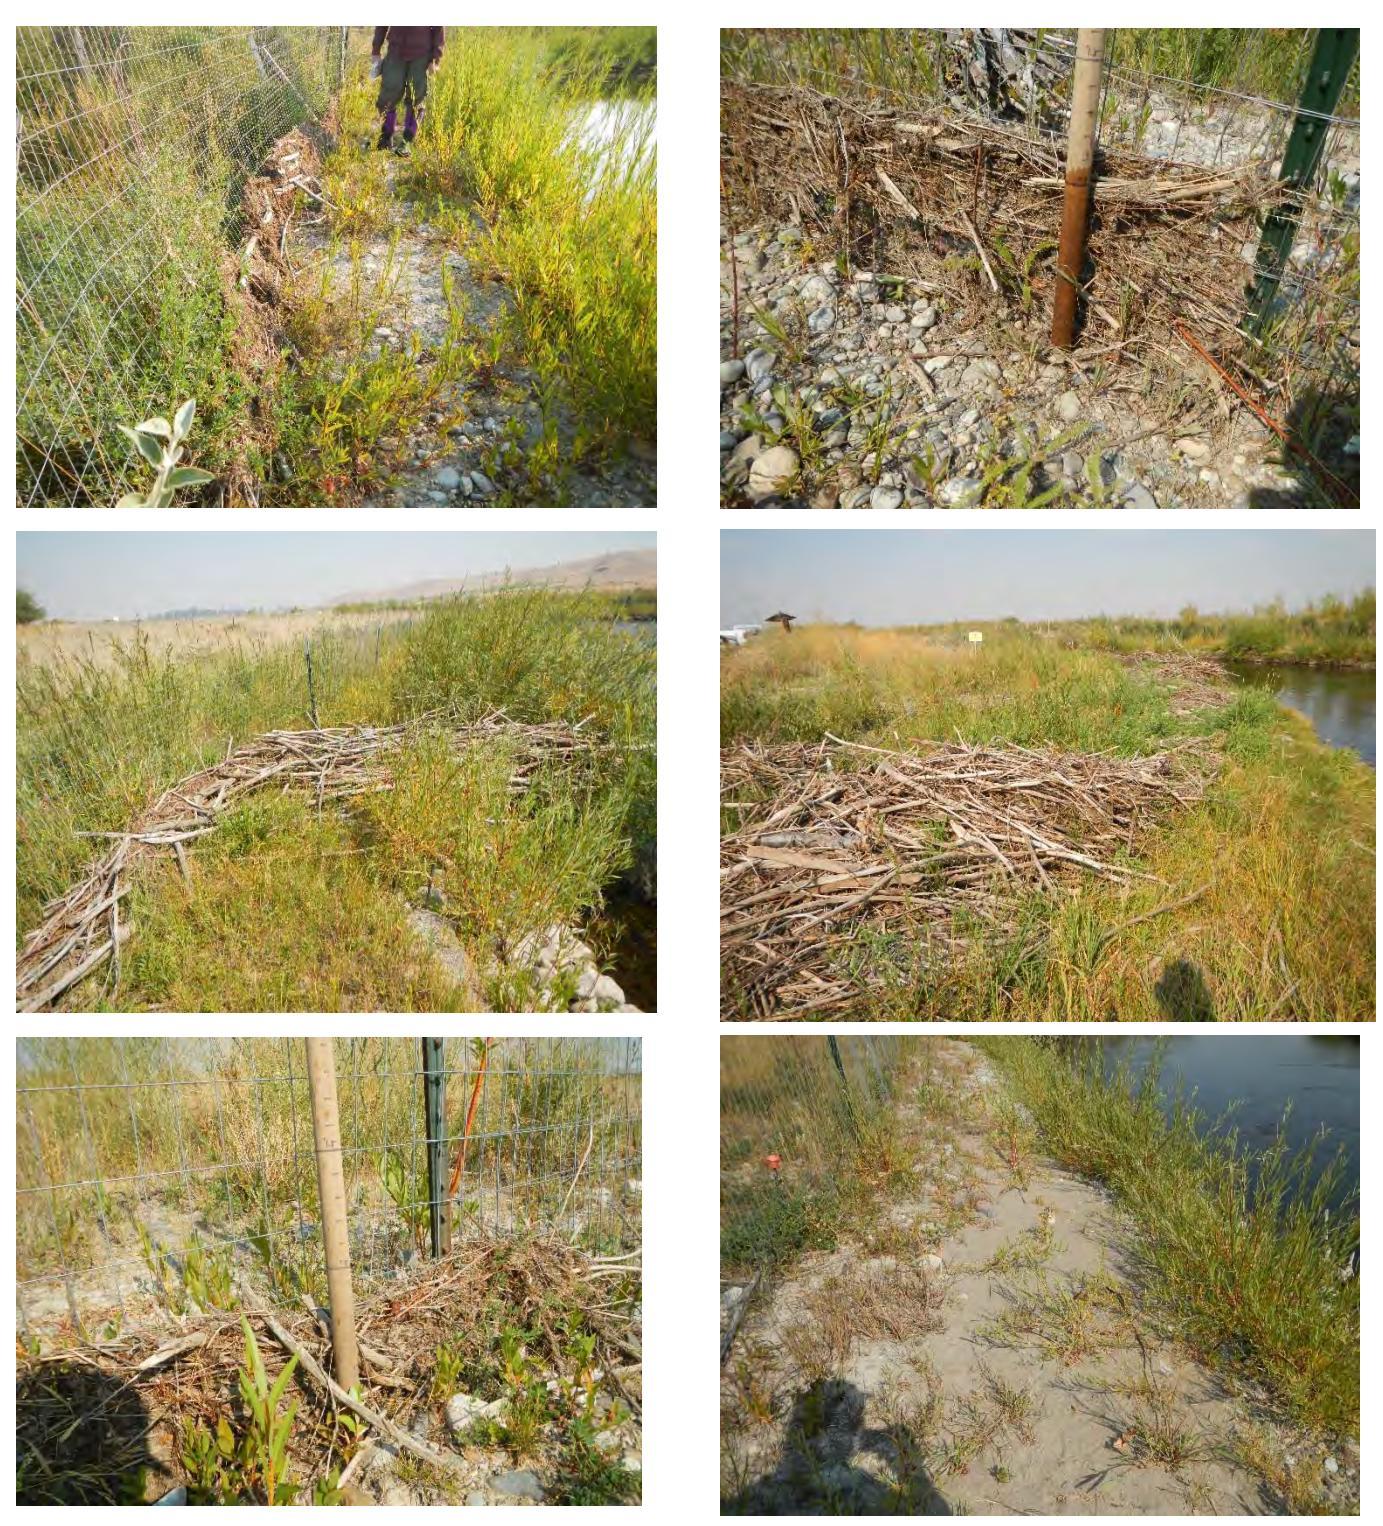
Photos 2-6. Indicators of June 2017 overbank flows.

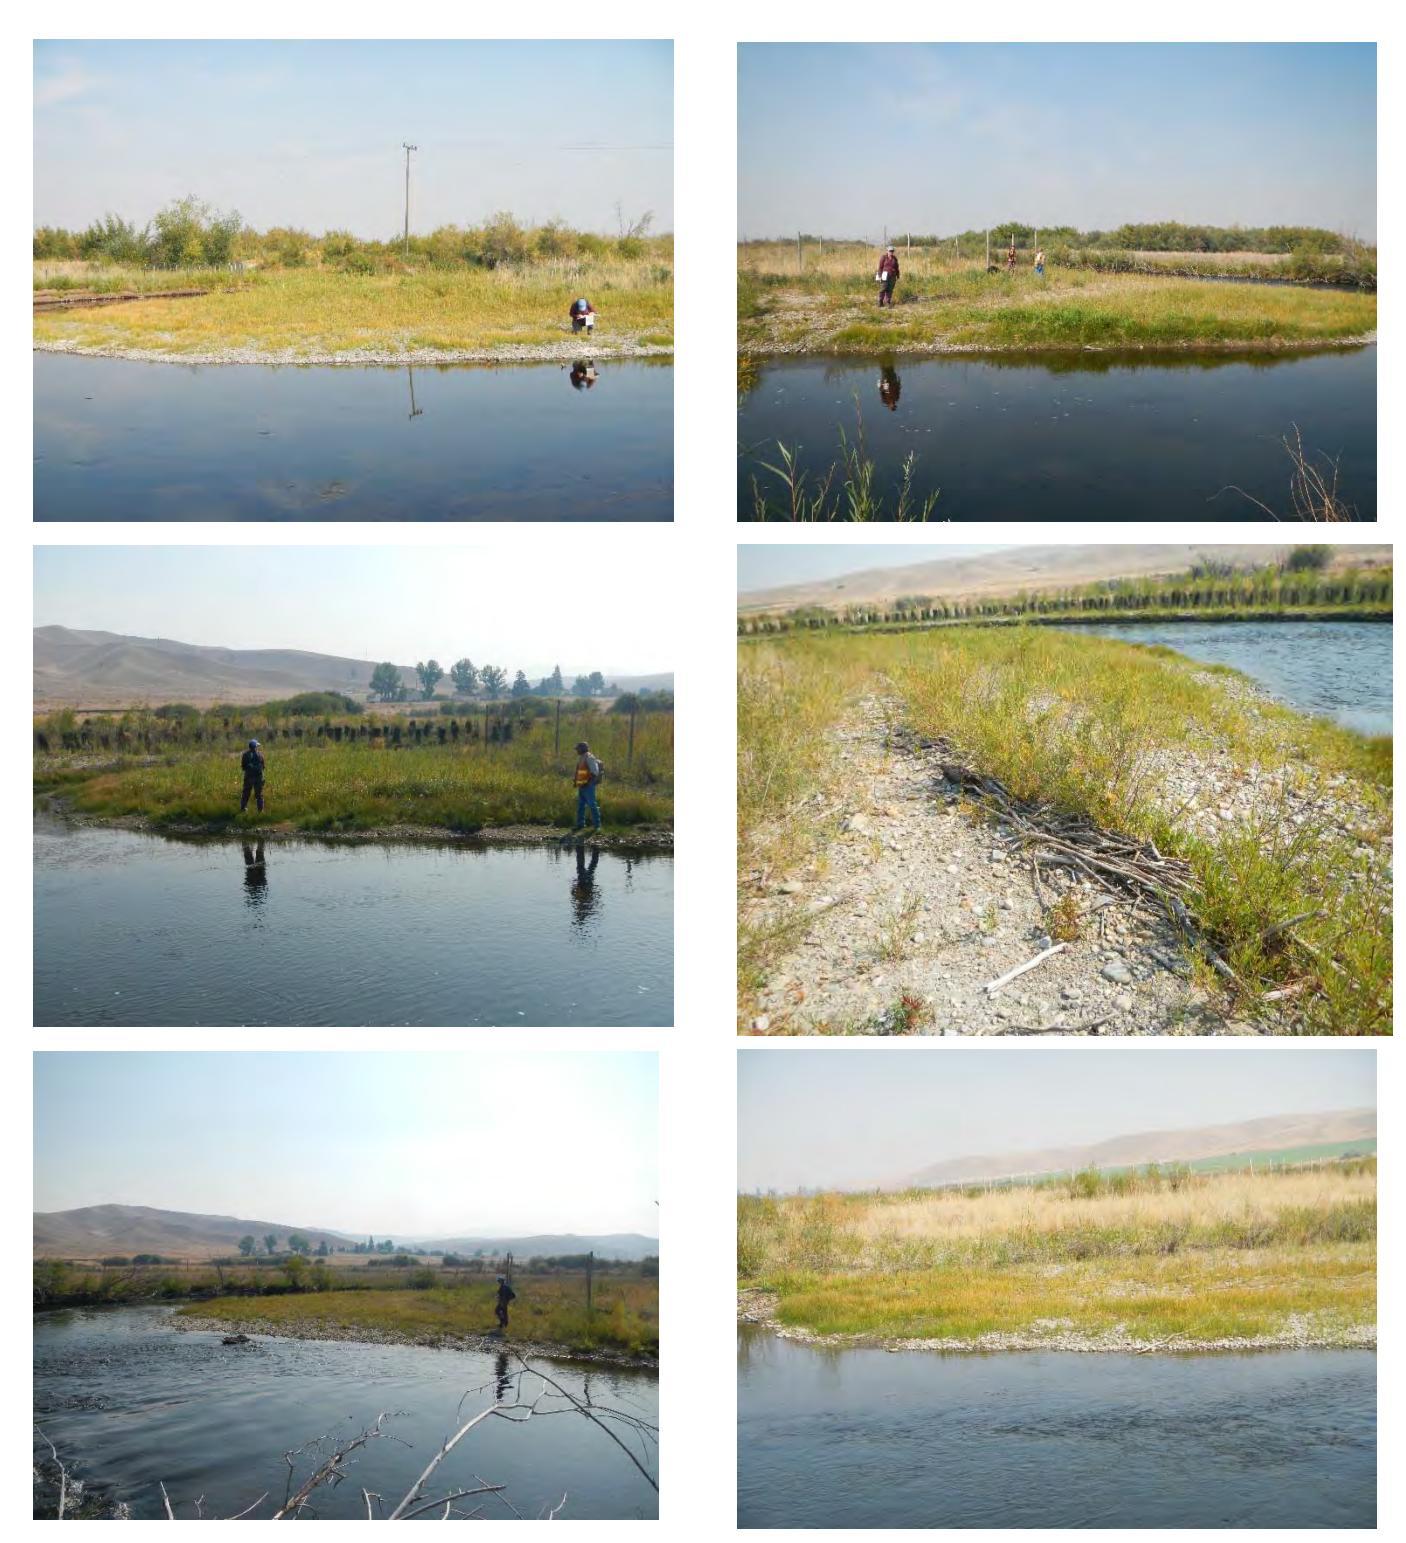
Photos 7-12. Examples of vegetation establishment on point bars, 2017.

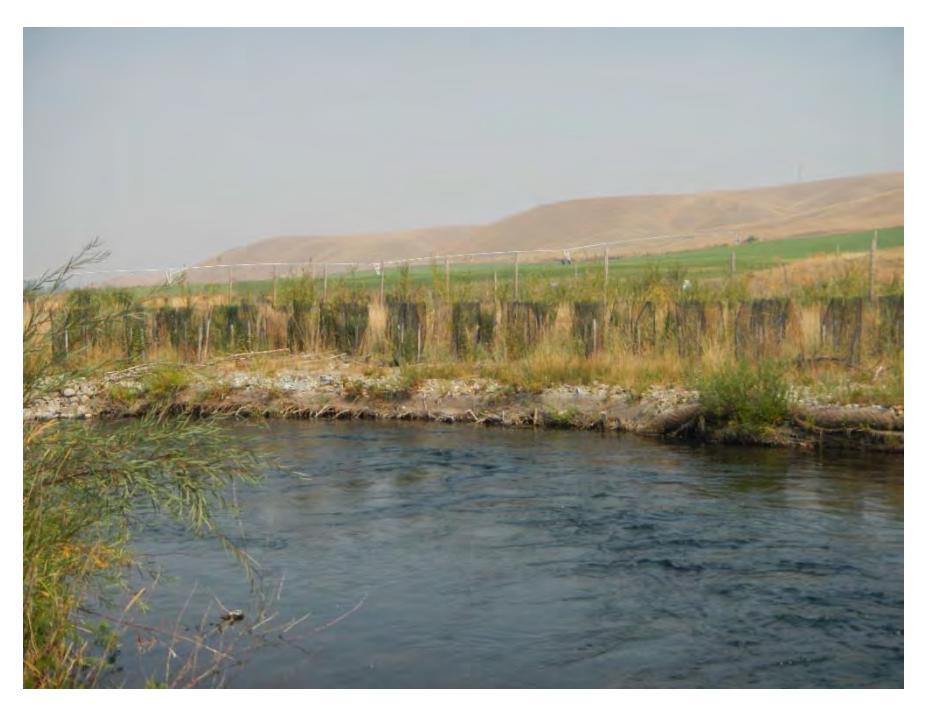
Streambank	None	One streambank treatment was noted for continued observation regarding toe stability.	Uncertain – continued monitoring is recommended for one specific bank. No management actions are recommended at this time.

Photo 13. View downstream of streambank treatment DVSL RB-N-47 identified for continued monitoring.

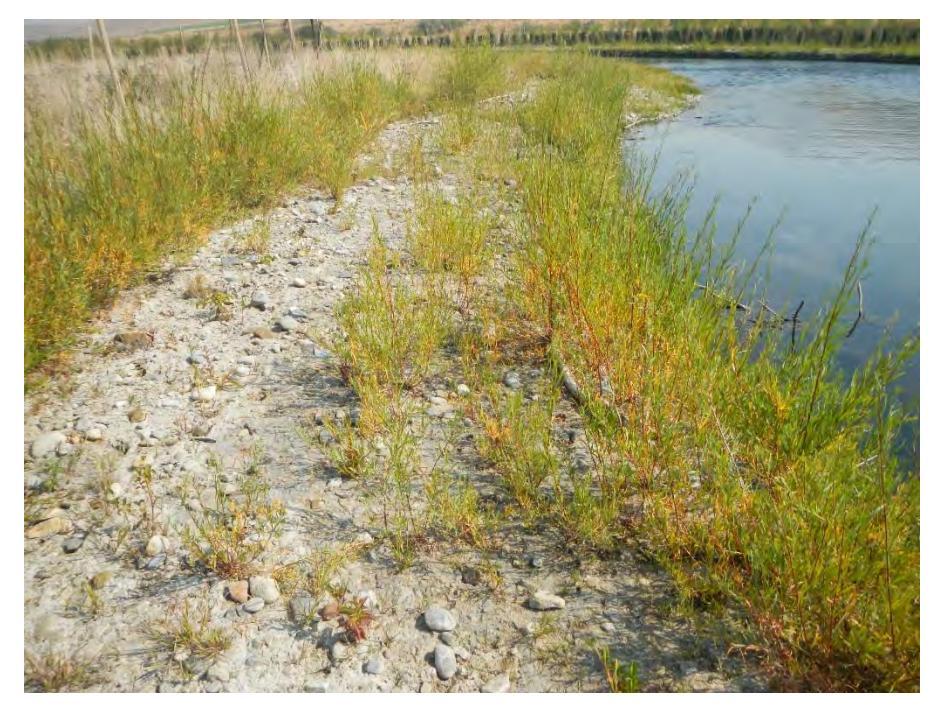
Photo 15. Willow expansion into alluvium placed behind streambank treatment.

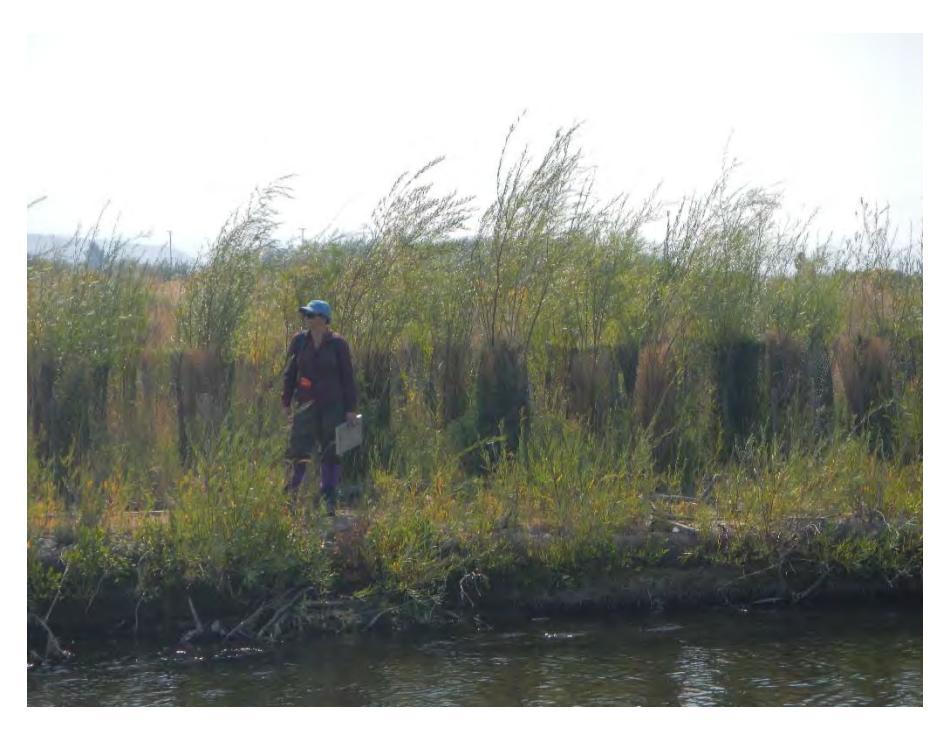
Photo 16. Woody vegetation expansion in streambank and on floodplain.

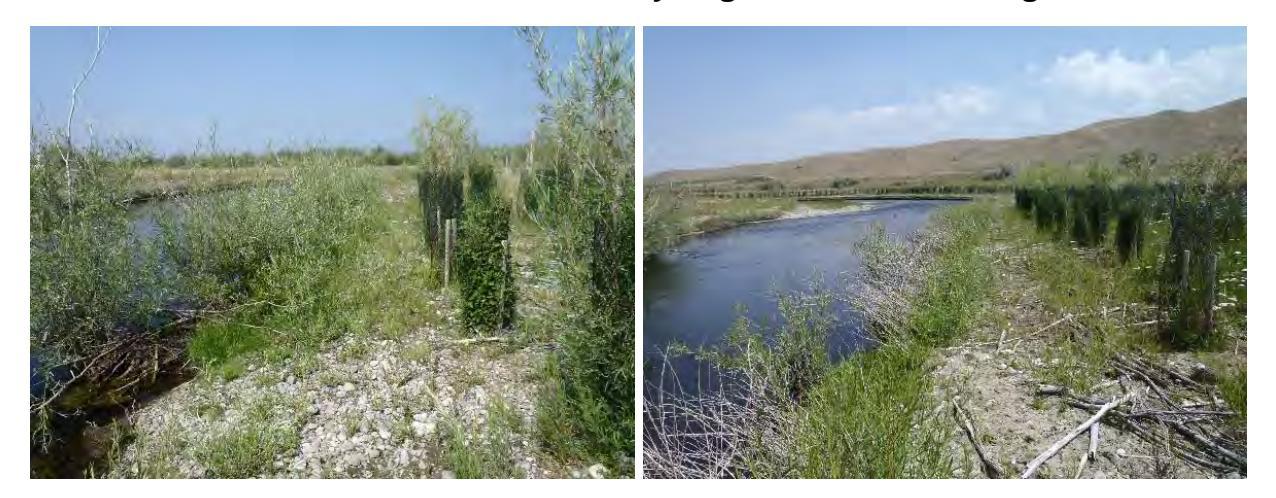
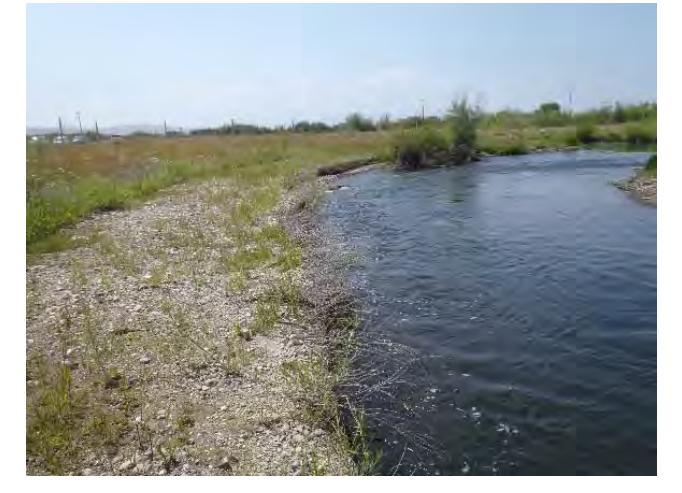
Phase 1 2015 Streambank Woody Vegetation Cover Categories

Top left: Category 1 (>40%) (RBN-2); Top right: Category 2 (10 to 40%) (RBN-22); Bottom center: Category 3 (<10%) (RBN-5).

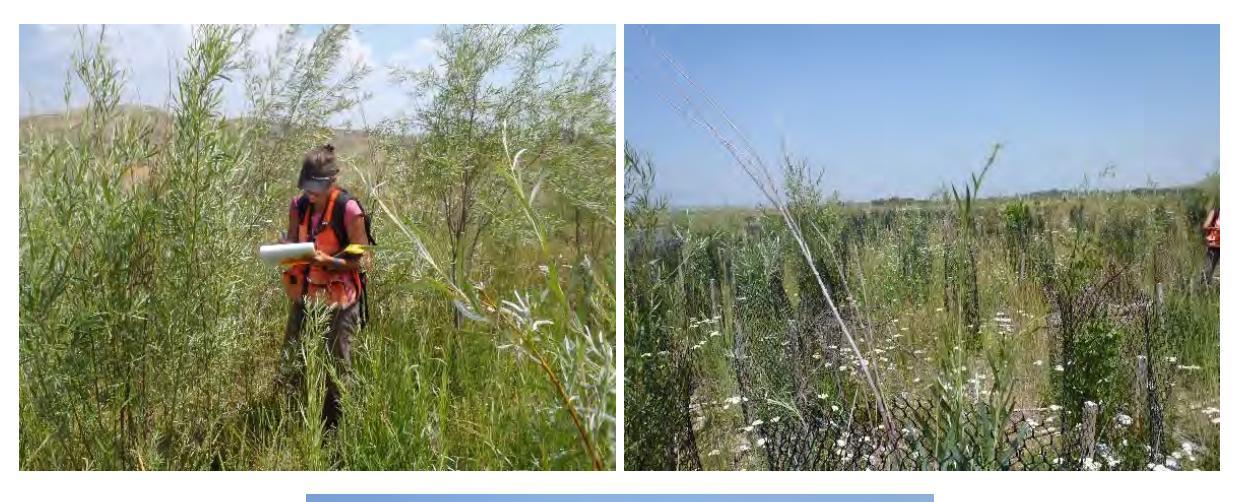
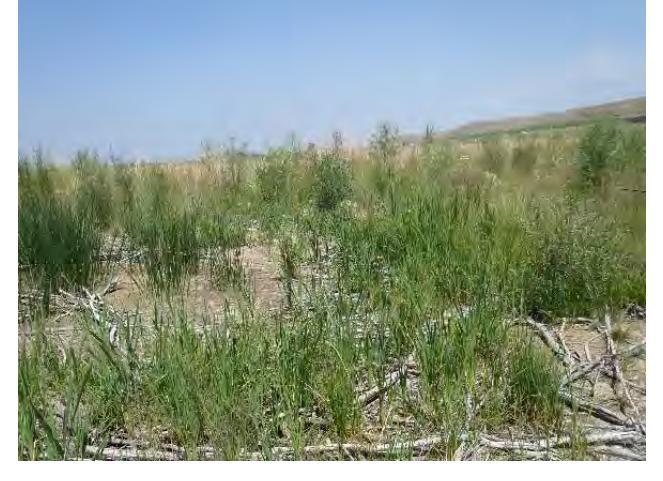
Phase 1 2015 Floodplain Woody Vegetation Cover Categories

Top left: Category 1 (>30%) (SW11); Top right: Category 2 (10 to 30%) (OM16); Bottom center: Category 3 (<10%) (SW08).

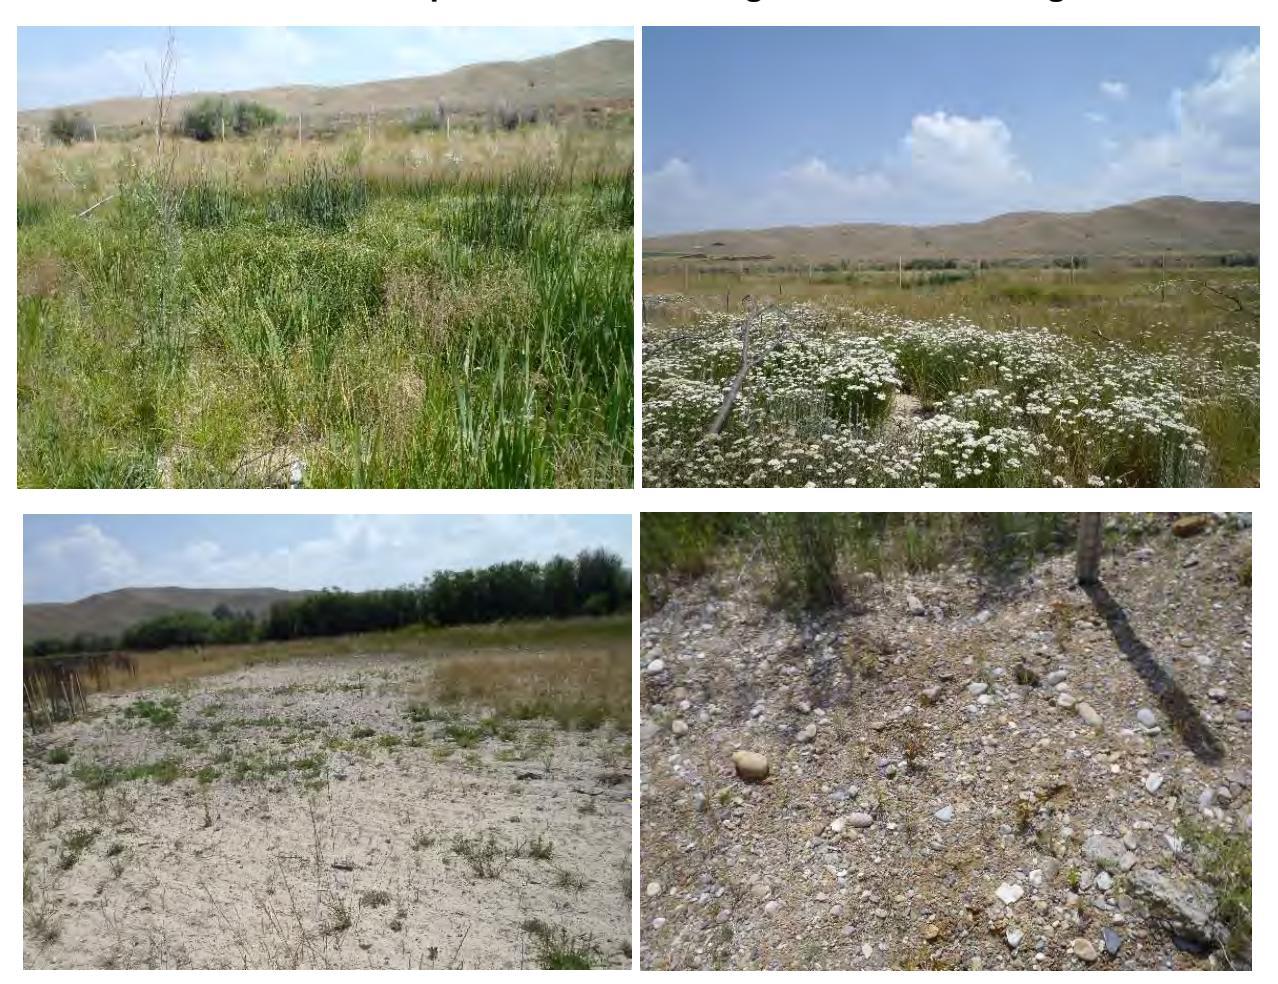
Phase 1 2015 Floodplain Herbaceous Vegetation Cover Categories

Top left: Category 1 (>80%) (Transect 7, wetland herbaceous); Top right: Category 2 (50-80%) (Transect 8, yarrow); Lower Left: Category 3 (20-50%) (Transect 3, staging area and haul road); Lower right: Category 4 (<20%) (Transect 5, behind bank).

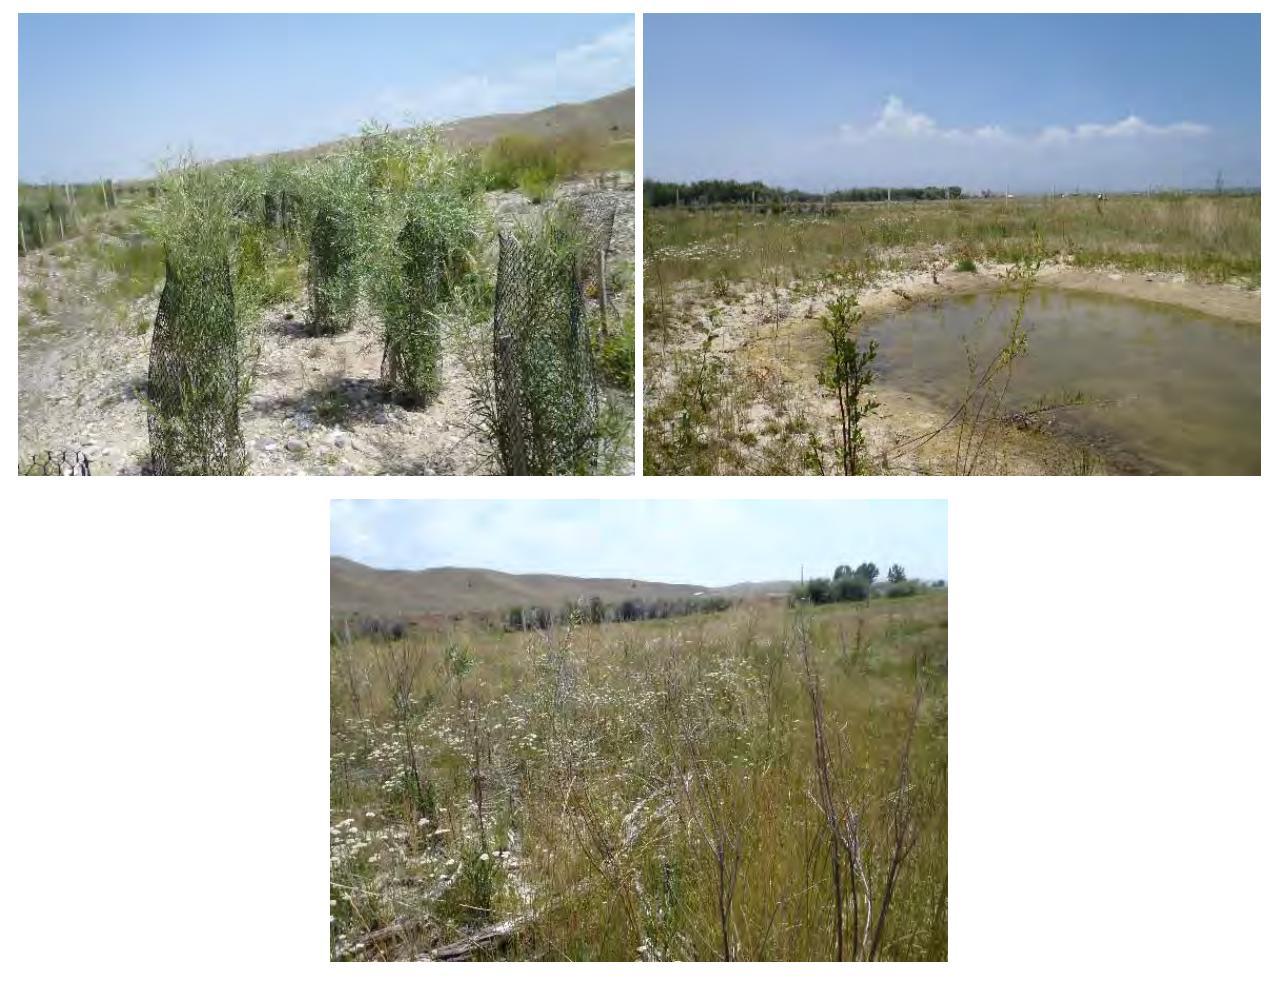
Phase 1 2015 Woody Vegetation Survival Categories

Top left: Category 1 (>80%) (OM12); Top right: Category 2 (50 to 80%) (SO81); Bottom center: Category 3 (<50%) (SW07).

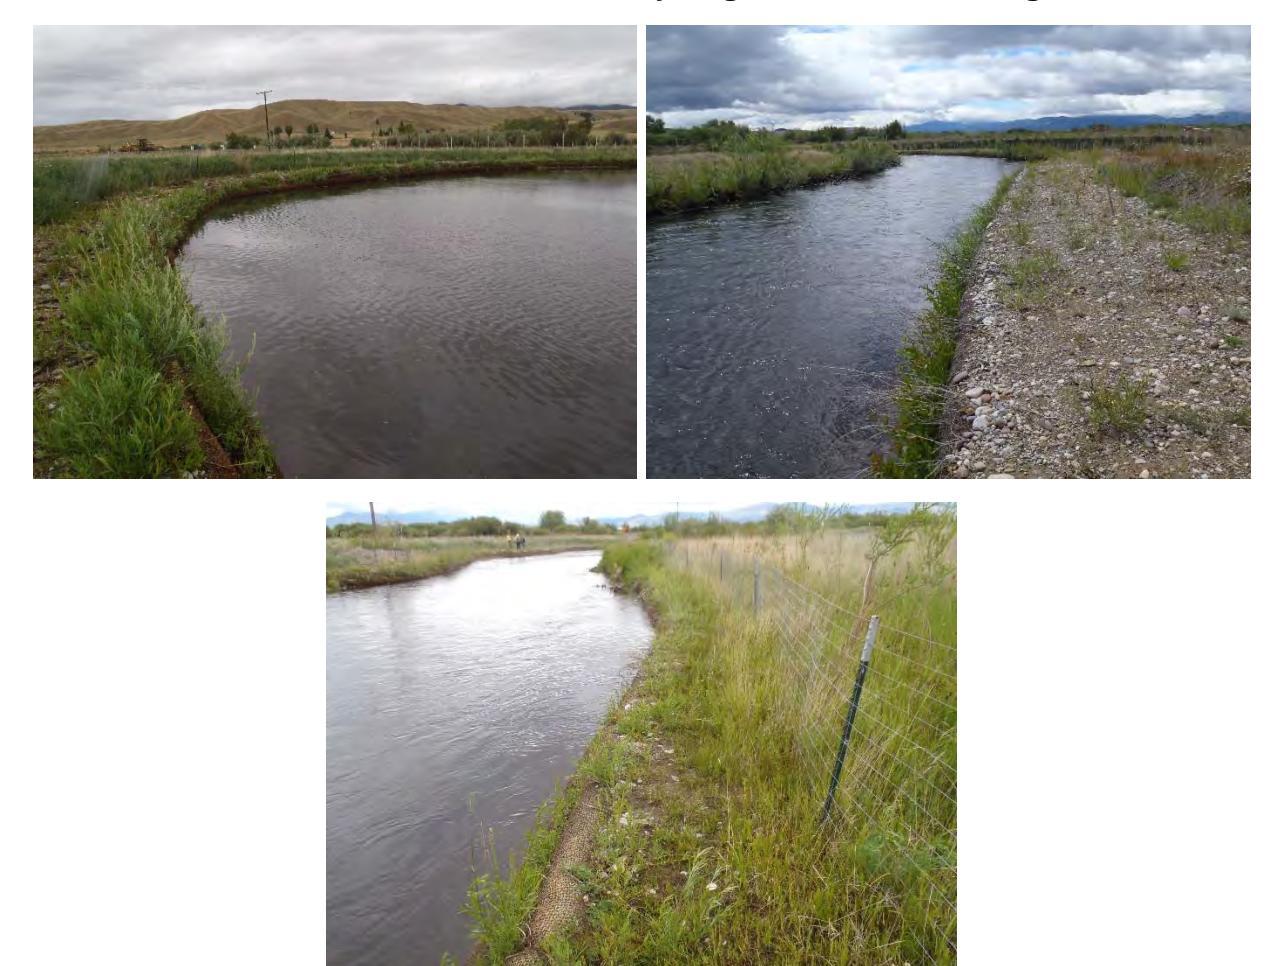
Phase 1 2016 Streambank Woody Vegetation Cover Categories

Top left: Category 1 (>40%) (RB-S-2); Top right: Category 2 (10 to 40%) (RB-N-9); Bottom center: Category 3 (<10%) (LB-S-12).

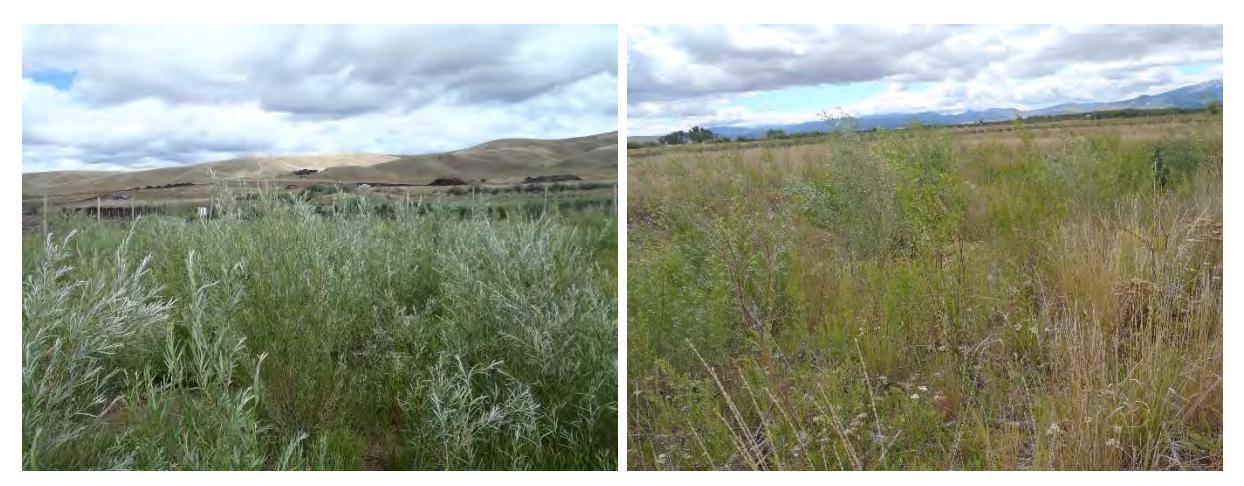
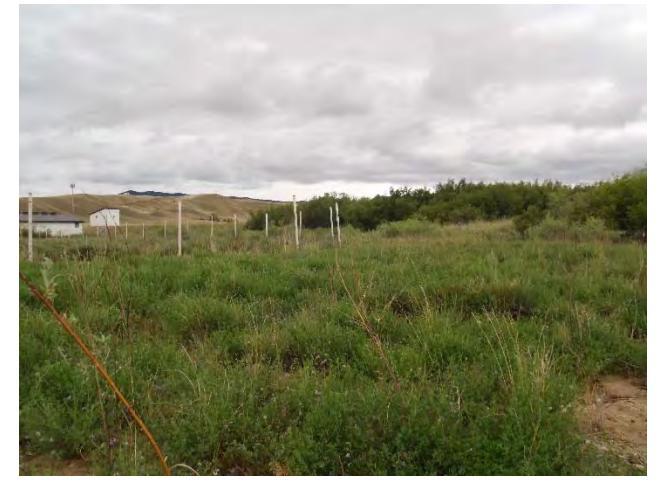
Phase 1 2016 Floodplain Woody Vegetation Cover Categories

Top left: Category 1 (>30%) (SW04A); Top right: Category 2 (10 to 30%) (SW08); Bottom center: Category 3 (<10%) (OM01).

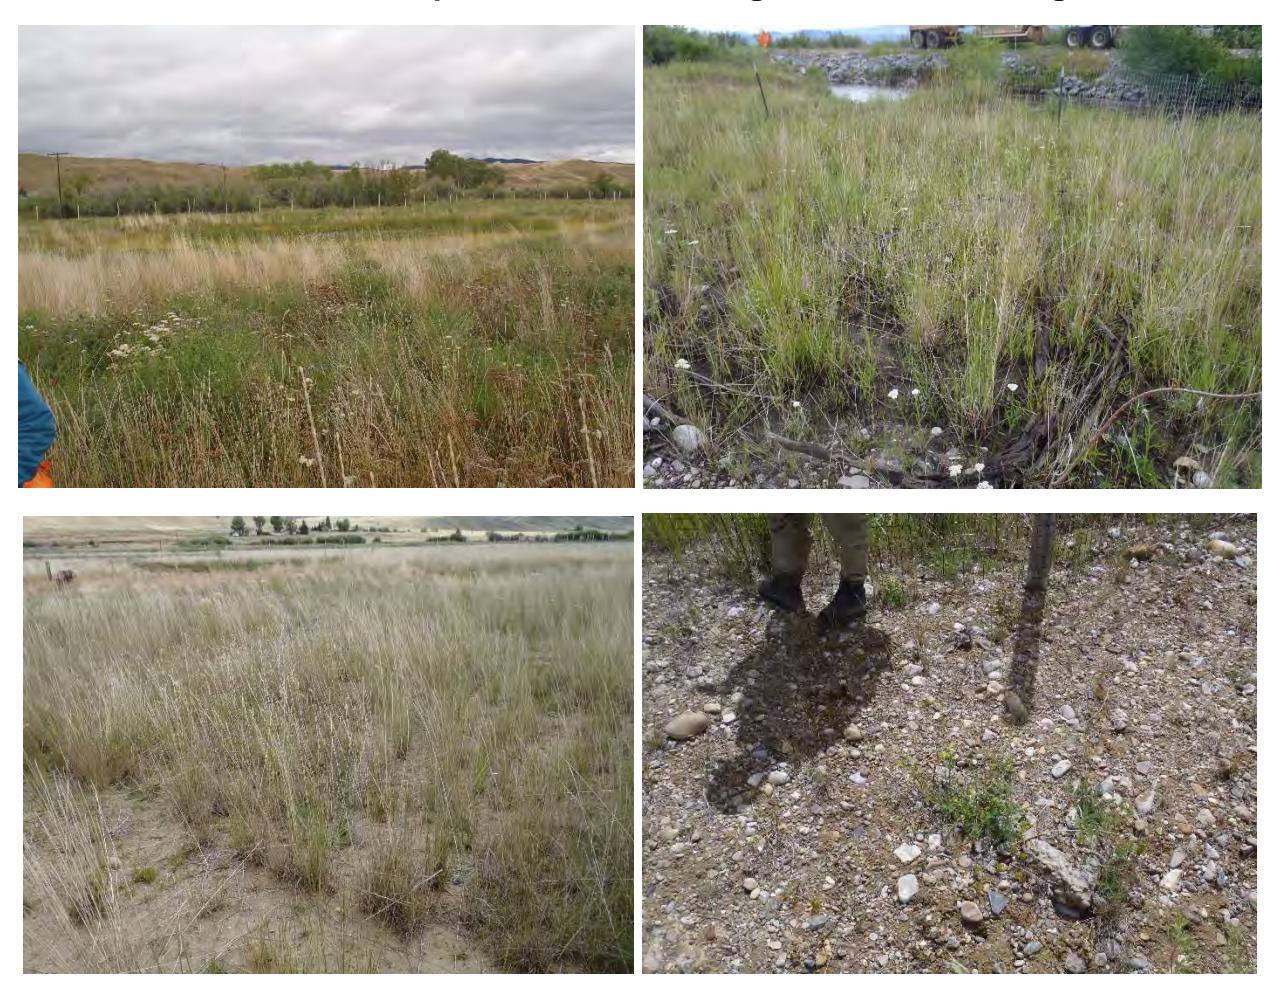
Phase 1 2016 Floodplain Herbaceous Vegetation Cover Categories

Top left: Category 1 (>80%) (Transect 2, wetland herbaceous slope); Top right: Category 2 (50-80%) (Transect 2, herbaceous behind bank); Lower Left: Category 3 (20-50%) (Transect 5, herbaceous); Lower right: Category 4 (<20%) (Transect 5, directly behind bank).
