# Qualitative Rapid Assessment 2015-2017 Status Report

Milltown Reservoir / Clark Fork River NPL Site Clark Fork River Operable Unit, Reach A, Phase 1, Phase 2 and Phases 5 and 6

Qualitative Rapid Assessment, 2015-2017 Status Report Milltown Reservoir / Clark Fork River NPL Site Clark Fork River Operable Unit, Reach A

> > January, 2018

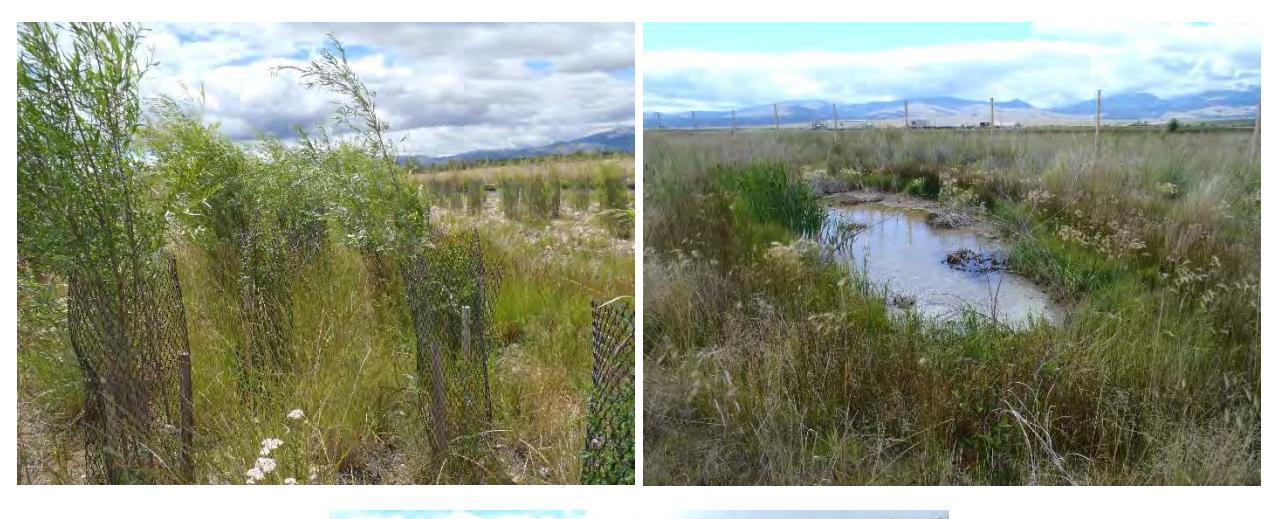
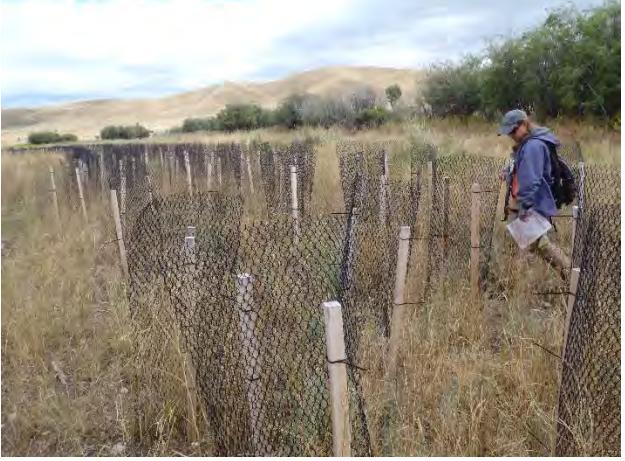
Top left: Category 1 (>80%) (OM12); Top right: Category 2 (50 to 80%) (S116); Bottom center: Category 3 (<50%) (TS07).

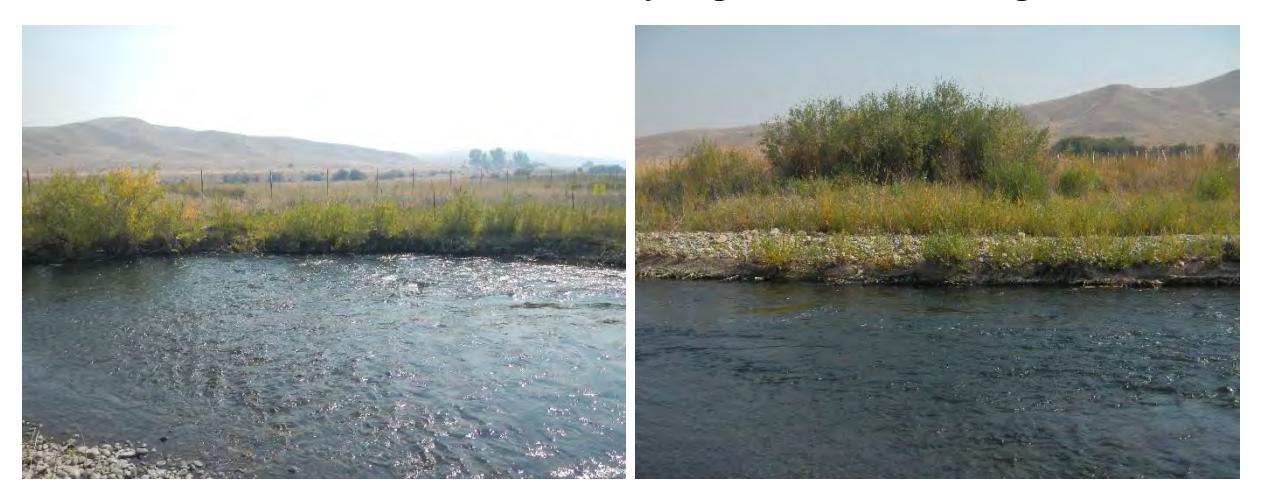
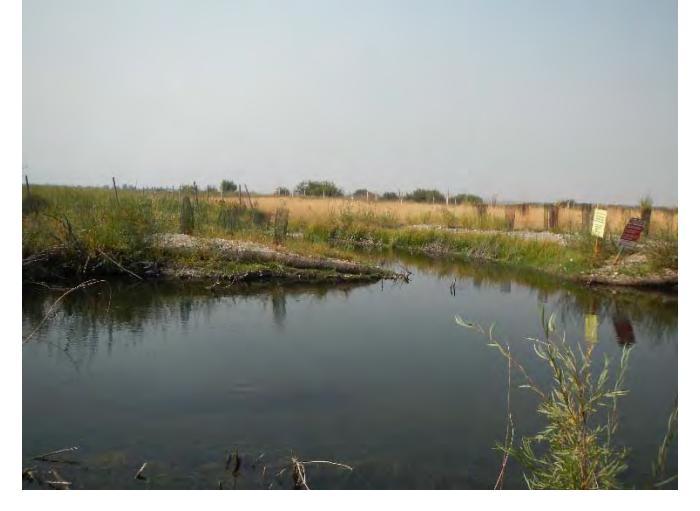
Phase 1 2017 Streambank Woody Vegetation Cover Categories

Top left: Category 1 (>40%) (RB-N-29 PV); Top right: Category 2 (10 to 40%) (RB-N-14 DVSL) Bottom: Category 3 (<10%) (LB-N-51 SVSL on left bank of side channel outlet)

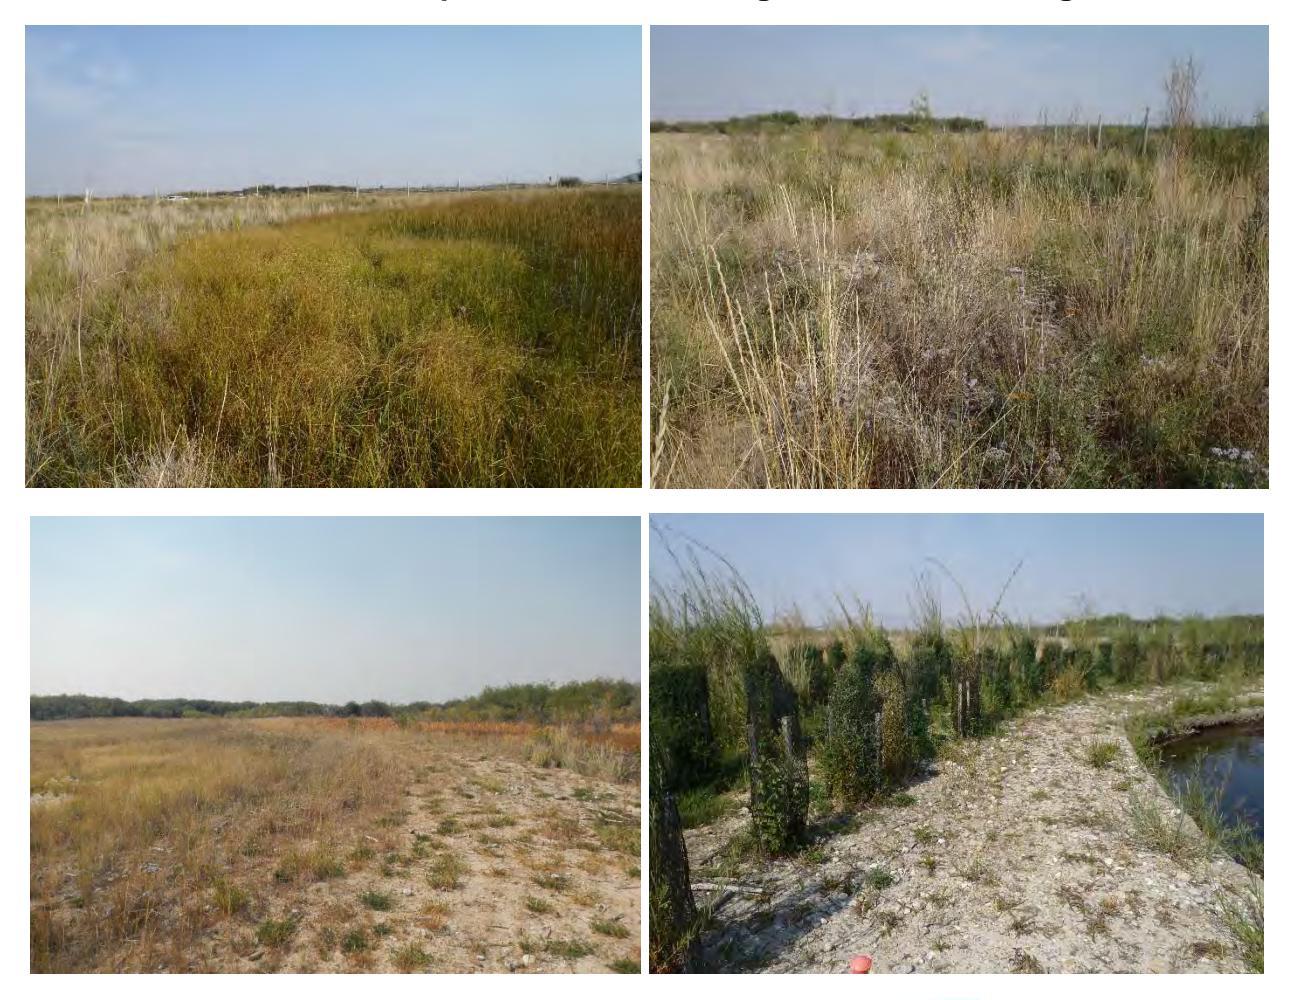
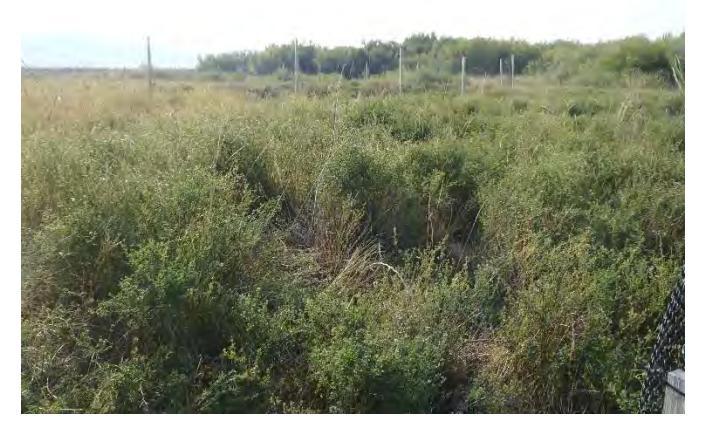
Phase 1 2017 Floodplain Herbaceous Vegetation Cover Categories

Top left: Category 1 (>80%) (Emergent wetland in SW01); Top right: Category 2 (50-80%) (herbaceous cover within MC02); Middle Left: Category 3 (20-50%) (access road on left bank); Middle right: Category 4 (<20%) (directly behind bank of OM10); Bottom: Category 1 (>80%) (alfalfa in floodplain upstream of bridge).

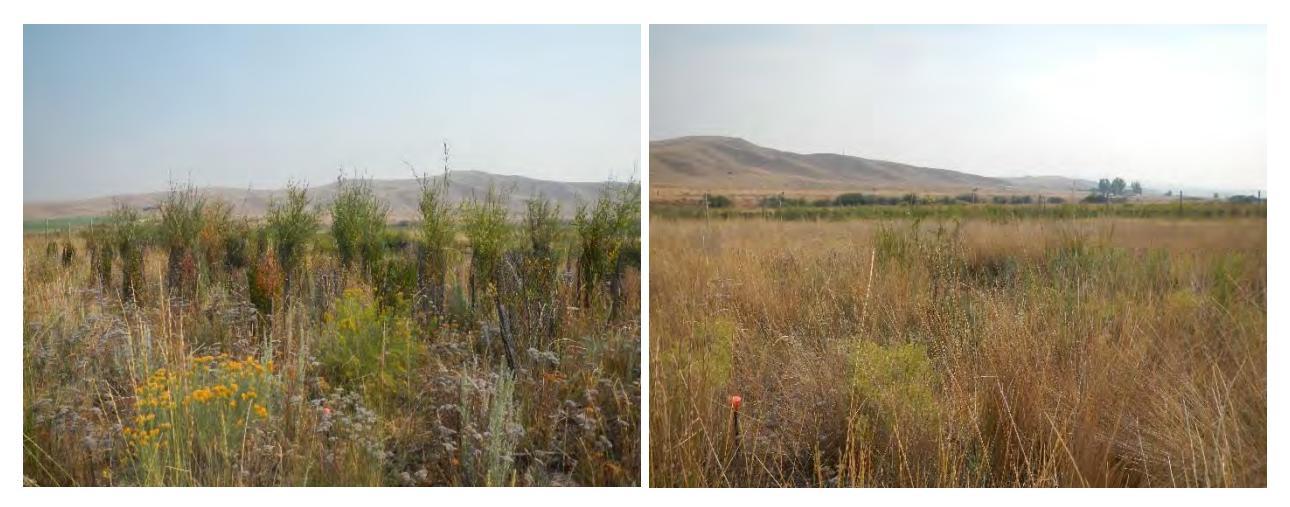
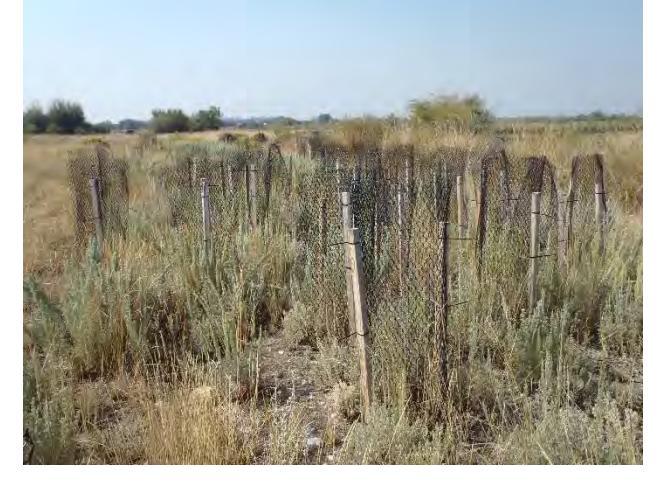
Phase 1 2017 Woody Vegetation Survival Categories

Top left: Category 1 (>80%) (OM19, 2013); Top right: Category 2 (50 to 80%) (s108); Bottom center: Category 3 (<50%) (ts07).

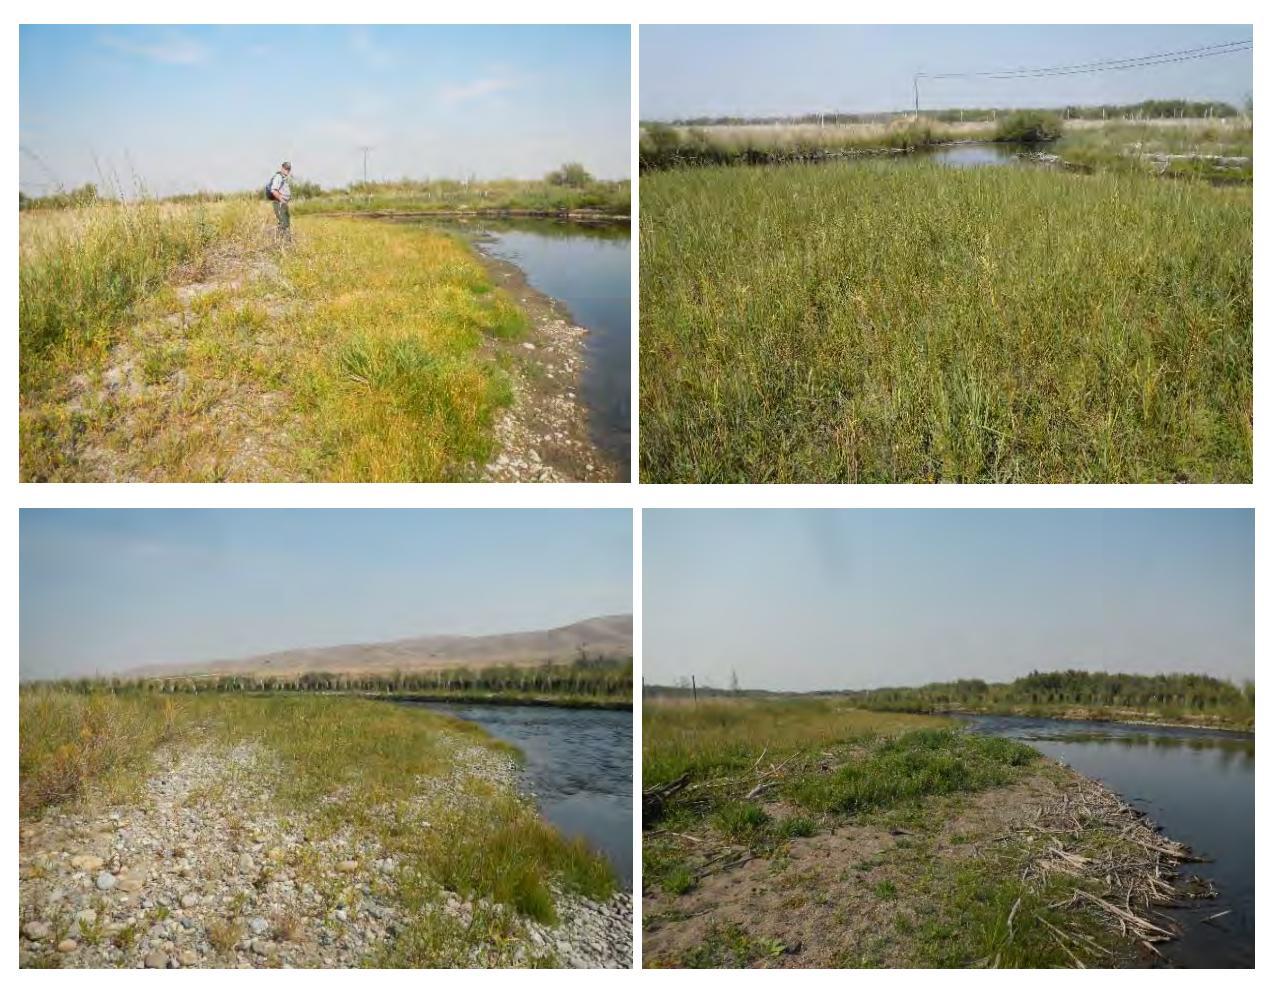
Phase 1 2017 Vegetation Miscellaneous Photographs

Both herbaceous and woody vegetation continues to increase on constructed point bar features in Phase 1. Reed canarygrass was observed on more point bars in 2017 compared with previous years. Photos 1-4 in Attachment D (*Phase 1 2017 Miscellaneous Vegetation Photographs*) show typical conditions of point bars in Phase 1 in 2017.

Photos 1-4. Point bar conditions in Phase 1 in 2017: Photo 1: herbaceous; Photo 2: island point bar with dense willow seedlings; Photo 3: Mix of herbaceous and woody vegetation; Photo 4: Fine sediment deposition on point bar.

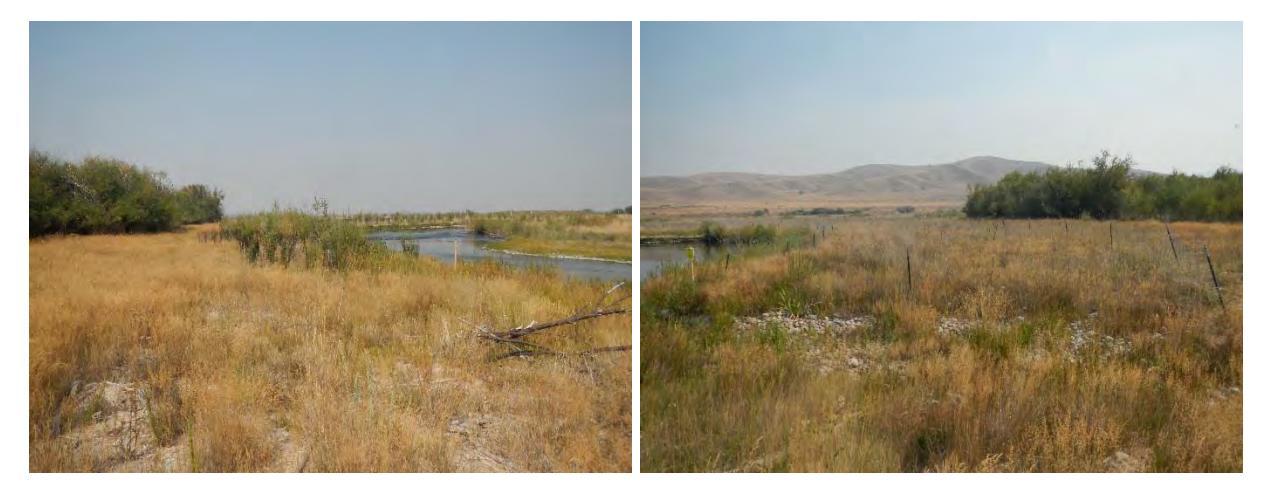
Photos 5-8. Willow expansion in areas inundated by high flows in Phase 1 in 2017. Photo 5: swale near backwater area left bank upstream of bridge; Photo 6: SCS04 area; Photo 7: right bank 2014 flood activated floodplain area; Photo 8: planting unit SW11 activated by 2014 flood.

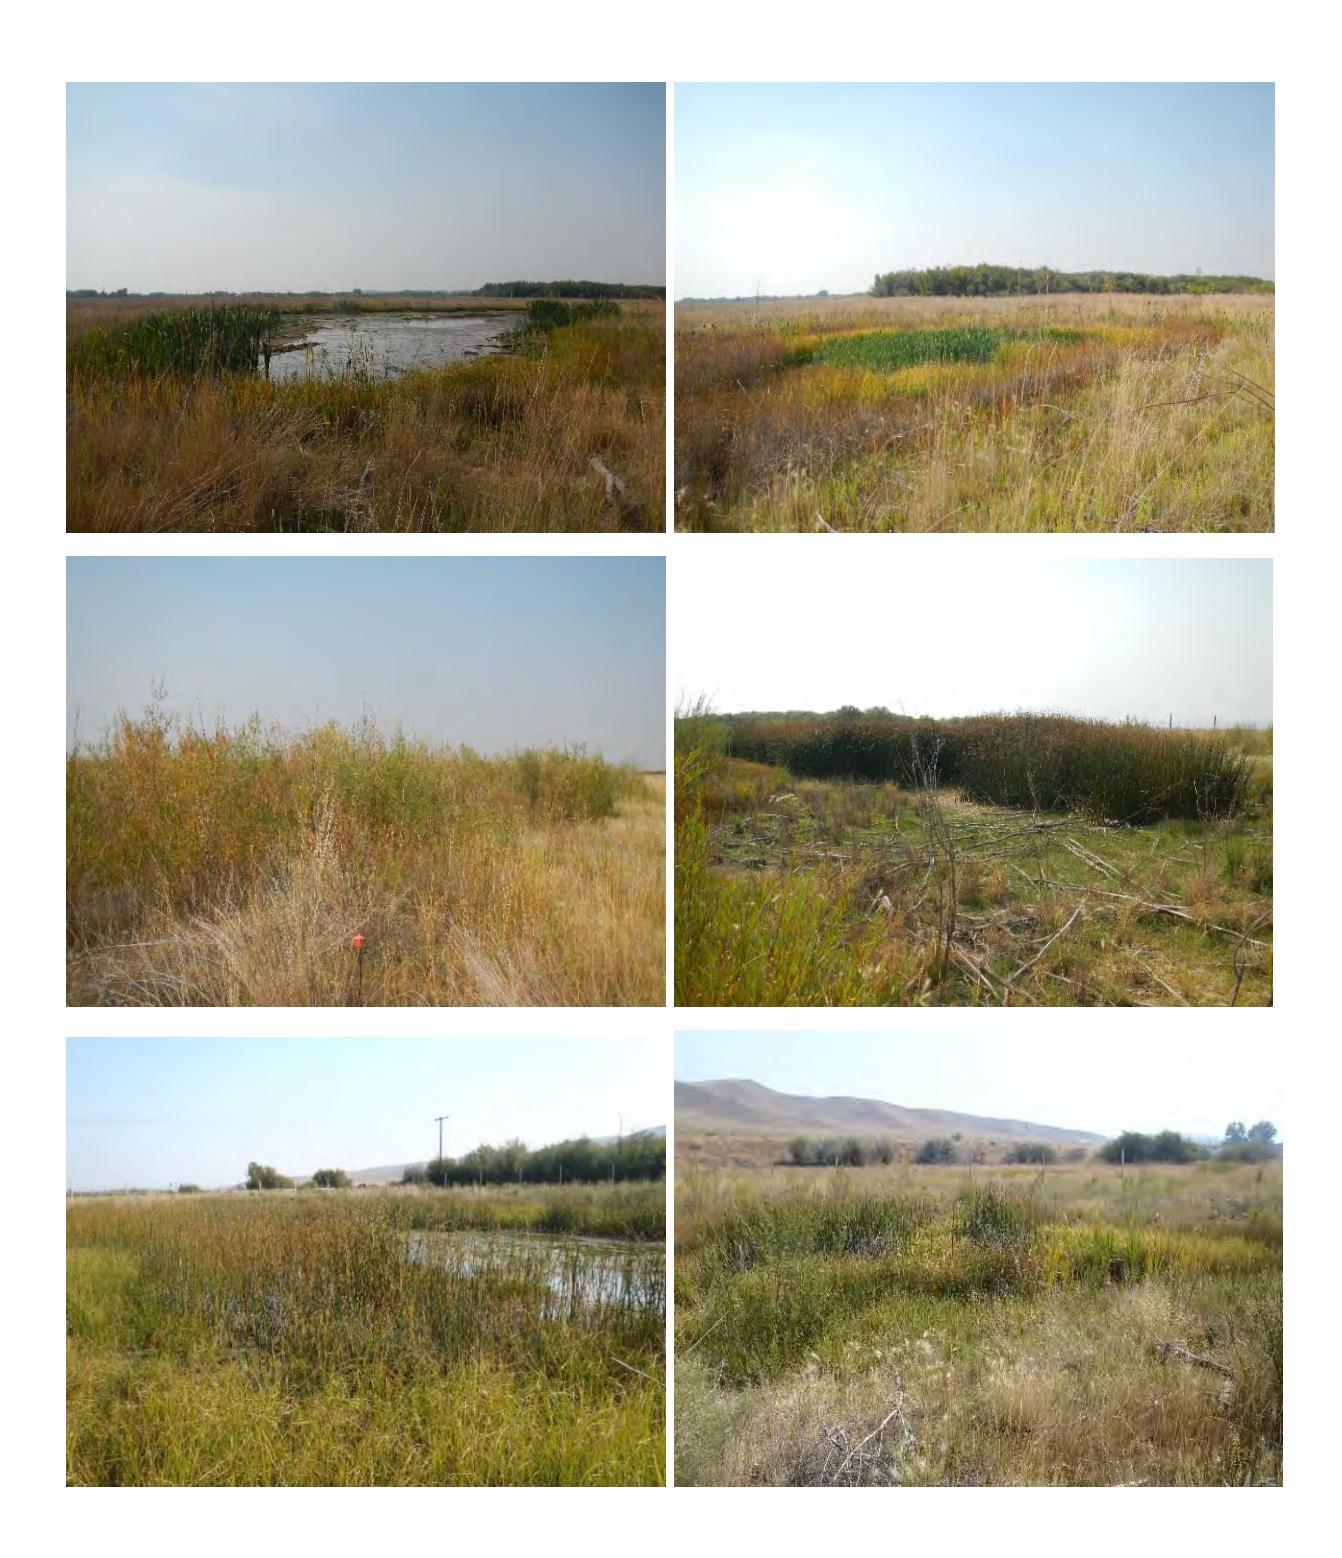
Photos 12-14. Planting units in the large floodplain area on the west side of the river near the center of the Phase 1 project reach. Survival of woody vegetation in this area is very low due to excessive deer browse. The large net exclosures has been ineffective in this area and has not excluded deer. Photo 12: planting unit S056; Photo 13: planting unit S062; Photo 14: planting unit S121.

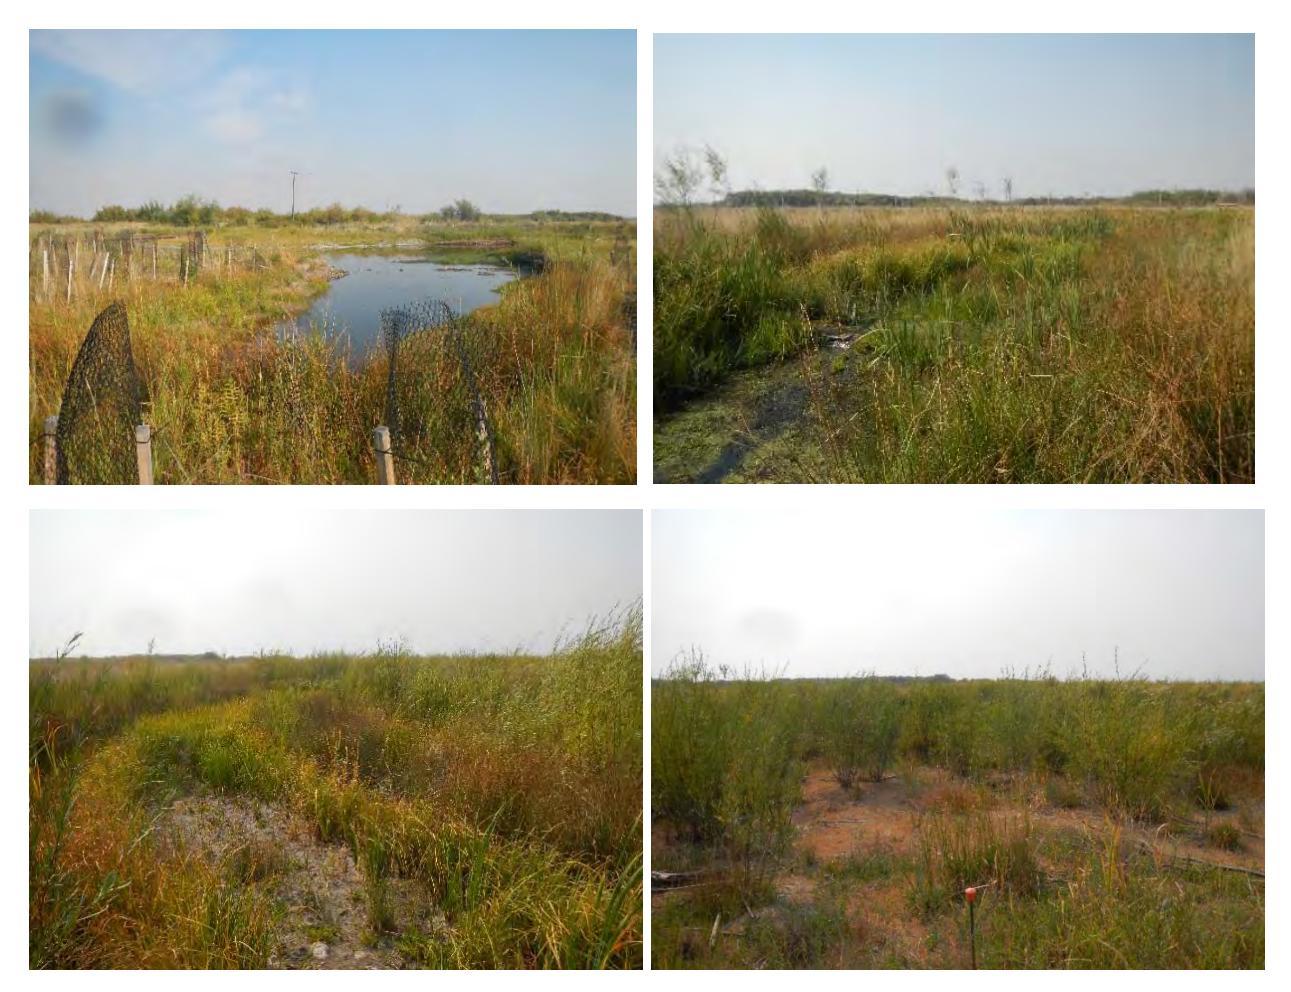
Photos 15-21. Conditions of wetlands in Phase 1 in 2017. Photo 15: SW05; Photo 16: S121; Photo 17 and Photo 18: SW09; Photo 19: SW01; Photo 20: SW07; Photo 21: SW11.

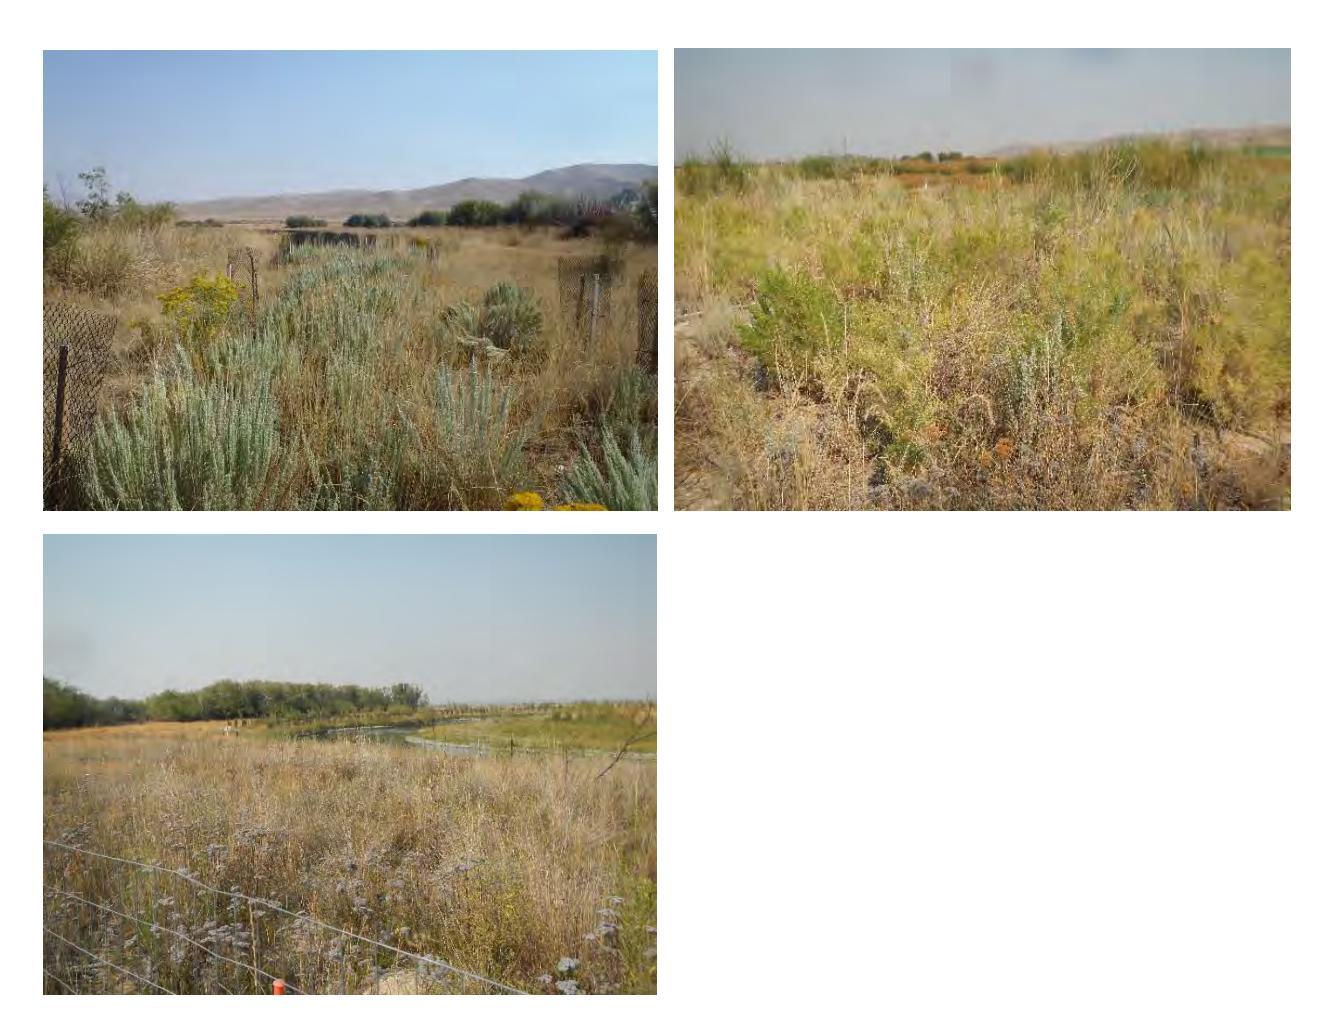
Photos 22-25. Side Channels and backwater features. Photo 22: SCS02; Photo 23: SCS03; Photo 24 and Photo 25: SCS04A.

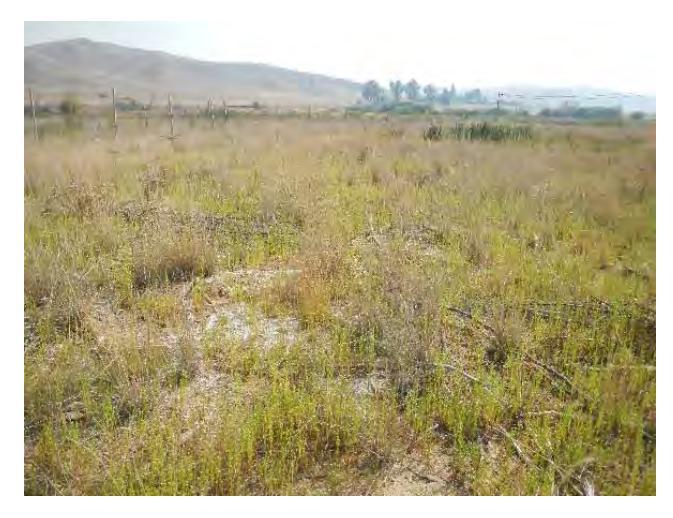
Photo 29. Reed canarygrass colonizing point bar across from LB-S-3. Reed canarygrass cover is highest on point bars upstream of the bridge. There are several dense stands upstream of the Phase 1 project site.

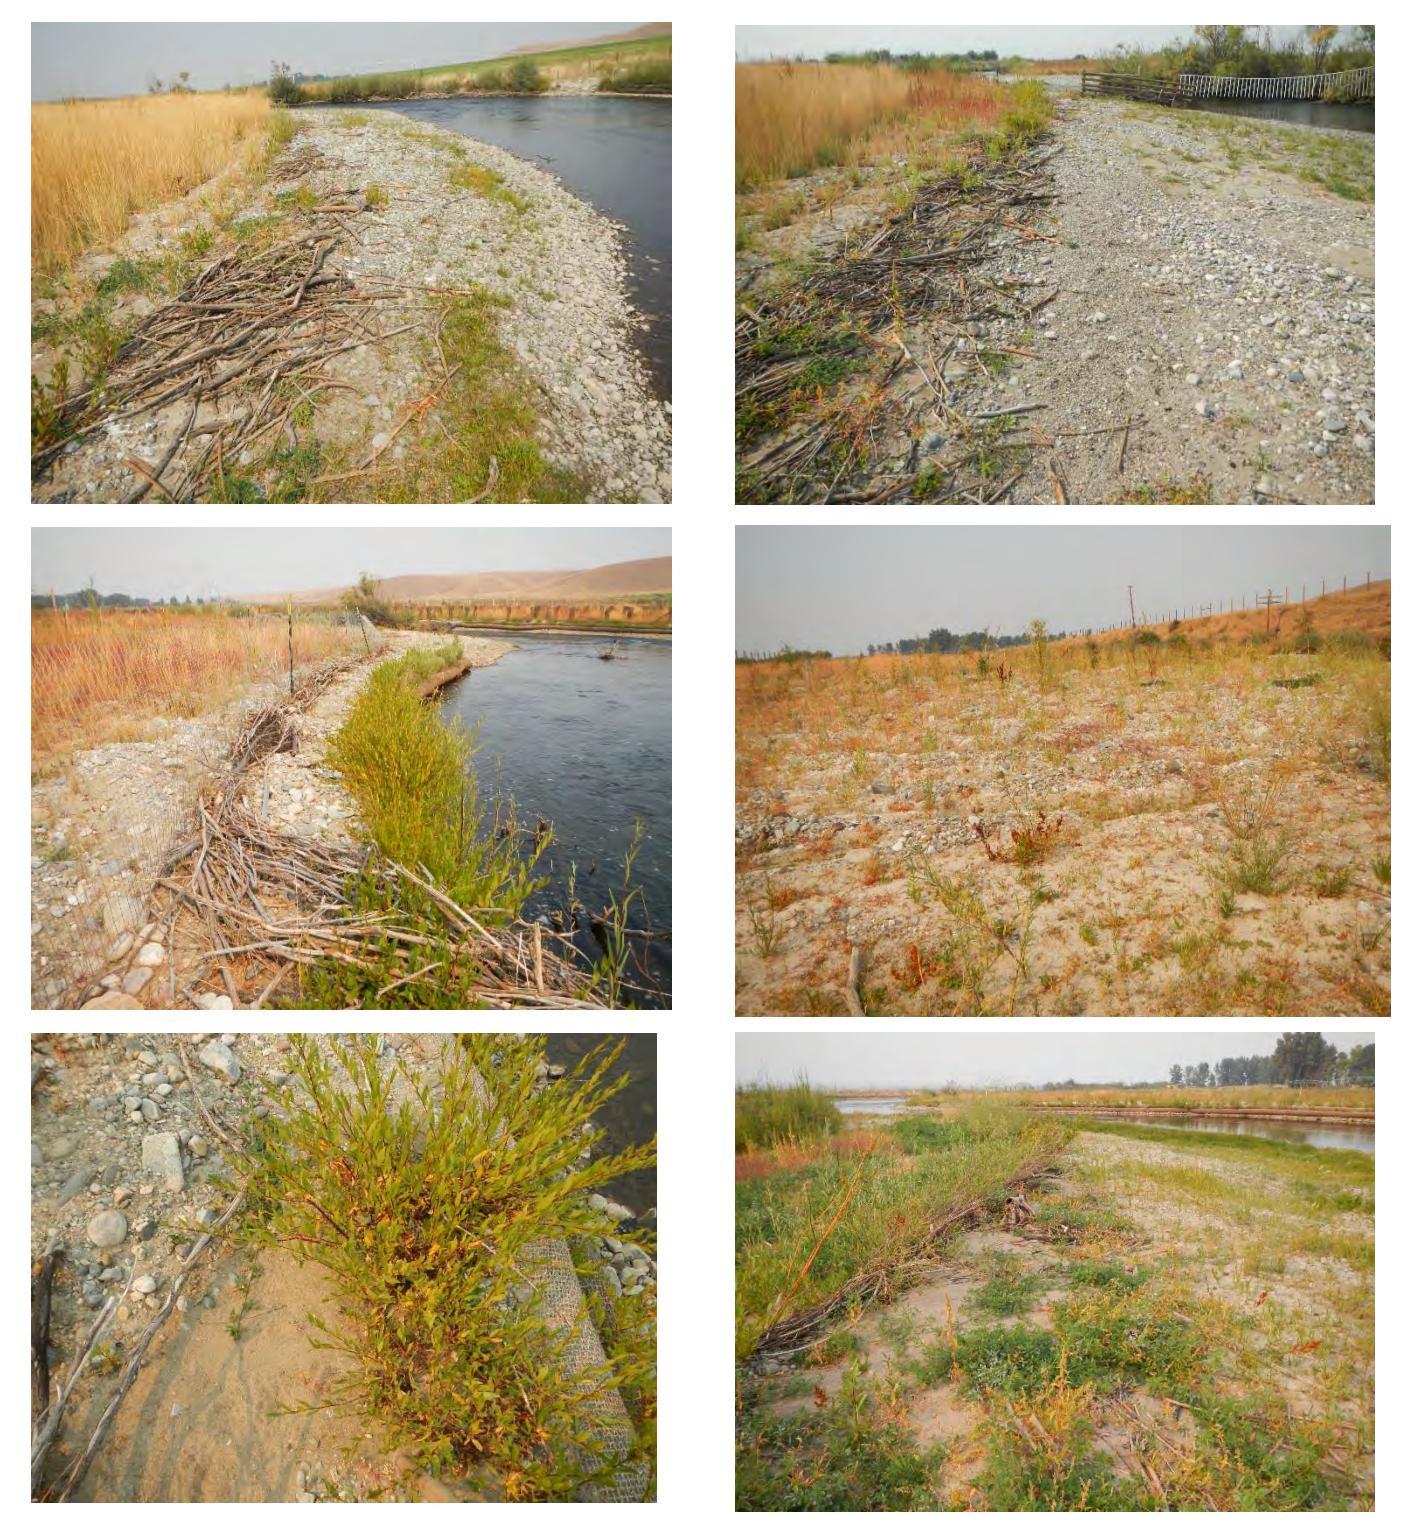
Photos 1-6. Indicators of June 2017 overbank flows.

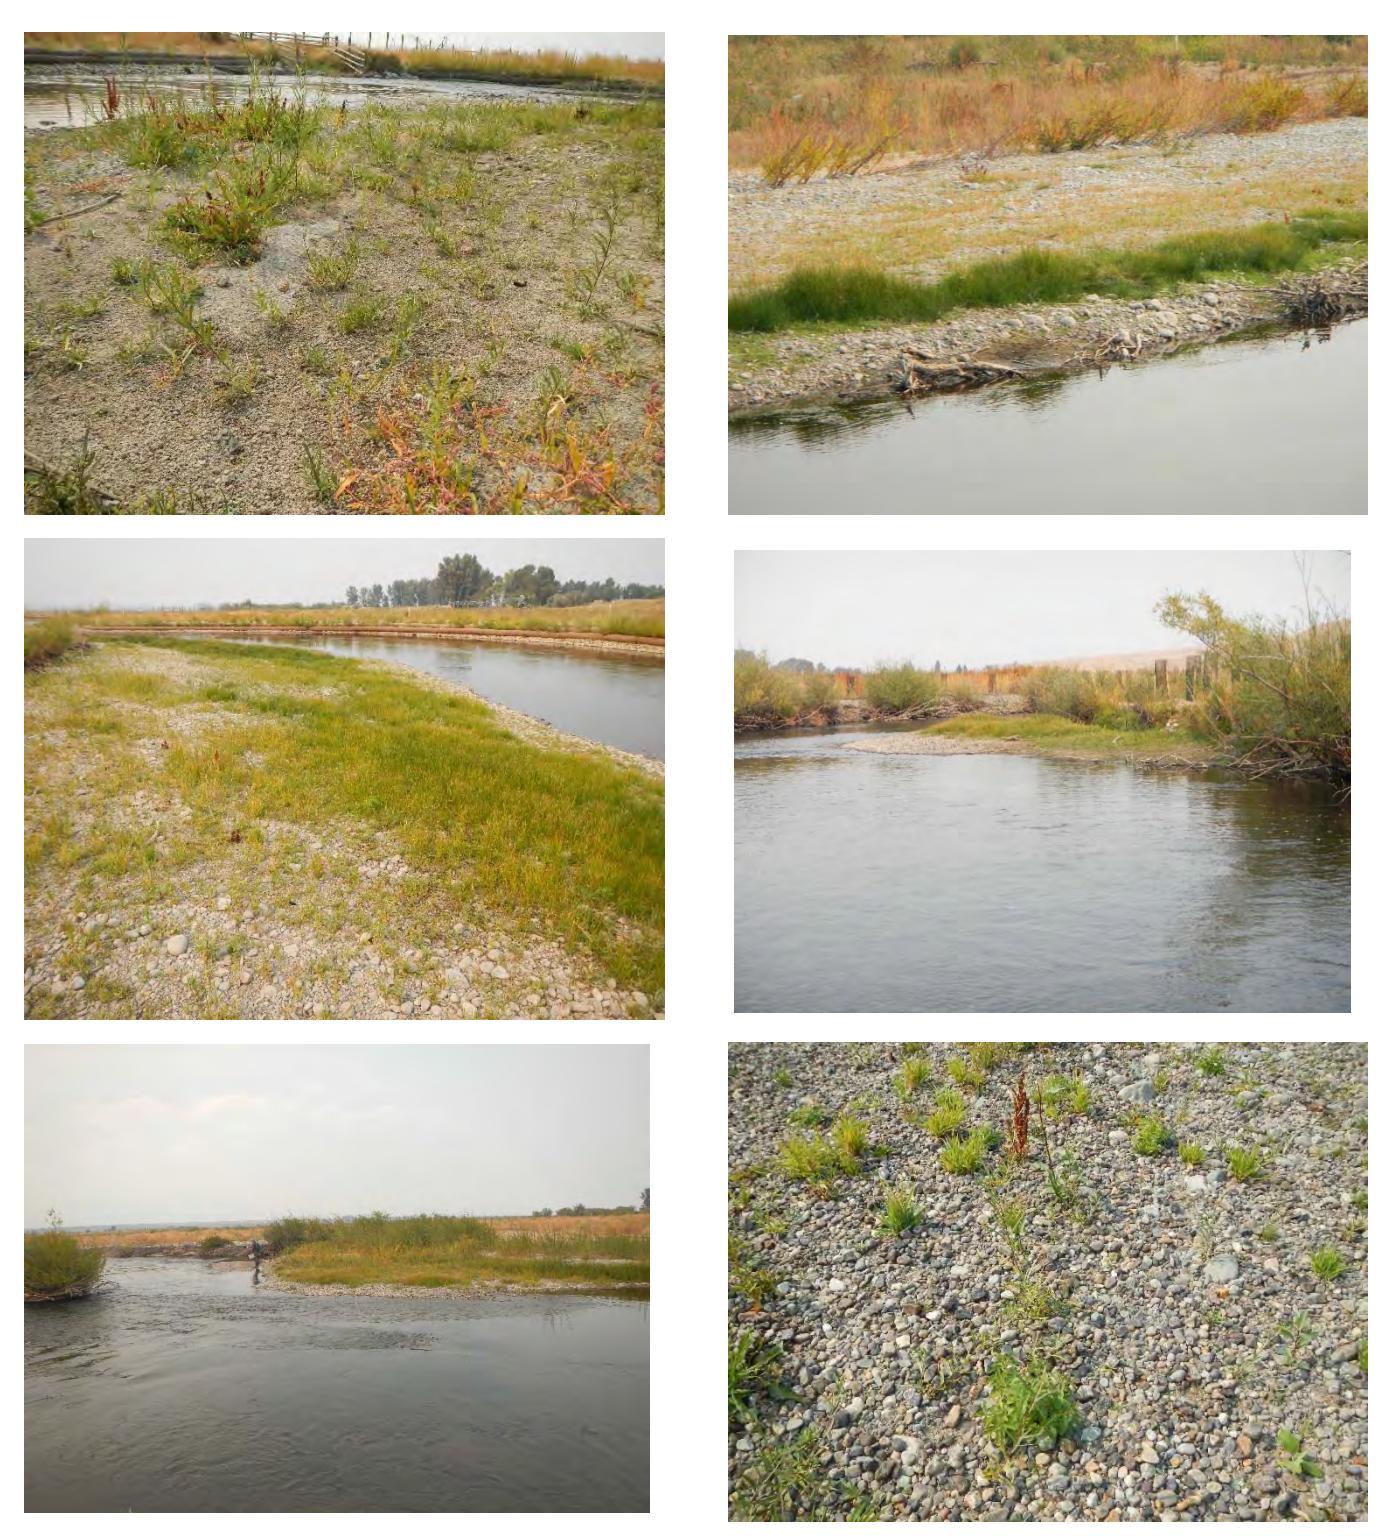
Photos 7-12. Examples of vegetation establishment on point bars.

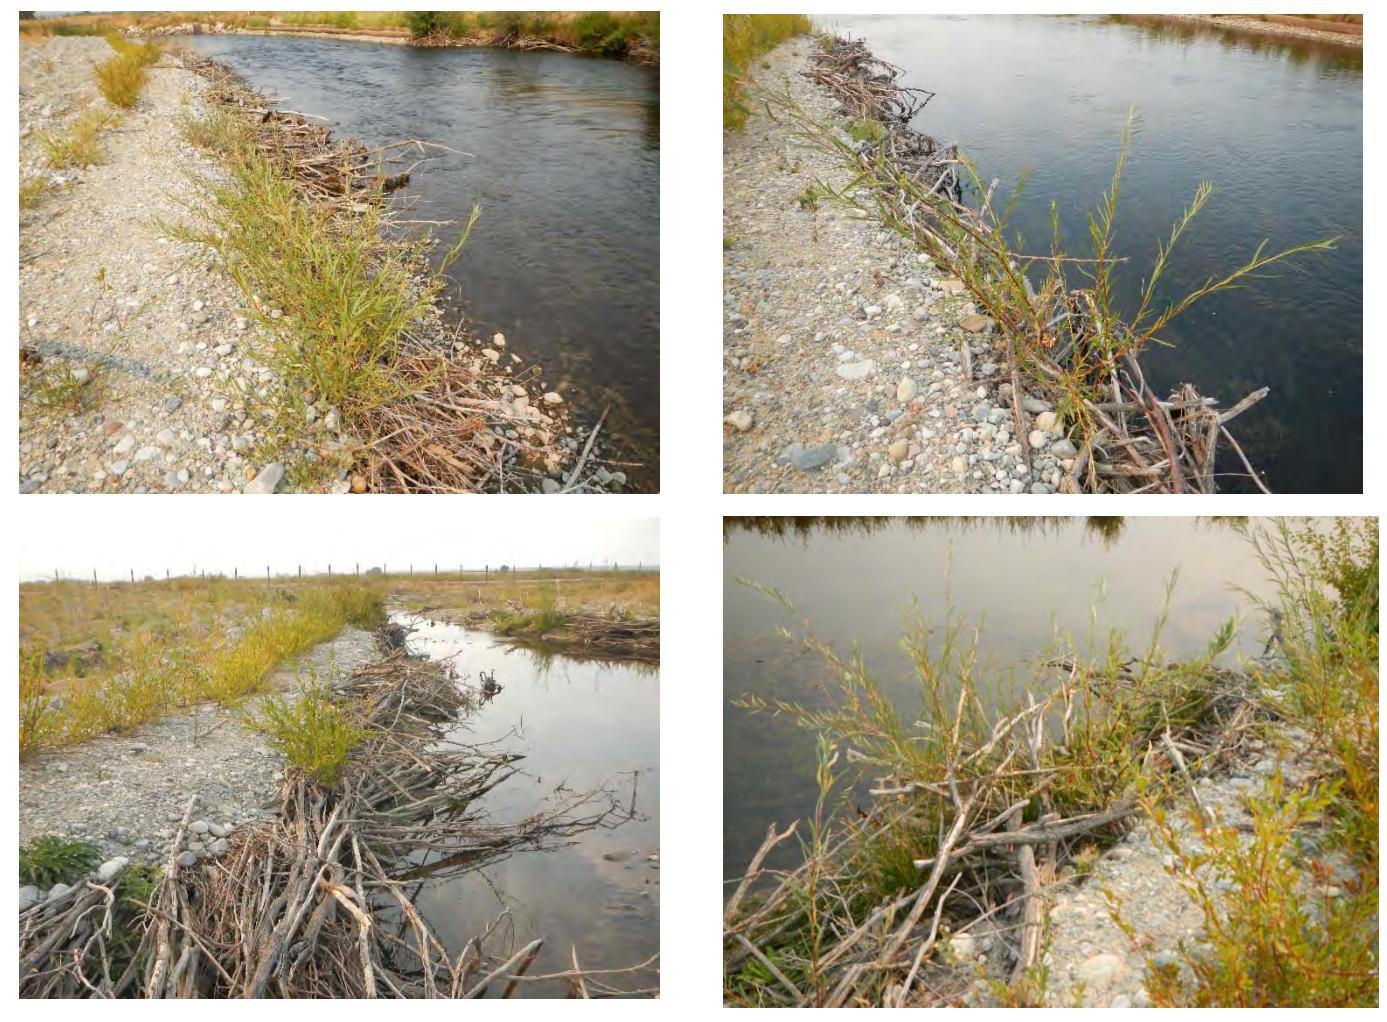
Photos 13-16. Examples of willow sprouting in brush matrix treatments.

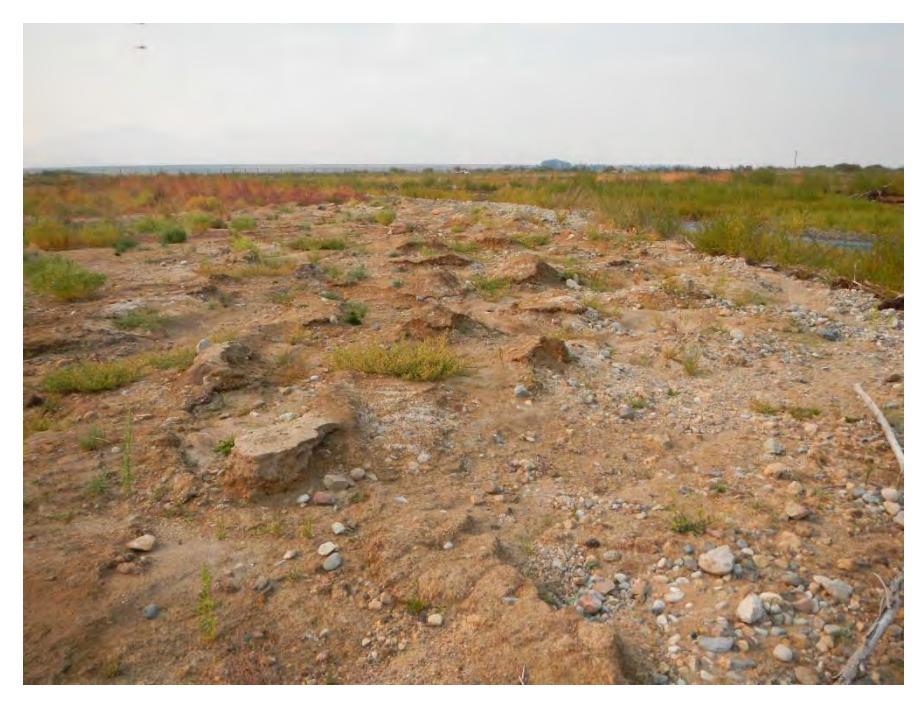
Photo 17. View downstream of floodplain erosion, 85+00L.

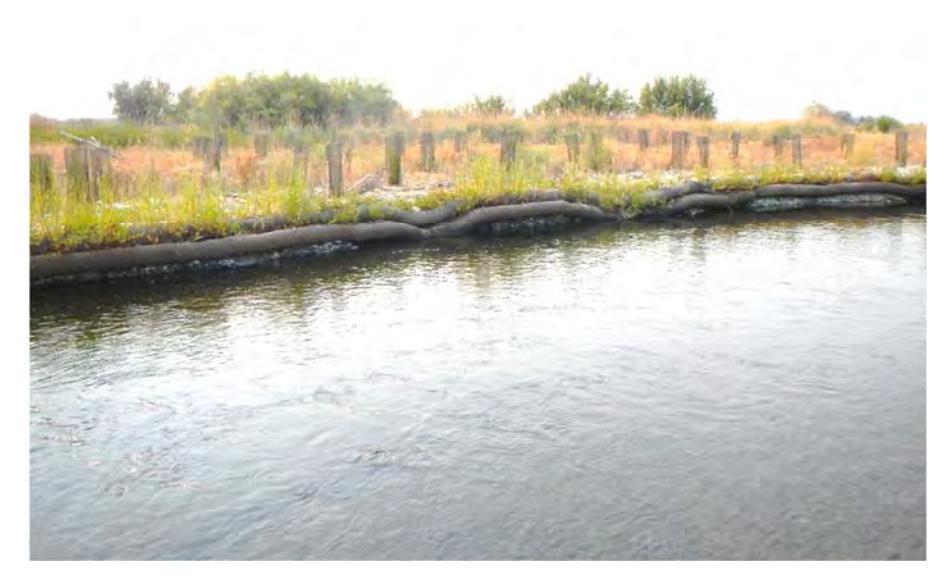
Photo 18. View downstream of bank LB-11 identified for continued monitoring.

Year	Streambank Treatment ID <sup>1</sup>	Issue	Recommended Management Action
2017	LB-11 DVSL	Slumping, toe gone, cracks in bankline	Monitor

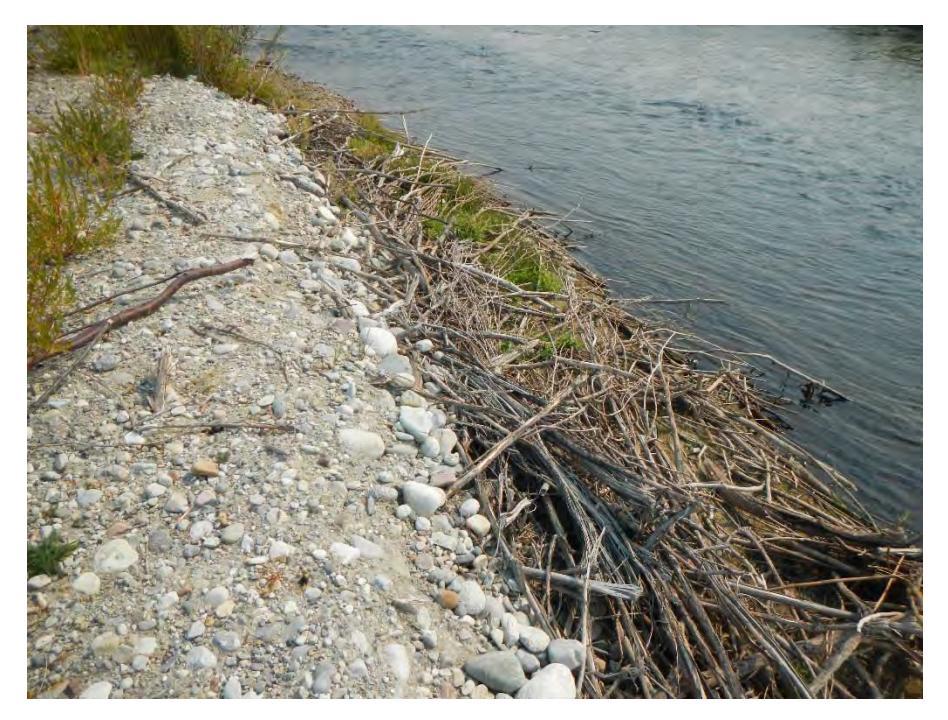
Photo 19. Fine grained deposition at toe of brush matrix.

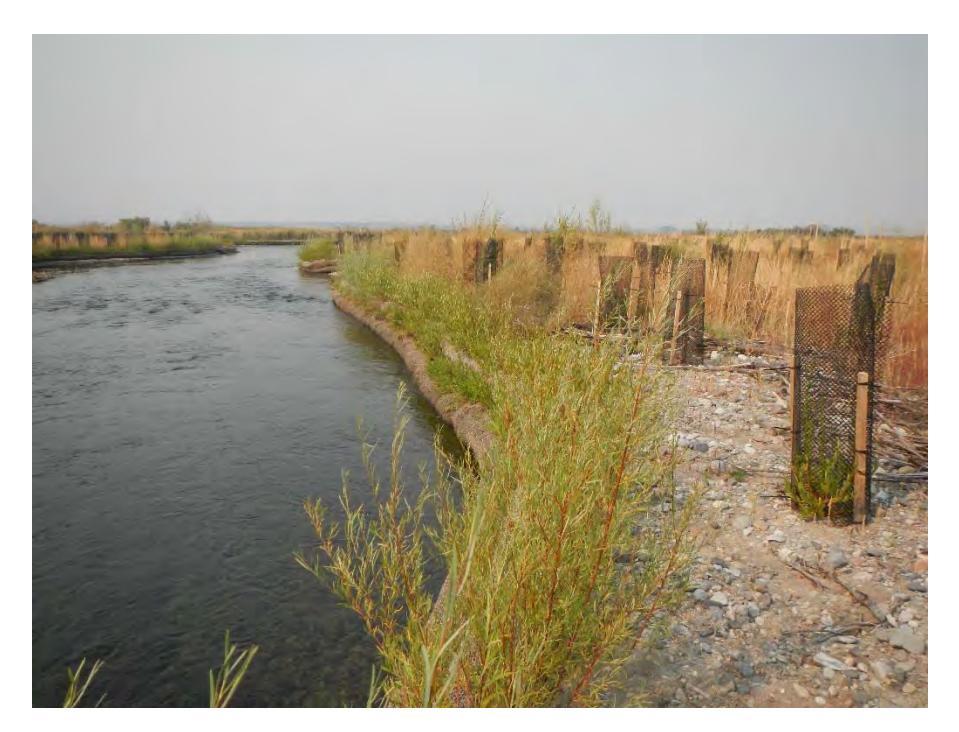
Photo 20. Vegetation expansion in DVSL, Phase 2.

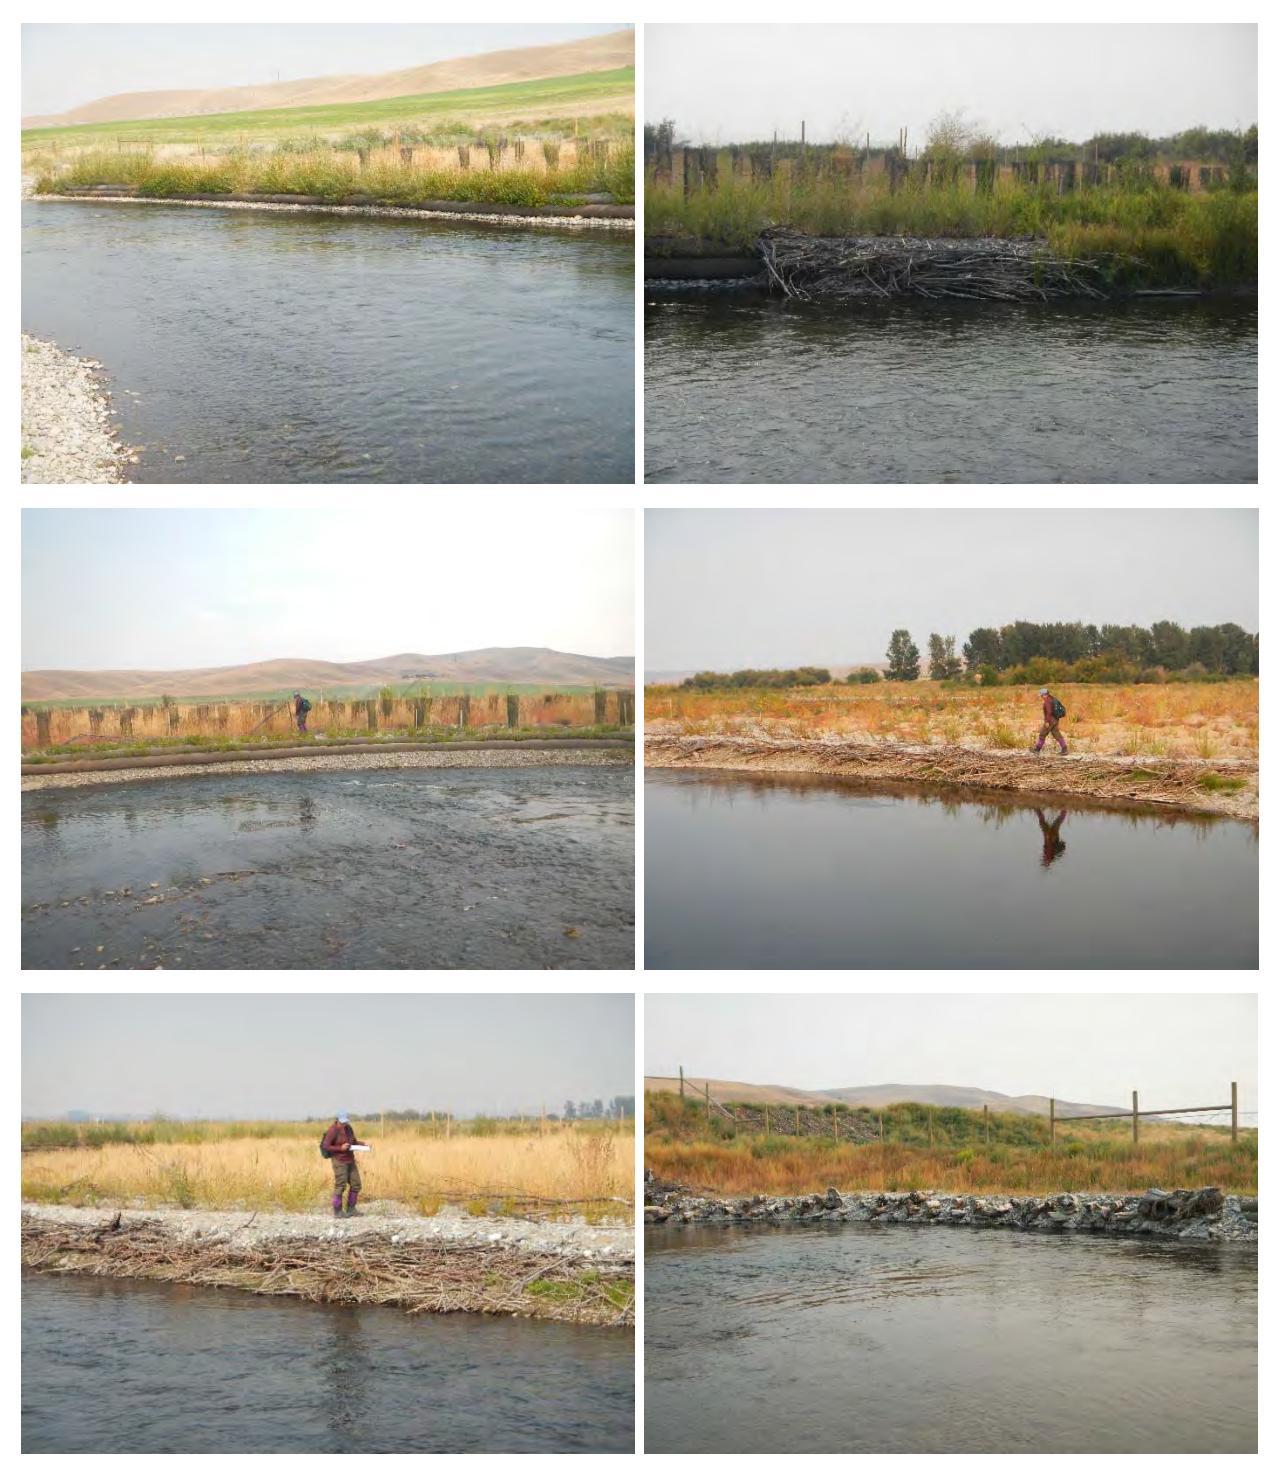
Top left: Category 1 (>40%) (RB-2); Top right: Category 1 (>40%) (LB-13A); Middle left: Category 2 (10 to 40%) (RB-18); Middle right: Category 2 (10 to 40%) (RB-43); Bottom left: Category 3 (<10%) (RB-12a); Bottom right: Category 3 (<10%) (LOGAN MATRIX)
