# Qualitative Rapid Assessment 2015-2017 Status Report

Milltown Reservoir / Clark Fork River NPL Site Clark Fork River Operable Unit, Reach A, Phase 1, Phase 2 and Phases 5 and 6

Qualitative Rapid Assessment, 2015-2017 Status Report Milltown Reservoir / Clark Fork River NPL Site Clark Fork River Operable Unit, Reach A

> > January, 2018

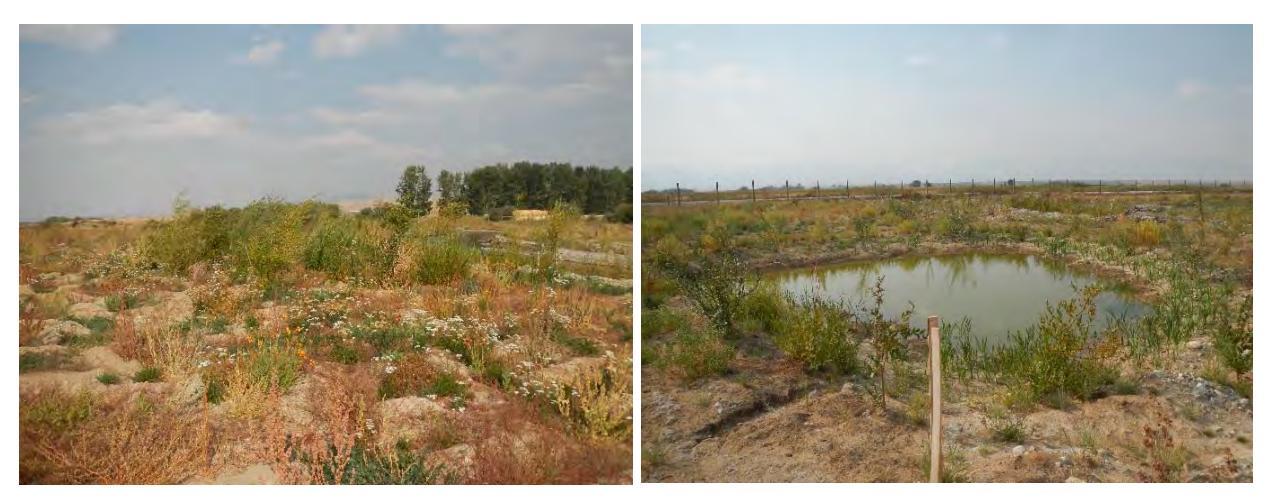
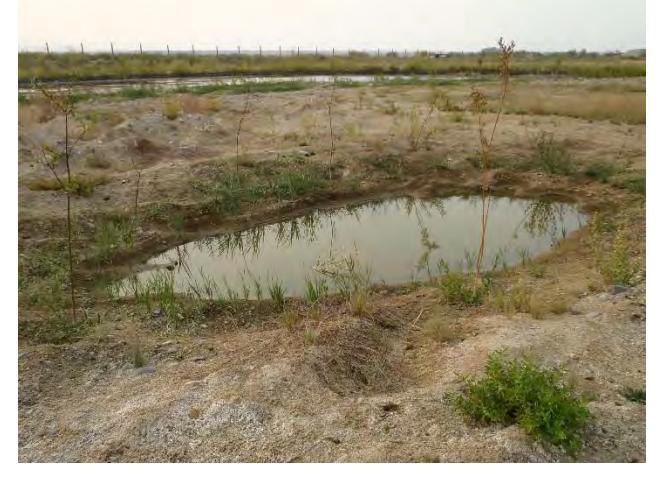
Top left: Category 1 (>30%) (om30); Top right: Category 2 (10 to 30%) (s101); Bottom center: Category 3 (<10%) (s125).

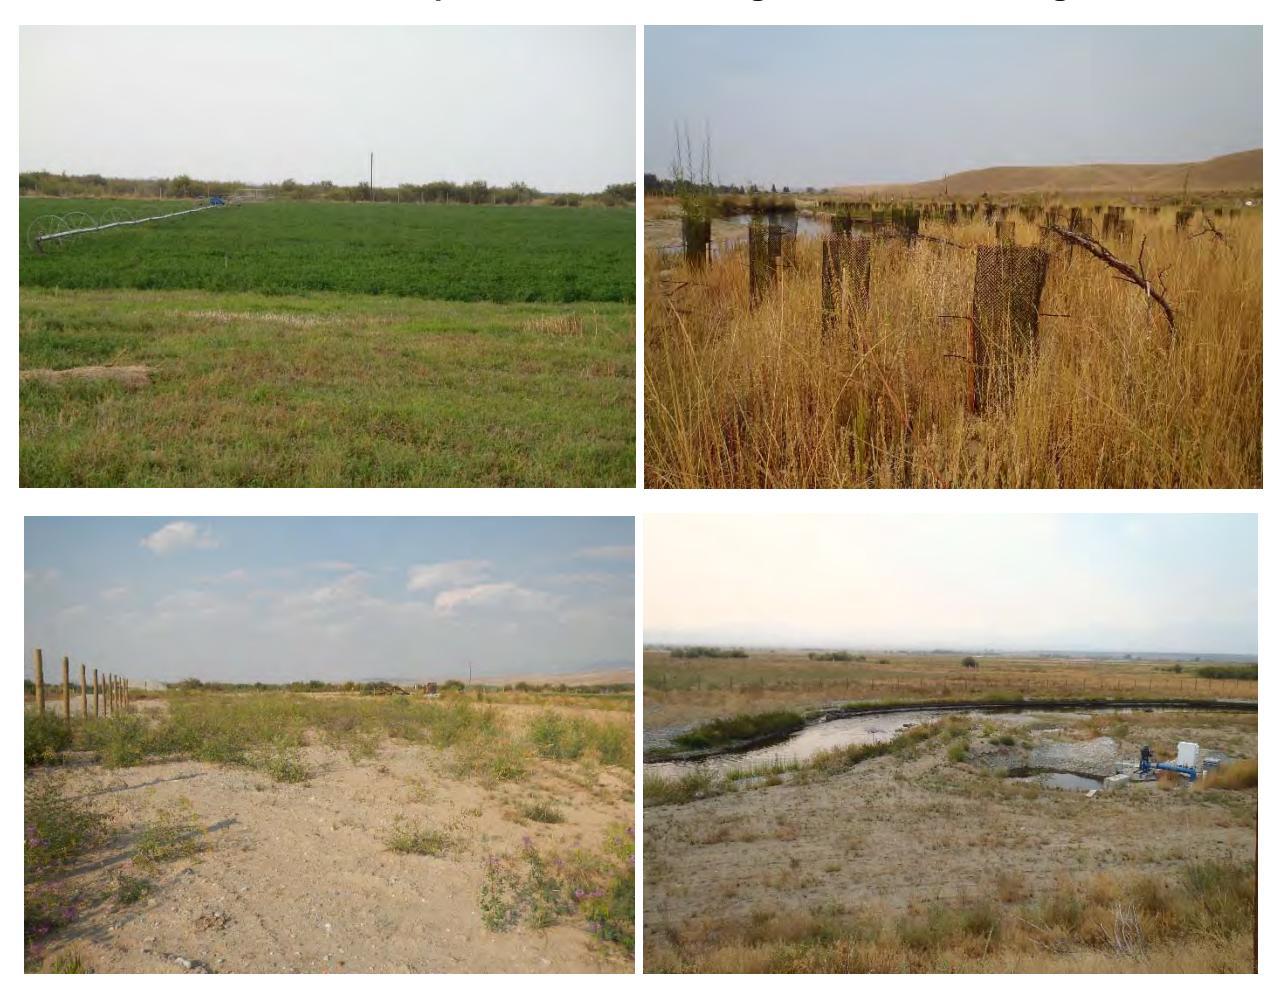
Top left: Category 1 (>80%) (irrigated hayfield on right bank, owner seeded); Top right: Category 2 (50-80%) (within om08 on right bank); Lower Left: Category 3 (20-50%) (downstream end of left bank along fence); Lower right: Category 4 (<20%) (pump area on right bank near om14).

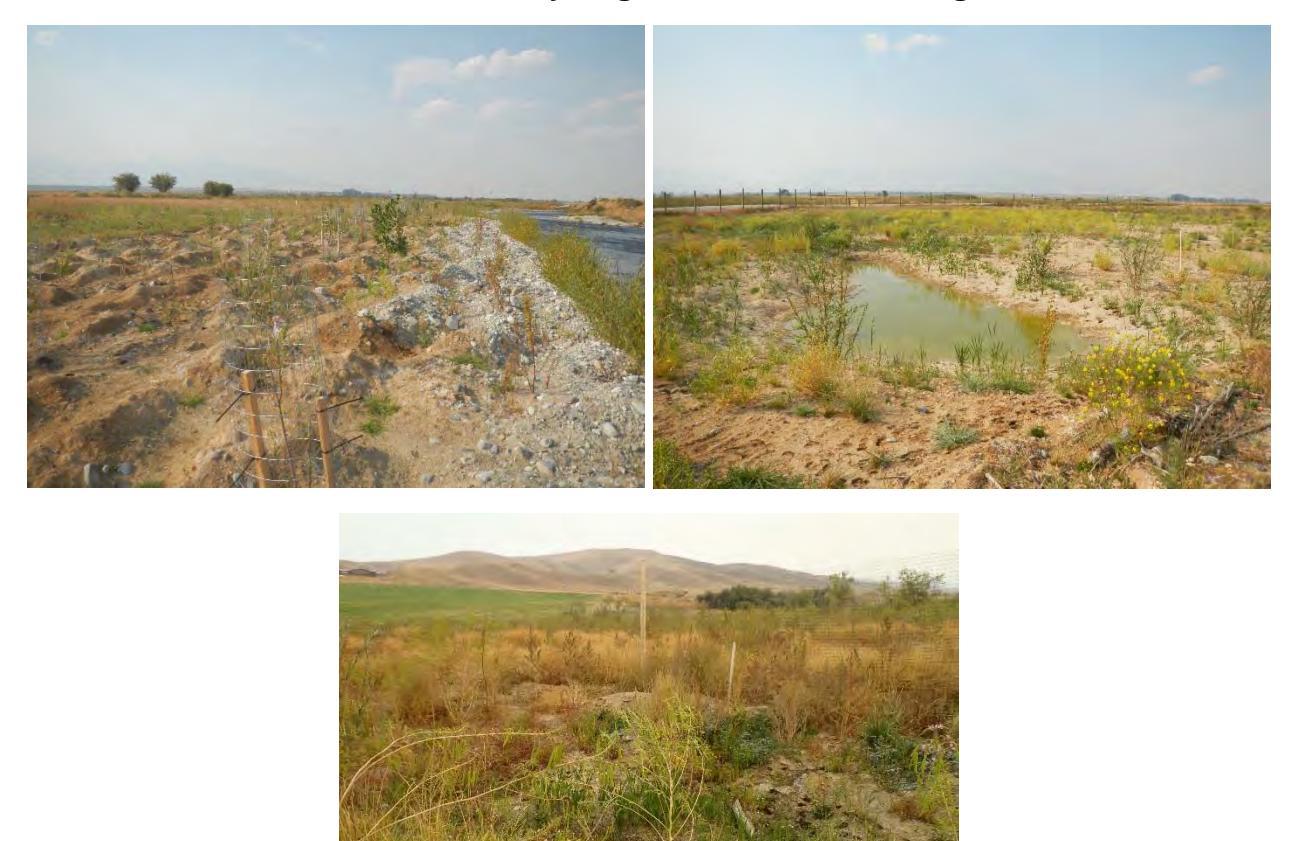
Top left: Category 1 (>80%) (om32); Top right: Category 2 (50 to 80%) (s97); Bottom center: Category 3 (<50%) (s16).

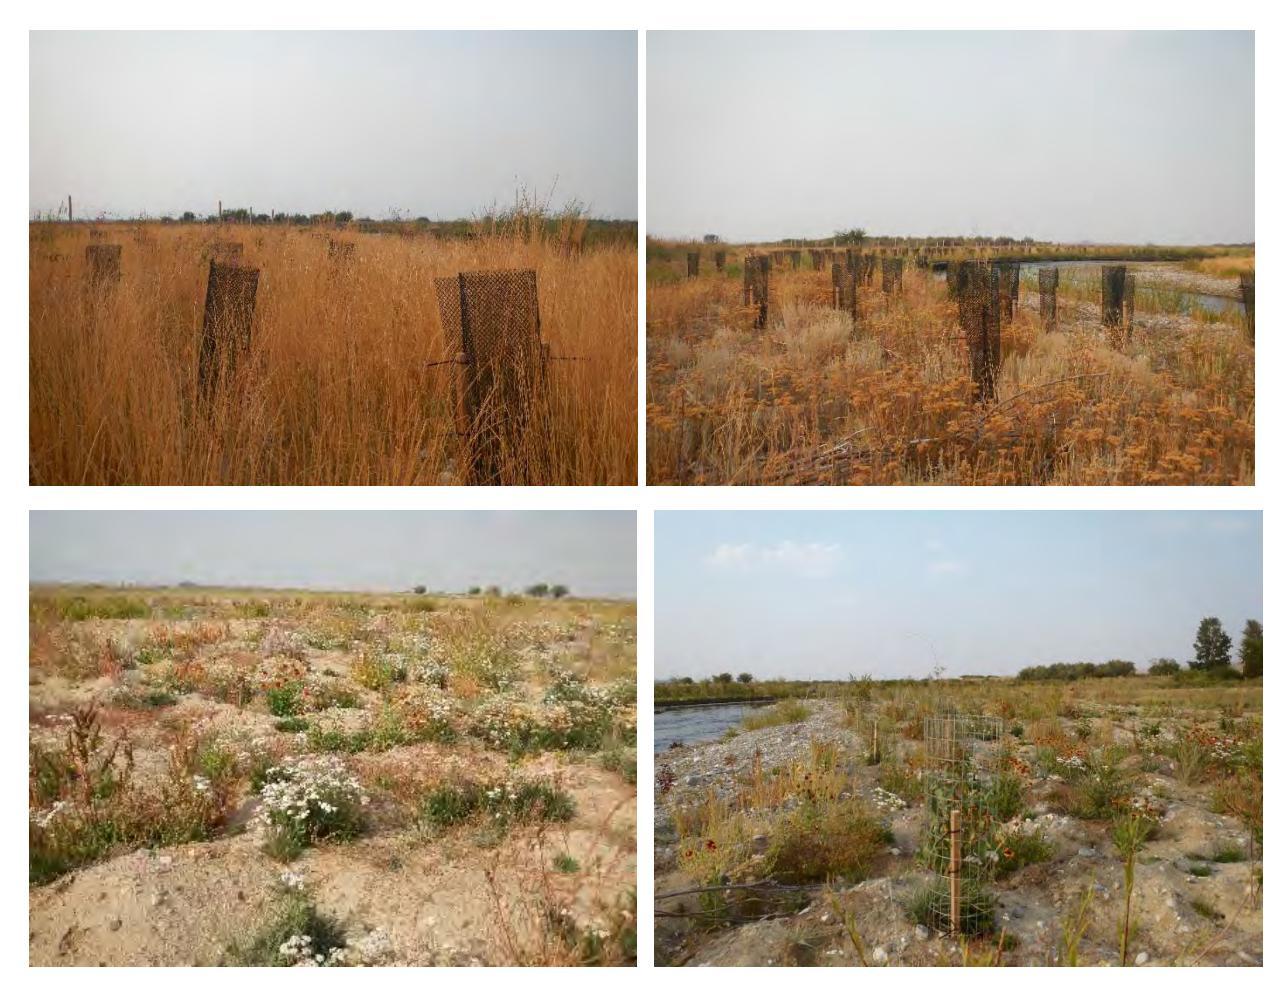
Photos 5-8. Herbaceous cover in Phase 2. Photo 5: high cover of seeded slender wheatgrass on west floodplain near mc01; Photo 6: high cover of yarrow in floodplain between om03 and om05; Photo 7: high cover of seeded forbs on island; Photo 8: high cover of seeded forbs in om29.

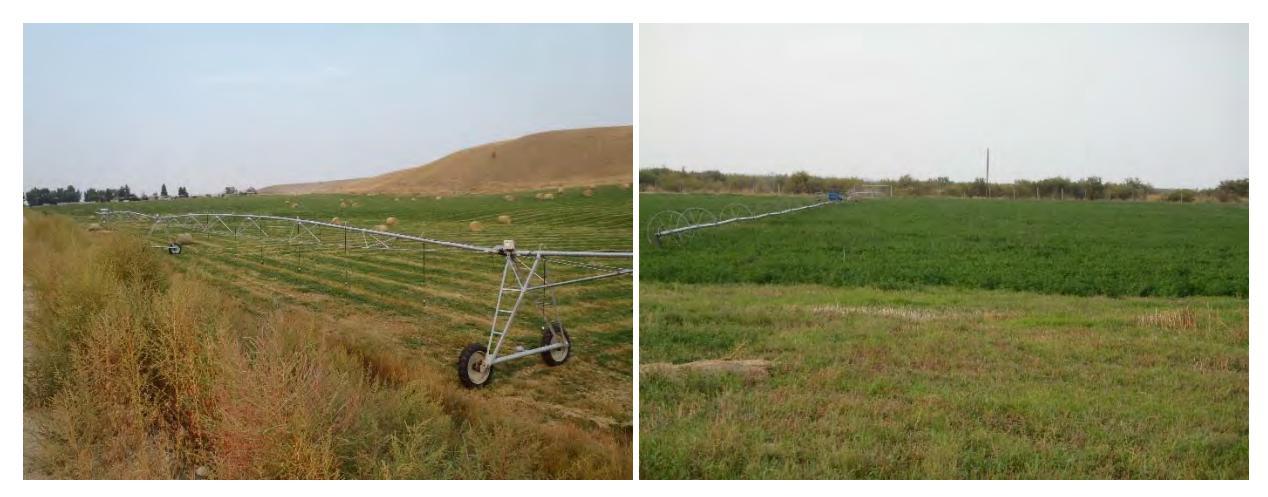
Photos 9-10. Irrigated hayfields within construction limits.

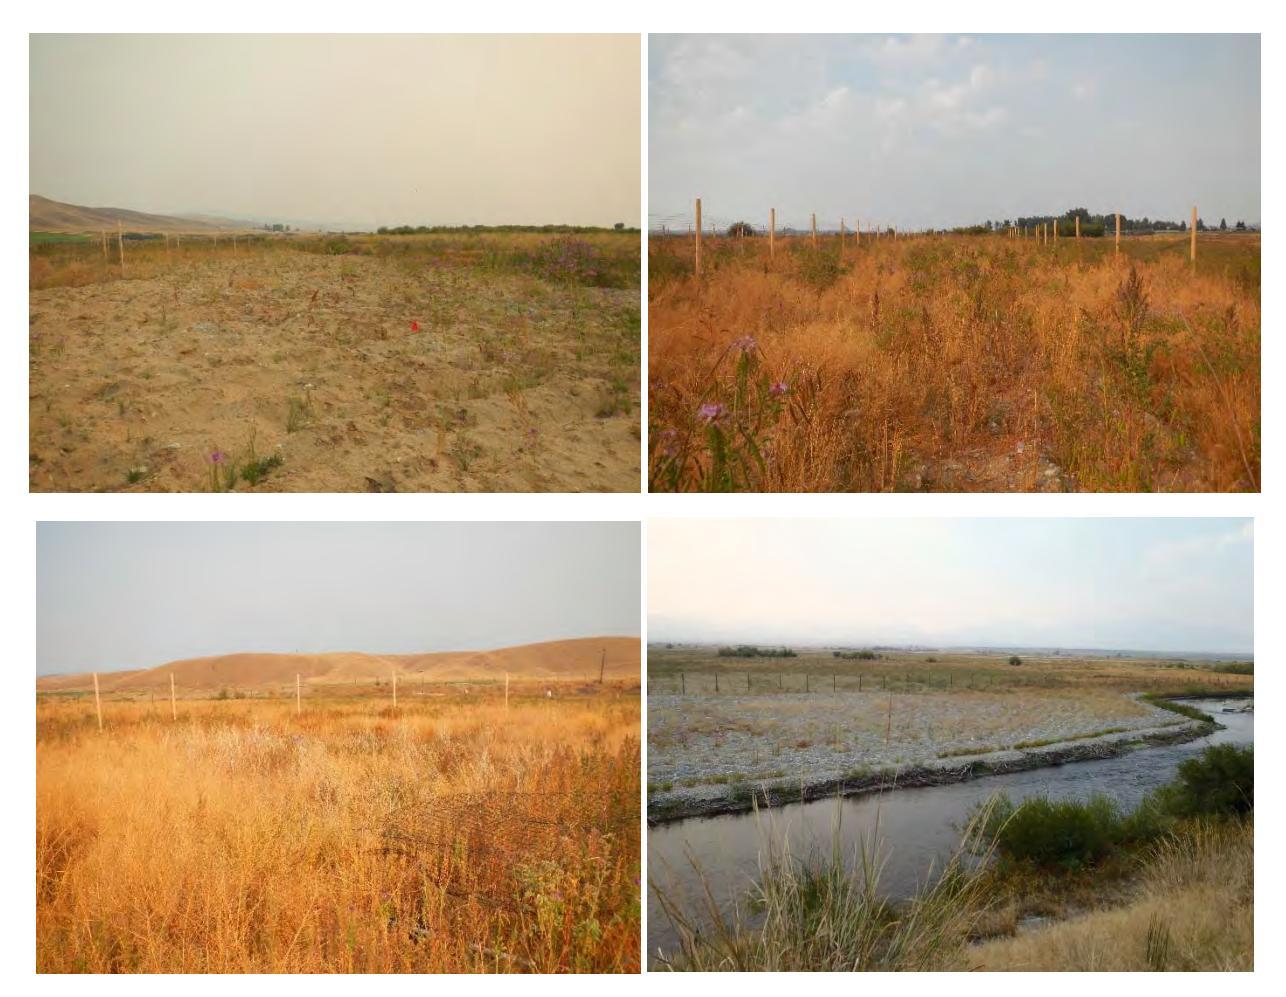
Photos 11-14. West floodplain between om07 and om11 where woody vegetation survival is very low and either herbaceous vegetation cover is very low or cover is dominated by invasive species. Photo 11: low herbaceous cover near om07; Photo 12: sb01 with no woody planted woody vegetation alive and high cover of invasive species; Photo 13: s71 with no woody planted woody vegetation alive and high cover of invasive species; Photo 14: area along the channel where no soil was used with very low cover.

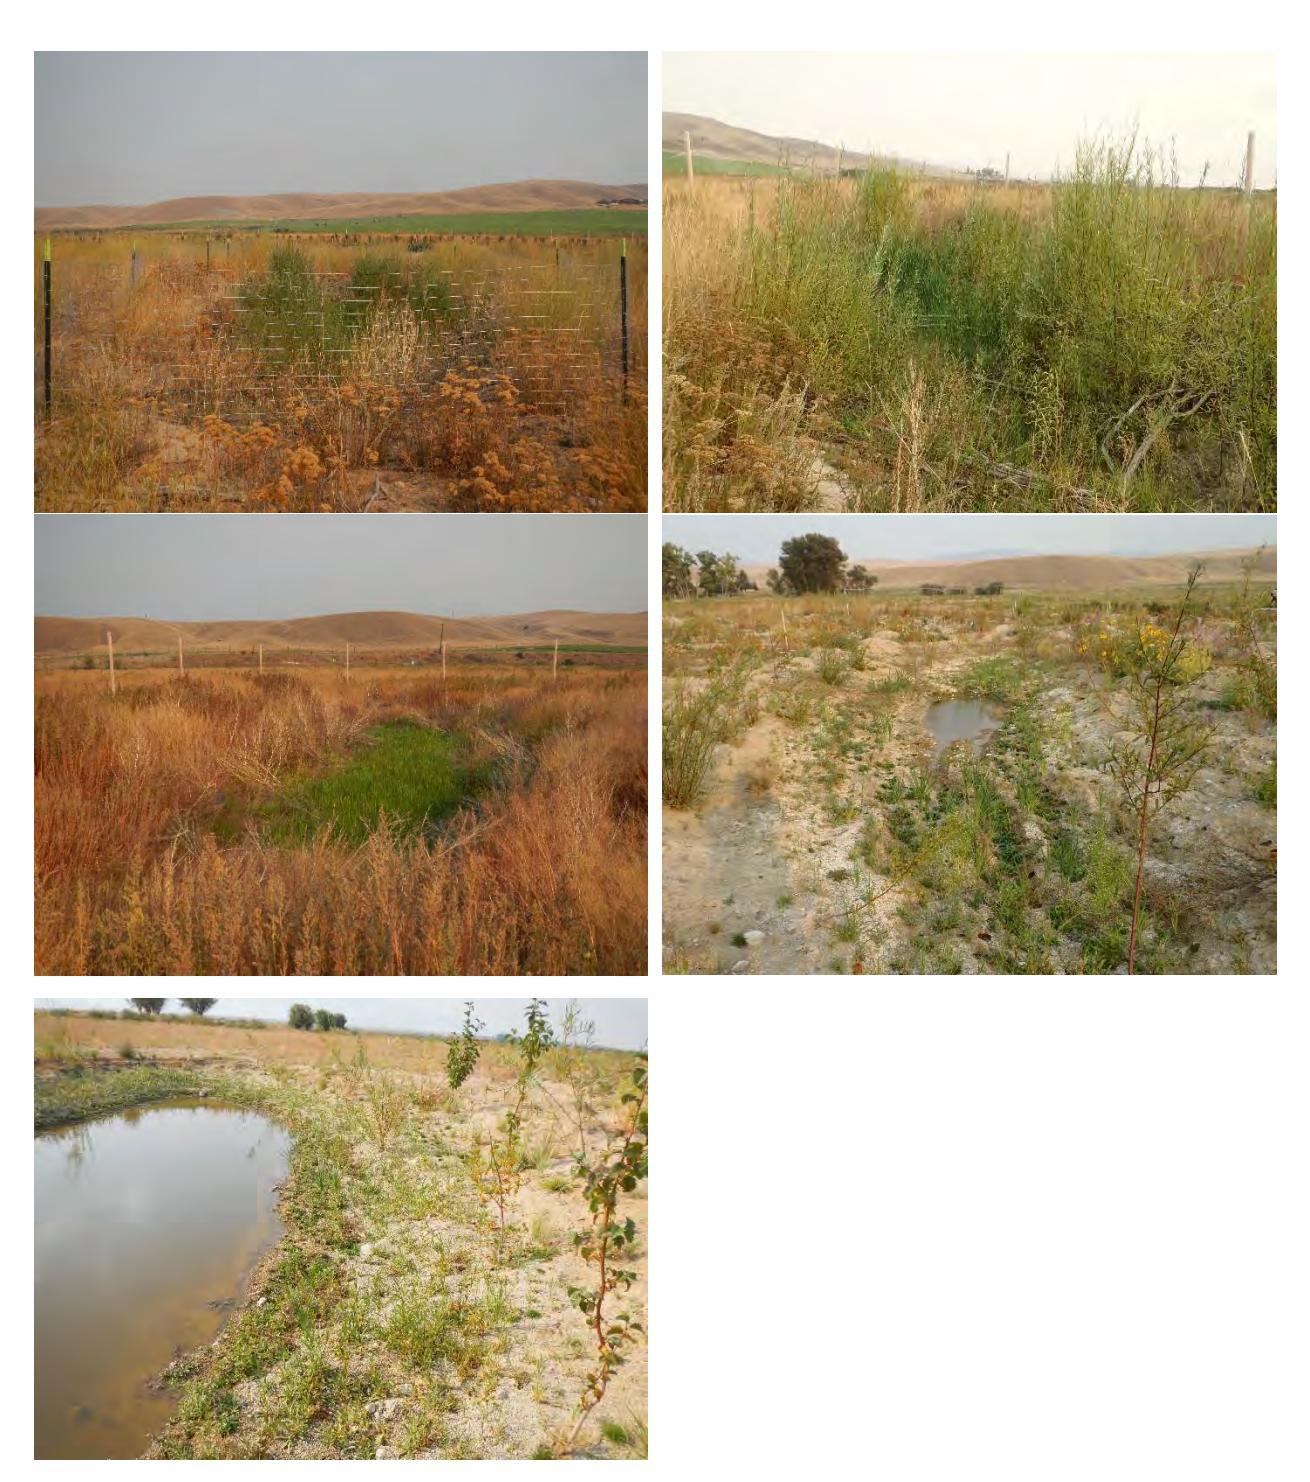
Photos 15-19. Swales in Phase 2. Photo 15: s23 with high survival and cover of woody vegetation; Photo 16: s46 with high survival and cover of woody vegetation; Photo 17: s75 with low woody vegetation survival and colonization of cattails in the bottom of the swale; Photo 18: s96 with moderate woody vegetation survival and cover and wet conditions in the bottom; Photo 19: s116 with standing water in bottom and ring of sandbar willow seedlings in a 1-foot band around the swale bottom above the open water.

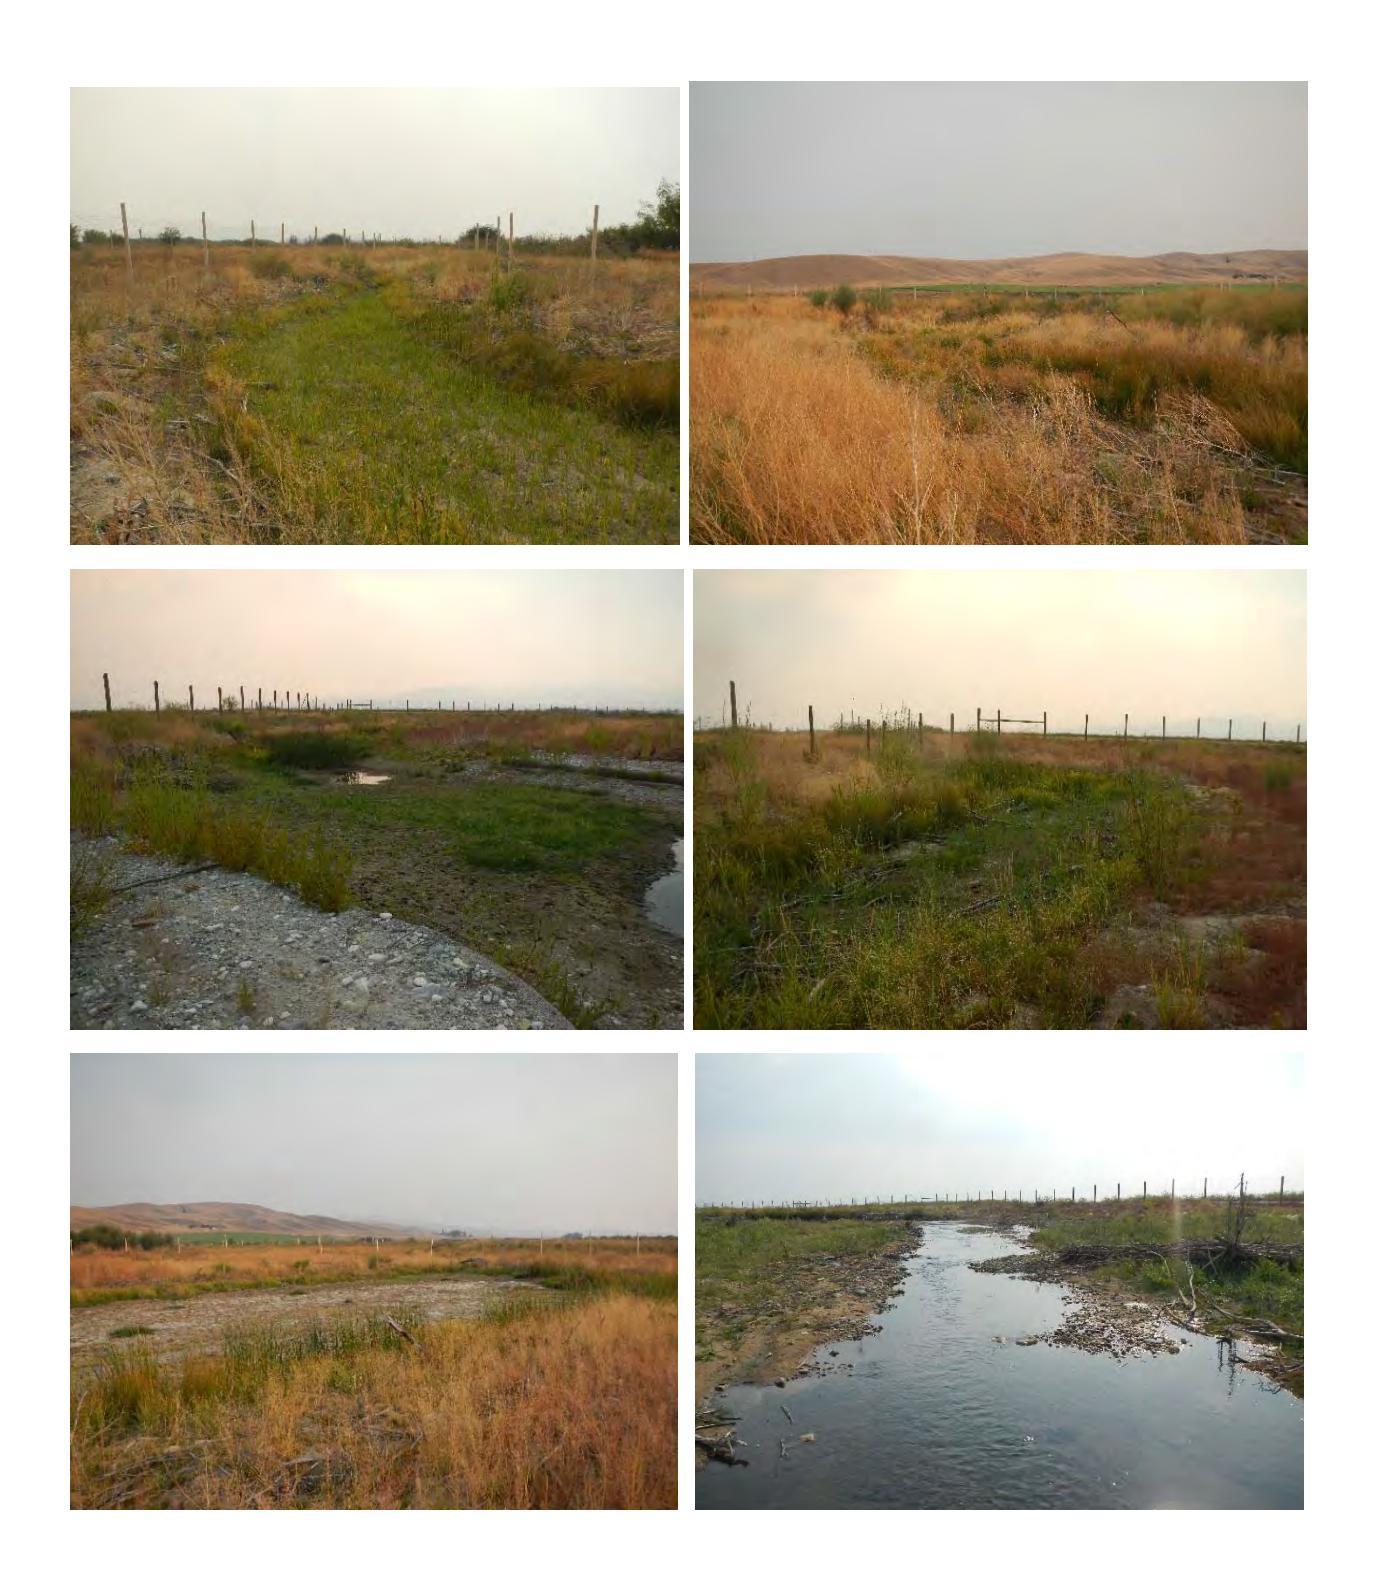
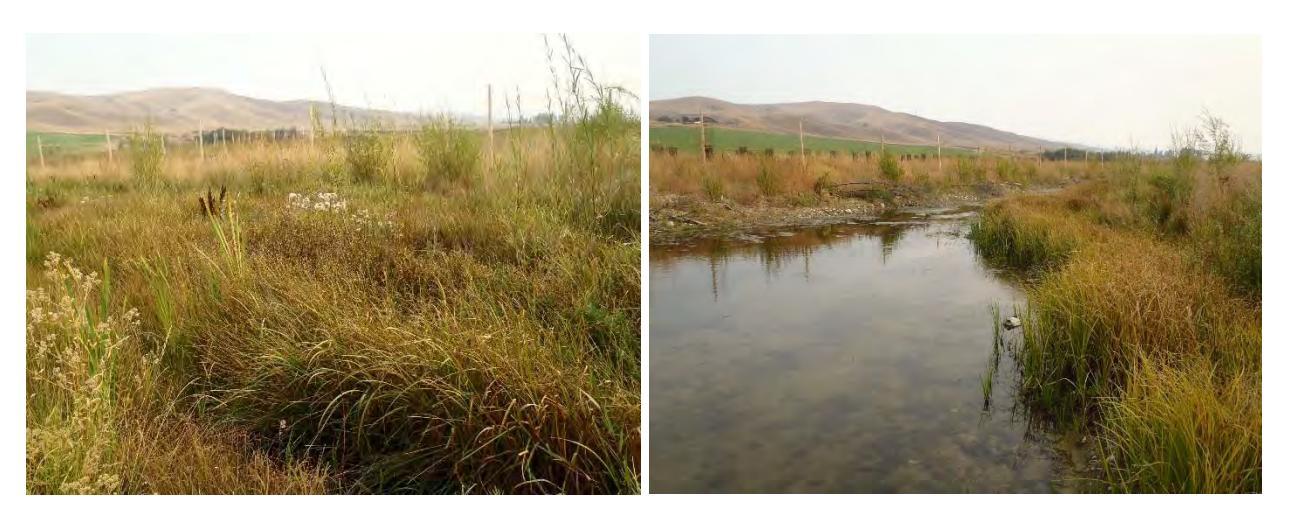
constructed wetlands over the next few years. Which species increase in cover and how far their zone expands will depend on site hydrology in the coming years. The oxbow wetland supported highly diverse conditions including emergent vegetation, shrub vegetation, open water, and gravels and cobbles where willows were naturally colonizing. The secondary channel wetland had high survival of herbaceous wetland plants and small woody plants, along with naturally recruited willows. Vegetation in this wetland is expected to expand rapidly and create diverse aquatic habitat for the Clark Fork River. Photos 20-27 in Attachment I (*Phase 2 2017 Vegetation Miscellaneous Photographs*) document wetland conditions in wetlands in 2017.

Photos 20-27. Wetland conditions in Phase 2 in 2017. Photo 8: sw02; Photo 9: sw04 with high cover of weeds on wetland slopes but high cover of sedges and rushes on wetland bottom - this wetland is much drier than other wetlands; Photos 10 and 11: wetland sw07 that connects to the Clark Fork River channel; Photo 12: sw05 and ew04 showing a narrow fringe of wetland vegetation and an area that has standing water most of the growing season; Photo 13: the secondary channel and ew11 located on the secondary channel; Photos 14 and 15: oxbow wetland.

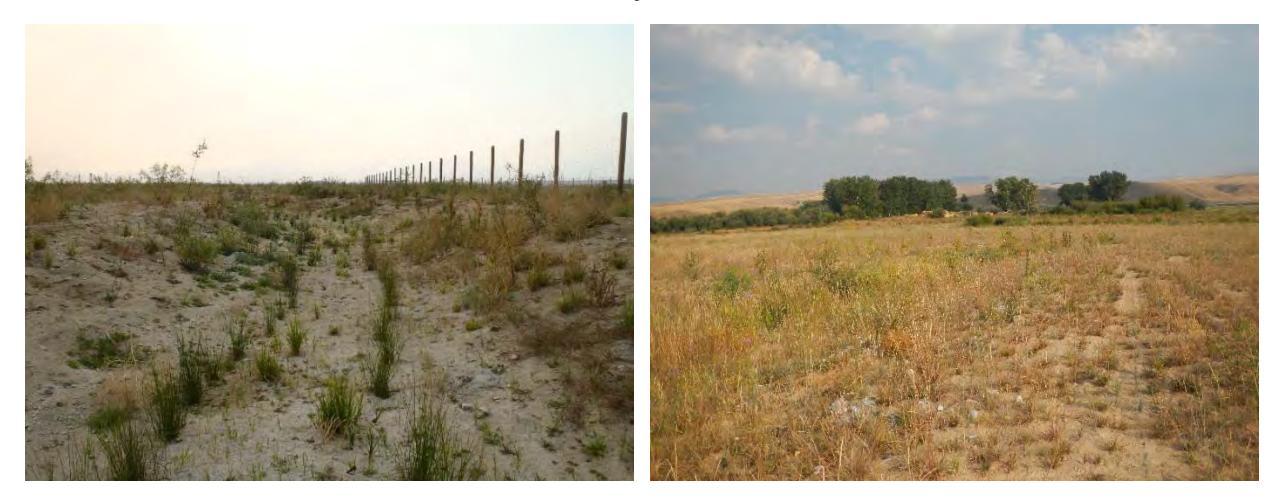
and the design dimensions of these features should be repeated in future designs. Unit wb01 receives irrigation return from the hayfield to the east of the railroad grade. This unit had slightly lower survival of planted woody vegetation compared to other windbreak units and it may be from prolonged inundation from irrigation return. The bottom of wb01 was planted with wetland herbaceous plugs in anticipation of the supplemented hydrology and these plants have high survival and growth. Photos 28-29 in Attachment I (*Phase 2 2017 Vegetation Miscellaneous Photographs*) show the condition of windbreak planting units in Phase 2 in 2017.

Photos 28-29. Photo 16: Windbreak 01 (wb01) with herbaceous wetland plants installed in the bottom; Photo 17: Windbreak 04 (wb04) with high survival of planted trees and shrubs.

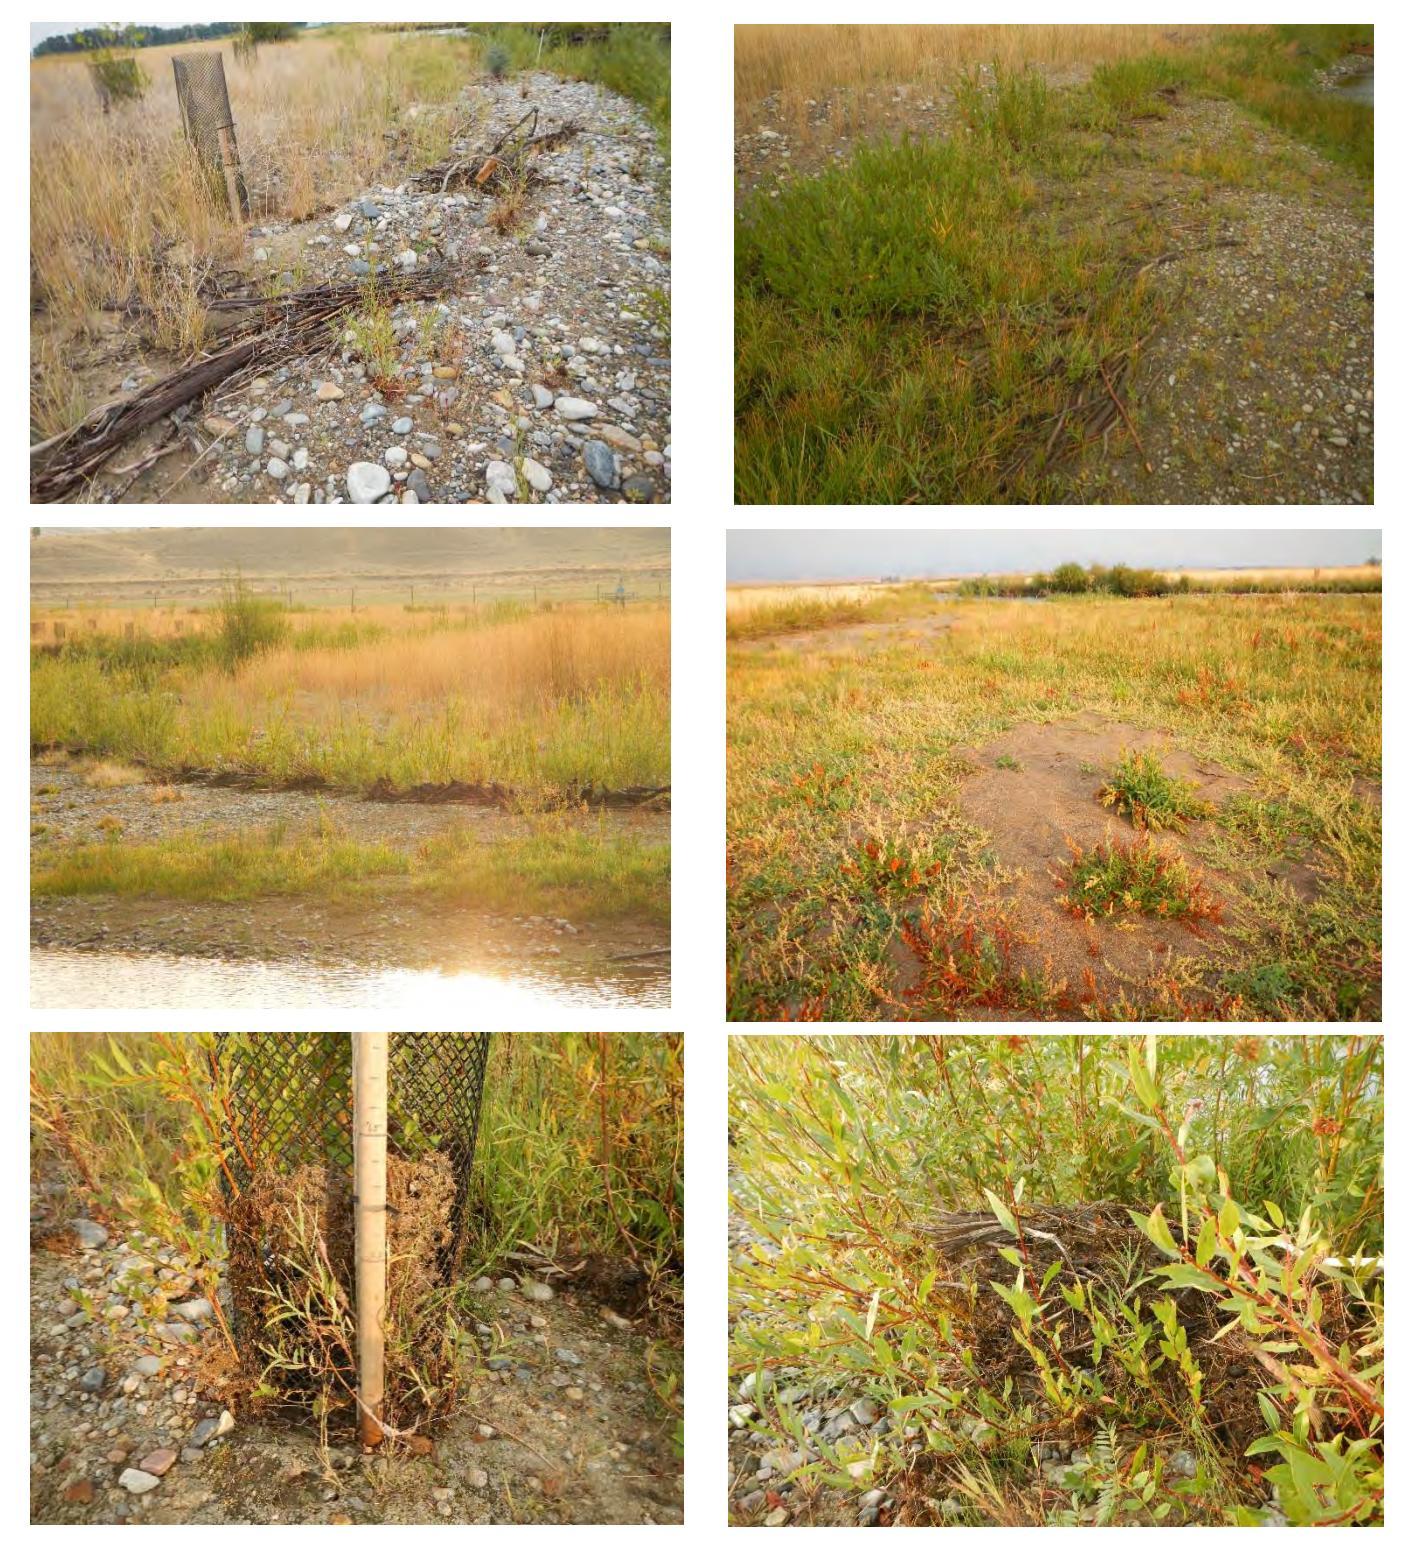
Photos 1-3. High water indicators from 2017 that indicate approximately bankfull conditions in Phase 5-6 (only localized floodplain overflow).

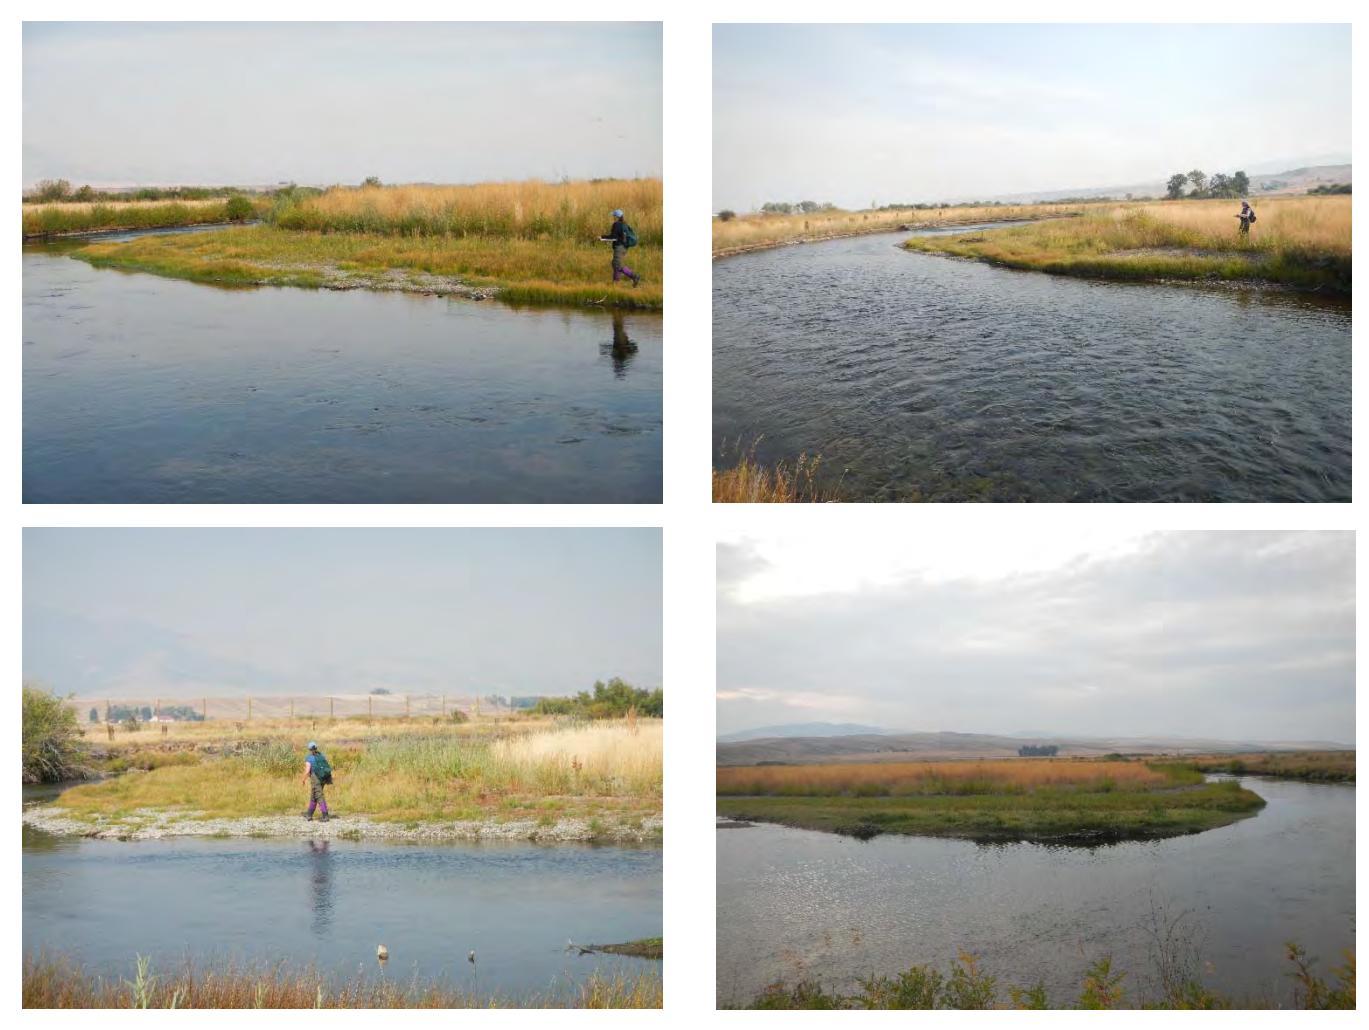
Photos 4-7. Examples of vegetation establishment on point bars, Phase 5-6, 2017.

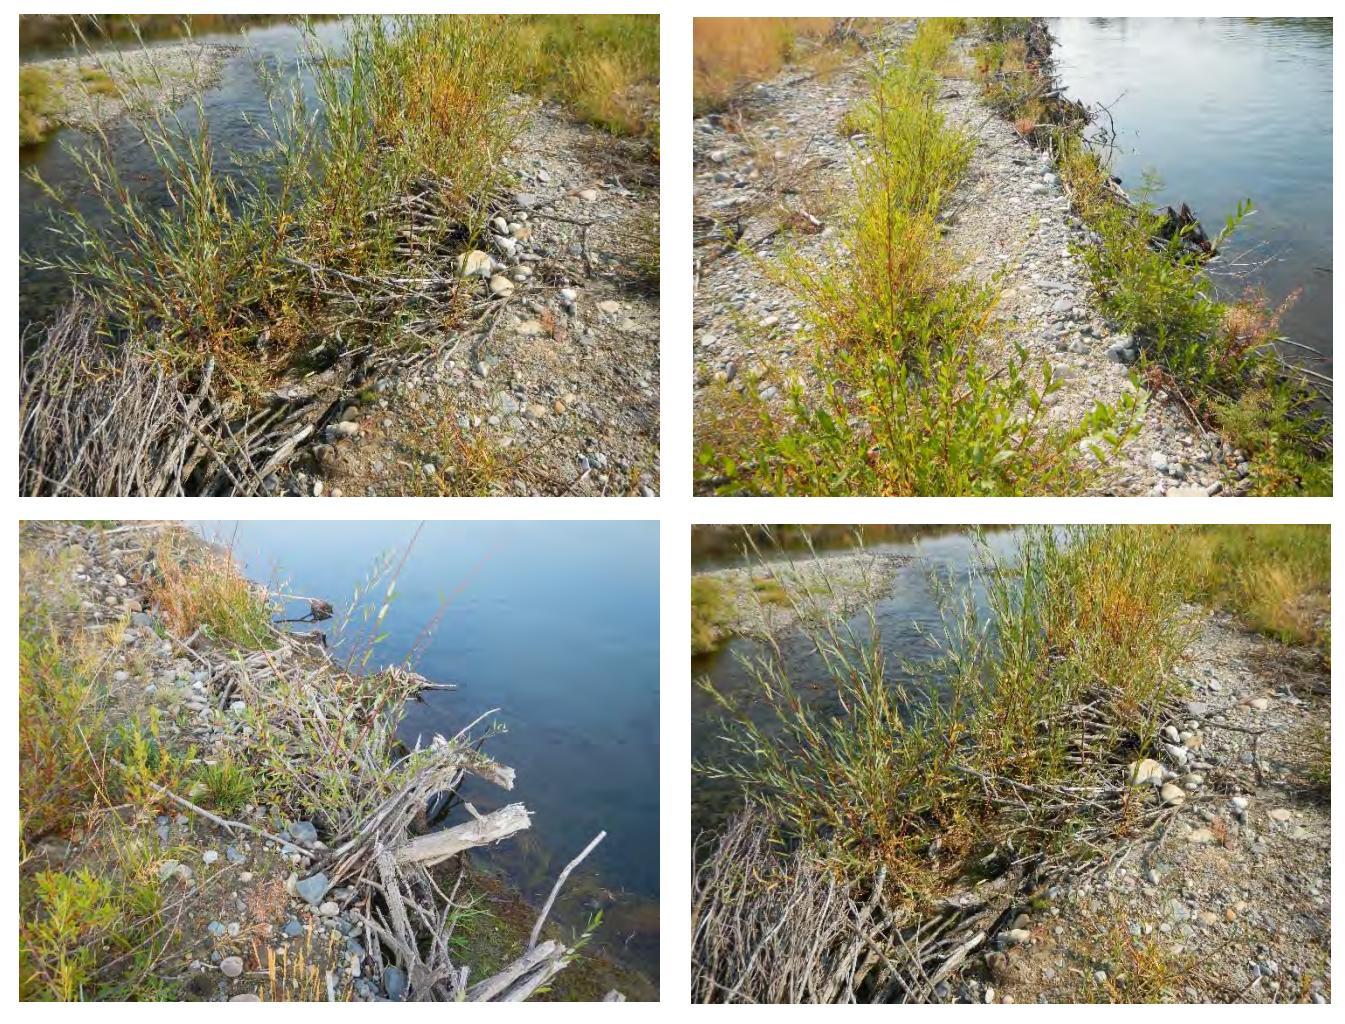
Photos 8-11. Examples of willow sprouting in brush matrix treatments, Phase 5-6, 2017.

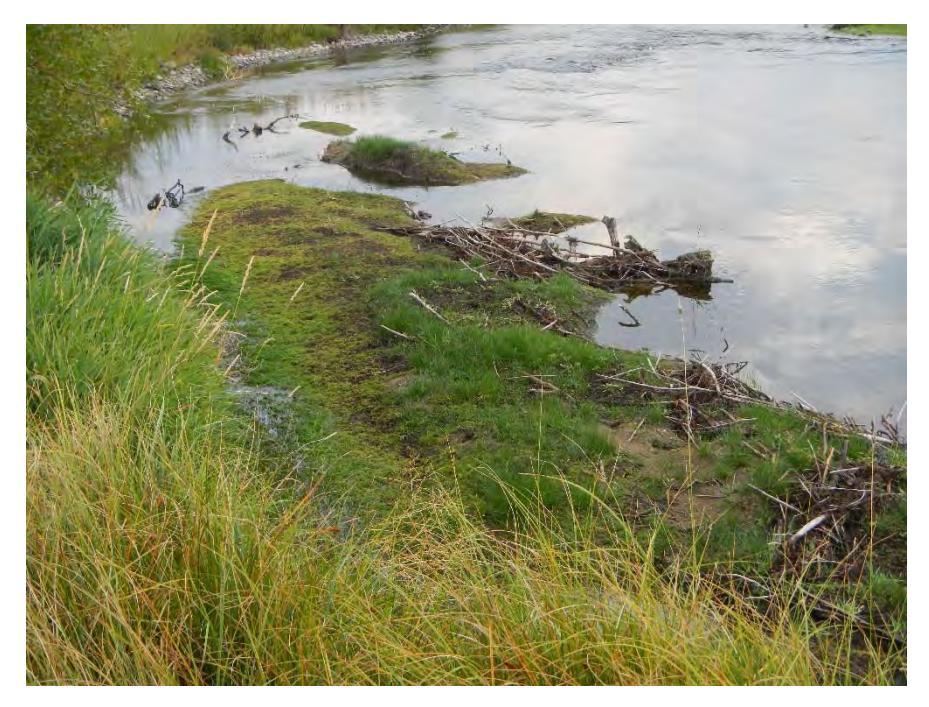
Photo 12. In-stream fine grained deposition, Phase 5.

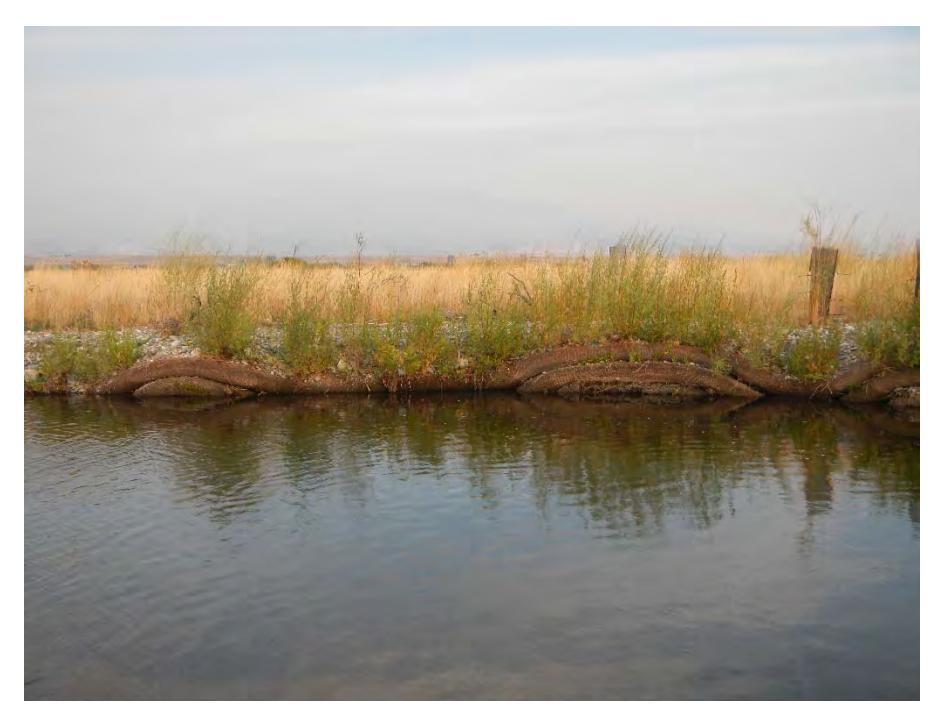
Photo 13. Bank RB-14 identified for continued monitoring.

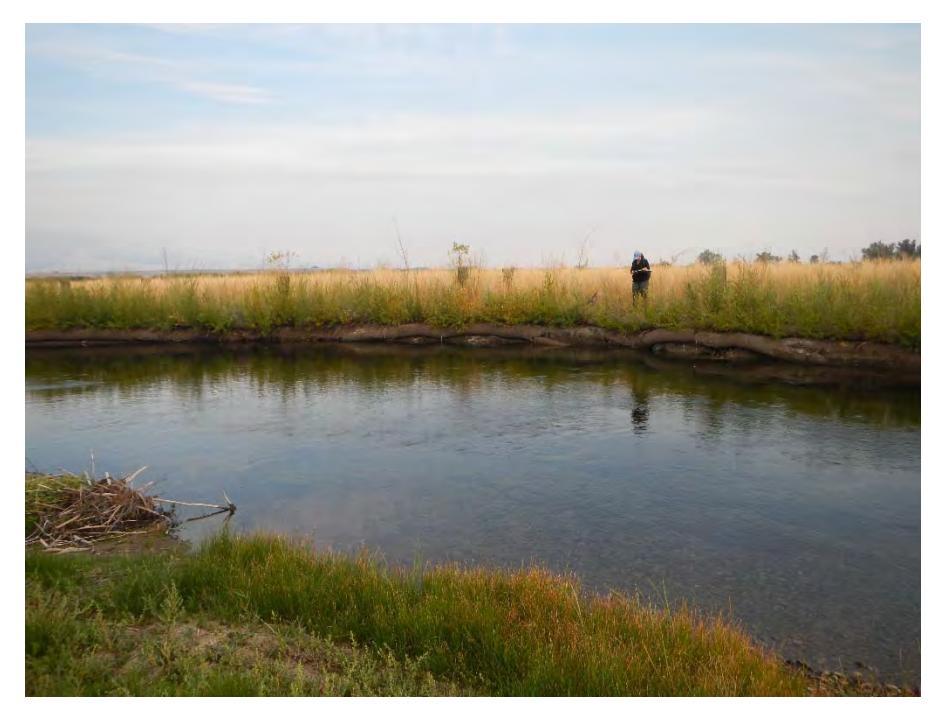
Photo 14. Bank RB-17 identified for continued monitoring.

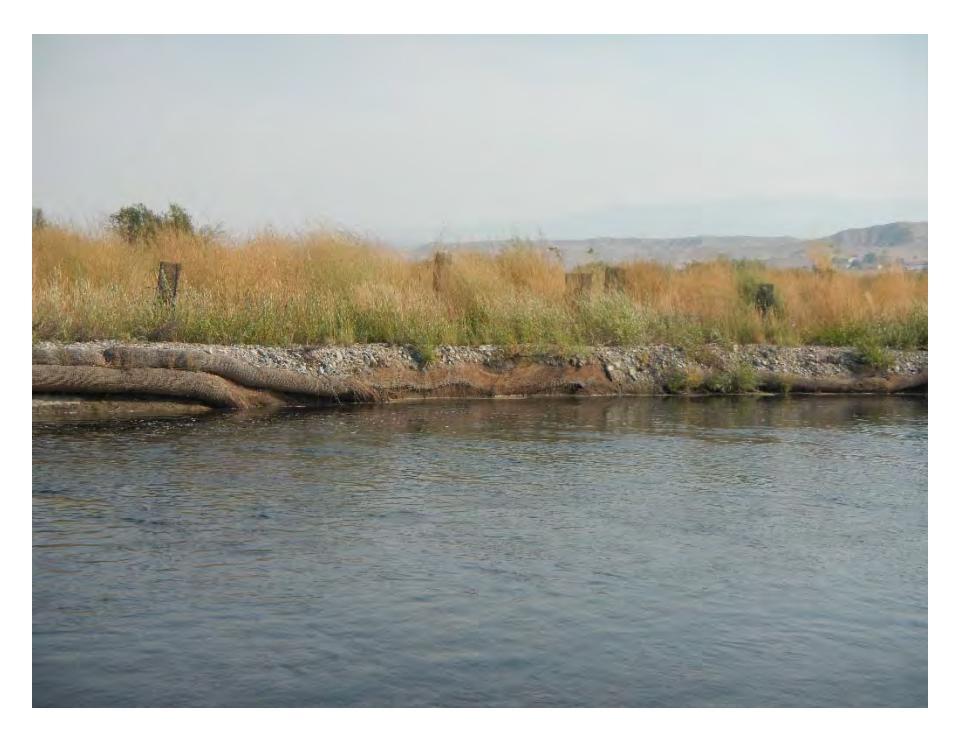
Photo 15. Bank LB-46E identified for continued monitoring.

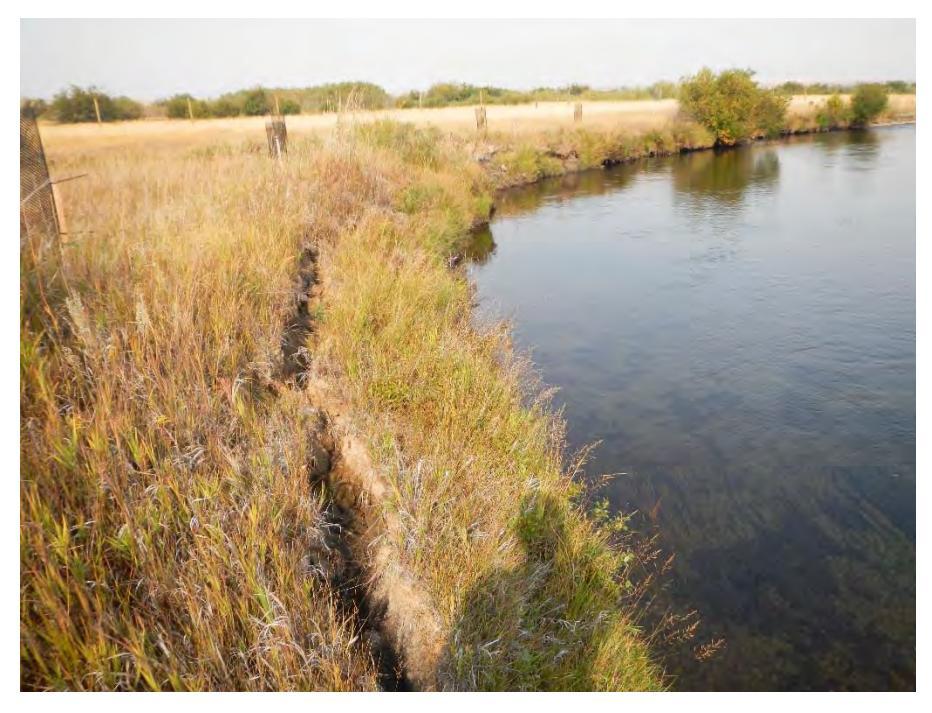
Photo 16. Actively eroding No Treatment bank (LB-40).

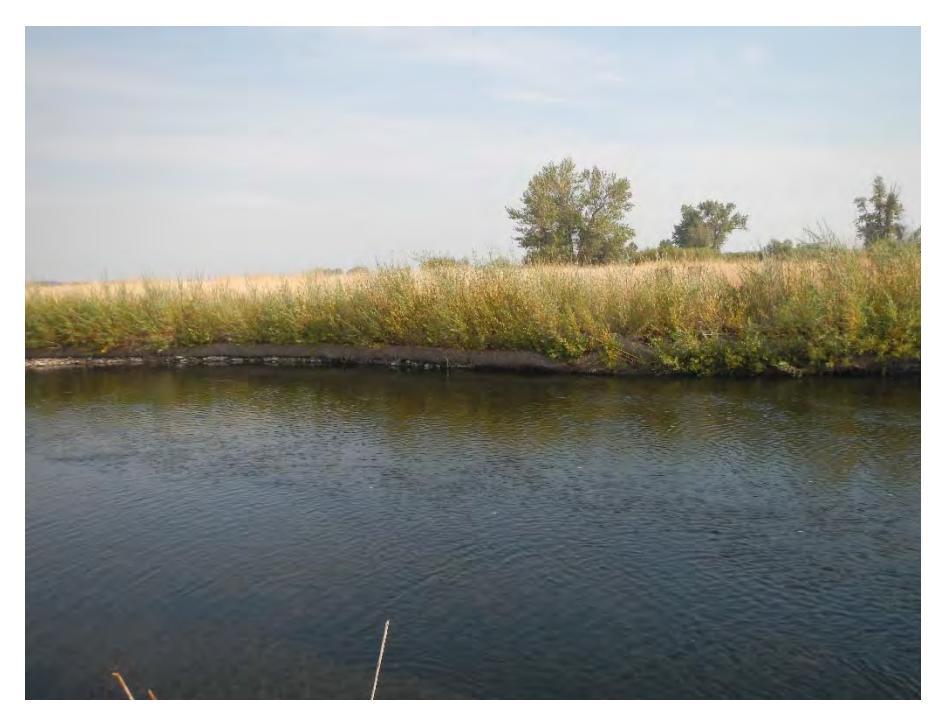
Photo 17. Vegetation expansion in DVSL.

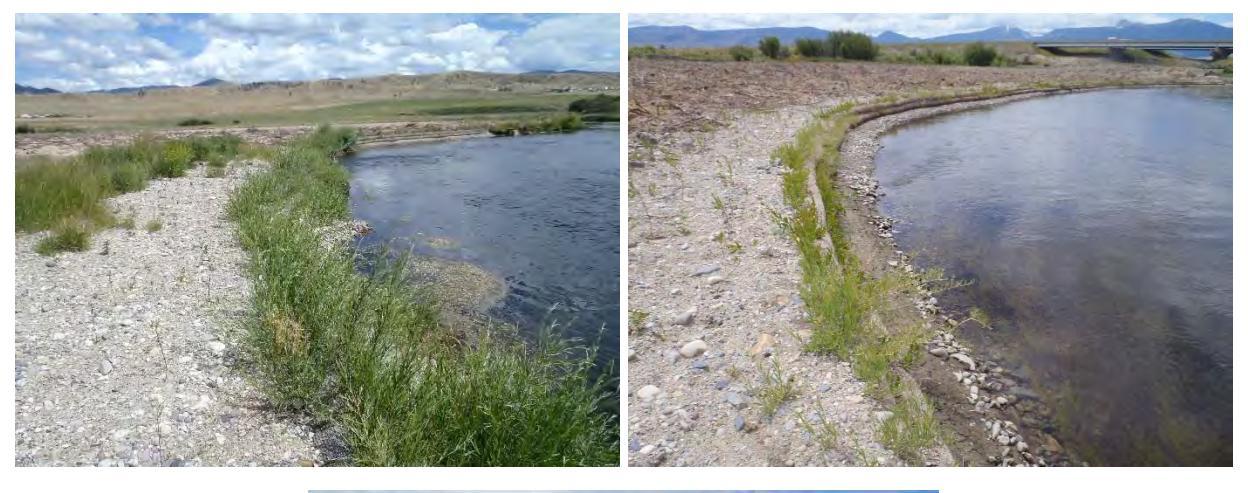
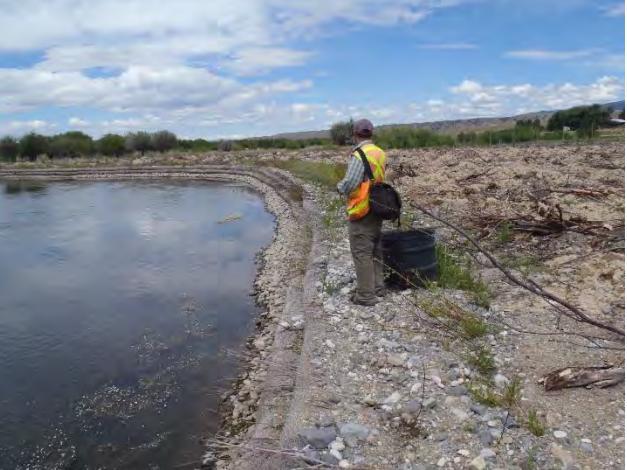
## Phases 5 and 6 2016 Streambank Woody Vegetation Cover Categories

Top left: Category 1 (>40%) (LB-79A); Top right: Category 2 (10 to 40%) (LB-73); Bottom center: Category 3 (<10%) (RB-103).
