# Qualitative Rapid Assessment 2015-2017 Status Report

Milltown Reservoir / Clark Fork River NPL Site Clark Fork River Operable Unit, Reach A, Phase 1, Phase 2 and Phases 5 and 6

Qualitative Rapid Assessment, 2015-2017 Status Report Milltown Reservoir / Clark Fork River NPL Site Clark Fork River Operable Unit, Reach A

> > January, 2018

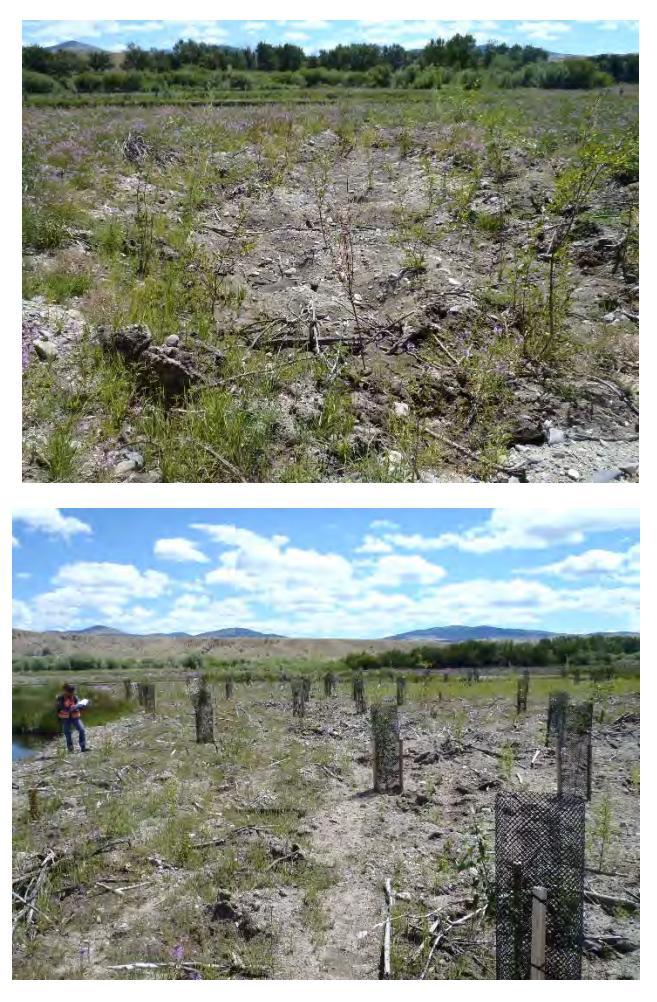
#### Phases 5 and 6 2016 Floodplain Woody Vegetation Cover Categories

Top: Category 2 (10 to 30%) (S105); Bottom: Category 3 (<10%) (OM29).

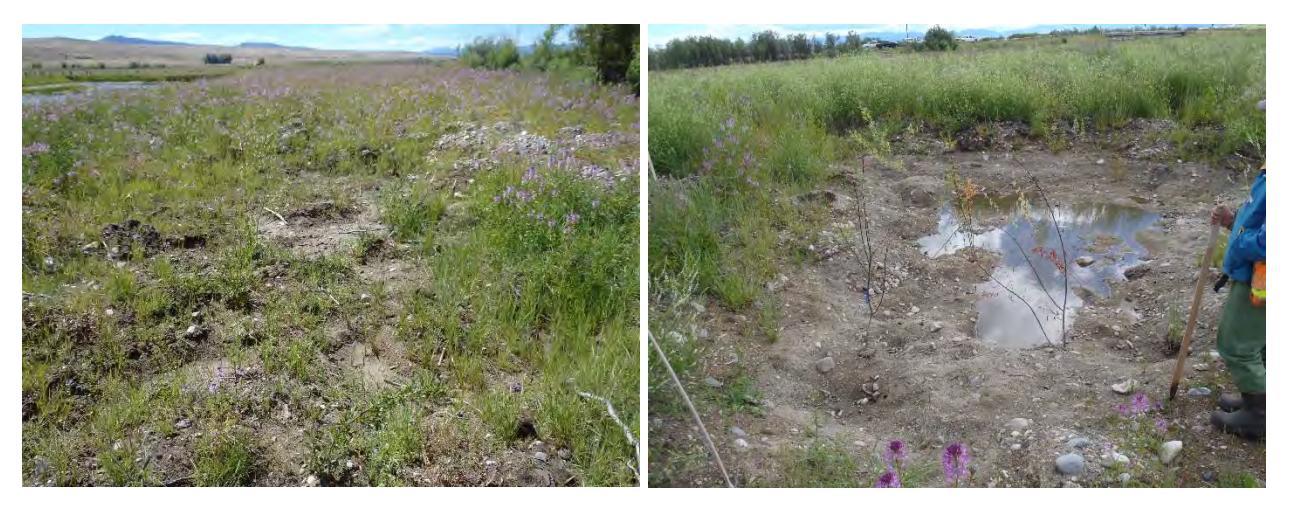
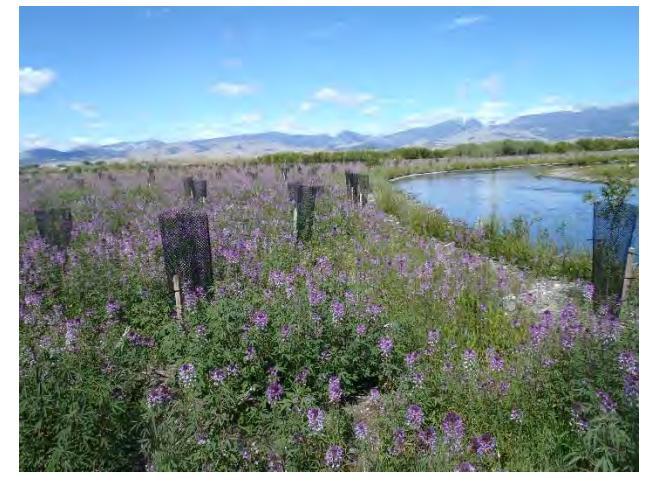
#### Phases 5 and 6 2016 Woody Vegetation Survival Categories

Top left: Category 1 (>80%) (S094); Top right: Category 2 (50 to 80%) (S006); Bottom: Category 3 (<50%) (OM16).

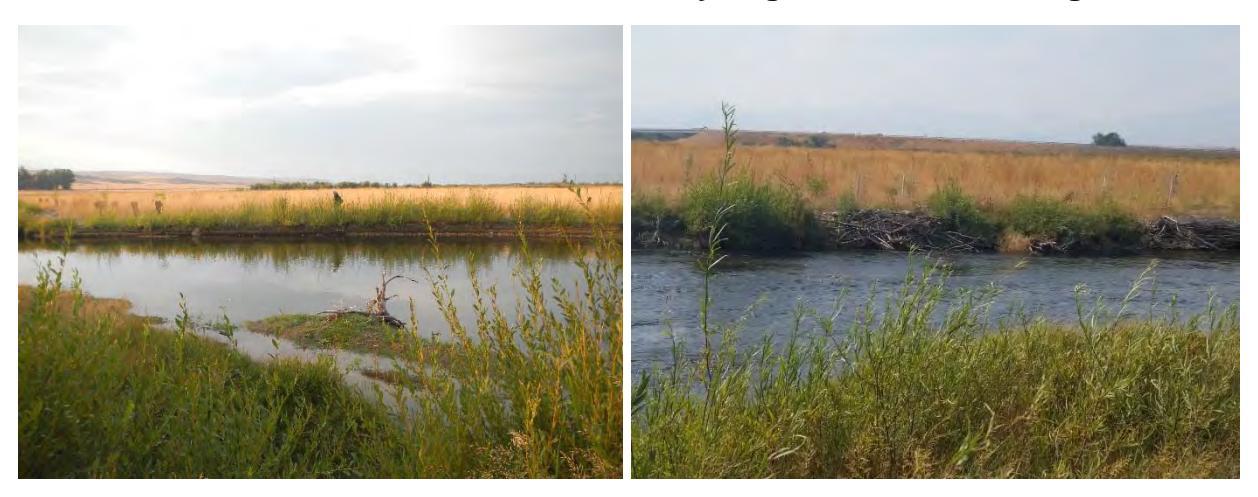
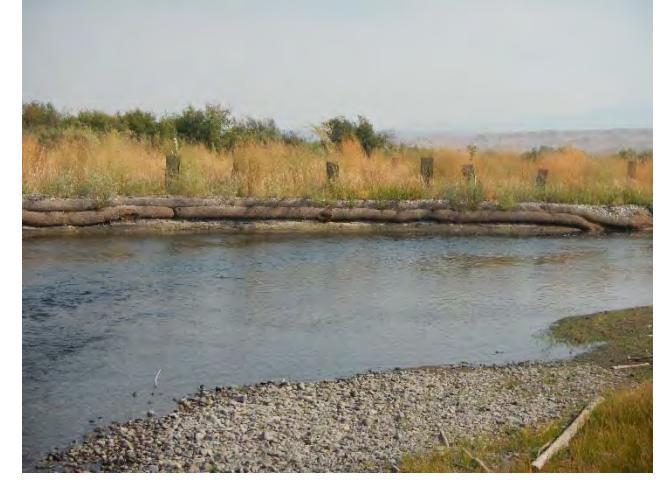
#### Phases 5 and 6 2017 Streambank Woody Vegetation Cover Categories

Top left: Category 1 (>40%) (RB-7); Top right: Category 2 (10 to 40%) (LB-83C); Bottom center: Category 3 (<10%) (LB-46E).

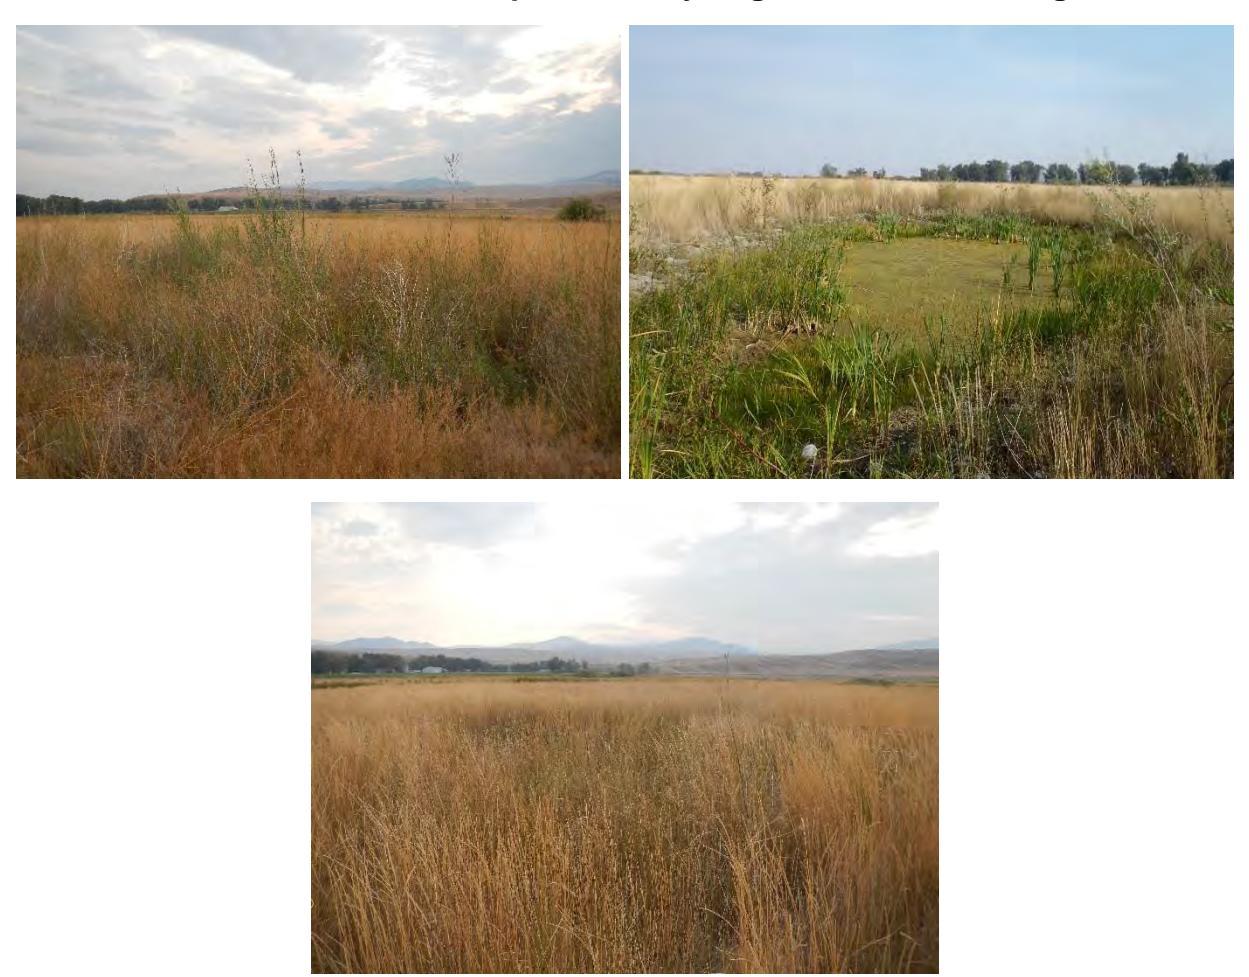
#### Phases 5 and 6 2017 Floodplain Woody Vegetation Cover Categories

Top left: Category 1 (>30%) (s20); Top right: Category 2 (10 to 30%) (sw09); Bottom center: Category 3 (<10%) (s043).

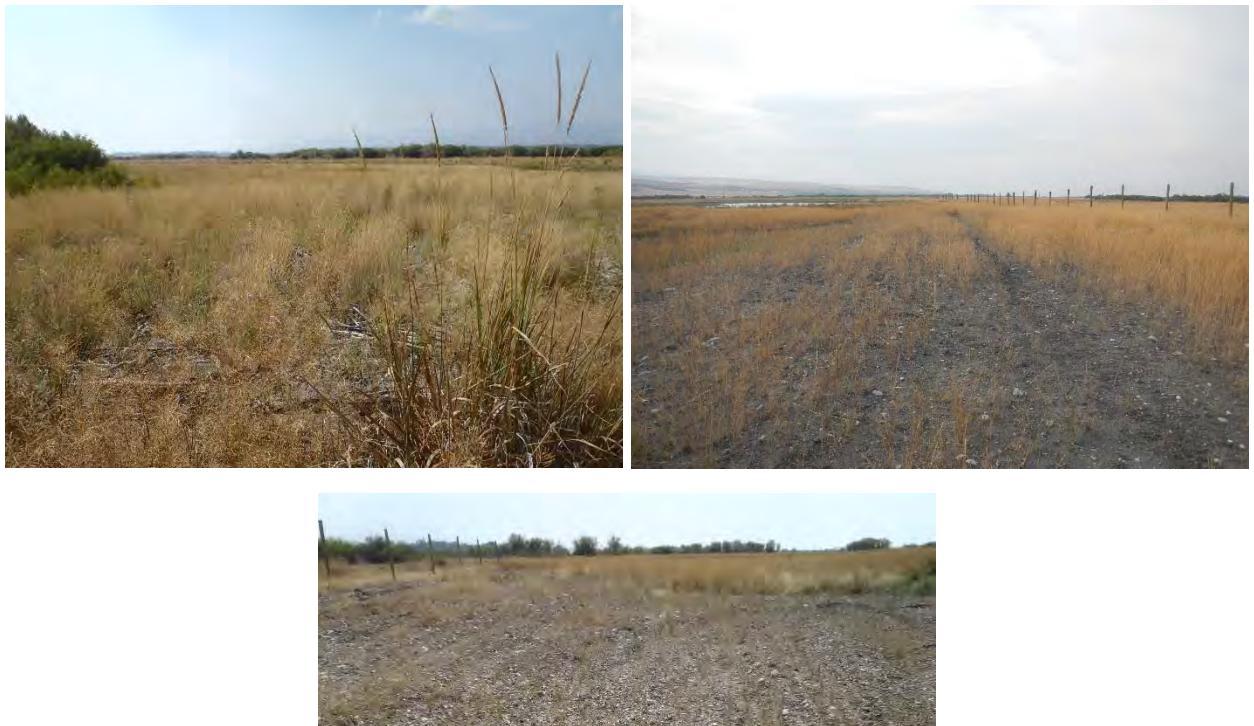
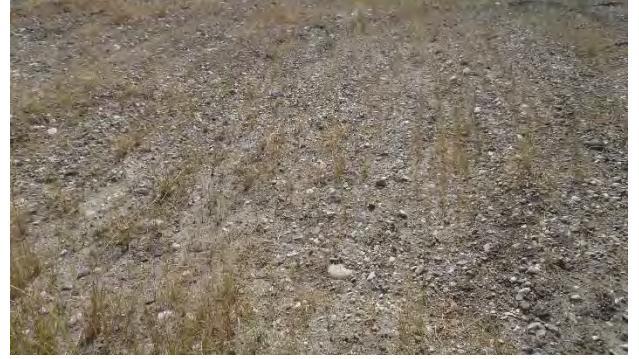
#### Phases 5 and 6 2017 Floodplain Herbaceous Vegetation Cover Categories

Top left: Category 1 (>80%) (overview looking toward channel from preserved oxbow on right bank); Top right: Category 2 (50-80%) (access road along west side of Phase 5 borrow ponds); Bottom center: Category 3 (20-50%) (area behind om57 on right bank).

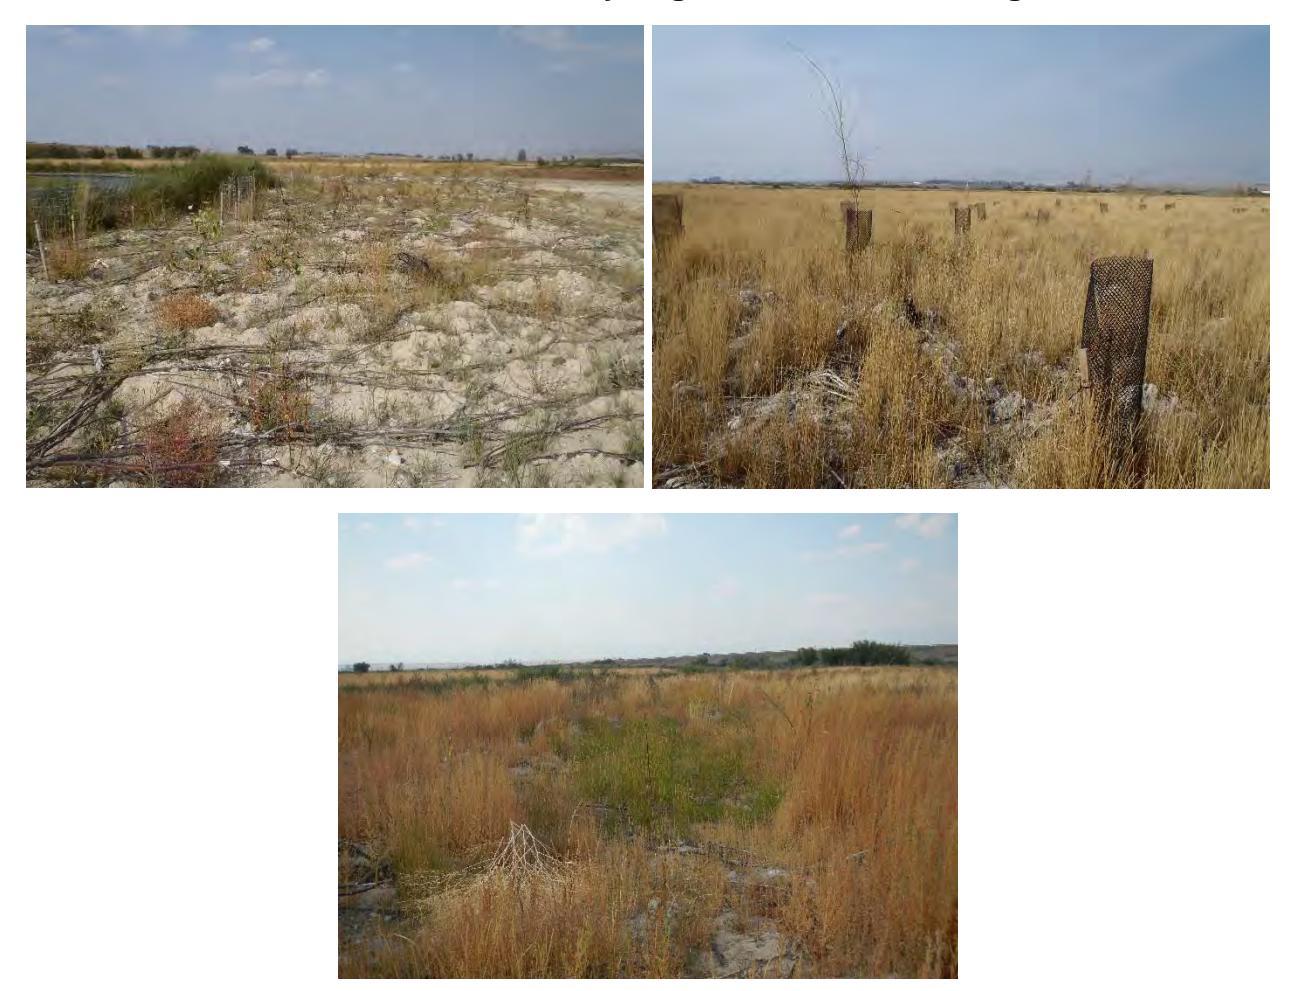
Phases 5 and 6 2017 Woody Vegetation Survival Categories

Top left: Category 1 (>80%) (om48); Top right: Category 2 (50 to 80%) (om14); Bottom: Category 3 (<50%) (s183).

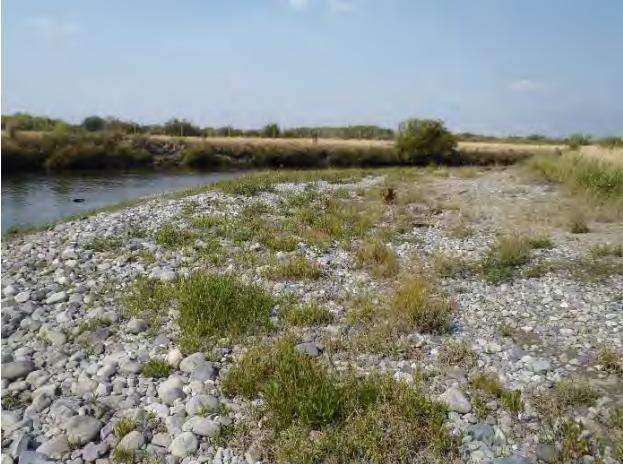
Photos 1-5. Point bar conditions in Phases 5 and 6 in 2017. Photo 1: point bar below RB-15-BT with high cover of willow seedlings; Photo 2: PB LB-12-BT with high cover of invasives but also high cover of willow seedlings and native wetland vegetation, also lots of sediment storage in downstream end where existing surface was preserved; Photo 3: PB LB-28-BT with dense wetland vegetation in the preserved portion of the surface; Photo 4: PB RB-23-BT with dense cover of willow seedlings; Photo 5: PB RB-43-BT with sparse cover of herbaceous vegetation.

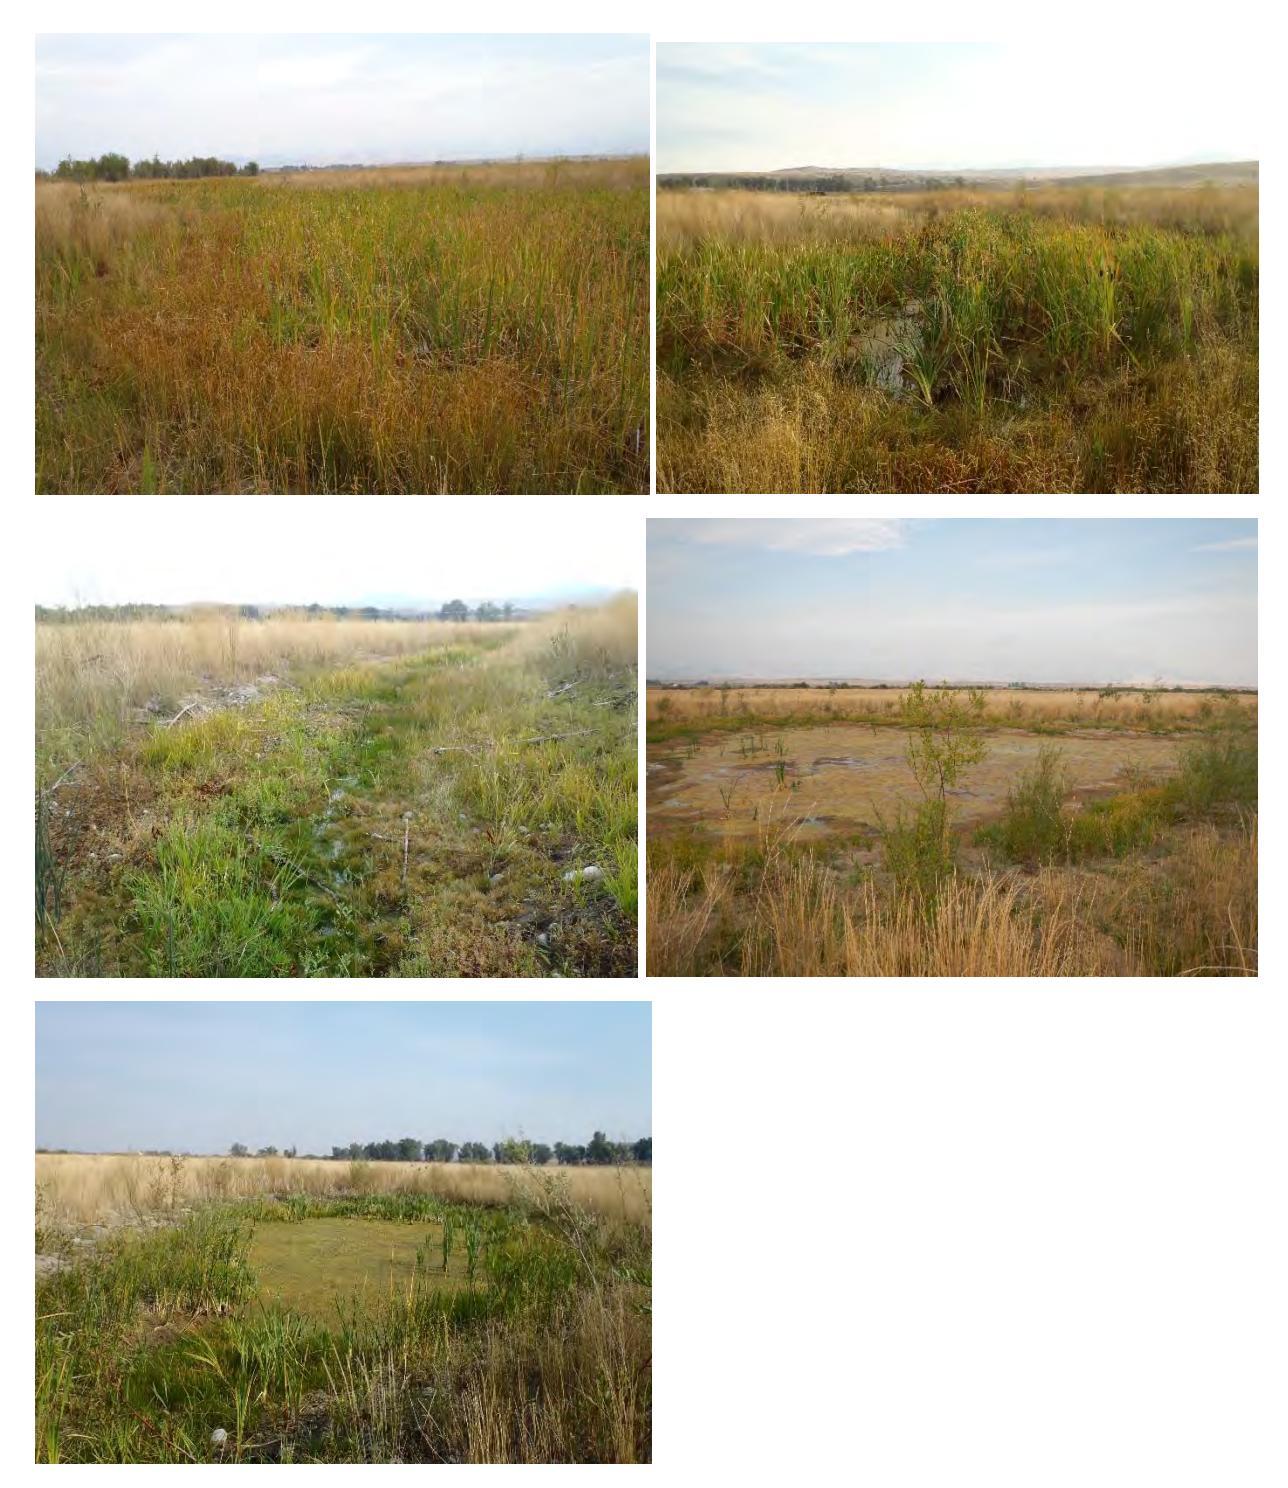
Photos 6-10. Wetland conditions in Phases 5 and 6 in 2017. Photo 6: wetland sw02; Photo 7: wetland sw03; Photo 8: oxbow wetland, sw08; Photo 9: sw06, em08; Photo 10: sw09.

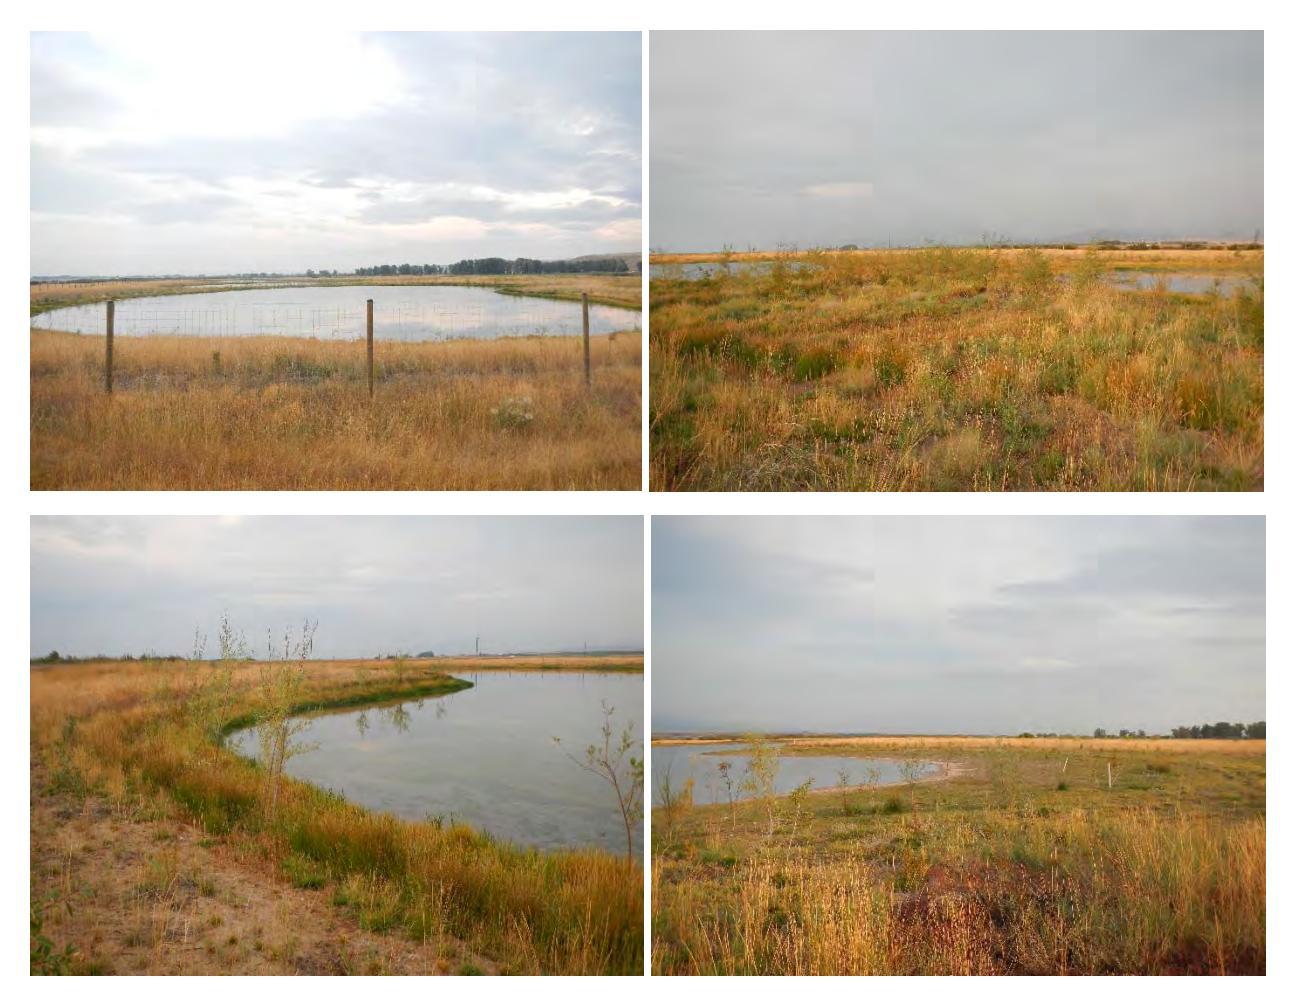
Photos 11-14. Phase 5 borrow pond conditions.

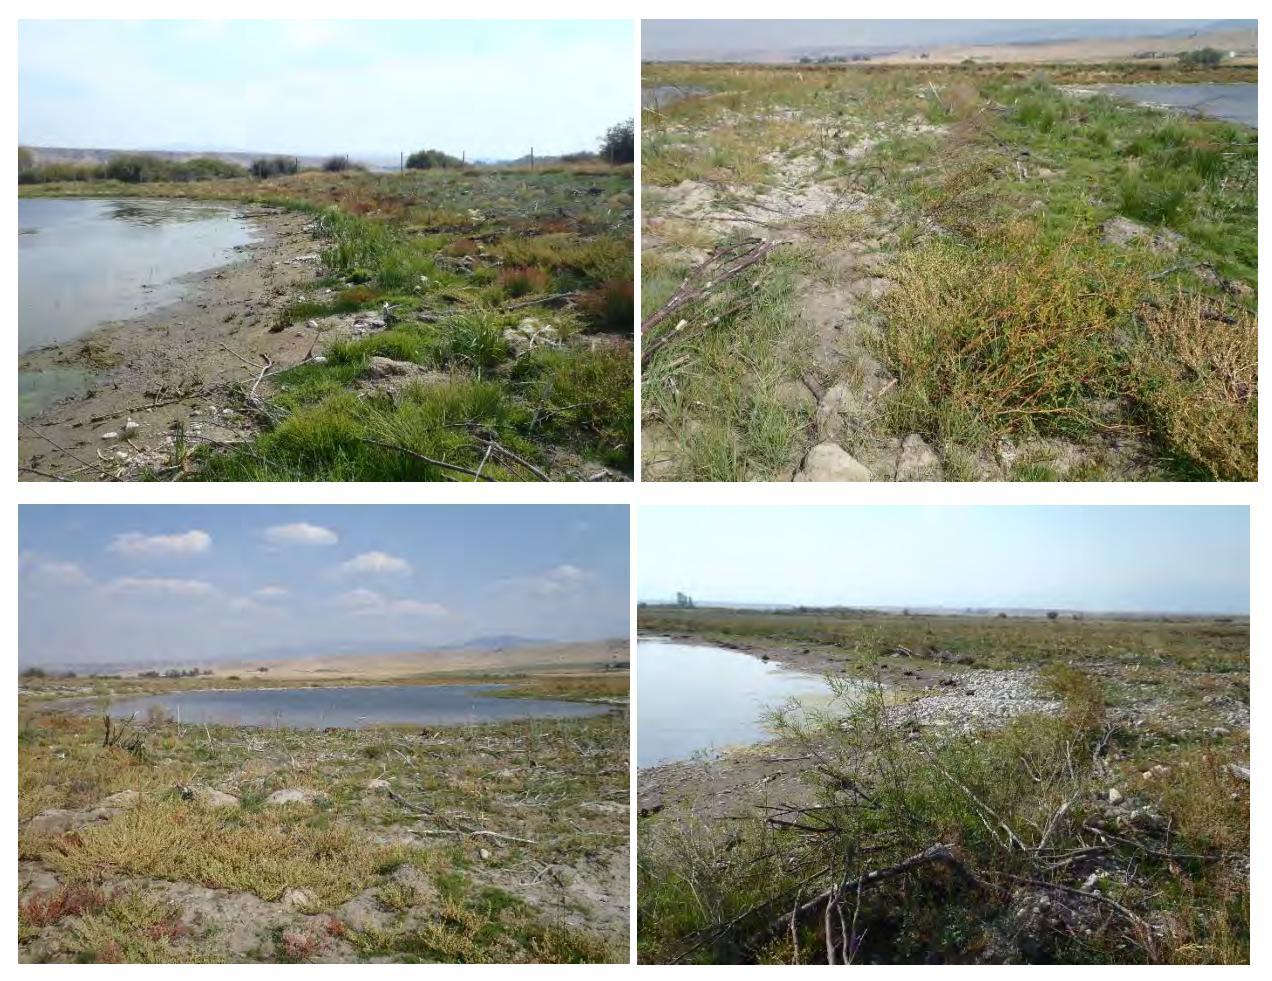
Photos 15-18. Phase 6 borrow pond conditions.

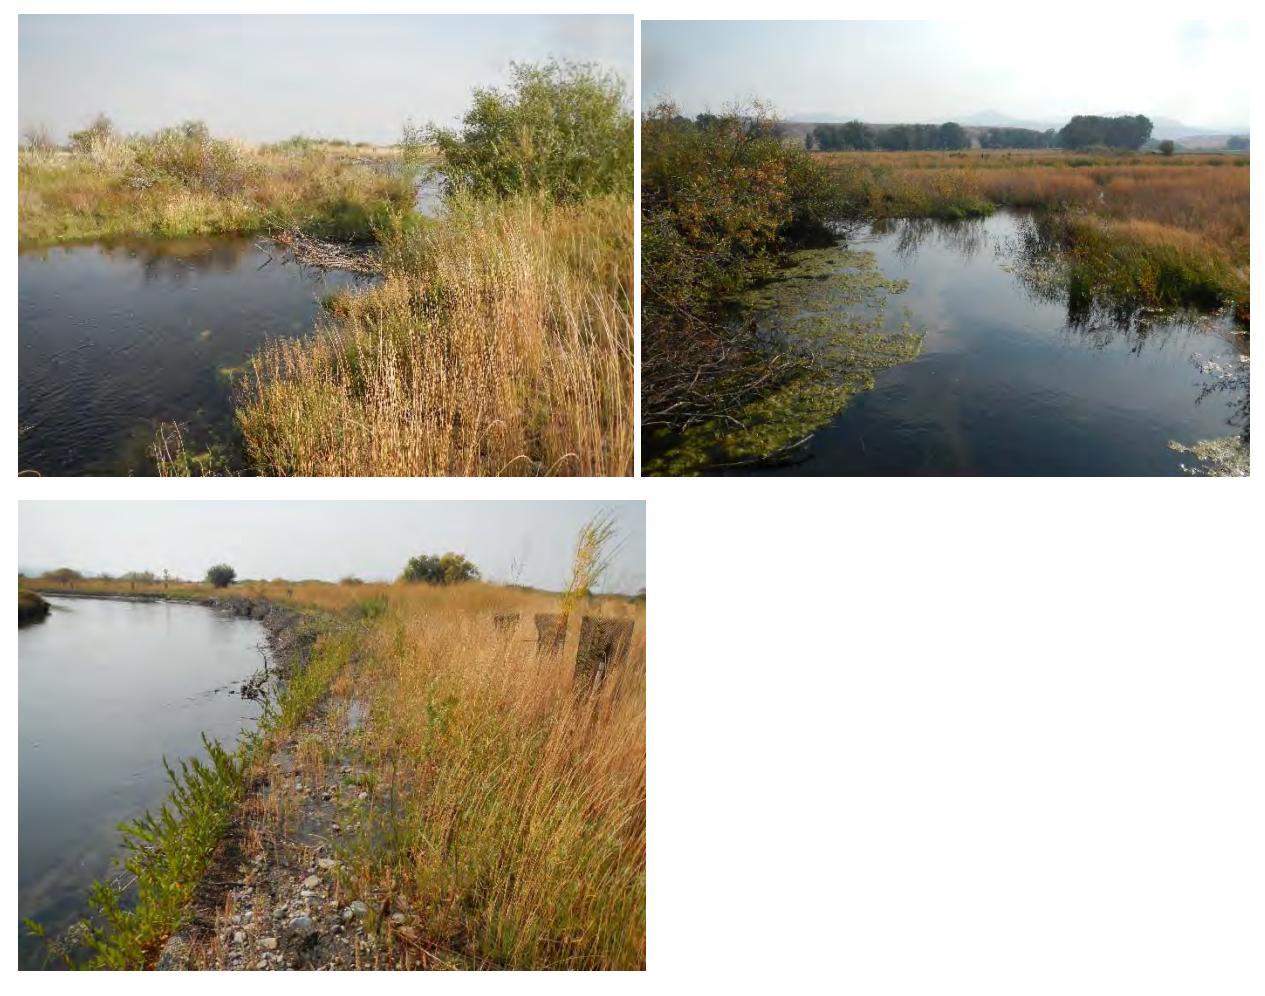
Photos 19-21. Ponding from Galen Creek beaver dams and surface water return flow into the river.

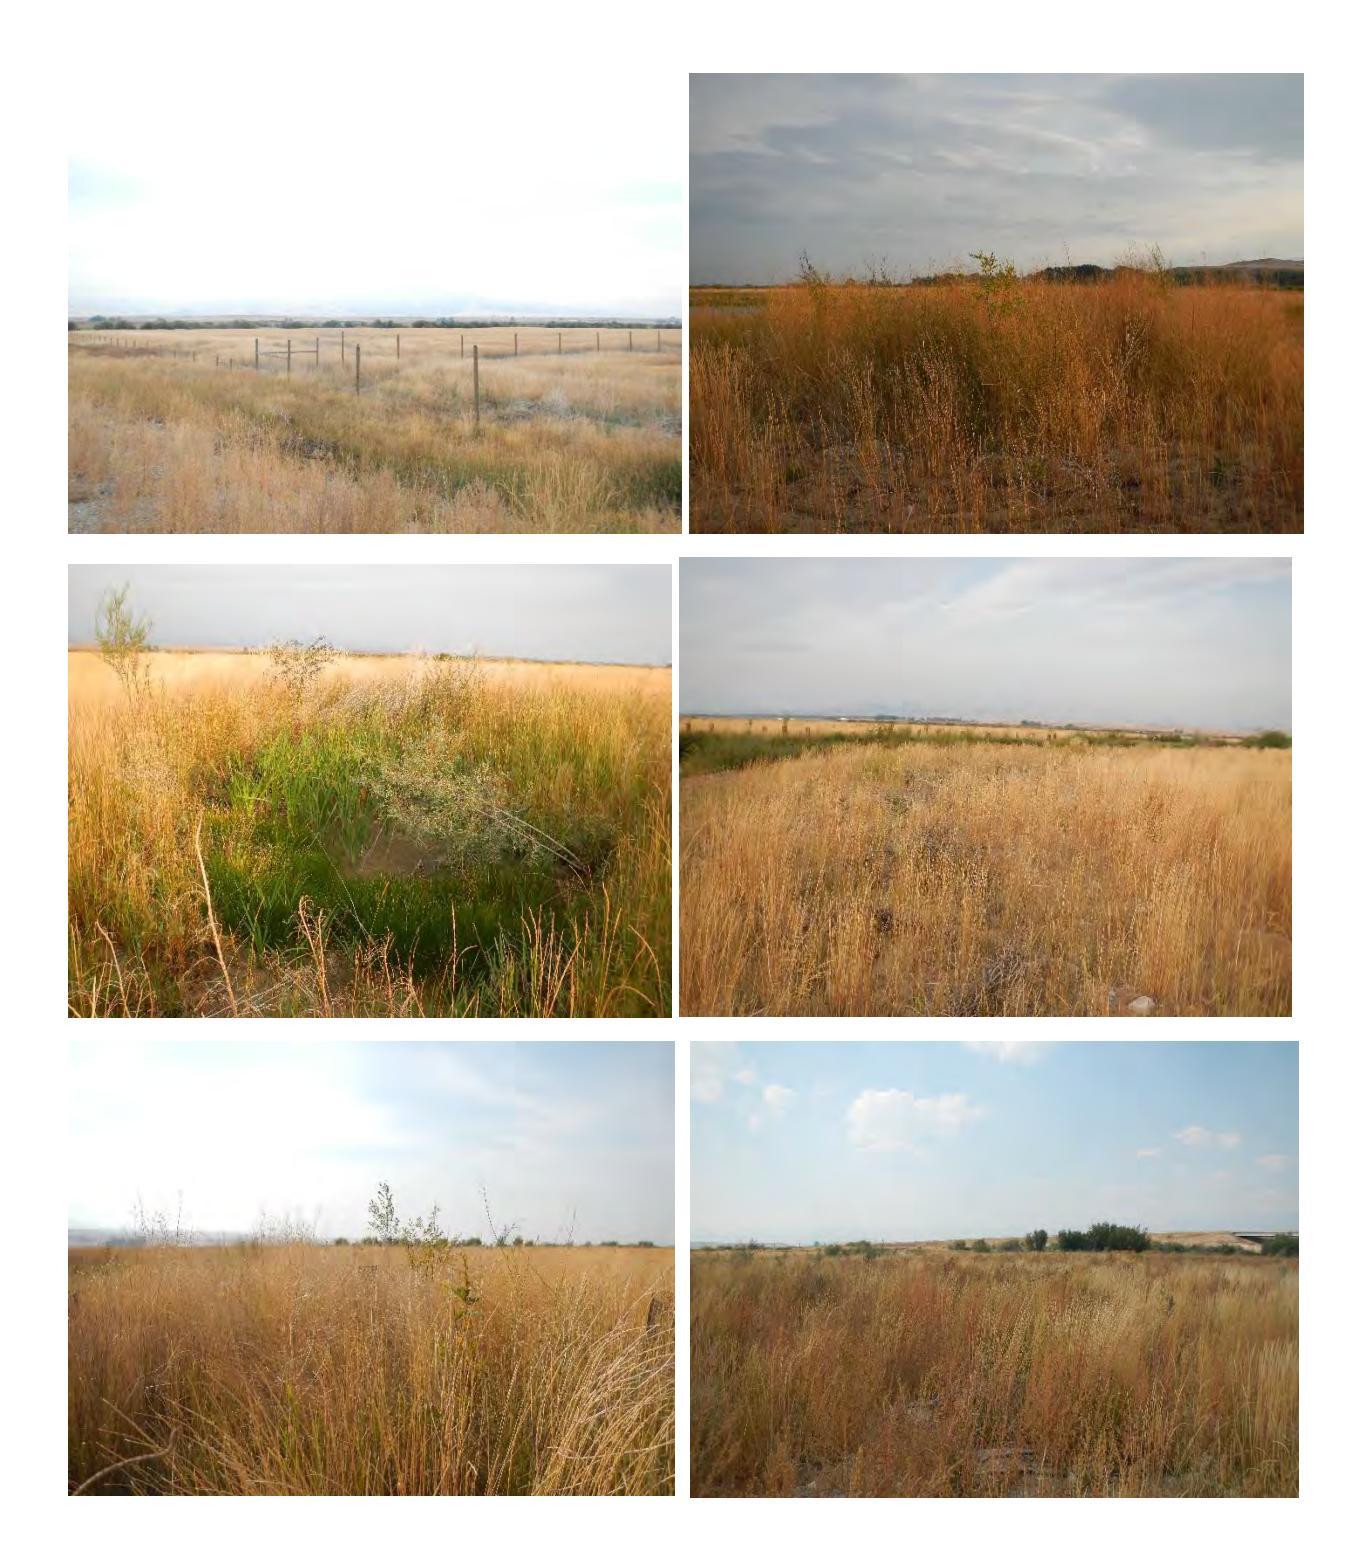
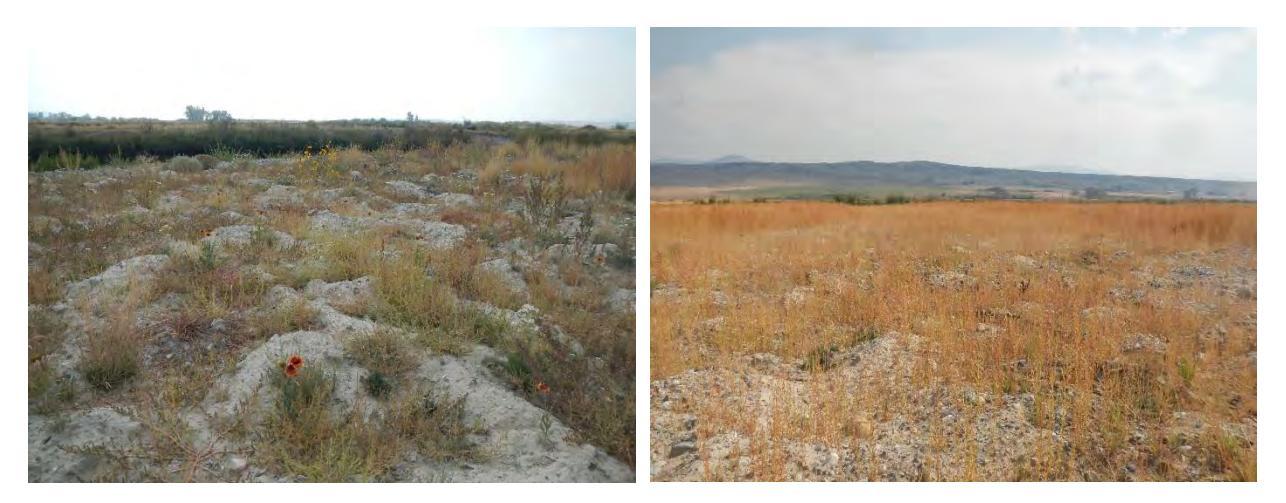
Photos 22-29. Herbaceous cover in Phases 5 and 6 west floodplain in 2017. Photo 22: high cover of seeded species in reclaimed borrow area near Galen Road; Photo 23: high cover of invasive species around planted swale with high cover of seeded species in adjacent floodplain; Photo 24: s072 with wetland vegetation colonizing the bottom; Photo 25: cover of seeded species after two growing seasons between micro/broadcast seeding in photo left and drill seeding in photo right; Photo 26: high cover of invasive species in mc02 area; Photo 27: mix of seeded species and exotic species in mc04 area; Photo 28: low total cover but high cover of seeded forbs closer to the

channel in mc04 area; Photo 29: Low overall cover and low cover of seeded species in om55 area.

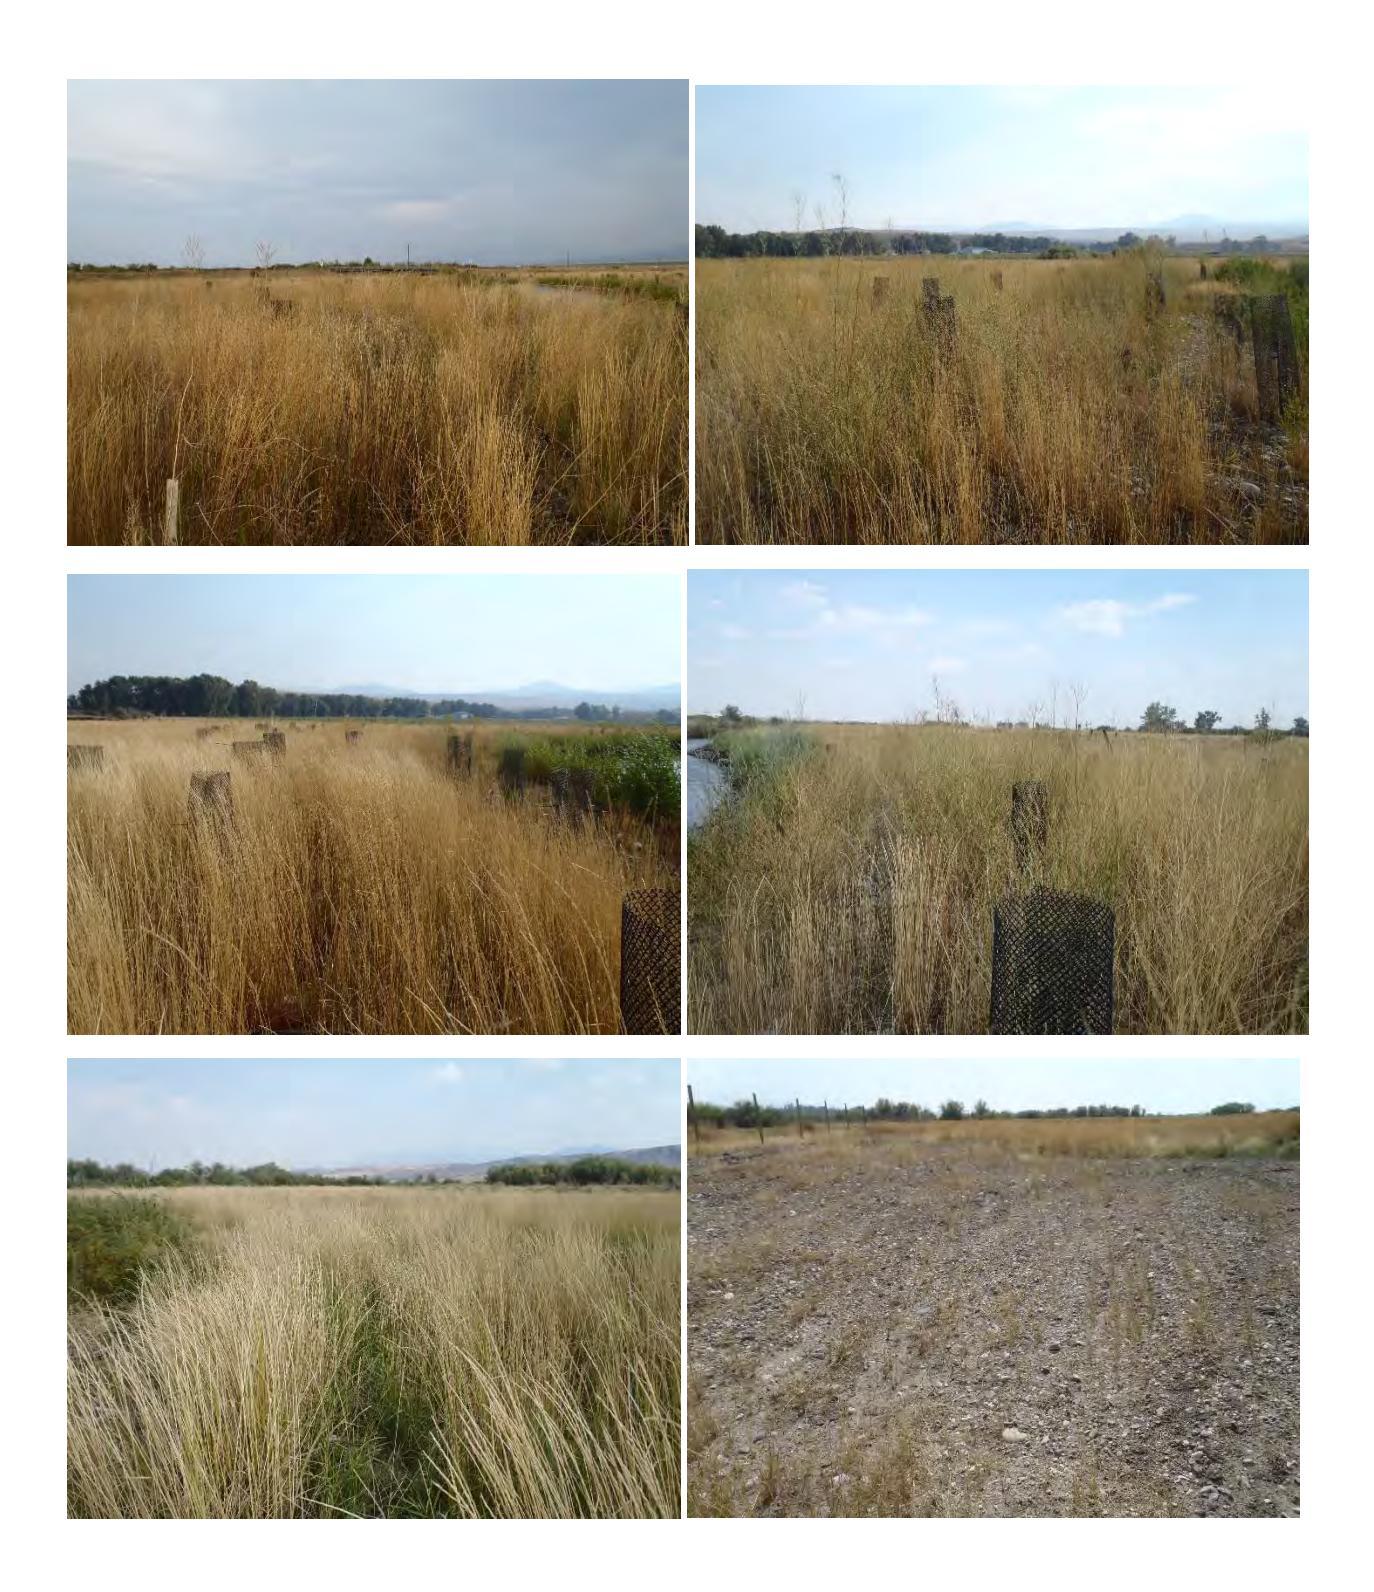
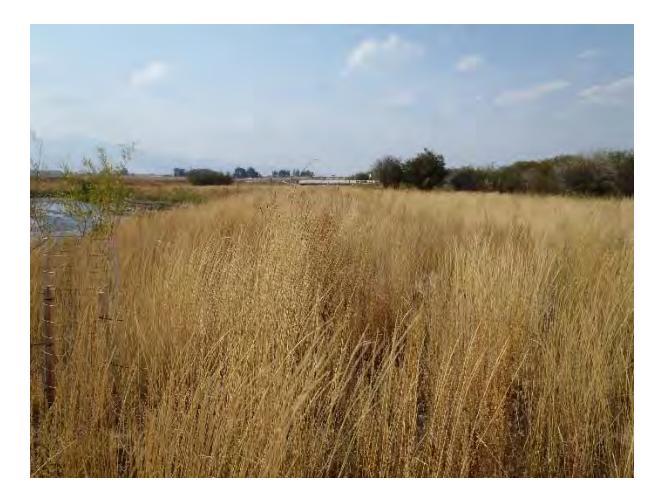
Photos 30-36. Herbaceous cover in Phases 5 and 6 east floodplain in 2017. Photo 30: high cover of seeded species in floodplain area downstream of Galen Road; Photo 31: mix of seeded species and invasive species north of oxbow; Photo 32: high cover of seeded species near om11; Photo 33: high cover of invasive species near OM56; Photo 34: high cover of seeded species (wheatgrass) in om30 area; Photo 35: low cover in seeded road area; Photo 36: mix of seeded and invasive species near om54.

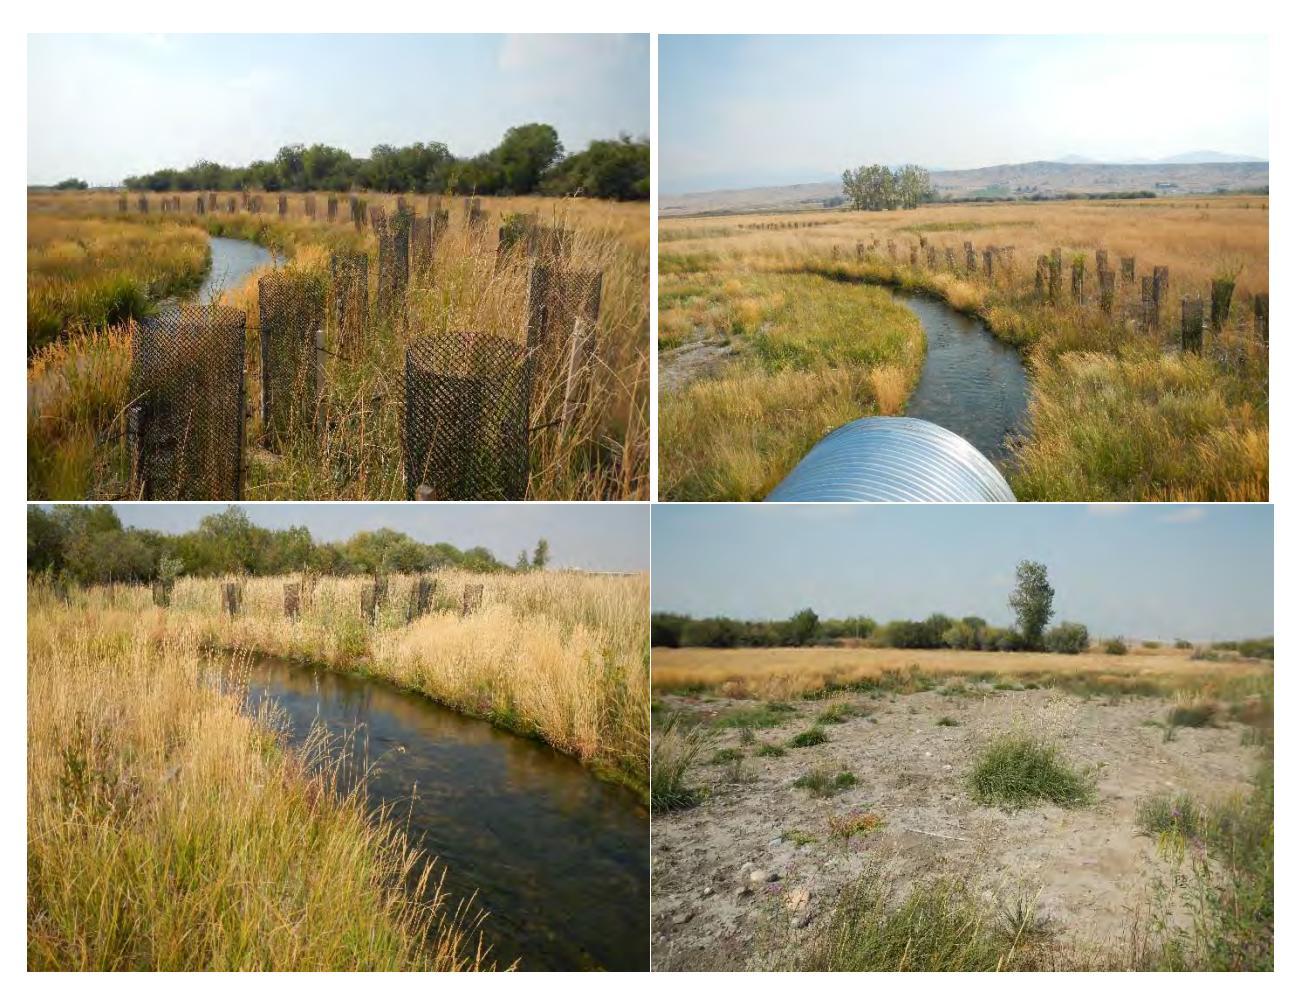
Photos 37-40. Modesty Creek.

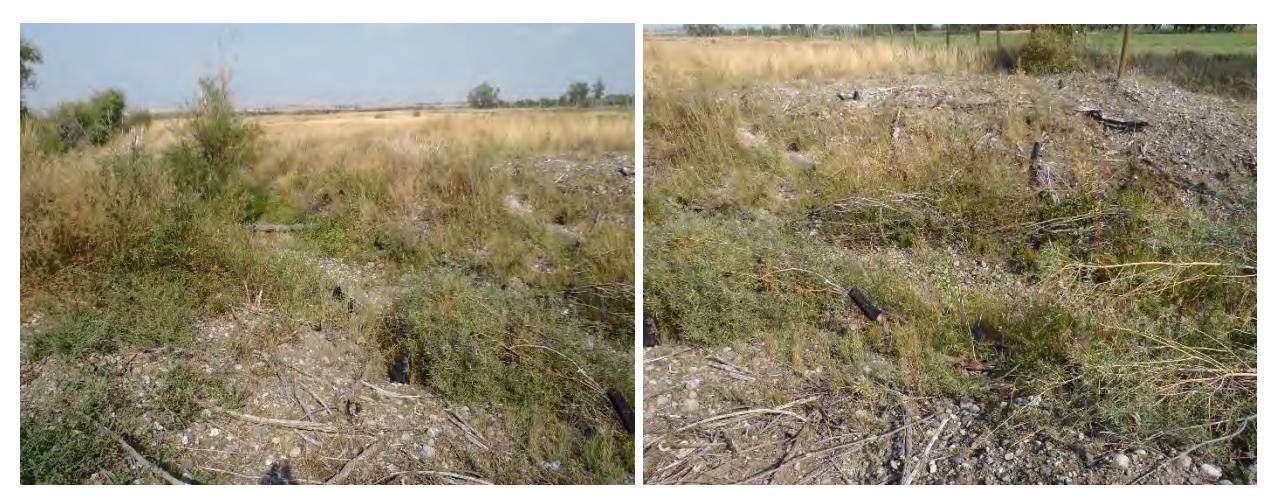
Photos 41-42. Dry Cottonwood Creek.
