**APPENDIX C**  
**2004 AERIAL PHOTO REVIEW AND FIELD SOURCE ASSESSMENT,**  
**UPPER JEFFERSON RIVER WATERSHED**

### **1.1 Upper Jefferson Watershed 2004 Aerial Photo Review and Field Source Assessment**

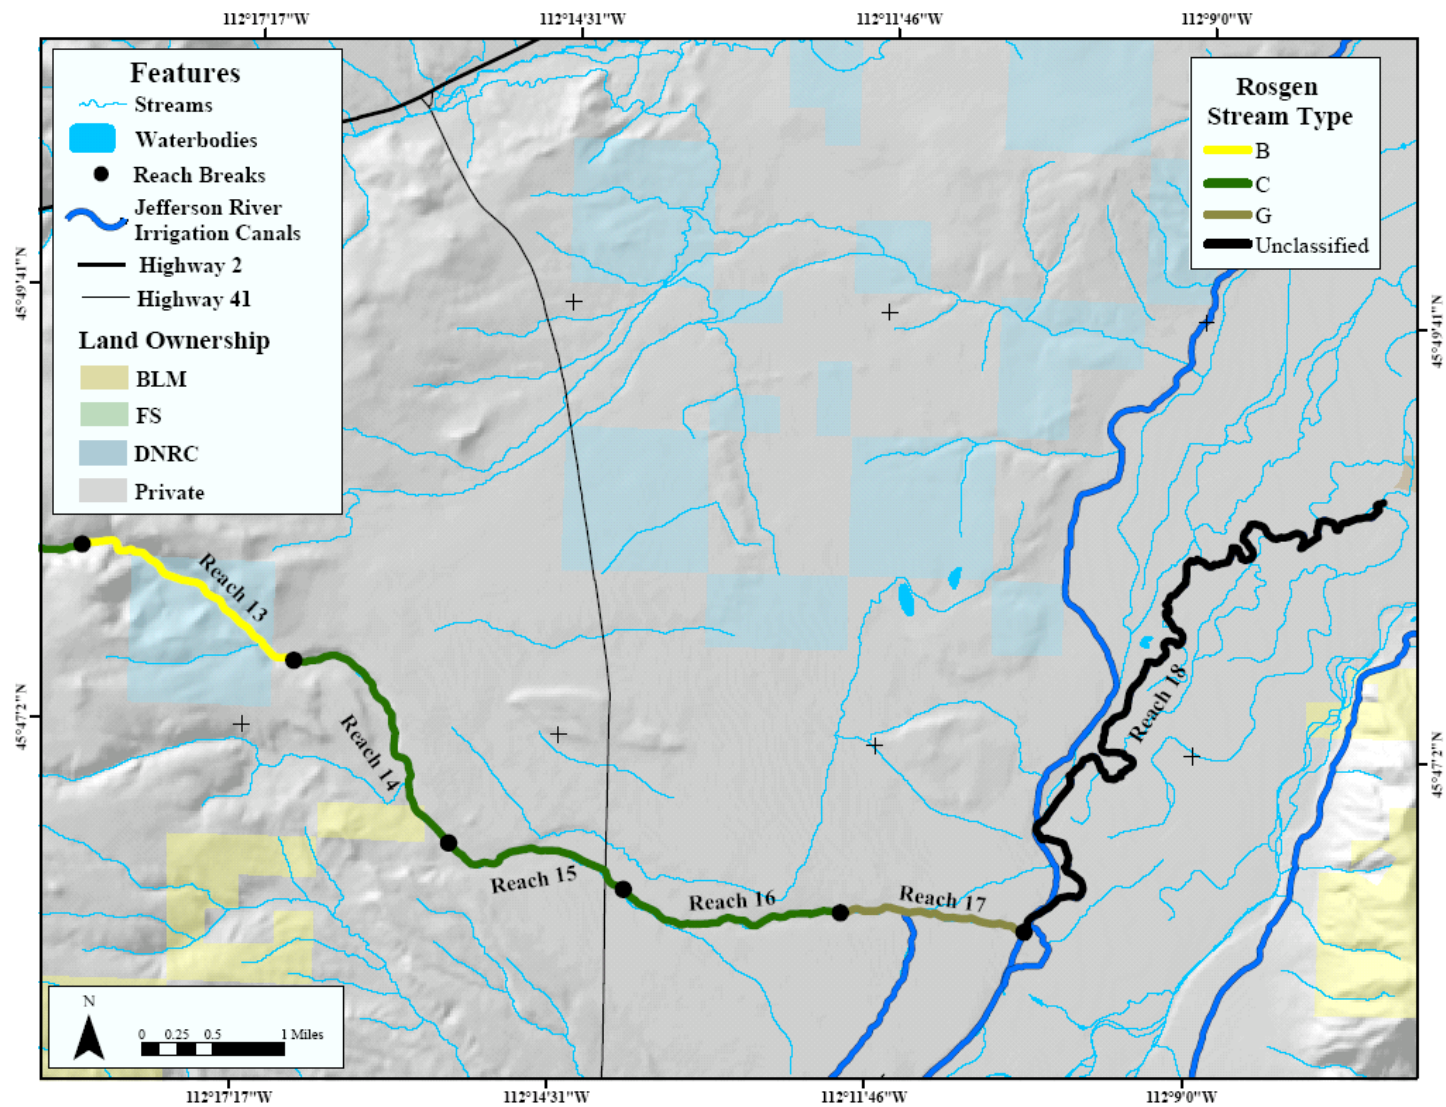
Figure 2-20. Lower Fish Creek Rosgen Stream Types

Many of the channel forms of Fish Creek in the Jefferson Valley are controlled by landform structure, and historical and current landuse activities (**Figure 2-20**). Channel form on the alluvial fan (Reaches 14 to 17) tended to be more unconfined than expected (C-type versus B-type). Portions of Reaches 14 and 15 viewed during the field survey exhibited C-type channels. Reach 17 was typed as a G channel due to the lack of water and vegetation, however this was not field verified. Fish Creek usually goes dry before entering Fish Creek Canal (Reach 18). Reach 18 was not classified due to the fact that it is part of a major irrigation canal system in the Jefferson Valley, and probably carries flow from the Jefferson River versus Fish Creek. For the valley portion of Fish Creek, only one time period was analyzed so significant changes in channel form since 1983 could not be determined.

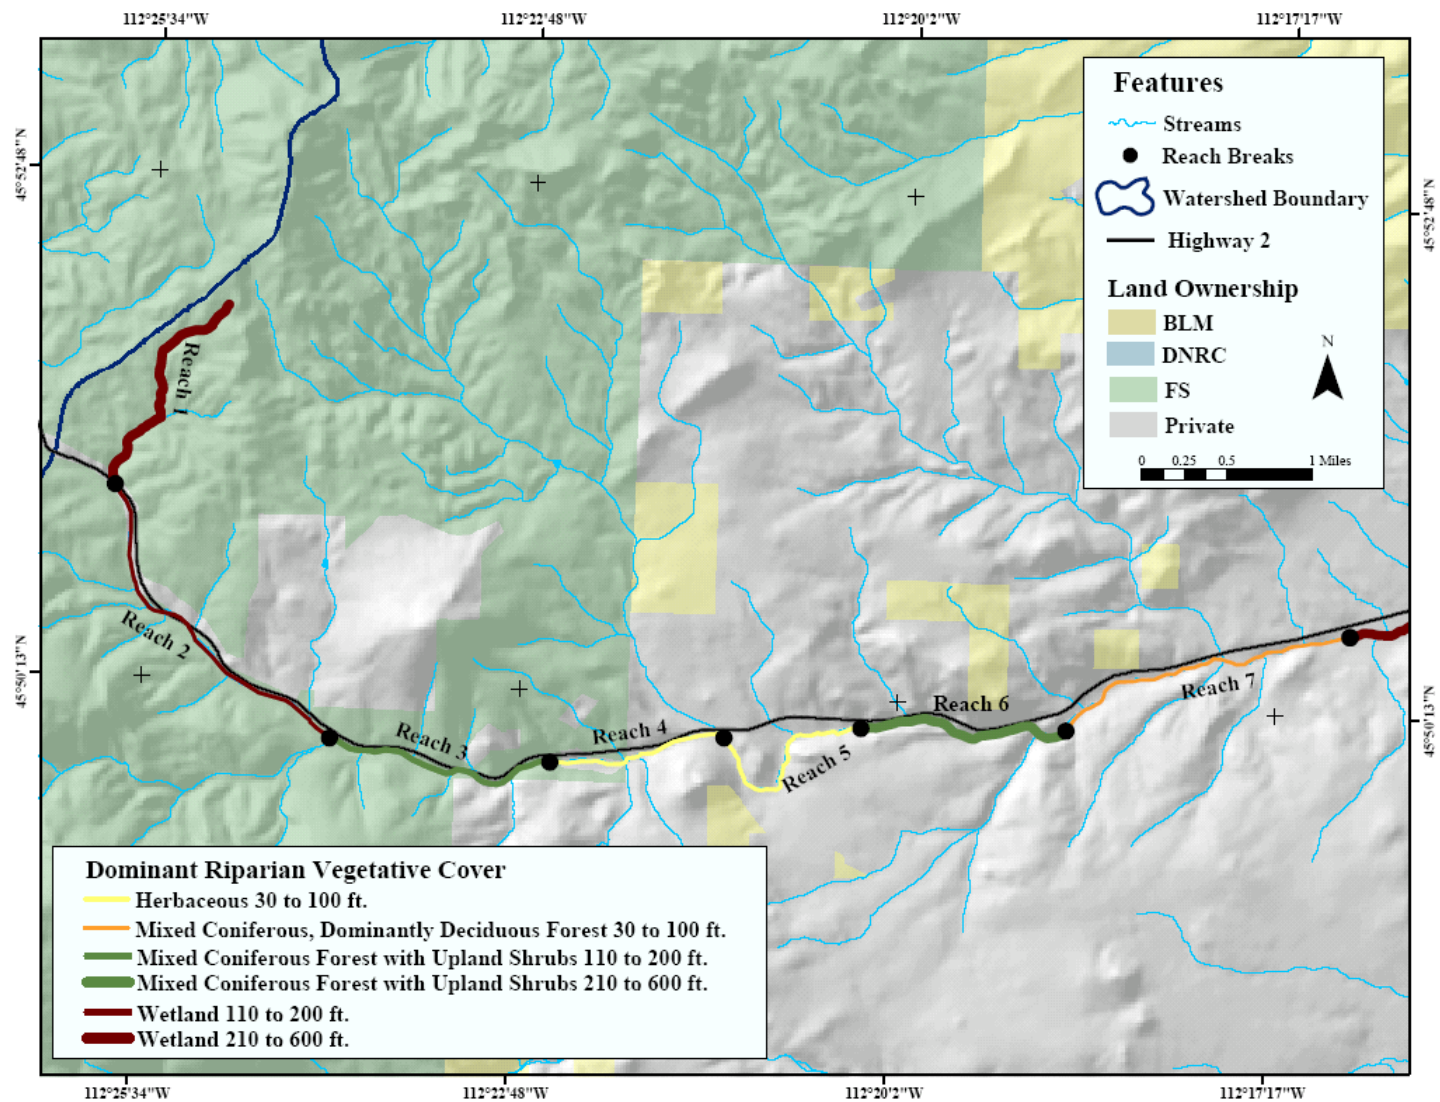
Figure 2-36. Upper Little Pipestone Creek Riparian Vegetation

Riparian cover along Upper Little Pipestone Creek was variable (**Figure 2-36**). The predominant cover in Reaches 1 and 2 was wetland vegetation. Field assessment in Reaches 1 and 2 revealed that the willows were decadent from heavy browsing, and dying in areas due to ponding. Buffer widths were limited in Reaches 2, 3, and 6 by proximity to the highway. Riparian vegetation type in Reaches 3 and 6 was mixed coniferous forest with upland shrubs. Development in Reaches 4 and 5 resulted in a loss of woody vegetation, and the classification was changed to predominantly herbaceous. Woody vegetation generally extended to a maximum of 20 feet on either side on the channel in these reaches. The relative health category assigned to the riparian vegetation progressed from excellent to poor in a downstream manner. There were no significant changes in riparian vegetation between 1983 and 2001.

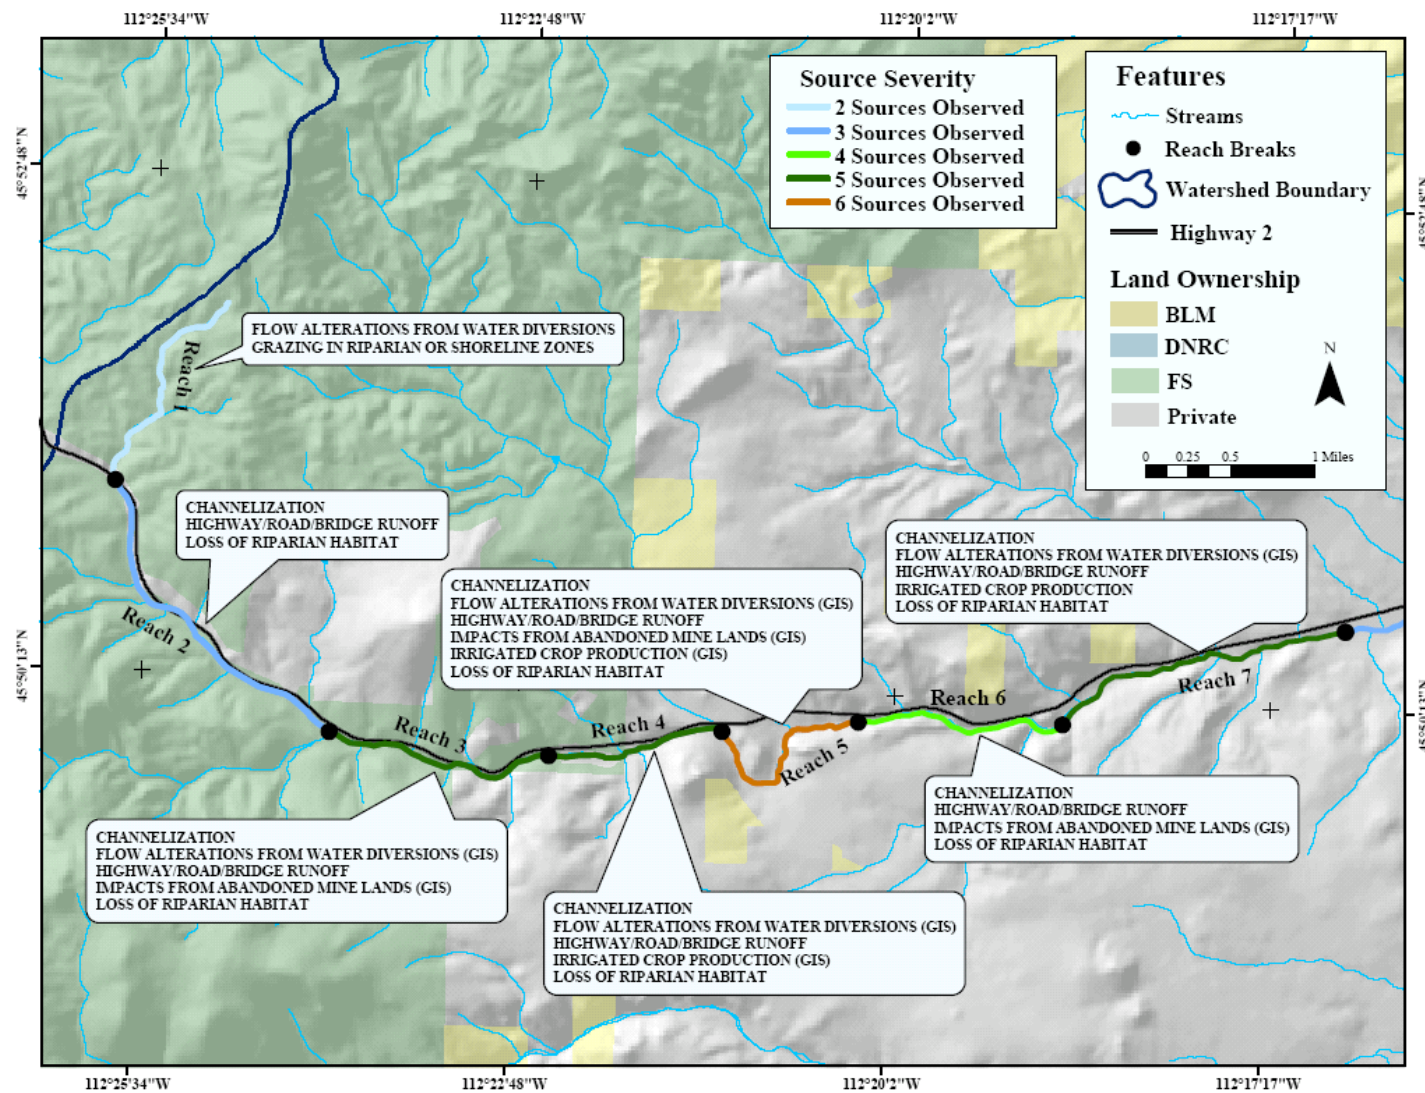
Figure 2-38. Upper Little Pipestone Creek Pollution Sources

**Figure 2-38** displays the pollution sources assigned to the upper reaches of Little Pipestone Creek. Many pollution sources observed along Upper Little Pipestone Creek were related to roads and riparian grazing. In many instances, the sources of flow alterations from water diversions and impacts from abandoned mine lands were taken from GIS layers which located water rights claims and abandoned mines. The GIS identified sources were not field verified, except in Reach 1 where 3 earthen dams have obstructed the channel. A large road sediment source was observed entering the creek in Reach 2. Channelization effects were prominent in Reaches 2 and 3. There were no significant changes in pollution sources between 1983 and 2001.

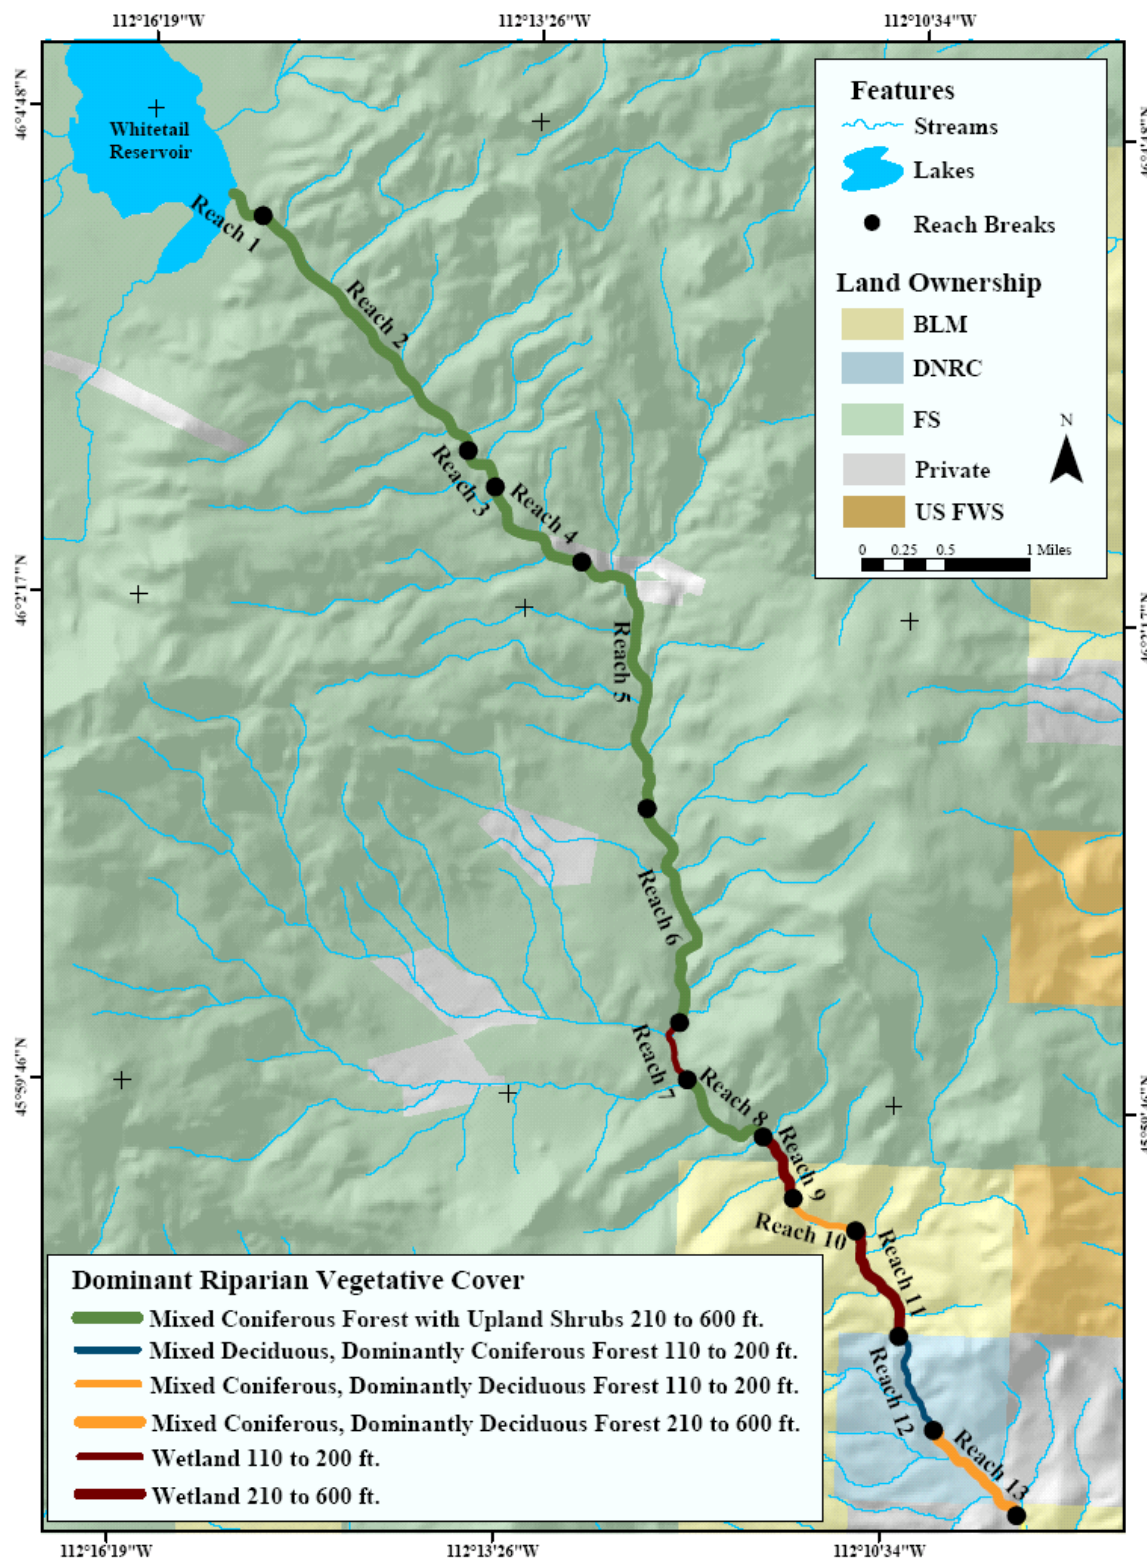
Figure 2-42. Upper Whitetail Creek Riparian Vegetation

The dominant riparian cover along Upper Whitetail Creek in Reaches 1 to 6 was mixed coniferous forest with upland shrubs (**Figure 2-42**). During the field review in Reach 5, sedges, alder, and willows were observed extending about 10 feet from the channel within the conifer forest. Riparian cover from Reaches 7 to 13 alternated between wetland (less confined valley bottom areas), mixed coniferous forest, and deciduous forest. Buffer widths were generally limited by valley bottom width and the availability of moisture. The relative health categories assigned to all of the upper reaches was either 'Excellent' or 'Fair', depending on whether disturbance was visible. Some areas of thistle infestation were observed in Reaches 5 and 13. Buffer widths were generally greater than 100 feet wide along both sides of the stream, and represented the distance of vegetation surrounding the stream before any disturbance was observed. There were no significant changes in riparian vegetation between 1983 and 2001.

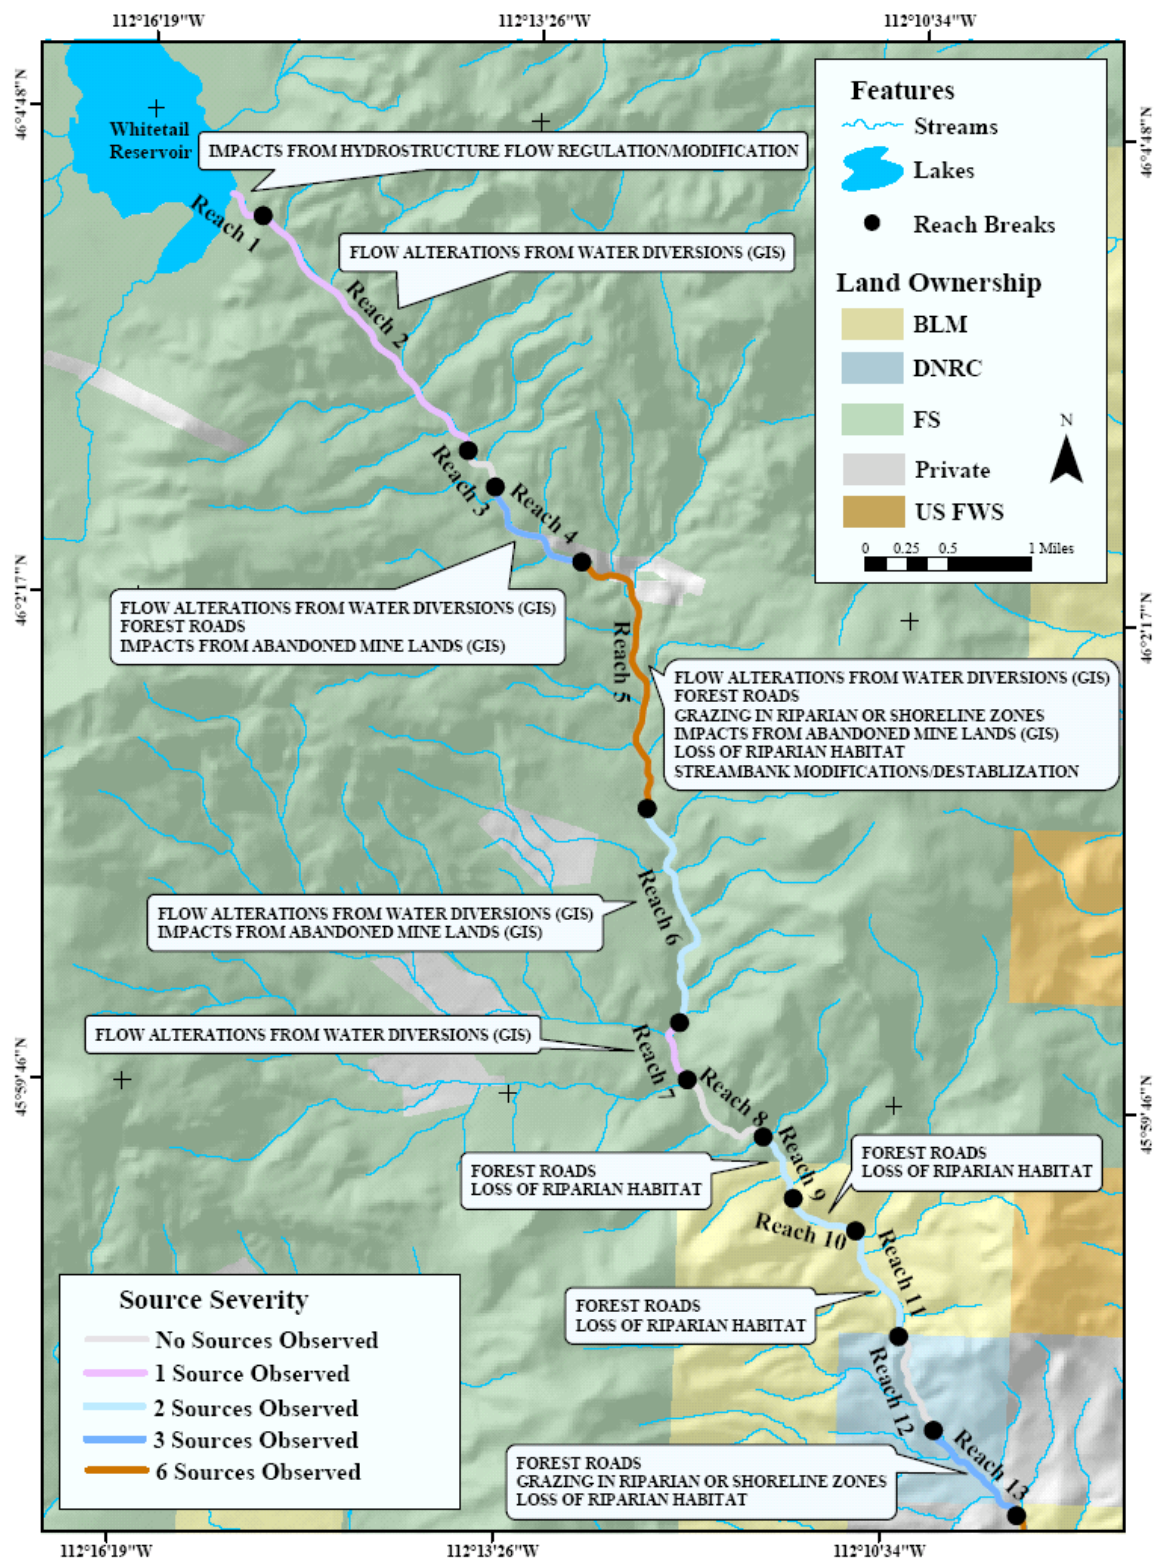
Figure 2-44. Upper Whitetail Creek Pollution Sources

**Figure 2-44** displays the pollution sources assigned to the upper reaches of Whitetail Creek. In many instances, the sources of flow alterations from water diversions and impacts from abandoned mine lands were taken from GIS layers, and were not field verified. Most of the pollution sources observed in the field along Upper Whitetail Creek were related to the riparian grazing and unpaved roads (Reaches 5 and 13). Brown trout were observed in the upper reaches of Whitetail Creek during the October field assessment. During the aerial assessment of the 1983 photos, disturbance below a prospect area was visible in Reach 4, but was not visible in 2001. In 1983, beaver ponds were visible on two major tributaries to Whitetail Creek: Grouse Creek and Gillespie Creek (Reach 7), but were gone by 2001.

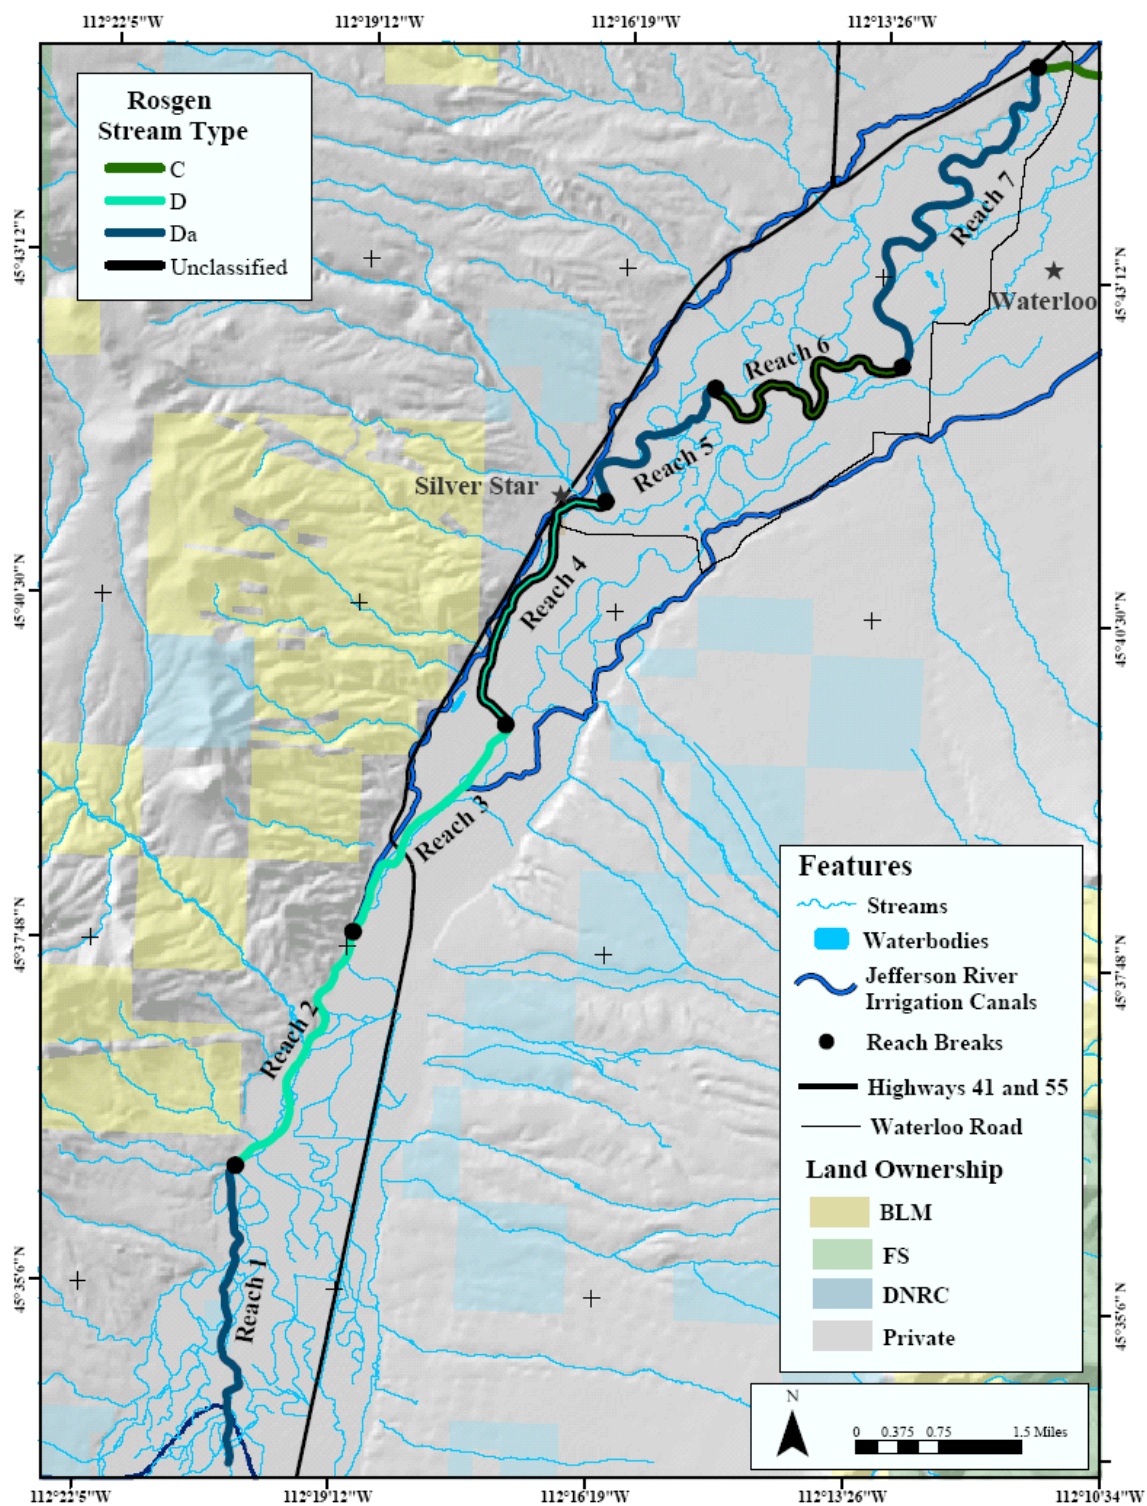
Figure 2-46. Upper Jefferson River Rosgen Stream Type, Reaches 1 to 7

An overall Rosgen stream type was assigned to the 14 designated reaches of the Upper Jefferson River (**Figures 2-46 and 2-47**). See **Table 2-9** for a review of the various channel patterns observed within the reaches. Overall Rosgen channel form changed for Reaches 4, 6, 11, 13, and 14 between 1983 and 1982. The changes were mostly due to the fact that drought impacts have reduced wetted channel width and exposed more gravel bars. Loss of wetted channel width has resulted in fewer channel anabranches in Reaches 6, 11 and 13; while exposure of gravel bars has increased channel braiding in Reaches 4 and 14. Subtle changes have occurred in Reaches 8, 10, and 12, but not enough to cause an overall change in the dominant channel type. It is the

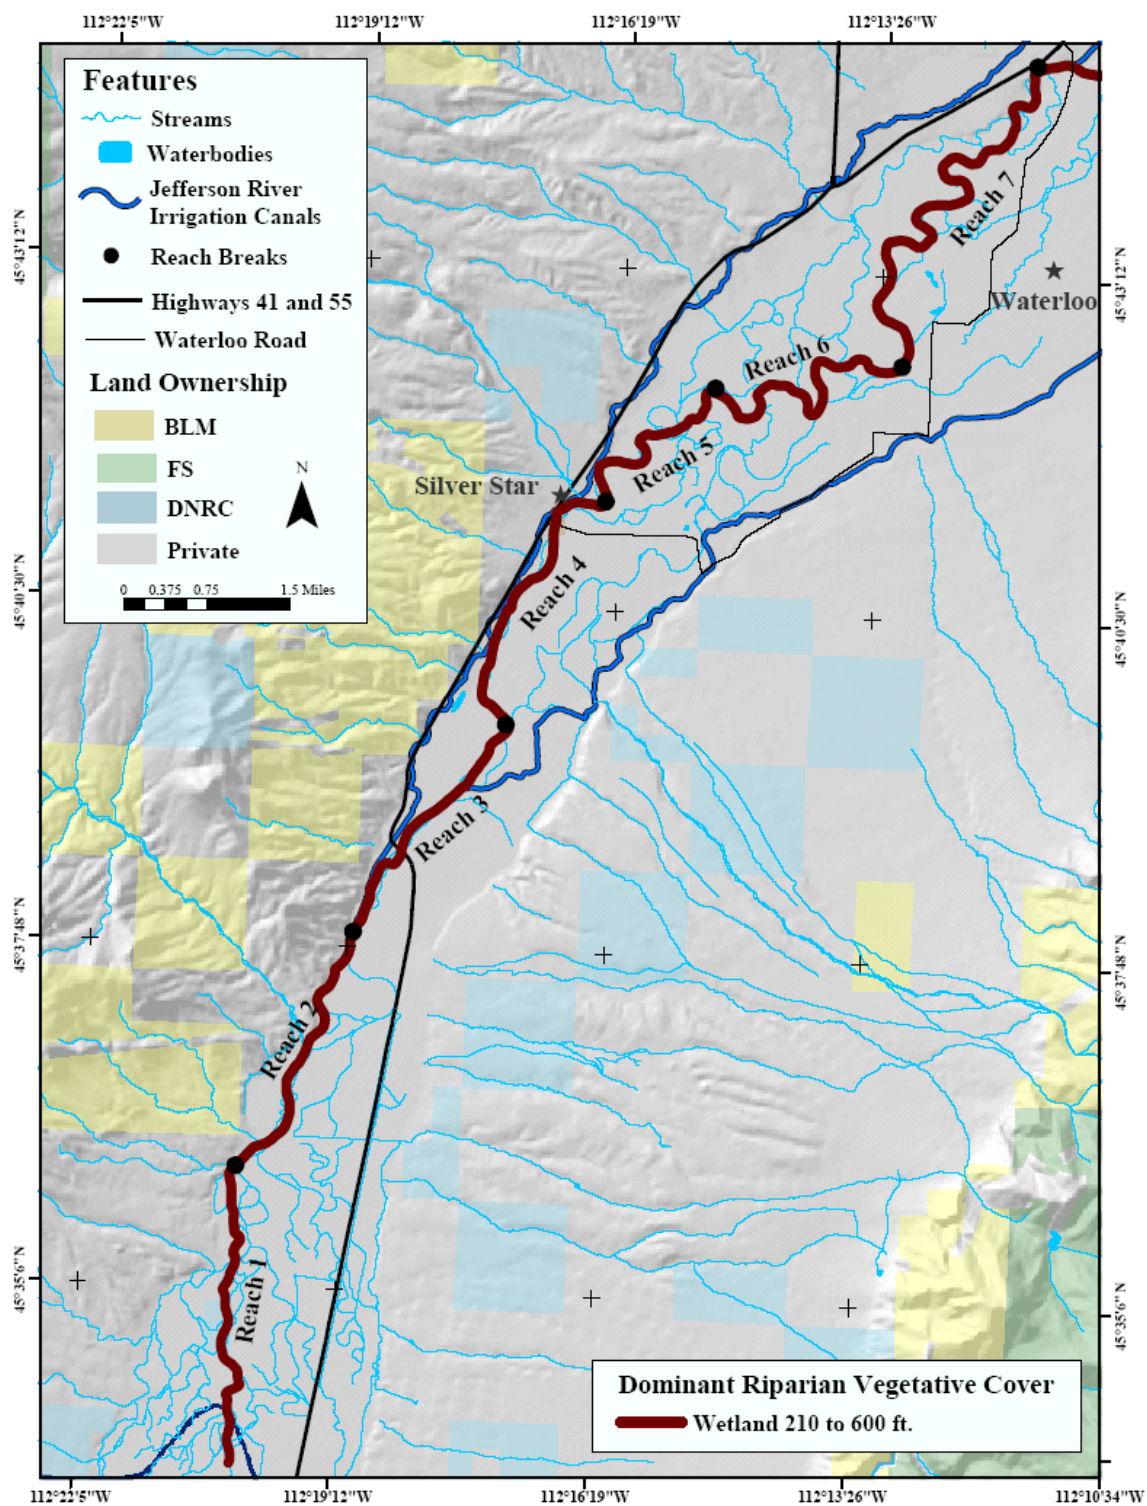
Figure 2-48. Upper Jefferson River Riparian Vegetation, Reaches 1 to 7

The dominant riparian cover along the Upper Jefferson River is wetland vegetation (**Figures 2-48 and 2-49**). Many types of cottonwoods, willows, shrubs and herbaceous plants were identified during the 2003 riparian inventory (Hoitsma Ecological, 2003). In general, wetland vegetation extended to 100 feet or more along both sides of the main river channel. Buffer widths for the 2002 photos were based on the GIS layer created by Hoitsma Ecological, but were measured from the aerial photographs for the 1983 analysis. Differences in riparian buffer widths between 1983 and 2002 should be interpreted with this in mind. Between 1983 and 2001, the riparian buffer width in Reaches 2, 3, and 4 appeared to increase by an average of 12 percent, 28 percent, and 26 percent, respectively. During the same time period, buffer widths appeared to decrease in Reaches 6, 7, and 14 by 25 percent, 57 percent, and 42 percent, respectively.

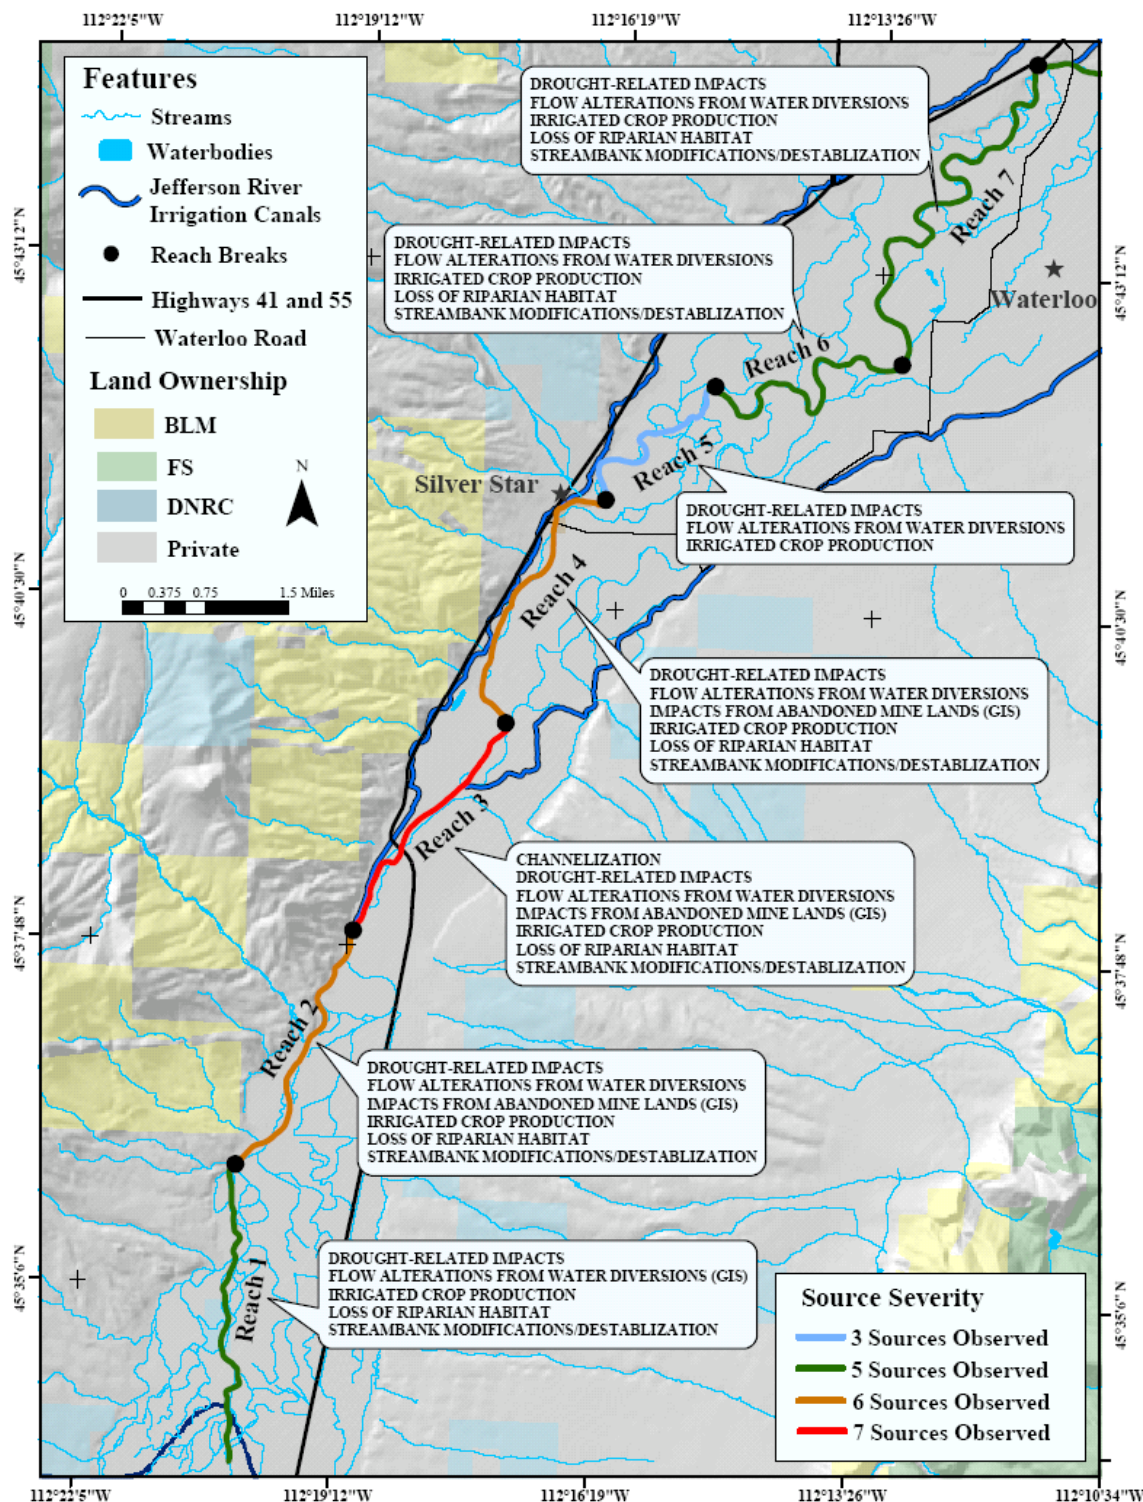
Figure 2-50. Upper Jefferson River Pollution Sources, Reaches 1 to 7

**Figures 2-50 and Figure 2-51** display the pollution sources assigned to the upper reaches of the Jefferson River. Aside from visible observations on the aerial photos and information from GIS layers, much of the pollution source information for the Upper Jefferson River for the 2002 analysis was taken from information collected during the 2003 riparian inventory (Hoitsma Ecological, 2003). The source of impacts from abandoned mine lands was taken from GIS layers which located abandoned mines up tributary drainages which eventually drain to reaches of the Upper Jefferson River.

This GIS identified source was not field verified, and results of the 2004 metals monitoring revealed no water quality violations for copper and lead in this section of the Jefferson River. Many pollution sources observed along the Upper Jefferson River were related to agricultural operations (irrigated agriculture, water diversions, loss of riparian habitat). All of the reaches assigned for the source of streambank modifications/destabilization were done so on the basis of information collected during the 2003 riparian inventory, and represent rip-rap, eroding banks, and impaired banks. The most notable difference in sources between 1983 and 2002 was the effect of drought.
