# McLaren Tailings

## Project Update

### August 8, 2013

Montana Department of Environmental Quality

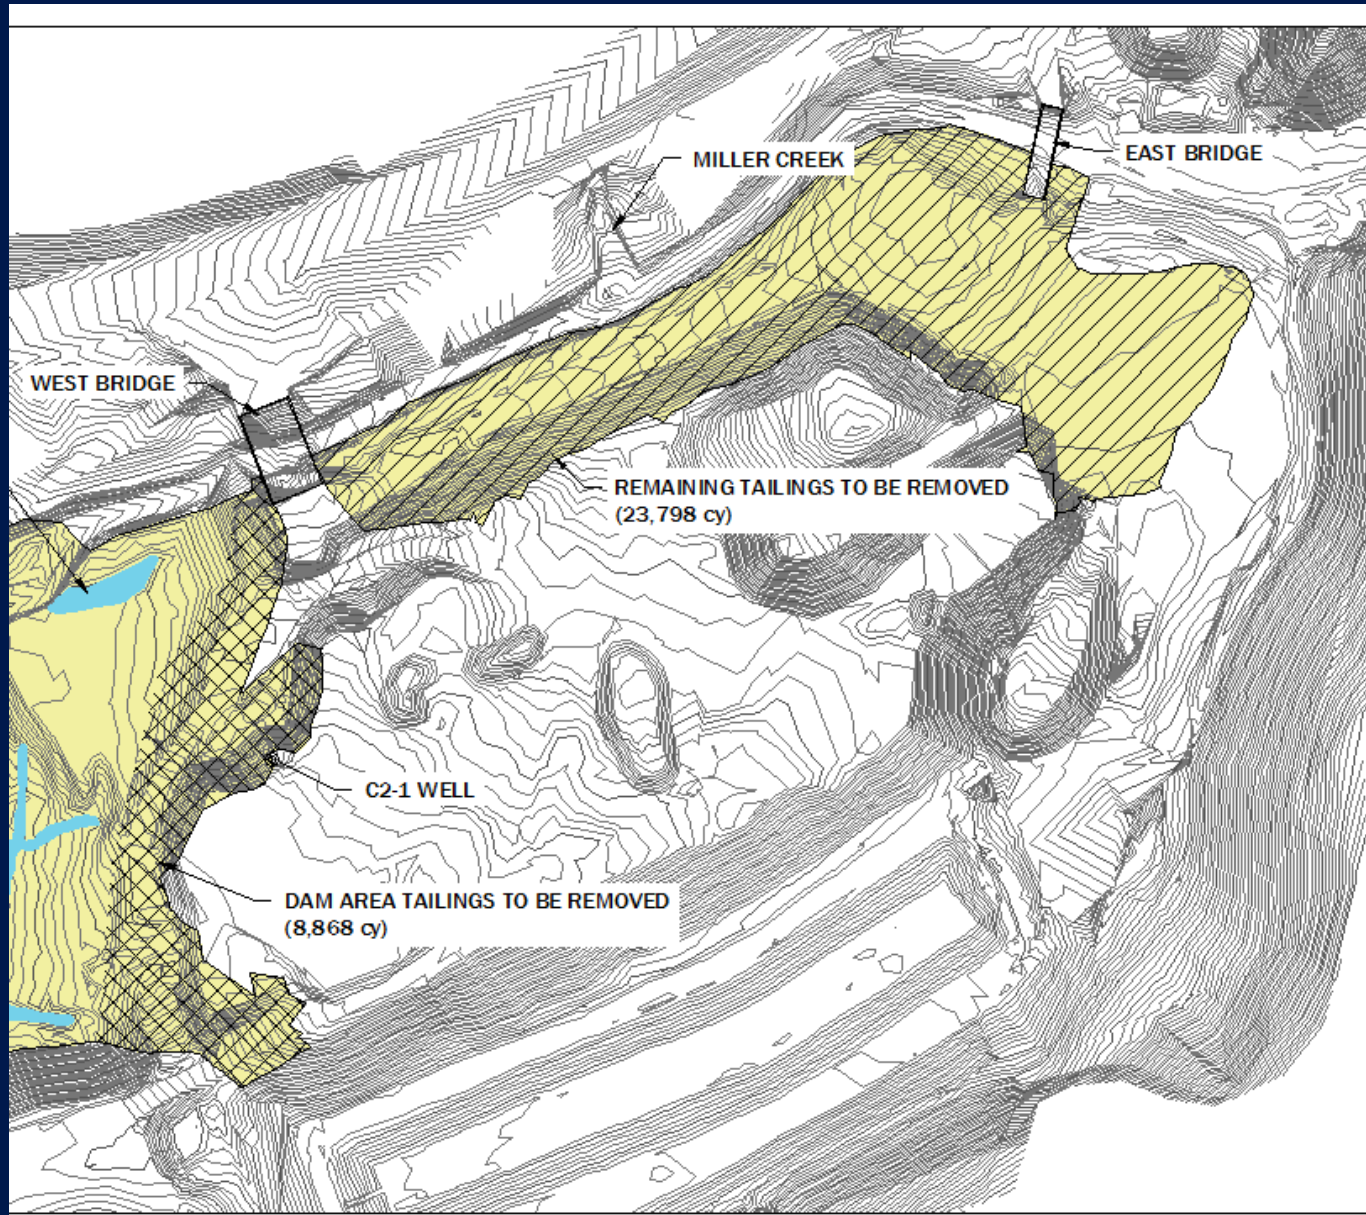
# 2013 Tailings Excavation

- Approximately 245,000 cubic yards of waste rock and tailings have been stabilized with lime and compacted in the repository.
- Compacted volume is approximately 230,000 cubic yards
- Approximately 4,000 cubic yards remain to be excavated along existing Soda Butte Creek.
- Soda Butte Creek will be relocated to new channel before remaining tailings are excavated.

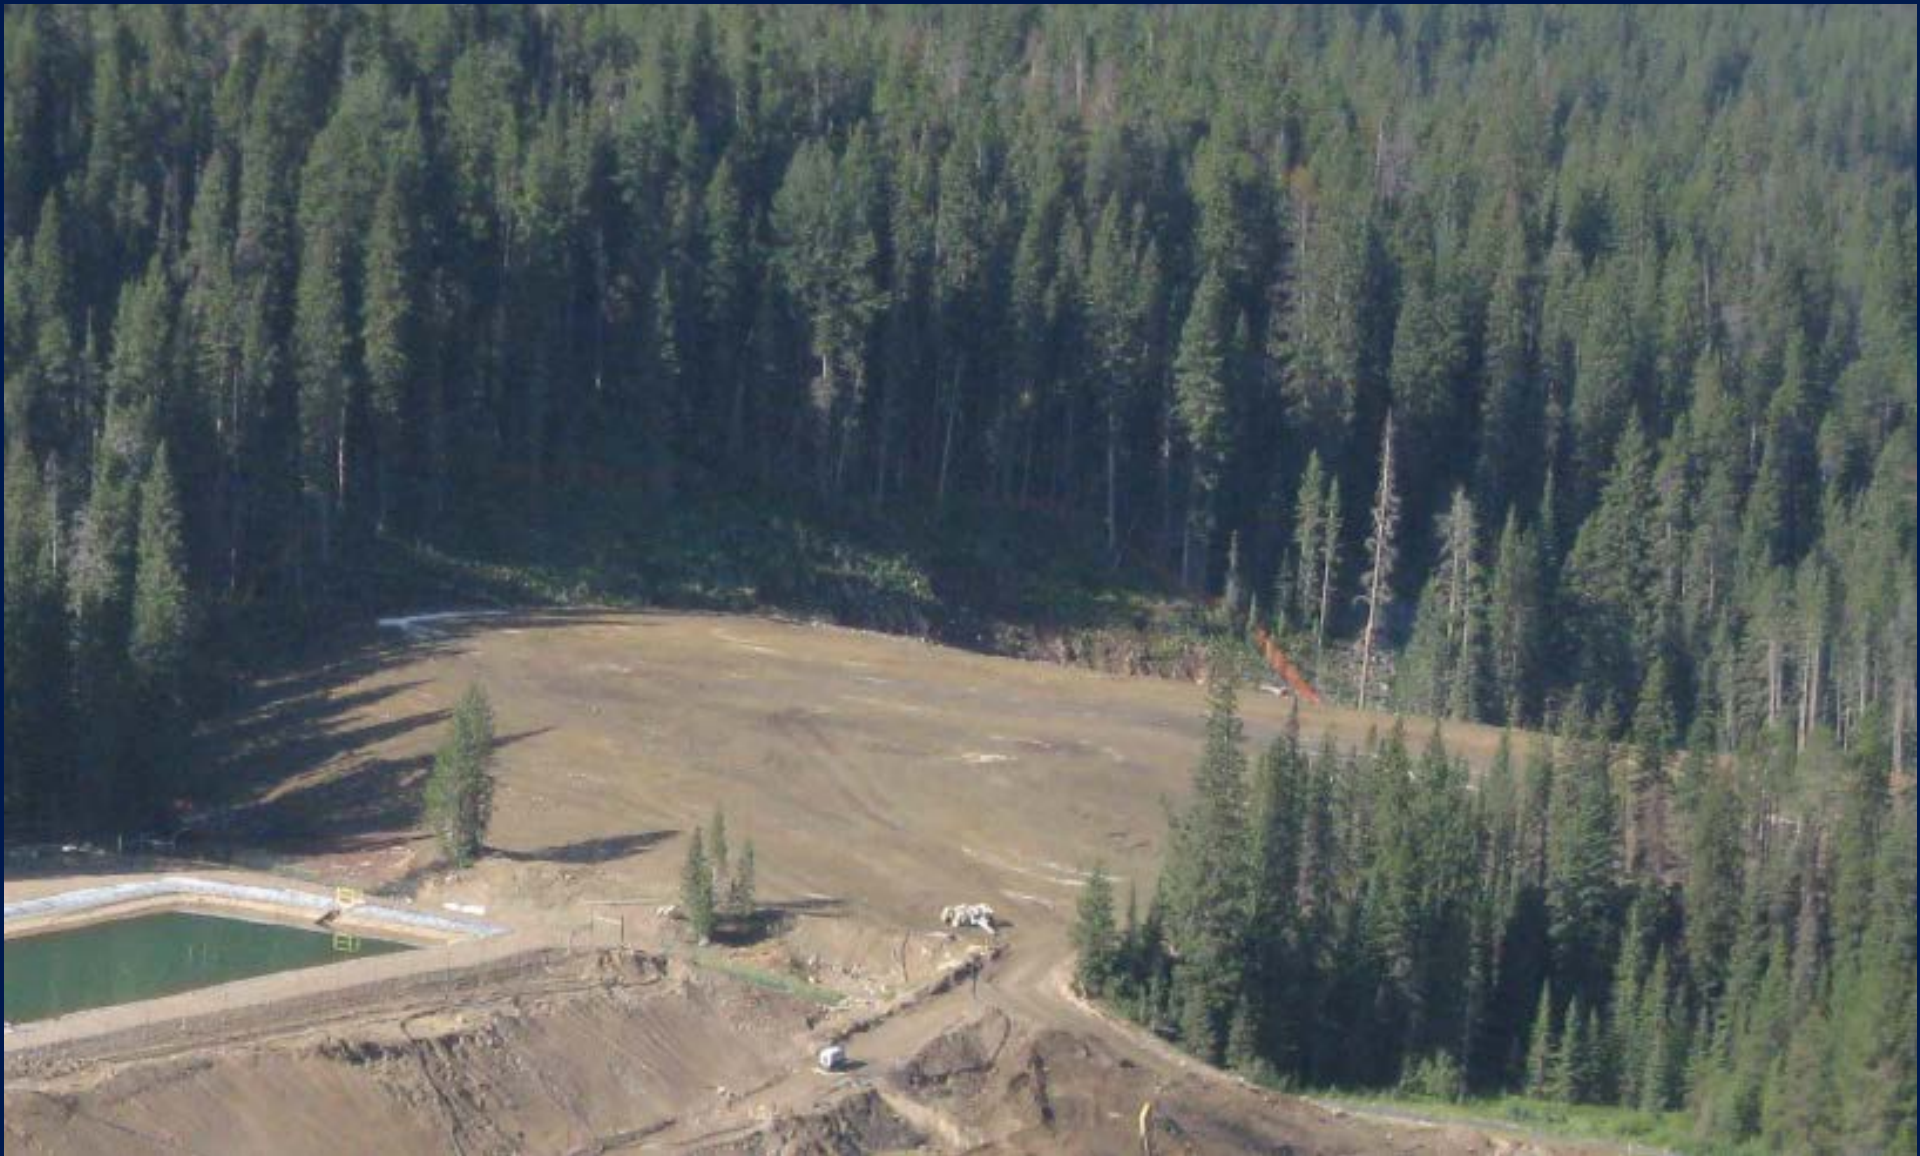
# Repository July 2013

- Design capacity is 236,000 cubic yards
- Currently contains 230,000 cubic yards
- Will be capped with a geochusion, 60-mil HDPE liner, drainage geocomposite, and 3 feet of cover soil.
- Side slopes are 5:1 horizontal to vertical based on seismic stability analysis for the area

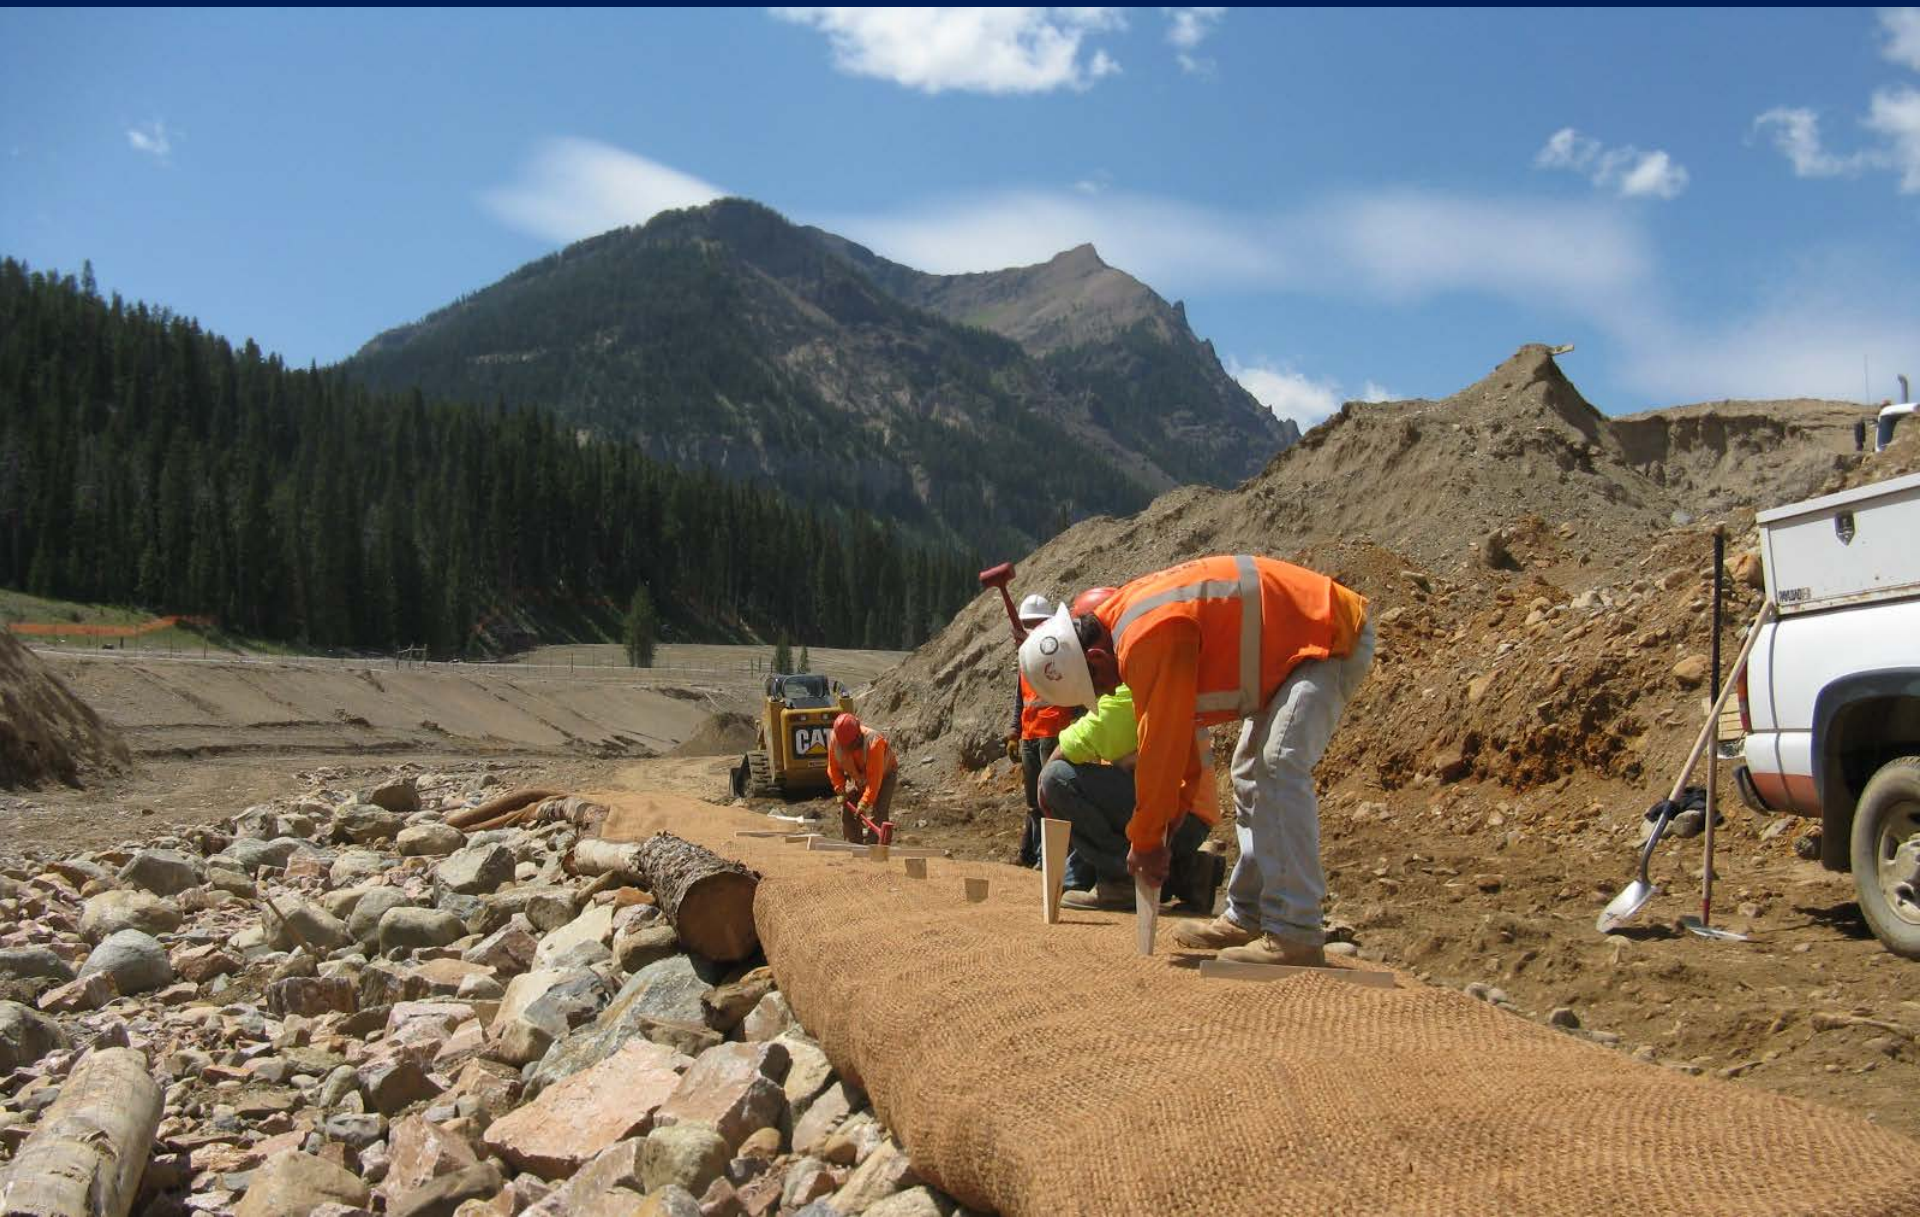
# Soda Butte Creek Reconstruction

- Initiated in July 2013
- Approximately 1,500 linear feet of Soda Butte Creek
- Approximately 525 linear feet of Miller Creek
- Willow brush, root wads and boulder clusters
- Riparian seeding
- Planting of willow stakes and shrub tubelings
