## DEARBORN TMDL PLANNING AREA

### *Channel and Riparian Aerial Assessment*

**LAND & WATER CONSULTING, INC.**  
PO Box 8254  
Missoula, MT 59807

July 2004

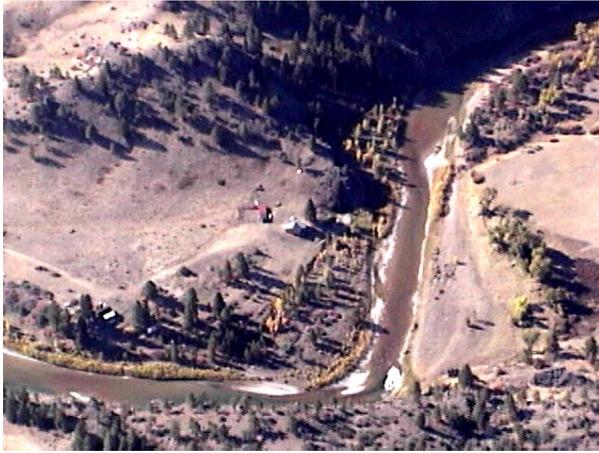
**Figure 3-3. Dearborn Reach DR1**

Shade provided by riparian vegetation to the stream channel was very limited on all reaches of the Dearborn mainstem. This resulted in part from low to moderate tree densities and canopy coverage, but also because tree heights and offset from the channel resulted in minimal shade projected to the water surface (e.g. **Figure 3-3**). Channel widths exceeding 100 feet limited effective shading potential from even mature Cottonwood stands adjacent to the river. The majority of shade to the Dearborn mainstem was related to topographic influences (see **Figures 3-3, 3-4, 3-7**).

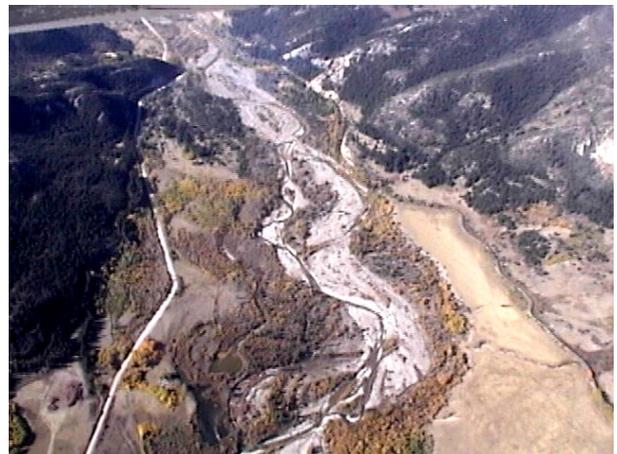
**Figure 3-8. Dearborn Reach DR6**

Impervious/urban impacts on the mainstem of the Dearborn were infrequent and were limited to isolated road crossings and channel modifications. Bare ground or disturbed areas were present as gravel bar deposits or rock formations. Bare ground was largely unrelated to anthropogenic influences. Bare ground was especially characteristic of the braided reach in DR6 (20%).

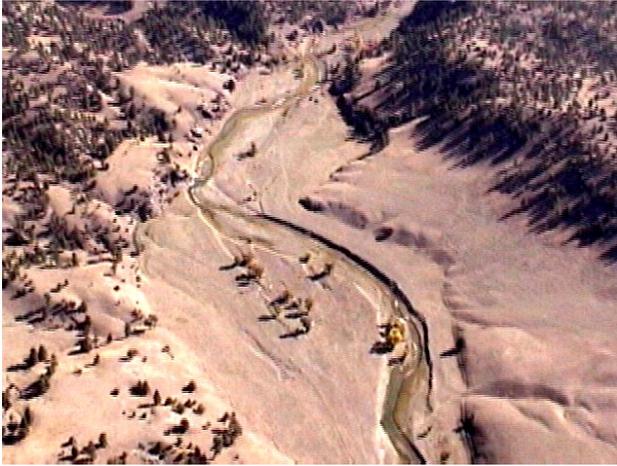
**Figure 3-17. Flat Creek Reach FC1  
Unconfined Lower Reach**

The lowermost reach FC1 had the highest frequency of tree components, although herbaceous species were the dominant vegetation type (**Figure 3-17**). Average riparian buffer width was 47 feet in reach FC1 and was composed of about 79% herbaceous vegetation and 21% mixed conifer/deciduous and woody shrubs

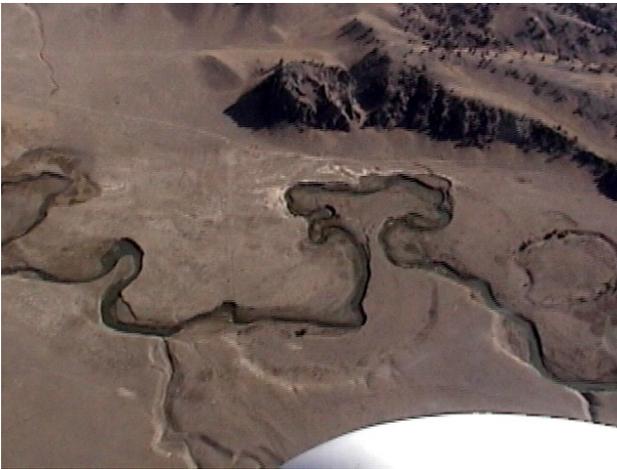
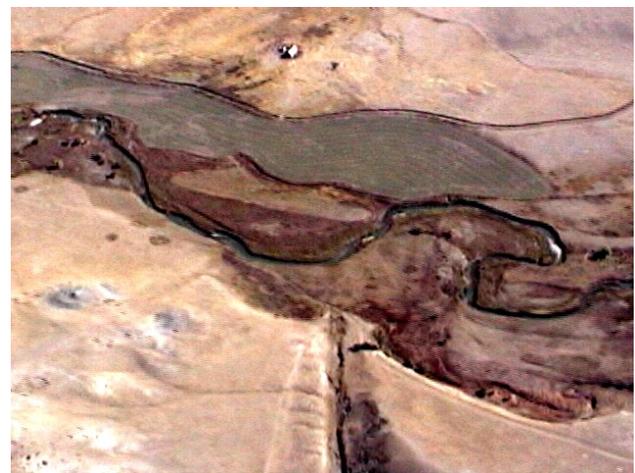
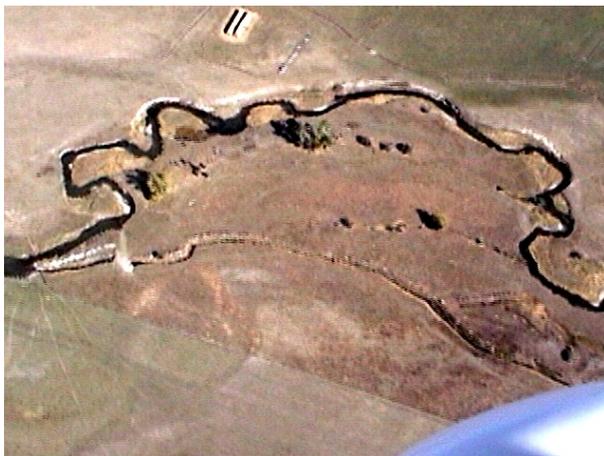
Vegetation in the upstream reaches FC2, FC3, FC4 was largely herbaceous, with lesser amounts of remnant and decadent woody shrub species. Riparian buffer width (36 to 78 feet) was low in these upper reaches of Flat Creek relative to potential (**Figures 3-19 to 3-21**).

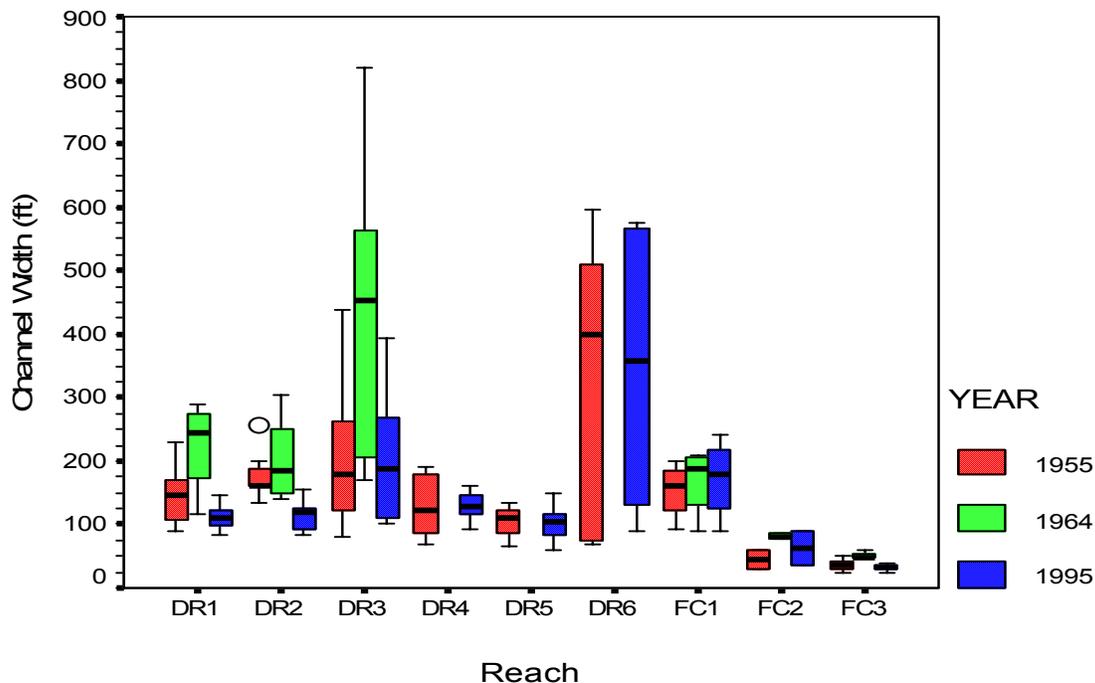
Figure 3-22. Estimated Channel Width in the Dearborn Planning Area in 1955, 1964, and 1995

In general, measurements showed that channel widths increased substantially following the 1964 flood, and that 1995 widths were comparable to pre-flood (1955) values ( **Figure 3-22**).

Channel response to the 1964 flood resulted in significantly increased channel widths. In Dearborn reach DR1, channel width increased about 50%, from a 1955 value of 146 feet to 223 feet post-flood (Table 3-7). The Dearborn reach DR2 increased about 17% from a 1955 value of 176 feet to 205 feet post-flood, and reach DR3 nearly doubled in width to 429 feet. By 1995 these reaches had returned to pre-flood channel widths. DR1 and DR2 were narrower in 1995 compared to 1955. For reaches DR4 and DR5, 1964 data was not available. However, 1955 and 1995 measures show channel widths to be nearly identical.

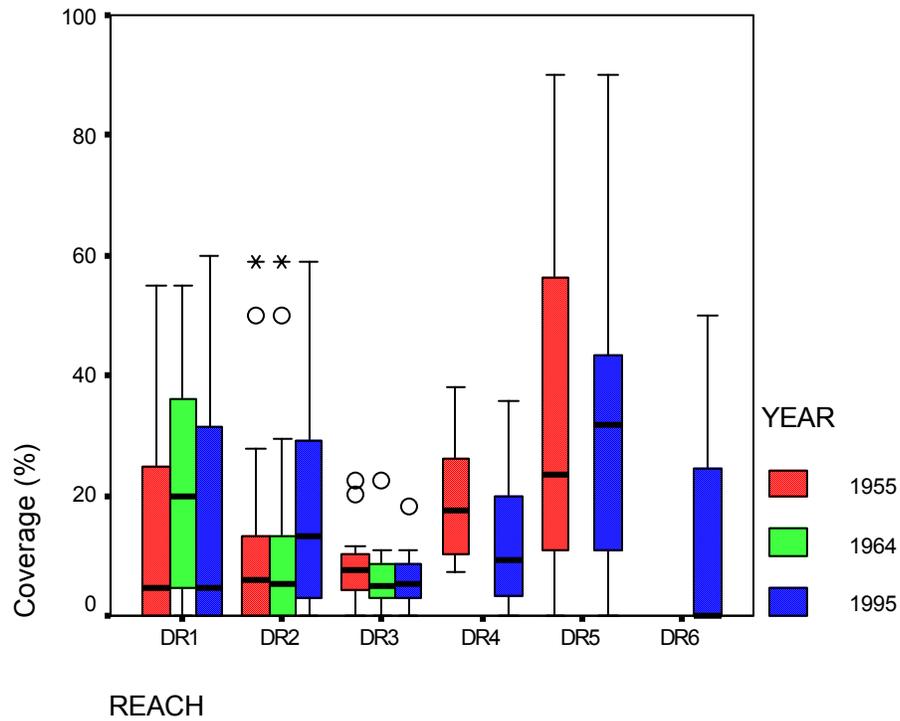
Figure 3-23. Conifer/Deciduous Coverage in the Dearborn Mainstem in 1955, 1964, and 1995

Boxplots of individual riparian vegetation components are shown in (Figures 3-23 to 3-26). Conifer and deciduous tree coverage in reach DR1 was similar in 1955 and 1995, and was significantly higher in 1964 (Figure 3-23). Reach DR2 was similar in 1955 and 1964, and increased in 1995. Reach DR3 showed little change in tree coverage from 1955 to 1995. Reach DR4 decreased from 1955 to 1995, and reach DR5 increased tree coverage over the same time period. No historic data was available for reach DR6.

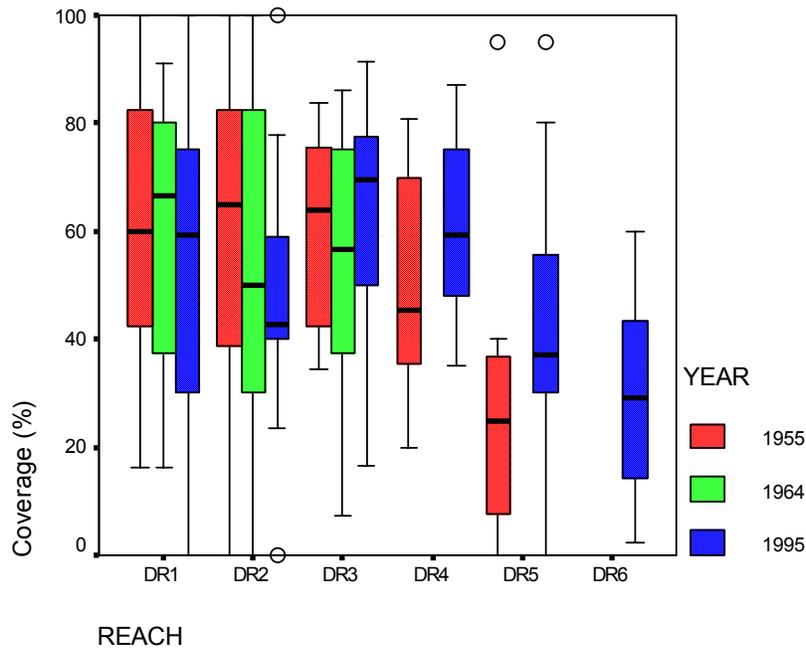
**Figure 3-25. Herbaceous Coverage in the Dearborn Mainstem in 1955, 1964, and 1995**

Overall, herbaceous coverage tended to increase in the downstream direction with median values of 60-70% in the lower reaches, and values of 20-40% in the upper reaches (**Figure 3-25**). Herbaceous coverage in reach DR1 was similar in 1955 and 1995, and showed a small increase in 1964. Reach DR2 herbaceous coverage decreased from 1955 to 1995, and showed corresponding increases in trees and shrubs. Reach DR3 showed a drop in herbaceous coverage in 1964, and was slightly higher in 1995 than 1955. Reaches DR4 and DR5 showed significant increases in herbaceous coverage from 1955 and 1995. Decreases in shrub coverage were also noted during this period. No 1955 or 1964 data was available for reach DR6.

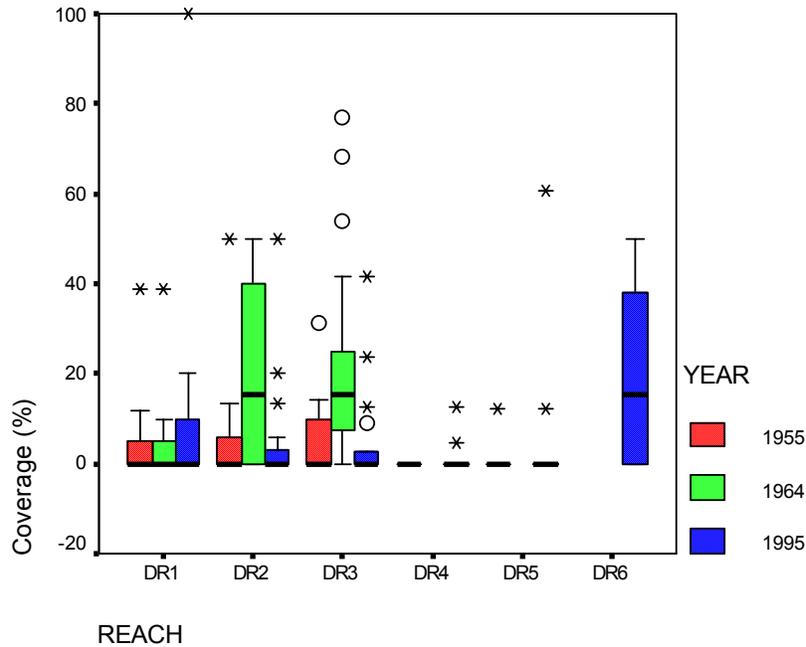
Figure 3-26. Bare Ground in the Dearborn Mainstem in 1955, 1964, and 1995

Overall, bare ground was a minor component in riparian areas, generally less than 10% (Figure 3-26). Significant increases in disturbed, bare ground was observed following the 1964 flood in DR2 and DR3. This increase in disturbed ground returned to pre-flood levels in 1995.

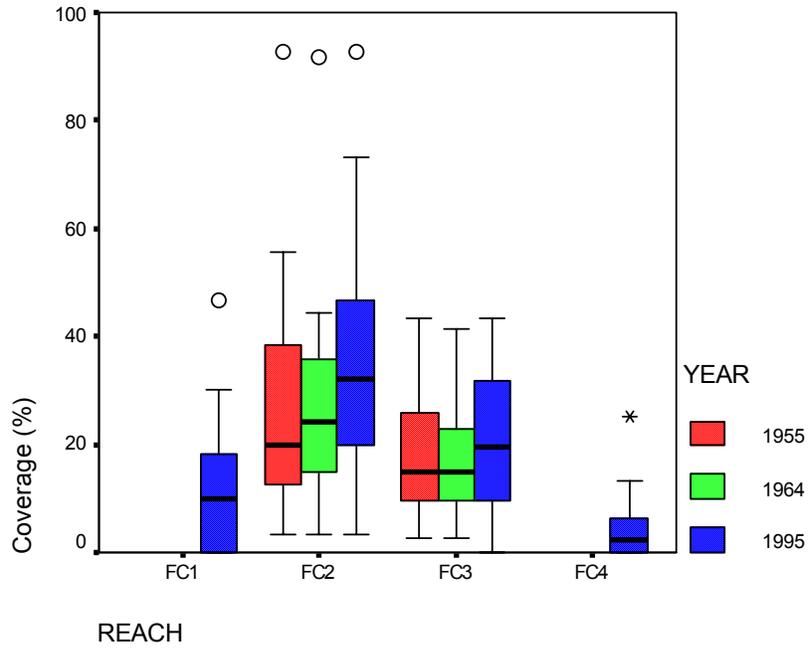
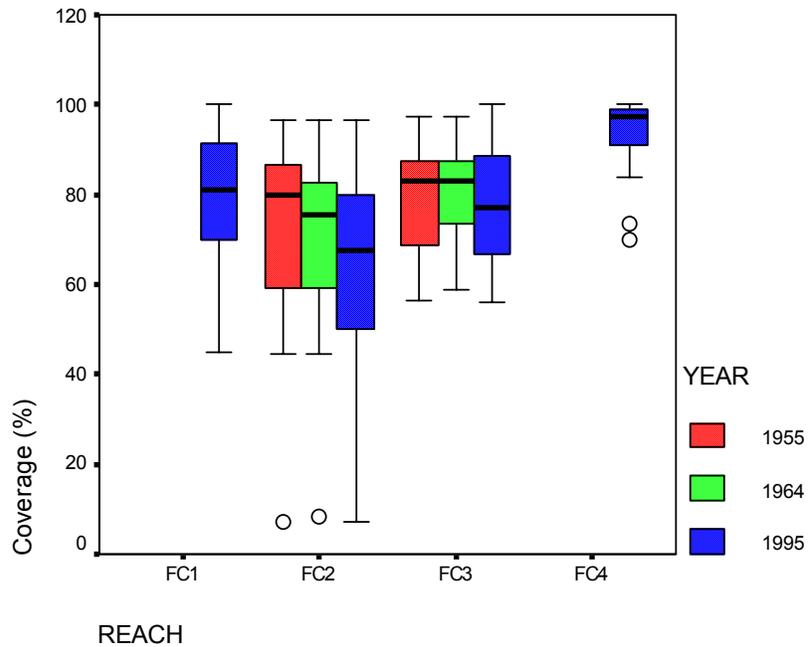
The proportion of woody shrub coverage tended to increase in Flat Creek reach FC2 and FC3 from 1955 to 1995. The increase amounted to 5 to 10% greater woody coverage in 1995 relative to 1955 (**Figure 3-28**). Herbaceous coverage also tended to decrease over the same time period reaches FC2 and FC3 (**Figure 3-29**). No historical coverage was available for reaches FC1 and FC4.

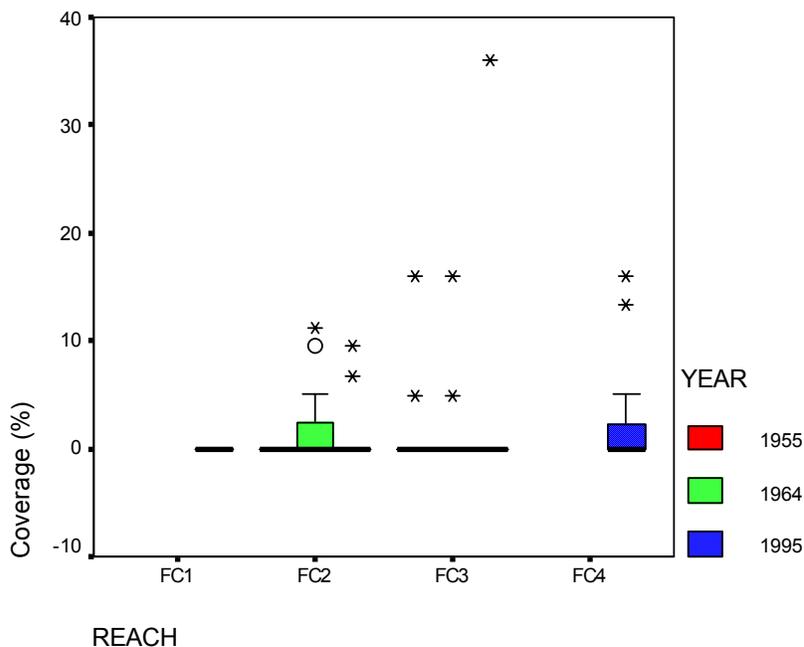
Figure 3-30. Bare Ground in Flat Creek in 1955, 1964, and 1995

Bare ground was infrequent in Flat Creek and amounted to less than 1% overall. A slight increase in bare ground was observed in 1964 in reach FC2, but was otherwise unchanged from 1955 to 1995.

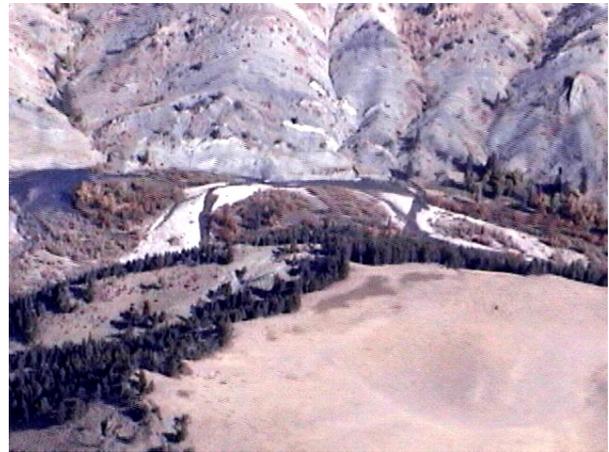
**Figure 3-34. Typical Smaller Contributing Drainages to the Dearborn Mainstem**

The majority of smaller drainages and tributaries to the Dearborn mainstem appeared to be vertically stable, and were not a significant source of sediment to the Dearborn (**Figure 3-34**). The Middle and South forks of the Dearborn did not show any significant sources of sediment from influent tributaries.
