Extra Insulation and Air Sealing Provides Helena Habitat Homeowner with Annual Heating Bill of \$100

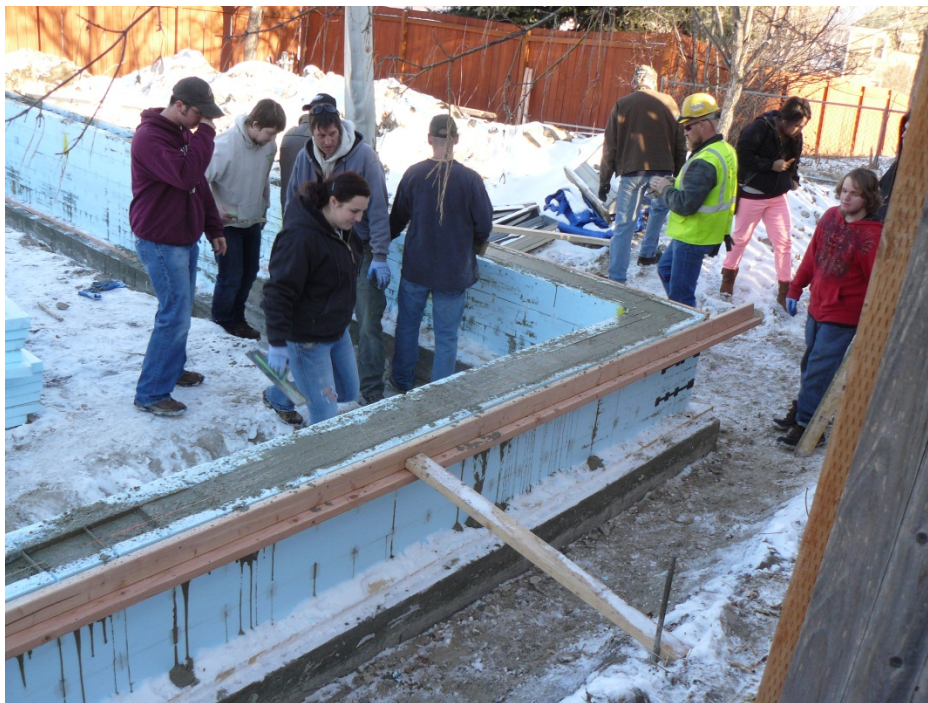
Foam Foundation – Youth Build Students cut 2-inch DOW boards for Lite Form inserts and placed and filled the forms with concrete.

the foundation and causing frost heave. DOW Chemical provides blue board free of cost to Habitat affiliates. The students cut DOW blue board to form the foundation walls and placed four inches of blue board (R-20) under the entire concrete floor.

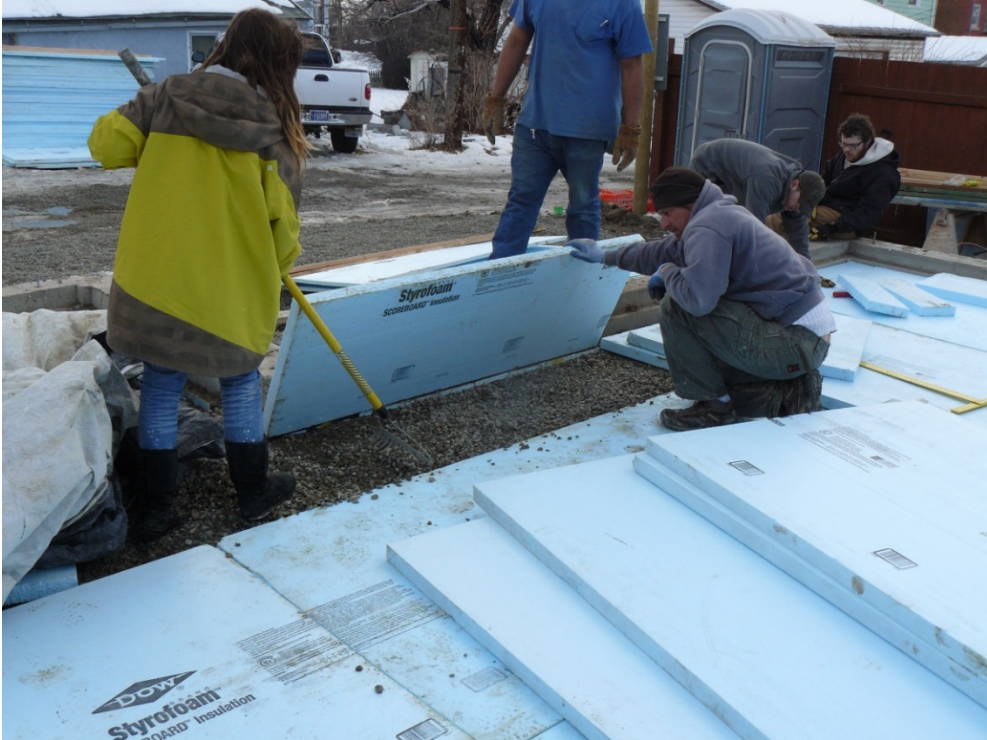
2 layers of 2-inch DOW board (insulating value of R-20) was placed under the entire under floor.

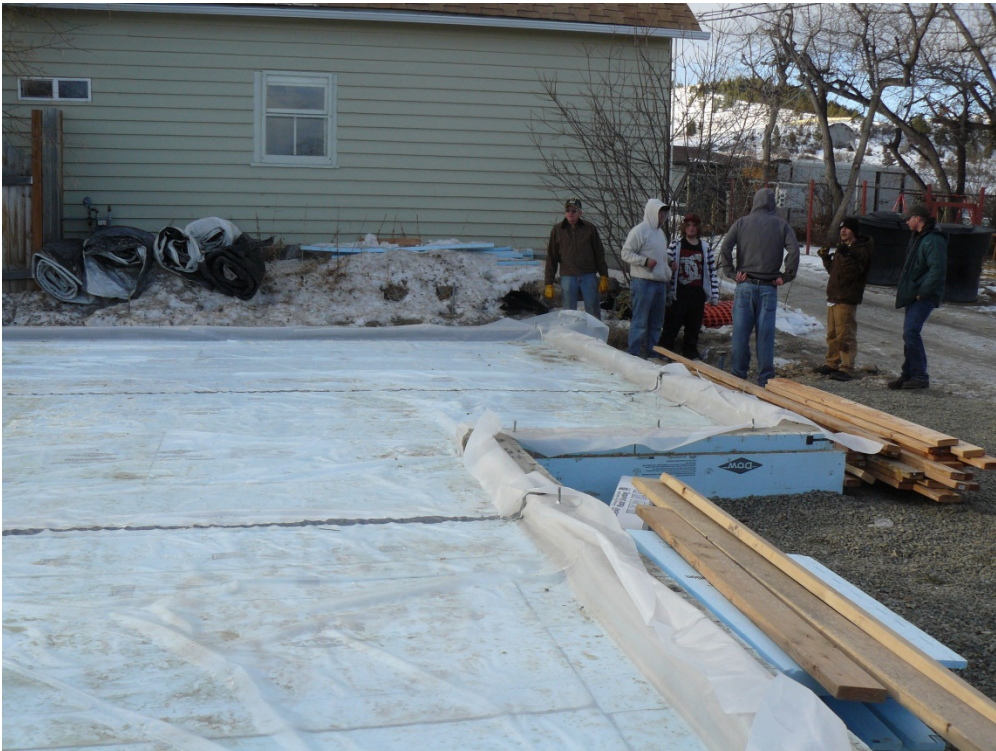
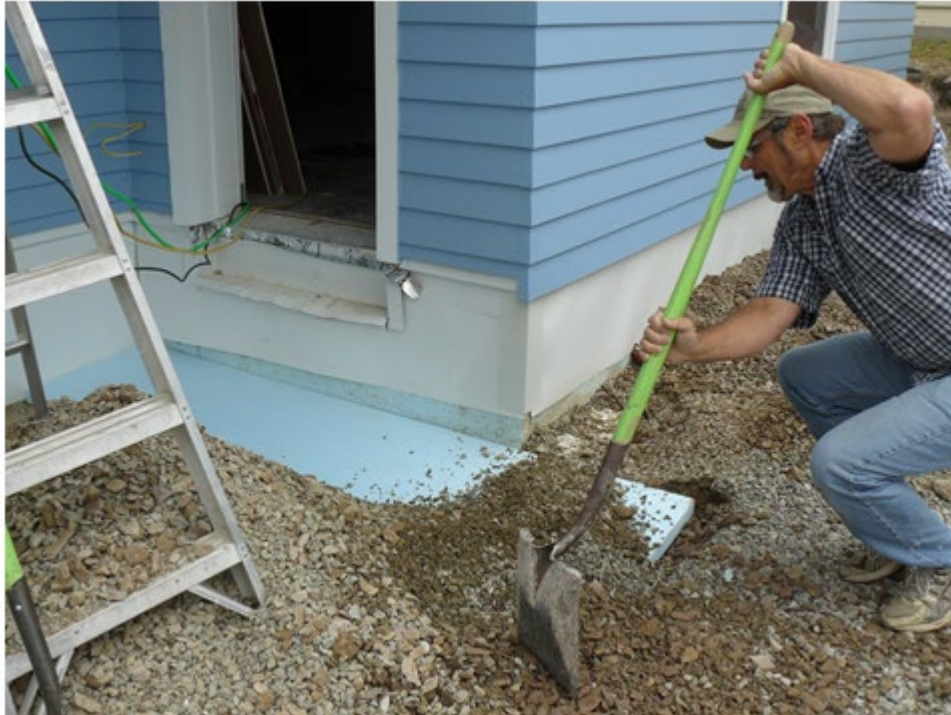
2 feet horizontal layer of R-10 prevents frost from getting under the foundation.

Building simple, decent, and affordable houses while keeping in mind the ability of families to afford utility bills is the model for Habitat affiliates. The home on Spencer Street was built on a shallow, frost protected slab-on-grade foundation, which requires less excavation— two feet compared to a conventional foundation requiring four feet. A two-foot horizontal wing of R-10 blue board foam prevents frost from getting under

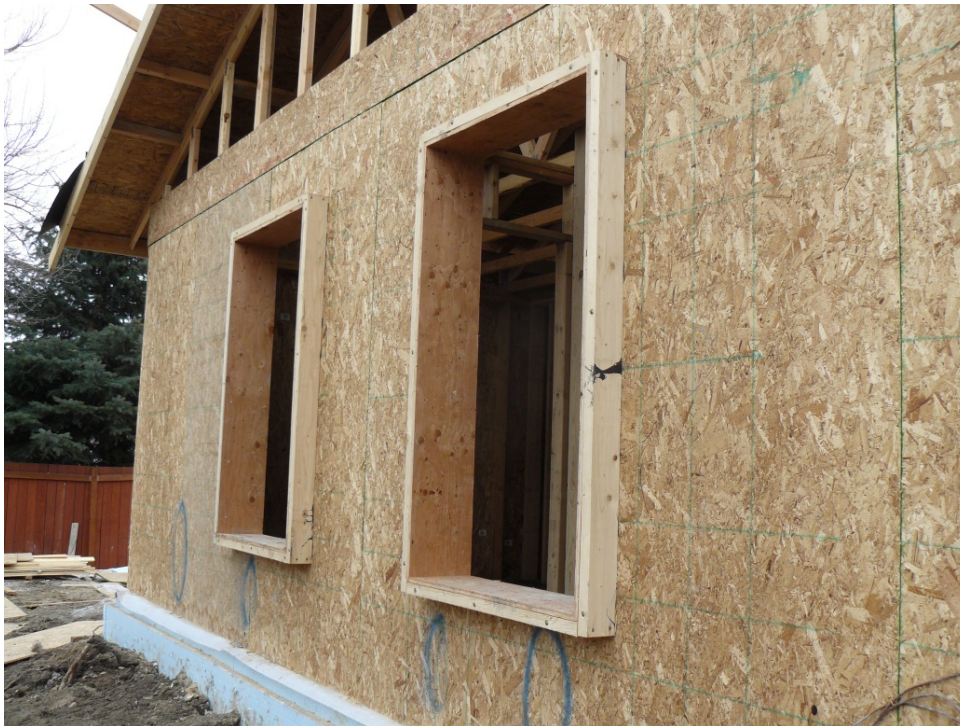
Wall extension framing for windows, ready for 4 inches of DOW board (R-20) foam sheathing.

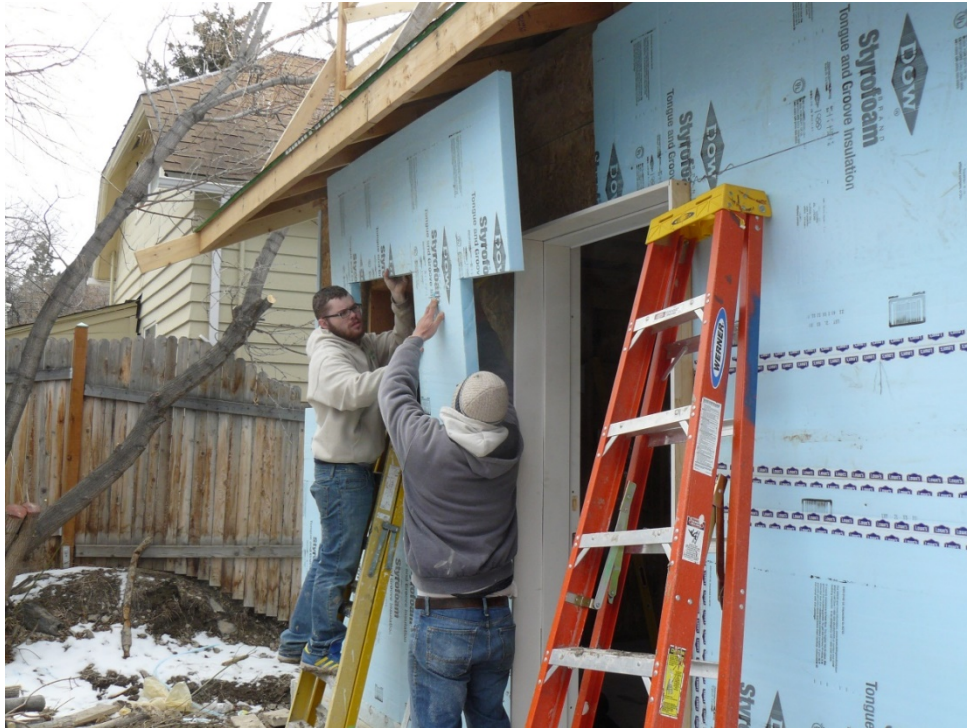
Exterior walls have R-21 fiberglass batt in the wall cavity and two layers of R-10 foam sheathing with seams taped on each layer for total wall of R-41.

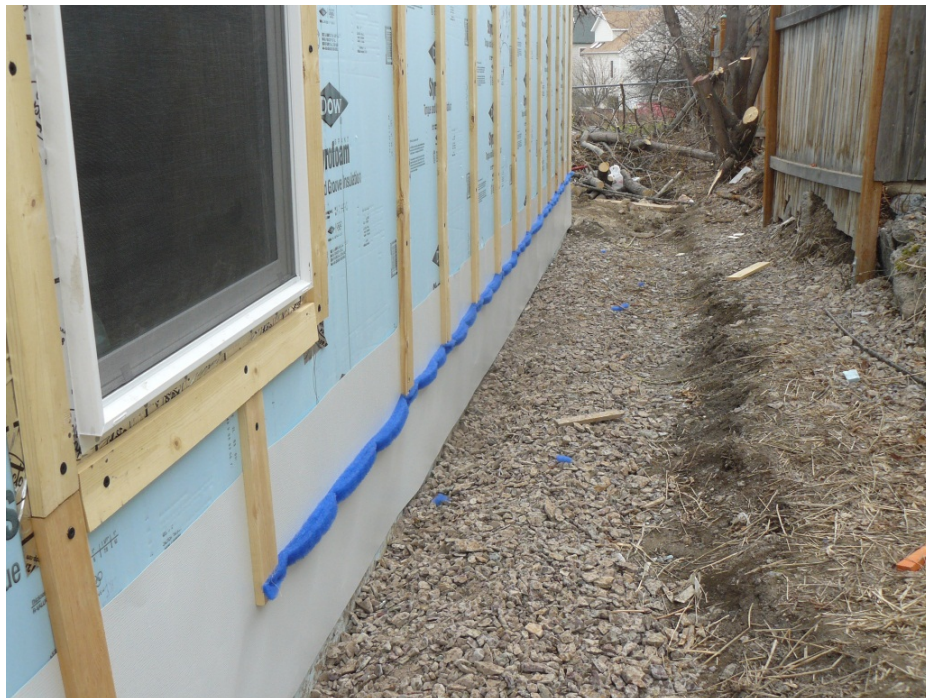
1X4 furring strips were screwed to wall framing creating a $\frac{3}{4}$ inch space (vented rain screen) behind the siding. Note: The blue bugs screen at bottom of the siding. Foam foundation is protected with coil stock metal covering.

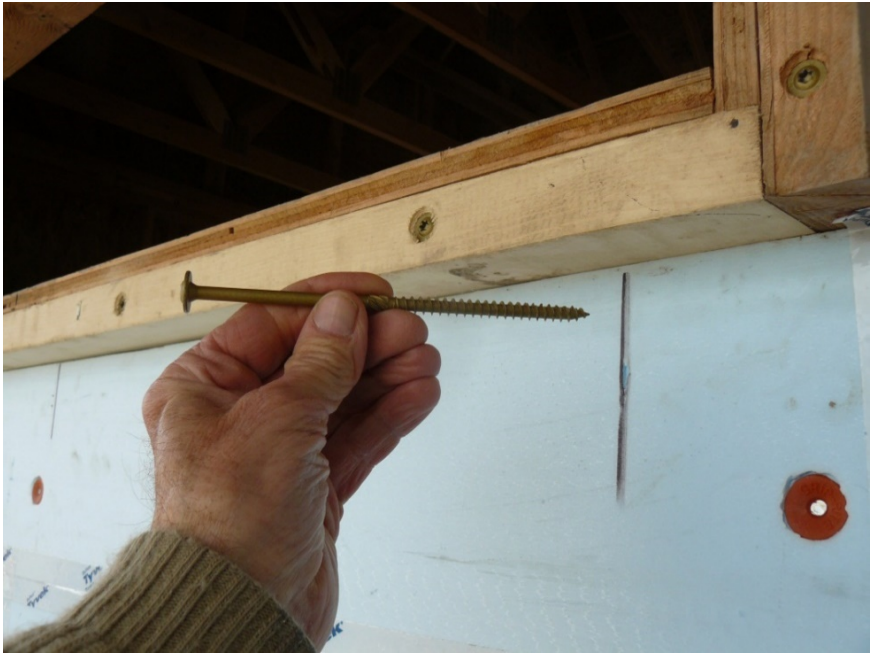
Long screws were used for attaching window and siding supports to the wall framing.

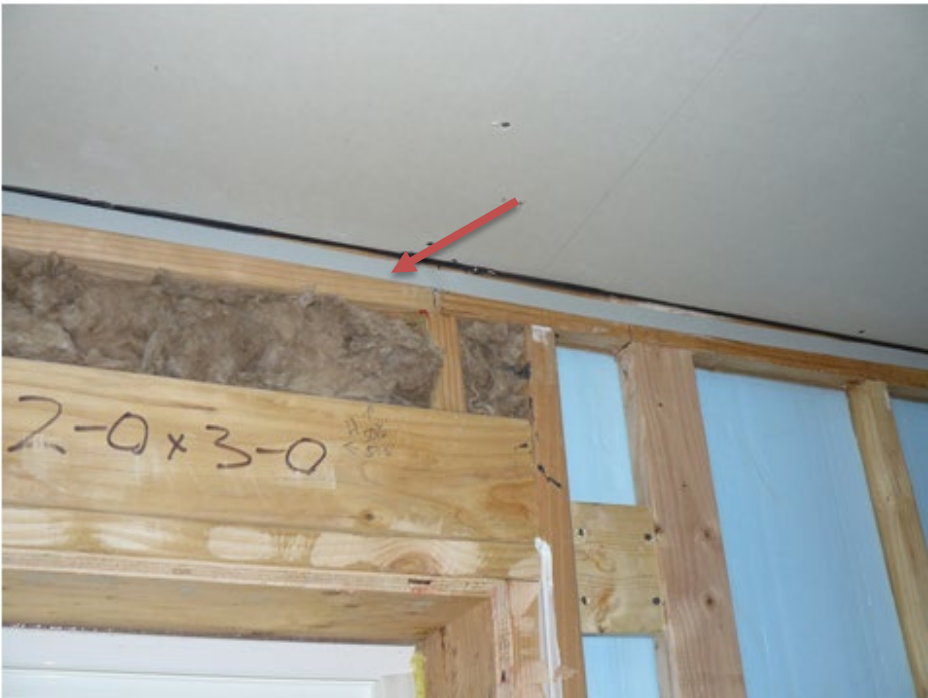
Foam seal used at top plate of interior and exterior walls. Note: The bathroom exterior wall has DOW board for cavity insulation.

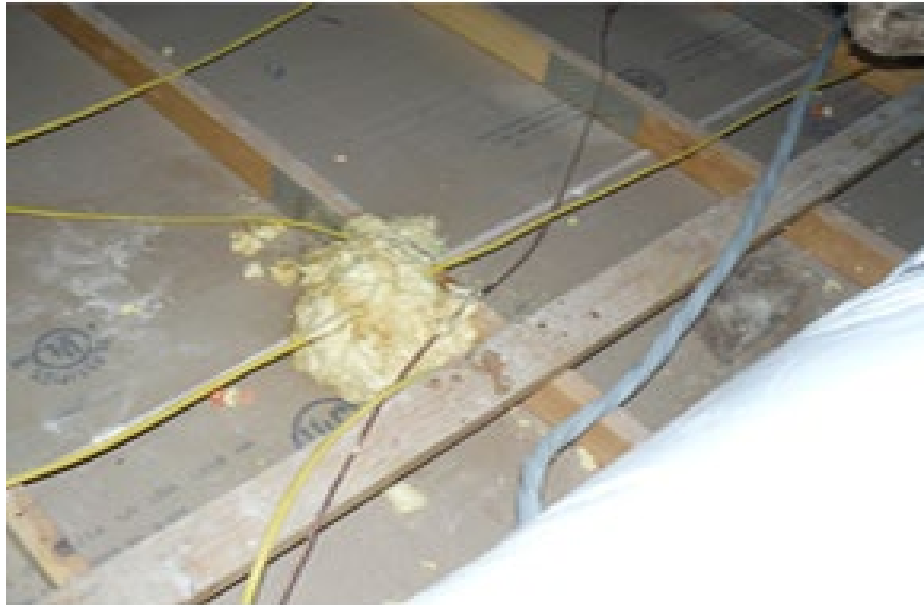
Spray foam air sealing at electrical boxes in the attic.

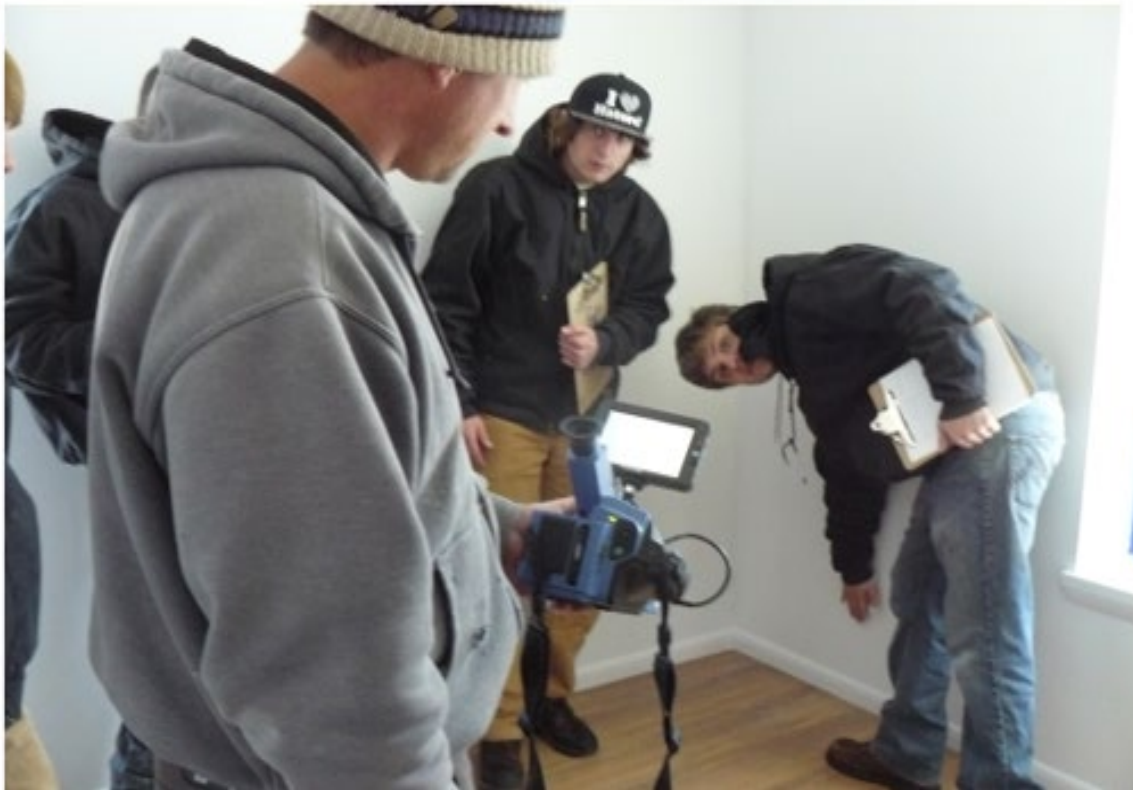
Montana DEQ conducted several trainings at the house with a blower door and infrared camera. Here Youth Build students detect slight air leakage at an exterior wall electrical outlet.
