# FINAL ENVIRONMENTAL ASSESSMENT

PARK MINE AND MILL SITE  
INDIAN CREEK RESTORATION  
ABANDONED MINE LANDS PROJECT  
BROADWATER COUNTY, MONTANA  
PA # MT004012

*November 2015*

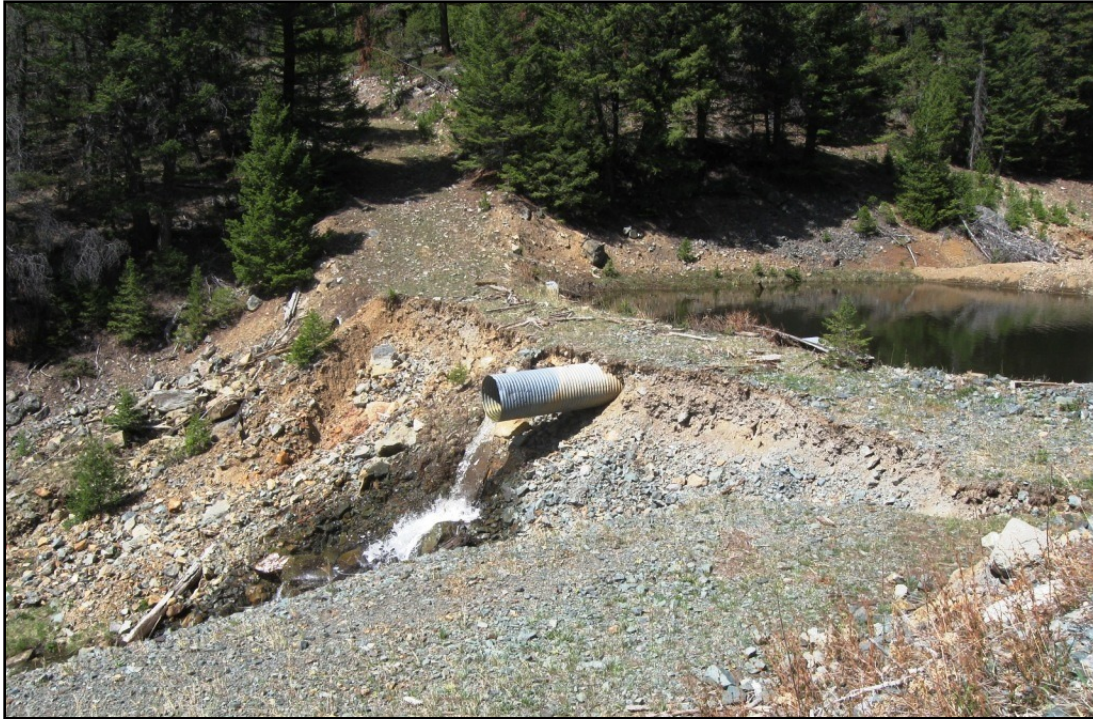
**Erosion of dam impounding Indian Creek.**

Currently, the roadway fill prism acts as a dam, which resulted in the development of an in-channel impoundment. Two corrugated metal pipe culverts were installed as outlets from the impoundment. This area, identified as area TP-3A in both the Final Reclamation Restoration Report for the Park Mine and Mill Site (Pioneer 1996) and the Expanded Engineering Evaluation/Cost Analysis (EE/CA) (Pioneer 1997) was not included in the reclamation activities completed in 1997 and 1998 because the impoundment was to be used as a sediment catch basin as the areas upstream revegetated. Substantial erosion of the downstream face of the prism has occurred prompting the need to remove the dam and sediments and complete restoration of Indian Creek that began in 1997. The feature has been categorized as a Priority 1 Dangerous Impoundment due to its potential risk to downstream resources including property, and environmental degradation.

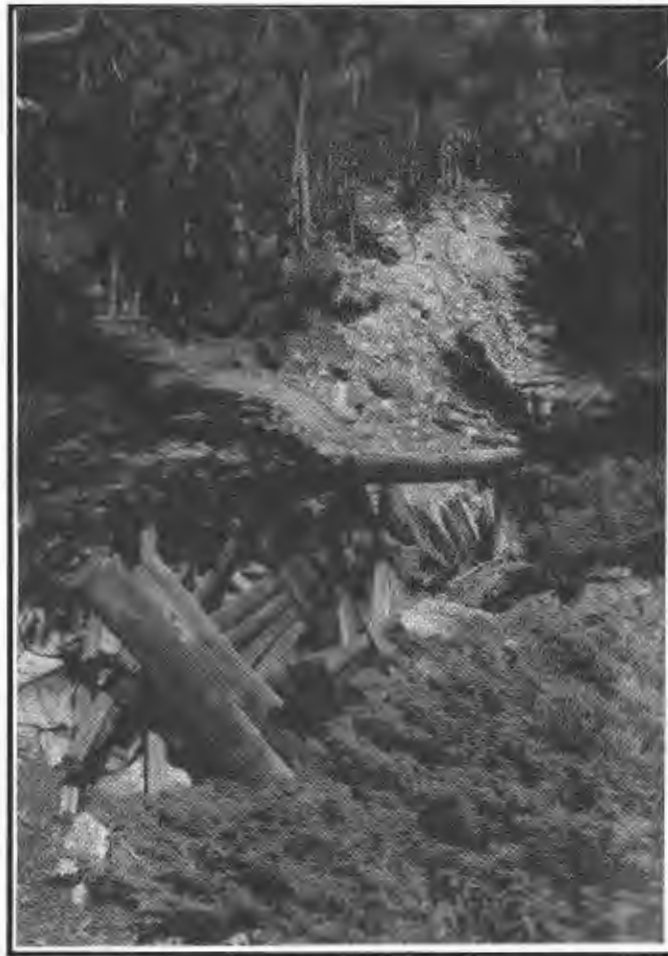
Figure 3. Feature 34 adit portal near center of 24BW210.

Twenty-five of the features recorded at the Park Mines site are adits, shafts, waste rock dumps, and associated features (Figures 3 and 4). The unusually large number of older scattered adits and waste rock piles may be explained by the independent operation of adjacent claims, and a pattern of leasing and sub-leasing portions of claims just before the turn of the century (Western Mining World 1898b). There are numerous depressions that were not recorded because they were thought to be prospects instead of mine openings. Also, some of those appear to post-date the historic period because of their large size, relatively little vegetation, or proximity to like depressions. This observation is consistent with one observer's report about his 1960 visit to the property. Schell (1963:24) noted bulldozer cuts where the vein of ore was exposed, presumably as part of Northern Milling Company's exploration and development of the Marietta Mine.

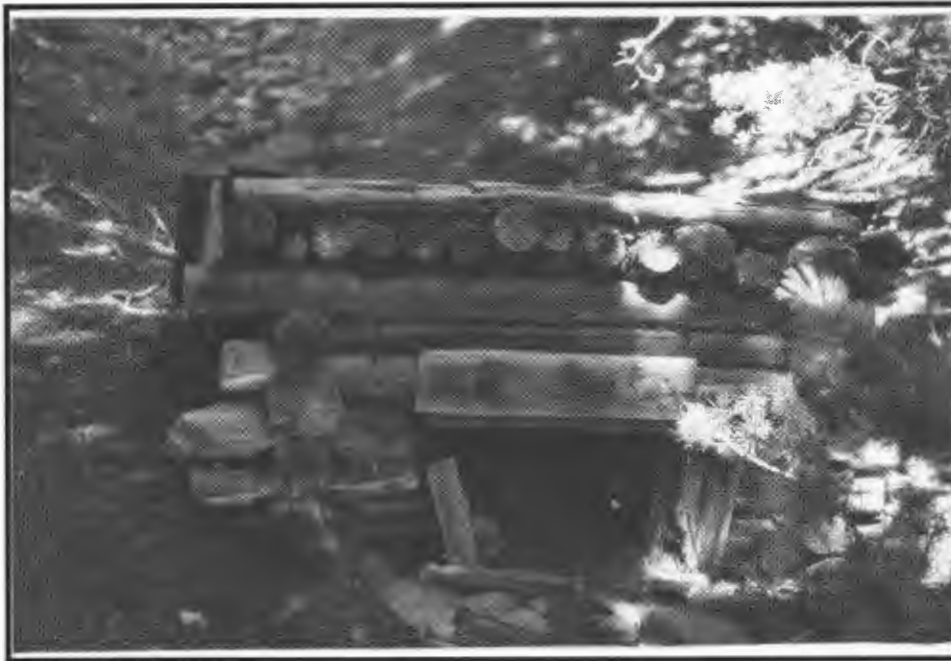
Figure 4. Feature 10 adit portal at north end of 24BW210.

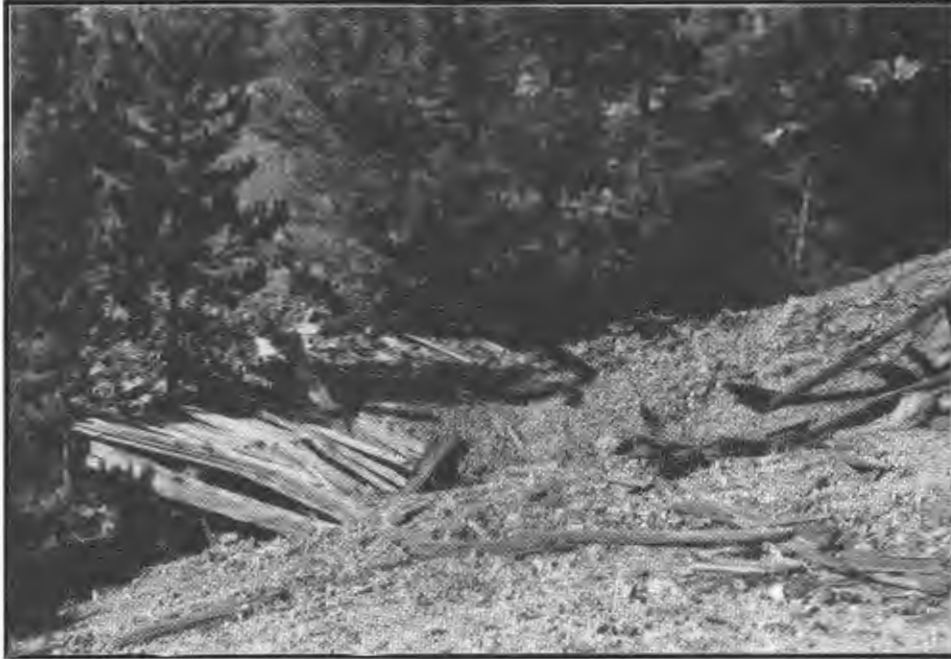
Figure 5. Loading platform at end of waste rock pile at Feature 5, north end of 24BW210.

Feature 5 is a collapsed adit, large waste rock pile, and ore loading platform located at the far north end of the site. The adit appears as a trench approximately 100 feet in length with a maximum width of about 30 feet and maximum depth of approximately 20 feet. The waste rock pile measures 150 feet in length and 60 feet wide. At the lower end of the waste rock pile are the remnants of a loading platform (Figure 5). The platform, constructed of logs and wire nails, is about 25 feet long.

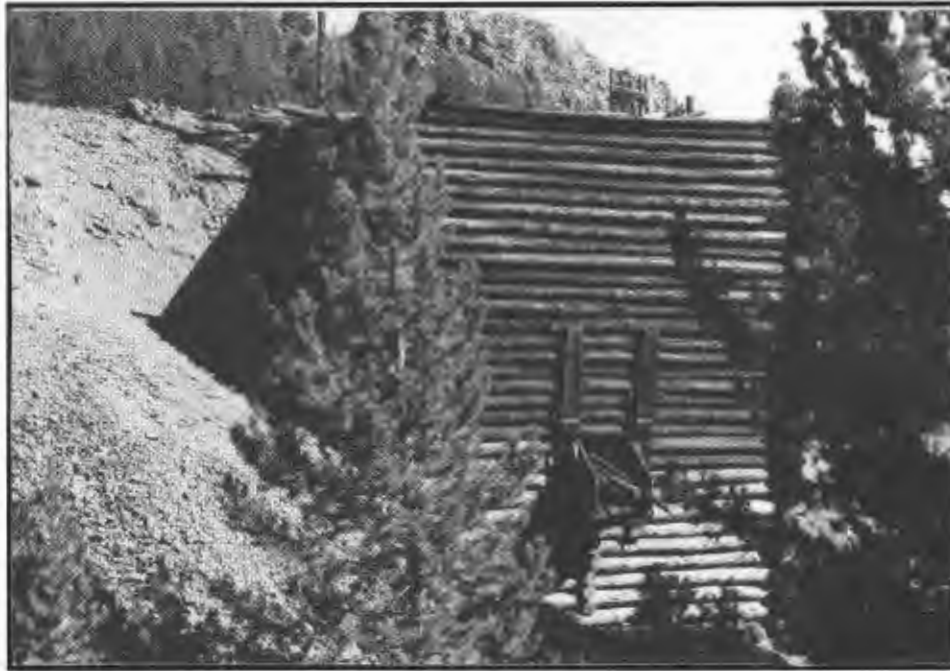
Figure 6. Ore bin at Feature 8, near center of 24BW210.

Feature 8 is a collapsed adit, large waste rock pile, loading platform, and ore bin. The adit is marked by a long trench which measures about 35 x 150 feet. The 80 x 170-foot waste rock pile is located 40 feet from the mouth of the trench. Near the north end of the pile is what appears to have been a wooden ore loading platform, which measures 12 feet across. The platform is partially covered and collapsed by waste rock, suggesting that it was abandoned before the most recent dumping on the waste rock pile. About 20 feet south of the platform and near the west edge of the pile is an ore bin. It is constructed of logs with small branches for chinking; the logs are saddle-notched at the corners (Figure 6). A wooden ladder leads from the top to the bottom of the bin in the interior southeast corner. There is a single wooden chute measuring about 2 feet square on the west wall of the bin. At the top of the bin is a 12-foot wide platform which extends over the waste rock pile. Feature 8 is in the approximate position of the 1896 Tunnel No. 2 on the New Era lode and the 1904 tunnel on the Marietta claim (U.S. Surveyor General's Office 1896, 1904). These dates suggest a turn of the century date for the adit.

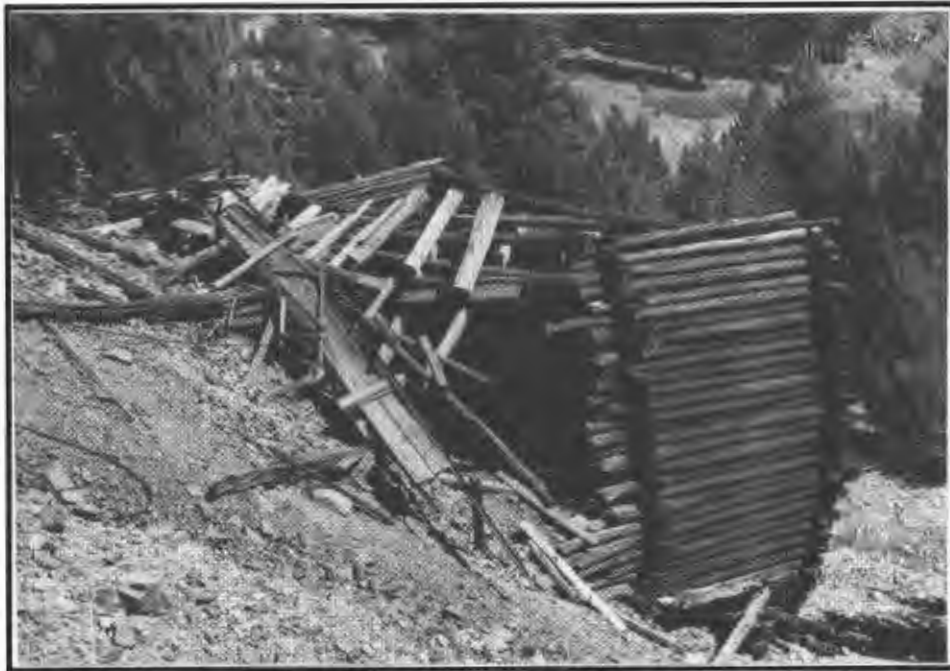
Figure 7. Ore bin at Feature 23, with Feature 25 shop in left background.

Feature 23 consists of a very large waste rock pile, an ore bin, and a platform. The Feature 32 adit which lies 70 feet from the upper end of the waste rock pile was apparently the source of the waste rock. The pile measures about 175 x 275 feet. On its southeast side and built against it is the ore bin, which is constructed of saddle-notched logs with small branches for chinking (Figure 7). The southeast wall of the bin has two wooden chutes, each measuring 3 feet square. Behind the ore bin and built out over the waste rock dump is a very deteriorated platform. Supporting mine rail, the platform is about 12 feet wide and was constructed of logs overlaid by boards. The large size of the waste rock pile, the relatively good condition of the Feature 32 adit portal, and the proximity of buildings estimated to date to the 1930s indicate that Feature 23 dates

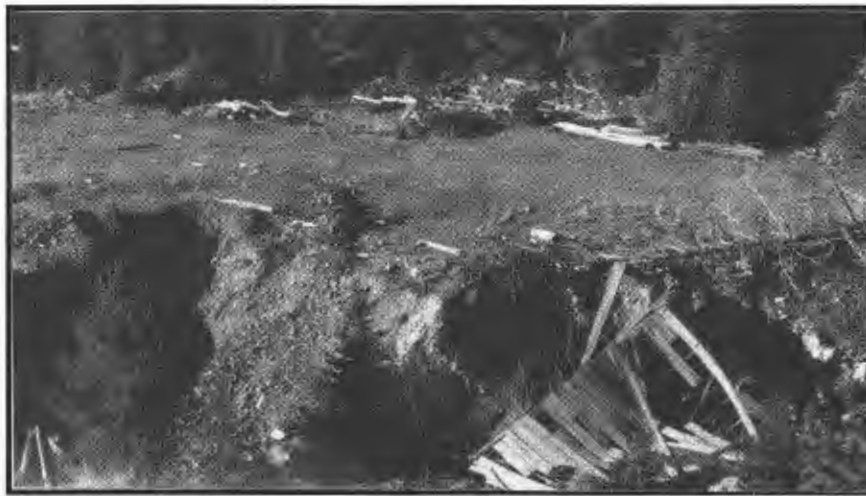
Figure 8. Waste rock pile and dumped building at Feature 59, on southeast edge of 24BW210.

Feature 59 is an adit, large waste rock pile, and associated structures near the west edge of the site. The adit portal, constructed of 7-inch logs and 2x8 planks, stands in relatively good condition. The waste rock pile measures about 200 feet long and up to 65 feet wide. Running atop the pile is the remnants of mine rail. At the far end of the pile, the rail is attached to a platform of 7-inch logs and 2x6s, which extends about 10 feet beyond the end of the pile. Also part of this feature and over the north edge of the waste rock pile are the remains of a building (Figure 8). The wood-frame building once may have stood on the pile, but was evidently pushed over and into Indian Creek below. Its location suggests the building may have been some type of blacksmith or repair shop.

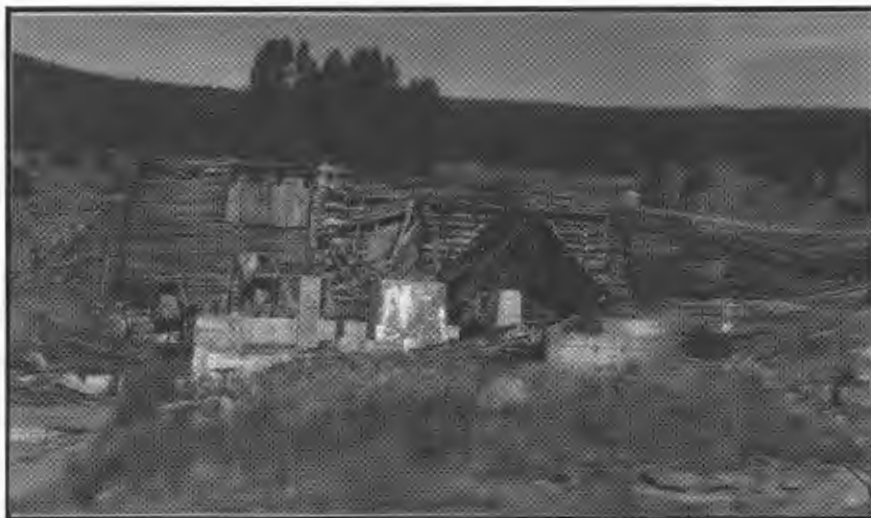
Figure 9. Feature 37 mill foundation and associated ore bin.

Feature 37 is the foundation of a mill which was built in 1959 (Schell 1963:21). It consists of concrete foundations and slabs, a log ore bin and retaining wall, and a flattened area, which together cover almost 5000 square feet (Figures 9 and 10). The concrete walls and slabs mark the rooms where the crushing and concentrating equipment was housed. At the short end of the mostly L-shaped feature is the ore bin, which remains basically intact. The bin, made of 6 to 8-inch logs, saddle-notched in the corners, measures about 14 x 18 feet and is about 23 feet tall. The inside of the bin is divided into two compartments, one of which is lined with boards set diagonally and with sheets of asbestos at the lower end. There is a grizzly at the top of the bin on the north side; it is made of mine rail welded into a grid. Abutting the north corner of the ore bin is a log crib wall. It extends north from the ore bin, and, along the top, has a remnant of the mine rail which originated at the Feature 67 adit. A flattened area east of the log wall and north of the concrete foundations suggests that a large shed was attached to the northeast end of the mill.

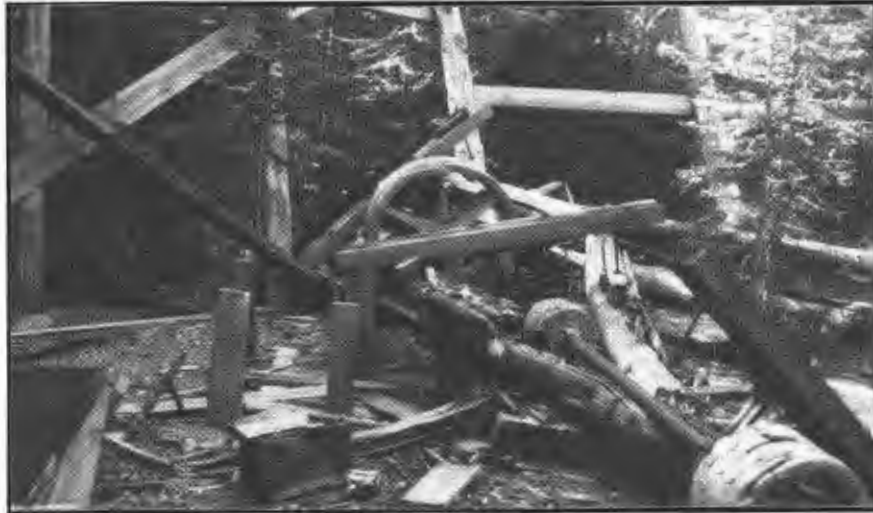
Figure 11. Remains of machinery at Feature 58, possible mill.

Feature 58 is the remains of a mill at the west edge of the Park Mines site. The feature consists of a wood-frame mill building, with a log ore bin attached to its west edge. The building stands in such poor condition that details of the building's construction are nearly impossible to determine. The frame building measures about 30-40 feet on a side. Apparently as siding, 2x10 and 2x12 planks were nailed to large vertical posts. The shed roof is completely gone. There was a double doorway and a set of two four-pane fixed windows. Inside the mill building are a cylindrical mill, wood wheels for transferring mechanical power to mill machinery, and a cyanide can (Figure 11). The attached ore bin was made of logs measuring 7 to 9 inches in diameter. It is lined with 4x20 planks.

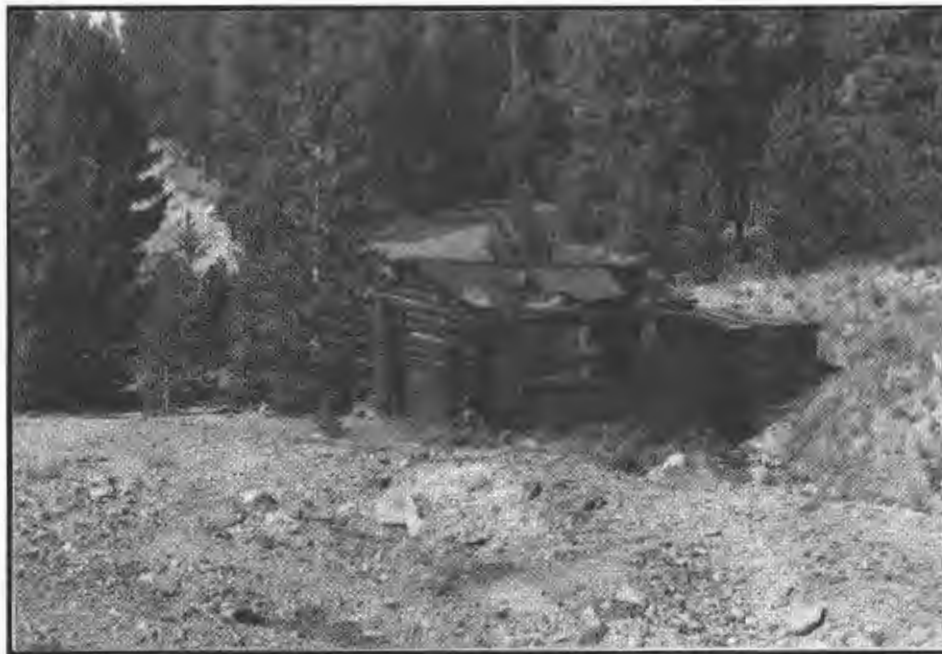
Figure 12. Feature 7 blacksmith's shop at edge of Feature 8 waste rock pile.

Feature 7 is a blacksmith's shop. It is a 12 x 15-foot log building with attached wood-frame shed (Figure 12). The logs are steeple-notched in the corners and chinked with small branches and mortar. More recently, the walls were covered with corrugated metal siding, but most of that is no longer attached. The shed addition is made with horizontal board siding. The remains of a forge are located in one corner of the main building. The fact that the logs of the original building meet in steeple-notched corners, instead of box corners as at nearby features which date to the 1930s, suggests that Feature 7 was built before the 1930s and perhaps in the early 1900s. The shed addition is likely of more recent construction, dating to the 1930s or later.

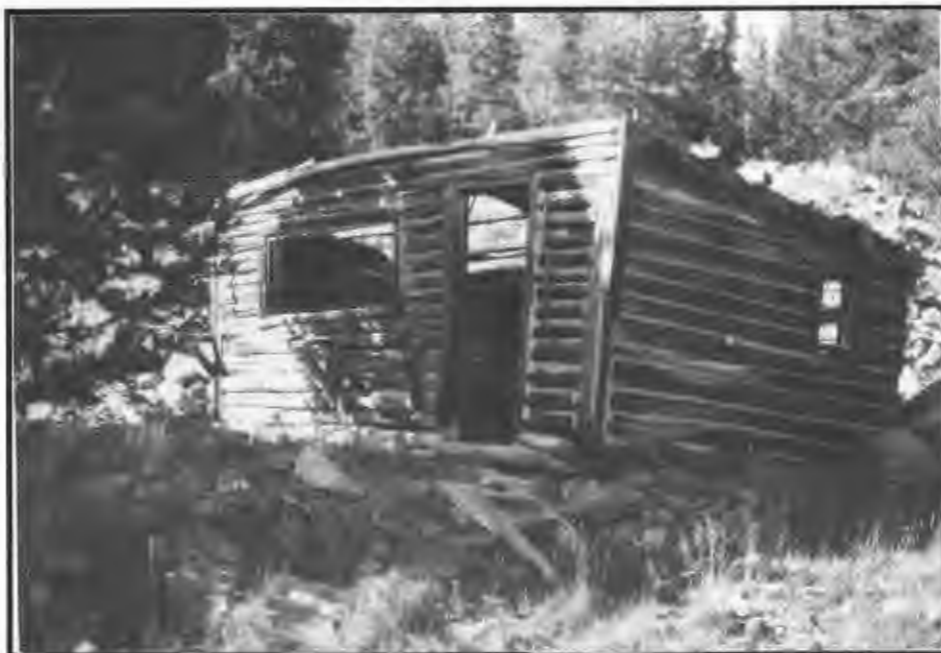
Figure 13. Feature 25 shop at base of Feature 23 waste rock pile, near center of 24BW210.

Feature 25 is a rectangular log building which appears to have been a workshop (Figure 13). It stands a single story tall and measures 12½ x 16 feet. The logs meet at 4x4 posts in the corners, and are chinked with branches, small wedges of wood, and mortar. The shed roof, now mostly collapsed, was made of log purlins covered with corrugated metal roofing. Identification of the building as a workshop is based on the presence of two interior work shelves, one 4-5 feet long and other 6-7 feet long, and the building's proximity to the Feature 32 adit. The box corners indicate a 1930s date of construction.

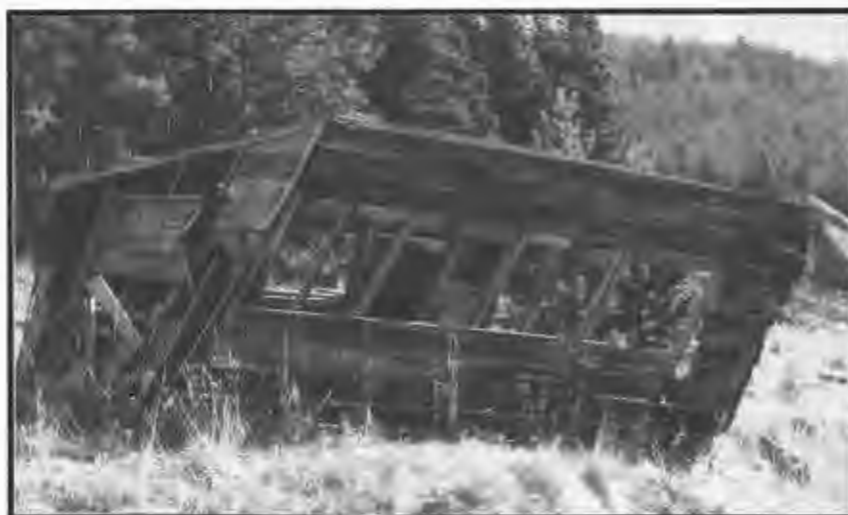
Figure 14. Feature 64 shop near center of 24BW210.

Feature 64 is a 10 x 12-foot, wood-frame building standing near the Feature 67 adit and waste rock pile. The 1x8 board siding is laid horizontally and covered with tarpaper (Figure 14). A shed roof covers the building. The only doorway is double-wide; there is a single window on an adjoining wall. The location of the building and the presence of a double door suggests that Feature 64 was a shop of some sort. Its age is unknown.

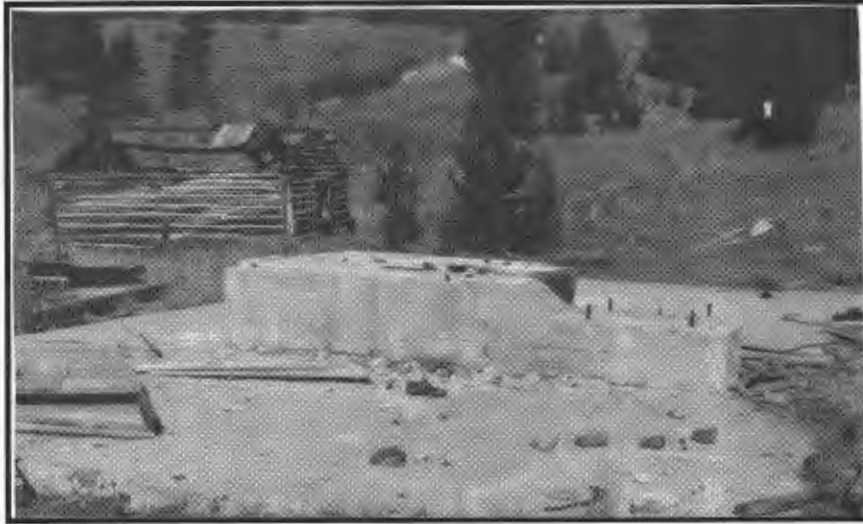
Figure 15. Feature 65 miner's dry and compressor room foundation; Feature 66 in background.

Feature 65 is a large, poured concrete slab measuring roughly 20 x 50 feet (Figure 15). It marks the location of a miners' dry (changing room) and compressor room presumably built in the late 1950s (Schell 1963:Plate I). On the eastern end of the feature is a J-shaped concrete footing measuring 8 x 14 feet. The compressor was presumably mounted to this large footing.

Feature 66 is a log blacksmith's shop. The 5 to 7-inch wall logs meet in box corners and are chinked with small boards and mortar (Figure 15). The gable roof, made with log purlins and covered with corrugated metal roofing, is all but gone. On the south side of the building, adjacent to the doorway, is a 3½-foot square wooden "box" supported by a single log post. The box is

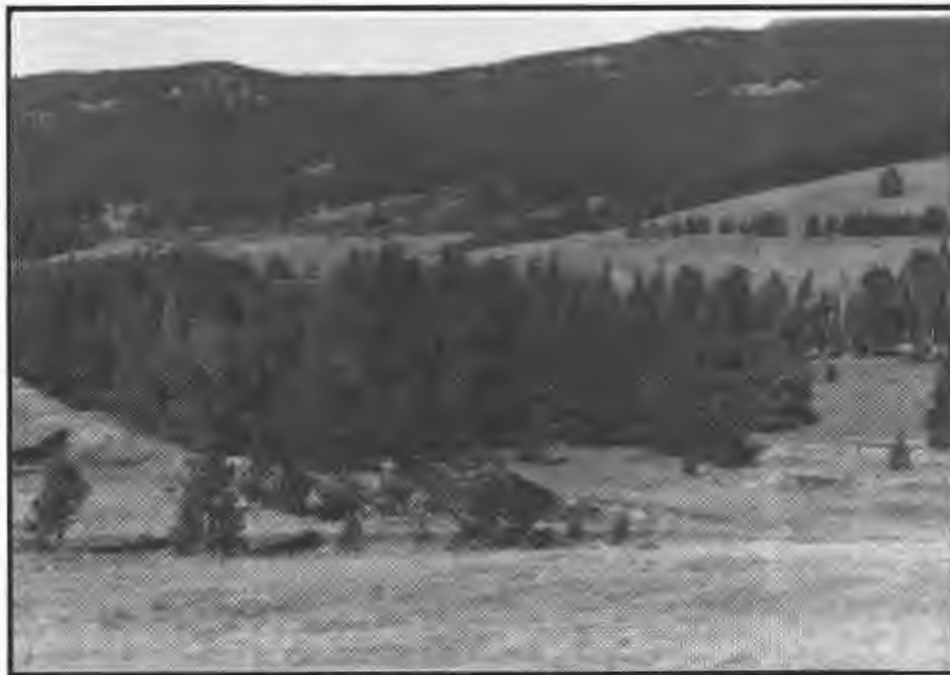
Figure 19. Feature 20, possible hoist house, in northeast corner of 24BW210; Feature 3 at far right.

Feature 20 is the collapsed remains of a relatively large industrial building (Figure 19). Measuring about 40 feet square, the building was made with large logs abutted to 8x8 posts in the corners, and fastened with wire spikes. Because it is completely collapsed, the specifics of construction, lumber dimensions, and fenestration are incomplete. The gable roof had an 8x8 beam ridge pole and end rafters. Others rafters were 2x6s. The board roofing beneath corrugated metal was held in-place by wire nails, although there are a few cut nails present. There were two doorways on the south side of the building, one person door and one double door. There may have been other doors and windows, but their sizes and positions could not be determined. There is a pit, possibly a collapsed shaft, about 20 feet south of Feature 20, and beyond that a large waste rock pile. A buried 1-1½ inch pipe leads south from the building toward the pit.

Feature 20 is located in the far northeast corner of the site in the general vicinity of some residential buildings thought to date to the turn-of-the-century. The advanced state of deterioration, large size of the lumber used in construction, and some cut nails suggest that Feature 20 may be contemporaneous with the early 1900s residences.

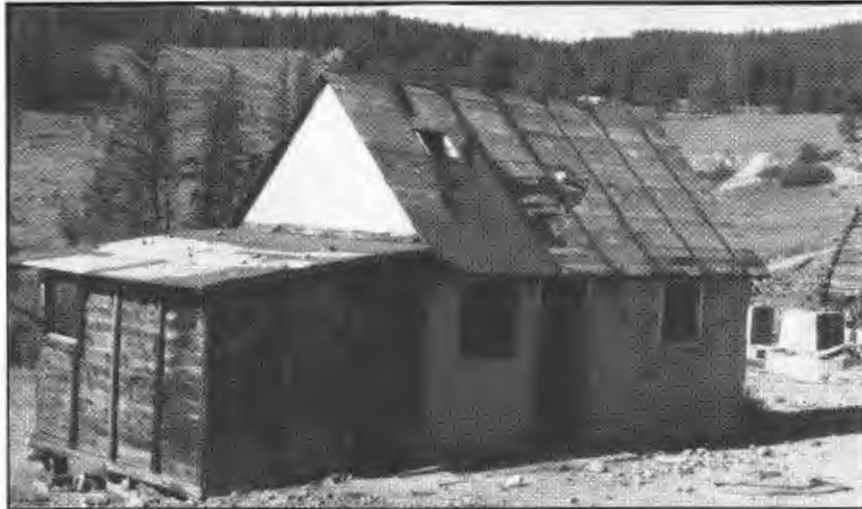
Figure 20. Feature 63 assay office, with Feature 37 mill in right background.

Feature 63 is an assay office located about 90 feet east of the Feature 37 mill. It is a 12 x 18-foot stuccoed, wood-frame building (Figure 20). The side-gable roof is covered with tarpaper. A shed addition is attached to the east side of the original building. It measures 8 x 12 feet, is sided with boards of varying widths, and is covered by a shed roof. The building may have been constructed in the late 1950s when the Northern Milling Company identified the building as an assay office (Schell 1963:Plate I).

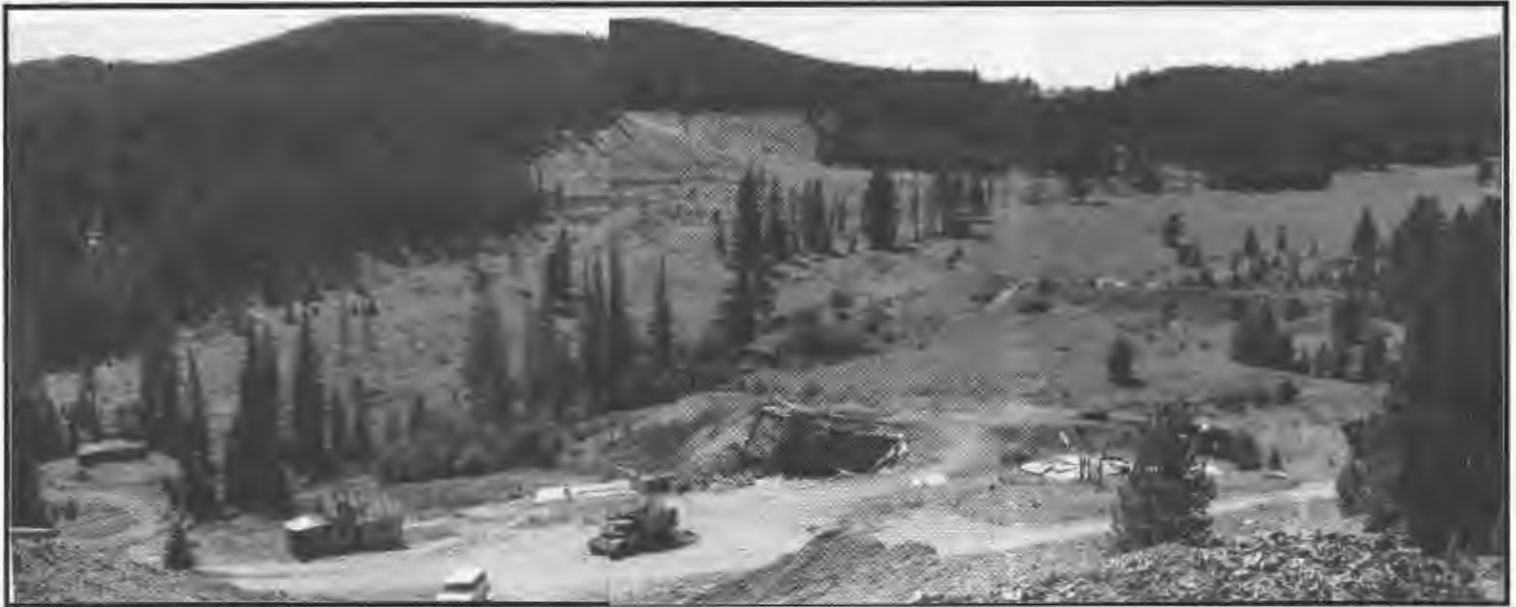
Figure 21. Panoramic view of west edge of 24BW210. Pictured features include Feature 62 residence (far left), Feature 63 assay office (next right), Feature 37 mill foundation (center), and Feature 69 dam (right).

Feature 69 is an earth-fill dam located at the west edge of the Park Mines site (Figure 21). It is about 500 feet long and 12 feet wide at its crest. To build the dam, workers took material from the pool area. There is an overflow outlet or breach on the north end of the structure. A 4-inch pipe lies between the pond and the Feature 37 mill; it apparently was the conduit which supplied water to the mill. Near the center of the crest of the dam is a piece of equipment that may have been a dragline. It was made from a truck differential and chassis and an ore car was used for a bucket. In 1957, Sahinen (1957:1) recommended that the mine owners could operate a small mill on-site "if a dam is built to store the spring flood waters." The owners apparently took him at his word; the dam was probably built in 1959 when the mill was erected.

The eighth residence at 24BW210 is Feature 62, another irregularly-shaped building with multiple additions (Figures 30 and 31). Feature 62 is not associated with other residences, standing about 275 feet south of the Feature 37 mill and adjacent to a large waste rock pile (Figure 21). The core of the building measures 18 x 19 feet and is made of 6 to 9-inch logs which are saddle-notched. The three additions are on the southwest, northwest, and southeast sides.

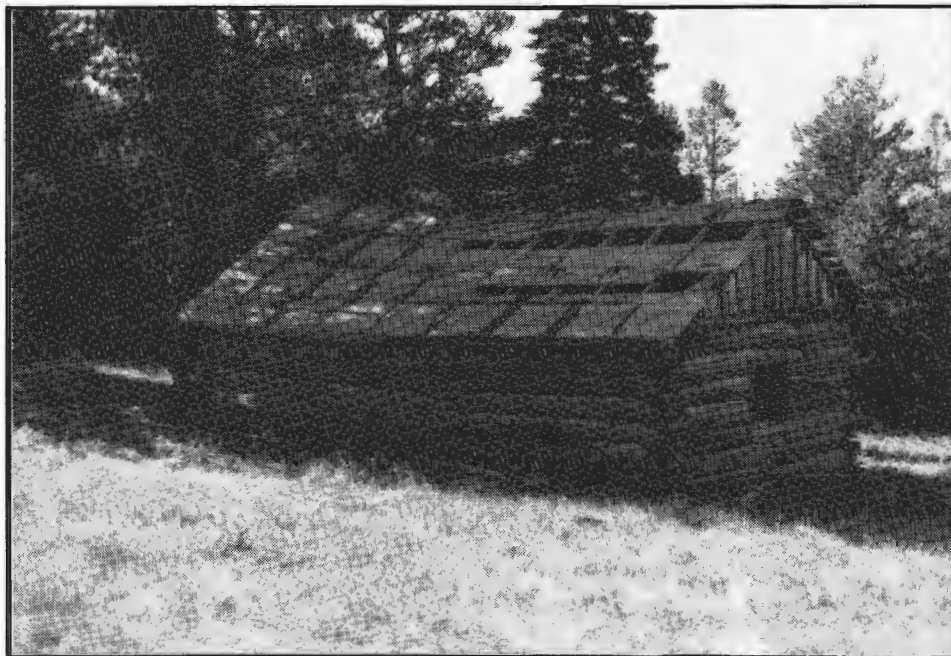
Figure 22. Rear and side of Feature 1 residence at northeast corner of 24BW210.

Feature 1 is a two-room log residence which measures  $17\frac{1}{2} \times 23\frac{1}{2}$  feet (Figure 22). The wall logs meet in lap-notched corners which are secured with wire nails. A single stovepipe pierces the board and tarpaper gable roof. The presence of clear modern bottle glass and a few sanitary cans indicates that the building was re-occupied sometime after the early 1900s.

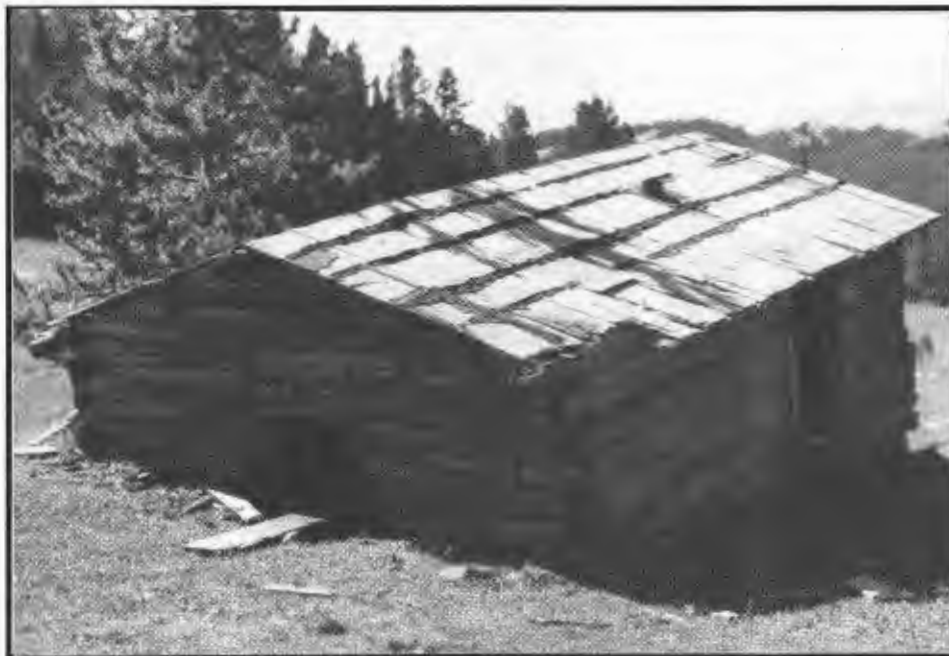
Figure 23. Rear and side of Feature 3 residence at northeast corner of 24BW210.

About 50 feet northwest of Feature 2, Feature 3 is a single room, hewn log residence which measures 13 x 17 feet (Figure 23). The logs are joined at the building corners with dovetail notching, and the ends are secured with wire spikes. The front gable roof is made of log purlins. The purlins are covered with boards, which in turn were once covered with tarpaper.

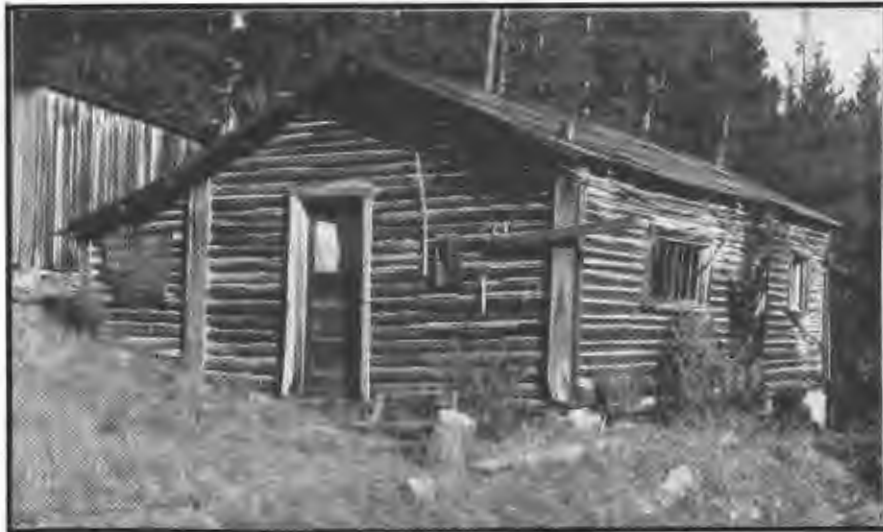
Figure 24. Front and side of Feature 50 residence; Feature 50 in left background.

Feature 50 is a one story, 21 x 30-foot, log building (Figure 24). The 6-inch wall logs meet in box corners. Part of the building rests on a poured concrete foundation, and part on cinder block footings (Figure 25). The front gable roof was made with log purlins, covered by boards and then tarpaper. There is a small, shed-roofed addition at the north corner of the building. The use of cinder blocks for footings along the feature's downhill side may indicate that the building was once moved from another location.

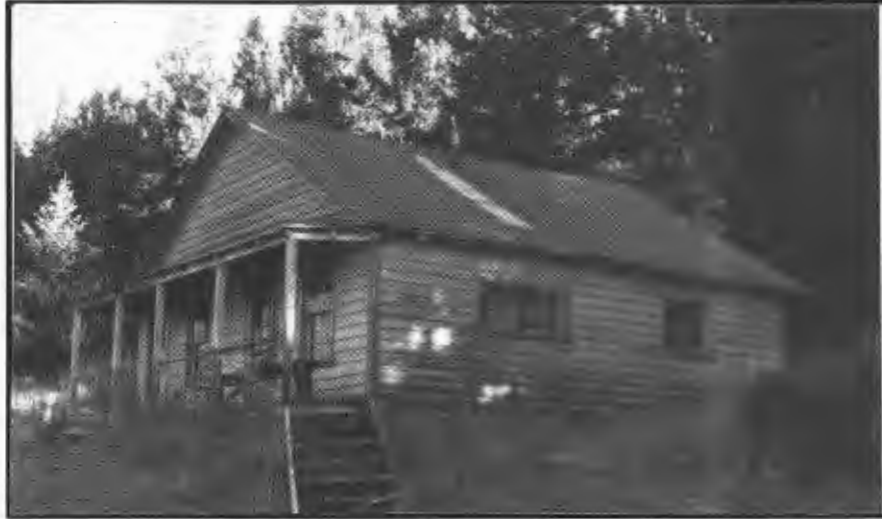
Figure 26. Feature 53 residence in south one-third of 24BW210.

Feature 53 is a 24½-foot square, one story, wood-frame residence. Its comparatively large size, good condition, and use of plain but good milled lumber in construction suggests that this was the residence of the mine or mill manager, possibly as early as the 1930s and until the early 1960s (Figure 26). The building has 1x6 lap siding with corner boards, and has been painted tan and yellow. The front-gable roof has exposed rafter tails and is covered with rolled asphalt roofing. The windows are 3/1 double hung, 6x6 sliding, or 6 pane fixed units. Both exterior

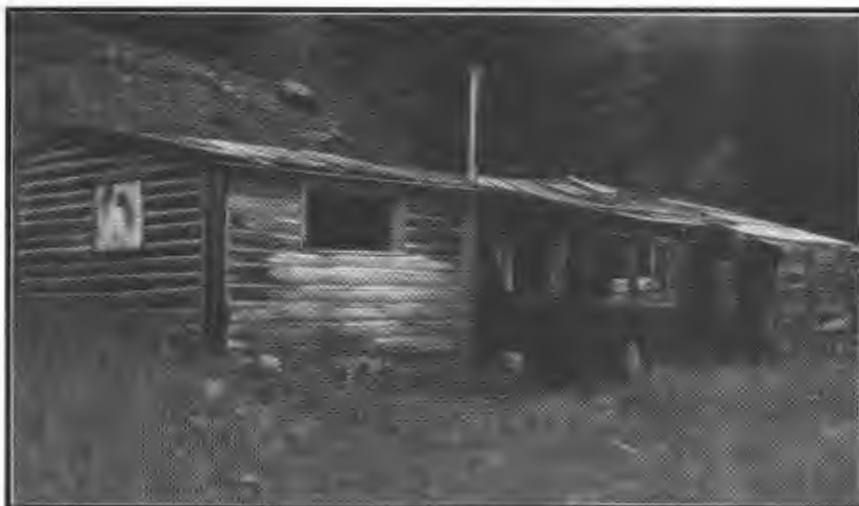
Figure 27. Front of Feature 54 residence, showing three additions.

Feature 54 is an irregularly-shaped log and wood-frame building which is presumed to have been a residence from its location, comparatively large size, and wood floor (Figures 27 and 28). The core building measures about 16 x 19 feet and is made of 7-inch logs which are saddle-notched in the corners. Additions have been attached to the northeast, northwest, and southwest sides of the building. On the northeast, the 8-foot square shed addition is also of logs, but the

logs meet at box corners. On the northwest, a 12-foot square log addition also has box corners. It has a gable roof, and, like the northeast addition, has no outside entry. On the southwest wall, one wood-frame addition measures only about 5 x 8 feet. Its size suggests its use as a mudroom where dirty clothes were removed before entering the main part of the house. The other addition on the southwest wall is about 10 x 11 feet. It is wood-frame and sided with 1x10s laid horizontally. The boards were once covered with tarpaper. Both additions on the southwest wall have shed roofs once covered with tarpaper. Because the original room was made with saddle-notched logs, it probably pre-dates the 1930s. In fact, the building may date to the turn of the century if it is the cabin marked at about this location on the 1896 survey plat for the New Era and Crowbar lodes (U.S. Surveyor General's Office 1896). The two additions with box corners likely date to the 1930s, and the other two additions slightly later.

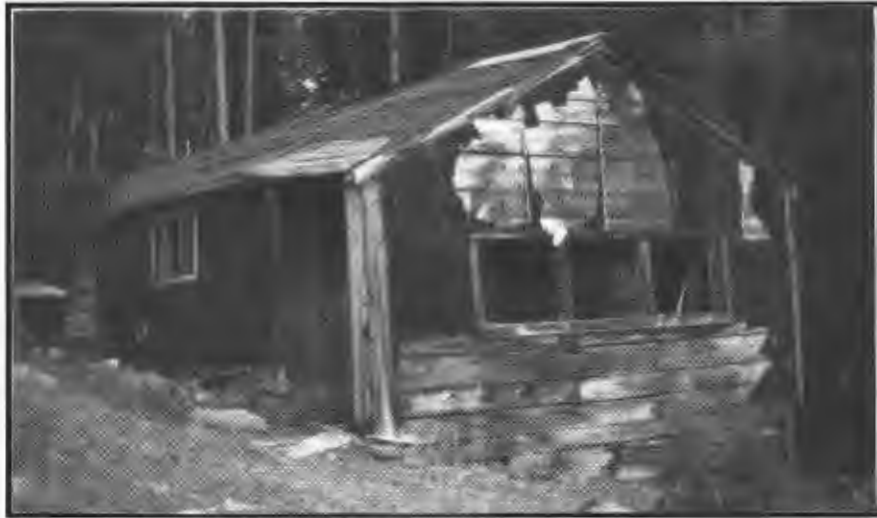
Figure 29. Feature 56 residence in south one-third of 24BW210.

The last of the residences in the south one-third of 24BW210, Feature 56, stands 130 feet northwest of the nearest house, Feature 54. Feature 56 is a one story, rectangular, log and wood-frame residence which consists of three parts (Figure 29). In all, the feature measures 16½ x 31 feet. The north approximate half of the building is made of 7-inch logs meeting in box corners, while the next section to the south is wood-frame. The second section is sided with 1x10 or narrower boards, and covered with tarpaper. Along the front or south end of the residence is a narrow, full-width addition which is also wood-frame and covered with tarpaper. A front-gable roof covers the entire building. Feature 56 was probably built in the 1930s, with the two additions dating later in that decade or to the 1940s.

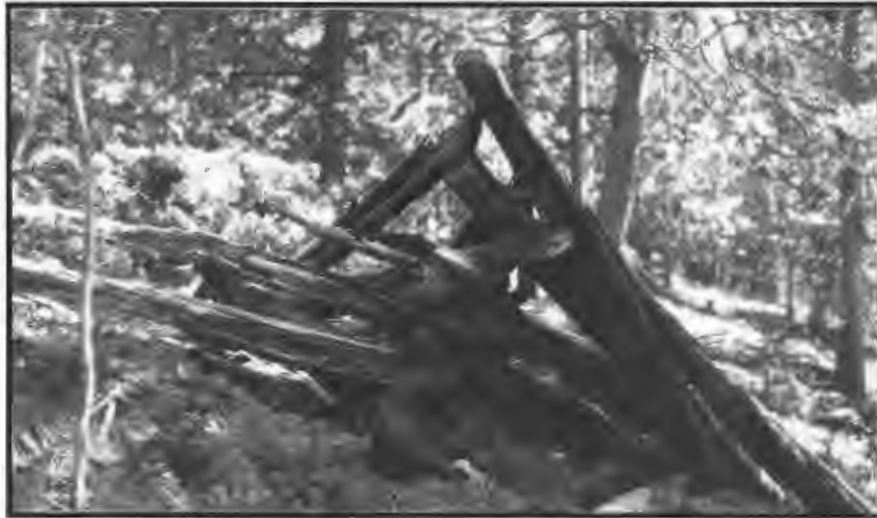
Figure 32. Collapsed remains of Feature 68 residence at south end of 24BW210.

One other residence is located on a steep hillside near the south end of the site, more than 150 feet from the nearest recorded feature. Feature 68 is almost completely collapsed, so measurements, fenestration, and roofing can only be estimated (Figure 32). The log building was small, measuring only about 10 feet square. The 6-inch logs are steeple-notched at the building's corners. Boards varying in size from 1x6s to 1x10s lie in the building debris, and may indicate roofing or other materials. A door on the east side of the building opened on leather hinges. Identification of Feature 68 as a residence was based on the presence of a domestic dump about 20 feet to the south. The dump contains miscellaneous metal, a piece of stove pipe chimney, rubber boots, about 10 hole-in-top crimped and soldered cans, purple flask with applied finish, stoneware jar, corrugated roofing, a sheet metal cookstove, a tin box with handle, and a lard bucket. Collectively, they date to about 1905-1910, and indicate the associated residence was built at about that time.

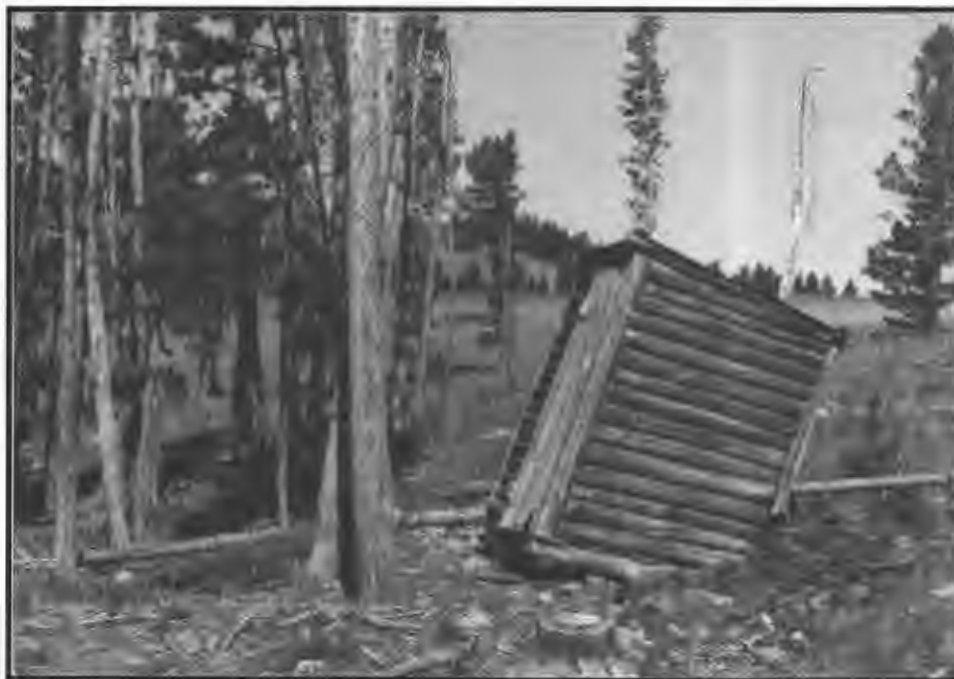
Figure 33. Feature 4 outhouse in northeast corner of 24BW210.

Feature 4 is a 4½ x 5-foot outhouse is made of small logs and assembled with wire nails. The logs abut vertical pole corners (Figure 33). The building is located northwest of Features 1-3, two residences and one foundation thought to date to the turn-of-the-century. The small logs

and the lack of notching, however, indicate that Feature 4 probably post-dates the three features. It is possible that it was built in the 1930s or later when (or if) the residences were re-occupied.

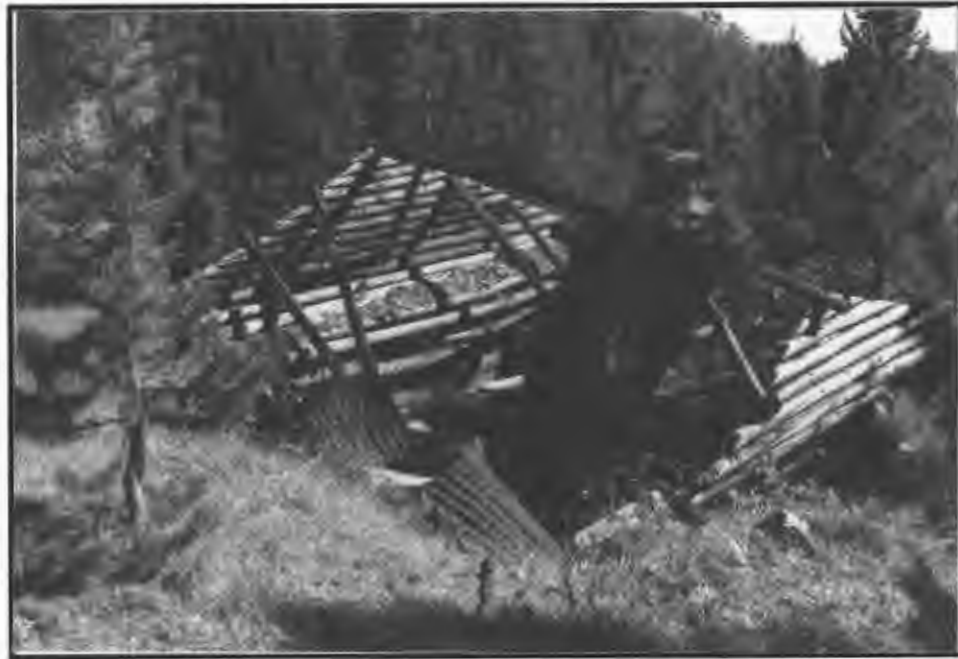
Figure 34. Partially collapsed Feature 15 at center of 24BW210.

Feature 15 is a 12½ x 16-foot log building located near the mouth of the Feature 8 adit. The wall logs meet at box corners made of 2x6s; there, they are secured with wire nails. There is a single doorway and single, 5-foot wide window opening. The gable roof, now mostly collapsed, had a log ridge pole and purlins; it was covered with corrugated metal roofing (Figure 34). Standing in a group with Features 16 and 17, the building may have been a residence, or perhaps an office. It apparently dates to the 1930s.

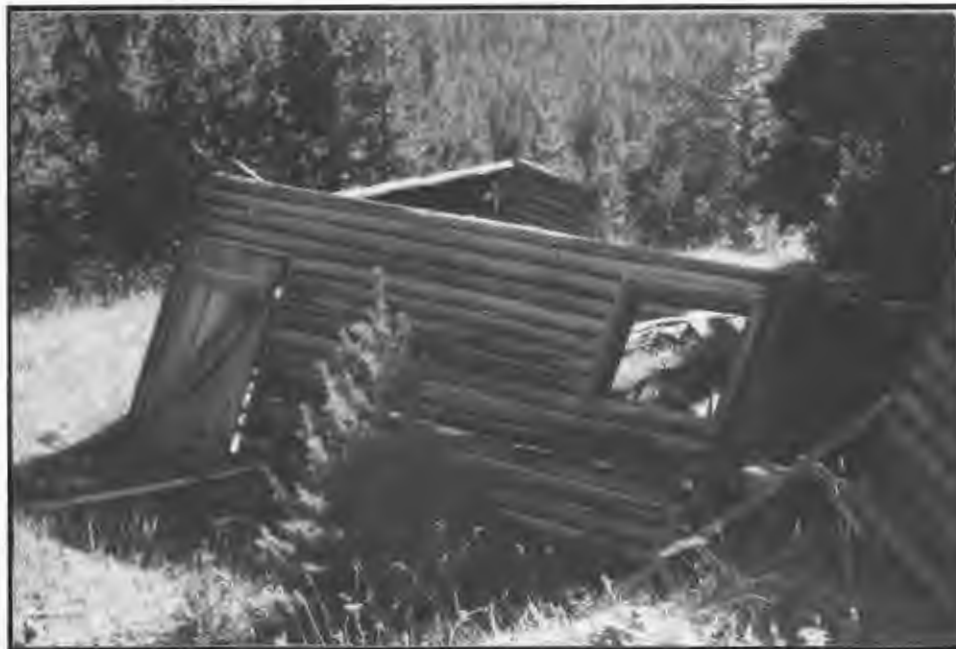
Figure 35. Partially collapsed Feature 17; Feature 16 outhouse at far right.

Feature 17, located 35 feet southwest of Feature 15, is slightly larger than that building, but was constructed using the same techniques (Figures 35 and 36). The walls and roof of the 15 x 16-foot building were virtually identical. There are two doorways and a single window opening at Feature 17. The feature is clearly contemporaneous with Features 15 and 16.

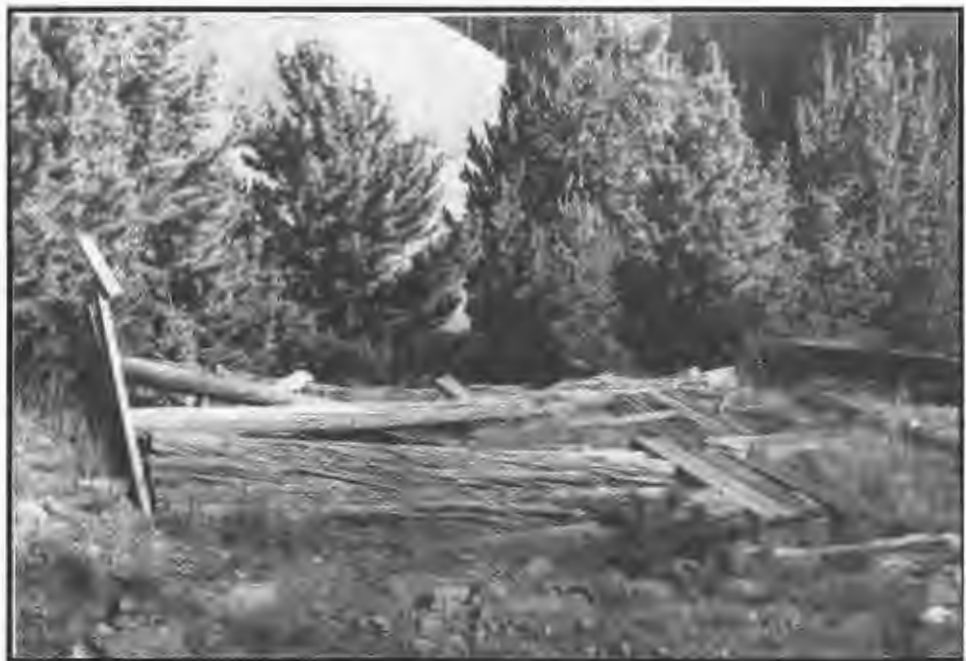
Figure 37. Feature 33 ruins, with Feature 8 waste rock pile in background.

Feature 33 consists of an artificial terrace on which lumber is scattered. It marks a building site, but almost all of the superstructure has been removed (Figure 37). What remains suggests that the building measured about 12 x 14 feet, was made of logs, and the logs abutted box corners. Located only about 15 feet from the Feature 25 workshop, it seems likely that Feature 33 functioned as some sort of mine-support facility. The use of box corners indicates a 1930s date of construction.

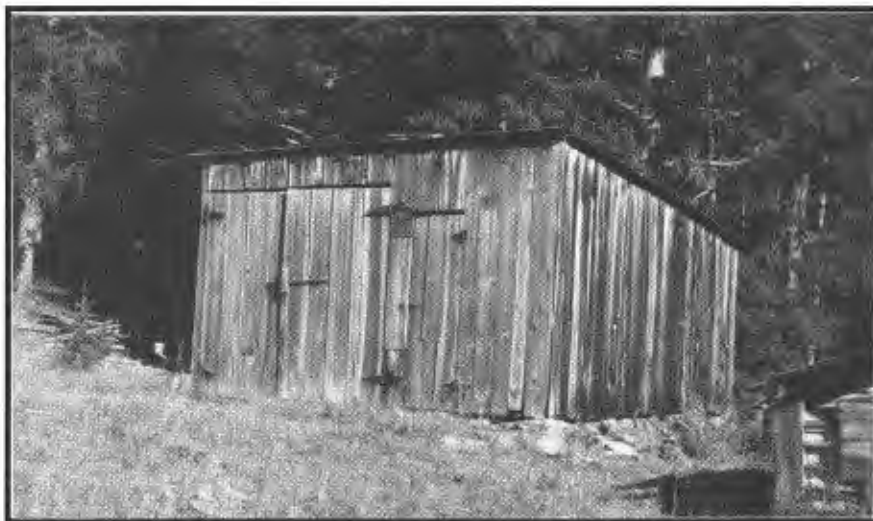
Figure 38. Feature 51 garage; shed addition on Feature 51 residence at right.

Feature 51 is a 14 x 16-foot, wood-frame garage (Figure 38) associated with the Features 50 and 53 residences. It is sided with 1x lumber of varying widths, set vertically. The shed roof is made of 1x8s on 2x4 rafters, and is covered with corrugated metal roofing. Feature 51's very good condition indicates it is of relatively recent construction, possibly dating after the historic period.
