# FINAL ENVIRONMENTAL ASSESSMENT

PARK MINE AND MILL SITE  
INDIAN CREEK RESTORATION  
ABANDONED MINE LANDS PROJECT  
BROADWATER COUNTY, MONTANA  
PA # MT004012

*November 2015*

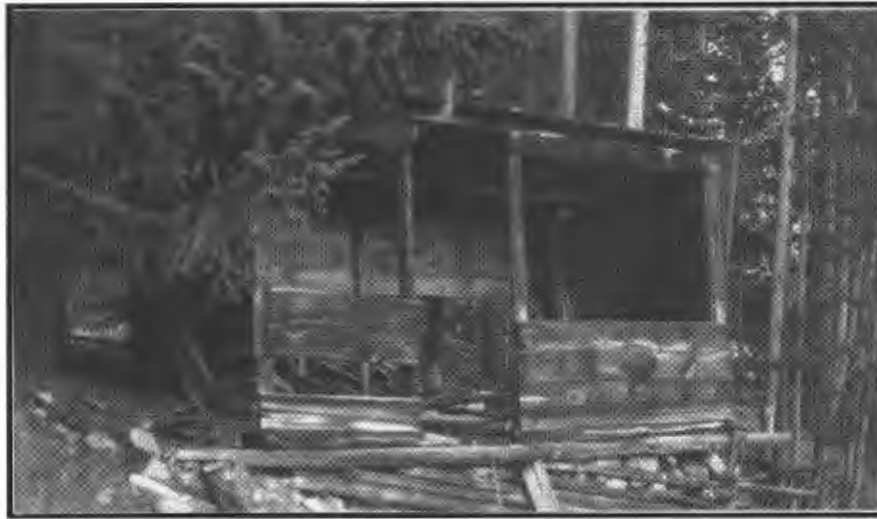
Figure 39. Feature 55 chicken house in south one-third of 24BW210.

Feature 55 is a wood-frame chicken house standing at the southeast edge of the Feature 56 residence. It measures 6 x 12 feet and was constructed of 1x lumber of varying widths. The doorway is on the southwest facade, as was a band of windows (now gone) which ran the full length of the building on either side of the door (Figure 39). The shed roof was constructed with 1x6s.

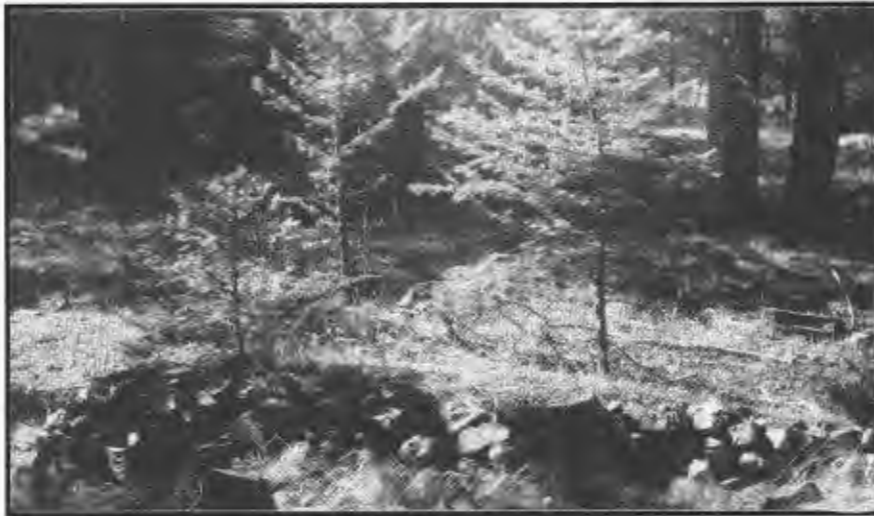
Figure 40. Feature 46 rubblestone wall/foundation at near south end of 24BW210.

Feature 45 is a rectangular building foundation which measures about 12 x 30 feet. It is made of dry-laid rubblestone (Figure 40).

Feature 46 is a collapsed dugout. Its edges are marked by a stone “foundation” about 16 feet square. A single saddle-notched log laying inside the feature may indicate the materials used in the building’s sidewalls. On the southeast side of the dugout is an opening about 3 feet wide, indicating the position of the doorway. Nearby artifacts include miscellaneous metal, soldered cans, a square metal can which measures 9 x 9 x 14 inches, one piece of undecorated whiteware, a canning jar lid, crockery fragments, and some purple glass. A date of occupation between 1900 and 1905 is indicated by bases to bottles manufactured by the Massillon Bottle & Glass Company between about 1900 and 1904 and William Franzen & Son between 1900 and 1929.
