PWS-6 REPORT

**Clark Lookout Major Subdivision
Dillon, Montana**

Public Water Supply System

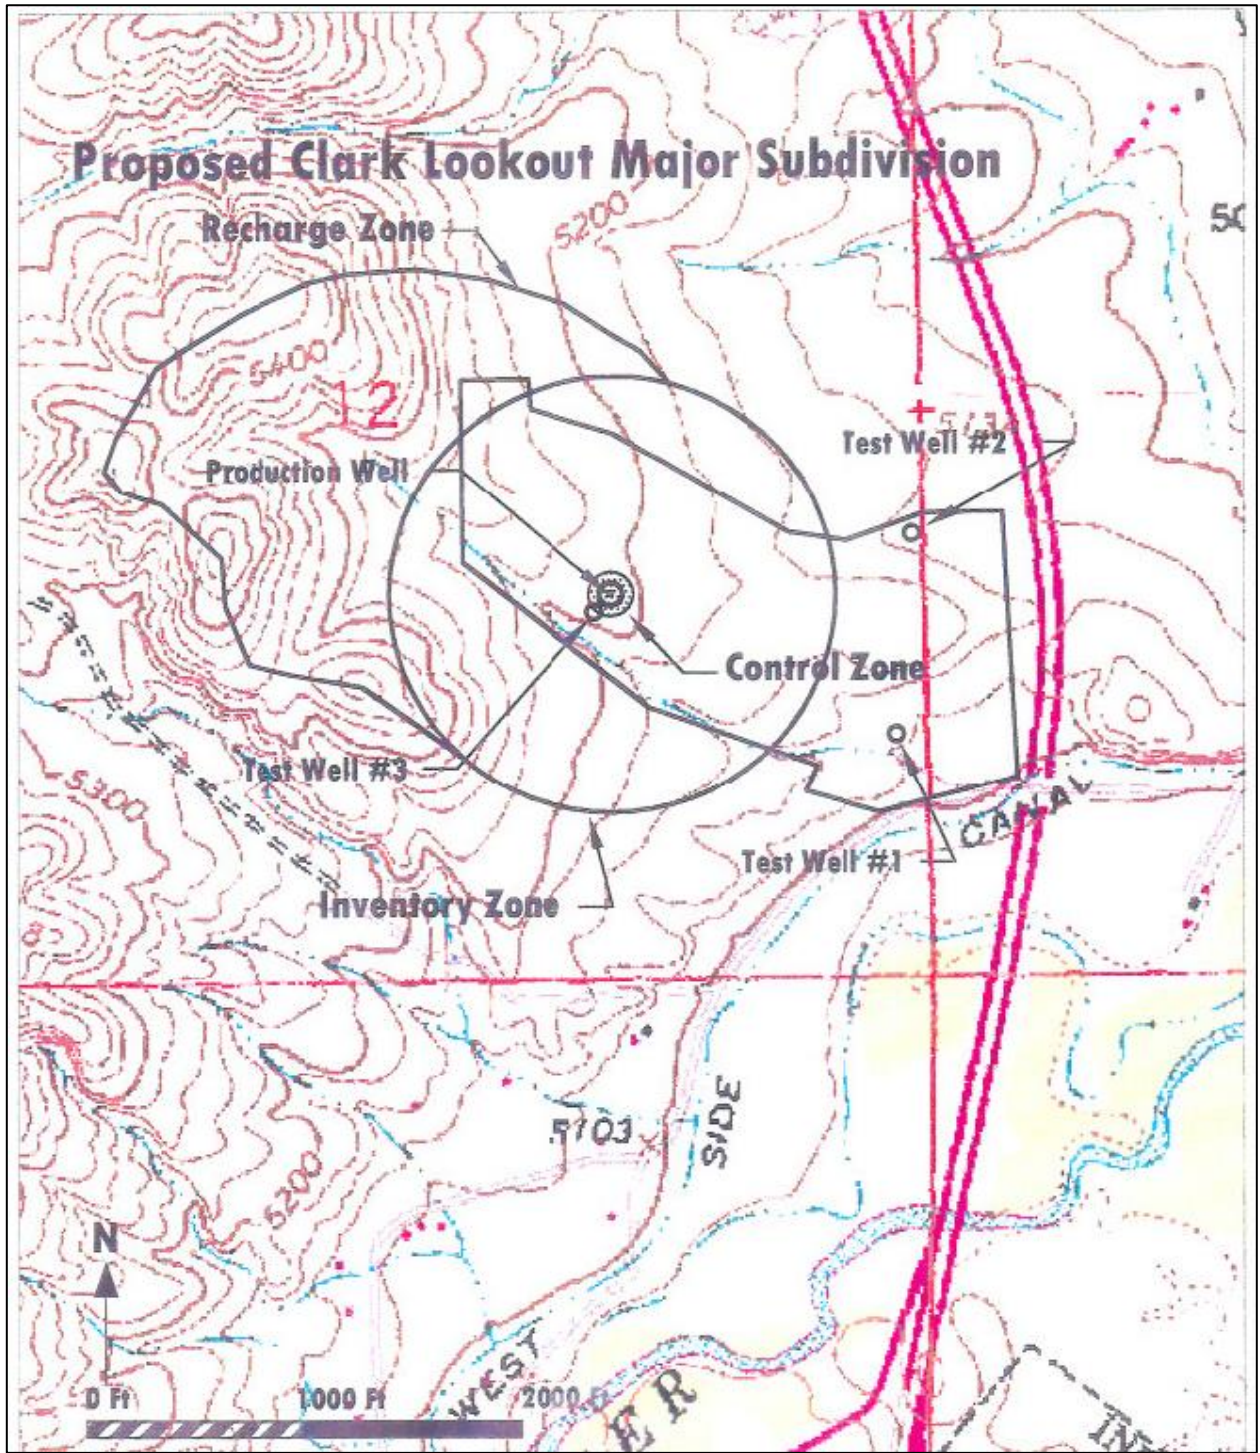
Figure 5. Clark Lookout Major Subdivision control, inventory, and recharge zones

The public water supply well for the Clark Lookout Major Subdivision is completed in a bedrock aquifer system that is confined due to overlying clay and clay-bound layers. Because the water supply well is deep and confined, the source water sensitivity is low. Delineation requirements include a 1 DO-foot radius control zone, an inventory zone, and a recharge zone around the public water supply well. The delineations are shown in Figure 5.
