## APPENDIX H

### Bank Condition Results and Maps

**Figure H-1**  
**Bank Condition**  
**Assessment Reaches**  
 Blue Joint Creek

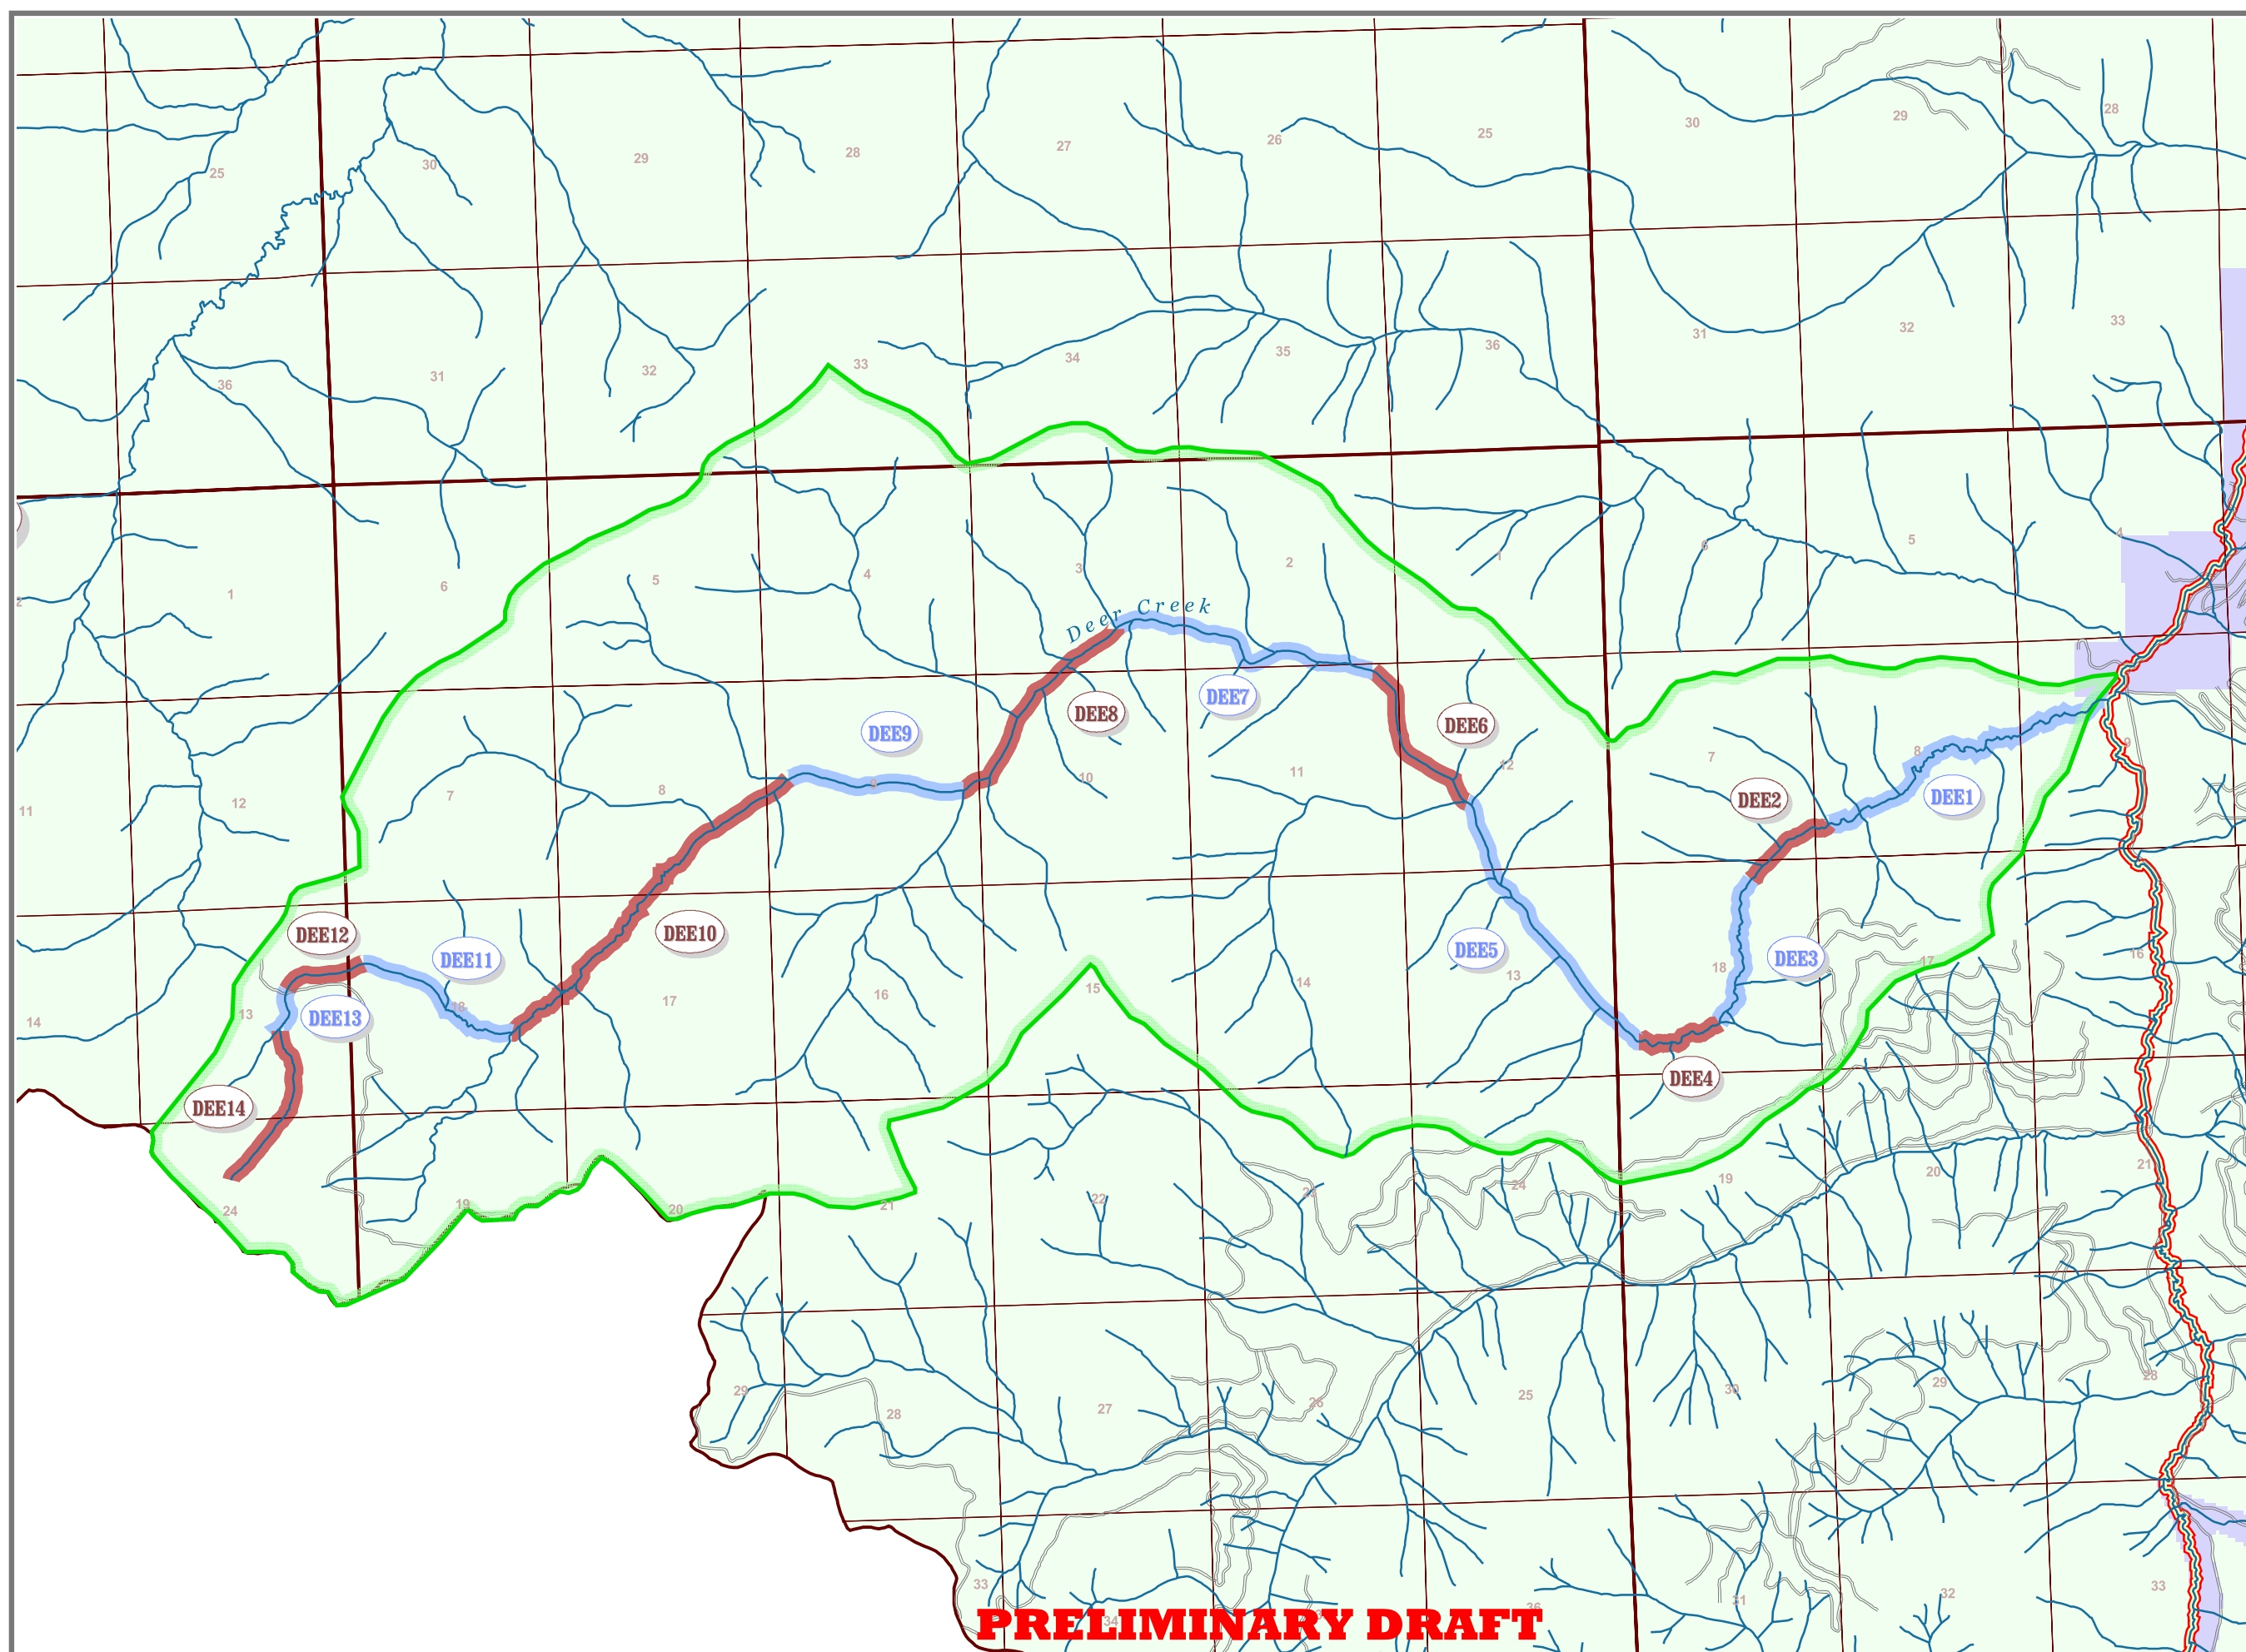
**Figure H-3**  
**Bank Condition**  
**Assessment Reaches**  
 Deer Creek

- Deer Creek Reaches
- Watershed Boundary
- East & West Forks of the Bitterroot River
- Other Streams
- Major Roads
- Other Roads
- Section Lines

[Figure H-3. Bank Conditions Assessment Reaches Deer Creek.](#)

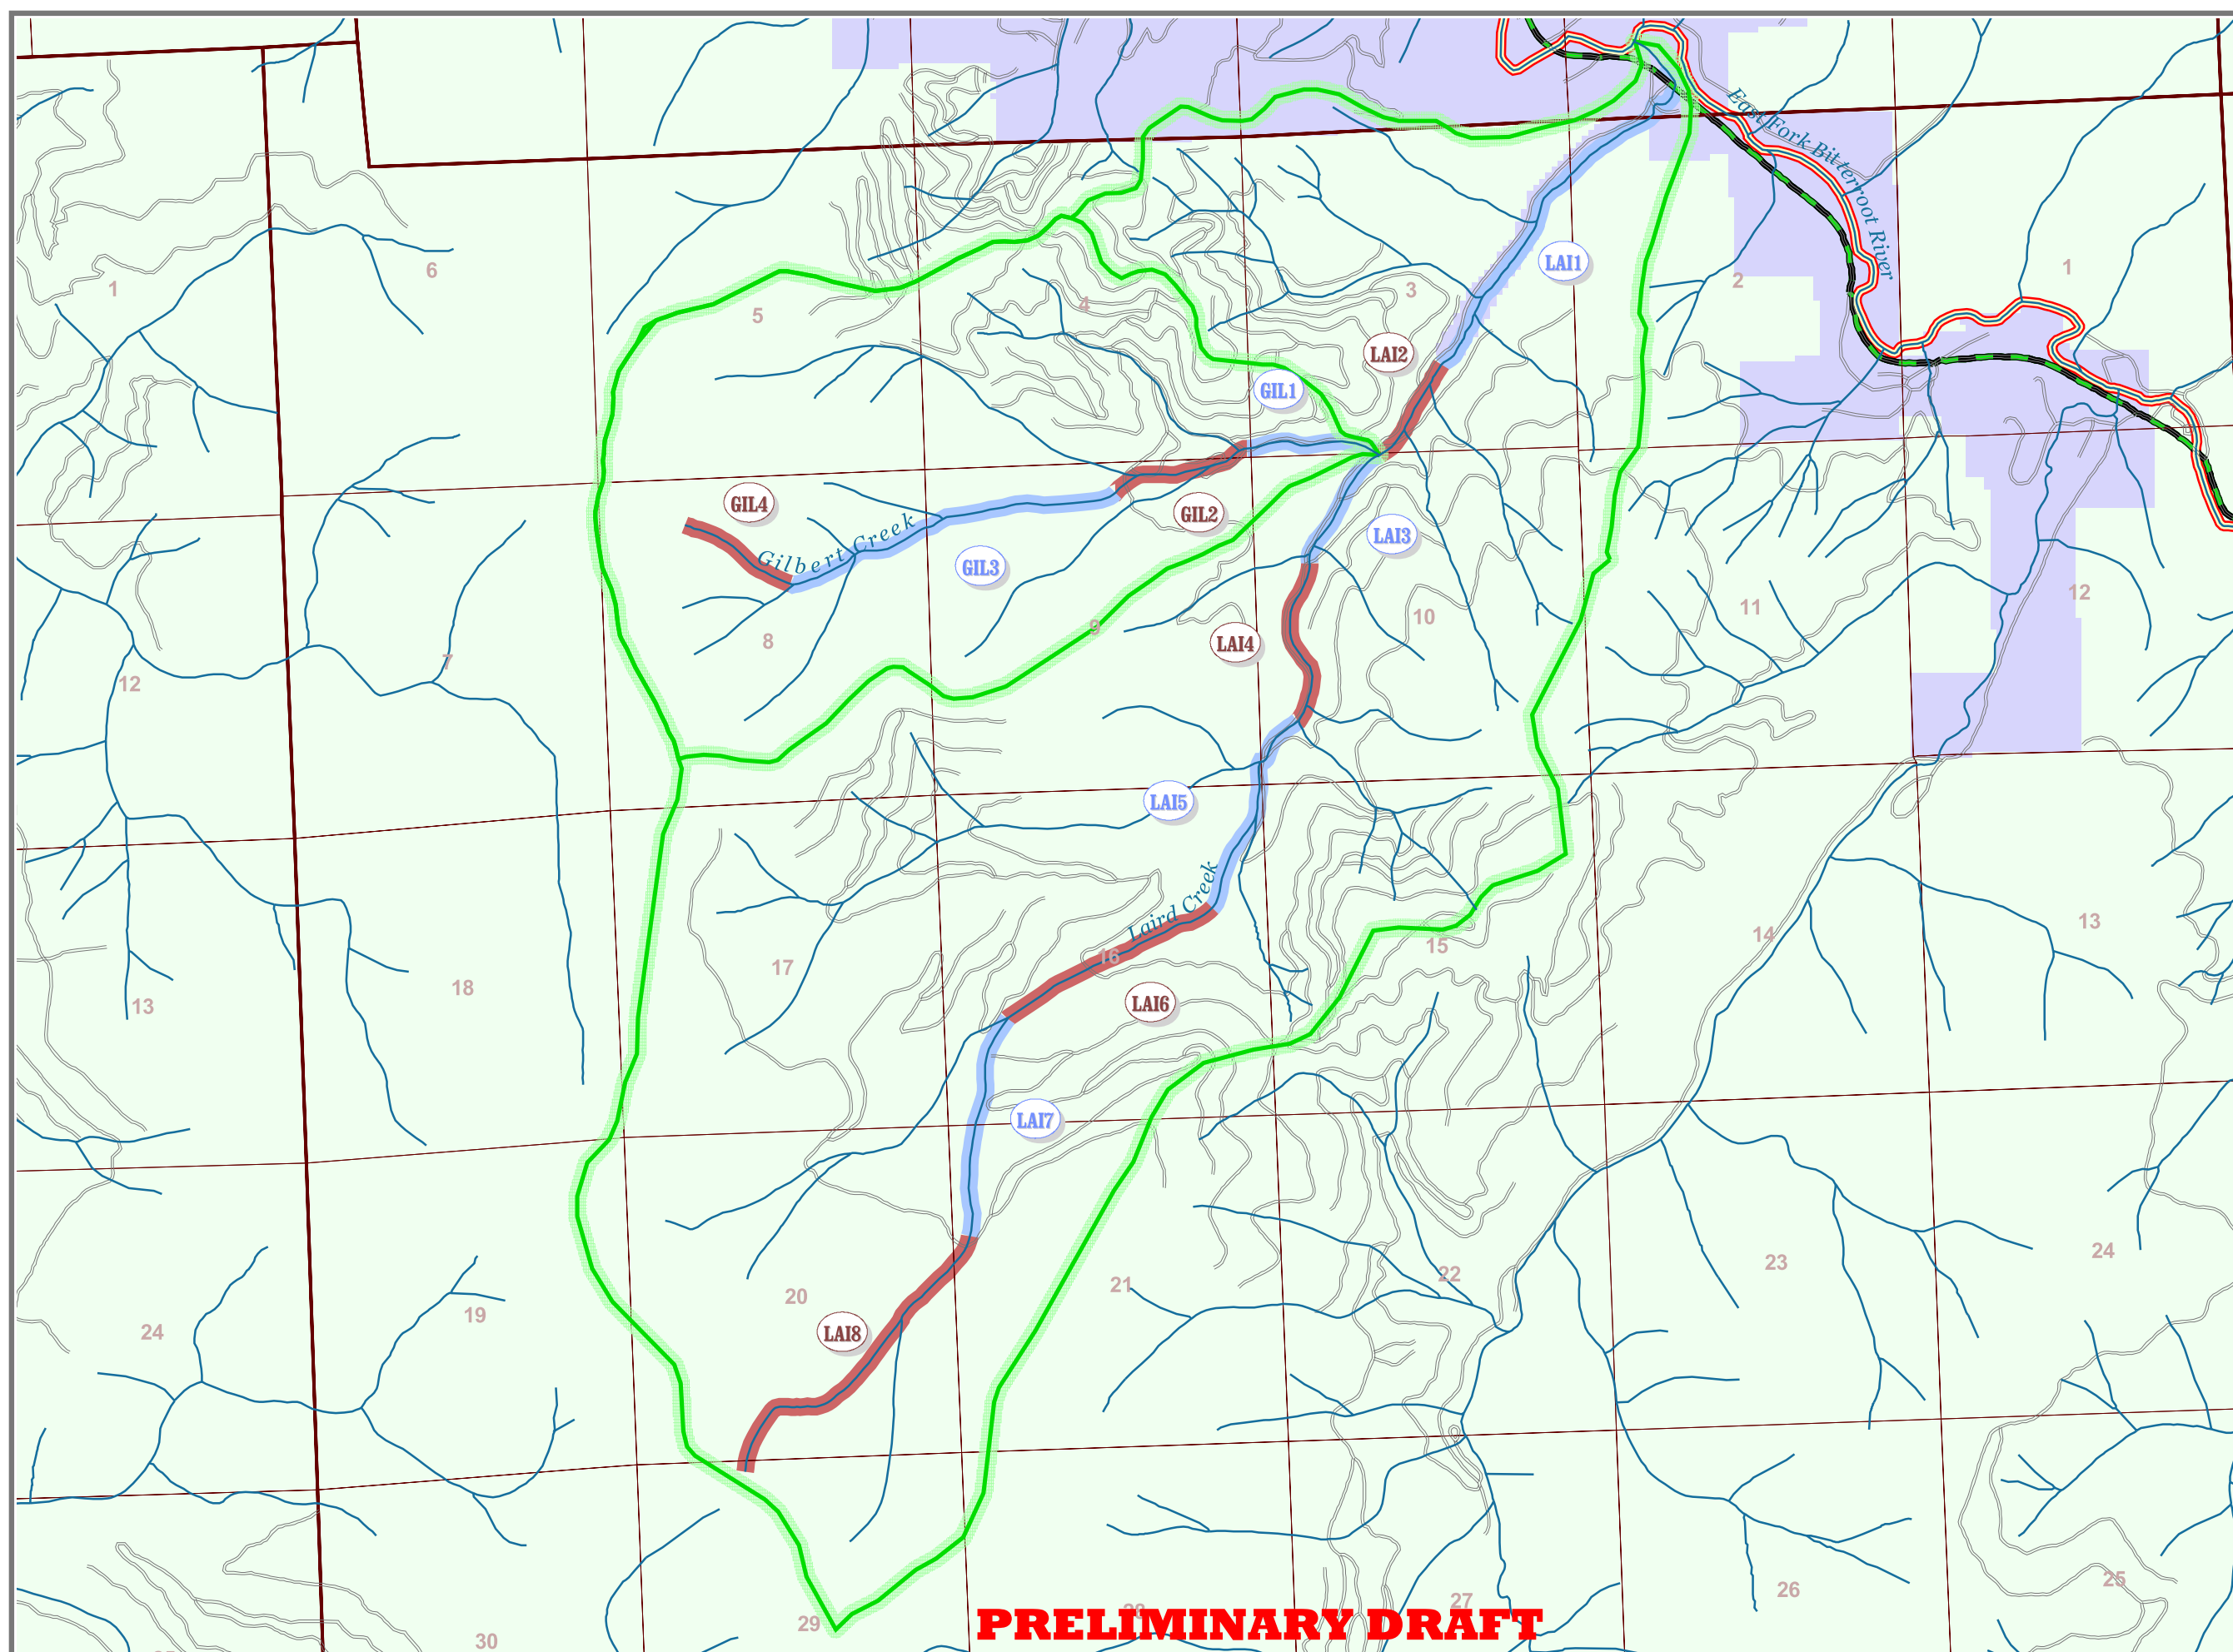
**Figure H-6**  
**Bank Condition**  
**Assessment Reaches**  
 Gilbert & Laird Creeks

- Gilbert & Laird Creek Reaches
- Watershed Boundary
- East & West Forks of the Bitterroot River
- Other Streams
- Major Roads
- Other Roads
- Section Lines

[Figure H-6. Bank Conditions Assessment Reaches Gilbert/Laird Creek.](#)

Reach	Total Bank Length (mi)	% Unstable Banks (air photo)	% Unstable Banks (on ground)	Total % of Bank Unstable (overlap removed)	% of Bank in 20+ Years Late Seral Condition	Comments
LAI1	2.47	0.00	38.50	38.50	0.00	Liard conflues with EFB at a new upstream location, not depicted on topo. Main highway crosses creek. Creek meanders through private property - some agric., but mostly homes with yards. Reach burned intensely leaving some green trees around homes, but most trees burned along with some structures. Main road and structures and access roads all occur within 100 feet of streambanks.
LAI2	0.68	0.00	0.00	0.00	50.00	Reach burned intensely leaving black toothpicks on slopes and in riparian. USFS roads occur on both sides of drainage, but only road on west stream side is near of less than 100 feet from bank. It appears like one structure occurs within 100 feet of west streambank, and may have been burned.

LAI3	0.81	0.00	16.42	16.42	0.00	Reach burned intensely with a patch of green trees remaining mid-way. USFS road constricts creek and occurs within 100 feet of west streambank. Road intersections occur mid-way up reach and at upper reach boundary.
LAI4	1.05	0.00	0.00	0.00	50.00	Main road occurs within 100 ft of west streambank (constricts). Logging roads on mountain slopes are greater than 220 feet horz. distance from banks. Fire intensity high- all trees burnt black.
LAI5	1.32	0.00	0.00	0.00	0.00	Reach is burnt with low intensity - some brown needled trees and many green trees occur. Main road constricts, occurring with 100 feet of streambanks. Main road crosses where Liard and Moon Creeks confluence. Regenerating clearcuts occur along east streambank. Difficult to see creek.
LAI6	1.43	0.00	0.00	0.00	0.00	Reach is moderately burned with a diversity in tree heights. Some logging roads and one road crossing occurs within 100 feet of streambank. Portion of reach appeared previously logged, but regenerating. Difficult to see creek. Loosely soiled forest openings occur on slopes north of stream.

LAI7	1.38	0.00	0.00	0.00	50.00	Reach is intensely burnt for 80% or more. Middle portion of reach is intensely burnt while green trees remain at lower and upper reach portions. Confluence marks lower reach boundary while road crossing marks upper reach boundary. Another logging road occurs within 100 feet of east streambank.

Reach	Total Bank Length (mi)	% Unstable Banks (air photo)	% Unstable Banks (on ground)	Total % of Bank Unstable (overlap removed)	% of Bank in 20+ Years Late Seral Condition	Comments
LAI8	1.28	0.00	0.00	0.00	50.00	Reach is not burnt except for maybe a small handful of trees scattered about 100 feet from streambank. Channel is barely discernable. Reach is unlogged and no roads occur within more than 100 feet of banks.
LAI9	0.85	0.00	0.00	0.00	50.00	Headwater reach ends at base of Medicine Point peak (7800 ft). Headwaters burnt intensely with a handful of green trees maybe. Many of the trees are brown-needled. Lower reach boundary occurs where fire boundary occurs.
<b>TOTALS</b>	<b>11.26</b>	<b>0.00</b>	<b>9.63</b>	<b>9.63</b>	<b>23.23</b>	
GIL1	0.84	0.00	0.00	0.00	0.00	Reach burned intensely in 2000 leaving black toothpicks. Main USFS road occurs within 100 ft of streambank. Riparian and slopes burned intensely. Upper reach boundary occurs where road switchbacks.

GIL2	0.88	0.00	0.00	0.00	0.00	Reach burned intensely in 2000 leaving black toothpicks. Logging roads occur within 100 ft of streambanks. Riparian and slopes burned intensely. Lower reach boundary ends at road switchback. Upper reach boundary ends at fire boundary where green trees occur.
GIL3	2.11	0.00	0.00	0.00	0.00	Reach burned moderately with some intense burnt riparian, but mostly green riparian. Trees are moderately dense due to talus and steep, loosely soiled slopes on the north side of drainage. No logging roads or harvesting were evident.
GIL4	0.75	0.00	0.00	0.00	50.00	Reach is the headwaters and did not burn. Mtn slopes to the southwest have fairly dense canopy while slopes to the northeast have a scattered canopy due to steep, loosely soiled ground. No roads or harvesting are observable.
<b>TOTALS</b>	<b>4.58</b>	<b>0.00</b>	<b>0.00</b>	<b>0.00</b>	<b>8.17</b>
