**Draft**  
**Supplemental Environmental Impact Statement**  
**Golden Sunlight Mine Pit Reclamation**

**December 2004**

Montana Department of Environmental Quality  
and  
U.S. Bureau of Land Management

**Draft  
Supplemental Environmental Impact Statement  
Golden Sunlight Mine  
Pit Reclamation Alternatives**

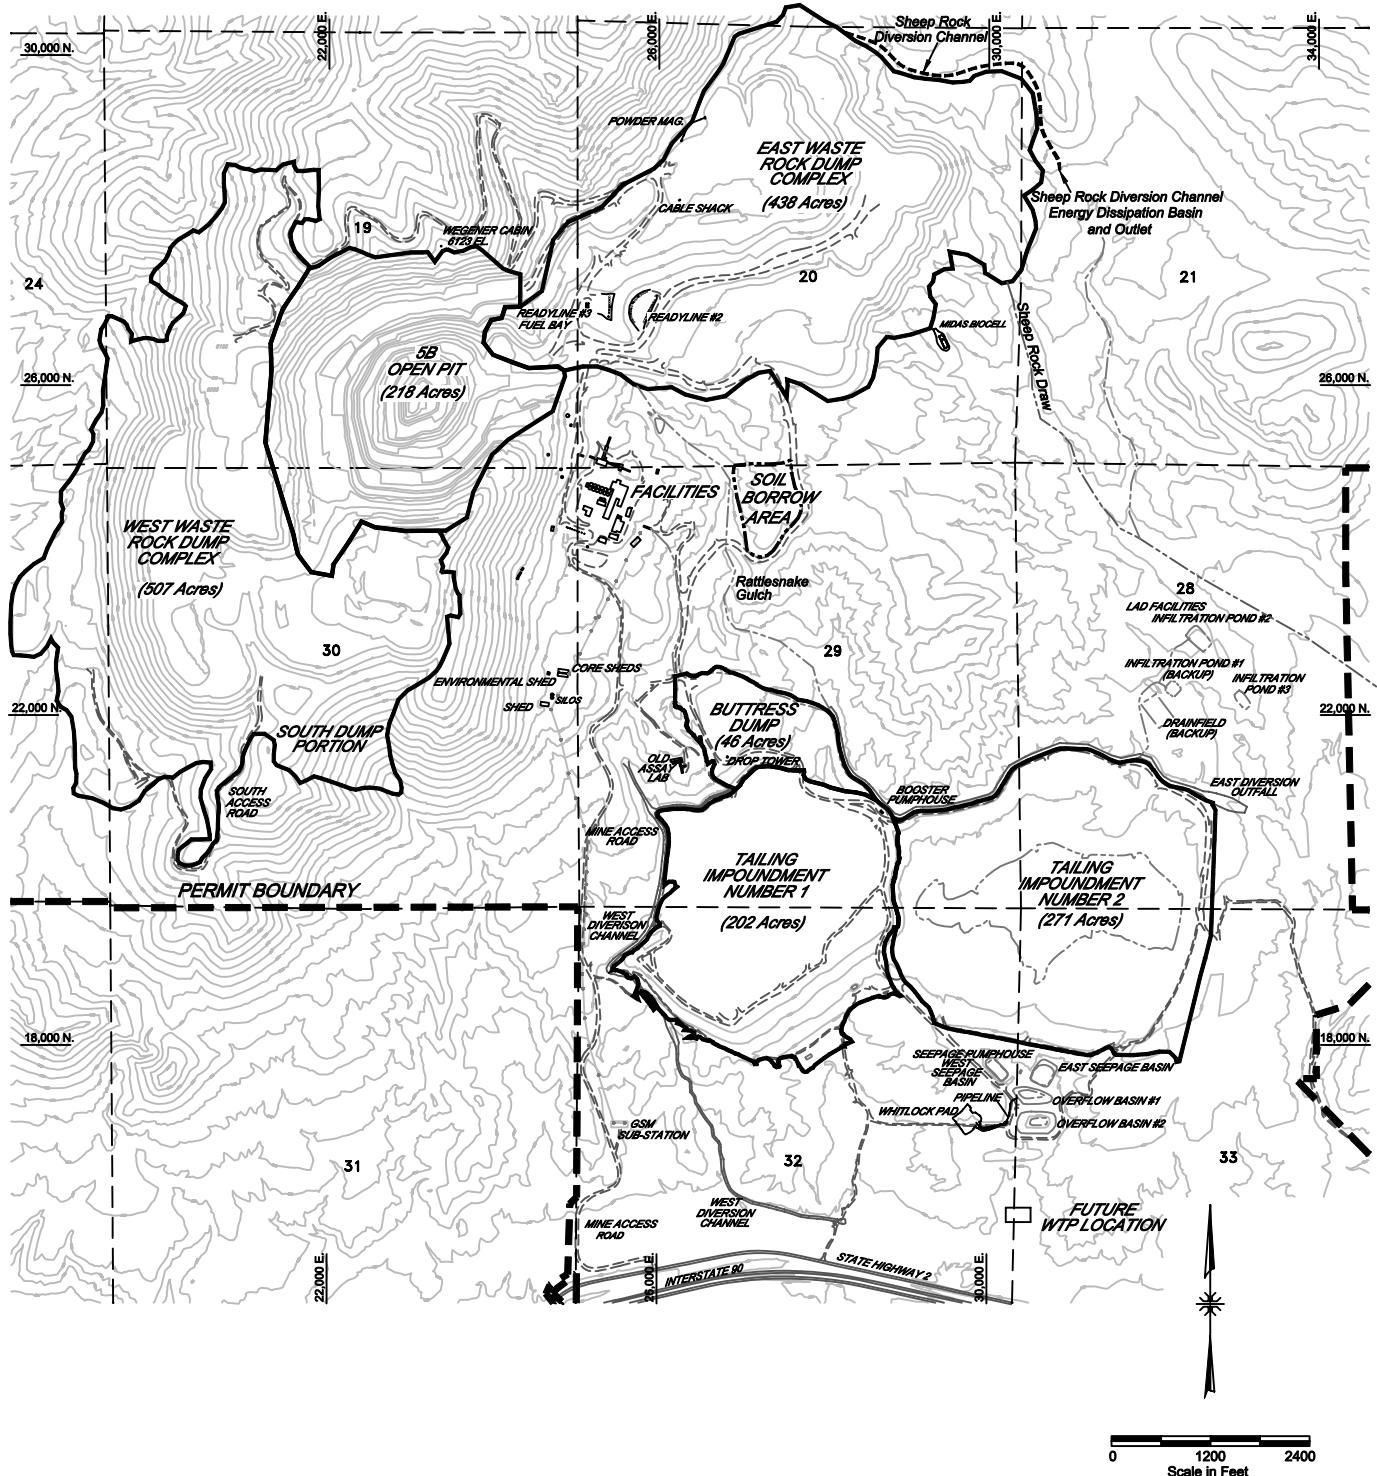
**MINE FACILITIES  
AS OF DECEMBER 2003**

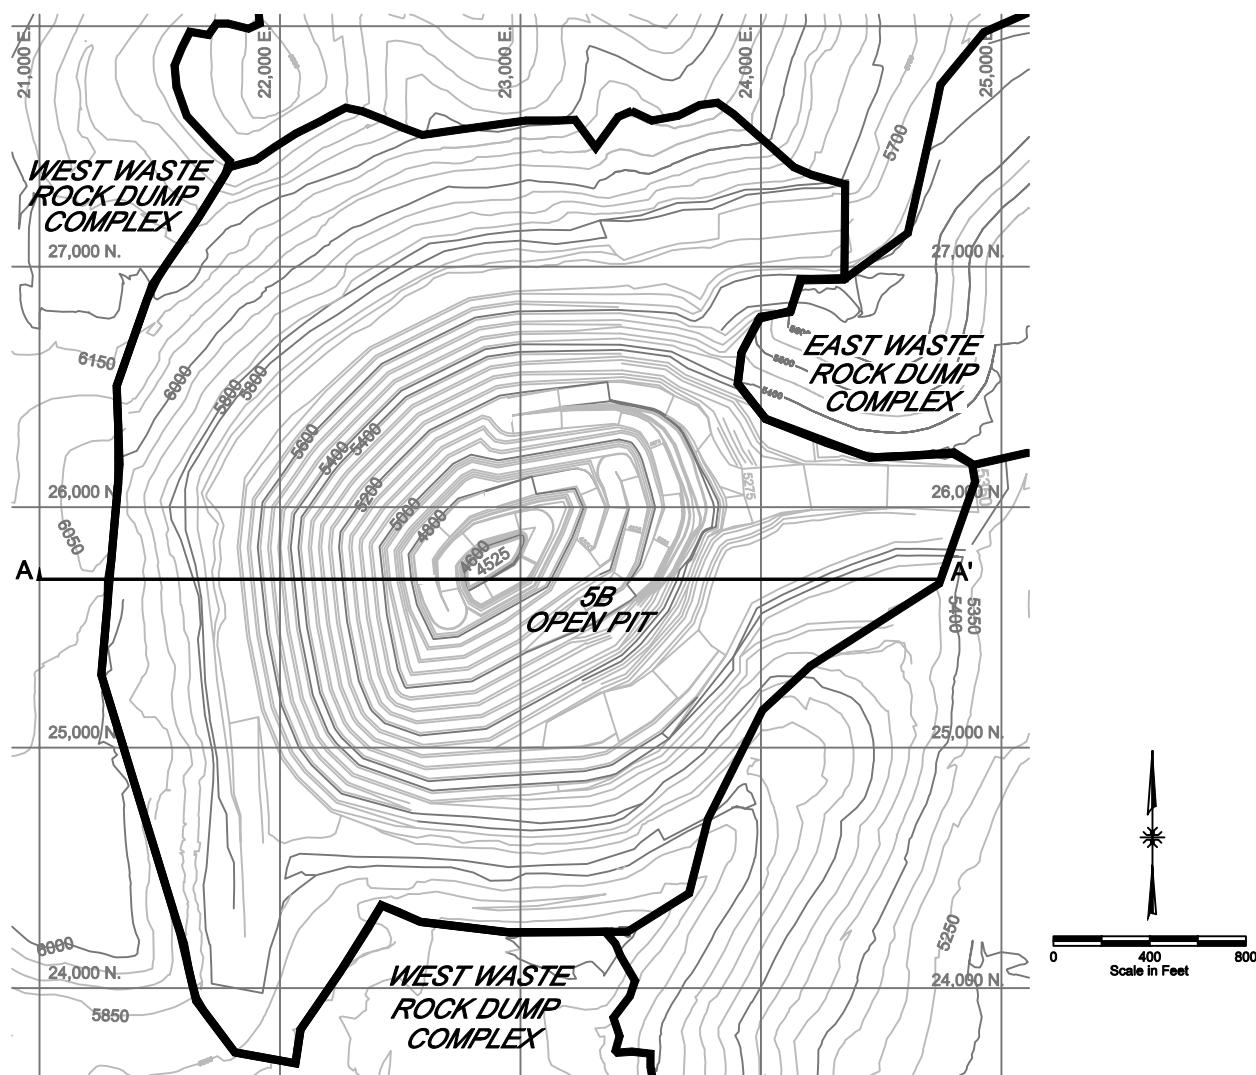
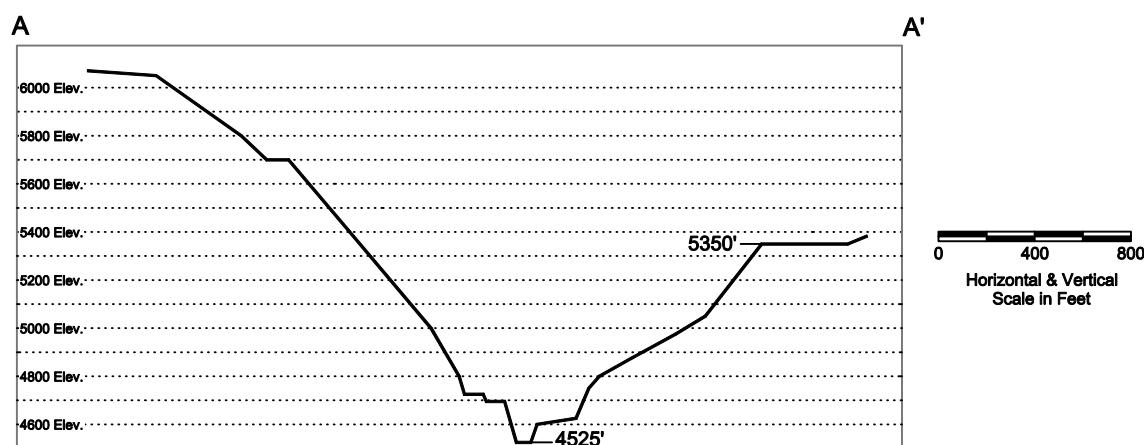
Ultimate Pit Floor Elevation = 4525 Feet

All Alternatives  
STAGE 5B  
PIT EXPANSION  
MINE PLAN

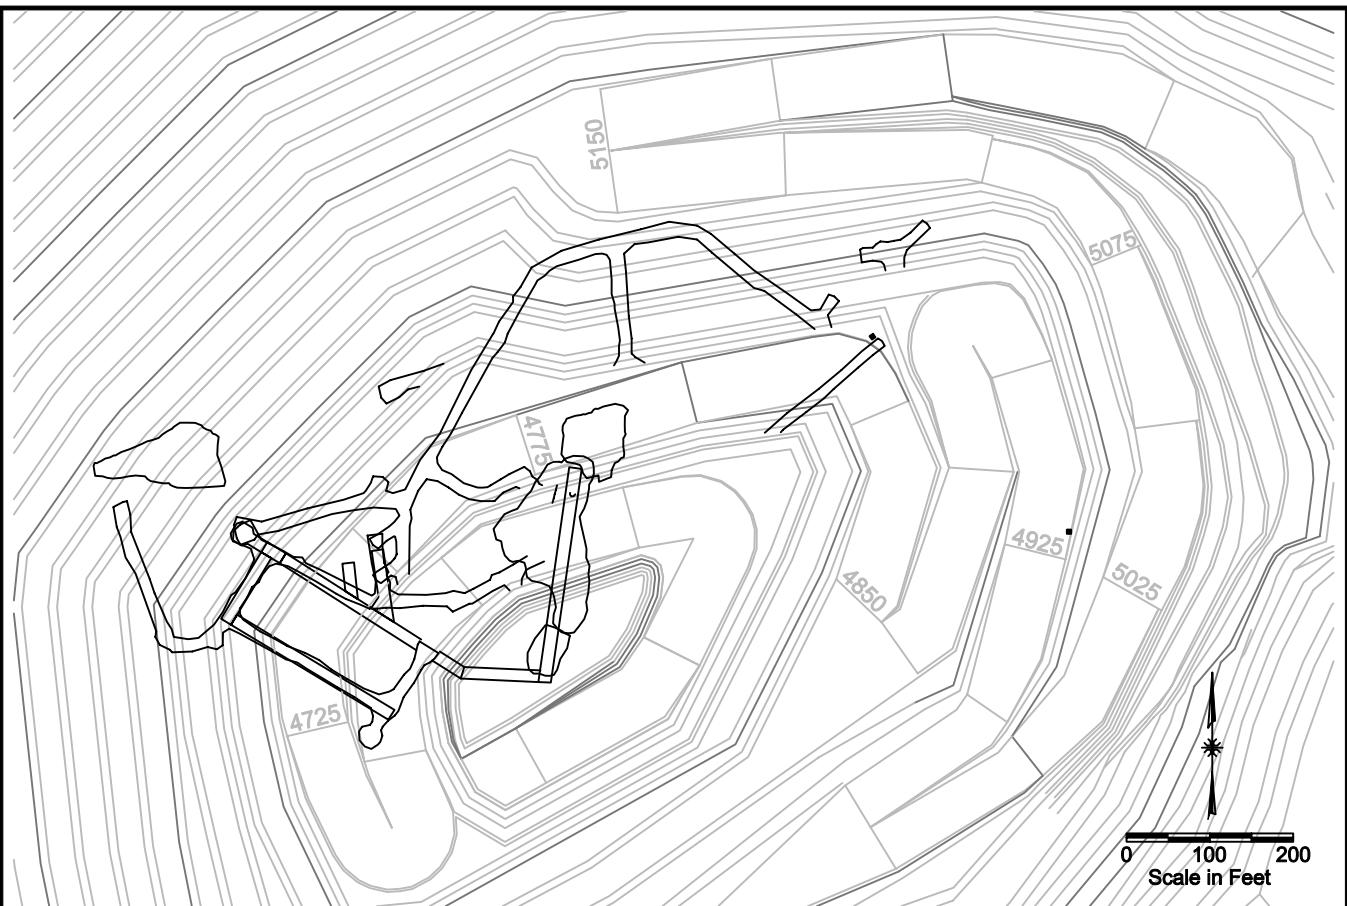
PLAN VIEW OF THE UNDERGROUND WORKINGS REMAINING AFTER MINING STAGE 5B

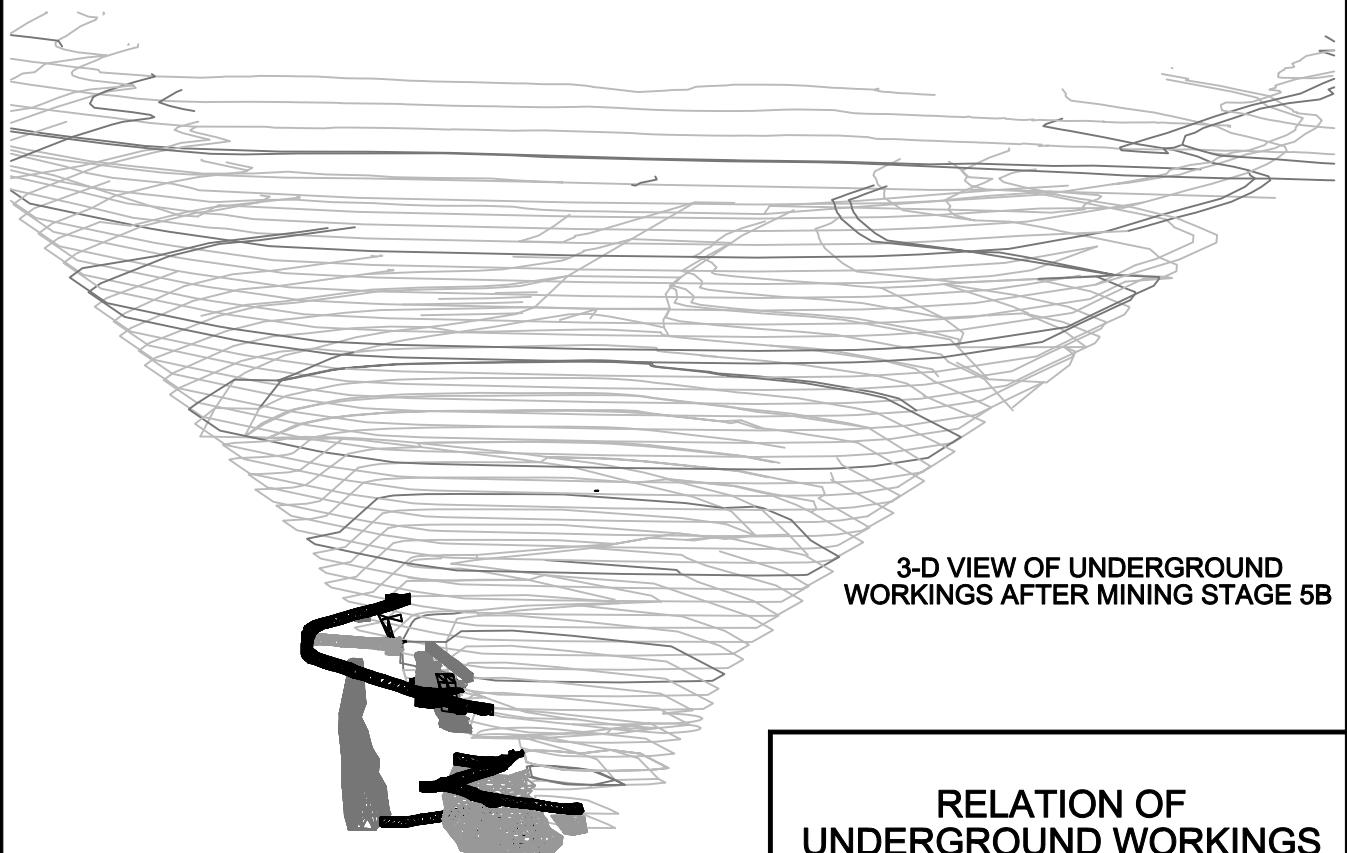
3-D VIEW OF UNDERGROUND WORKINGS AFTER MINING STAGE 5B

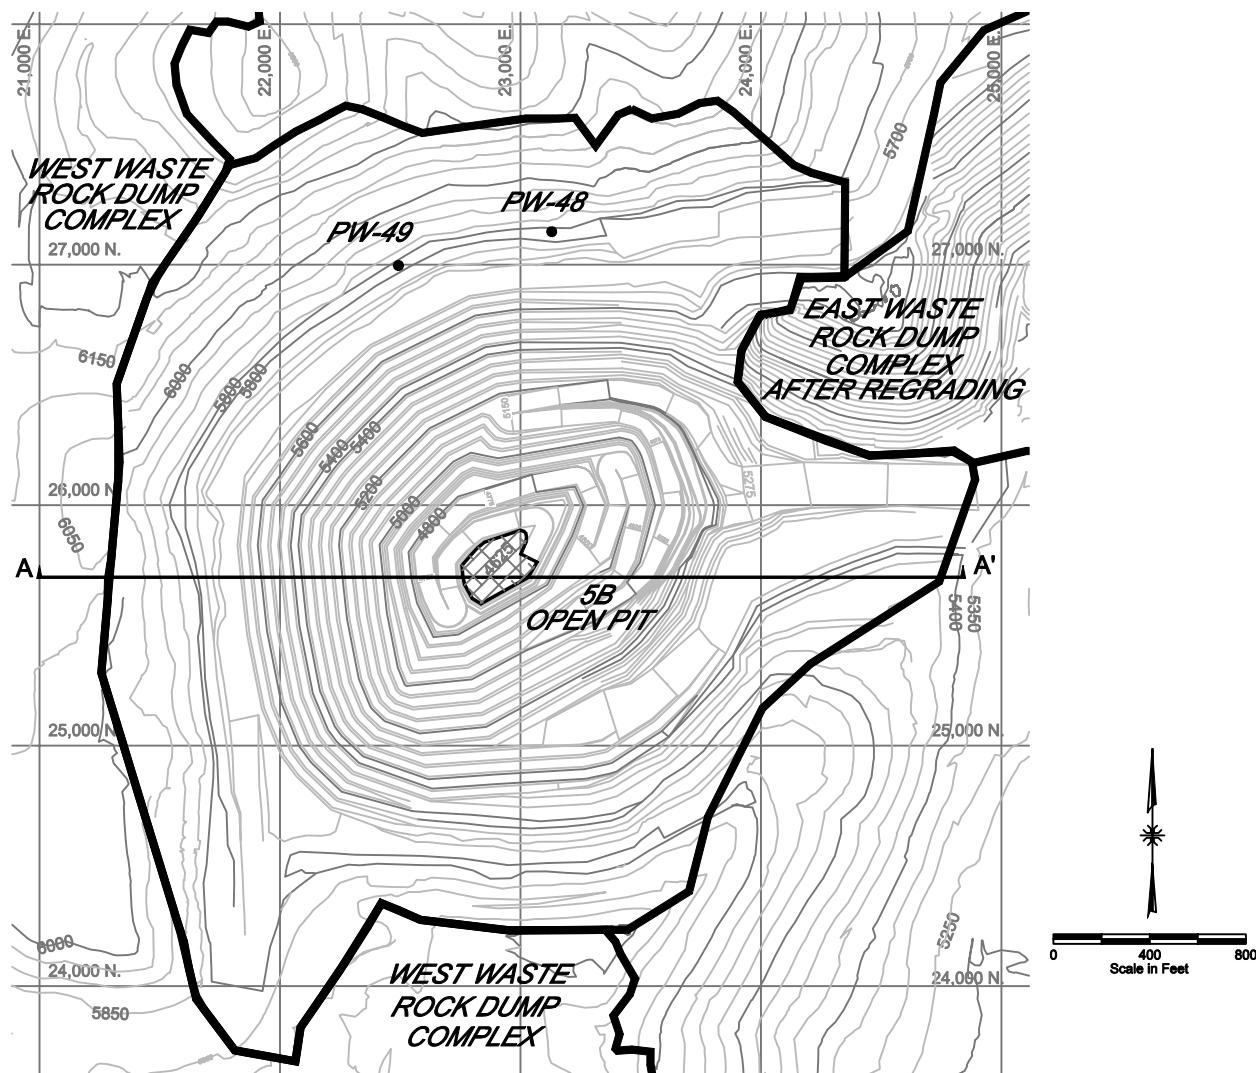
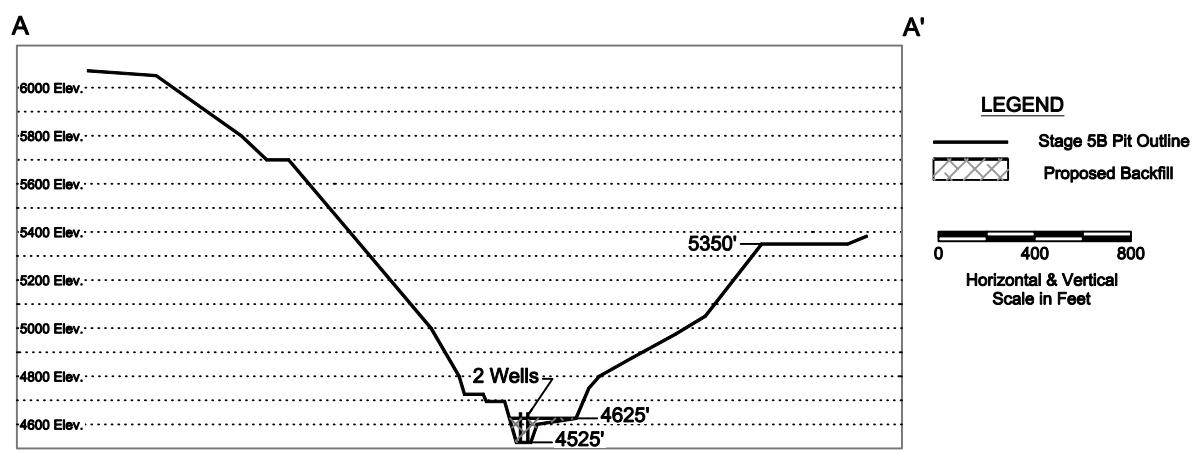
No Pit Pond Alternative  
would have two dewatering wells  
through the 100 feet of backfill  
from the 4525 to 4625 elevation

No Pit Pond (No Action) Alternative

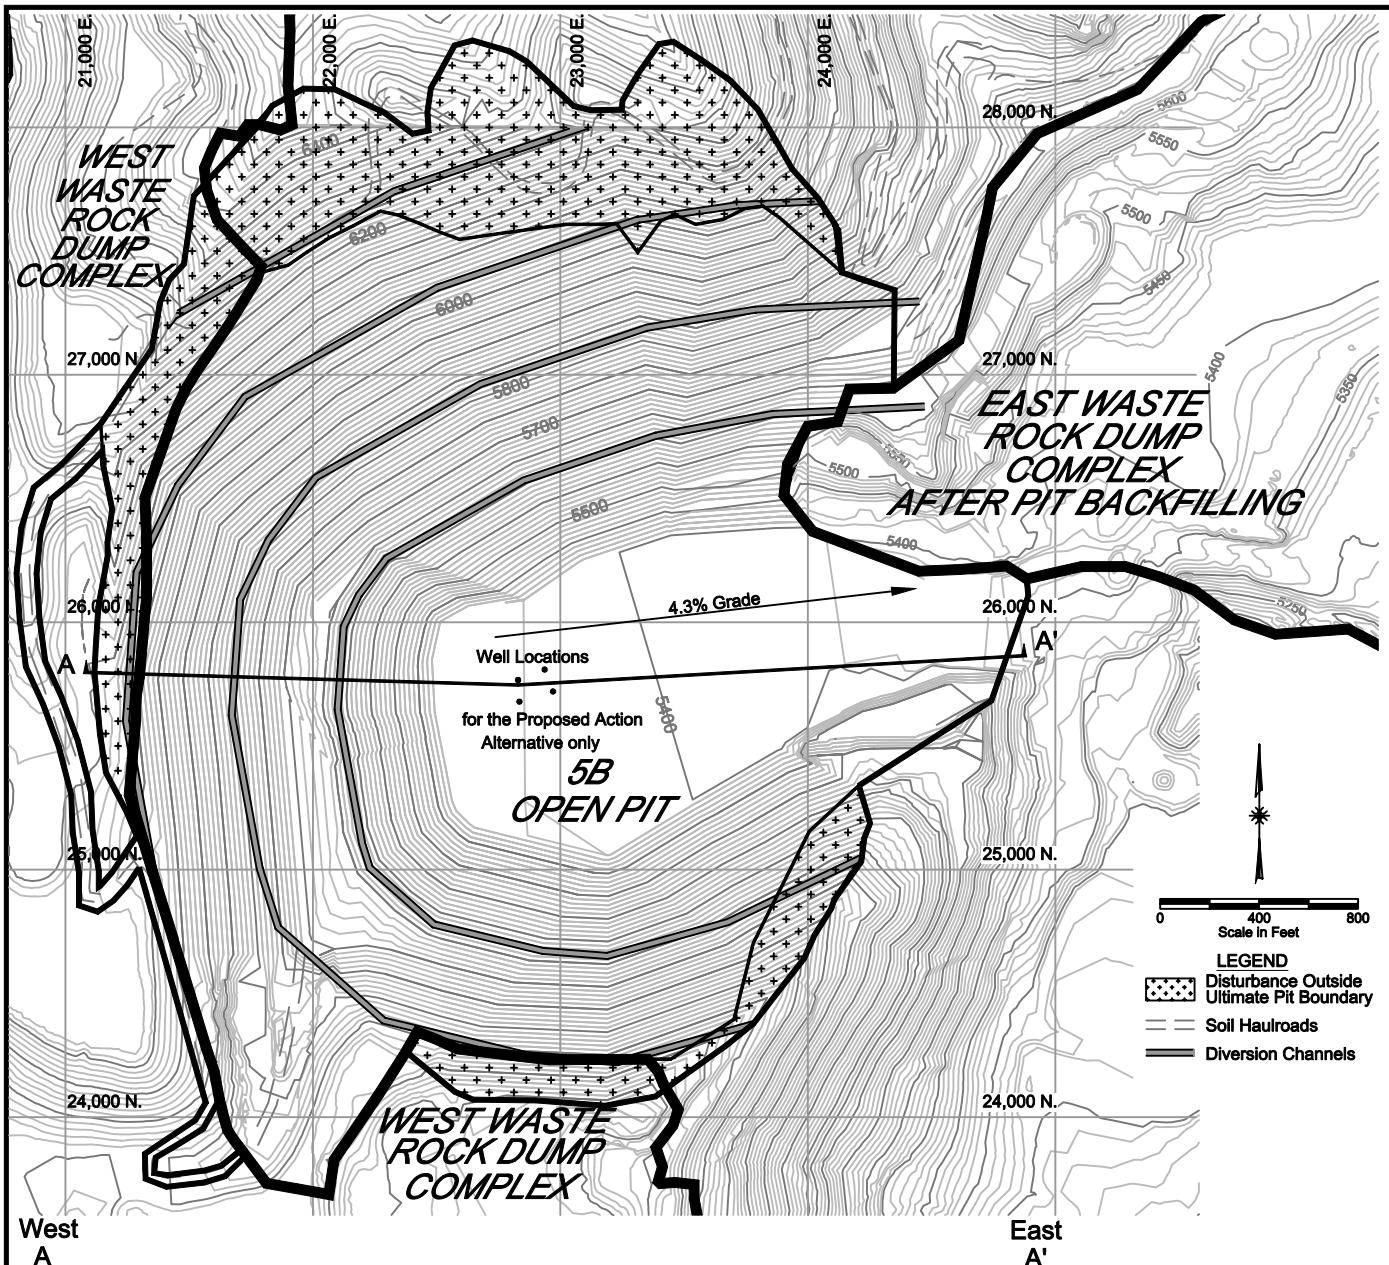
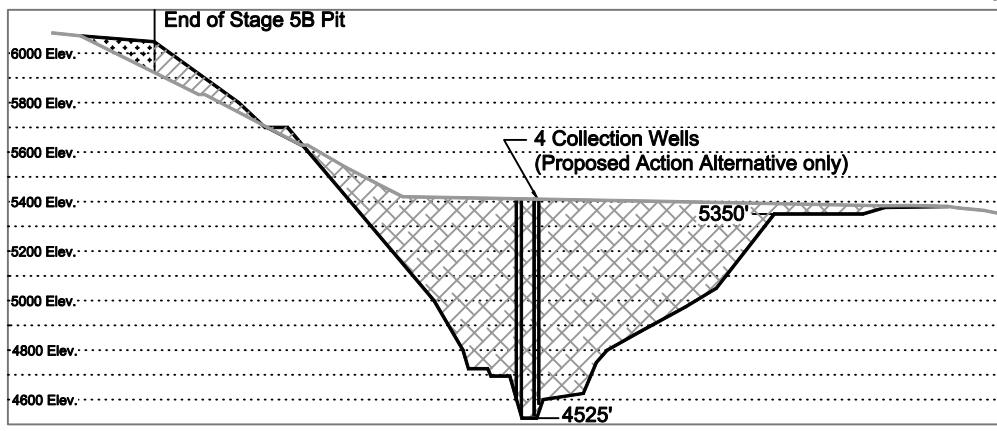
Partial Pit Backfill with In-Pit Collection Alternative would have four 800-875 foot dewatering wells drilled to approximately the 4525-foot elevation.

Partial Pit Backfill with Downgradient Collection Alternative would have no in-pit wells.

Waste rock for backfilling the pit would not be hauled from the reclaimed West Waste Rock Dump Complex. GSM would reduce the pit highwall above the 5,400-foot elevation to 2H:1V slopes by employing cast blasting and dozing. Approximately 11,900,000 cubic yards (17,850,000 tons) of pit highwall material and 56 acres of additional disturbance in the pit area would be needed to recontour these slopes and develop roads for soil distribution (Figure 2-4). Storm water diversions would be installed every 200 vertical feet down the backfill slope to minimize erosion and to intercept runoff. The benches would be constructed similarly to those constructed for the waste rock dumps. Drainage diversions on the benches would be sloped to collect runoff and route it off the backfill material. The final pit configuration after backfilling the Stage 5B Pit is shown in Figure 2-4, which includes both plan and cross-sectional views.

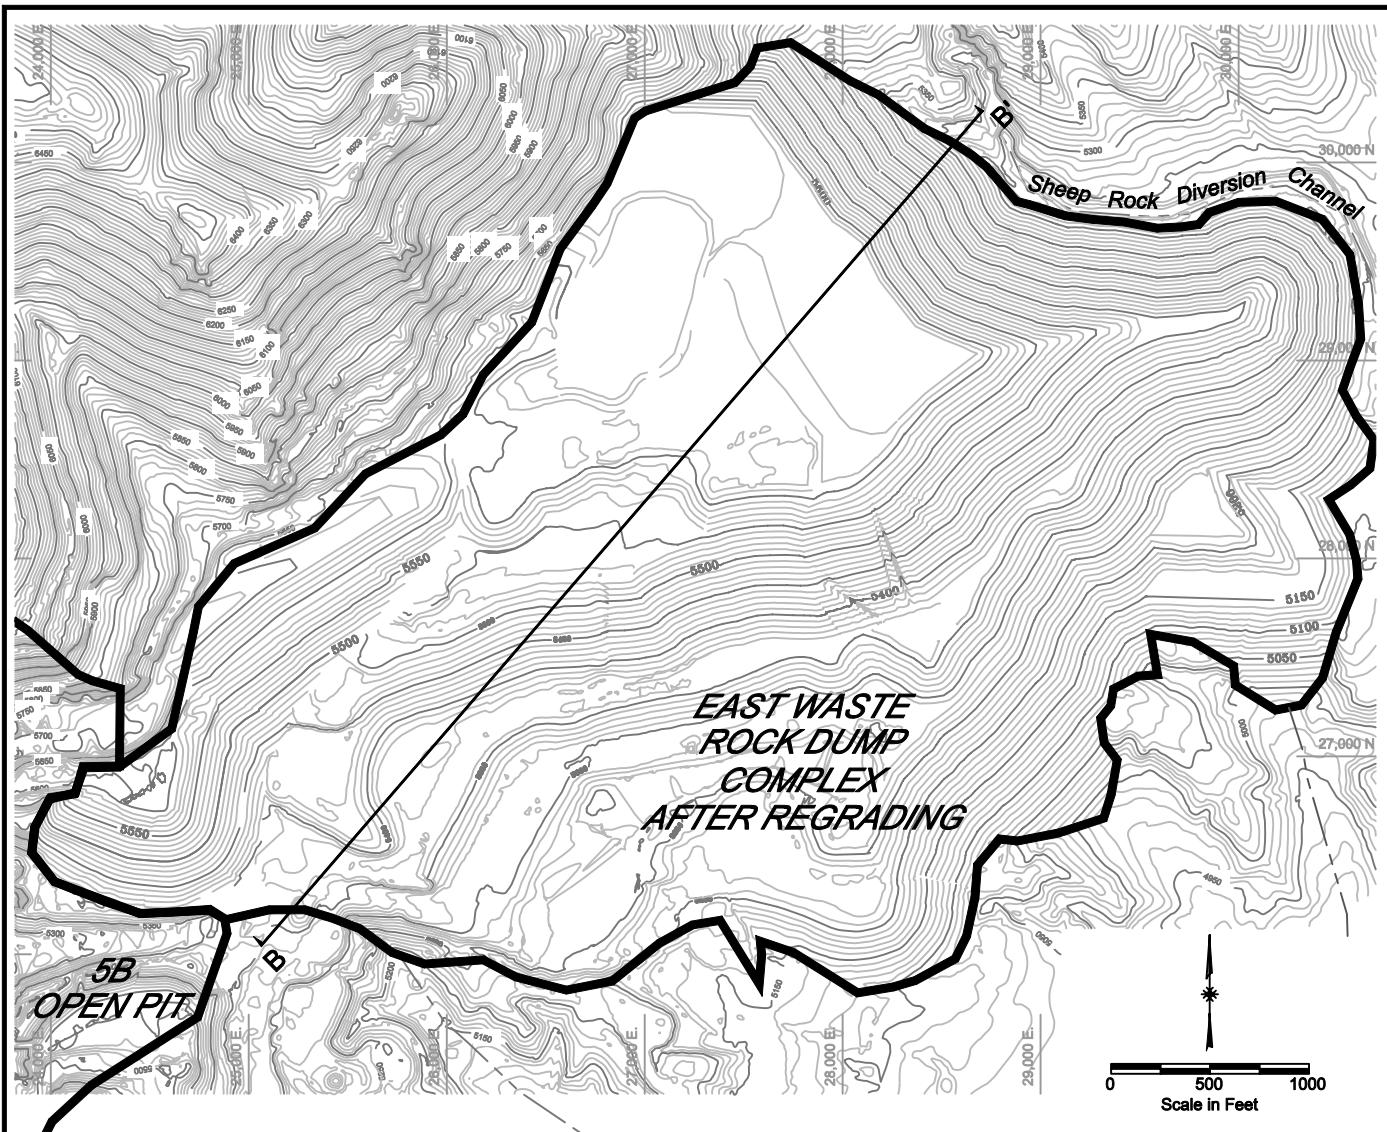
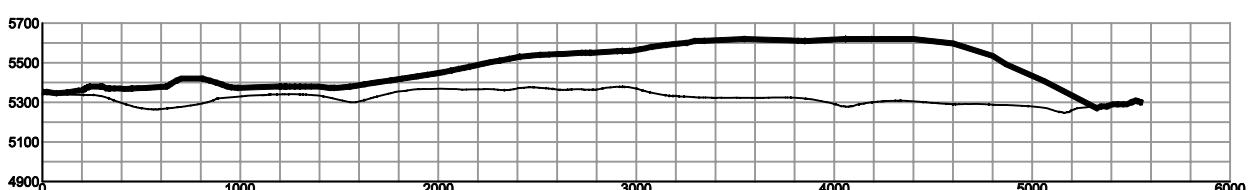
B B' CROSS SECTION

No Pit Pond & Underground Sump Alternatives

**EAST WASTE ROCK DUMP  
COMPLEX TOPOGRAPHY  
AFTER REGRADING**

The topography of the East Waste Rock Dump Complex after mining under the Stage 5B Pit plan is shown in both plan and cross-sectional views on Figure 2-5. Figure 2-6 shows the final configuration of the East Waste Rock Dump Complex after removing 33,200,000 cubic yards of material for backfilling from a 222 acre area. As of the end of 2003, this dump contained 76,700,000 cubic yards (114,750,000 tons). However, another 25,000,000 cubic yards (37,500,000 tons) will be added during Stage 5B mining. The Partial Pit Backfill With In-Pit Collection Alternative would remove 33 percent of the total volume in the East Waste Rock Dump Complex into the pit. None of the backfilling operations would reduce the current footprint of the dump of 438 acres. This varies from the 1997 Draft EIS, Chapter II, Section II.B.7.b, which would have used 30 to 32 percent of the total permitted volume and would have completely removed 82 acres of the dump complex.

Under the No Pit Pond Alternative, up to 500,000 cubic yards (750,000 tons) would have been removed from the top of the East Waste Rock Dump Complex for the backfill sump (1997 Draft EIS, Chapter II, Section II.B.6.b; 1998 ROD). Based on the revised pit design in this SEIS under the No Pit Pond Alternative, only 111,000 cubic yards (167,000 tons) would be removed from the top for backfill. This is about 0.1 percent of the total waste rock volume and would not change the footprint of the dump (Figure 2-5, showing waste rock after Stage 5B).

The topography of the East Waste Rock Dump Complex after mining Stage 5B is shown in plan and cross-section views on Figure 2-5, and the final configuration of the East Waste Rock Dump Complex after removing material for backfilling is shown on Figure 2-6.

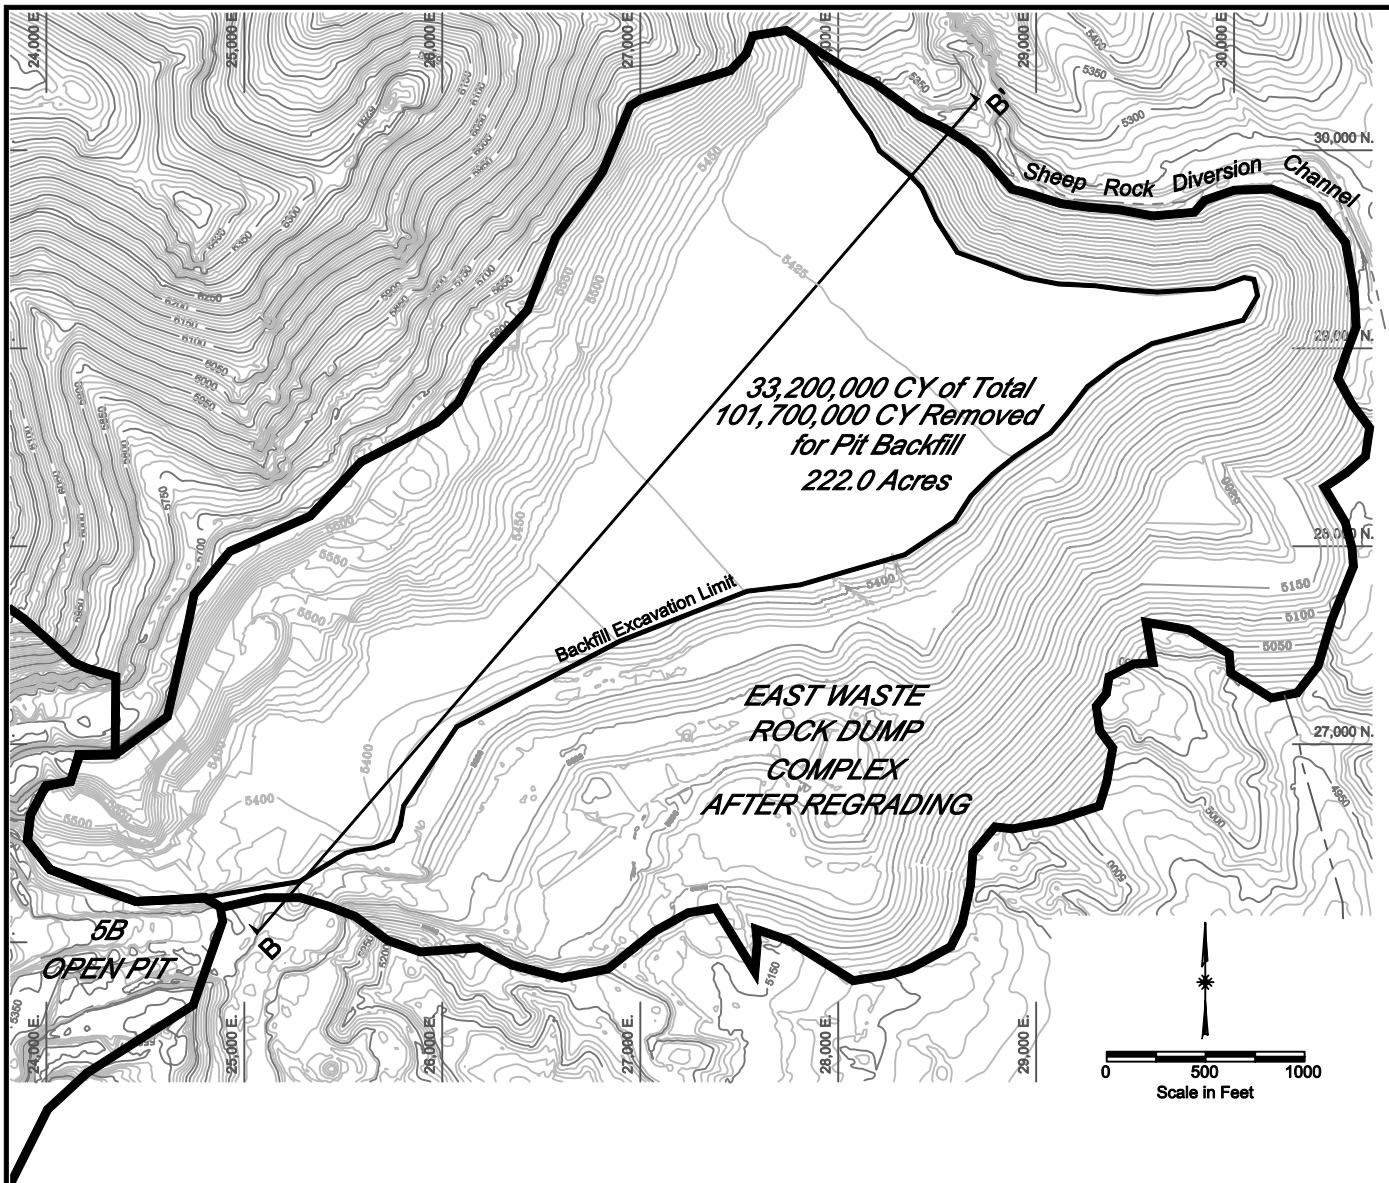
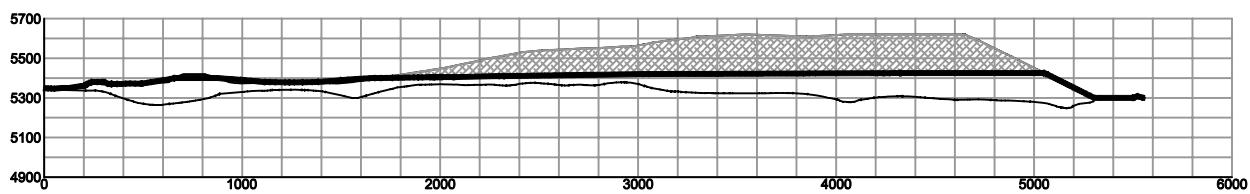
- Pre-Mining Topography
- Regraged Topography
- East Waste Rock Dump Complex Removed  
For Partial Pit Backfill Alternatives

This SEIS addresses potential environmental consequences as a result of the Proposed Action, No-Action and other alternatives presented in Chapter 2. The most important issue in this SEIS, as determined through scoping including the MAA process, is the potential impact to groundwater. The open pit is the principal facility affected by the actions and alternatives of this SEIS. The East Waste Rock Dump Complex is partially affected since, for alternatives where backfill occurs, waste rock to backfill the pit would be obtained by removing about 33 percent of the volume from the top of the East Waste Rock Dump Complex as shown in Figure 2-6. The footprint of the East Waste Rock Dump Complex would not change.

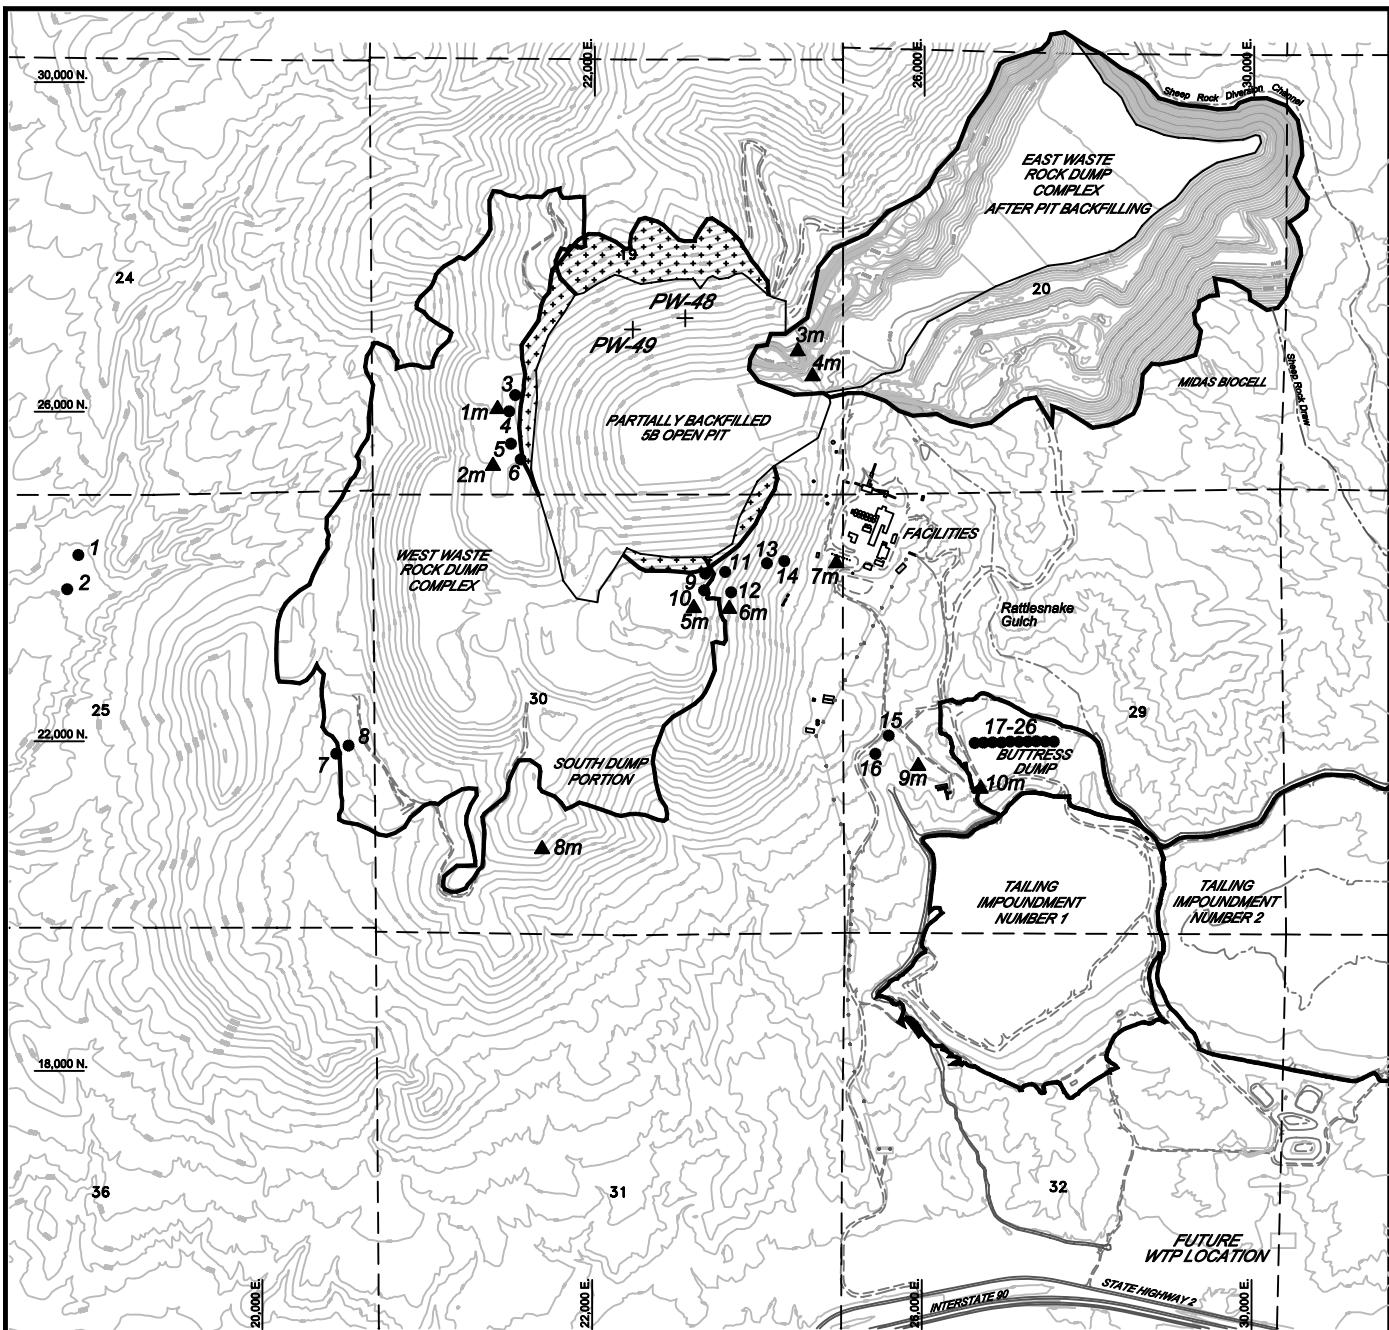
- New Dewatering Well (1-26)
- ▲ New Monitoring Well (1m-10m)
- ✚ Existing Dewatering Wells (PW-48, PW49)
- ◆ Highwall Reduction Area

Conceptual new well locations are shown on Figure 2-7. A hydrogeologic study would be conducted to locate the wells, and GSM would have to submit an application to modify the approved mixing zone.

After closure of the pit, precipitation could collect in the pit by falling directly into the pit and by infiltrating into the fractured highwall and flowing to the pit bottom as is occurring during active mining. A groundwater dewatering system would be designed and constructed to maintain the groundwater level below the final 4,525-foot pit bottom elevation. At least initially, the two highwall wells (PW-48 and PW-49) would also be operated (Figure 2-7).

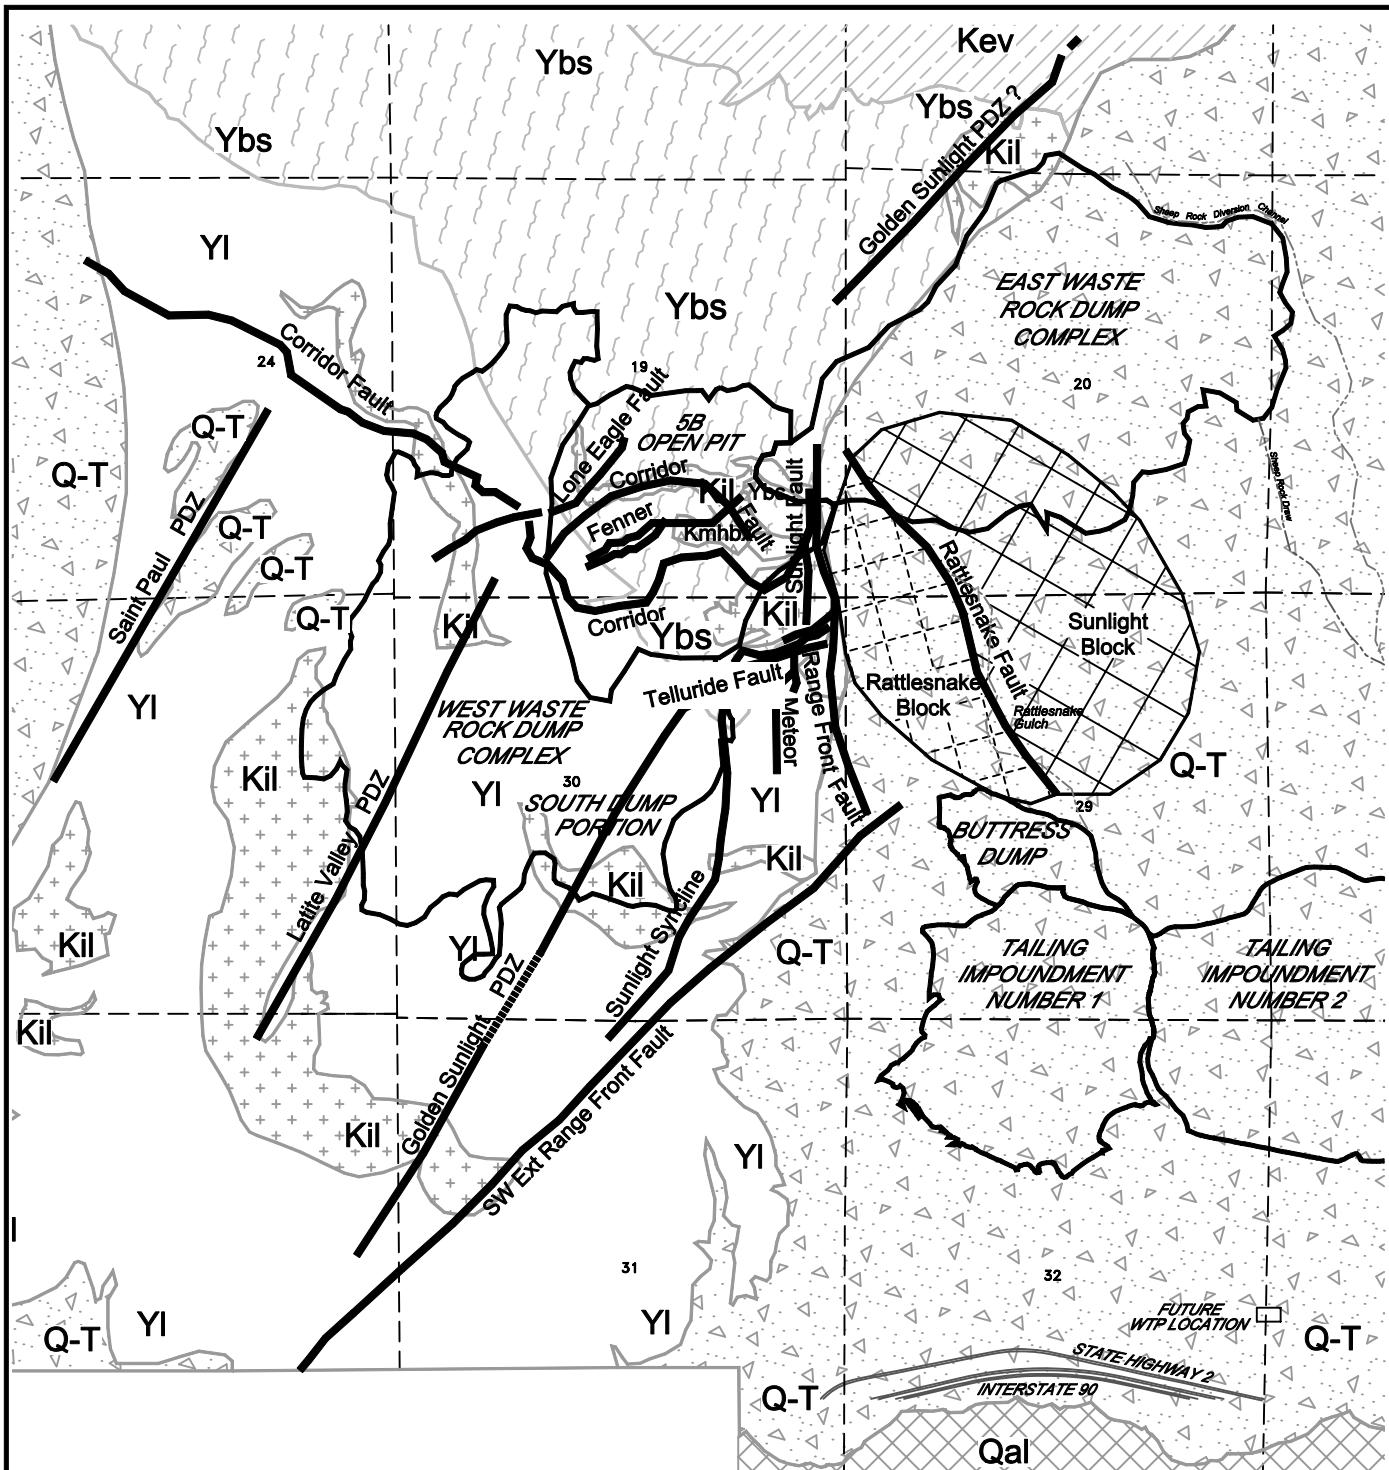
FIGURE 3-1

- Qal Quaternary Alluvial Deposits (Jefferson River Alluvium)
- Q-T Quaternary and Tertiary Deposits
- Kil Cretaceous Latite
- Kev Cretaceous Elkhorn Volcanics
- Kmbx Cretaceous Mineral Hill Breccia
- Ybs Precambrian Bull Mountain Shale
- YI Precambrian LaHood Formation
- Fault**
- PDZ** Principal Deformation Zone

GSM is located on the southern flank of Bull Mountain. Figure 3-1 shows a general map of the surficial geology in the vicinity of the mine. Bull Mountain is composed of ancient sedimentary rock that was deposited in a shallow sea during late Precambrian time approximately 1.4 billion years ago. The Precambrian rock types in the vicinity of the mine include sandstone, siltstone, and shale. These rock units are part of the Precambrian Belt Supergroup, and also have been referred to as the LaHood, Greyson, and Newland formations, and the Bull Mountain Shale.

The Jefferson River alluvial aquifer is near the southern permit area boundary and consists of unconsolidated gravel, sand, and finer-grained overbank deposits (Figure 3-1). Saturated thickness of the aquifer within the permit boundary is estimated to be approximately 20 feet (SHB, 1986). The majority of inflow to the Jefferson River alluvial aquifer south of GSM is through-flow from the west. Relatively minor amounts are contributed from the T/Q alluvial aquifer and Tdf/colluvial aquifer at the mine site to the north (SHB, 1986). The Jefferson River alluvial aquifer is in direct contact with an alluvial channel that underlies Tailings Impoundment No. 1 to the north (SHB, 1985). The direction of groundwater flow in the Jefferson River alluvial aquifer is generally believed to be to the east (SHB, 1985). Hydraulic conductivity estimates for the Jefferson River alluvial aquifer are approximately  $2 \times 10^{-1}$  cm/sec (SHB, 1986). Pumping rates ranging from 10 to 300 gpm have been reported on drillers' logs filed with the Montana Department of Natural Resources and Conservation (DNRC) (SHB, 1987). Gentle groundwater gradients have been documented within the Jefferson River alluvial aquifer and are considered indicative of a highly permeable groundwater flow system (SHB, 1986).

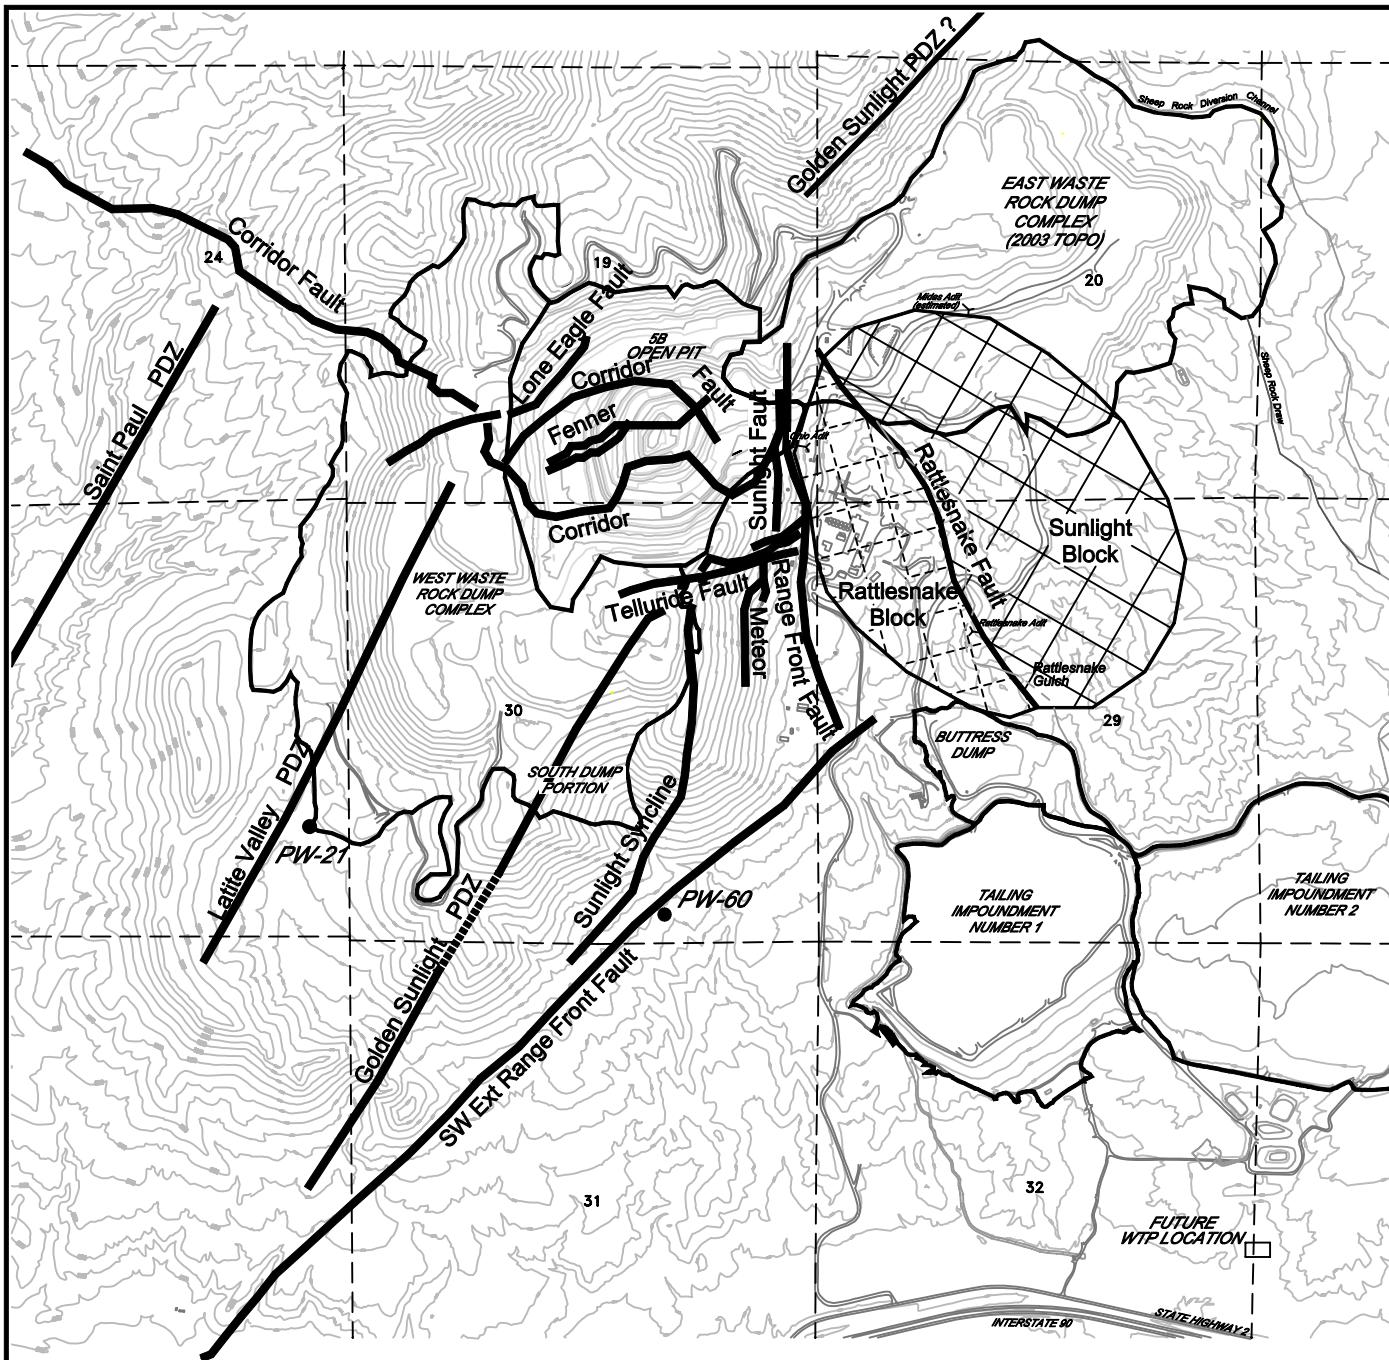
**PDZ** Principal Deformation Zone  
**—** Fault

The open pit is centered on a breccia pipe in the Precambrian host rocks. The pit cuts through and is bounded by a highly complex series of east and northeast trending high-angle faults (Foster and Chadwick, 1990; Foster et al., 1993; Foster and Smith, 1995). The Range Front Fault is a major north-south high-angle slip fault that separates the Precambrian and Cretaceous rocks of the upland from the late Tertiary valley fill sediments. The Corridor Fault is a lens-shaped zone up to several hundred feet thick of low-angle faulting that dips approximately 16 degrees to the northeast (Hydrometrics, 1995). The major geologic structures in the vicinity of the pit are shown in Figure 3-2.
