**Draft**  
**Supplemental Environmental Impact Statement**  
**Golden Sunlight Mine Pit Reclamation**

**December 2004**

Montana Department of Environmental Quality  
and  
U.S. Bureau of Land Management

**Draft  
Supplemental Environmental Impact Statement  
Golden Sunlight Mine  
Pit Reclamation Alternatives**

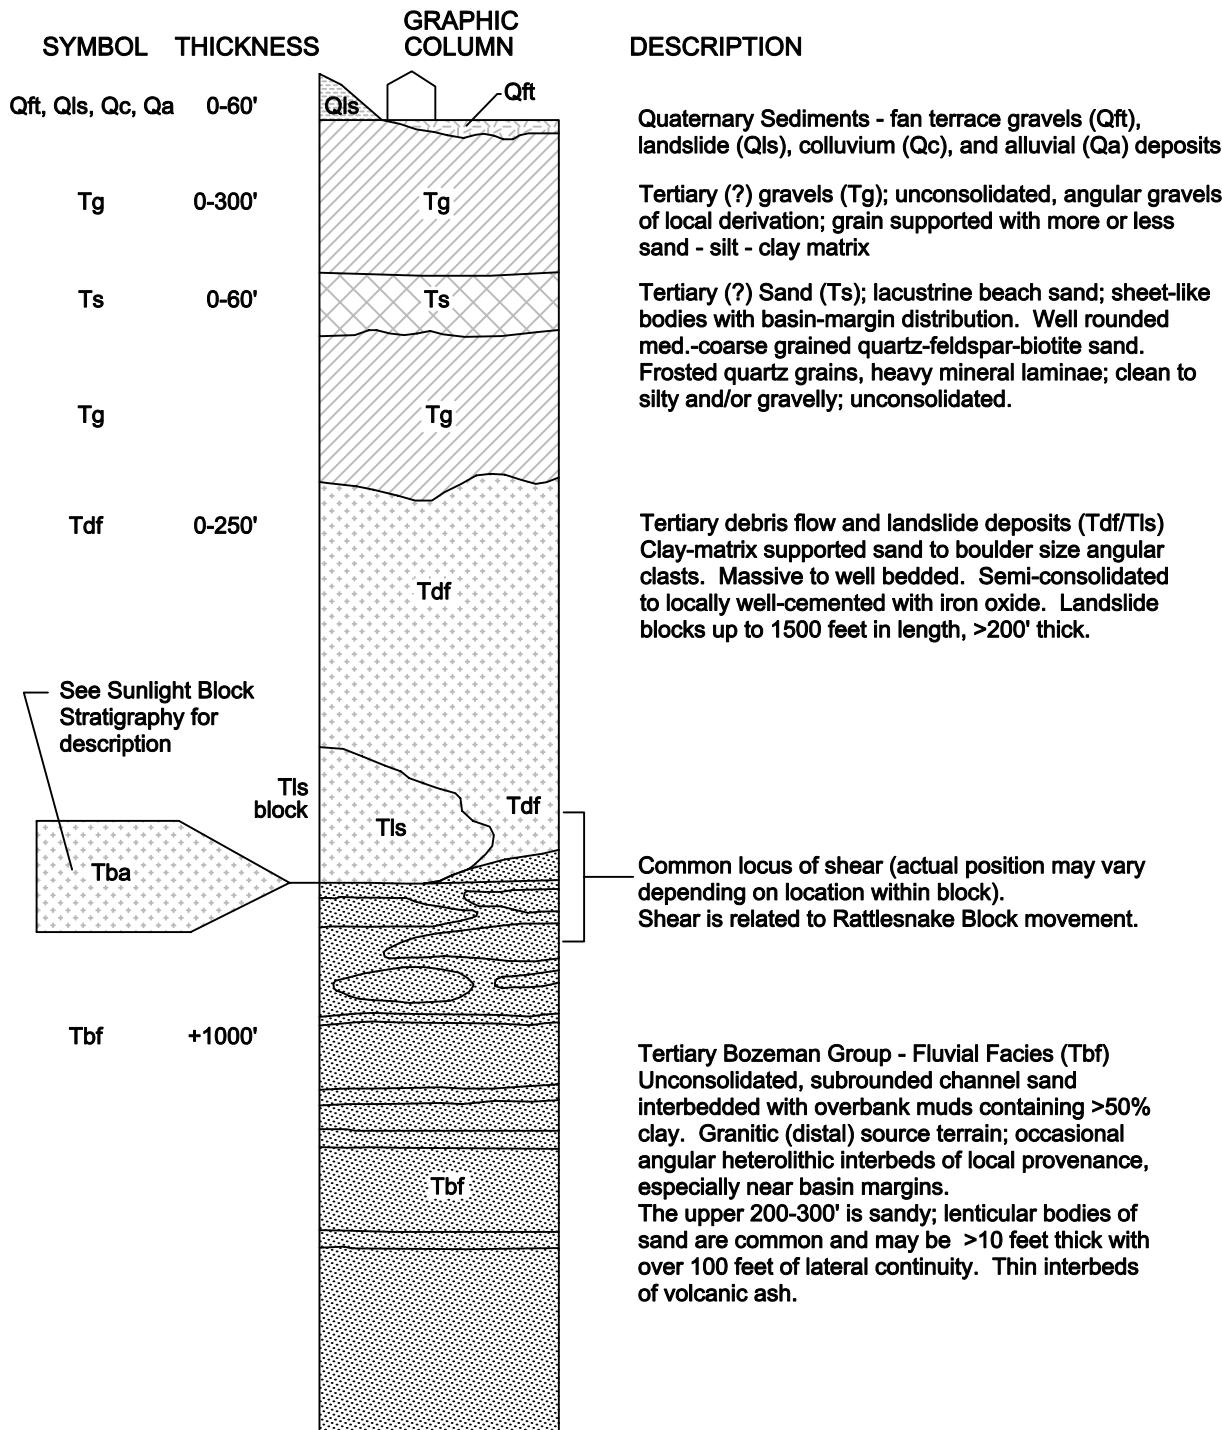
GEOLOGY: T.H. CHADWICK  
SOURCE: GOLDER, 1995a

# TYPICAL STRATIGRAPHIC COLUMN FOR RATTLESNAKE BLOCK

The area east of Bull Mountain contains valley fill Tertiary Bozeman Group sediments up to 1,500 feet thick (Hanneman, 1990). Figures 3-3 and 3-4 show stratigraphic sections from two locations east of Bull Mountain. These rocks and sediments have diverse lithologies including low permeability clays, moderate permeability sandstone and conglomerate, and carbonate-bearing shales and limestones (1997 Draft EIS, Chapter III, Section A).

The Bozeman Group in the vicinity of the mine has been recognized as having a lower fluvial (stream deposits) facies (Tbf) and alluvial facies (Tba) (Figure 3-3). The fluvial facies generally consists of interbedded medium to high plastic clays and silts, sands and clayey sands. The fluvial facies contains unconsolidated channel sand interlayers, but the bulk of the unit consists of clays, which are interpreted as overbank deposits, exhibiting good lateral continuity (Golder, 1995a). The alluvial facies commonly contains less than 20 percent clay, and consists of light brown, lightly calcareous, silty sands and gravels.

Late Tertiary mass-wasting deposits consisting of landslide (Tls) and debris flow deposits (Tdf) overlie the Bozeman Group sediments unconformably along the east front of Bull Mountain. The mass-wasting deposits are generally confined to the Rattlesnake Block (Golder, 1995a) (Figure 3-3). The debris flow deposits are described as consisting of sandy and silty gravel that is fine to coarse and subrounded to angular, with cobbles and boulders. The debris flow deposits are up to 250 feet thick, massive to bedded, and unconsolidated to well cemented with iron oxide. Associated landslide deposits are composed of more or less intact blocks of latite and other pre-Tertiary bedrock blocks that may be up to 1,500 feet long and 200 feet thick.

Alluvial fan gravels (Tg) and intercalated lacustrine sands (Ts) unconformably overlie the landslide-debris flow complex, with a thickness of as much as 360 feet. Disconformably overlying the Tertiary gravels and sands is a variety of thin Quaternary cover, including fan-terrace gravels, landslide, colluvial and alluvial deposits (Golder, 1995a) (Figure 3-3).

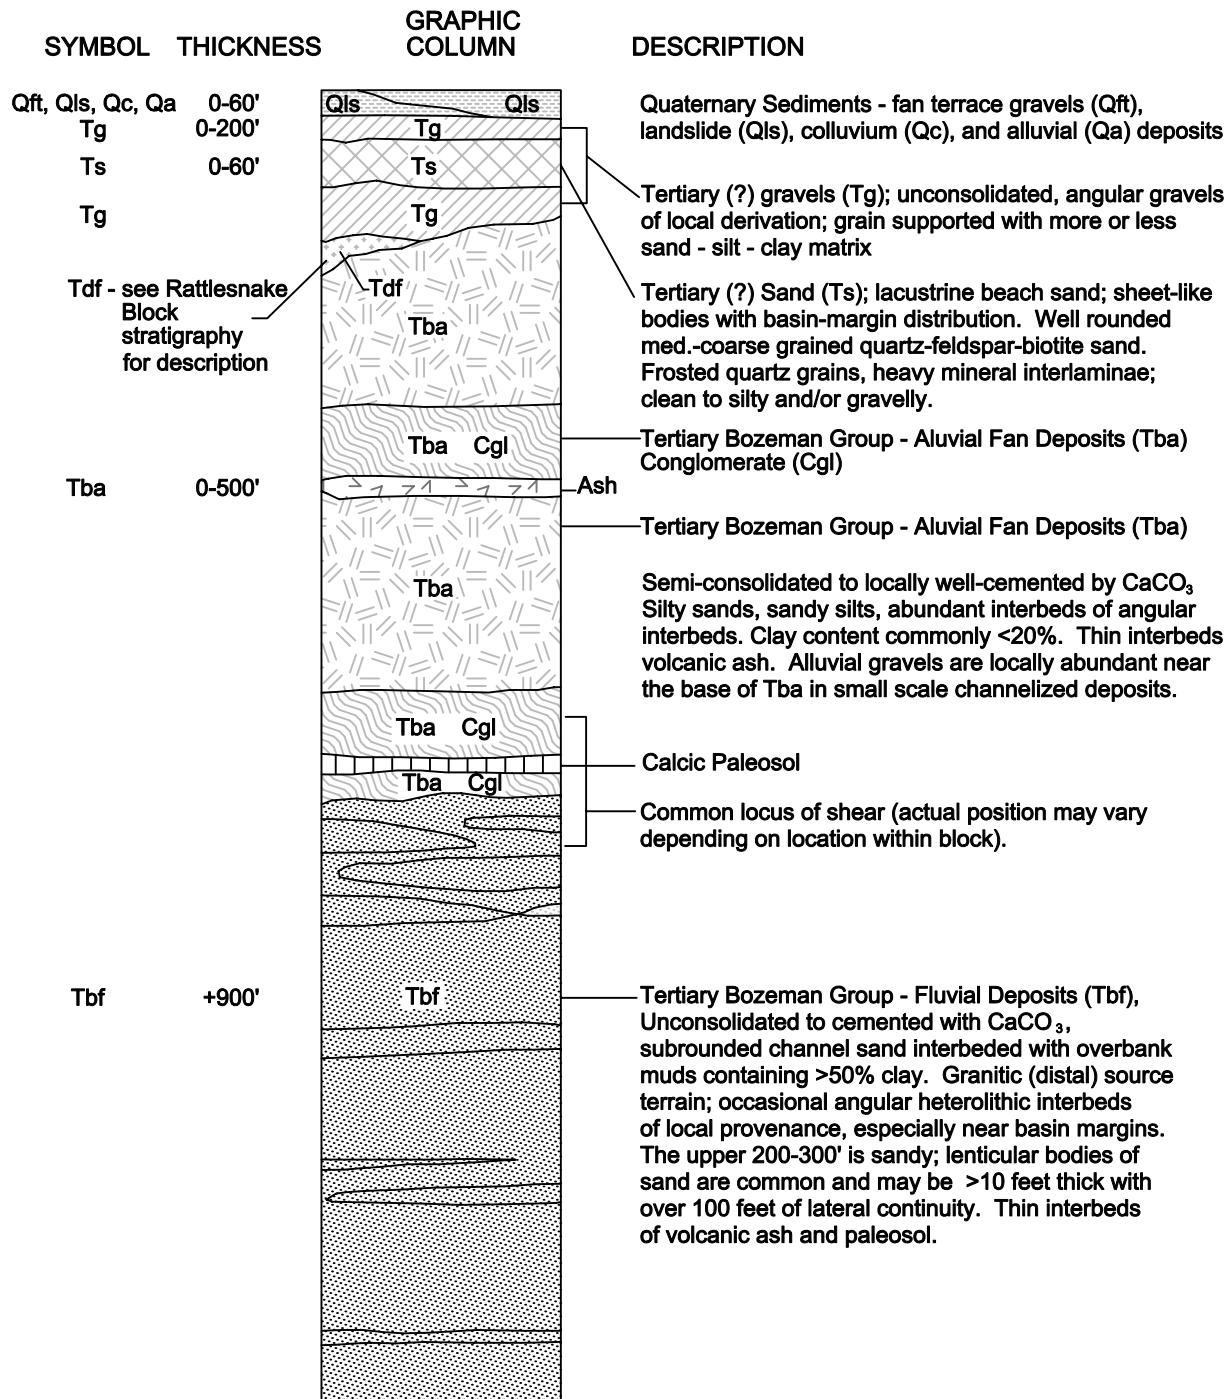
GEOLOGY: T.H. CHADWICK  
SOURCE: GOLDER, 1995a

**TYPICAL  
STRATIGRAPHIC COLUMN  
FOR SUNLIGHT BLOCK**

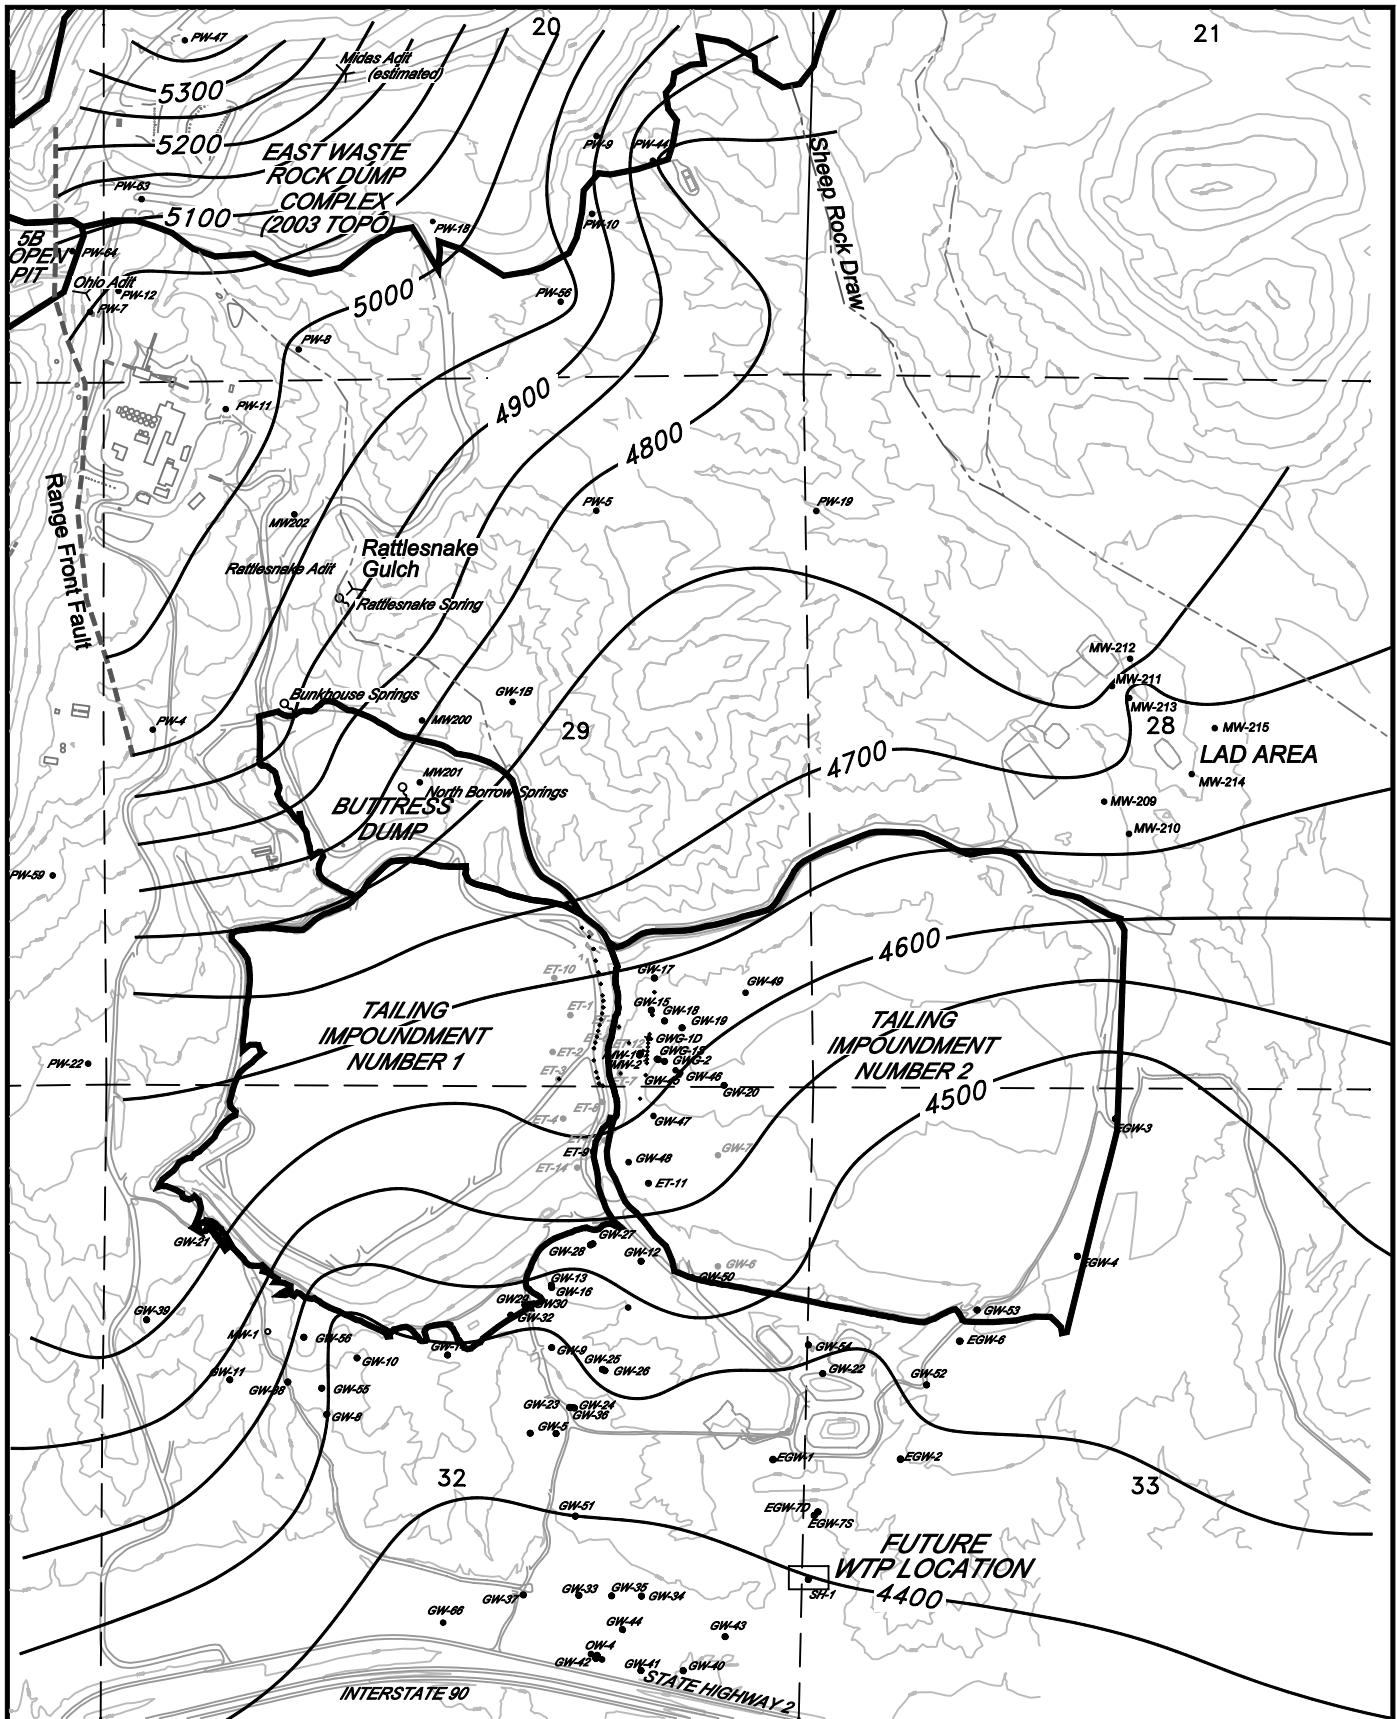
### Potentiometric Contour Line (50 Foot Interval)

The Jefferson River alluvial aquifer abuts the T/Q alluvial aquifer on the GSM property several hundred feet north of I-90. Studies by Hydrometrics (1994) and Keats (2001-2002) indicate that these aquifers are hydrologically connected. Therefore, the potentiometric map included data from wells completed in the Jefferson River alluvial aquifer, including the southernmost GSM monitoring wells along the permit boundary and private water wells in the valley just south of the boundary. Elevations of the private wells were estimated from the United States Geological Survey (USGS) topographic map and adjusted (+91.4 feet) to GSM datum.

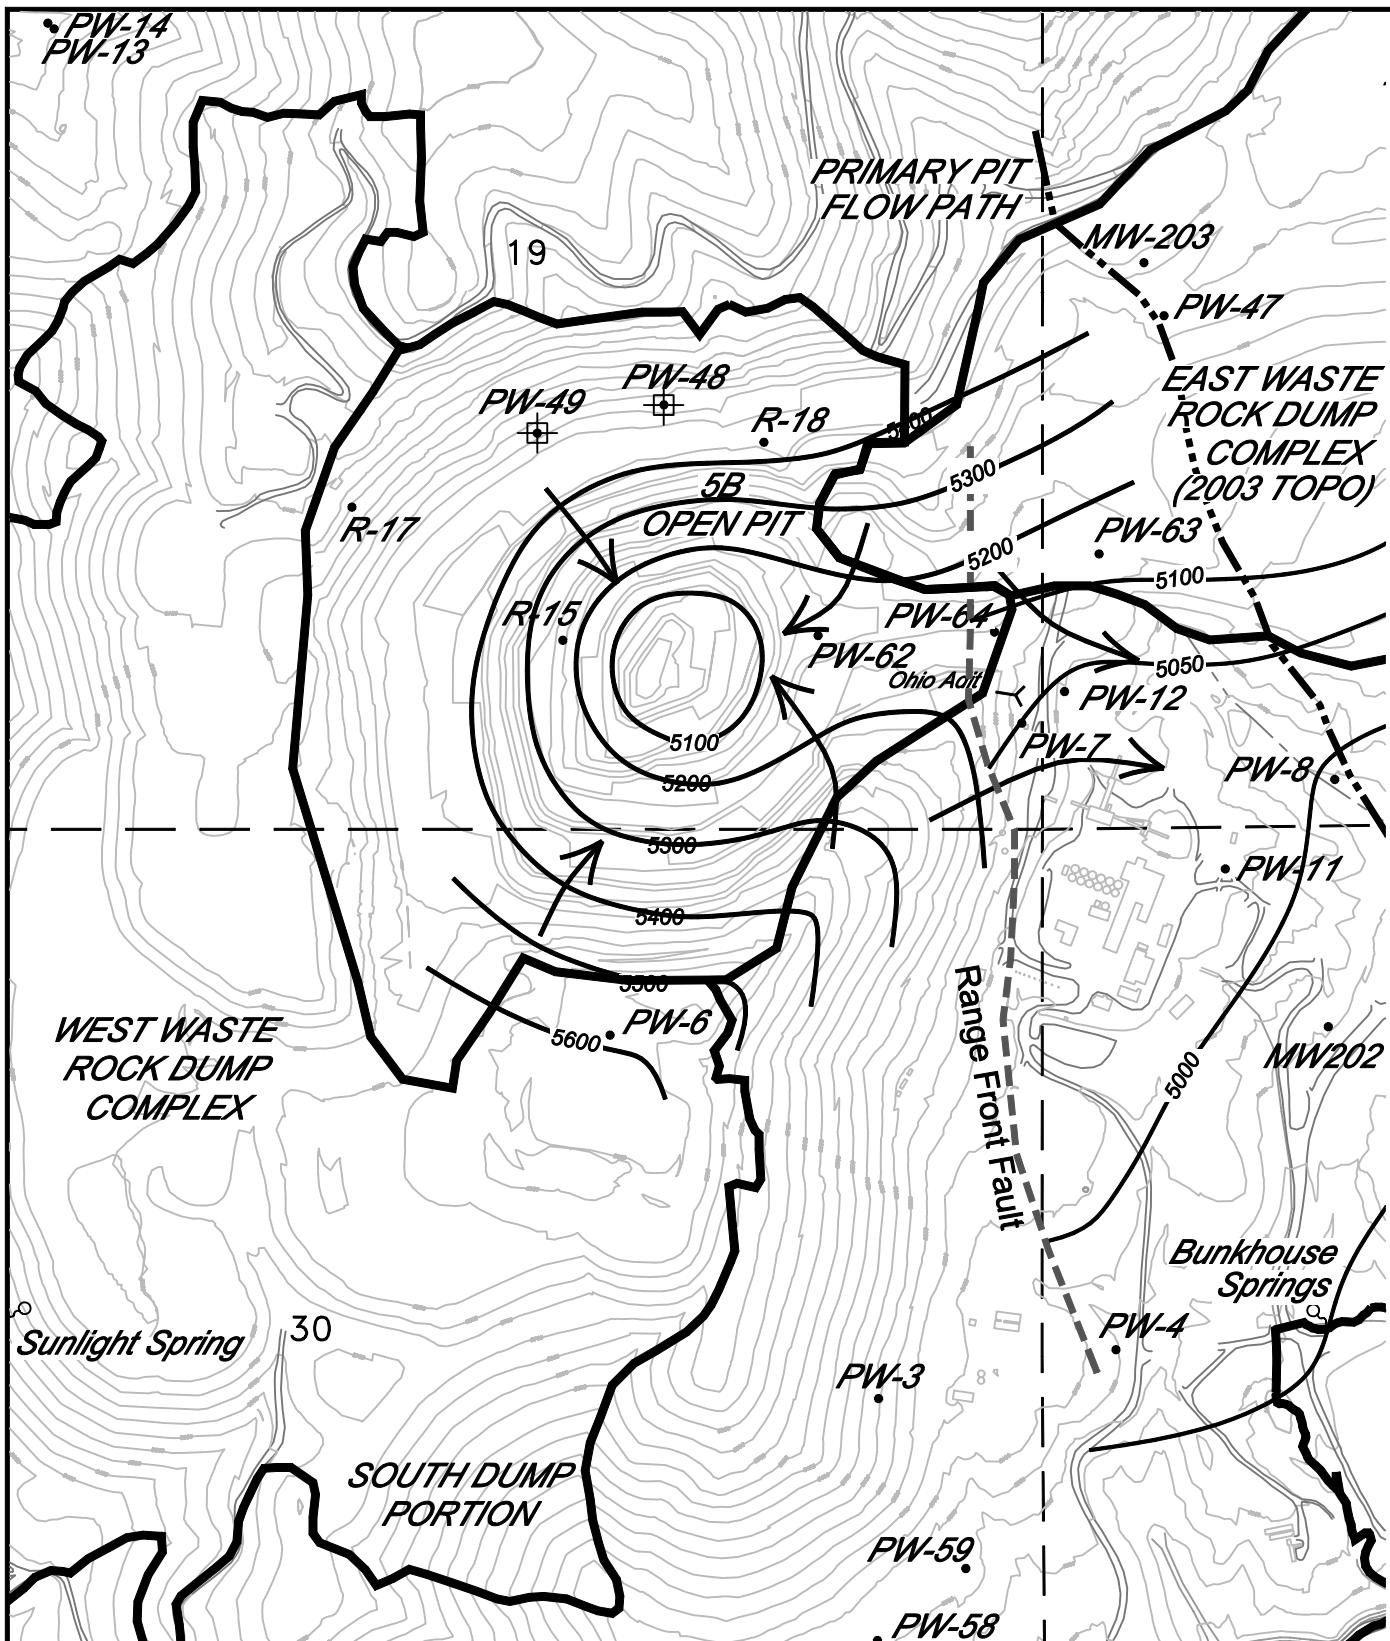
FIGURE 3-7

- Potentiometric Line with Elevation (As of 9/2001)
- ← Groundwater Flow Direction
- Groundwater Monitoring Well
- Approximate Location of Range Front Fault
- Existing Dewatering Wells
- PW-49

The pit is currently maintained as a hydrologic sink as described in Section 3.3.7.2. A generalized depiction of groundwater elevations in the vicinity of the pit in September 2001 is shown on Figure 3-7. In the 1997 Draft EIS, Chapter II the agencies predicted that 102 gpm (Section II.B.2.b, page 69) of groundwater would need to be pumped and treated under the No Pit Pond Alternative and 47 gpm (Section II.B.7.b, page 100) under the Partial Pit Backfill Alternative. The 1997 Draft EIS, Chapter IV, Section IV.B relied on model simulations of the local pit groundwater system as the primary basis for evaluating impacts to water quantity from pit dewatering (Hydrometrics, 1995). A detailed discussion of the groundwater model configuration and input parameters can be found in Volume 3, Appendix 4.7-1 of GSM's Permit Application (GSM, 1995b). This SEIS uses additional studies, including a pit hydrogeology investigation (URS, 2001), a pit highwall seep study (Gallagher, 2003b), a water balance model of the pit (Telesto, 2003b), and an analysis of well and spring hydrographs (HSI, 2003).

Impacts of ARD quality and quantity from the East Waste Rock Dump Complex were reevaluated in this SEIS and were similar to those identified in the 1997 Draft EIS. The following section addresses East Waste Rock Dump Complex ARD from the 13 percent of the dump complex that is in the Rattlesnake Gulch drainage (Figure 3-7).
