Dearborn River TMDL Planning Area: Appendix B

SAMPLING AND ANALYSIS PLAN

DEARBORN RIVER MAINSTEM

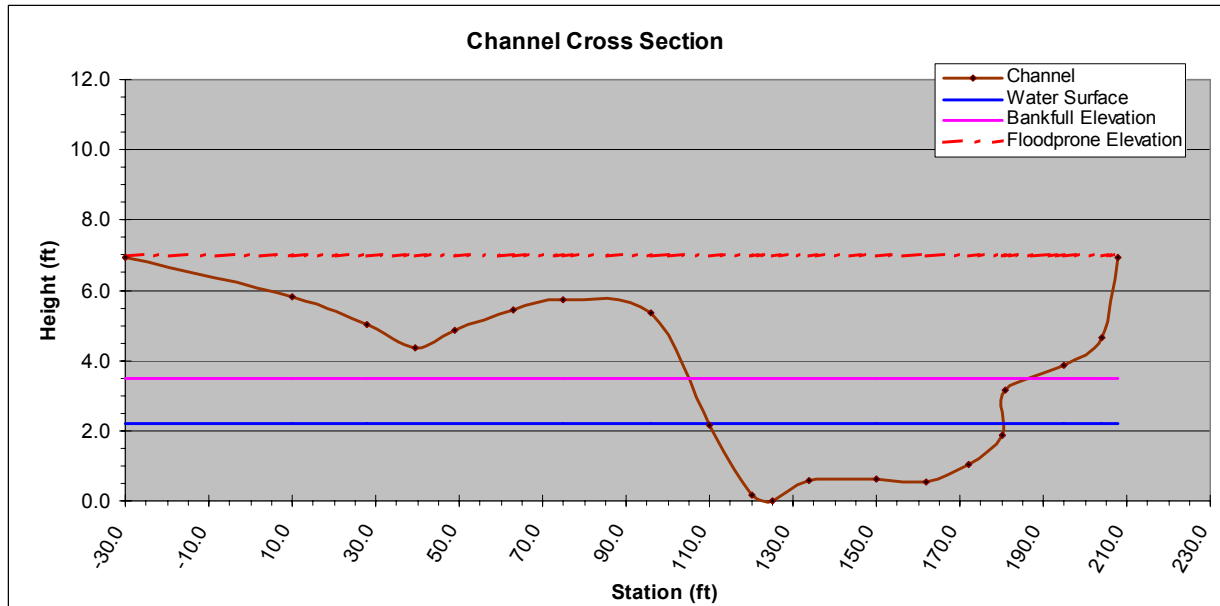
BEHI Field Measures				BEHI Calculated Values		
	Parameter		Value	Units	Parameter	Value	Units
Longitudinal Information	Rod reading @ Upstream Edge of Water		10.47	feet	Slope	0.0010	
	Rod reading @ Downstream Edge of Water		11.07	feet	Sinuosity		
	Stream Distance		625.00	feet	Max Depth	3.49	feet
	Straightline Distance			feet	Floodprone Height	6.98	feet
					Mean Depth	2.60	feet
Cross-Sectional Information	Left Edge of Bankfull		110.00	feet	Bankfull Width	75.00	feet
	Right Edge of Bankfull		185.00	feet	Floodprone Width	238.00	feet
	Rod reading @ Thalweg		11.22	feet	Bankfull Area	195.13	ft^2
	Rod reading @ Bankfull Depth		7.73	feet	Floodprone Area		ft^2
	Rod reading @ Floodplain Depth		4.24	feet	W/D Ratio	28.83	
	Left Edge of Floodprone depth		-30.00	feet	Cross Sectional Area	195.13	ft^2
	Right Edge of Floodprone depth		208.00	feet	Entrenchment Ratio	3.17	
BEHI Information	Bank Height			feet			
	Bankfull Height			feet	Bank Ht/Bankfull Ht

Root Depth			feet	Root Depth/Bank Ht		
	Root Density			%	Root Density		%
	Bank Angle			Degrees	Bank Angle		degrees
	Surface Protection			%	Surface Protection		%
Near Bank Stress Information	Velocity at thalweg			ft/sec	Velocity Gradient		ft/sec/ft
	Tape reading at thalweg			feet	Near Bank stress / Mean Shear stress		
	velocity at left bank			ft/sec			
	tape reading at left bank			feet	A_{nb} / A		
	Near bank stress						
	Mean shear stress						
	Near bank x-sectional area			ft^2

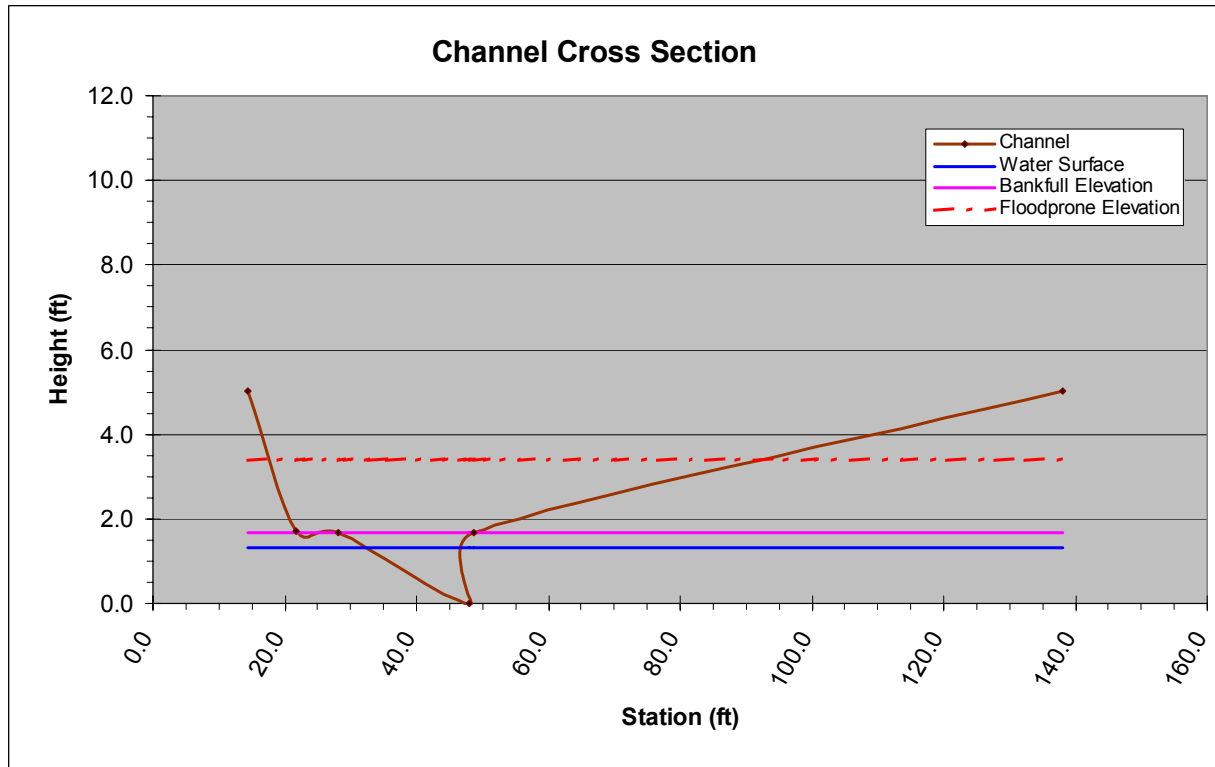
BEHI Field Measures				BEHI Calculated Values		
	Parameter	Value	Units		Parameter	Value	Units
Longitudinal Information	Rod reading @ Upstream Edge of Water	4.60	feet		Slope	0.0068	
	Rod reading @ Downstream Edge of Water	6.40	feet		Sinuosity		
	Stream Distance	263.50	feet		Max Depth	1.69	feet
	Straightline Distance		feet		Floodprone Height	3.38	feet
Cross-Sectional Information	Left Edge of Bankfull	21.70	feet		Mean Depth	0.65	feet
	Right Edge of Bankfull	48.70	feet		Bankfull Width	27.00	feet
	Rod reading @ Thalweg	8.35	feet		Floodprone Width	123.70	feet
	Rod reading @ Bankfull Depth	6.66	feet		Bankfull Area	17.60	ft^2
	Rod reading @ Floodplain Depth	4.97	feet		FloodproneArea		ft^2
	Left Edge of Floodprone depth	14.30	feet		W/D Ratio	41.42	
BEHI Information	Right Edge of Floodprone depth	138.00	feet		Cross Sectional Area	17.60	ft^2
	Bank Height		feet		Entrenchment Ratio	4.58	
	Bankfull Height		feet

Root Depth		feet				
	Root Density		%				
	Bank Angle		Degrees				
	Surface Protection		%				
Near Bank Stress Information	Velocity at thalweg		ft/sec		Velocity Gradient		ft/sec/ft
	Tape reading at thalweg		feet		Near Bank stress / Mean Shear stress		
	velocity at left bank		ft/sec				
	tape reading at left bank		feet				
	Near bank stress						
	Mean shear stress						
	Near bank x-sectional area		ft^2
