Appendix G
Otter Creek Mine Baseline Report 304E
Spring and Seep Inventory

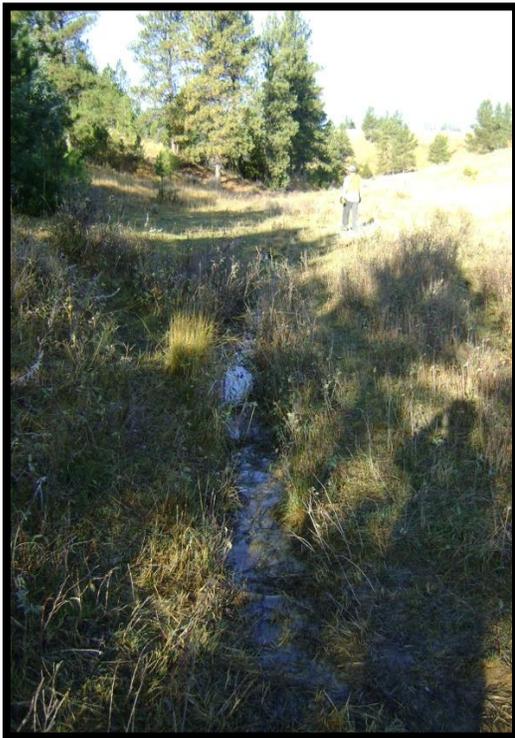
Figure 1. View to the west

Notes: Water standing in micro depressions created from cattle hoof prints. Deciduous vegetation possibly suggests long-term presence of water. Precipitation occurred within last 24 hrs. Standing water continues intermittently 400-600ft west to a stock pond (SSI-11-02). Interpreted as water from a seep.

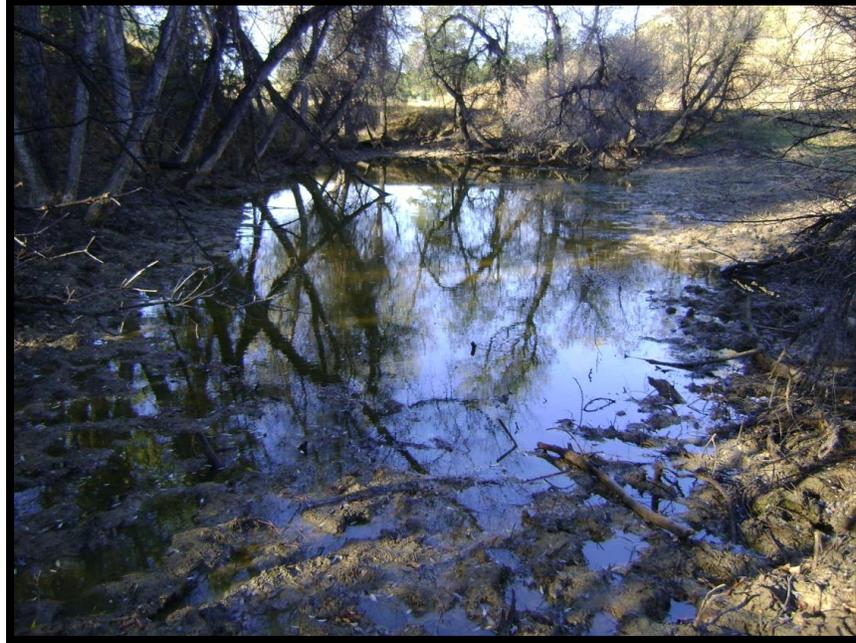
Figure 1. View to the southwest

Notes: Stock pond developed from man-made reservoir. Pond is situated in the middle of the drainage; source appears to be groundwater seepage or surface water run-off. Interpreted as water from surface run-off.

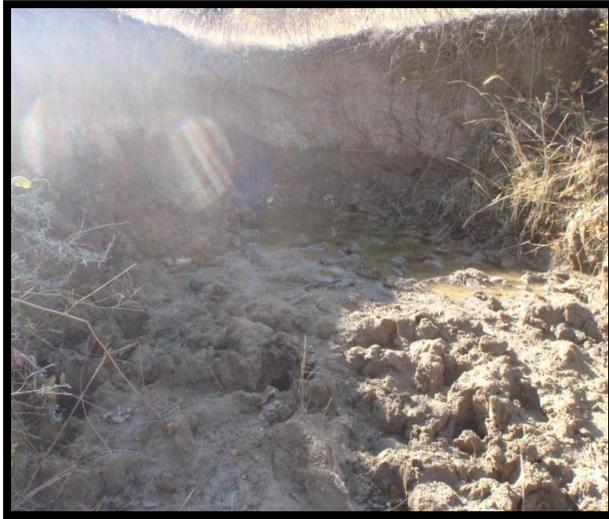
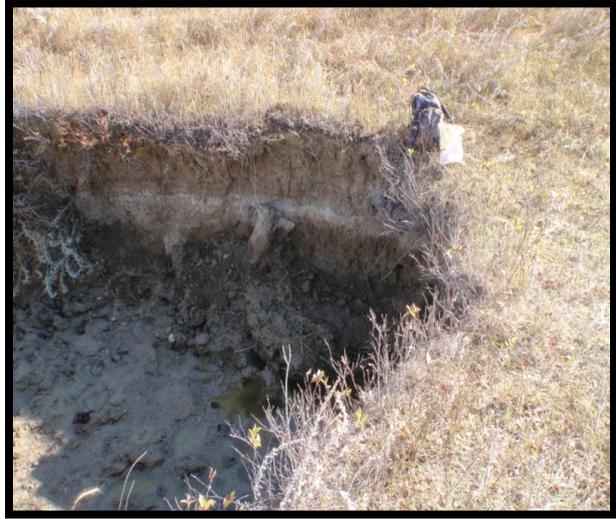
Notes: Standing water in depression approximately 150ft below man-made berm of SSI-11-02. 3-4 inches of ponding water appears in livestock made tracks. Interpreted as water from a seep.

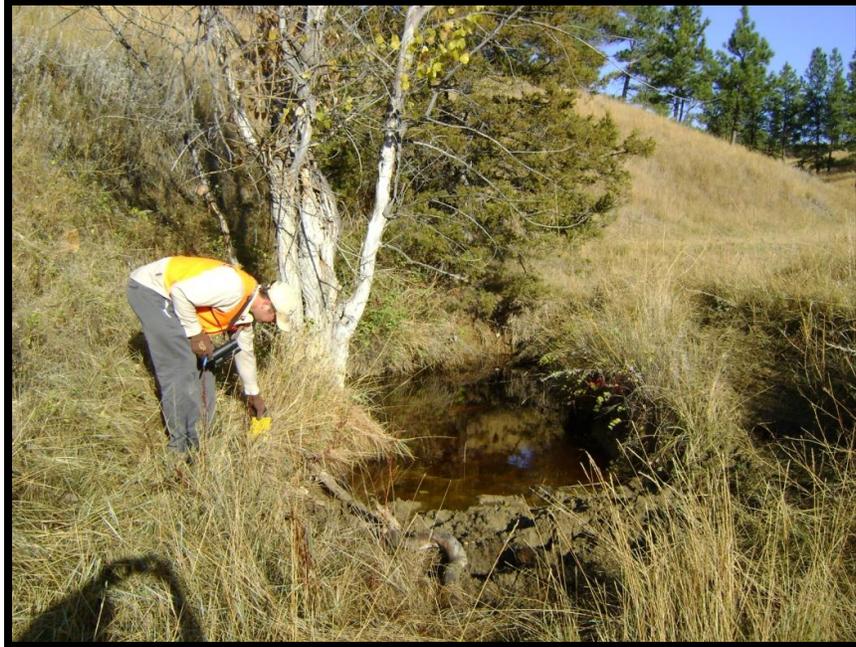
Figure 1. View to the North

Notes: Drainage west of SSI-11-02, above confluence; converges with SSI-11-02 six feet below seep. Pool of standing water 1'x6'x1'. Interpreted as ponding surface water, with slight seepage.

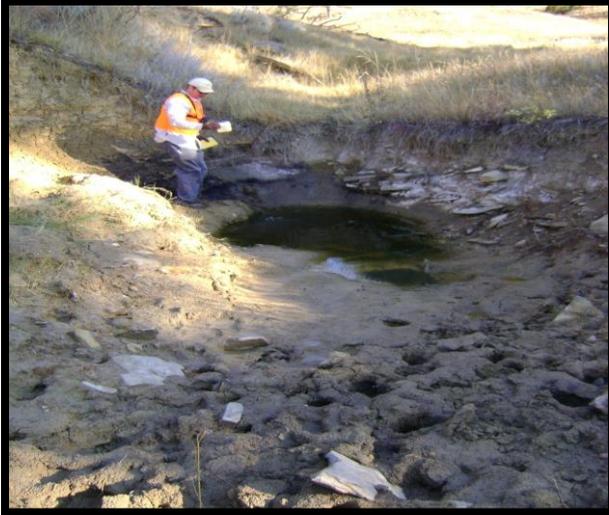
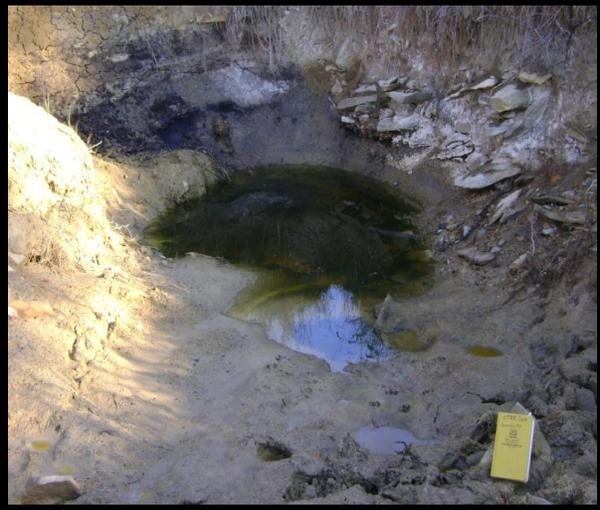
Notes: Water issued from shallow coal outcrop. Coal is approximately 1 ft. thick. Water continues intermittently down drainage. Interpreted as seeping surface water.

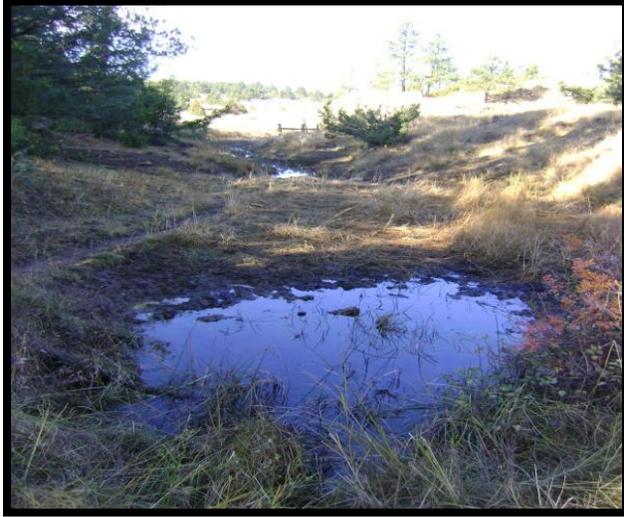
Figure 1. View to the West

Notes: Cottonwoods around seep, suggesting possible long-term presence of water. Black mud around banks and in hoof prints of cattle within the seep. Flow continues intermittently down drainage (Figure 1). Interpreted as possible year around seep with ponding surface water and no estimable flow.

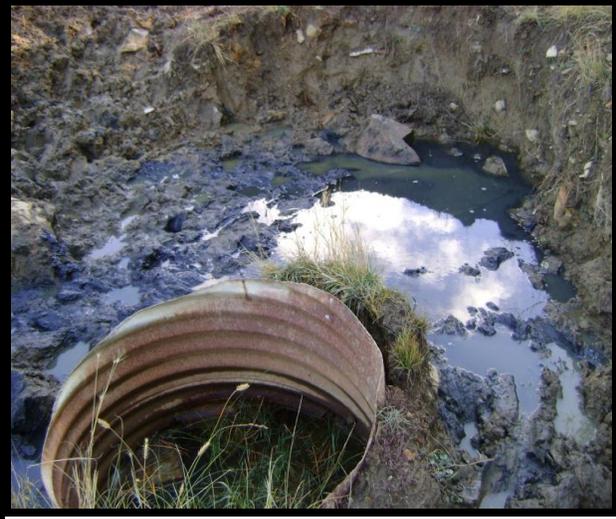
Figure 2. View to the West

Notes: Seep twenty feet down gradient of SSI-11-200. A corrugated metal pipe partially buried in channel. Water issuing freely from substrate behind metal pipe; black coloration issuing from disturbed mud, suggesting coal seam (Figure 2). Flow continues intermittently down drainage to the East. Interpreted as a seep with the potential to be completely dry as summer progresses.

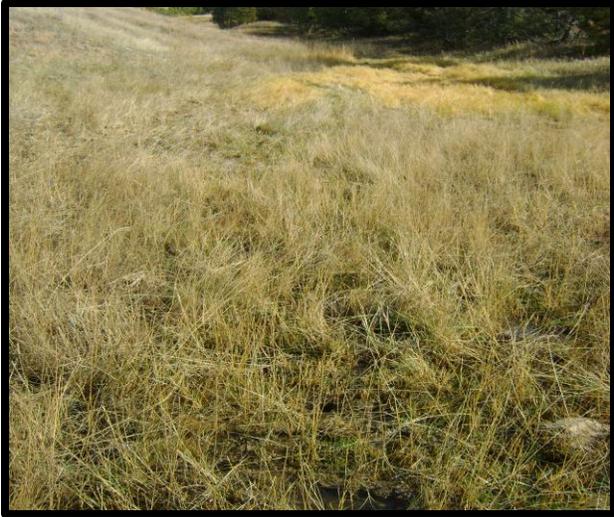
Figure 1. View to the East

Notes: Small seep that forms into a more distinct channel 90 feet from source (Figure 1). Seep originates from a flat marshy area.

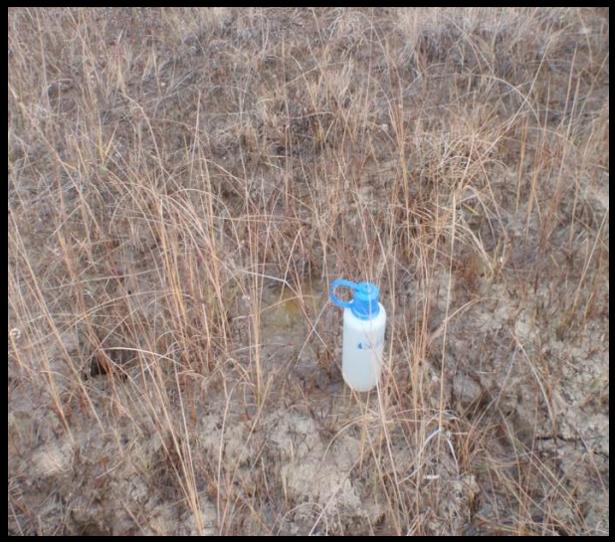
Figure 2. View to the North

Notes: Fifty feet wide seep with livestock hoof imprints collecting small amounts of water (Figure 2). Trace amounts of saline precipitation forming on edges of divots and grasses; present seep confluences SSI-11-206A to produce a flat saline mud flat.

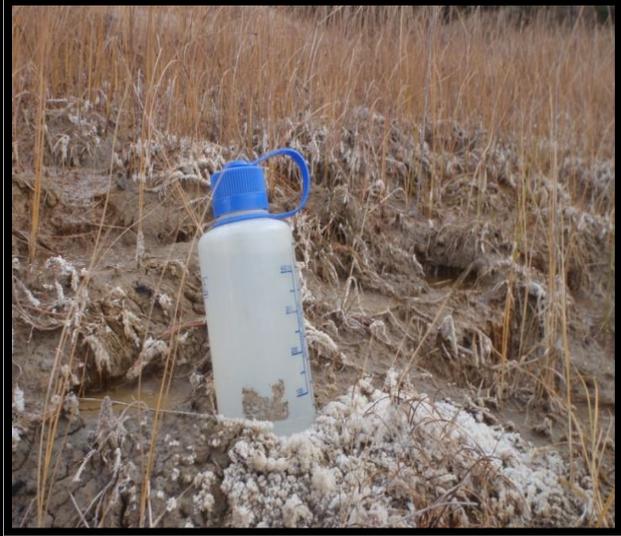
Figure 2. Saline precipitation

otes: Saline deposit with ponding water forming in divots. Water issues from a leaching drainage to the Southeast and a hillside to the East; intersects SSI-11-206 from the south to form SSI-11-206B. Interpreted as seeping surface water.

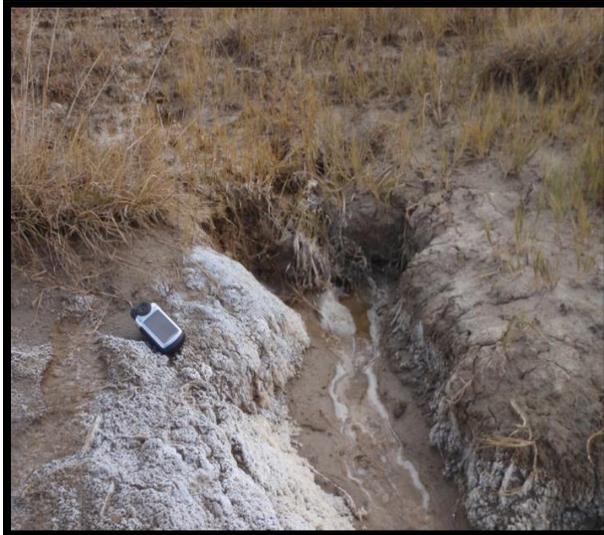
Figure 1. Saline precipitation

Notes: Large amounts of saline precipitate (Figure 1). Confluence of SSI-11-206 and SSI-11-206A; forming a more distinctive seeping channel (Figure 2).

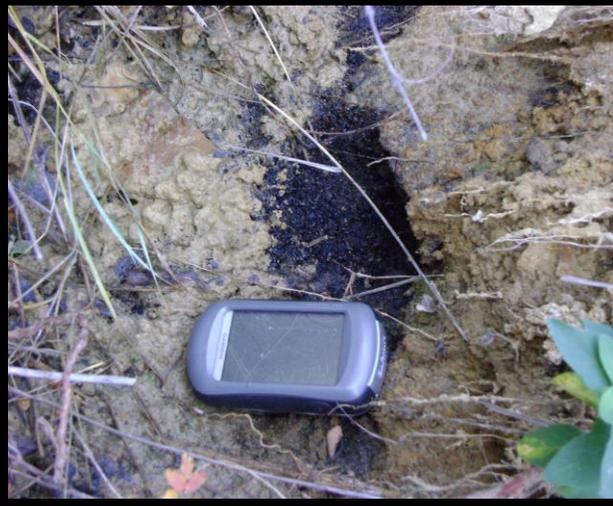
Figure 1. Coal Seam

Notes: Coal seam near seep, less than one foot in thickness (Figure 1). 3x3ft pond with lush vegetation, no flow visible, suggesting year around seepage (Figure 2).

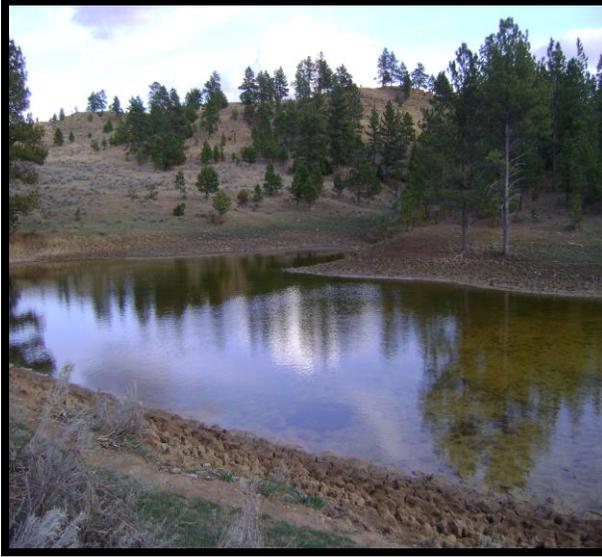
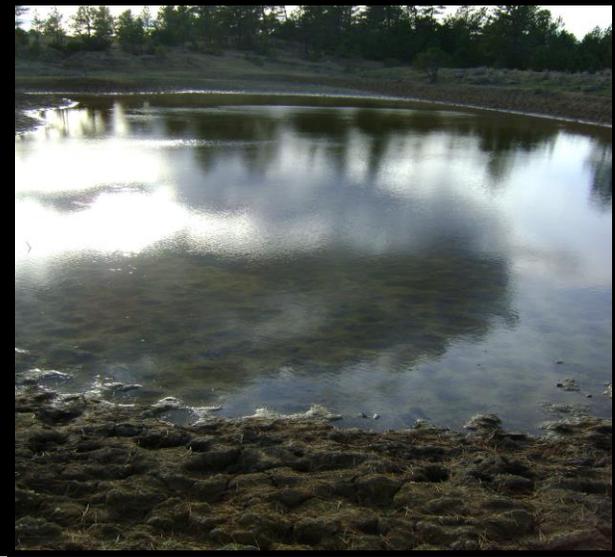
Notes: Man-made reservoir with saline precipitates forming along edges; appears to have livestock recently drinking from pond. No evident output/input into body of water. Interpreted as water collected from surface runoff only.

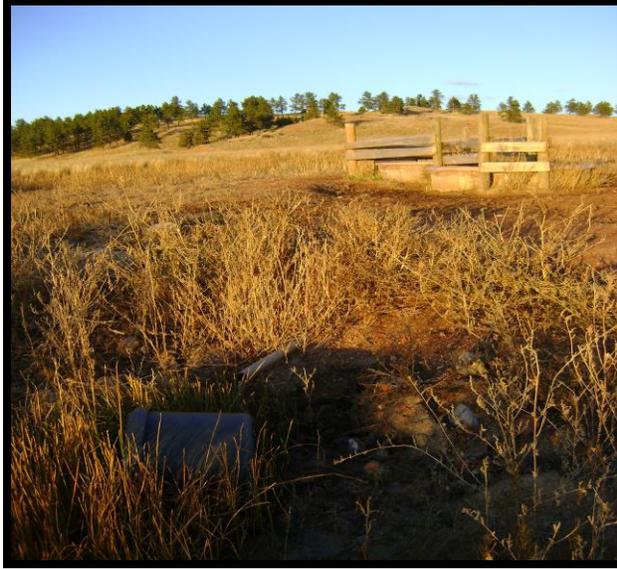
Figure 1. View to the East

Notes: Stock tank in background, foreground shows overflow pipe down gradient of tank where flow was taken (Figure 1). Figure 2 shows surface water ponding as a result of excess water from stock tank. Water was not derived from either a spring or seep.

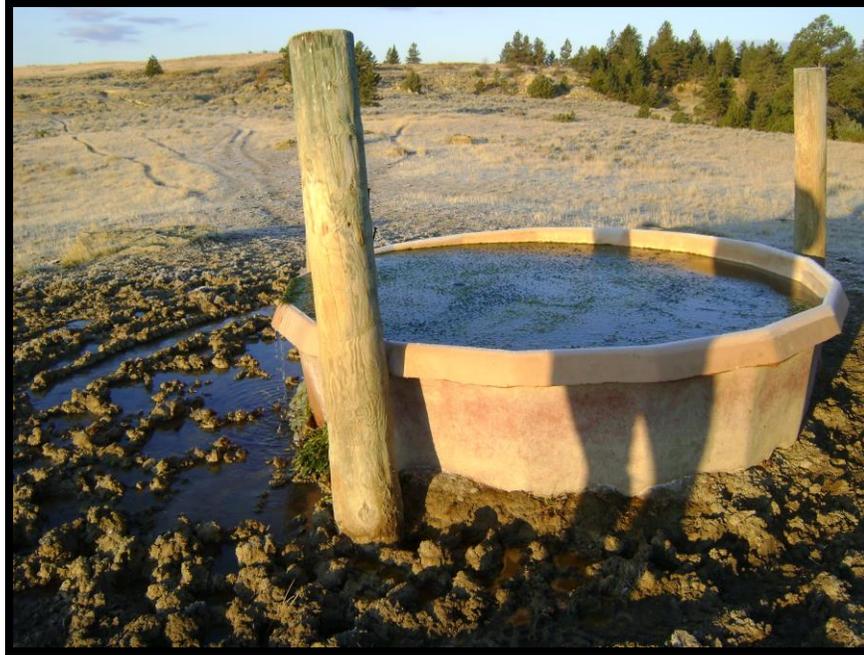
Figure 1. View to the West

Notes: Stock tank in foreground. Large amounts of aquatic life present inside of tank. Water is piped from an offsite source to the tank via a two-inch galvanized water line. Water was not derived from either a spring or seep.

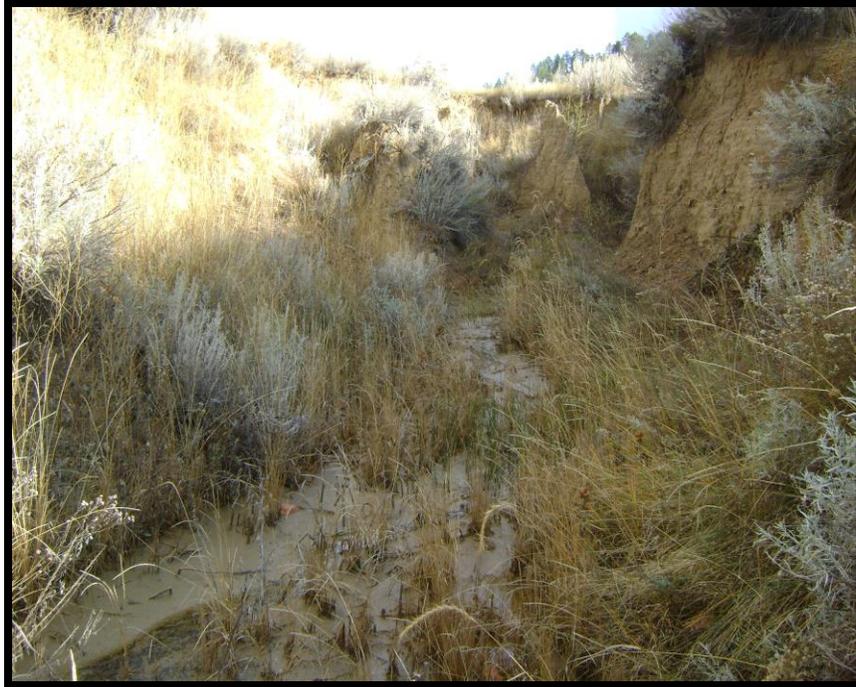
Figure 1. View to the East

Notes: Seep issuing from clay outcropping, within channelized bed; delicious trees adjacent to the site.

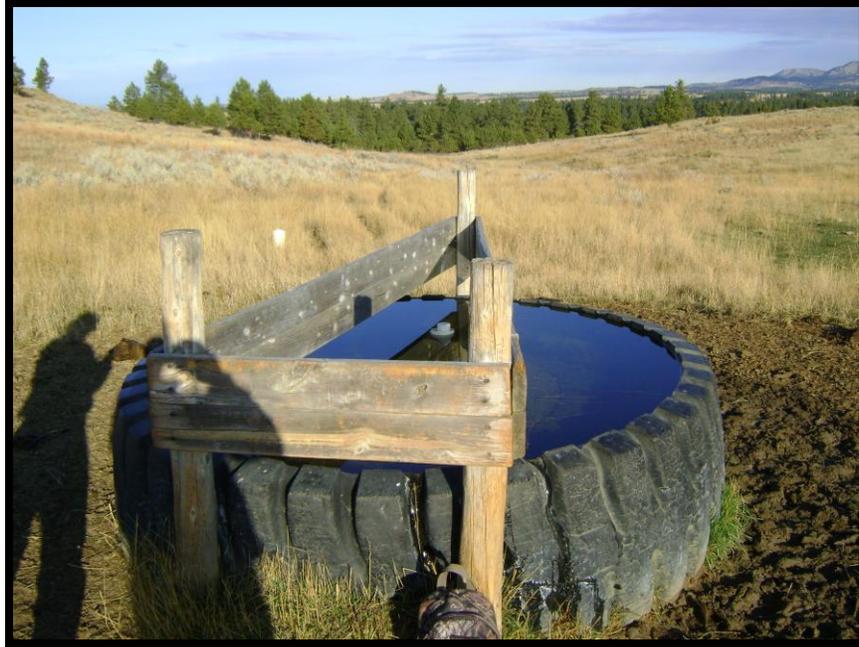
Figure 1. View to the North

Notes: Stock tank fed from well adjacent to Stevens' main ranch house.

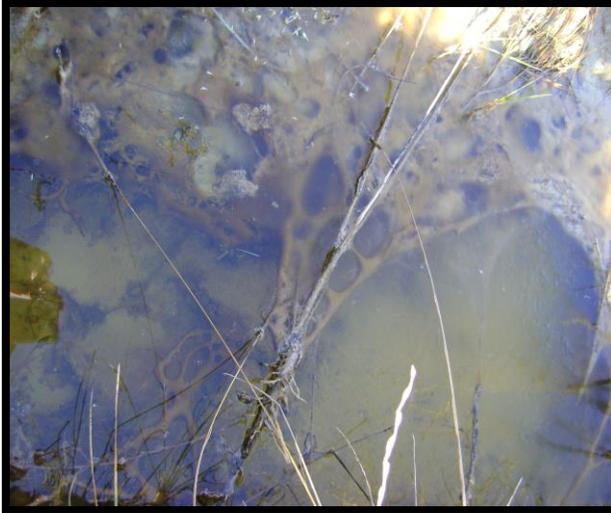
Figure 1. Algae Present

Notes: Seep 6x4x1'. Junipers present near edge of surface water, algae growing near edges of issuing water.

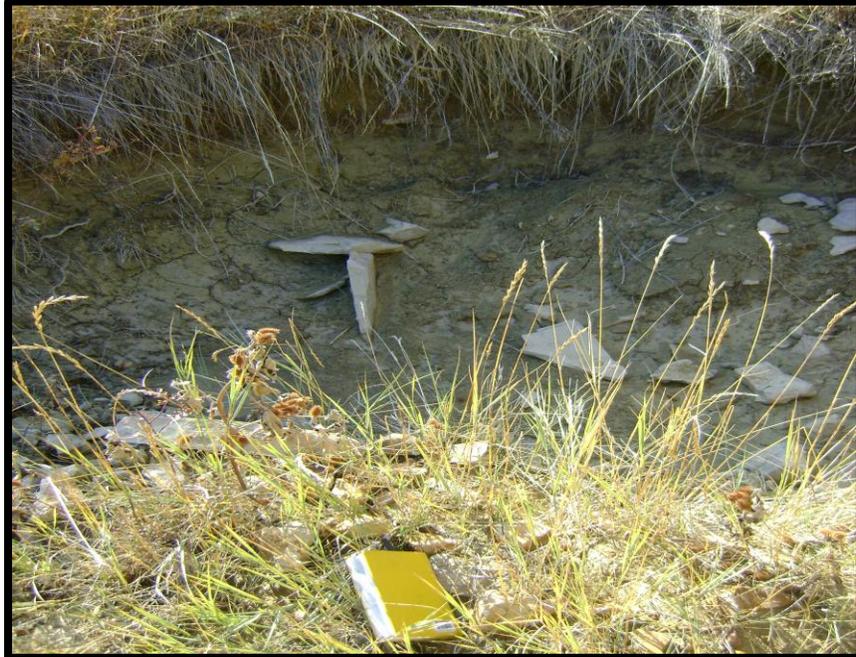
Figure 1. Dry Seep

Notes: Dry seep although ground still saturated. Junipers down gradient of where picture was taken.

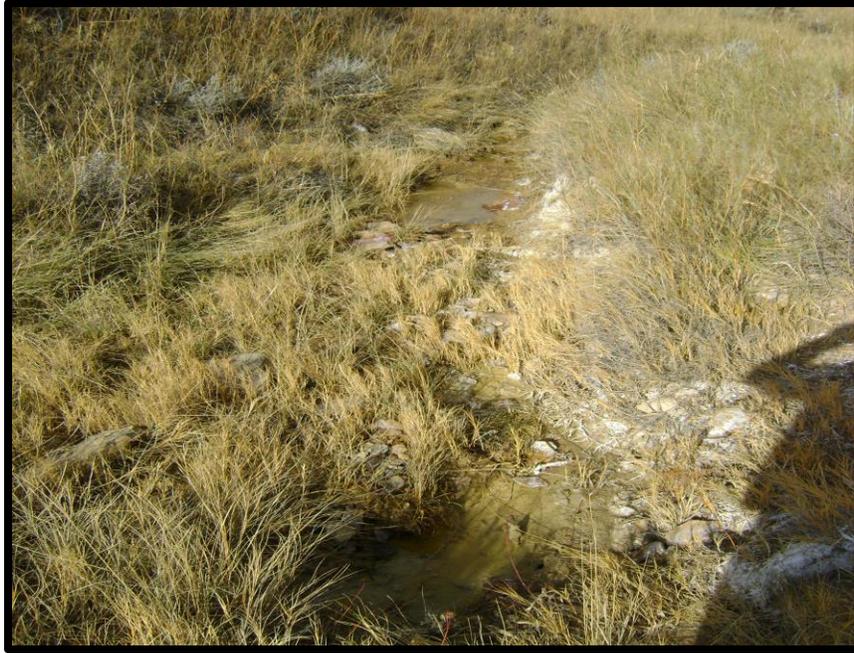
Figure 1. View to the North

Notes: Seep within meandering channel; intermittent flow down gradient of picture.

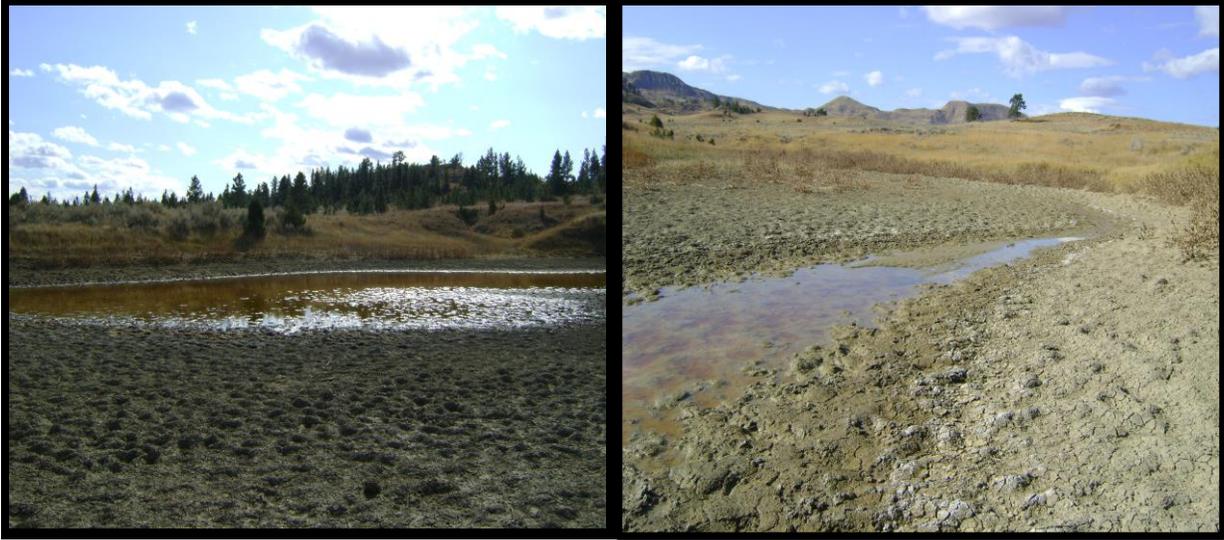
Figure 1. View to the West

Notes: Water pooled behind man-made berm, 80x30' across channel. Sparse saline precipitation forming against edges of water; reservoir fed by spring to the west as shown in Figure 2.

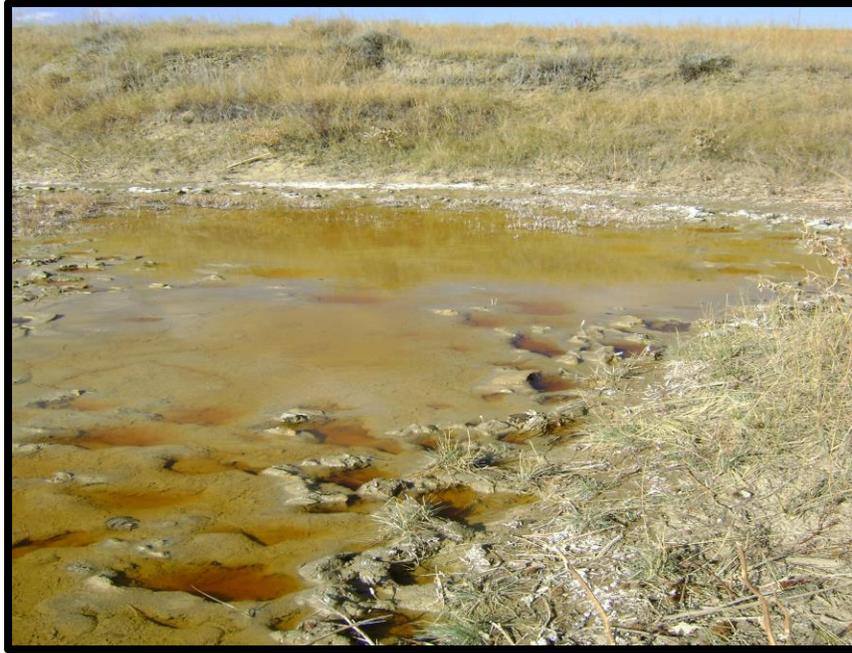
Figure 1. View to the North

Notes: Surface water issues from dry channel up gradient of Figure 1 and drains into SSI-11-220. Saline precipitates around edges of water. Interpreted as a seasonal spring.

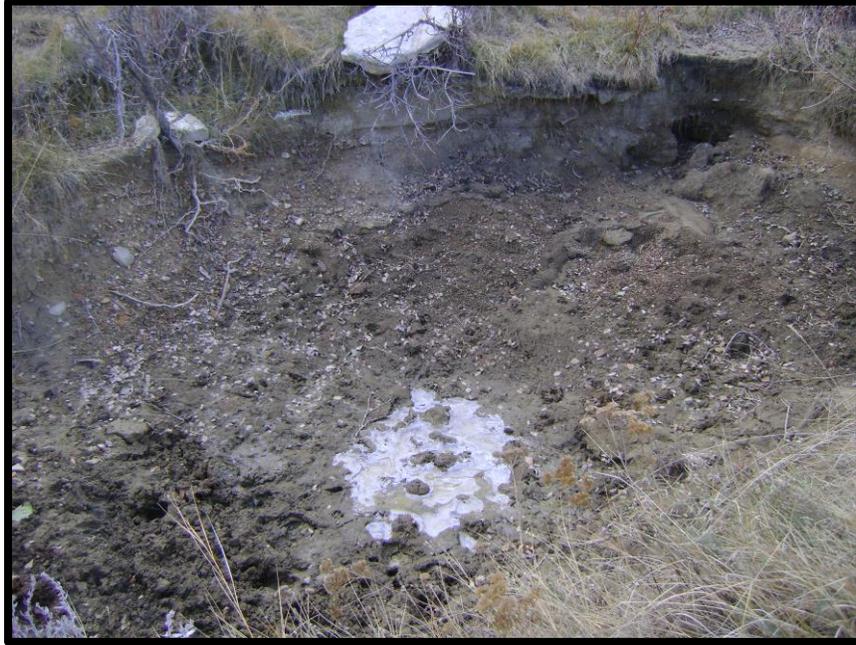
Figure 1. View to the Southwest

Notes: Site Dry with frozen puddle in middle of center of seep; several deciduous trees down gradient of Figure 1. 2''-6'' coal seam located below 3 inches of topsoil.

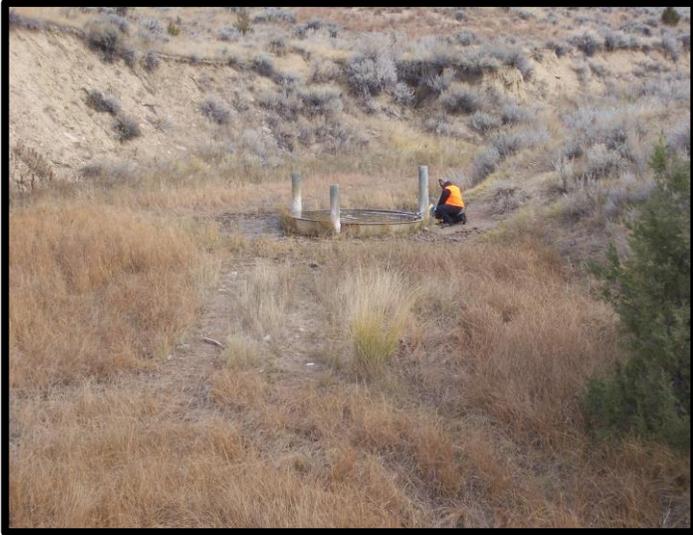
Figure 1. View to the East

Note: Water accumulated into small puddles above and below stock tank. Surface water dries up 600 feet down gradient and 800 feet above gradient of tank. In Figure 1 photo was taken down gradient of the tank. Figure 2 was taken across the draw where the tank is situated looking North to South. Site is supplied from up gradient Fortune Spring.

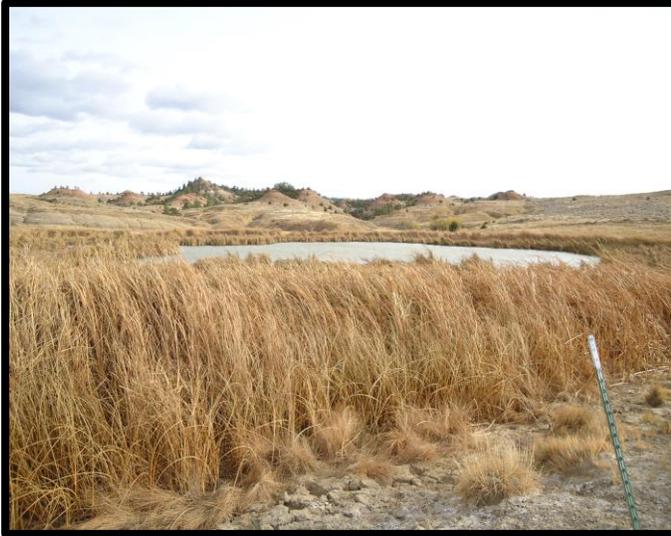
Figure 1. View to the Southeast

Note: Dense vegetation mainly cattails, surround the pond. No evident flow of input or output of water was found. Before sampling the water was observed to have had a green color. Site interpreted to be a spring.

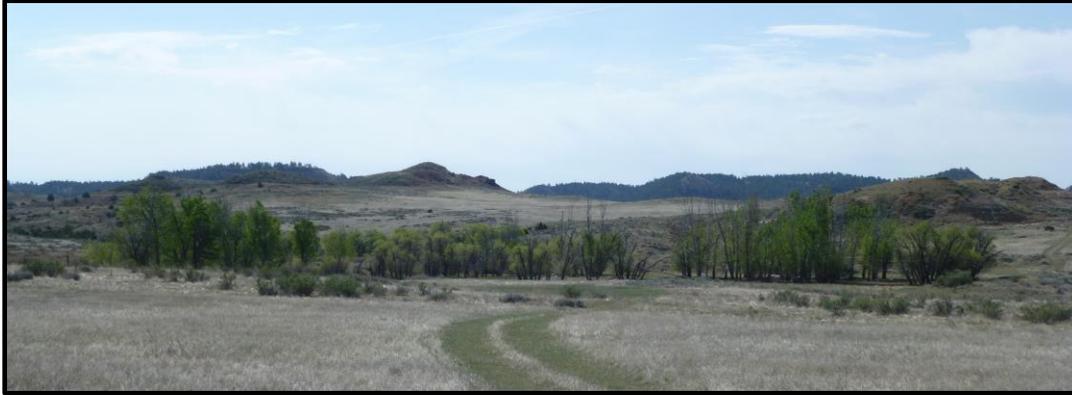
Note: Pond fed from surface run-off only. Site surrounded by cottonwood trees.

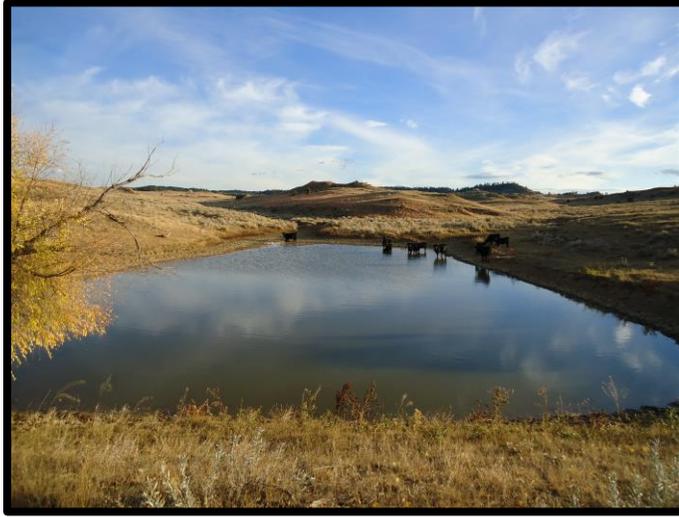
Figure 1. View to the East

Note: No visible water entering upslope or exiting down slope of the pond. When arrived at site 15-20 head of livestock were drinking from the pond water. Figure 1, was taken from the northern dyke of the pond. Figure 2, shows the inlet drainage on the east side of the pond, which had no visible surface water. Surface water not derived from seeping water or a spring.

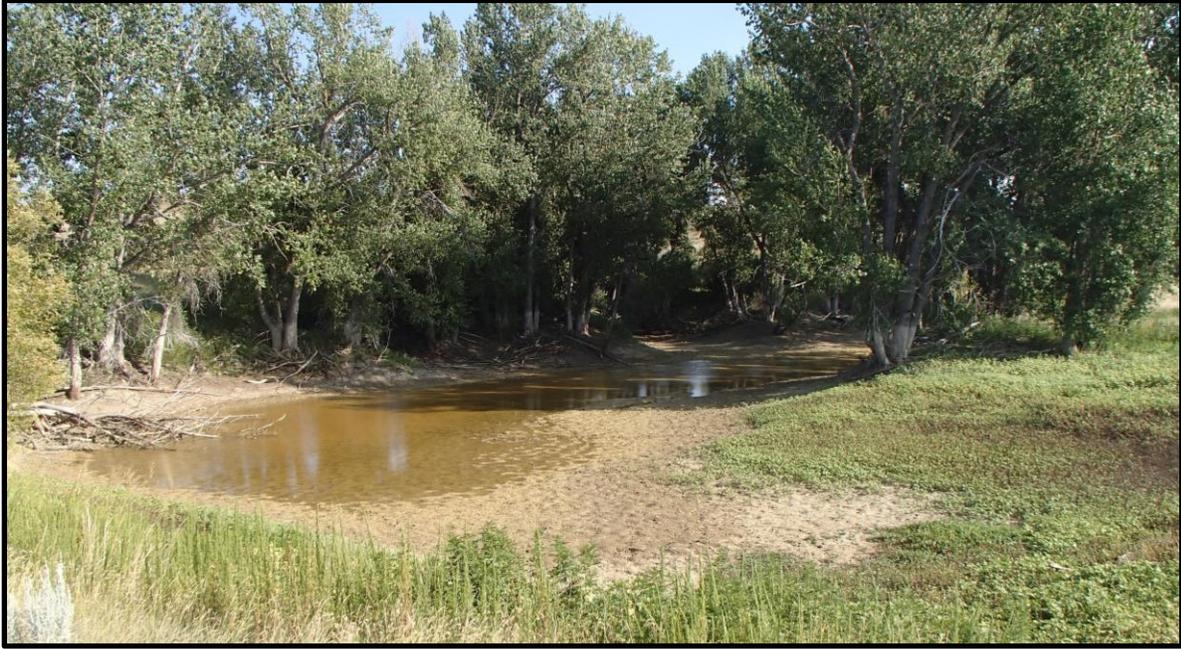
Note: Pond fed from surface run-off and self-fed spring water. Site surrounded by cottonwood trees.

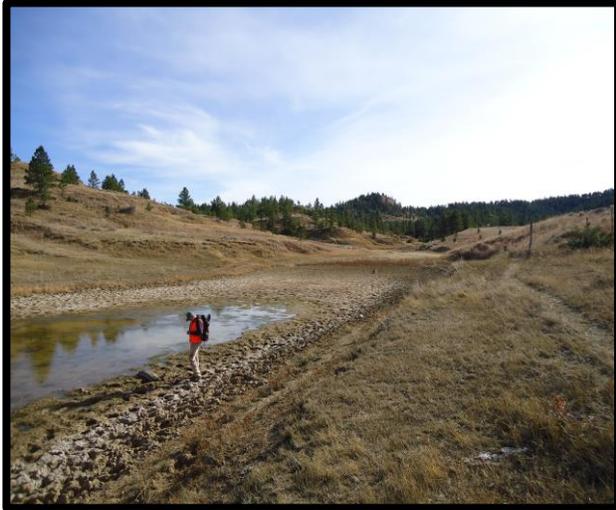
Figure 1. View to the Southeast

Note: No input/output was visible surrounding the pond. While sampling, noticed insects swimming in the water. Cattle have appeared to water at this site but have not for several weeks. The pond had a depth of 6-8 inches of water along the dyke (Figure 2). Site replenished by surface runoff.

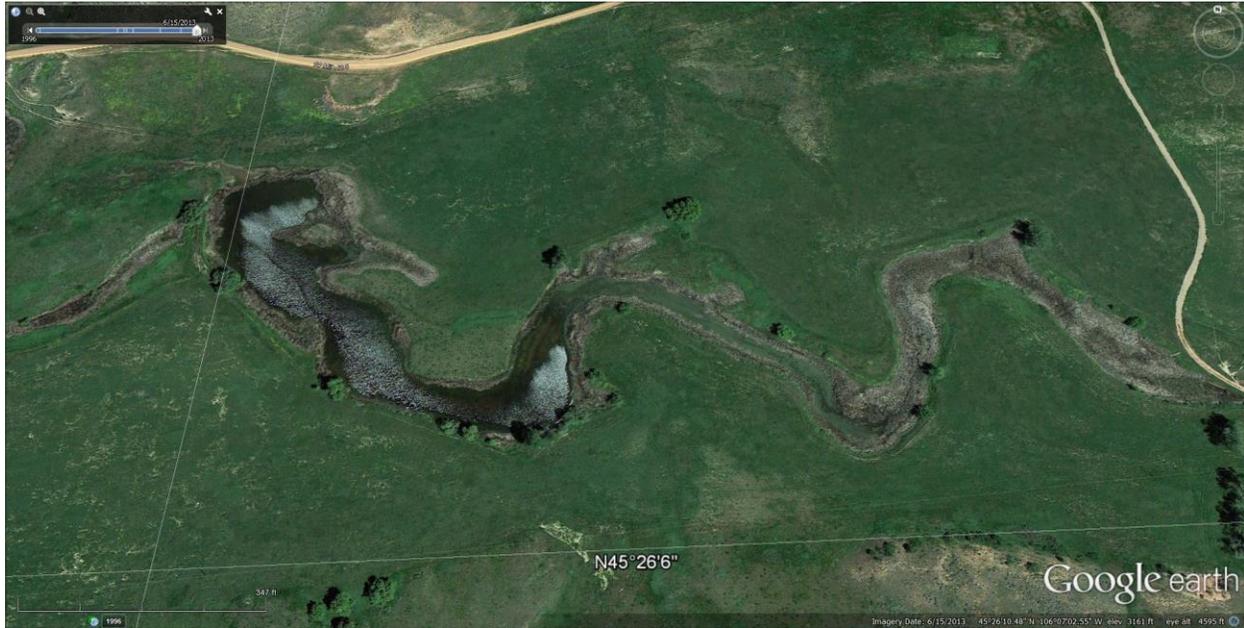
Pond 6 is located in Tenmile Creek just outside the southeast Tract 2 boundary (Section 1, T5S, R45E) and was included in the baseline study. A screen shot from Google Earth imagery shows the pond in 2013 above.

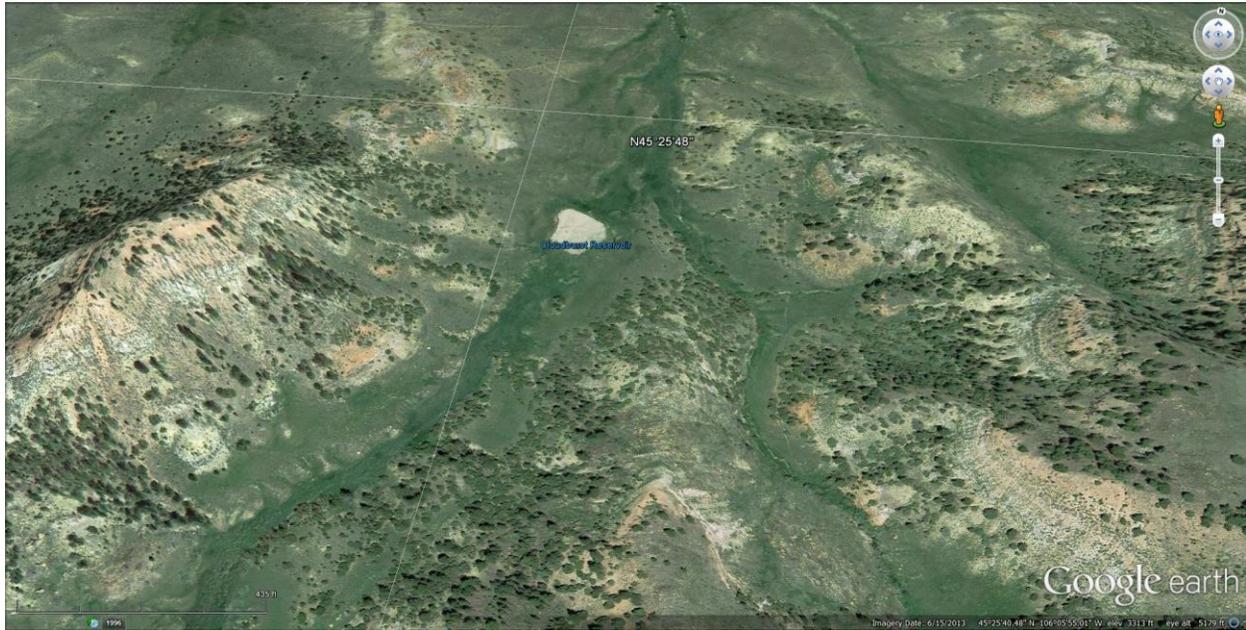
Pond 7 is located on an ephemeral tributary to Tenmile Creek approximately one mile southeast of the south east corner of the Tract 2 boundary (Secion 6 T5S, R46E). No access to this site was available during baseline studies. A screen shot from Google Earth imagery shows the pond in 2013 above.

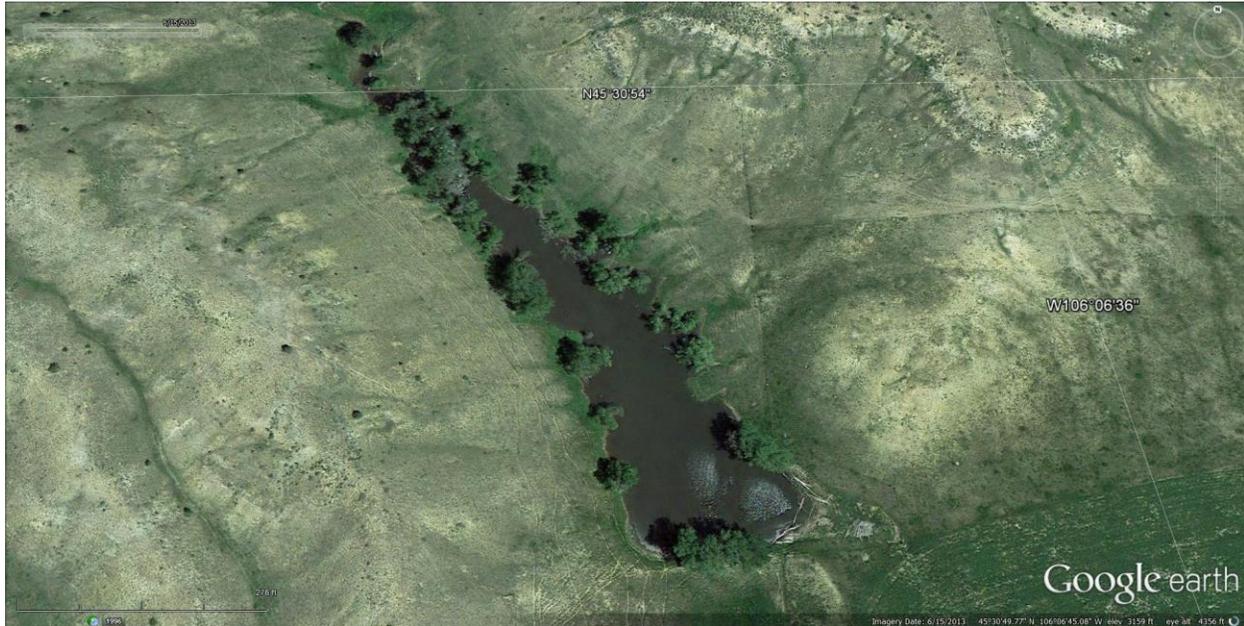
Pond 8 is located in the southeast corner of Tract 1 (Section 1 T4S, R45E). Access to this site was not available during baseline studies. A screen shot from Google Earth imagery shows the pond in 2013 above.

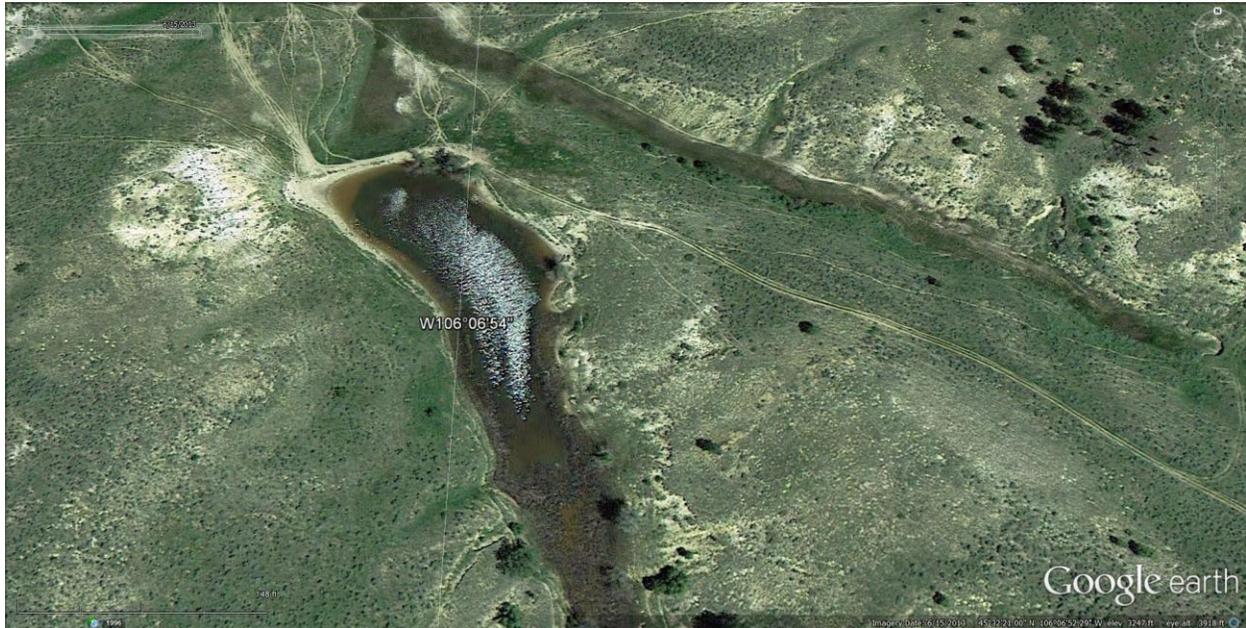
Pond 9 is located in Tract 1 (Section 25, T3S, R45E) on a tributary to Home Creek. The pond is located above a man-made dam. This site was not visited during the spring and seep inventories conducted during the baseline study. A screen shot from Google Earth imagery shows the pond in 2013 above.

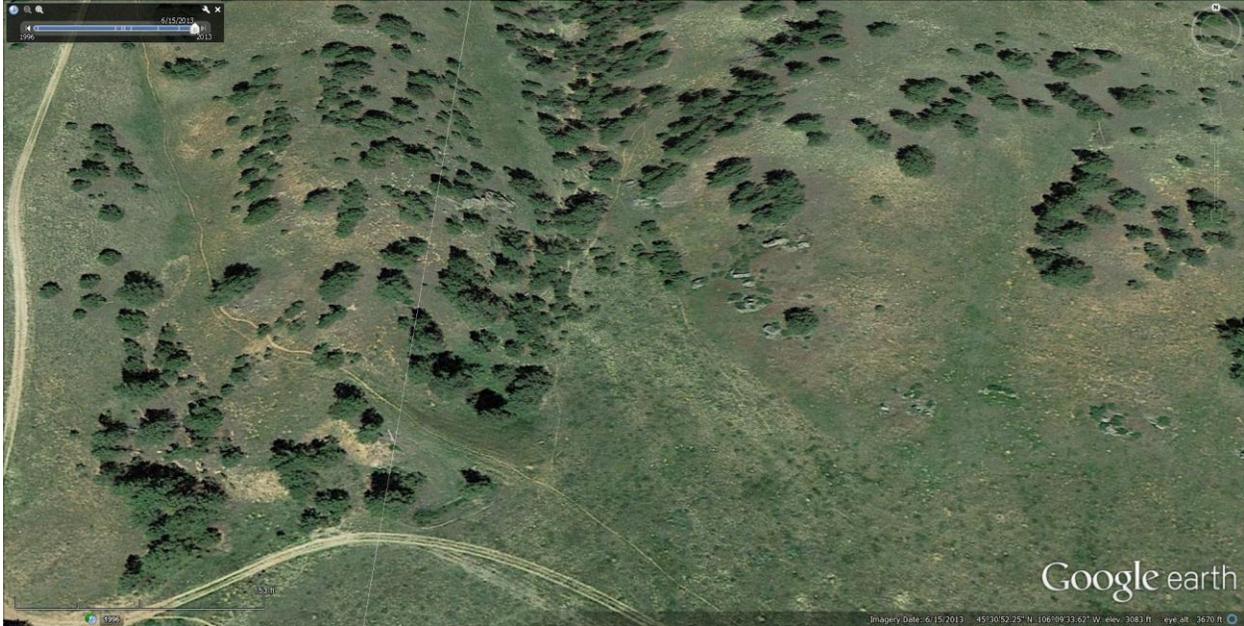
Pond 11 is located in Tract 1 (Section 3, T4S, R45E) in a small tributary to Threemile Creek. It is created by a small man made dam across the drainage to retain surface water runoff. No water has been observed at this pond. This site is underlain by clinker. A screen shot from Google Earth imagery shows the pond in 2013 above.

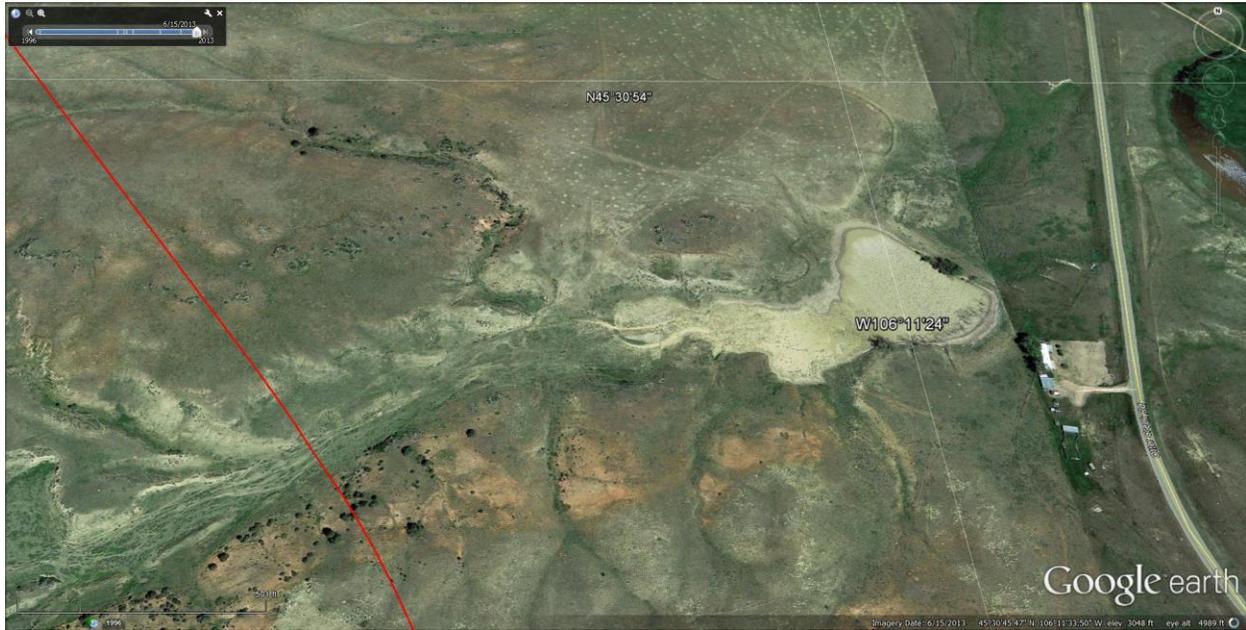
Pond 12 is located between Tract 1 and Tract 3 (Section 4, T4S, R45E) in a tributary to Otter Creek. It is created by a man made dam across the drainage. Access this site was not available during the baseline study. A screen shot from Google Earth imagery shows the pond in 2013 above.

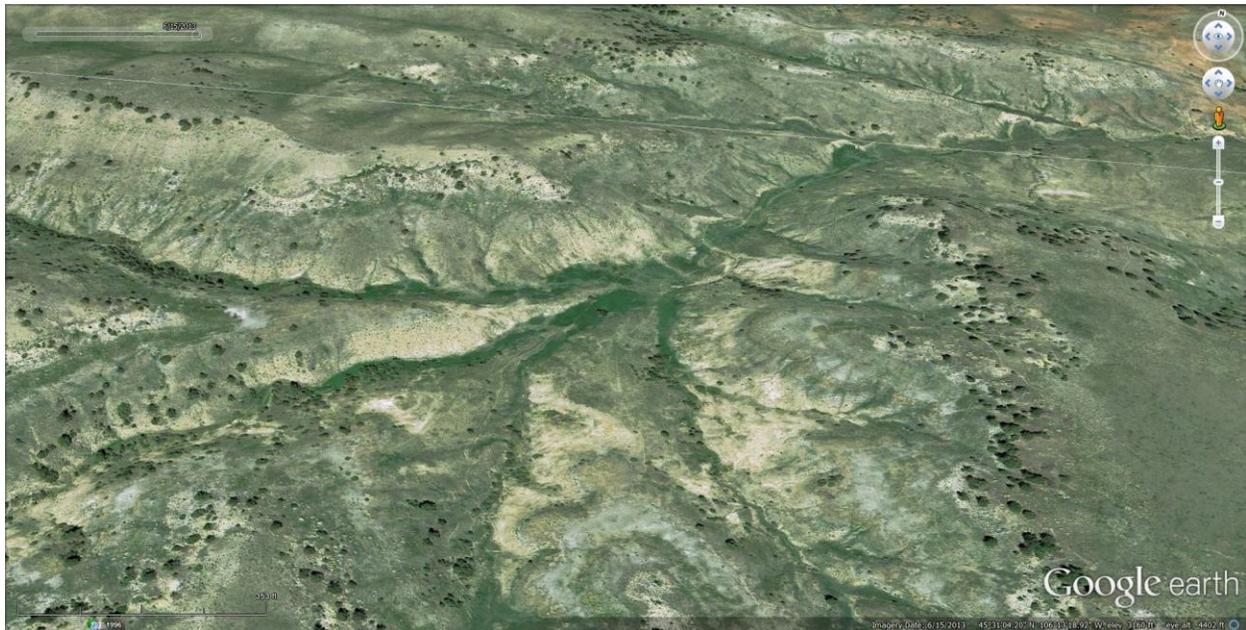
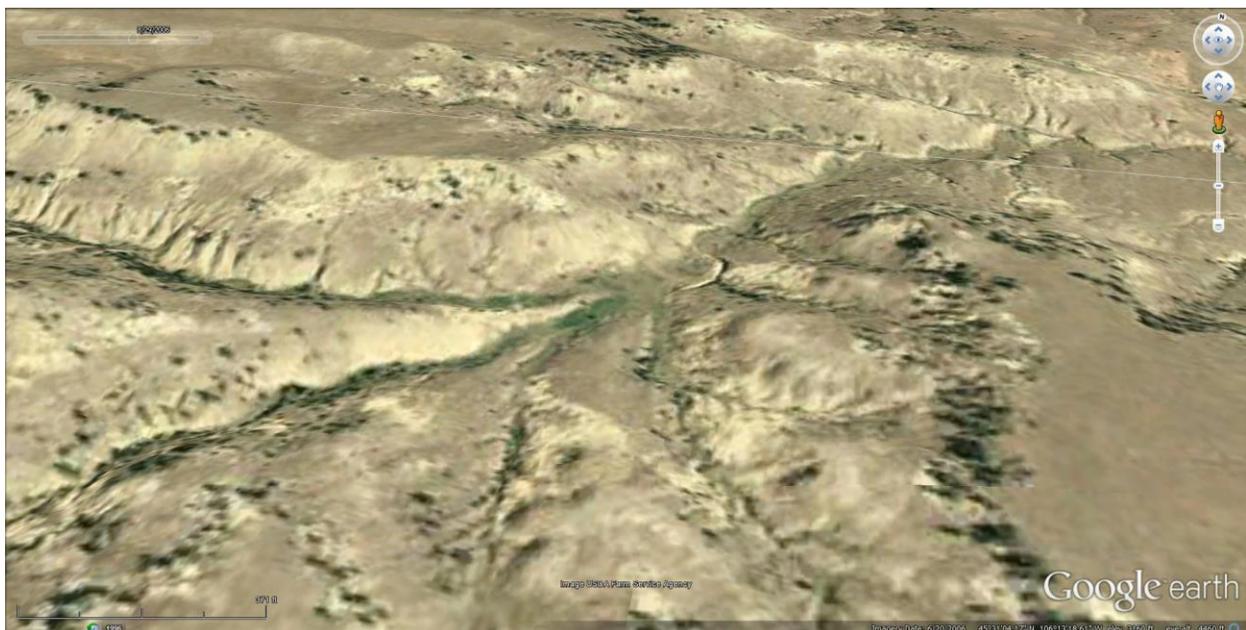
Pond 13 is identified as a pond on the 1995 USGS Willow Crossing, MT quadrangle. A review of historical aerial imagery did not show any evidence of ponded water at that location. Screen shots from Google Earth imagery shows the site in 2013 above and from 2006 below.

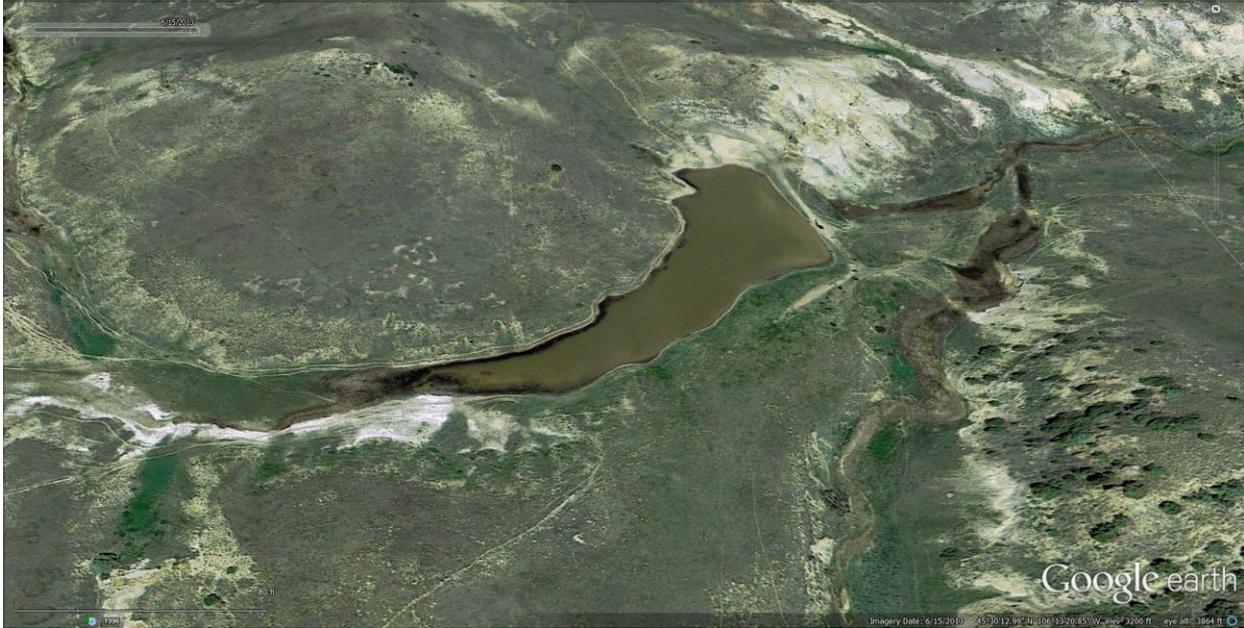
Pond 14 is in Tract 3 (Section 7, T4S, R45E) in a tributary to Otter Creek. It is created by a man made dam across the drainage. This site was not accessed during the baseline study. A screen shot from Google Earth imagery shows the pond in 2013 above.
