Appendix G
Otter Creek Mine Baseline Report 304E
Spring and Seep Inventory

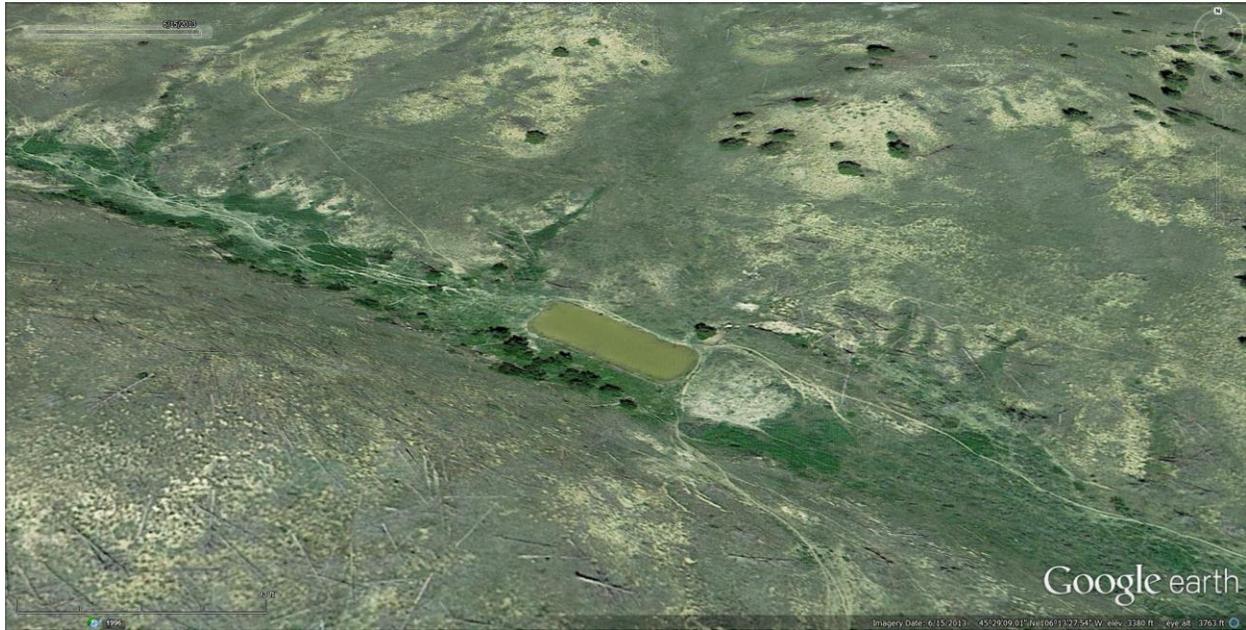
Pond 15 is in Tract 3 (Section 18, T4S, R45E) on Newel Creek, a tributary to Otter Creek. It appears to be created by a man made dam across the drainage. This site was not accessed during the baseline study. A screen shot from Google Earth imagery shows the pond in 2013 above.

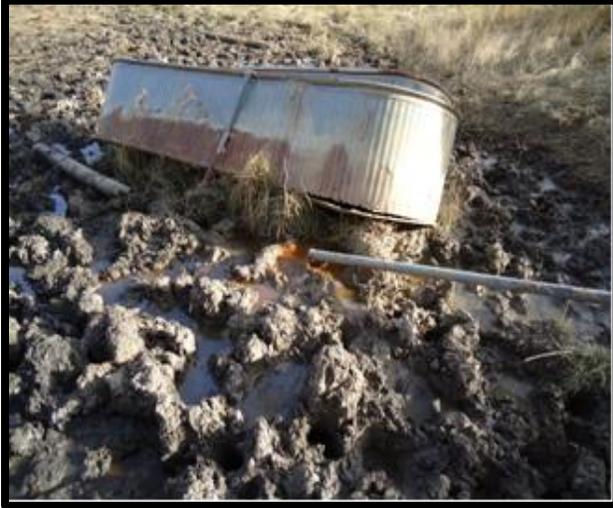
Figure 1. Abandoned stock tank

Note: Figure 1 shows the inlet pipe, source feeding pipe is a spring up gradient. Figure 2, was taken from the dyke of the pond looking at the dry reservoir.

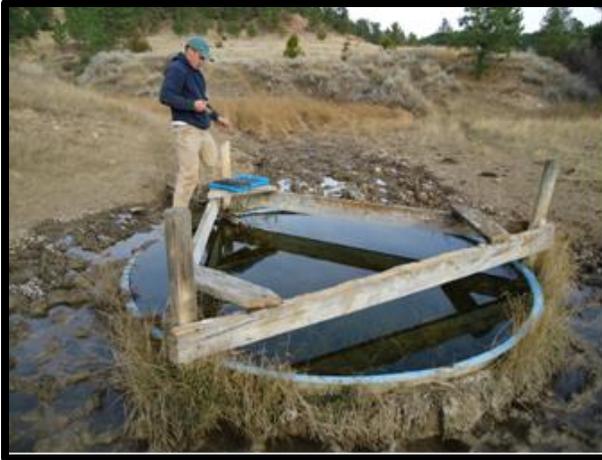
Figure 1. Stock tank near Coal Creek Spring

Note: The flow rate was taken from inlet pipe coming into the top of the tank. Water flowing on ground beside tank estimated at 0.5 gpm. Figure 2, ponding water occurring down gradient of stock tank. Water supplying the tank comes from Coal Creek Spring.

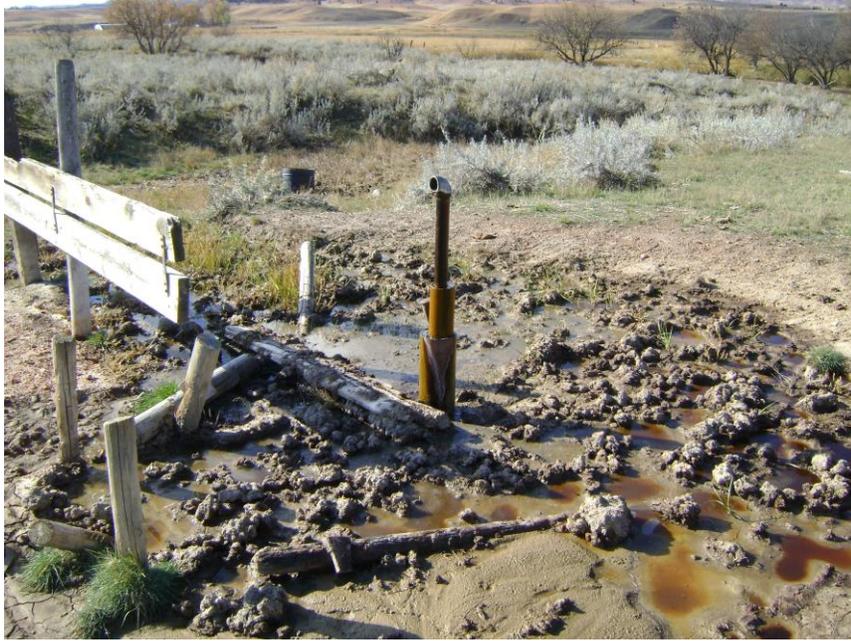
Note: Flowing well.

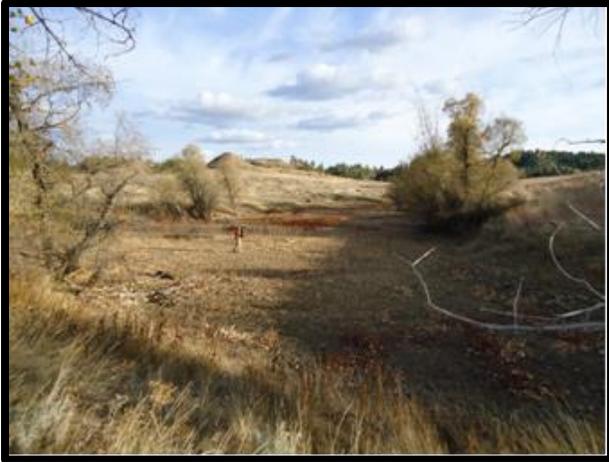
Figure 1. View to the South

Note: Reservoir was dry when inventoried. Thick amount of grass was growing on the floor of the pond. Figure 1 gives an example of the size of the reservoir. Figure 2 displays the down gradient drainage leading away from the dry pond, which was also dry. Surface runoff is only means of recharge.

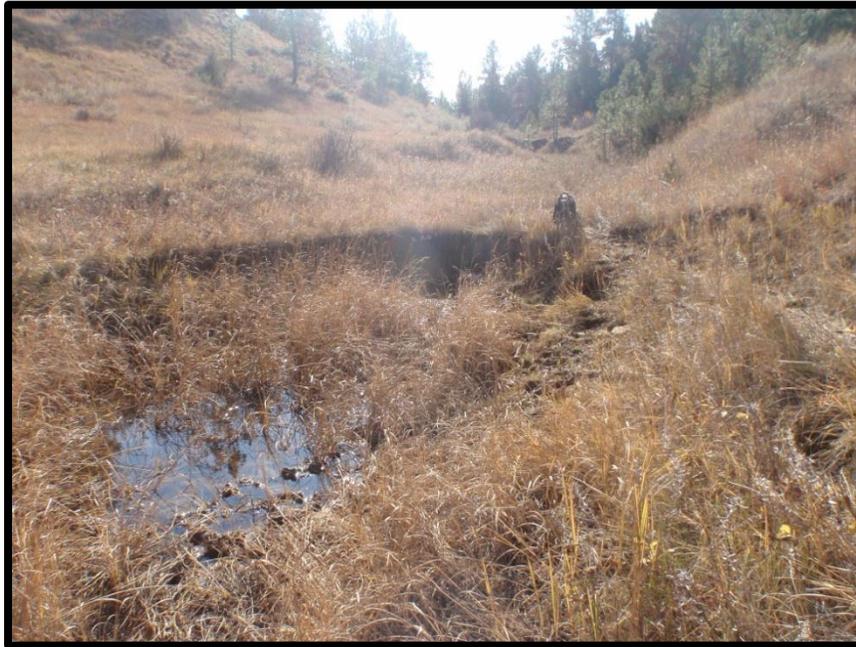
Notes: Very wet marshy area above confluence with larger drainage. Water down gradient of Figure 1 continues intermittently 200 feet before flowing into another drainage; interpreted to be a seep.

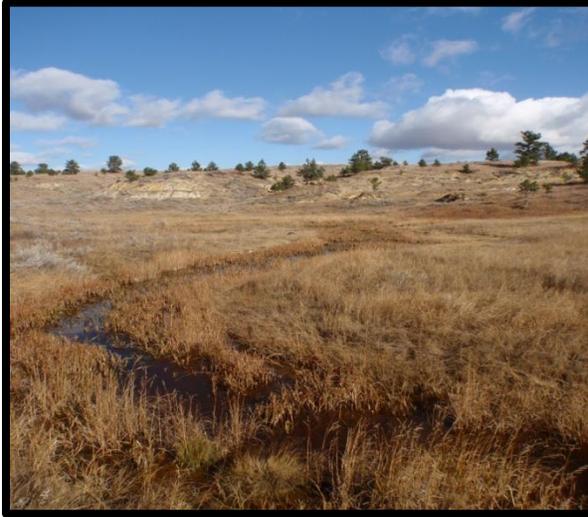
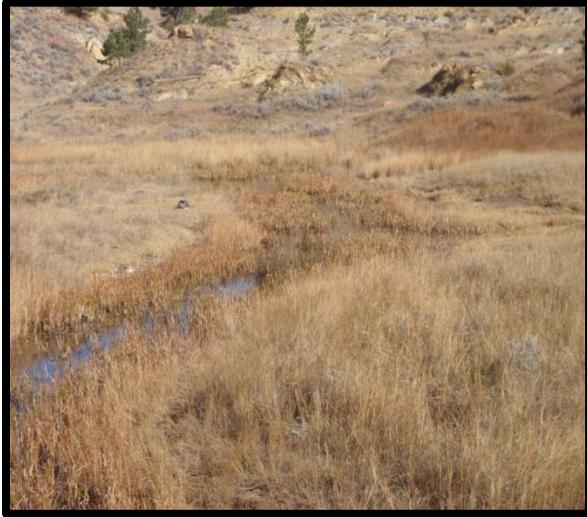
Figure 1. View to the North

Notes: Standing water in main channel, pooled water possibly flows to the West. Pooled, standing water continues down the drainage intermittently.

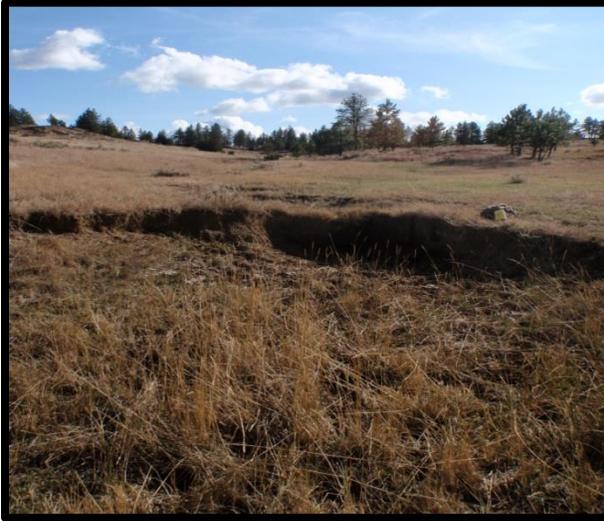
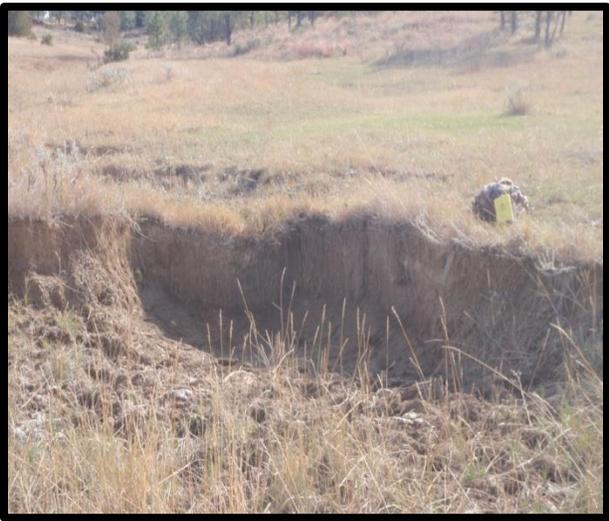
Figure 1. View to the Southeast

Notes: Precipitation occurred in the last 24 hours; signs of water issuing, seeping to the surface, i.e. cattle tracks and surface subsidence. Very little actual standing water.

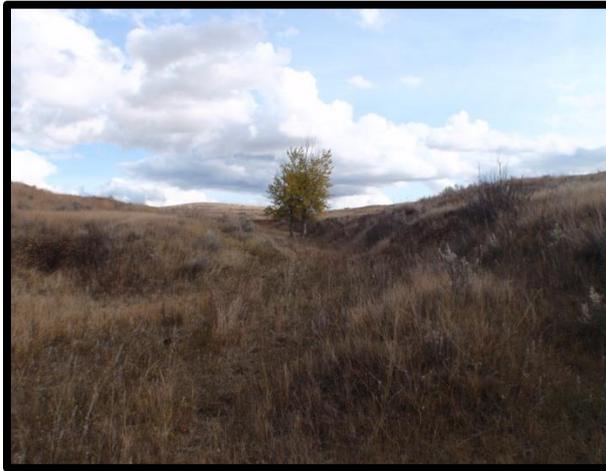
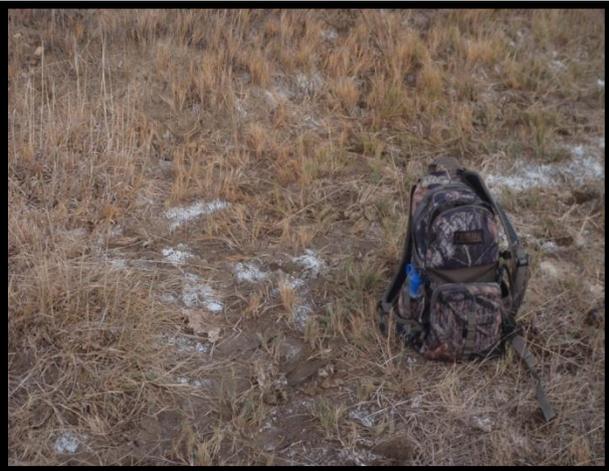
Figure 1. View to the Southeast

Notes: Site Dry. Figures 1 and 2 taken at the confluence of three drainages; salt precipitation on surface of ground.

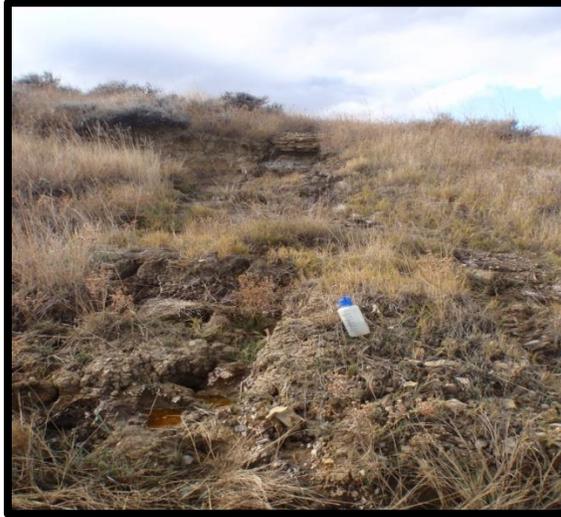
Figure 1

Notes: Seep present in most Northwestern drainage above SSI-11-10. Water issuing from the Northwest, could not estimate flow. Algae bloom present on top of issuance (Figure 1).

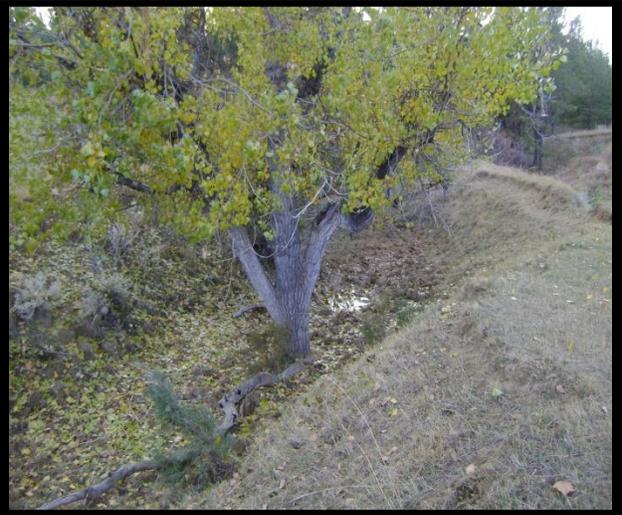
Figure 2. View to the West

Notes: Seeps emerge from two nick points in channel identified by larger cottonwood tree Figure 2. Cattle imprints all contain water.

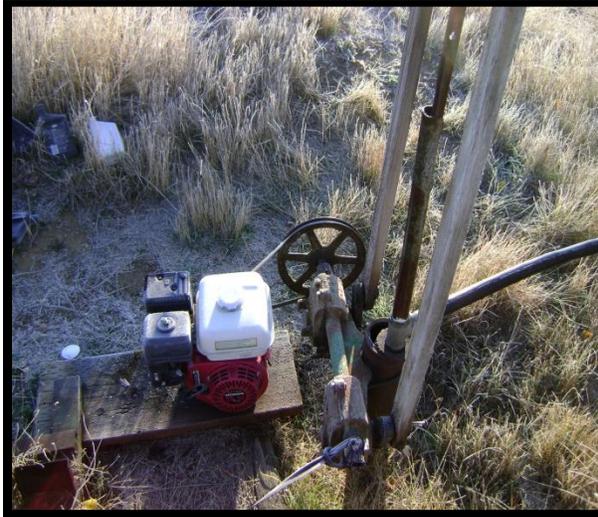
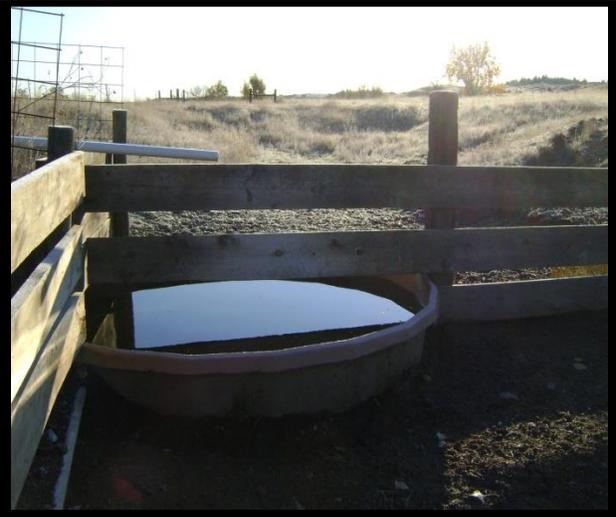
Figure 1. View to the East

Notes: Stock tank water originates from Steven's well nearby, overflow discharges into Threemile drainage.

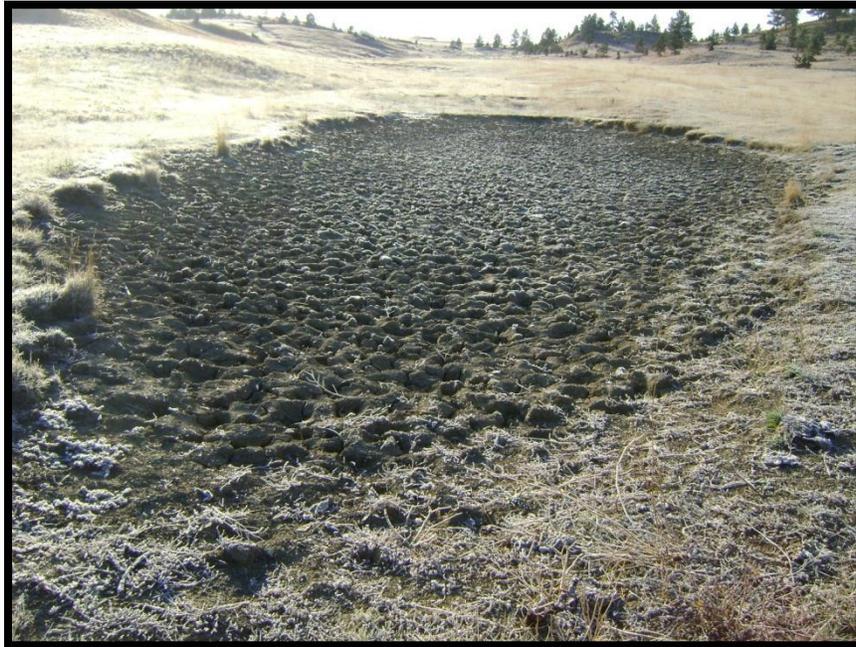
Figure 1

Notes: Stock pond in a small drainage with evidence of seasonal water. Water ponds behind small man-made berm, pond recharges with seasonal runoff.

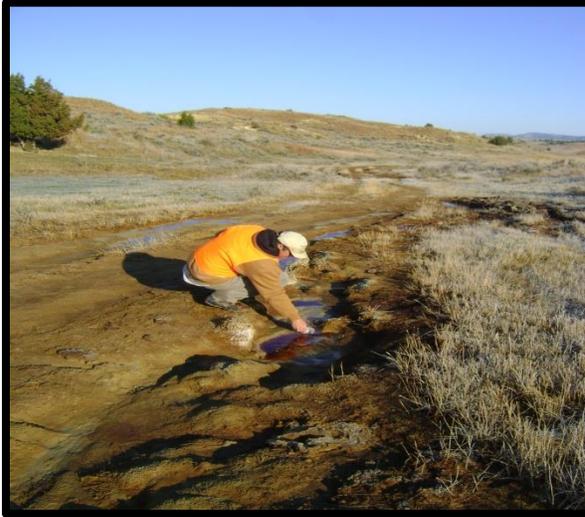
Figure 1. View to the Southeast

Notes: Standing water seeping from hillside spring east of road. Ponding water is intermittently visible up to 200 feet down gradient of hillside spring. Interpreted as a seasonal seep.

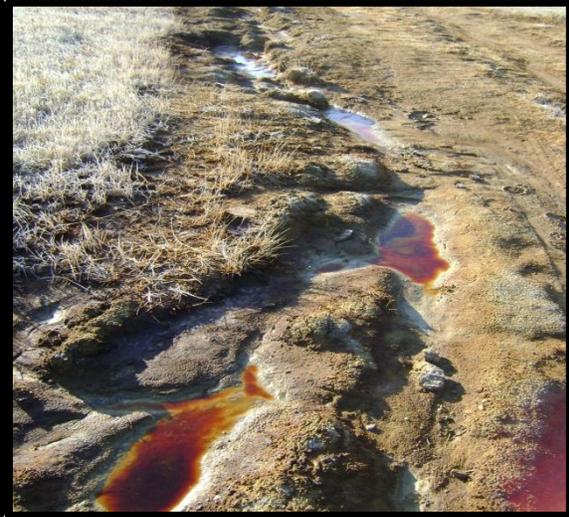
Figure 2. View of erosion cuts next to road

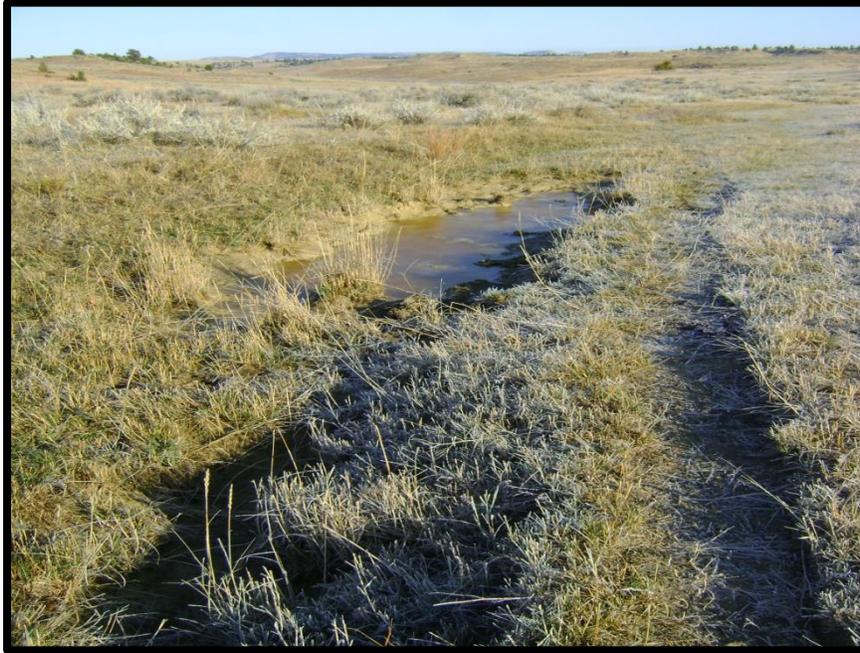
Figure 1

Notes: Site 250 feet North of SSI-11-15, water emerges from nick point in a small drainage. No visible flow. Algae bloom evident, vegetation green around edges of water. Interpreted as a seep.

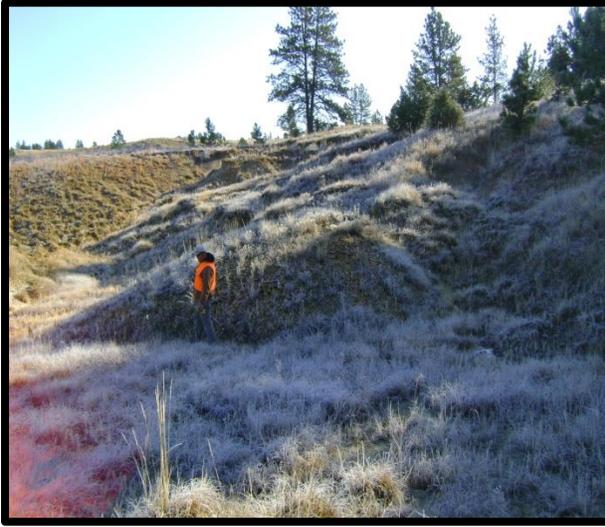
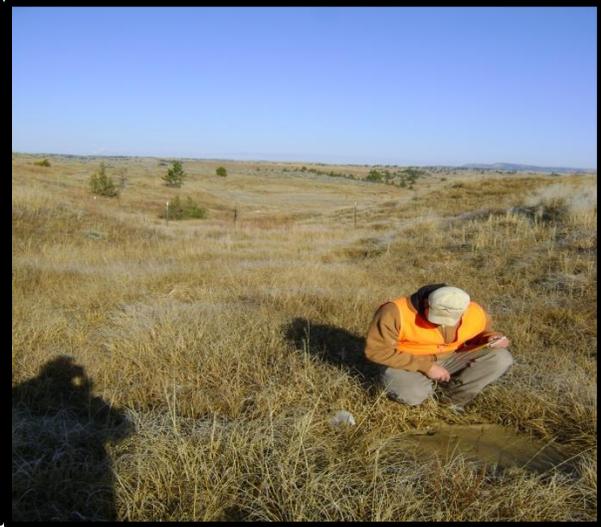
Figure 1. View to the East

Notes: Point originates south of B6 well battery. Intermittent water present from SSI-11-17 to culvert and beyond; salt precipitation present throughout channel. Interpreted as a seep.

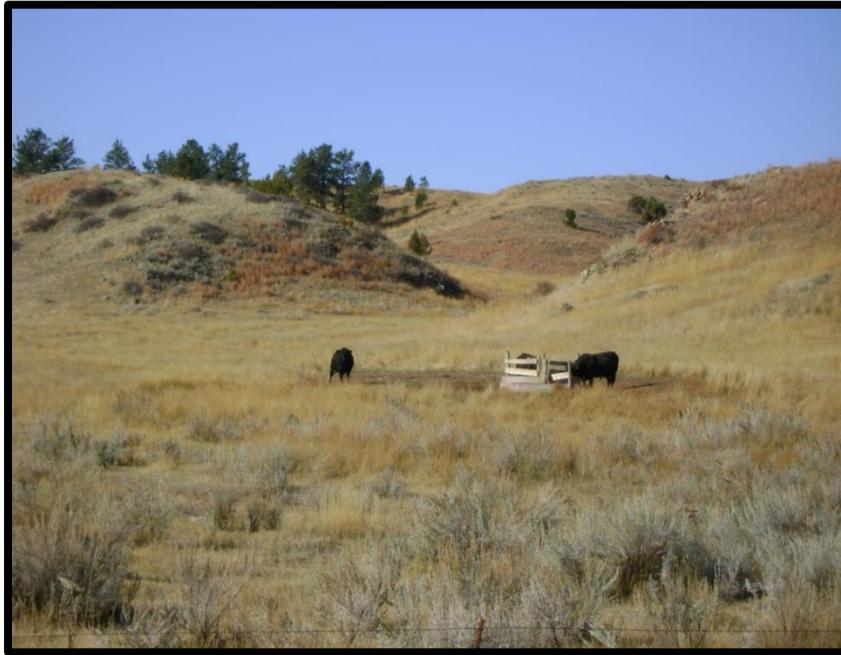
Figure 1. View to the West

Notes: No access to collect field parameters. Stock tank across Highway 484 (MP 5, Section 9); Consol Energy, Inc. property.

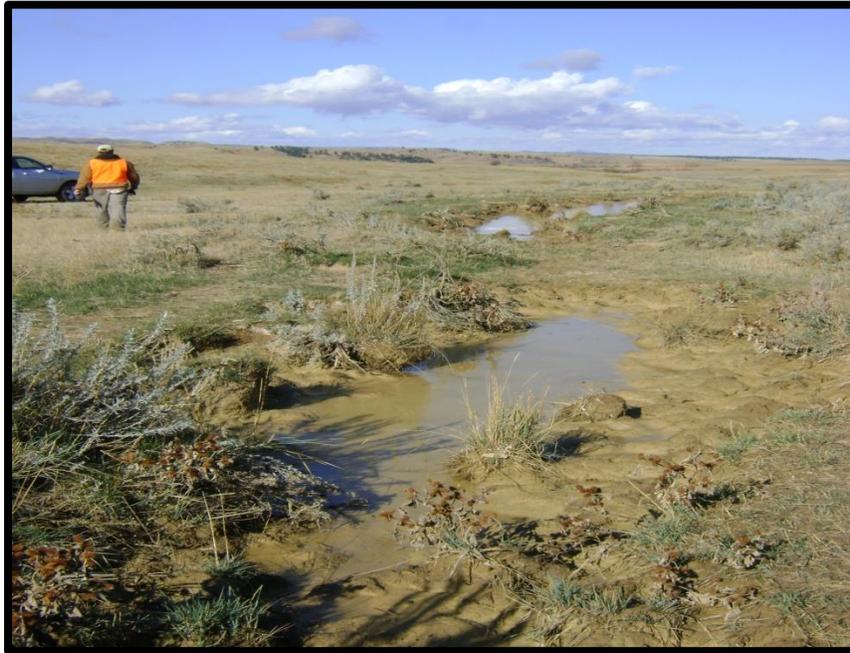
Figure 1. View to the Northwest

Notes: Ponding surface water in ephemeral drainage south of K5 well and east of AVF-3 battery. After walking up gradient in drainage only sporadic ponding was found. Standing water suspected to runoff from last precipitation event.

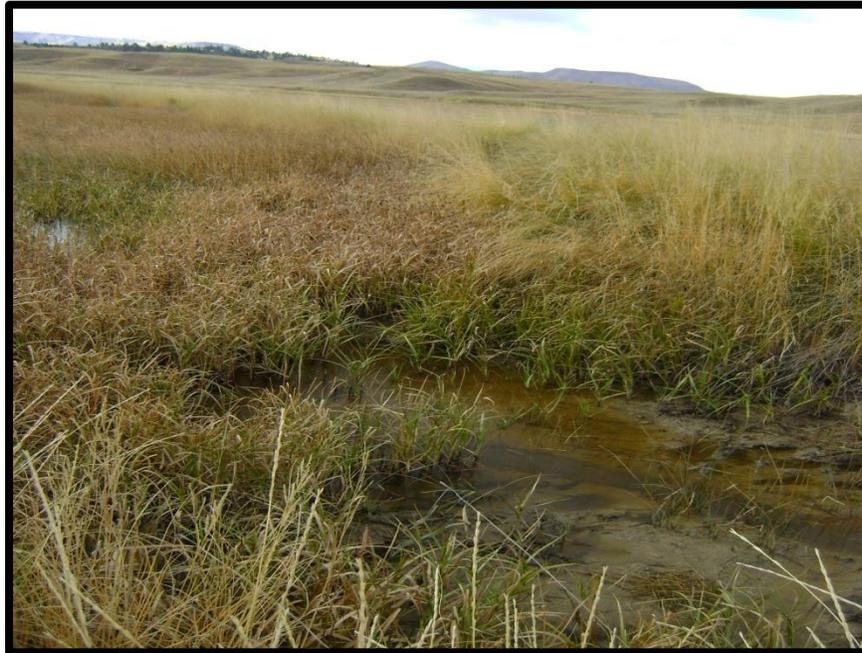
Figure 1. View to the Southwest

Notes: Oxbow lake opposite AVF-3 battery in Section 15. Standing water, parameters taken above clinker creek crossing. Interpreted as groundwater recharge from nearby Otter Creek.

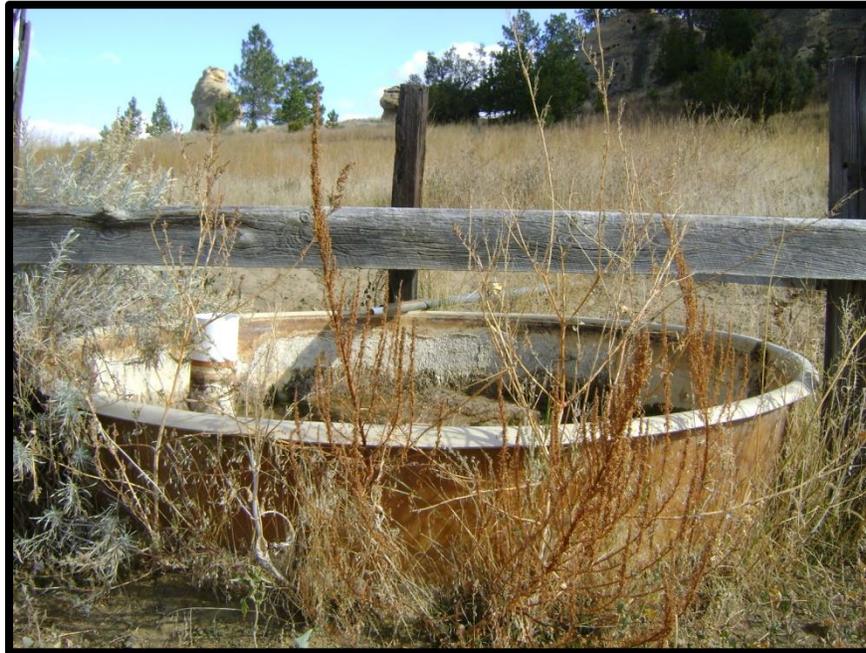
Figure 1. View to the Northwest

Notes: Stock tank on Denson's property not being used at this moment. Water source not near site.

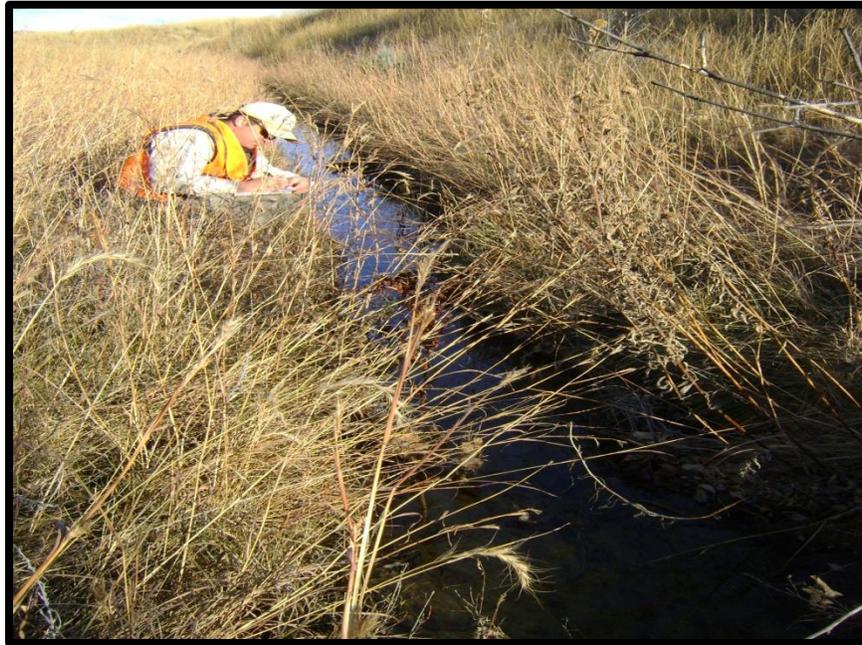
Figure 1. View to the West

Notes: Chromo Creek East of B-10 battery. Source of water Chromo Reservoir.

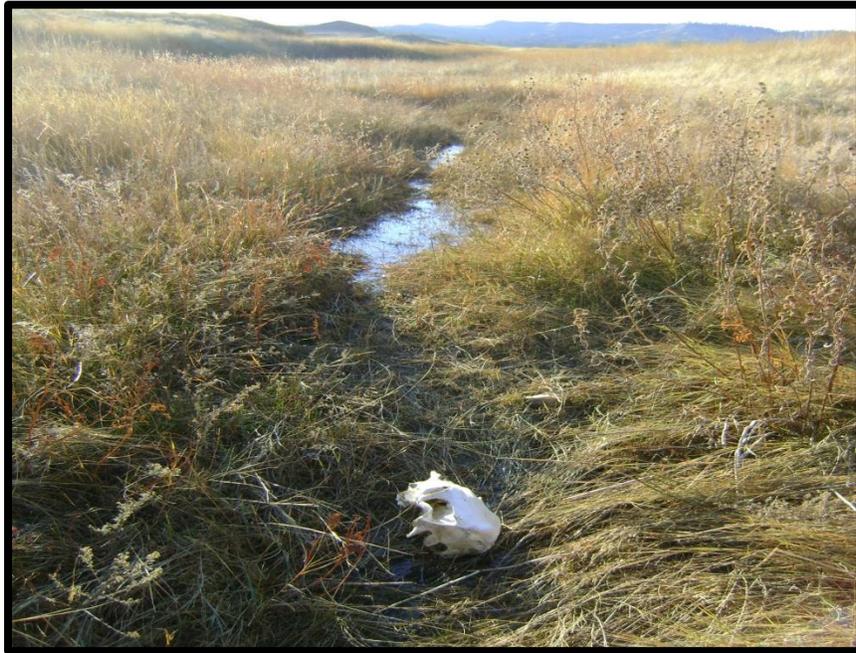
Figure 1. View to the West

Notes: Chromo Creek, where surface water disappears underground. Ponding water in background of Figure 1.

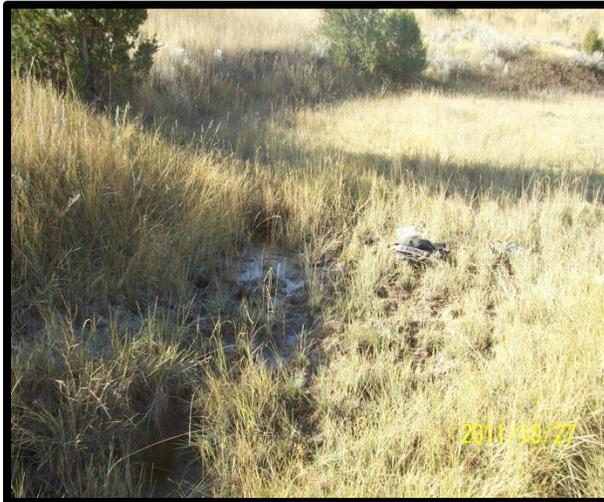
Figure 1. View to the Southwest

Notes: Figure 1 took looking up gradient into the drainage. No flow visible, ponding water in livestock imprints. Figure 2 nick point where surface water in Figure 1 originates. Interpreted as seeping surface water.

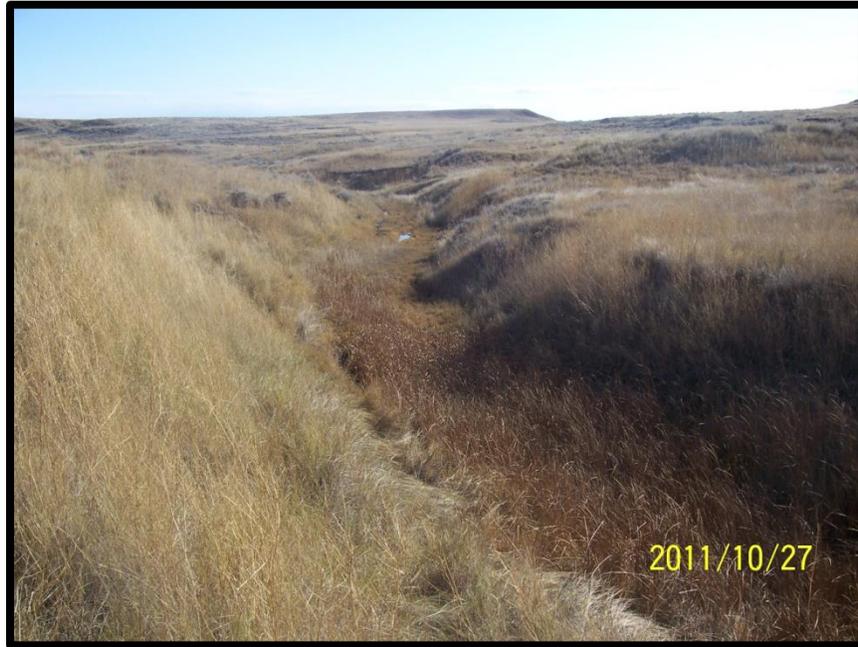
Figure 1. View to the Southeast

Notes: Seep extends 200 feet up gradient from where figure was taken, water intermittently flowing in a Southeastern direction.

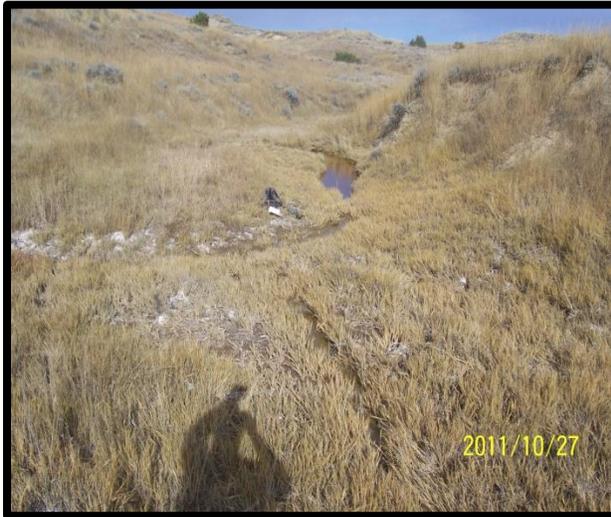
Figure 1. View to the Northeast

Notes: Spring has flow, sporadically ponding water in between flowing channels. Channelized water flowing Northeast towards Highway 454.

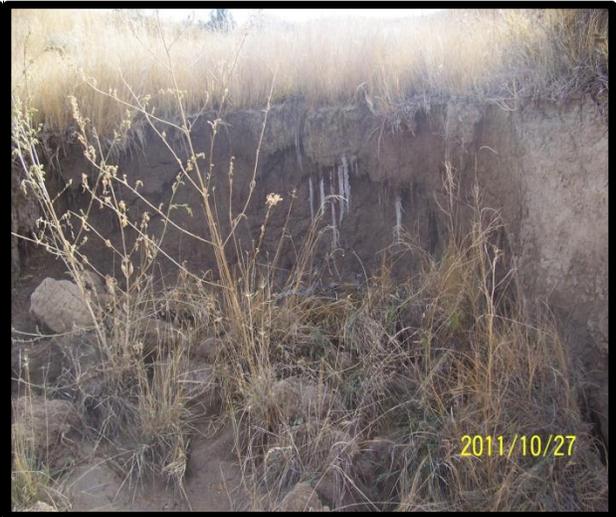
Figure 2. View of the originating nick point

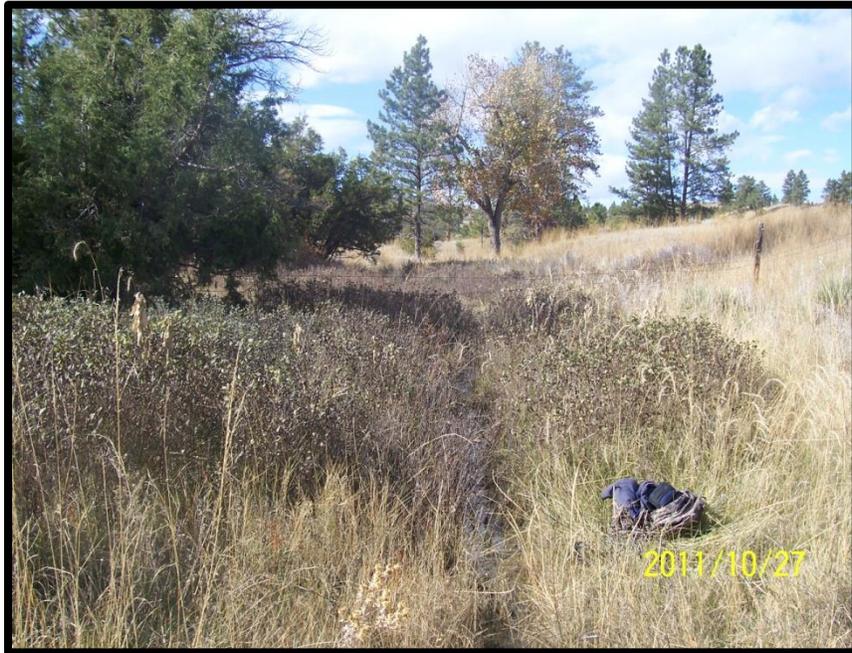
Figure 1. View to the West

Specific Conductivity (μm)	6080
pH	8.45
Temperature ($^{\circ}\text{C}$)	5.2
Latitude	45.45736
Longitude	106.19490
Flow Rate	Visual~10-15 GPM
Water Color	Clear
