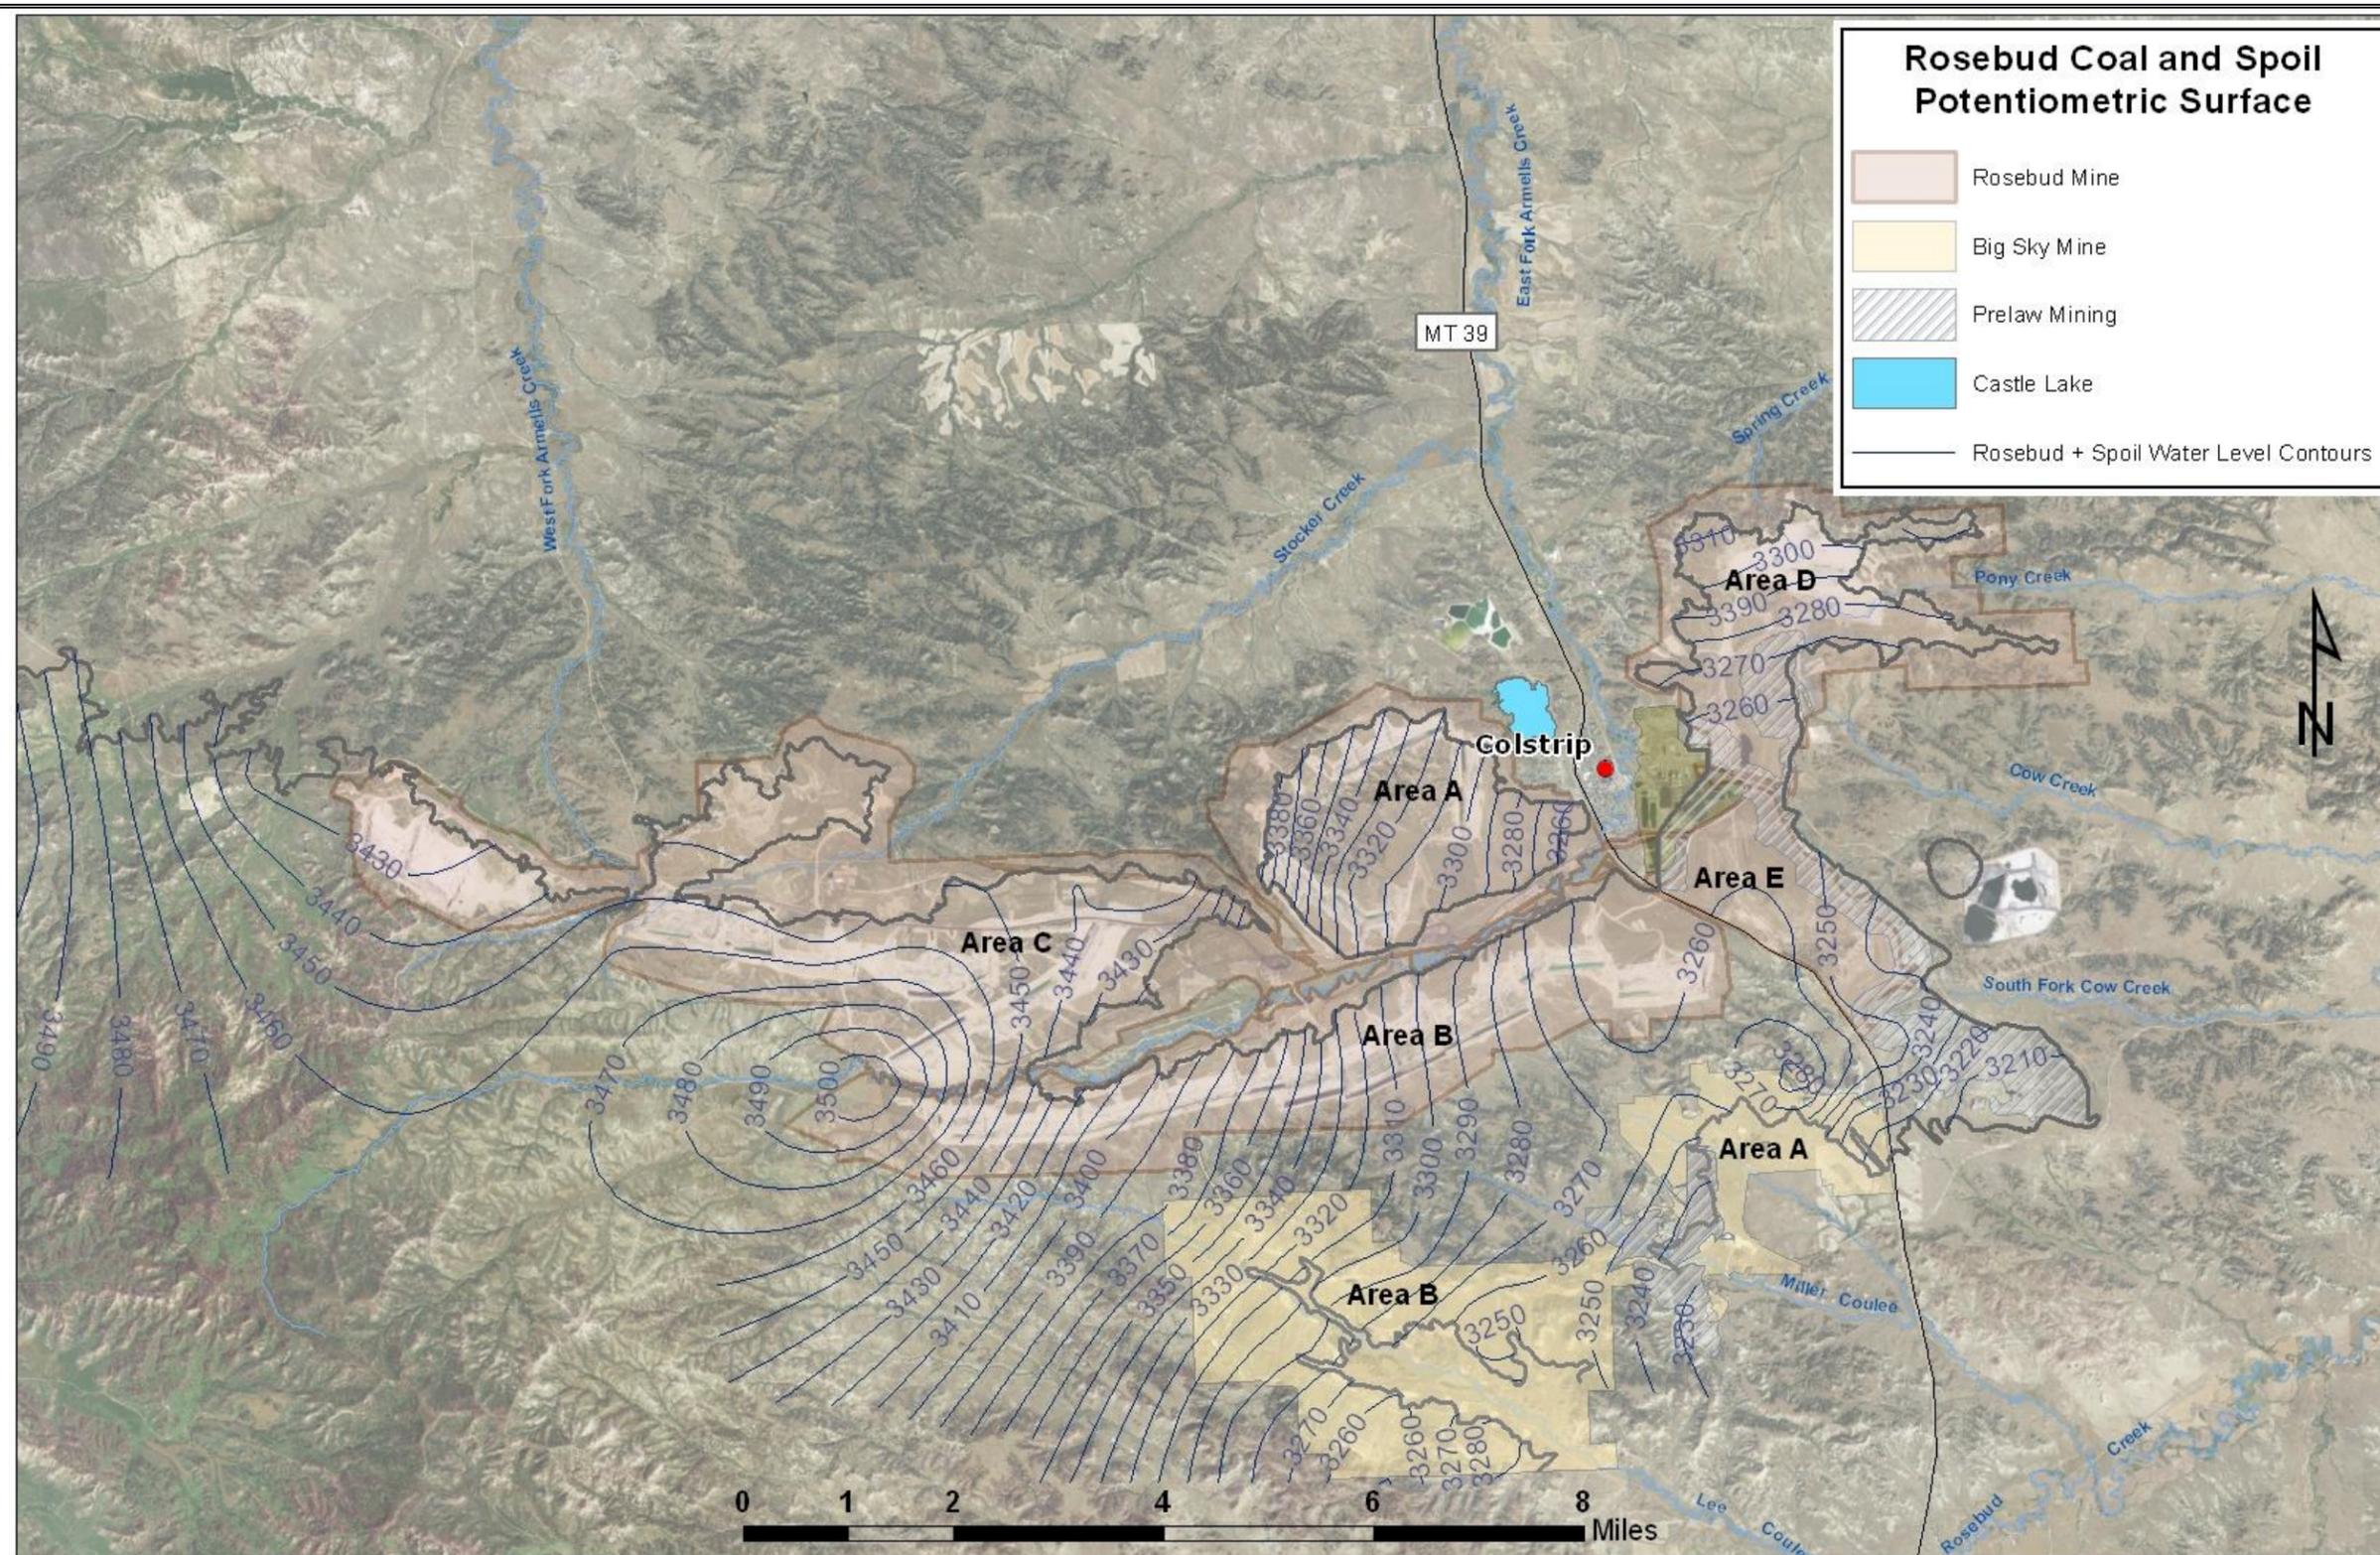
Figure 8-5: Potentiometric surface of the Rosebud coal and spoil.
 Plotted from monitoring well water levels at the Rosebud and Big Sky Mines in 2012. (Western Energy Company, 2012; Big Sky Coal Company, 2013).
