**Clark Fork River  
Operable Unit of the  
Milltown Reservoir Clark  
Fork River  
Superfund Site**

# River Review

November 2013

## Phase I Construction Update

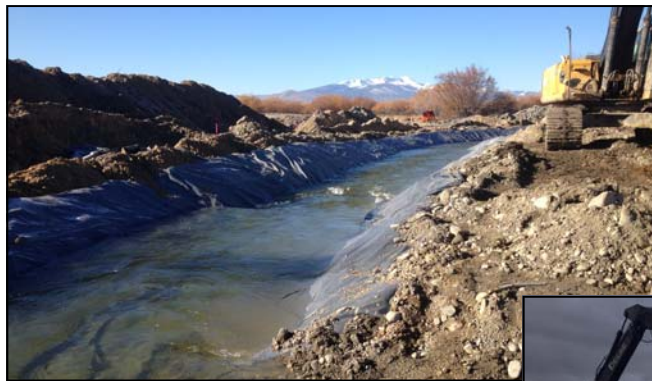
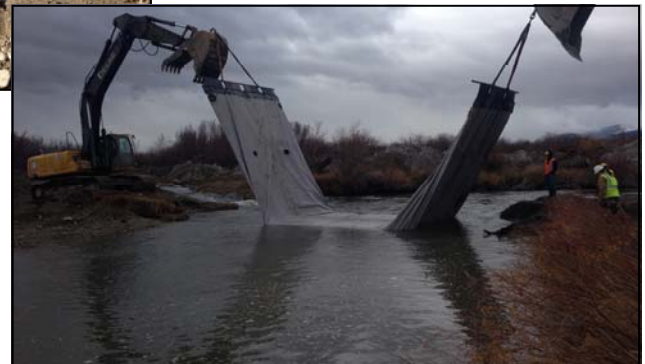
Left: Temporary diversion channel.

Right: Aqua barriers (temporary inflatable dams filled with water) were placed upstream and downstream of the existing channel. This created a dam to push water into the diversion channel to allow for the excavation of contamination.

Near the end of October, Helena Sand and Gravel diverted 420 feet of the existing river channel to remove deep contamination from the banks and under the channel bed. The process included diverting that portion of the river into a temporary diversion channel; this allowed for excavation of material but still allowed fish passage. Montana Fish, Wildlife and Parks rescued fish that got stuck in pools in the original river channel during this process.

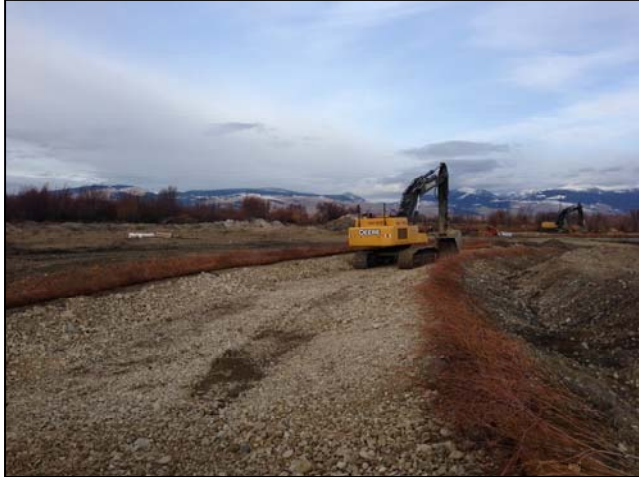
The excavator operator works to shape the streambed materials in the rebuilt Clark Fork River channel.

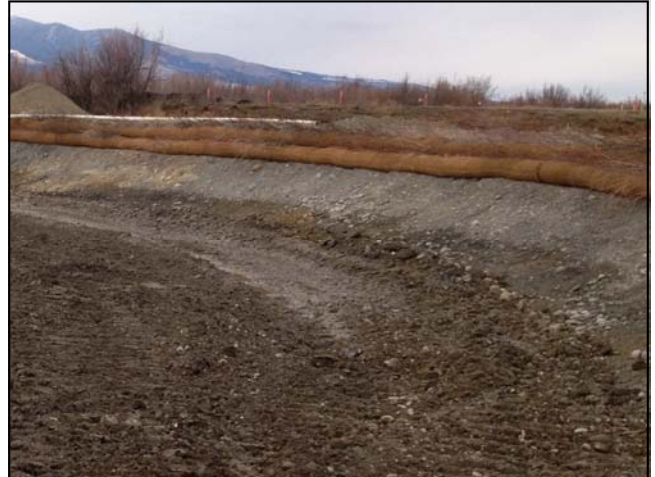
Double vegetated soil lifts were constructed to form the new channel banks.

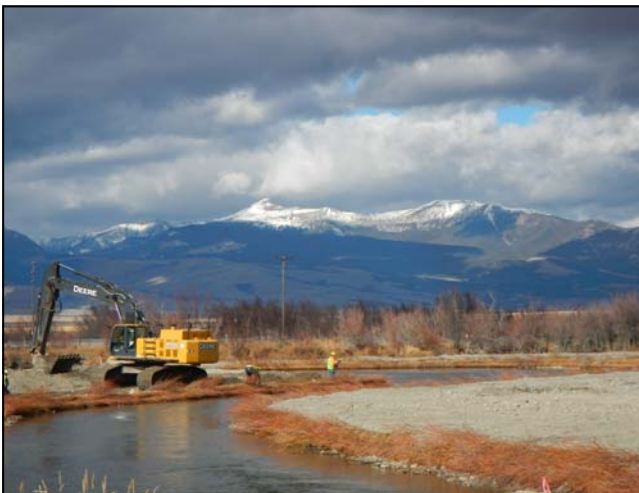
The crew builds streambanks along the newly rebuilt river channel.

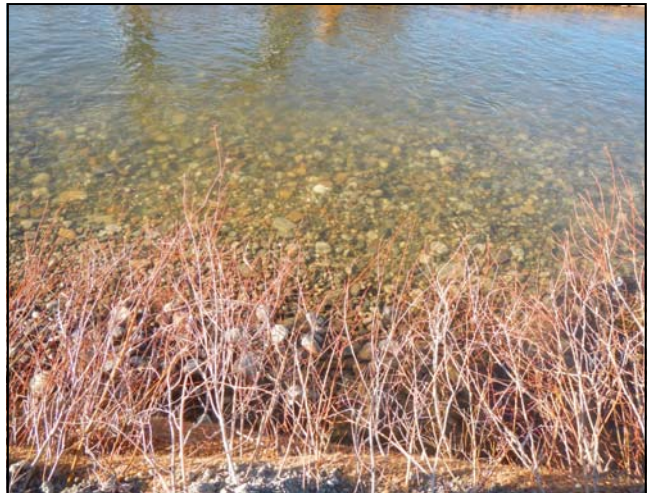
Clean channel bed rock of appropriate native material size was used to rebuild the streambed.
