# **CR Kendall Mine Closure**

# **Environmental Impact Statement**

**September 2015**

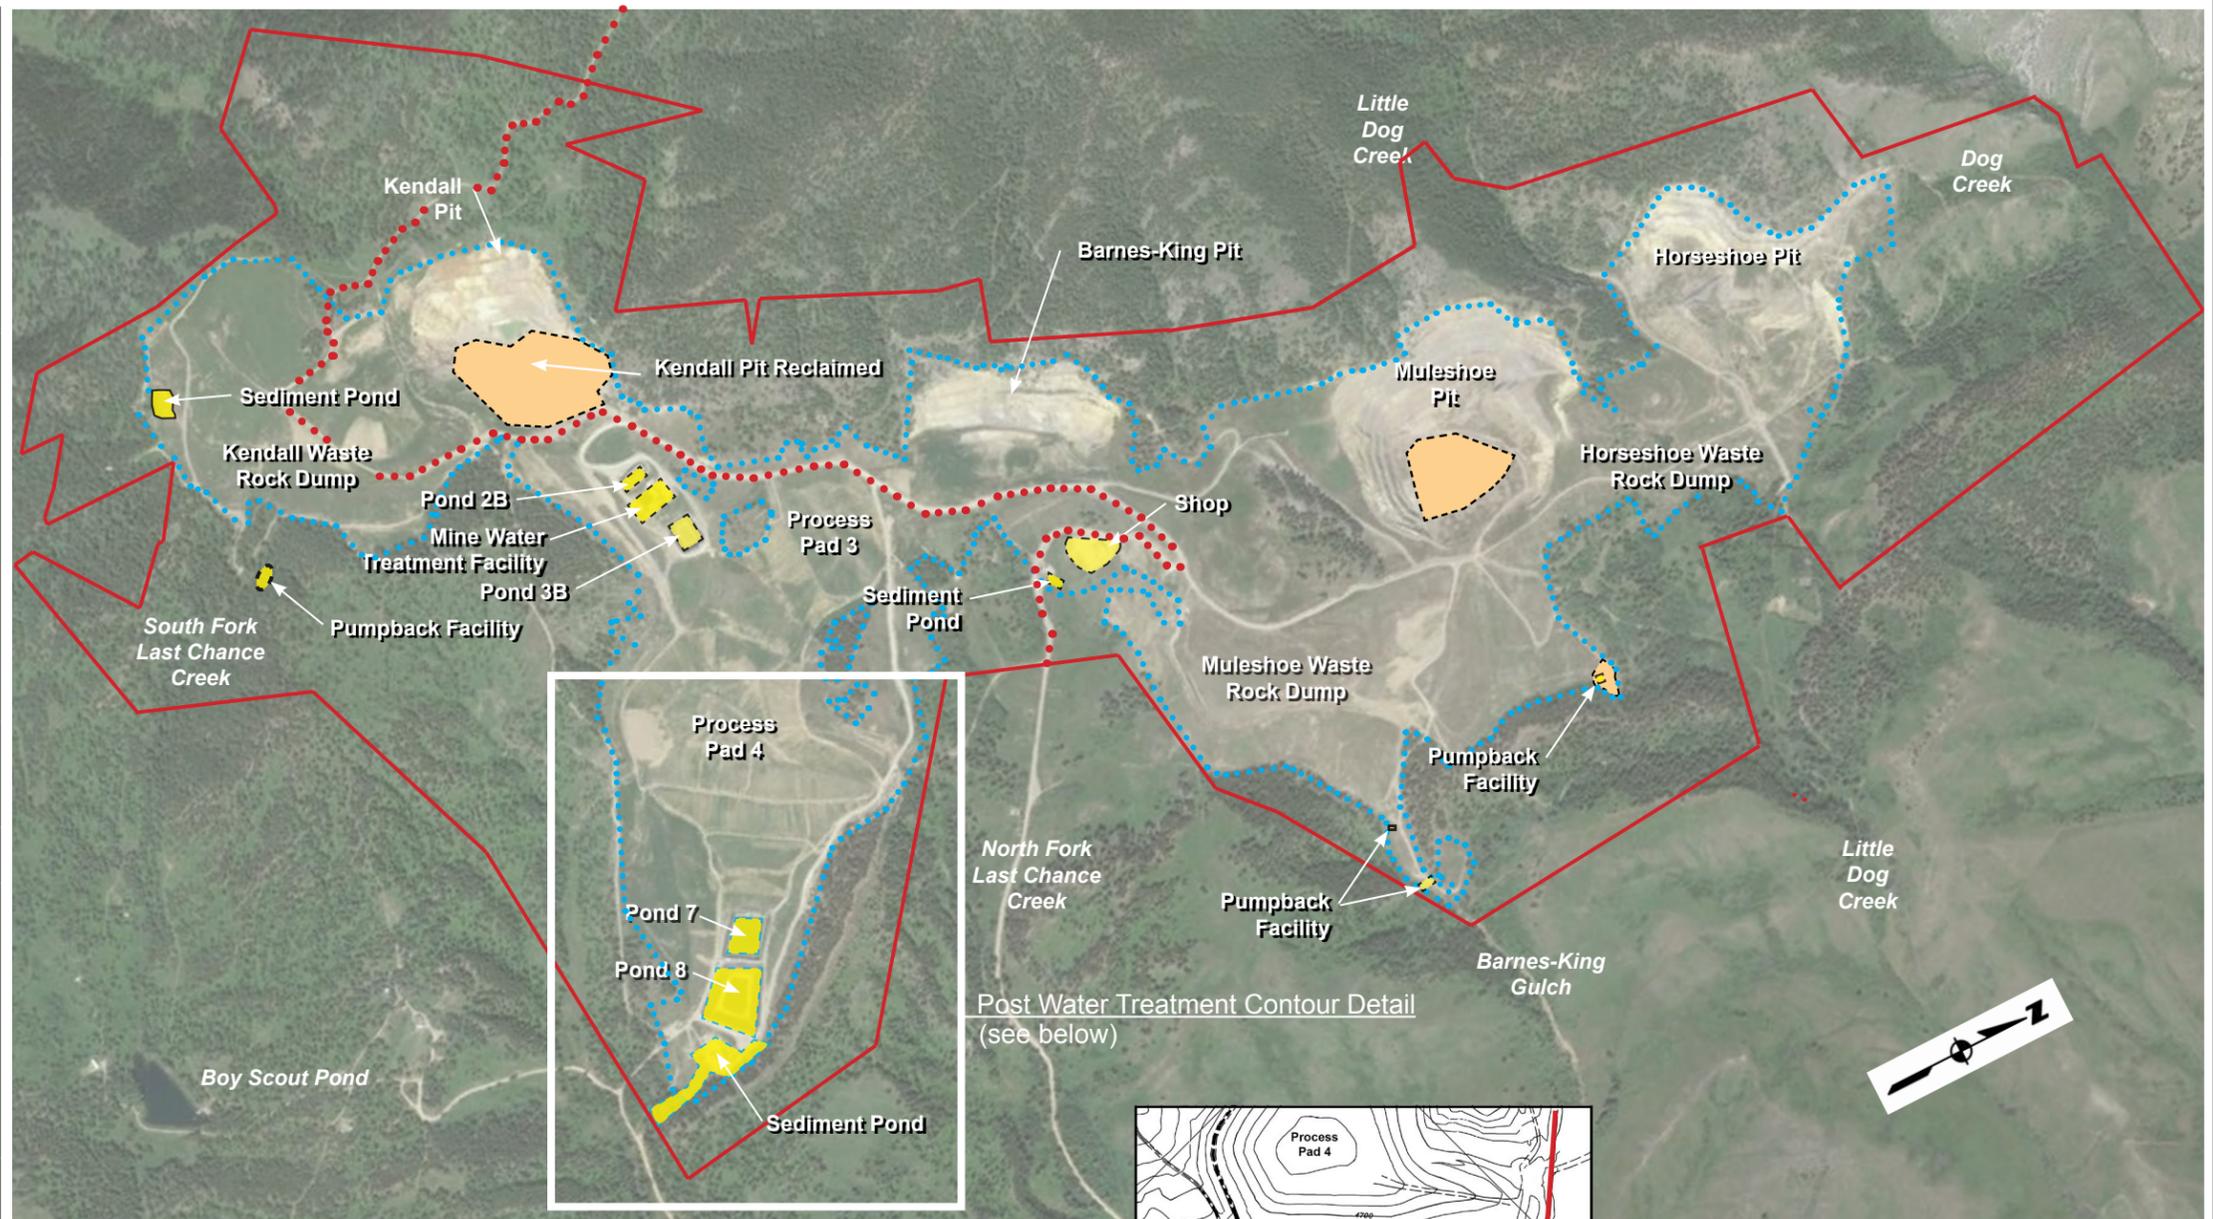
**FIGURE 2-1**  
CR Kendall Mine  
No Action Alternative

Disposal of Spent Zeolites	Disposal in leach pads until capped in 2012. Currently retained on site and stored in the truck shop.
<b>Reclamation</b>	
Process Pads Reclamation Design	Process pads were regraded to 3:1 slopes with 10 foot benches every 100 feet in 2004 (1989 Plan of Operations). A modified water-balance cover was installed in 2008 and 2012 consisting of 17 inches of growth media over 6 inches of subsoil basal layer material amended with 5 to 8 percent bentonite, over 12 inches of subsoil basal layer material (Minor Revision 11-001). Process pads were seeded in 2012.
Process Pads Underliner	Underliner would be perforated by drilling to the underdrain to eliminate water ponding (1989 Plan of Operations).
Kendall and Muleshoe Pits	Rock stockpiles in the Kendall Pit were regraded in 2006 (Minor Revision 06-001). The placement of 8 to 10 inches of soil on regraded areas with less than 2:1 slopes and reseeding has not been completed. The lower slopes of the Muleshoe Pit were backfilled but not covered with soil and are poorly vegetated.

Facilities	All buildings (including the WTP) will be removed at closure when reclamation is completed (1989 Plan of Operations). All ponds will be backfilled or graded to drain and the areas covered with soil and reseeded after water treatment is no longer required.
Roads	All reclaimed except BLM right of way.

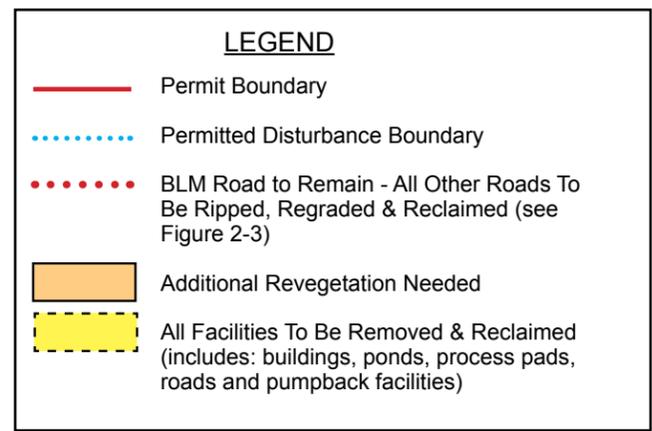
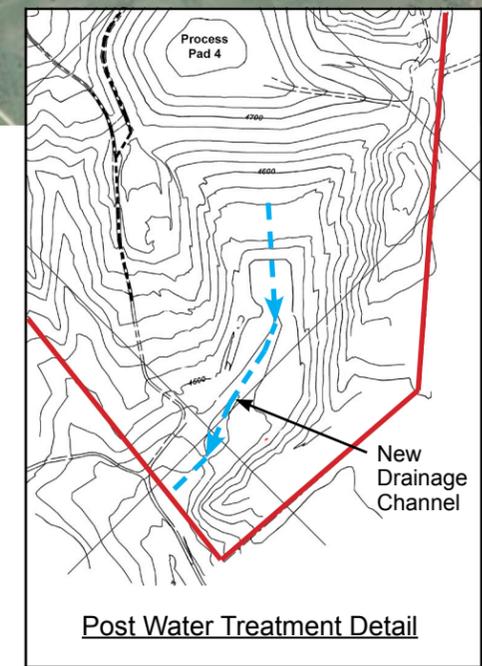
For this EIS, the 1989 Plan of Operations (Kendall Venture and Hydrometrics, 1989; Revised 1995), Soils and Revegetation Plan (Shafer and Associates, 1995), and the pumpback and water treatment plans are considered to be the No Action Alternative. The main features of the No Action Alternative are shown on **Figure 2-1** and the pumpback and water treatment components are shown on **Figure 2-2**.

The placement of soil from stockpile TS-13a (**Figure 2-1**) onto the Kendall and Muleshoe Pit slopes and reseeded the areas was a component included in both Agency-Modified alternatives. The two Agency-Modified alternatives are described in more detail below.

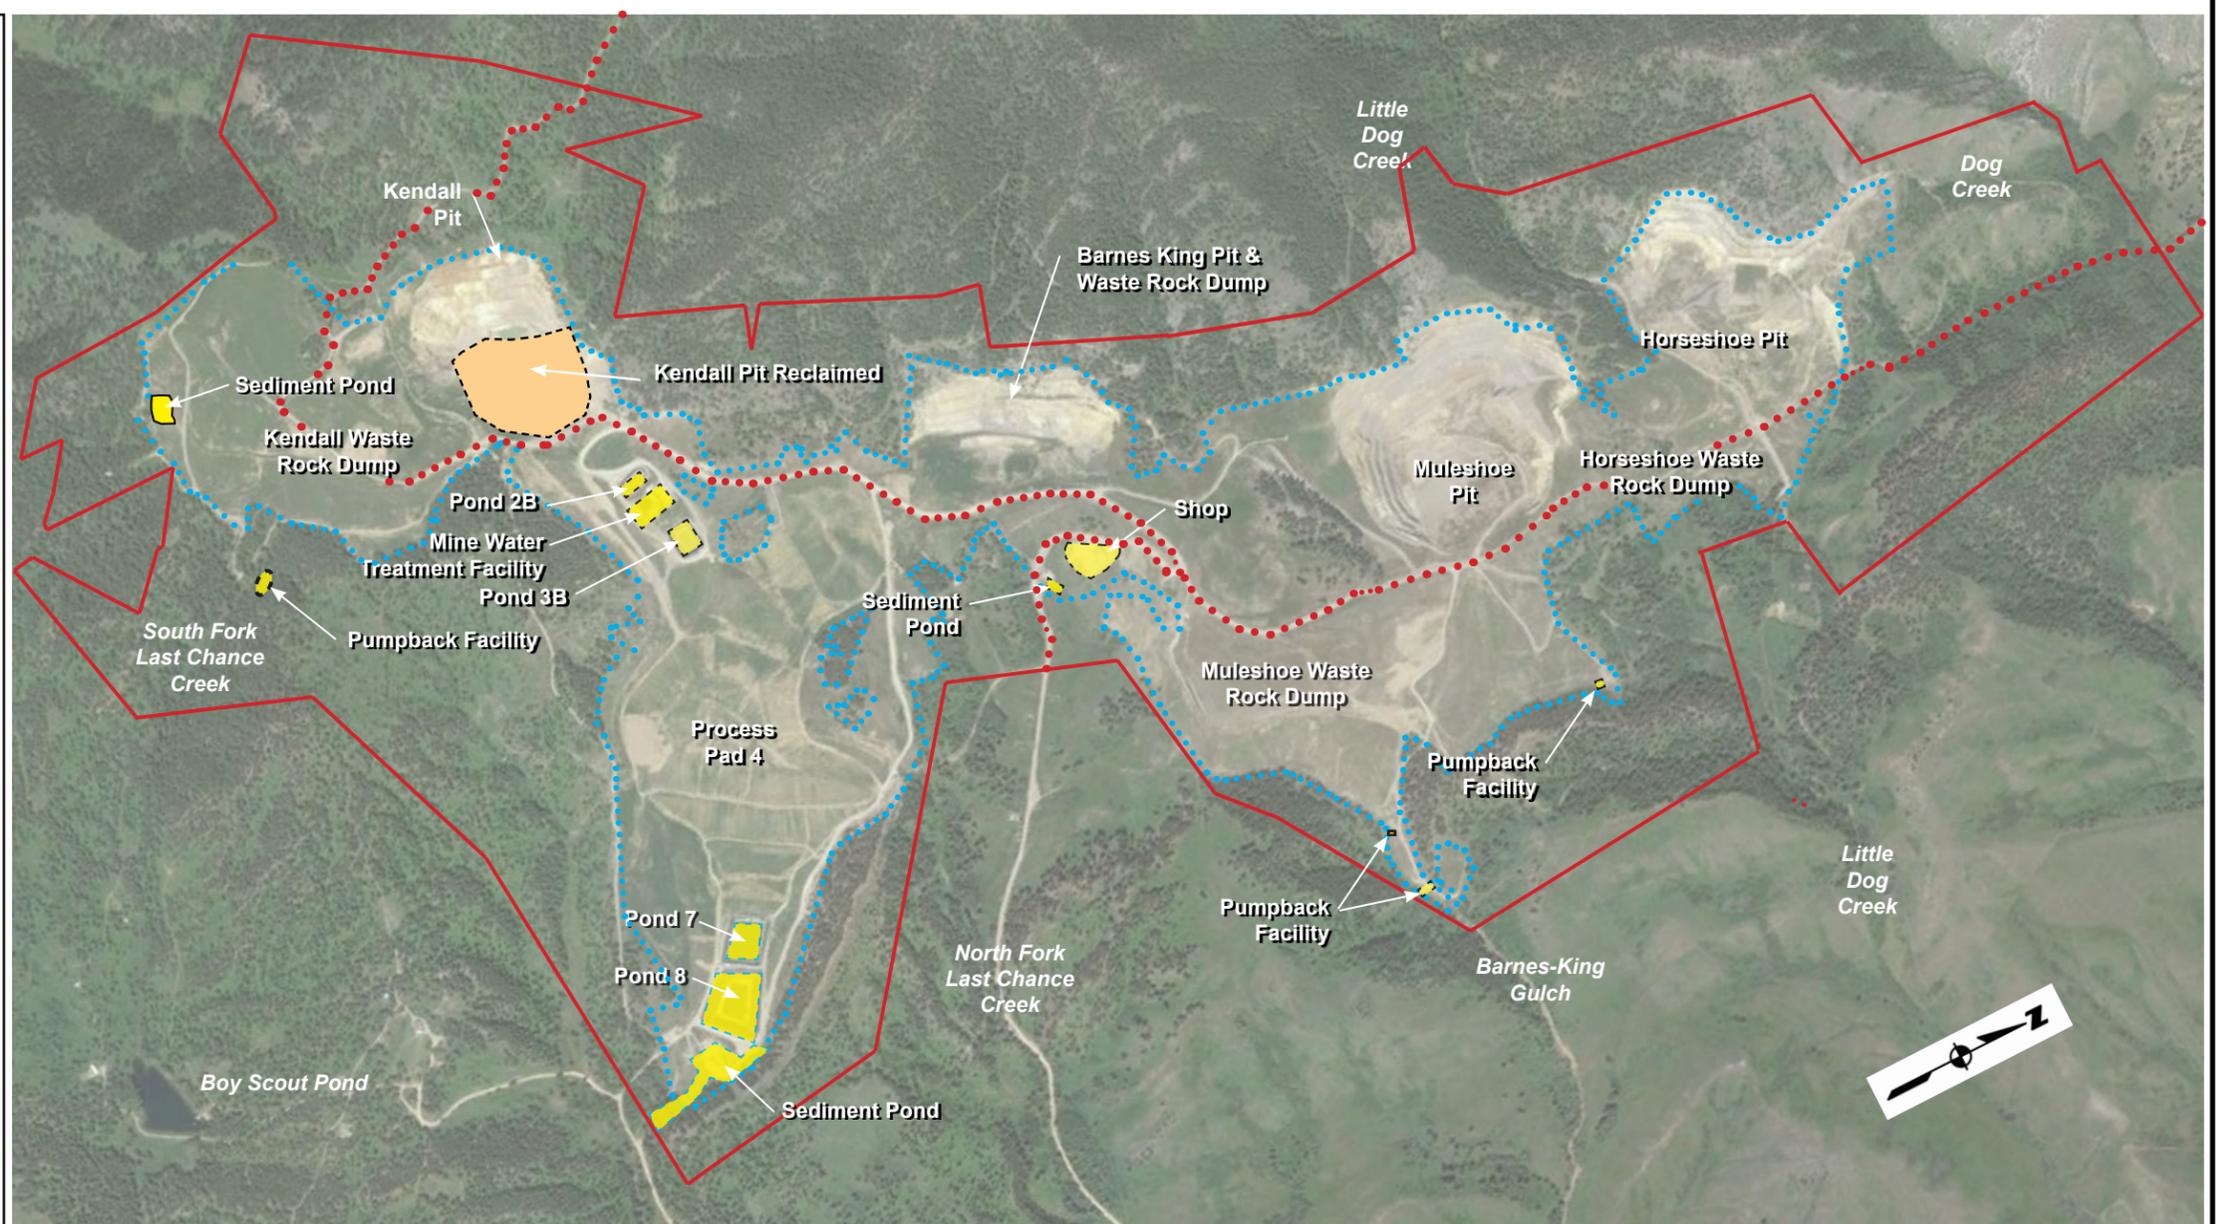
**FIGURE 2-4**  
 CR Kendall Mine  
 Proposed Action

Alternative Component	Proposed Action
<b>Water</b>	
Process Pad Drainage Water	Process pad drainage water would be captured, combined with other mine waters, filtered to remove particulate, treated by zeolite adsorption, and discharged to the Kendall Pit. LAD would be retained as contingency disposal during the growing season.
Groundwater Capture and Pumpback Water Treatment	All captured groundwater would be combined with process pad drainage water in Ponds 7 and 8, filtered to remove particulate, and treated with zeolite adsorption before being discharged to groundwater through the Kendall Pit. LAD would be retained as contingency disposal during the growing season. Pumpback and discharge to the Kendall Pit is assumed to continue for 100 years.
Disposal of Spent Zeolites	Place into Pond 7. If zeolite generation is higher than anticipated, could transport off-site for disposal at a Class II or III landfill, or store in a purpose-built, on-site repository. All disposal methods would comply with Montana solid waste regulations.

<b>Reclamation</b>	
Process Pads Reclamation Design	Same as No Action.
Process Pads Underliner	Maintain underliner integrity for drainage water discharge to Ponds 7 and 8.
Kendall and Muleshoe Pits	Same regrading (completed in 2006) in Kendall Pit but no additional soil placed on areas in Kendall or Muleshoe Pits.
Facilities	Most buildings will remain after closure for private use. After water treatment is no longer required, all ponds will be backfilled or graded to drain and the areas covered with soil and reseeded.
Roads	All roads retained until no longer needed for access for water treatment. After water treatment is no longer needed, all roads reclaimed except BLM right of way.

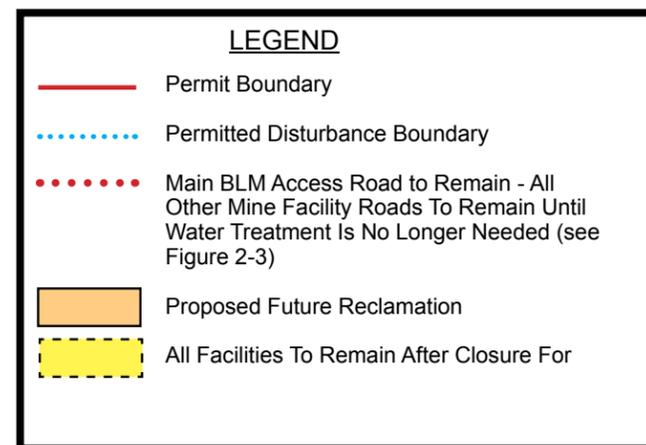
The Proposed Action consists of the Amended Closure Water Management Plan in CR Kendall's application to amend its operating permit (Hydrometrics & CR Kendall Corp., 2012). It primarily addresses the long-term water treatment of the process pad drainage and captured groundwater. The alternative would retain the installed vegetated soil cover authorized under Minor Revision 11-001 and outlines reclamation monitoring and maintenance activities. The main features of the Proposed Action are shown on **Figure 2-4**. The specific items different from the No Action Alternative are:

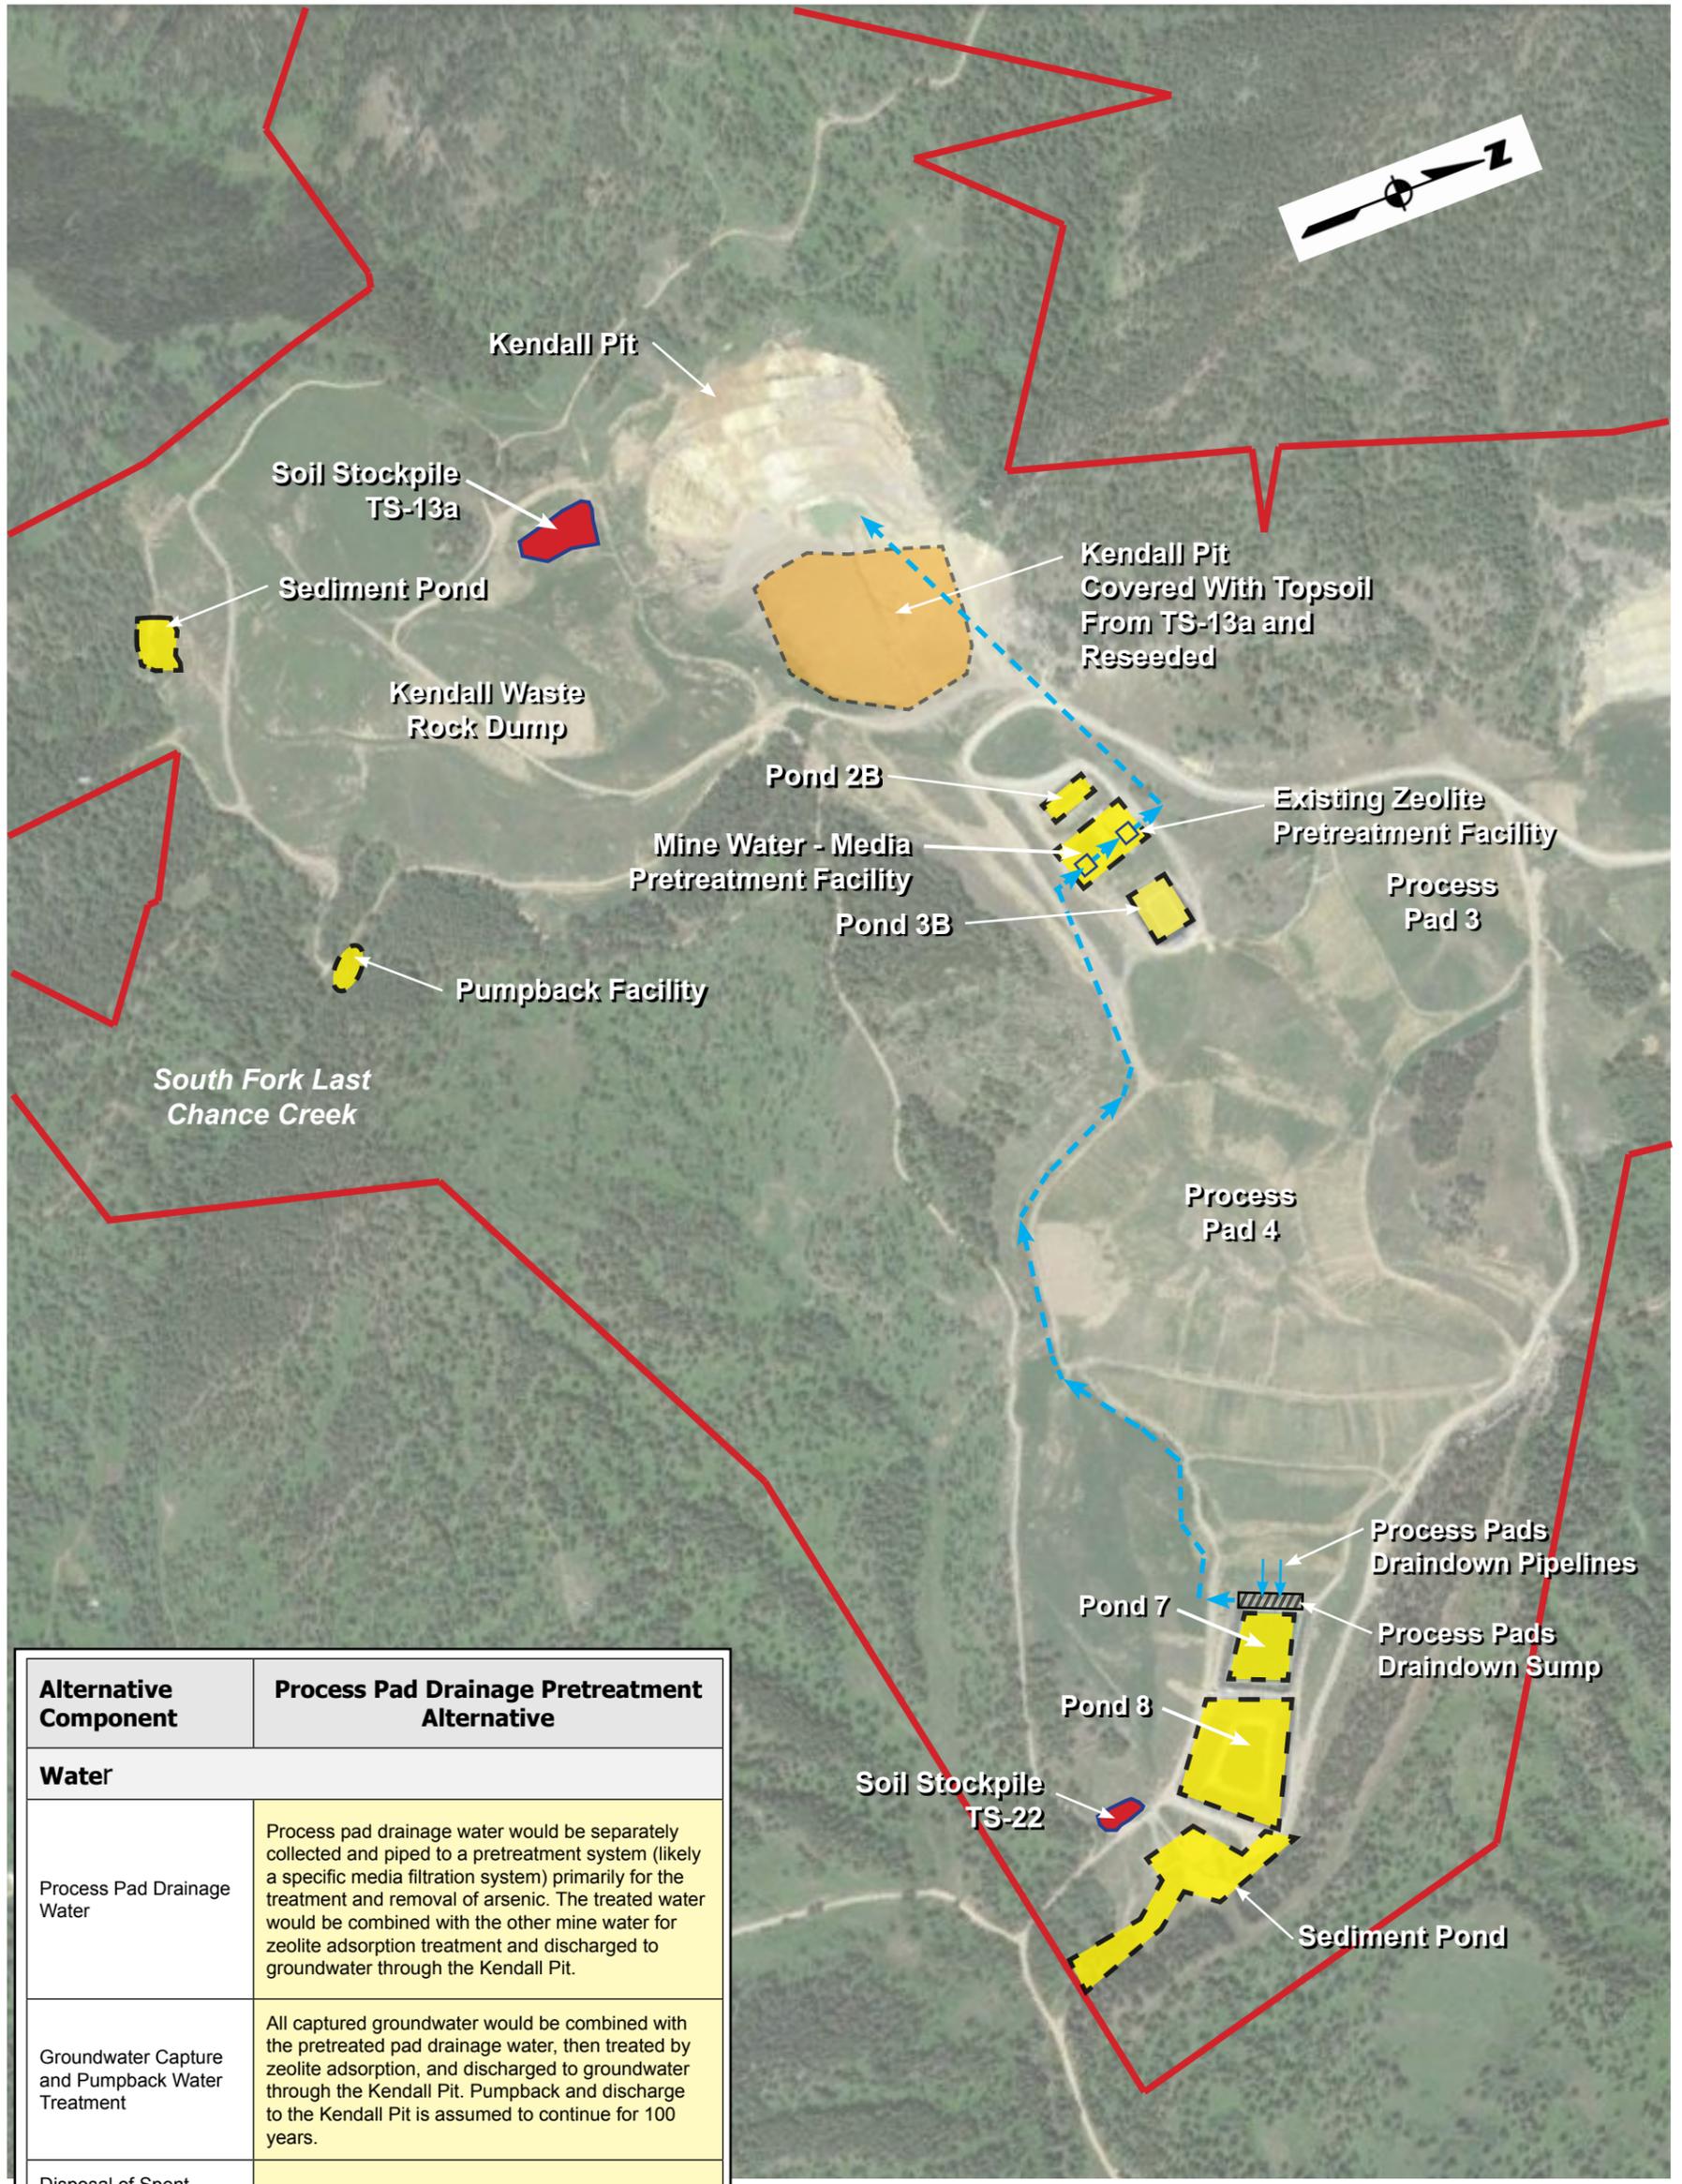
**Process Pad Drainage Pretreatment** – A separate piping system would collect the drainage water from process pads 3 and 4 for pretreatment prior to blending the drainage water with other mine waters. Arsenic is one of the contaminants in the process pad drainage water, and is projected to exceed groundwater standards even after waters are combined. The pretreatment system could remove other contaminant constituents, if necessary to comply with discharge criteria. A conceptual diagram and flow chart of a possible pretreatment method for the process pad drainage water is on **Figure 2-5**.

Alternative Component	Process Pad Drainage Pretreatment Alternative
<b>Water</b>	
Process Pad Drainage Water	Process pad drainage water would be separately collected and piped to a pretreatment system (likely a specific media filtration system) primarily for the treatment and removal of arsenic. The treated water would be combined with the other mine water for zeolite adsorption treatment and discharged to groundwater through the Kendall Pit.
Groundwater Capture and Pumpback Water Treatment	All captured groundwater would be combined with the pretreated pad drainage water, then treated by zeolite adsorption, and discharged to groundwater through the Kendall Pit. Pumpback and discharge to the Kendall Pit is assumed to continue for 100 years.
Disposal of Spent Zeolites	Same as Proposed Action.
<b>Reclamation</b>	
Process Pads Reclamation Design	Same as No Action.
Process Pads Underliner	Same as Proposed Action.

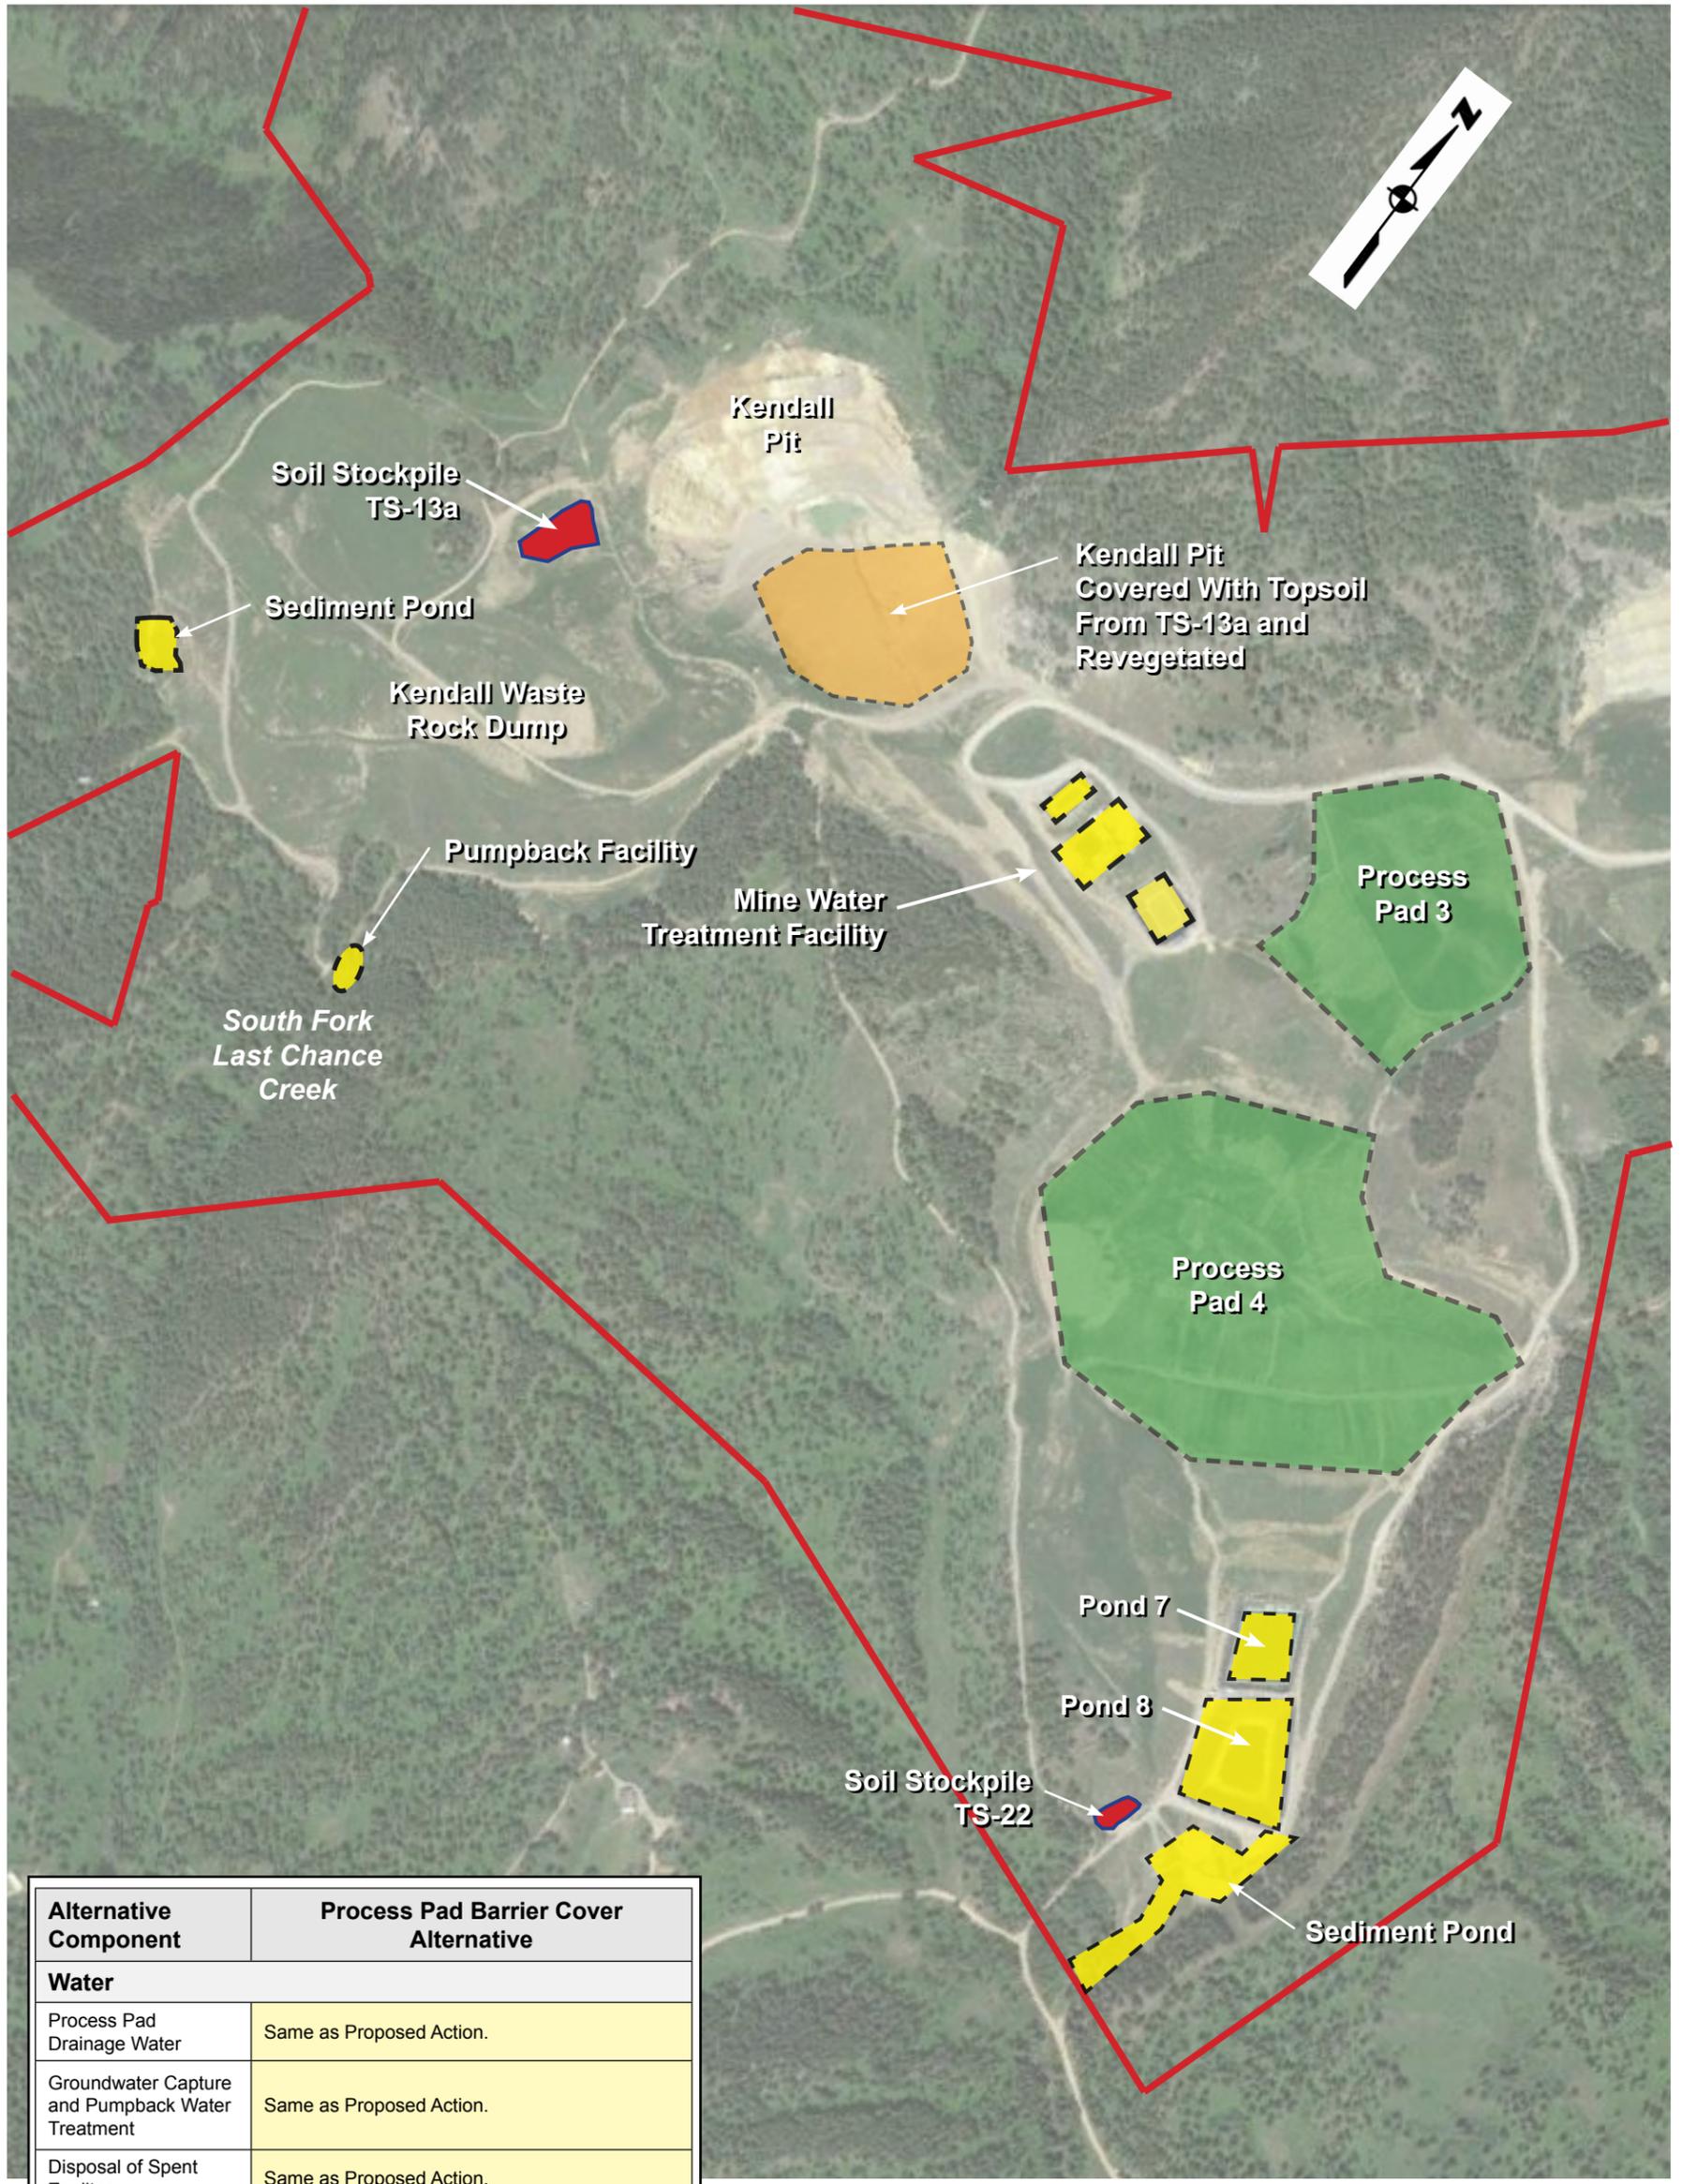
**FIGURE 2-6**  
 CR Kendall Mine  
 Process Pads Barrier Cover Alternative  
 (Mine Facilities, Permitted Disturbance Boundary, and Permit Boundary)

Alternative Component	Process Pad Barrier Cover Alternative
<b>Water</b>	
Process Pad Drainage Water	Same as Proposed Action.
Groundwater Capture and Pumpback Water Treatment	Same as Proposed Action.
Disposal of Spent Zeolites	Same as Proposed Action.
<b>Reclamation</b>	
Process Pads Reclamation Design	Remove the upper 17 inches of growth media and vegetation from process pads 3 and 4 and install barrier cap (liner with drainage net). Replace the growth media on top of liner and revegetate.
Process Pads Underliner	Same as Proposed Action.
Kendall and Muleshoe Pits	Same as Process Pad Drainage Pretreatment.
Facilities	Same as Proposed Action.
Roads	Same as Proposed Action

**Process Pad Reclamation Design** - CR Kendall would remove the upper 17 inches of growth media (soil) and vegetation from process pads 3 and 4. A barrier cover cap, consisting of a textured HDPE liner and geocomposite drainage net, would be installed on top of the existing 6 inches of subsoil basal layer material amended with 5 to 8 percent sodium bentonite, over 12 inches of subsoil basal layer material. The approximate 17 inches of growth media would then be replaced on the geomembrane liner and the area reseeded with an approved reclamation grass mixture. A textured PVC or HDPE material would be needed to reduce slipping and movement of the soil on the barrier cover cap.

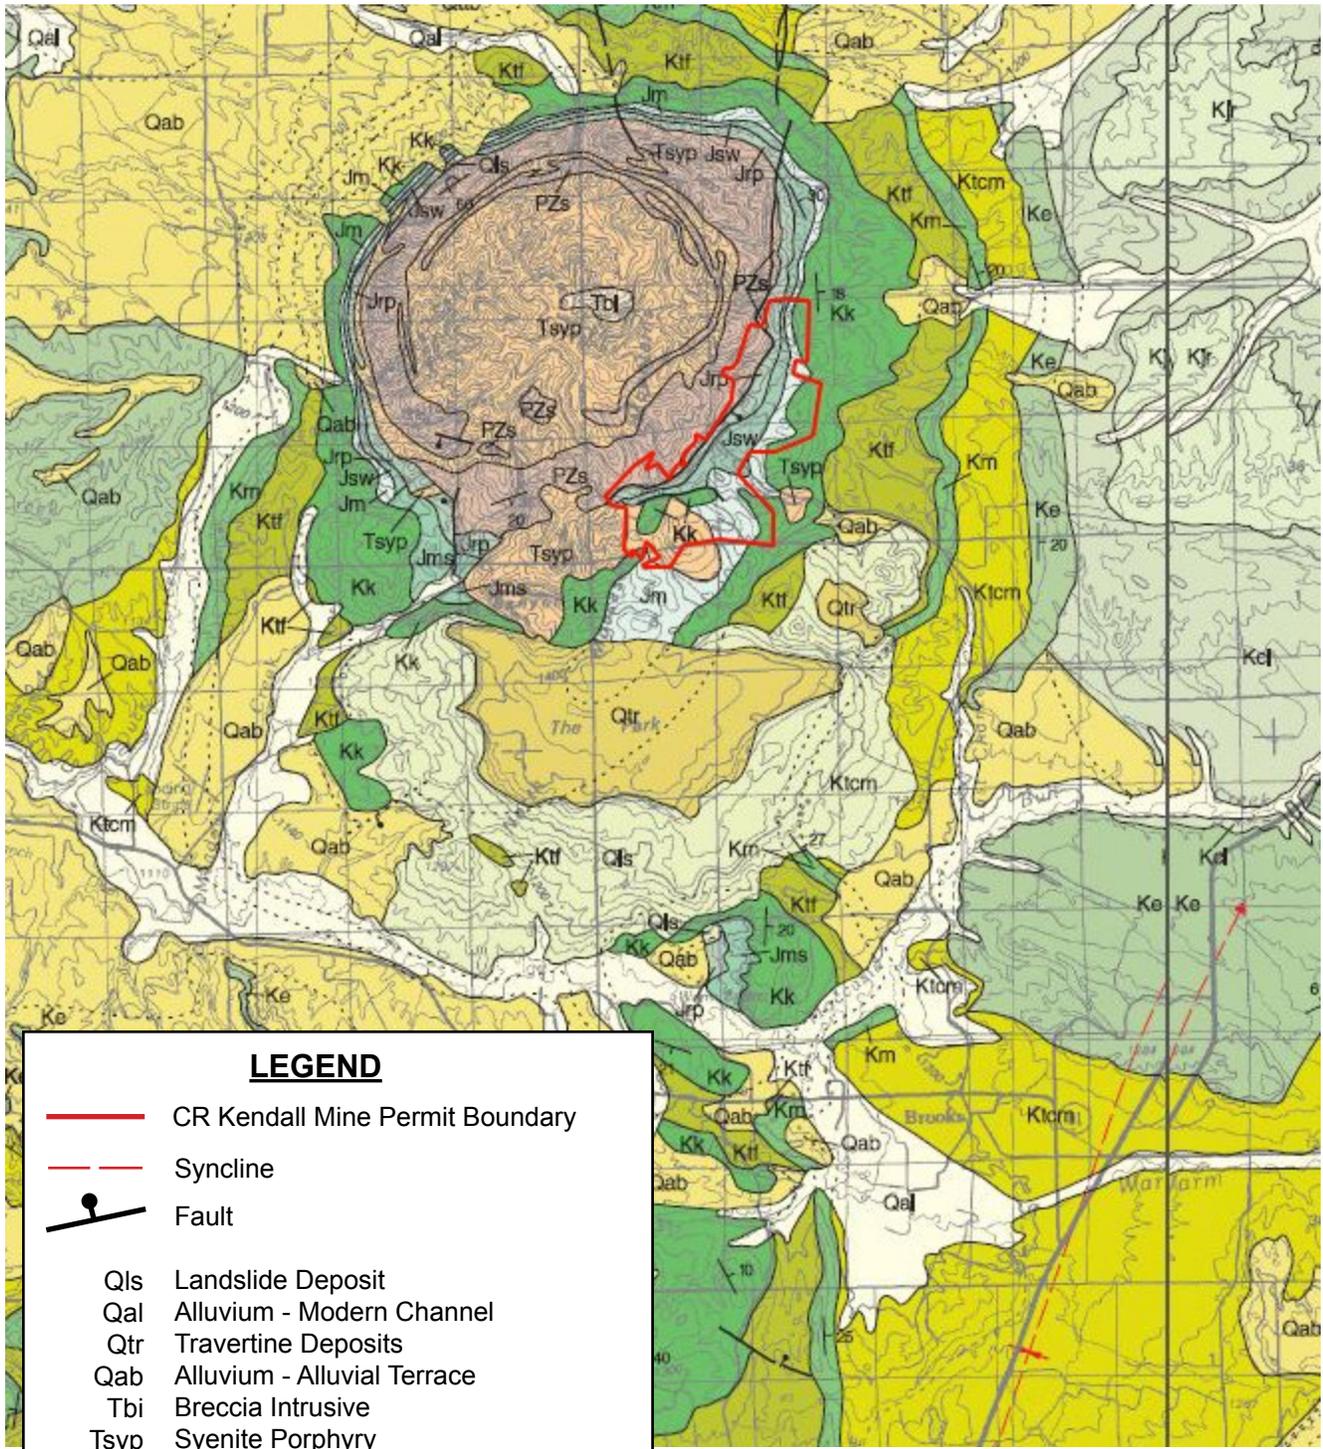
The geology and mineral deposits of the North and South Moccasin Mountains were evaluated by Lindsey (1982) who describes the area as dominated by Tertiary laccolith intrusions of syenite and quartz monzonite porphyry mantled by older Paleozoic and Mesozoic sedimentary rocks. The Paleozoic and Mesozoic formations are steeply dipping on the flanks of the intrusions with dip angles decreasing away from the mountains. Mineralization at the CR Kendall Mine on the eastern flank of the North Moccasin Mountains was initially exploited in the late 1800s. The primary ore zone was an oxidized and silicified limestone breccia at the top of the Madison Limestone Group emplaced along a north-south trending normal fault (hanging wall on the east). The regional geology map with the boundary of the CR Kendall Mine is provided in **Figure 3-1**.

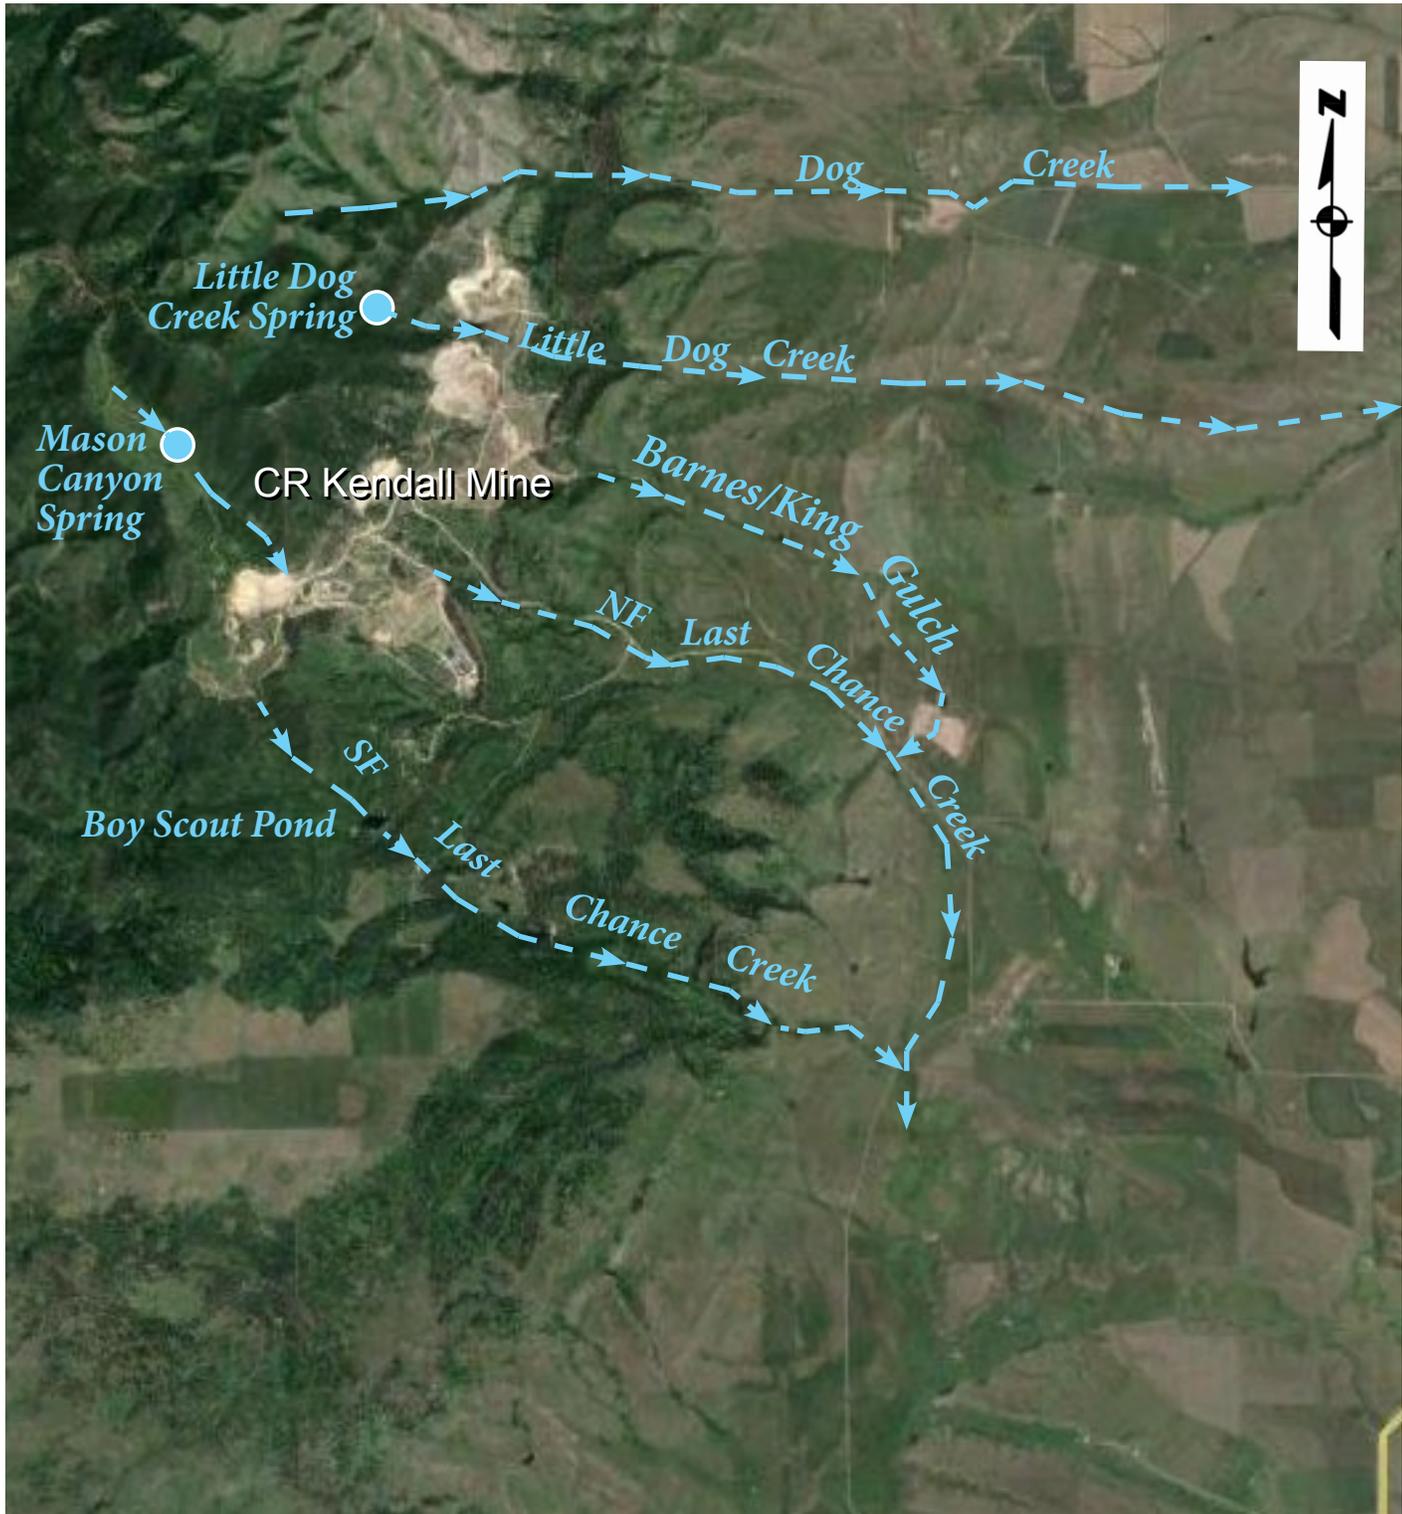
**FIGURE 3-2**  
CR Kendall Mine  
Regional Water Features Map

The analysis area for all surface water and groundwater resources and water treatment is the eastern side of the North Moccasin Mountains, including all upgradient and downgradient drainages that flow across or near the CR Kendall Mine permitted mine boundary. **Figure 3-2** shows these major drainages in relationship to the mine.

There are six surface drainage systems in the mine permit area that generally trend east to southeast (**Figures 3-2 and 3-3**). These drainages, from south to north, are:
