# **CR Kendall Mine Closure**

# **Environmental Impact Statement**

**September 2015**

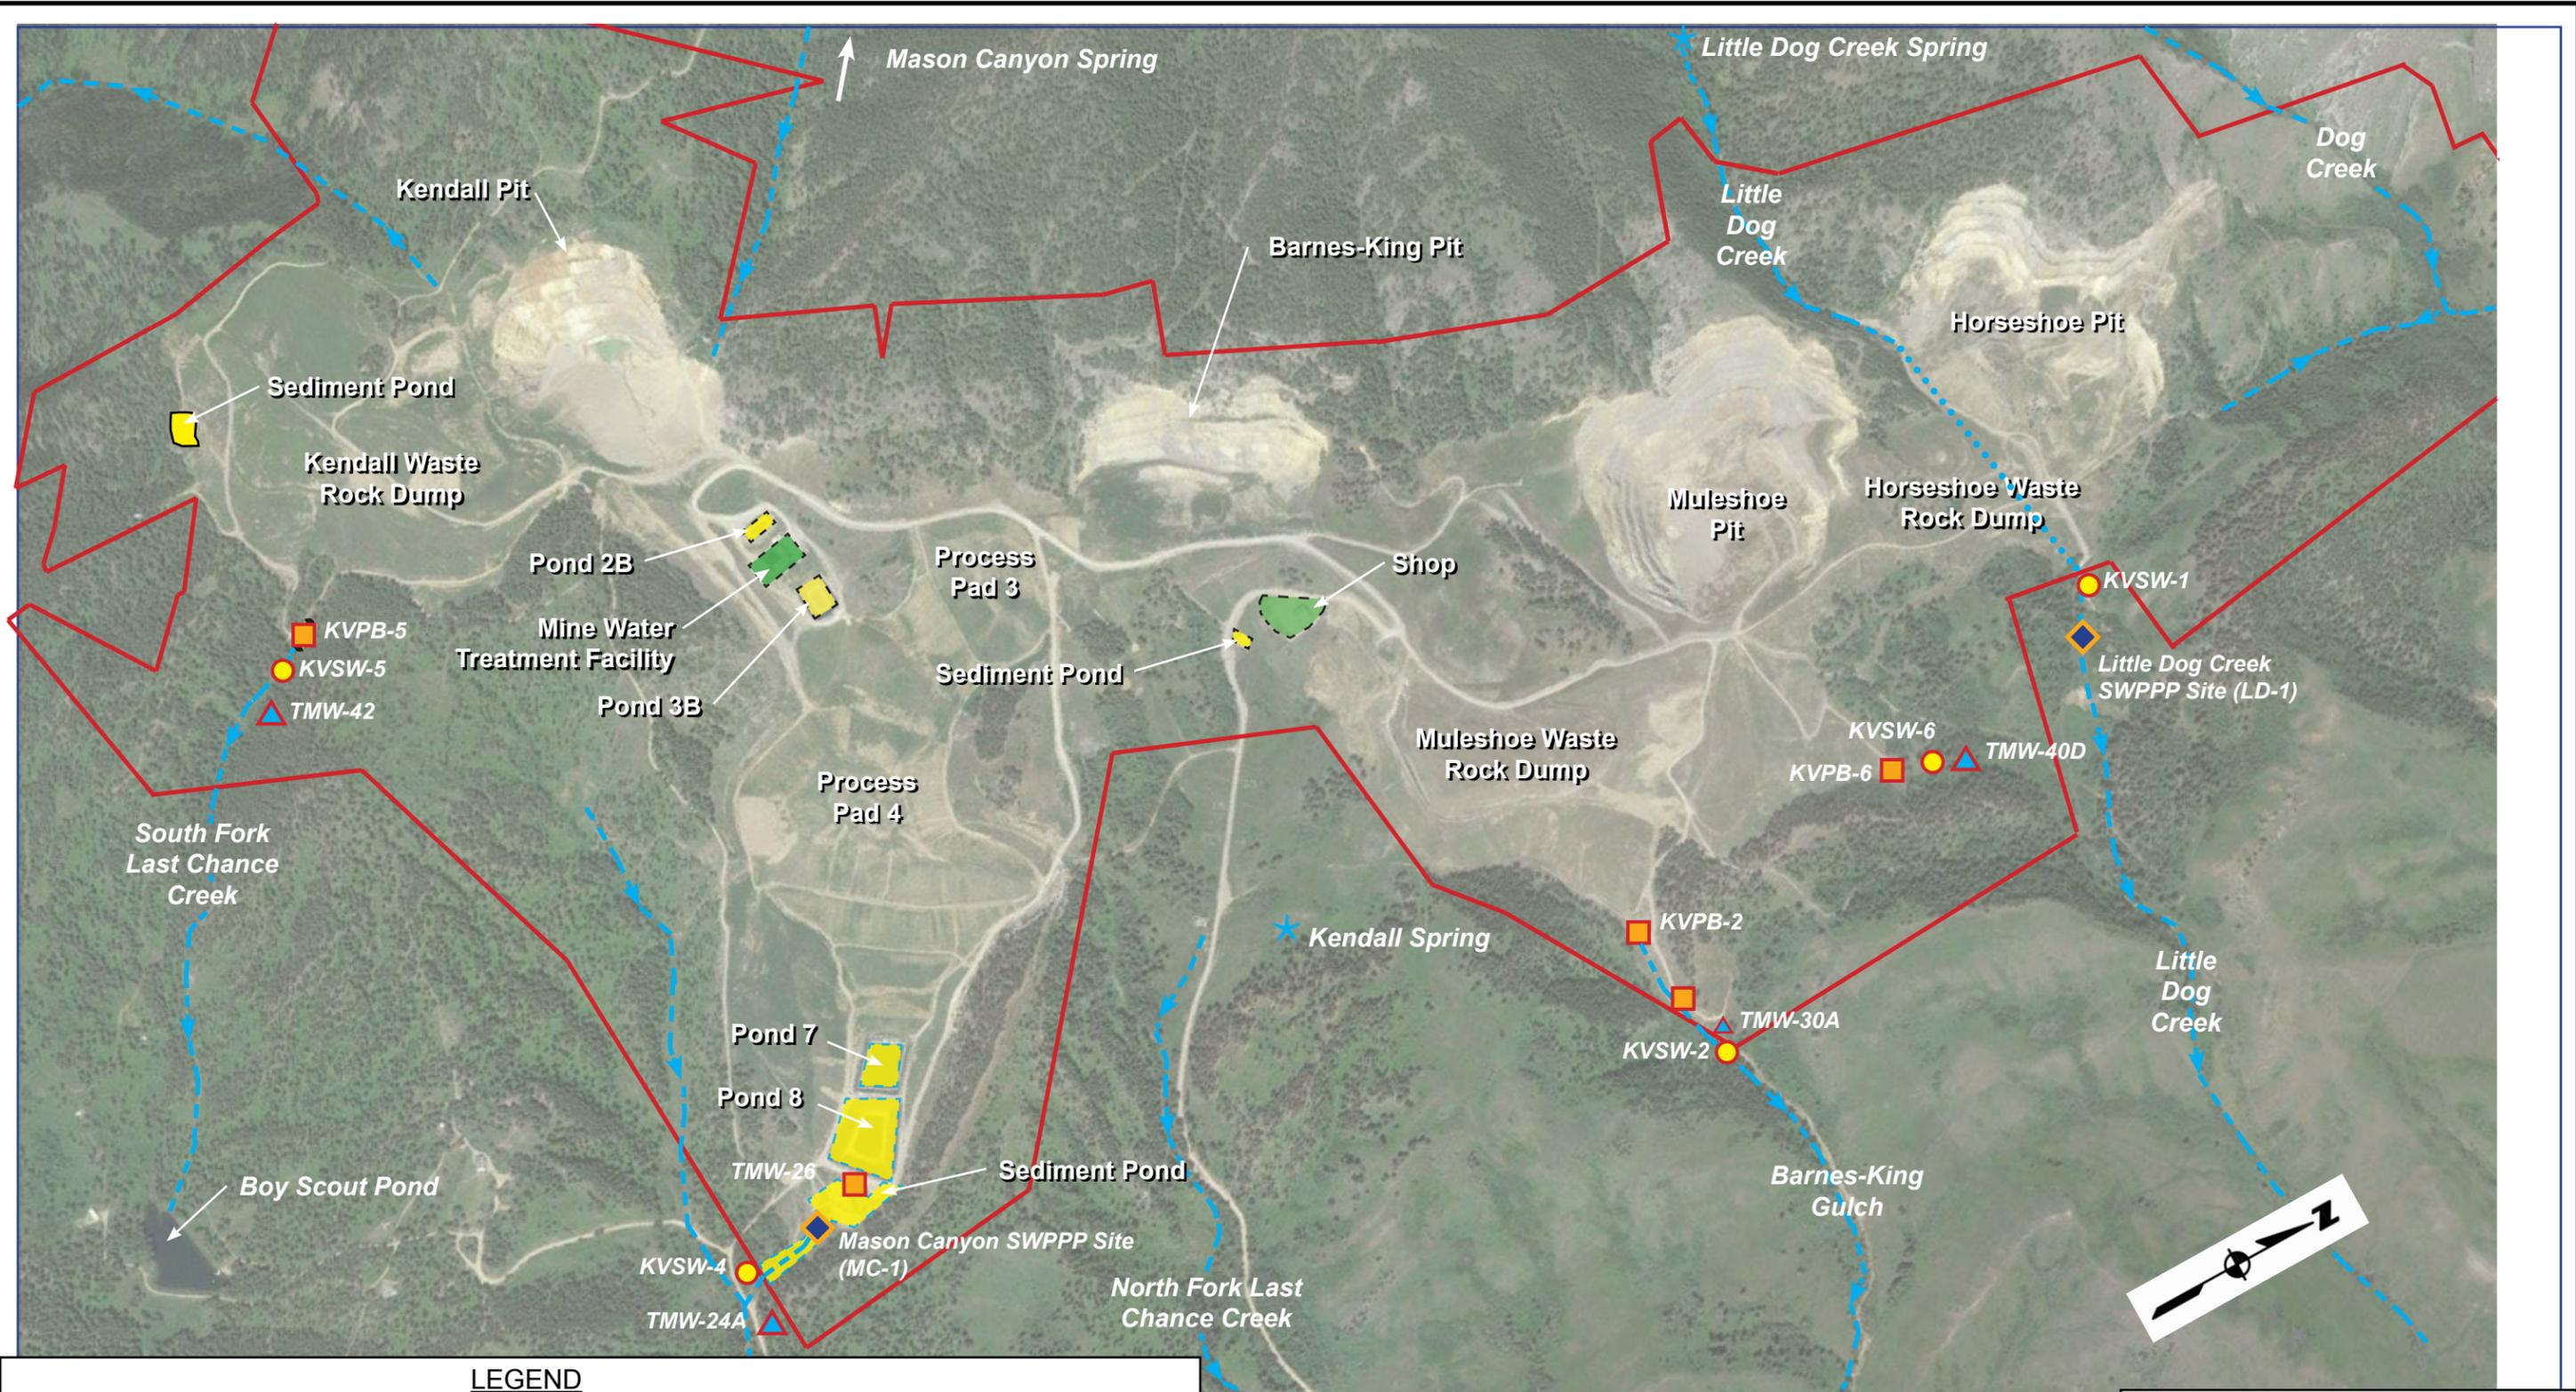
Surface water monitoring began in 1990-91 at four stations in the mine permit area (KVSU-1 through KVSU-4) (**Figure 3-3**). Three additional sites (KVSU-5 through KVSU-7) were added in 1994. Instantaneous flow measurements collected between 1990 and 2014 are summarized in **Table 3-2** (CR Kendall, 2015b). In general, the maximum flow occurred in the wetter spring months, followed by declining flows over the summer. Little or no flow was observed during fall months. All stations exhibited periods of no flow.

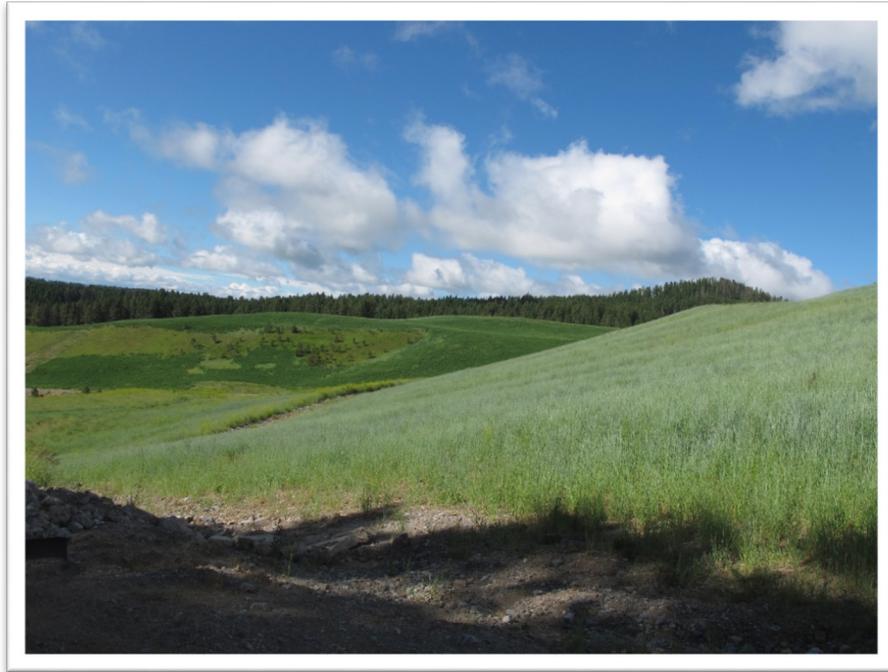
Figure 3-4 Revegetated Plant Communities at the CR Kendall Mine

July 7, 2014 photograph of vegetation on Process Pad 4 (foreground)

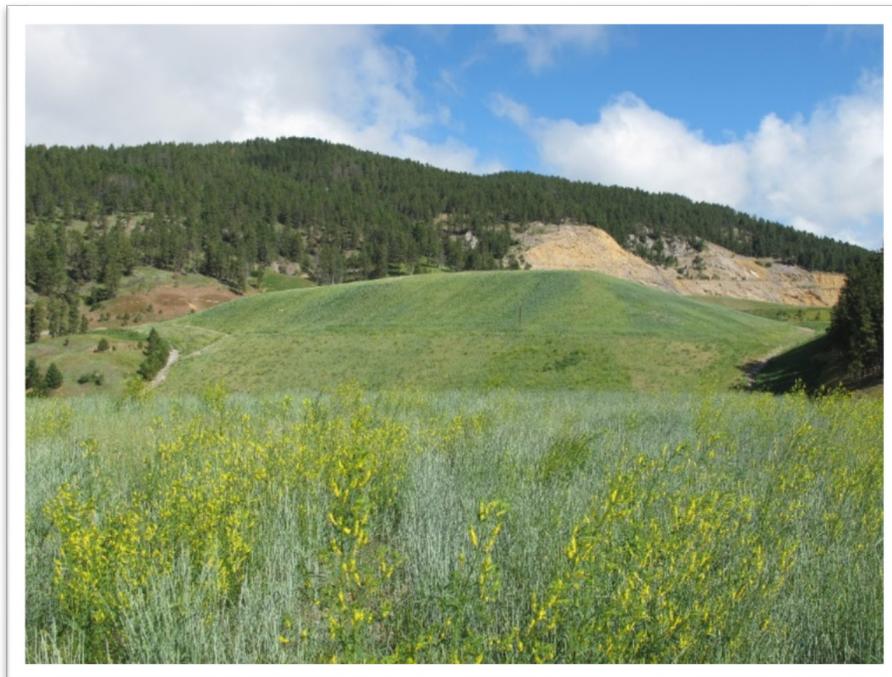
July 7, 2015 photograph of top of Process Pad 4 (foreground) and Process Pad 3 (background) with vegetation on slopes and tops.

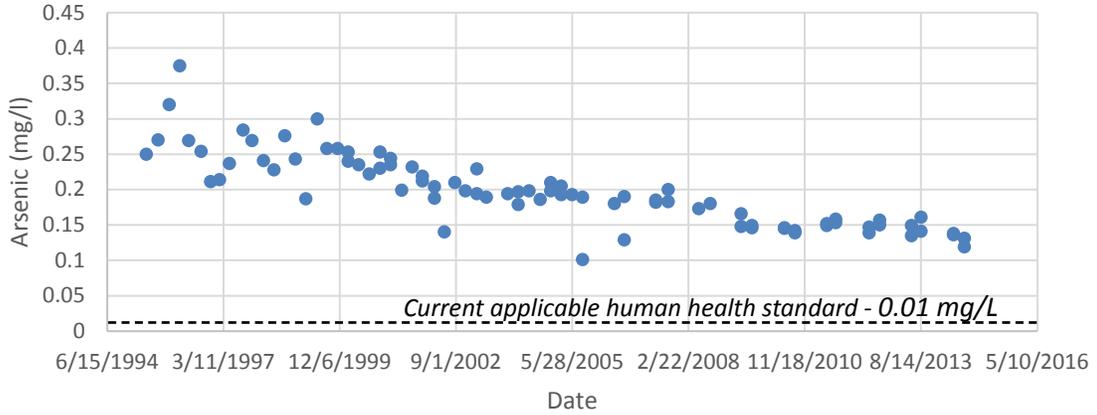
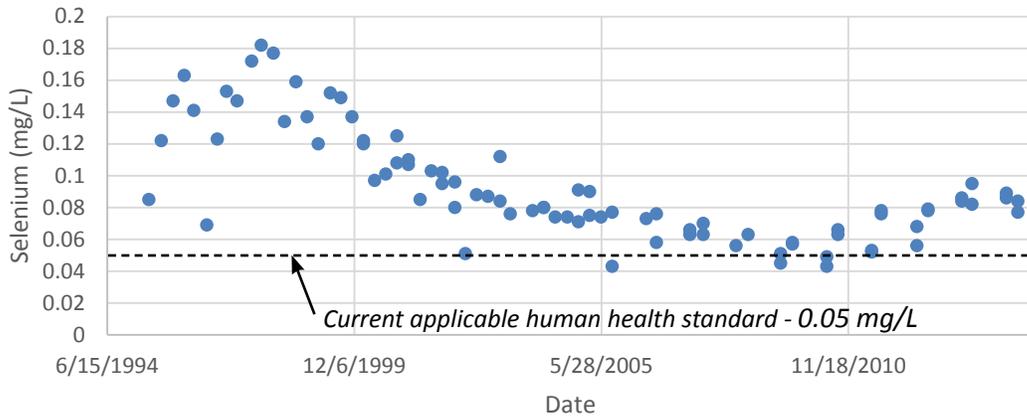
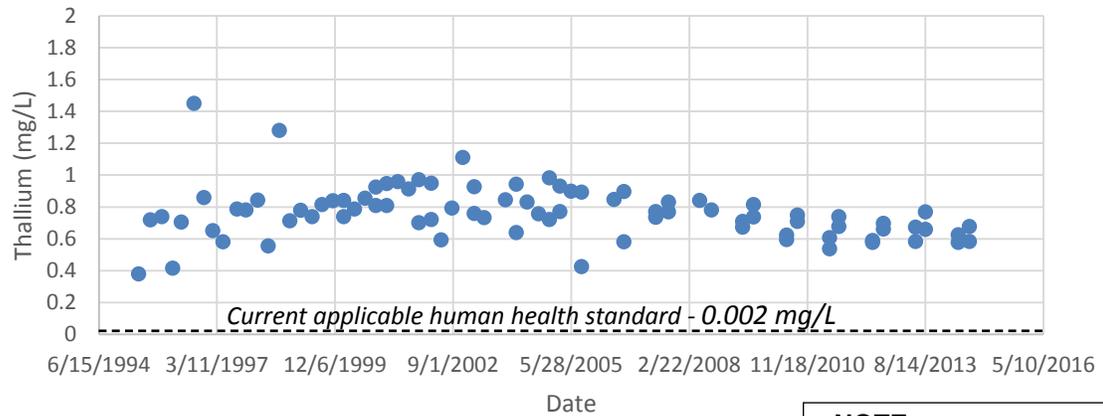
**FIGURE A-1**  
CR Kendall Mine  
Arsenic, Selenium, and Thallium Levels in  
Process Pad Drainage

### Arsenic Concentrations in Process Pad Drainage

### Selenium Concentrations in Process Pad Drainage

### Thallium Concentrations in Process Pad Drainage

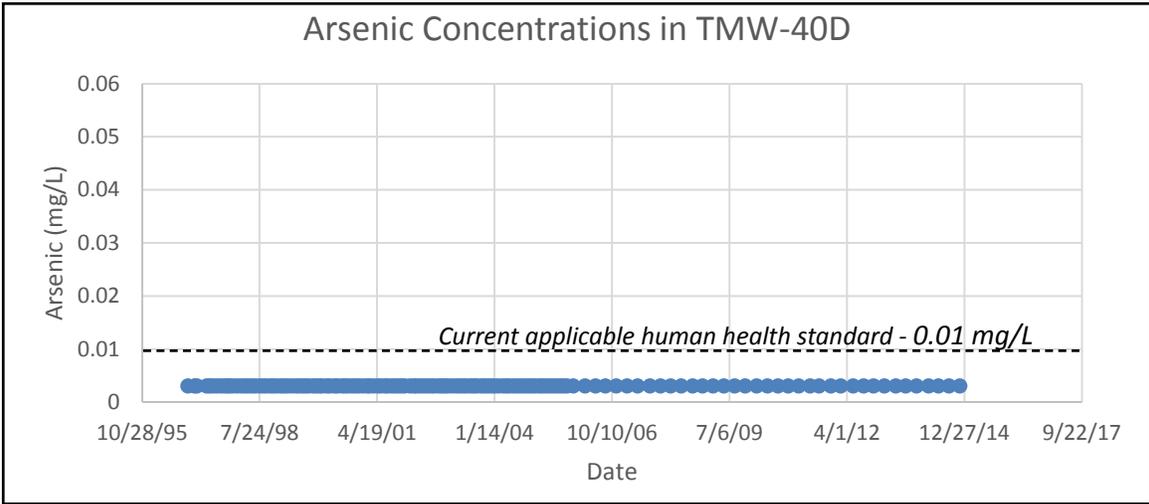
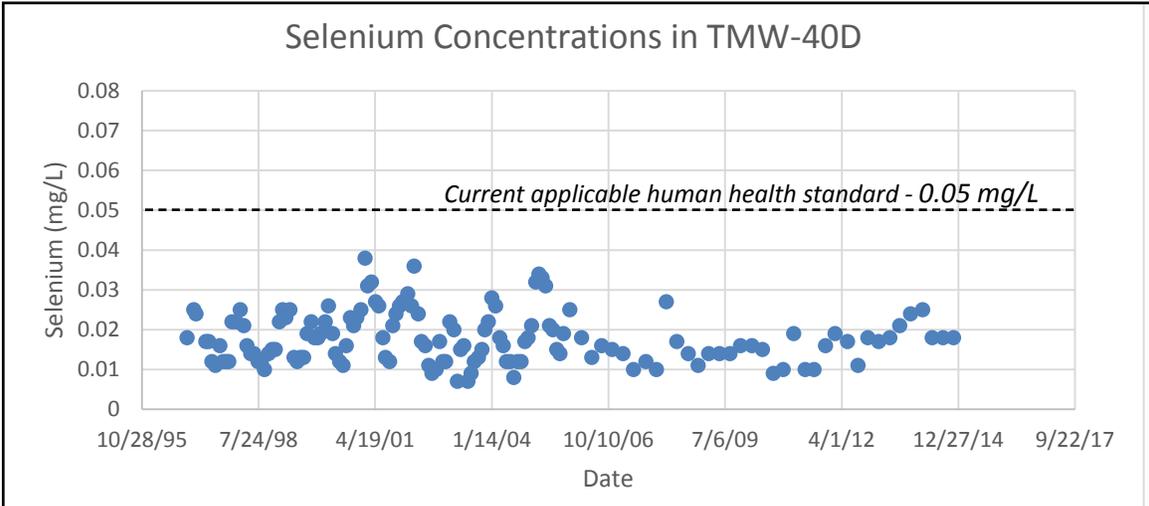
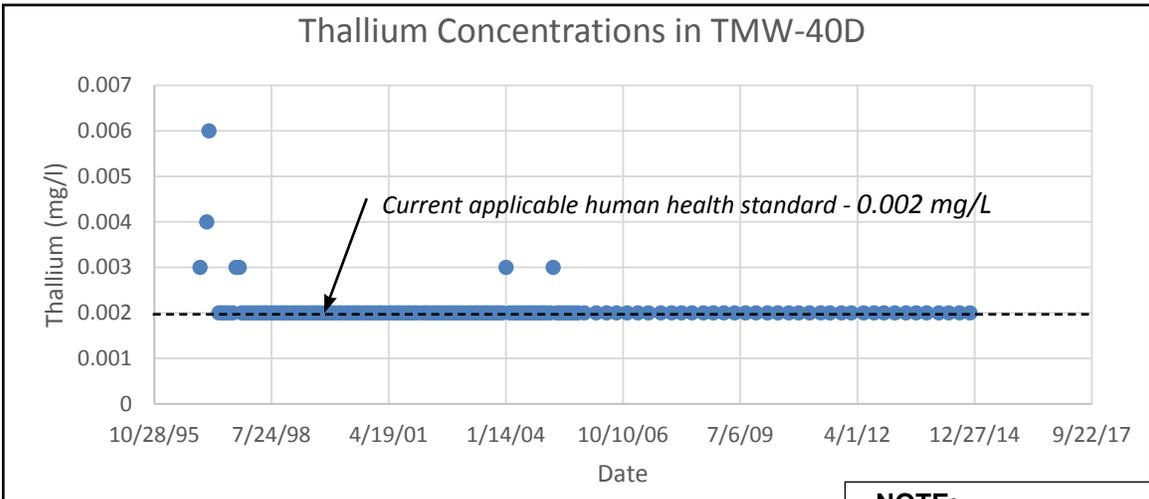
**FIGURE A-8**  
CR Kendall Mine  
Arsenic, Selenium, and Thallium Levels in  
South Fork Little Dog Creek Groundwater  
(TMW-40D)

### Arsenic Concentrations in TMW-40D

### Selenium Concentrations in TMW-40D

### Thallium Concentrations in TMW-40D
