**DRAFT FINAL
PHASE I PRE-DESIGN INVESTIGATION
EVALUATION REPORT**

**BLACKTAIL CREEK RIPARIAN ACTIONS
BUTTE PRIORITY SOILS OPERABLE UNIT OF THE
SILVER BOW CREEK/BUTTE AREA SUPERFUND SITE
SILVER BOW COUNTY, MONTANA**

Project: Blacktail Creek Riparian Action
Remedial Design and Pre-Investigation
Task Order Number: 04

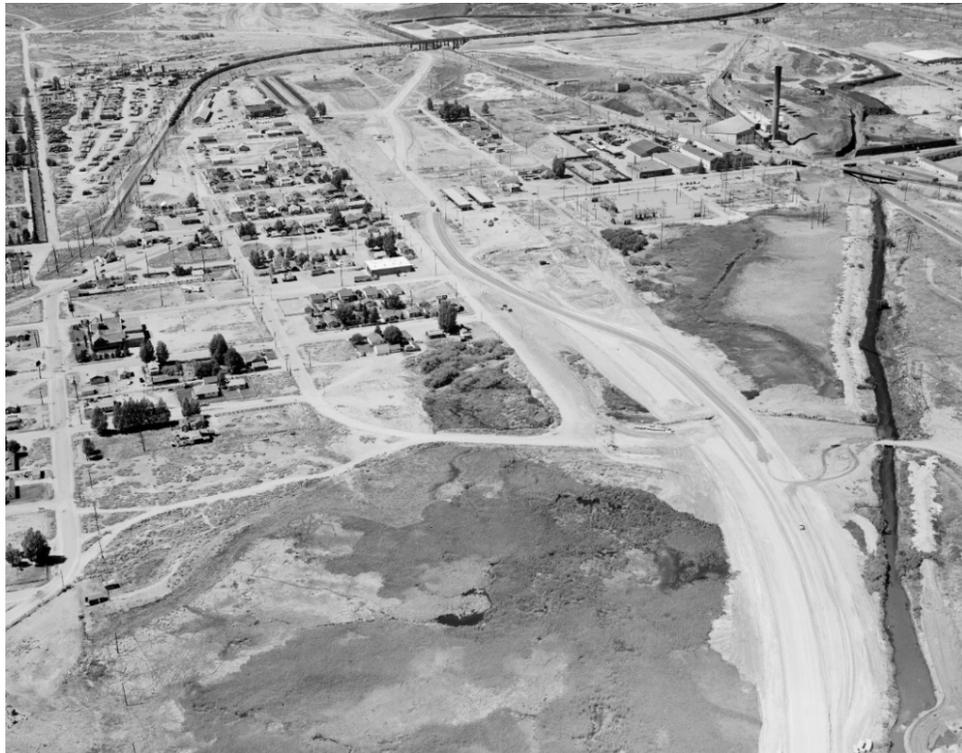
An aerial photograph from 1962 shows the location of the tailing impoundment in the project area during construction of Interstate 15/90 through Butte.

Photograph 1 – 1962 Aerial Image Showing the BTC site
