KRY SITE
 KALISPELL, MONTANA

FIGURE 3-1
 APPROXIMATE EXTENT OF GROUNDWATER
 EXCEEDING CLEANUP LEVELS

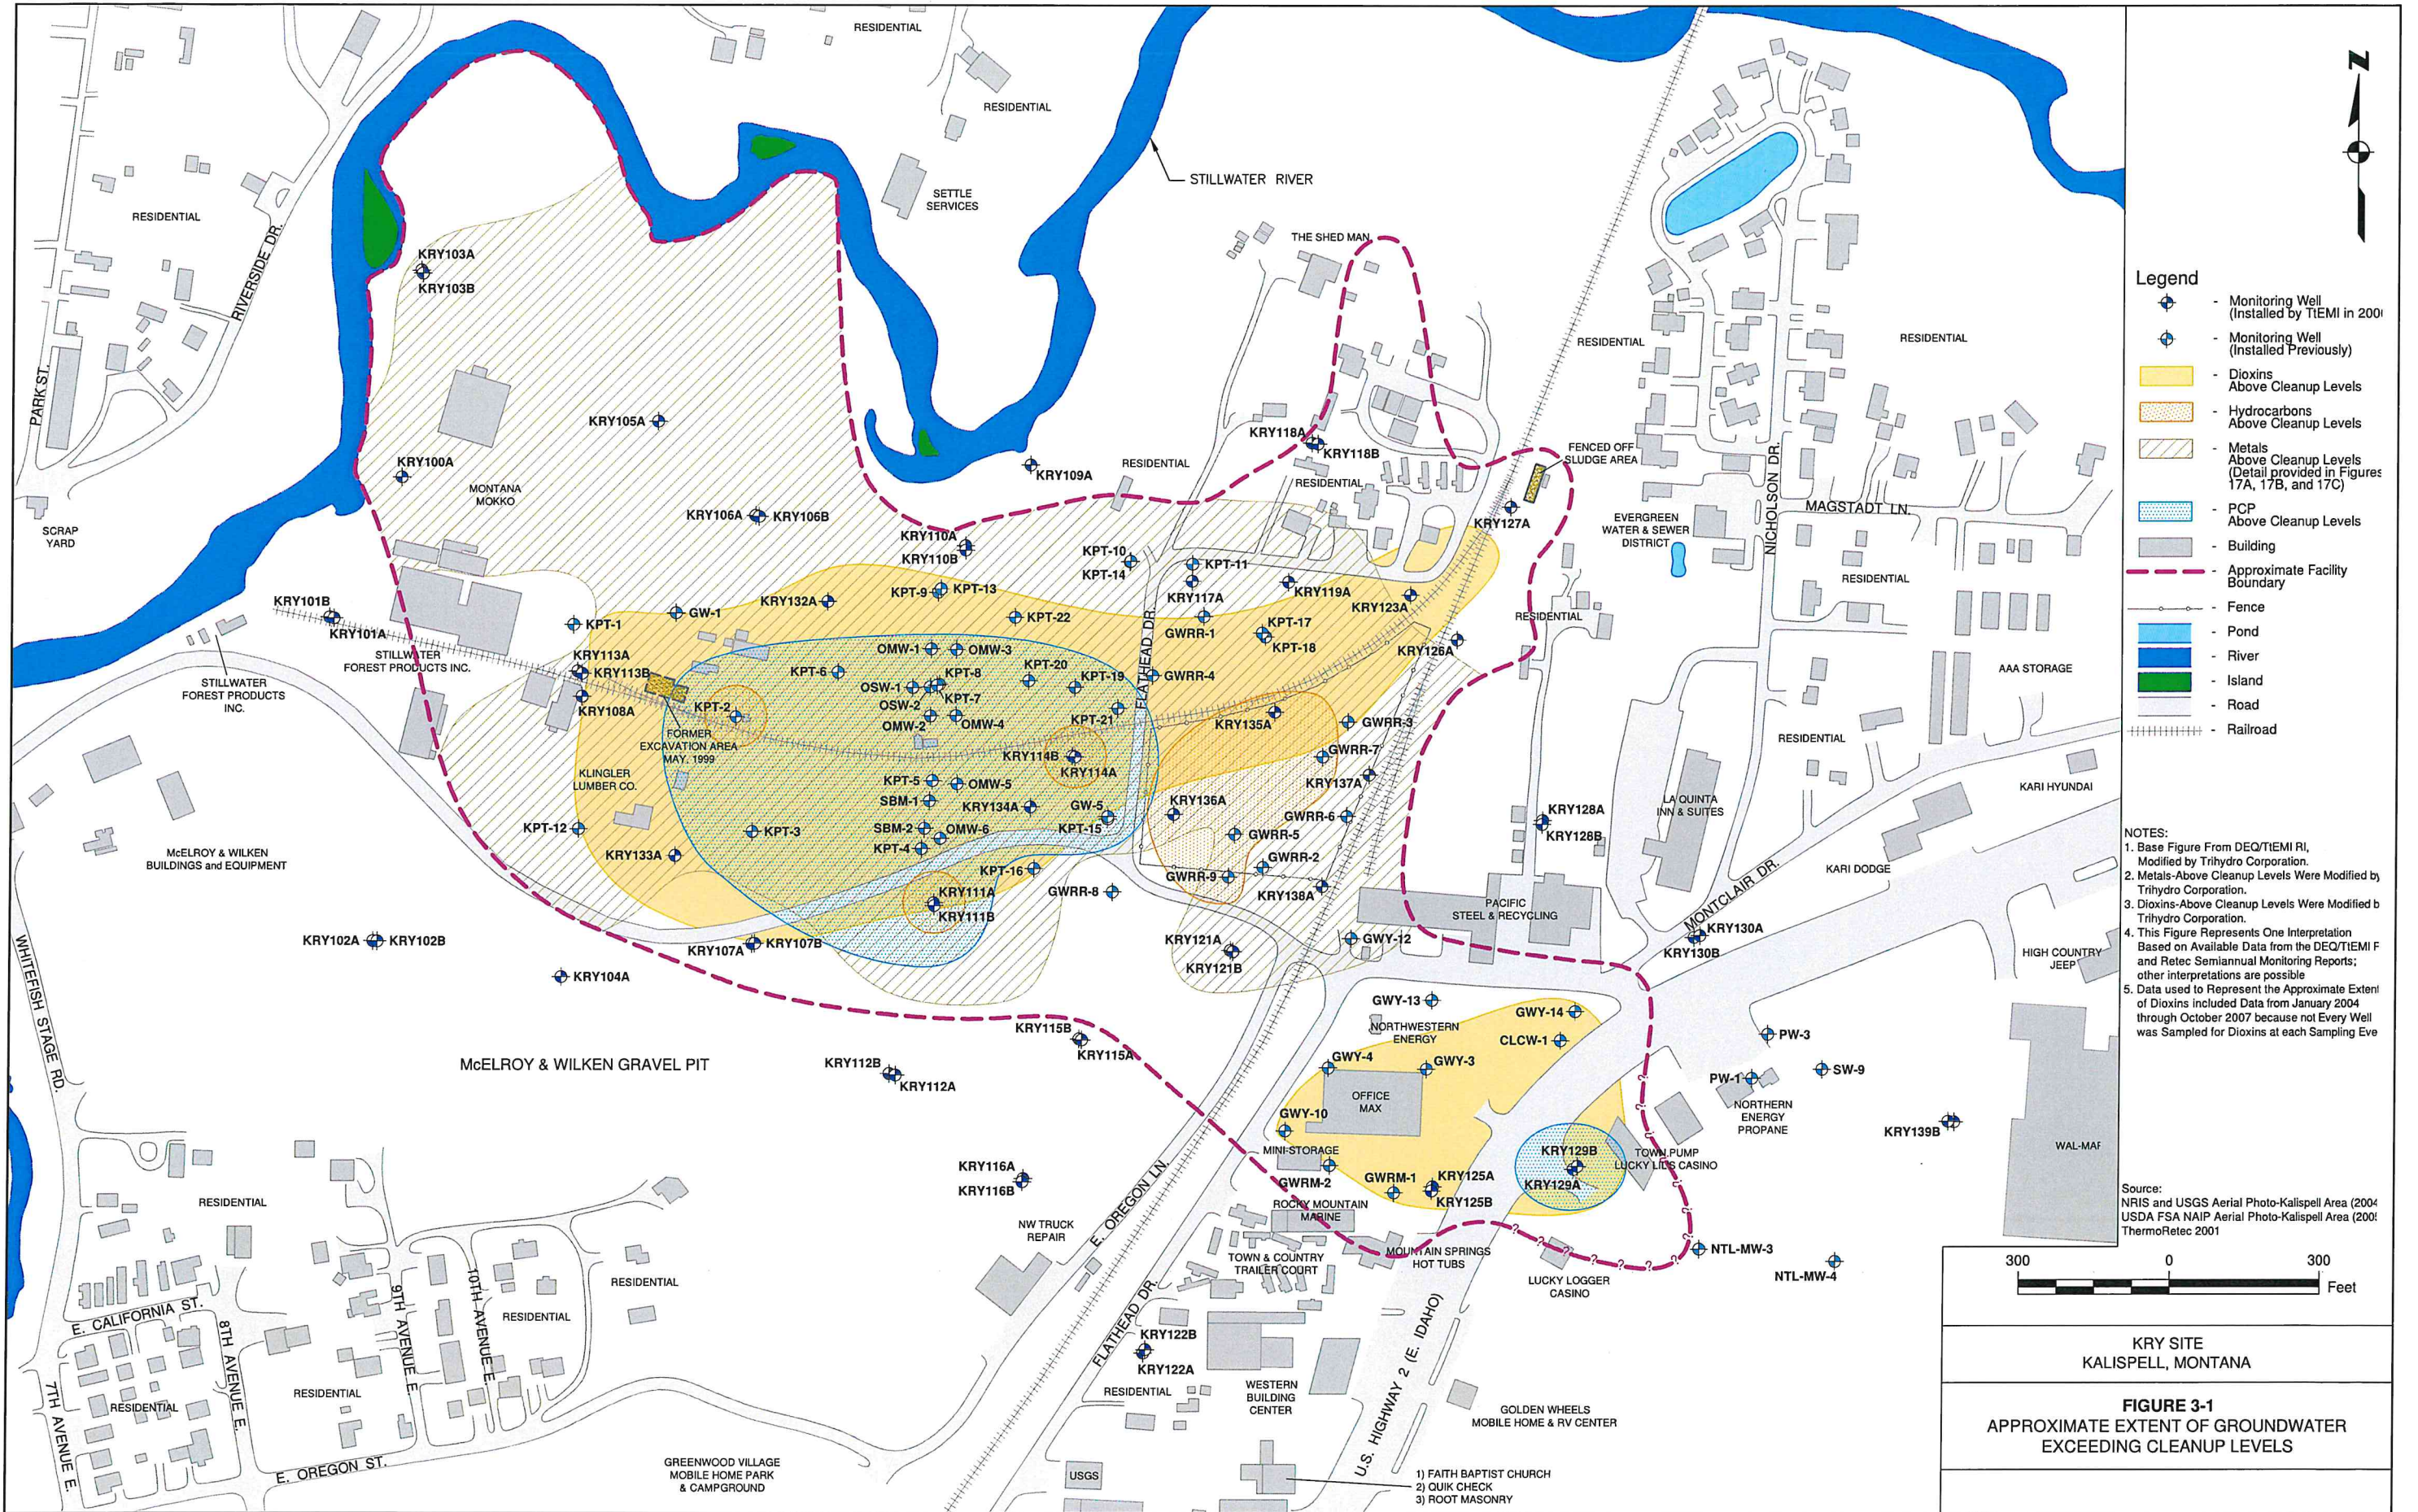
1. Base Figure From DEQ/TIEMI RI, Modified by Trihydro Corporation.
2. Metals-Above Cleanup Levels Were Modified by Trihydro Corporation.
3. Dioxins-Above Cleanup Levels Were Modified by Trihydro Corporation.
4. This Figure Represents One Interpretation Based on Available Data from the DEQ/TIEMI F and Retec Semiannual Monitoring Reports; other interpretations are possible.
5. Data used to Represent the Approximate Extent of Dioxins included Data from January 2004 through October 2007 because not Every Well was Sampled for Dioxins at each Sampling Event.
