**WATER QUALITY MANAGEMENT PLAN &
TMDLs
FOR THE
TETON RIVER WATERSHED**

**FINAL
September 2003**

EXECUTIVE SUMMARY: WATER QUALITY MANAGEMENT PLAN & TMDLS FOR THE TETON RIVER WATERSHED

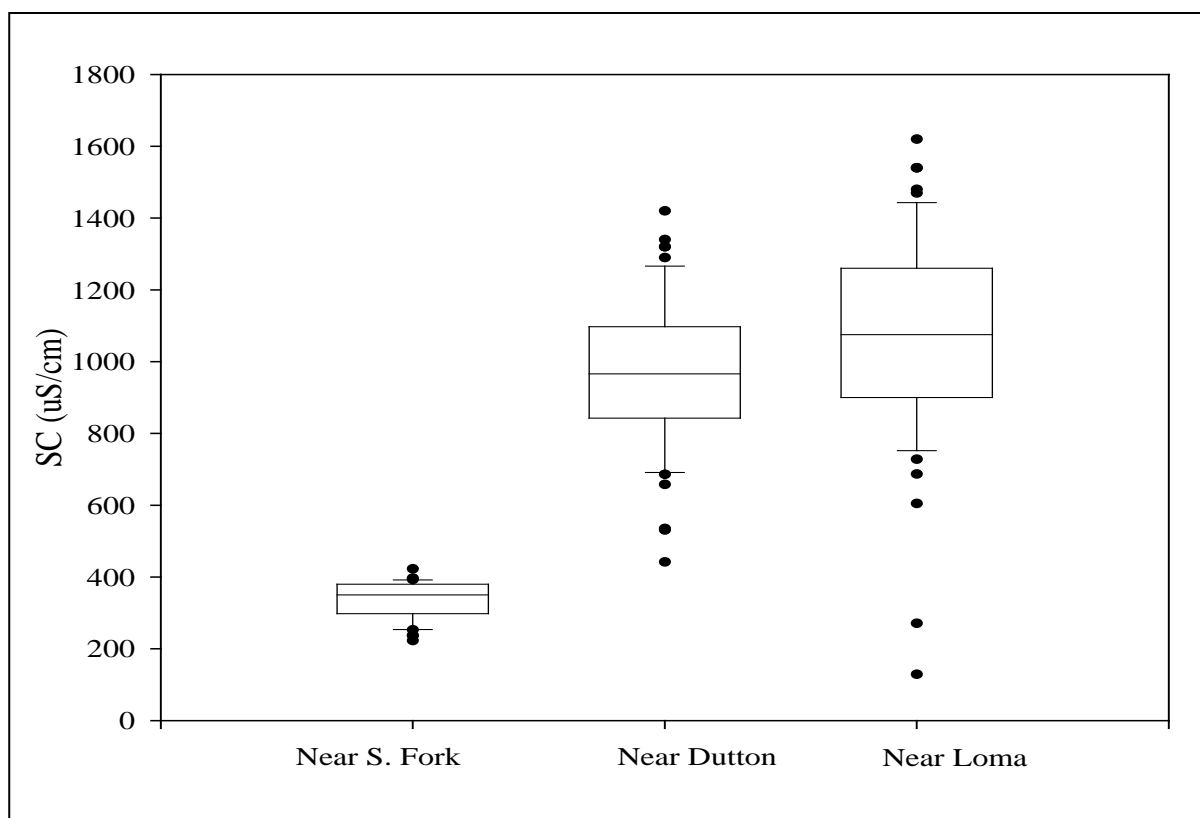
Figure 3-2. Specific conductance data collected at USGS gaging stations along the Teton River. The South Fork station is the most upstream station and Loma is the most downstream. Data presented are from 1998 to 2001 (Table 3-4).

Measured median SC levels and overall SC variability in the Teton River increased from the upper to lower reaches of the river during 1998 to 2001 (Figure 3-2). Between the “South Fork” and “Dutton” stations, median SC values increased by 276% and the minimum and maximum recorded values increased by 198% and 336%, respectively. Between the “South Fork” and “Loma” stations median and maximum values increased 307% and 383%, respectively while the minimum recorded SC value decreased by 58%. The reason for the decrease in this minimal value is unclear. However, the majority of the SC samples, or those defined as between the 5th and 95th percentiles, are greater than the equivalent percentile values at the Dutton station.

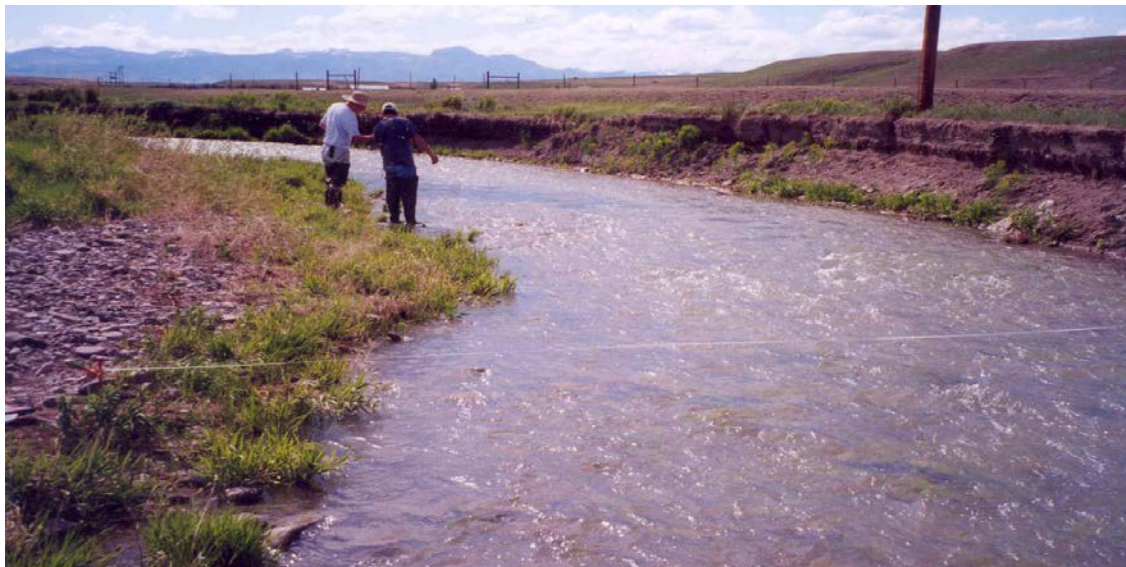
Figure 3-6. Riparian zone devoid of stabilizing or shading vegetation on Deep Creek (outside bank).

Photos from Deep Creek show a channel that has potentially downcut and has minimal to no riparian vegetation (Figure 3-6). Willow Creek shows similar characteristics, along with vertical, actively eroding banks (Figure 3-9). MDEQ notes from 2002 field visits on Teton Spring Creek state that some reaches of the stream are over-widened and lack proper riparian communities (i.e. a suite of plants with good root binding characteristics that can slow high stream flows and trap sediment), while other reaches show evidence of channelization. As a result, many locations were noted to have “excessive sediment deposition” or high embeddedness of gravels. Channelization of Spring Creek and the conversion of woody riparian species to turf grasses (Figure 3-10) are common through the town of Choteau (Decker-Hess, 1986). A site located downstream of Choteau was found to have sufficient riparian species and no active widening or downcutting was noted (Figure 3-11).

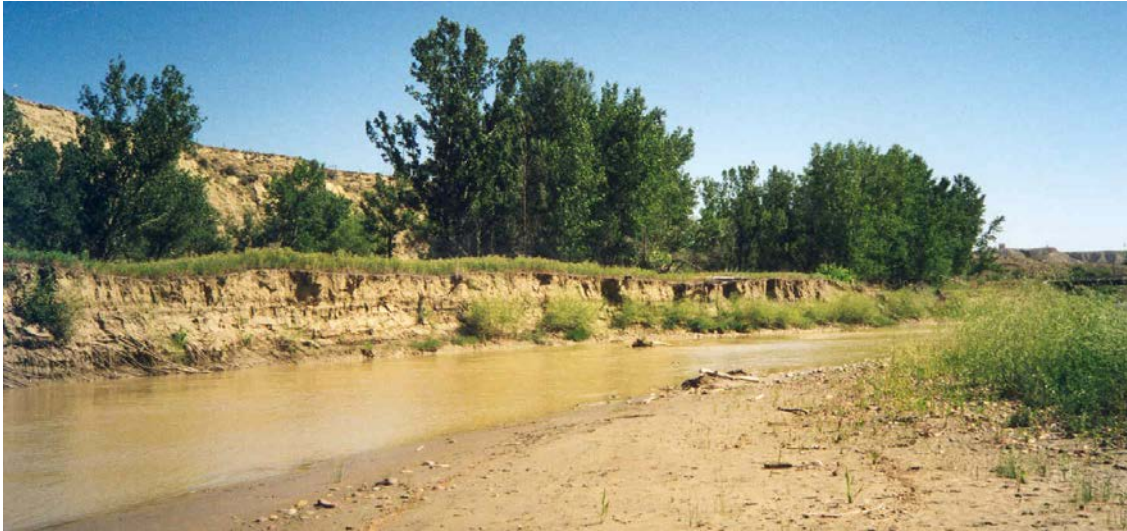
Figure 3-7. High banks along the Teton River are indicative of downcutting and restricted access to the flood plain (far bank in photo).

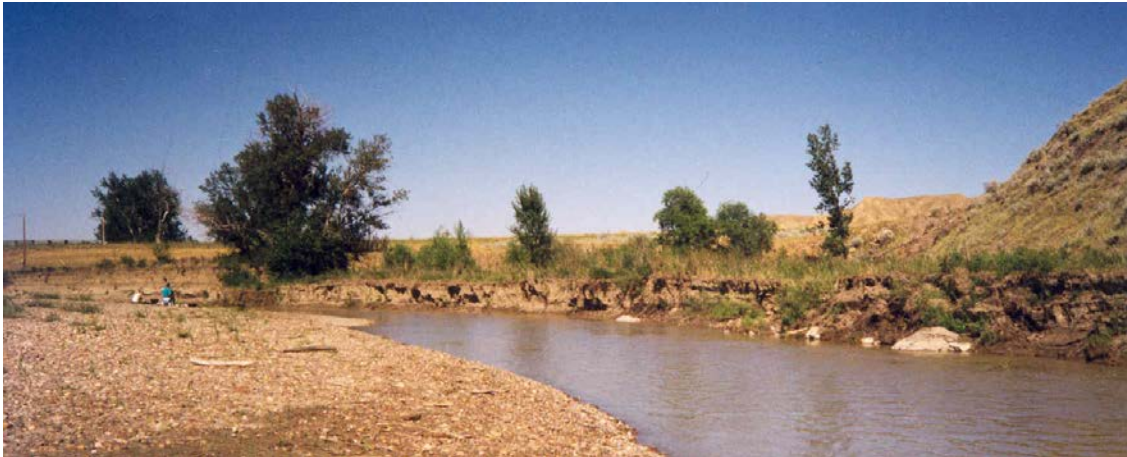
Figure 3-8. Farmland and vegetation removal along the Teton River has restricted flood plain and riparian function.

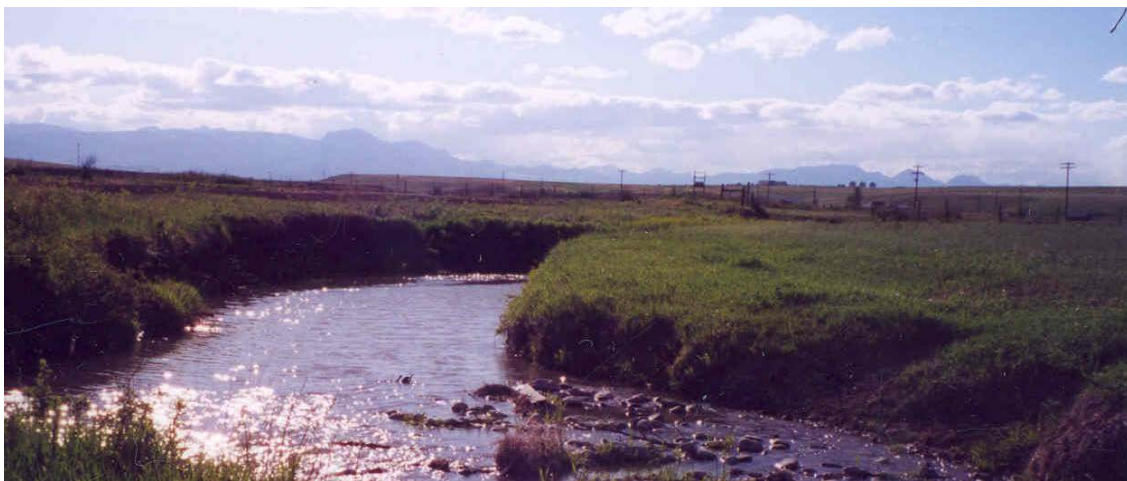
Figure 3-9. Riparian removal and apparent downcutting on Willow Creek.

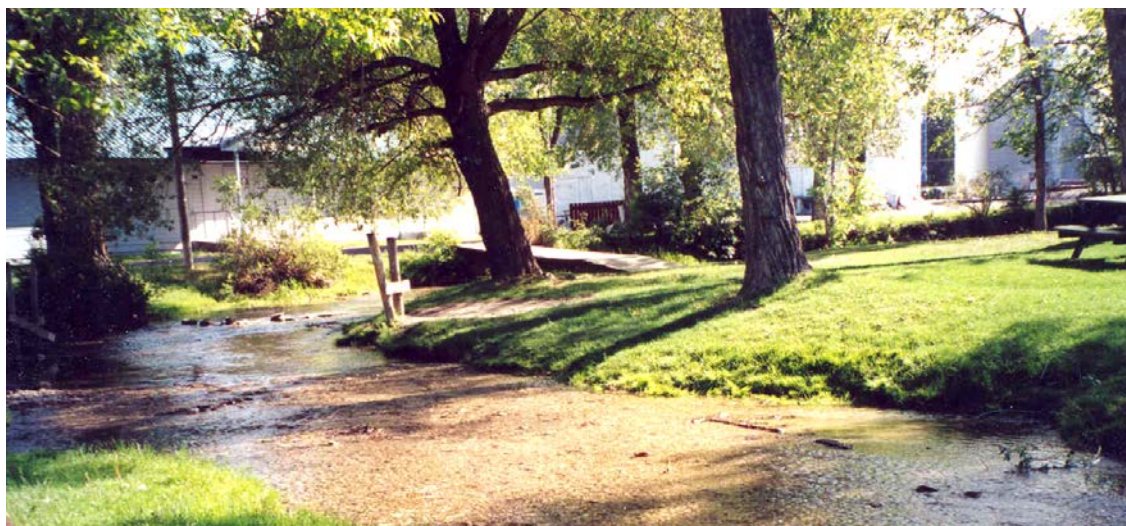
Figure 3-10. Teton Spring Creek shows a tendency to be over-widened through Choteau.

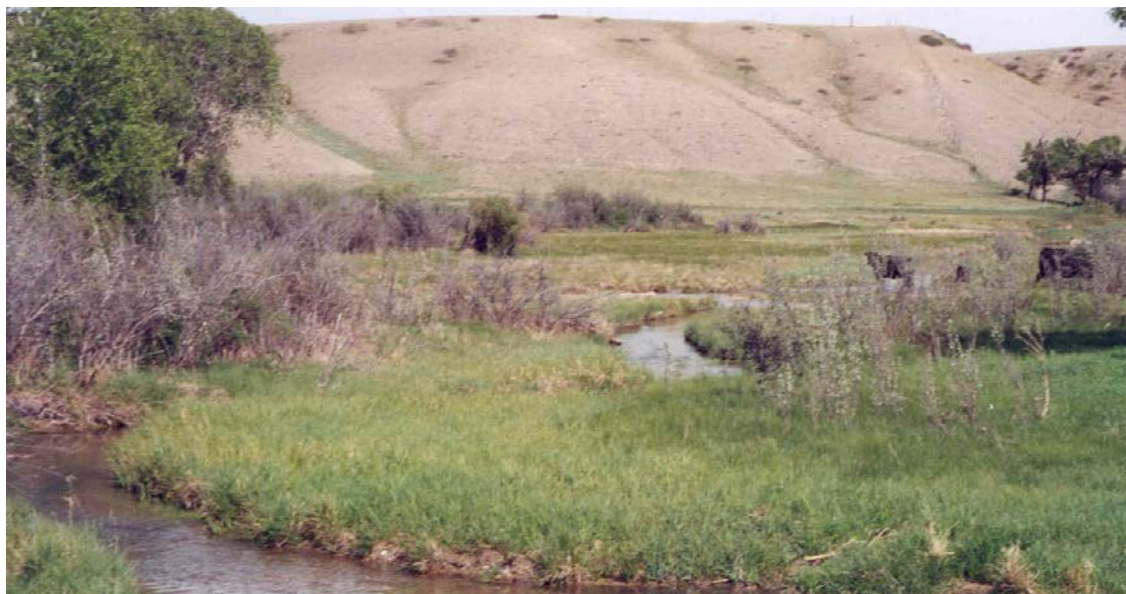
Figure 3-11. Teton Spring Creek downstream of Choteau; channel has narrowed.

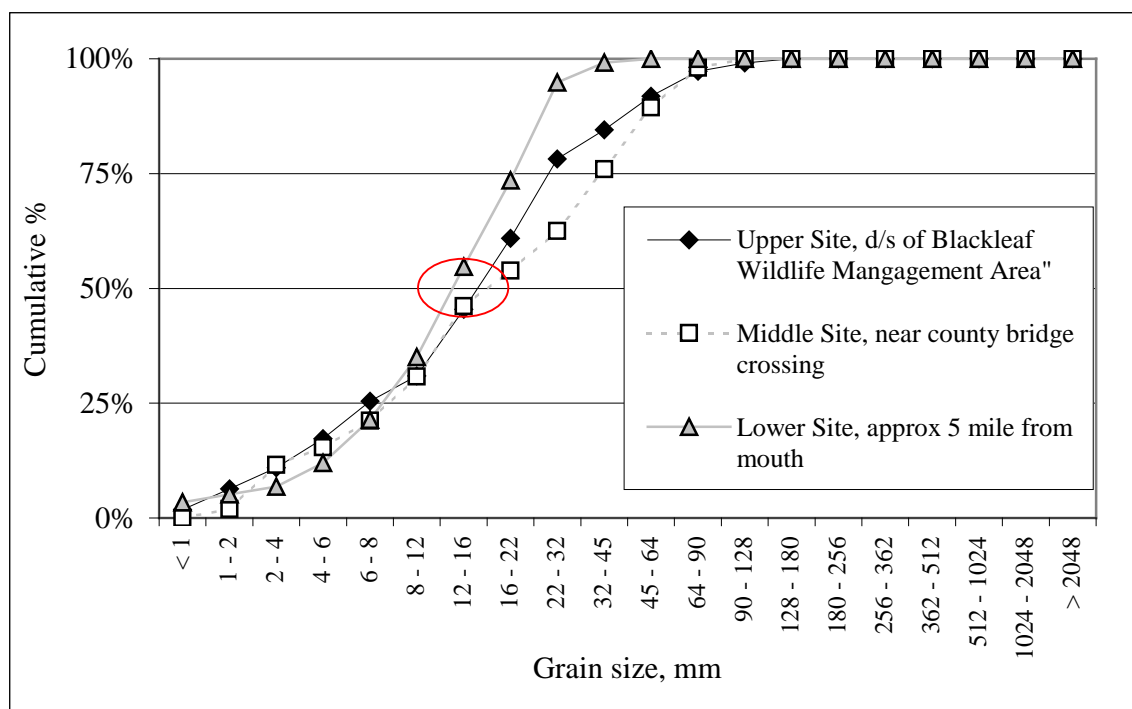
Figure 3-12. Wolman pebble count data collected along Blackleaf Creek by MDEQ, July 2002. The red circle indicates the D₅₀ value, or the median particle size.

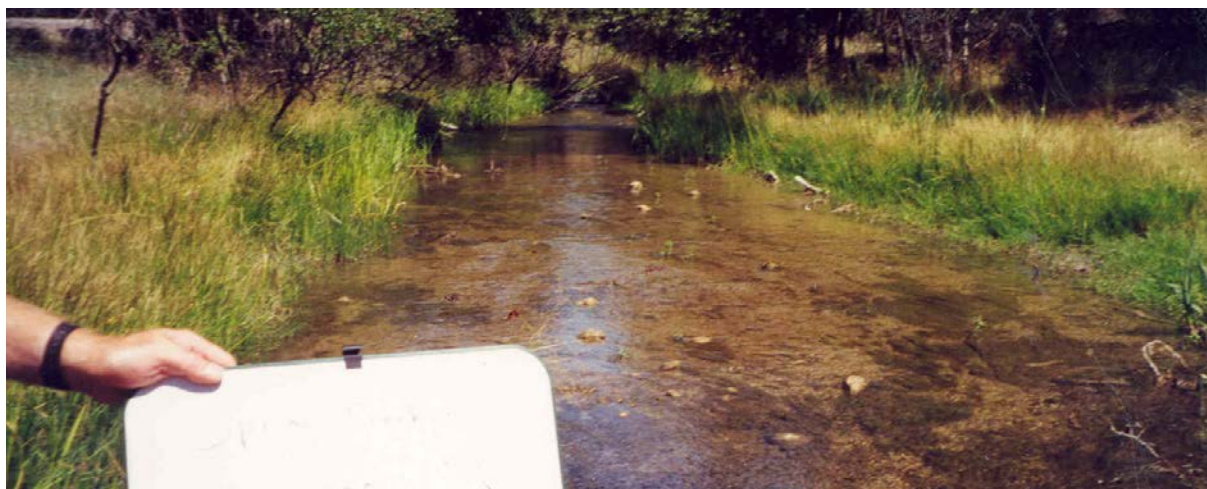
Figure 3-13. Teton Spring Creek upstream of Choteau. Channel is wide and shallow.

Other factors that contribute to increased temperatures include channel geometry, lack of riparian cover, and low flow. Field observations and photos show a channel that is wide and shallow and lacking shading vegetation. An "E-type" channel, which is narrow and deep, is the expected classification for Teton Spring Creek, given the gentle gradient of the valley. Photos collected in the field show how the stream has been over-widened (Figures 3-10 and 3-13) in comparison to a more typical "E" channel (Figure 3-14). Teton Spring Creek is considered chronically dewatered (by MFWP), which during August would suggest that flows are extremely low, if existent at all. Because it is a spring creek, groundwater influences should aid in maintaining a constant water temperature, close to that of groundwater. However, 25° C (77° F) is much higher than reported groundwater temperatures and this area is not known for thermal springs.

The upper section of Teton Spring Creek was evaluated as a C-type Rosgen stream channel (Figure 3-13) based on field measurements of stream channel geometry. Given the nature of stream flow (i.e., spring creek) and a valley type that is a broad, gently sloping riverine valley an E-type channel would be expected (e.g., Figures 3-11 and 3-14). These two channel types differ significantly in the amount of surface area of stream that is exposed to incident solar radiation. C-type channels have bankfull width-to-depth ratios (W/D) greater than 12 while E-type channels have W/D ratios less than 12 (Rosgen, 1996). In other words, C-type channels are wider and shallower relative to E-type channels, which are more narrow and deep. Thus, given the same amount of thermal energy and stream flow, a C-type channel will increase in temperature more quickly and readily than an E-type channel.

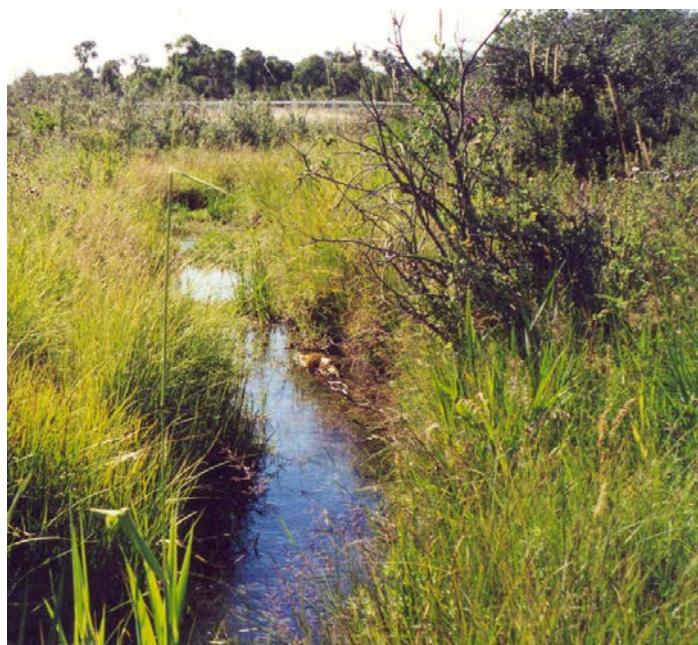
Figure 3-14. Teton Spring Creek, upstream of Choteau. E-Type channel: narrow and deep, with well-vegetated banks.

Channel geometry also influences the instream environment affecting growth of algae and aquatic flora. Spring creeks in gentle gradient valleys are more typically Rosgen E-type channels that are narrow and deep (e.g. Figures 3-11 and 3-14) where less light penetrates to the channel bottom, stream temperatures tend to remain cooler and macrophytes dominate. Periphyton and filamentous algae have a preference to warmer, high sunlight environments (Chapra, 1997). Channels that tend to be wide and shallow propagate algae in preference to macrophytes. Field investigations by MDEQ monitoring staff have documented where Teton Spring Creek has changed to a Rosgen C-type stream channel in Choteau (Figure 3-13). Algal growth is prolific at this location, as measured by benthic chlorophyll *a* (Table 4-19). Upstream landuse practices that alter natural riparian vegetation often results in the widening of the stream channel which also decreases stream depth. Instream water temperatures then increase due to greater water surface area. Irrigation return flows and reduced overall flow volumes due to consumptive losses also contribute to thermal warming of the stream.

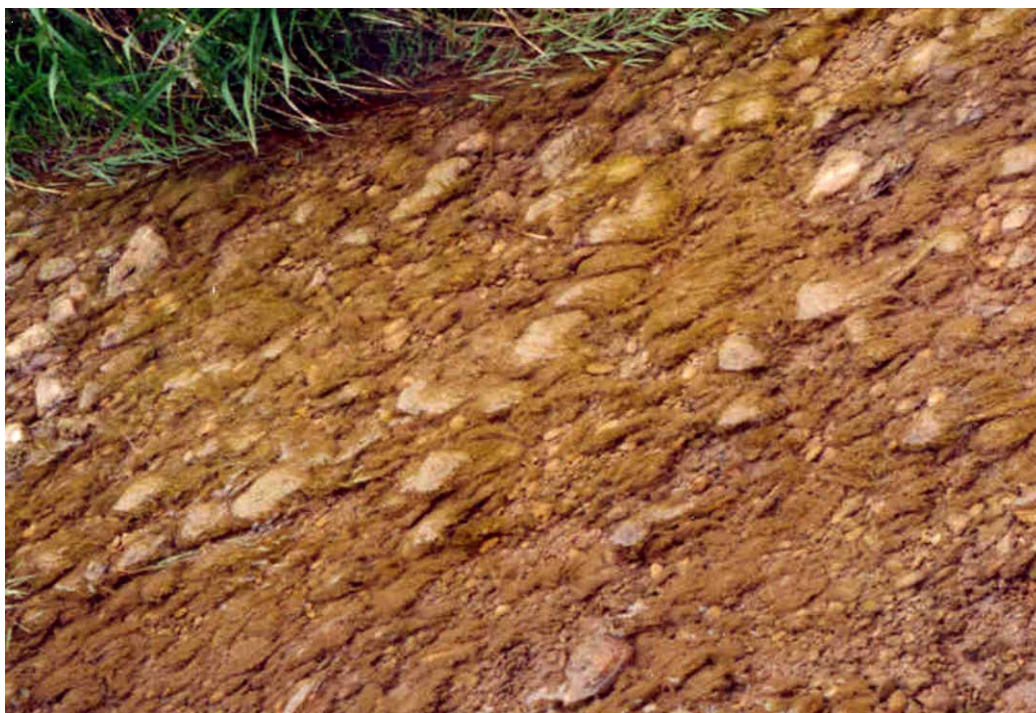
Figure 3-17. Algae in Teton Spring Creek, downstream of Choteau, May 2001.

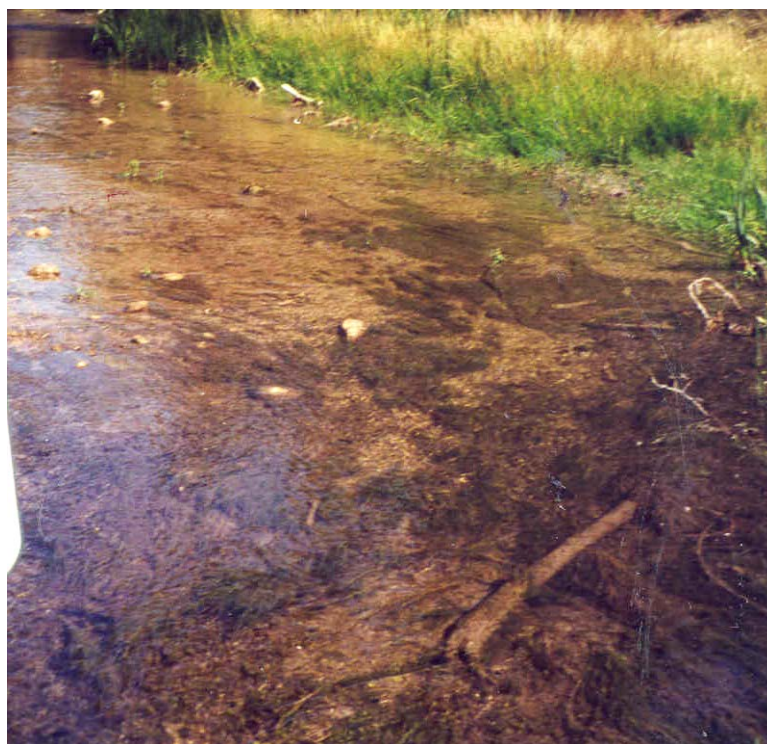
Figure 3-18. Aquatic vegetation in Teton Spring Creek, upstream of Choteau, August 2000.

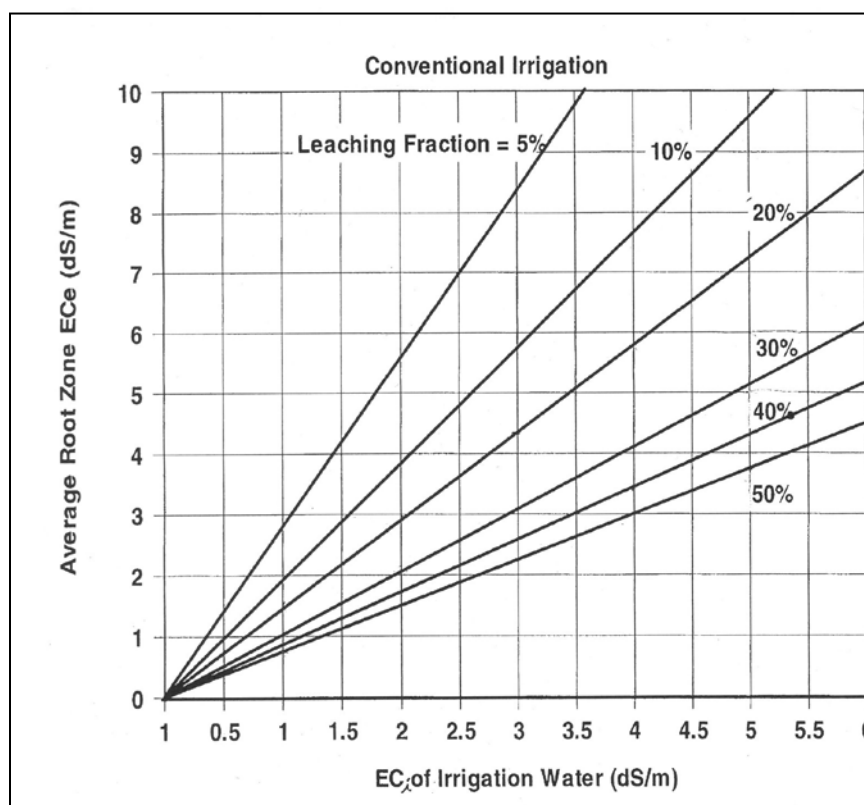
Figure 4-9. Relationship between leaching fractions, irrigation water, and soil water SC (adopted from Hansen et al., 1999).

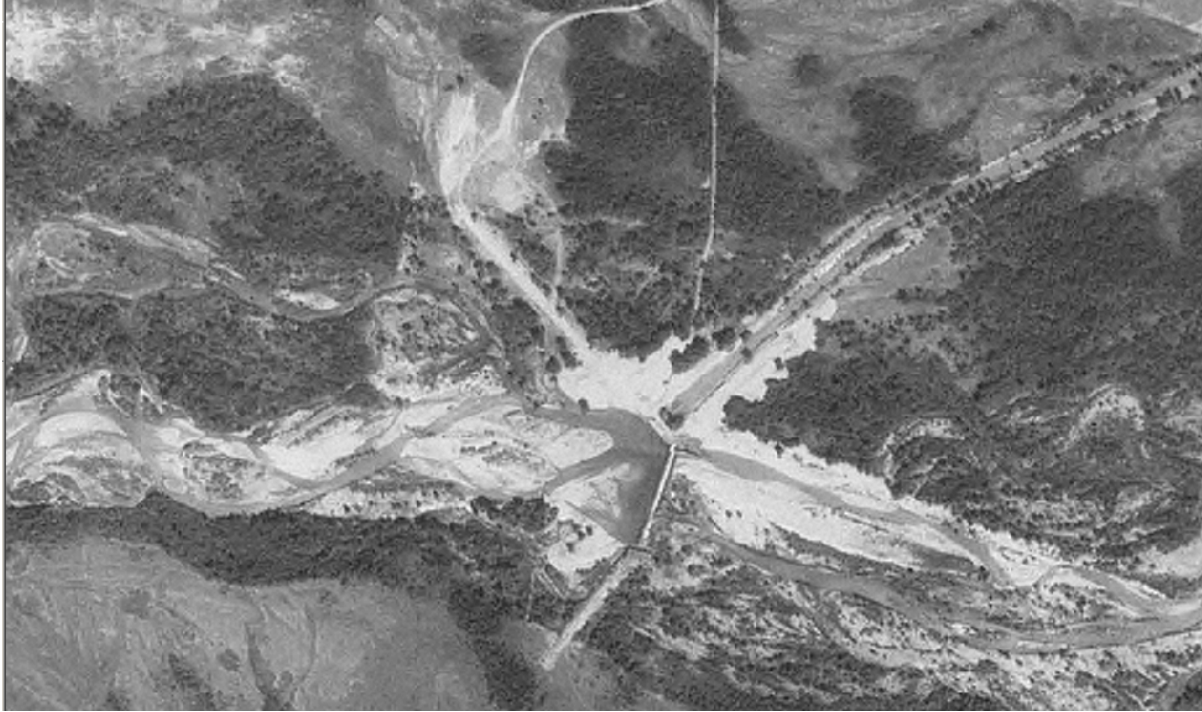
Figure 4-12. Example of an instream diversion structure on the upper Teton River (photo scale is 1:4,000).

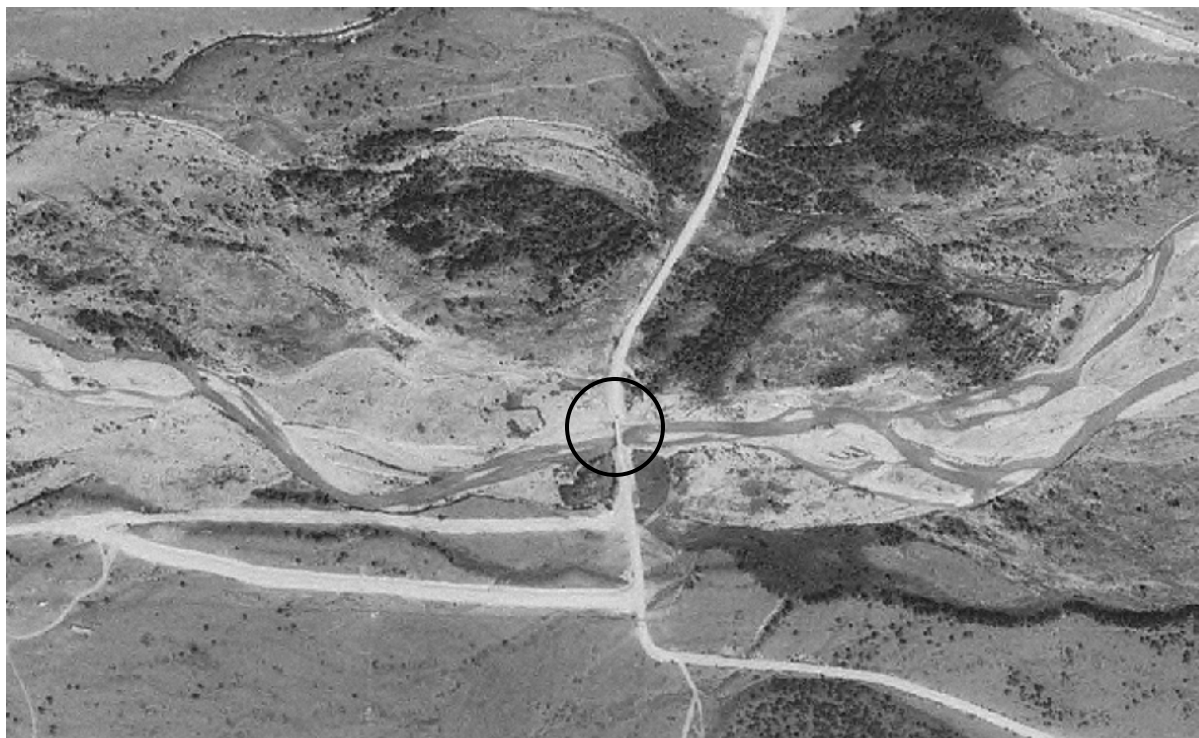
Figure 4-13. An undersized highway structure (bridge in circle) on the upper Teton River that limits floodway access and creates a constricted stream channel (photo scale is 1:5,000).

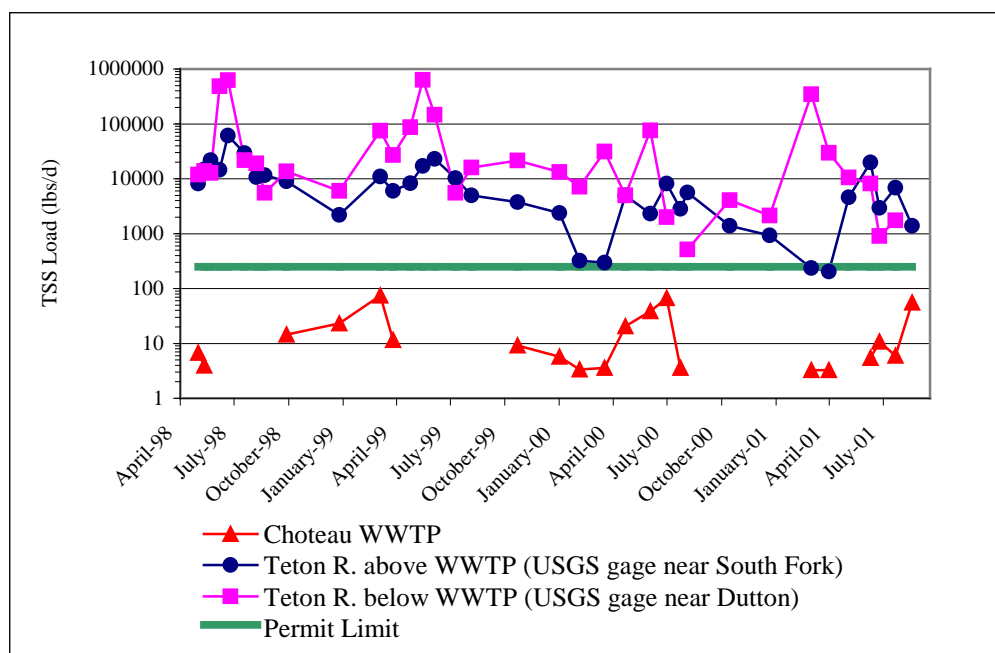
Figure 4-16. Average annual TSS loads from the City of Choteau's WWTP discharge and the Teton River upstream and downstream of the discharge in relation to the TSS load limit set in the Choteau's MPDES permit. Note: the y-scale is logarithmic and is used to accommodate the full range of measured load values.

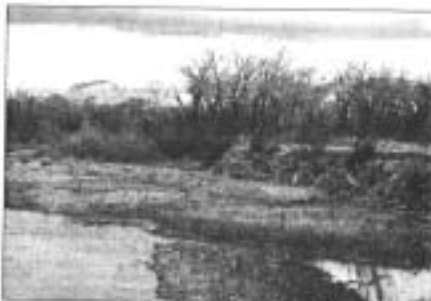
In November workers used root wads and quarry rock to stabilize 100 feet of eroding Teton River stream bank on Clay Crawford's ranch northwest of Chouteau. Sponsored by the Teton River Watershed Group and the Teton County Conservation District, the \$5,000 project by T&L Construction of Lincoln was paid for with a grant from the U.S. Fish and Wildlife Service. The five-foot high bank had been eroding at about two feet per year, according to TRWG coordinator Alan Rolfo. A second project to place root wads and rock on 200 feet of riverbank on the Charles Fellows ranch south of Chouteau cost \$7,000 and was completed in five days.
