**RECLAMATION DESIGN REPORT  
FOR THE  
McLAREN TAILINGS ABANDONED MINE SITE  
COOKE CITY, MONTANA**

## **APPENDIX A**

### **PHOTO LOG**

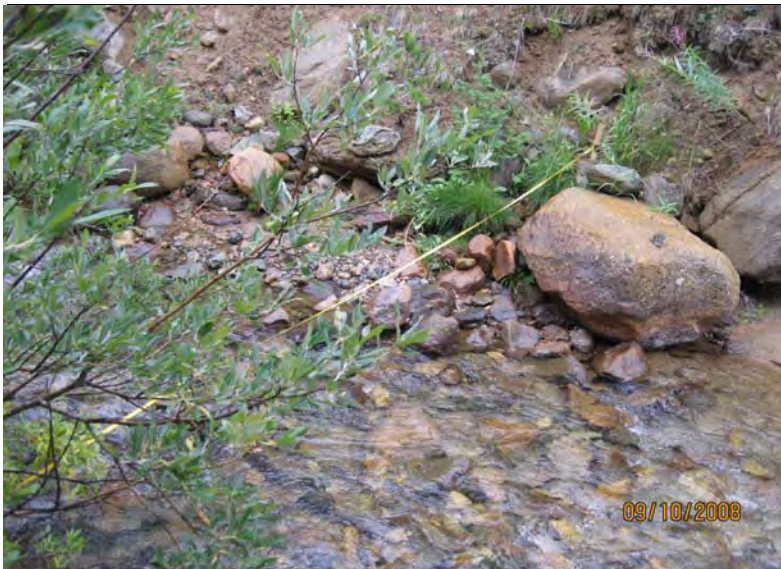
Description: Soda Butte Creek - Surface water flow measurement location #3.

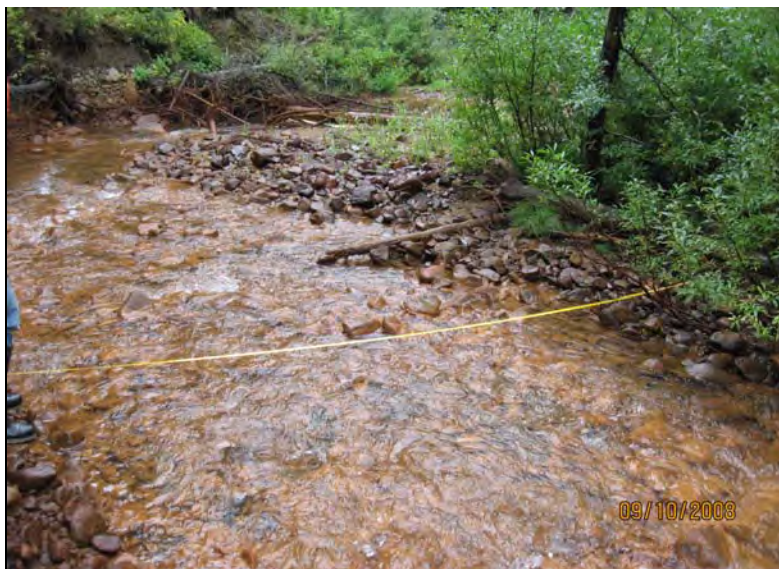
Description: Soda Butte Creek - Surface water flow measurement location #4.

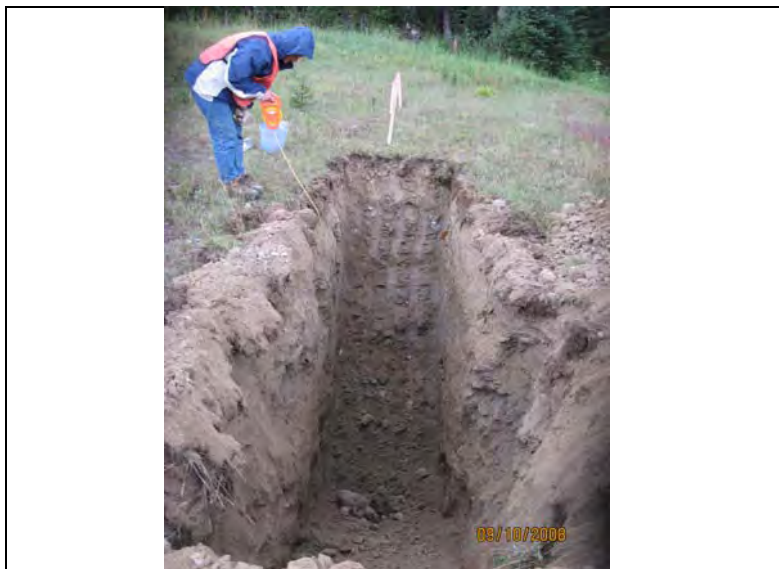
Description: Looking west at TP-21 test pit.

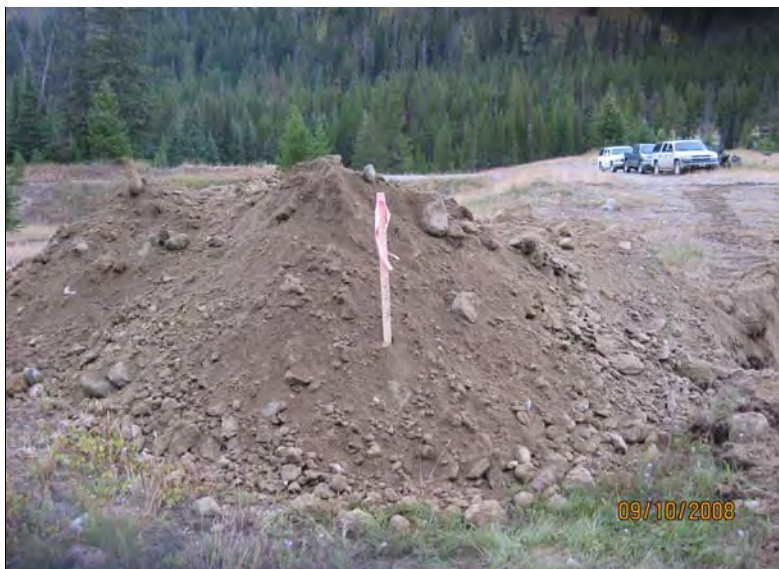
Description: Looking south at spoils pile from TP-21.

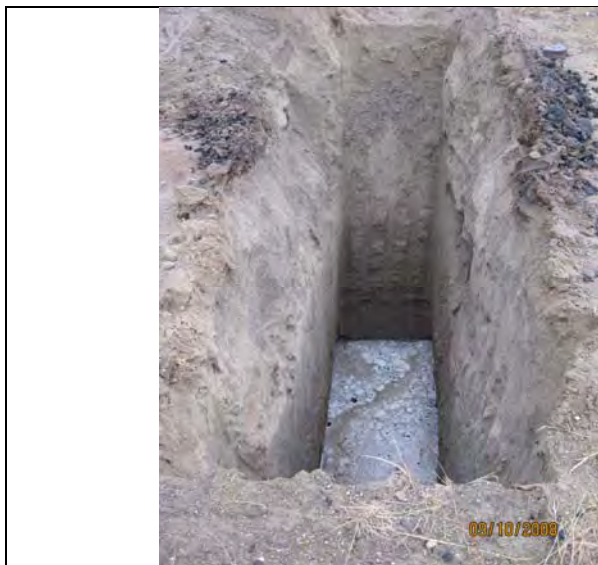
Description: Looking south at TP-22.

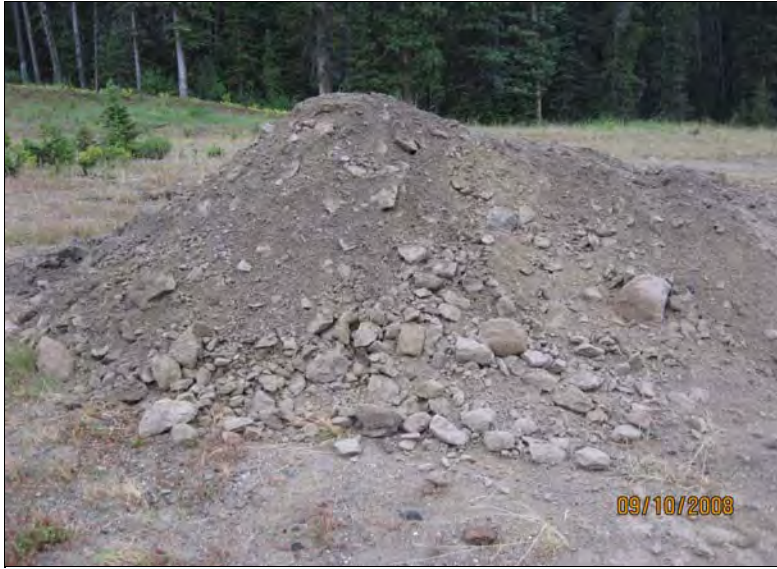
Description: Looking east at spoils pile from TP-22.

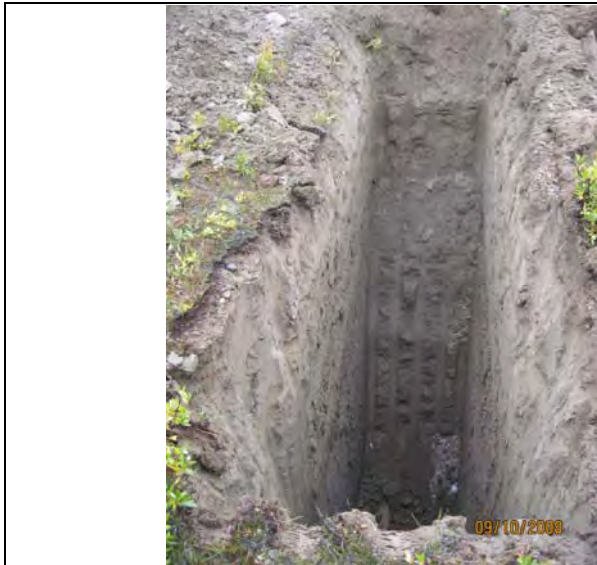
Description: Looking south at TP-23 test pit.

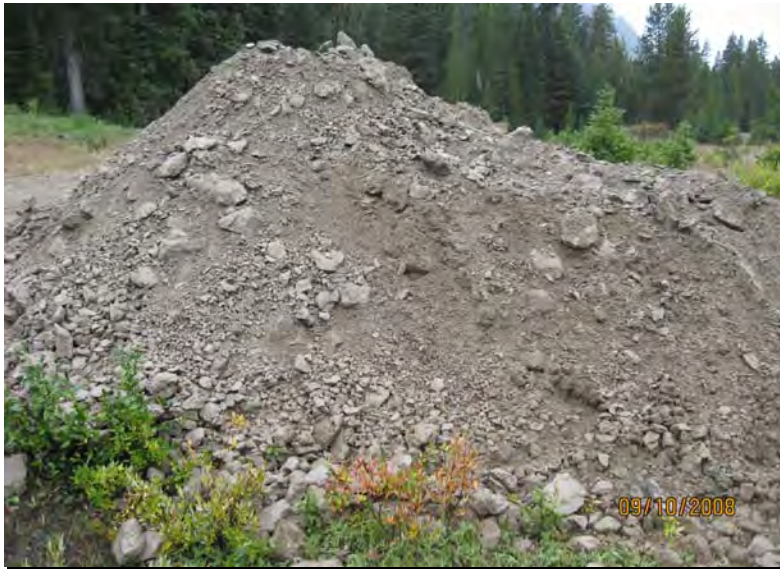
Description: Looking east at spoils pile from TP-23 test pit.

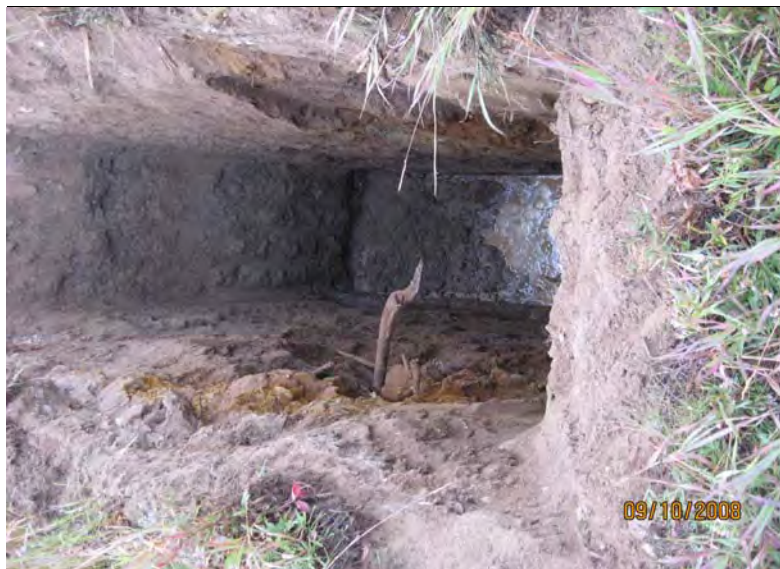
Description: TP-24 test pit

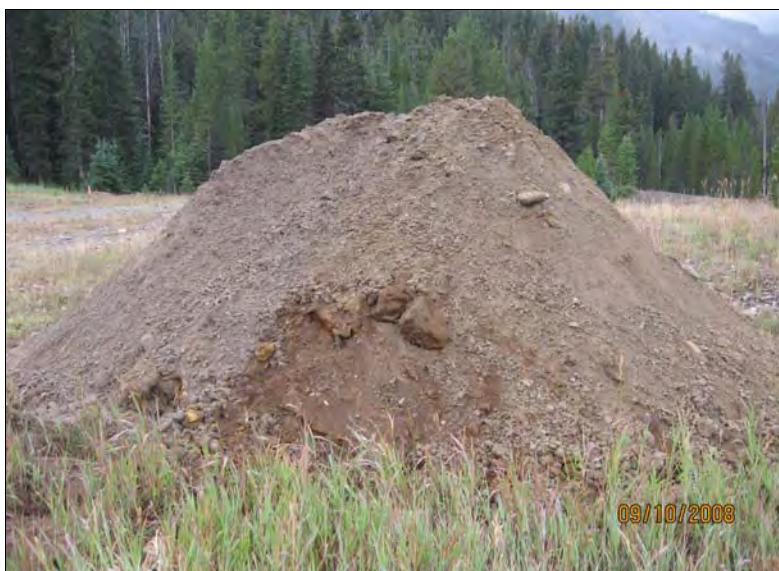
Description: Spoils pile from TP-24.

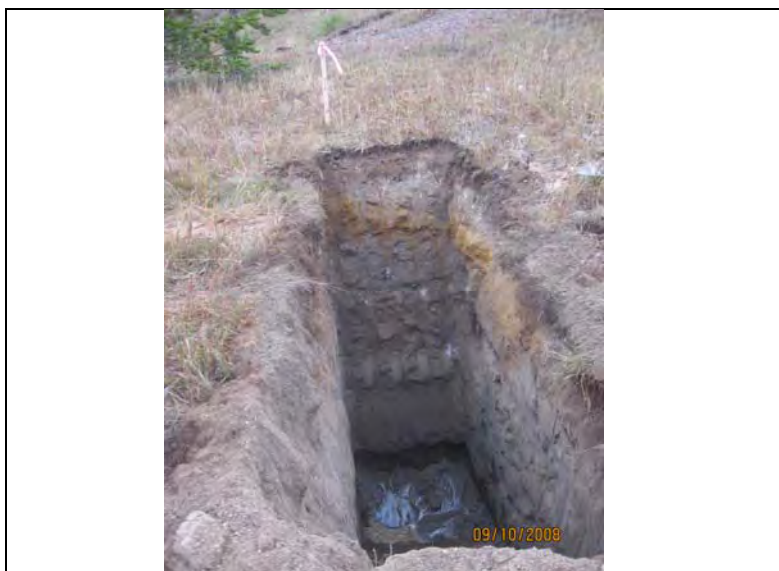
Description: TP-25 test pit.

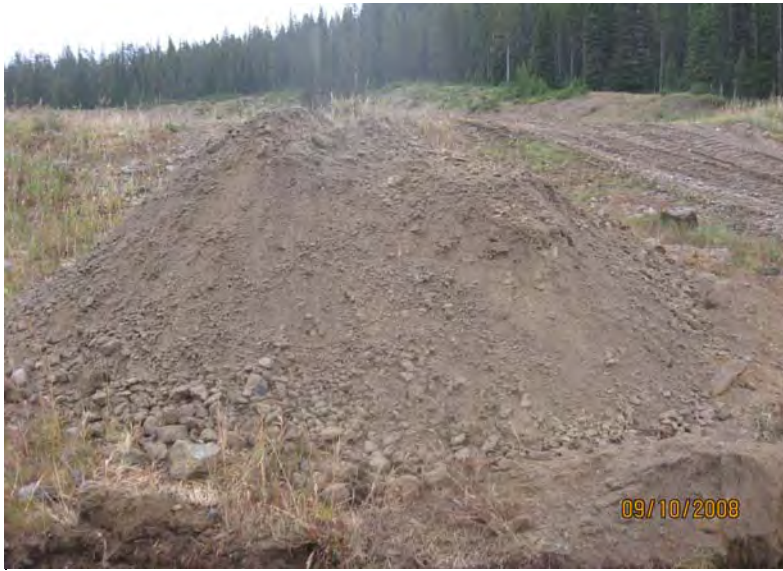
Description: Spoils pile from TP-25.

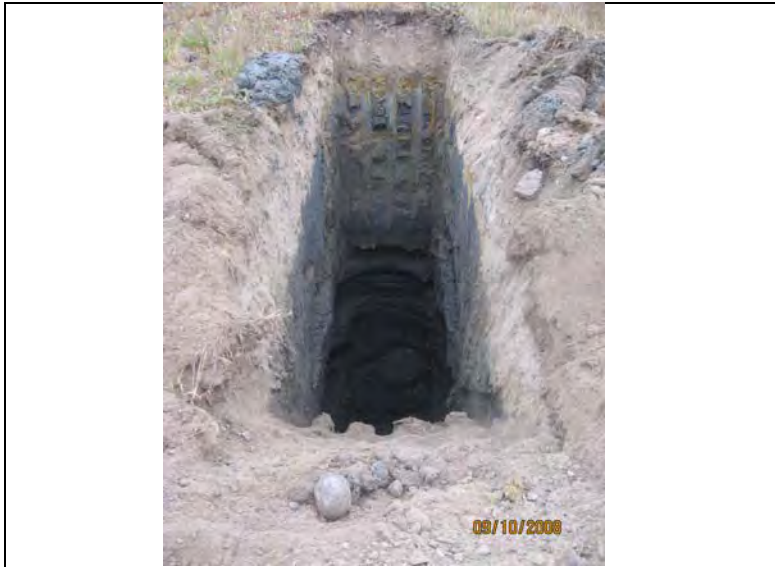
Description: TP-01 test pit.

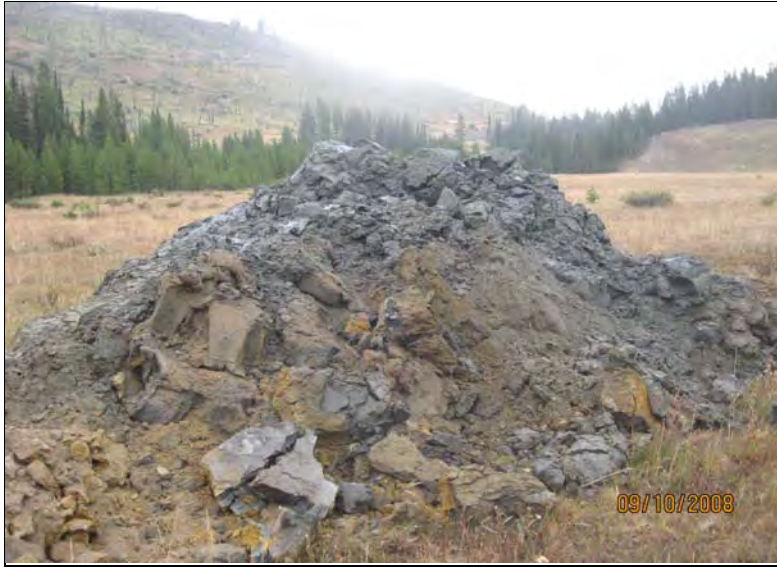
Description: Spoils pile from TP-01.

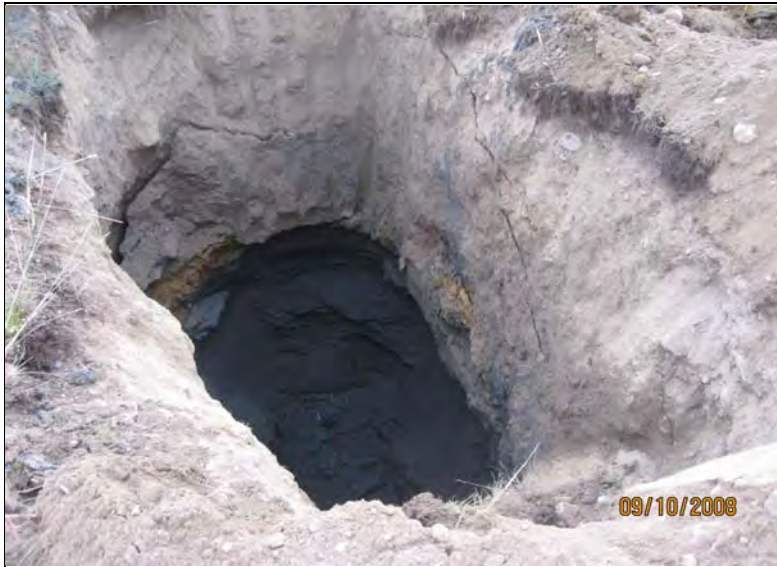
Description: TP-02 test pit.

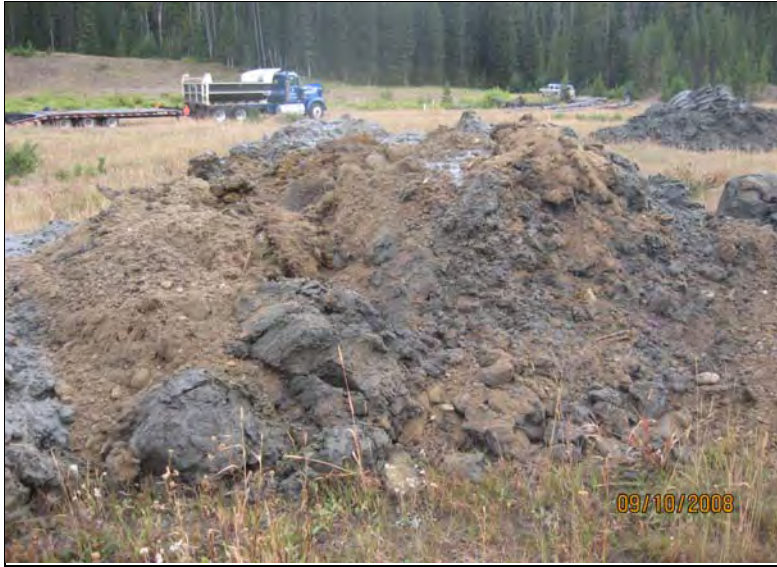
Description: Spoils pile from TP-02.

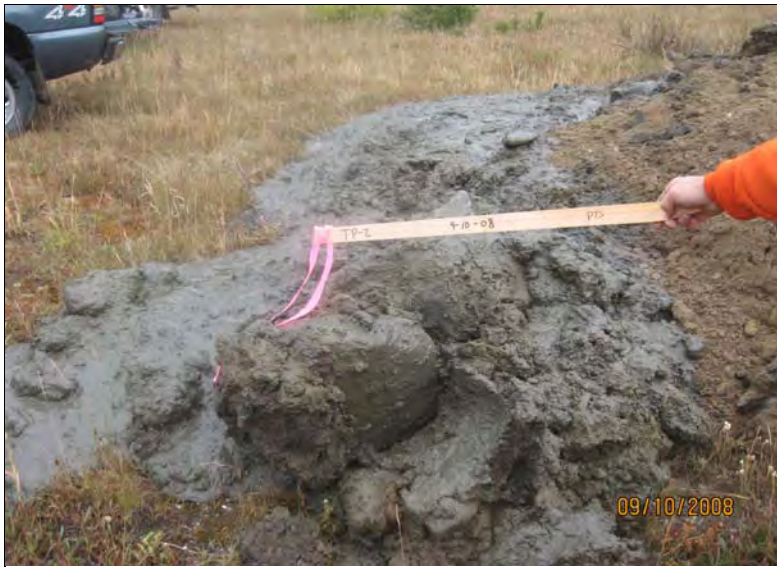
Description: Large boulders from TP-02.

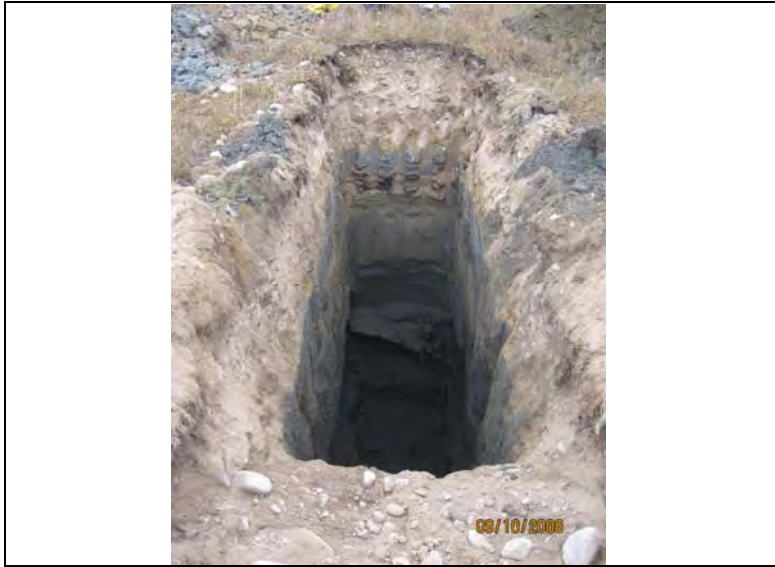
Description: TP-03 test pit.

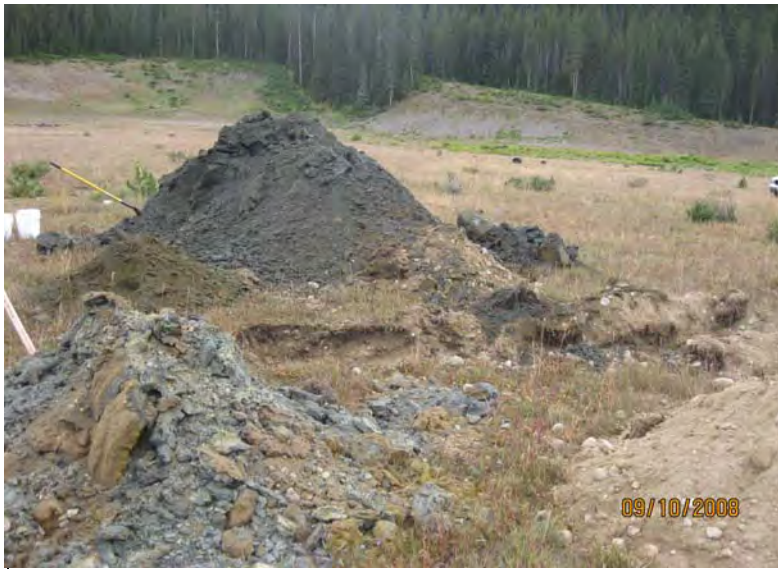
Description: Spoils pile from TP-03.

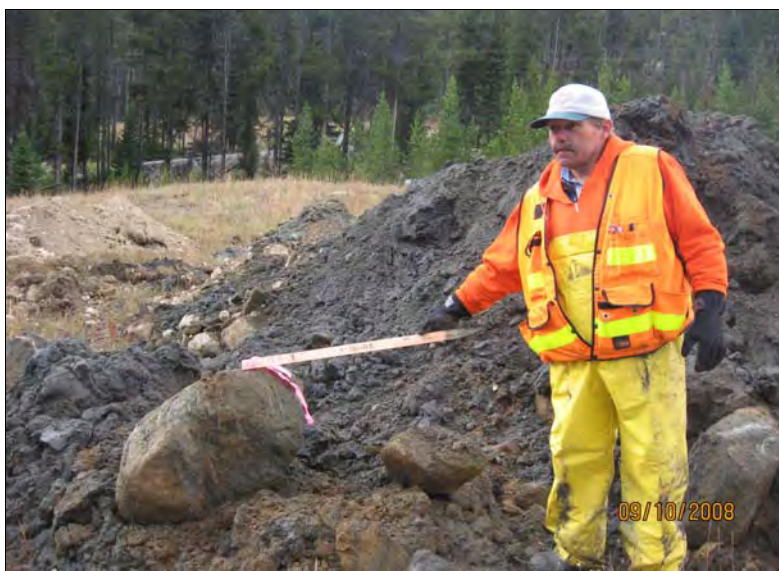
Description: Boulders from the bottom of TP-03.

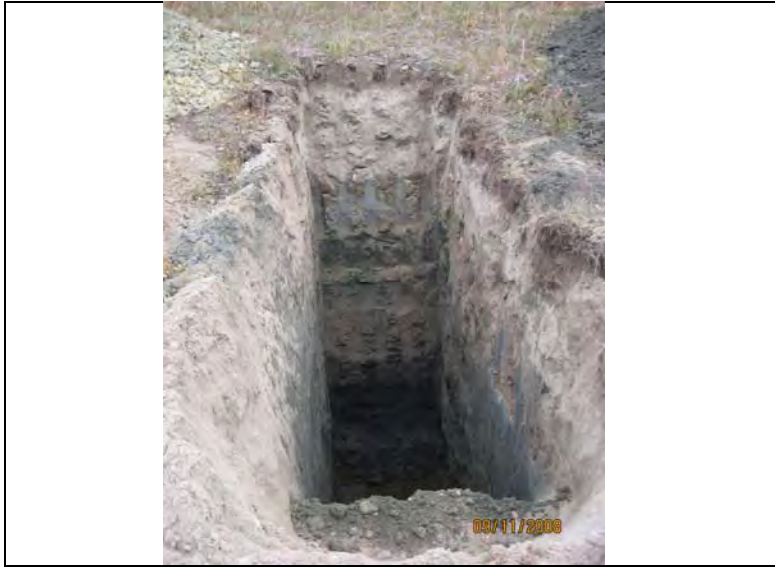
Description: Looking east at TP-04 test pit.

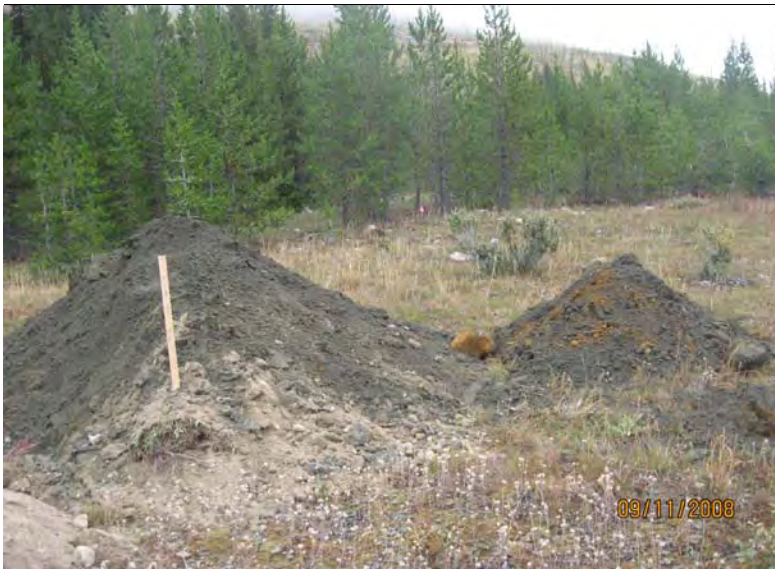
Description: Looking east at spoils pile from bottom half of TP -04 test pit.

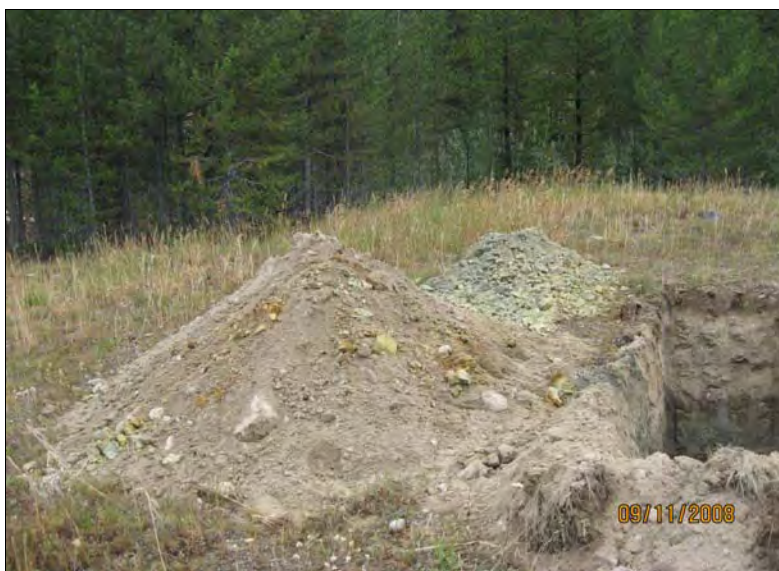
Description: Looking east at spoils pile from top half of TP-04 test pit.

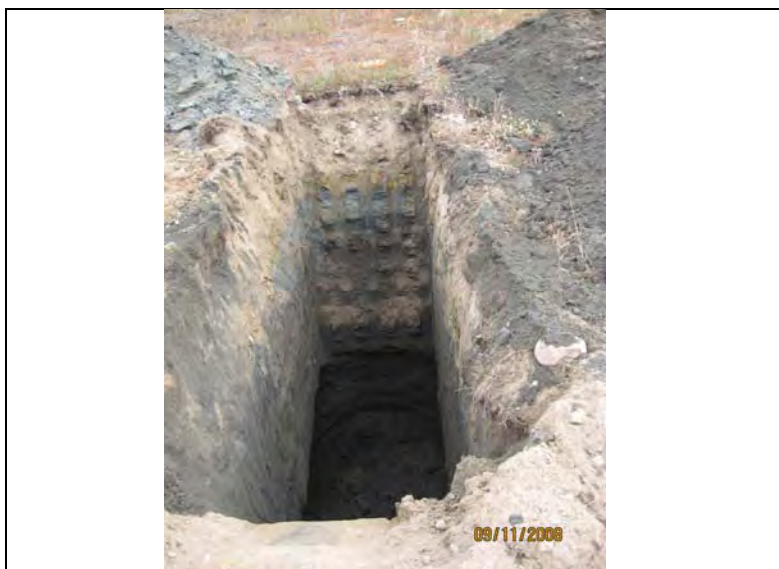
Description: Looking east at TP-05 test pit.

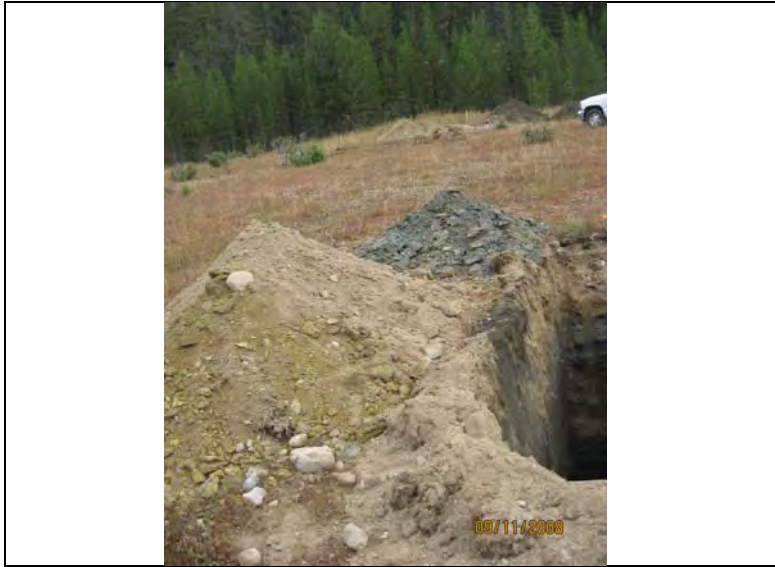
Description: Looking east at spoils pile from the top half of TP-05 test pit.

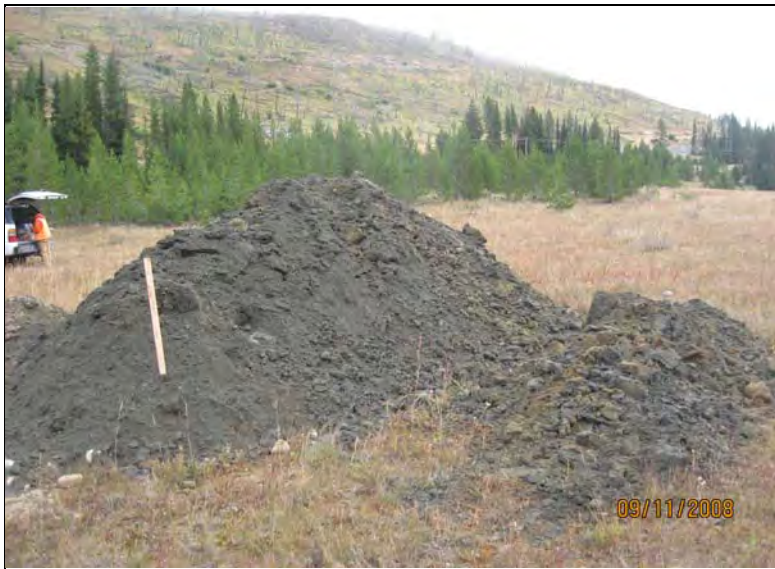
Description: Looking east at spoils pile from the bottom half of TP-05 test pit.

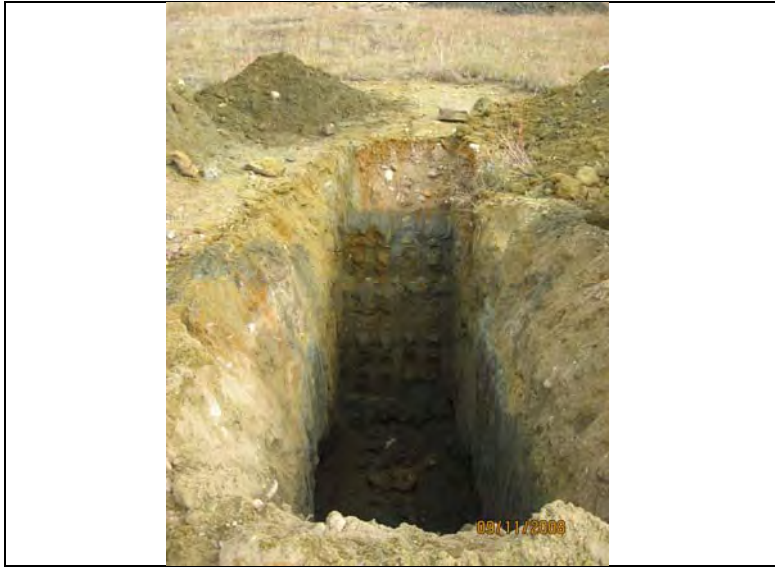
Description: Looking east towards TP-06 test pit.

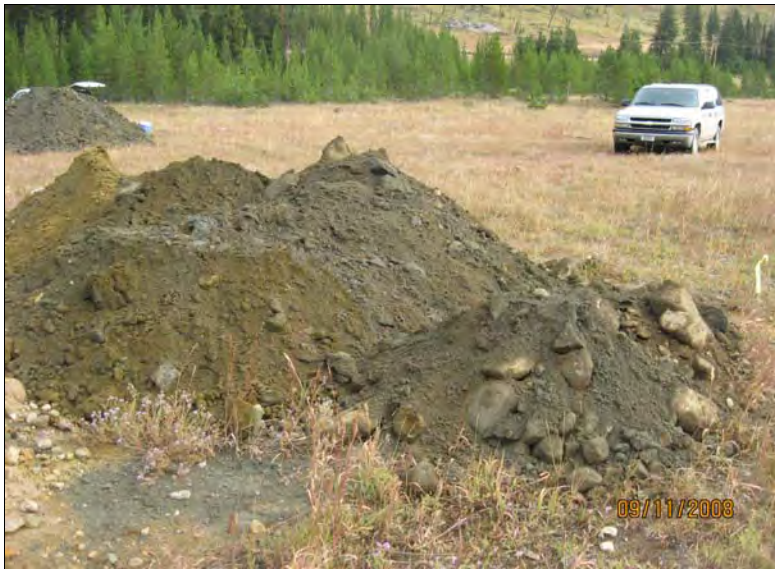
Description: Spoils pile from TP-06 - suburban in background.

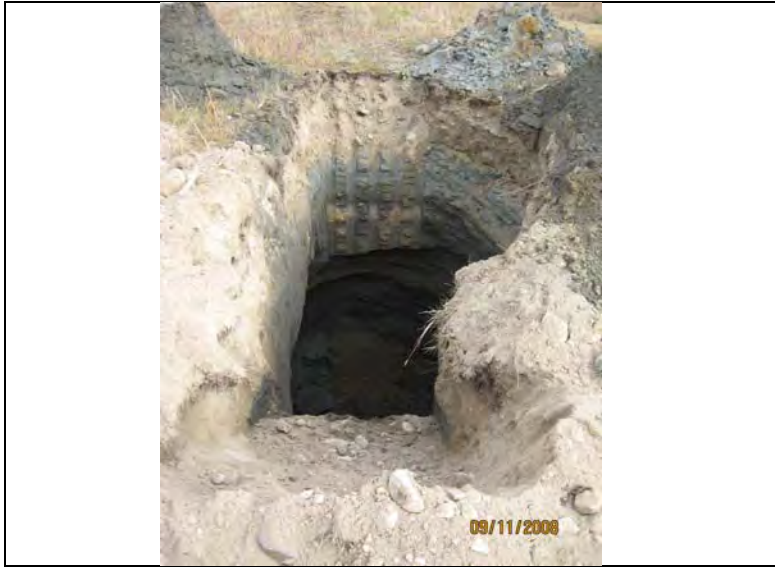
Description: Looking west towards TP-07 test pit.

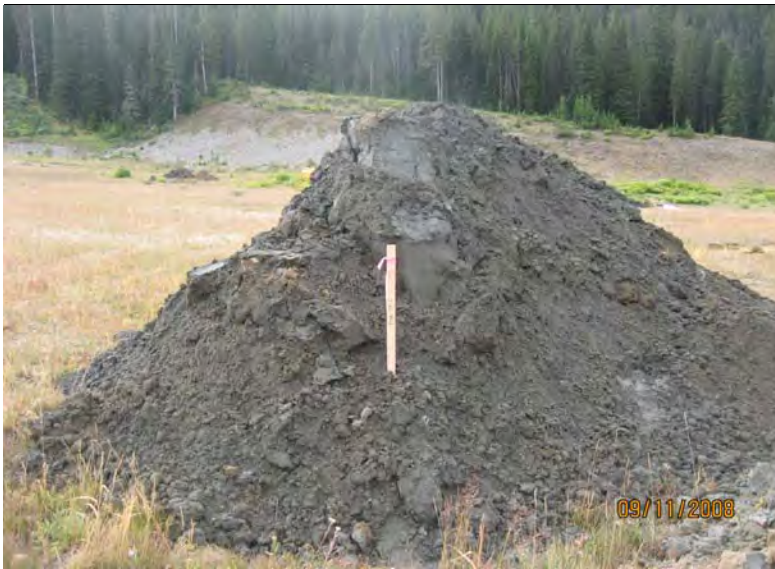
Description: Spoils pile from TP-07 test pit.

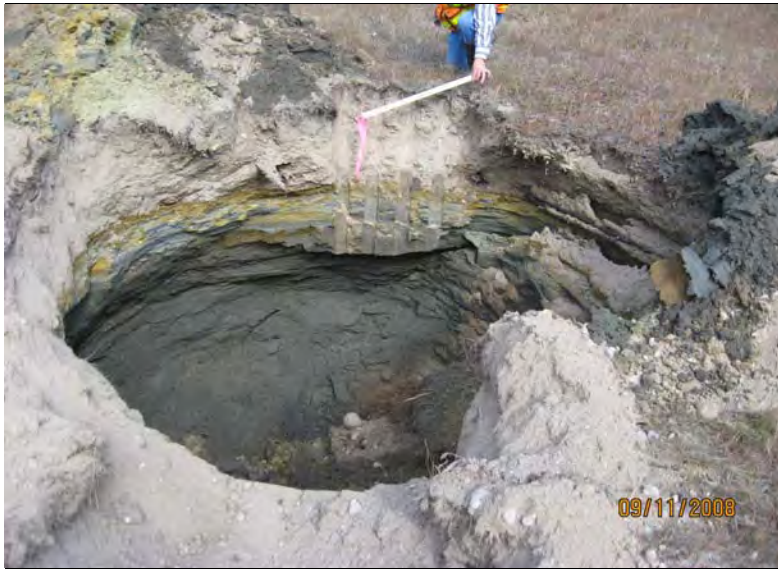
Description: Looking east at TP-08 test pit.

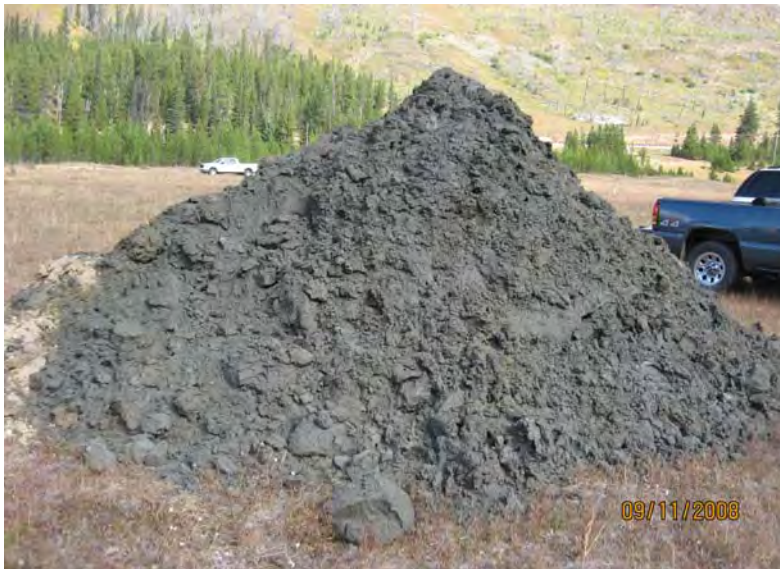
Description: Looking east at spoils pile from TP-08 test pit.

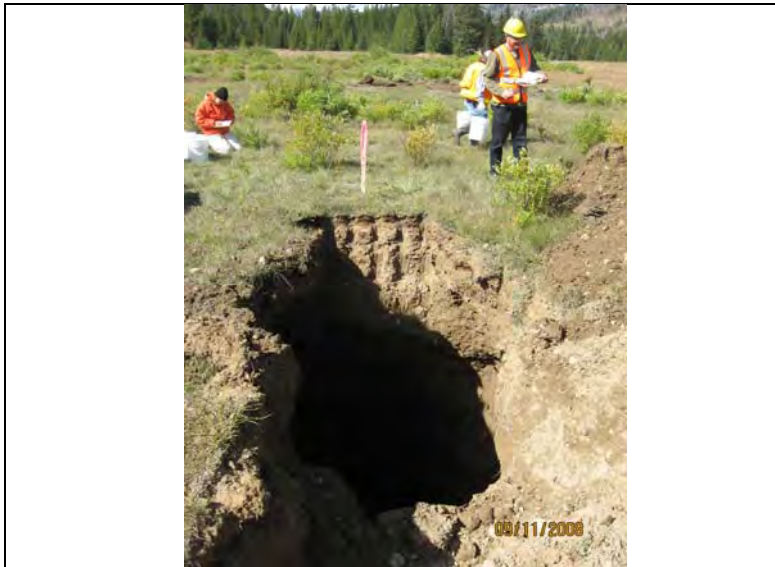
Description: Looking at TP-12 test pit.

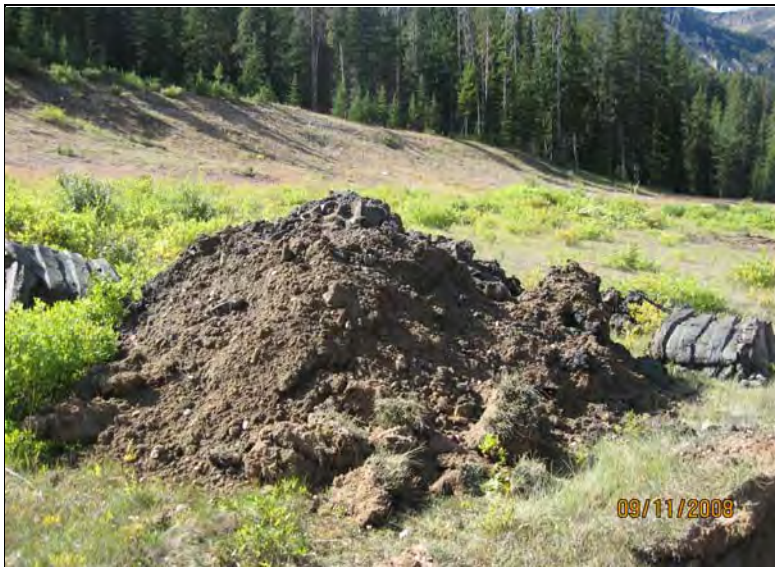
Description: Looking spoils pile from TP-12.

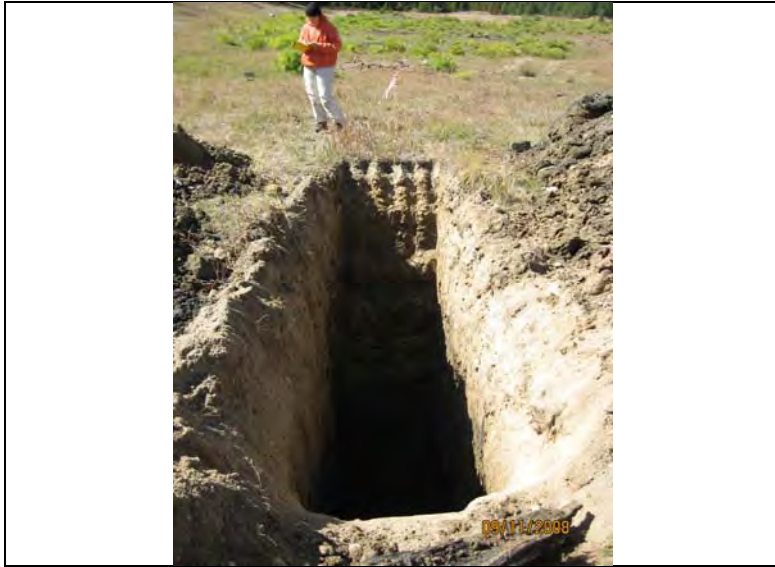
Description: Test pit TP-13.

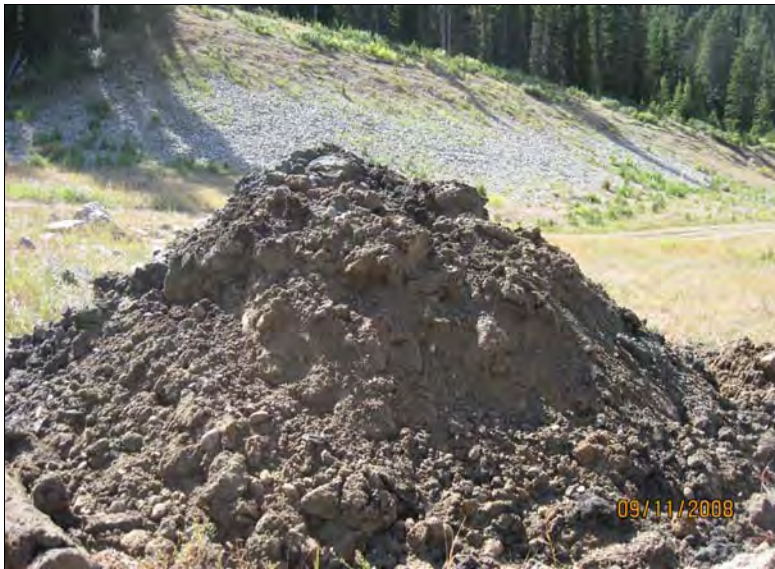
Description: Spoils pile from TP-13.

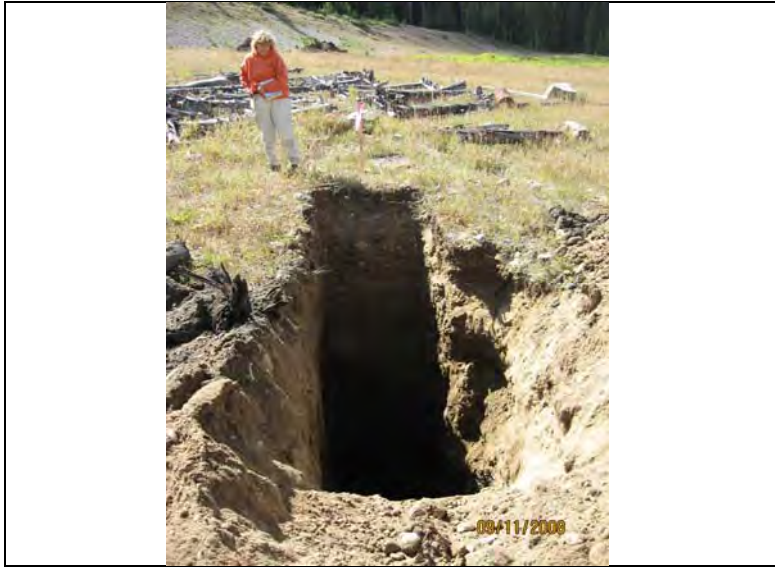
Description: Test pit TP-14.

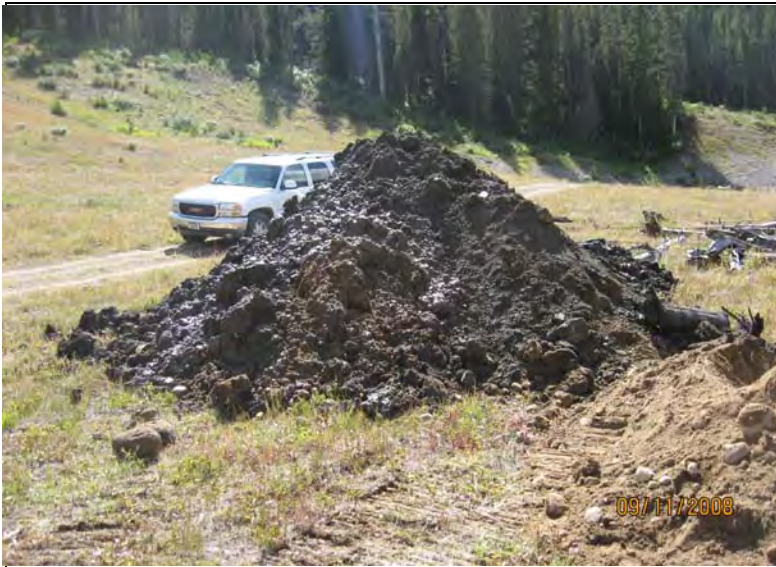
Description: Spoils pile from TP-14.

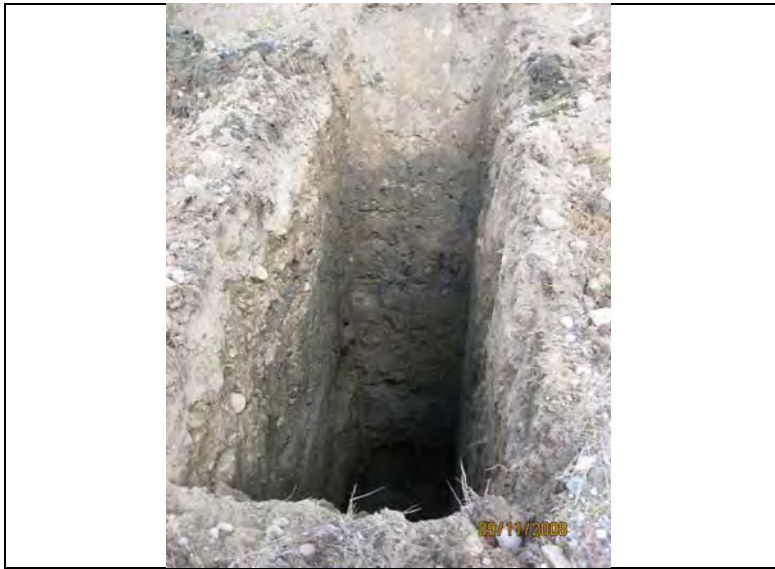
Description: TP-15 test pit.

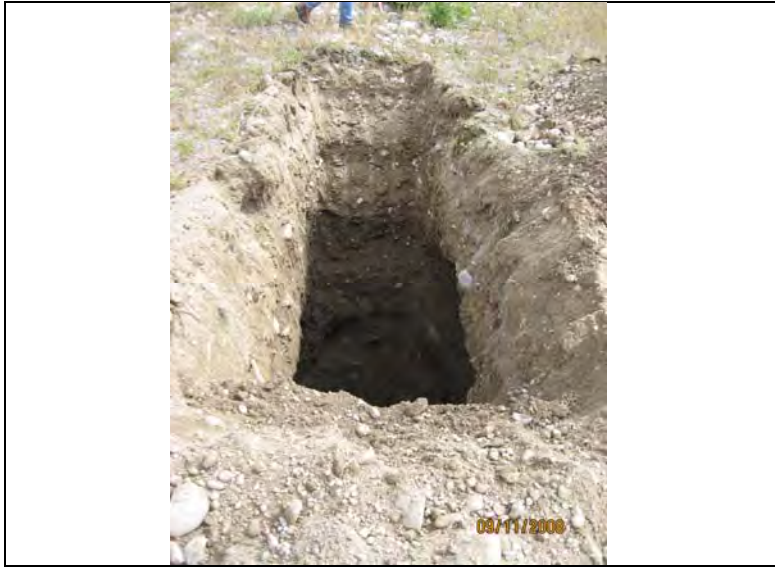
Picture #: McLaren RA Project\Site Investigation Photos\Julies Photos\McLaren SI108

Description: Test pit TP-16.

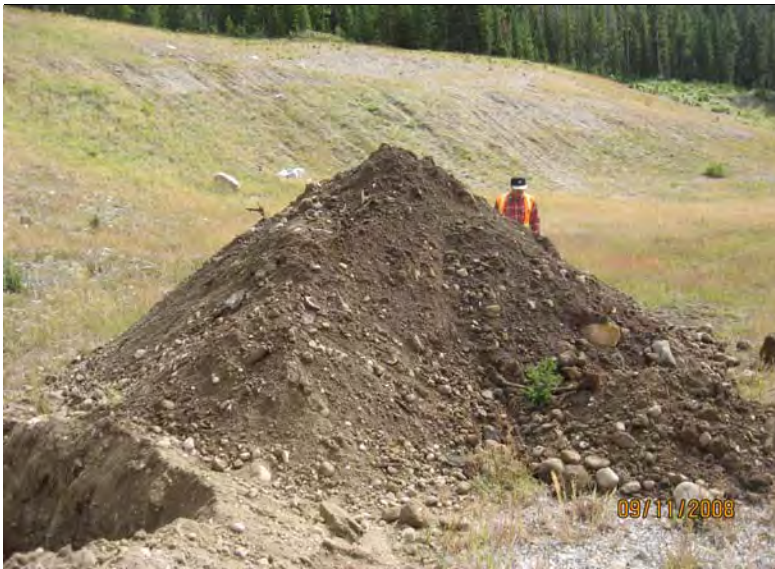
Picture #: McLaren RA Project\Site Investigation Photos\Julies Photos\McLaren SI109

Description: Spoils pile from TP-16.

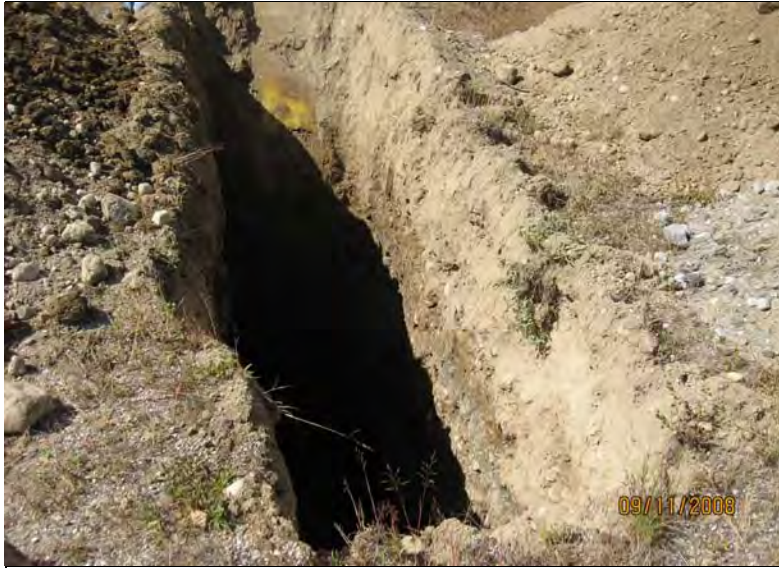
Picture #: McLaren RA Project\Site Investigation Photos\Julies Photos\McLaren SI110

Description: Test pit TP-17.

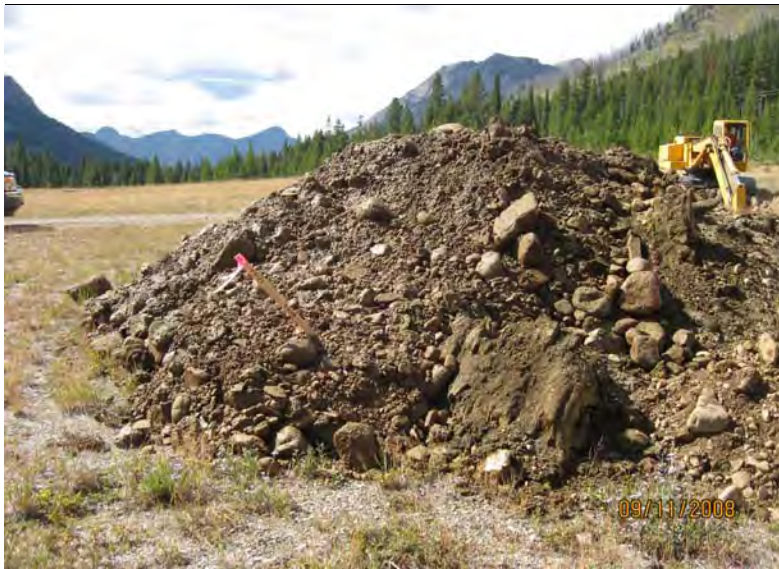
Picture #: McLaren RA Project\Site Investigation Photos\Julies Photos\McLaren SI111

Description: Spoils pile TP-17.

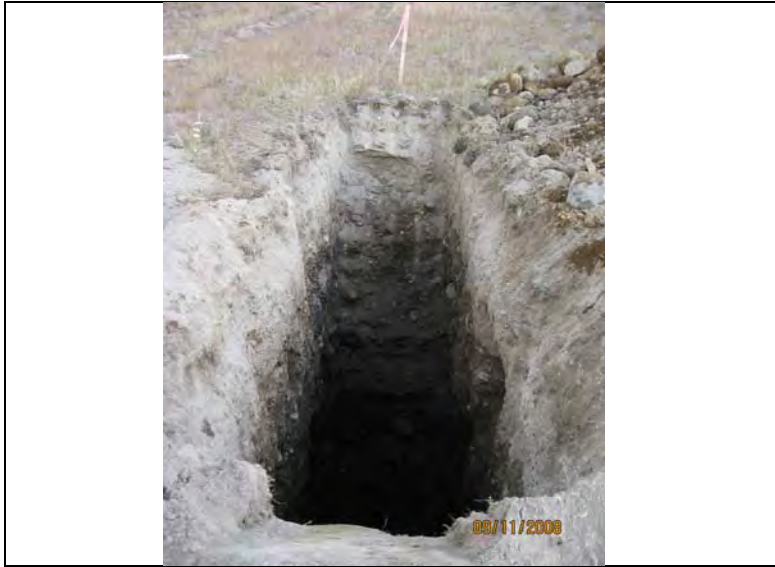
Picture #: McLaren RA Project\Site Investigation Photos\Julies Photos\McLaren  
SI112

Description: Test pit TP-18.

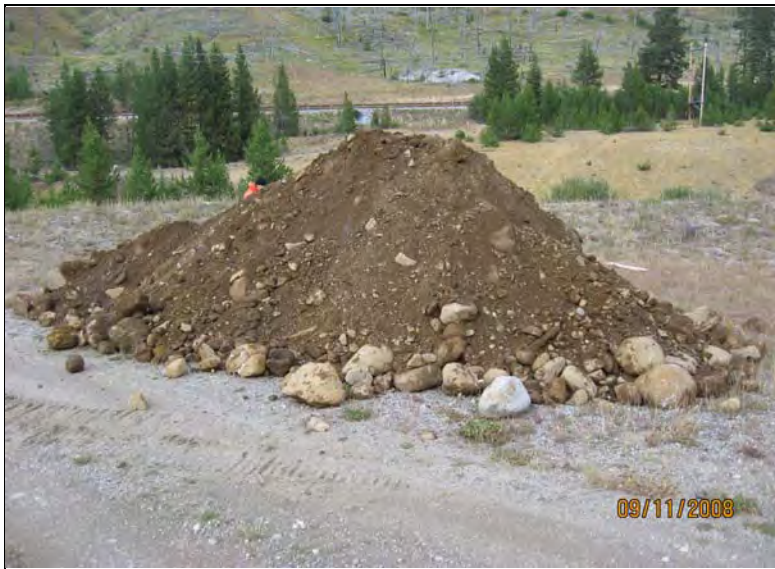
Picture #: McLaren RA Project\Site Investigation Photos\Julies Photos\McLaren  
SI13

Description: Spoils pile from test pit TP-18.

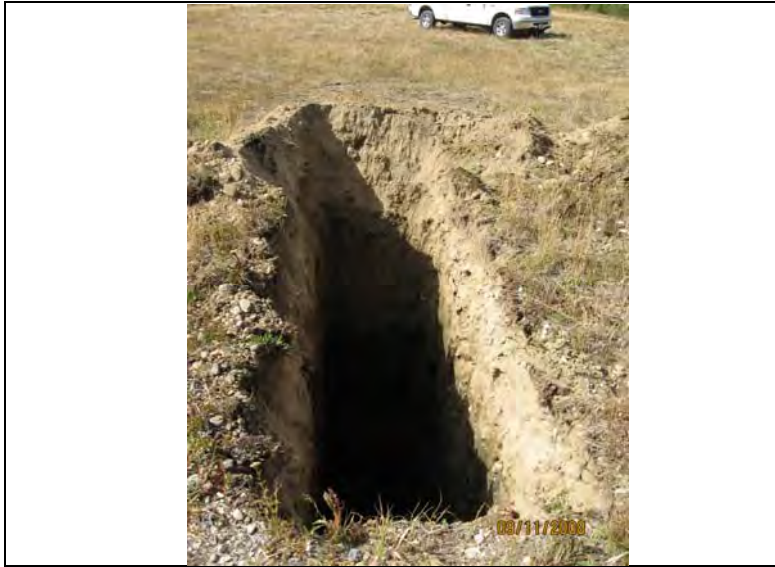
Picture #: McLaren RA Project\Site Investigation Photos\Julies Photos\McLaren SI114

Description: Test pit TP-19.

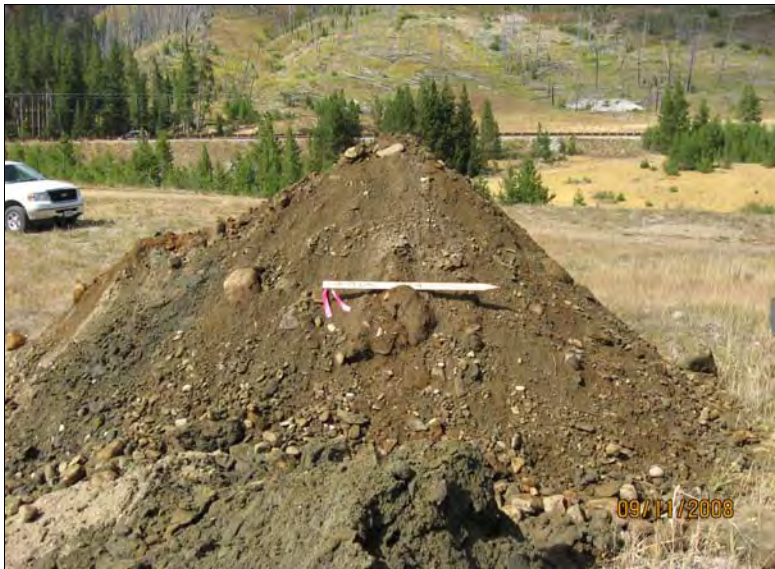
Picture #: McLaren RA Project\Site Investigation Photos\Julies Photos\McLaren SI115

Description: Spoils pile from TP-19.

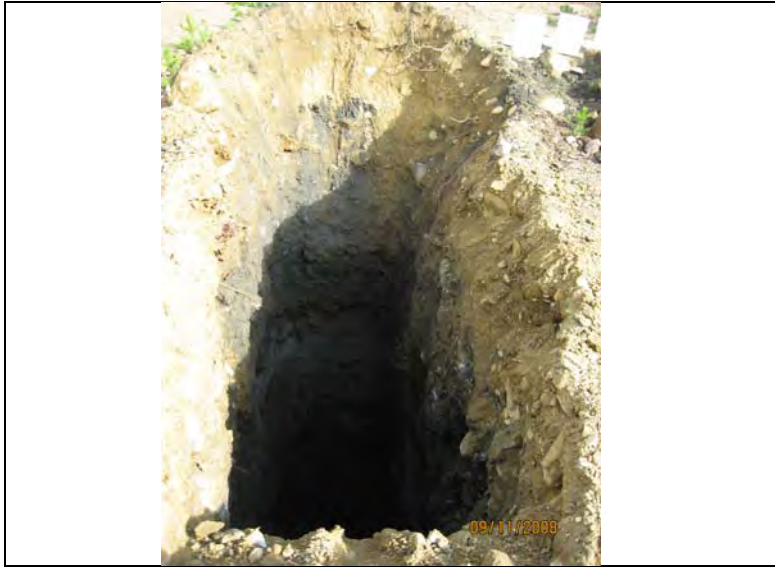
Picture #: McLaren RA Project\Site Investigation Photos\Julies Photos\McLaren SI116

Description: Test pit TP-20.

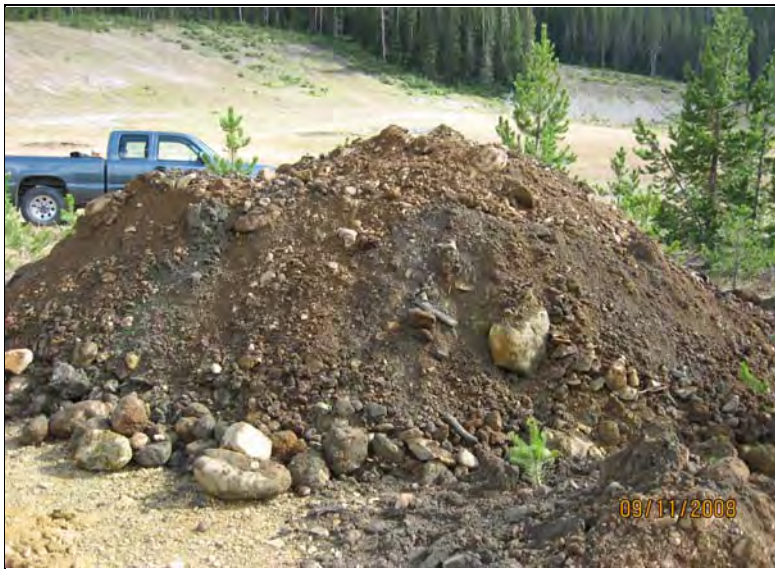
Picture #: McLaren RA Project\Site Investigation Photos\Julies Photos\McLaren SI117

Description: Spoils pile from TP-20.

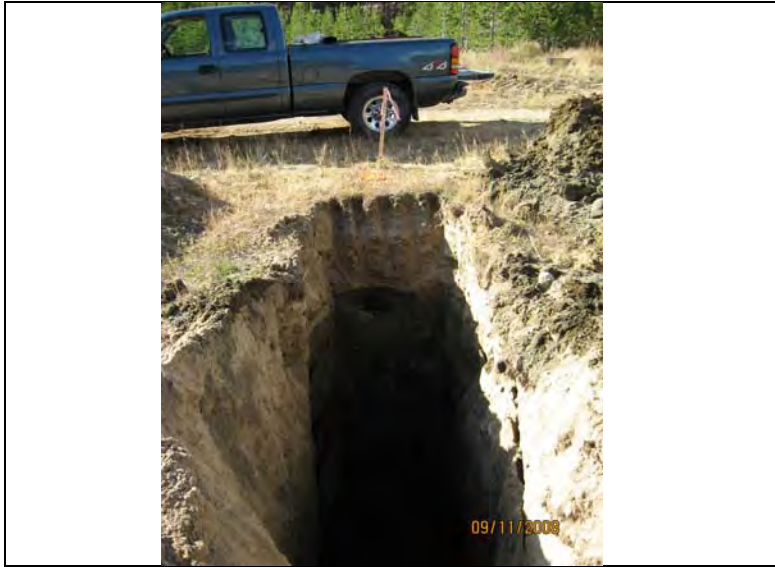
Picture #: McLaren RA Project\Site Investigation Photos\Julies Photos\McLaren SI 118

Description: Test pit TP-27.

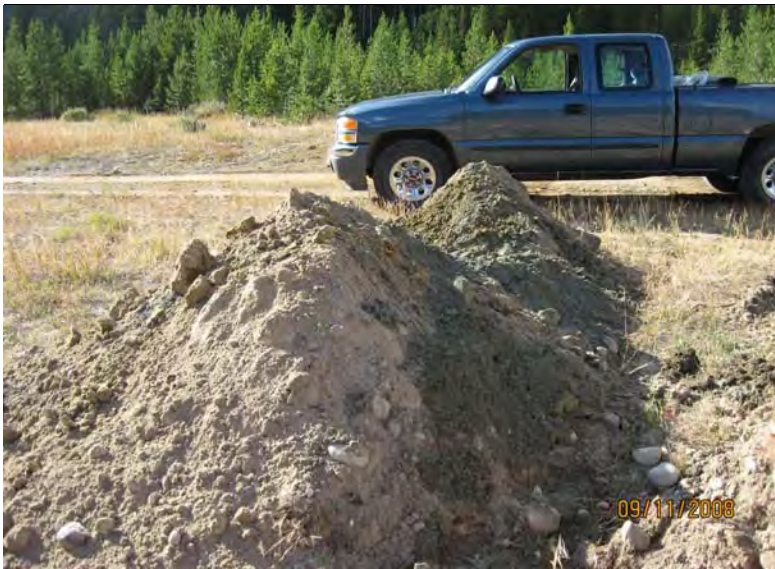
Picture #: McLaren RA Project\Site Investigation Photos\Julies Photos\McLaren SI119

Description: Spoils pile for A bucket from TP-27.
