**RECLAMATION DESIGN REPORT  
FOR THE  
McLAREN TAILINGS ABANDONED MINE SITE  
COOKE CITY, MONTANA**

## **APPENDIX A**

### **PHOTO LOG**

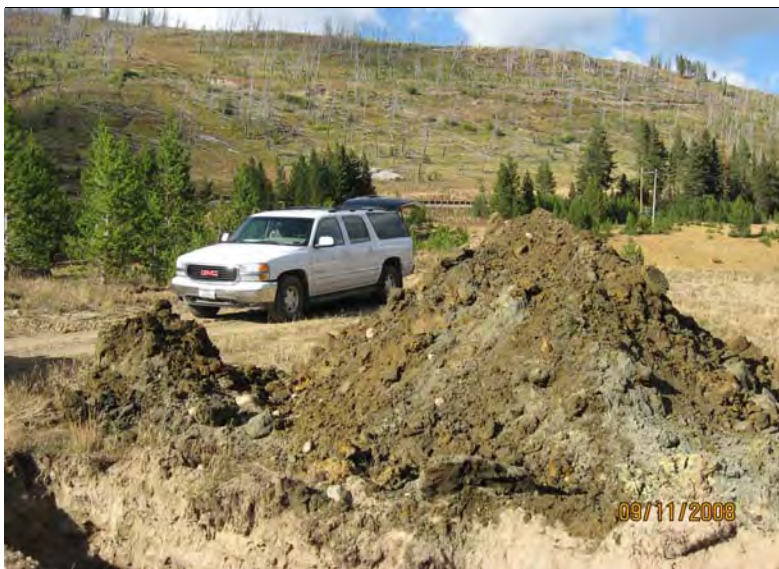
Picture #: McLaren RA Project\Site Investigation Photos\Julies Photos\McLaren SI120

Description: Spoils pile for B bucket from TP-27.

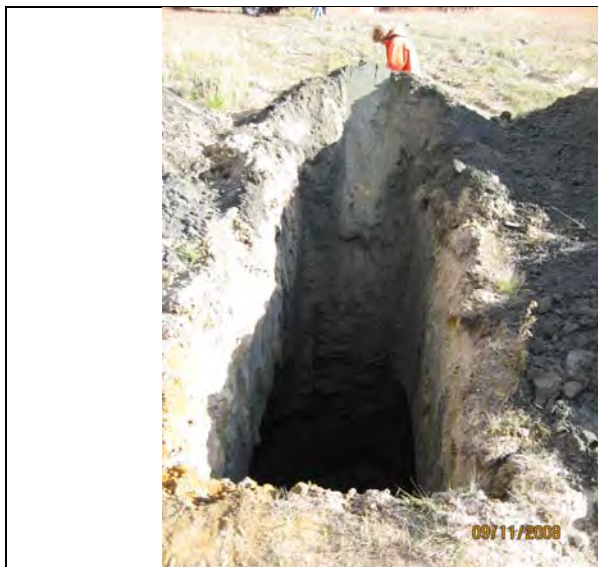
Picture #: McLaren RA Project\Site Investigation Photos\Julies Photos\McLaren SI121

Description: Test pit TP-28.

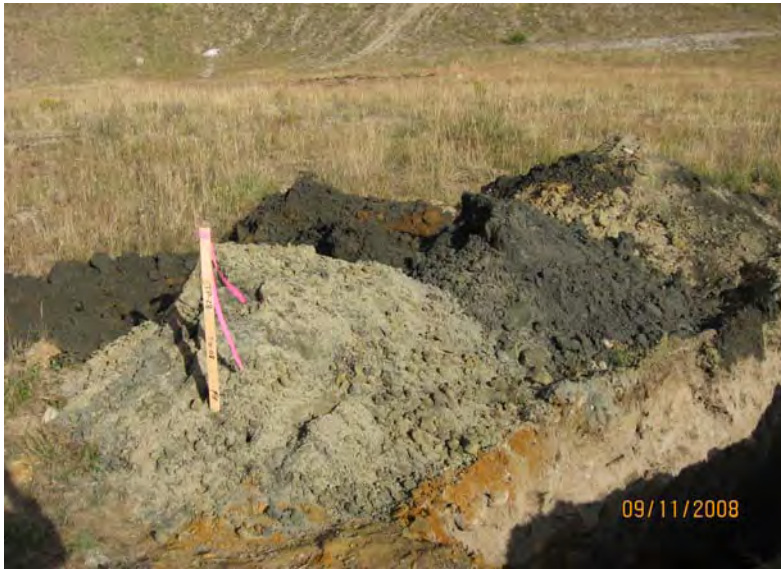
Picture #: McLaren RA Project\Site Investigation Photos\Julies Photos\McLaren  
SI122

Description: Spoils pile from TP-28.

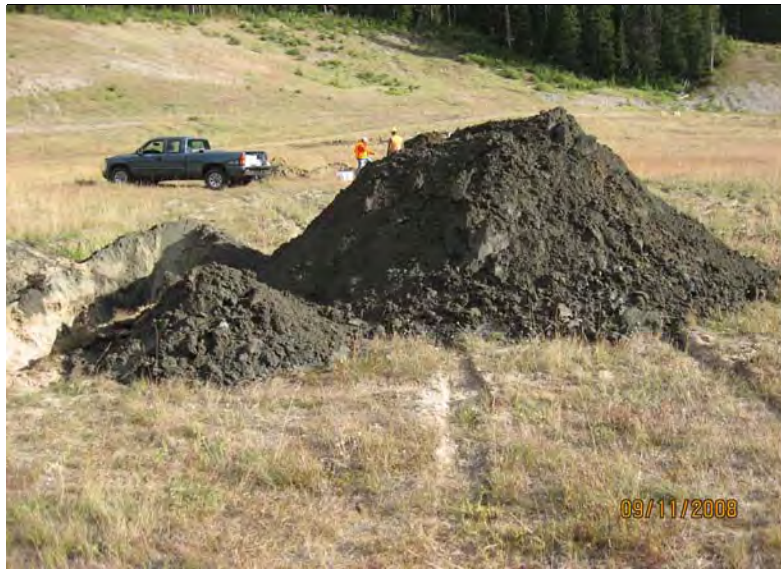
Picture #: McLaren RA Project\Site Investigation Photos\Julies Photos\McLaren  
SI123

Description: Spoils pile from TP-28.

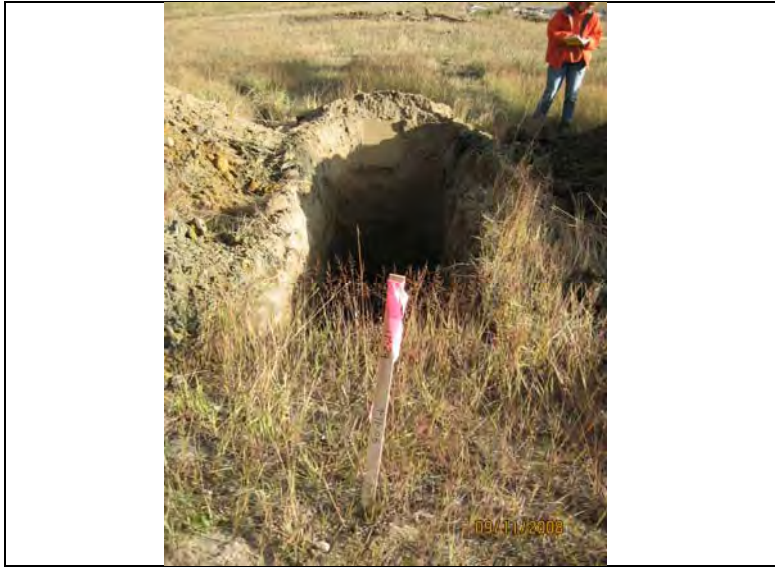
Picture #: McLaren RA Project\Site Investigation Photos\Julies Photos\McLaren  
SI124

Description: Tes pit TP-29.

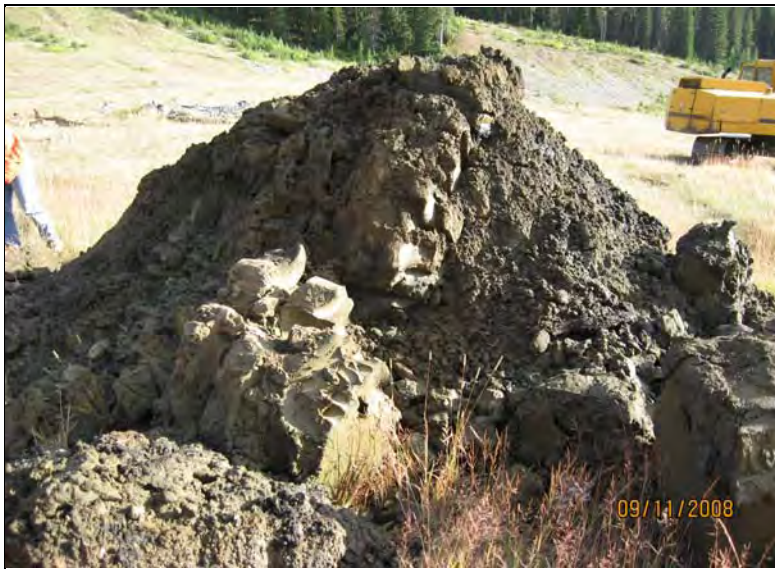
Picture #: McLaren RA Project\Site Investigation Photos\Julies Photos\McLaren  
SI125

Description: Spoils pile from top half of TP-29.

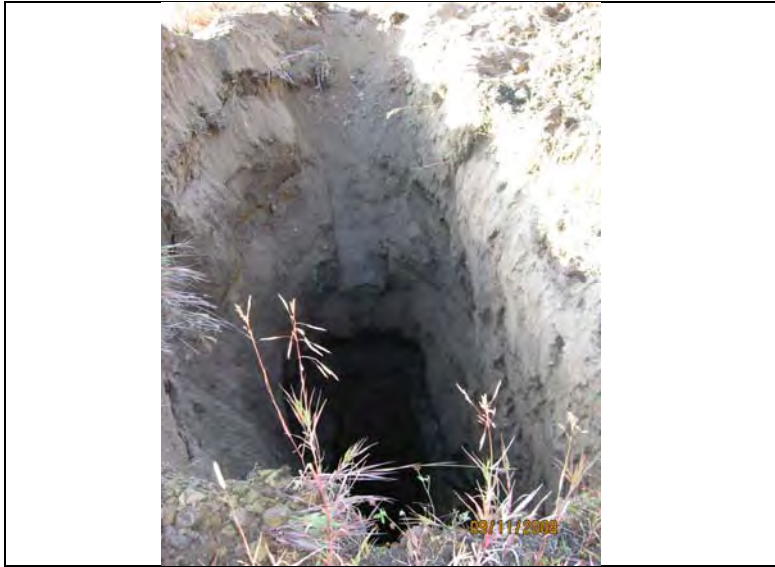
Picture #: McLaren RA Project\Site Investigation Photos\Julies Photos\McLaren  
SI126

Description: Test pit TP-30.

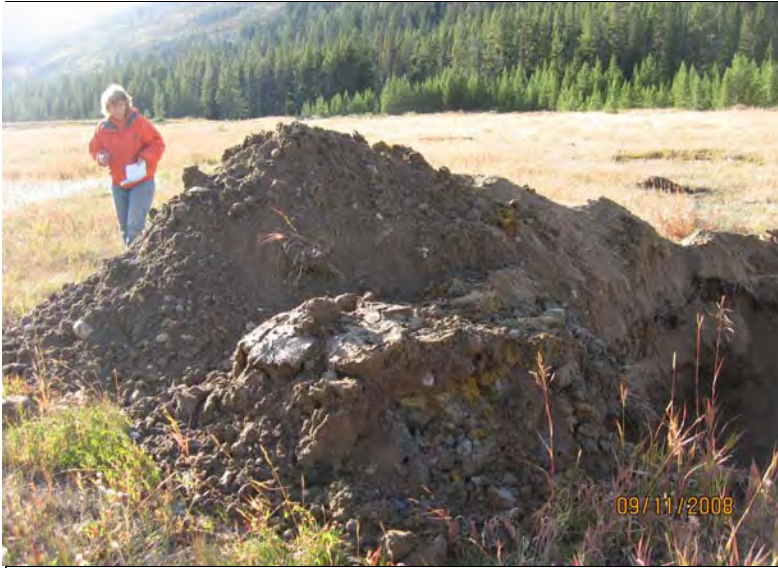
Picture #: McLaren RA Project\Site Investigation Photos\Julies Photos\McLaren  
SI127

Description: Spoils pile from top half of TP-30.

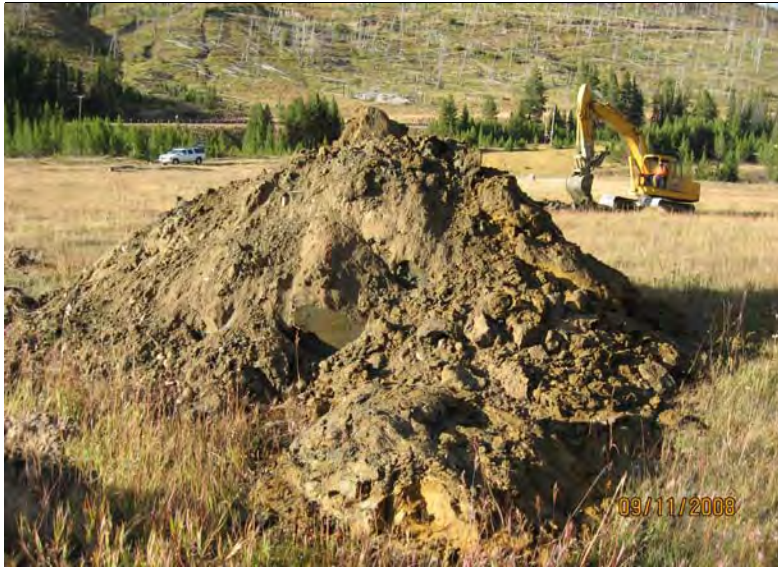
Picture #: McLaren RA Project\Site Investigation Photos\Julies Photos\McLaren  
SI128

Description: TP-30 spoils pile from bottom half of test pit.

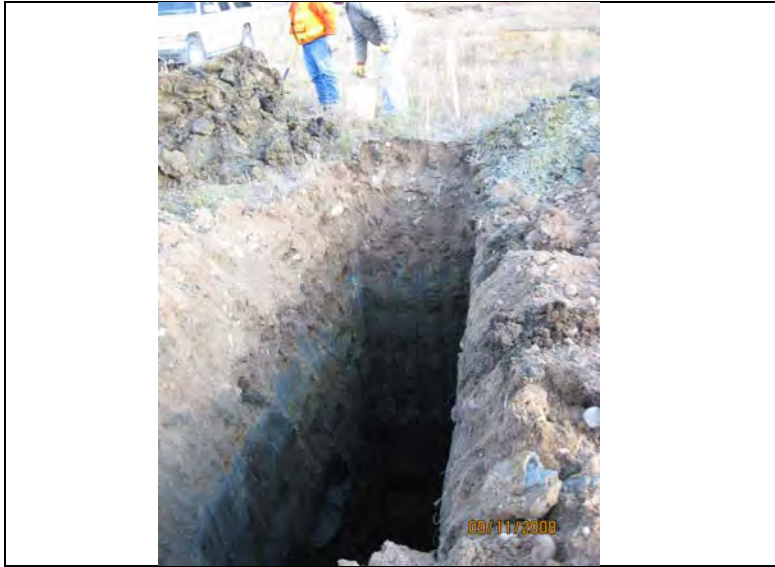
Picture #: McLaren RA Project\Site Investigation Photos\Julies Photos\McLaren  
SI 129

Description: Test pit TP-31.

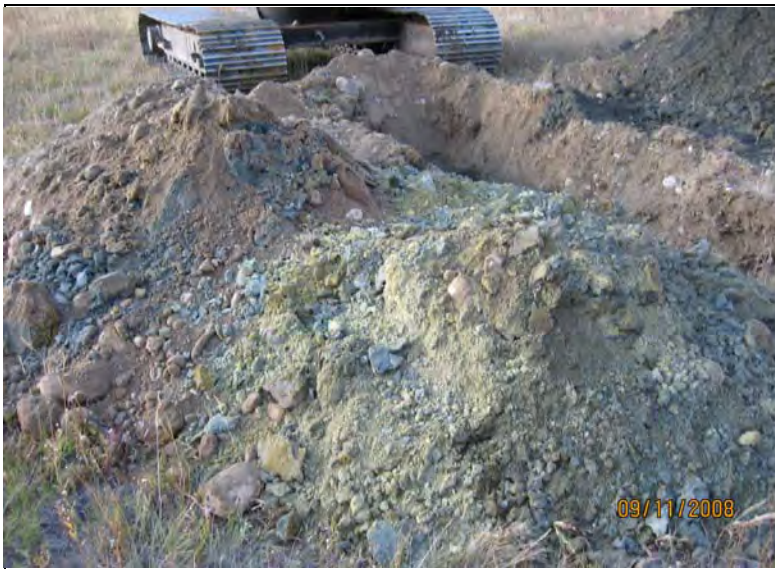
Picture #: McLaren RA Project\Site Investigation Photos\Julies Photos\McLaren  
SI 130

Description: TP-31 spoils pile from top half of test pit.

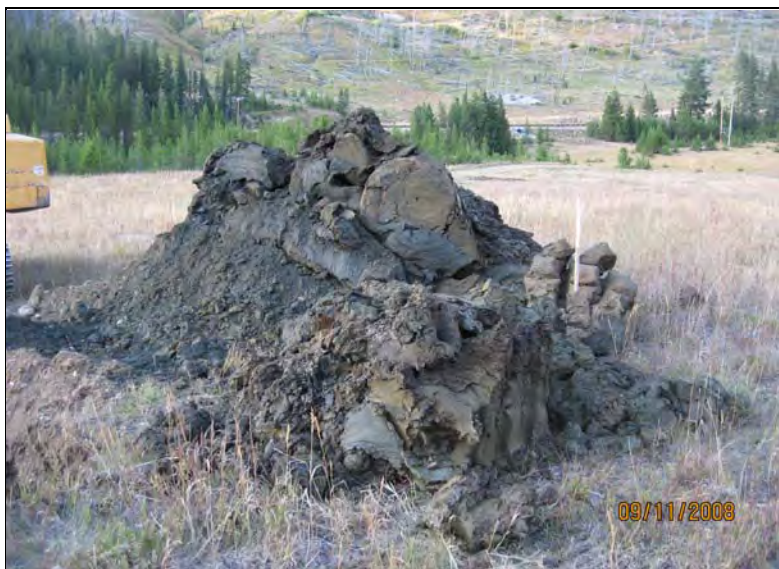
Picture #: McLaren RA Project\Site Investigation Photos\Julies Photos\McLaren  
SI 131

Description: TP-31 spoils pile from bottom half of test pit.

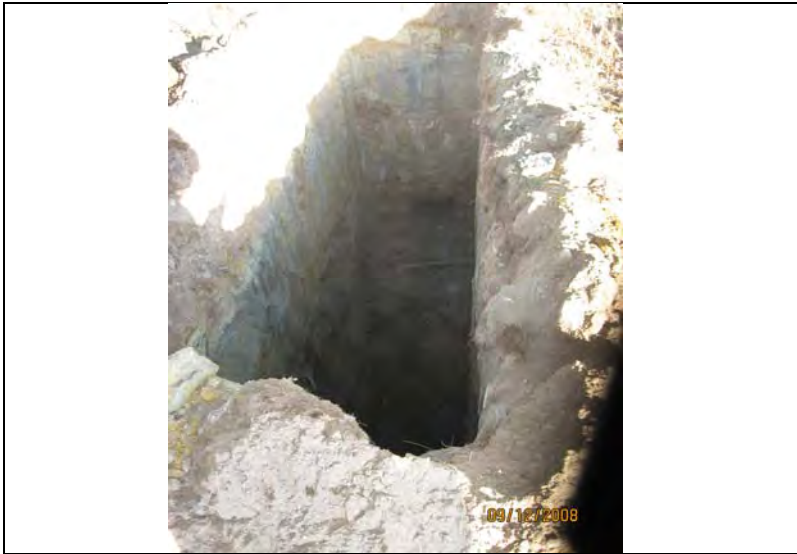
Picture #: McLaren RA Project\Site Investigation Photos\Julies Photos\McLaren  
SI 132

Description: Test pit TP-32.

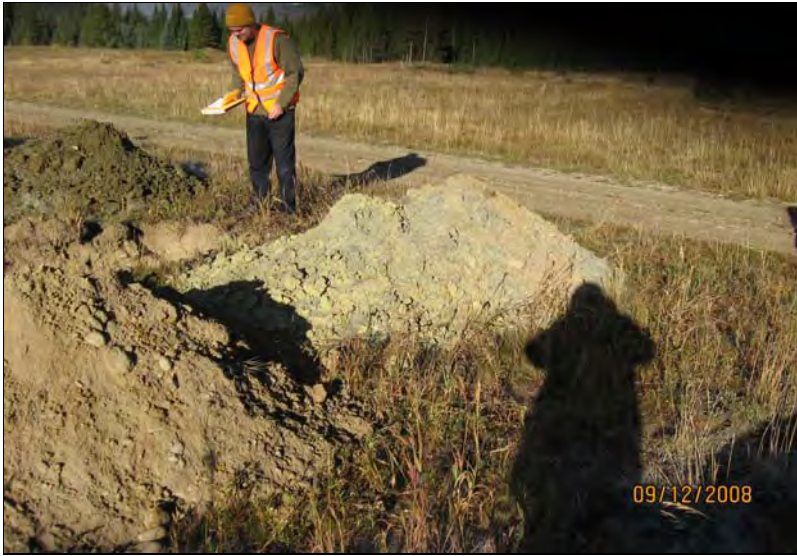
Picture #: McLaren RA Project\Site Investigation Photos\Julies Photos\McLaren SI 133

Description: TP-32 spoils pile from the top half of the test pit.

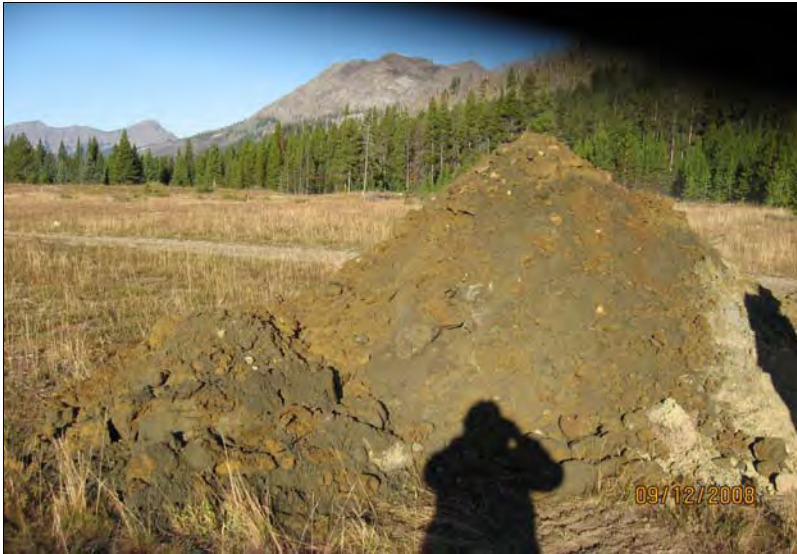
Picture #: McLaren RA Project\Site Investigation Photos\Julies Photos\McLaren SI 134

Description: TP-32 spoils pile from the bottom half of the test pit.

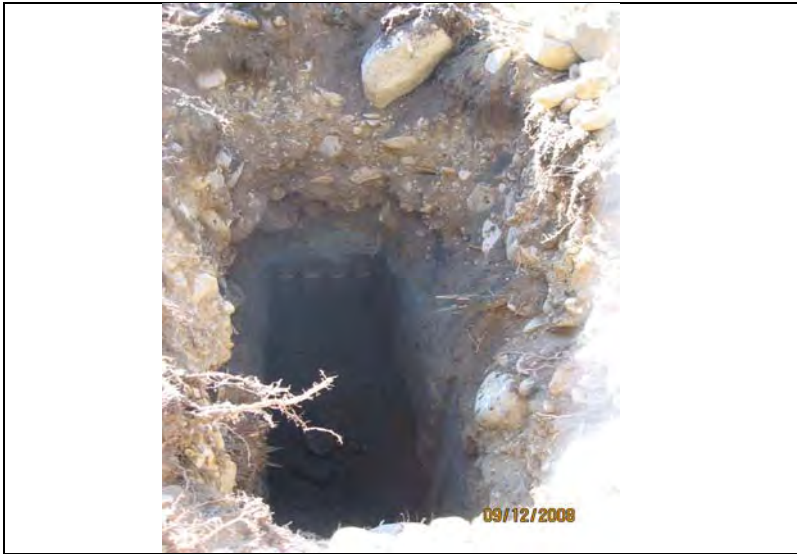
Picture #: McLaren RA Project\Site Investigation Photos\Julies Photos\McLaren SI 135

Description: Test pit TP-33.

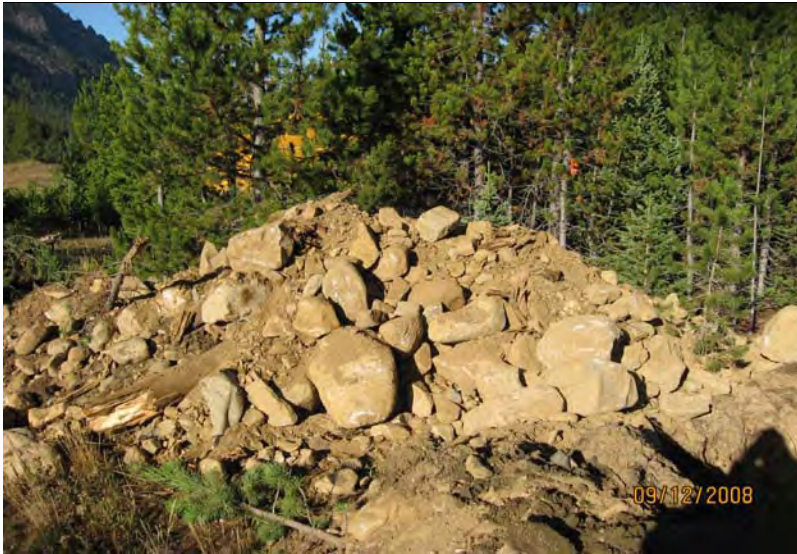
Picture #: McLaren RA Project\Site Investigation Photos\Julies Photos\McLaren SI 136

Description: Cover soil spoils pile.

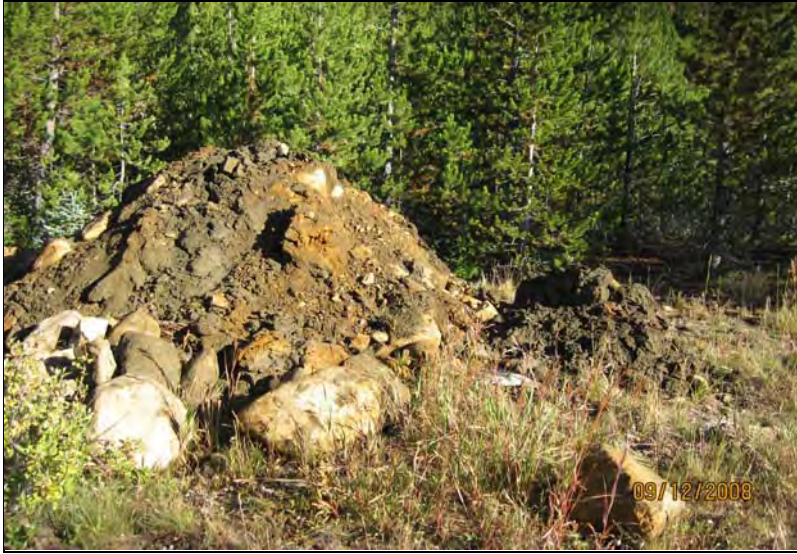
Picture #: McLaren RA Project\Site Investigation Photos\Julies Photos\McLaren SI 137

Description: Tailings spoils pile from TP-33.

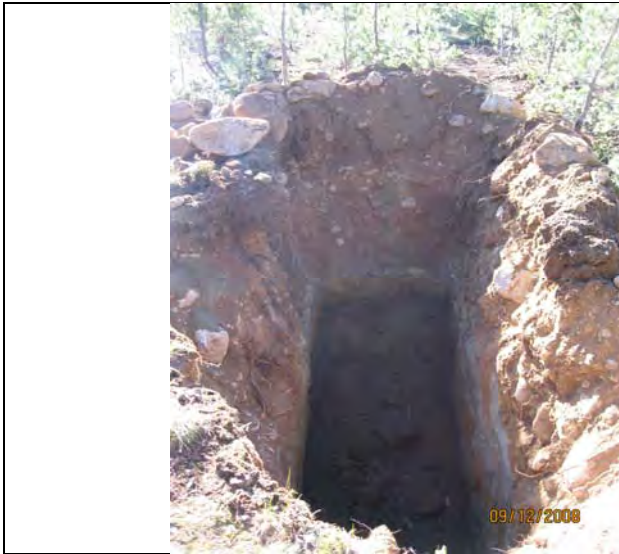
Picture #: McLaren RA Project\Site Investigation Photos\Julies Photos\McLaren SI 138

Description: Test pit TP-34.

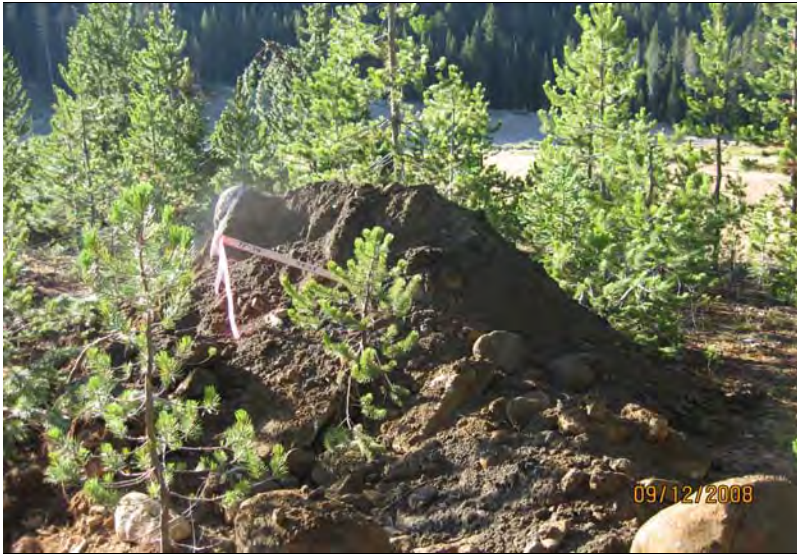
Picture #: McLaren RA Project\Site Investigation Photos\Julies Photos\McLaren SI 139

Description: Tailings pile from TP-34.

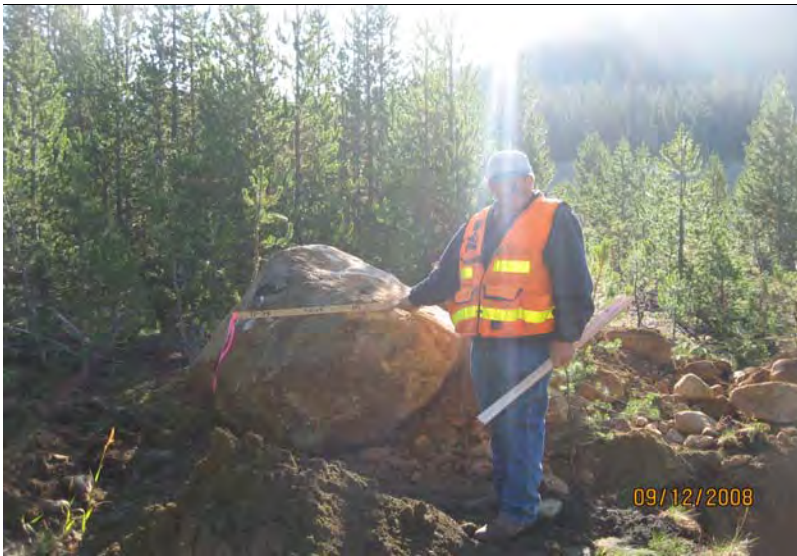
Picture #: McLaren RA Project\Site Investigation Photos\Julies Photos\McLaren SI 140

Description: Large rock from cover soil in TP-34.

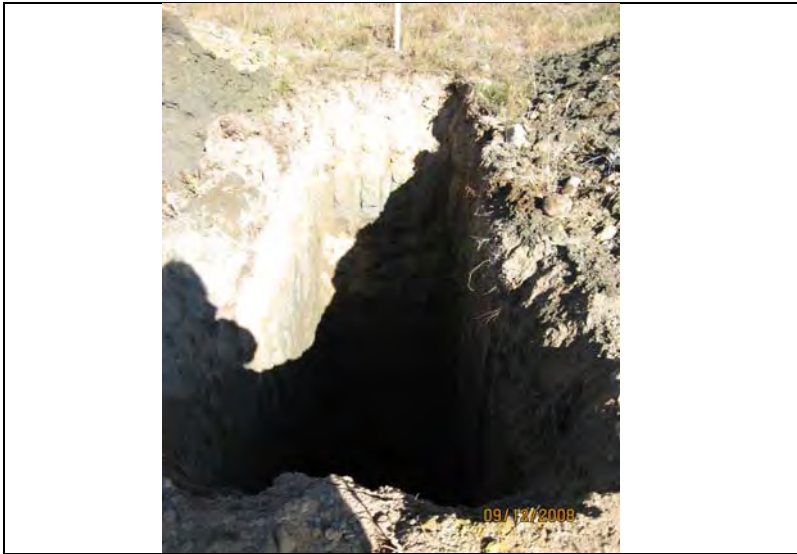
Picture #: McLaren RA Project\Site Investigation Photos\Julies Photos\McLaren SI 141

Description: Test pit TP-35.

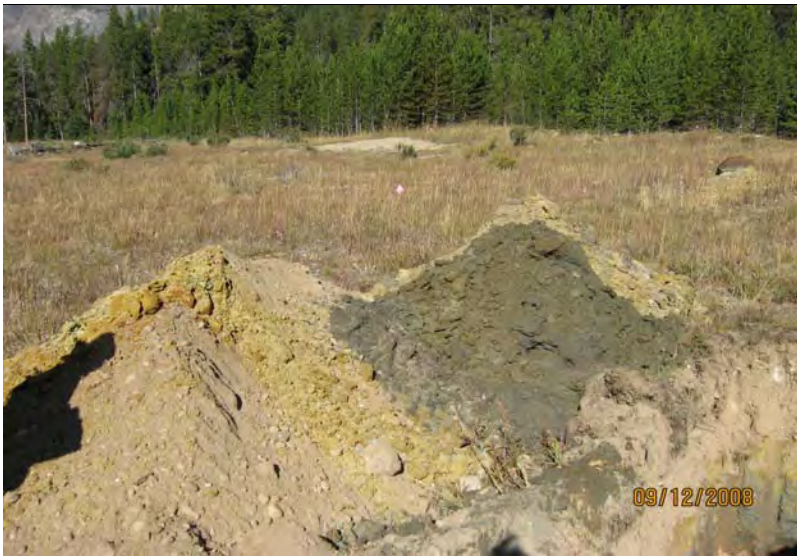
Picture #: McLaren RA Project\Site Investigation Photos\Julies Photos\McLaren SI 142

Description: Spoils pile from the top half of TP-35 (tailings and cover soil).

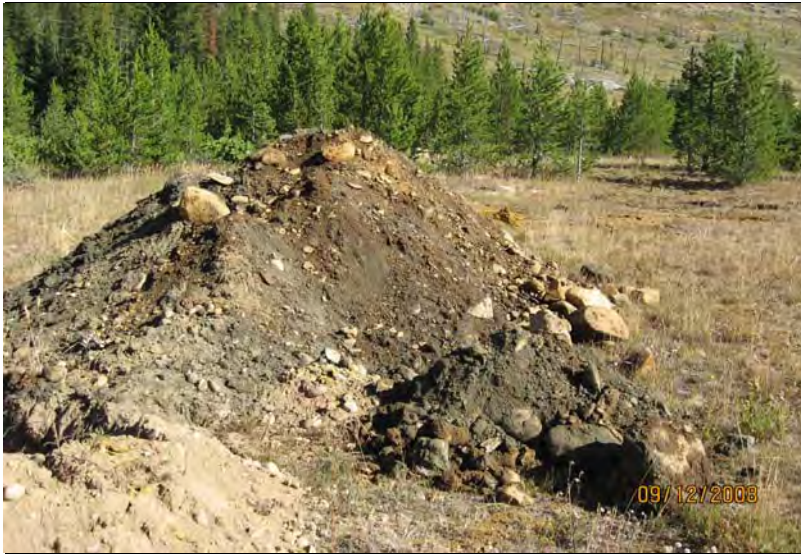
Picture #: McLaren RA Project\Site Investigation Photos\Julies Photos\McLaren SI 143

Description: Spoils pile from the bottom half of TP-35 (tailings).

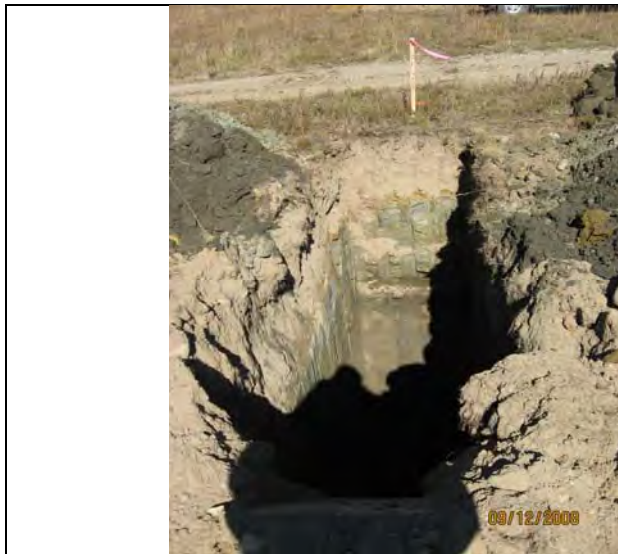
Picture #: McLaren RA Project\Site Investigation Photos\Julies Photos\McLaren SI 144

Description: Test pit TP-36.

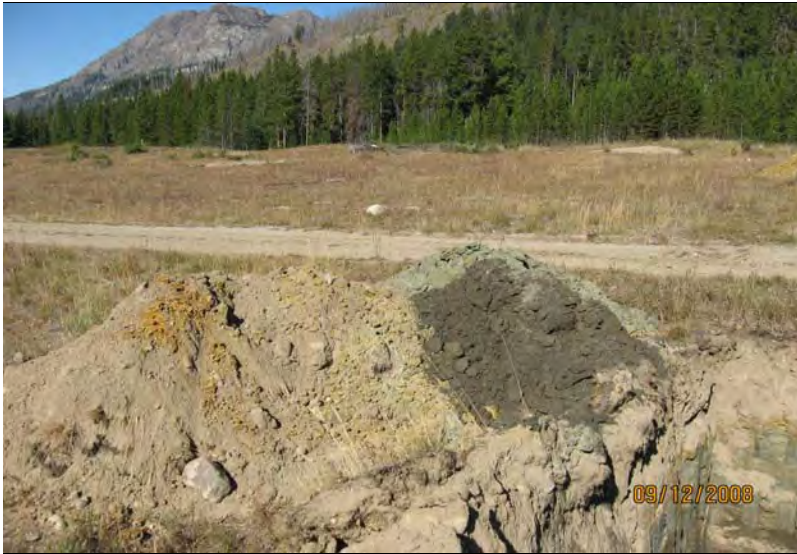
Picture #: McLaren RA Project\Site Investigation Photos\Julies Photos\McLaren SI 145

Description: Spoils pile from the top half of TP-36 (cover soil and tailings).

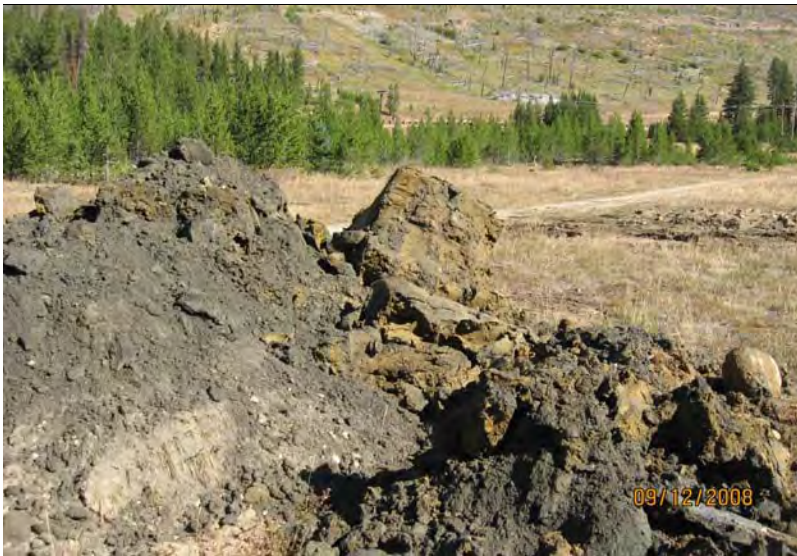
Picture #: McLaren RA Project\Site Investigation Photos\Julies Photos\McLaren SI 146

Description: Spoils pile of tailings from the bottom half of TP-36.

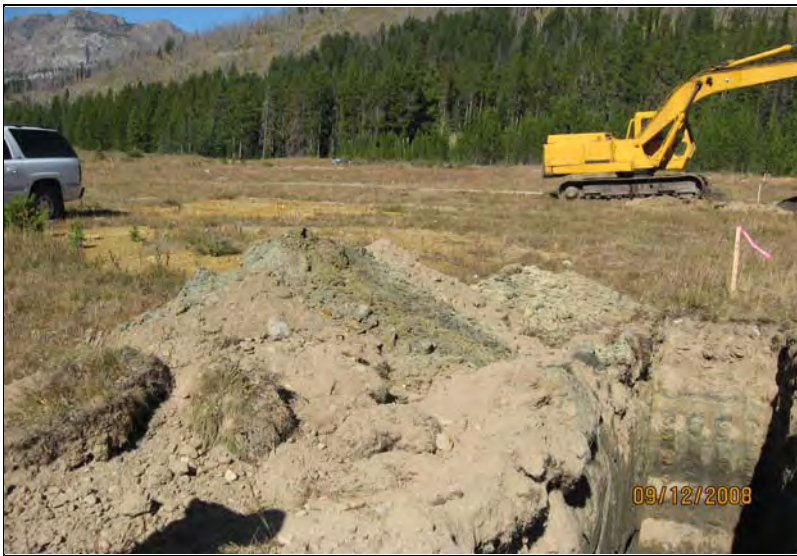
Picture #: McLaren RA Project\Site Investigation Photos\Julies Photos\McLaren SI 148

Description: Spoils pile from top half of TP-37.

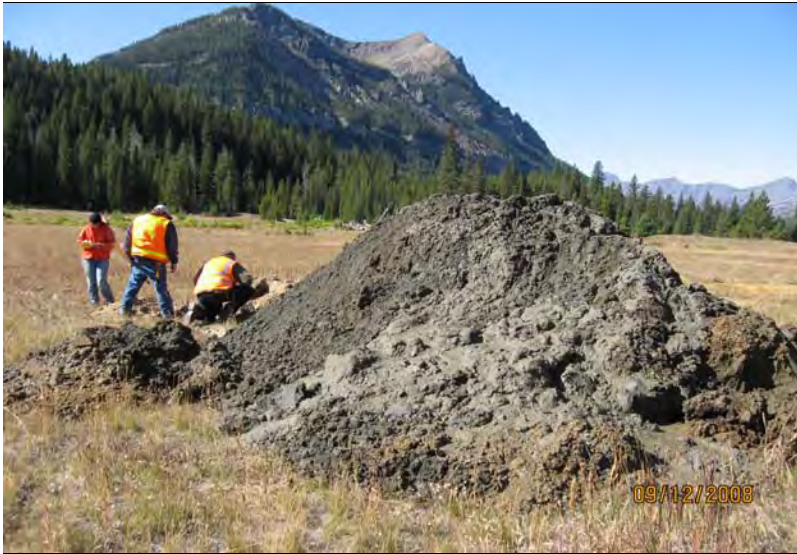
Picture #: McLaren RA Project\Site Investigation Photos\Julies Photos\McLaren SI 149

Description: Spoils pile from bottom half of TP-37.

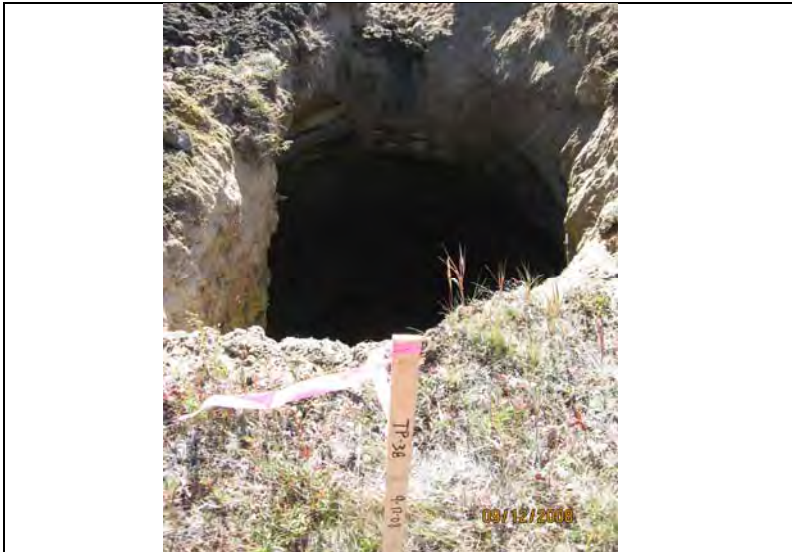
Picture #: McLaren RA Project\Site Investigation Photos\Julies Photos\McLaren SI 150

Description: Test pit TP-38.

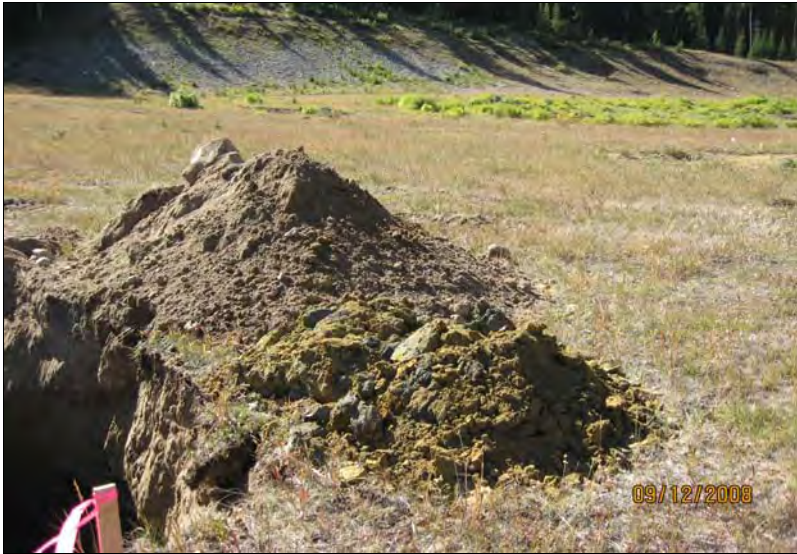
Picture #: McLaren RA Project\Site Investigation Photos\Julies Photos\McLaren SI 151

Description: Spoils pile from top half of TP-38.

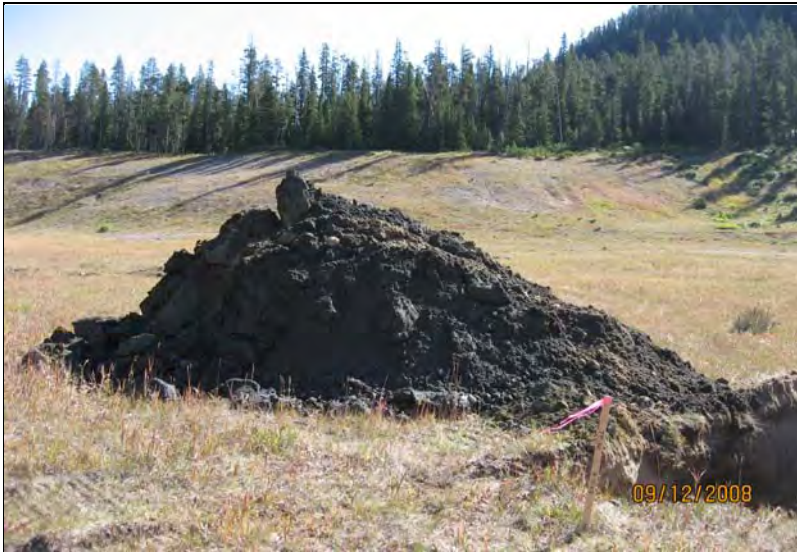
Picture #: McLaren RA Project\Site Investigation Photos\Julies Photos\McLaren SI 152

Description: Spoils pile from the bottom half of TP-38.

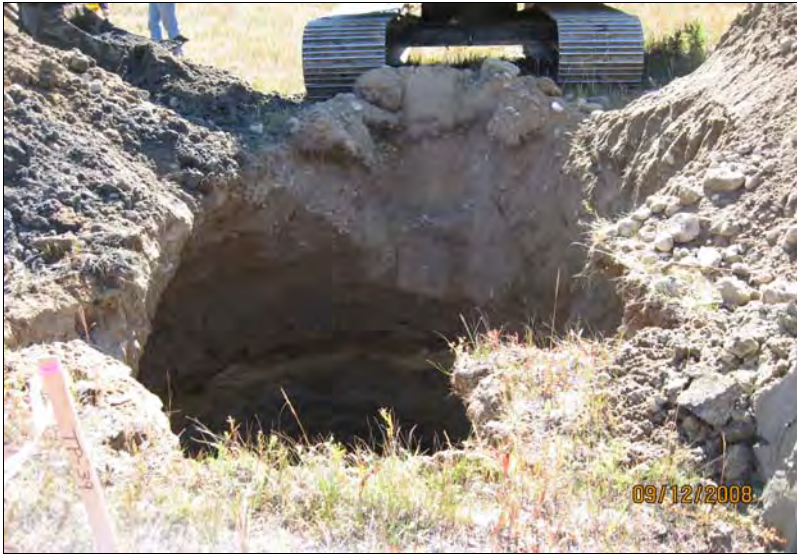
Picture #: McLaren RA Project\Site Investigation Photos\Julies Photos\McLaren SI 153

Description: Test pit TP-39.

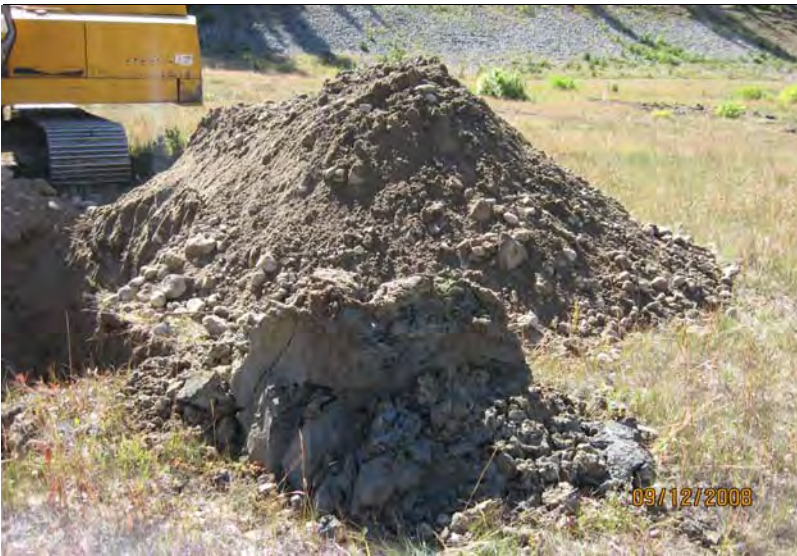
Picture #: McLaren RA Project\Site Investigation Photos\Julies Photos\McLaren SI 154

Description: Spoils pile from the top half of test pit TP-39.

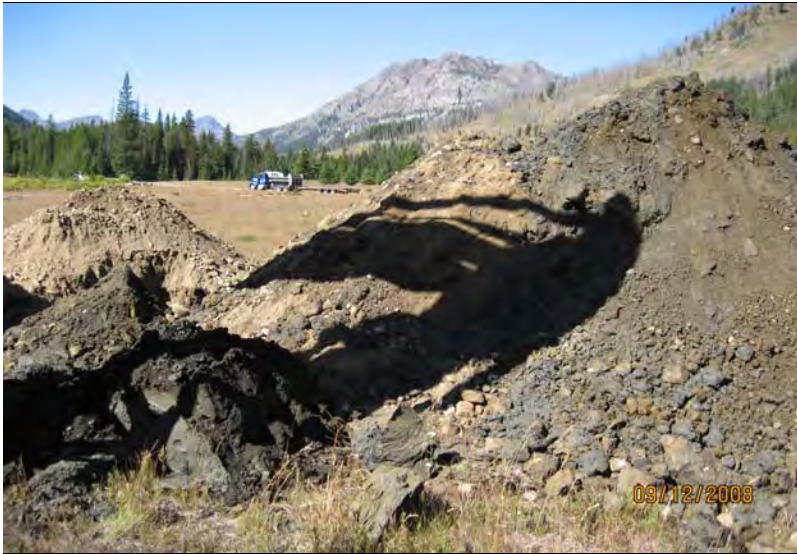
Picture #: McLaren RA Project\Site Investigation Photos\Julies Photos\McLaren SI 155

Description: Spoils pile from the bottom half of test pit TP-39.

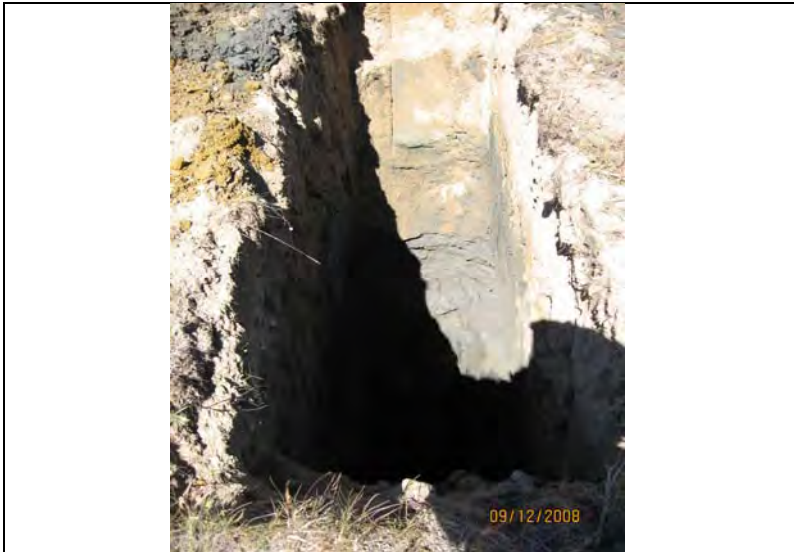
Picture #: McLaren RA Project\Site Investigation Photos\Julies Photos\McLaren SI 156

Description: Test pit TP-40.

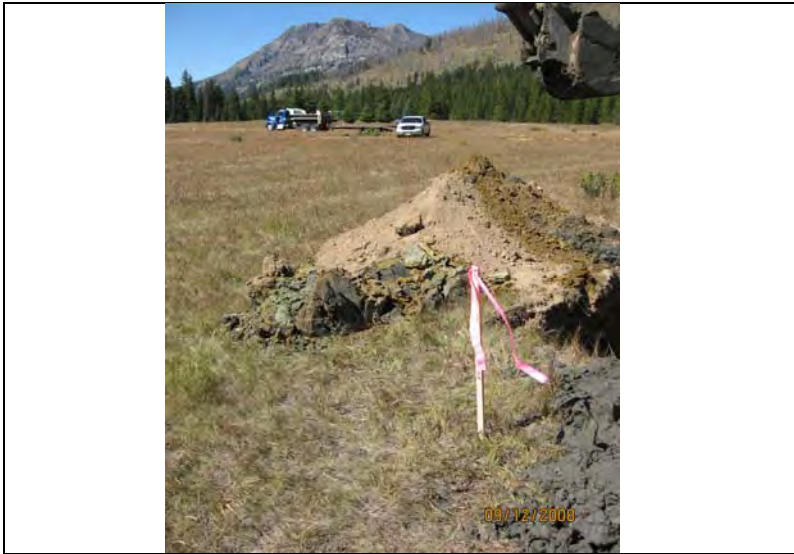
Picture #: McLaren RA Project\Site Investigation Photos\Julies Photos\McLaren SI 157

Description: Spoils pile from top 7 ft of TP-40.

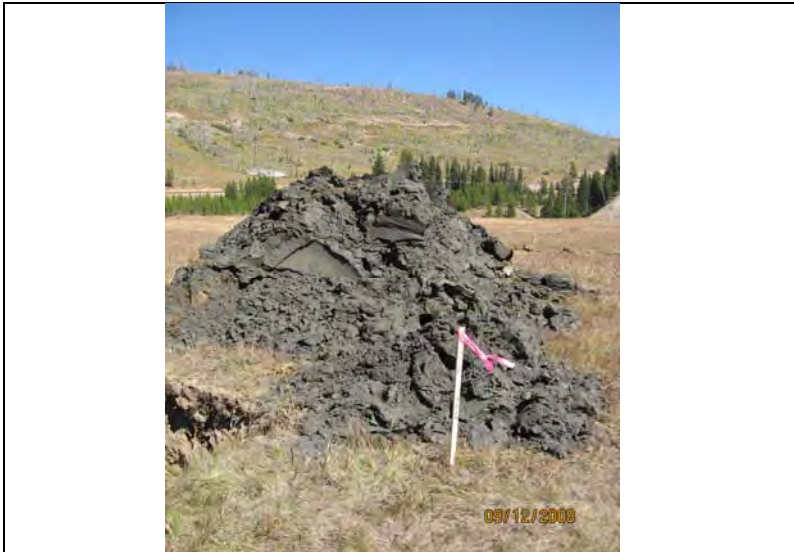
Picture #: McLaren RA Project\Site Investigation Photos\Julies Photos\McLaren SI 158

Description: Spoils pile from bottom of TP-40.

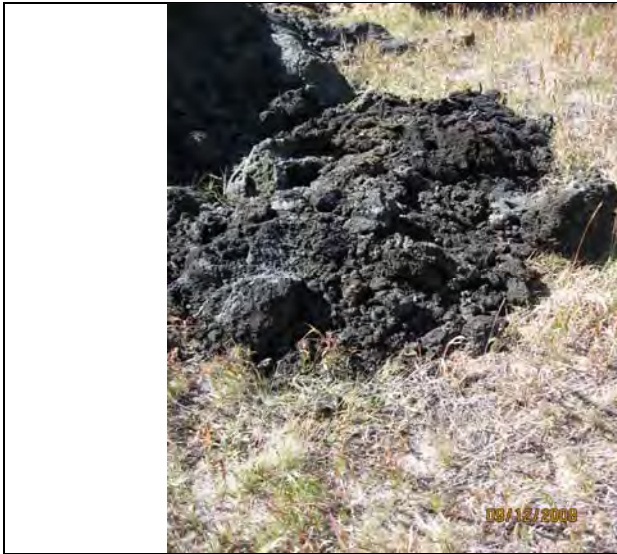
Picture #: McLaren RA Project\Site Investigation Photos\Julies Photos\McLaren SI 159

Description: Black loamy material from base of pile (TP-40).

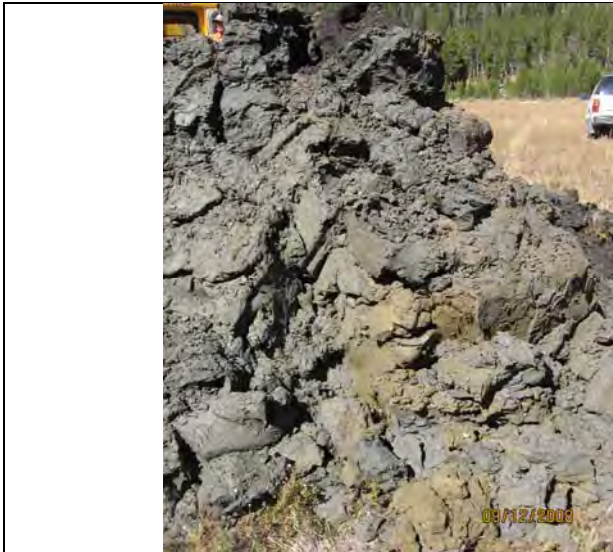
Picture #: McLaren RA Project\Site Investigation Photos\Julies Photos\McLaren SI 160

Description: Brown clayey silty sand from bottom of pile (TP-40).

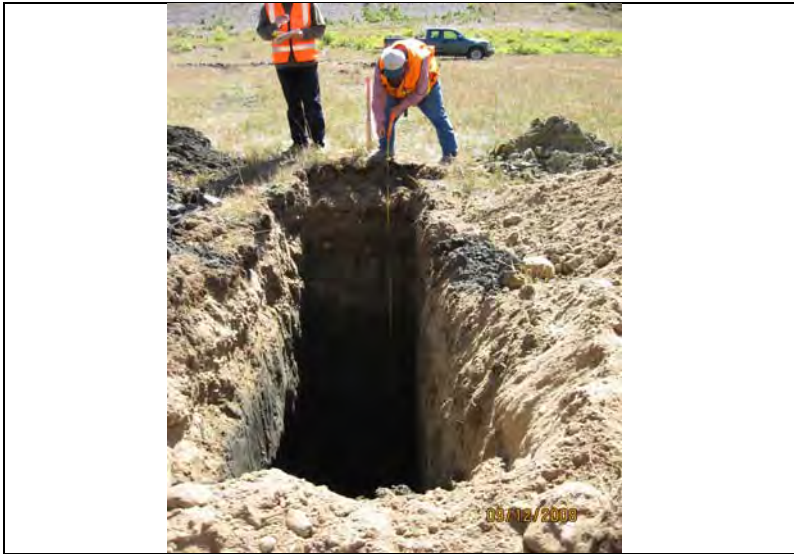
Picture #: McLaren RA Project\Site Investigation Photos\Julies Photos\McLaren SI 161

Description: Test pit TP-41

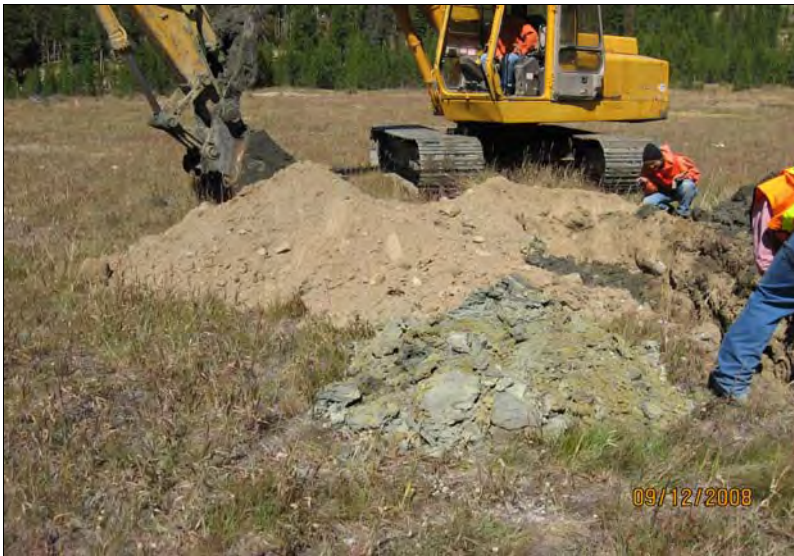
Picture #: McLaren RA Project\Site Investigation Photos\Julies Photos\McLaren SI 162

Description: Spoils pile from top half of TP-41

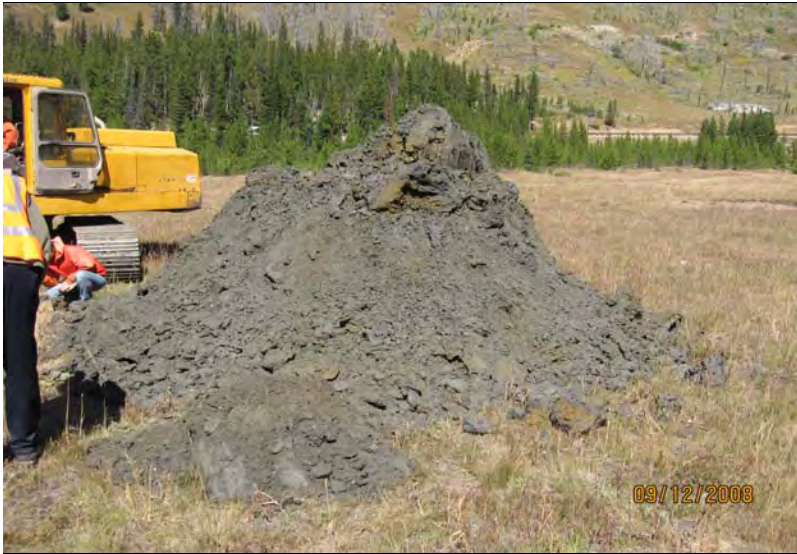
Picture #: McLaren RA Project\Site Investigation Photos\Julies Photos\McLaren SI 163

Description: Spoils pile from bottom half of TP-41

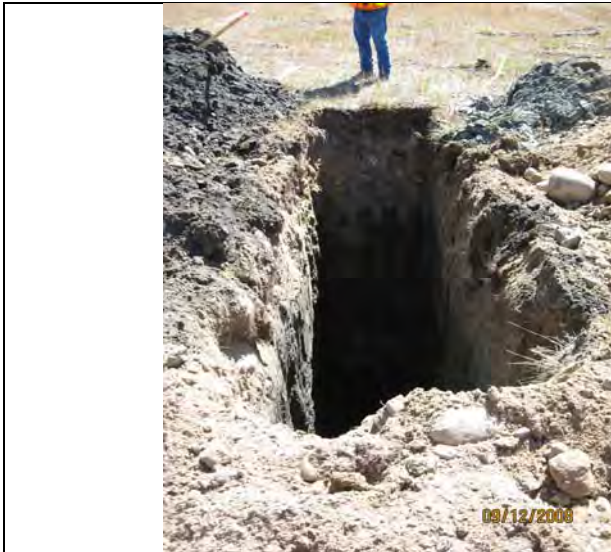
Picture #: McLaren RA Project\Site Investigation Photos\Julies Photos\McLaren SI 164

Description: Test pit TP-42

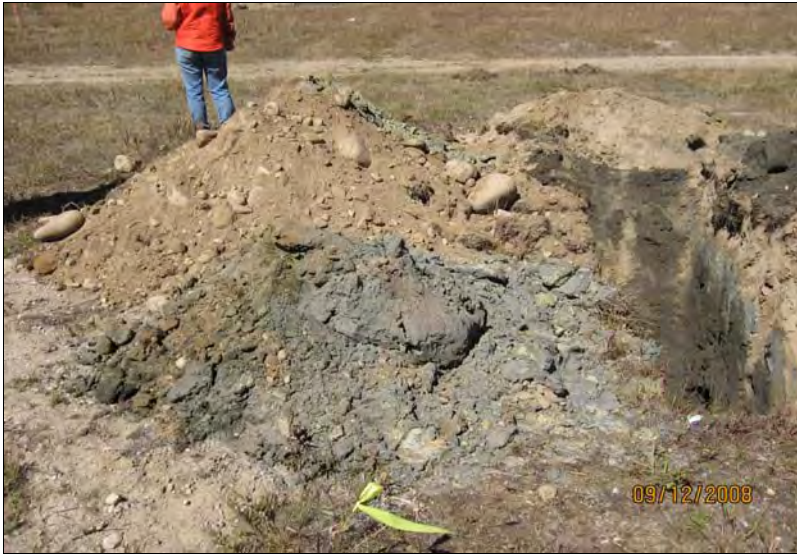
Picture #: McLaren RA Project\Site Investigation Photos\Julies Photos\McLaren SI 165

Description: Spoils pile from top half of TP-42

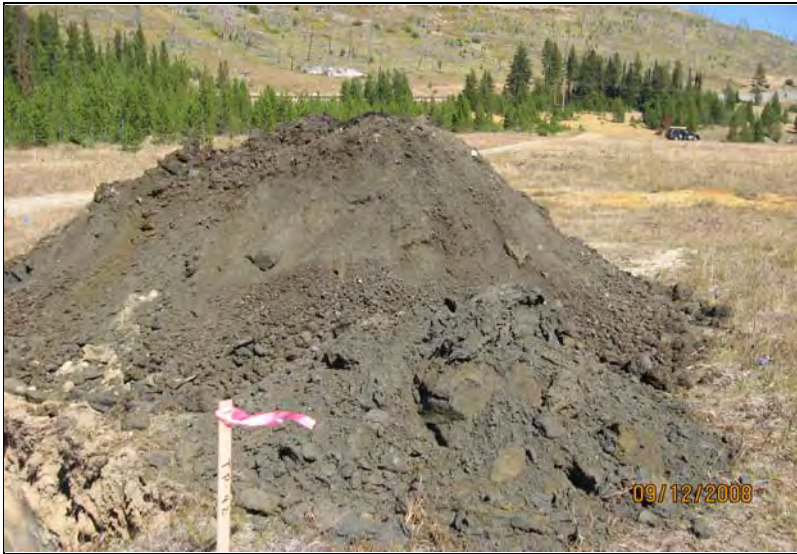
Picture #: McLaren RA Project\Site Investigation Photos\Julies Photos\McLaren SI 166

Description: Spoils pile from bottom half of TP-42

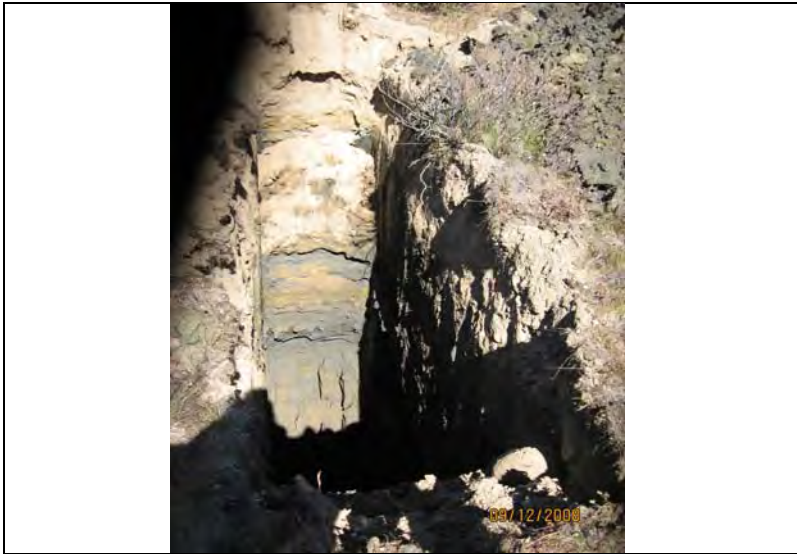
Picture #: McLaren RA Project\Site Investigation Photos\Julies Photos\McLaren SI 167

Description: Test pit TP-43

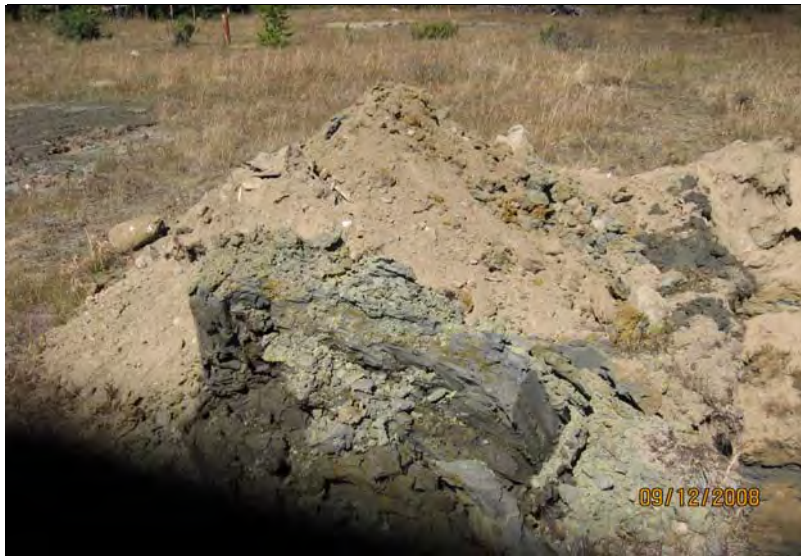
Picture #: McLaren RA Project\Site Investigation Photos\Julies Photos\McLaren SI 168

Description: Spoils pile from the top half of TP-43

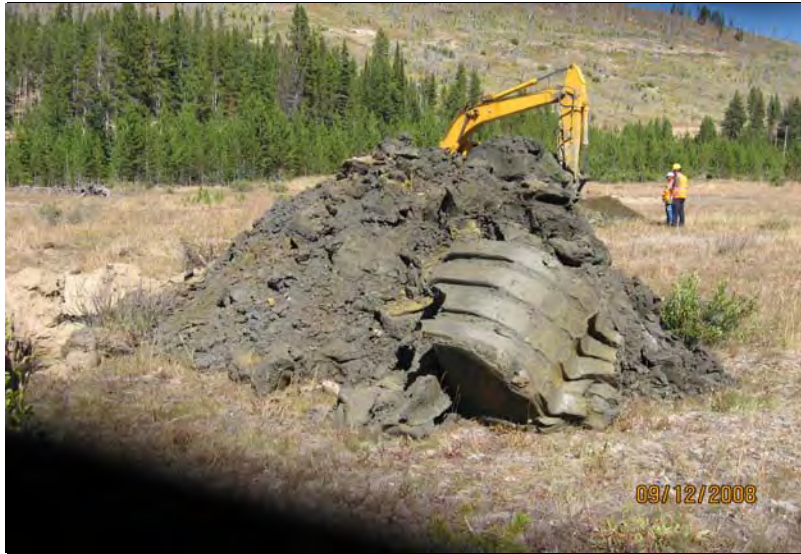
Picture #: McLaren RA Project\Site Investigation Photos\Julies Photos\McLaren SI 169

Description: Spoils pile from the bottom half of TP-43

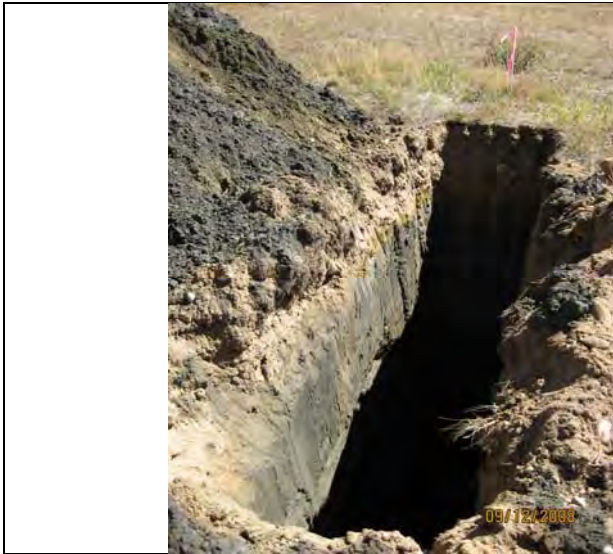
Picture #: McLaren RA Project\Site Investigation Photos\Julies Photos\McLaren SI 170

Description: Test pit TP-44
