**RECLAMATION DESIGN REPORT  
FOR THE  
McLAREN TAILINGS ABANDONED MINE SITE  
COOKE CITY, MONTANA**

## **APPENDIX A**

### **PHOTO LOG**

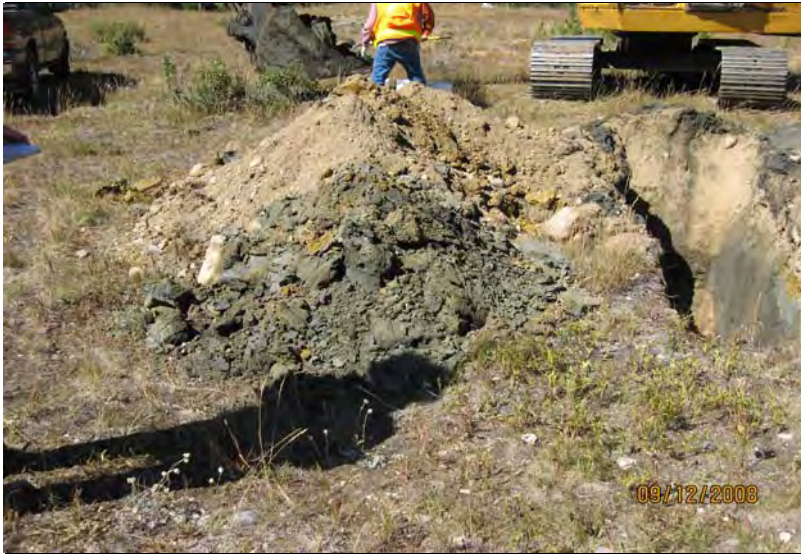
Picture #: McLaren RA Project\Site Investigation Photos\Julies Photos\McLaren SI 171

Description: Spoils pile from top half of TP-44

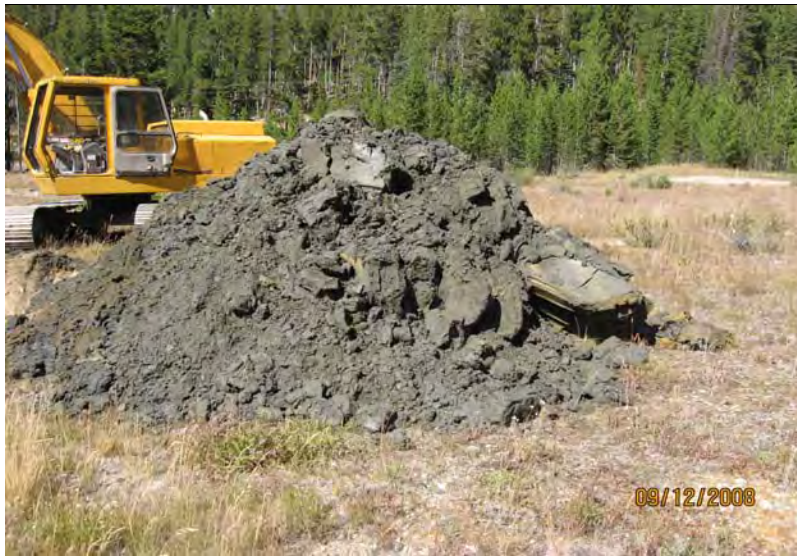
Picture #: McLaren RA Project\Site Investigation Photos\Julies Photos\McLaren SI 172

Description: Spoils pile from top half of TP-44

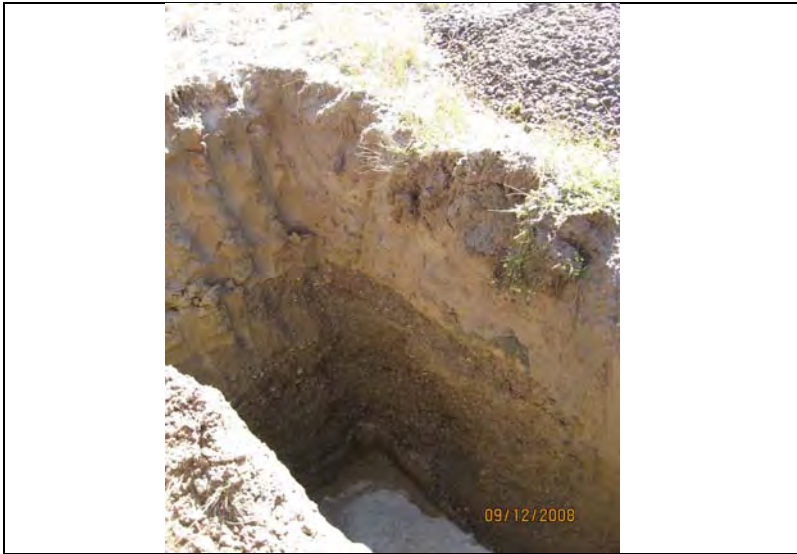
Picture #: McLaren RA Project\Site Investigation Photos\Julies Photos\McLaren SI 173

Description: Test pit TP-45

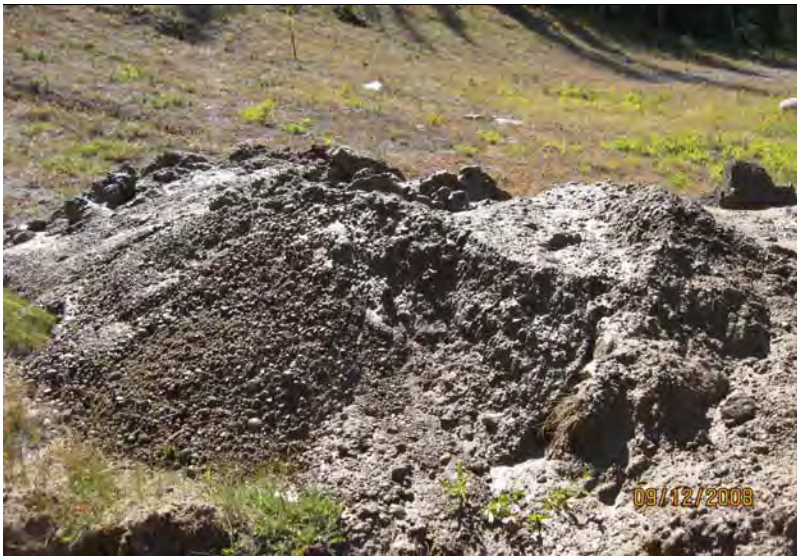
Picture #: McLaren RA Project\Site Investigation Photos\Julies Photos\McLaren SI 174

Description: Spoils pile from TP-45

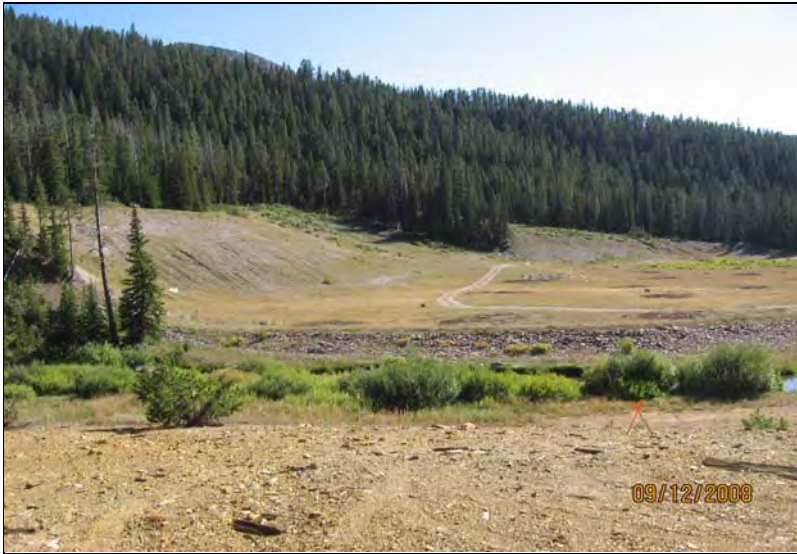
Picture #: McLaren RA Project\Site Investigation Photos\Julies Photos\McLaren SI 175

Description: Tailings test pit overview - looking east

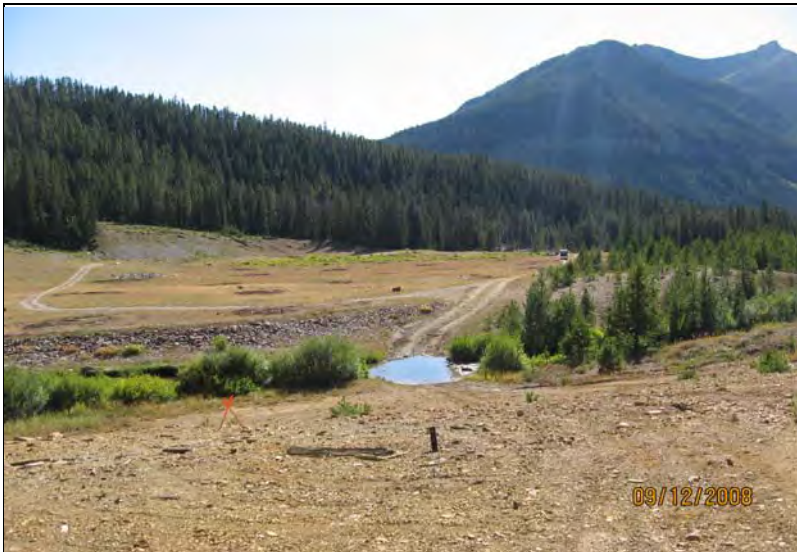
Picture #: McLaren RA Project\Site Investigation Photos\Julies Photos\McLaren SI 176

Description: Tailings test pit overview - looking west

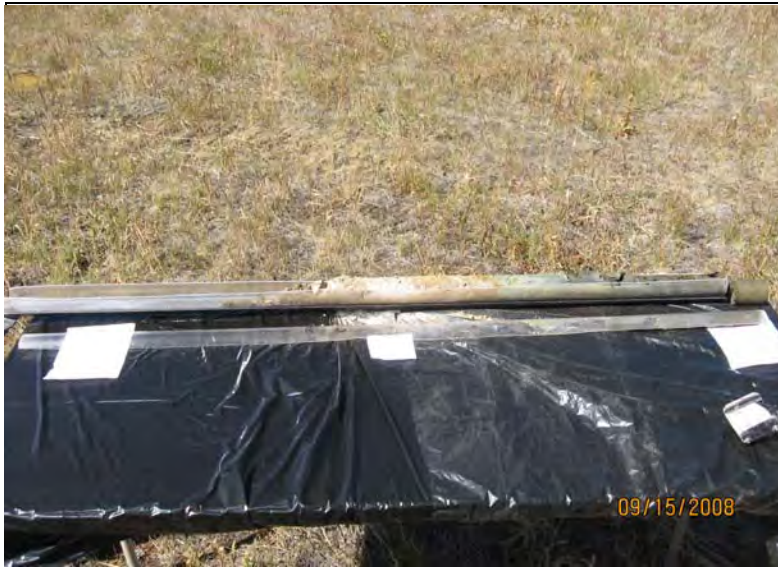
Picture #: McLaren RA Project\Site Investigation Photos\Julies Photos\McLaren SI 177

Description: Cover soil investigation - CS-3

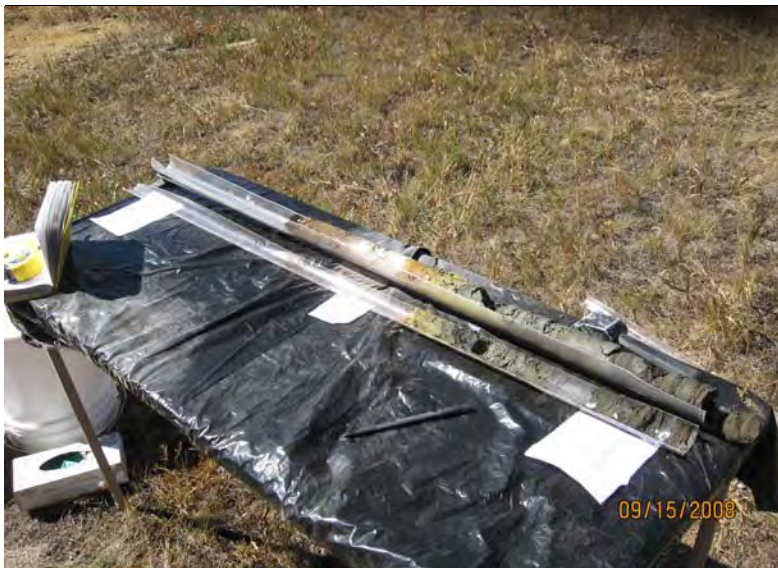
Picture #: McLaren RA Project\Site Investigation Photos\Julies Photos\McLaren SI 178

Description: Cover soil investigation - CS-11

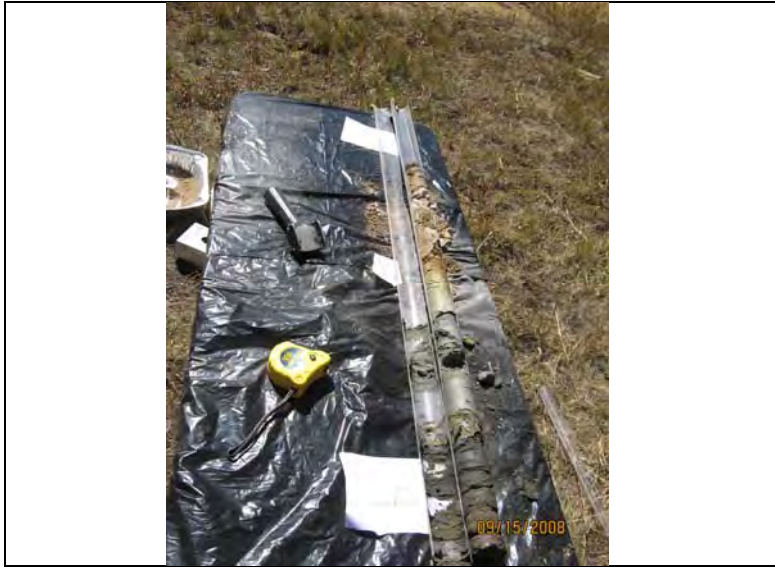
Picture #: McLaren RA Project\Site Investigation Photos\Julies Photos\McLaren  
SI 179

Description: Cover soil investigation - CS-4

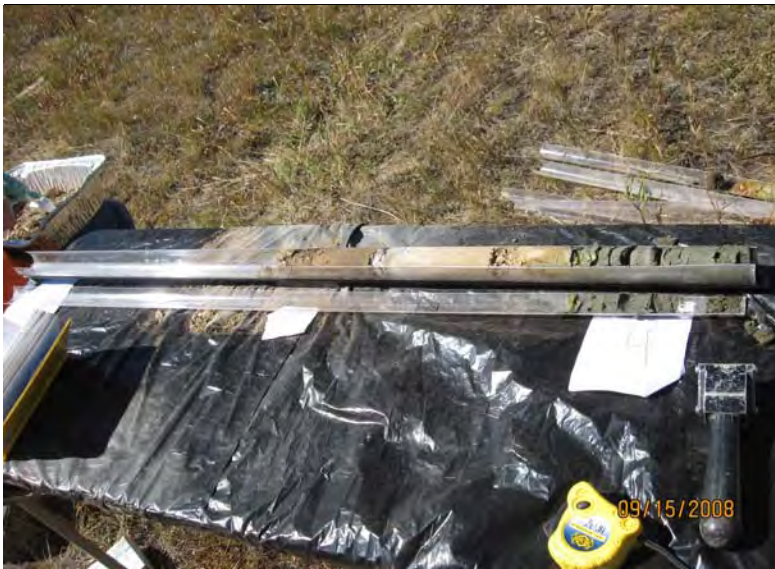
Picture #: McLaren RA Project\Site Investigation Photos\Julies Photos\McLaren  
SI 180

Description: Cover soil investigation - CS-1

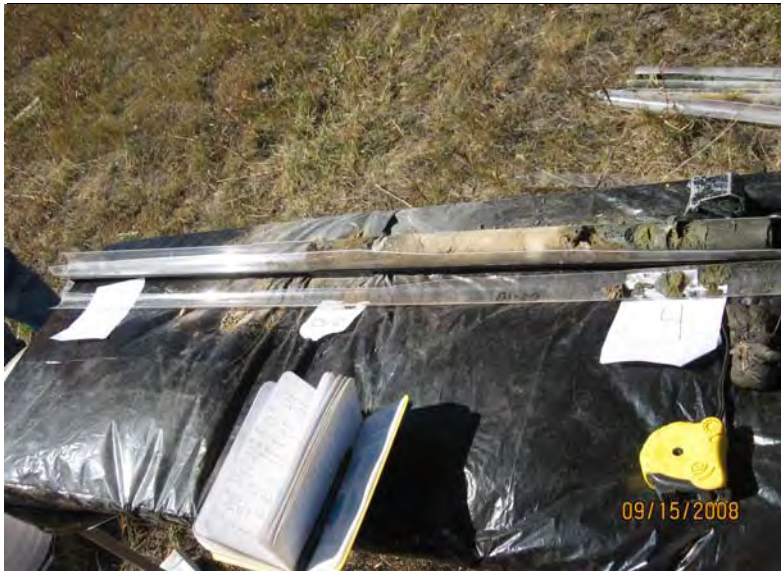
Picture #: McLaren RA Project\Site Investigation Photos\Julies Photos\McLaren  
SI 181

Description: Cover soil investigation - CS-10

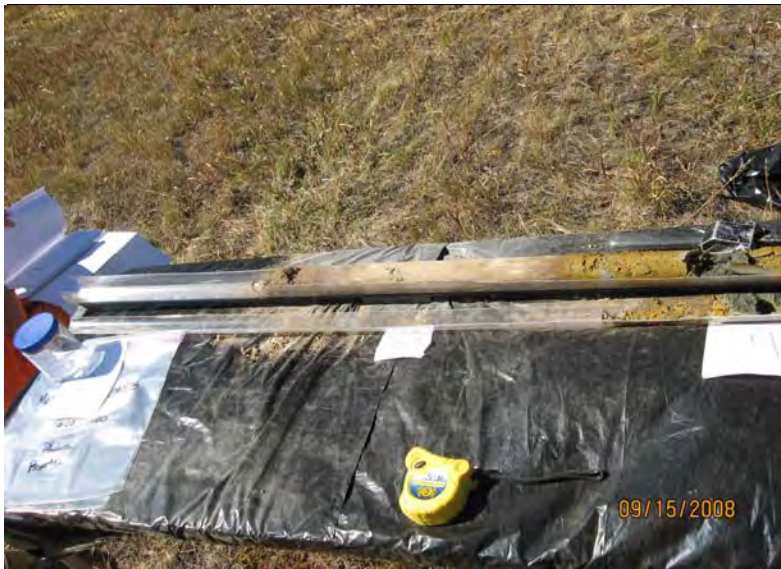
Picture #: McLaren RA Project\Site Investigation Photos\Julies Photos\McLaren  
SI 182

Description: Cover soil investigation - CS-9

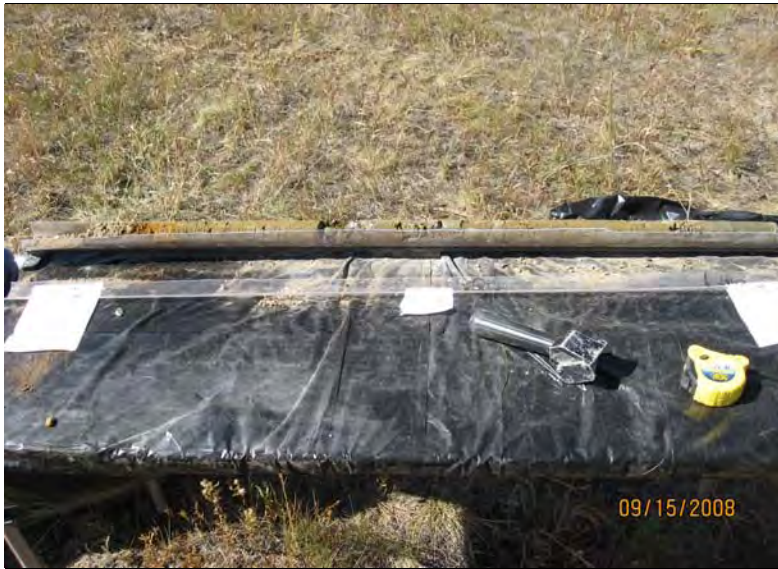
Picture #: McLaren RA Project\Site Investigation Photos\Julies Photos\McLaren  
SI 183

Description: Cover soil investigation - CS-7

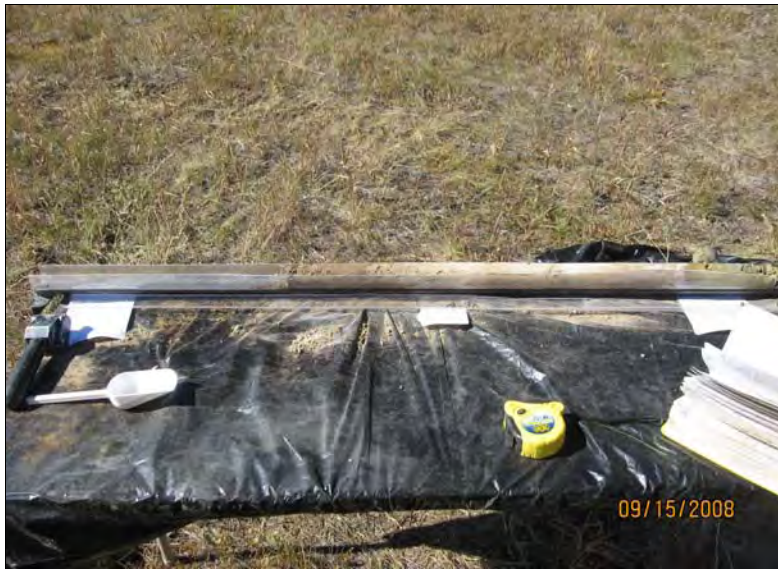
Picture #: McLaren RA Project\Site Investigation Photos\Julies Photos\McLaren  
SI 184

Description: Cover soil investigation - CS-6

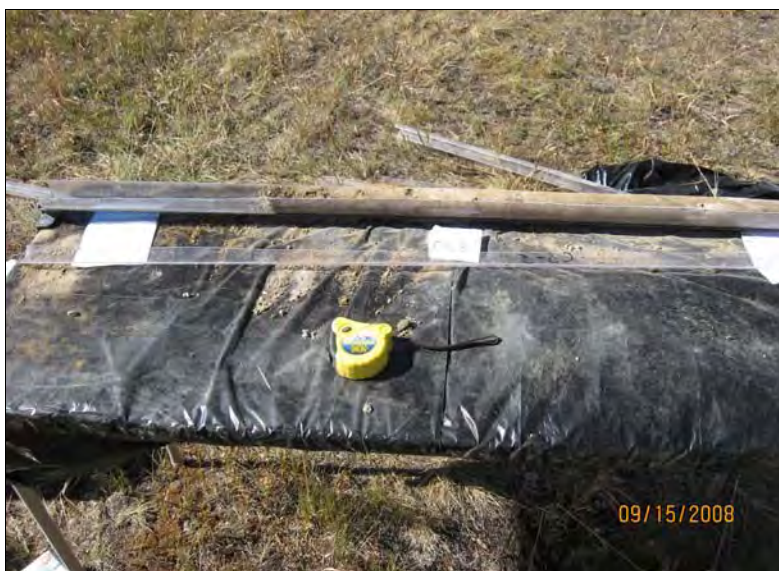
Picture #: McLaren RA Project\Site Investigation Photos\Julies Photos\McLaren  
SI 185

Description: Cover soil investigation - CS-5

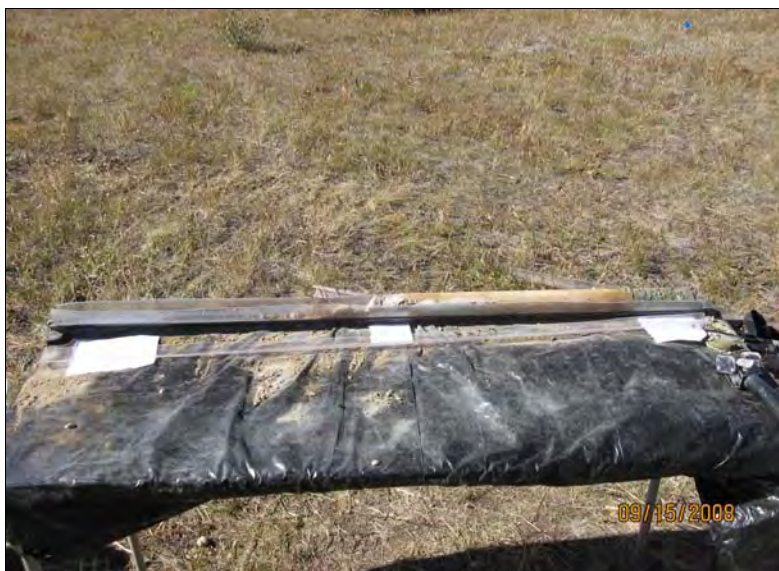
Picture #: McLaren RA Project\Site Investigation Photos\Julies Photos\McLaren  
SI 186

Description: Cover soil investigation - CS-2

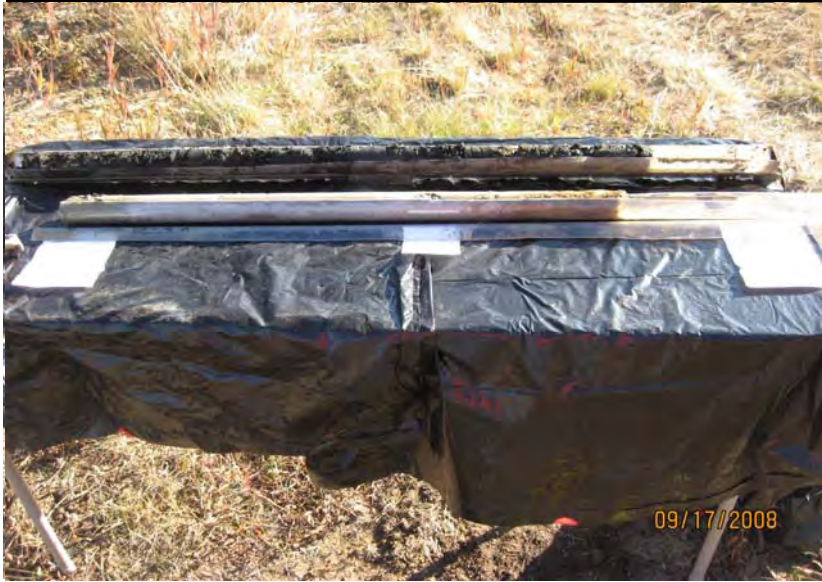
Picture #: McLaren RA Project\Site Investigation Photos\Julies Photos\McLaren SI 228

Description: Piezometer-04D

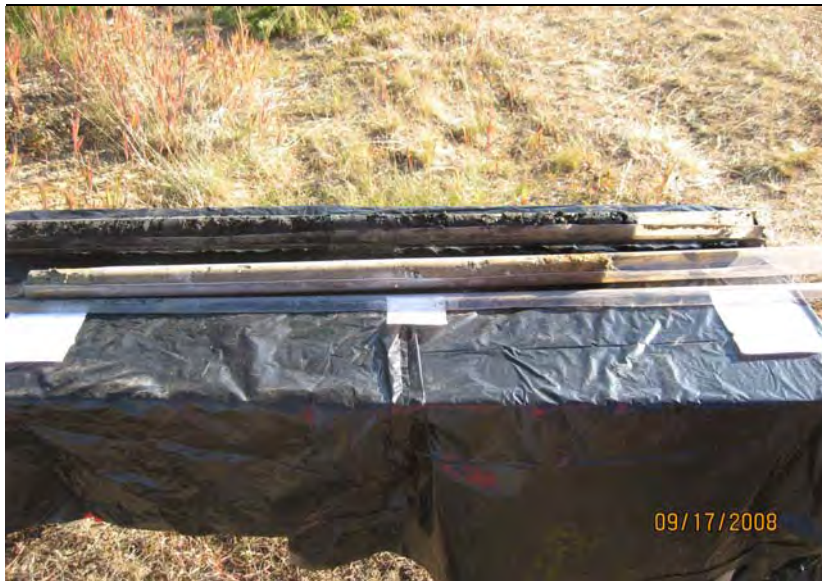
Picture #: McLaren RA Project\Site Investigation Photos\Julies Photos\McLaren SI 229

Description: Piezometer-04D

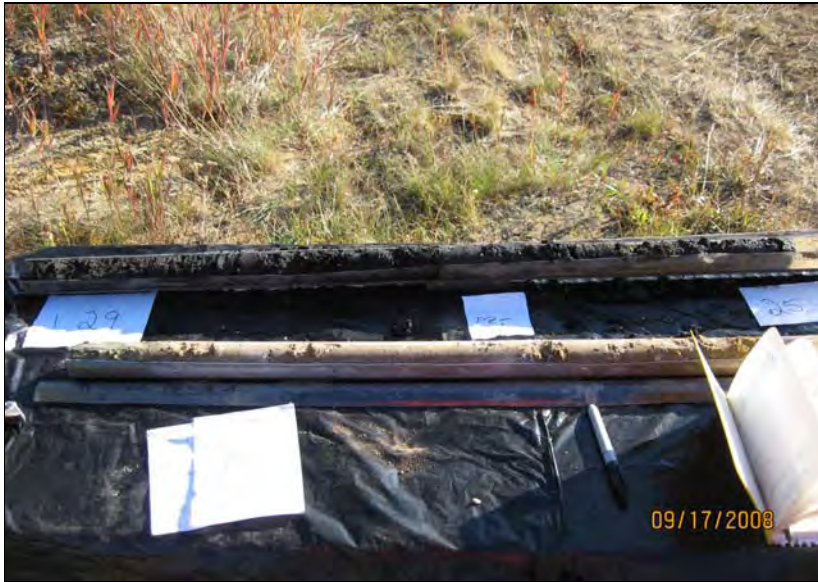
Picture #: McLaren RA Project\Site Investigation Photos\Julies Photos\McLaren SI 230

Description: Piezometer-04D

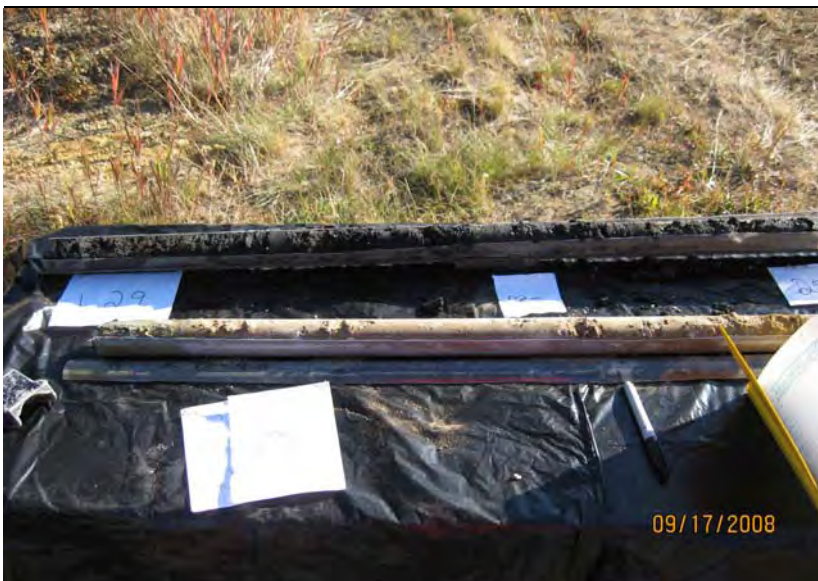
Picture #: McLaren RA Project\Site Investigation Photos\Julies Photos\McLaren SI 231

Description: Piezometer-04D

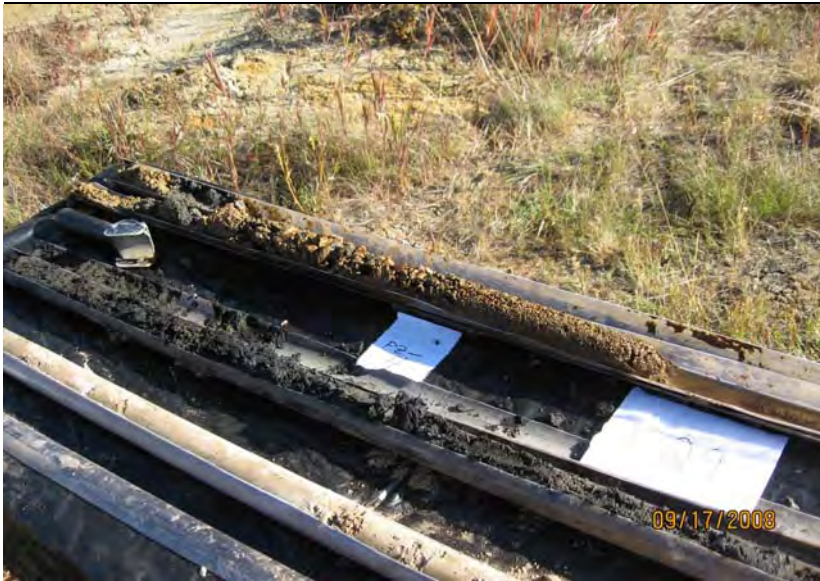
Picture #: McLaren RA Project\Site Investigation Photos\Julies Photos\McLaren SI 232

Description: Piezometer-04D

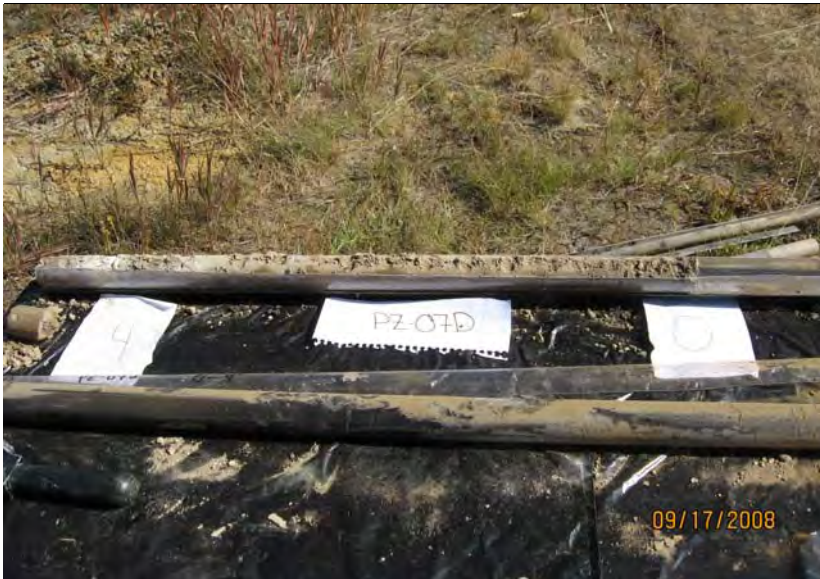
Picture #: McLaren RA Project\Site Investigation Photos\Julies Photos\McLaren SI 233

Description: Piezometer-07D

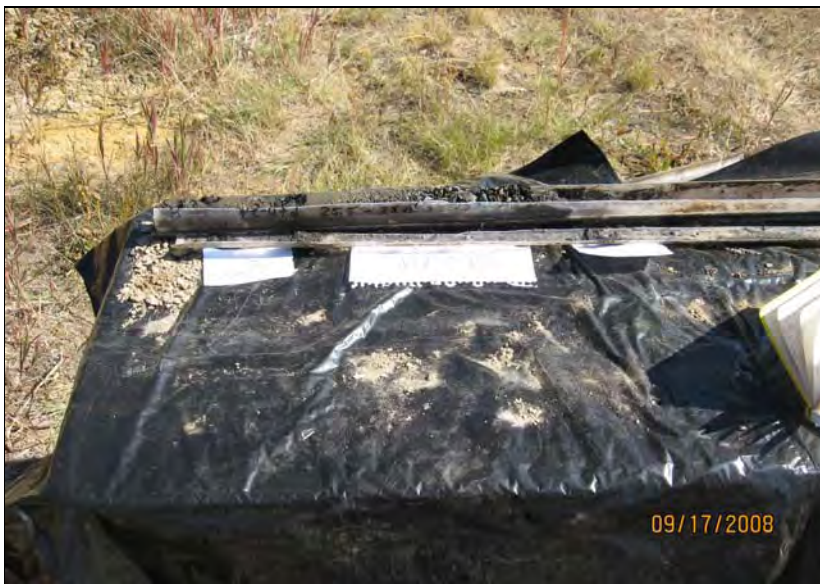
Picture #: McLaren RA Project\Site Investigation Photos\Julies Photos\McLaren SI 234

Description: Piezometer-07D

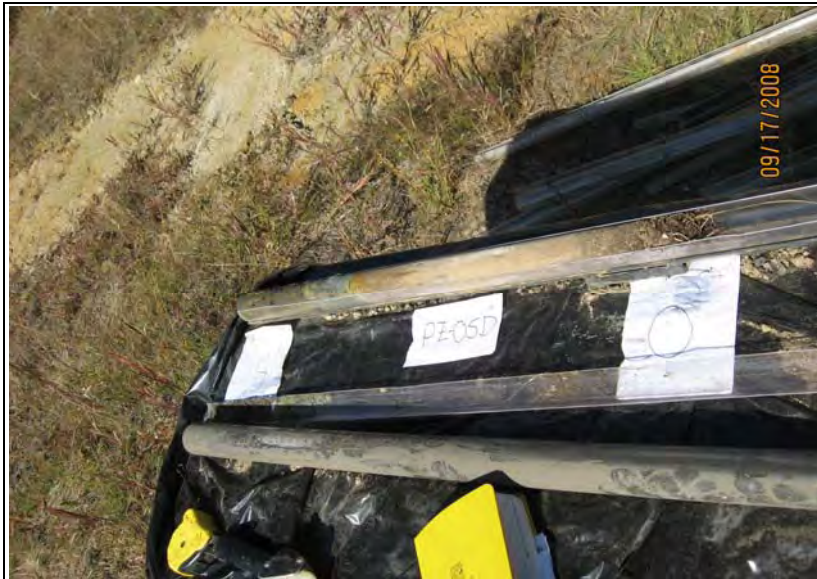
Picture #: McLaren RA Project/Site Investigation Photos/Julies Photos/McLaren SI 236

Description: Piezometer-05D

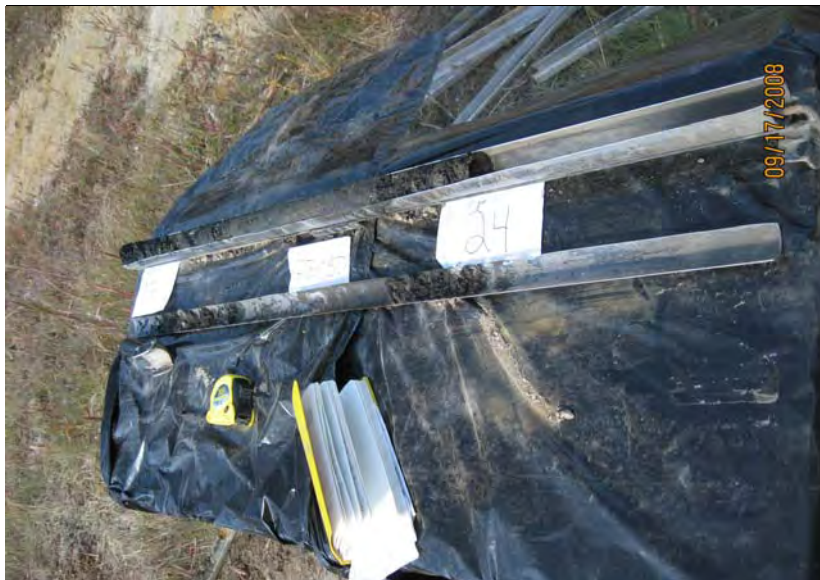
Picture #: McLaren RA Project/Site Investigation Photos/Julies Photos/McLaren SI 237

Description: Piezometer-05D

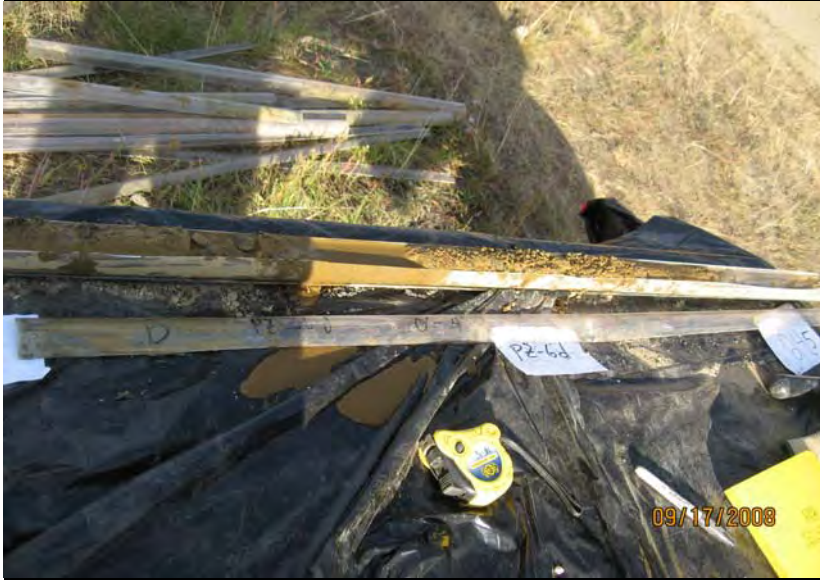
Picture #: McLaren RA Project\Site Investigation Photos\Julies Photos\McLaren  
SI 238

Description: Piezometer-06D

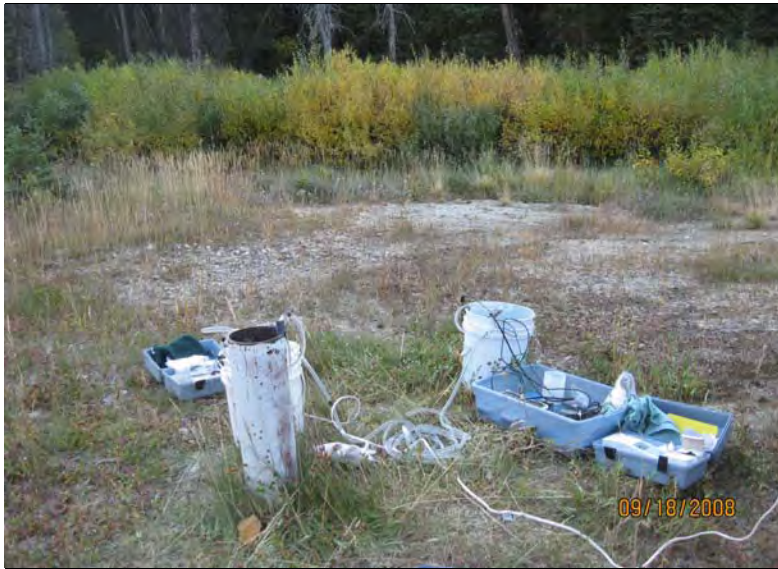
Picture #: McLaren RA Project\Site Investigation Photos\Julies Photos\McLaren  
SI 239

Description: Monitoring Well-05

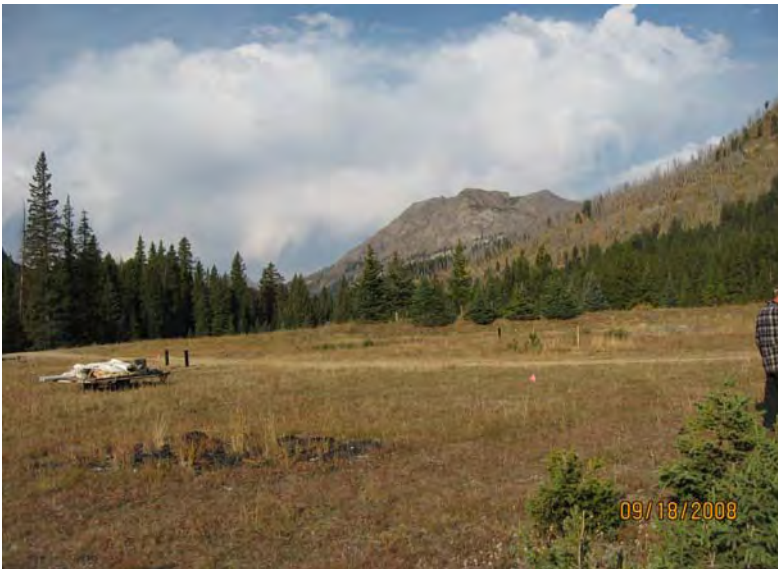
Picture #: McLaren RA Project\Site Investigation Photos\Julies Photos\McLaren  
SI 240

Description: Overview of Monitoring Wells

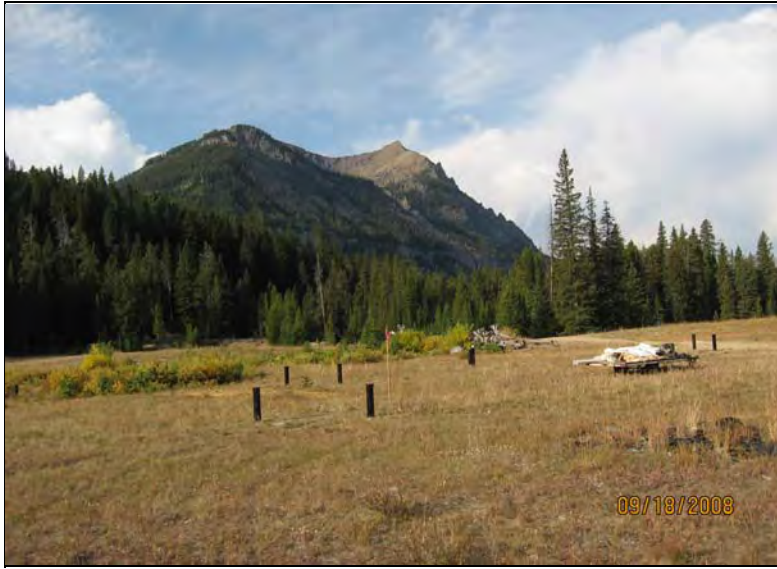
Picture #: McLaren RA Project\Site Investigation Photos\Julies Photos\McLaren  
SI 241

Description: Overview of Monitoring wells

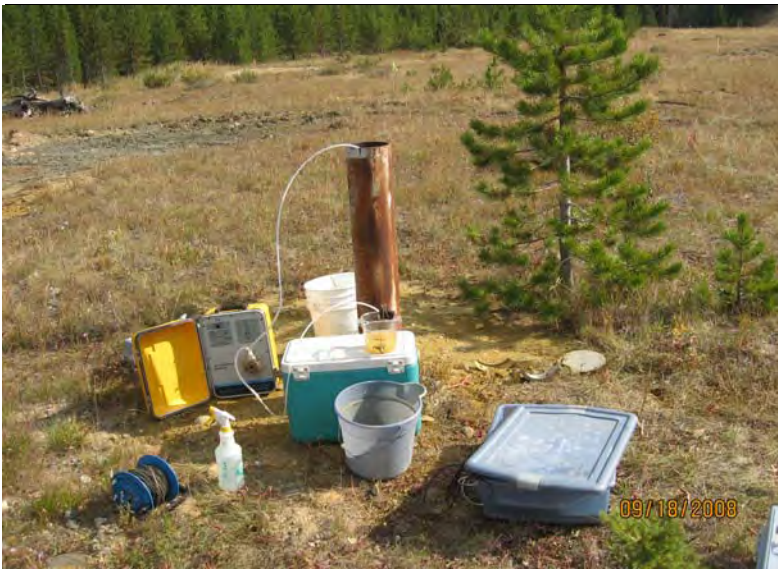
Picture #: McLaren RA Project\Site Investigation Photos\Julies Photos\McLaren  
SI 242

Description: Monitoring Well-04

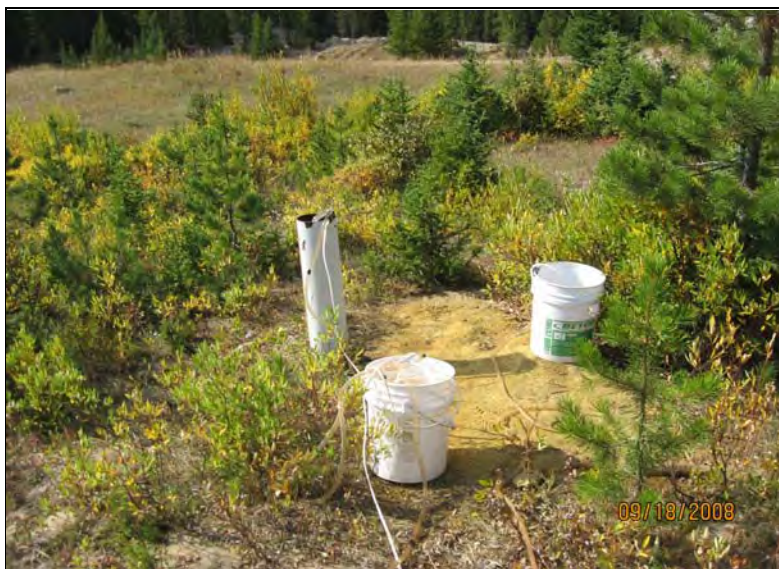
Picture #: McLaren RA Project\Site Investigation Photos\Julies Photos\McLaren  
SI 243

Description: Monitoring Well-02

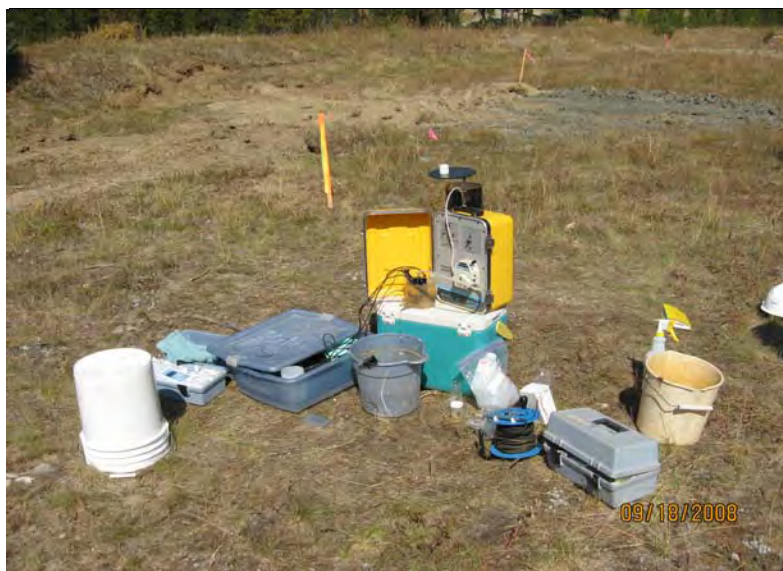
Picture #: McLaren RA Project\Site Investigation Photos\Julies Photos\McLaren  
SI 244

Description: Monitoring Well-03

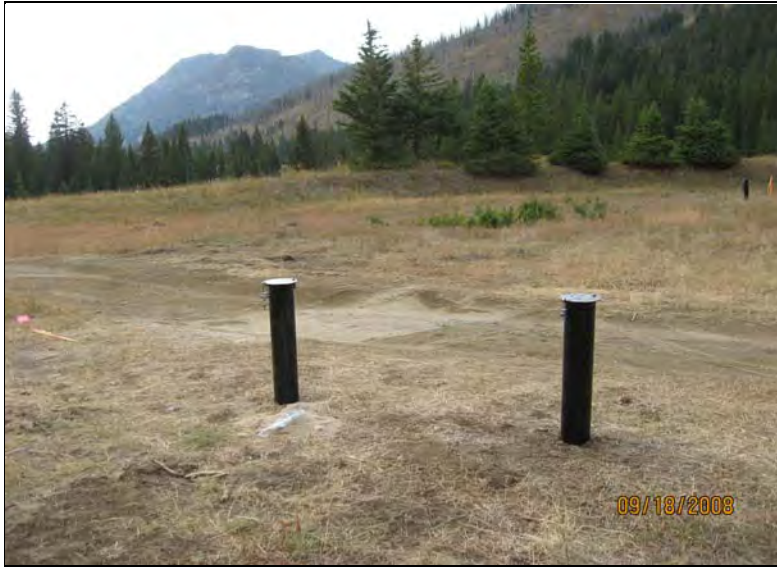
Picture #: McLaren RA Project\Site Investigation Photos\Julies Photos\McLaren  
SI 245

Description: Piezometer-02D with Piezometer-02S

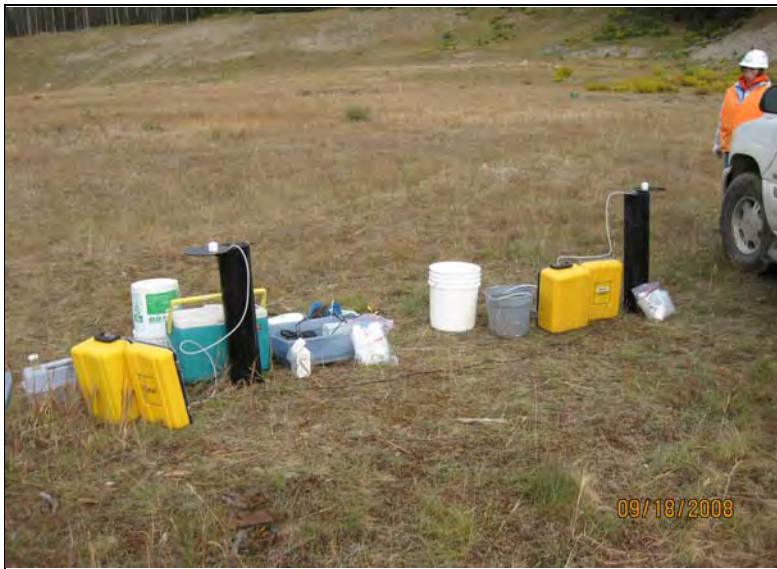
Picture #: McLaren RA Project\Site Investigation Photos\Julies Photos\McLaren  
SI 246

Description: Piezometer-02S with Piezometer-02D

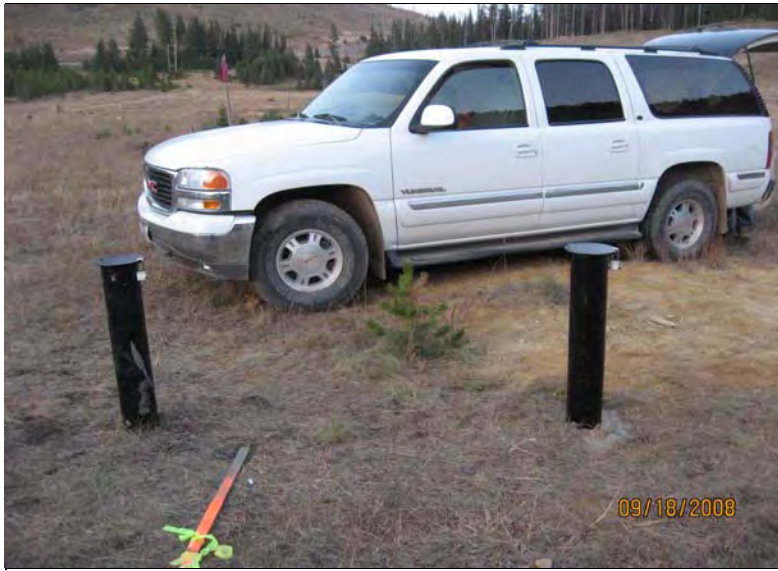
Picture #: McLaren RA Project\Site Investigation Photos\Julies Photos\McLaren  
SI 247

Description: Piezometer-05D with Piezometer-05S

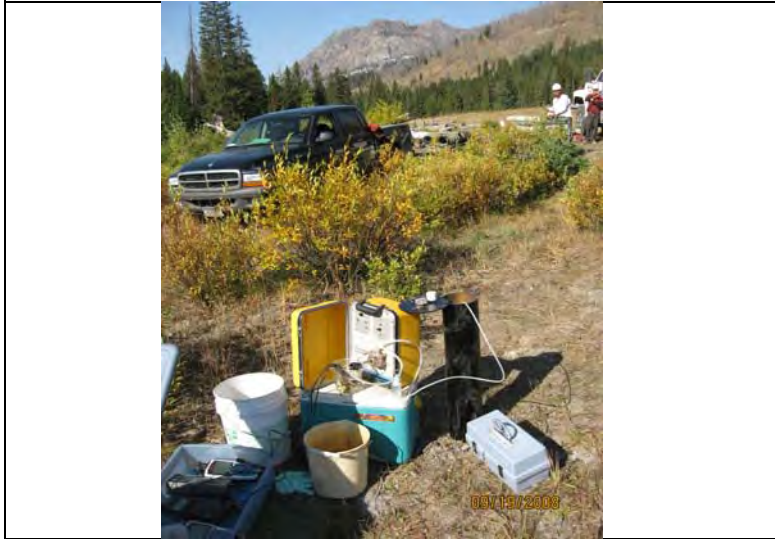
Picture #: McLaren RA Project\Site Investigation Photos\Julies Photos\McLaren  
SI 251

Description: Piezometer-07

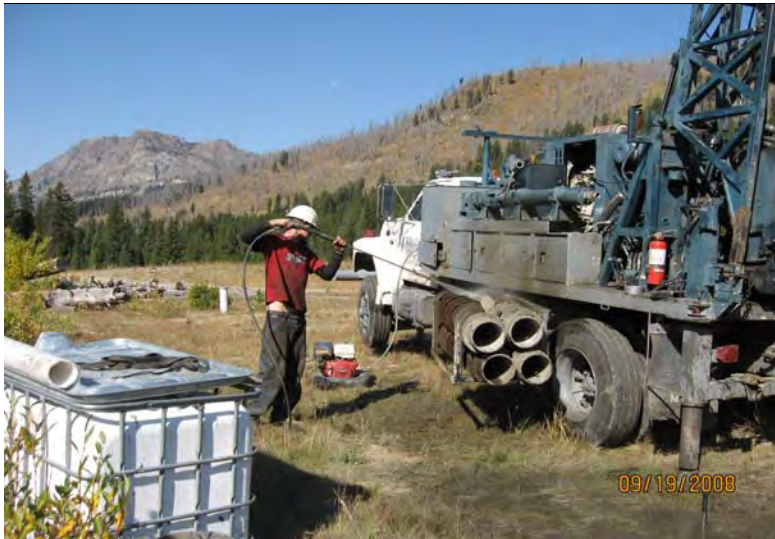
Picture #: McLaren RA Project\Site Investigation Photos\Julies Photos\McLaren  
SI 252

Description: Decon of Drill

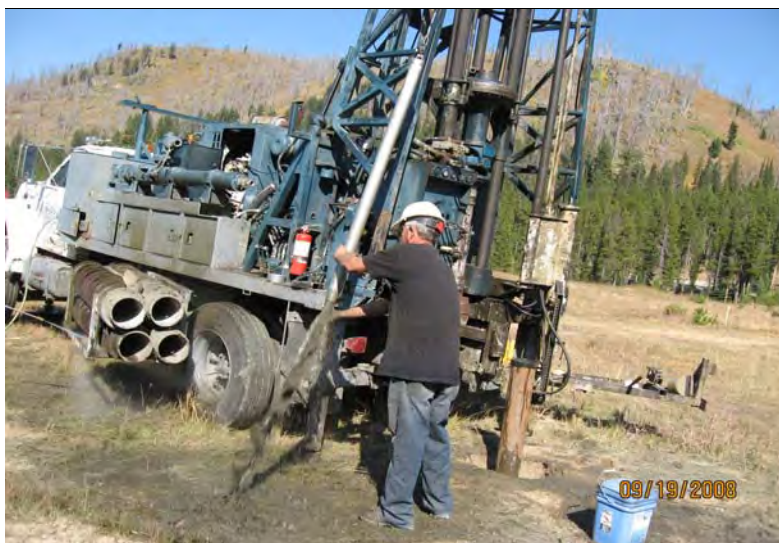
Picture #: McLaren RA Project\Site Investigation Photos\Julies Photos\McLaren  
SI 253

Description: Decon of Drill

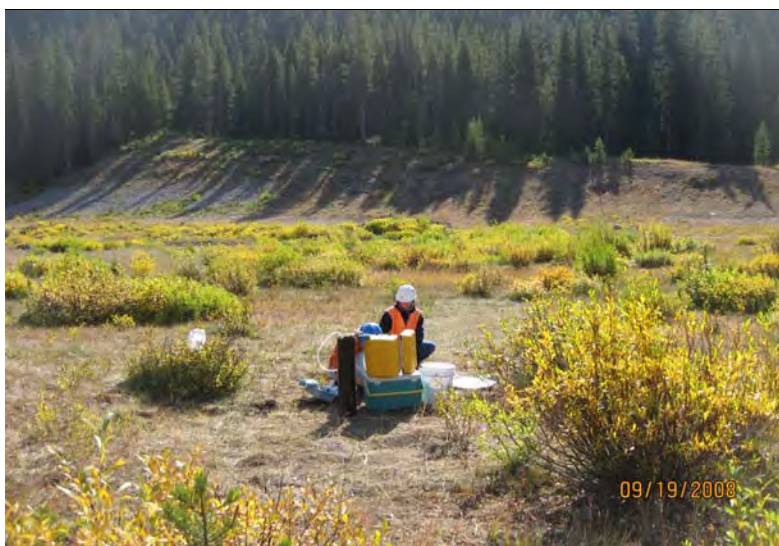
Picture #: McLaren RA Project\Site Investigation Photos\Julies Photos\McLaren  
SI 254

Description: Piezometer-07

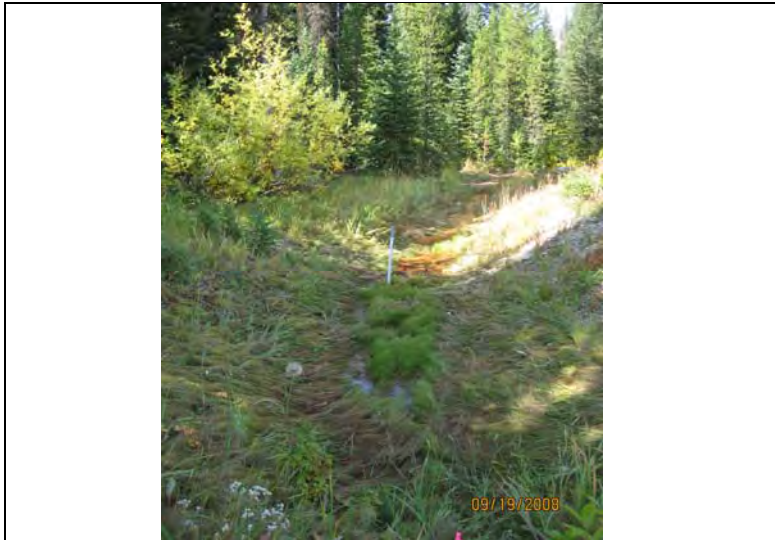
Picture #: McLaren RA Project\Site Investigation Photos\Julies Photos\McLaren  
SI 256

Description: Seep 5 with Staff Gauge

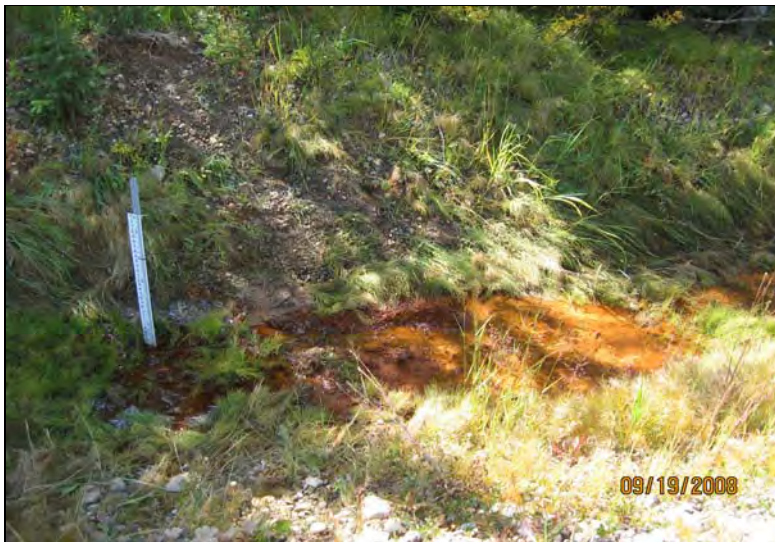
Picture #: McLaren RA Project\Site Investigation Photos\Julies Photos\McLaren  
SI 257

Description: Seep #5 with Staff Gauge

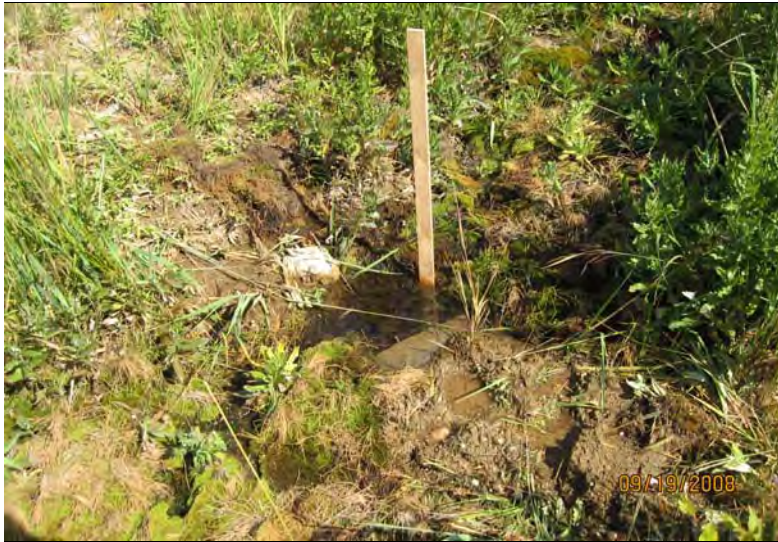
Picture #: McLaren RA Project\Site Investigation Photos\Julies Photos\McLaren  
SI 258

Description: Seep #4

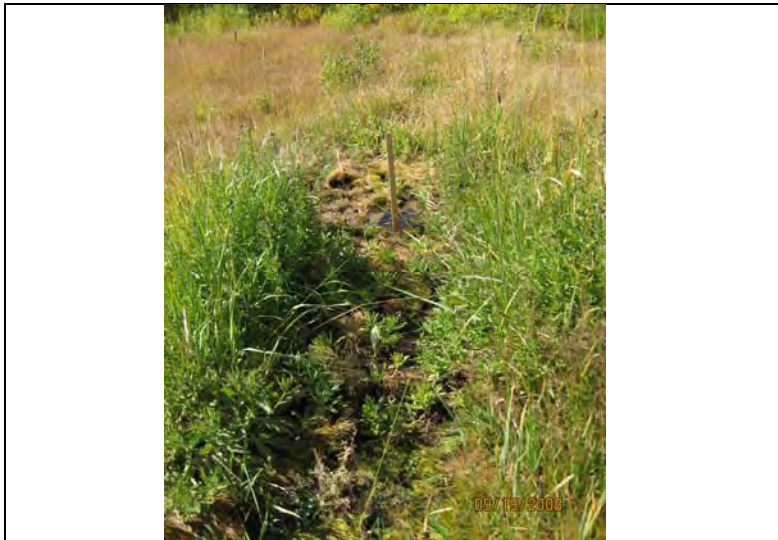
Picture #: McLaren RA Project\Site Investigation Photos\Julies Photos\McLaren  
SI 259

Description: Seep #4

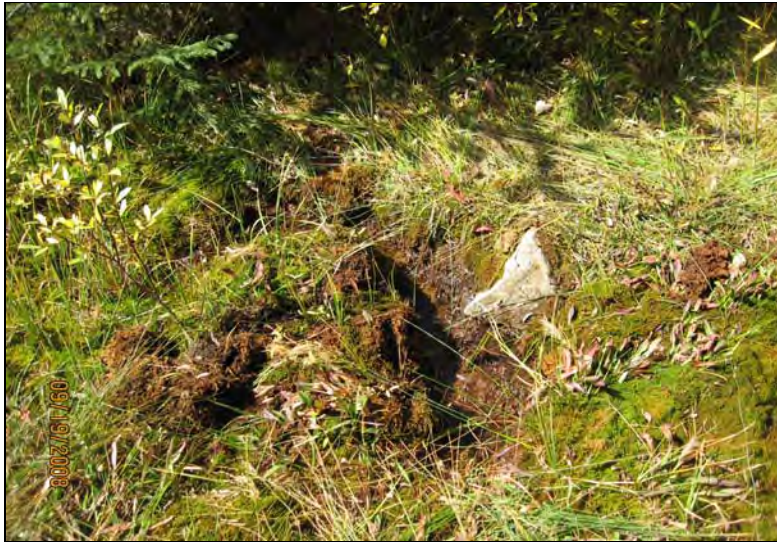
Picture #: McLaren RA Project\Site Investigation Photos\Julies Photos\McLaren  
SI 260

Description: Seep #3
