OTTER CREEK MINE - BASELINE REPORT 325A

**PHOTOS OF SURFACE WATER RUNOFF MANAGEMENT STRUCTURES,  
SEPTEMBER, 2013**

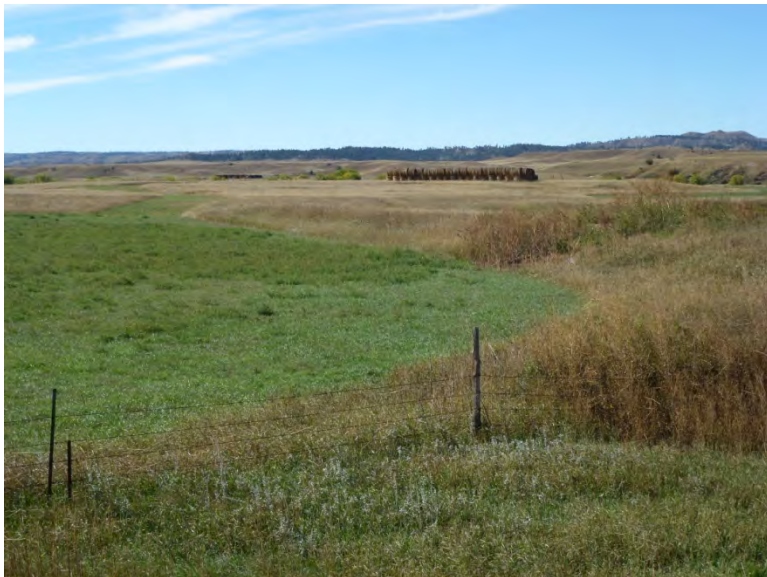
7. Tenmile Creek looking south; dike along Otter Creek.

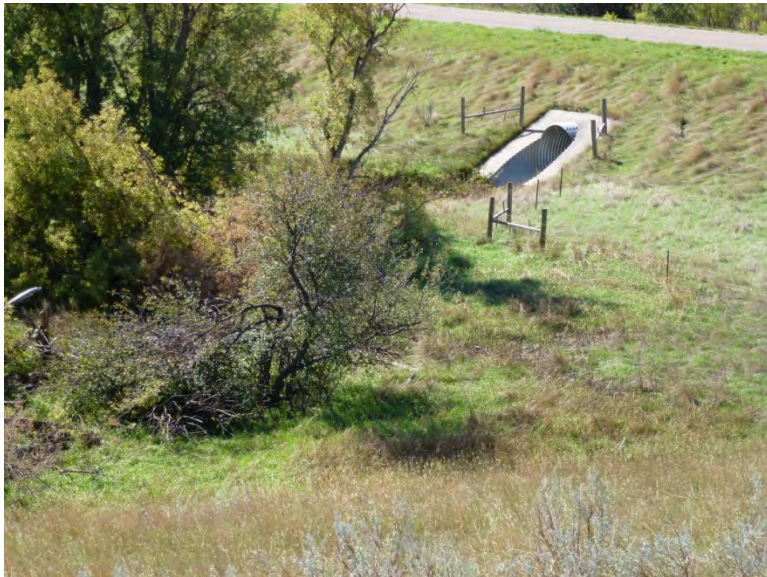
15. Chromo Creek culvert.

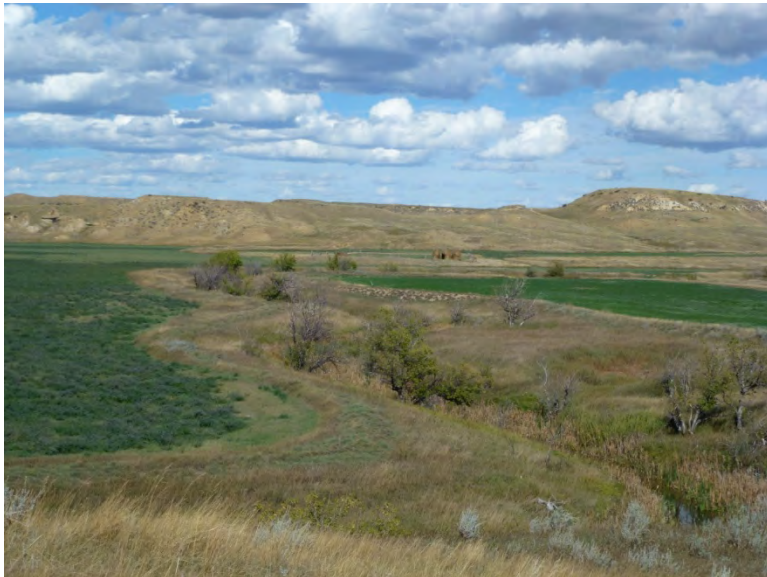
27. Dikes along Otter Creek.

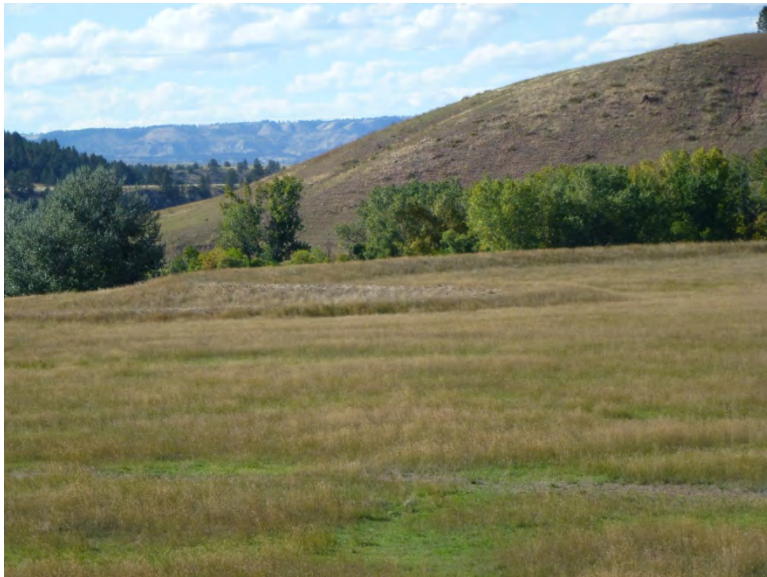
43. Dike on lower edge of upper terrace south of East Fork.

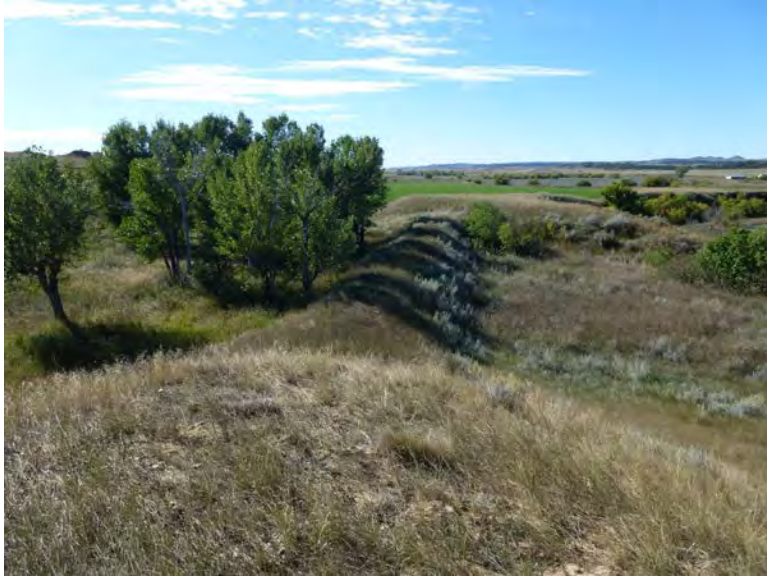
45. Dike at mouth of Fortune Coulee diverting flow to field to south.

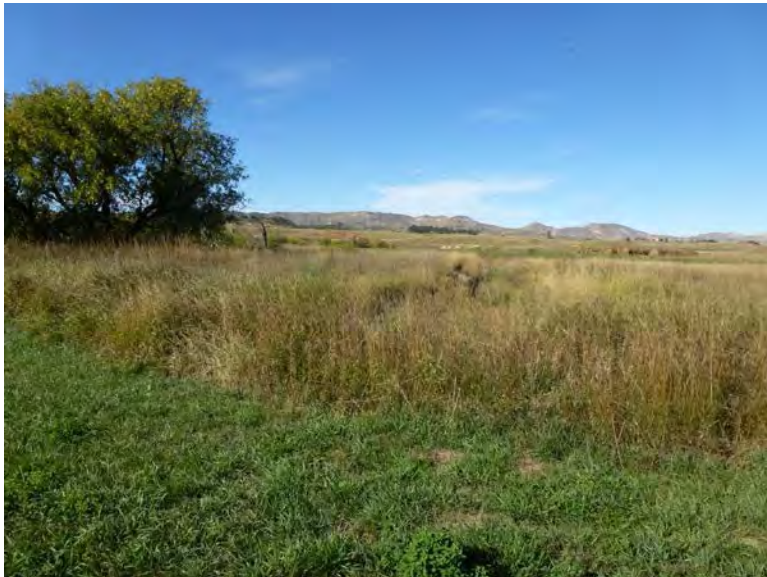
47. Ditch diverting flow away from Otter Creek and into another field below.

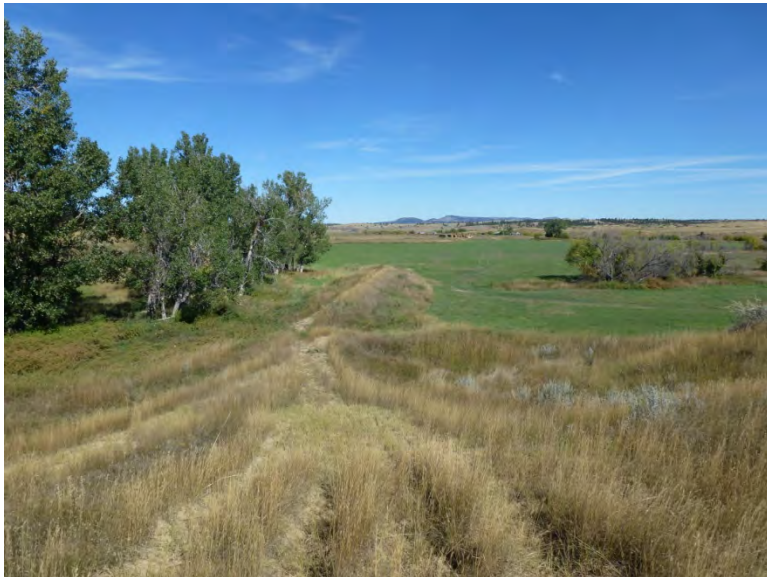
51. Dike at mouth of W side drainage diverting flow away from Otter Creek.

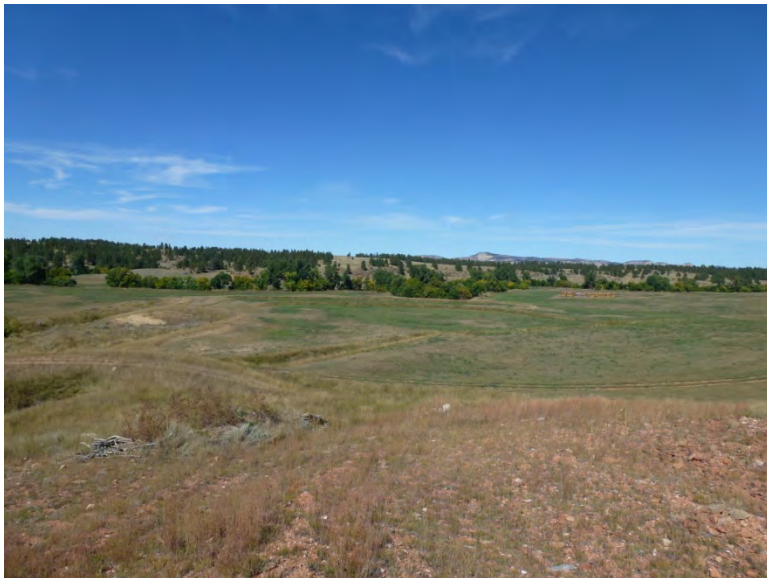
63. Dam and spreader dikes below south side drainage on Home Creek.

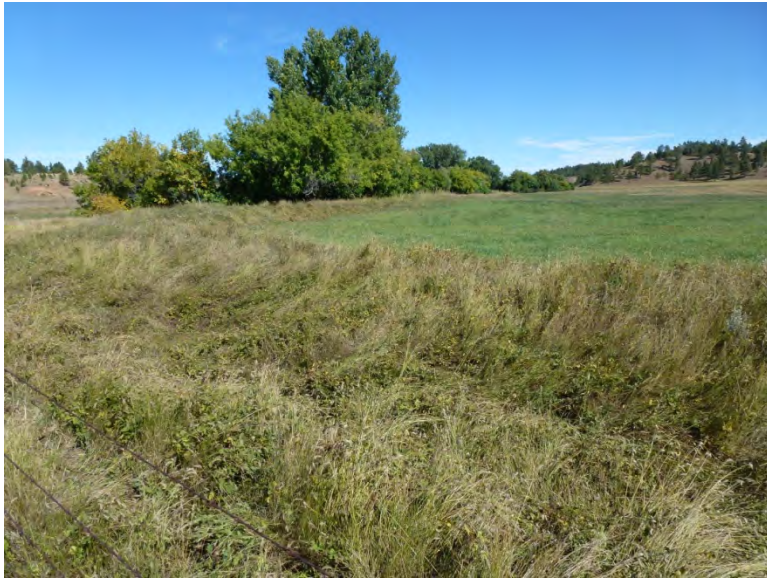
65. Dike at lower edge of field shown in Photos 63 and 64.

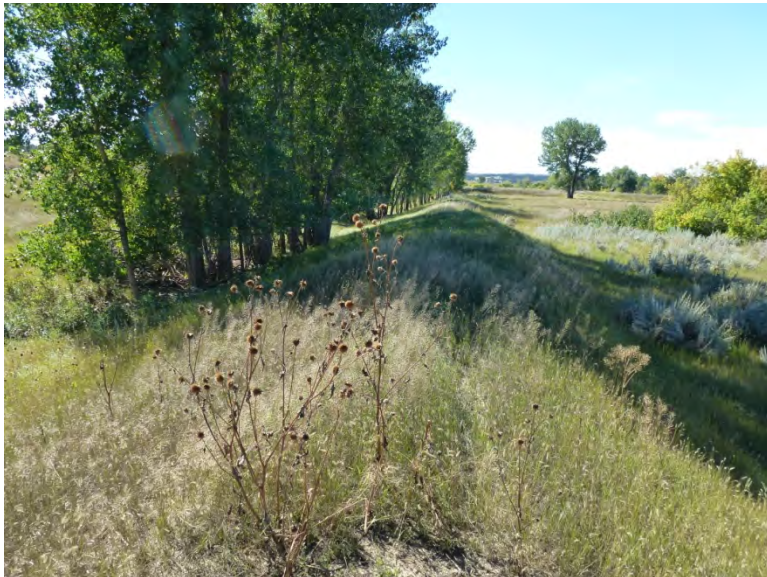
67. Diversion dike on lower Home creek looking downstream.

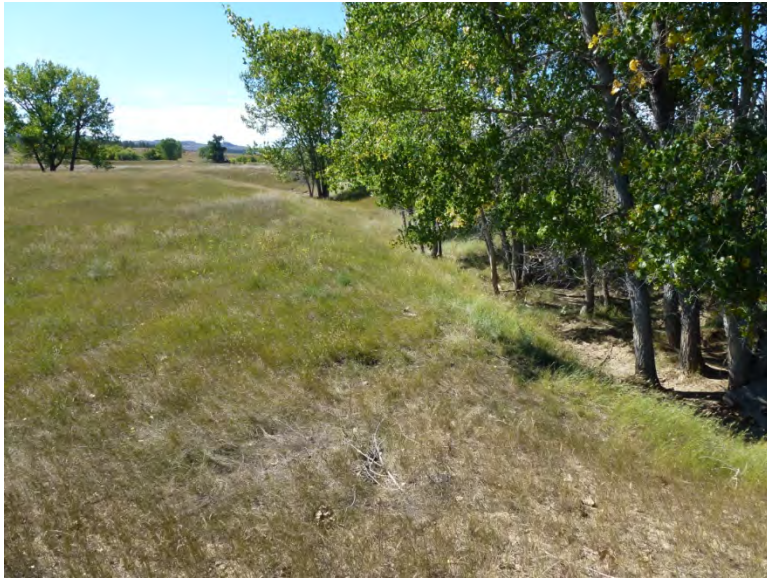
69. Ditch below head gate.

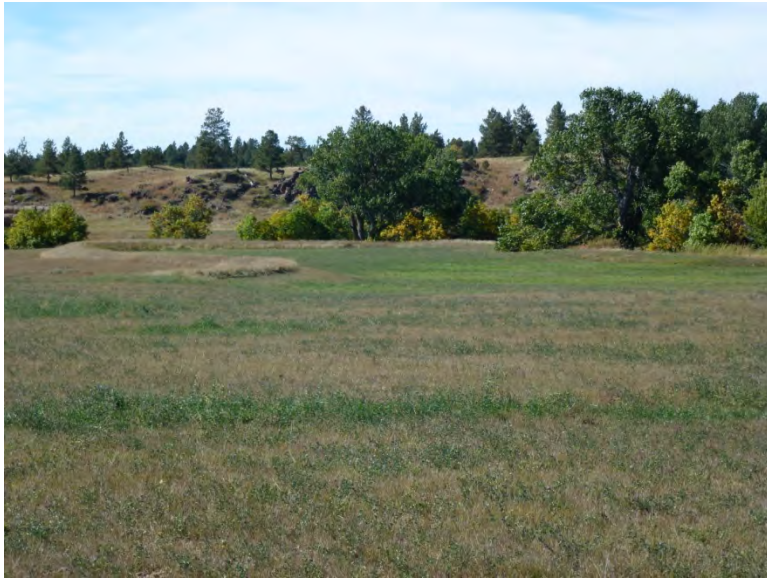
73. Spreader and lower dikes along Home Creek.

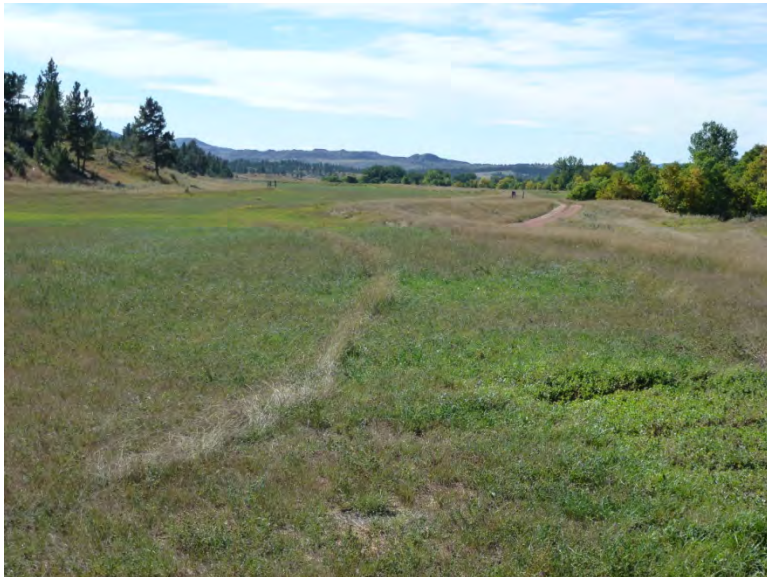
75. Another view of spreader/diversion dike shown in Photo 74.

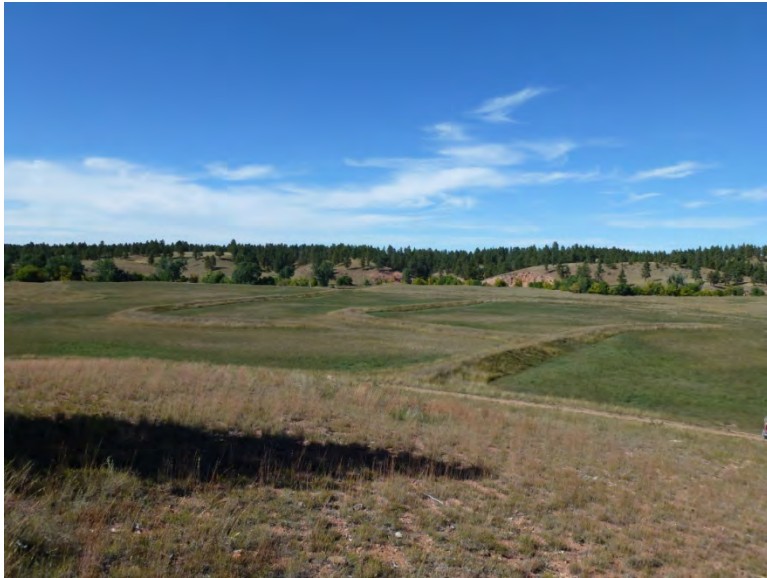
77. Home Creek spreader dikes.

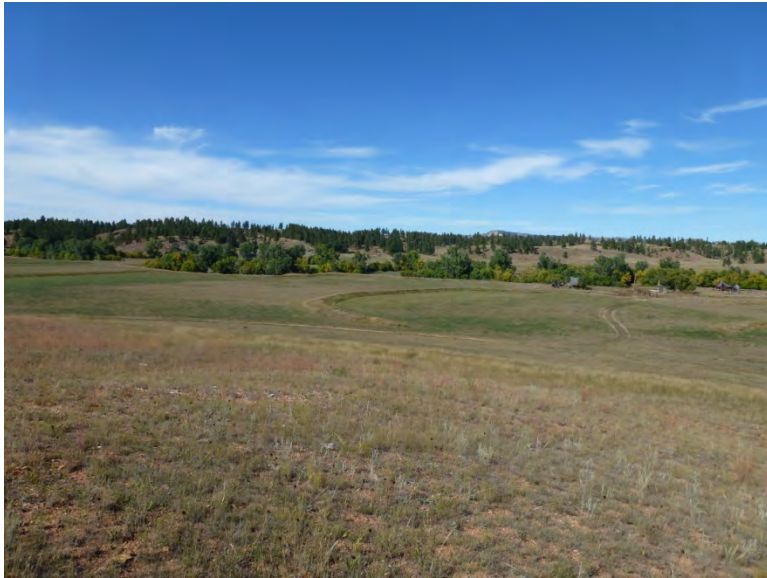
81. Spreader dikes below upper Home Creek side drainage (below Photo 80).

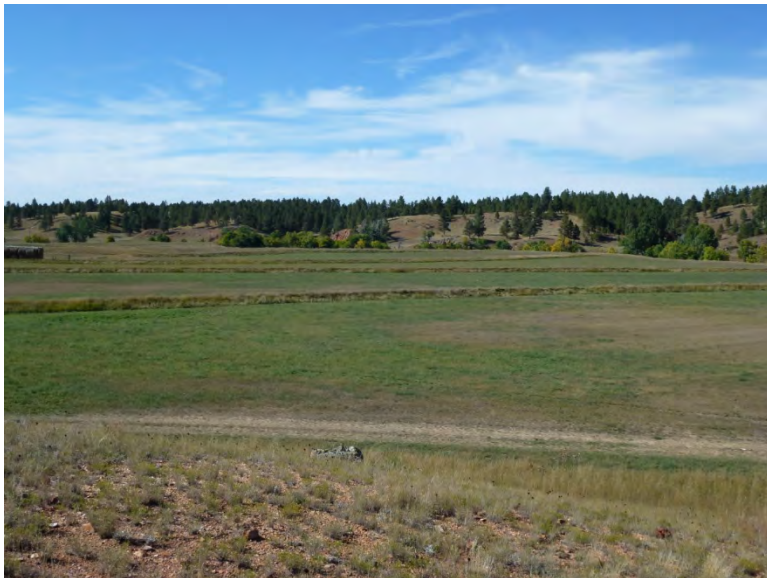
83. Spreader dikes below upper Home Creek side drainage (below Photo 82).
