ATTACHMENT B – 2009 LOWER GALLATIN TMDL PLANNING AREA NUTRIENT, ALGAE AND *E. COLI* SOURCE ASSESSMENT

December, 2009

OASIS Environmental, Inc.
PO Box 582
Livingston, MT 59047

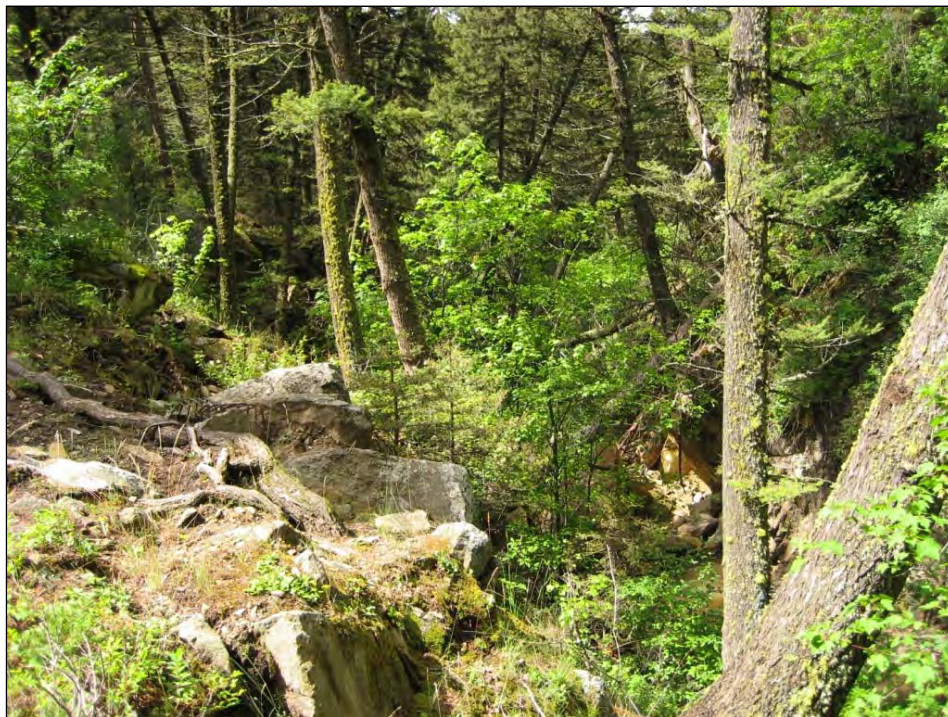
The reach is located almost entirely within the Gallatin National Forest, and is primarily in its natural condition with the dominant land use being recreation. The riparian vegetation is very robust and healthy, consisting of a mixed conifer-cottonwood overstory with a willow-grass-forb understory (Figure 5). Severe bank erosion was observed in select areas, but overall erosion within the reach was considered low. Erosion was associated with cattle grazing and motorized-use trail crossings (Figures 6 and 7), and natural erosion due to the highly erosive soil. The Gallatin National Forest rerouted the trail between approximately miles 2-4 from the trailhead, reducing recreation-related stream erosion in that area. In addition, several water bars have been installed across the trail to route water off of the trail during storm events, thereby mitigating trail erosion that could deliver sediment to the stream. No roads encroach on the stream within the reach.

FIGURE 5. ROBUST RIPARIAN VEGETATION IN REACH BEAR 01 N (STREAM IN RIGHT SIDE OF PHOTO)

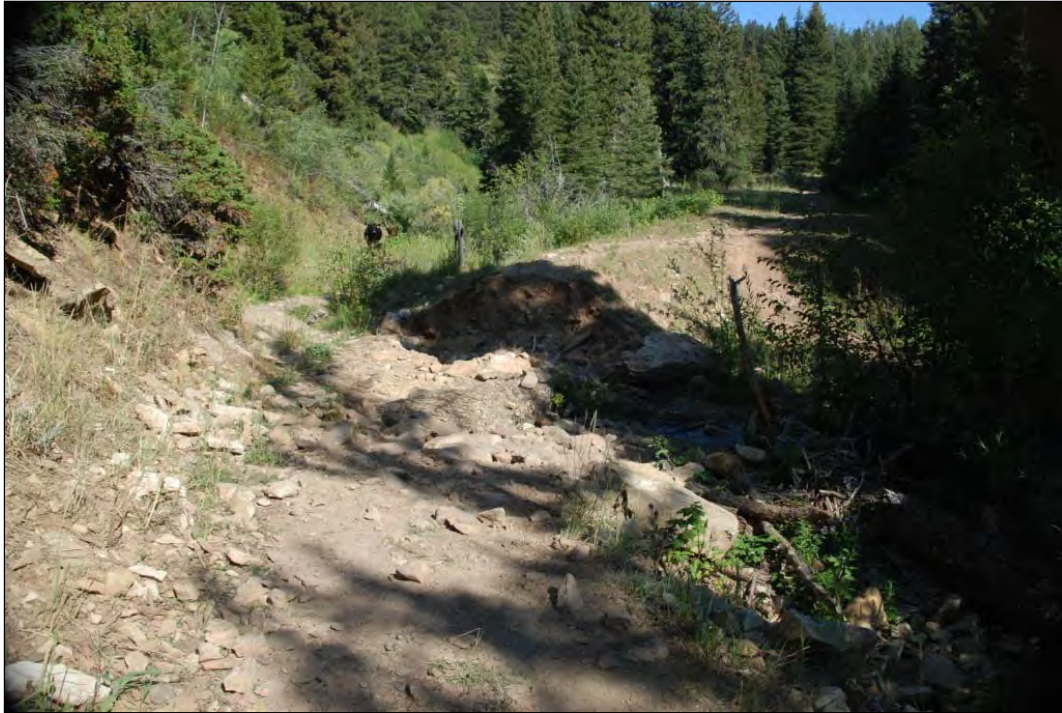
FIGURE 6. BANK EROSION AGAINST OLD ROAD WHICH IS NOW A TRAIL. CATTLE IN BACKGROUND.

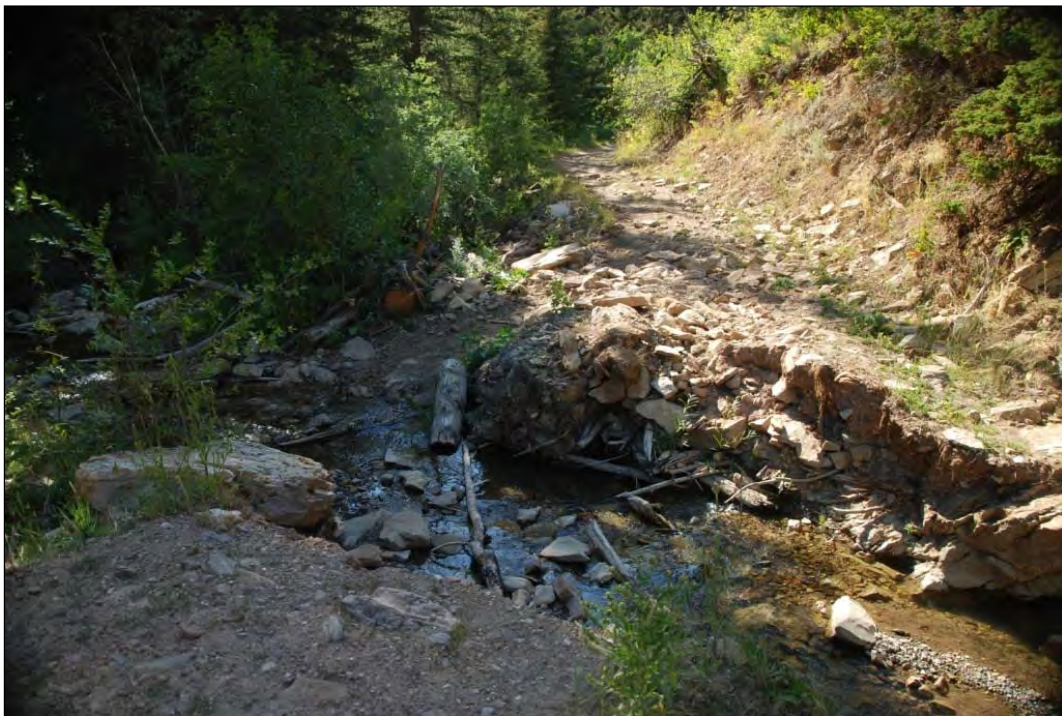
FIGURE 7. BANK EROSION AT TRAIL CROSSING.

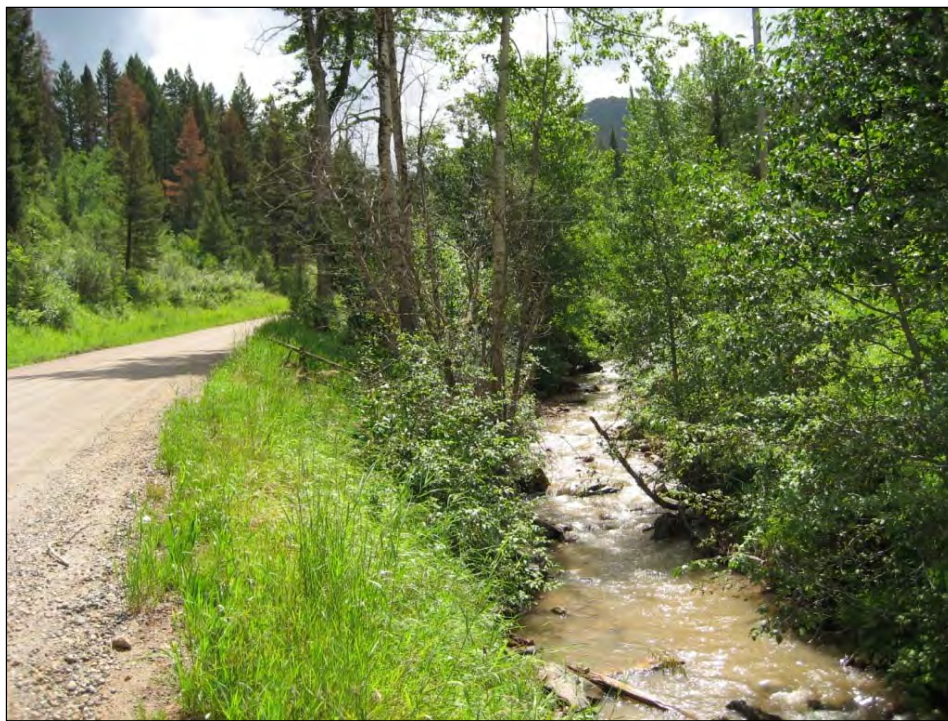
FIGURE 10. BEAR CANYON ROAD ENCROACHMENT ALONG REACH BEAR 02 N

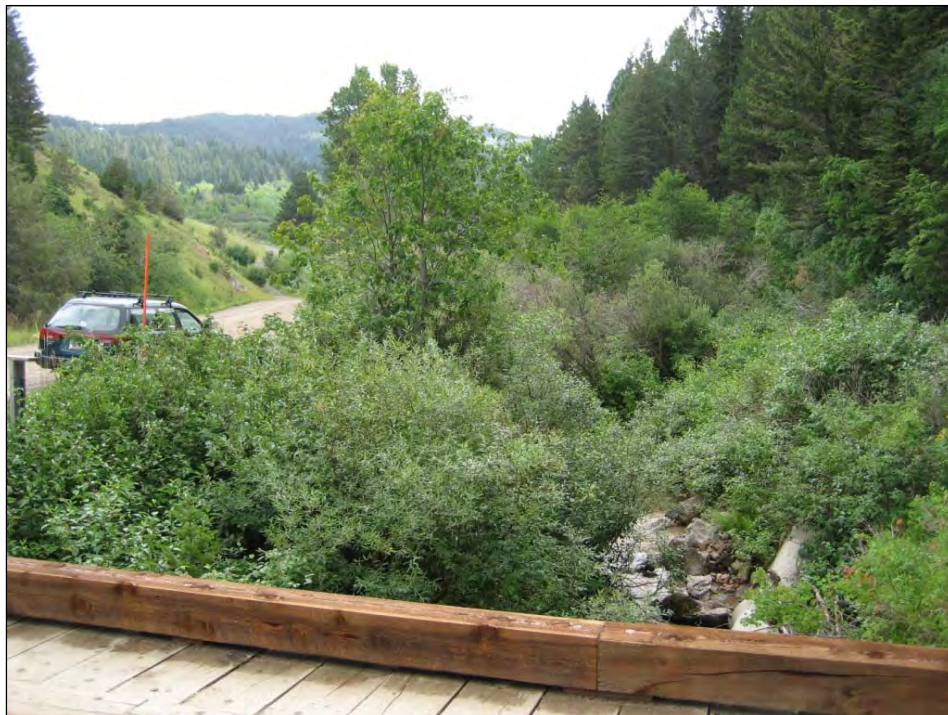
FIGURE 11. WELL-MAINTAINED DRIVEWAY CROSSING WITHIN REACH BEAR 02 N

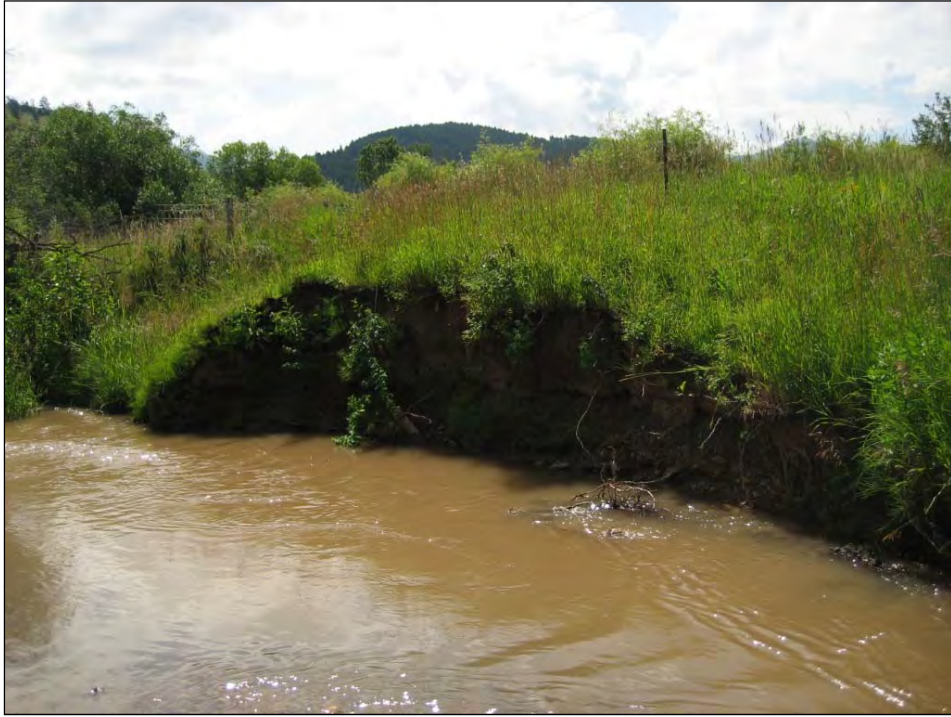
FIGURE 14. LIMITED BANK EROSION ON OUTER MEANDER BEND BEHIND LAMOTTE SCHOOL

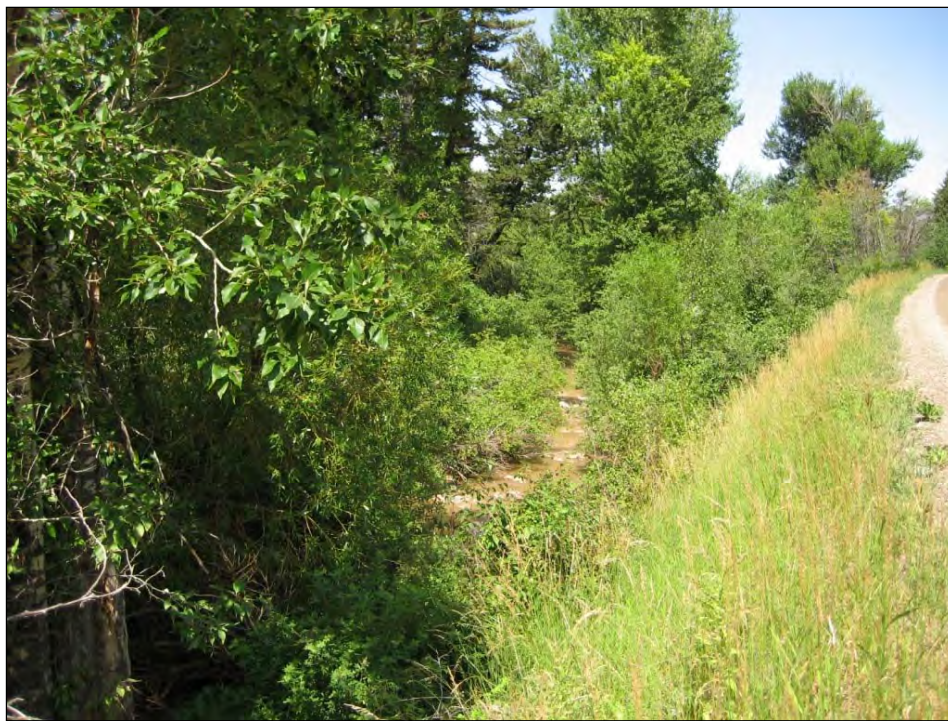
FIGURE 15. BEAR CANYON ROAD ENCROACHMENT WITH GOOD RIPARIAN BUFFER IN BEAR 03 N

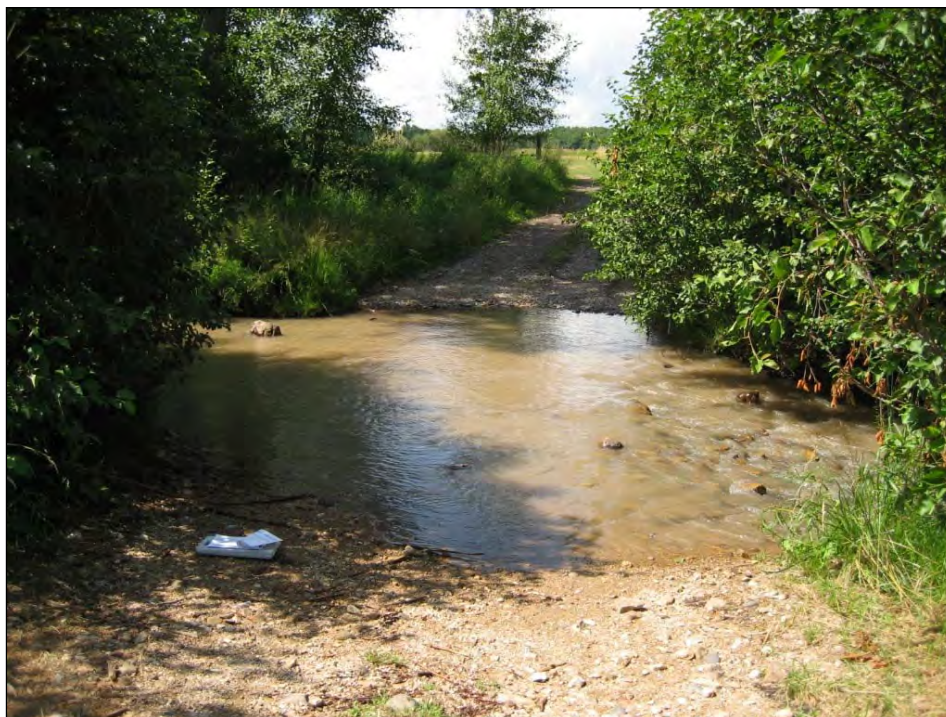
FIGURE 16. FORD CROSSING WITHIN REACH BEAR 03 N

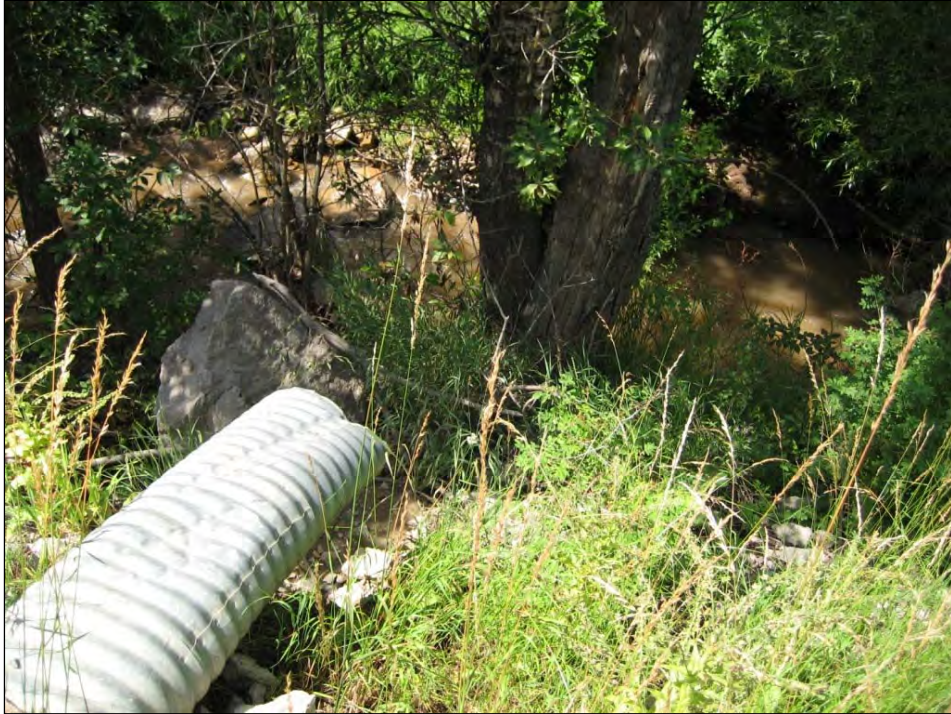
FIGURE 17. PIPE DRAINING BEAR CANYON ROAD DITCH WITHIN REACH BEAR 03 N

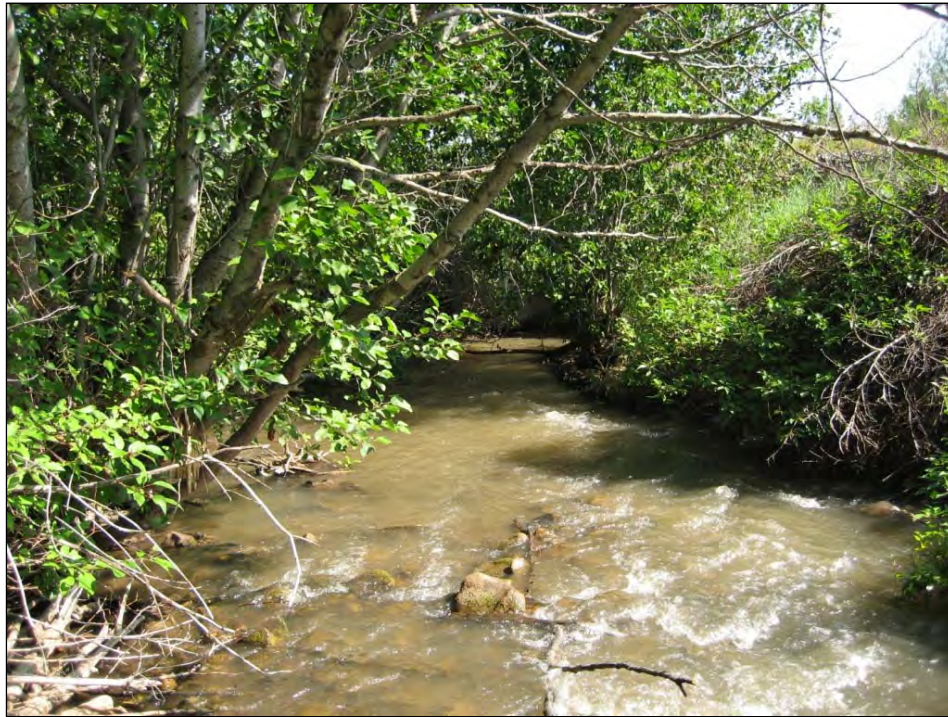
The dominant land uses within the reach are hay production and residential. Although there are several residences along the stream, the riparian zone remains dense with a cottonwood overstory and dense alder, dogwood and willow understory (Figures 19 and 20). Bank erosion was low within the reach; the only bank disturbance observed was some minor trampling downstream of Bozeman Trail Road near the Mt. Ellis Academy. Three irrigation withdrawals were identified within reach BEAR 04 N.

FIGURE 19. DENSE RIPARIAN DOWNSTREAM OF THE FRONTAGE ROAD WITHIN BEAR 04 N

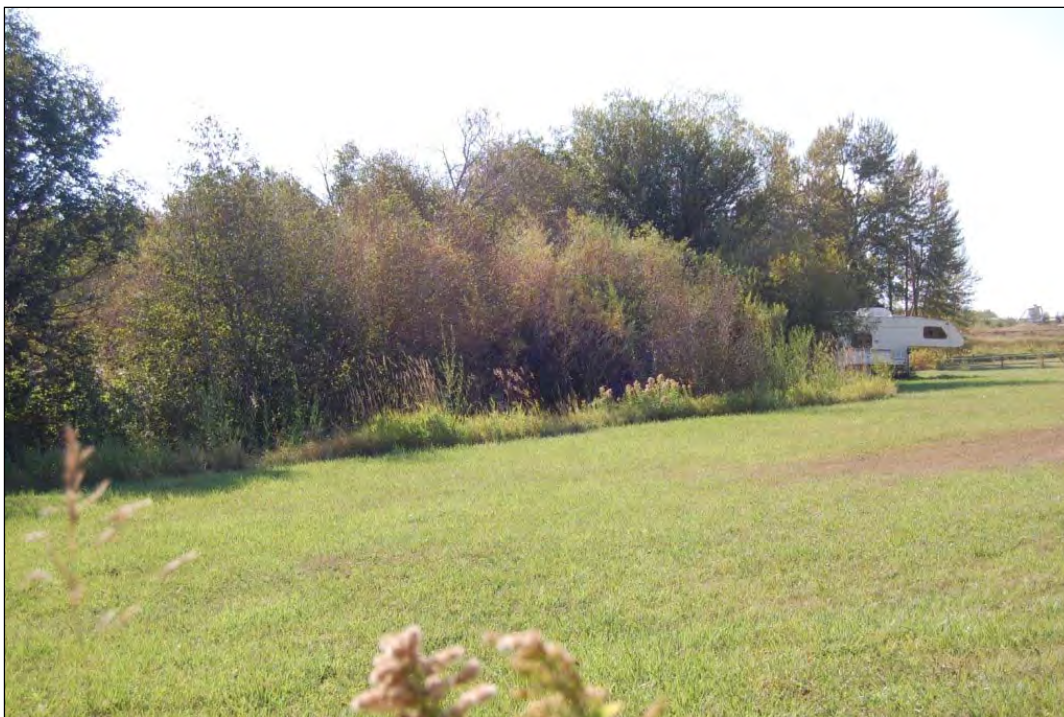
FIGURE 20. YARD ENCROACHMENT ON STREAM WITH DENSE RIPARIAN BUFFER ON REACH BEAR 04 N

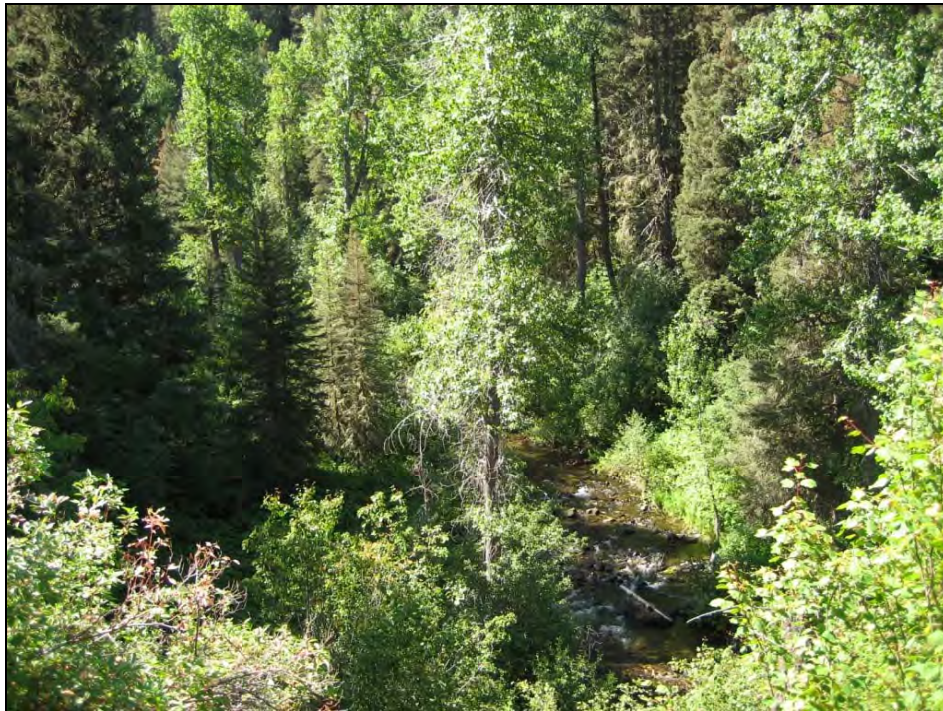
FIGURE 5. DENSE COTTONWOOD-CONIFER RIPARIAN UPSTREAM OF THE BOZEMAN CREEK TRAILHEAD

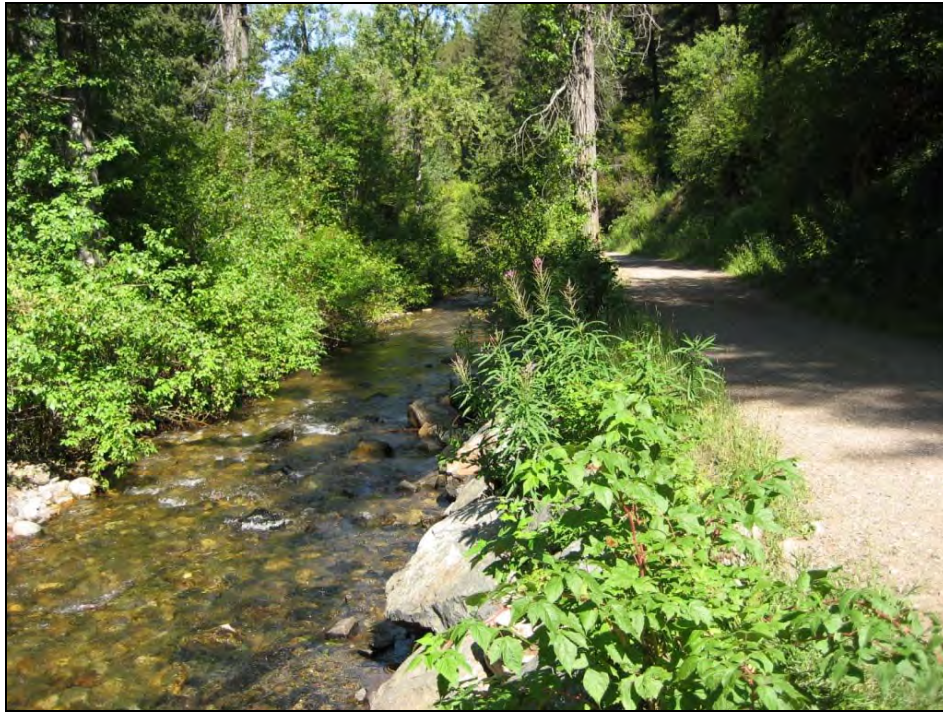
FIGURE 6. BOZEMAN CREEK TRAIL WITHIN 5 FEET OF SOURDOUGH CREEK, WITHIN THE FIRST MILE UPSTREAM OF THE TRAILHEAD

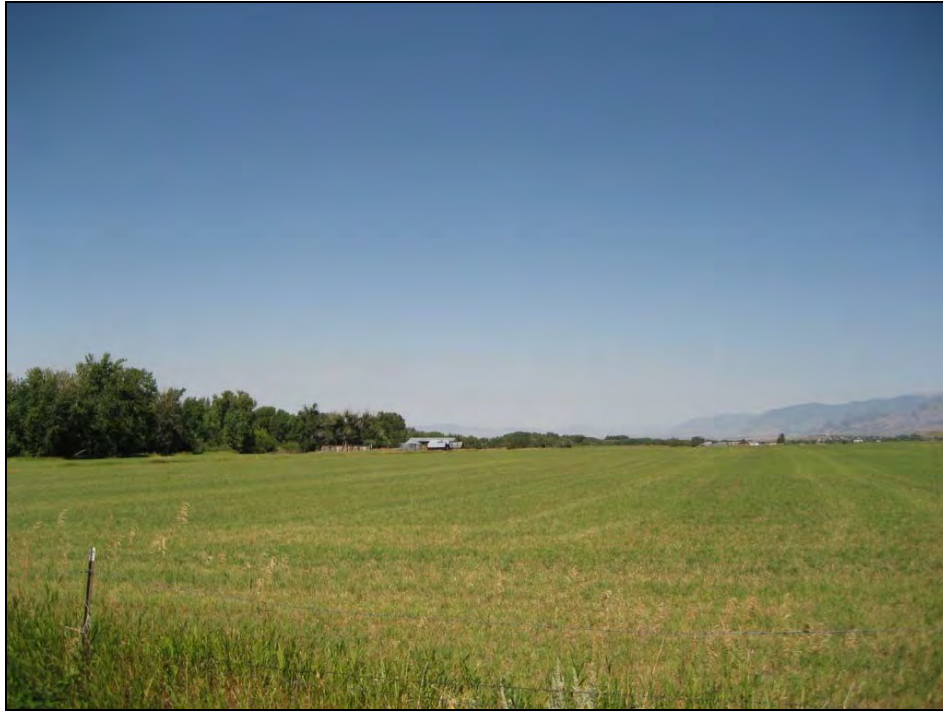
FIGURE 8. IRRIGATED HAY FIELD DOWNSTREAM OF NASH RD. SOURDOUGH CR RIPARIAN IN LEFT OF PHOTO

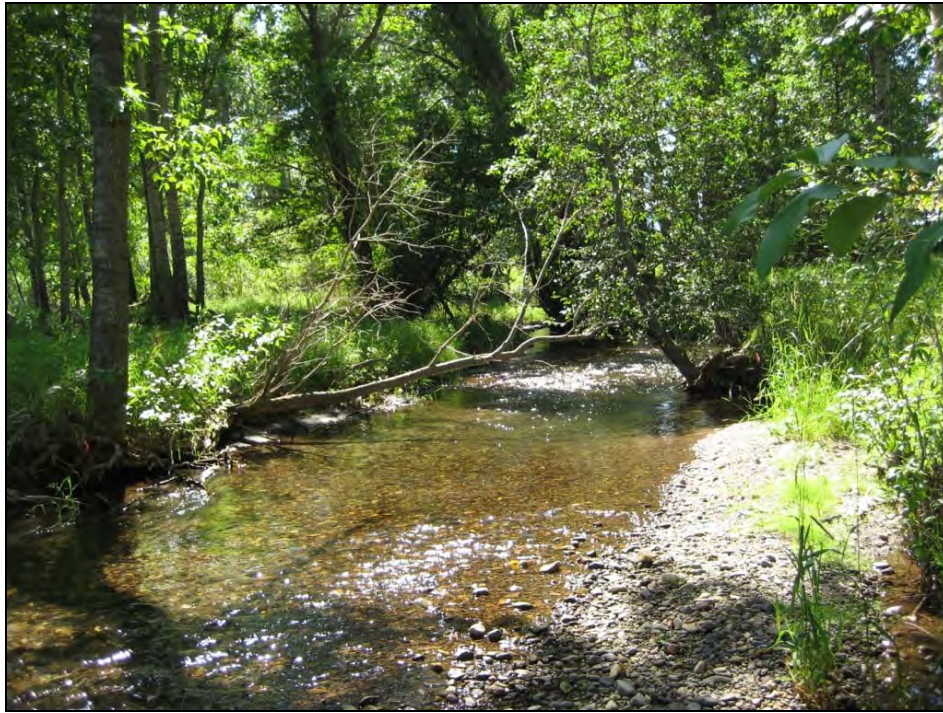
FIGURE 9. DENSE WILLOW-COTTONWOOD RIPARIAN

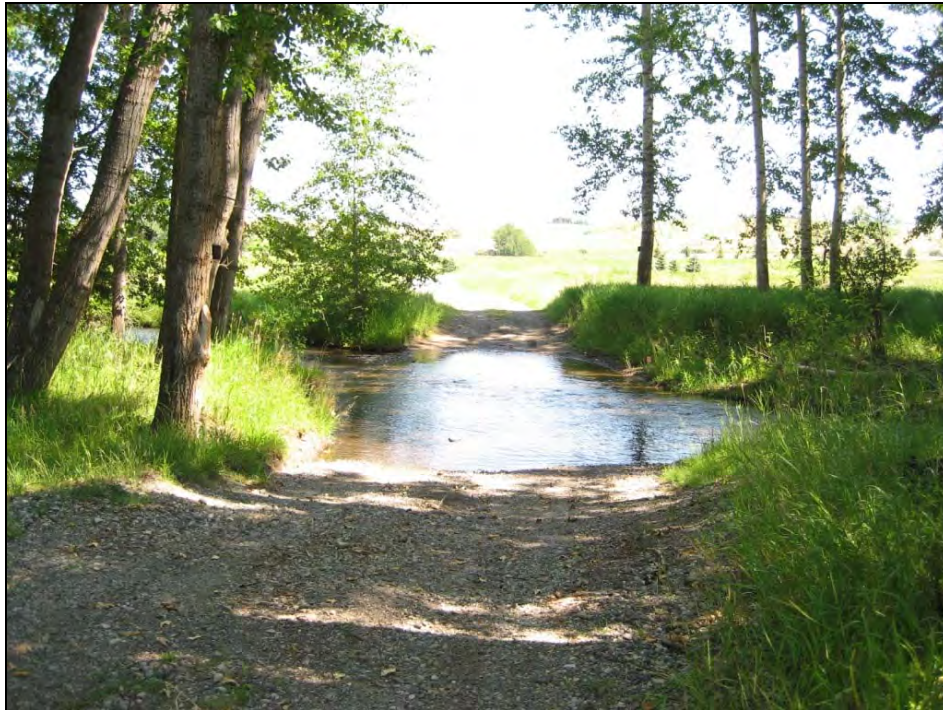
FIGURE 10. TWO-TRACK FORD ACROSS STREAM BETWEEN ABIGAIL RANCH RD AND COBBLE CREEK RD

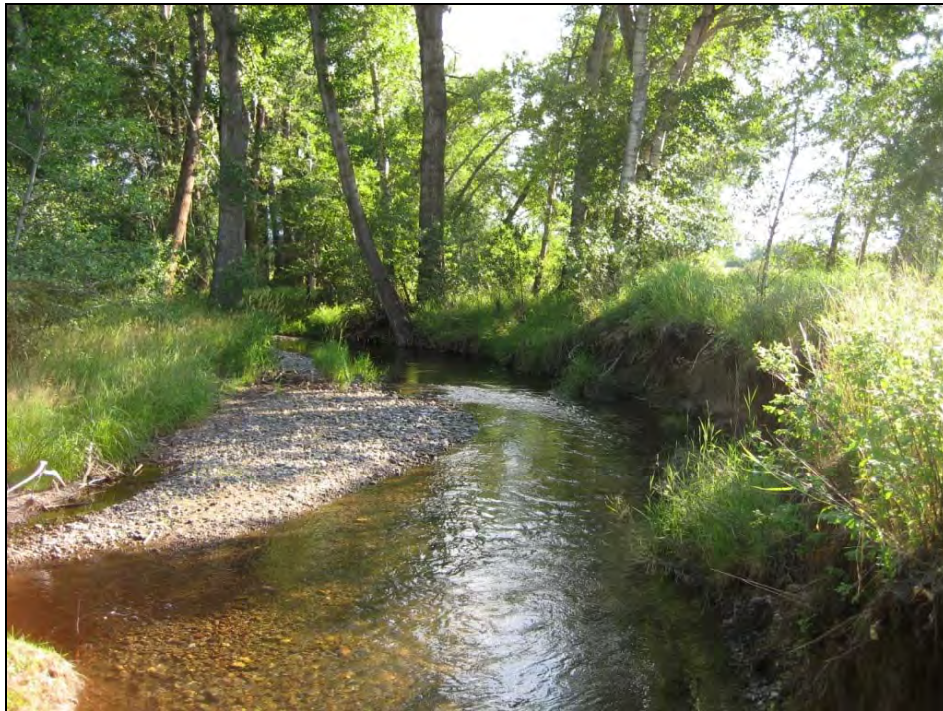
FIGURE 12. HEALTHY COTTONWOOD RIPARIAN UPSTREAM OF GOLDENSTEIN RD

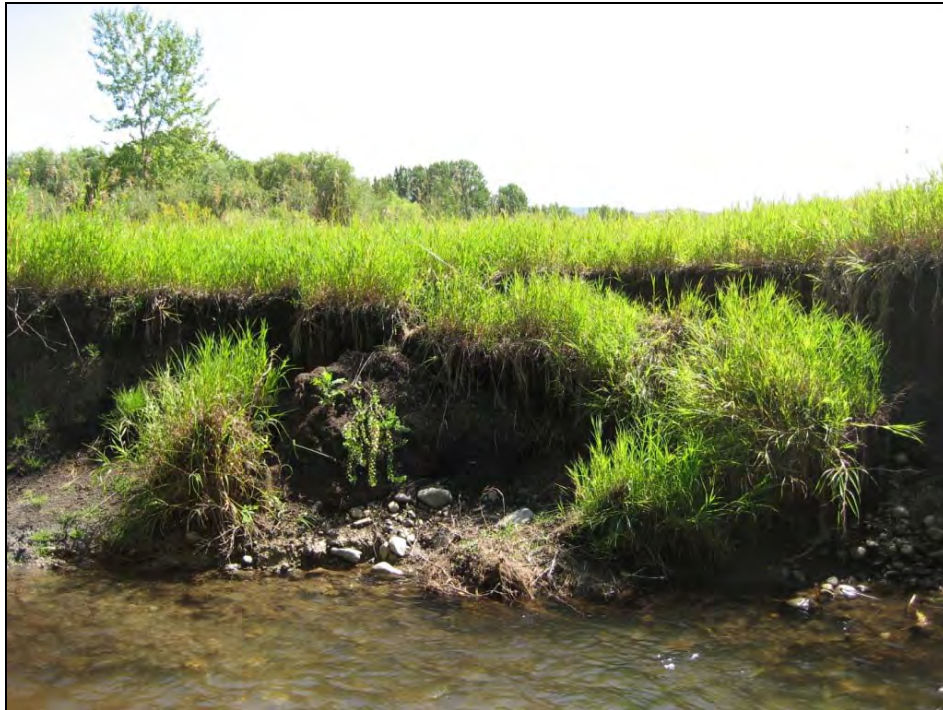
FIGURE 13. EROSION AND PASTURE ENCROACHMENT UPSTREAM OF KAGY BLVD

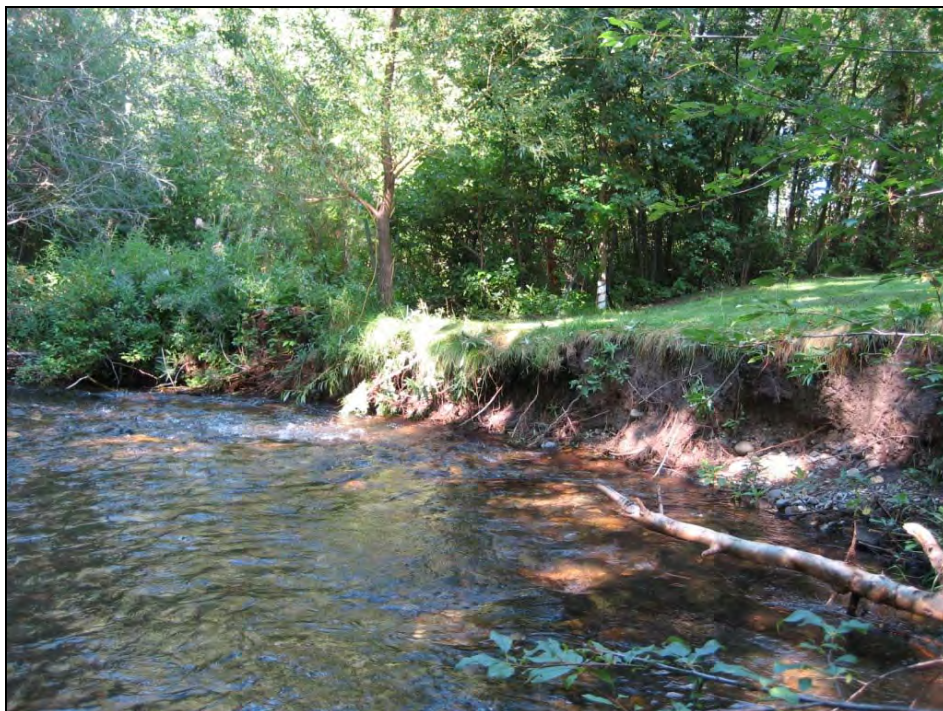
FIGURE 14. EROSION AND YARD ENCROACHMENT DOWNSTREAM OF GOLDENSTEIN RD

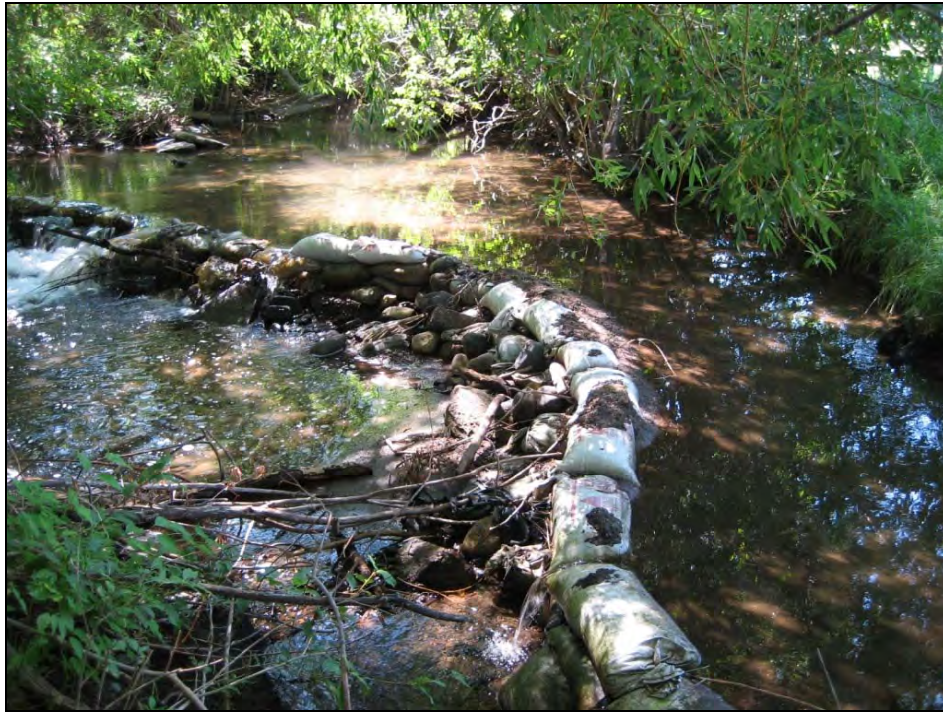
FIGURE 15. SANDBAGS DIVERTING WATER FOR WITHDRAWAL FOR RESIDENTIAL POND

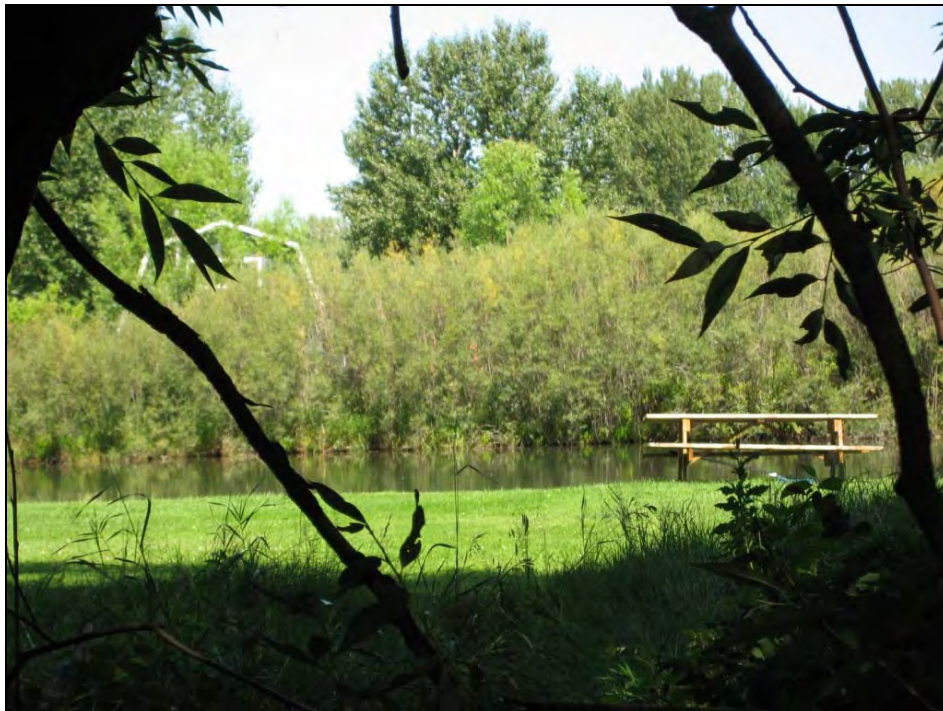
FIGURE 16. WITHDRAWAL IN FIGURE 15 APPEARS TO LEAD TO RESIDENTIAL POND ON WEST SIDE OF STREAM

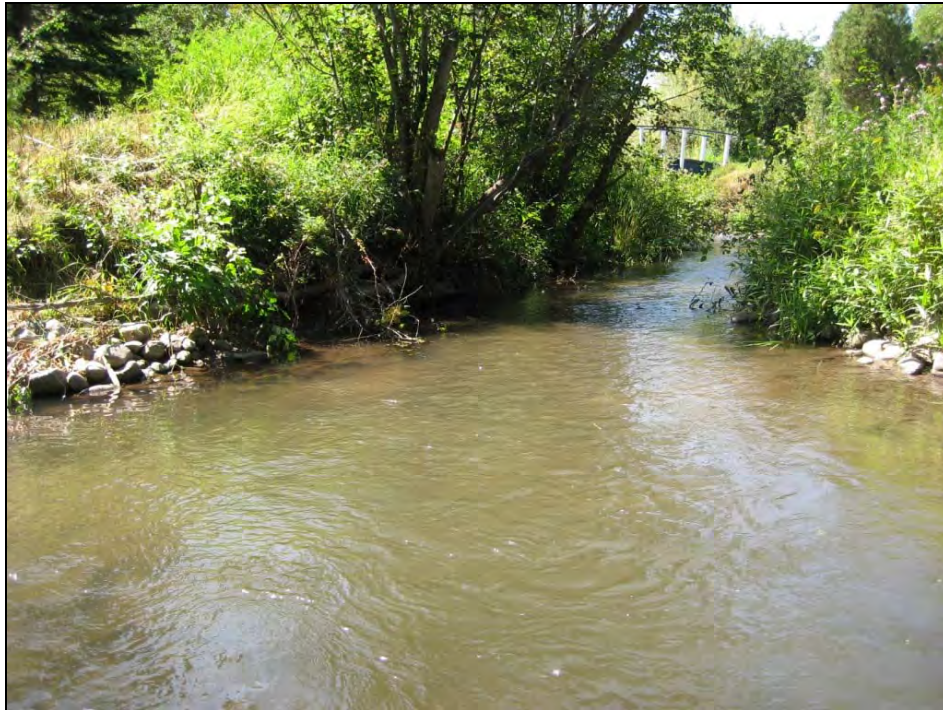
FIGURE 17. SPRING CR TRIBUTARY ENTERS UPSTREAM OF KAGY BLVD AFTER FLOWING THROUGH THE VALLEY VIEW GOLF COURSE

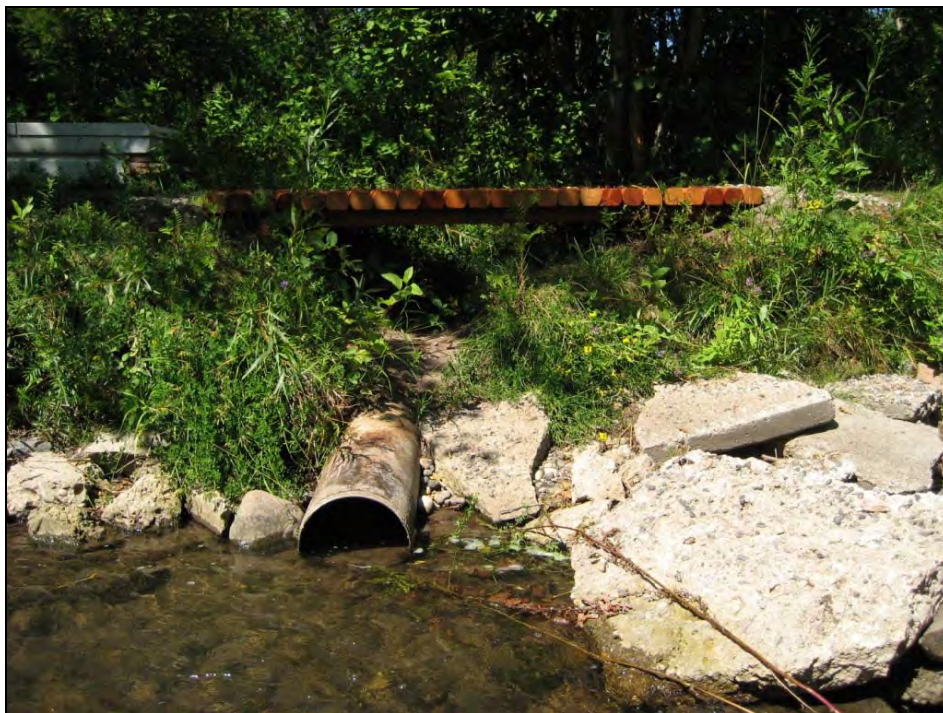
FIGURE 18. PIPE OF UNKNOWN SOURCE ENTERING STREAM; NOT FLOWING

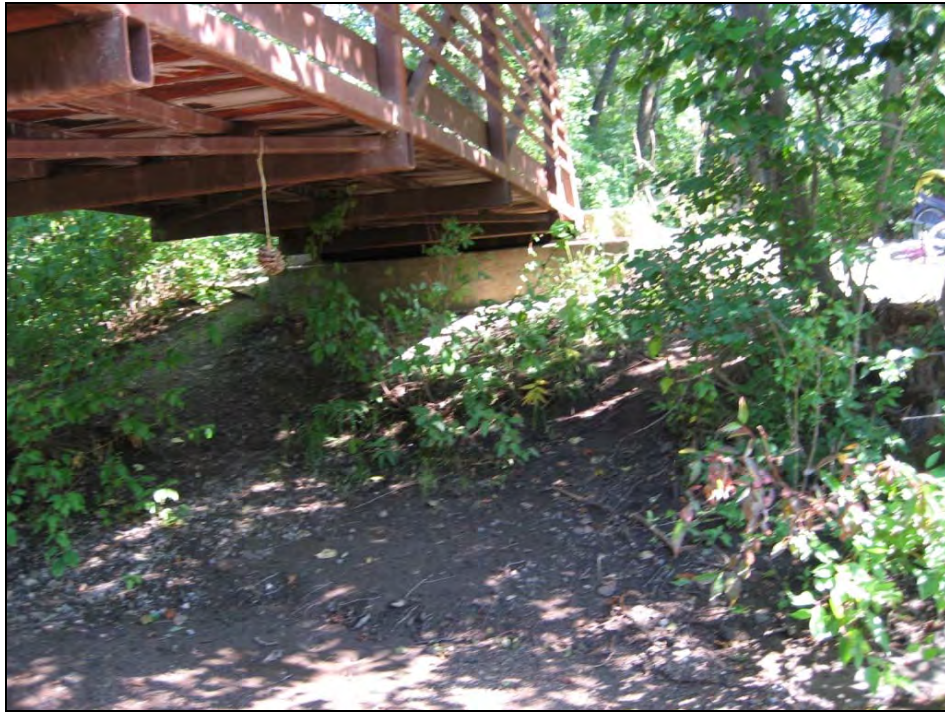
Septic system density was relatively high within the reach, primarily within 1000 feet of the stream, and was considered a significant potential nutrient and E. coli source. Three unpaved crossings were identified: a private driveway, the GVLT linear trail footbridge at water quality site SD05 (Figure 19), and a two-track ford located just downstream of the GVLT footbridge (Figure 20). The footbridge and the ford were considered minor potential sediment sources.

FIGURE 19. GALLATIN VALLEY LAND TRUST LINEAR TRAIL FOOTBRIDGE AT WATER QUALITY SITE SD05

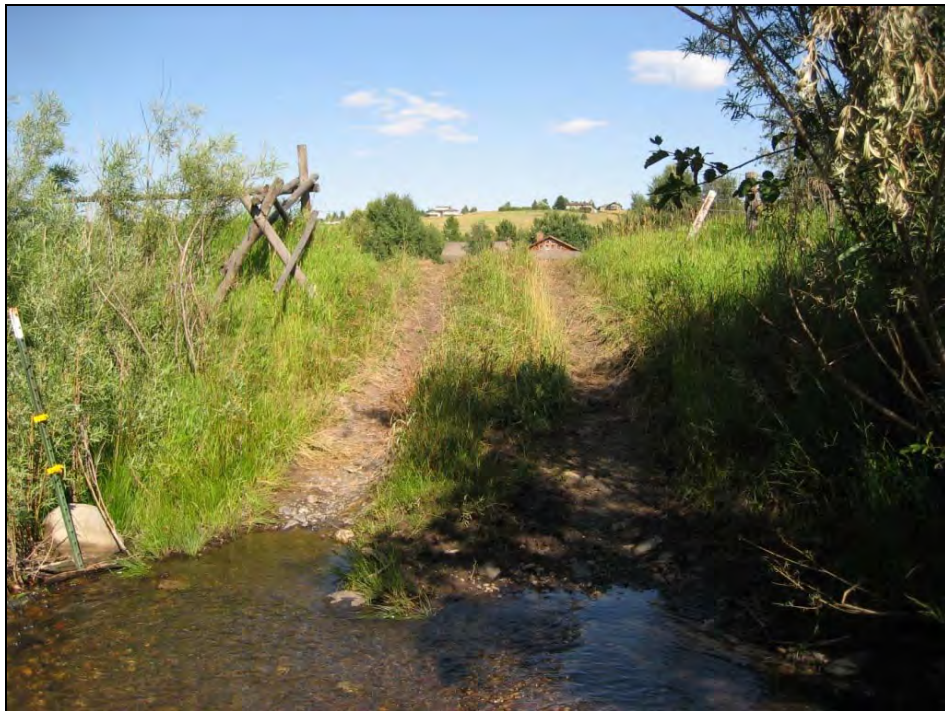
FIGURE 20. TWO-TRACK FORD DOWNSTREAM OF GVL T FOOTBRIDGE

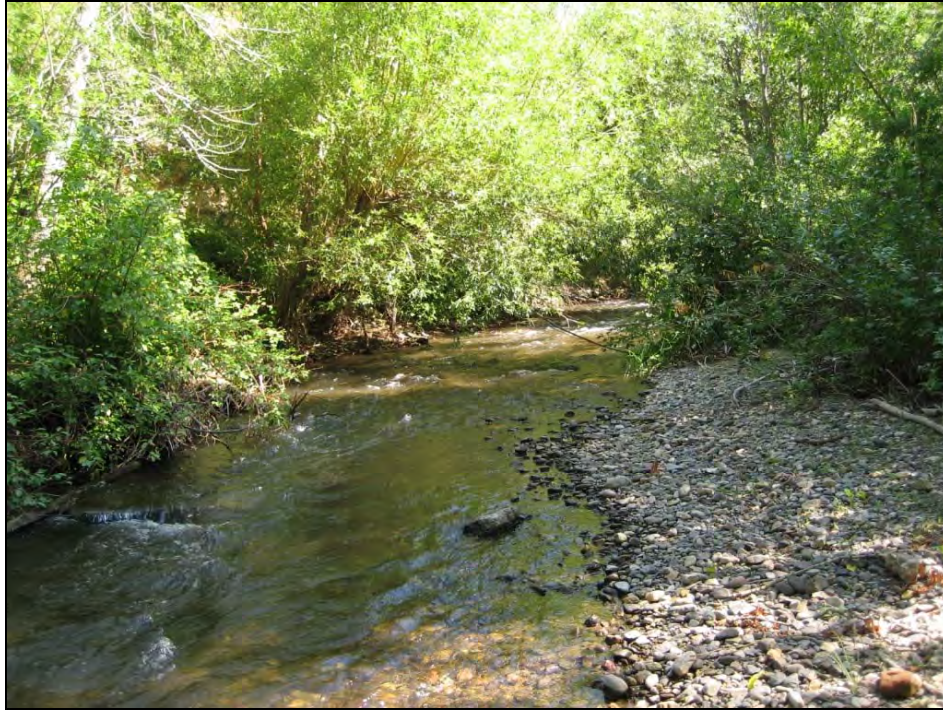
The dominant land uses within the reach are pasture land and residential. The riparian condition varies throughout the reach. Through most of the pasture land areas the riparian vegetation is characterized by dense, healthy stands of willow and cottonwood, with stable banks (Figure 22). In contrast, yard encroachment, bank erosion, and significant trampling are common through residential and industrial sections along South Church St (Figures 23 and 24). One significant tributary, Mathew Bird Cr, enters at the lower end of the reach (Figures 11 and 25).

FIGURE 22. DENSE WILLOW RIPARIAN DOWNSTREAM SOUTH CHURCH STREET

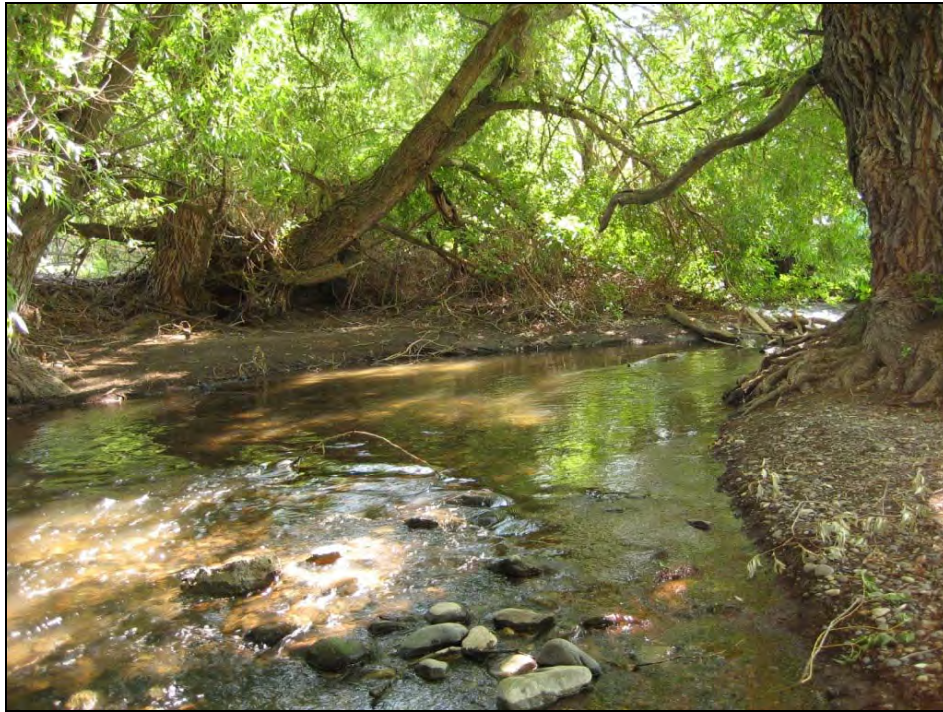
FIGURE 23. TRAMPLING AND RESIDENTIAL ENCROACHMENT DOWNSTREAM OF MARTEL BRIDGE ALONG SOUTH CHURCH STREET

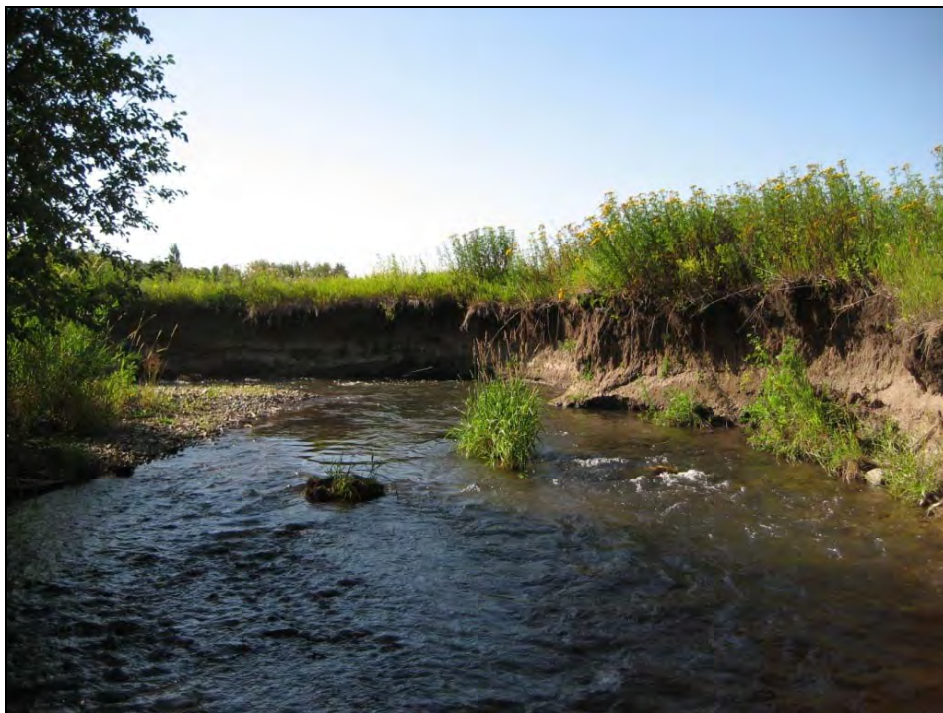
FIGURE 24. ERODING BANK DOWNSTREAM OF KAGY BLVD

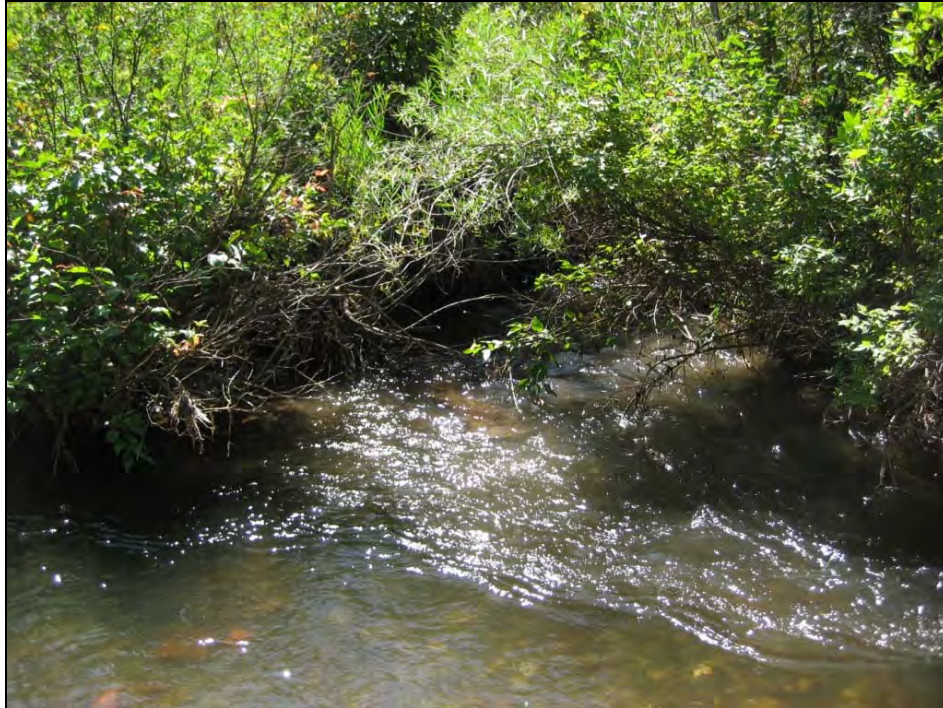
FIGURE 25. MATHEW BIRD CR ENTERING NEAR THE DOWNSTREAM END OF THE REACH

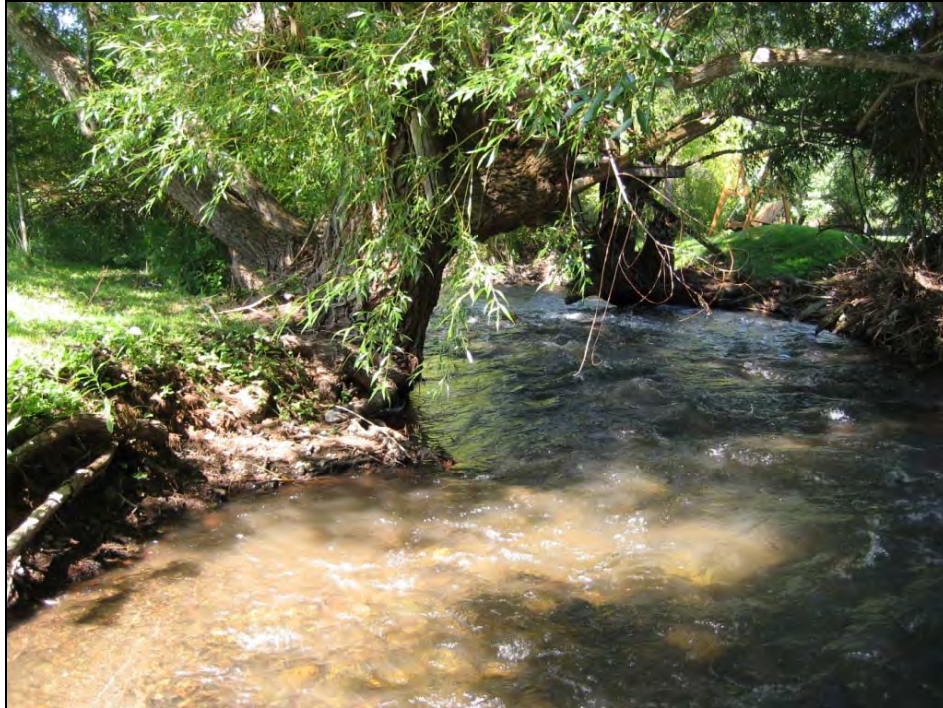
FIGURE 26. RESIDENTIAL LAWN ENCROACHMENT

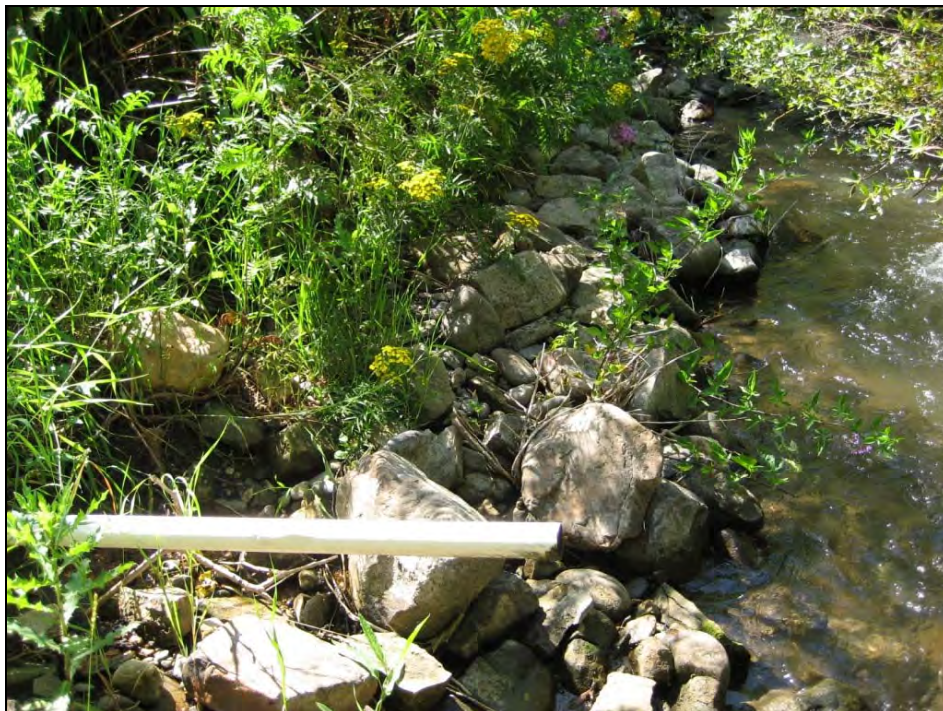
Two pipes of unknown origin were identified exiting a single yard just downstream of South Church St. A small diameter PVC pipe was identified dripping into the stream (Figure 27). A second pipe was noted at the same location entering below base flow. A large stormwater pipe enters Sourdough Creek at the Manion residence off East Lincoln St, across the stream from the power station on South Church St. This is a concrete stormwater pipe with significant flow (Figure 28) witnessed during a dry period, suggesting significant infiltration and/or inflow into the storm sewer system. Because of the significant flow, this pipe was considered a moderately significant source of nutrients and E. coli. One livestock confinement area, a horse corral located directly adjacent to the stream, was identified just downstream of Kagy Blvd. Only a single horse in the corral during

FIGURE 27. PVC PIPE ENTERING LEFT BANK JUST DOWNSTREAM OF SOUTH CHURCH ST. DRIPPING AT TIME OF ASSESSMENT
