ATTACHMENT B – 2009 LOWER GALLATIN TMDL PLANNING AREA NUTRIENT, ALGAE AND *E. COLI* SOURCE ASSESSMENT

December, 2009

OASIS Environmental, Inc.
PO Box 582
Livingston, MT 59047

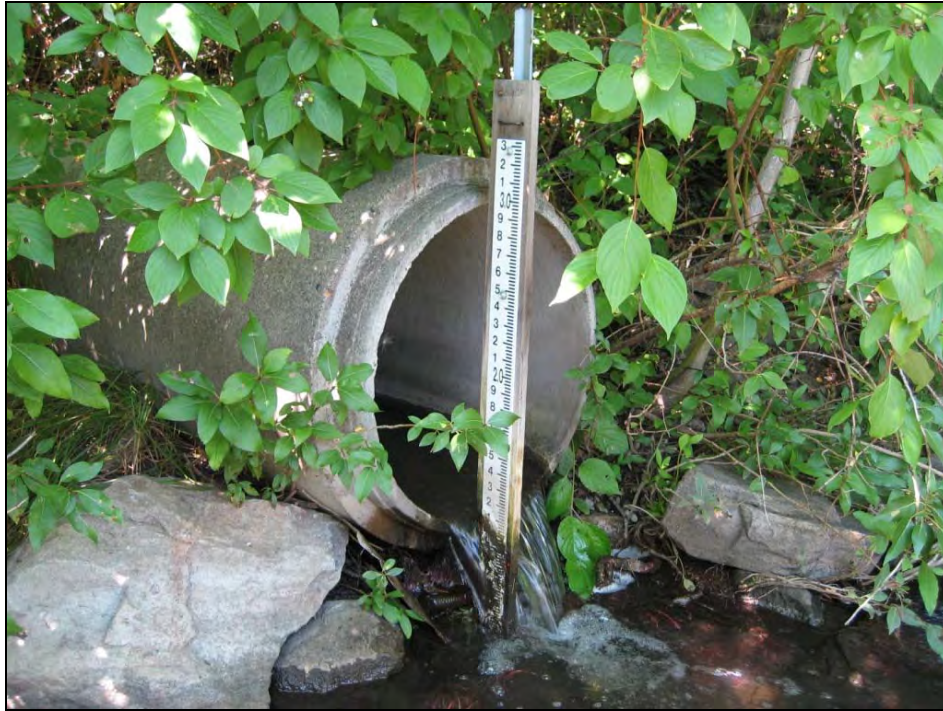
Two pipes of unknown origin were identified exiting a single yard just downstream of South Church St. A small diameter PVC pipe was identified dripping into the stream (Figure 27). A second pipe was noted at the same location entering below base flow. A large stormwater pipe enters Sourdough Creek at the Manion residence off East Lincoln St, across the stream from the power station on South Church St. This is a concrete stormwater pipe with significant flow (Figure 28) witnessed during a dry period, suggesting significant infiltration and/or inflow into the storm sewer system. Because of the significant flow, this pipe was considered a moderately significant source of nutrients and E. coli. One livestock confinement area, a horse corral located directly adjacent to the stream, was identified just downstream of Kagy Blvd. Only a single horse in the corral during

FIGURE 28. STORMWATER PIPE ENTERING AT MANION PROPERTY. 2009 WATER QUALITY SAMPLING SITE SDP01.

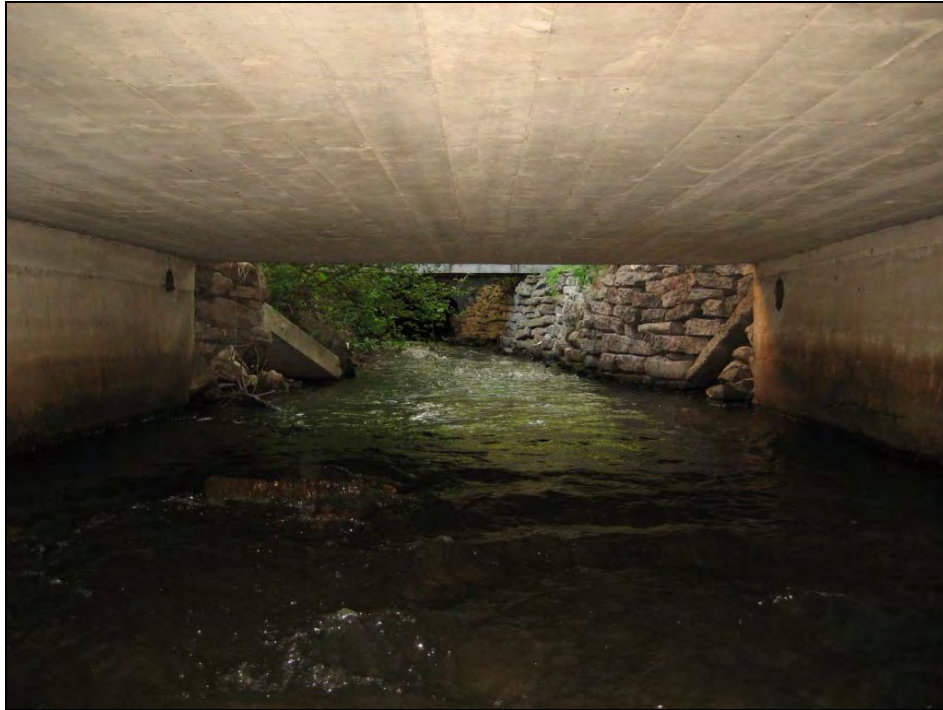
Reach 5 is the most impacted by urban development and is in very poor physical condition. The reach flows through downtown Bozeman, thus the dominant land use is urban for its entire length. The stream flows under streets and businesses in a large culvert under downtown Bozeman for approximately one city block. It goes into the culvert downstream of Babcock St just west of Rouse St, and re-surfaces downstream of the alley between Main St and Mendenhall St (Figure 30).

FIGURE 30. BRIDGE UNDER ALLEY BETWEEN MAIN ST AND MENDENHALL ST WHERE STREAM RE-SURFACES FROM BEING CHANNELIZED UNDER MAIN ST AND BUSINESSES

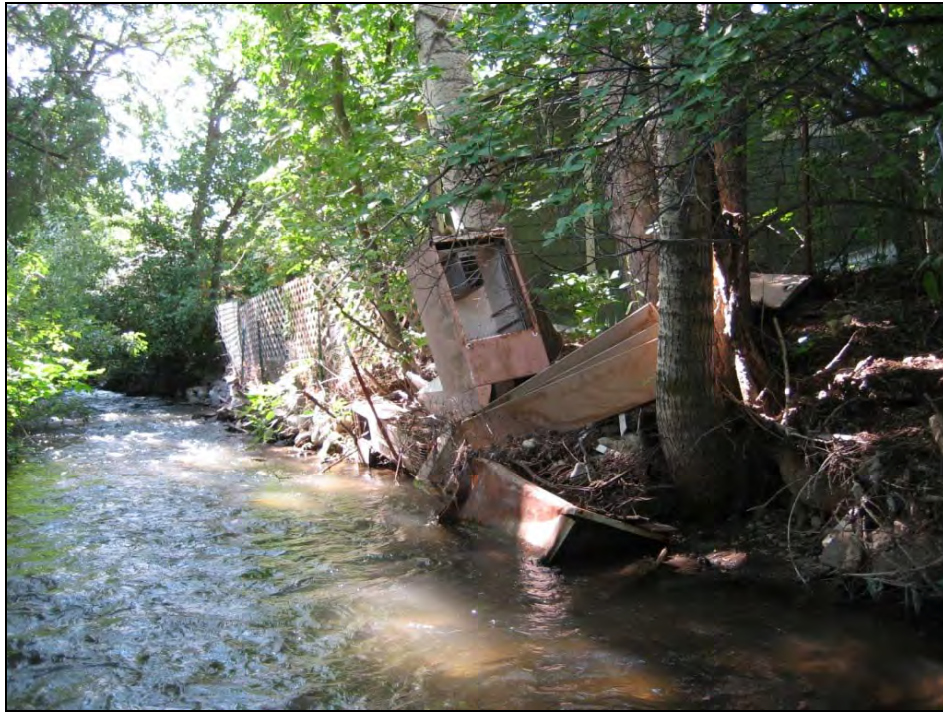
Typical of an urban stream, it is channelized along roads and residences in many locations, using a variety of materials from traditional boulder and concrete rip-rap to car bodies, old appliances and stone walls (Figure 31). The riparian zone is in very poor condition for the entire length of the reach. Vegetation is characterized by tree willows, cottonwoods and green ash, with extensive trampling underneath and minimal understory vegetation (Figure 32). Bank erosion is common (Figure 33), but is also mitigated by extensive rip-rap along residential back yards (Figure 34). Lawns associated with both residences and Bogert Park encroach on the stream for most of its length (Figures 32, 34, 35 and 36).

FIGURE 31. OLD APPLIANCES ADJACENT TO THE STREAM DOWNSTREAM OF ROUSE AVE

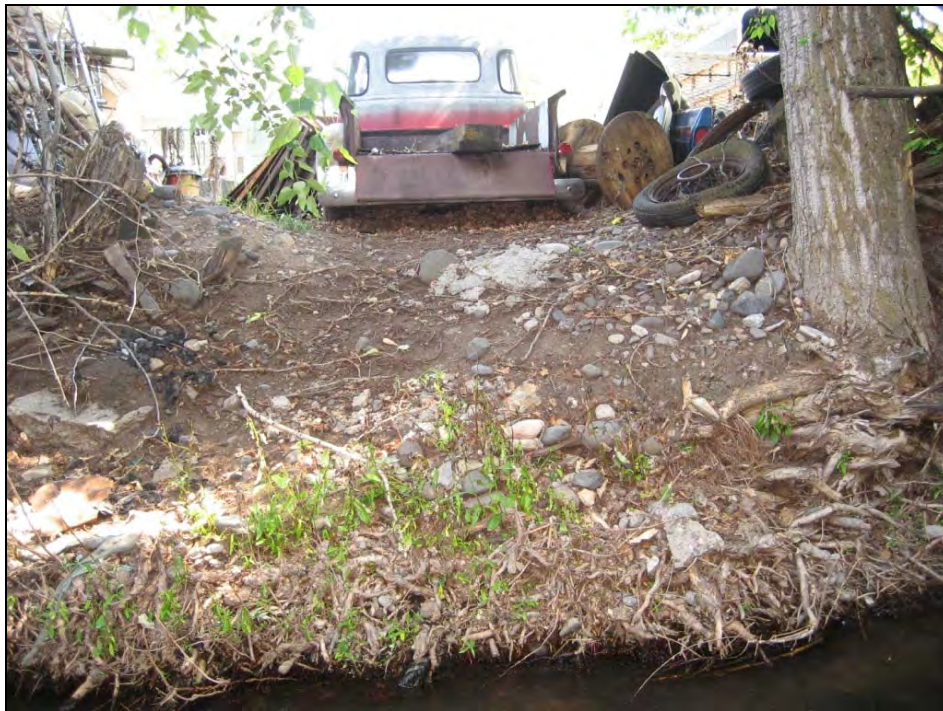
FIGURE 32. TRAMPLED BANK DOWNSTREAM OF PEACH ST

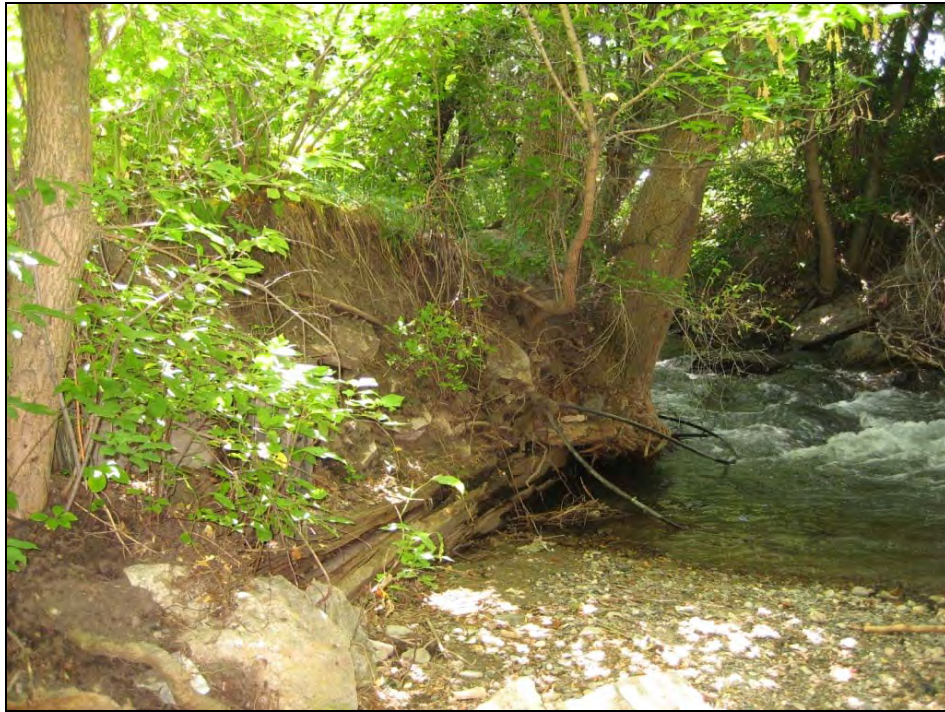
FIGURE 33. ERODING BANK

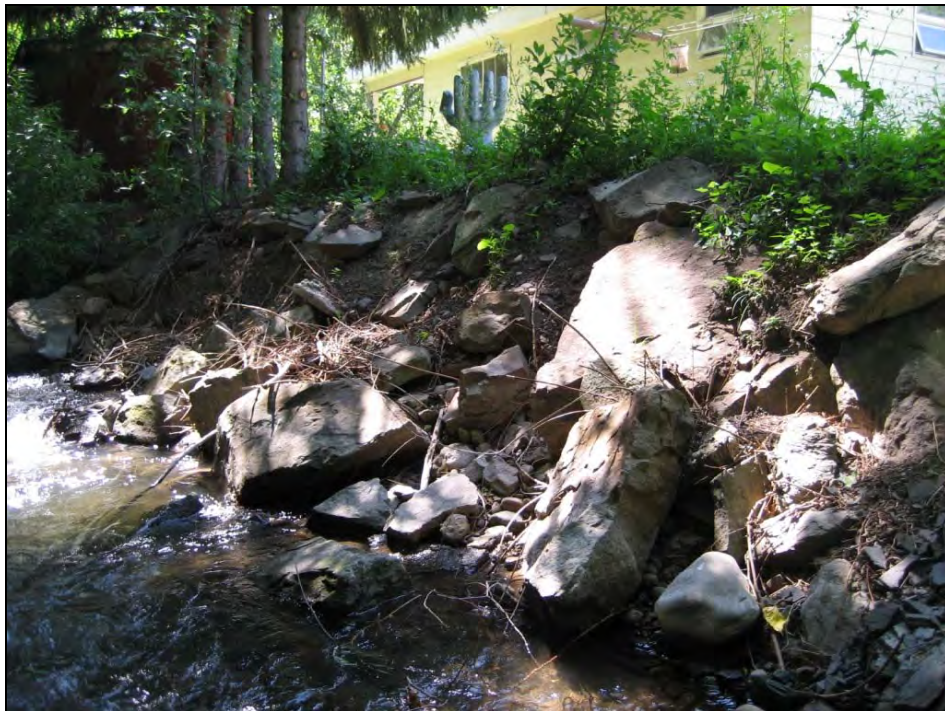
FIGURE 34. RIP-RAPPED BANK BEHIND RESIDENCE

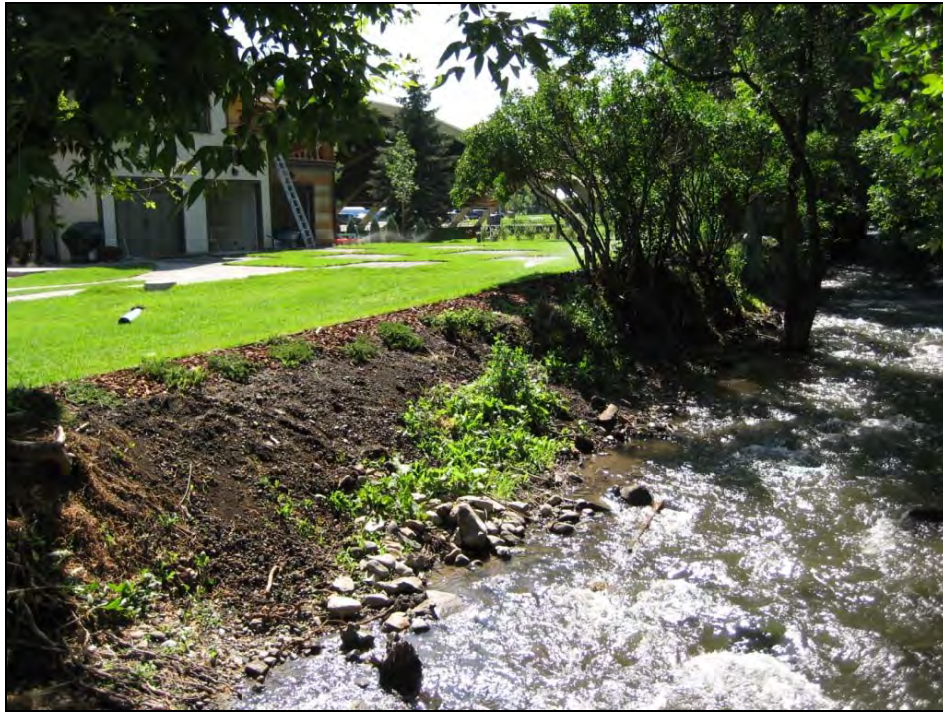
FIGURE 35. LAWN ENCROACHMENT UPSTREAM OF OLIVE ST

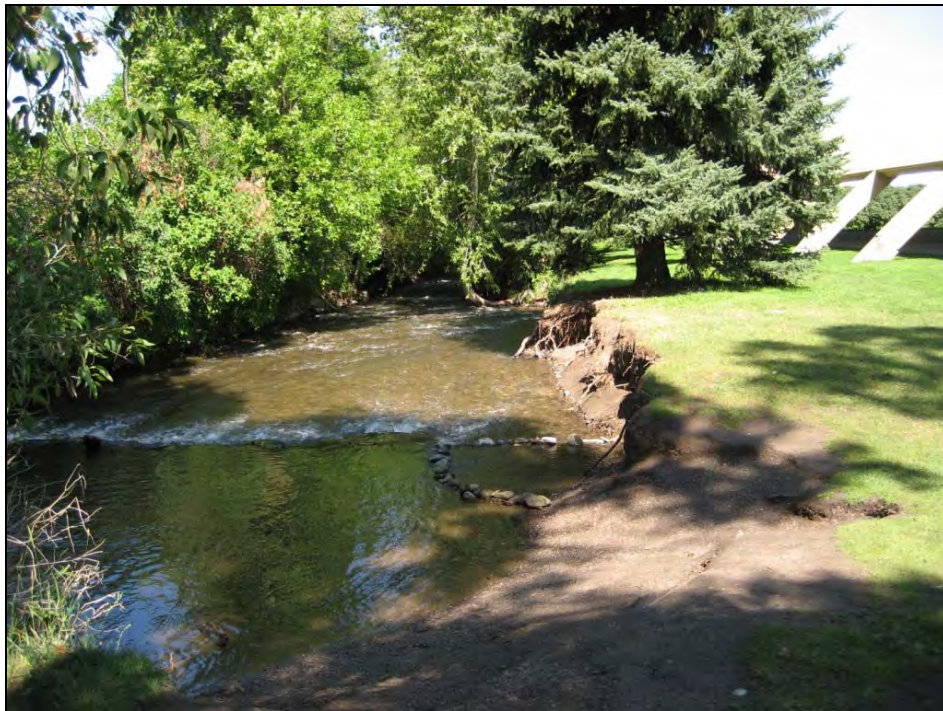
FIGURE 36. LAWN ENCROACHMENT AND BANK EROSION AT BOGERT PARK

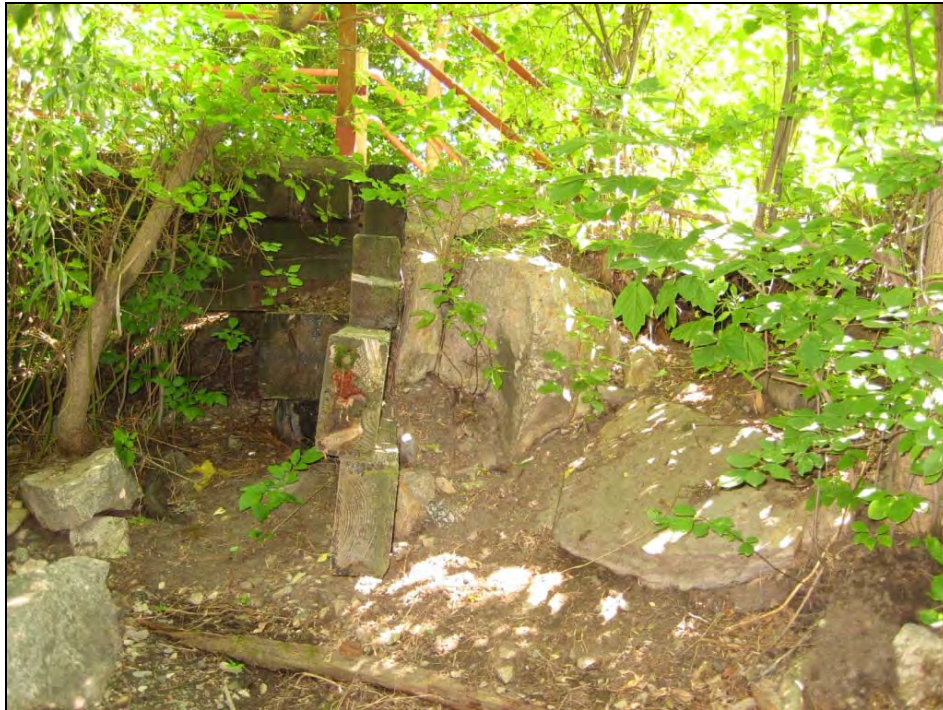
Two unpaved trail foot bridges cross the stream, the foot bridge at Bogert Park and the GVLT trail bridge upstream of Tamarack St (Figure 37). Both were in good condition and well vegetated but with erosion around the abutments. Rouse Ave encroaches on the stream for about 3000 ft and Bonner St encroaches in the upstream end of the reach for about 900 ft. No vegetation is present along 1500 ft of the encroachment along Rouse Ave and could be a significant nutrient source (Figure 38).

FIGURE 37. RECREATION EROSION AT GVLt TRAIL FOOTBRIDGE UPSREAM OF TAMARACK ST

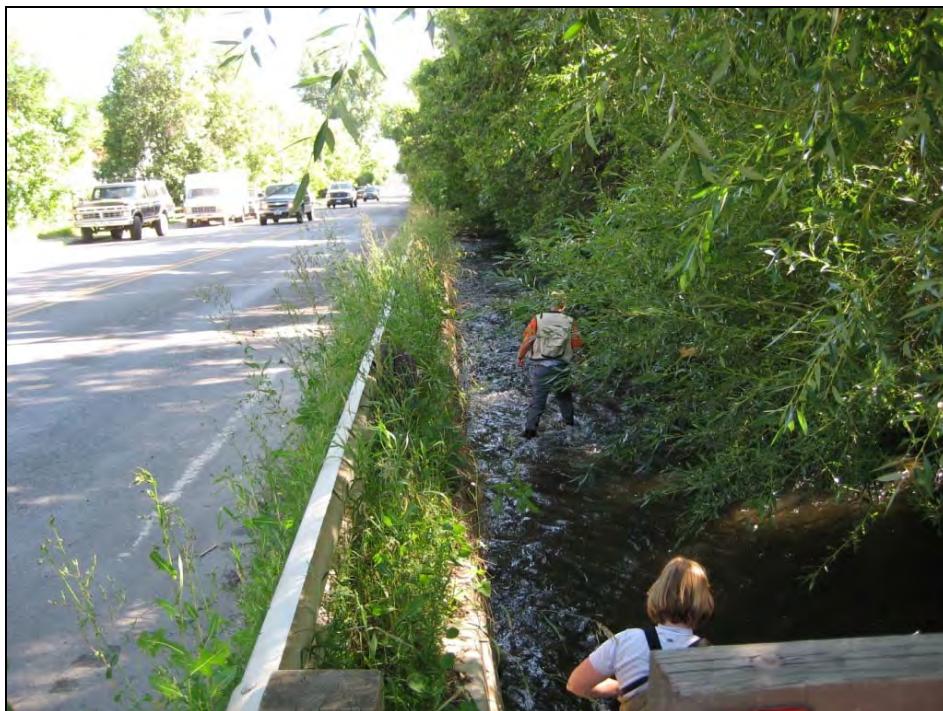
FIGURE 38. ROUSE ST ENCROACHES ON THE STREAM

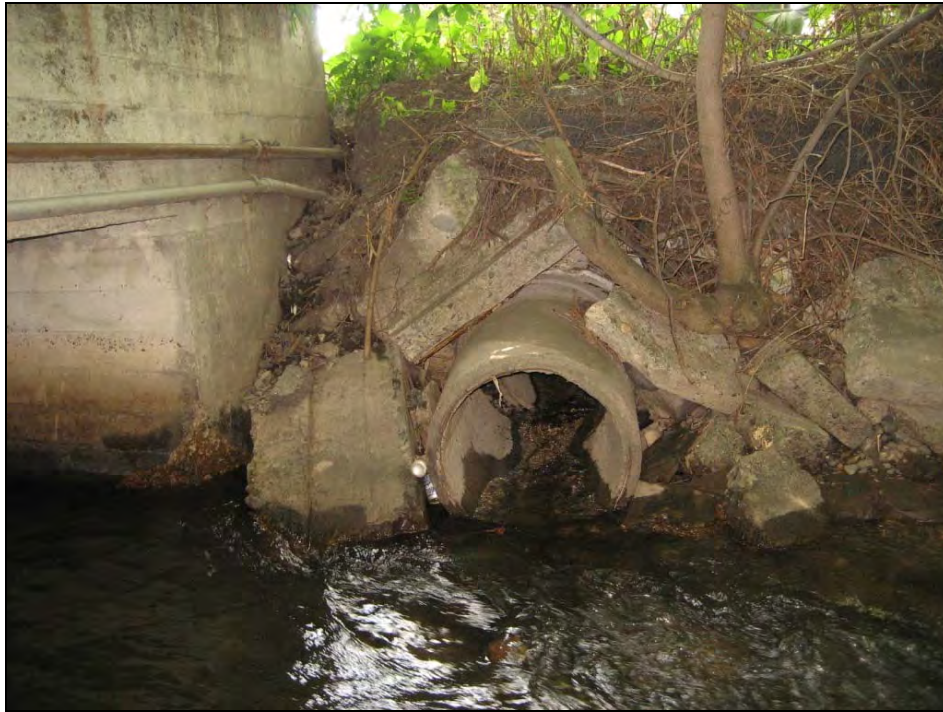
Eight pipes of unknown origin were identified entering the stream, none of which were flowing during the assessment, nor did any of the pipe exhibit evidence of recent flow such as sediment within the pipe or erosion below the pipe. Most were likely residential drain pipes and/or sump pump drains to mitigate high groundwater tables during snowmelt and storm events. These pipes were not considered a highly significant nutrient or E. coli source. In contrast, the eight stormwater pipes pose a greater potential to be nutrient and E. coli sources. Of these, three were flowing and one contained evidence of recent flow (sediment build up in the pipe). Two of the flowing stormwater pipes are particularly noteworthy. The pipe at Peach St enters on the left bank, and the water was warm with a distinctly chlorine odor (Figure 39). The pipe adjacent to Rouse Ave smelled very strongly of methane and sewage, and brown, solid, dime-sized particles were observed floating out of the pipe. The latter pipe was since confirmed to contain very high levels of E. coli (greater than 2000 cfu/100 ml) during the September 2009 water quality monitoring effort.

FIGURE 39. FLOWING STORMWATER PIPE DOWNSTREAM OF PEACH ST, WATER WARM AND SMELLED OF CHLORINE

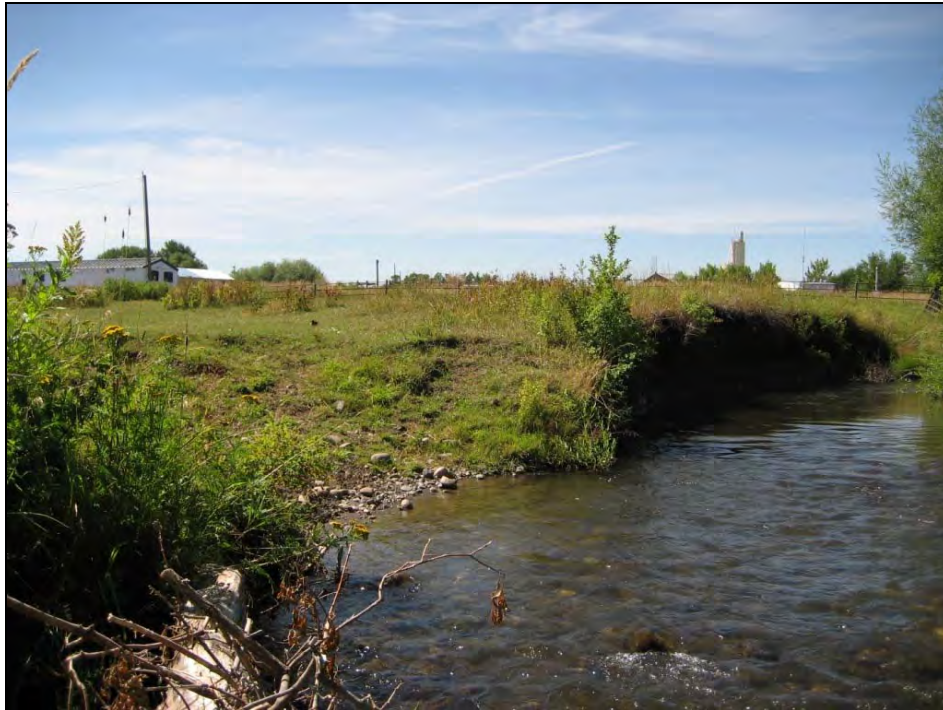
FIGURE 42. BANK EROSION AND PASTURE ENCROACHMENT UPSTREAM OF INTERSTATE 90

Potential nutrient and E. coli sources within the reach are detailed in Table 8. Residential lawns and small horse pastures encroach on the stream for a limited portion of the reach but are associated with some bank erosion (Figures 42 and 43). Lawns and small pastures were considered a potential nutrient and E. coli source via both overland flow and groundwater delivery.

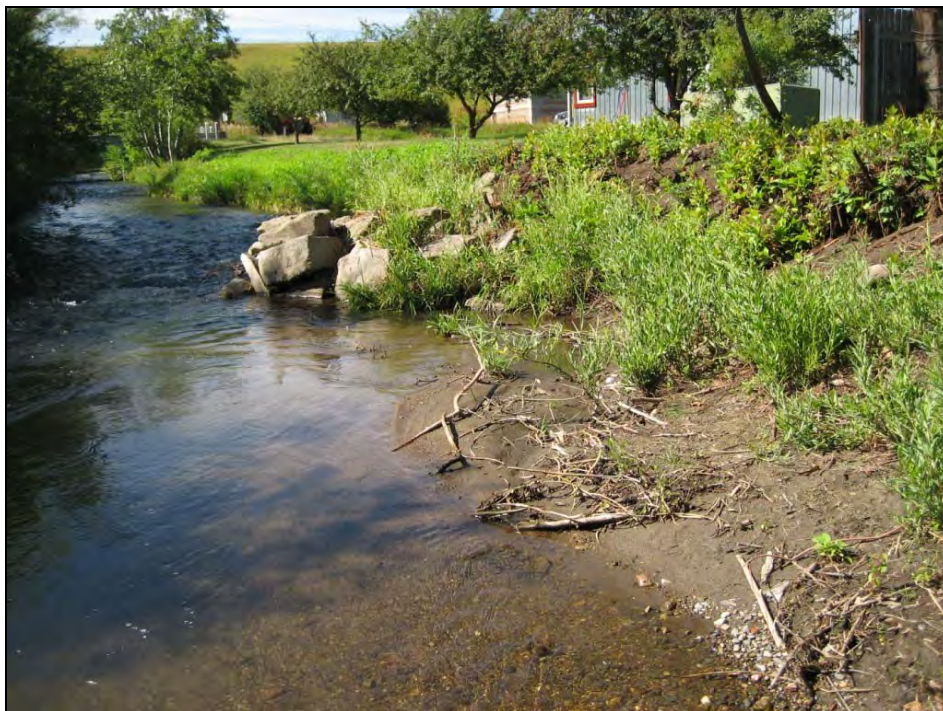
FIGURE 43. LAWN ENCROACHMENT DOWNSTREAM OF INTERSTATE 90

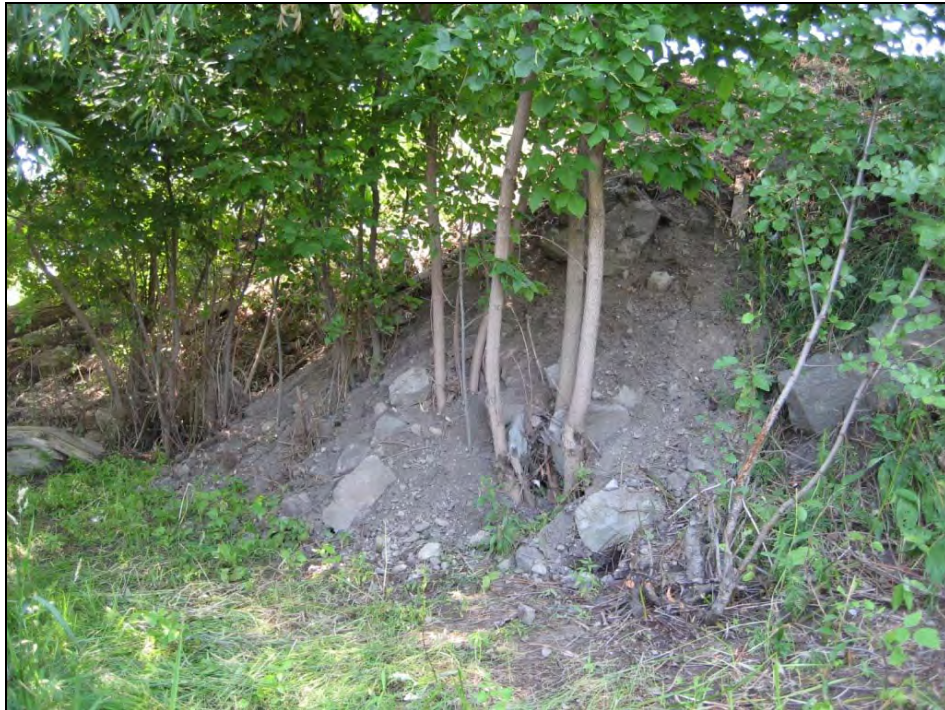
One unpaved driveway crosses the stream but it was well-vegetated near the abutments and is not likely a sediment source. Although no roads encroached, parking lots through the industrial areas were located directly adjacent to the stream, often with no riparian buffer. Gravel was pushed into the stream from one adjacent parking lot, likely causing sediment input during storm events (Figure 44). Two LCAs were identified adjacent to the stream and were considered potential nutrient and E. coli sources through both overland and groundwater delivery. One of the LCAs, observed just upstream of Interstate 90, was associated with manure piles located within 3 feet of the active channel (Figure 45).

FIGURE 44. GRAVEL PUSHED INTO RIPARIAN FROM ADJACENT PARKING LOT

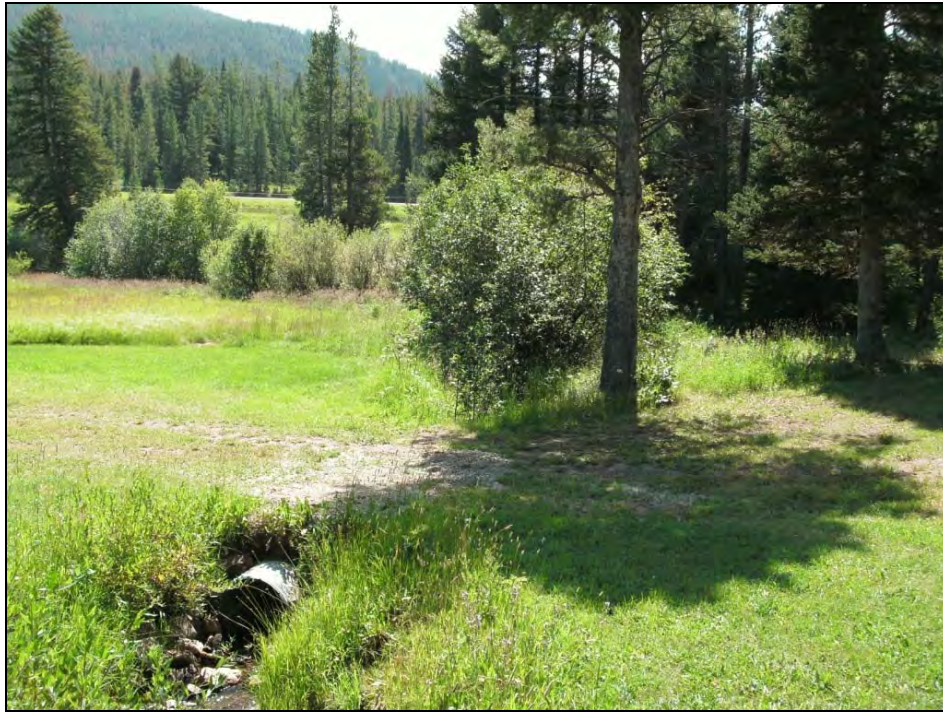
Nutrient Source	Source Prevalence	Pathway	Riparian Quality	Comments	Potential Significance
Septic system per mi (150 ft/1000 ft)	0.5/4.8	GW	Excellent		low
Unpaved road crossings (#)	2	SW	Excellent	culverted ski/hiking trail crossings at Bohart Ranch	low

FIGURE 7. SKI TRAIL CROSSING AT BOHART RANCH

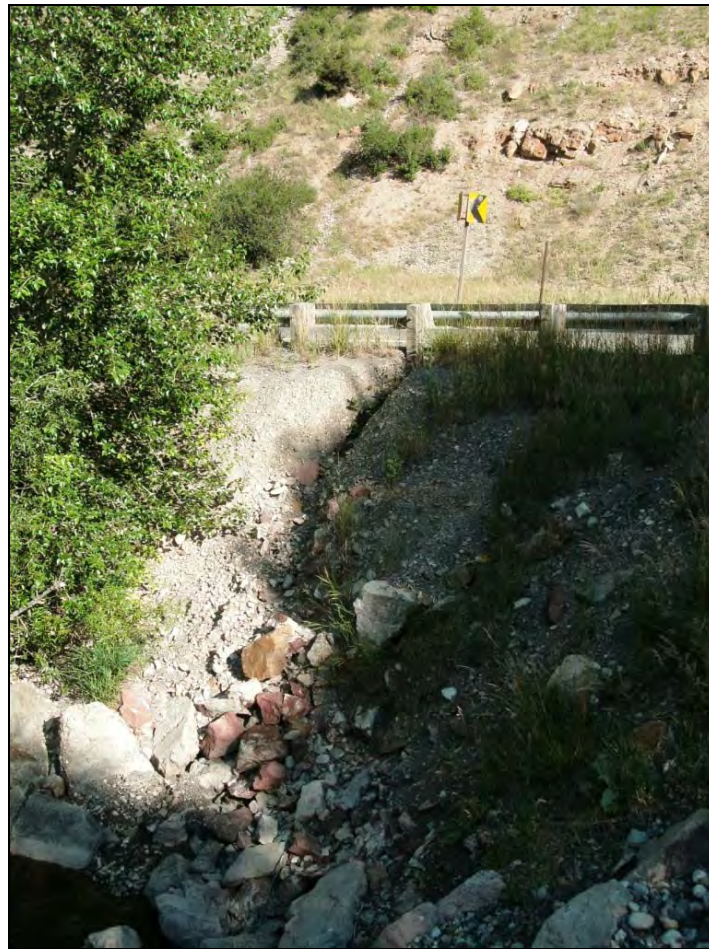
FIGURE 14. EROSION FROM POOR DRAINAGE OFF BRIDGER CANYON RD

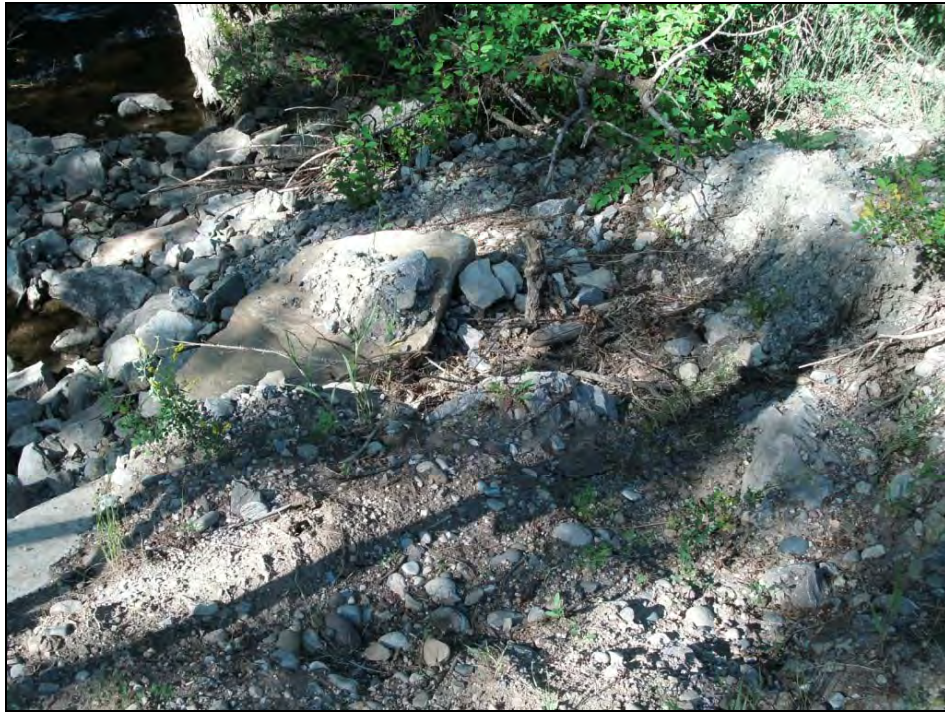
Pollutant Source	Source Prevalence	Pathway	Riparian Quality	Comments	Potential Significance
Septic system per mi (150 ft/1000 ft)	1.8/0.0	GW	Good		low
Unpaved road crossings (#)	1	SW	Good	Maiden Rock Rd, some erosion occurring downstream	low

FIGURE 15. EROSION DOWNSTREAM OF MAIDEN ROCK RD BRIDGE

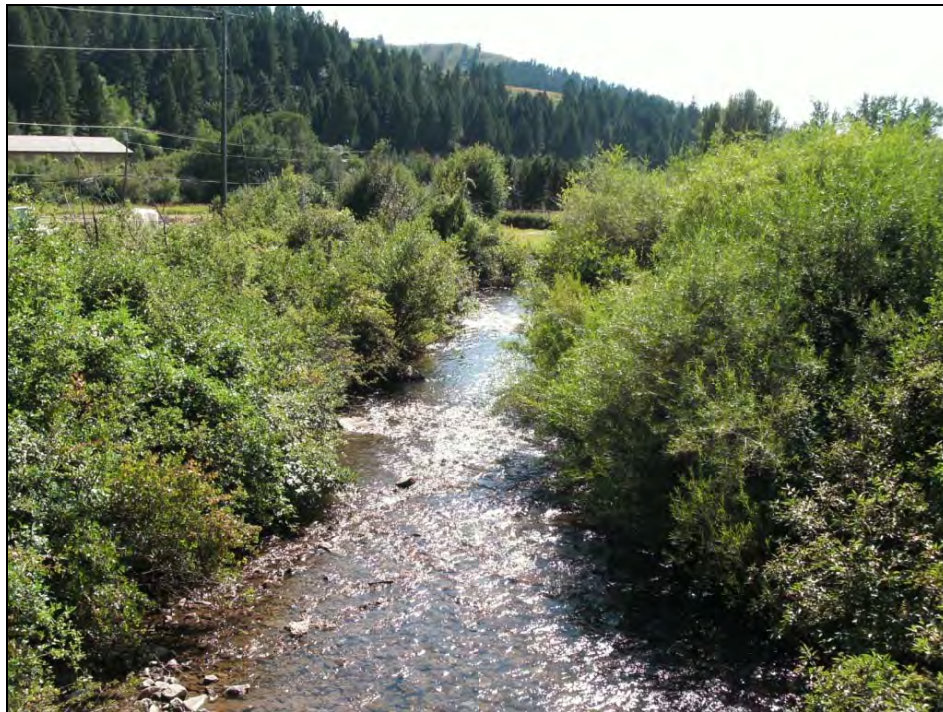
The dominant land uses within the reach are rural residence, hay production, and irrigated and dry pasture land. The riparian vegetation is quite healthy, with dense willows and scattered cottonwoods (Figure 17), with very little bank erosion observed. Rip-rapped banks were observed in the section through the USFWS Bozeman Fish Technology Center (Fish Tech Center) (Figure 16). Three irrigation withdrawals were identified within the reach, two of which were definitively confirmed on the aerial and one was confirmed in the field.

FIGURE 17. DENSE WILLOW RIPARIAN DOWNSTREAM OF DRINKING HORSE SUBDIVISION FOOTBRIDGE

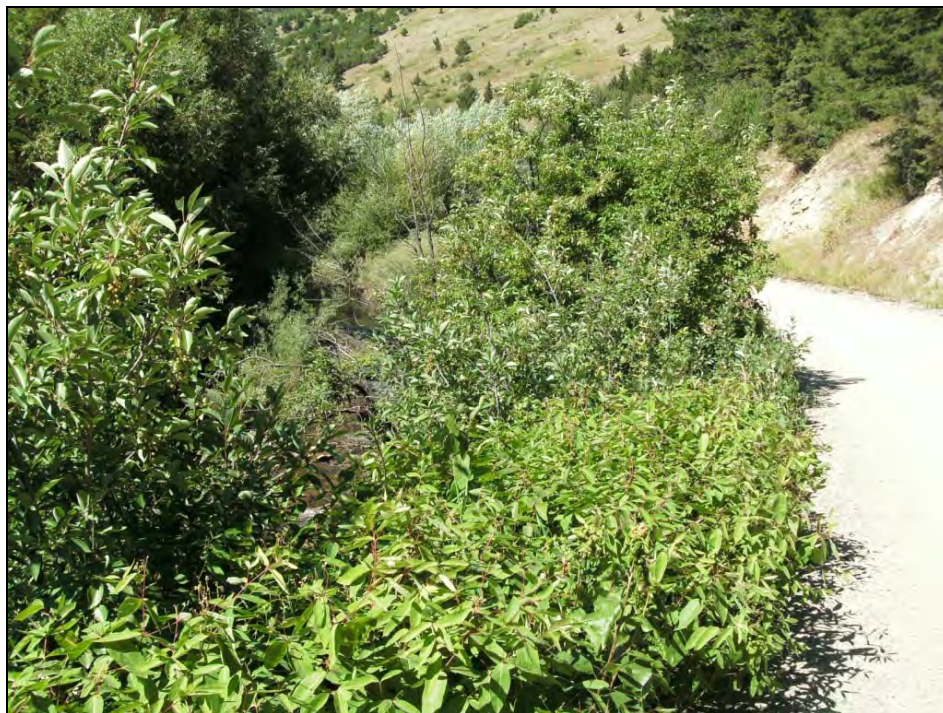
FIGURE 18. FISH HATCHERY RD ENCROACHMENT LOOKING UPSTREAM

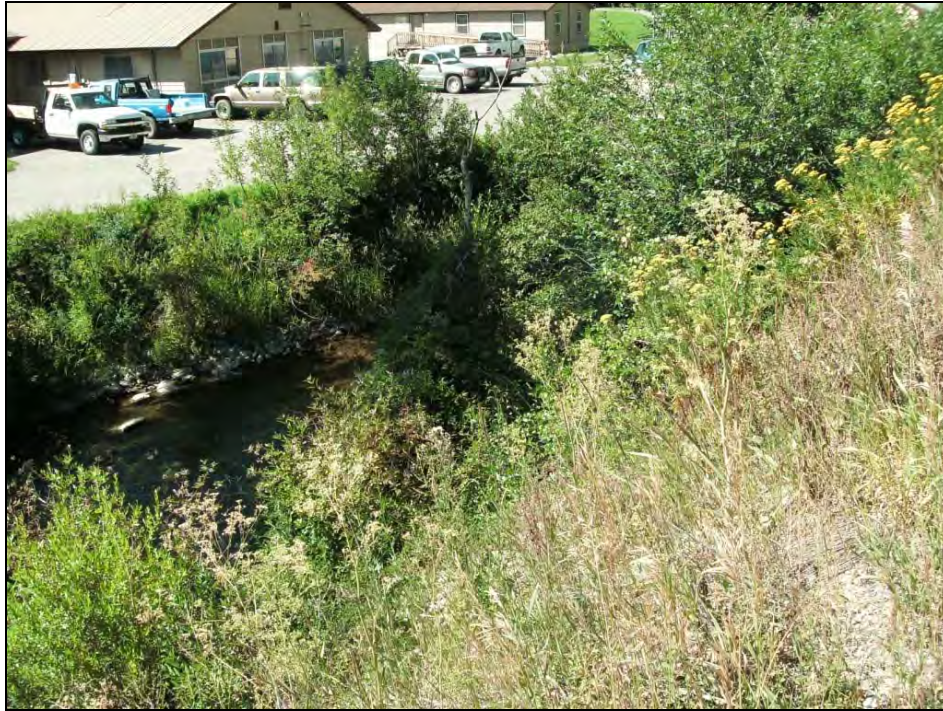
FIGURE 19. BRIDGER FISH TECHNOLOGY CENTER PARKING LOT ADJACENT TO STREAM

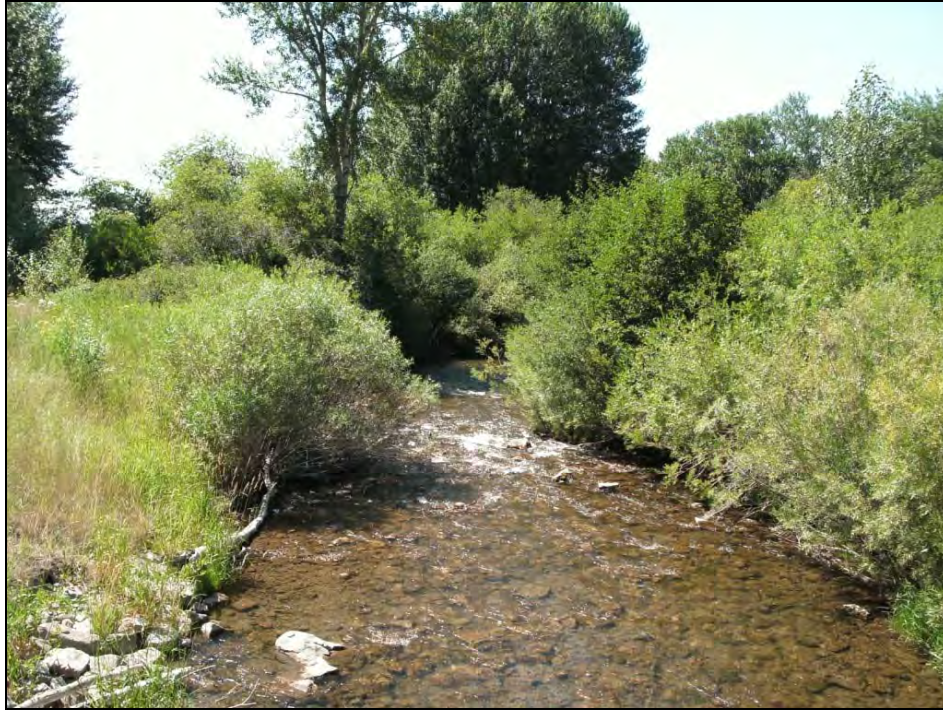
The dominant land uses within the reach are residential subdivision and irrigated and dry pasture land. The riparian vegetation is robust with a dense willow-cottonwood overstory (Figure 21), with very little bank erosion observed. Several old cars are placed as rip-rap along the reach indicating the current and historic potential for bank erosion (Figure 22). Two irrigation withdrawals were identified within the reach, neither of which were confirmed in the field. One tributary, Lyman Cr, enters from the north at the start of the reach.

FIGURE 21. DENSE WILLOW-COTTONWOOD RIPARIAN VEGETATION DOWNSTREAM OF BRIDGER CANYON RD

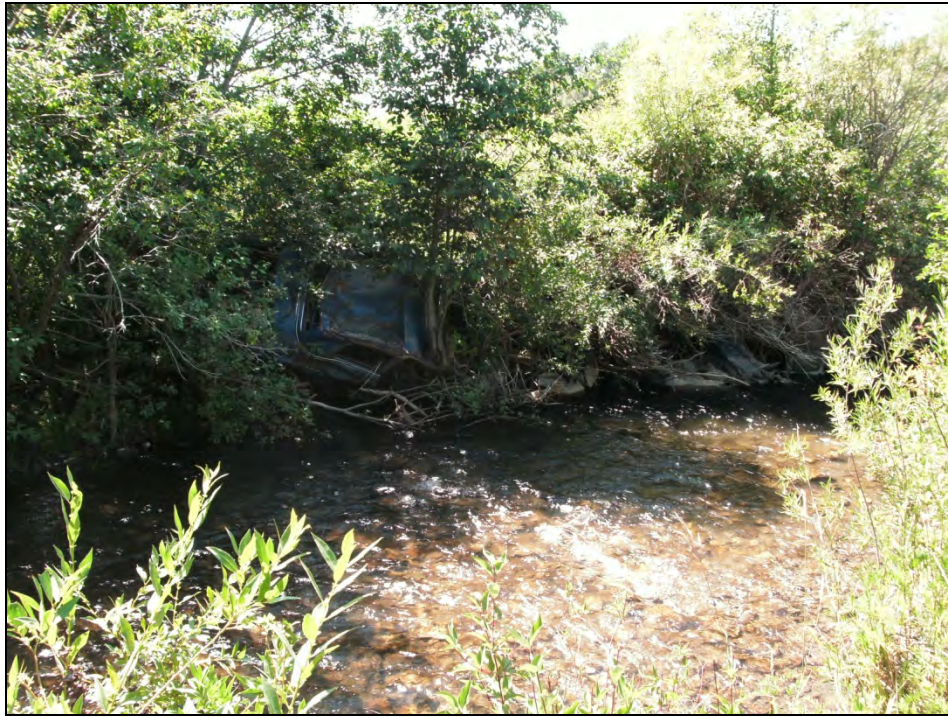
FIGURE 22. CAR BODIES USED AS RIP-RAP

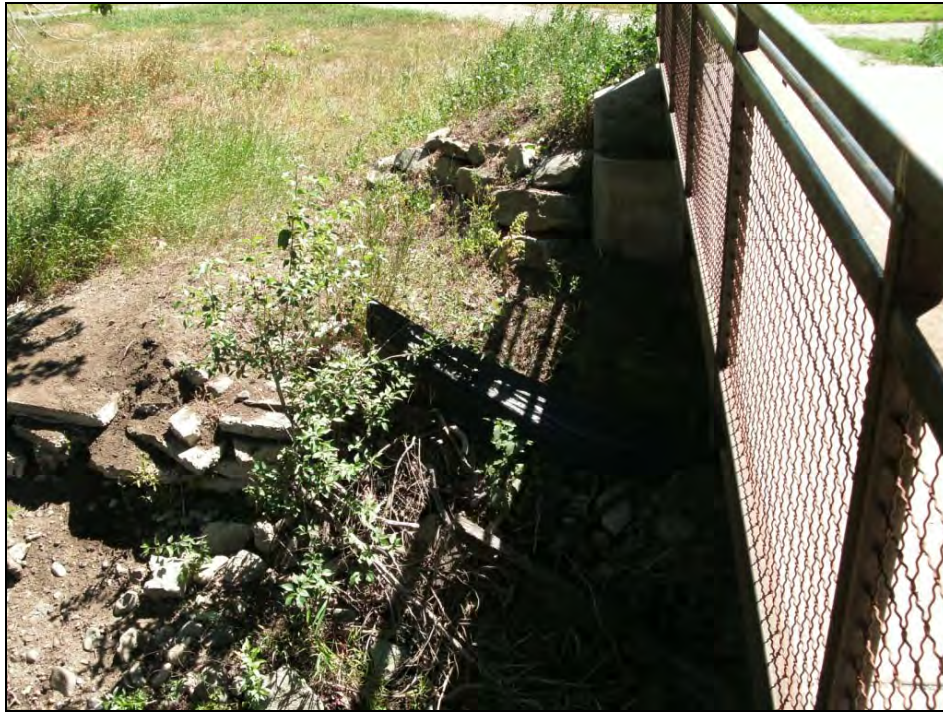
Potential nutrient sources within the reach are detailed in Table 8. Irrigated pasture land was abundant along the reach and was considered a moderately significant nutrient source. With an increase in residences at the lower end of the reach, septic systems are potentially a moderately significant nutrient source. A single unpaved crossing was identified, the footbridge at Cottonwood Subdivision. The footbridge was recently constructed with silt fences still in place; however this bridge had the potential to function as a sediment source near the abutments (Figure 23).

FIGURE 23. FOOTBRIDGE AT COTTONWOOD SUBDIVISION

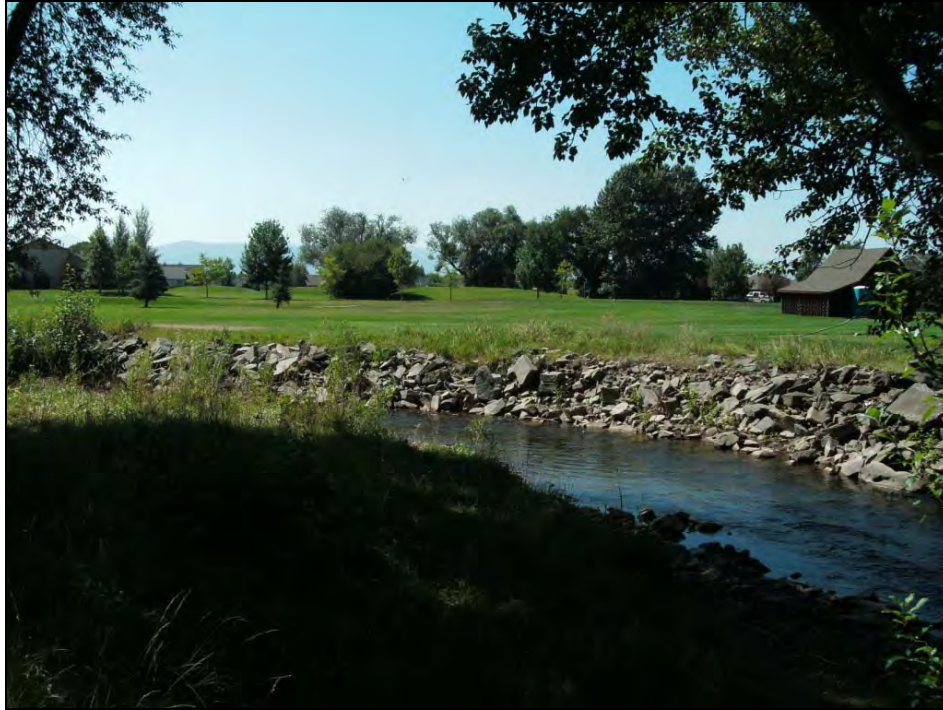
The Bridger Creek Golf Course comprises the majority of the land use along the reach, with a small subdivision. Golf course turf was mowed directly adjacent to the stream in several locations (e.g. Figure 25). Where the stream was buffered from the turf the riparian was healthy and dense, composed of a cottonwood overstory and willow understory (Figure 26). Bank erosion was minor, limited to select outer meander bends (Figure 27). However, both rock and car body rip-rap was quite common, indicating the potential for significant bank erosion.

FIGURE 25. GOLF COURSE TURF ENCROACHMENT AND RIP-RAP

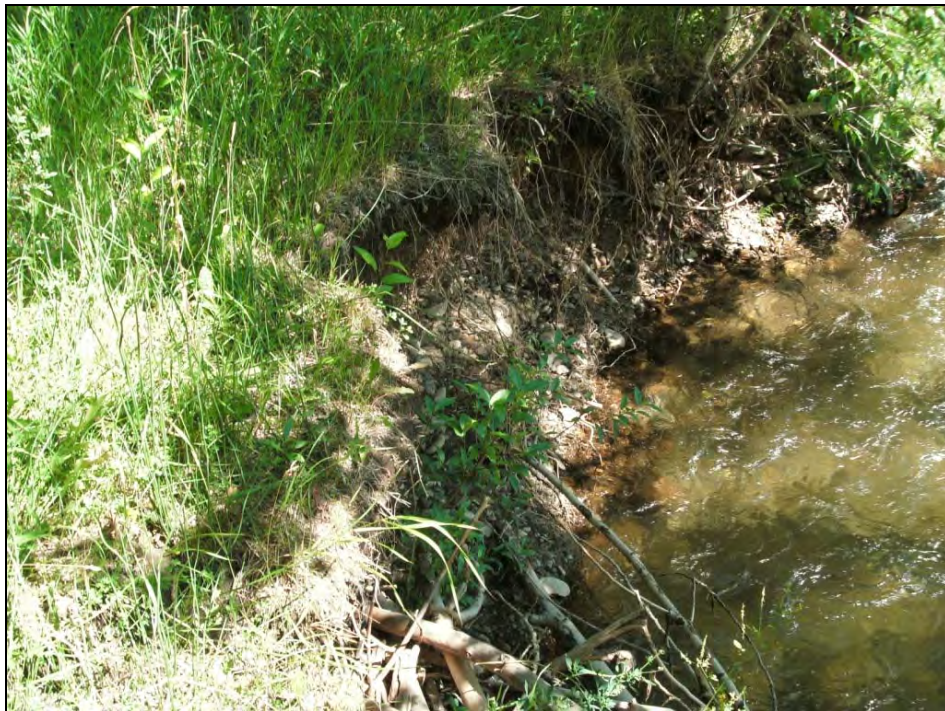
FIGURE 27. MINOR BANK EROSION ON OUTER MEANDER BEND

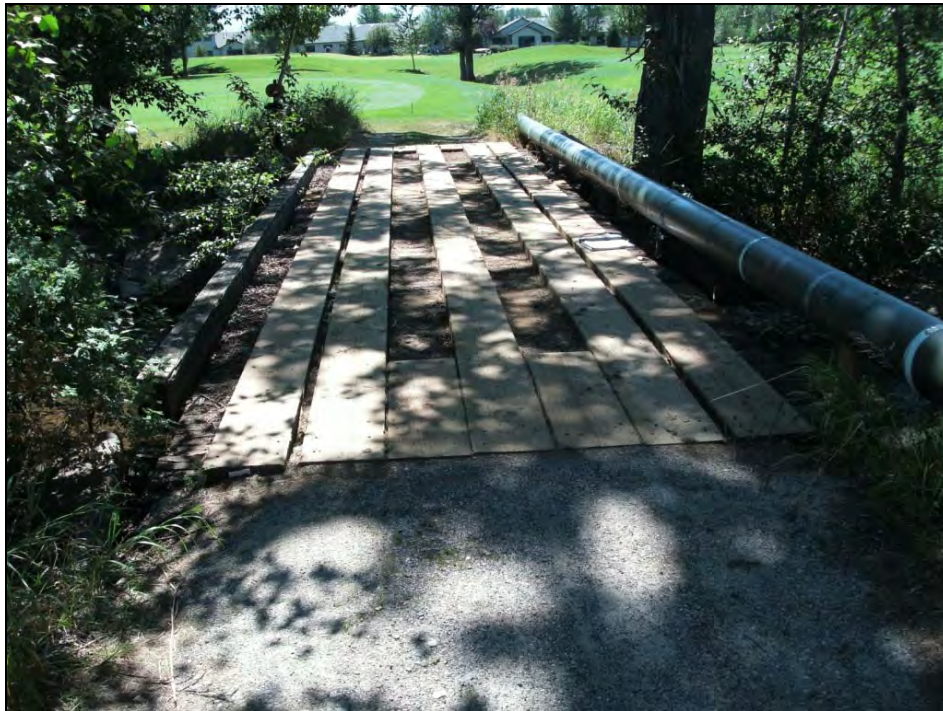
Potential nutrient sources within the reach are detailed in Table 9. The golf course was identified as the primary nutrient source within the reach, as it extends the length of the reach on both sides of the stream. The riparian buffer was dense in some areas while turf encroached directly on the stream in many locations (e.g. Figure 25). The paved McIlhatten Rd and Story Mill Roads encroach within 50 feet of the stream for a total of 550 feet. Vegetation along both roads is relatively dense, with some rip-rap. Neither of the roads was considered a significant nutrient source. One unpaved crossing, a golf cart bridge, crosses the stream but this bridge receives only minimal usage by electric vehicles and was well vegetated at the abutments (Figure 28).

FIGURE 28. GOLF CART BRIDGE

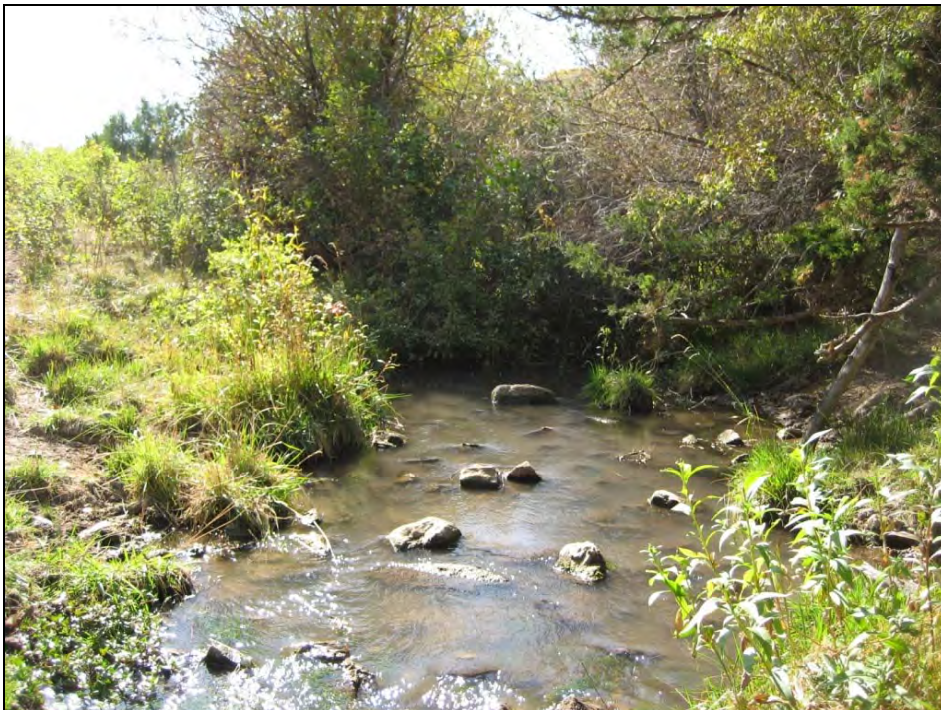
Land use within reach 2 is primarily rangeland and non-irrigated crops. The riparian zone was relatively intact, comprised of dense herbaceous wetlands in the upper section and dense willow-juniper and scattered cottonwood in the lower section (Figures 10 and 11). Banks were generally stable however some livestock trampling was observed (Figure 11).

FIGURE 11. DENSE WILLOW-JUNIPER RIPARIAN WITH LIVESTOCK ACCESS AND TRAMPLING

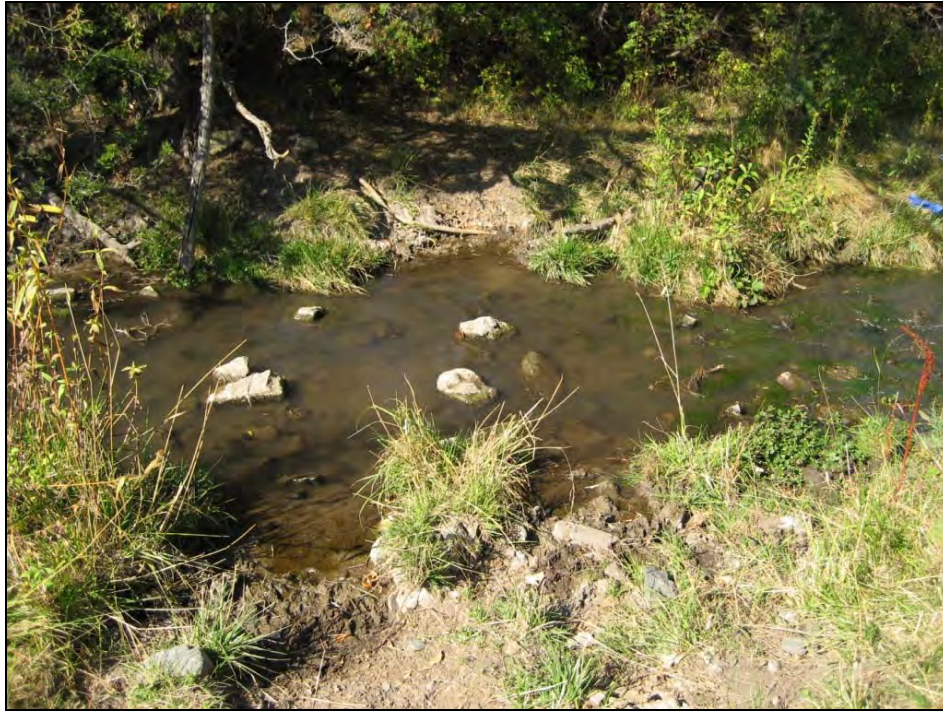
Livestock grazing on the rangeland within the reach, as indicated by bank trampling at livestock crossings (e.g. Figure 12), was identified as a moderate potential nutrient and E. coli source. Pasture and range lands comprise the majority of land use in the reach: livestock use was evident throughout the reach and it appears that livestock had full stream access at locations observed in the field (figures 7.1 and 7.2).

FIGURE 12. BANK TRAMPLING AT LIVESTOCK CROSSING EAST OF AXTELL ANCENY ROAD

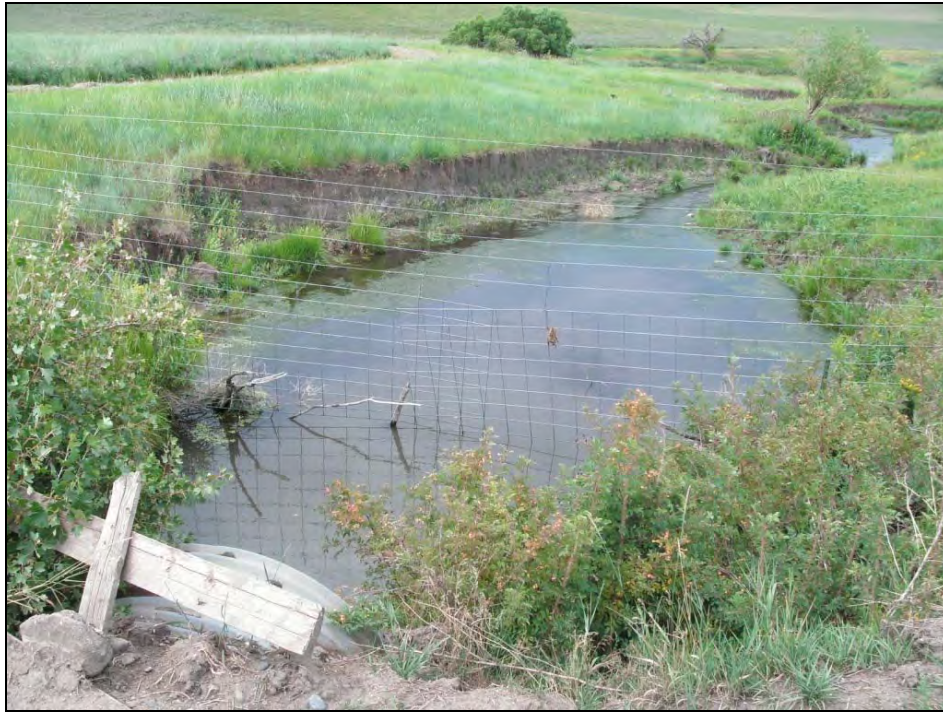
Land use within the reach is primarily rangeland and non-irrigated crops. Upstream of Axtell Anceny Rd the riparian zone was comprised of healthy cottonwoods and willows, with minimal bank erosion (Figure 14). Riparian quality decreased downstream of the crossing, with significant bank erosion, livestock trampling, and pasture encroachment observed (Figure 15). No road encroachment was observed within the reach. One irrigation withdrawal was identified at the lower end of the reach but was not confirmed in the field.

FIGURE 15. NARROW RIPARIAN, ERODING BANKS & ALGAL GROWTH: LOOKING WEST AT AXTELL ANCENY ROAD CROSSING
