ATTACHMENT B – 2009 LOWER GALLATIN TMDL PLANNING AREA NUTRIENT, ALGAE AND *E. COLI* SOURCE ASSESSMENT

December, 2009

OASIS Environmental, Inc.
PO Box 582
Livingston, MT 59047

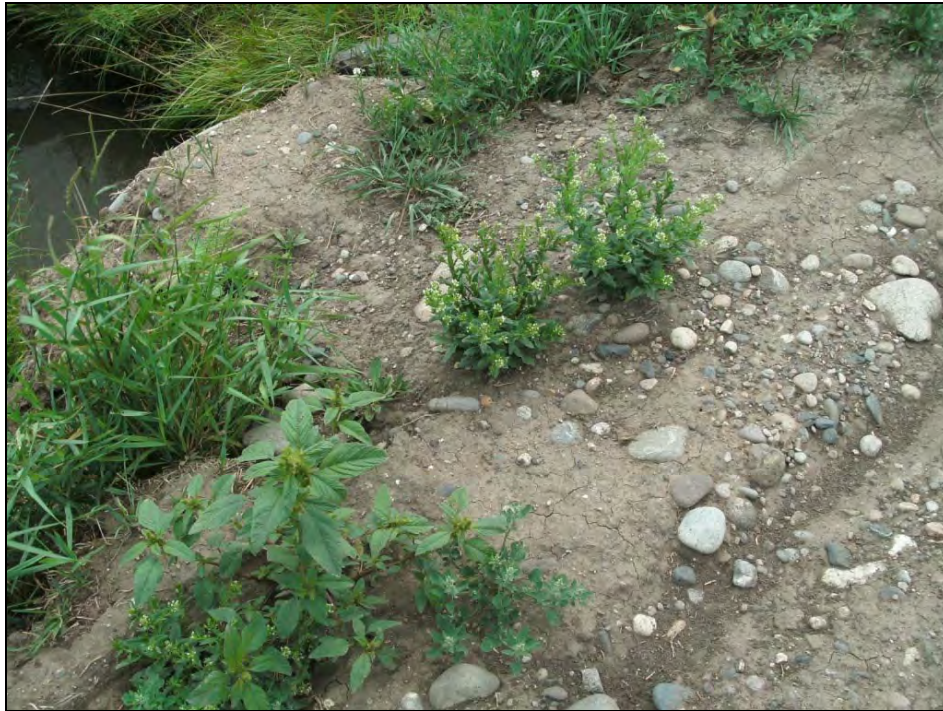
Potential pollutant sources to reach CAMP 03 N are listed in Table 3. Irrigated crops were present throughout a third of the reach and were considered to have a moderated potential as a nutrient source. Pasture land comprised 40% of the reach. While pasture encroachment was sparse in the upper section of the reach, pasture encroachment and associated bank erosion were common in the lower section. Therefore pasture was considered a moderate potential nutrient and E. coli source. No riparian fencing or other BMPs were observed. The unpaved Axtell Anceny Rd crosses the lower section of the reach and the crossing was considered a potential sediment source (Figure 16). Due to the low prevalence of unpaved crossings, this single culvert was considered to have low relative significance for nutrient delivery.

FIGURE 16. CULVERT AT AXTELL ANCENY ROAD WITHIN REACH CAMP 03 N; POTENTIAL SEDIMENT SOURCE

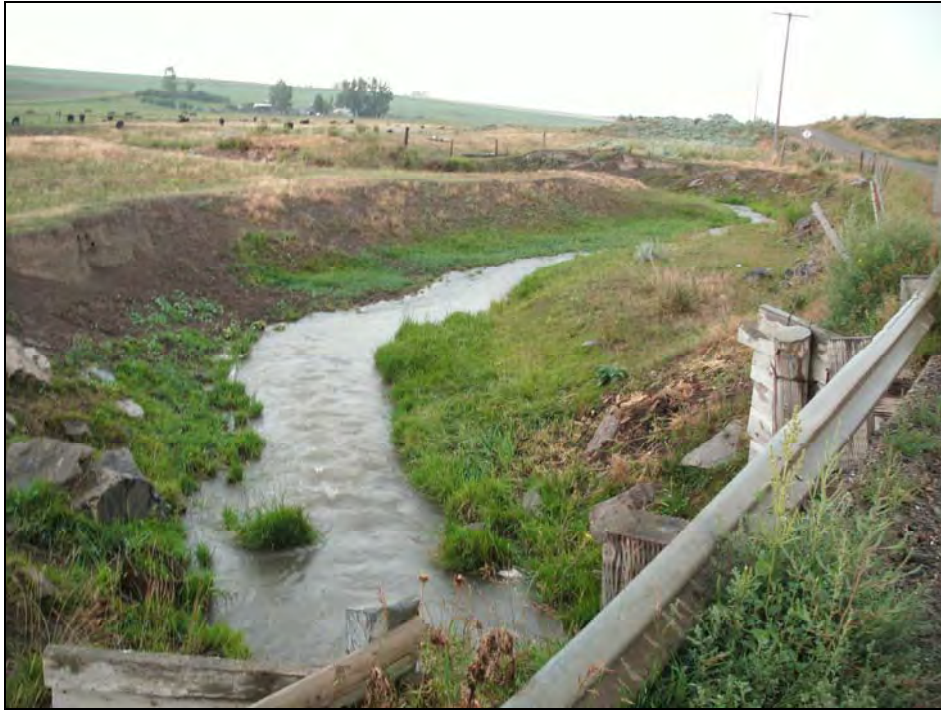
FIGURE 19. HIGHLY GRAZED RIPARIAN ZONE WITH ERODING BANKS

Potential pollutant sources to reach CAMP 04 N are listed in Table 4. The range/pasture adjacent to the stream was generally highly grazed, weedy, and associated with significant bank erosion (Figures 19 and 20). Adjacent rangeland and pasture was therefore considered a highly significant potential source of nutrients and E. coli. Although pasture land comprised an average of only 15% of the land use along the reach, it was considered a moderately significant nutrient and E. coli source. Riparian fencing and other BMPs were limited, allowing livestock direct access to the creek. Two livestock confinement areas were identified, located adjacent to the stream upstream of Arnold Rd and at the intersection of Norris Rd and Camp Creek Rd (Figure 22). Nineteen unpaved crossings were identified. The crossings were both bridge and culverts, located on Camp Creek Rd, private driveways, and other small roads. Due to their high number, unpaved crossings were considered a moderately significant sediment source.

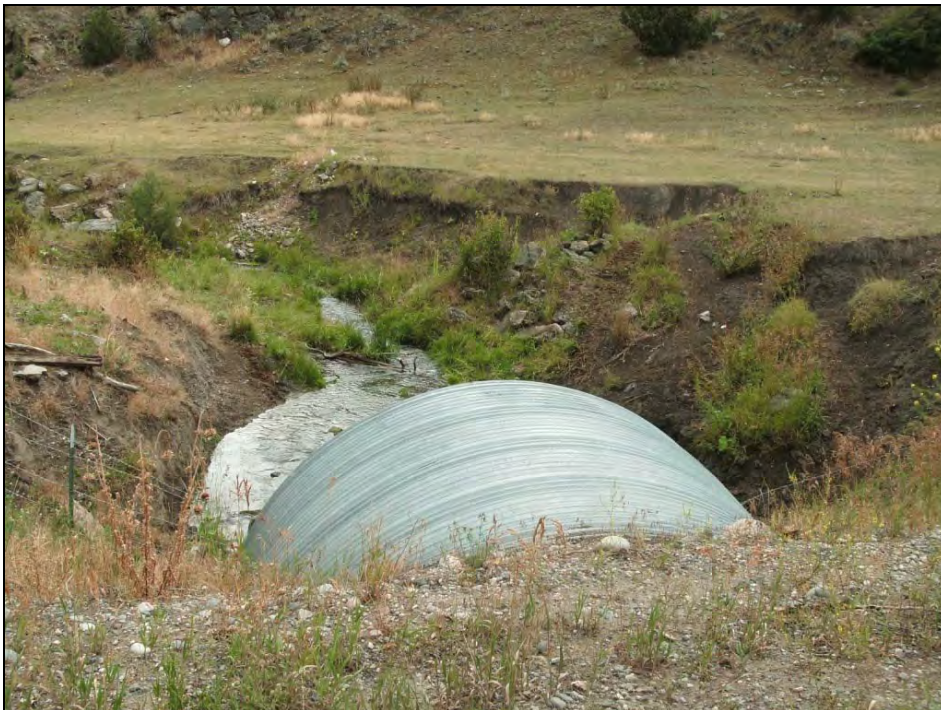
FIGURE 20. DEGRADED RIPARIAN ZONE DOWNSTREAM OF CAMP CREEK RD

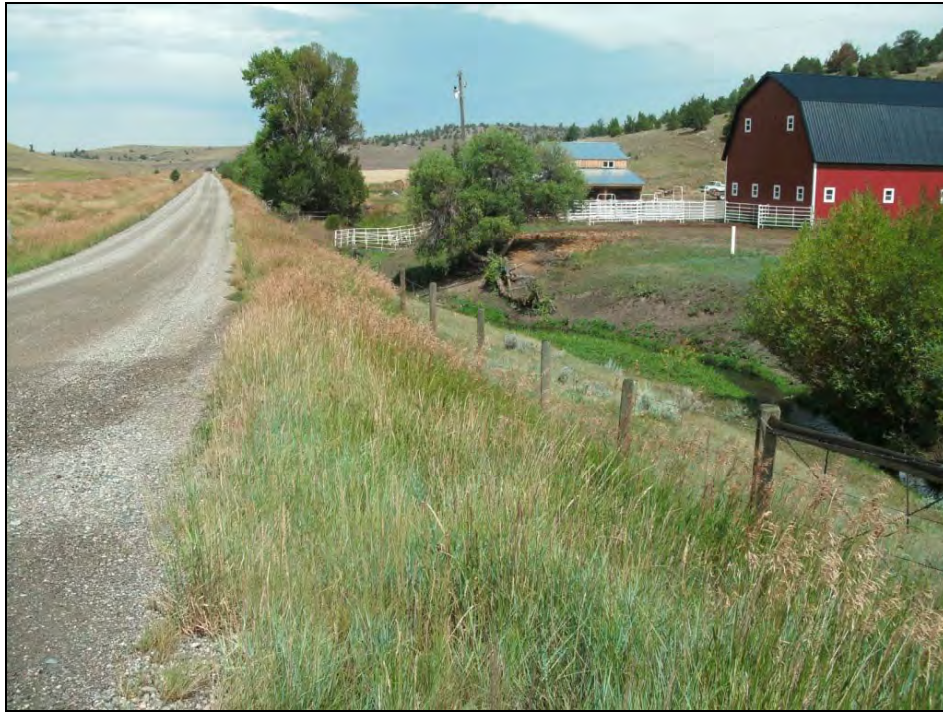
FIGURE 21. CAMP CREEK ROAD ENCROACHES ON REACH CAMP 04 N

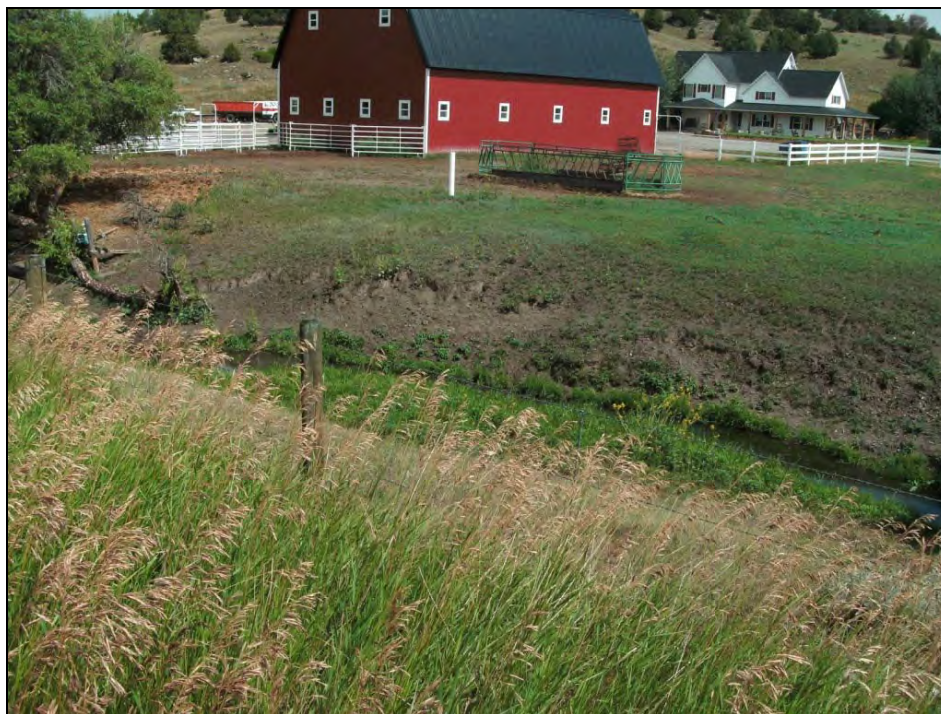
FIGURE 22. LCA LOCATED AT INTERSECTION OF NORRIS AND CAMP CREEK ROADS

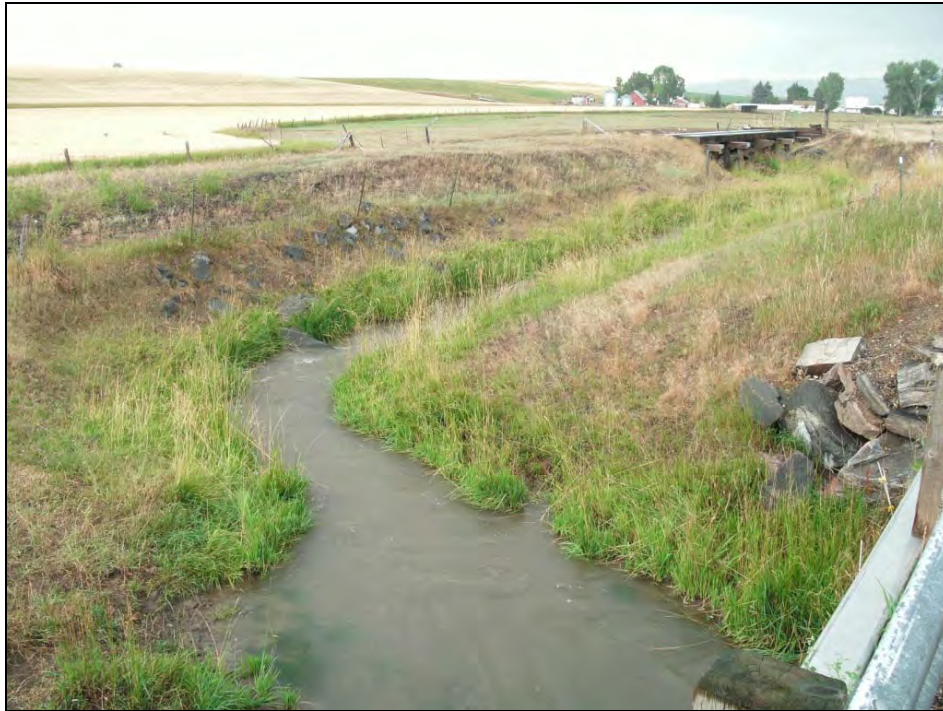
Land use within the reach is primarily pasture, residential and cropland. The riparian zone was rather narrow (Figure 24), comprised of native sedges, rushes, invasive reed canarygrass and scattered willows (Figure 25). Despite the narrow riparian zone bank erosion was limited. Yard encroachment was common throughout the reach (Figure 26). One irrigation withdrawal was identified within the reach but was not confirmed in the field.

FIGURE 24. WEEDY, NARROW RIPARIAN, UPSTREAM OF OLD RAILROAD GRADE

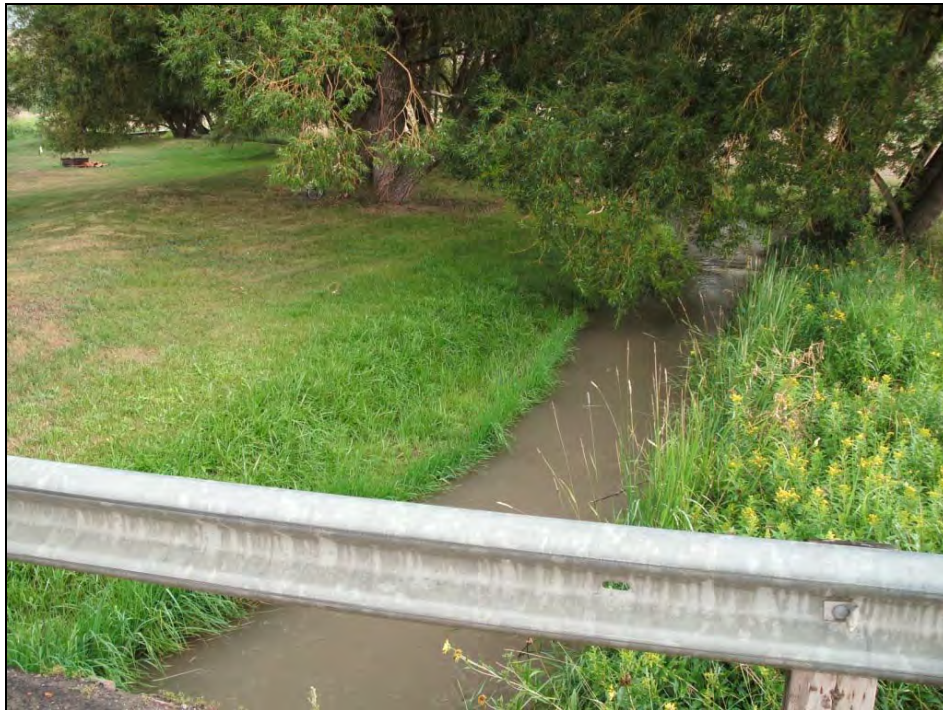
FIGURE 26. YARD ENCROACHMENT WITH TALL WILLOWS, DOWNSTREAM OF CAMP CREEK RD

Potential pollutant sources to reach CAMP 05 N are listed in Table 5. Pasture land comprised a majority of the adjacent land use within the reach, and was considered to be of moderate significance as a nutrient and E. coli source. Residential yards, which commonly encroached on the stream within the reach (Figure 26) may also contribute nutrients to Camp Creek in this reach, but were considered less significant than pasture lands. A single livestock confinement area, located approximately 1/3 mile from the stream, was not considered a significant potential nutrient and E. coli source.

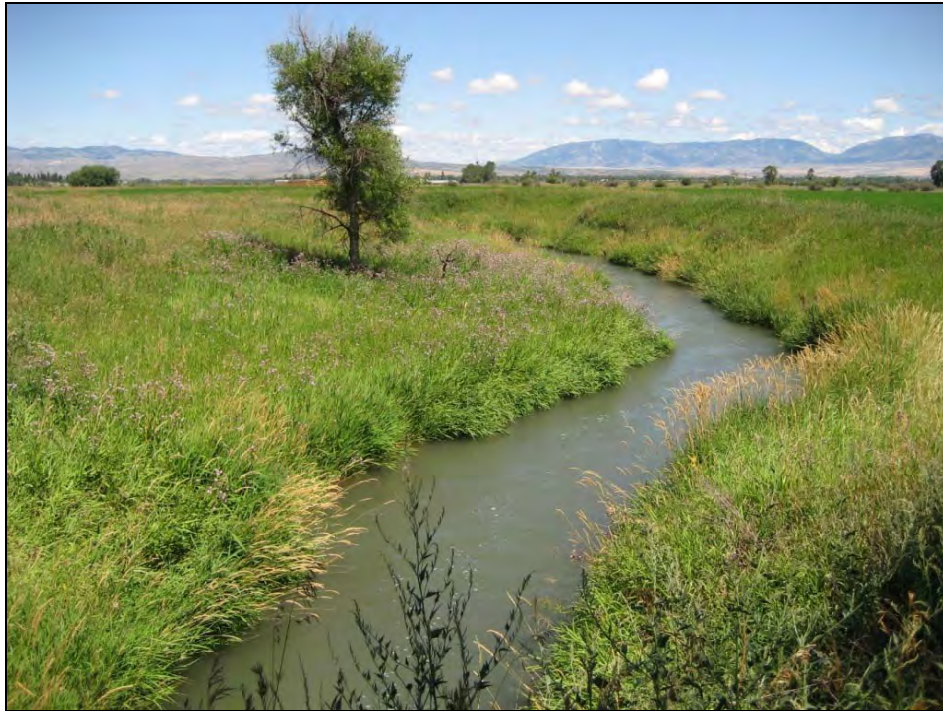
Land use within the reach is primarily irrigated crops and pasture. The riparian zone varied from dense reed canarygrass and weedy thistles (Figure 28), to heavily grazed vegetation where pasture encroached (Figure 29). Banks were generally very stable with the exception of the section at a private driveway crossing west of Amsterdam Rd-Churchill Rd intersection where heavy grazing and trampling were observed (Figures 27 and 30).

FIGURE 28. WEEDY BUT DENSE RIPARIAN, DOWNSTREAM OF WATER QUALITY SITE CP02 AT PRIVATE DRIVEWAY IN LOWER REACH

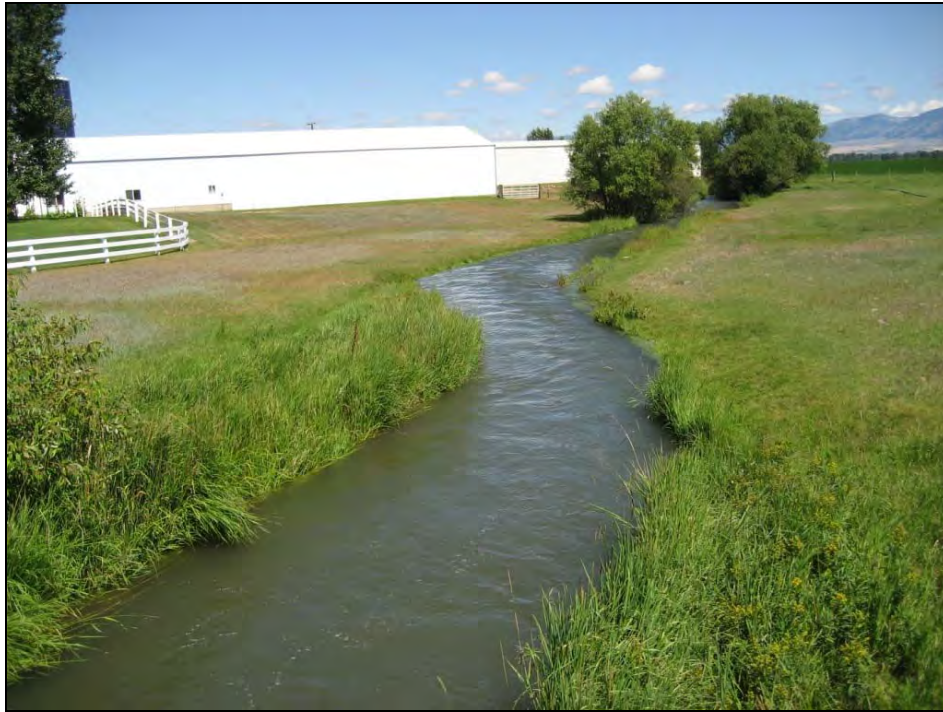
FIGURE 29. GRAZED RIPARIAN AND PASTURE ENCROACHMENT DOWNSTREAM OF CHURCHILL RD

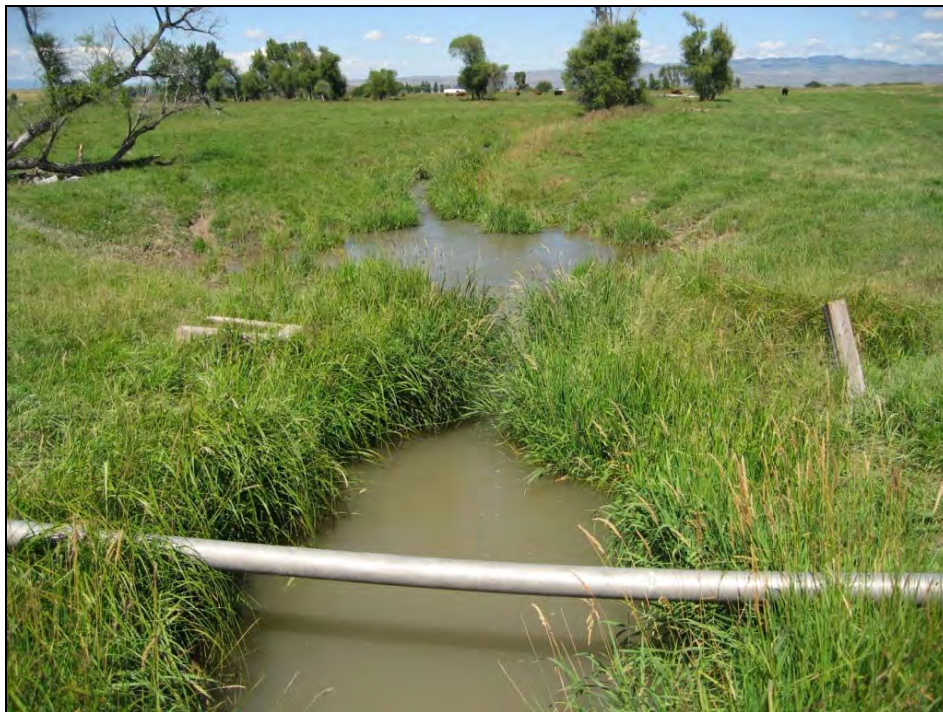
**FIGURE 30. HEAVY GRAZING AND BANK TRAMPLING DOWSTREAM OF PRIVATE DRIVE WEST OF
AMSTERDAM-CHRUCHILL RD INTERSECTION**

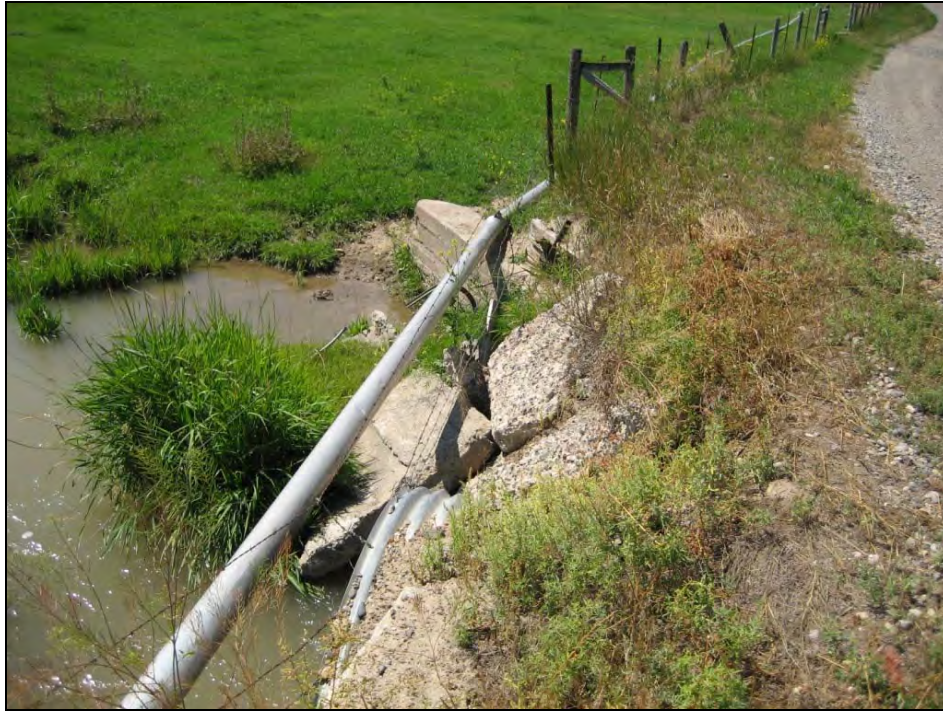
Potential pollutant sources to reach CAMP 06 N are listed in Table 6. The Amsterdam wastewater treatment ponds are located within 100 feet of Camp Creek, downstream of Amsterdam Rd (Figure 31) and are considered a potentially moderately significant source of nutrients and E. coli. Irrigated crops make up a high percentage of land use along the stream and were considered a highly significant nutrient source. Pasture land often encroached on the stream (Figure 29) and was a moderately significant nutrient and E. coli source. No riparian fencing or other BMPs were observed. Three unpaved crossings were identified. All were private driveways, with the driveway west of Amsterdam Rd considered a minor sediment source (Figure 32).

FIGURE 32. CULVERT AT DRIVEWAY WEST OF AMSTERDAM RD

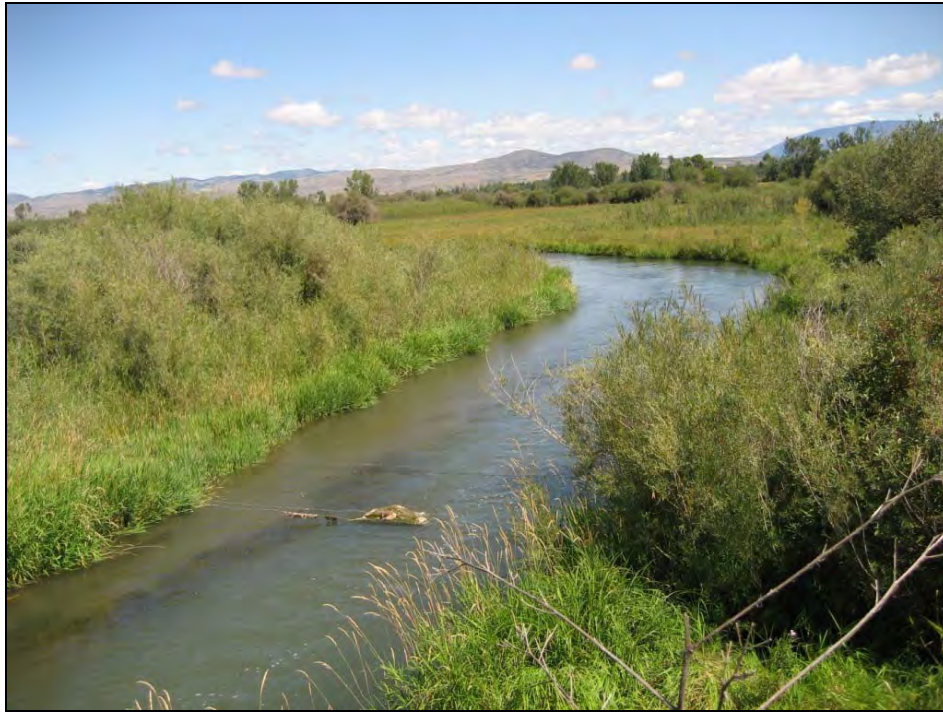
FIGURE 35. ROBUST RIPARIAN ZONE, DOWNSTREAM OF FRONTAGE RD

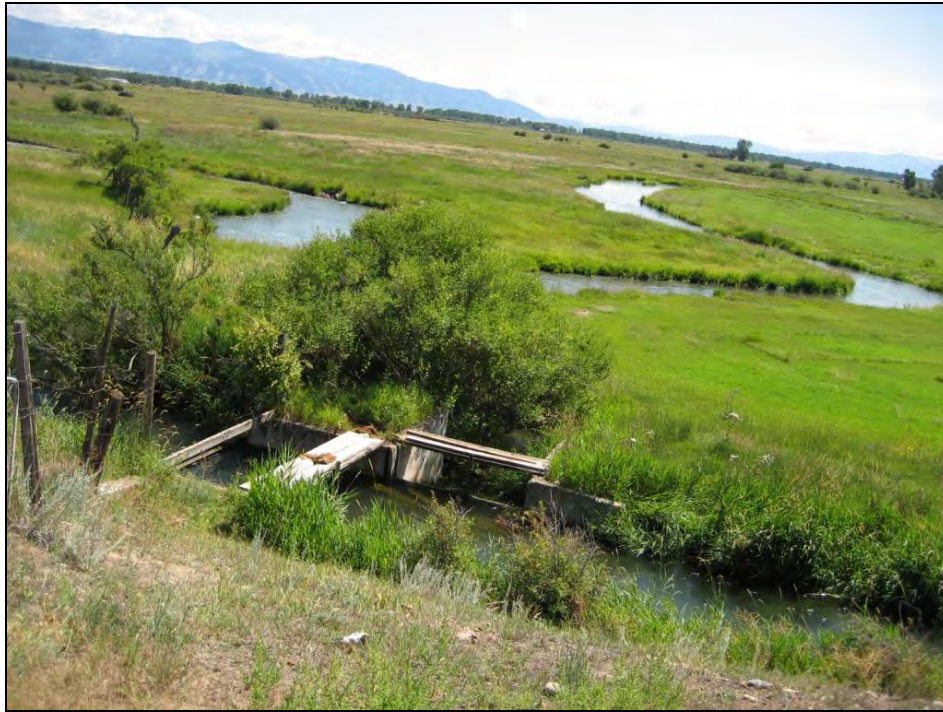
FIGURE 36. HAY/PASTURE ENCROACHMENT WITH DENSE, HERBACEOUS RIPARIAN. VIEWED FROM MOUNTAIN VIEW CEMETARY. IRRIGATION RETURN IN FOREGROUND.

Potential pollutant sources to reach CAMP 07 N are listed in Table 7. Irrigated hay fields were a potential nutrient source but were not as common as irrigated pasture. The abundance of irrigated pasture land was deemed to have a potentially high significance for delivery of nutrients and E. coli to Camp Cr. No riparian fencing or other BMPs were observed. One unpaved crossing, a private driveway, was confirmed but was not directly observed in the field due to private property issues. The four tributary streams identified entering the reach could potentially be significant nutrient and E. coli sources, as they drain large agricultural areas (Figure 34). The two irrigation returns were both relatively large (e.g. Figure 36) and could also be significant nutrient and E. coli sources.

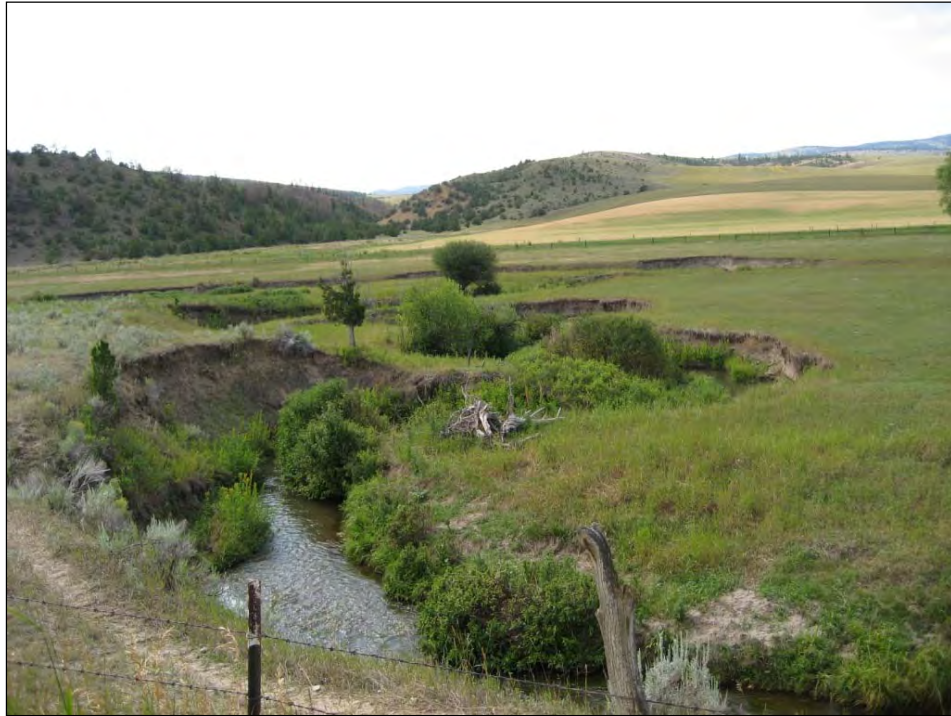
FIGURE 6. POOR RIPARIAN QUALITY AND ERODING BANKS DOWNSTREAM OF MENARD ROAD

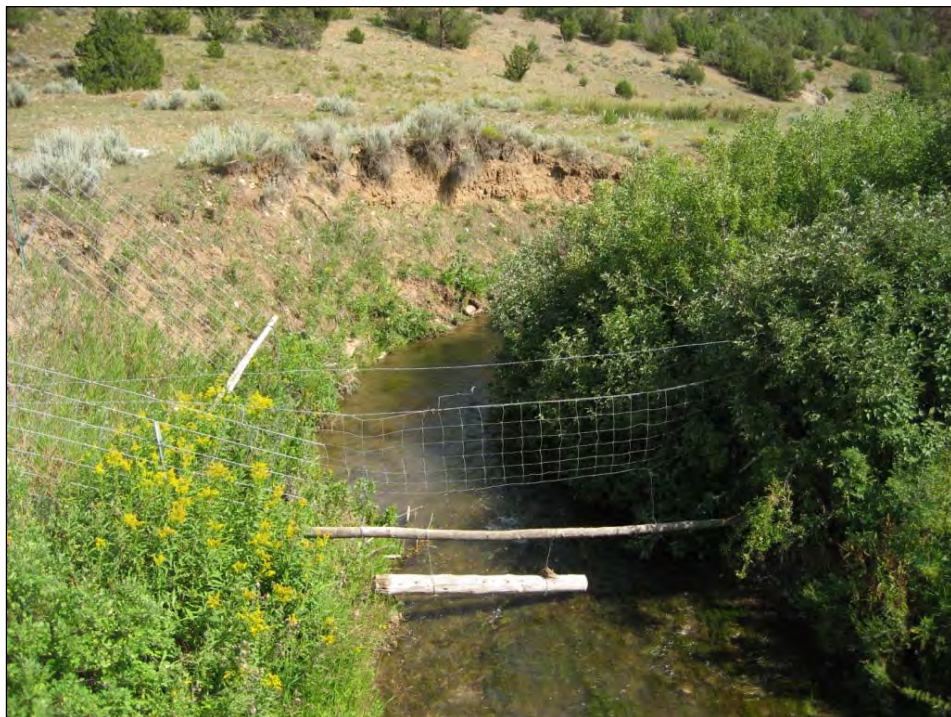
FIGURE 7. BANK EROSION IN HIGHLY-EROSIVE SOILS

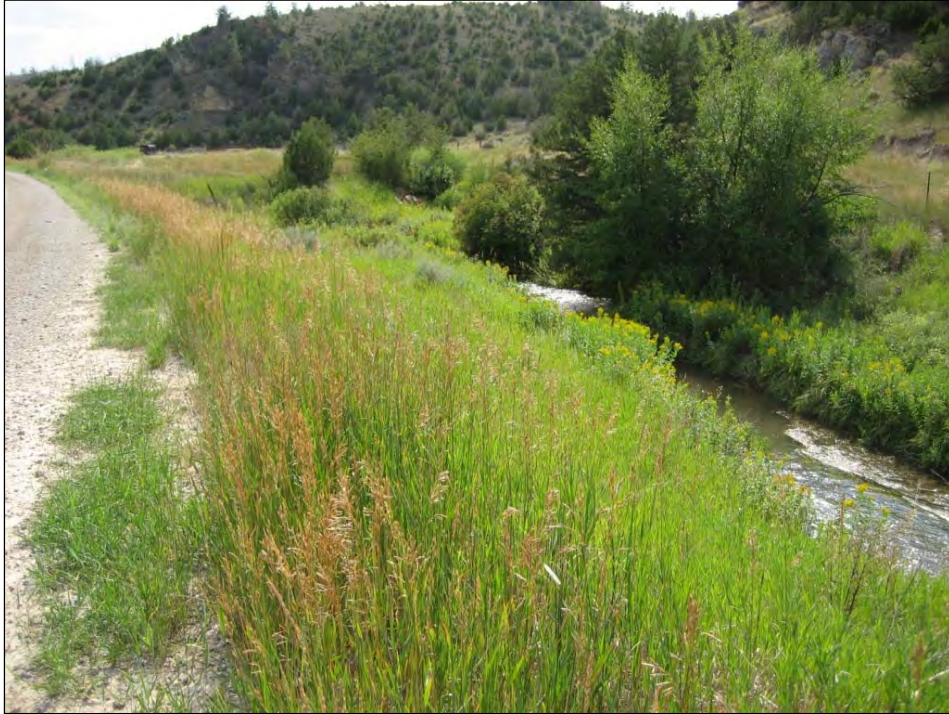
FIGURE 8. NORTH DRY CREEK ROAD ENCROACHMENT

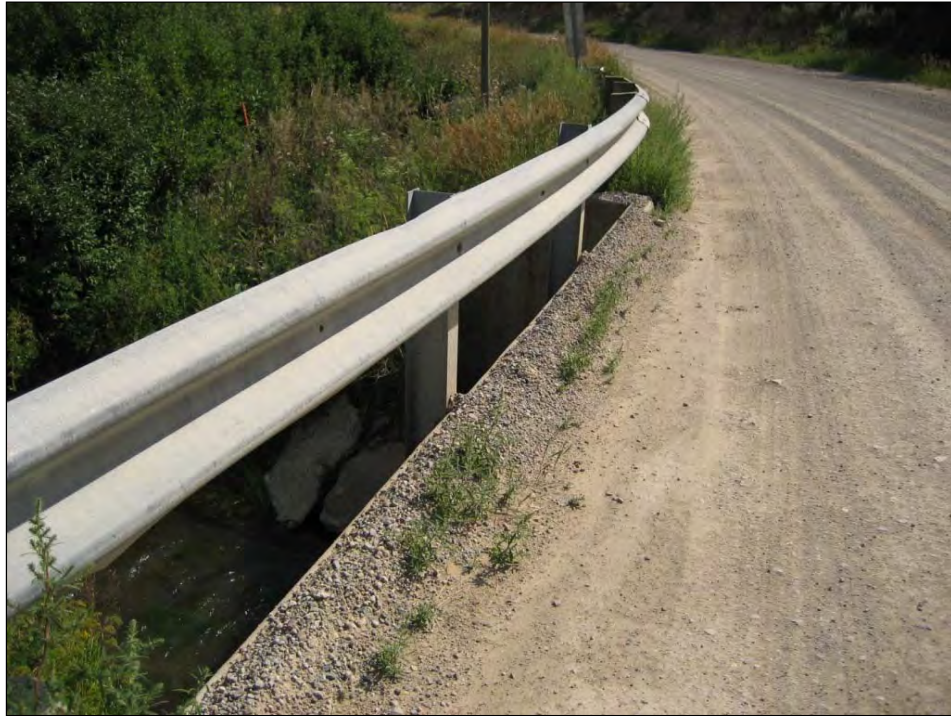
several of the driveways, were not observed in the assessment. The two crossings on North Dry Creek Road were considered potential sediment sources during storm events, as there was gravel on the decking at the lower crossing (Figure 9), and evidence of flooding over the road on the upper crossing.

FIGURE 9. GRAVEL ON BRIDGE DECKING AT DOWNSTREAM CROSSING ON NORTH DRY CREEK ROAD

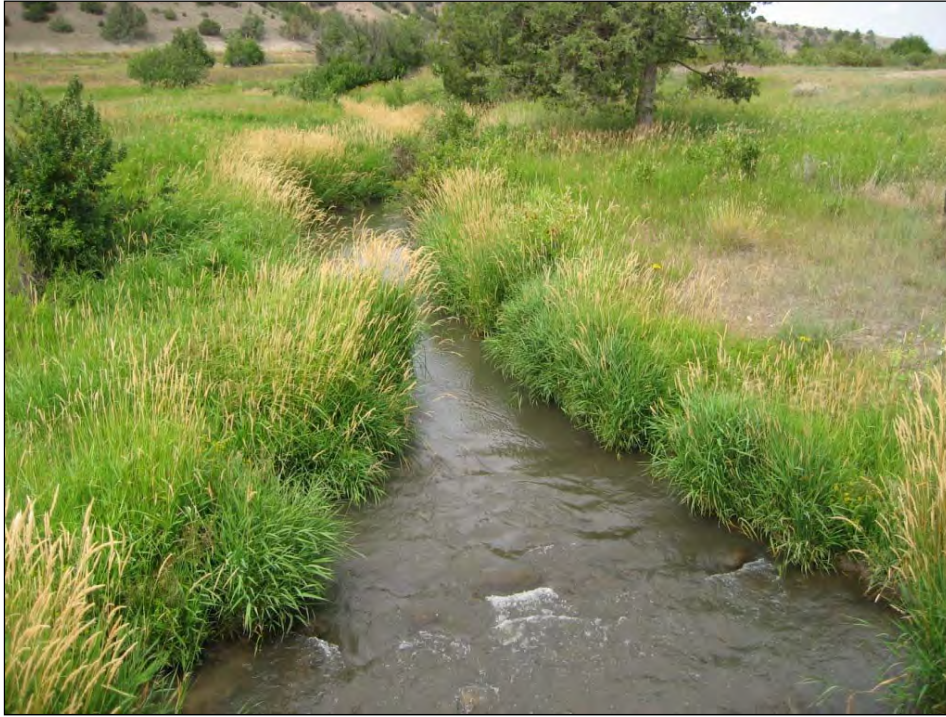
FIGURE 12. DENSE RIPARIAN UPSTREAM OF PRIVATE DRIVEWAY OFF NORTH DRY CREEK ROAD

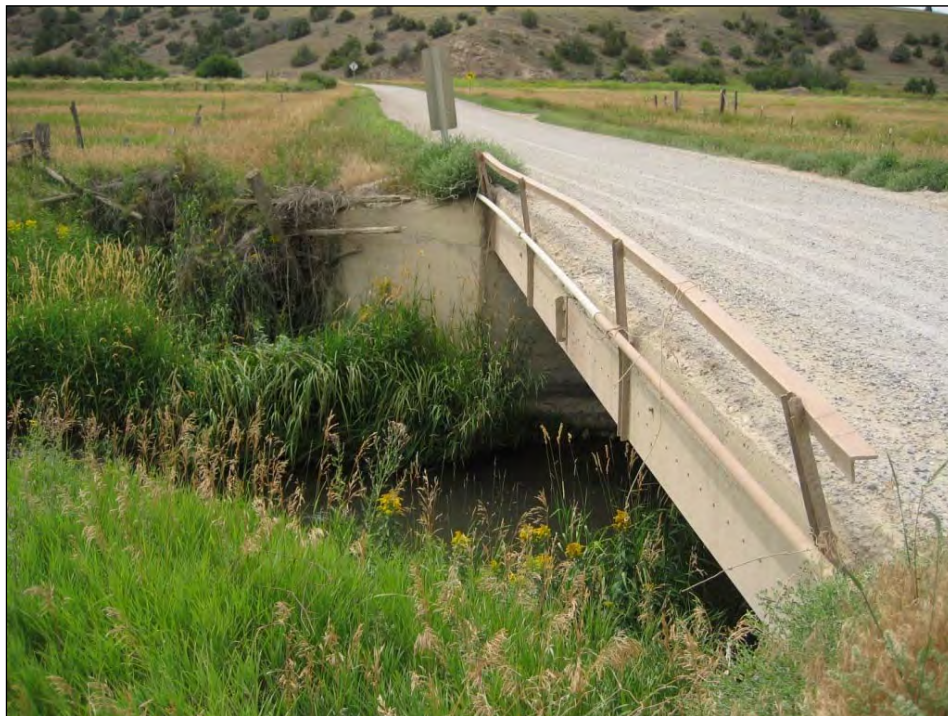
Five unpaved road crossings were identified within the reach, including two crossings on North Dry Creek Road and three driveways. Both of the North Dry Creek Road crossings were considered potential sediment sources during storm events due to gravel and fine sediment observed on their bridge decking (Figure 13). However, due to their low prevalence the crossings were considered to

have a low potential significance. Abutments at all of the observed crossings were stable and well vegetated (Figure 13).

FIGURE 13. GRAVEL ON BRIDGE DECKING AT NORTH DRY CREEK ROAD WITH STABLE, WELL-VEGETATED ABUTMENTS

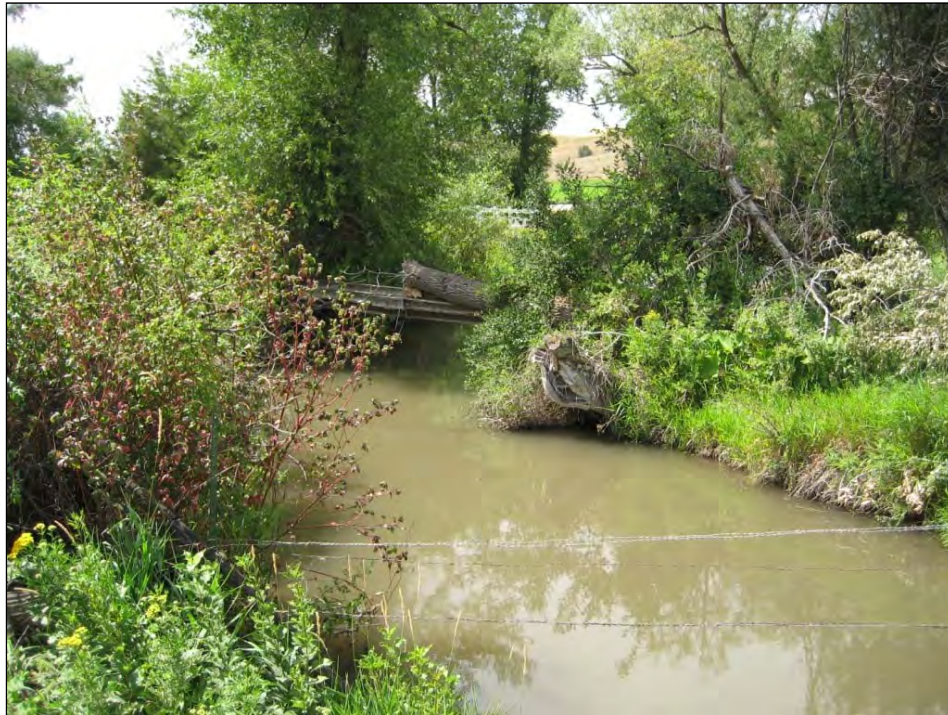
The dominant land uses within the reach are pasture land mixed with irrigated and dry cropland. The reach was only accessible at the North Dry Creek Road and Dry Creek Road crossings. Where observed, the riparian zone is rather narrow, but vegetation is dense with reed canarygrass and scattered cottonwoods (Figures 15 and 16). Banks were generally stable due to the dense riparian vegetation; however erosion is possible in the pastures between Dry Creek Road and the East Gallatin confluence. One significant irrigation ditch exits just downstream of Dry Creek Road (Figure 16). No roads encroach on the stream in this reach.

FIGURE 15. DENSE RIPARIAN WITH COTTONWOOD OVERSTORY DOWNSTREAM OF NORTH DRY CREEK ROAD

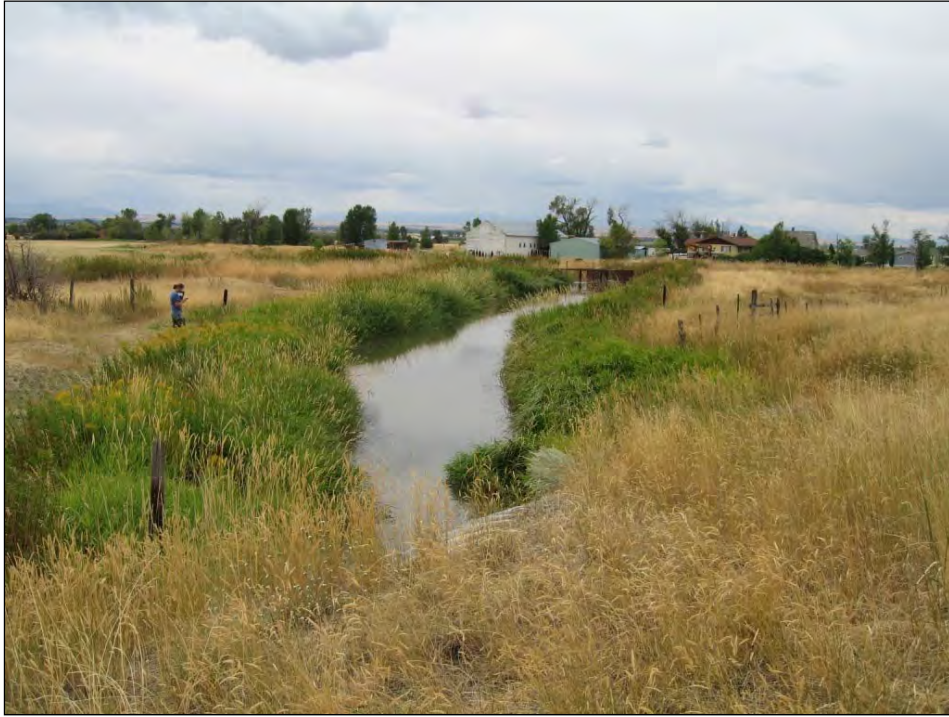
FIGURE 16. DENSE REED CANARYGRASS VEGETATION WITH LARGE HEADGATE ON RIGHT BANK IN BACKGROUND, DOWNSTREAM OF DRY CREEK ROAD

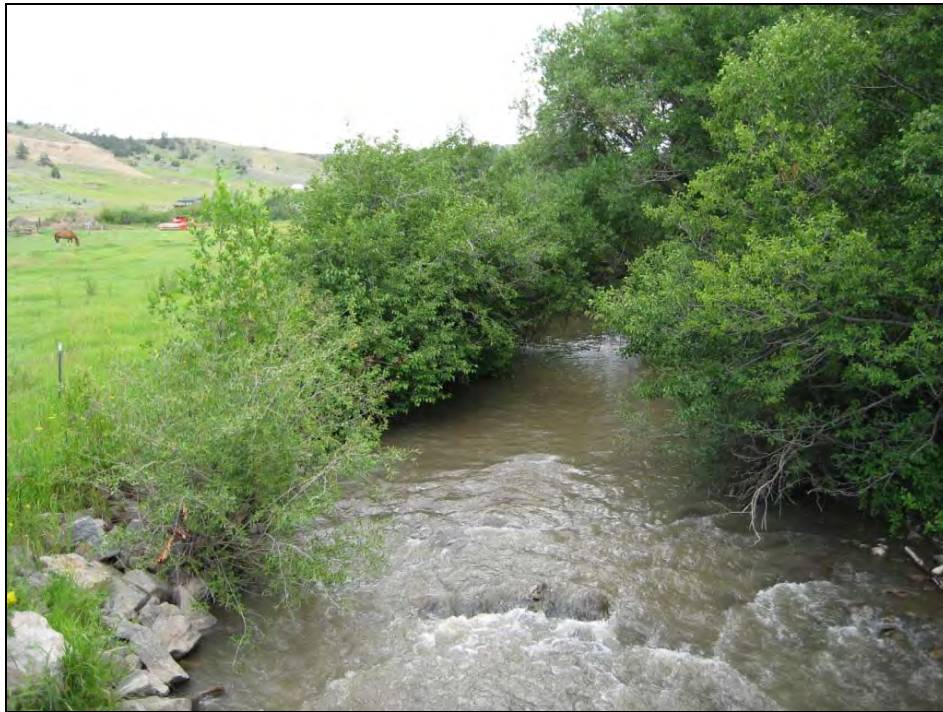
The dominant land uses within the reach are rural residence and irrigated and dry pasture land. The riparian vegetation is quite healthy, with dense willows and cottonwoods and adjacent pasture land (Figures 7 and 8). Very little bank erosion and pasture encroachment were observed. Two irrigation withdrawals were identified within the reach, both of which were definitively confirmed on the aerial. Two small tributary streams enter within the reach, Kelly Cr and Little Bridger Cr. A water gap extending approximately 20 feet into the channel was observed downstream of Kelly Canyon Rd. Riparian fencing was observed upstream of Story Hill Rd and is likely common in this reach where land use is dominated by low livestock densities on pasture land associated with small-acreage landowners (e.g. Figure 7).

FIGURE 7. DENSE WILLOW/COTTONWOOD RIPARIAN WITH ADJACENT PASTURE AND RIPRAP

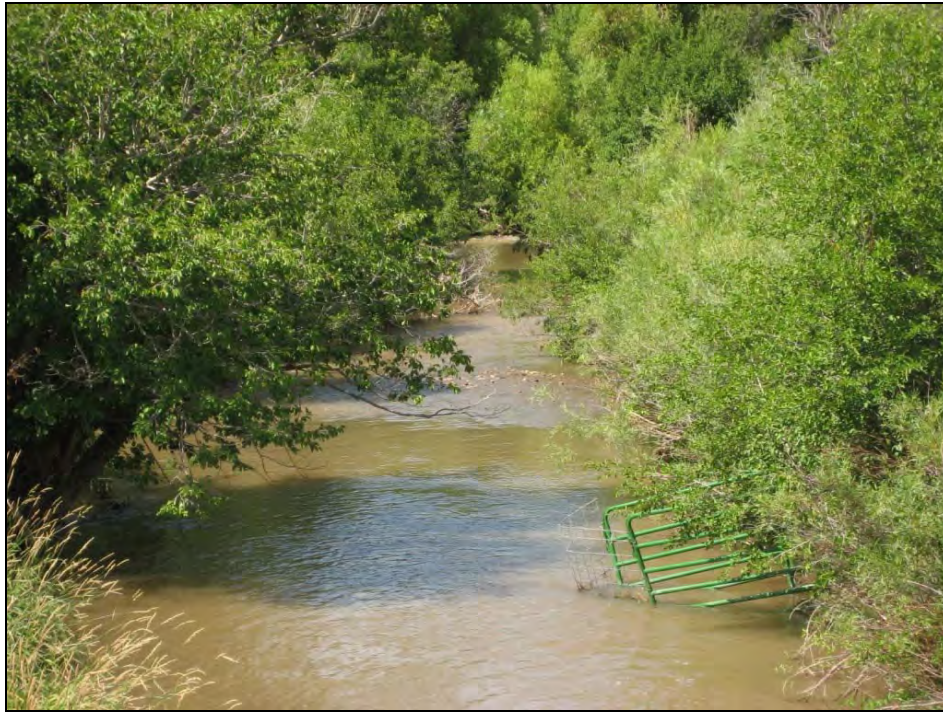
FIGURE 8. DENSE WILLOW/COTTONWOOD RIPARIAN WITH WATER GAP ON RIGHT BANK

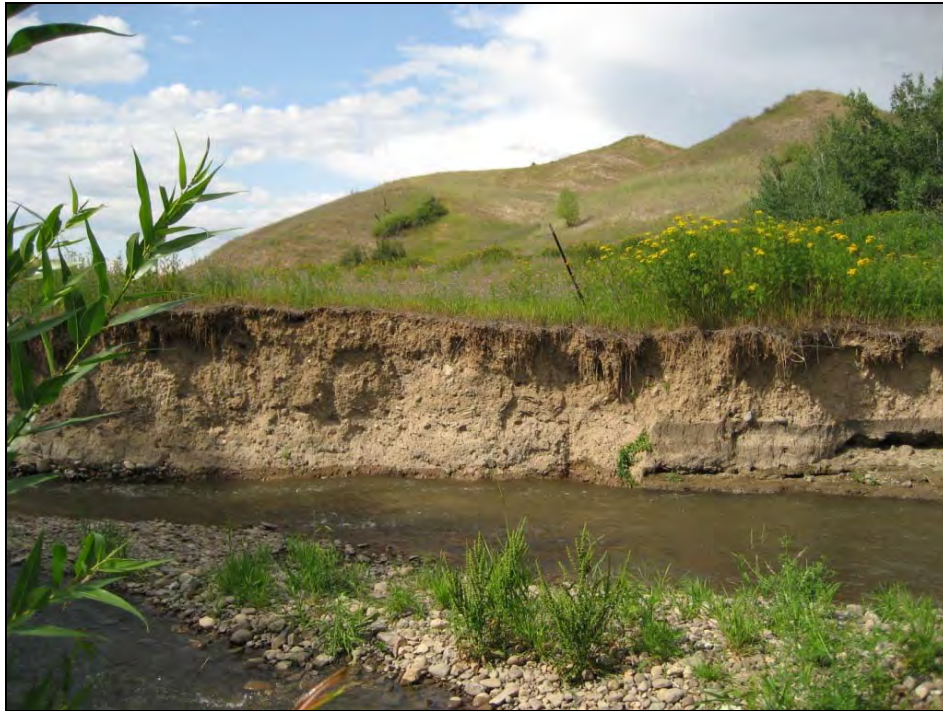
FIGURE 11. ERODING BANK ALONG BOHART DRIVE, INVASIVES KNAPWEED AND TANSY ON BANK

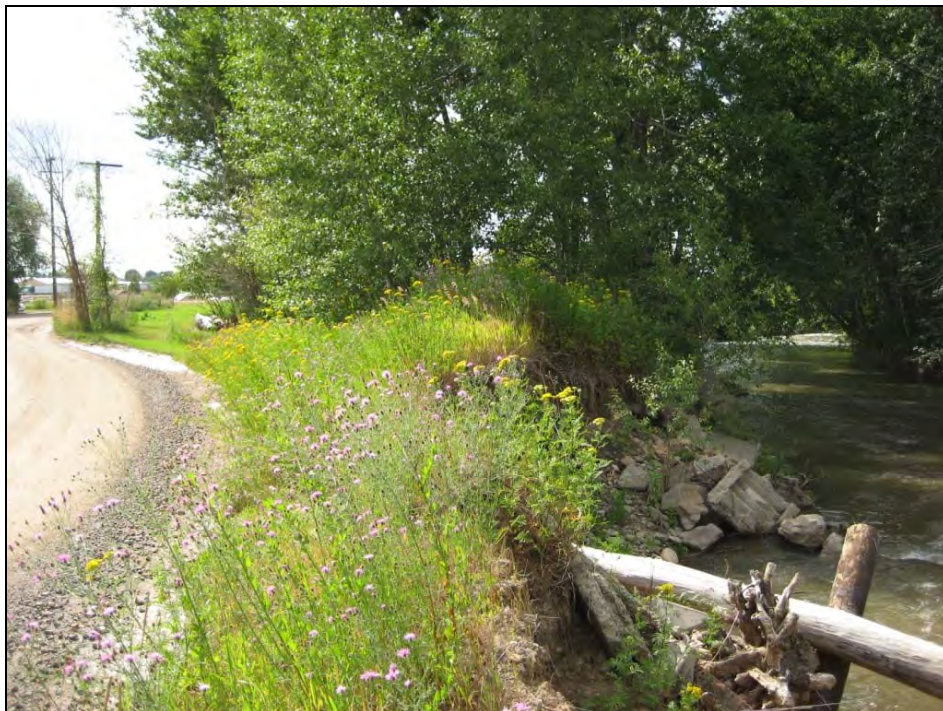
FIGURE 12. BOHART DRIVE ENCROACHING ALONG RIVER, RIPRAP, AND INVASIVES KNAPWEED AND TANSY ON BANK

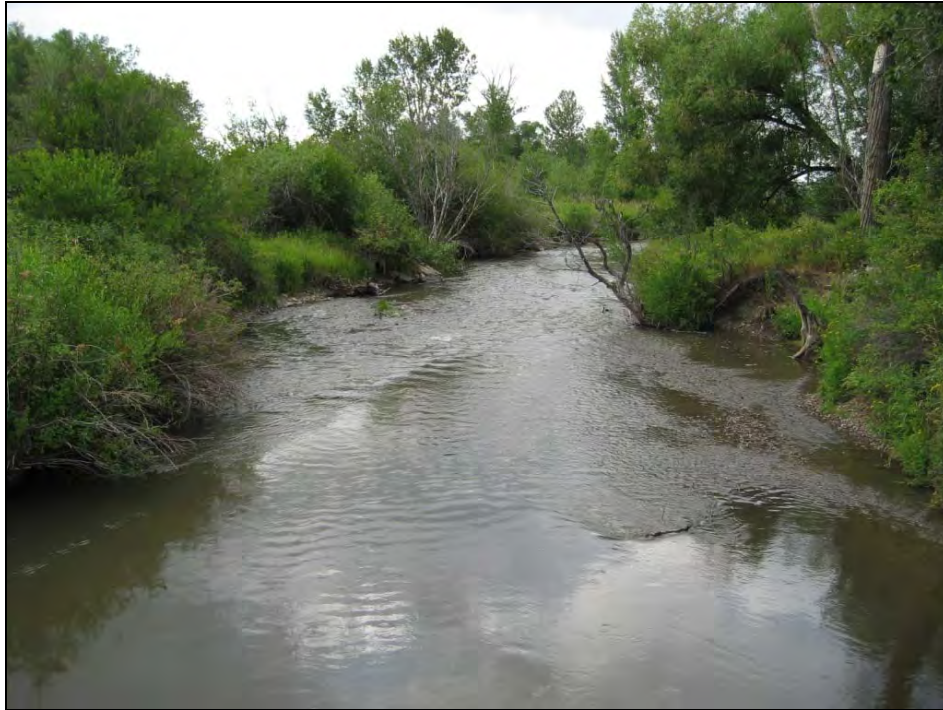
The dominant land use within the reach is dry pasture in the form of the old Headwaters Livestock Auction stockyard adjacent to the river, and other moderately-used pasture land. Overall the riparian vegetation is robust with healthy cottonwoods (Figure 14), yet it is narrow in some places and dense tansy and pasture grasses are common in the understory (Figure 15). Pasture encroachment was specifically noted on the aerial adjacent to the stockyard, and bank failures and extensive rip-rap were observed on the banks adjacent to the old stockyard. Bank erosion was also observed downstream of the Gallatin Valley Land Trust trail footbridge (Figure 16).

FIGURE 14. HEALTHY COTTONWOOD RIPARIAN DOWNSTREAM OF GALLATIN VALLEY LAND TRUST FOOTBRIDGE

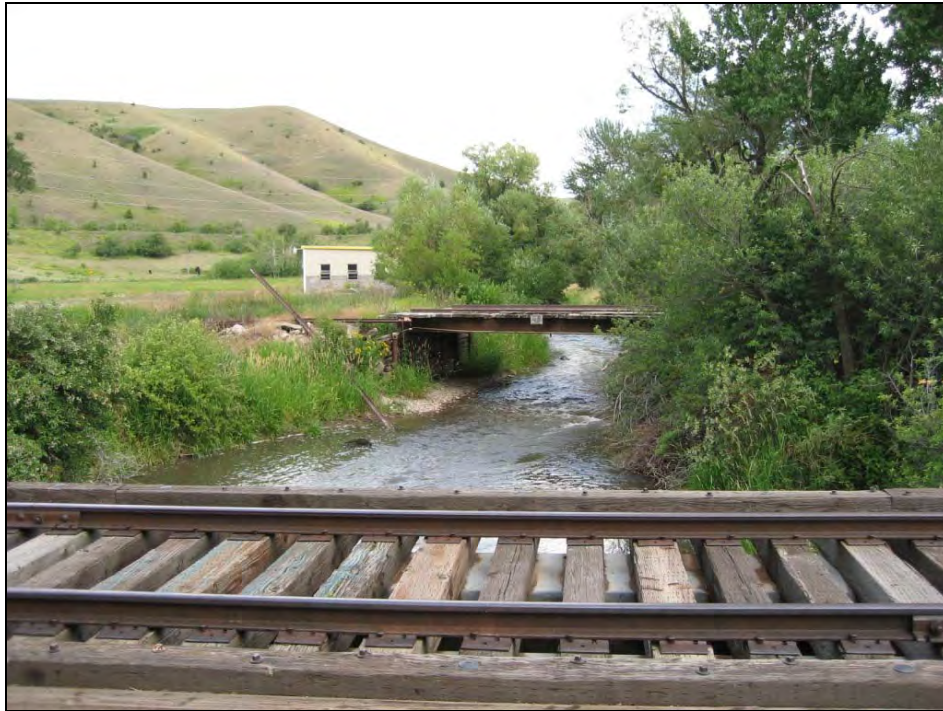
FIGURE 15. NARROW RIPARIAN WITH ADJACENT PASTURE

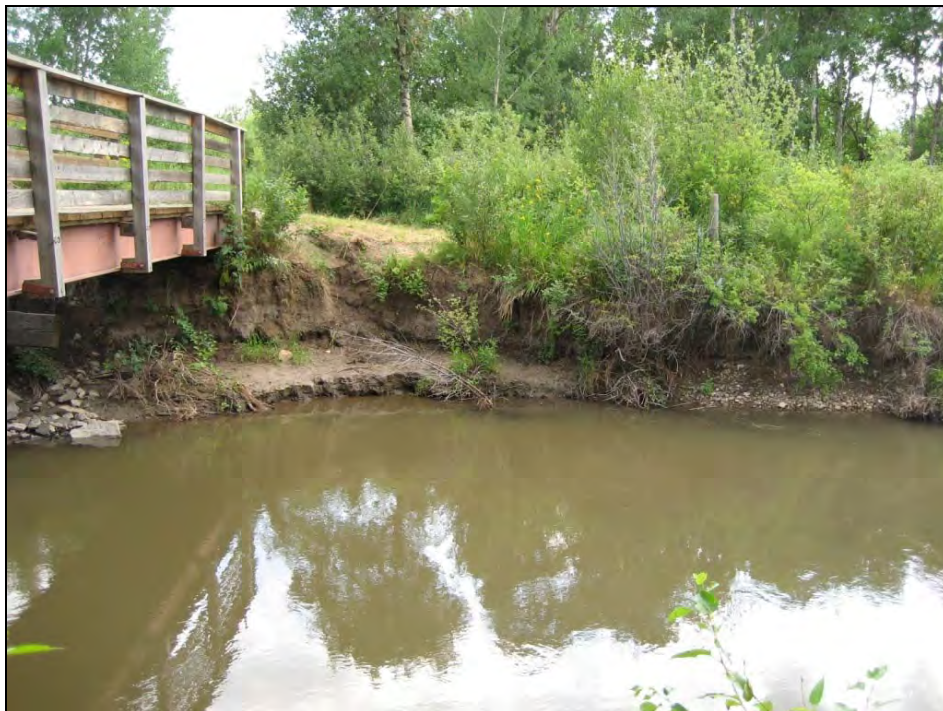
FIGURE 16. BANK EROSION DOWNSTREAM OF GALLATIN VALLEY LAND TRUST FOOTBRIDGE

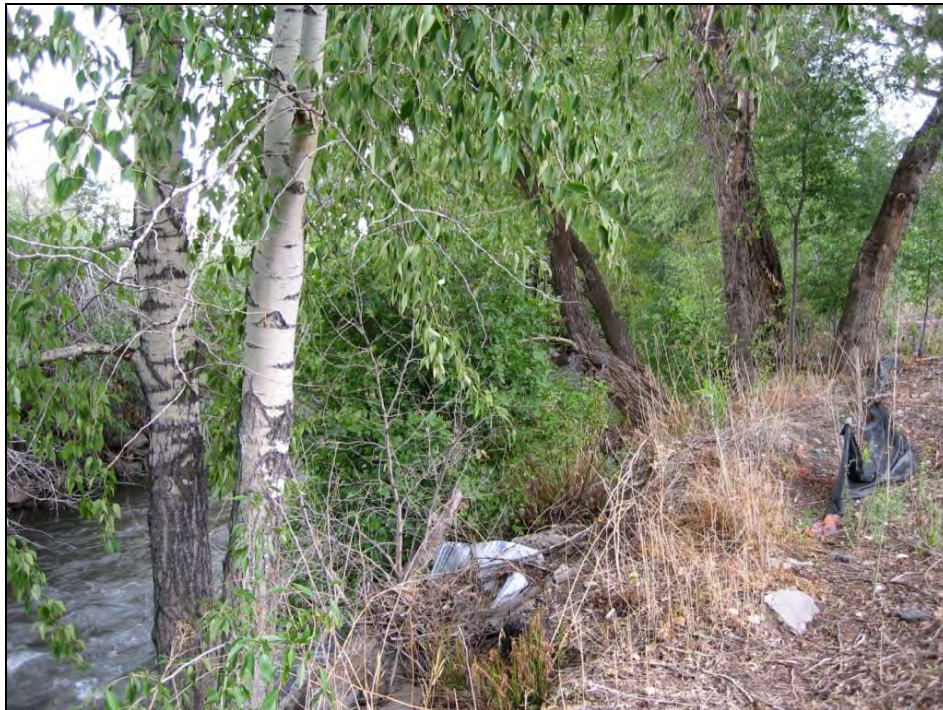
The river flows through primarily urban land use within this reach, including both industrial and residential areas. The riparian condition and bank stability varied throughout the reach. At the Rouse Ave crossing riparian quality was very low, consisting of a narrow strip of cottonwoods directly adjacent to commercial and residential yards (Figure 18). Bank stability at this location was moderate, with banks heavily rip-rapped (Figure 19). Upstream and downstream of Rouse Ave the riparian area was wider, with healthy willows and cottonwoods and stable banks (Figure 20). Sourdough/Bozeman Cr enters at the upstream end of the reach. Road encroachment was limited to 50 ft along the paved North Rouse Avenue.

FIGURE 18. RIPARIAN DOWNSTREAM OF NORTH ROUSE AVE COMPRISED OF NARROW STRIP OF COTTONWOODS
