ATTACHMENT B – 2009 LOWER GALLATIN TMDL PLANNING AREA NUTRIENT, ALGAE AND *E. COLI* SOURCE ASSESSMENT

December, 2009

OASIS Environmental, Inc.
PO Box 582
Livingston, MT 59047

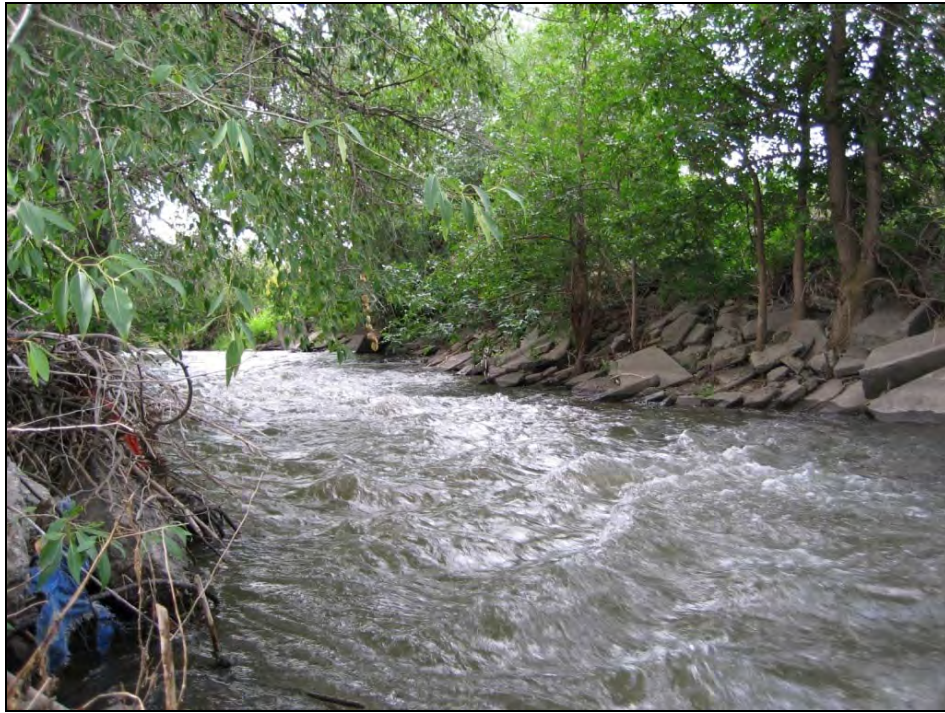
FIGURE 19. RIPRAP DOWNSTREAM OF NORTH ROUSE AVE, LOW RIPARIAN QUALITY

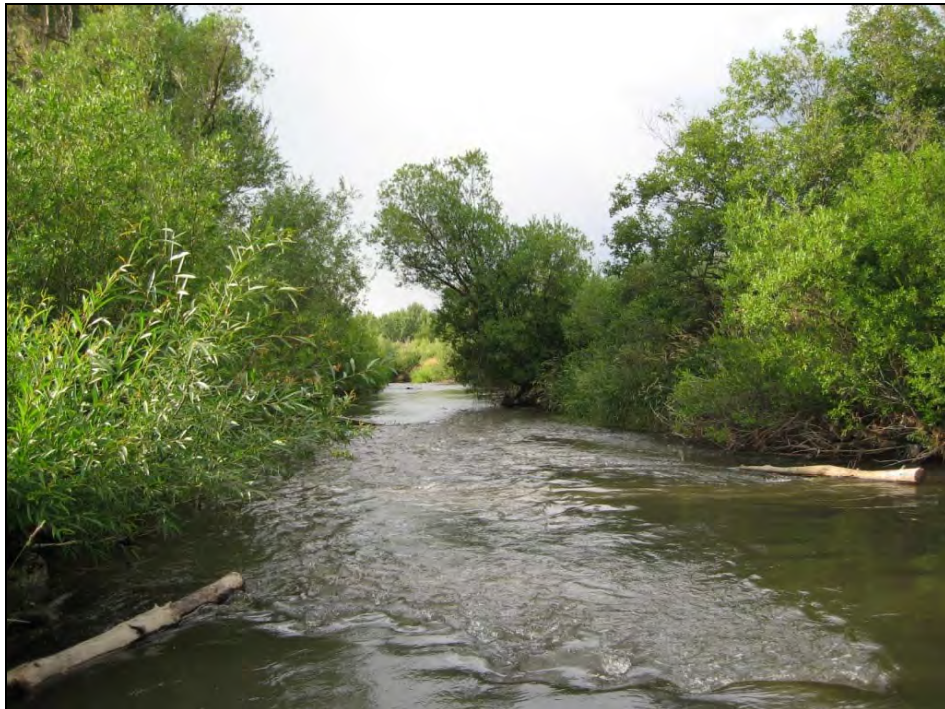
FIGURE 20. HEALTHY RIPARIAN AT DOWNSTREAM END OF REACH

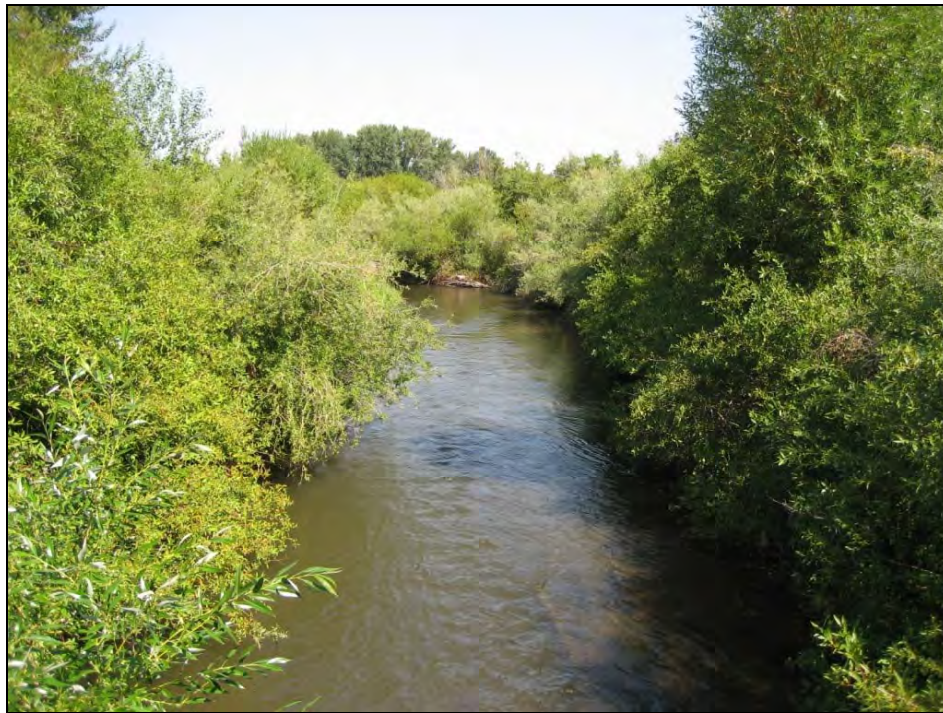
FIGURE 22. DENSE WILLOW-COTTONWOOD RIPARIAN VEGETATION WITHIN EAST GALLATIN RECREATION AREA

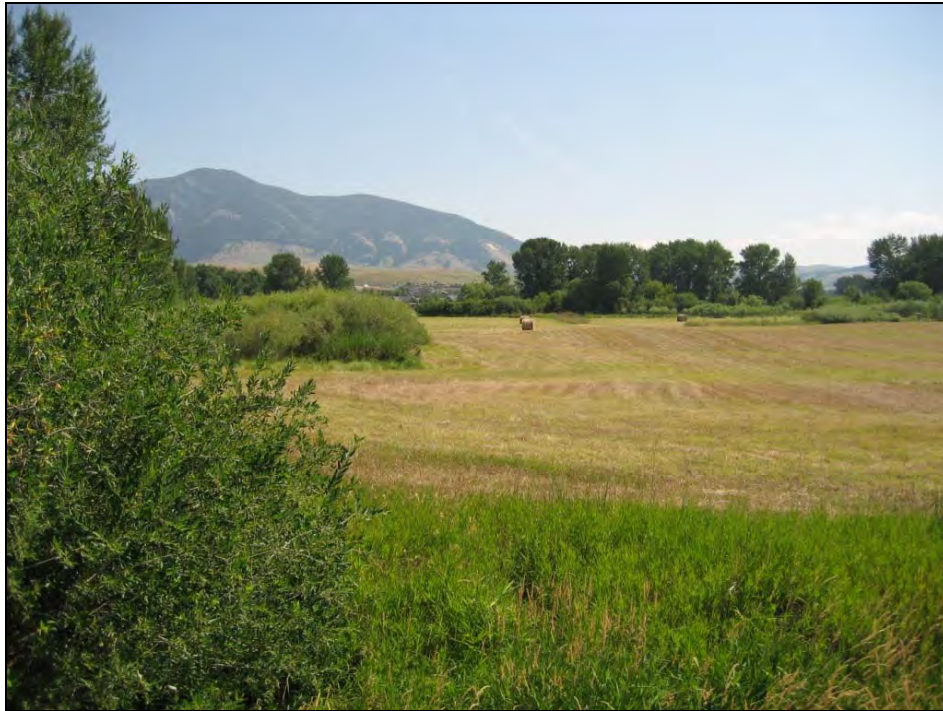
FIGURE 24. HAY PRODUCTION AND DENSE, HEALTHY RIPARIAN UPSTREAM OF MANLEY RD

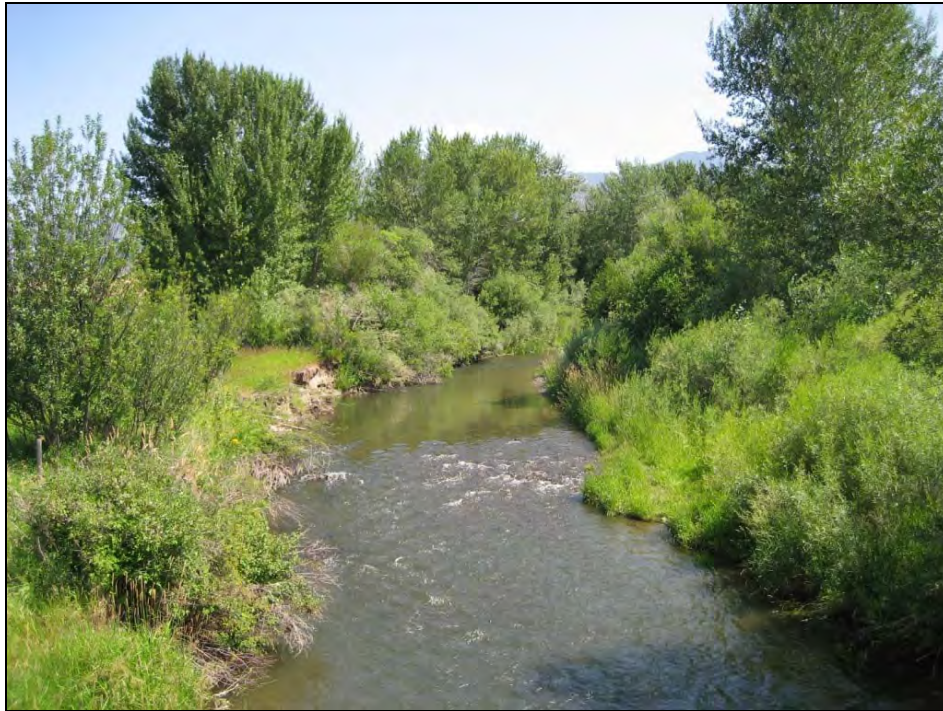
FIGURE 25. DENSE COTTONWOOD-WILLOW RIPARIAN UPSTREAM OF MANLEY RD

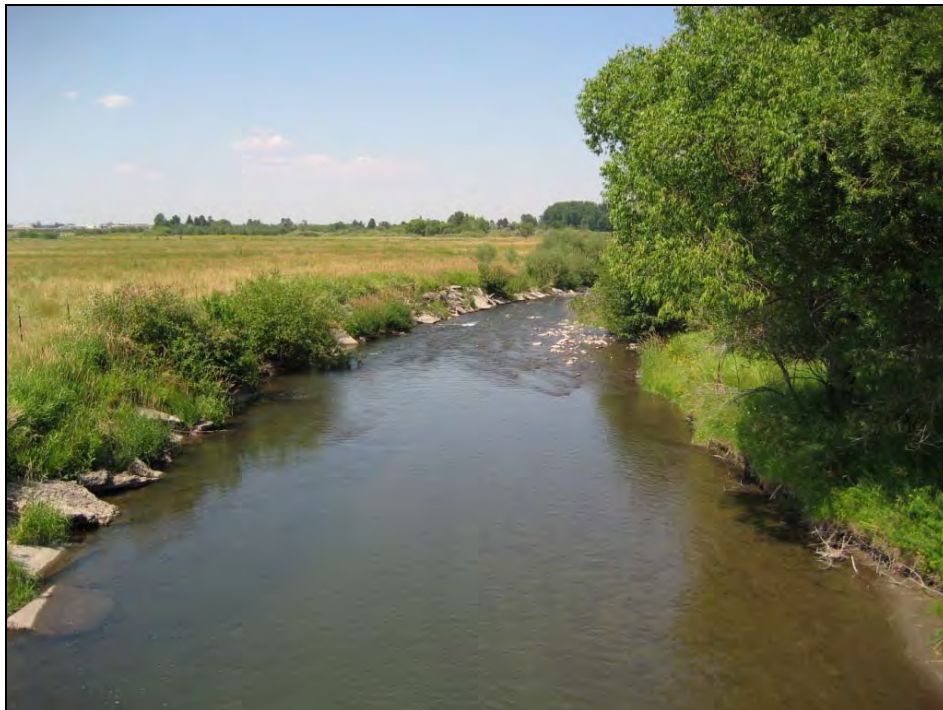
FIGURE 26. PASTURE ENCROACHMENT AND DENSE COTTONWOOD RIPARIAN DOWNSTREAM OF MANLEY RD

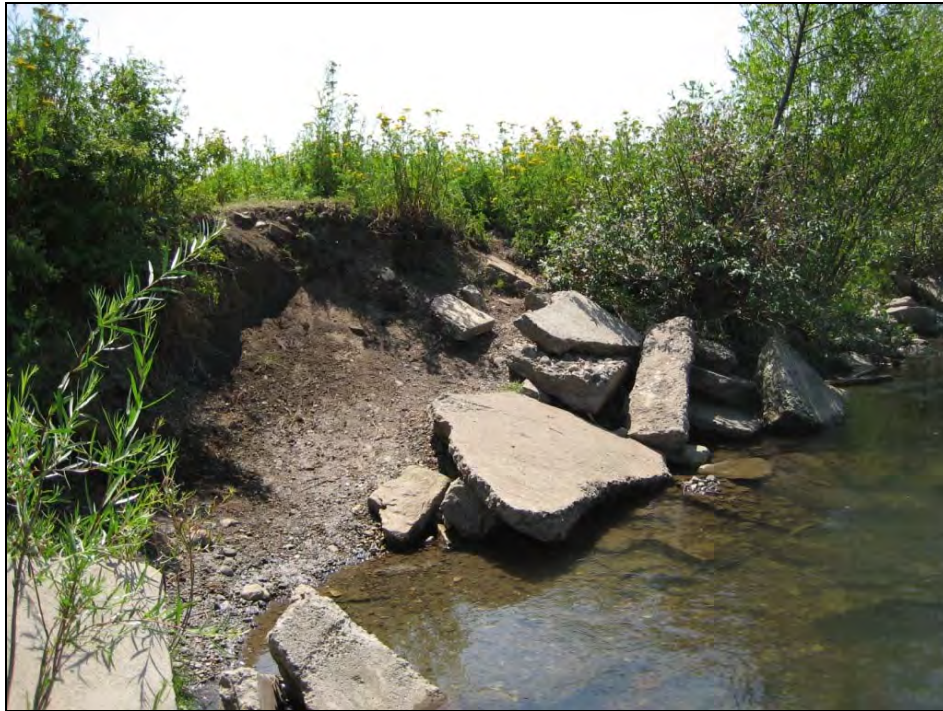
FIGURE 27. BANK EROSION AND RIPRAP WITHIN THE CHERRY RIVER FAS

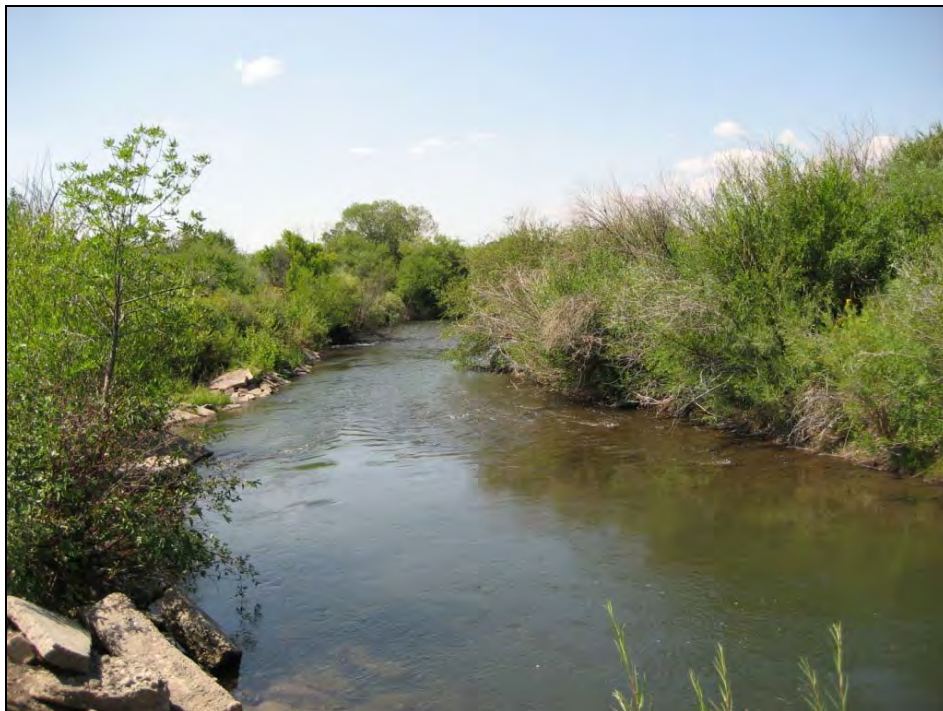
FIGURE 28. HEALTHY RIPARIAN AND RIPRAP, WITHIN THE CHERRY RIVER FAS

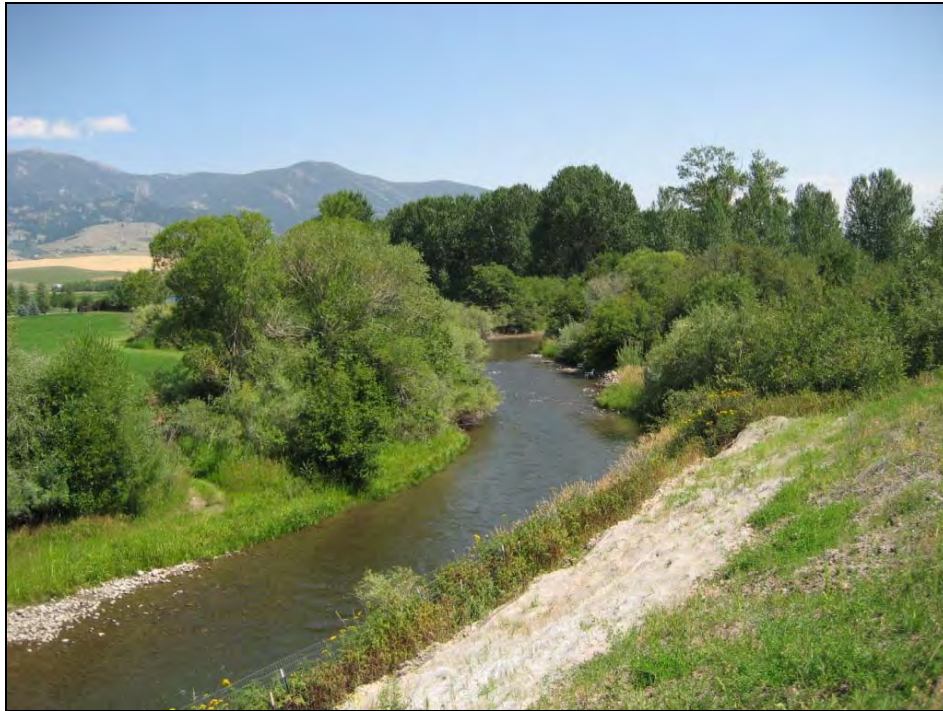
FIGURE 29. HEALTHY RIPARIAN IN BACKGROUND, BANK STABILIZATION PROJECT IN FOREGROUND

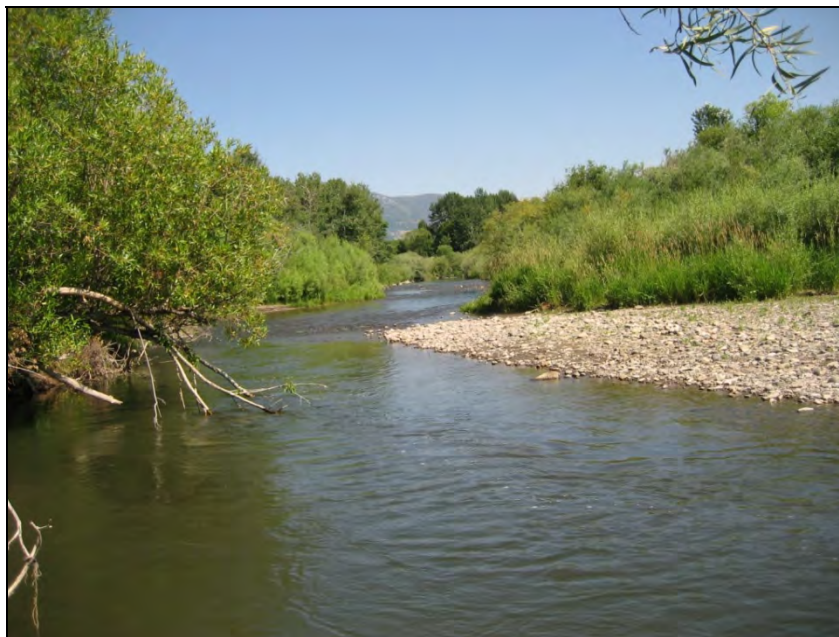
FIGURE 31. DENSE COTTONWOOD-WILLOW RIPARIAN UPSTREAM OF SPRINGHILL RD

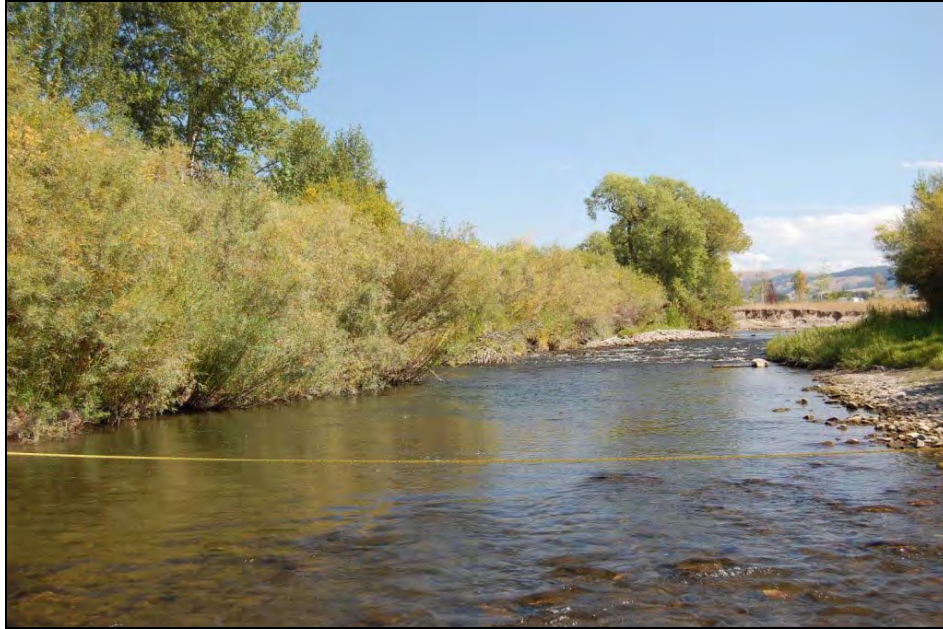
**FIGURE 32. COTTONWOOD-WILLOW RIPARIAN ALONG THE RIVERSIDE COUNTRY CLUB.
PASTURE ENCROACHMENT AND BANK EROSION IN BACKGROUND.**

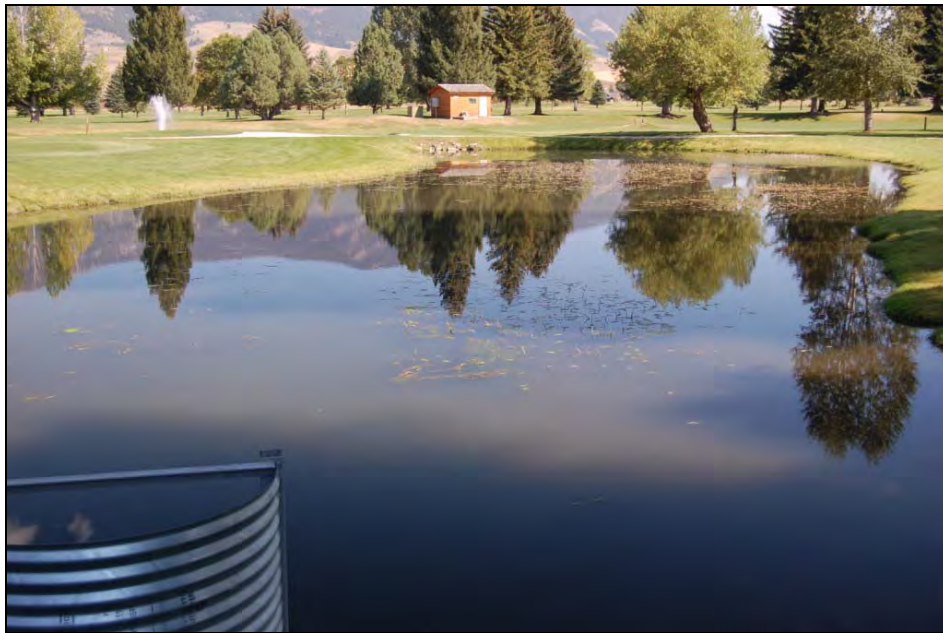
No tributaries enter the reach, but an historic oxbow on the river channel, now filled with water within the golf course, returns water to the river at the upstream end of the reach (see oxbow noted on Figure 30). This oxbow channel now functions as a pond feature on the golf course (Figure 33). Golf course turf is mowed directly to its edges, and it is eutrofied with dense algal growth. One irrigation withdrawal was identified but was not confirmed on the aerial or in the field.

**FIGURE 33. NUTRIENT-RICH OXBOW CHANNEL (NOW GOLF POND) WITHIN RIVERSIDE COUNTRY
CLUB GOLF COURSE, DRAINS THROUGH CHANNEL TO REACH EGAL 07**

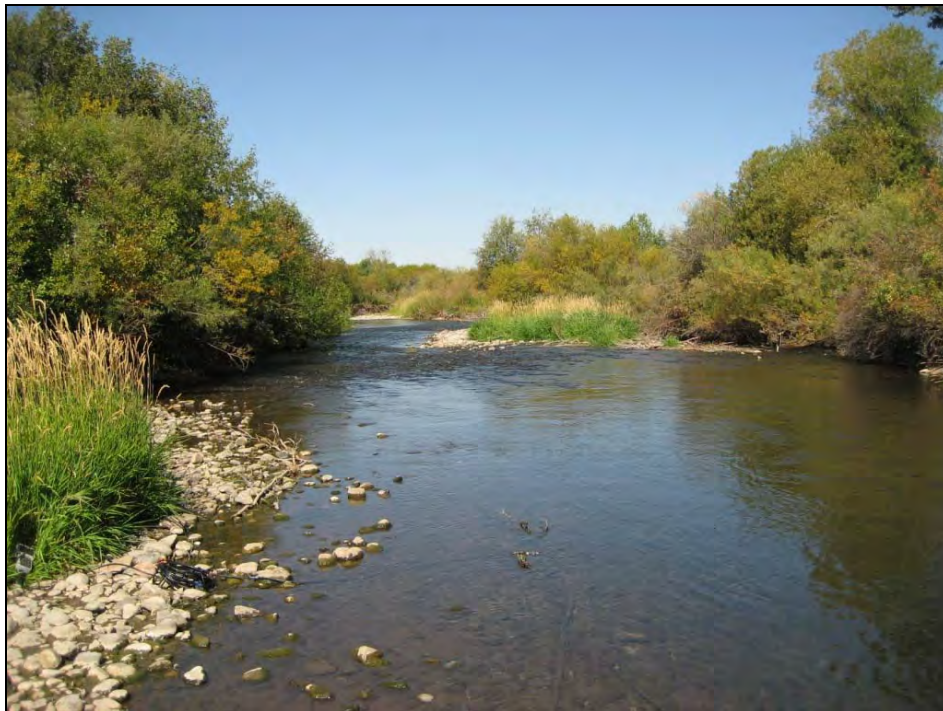
FIGURE 35. HEALTHY, WIDE RIPARIAN IN UPPER SECTION OF REACH AT CITY OF BOZEMAN WASTEWATER TREATMENT PLANT

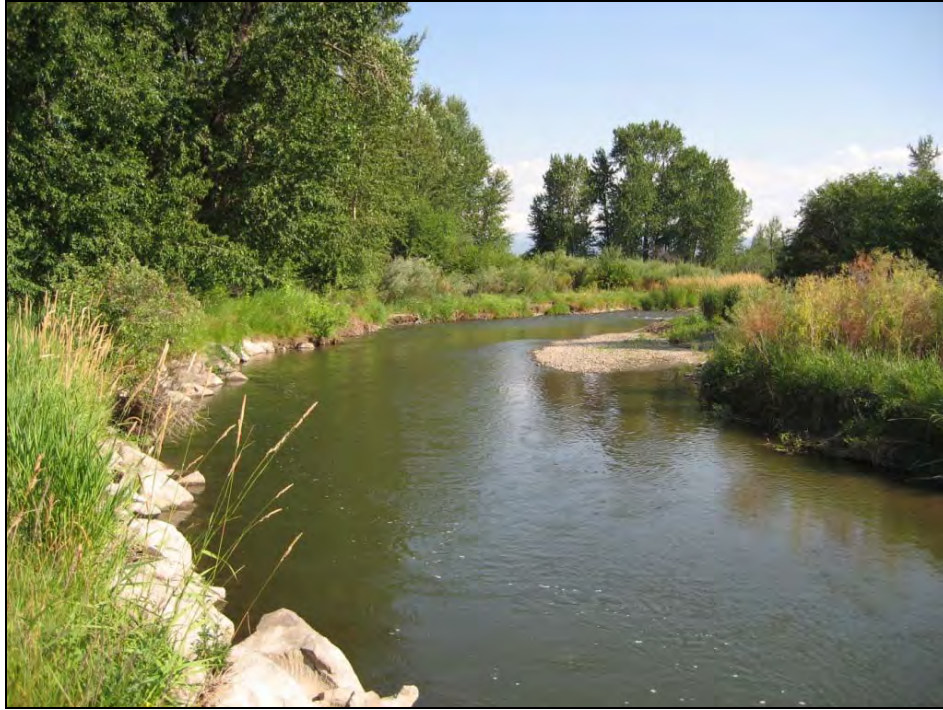
**FIGURE 36. DENSE, WIDE COTTONWOOD RIPARIAN WITH RIPRAP ON BANK, AT DOWNSTREAM
END OF REACH**

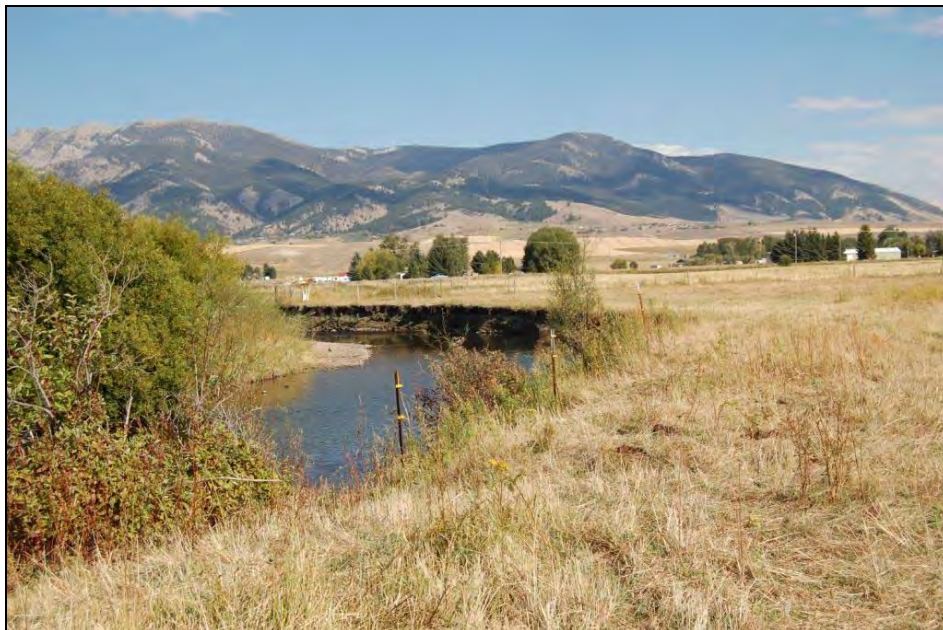
**FIGURE 37. NARROW RIPARIAN WITH PASTURE ENCROACHMENT, INVASIVE WEEDS AND
ERODING BANKS IN MIDDLE SECTION OF REACH**

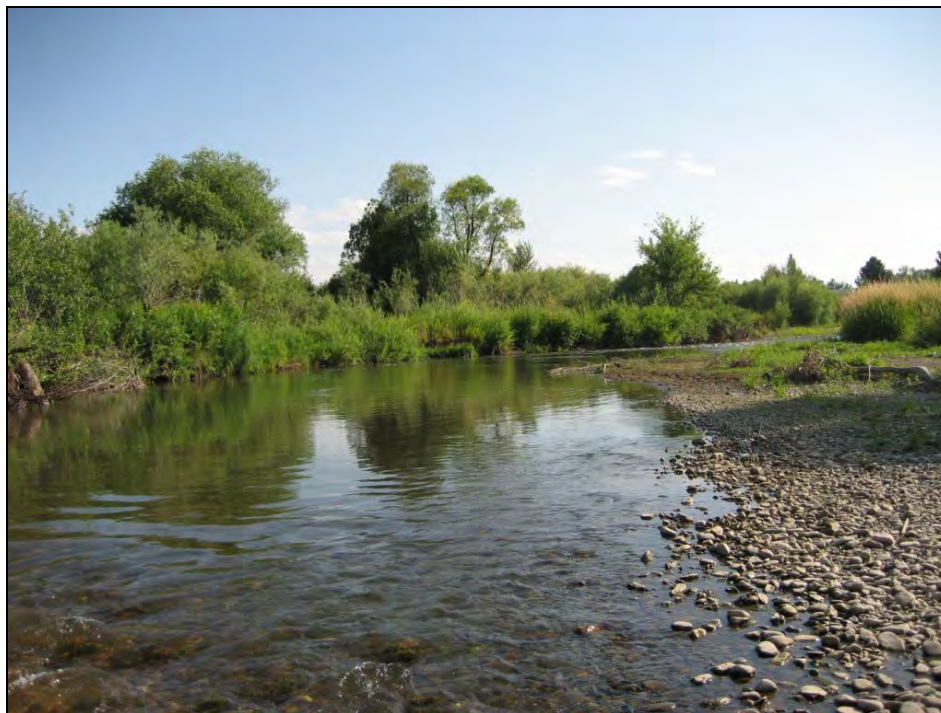
FIGURE 39. DENSE COTTONWOOD-WILLOW RIPARIAN NEAR NELSON RD AT WATER QUALITY MONITORING SITE EG08

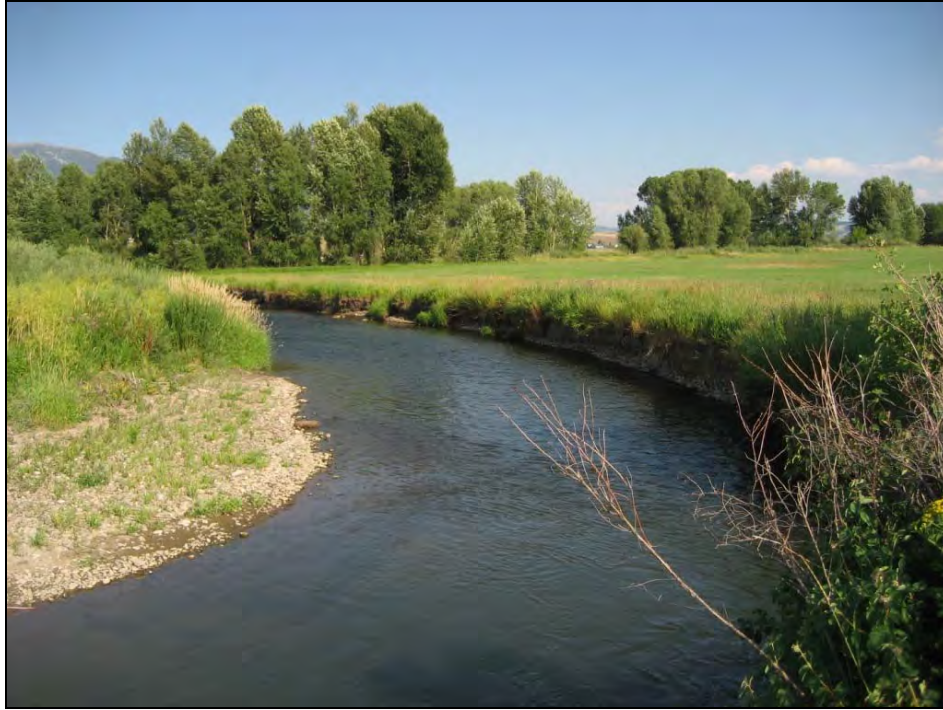
**FIGURE 40. COTTONWOOD RIPARIAN WITH YARD/PASTURE ENCROACHMENT NEAR NELSON RD
AT WATER QUALITY MONITORING SITE EG08**

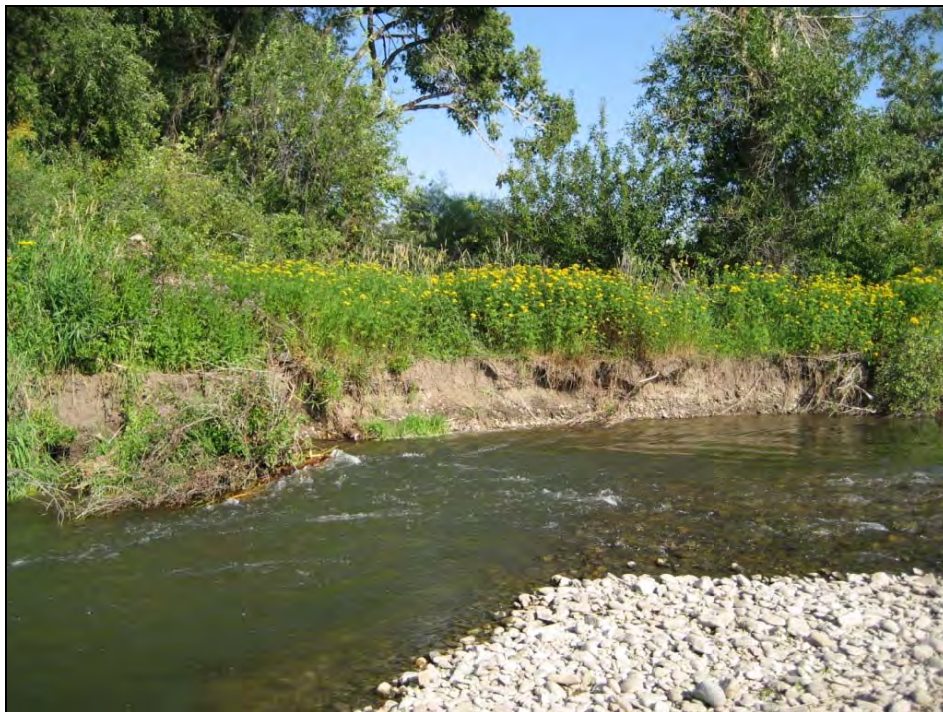
Primary land uses within reach 9 were pasture and hay production, and residential subdivisions. Access was difficult in this reach due to a lack of road crossings, and was only directly observed at four locations along the six mile reach (at the Springhill Sod Farm, water quality site EG08 off of Nelson Rd, water quality site EG09 at Spain Bridge Rd, and at the confluence with Hyalite Cr). Riparian quality was relatively good where the river was observed (Figure 39), with some pasture encroachment and invasive weeds noted (Figures 40 and 41). However, based on the aerial it appears that pasture encroachment was common throughout the reach. Bank erosion was moderate within the reach, with erosion observed on outer meander bends. Extensive areas of riprap indicate low bank stability in the erodible soils within the river bottom (Figure 41).

FIGURE 41. INVASIVE TANSY AND HIGH SLOUGHING BANK ON OUTER MEANDER

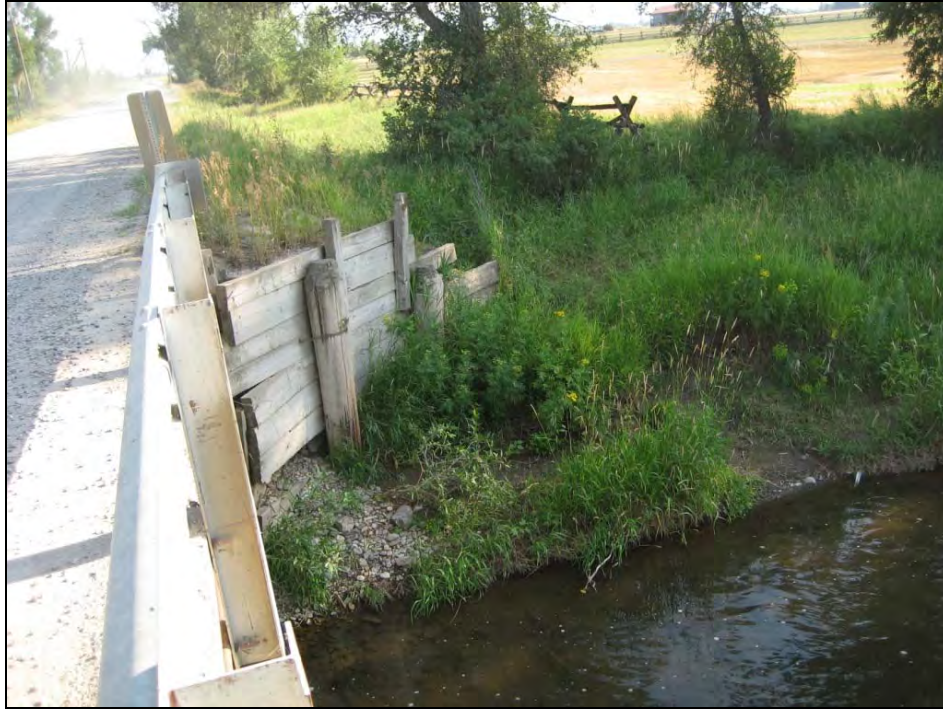
FIGURE 42. STABLE BANKS AT UNPAVED SPAIN BRIDGE RD CROSSING

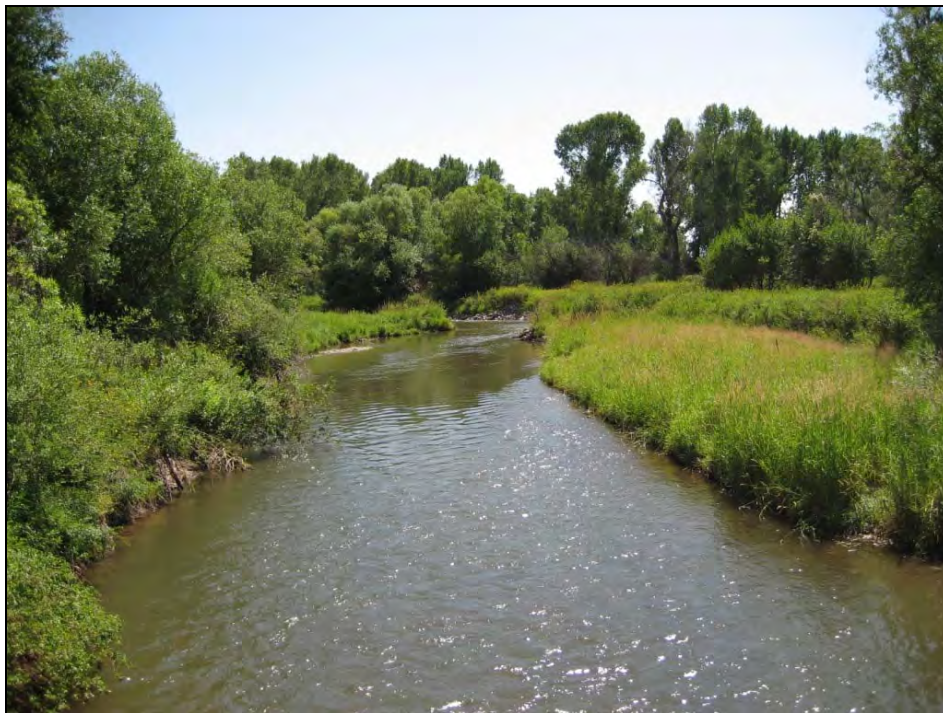
FIGURE 44. HEALTHY RIPARIAN UPSTREAM OF PENWELL BRIDGE RD

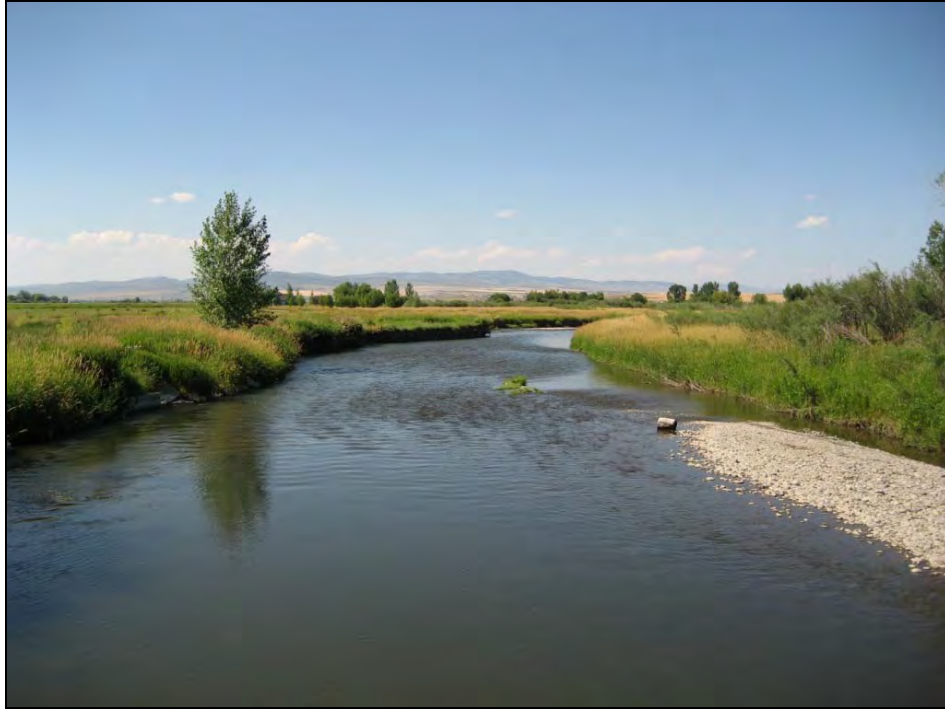
**FIGURE 45. WILLOW RIPARIAN WITH PASTURE AND DENSE REED CANARYGRASS ON BANKS
DOWNSTREAM OF HAMILTON BRIDGE RD**

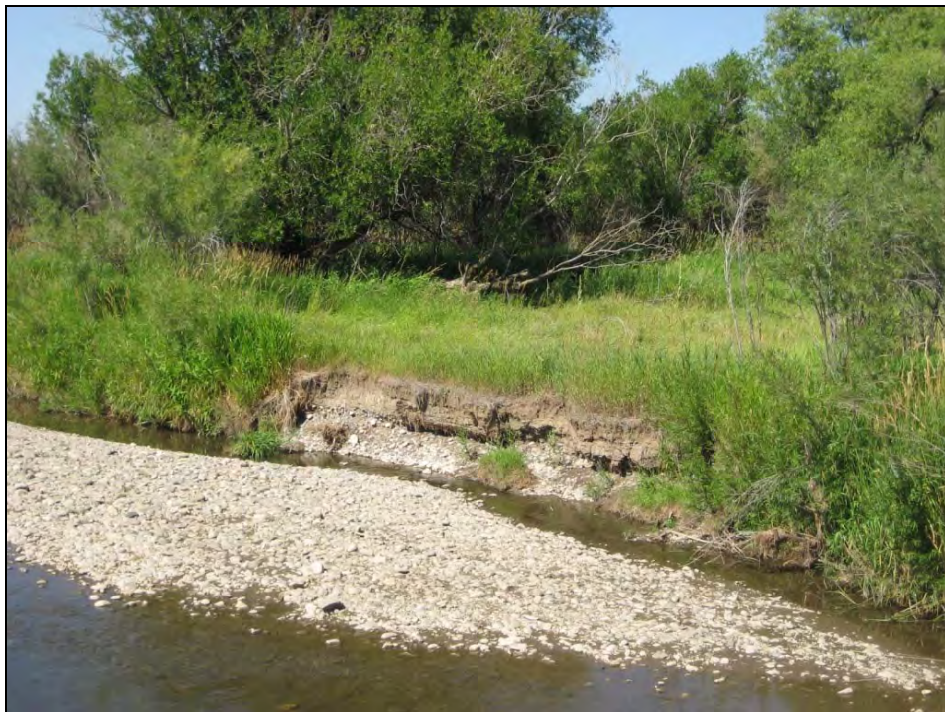
Reach 10 is highly sinuous, flowing through the subirrigated agricultural valley north of Belgrade. The twelve mile reach was observed at the Hyalite Cr confluence, at Penwell Bridge Rd, Hamilton Bridge Rd, Dry Creek Rd, and at the Ben Hart Cr and Smith Cr confluences. Primary land uses along the reach are hay production and pasture land with springs common within the valley bottom. Riparian vegetation was a mosaic of cottonwoods with willow understory (Figure 44), willows only, and pasture and hay land (Figure 45). Invasive weeds such as reed canarygrass and thistles were abundant along the banks. Bank erosion was moderate throughout the reach, with instability and sloughing observed on meander bends and in areas of pasture encroachment and livestock trampling (Figures 46 and 47).

FIGURE 46. BANK EROSION DOWNSTREAM OF HAMILTON BRIDGE RD

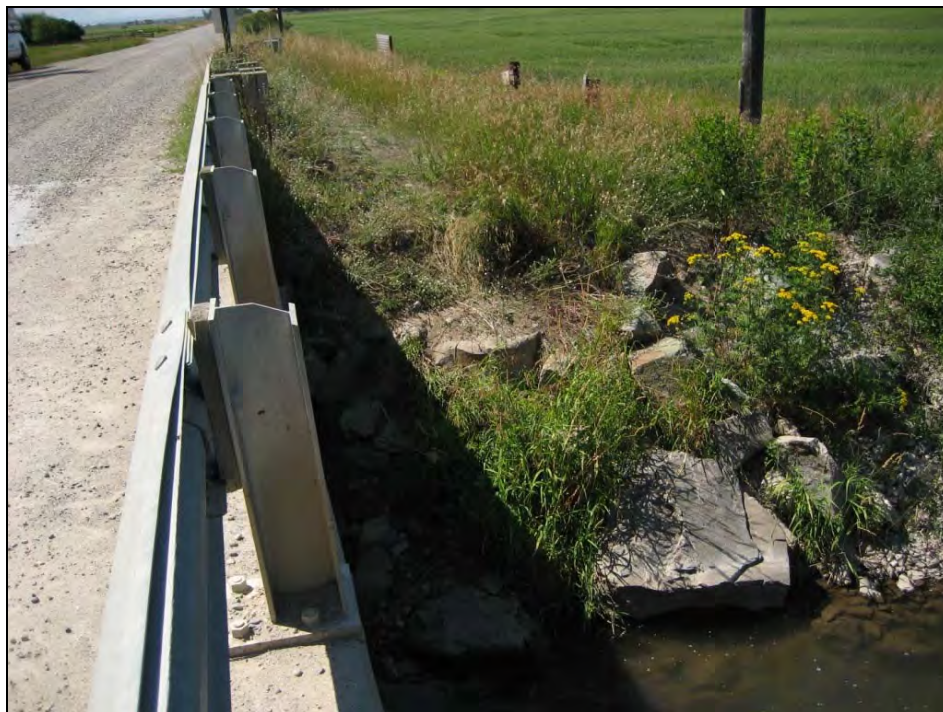
The Hamilton Bridge Rd and Penwell Bridge Rd crossings were both well-vegetated and stable and were not considered potential nutrient sources, although some sedimentation likely occurs during runoff events (Figure 48).

FIGURE 48. STABLE BANKS AND WELL-VEGETATED AT PENWELL BRIDGE CROSSING

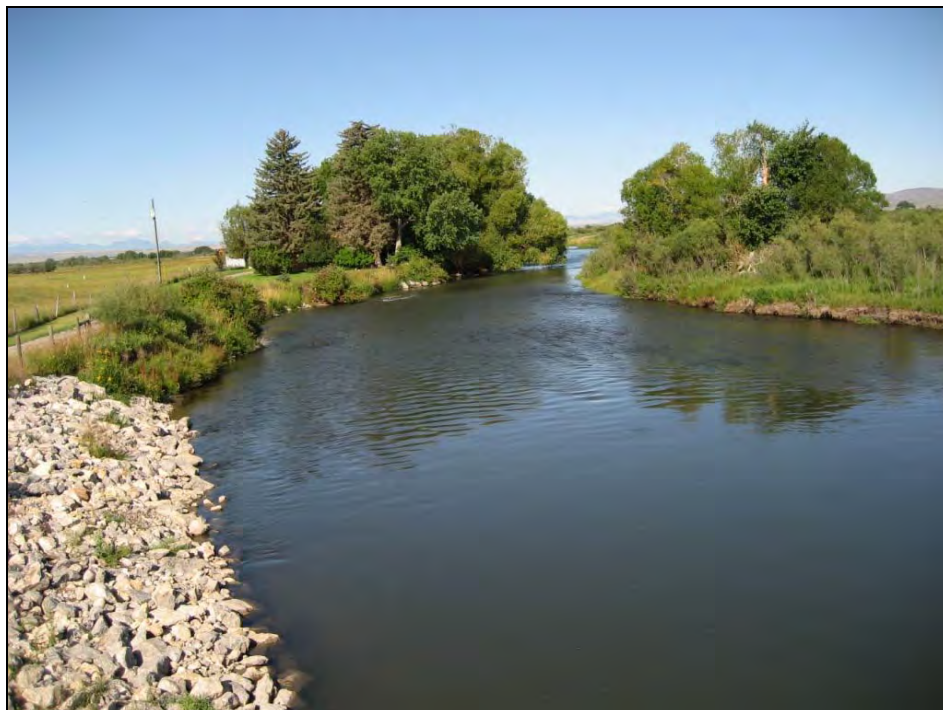
FIGURE 50. COTTONWOOD-WILLOW RIPARIAN IN UPPER REACH, DOWNSTREAM OF SWAMP CREEK RD

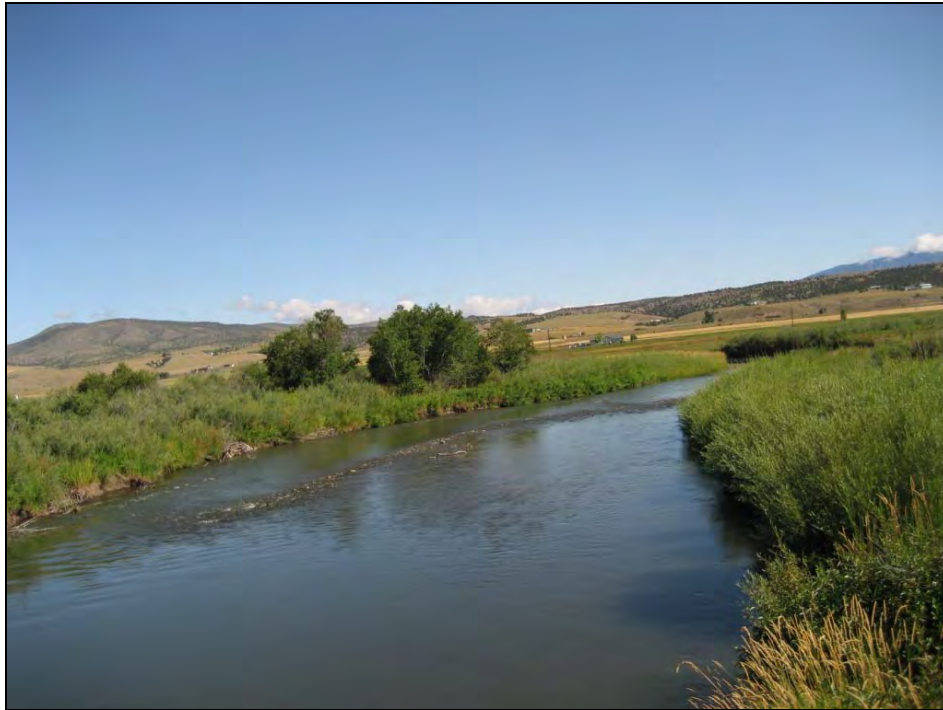
FIGURE 51. WILLOW-REED CANARYGRASS RIPARIAN DOWNSTREAM OF WEST DRY CREEK RD

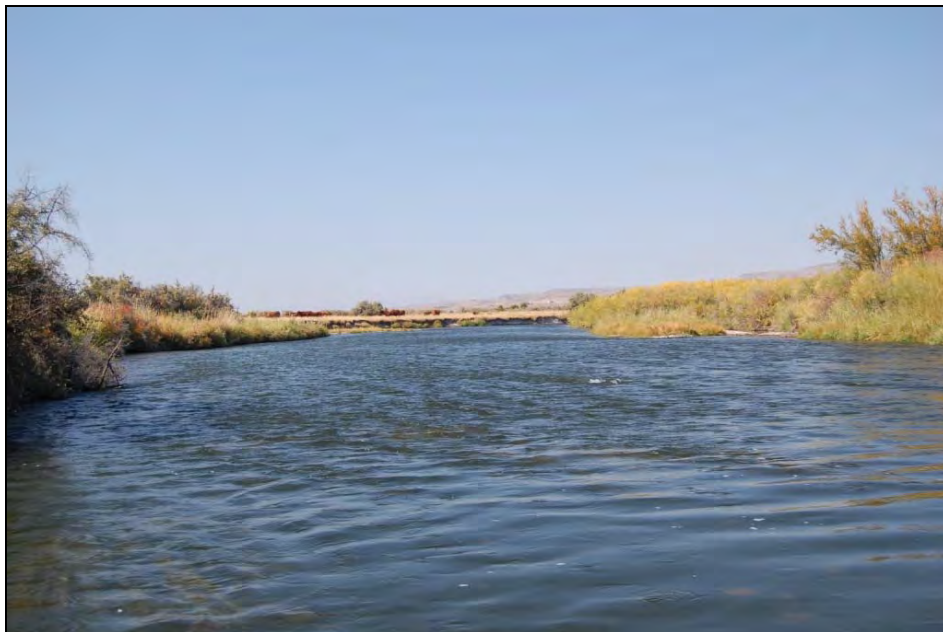
The river size increases in reach 11, winding through the agricultural valley bottom north of Manhattan. Primary land uses along the reach are hay production and pasture land. The adjacent landscape is dryer than in reach 10 where springs and seeps were common. Riparian vegetation transitions from the cottonwood overstory and reed canarygrass in the upper reach (Figure 50), to primarily willows, buffaloberry and juniper, with dense reed canarygrass and pasture grasses in the lower reach (Figure 51). Riparian vegetation is generally healthy, although pasture encroachment is common (Figure 52). Soils are naturally erosive throughout the reach, with instability and sloughing observed on meander bends and in areas of pasture encroachment (Figures 52 and 53).

**FIGURE 52. BANK EROSION AND PASTURE ENCROACHMENT DOWNSTREAM OF FSPAULDING
BRIDGE RD AT WATER QUALITY SITE EG13**

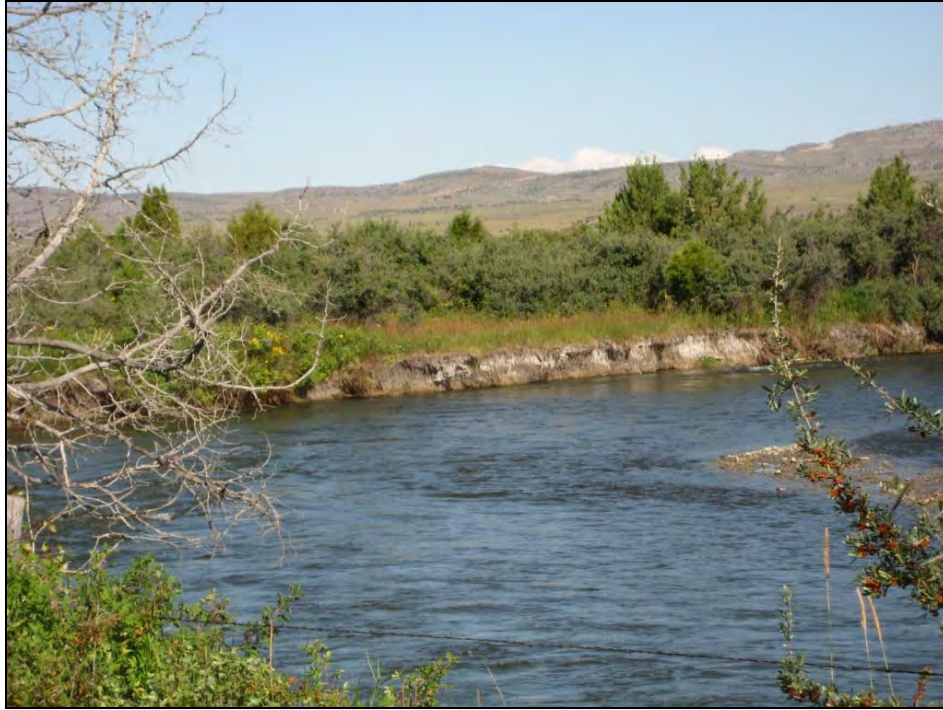
FIGURE 53. BANK EROSION ON OUTER MEANDER BEND DOWNSTREAM OF DRY CREEK SCHOOL RD

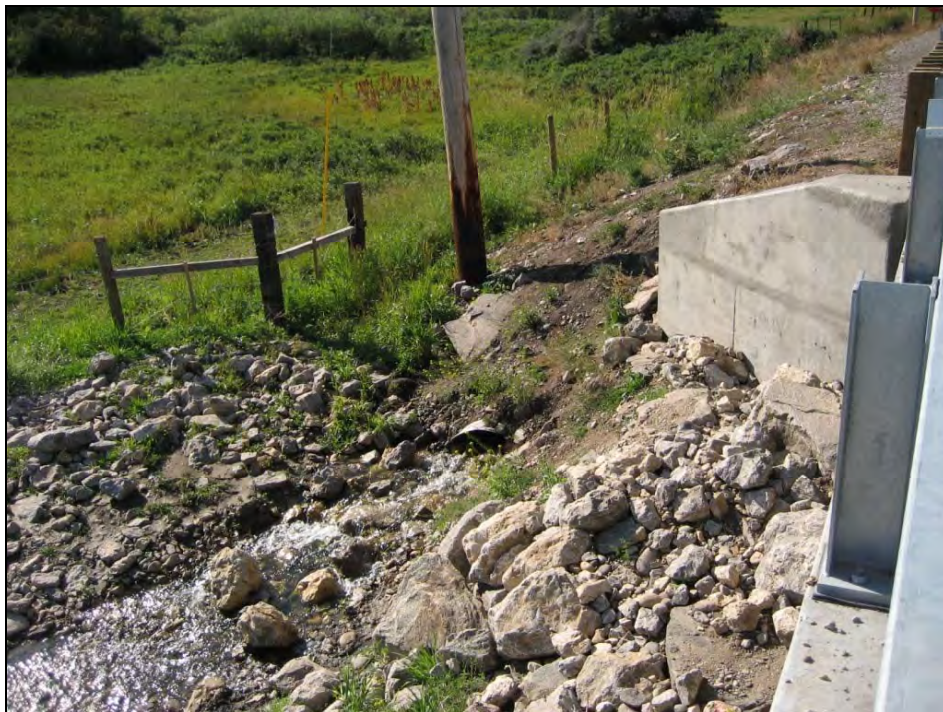
FIGURE 54. CULVERT ENTERING UPSTREAM OF SWAMP CREEK RD (MIDDLE OF PHOTO)

Three unpaved roads cross the reach, Swamp Creek Rd, Dry Creek School Rd, and Spaulding Bridge Rd. Minor erosion was noted upstream of Swamp Creek Rd where the culvert returns water to the river (Figure 54). The other two crossings were well vegetated and were not considered a significant nutrient source. The two irrigation returns were considered low to moderately significant potential nutrient sources. Both returns drain agricultural land, yet no channel indicating the source of the return upstream of Swamp Creek Rd was identified.

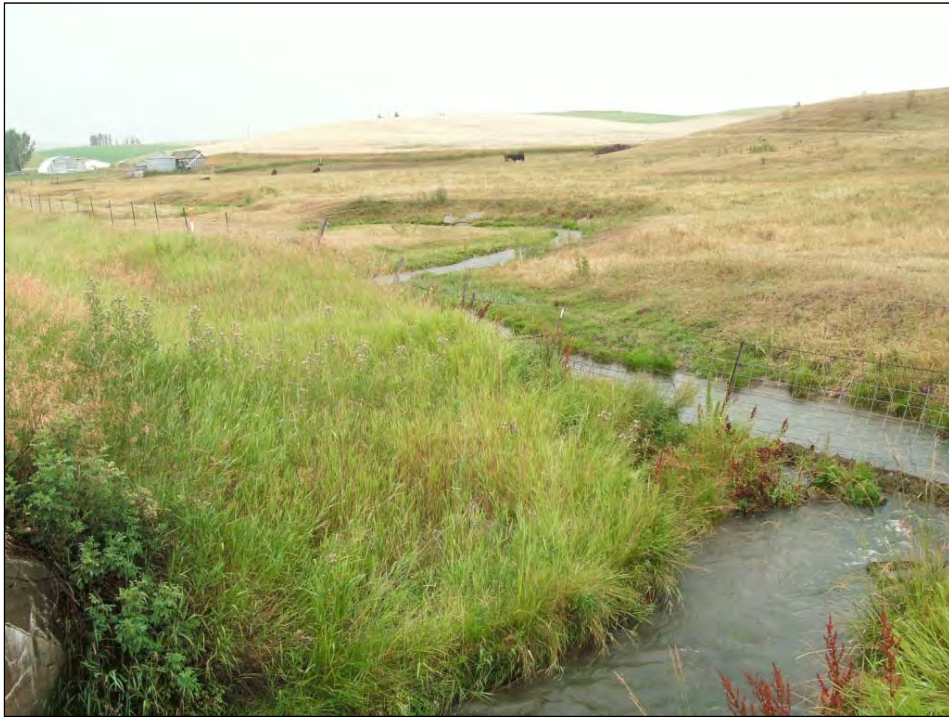
Land use within the reach is primarily cattle grazing, resulting in an unhealthy overgrazed riparian zone in many areas (Figure 5), with select sections of dense grass and ungrazed riparian in the upper portion of the reach (Figure 6). Although the riparian zone was encroached by crop production and impacted by cattle in several areas, due to the small size of the stream and low flow, bank erosion was generally moderate (Figure 6). However, select areas of bank erosion were observed (Figure 7). The paved Amsterdam-Churchill road encroached on the stream for ~200 ft at the lower end of the reach but the bank between the stream and the road was well vegetated, reducing the likelihood of pollutant delivery. No significant irrigation withdrawals were identified within the reach.

FIGURE 5. GRAZED, WEEDY RIPARIAN UPSTREAM OF CHURCHILL ROAD WITH NO PASTURE BUFFER

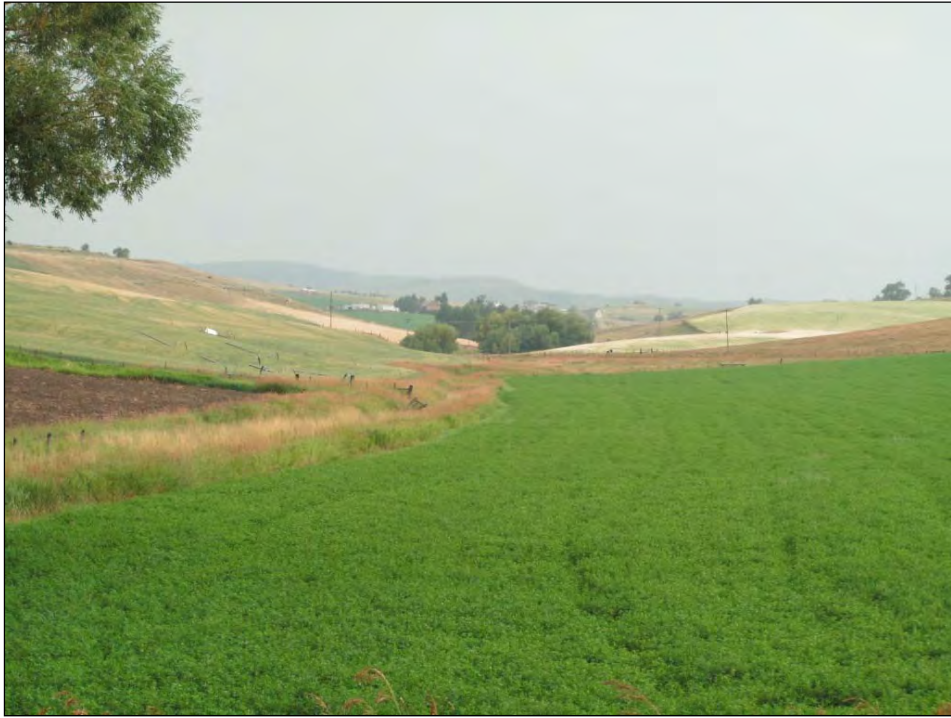
FIGURE 6. DENSE GRASS RIPARIAN BUFFER UPSTREAM OF LITTLE HOLLAND ROAD

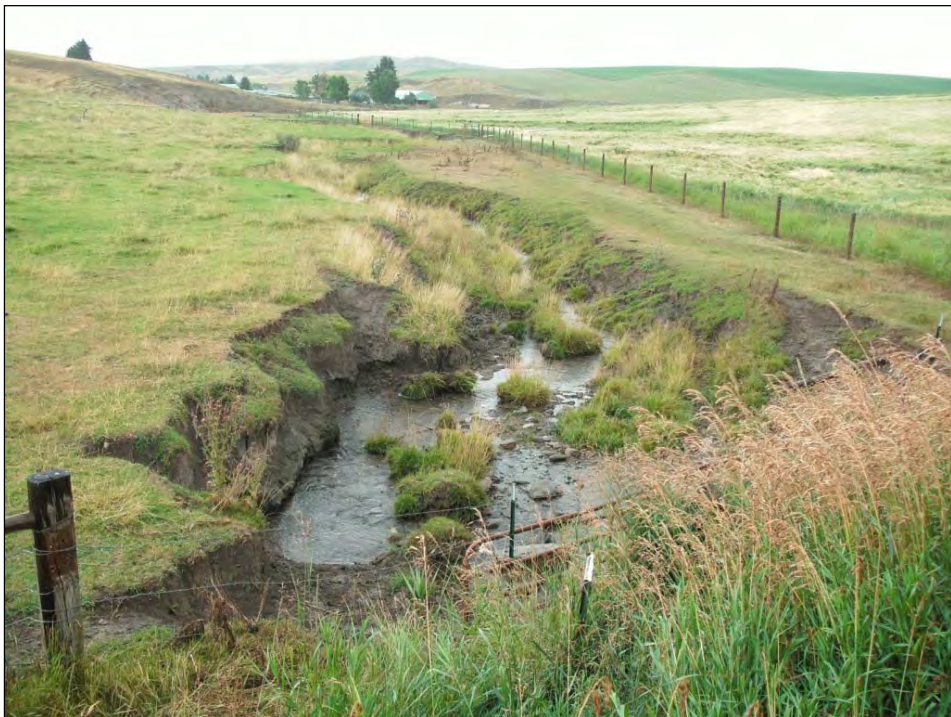
FIGURE 7. ERODING BANK DOWNSTREAM OF LITTLE HOLLAND ROAD

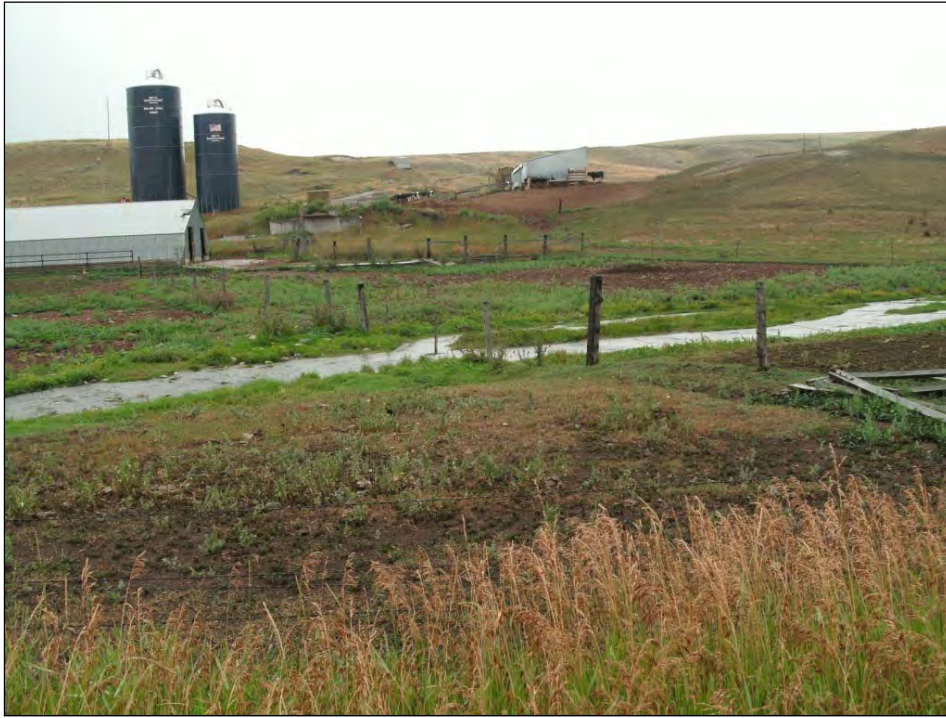
FIGURE 10. ERODING, TRAMPLED BANKS WITHIN LIVESTOCK CONFINEMENT AREA
