ATTACHMENT B – 2009 LOWER GALLATIN TMDL PLANNING AREA NUTRIENT, ALGAE AND *E. COLI* SOURCE ASSESSMENT

December, 2009

OASIS Environmental, Inc.
PO Box 582
Livingston, MT 59047

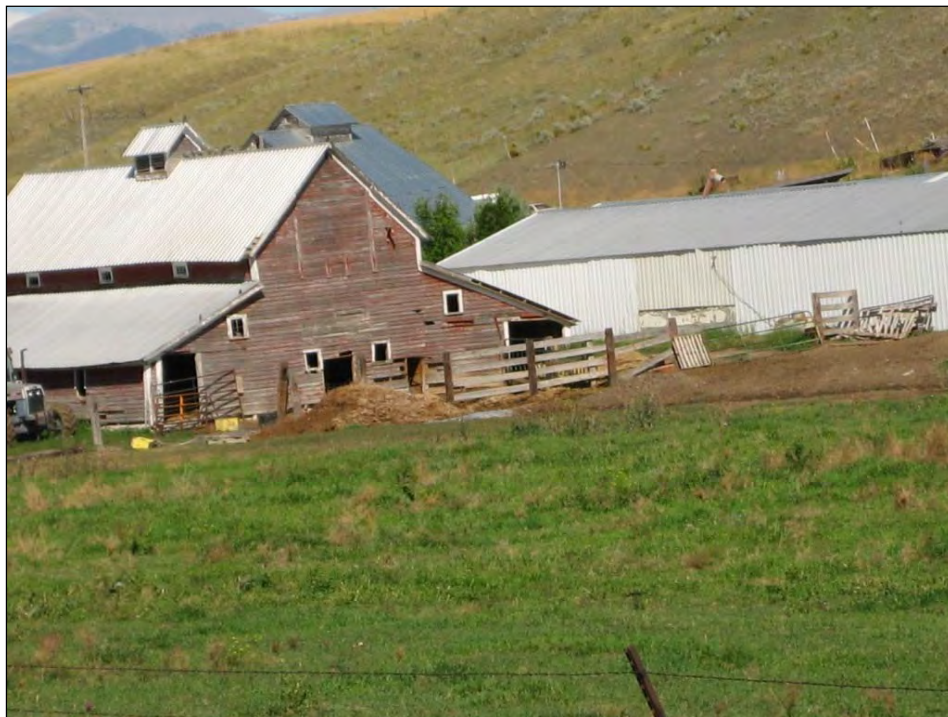
FIGURE 11. LIVESTOCK CONFINEMENT AREA WITH MANURE PILE WITHIN 30 FT OF STREAM

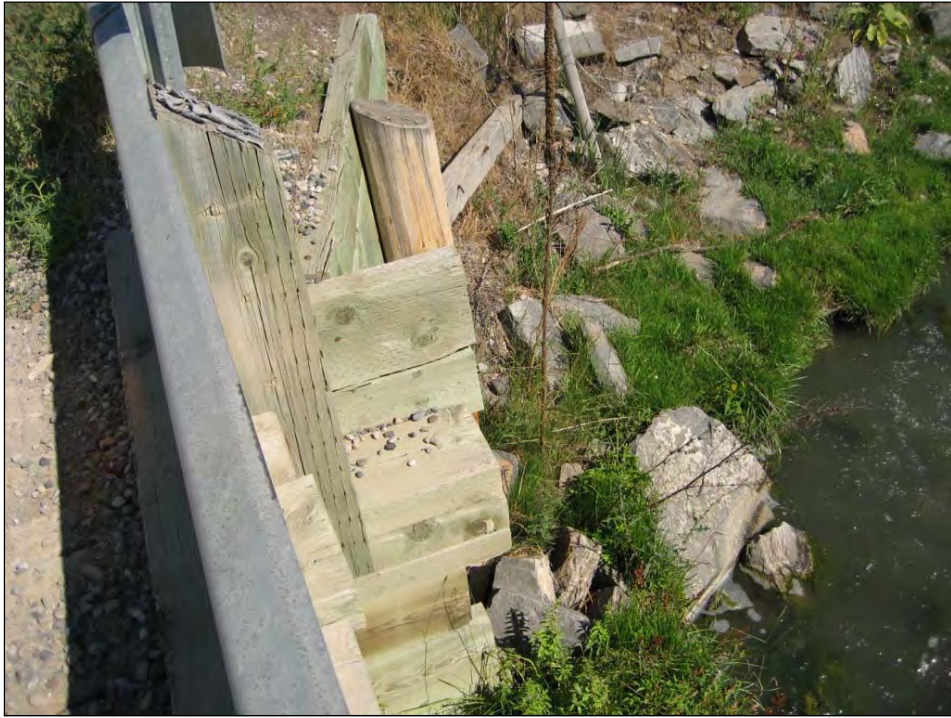
FIGURE 12. STABLE, WELL-VEGETATED ABUTMENT AT CANAL ROAD CROSSING

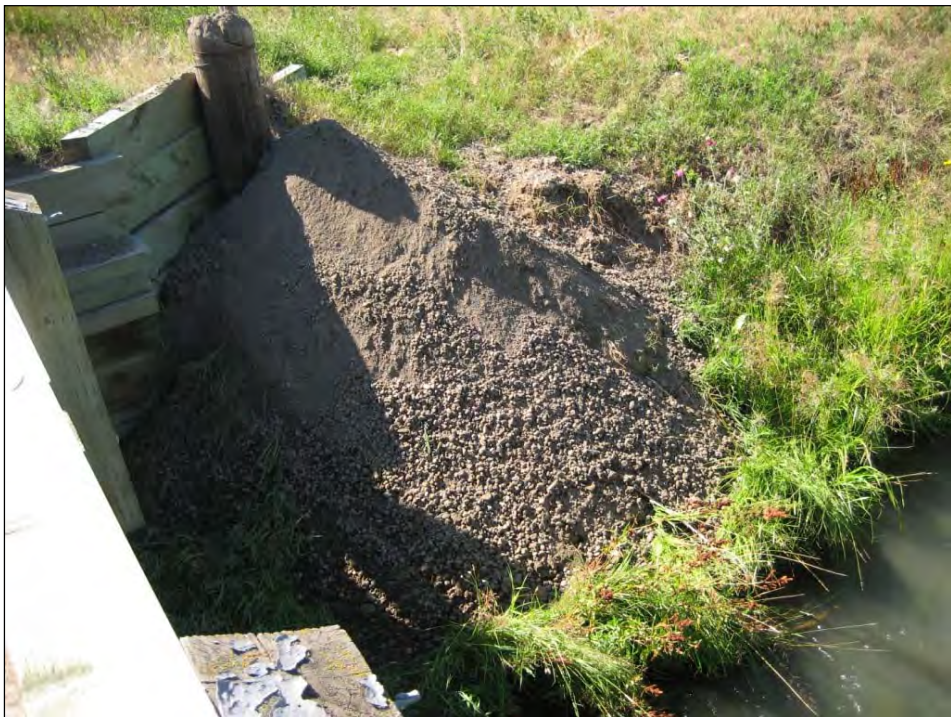
FIGURE 13. PILE OF DIRT DUMPED NEXT TO STREAM AT CANAL ROAD CROSSING

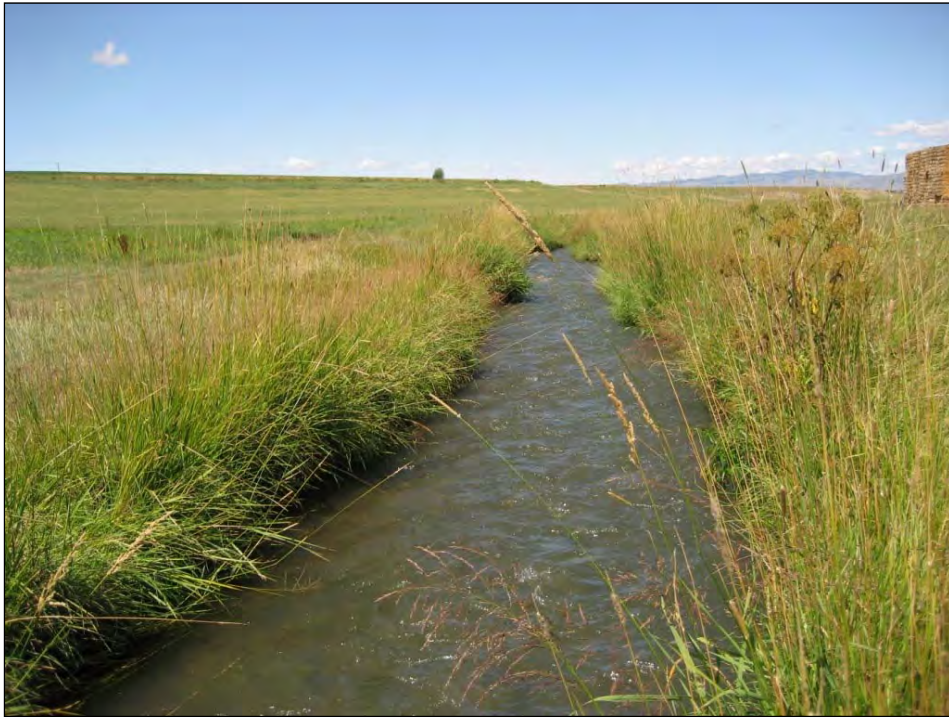
Land uses within the reach are primarily pasture, crop and hay production, with fewer livestock observed in or near the stream. The riparian zone appeared to be in better condition than reach GOD 02 N upstream, with areas of dense riparian grass (Figure 15). Bank erosion was considered moderate, with erosion observed primarily upstream and downstream of the driveway upstream of water quality monitoring site GD01 (Figure 16). Bank erosion throughout the remainder of the reach was relatively minor due to the dense riparian vegetation. No roads encroached within this reach; the stream does not cross the road upstream of Cameron Bridge Road, as indicated in Figure 14. One significant irrigation withdrawal was identified, located just downstream of Cameron Bridge Road. This withdrawal is likely a continuation of the irrigation return that enters at the same location across the stream, constituting the crossing of a large canal.

FIGURE 15. DENSE GRASS RIPARIAN IN DOWNSTREAM PORTION OF REACH

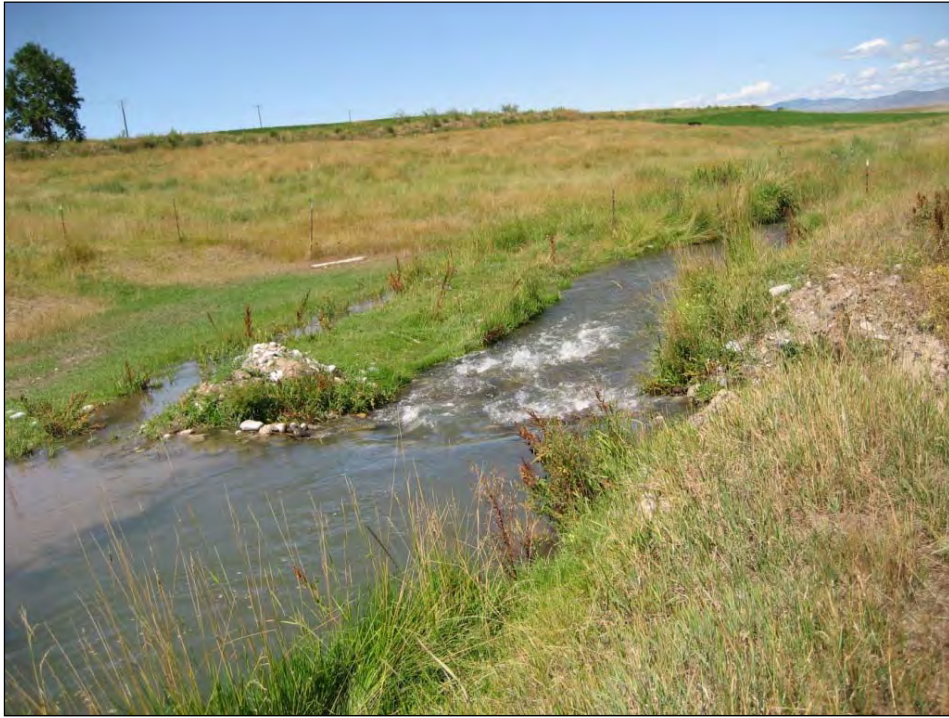
FIGURE 16. TRAMPLED AND ERODING PASTURE JUST UPSTREAM OF WQ SITE GD01

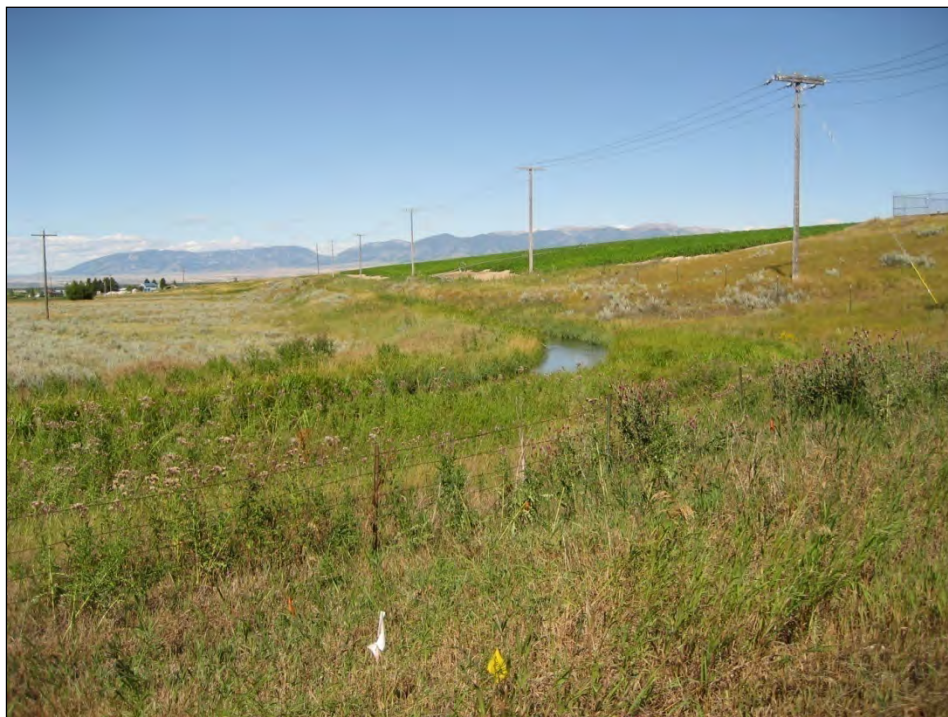
An irrigation return, two LCA's, and two unpaved road crossings were identified within the reach (Table 4). The irrigation return was rather large, entering from the right bank just downstream of Cameron Bridge Road (Figure 17). This canal flows through irrigated and dry crop land and could potentially be a significant nutrient source. Overall, irrigated crops had a moderate potential for nutrient delivery to the reach. Less pasture encroachment was observed in this reach as compared to reach GOD 02 N. Although only one area of riparian fencing was observed, livestock were not often observed directly in and adjacent to the stream. With the good riparian vegetation quality, pasture was considered to have moderate potential significance for nutrient and E. coli delivery to this reach.

FIGURE 17. IRRIGATION RETURN PRIOR TO FLOWING INTO REACH GOD 03 N; LOCATED JUST DOWNSTREAM OF CAMERON BRIDGE ROAD.

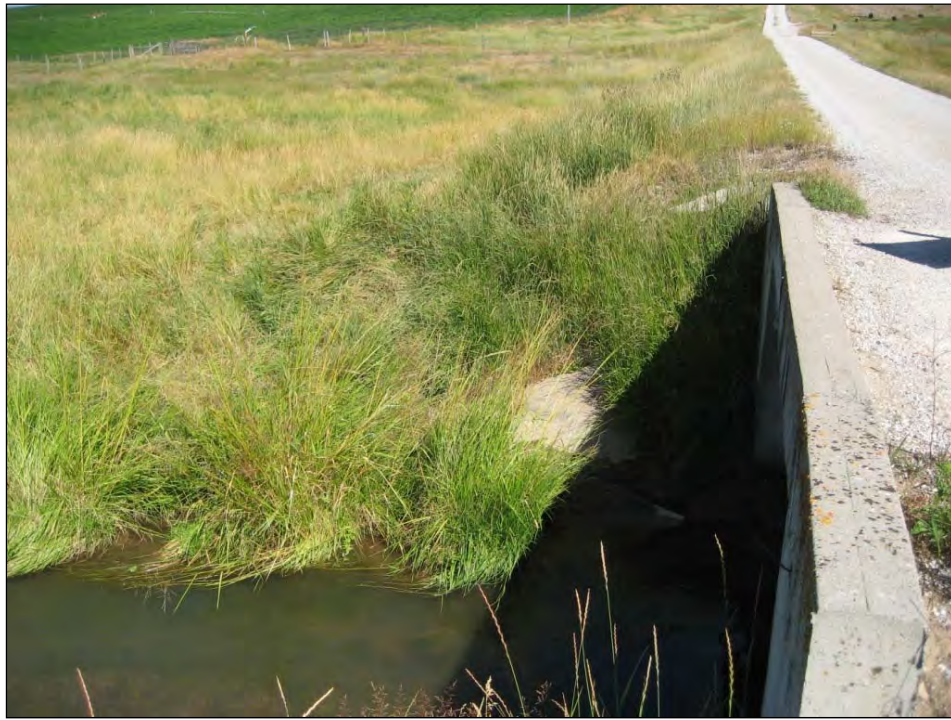
FIGURE 18. MINOR SEDIMENTATION POTENTIAL AT DRIVEWAY UPSTREAM OF CAMERON BRIDGE ROAD

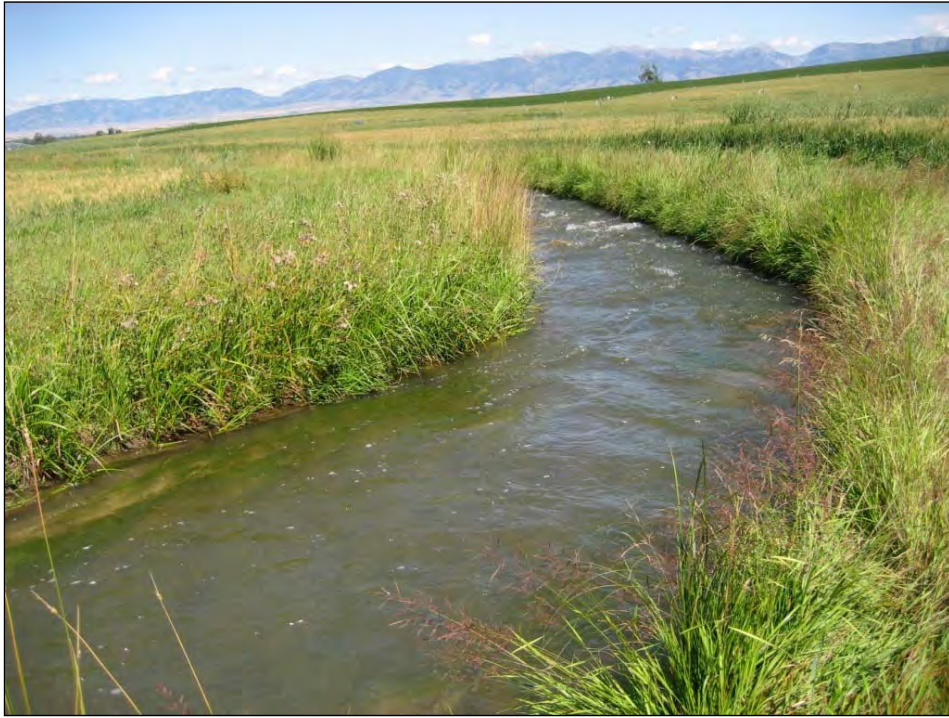
FIGURE 20. DENSE RIPARIAN WITH WEEDY AND NATIVE SPECIES

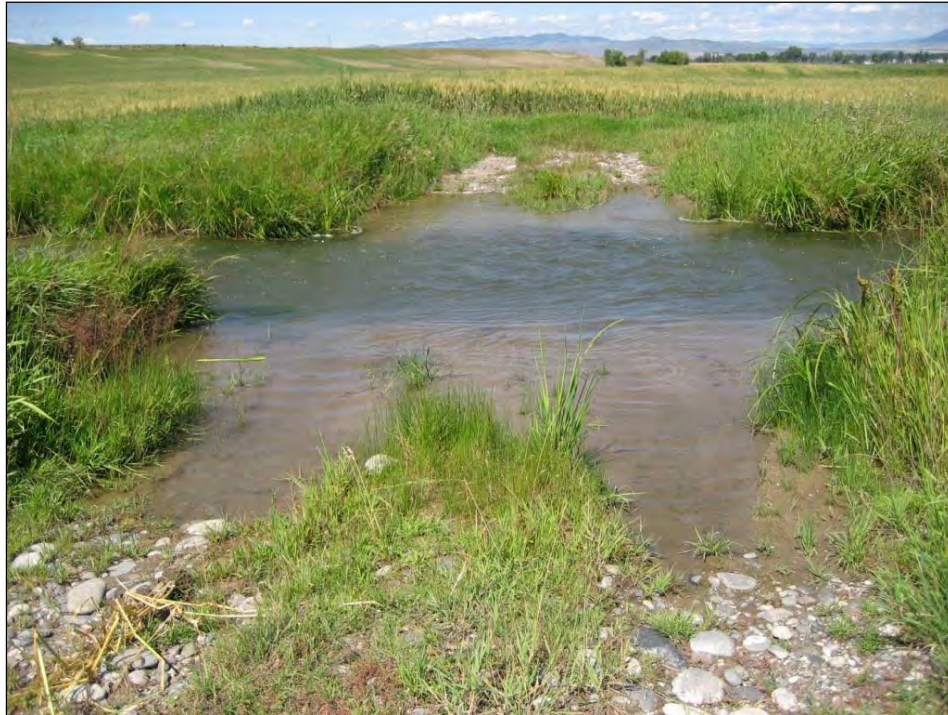
Irrigated crop fields, primarily hay production, were considered to have a moderate potential for nutrient delivery to the reach (Table 5). Horse and cattle pasture comprised the bulk of the land adjacent to the reach. Although the prevalence was high, very few animals and almost no bank trampling was observed during the assessment. Therefore pasture was considered to have a low potential significance for nutrient and E. coli delivery to the reach. No septic systems or unpaved roads were located within the reach. However, an ATV ford was identified in the upper portion of the reach which was causing some minor sedimentation (Figure 21). The ford did not appear to be frequently used.

FIGURE 21. SEDIMENTATION OCCURING AT ATV FORD IN UPSTREAM PORTION OF REACH

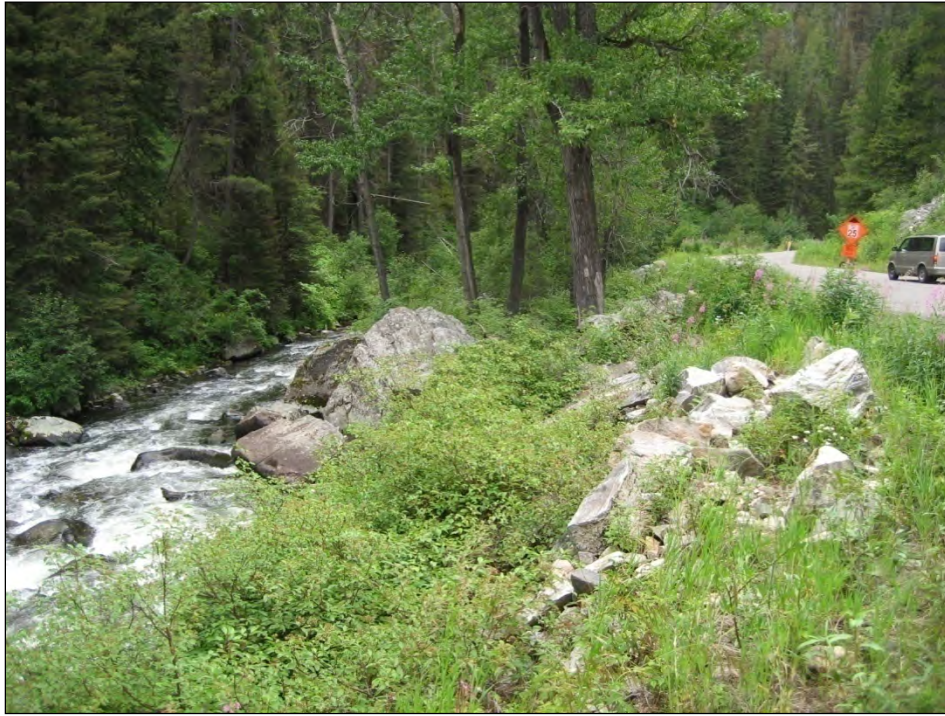
FIGURE 10. ROAD ENCROACHMENT ALONG HYALITE CANYON ROAD

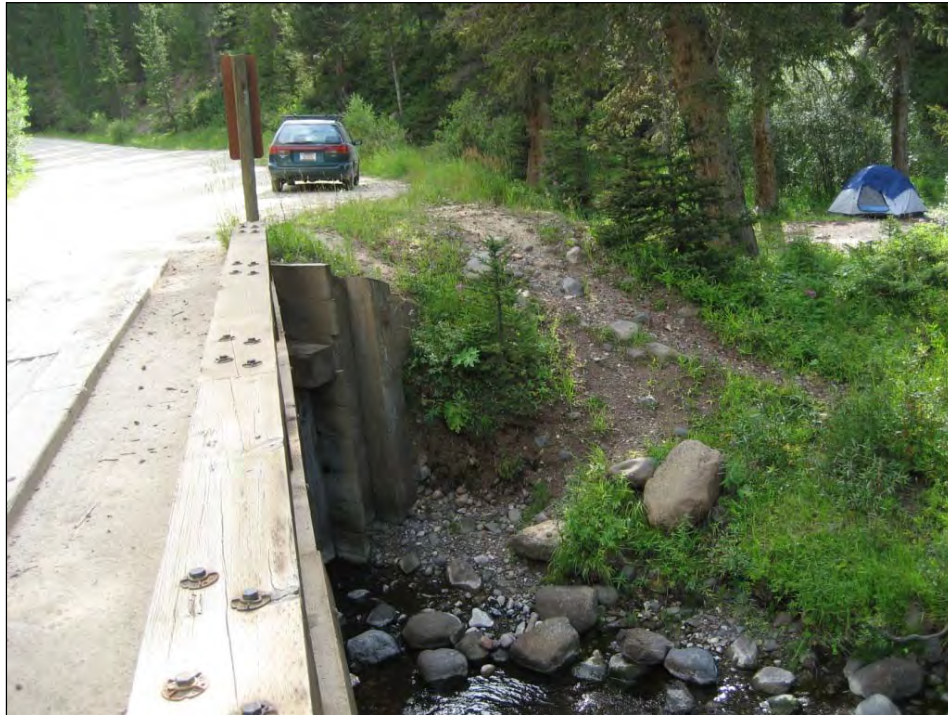
FIGURE 11. MINOR TRAMPLING DOWNSTREAM OF LANGHOR ROAD

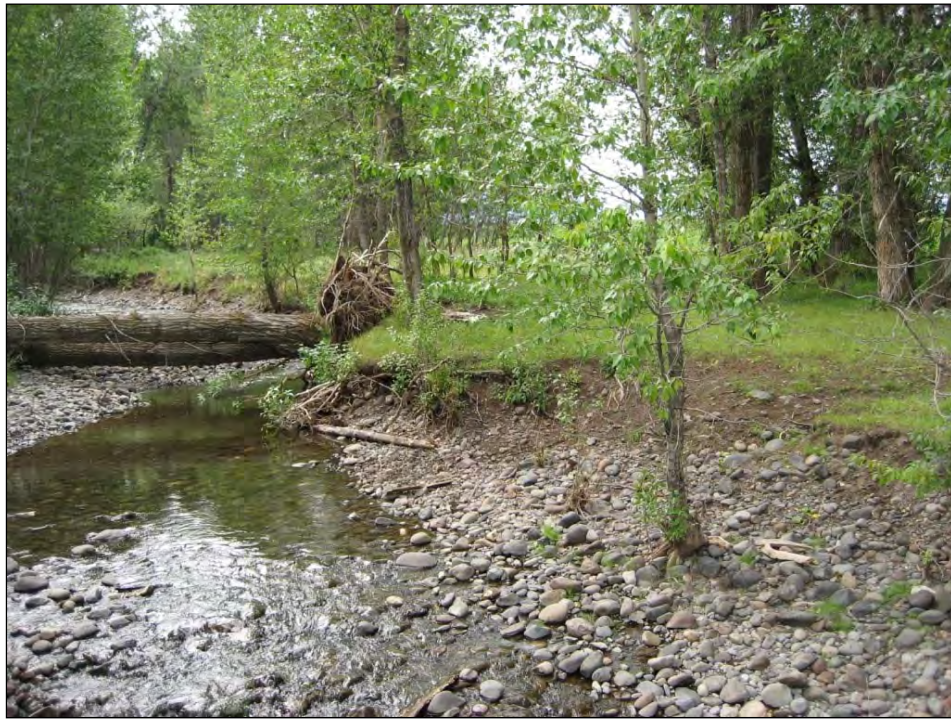
FIGURE 14. EXAMPLE OF ERODING/TRAMPLED BANK UPSTREAM OF ELK ROAD IN HYAL 04 N

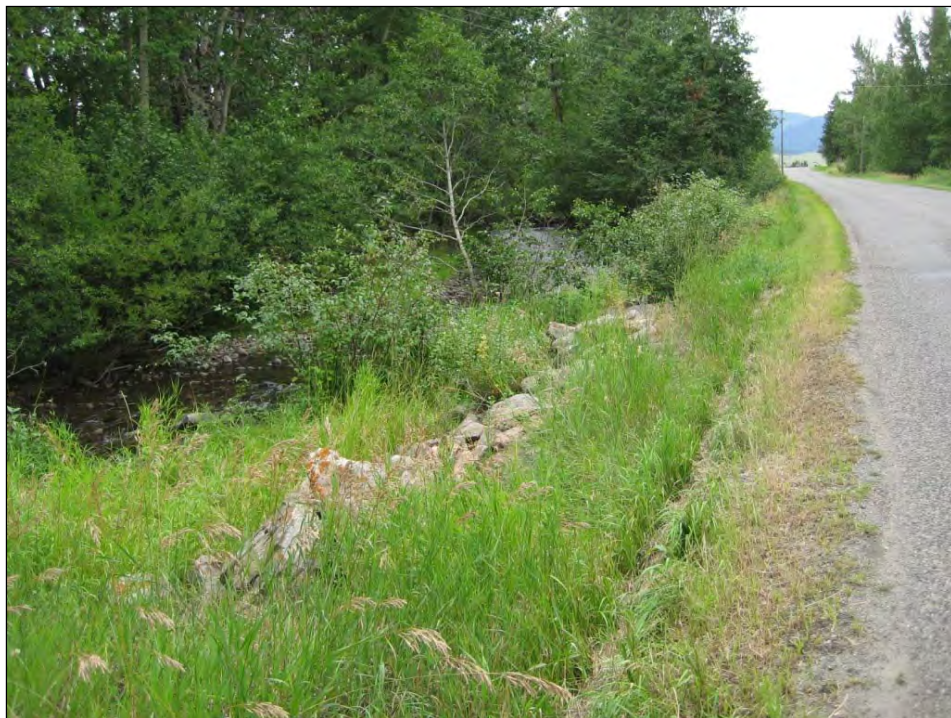
Cottonwood Road and South 19th Avenue encroach on the stream within this reach. Cottonwood Road encroaches within 35 ft for approximately 400 ft; South 19th encroaches within 20 ft for approximately 300 ft. Both areas of encroachment are well vegetated and relatively well buffered from these paved roads (Figure 15).

FIGURE 15. WELL-VEGETATED BANK WHERE COTTONWOOD ROAD ENCROACHES IN HYAL 04 N

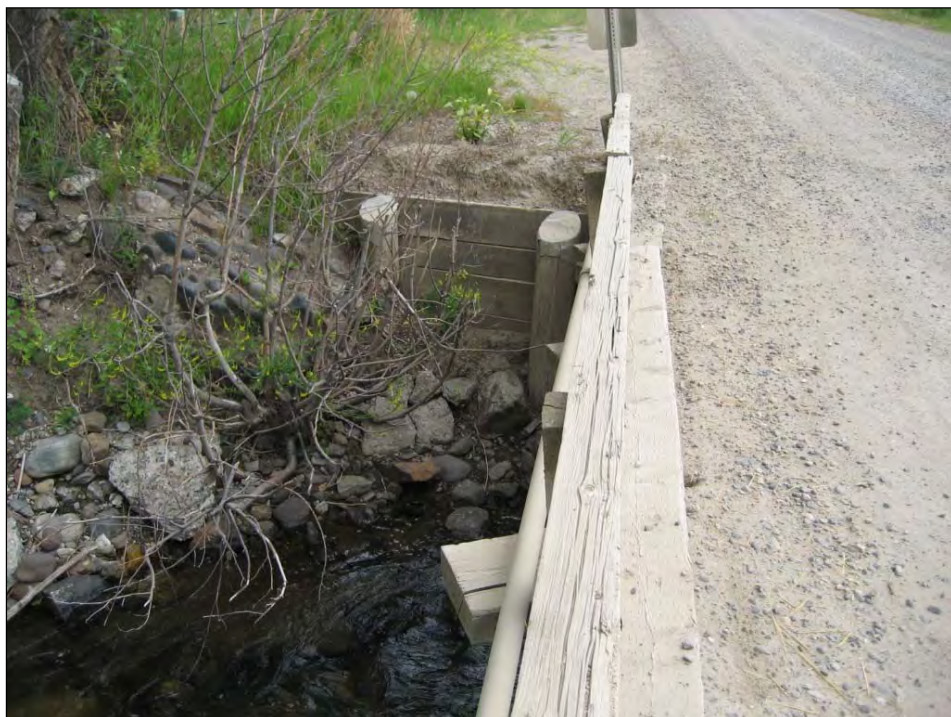
FIGURE 17. EXAMPLE OF STABLE, NON-EROSIVE CROSSING AT JOHNSON ROAD IN HYAL 04

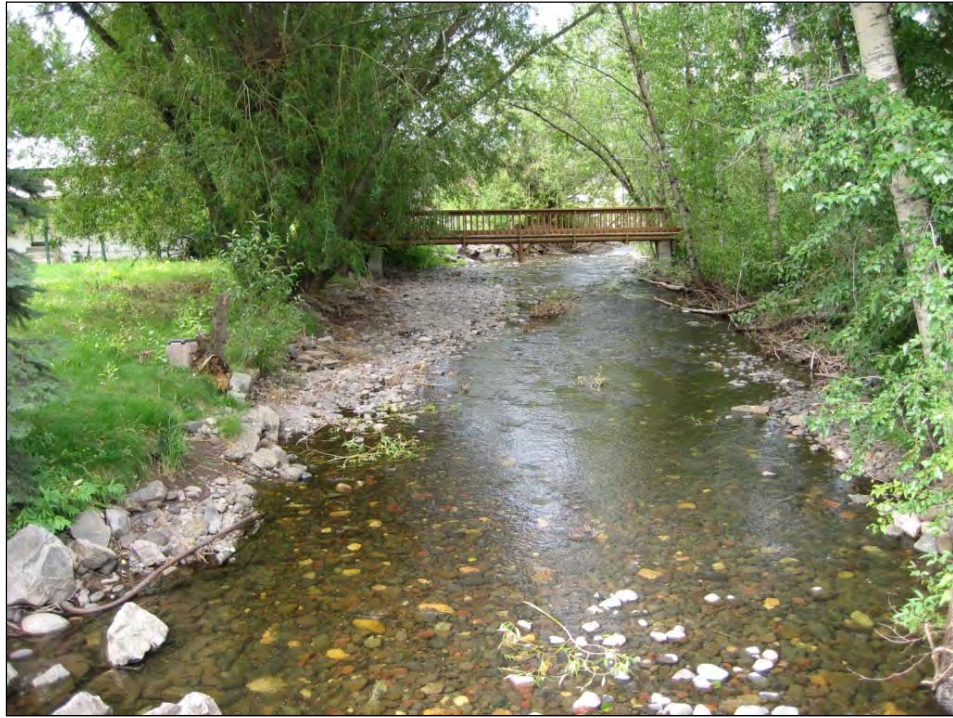
FIGURE 20. YARD ENCROACHMENT UPSTREAM OF COBB HILL ROAD

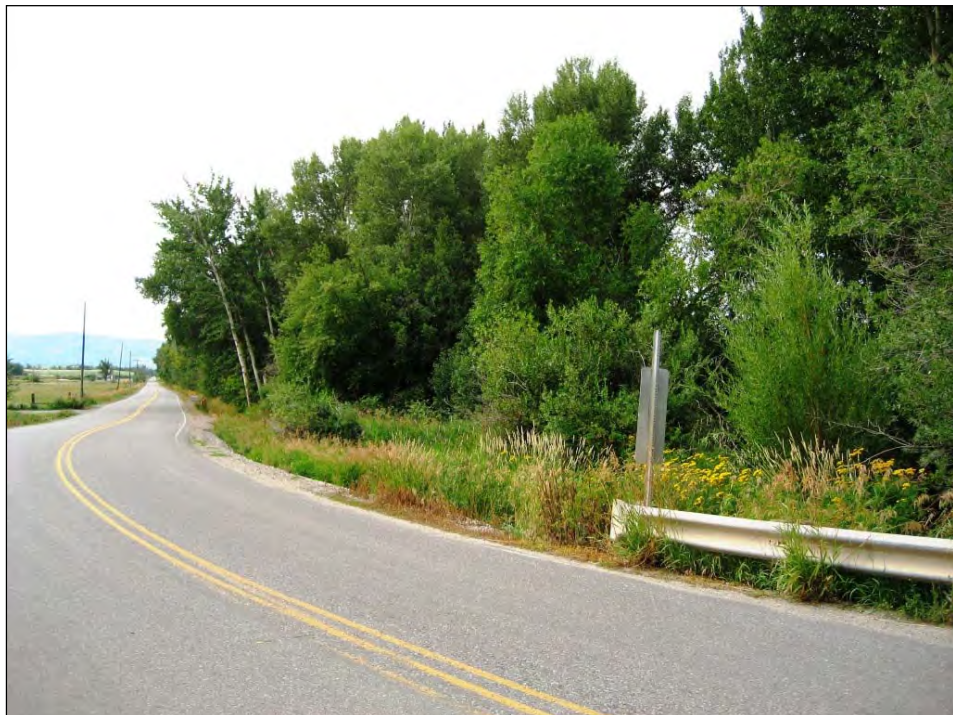
The dominant land use within reach HYAL 05 N is residential, mixed with hay production and irrigated and dryland pasture. The riparian area is relatively healthy throughout the reach, with an overstory of cottonwood and a willow/chokecherry understory, with limited grazing impact (Figure 19). There is some concentrated yard encroachment around the Cobb Hill-Huffine Lane and Monforton School Road crossings (Figure 20). Overall banks appeared well-vegetated and erosion was limited to areas of yard and pasture encroachment, of which there were few. Monforton School Road, which is paved, encroaches within 30 ft for approximately 1,000 ft. The bank between the road and the stream is well-vegetated for the entire length of encroachment, buffering the stream from the road (Figure 21).

FIGURE 21. MONFORTON SCHOOL ROAD ENCROACHING ON REACH HYAL 05 N

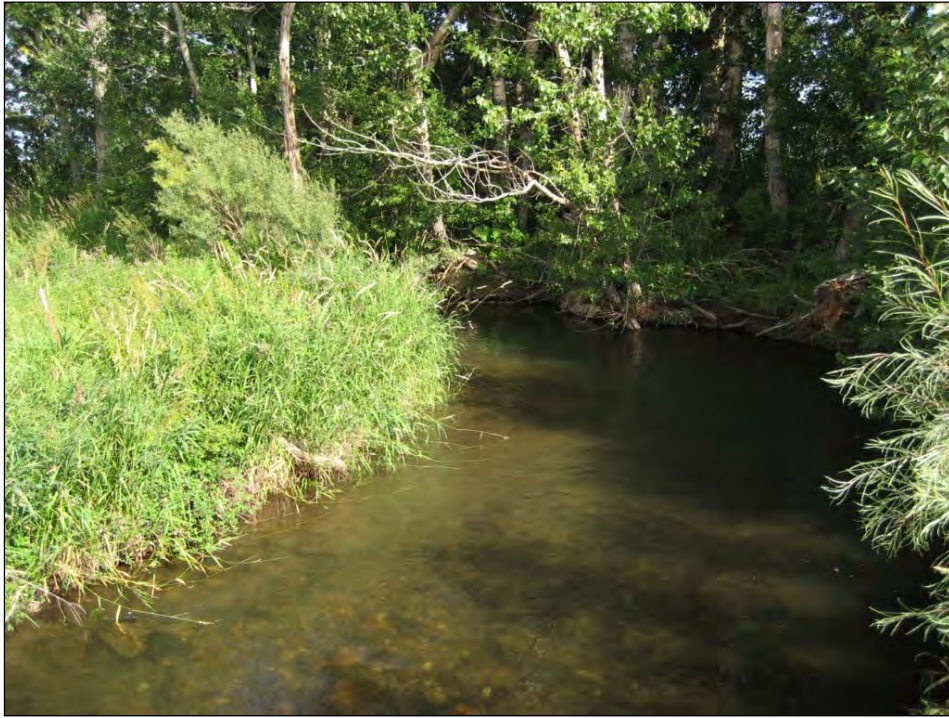
The dominant land use within reach HYAL 06 N is pasture mixed with hay production. Riparian condition was rather poor in the lower section of the reach downstream of Valley Center Road, often very weedy and overgrazed with unhealthy cottonwoods and yard encroachment (Figure 24). Riparian condition improved in the upstream sections, with a healthy cottonwood overstory and willow/grass understory (Figure 25). Pasture was still common in the upper sections but overgrazing was not observed.

FIGURE 25. HEALTHY RIPARIAN AT VALLEY CENTER ROAD

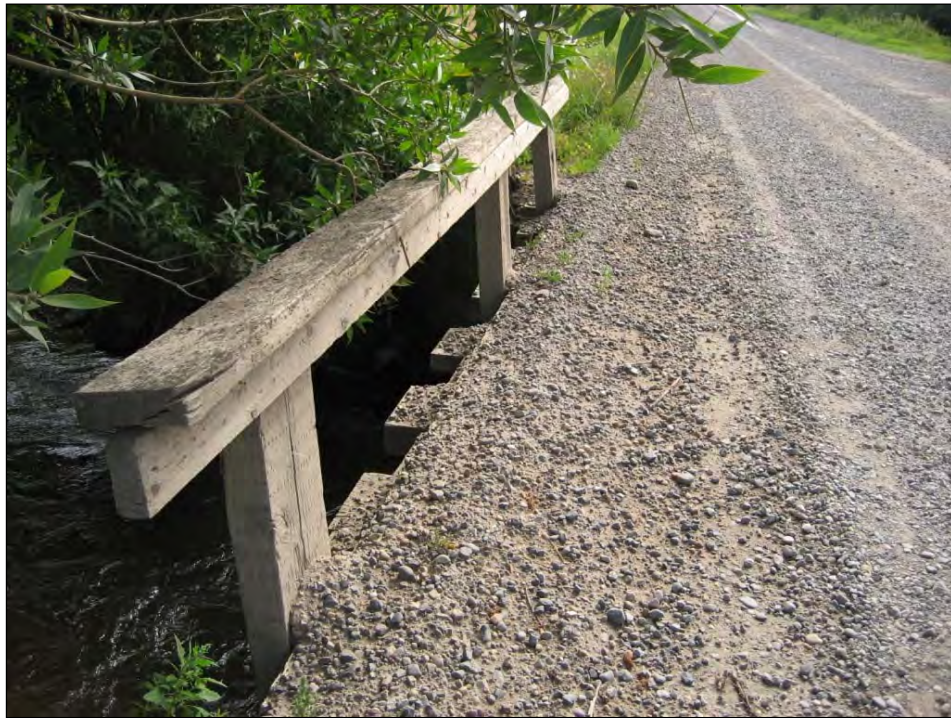
Two unpaved road crossings were identified. The bridge at Cameron Bridge road was well-vegetated around the abutments and was not likely causing any significant sediment delivery. Hulbert Road had gravel covering the decking and was potentially a sediment source during storm events (Figure 26). The LCA was a small sheep operation located adjacent to the stream just

FIGURE 26. GRAVEL ON BRIDGE DECKING AT HULBERT ROAD

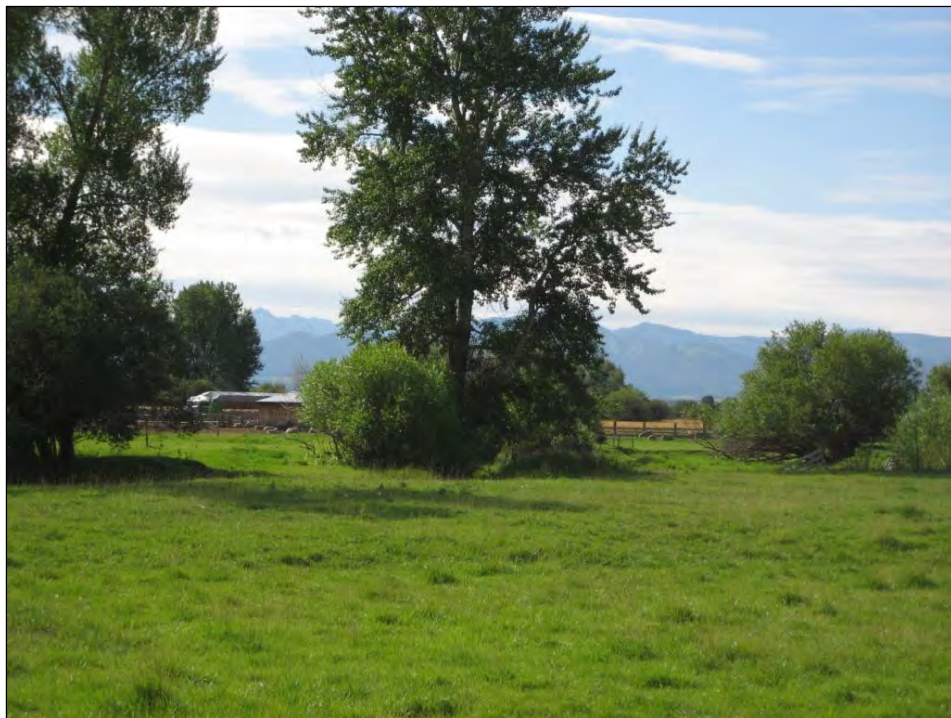
upstream of Hulbert Road. The area was overgrazed but it was difficult to discern whether the sheep were fenced from the creek (Figure 27).

FIGURE 27. SHEEP OPERATION IN DISTANCE, UPSTREAM OF HULBERT ROAD

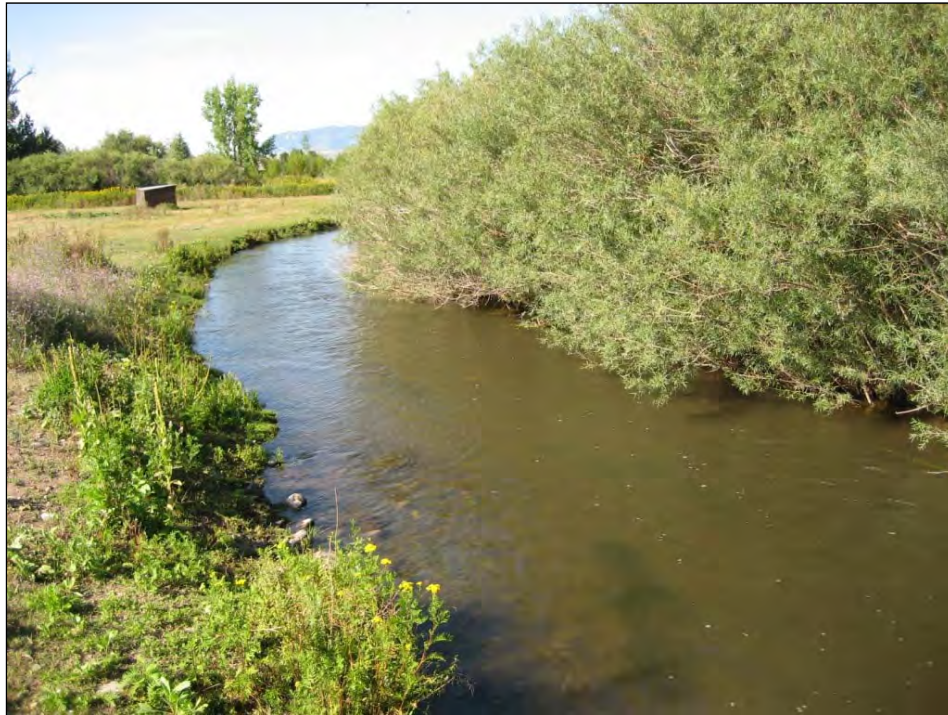
The dominant land use within reach HYAL 07 N is pasture, mixed with irrigated and dryland crops and rural residential. Riparian condition was considered fair to good throughout the reach, with some areas dominated by weedy, overgrazed pasture, as seen at the crossing of Airport Road (Figure 29). Other areas, such as upstream of the confluence with the East Gallatin River, the riparian was dense, although thick with invasive reed canarygrass (Figure 30). Although weedy and overgrazed in some areas, banks appeared to be relatively stable and not highly erosive. No roads encroached on the stream within the reach and two irrigation withdrawals were identified. One of the withdrawals was not confirmed on the aerial or in the field.

FIGURE 29. REACH 7 DOWNSTREAM OF AIRPORT ROAD. RIPARIAN IS WEEDY AND OVERGRAZED ON LEFT BANK, DENSE WILLOWS RIGHT BANK.

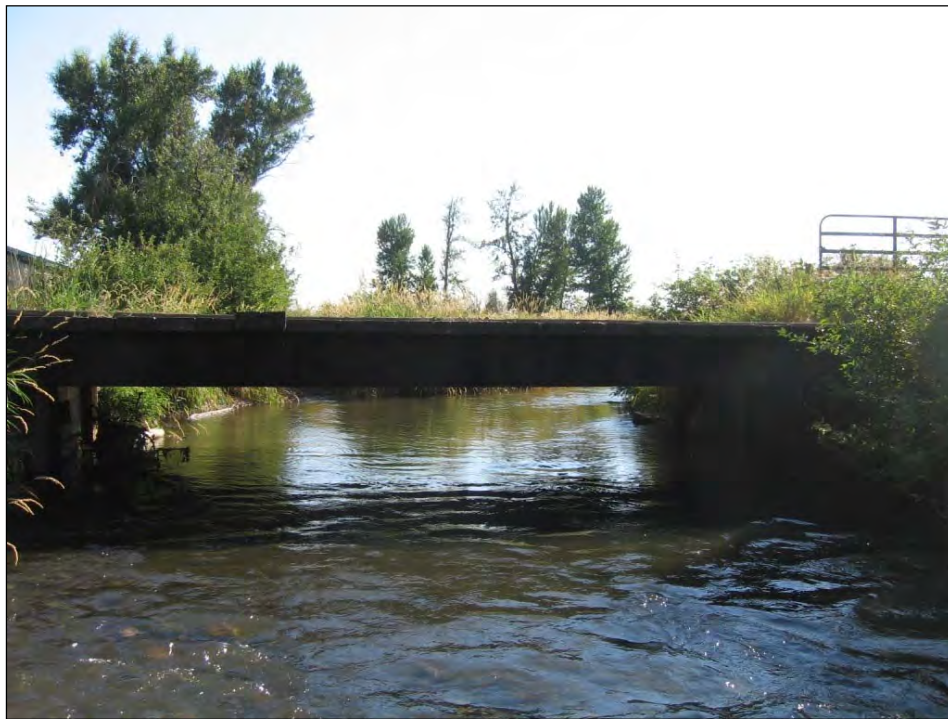
One irrigation return and one tributary were identified entering the reach. The one unpaved road crossing was a well-maintained driveway bridge that was well-vegetated near the abutments (Figure 31) and was not considered to be a sediment or nutrient source. Septic system influence was relatively low, with a septic density of 0.5/mi within 150 ft and 6.1/mi within the 15 to -1,000 ft buffer (Table 11).

FIGURE 31. UNPAVED DRIVEWAY CROSSING WITH WELL-VEGETATED ABUTMENTS UPSTREAM OF THE CONFLUENCE WITH THE EAST GALLATIN RIVER

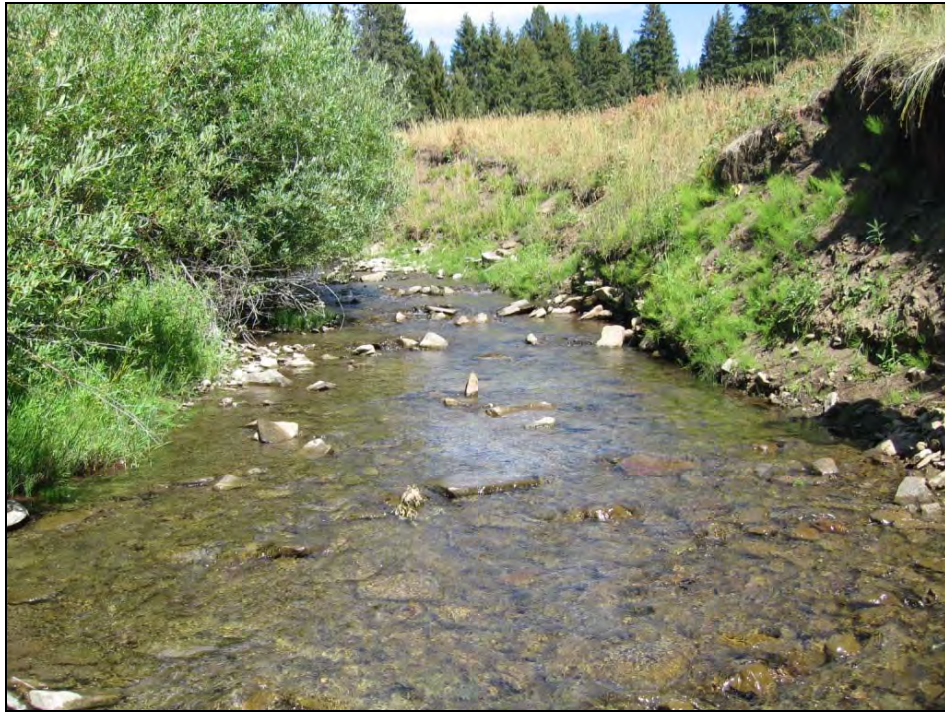
FIGURE 6. WILLOW-CONIFER RIPARIAN WITH NATURAL BANK EROSION ON OUTER MEANDER BEND.

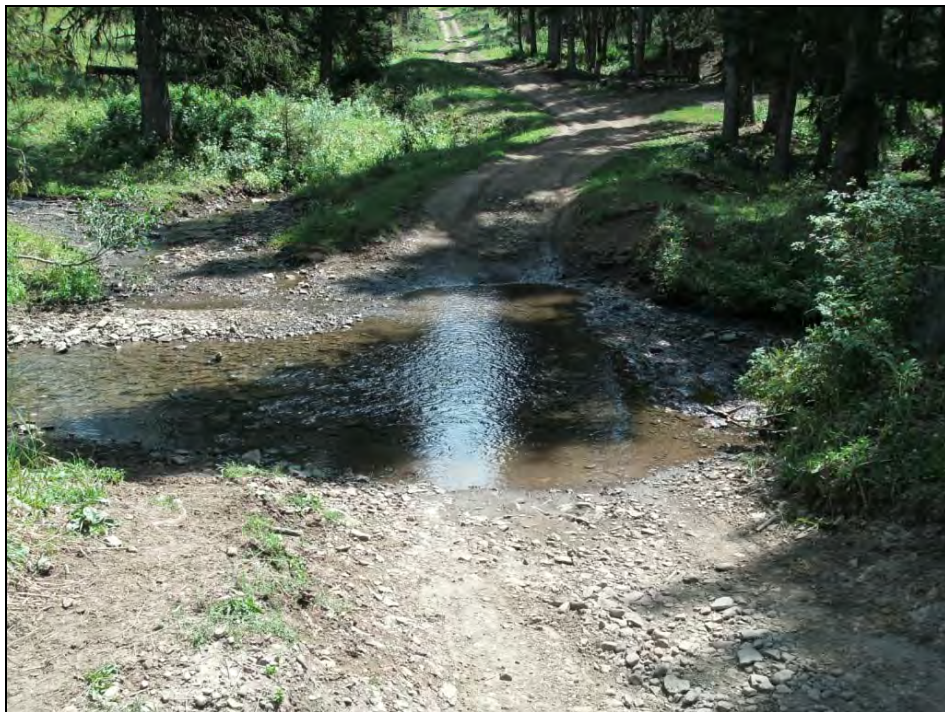
FIGURE 7. LOGGING ROAD CROSSING IN UPPER SECTION

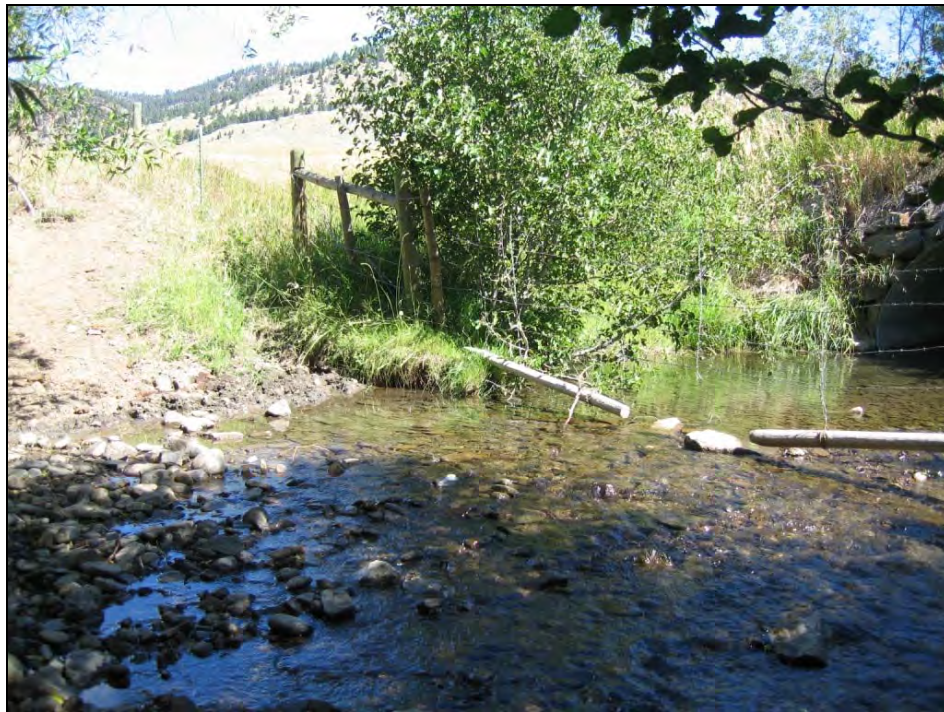
FIGURE 10. CATTLE CROSSING DOWNSTREAM OF JACKSON CREEK RD AT 2008 WATER QUALITY SITE JK02

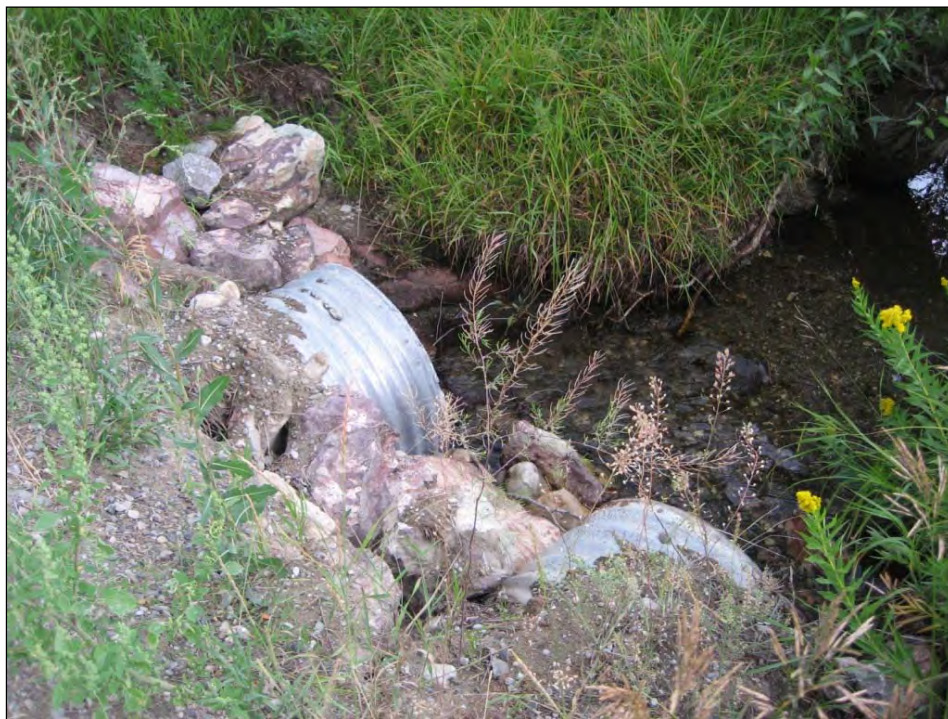
FIGURE 12. GRAVEL ON CULVERT AT GEE NORMAN RD

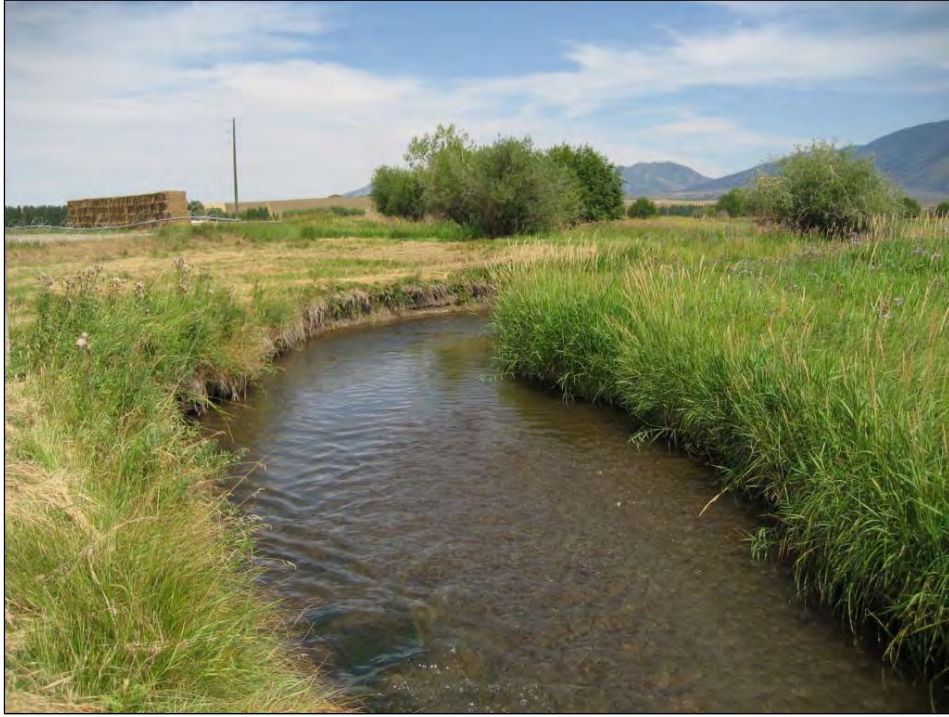
The dominant land uses within the reach are hay production and pasture. Although narrow, the riparian was dense, consisting of weedy reed canarygrass, pasture grasses and thistles, with patches of willows and buffaloberry (Figure 14). Pasture/hay field encroachment was observed in some areas (Figure 15). Banks were generally stable due to the dense riparian vegetation. However, bank erosion was observed in areas where pasture encroached along meander bends (Figure 15). No roads encroach on the reach.

FIGURE 14. BANK EROSION WHERE PASTURE ENCROACHES ON A MEANDER BEND

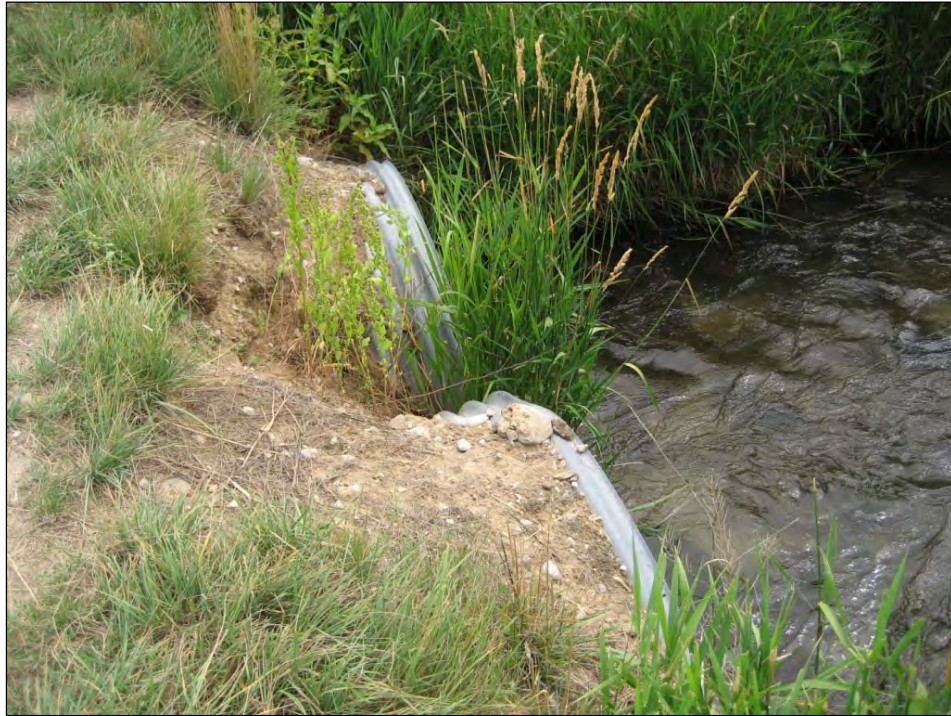
Potential nutrient and E. coli sources within the reach are identified in Table 5. The irrigated agriculture along the stream was considered to be of moderate potential significance, due to the moderate source prevalence and sometimes narrow riparian buffer. An unpaved private ranch road crosses the stream within the reach. The road is well-maintained gravel and is infrequently used, but loose gravel was observed on top of and around the culvert and some minimal sedimentation could be occurring during storm events (Figure 16).

FIGURE 15. CULVERT AT RANCH ROAD CROSSING

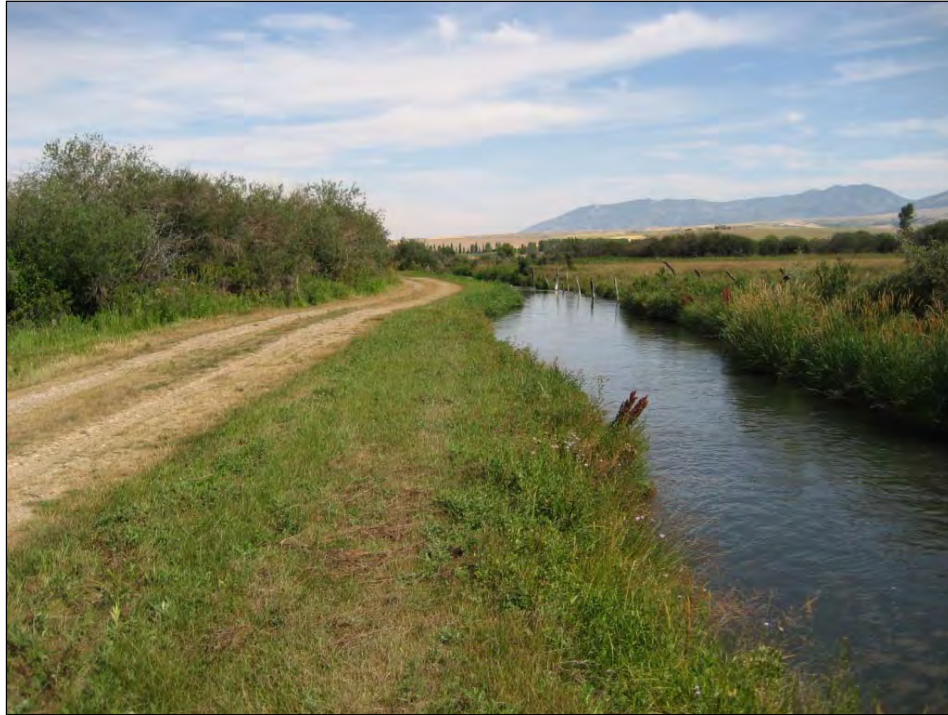
FIGURE 4. SMITH CREEK CHANNELIZED UPSTREAM OF REESE CREEK CONFLUENCE

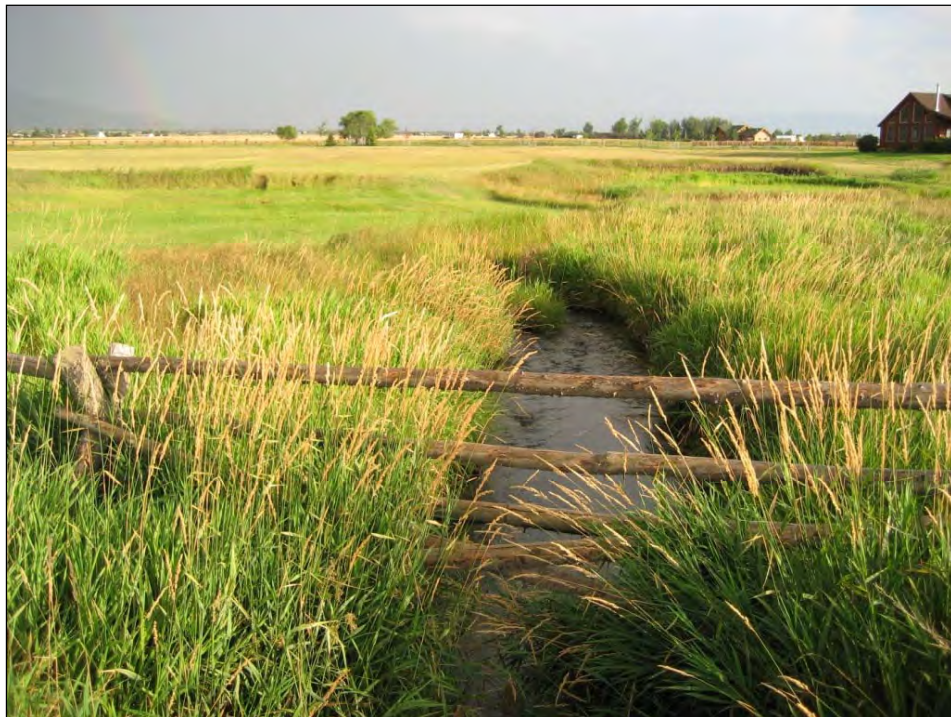
The dominant land use within the reach is hay production and pasture, with scattered residences. The riparian condition varied widely throughout the reach. In the upstream section the riparian zone ranged from a narrow dense grass buffer (Figure 8) to no riparian where pasture and lawns were directly adjacent to the stream (Figures 9 and 10). Lower in the reach, starting downstream of Penwell Bridge Rd to the west of Springhill Rd, the riparian zone was wider, consisting of dense willows and grasses (Figure 11). Limited riparian fencing was observed within the reach. Due to the naturally-erosive soils and the prevalence of livestock grazing, bank erosion was considered moderate throughout the reach. Although pasture encroachment was common in the upper reach,

FIGURE 8. REED CANARYGRASS RIPARIAN DOWNSTREAM OF PENWELL BRIDGE RD EAST
