ATTACHMENT B – 2009 LOWER GALLATIN TMDL PLANNING AREA NUTRIENT, ALGAE AND *E. COLI* SOURCE ASSESSMENT

December, 2009

OASIS Environmental, Inc.
PO Box 582
Livingston, MT 59047

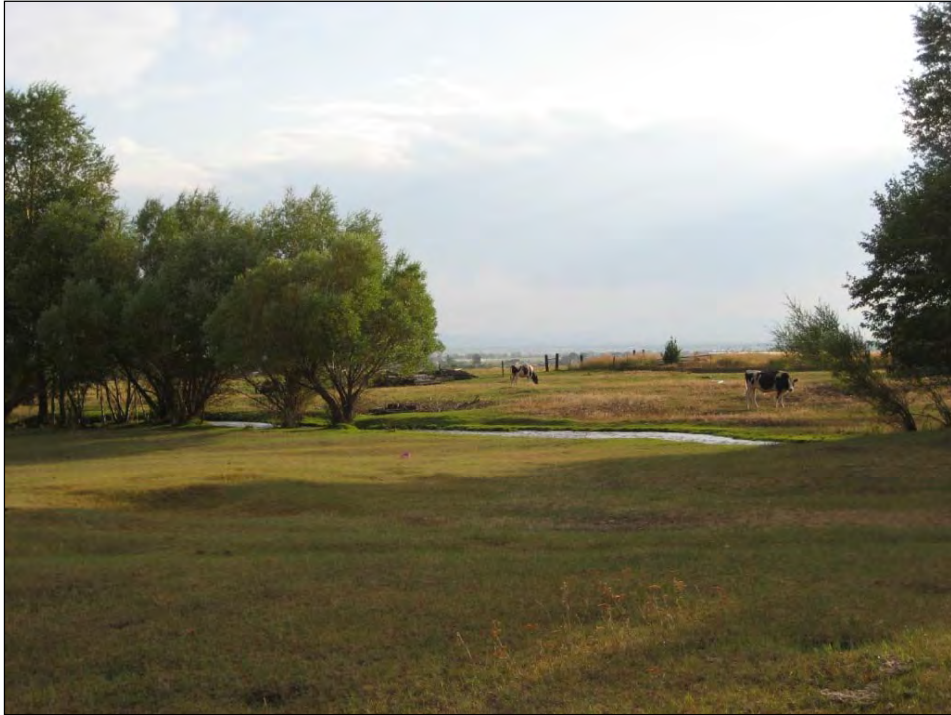
The dominant land use within the reach is hay production and pasture, with scattered residences. The riparian condition varied widely throughout the reach. In the upstream section the riparian zone ranged from a narrow dense grass buffer (Figure 8) to no riparian where pasture and lawns were directly adjacent to the stream (Figures 9 and 10). Lower in the reach, starting downstream of Penwell Bridge Rd to the west of Springhill Rd, the riparian zone was wider, consisting of dense willows and grasses (Figure 11). Limited riparian fencing was observed within the reach. Due to the naturally-erosive soils and the prevalence of livestock grazing, bank erosion was considered moderate throughout the reach. Although pasture encroachment was common in the upper reach,

FIGURE 9. PASTURE ENCROACHMENT IN UPPER REACH, DOWNSTREAM OF MCGUIRE RD

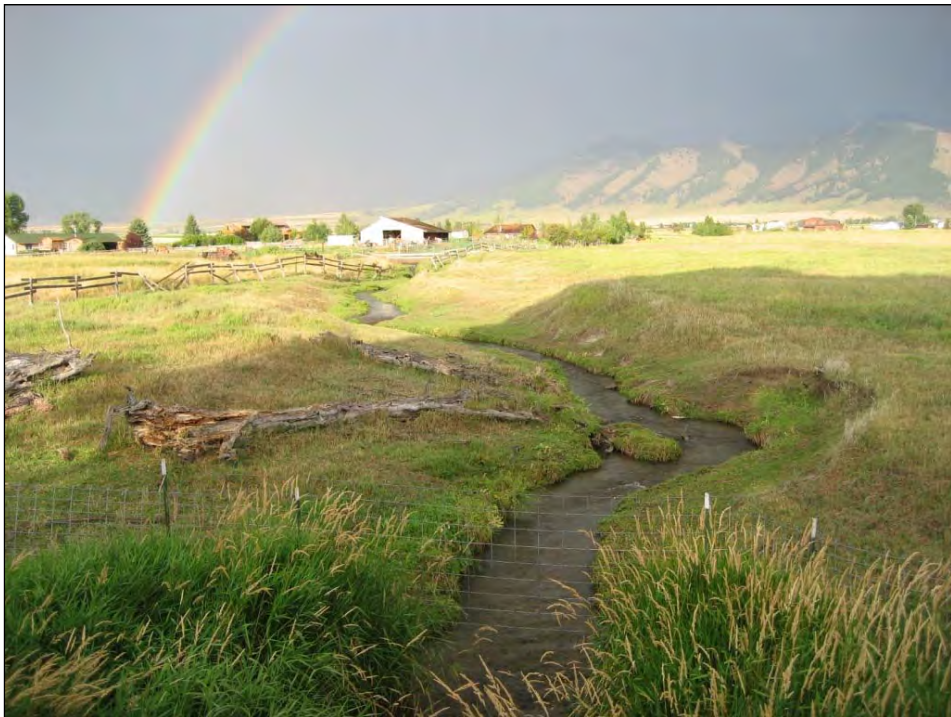
FIGURE 10. TRAMPLED RIPARIAN UPSTREAM OF STIMPSON RD

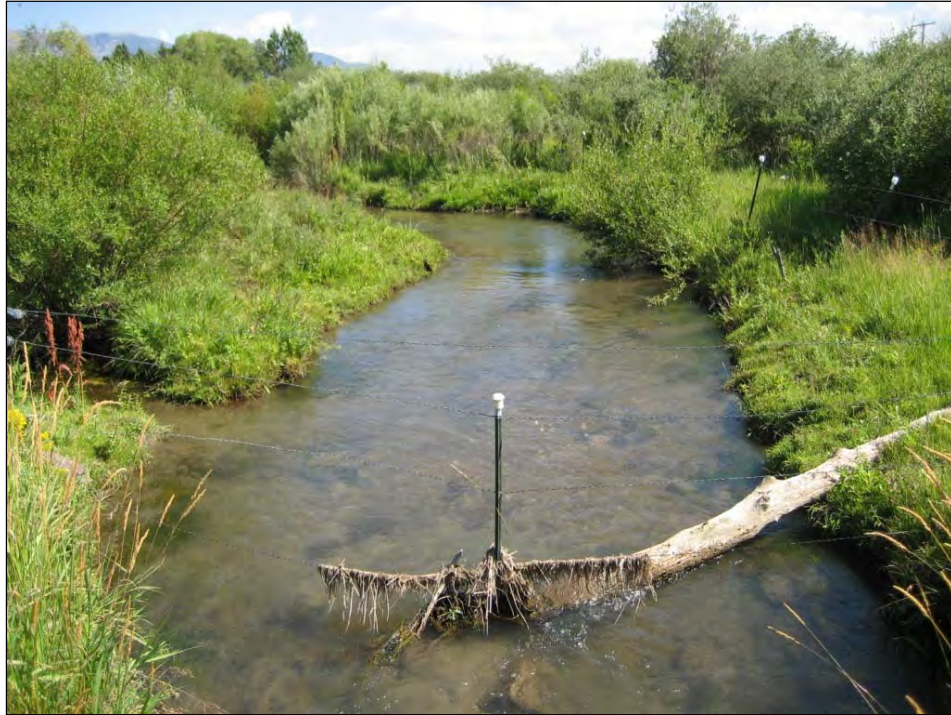
FIGURE 11. HEALTHY RIPARIAN ZONE UPSTREAM OF GALLATIN RD

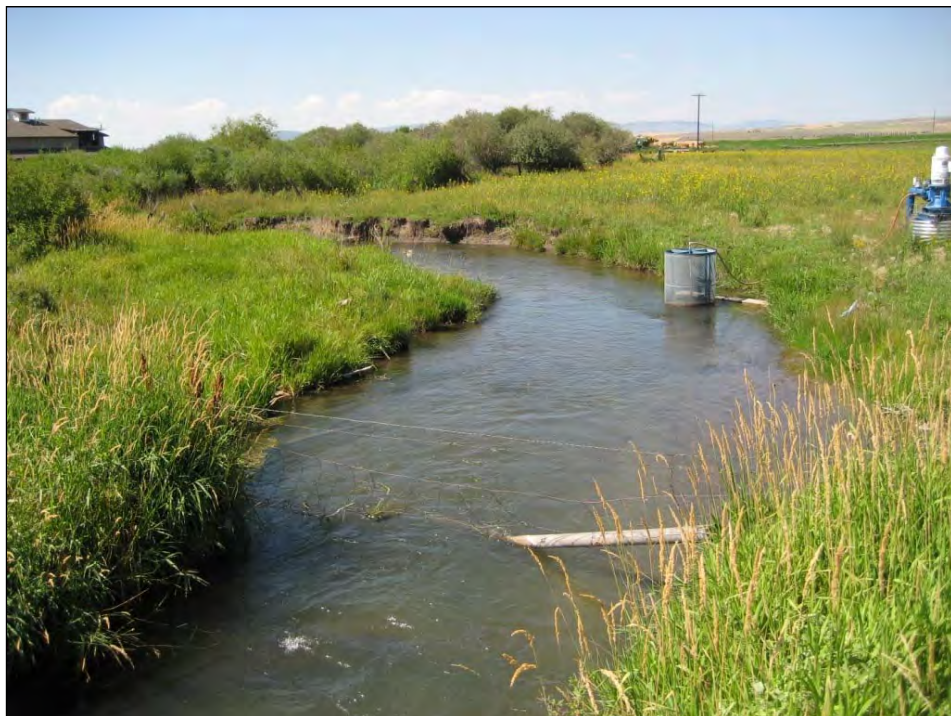
due to the small stream size and low flow energy, erosion was not as severe as in the lower reach where bank erosion was commonly documented (Figures 12 and 13).

FIGURE 12. BANK EROSION DOWNSTREAM OF GALLATIN RD WHERE PASTURE ENCROACHES

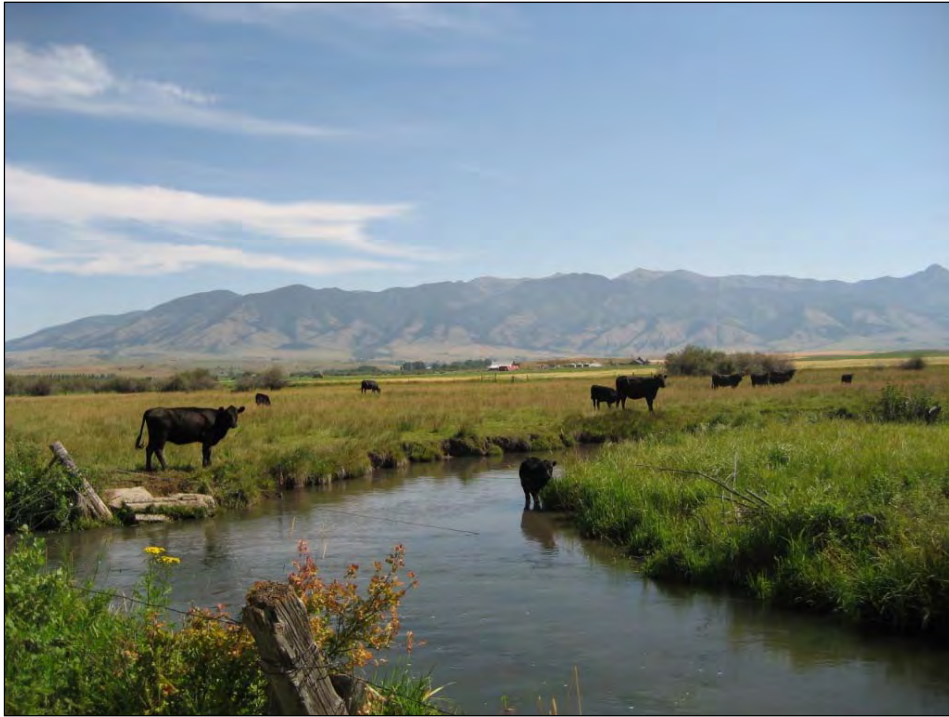
FIGURE 13. BANK EROSION IN PASTURE UPSTREAM OF REESE CR CONFLUENCE

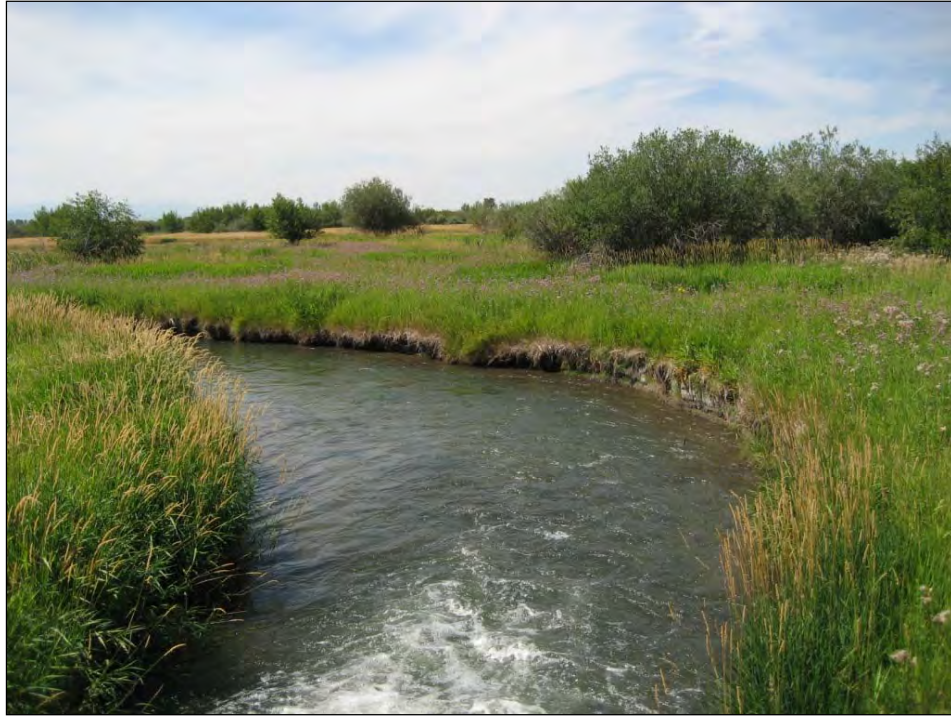
The dominant land use within the reach is crop production and pasture, with scattered residences. The riparian was generally dense but very weedy with thistle and reed canarygrass. Willows and buffaloberry were present in sparse clumps throughout the reach (Figure 16), and pasture and yard encroachment were also common (Figure 17). While areas with dense riparian vegetation are relatively stable, areas with cropland and pasture encroachment are actively eroding in the highly erosive, fine silty loam soils (Figures 16 and 17). Limited riparian fencing was observed within the reach. Overall, bank erosion was considered moderate throughout the reach.

FIGURE 16. DENSE BUT WEEDY RIPARIAN WITH SCATTERED SHRUBS, DOWNSTREAM OF REESE CR

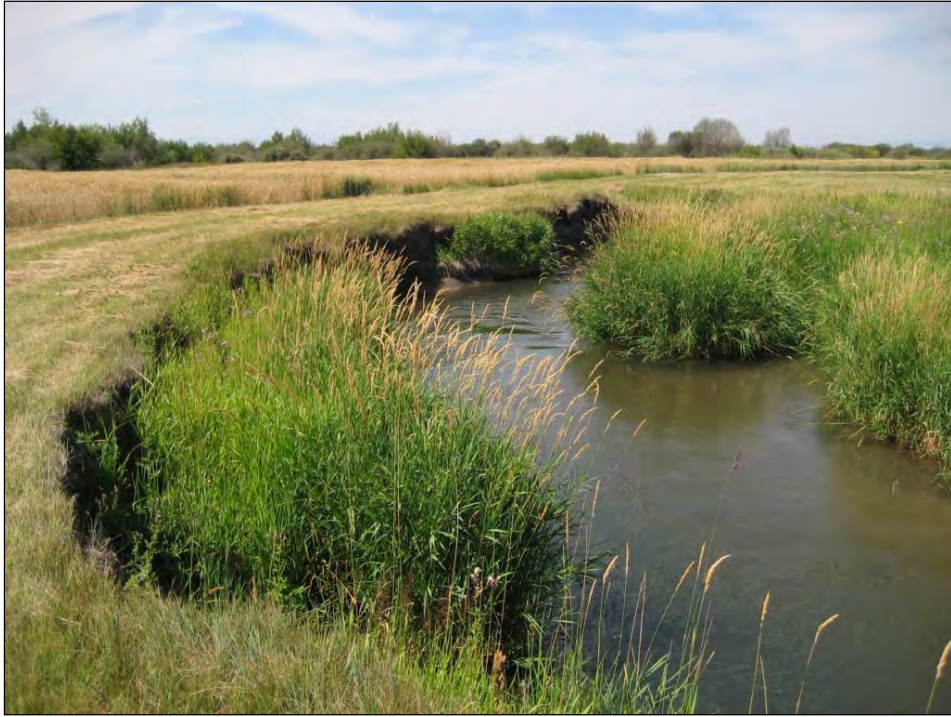
FIGURE 17. CROP ENCROACHMENT DOWNSTREAM OF REESE CR

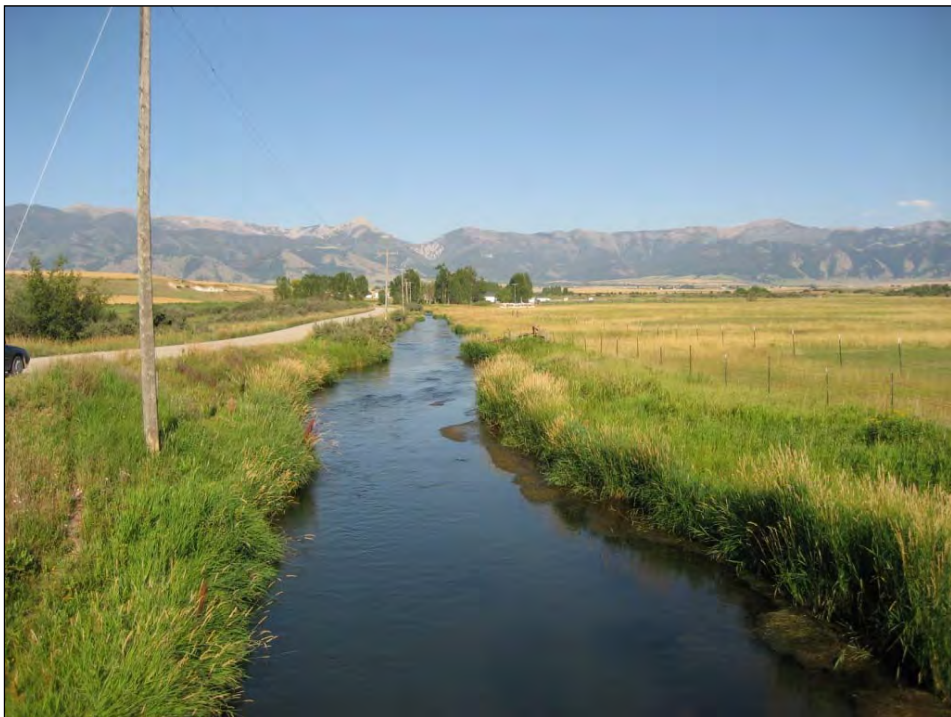
The unpaved Reese Creek Road encroaches within 30 ft of the stream for approximately 0.2 miles, upstream of Dry Creek Rd (Figure 18). Riparian grasses along the stream are very dense along the road and thus it was not considered a significant sediment source. Four irrigation withdrawals were identified on the GIS layer (Figure 15), only one of which was confirmed in the field. The confirmed withdrawal was relatively large, exiting at the upper end of the reach, just downstream of the Reese Cr confluence. The other three withdrawals were roughly confirmed on the aerial, but this was difficult to discern due to the abundance of paleochannels and the irrigated bottomland.

FIGURE 18. REESE CREEK RD ENCROACHES UPSTREAM OF DRY CREEK RD

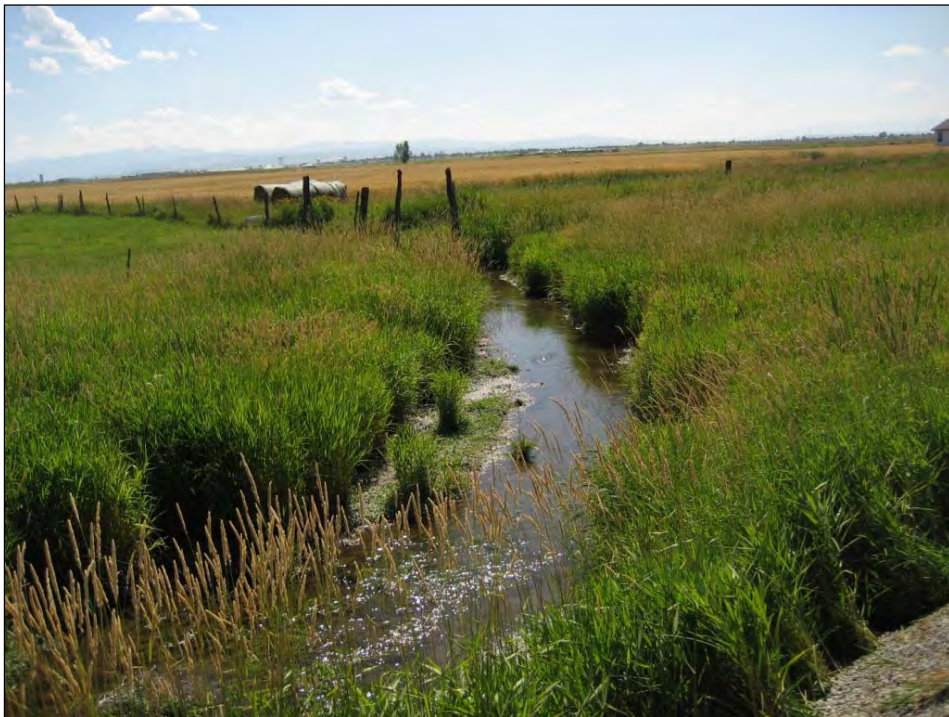
The dominant land use within the reach is pasture and a few scattered residences. Where the stream was observed, the riparian was dense with sedges and scattered willow, as well as invasive thistles and reed canarygrass (Figure 4). Vegetation within the riparian zone was not overgrazed. Due to the dense riparian and low-energy spring-fed flow, minimal bank erosion was observed, but increased bank erosion is possible where the stream was not observed, due to the likelihood of pasture encroachment and grazing influences.

FIGURE 4. DENSE SEDGE AND REED CANARYGRASS RIPARIAN UPSTREAM OF PENWELL BRIDGE RD

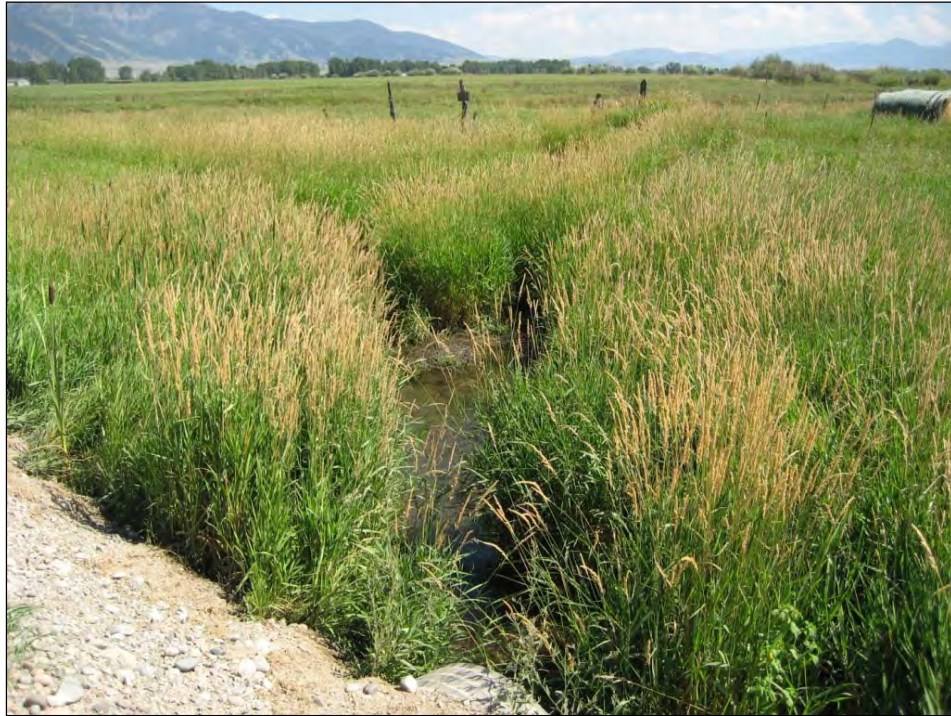
FIGURE 5. CULVERT AT PENWELL BRIDGE ROAD

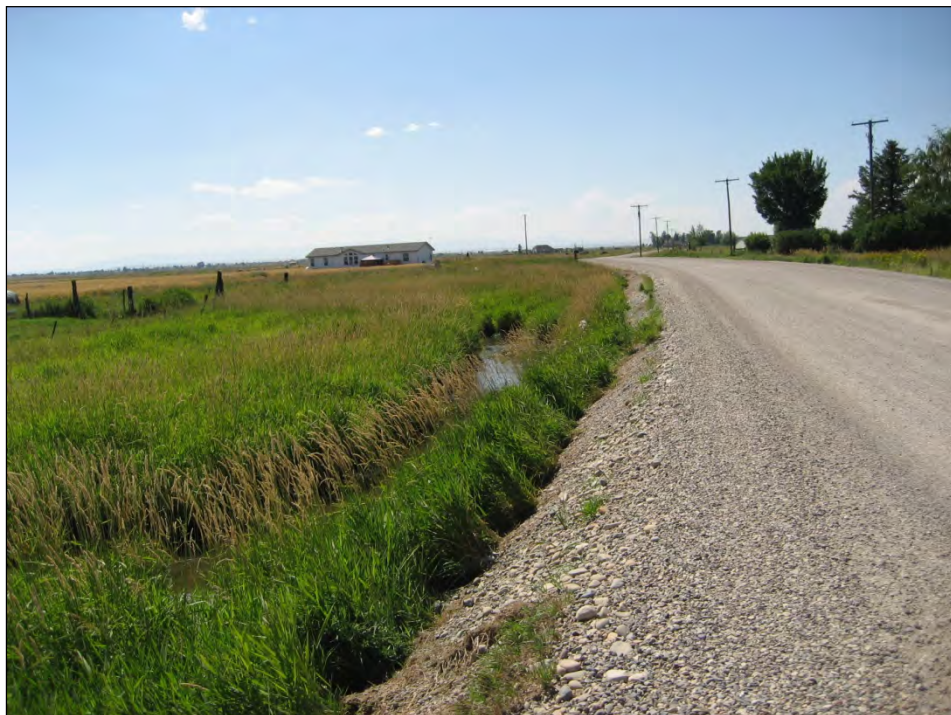
FIGURE 6. PENWELL BRIDGE ROAD ENCROACHMENT

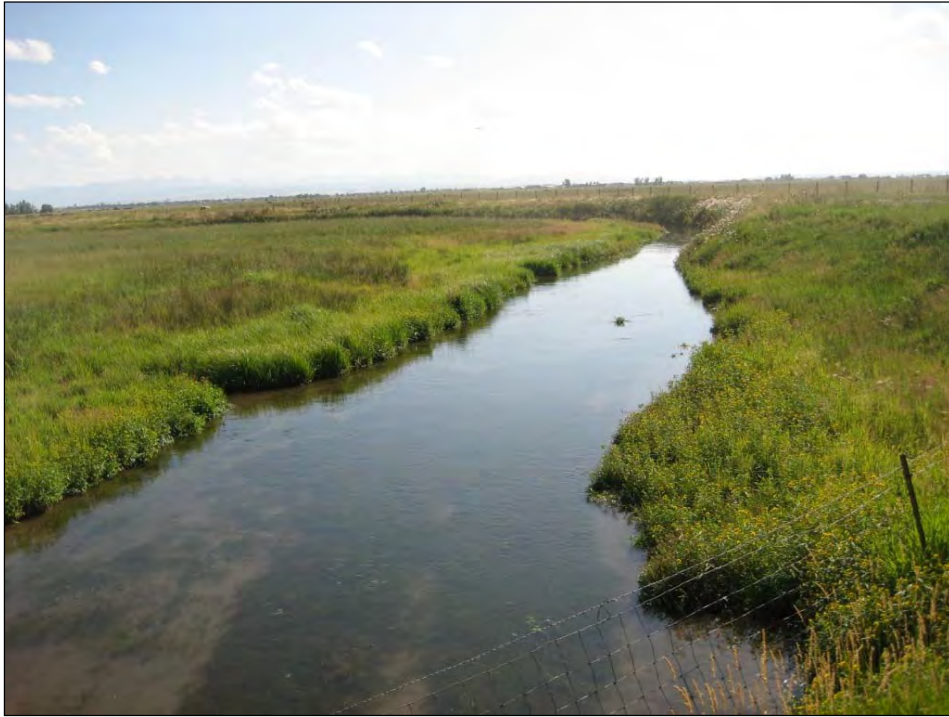
The dominant land use within the reach is irrigated and non-irrigated pasture with some hay production. The riparian zone is generally robust, composed of sedges, native wetland grasses, mixed with non-native pasture grass, thistles, and invasive reed canarygrass (Figure 7). Although there is some pasture encroachment (Figure 8), vegetation within the riparian zone was generally not overgrazed. Due to the dense riparian vegetation, its small size and low, spring-fed flow, minimal bank erosion was observed within the reach. The paved Dry Creek Road encroaches for 100 feet but with densely vegetated banks this was not considered a significant nutrient source. Three irrigation withdrawals were identified on the GIS layer, but they were not definitively observed on the aerial nor confirmed in the field.

FIGURE 7. ROBUST RIPARIAN, UPSTREAM OF HAMILTON ROAD

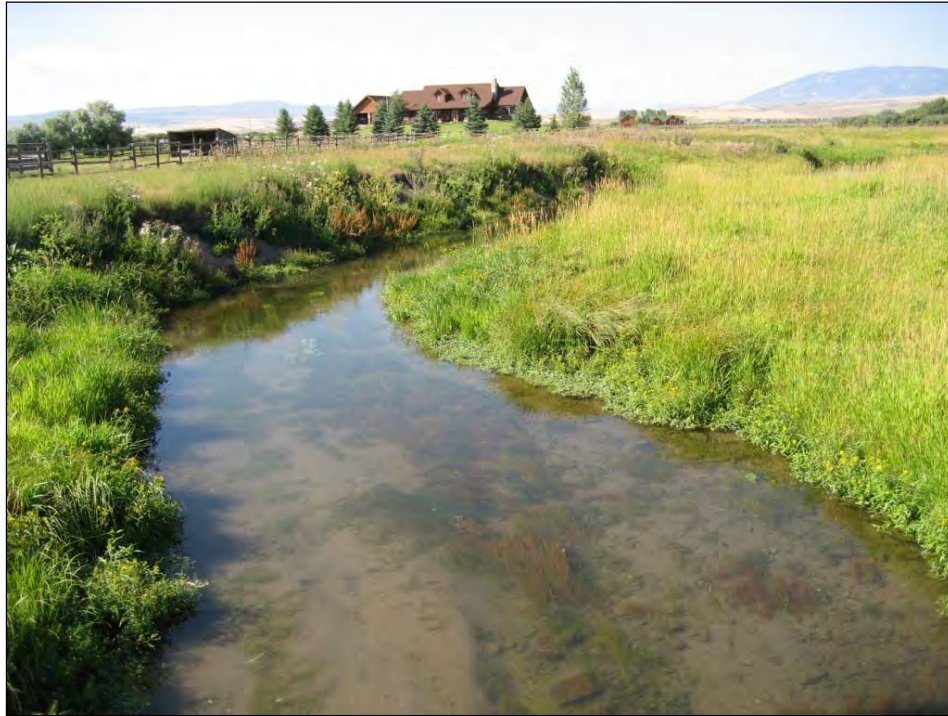
FIGURE 8. PASTURE ENCROACHMENT LEFT BANK BUT GENERALLY DENSE RIPARIAN

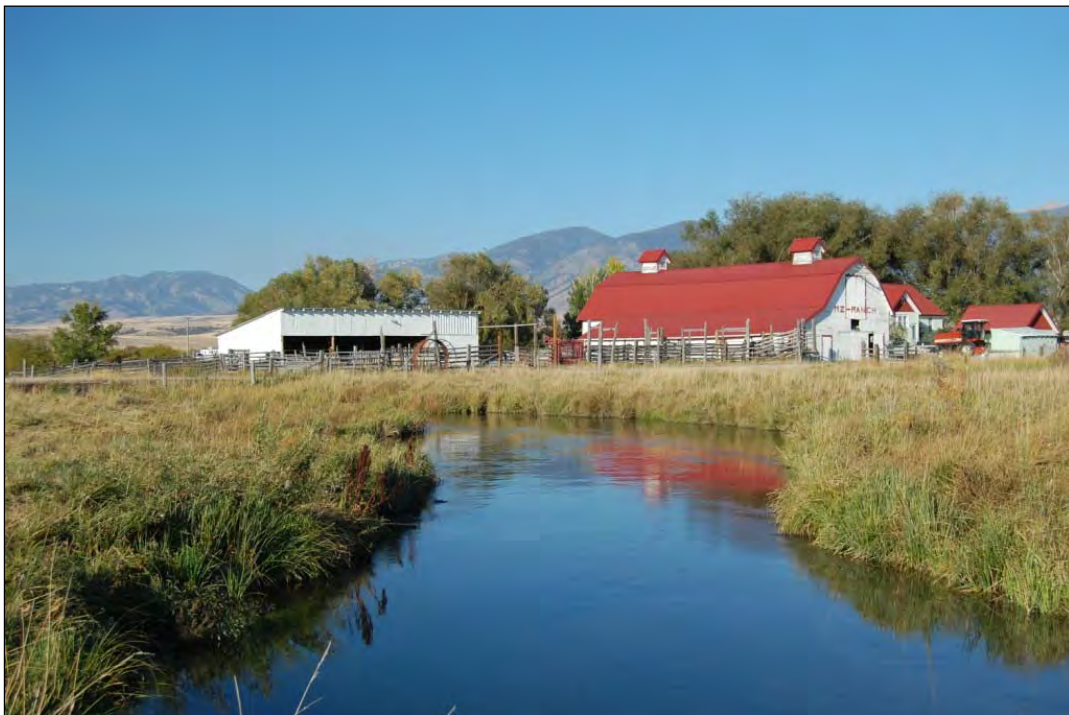
FIGURE 9. HORSE CORRAL ON REACH THOM 02 N UPSTREAM OF EAST GALLATIN CONFLUENCE

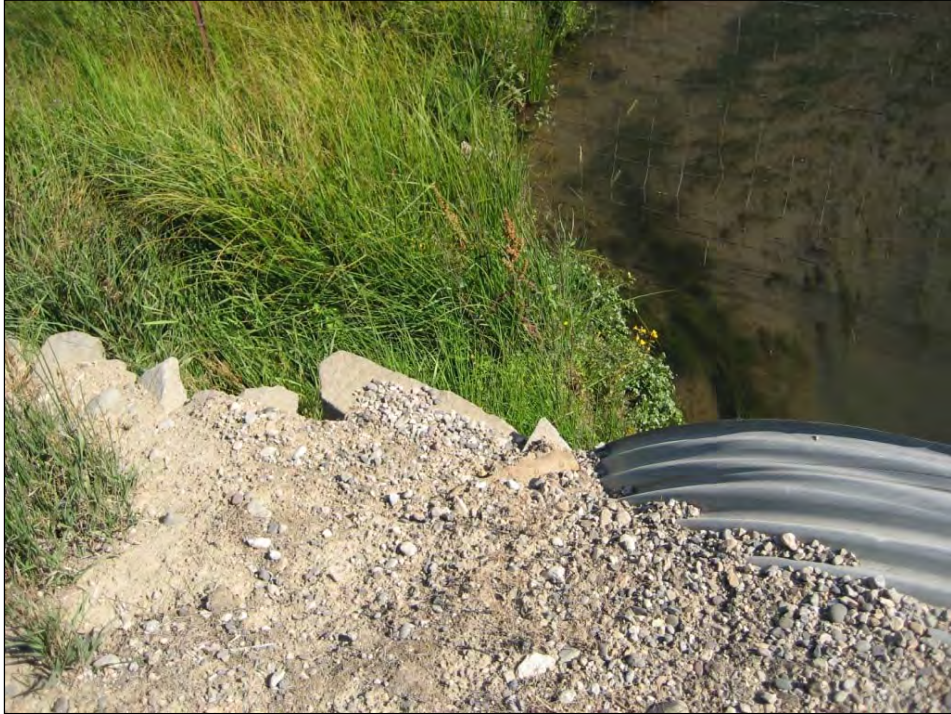
FIGURE 10. HAMILTON BRIDGE ROAD CROSSING
