# MADISON WATERSHED

**STREAM SUMMARIES  
2020**

Montana Department of Environmental Quality, Water Quality Planning Bureau, Watershed Protection Section

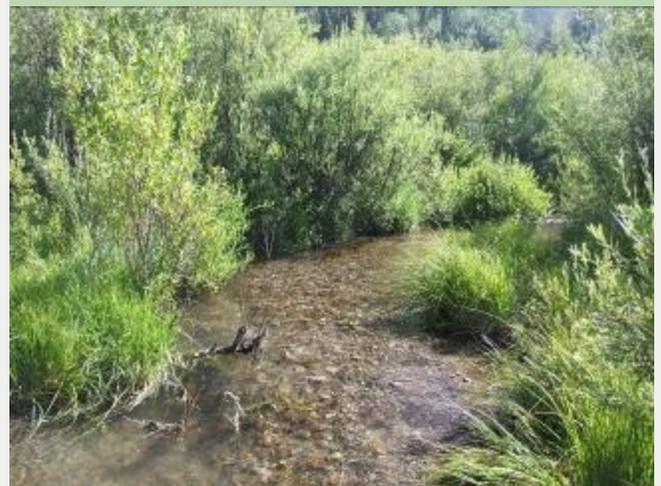
**Healthy riparian vegetation along Antelope Creek**

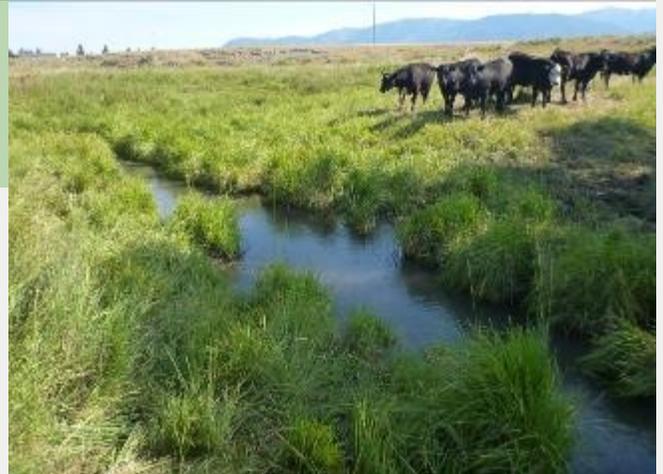
Excess fine sediment in Bear Creek is primarily linked to livestock grazing within the riparian area. Extensive pugging and hummocking, bank trampling, over-widened sections of stream where cattle crossings are located, and loss of riparian vegetation have been observed throughout the watershed.

**Hummocked streamside vegetation due to livestock grazing along Bear Creek**

Almost the entirety of Bear Creek, once the stream emerges into the valley, is grazed and contains an extensive network of irrigation ditches reducing instream flows; therefore, there are few areas of the stream that are not candidates for a restoration project. However, downstream of Longhorn Road, there are multiple beaver dams that are creating healthy riparian habitat, and this area should be protected. Upstream of Longhorn Road, there are many small homeowner ponds intersecting the flow of Bear Creek, which are likely increasing water temperatures; discouraging this type of future development may prove beneficial to stream health. There is also a series of two ponds downstream of Highway 287, below which Bear Creek runs dry. Efforts should be considered to increase flow in Bear Creek below these two ponds. Additionally, downstream of Highway 287, heavy grazing occurs on both sides of the stream; many areas are denuded of vegetation and the stream is over-widened at cattle crossings. Hay fields also appear to lack riparian buffers. This entire stretch of the stream is in need of improved riparian zone management. Undersized culverts at road crossings on Valley Cutoff Road were also noted during DEQ assessments of sediment contributions from unpaved roads.

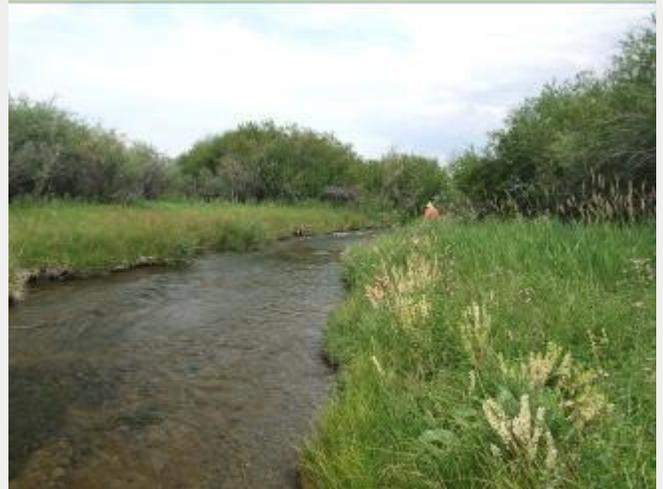
**Streamside vegetation conditions of Blaine Spring Creek**

The riparian zone along Blaine Spring Creek may be limited in some sections due to confined conditions and road encroachment, but other areas could improve where livestock grazing is occurring. Downstream of Gravelly Range Road, there are areas in need of improved grazing management practices and larger riparian buffers.

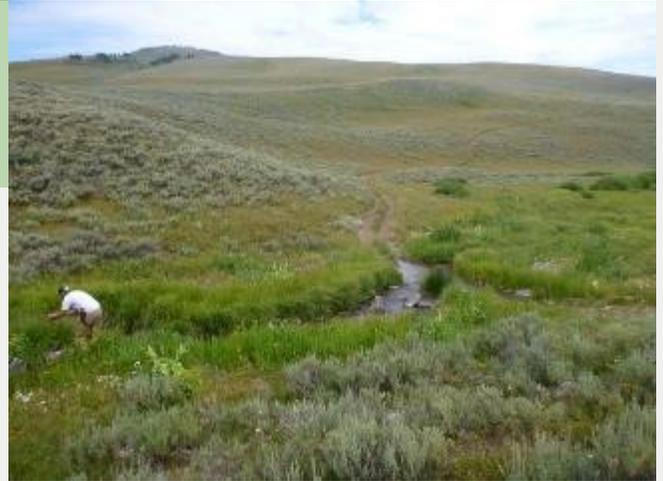
**Downstream end of Buford Creek (monitoring site BFRD 07-01). Picture shows a stream ford.**

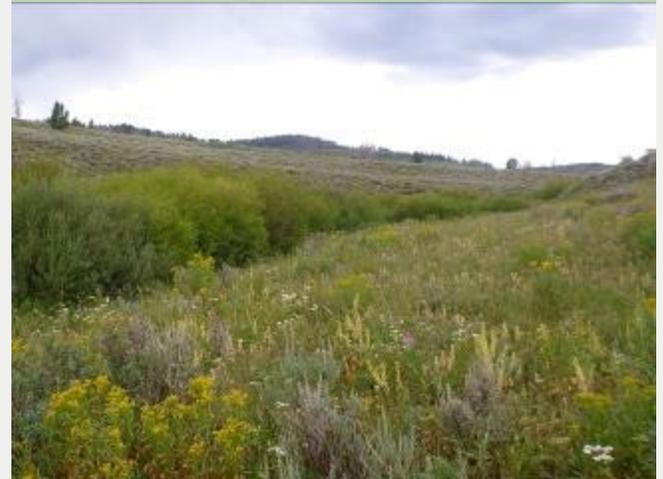
**Upper monitoring site (BFRD 06-01), showing riparian vegetation potential for entirety of Buford Creek**

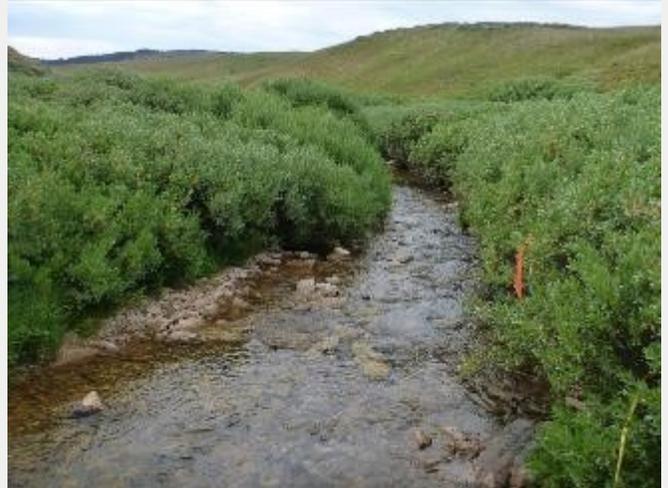
**Healthy streamside vegetation in the headwaters of the Elk River**

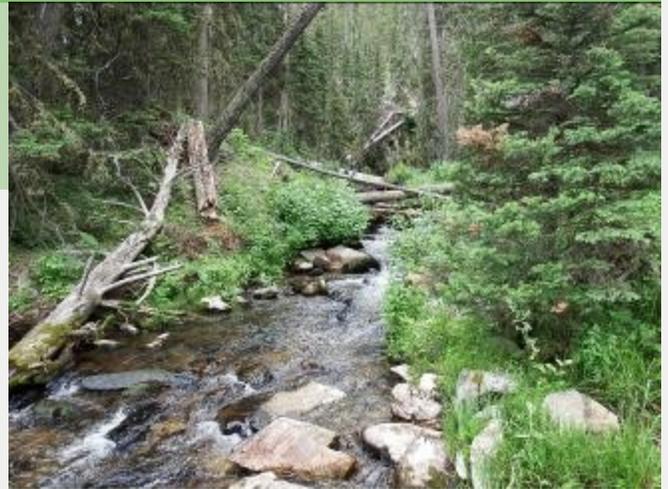
**Gazelle Creek monitoring site GAZL 09-01 containing healthy amounts of large woody debris**

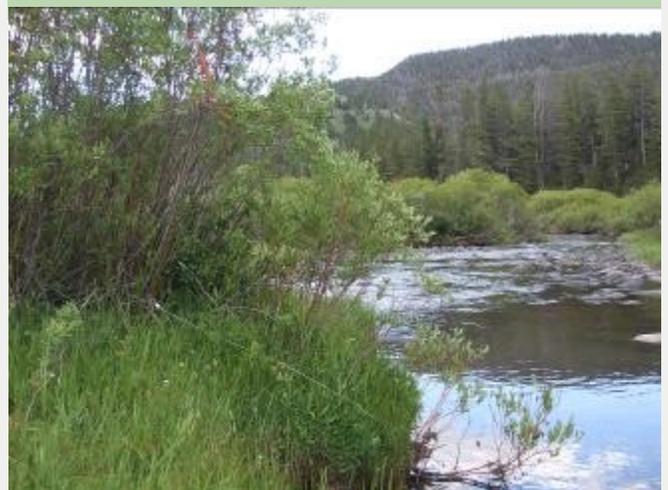
**Healthy streamside vegetation along Gazelle Creek**

Except for the headwaters and the lower reach near the mouth, the majority of Gazelle Creek appears to move through a heavily forested landscape. Nevertheless, best management practices related to livestock grazing should be implemented to protect the riparian area and streambanks. Wetland areas in the headwaters should also be protected.

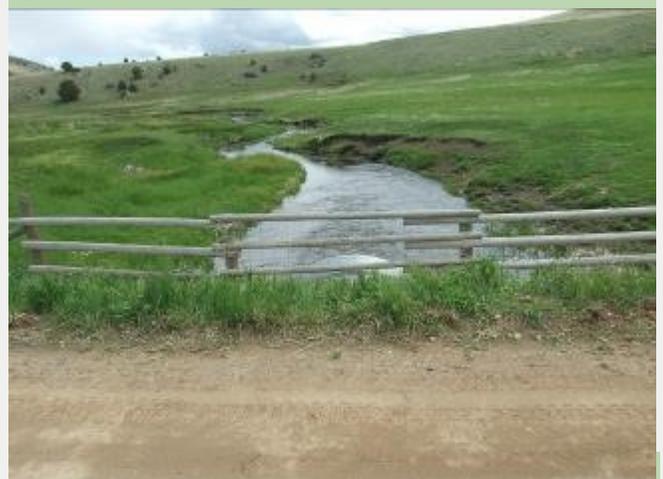
Unpaved roads and riparian grazing are the biggest contributors of excess fine sediment reaching Hot Springs Creek. Overgrazed riparian areas have led to unhealthy riparian vegetation and compromised streambanks. A wildfire burned the lower reach of the stream in 2012 (at DEQ monitoring site HOTS 16-01), which has undoubtedly contributed to excess fine sediment in this portion of the stream. However, riparian vegetation is quickly rebounding to create a buffer against unstable soils in the burned uplands.

**An undersized road culvert and eroding streambanks along Hot Springs Creek**

The majority of Hot Springs Creek has opportunities for grazing management improvements within the riparian area; however, downstream of Sterling is in the most need, particularly between Sterling and Norris. It was noted during DEQ field work that better best management practices could be implemented around the Red Bluff Research Ranch, as a lot of fine sediment was observed in the stream at this location and hummocking was prominent along streambanks. Additionally, riparian areas adjacent to irrigated fields in the Hot Springs Creek drainage could be improved with expanded buffers. Culverts along Sterling Road were observed to be large contributors of sediment, and there is opportunity for improved road best management practices (BMPs) along a tributary that follows Bradley Creek Road.

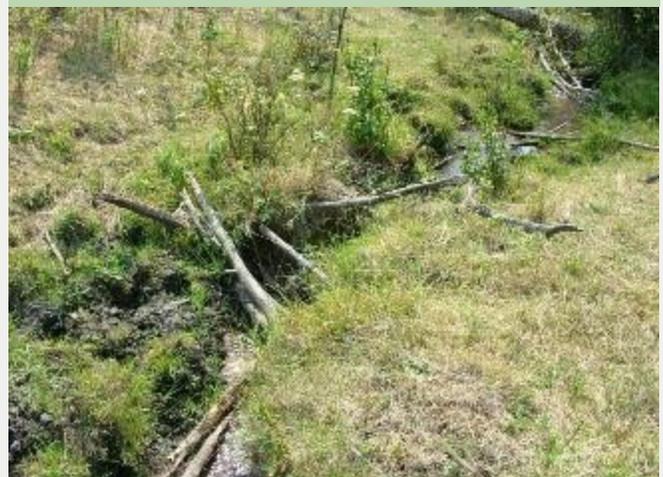
**Unhealthy streamside vegetation and hummocking as a result of livestock grazing along Hot Springs Creek**

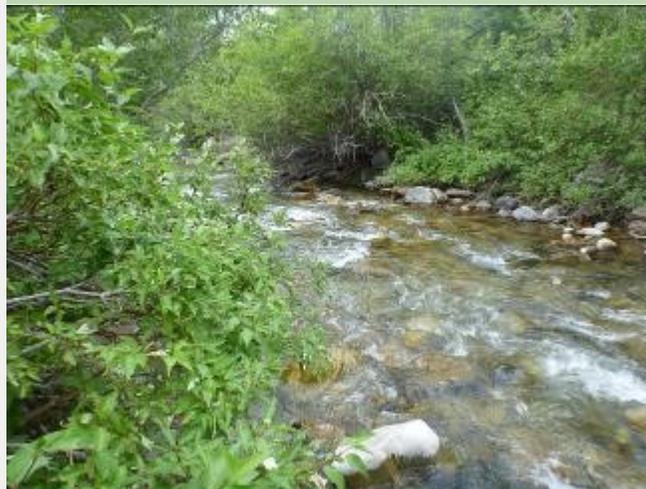
**Healthy streamside vegetation at monitoring site INDN 23-01**

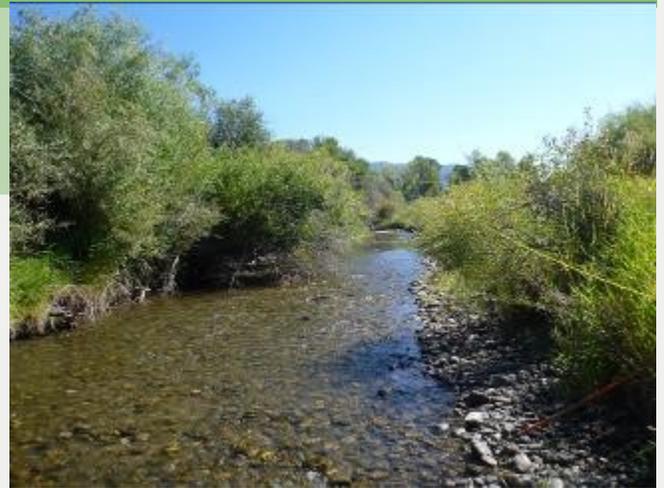
**Healthy streamside vegetation at Jack Creek monitoring site JACK 14-06**

Implementation of construction stormwater best management practices, that will limit impacts to Jack Creek in its headwaters, are required by Montana state law for projects greater than one acre in size. The same best management practices should be encouraged for construction projects smaller than one acre. Efforts should be made to maintain riparian buffers for all new home construction anywhere along Jack Creek, as well as for existing irrigated fields. Improved grazing management practices and possibly revegetation of native riparian species in the middle and lower sections of Jack Creek should be evaluated. Obvious sources of sediment from unpaved roads should also be addressed where possible.

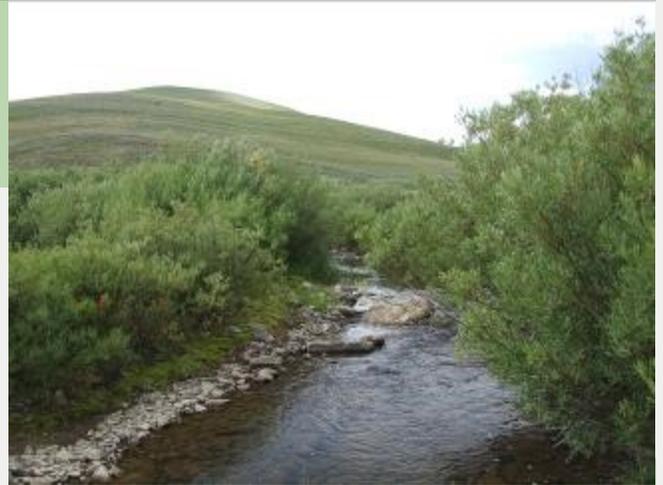
**Healthy streamside vegetation along an upper reach of North Meadow Creek**

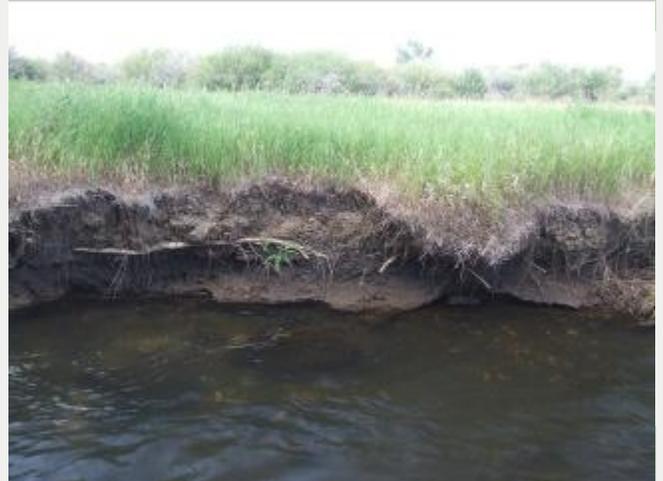
**Lack of stabilizing streamside vegetation resulting in an eroding streambank due to livestock grazing**

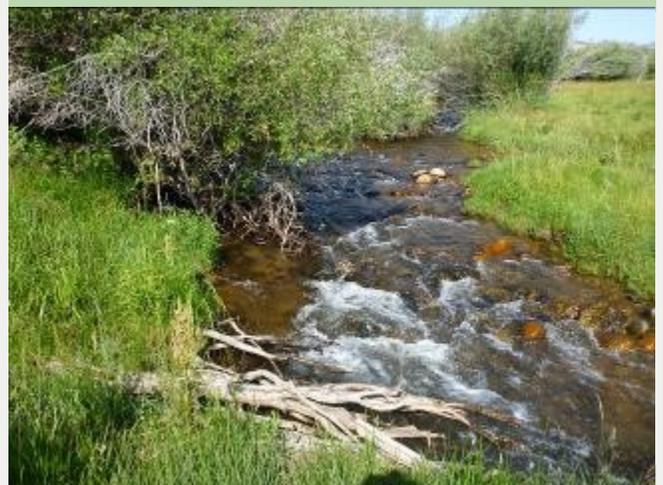
**Streamside vegetation conditions along North Meadow Creek**

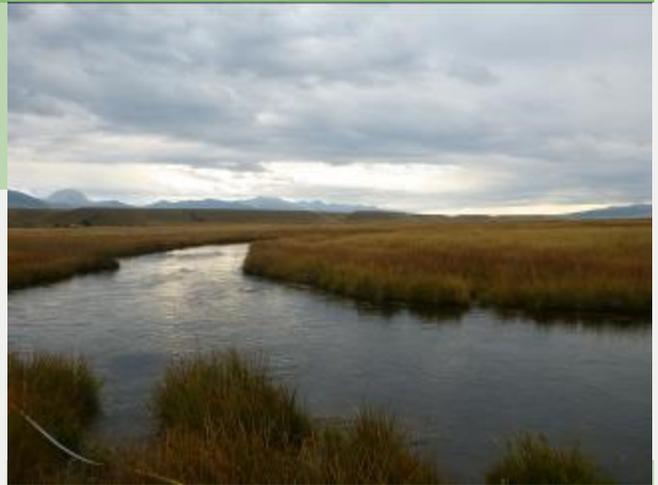
**Stabilizing wetland vegetation at monitoring site ODEL 02-01**

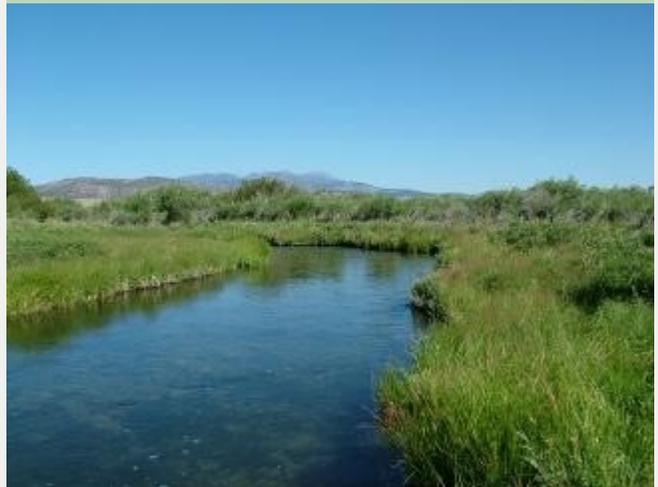
**Healthy streamside vegetation conditions along O'Dell Spring Creek**

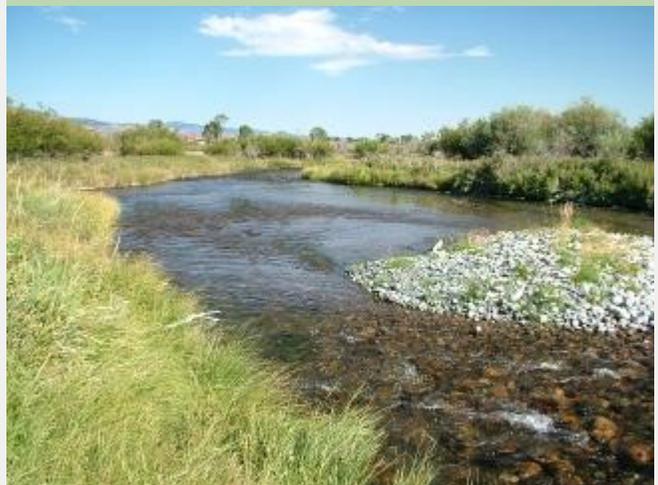
**Healthy streamside vegetation conditions along O'Dell Spring Creek**

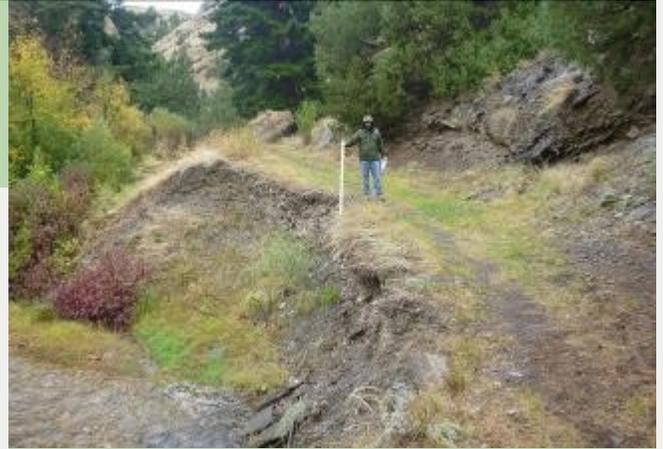
Current and historical riparian grazing is the primary human-caused source of excess fine sediment in Ruby Creek. Livestock access to the stream has resulted in trampled streambanks and over-widened sections at access points. An unpaved road was also noted during DEQ field work as having a significant contribution of sediment to the stream near the McAtee Homestead and DEQ monitoring site RUBY 17-01.

**Sediment erosion from an unpaved road along Ruby Creek**

Decommissioning of the old road near the McAtee Homestead should also be considered to discourage future use and reduce sediment inputs to the stream.

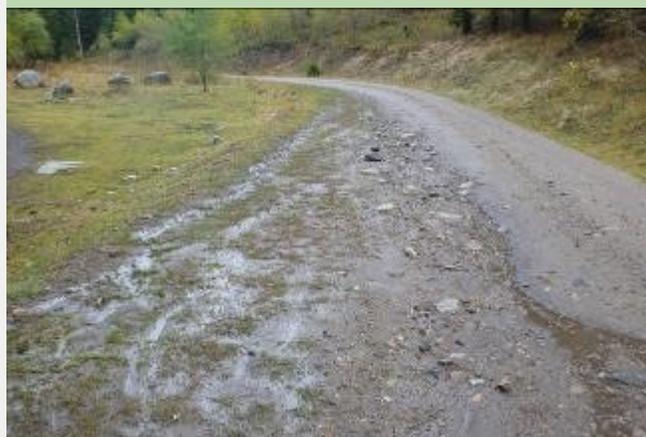
In the upper headwaters of South Meadow Creek, road crossings and parallel segments of roads may be contributing fine sediment. Further downstream, riparian vegetation is not at desired conditions for protection of streambanks and capacity to filter sediment from reaching the stream, particularly above North Meadow Creek Road. In areas of beaver conflict, discussions should occur of how to support beaver habitat to improve riparian vegetation conditions, while also ensuring efficient agricultural production.

**Sediment erosion/runoff from an unpaved road adjacent to South Meadow Creek**

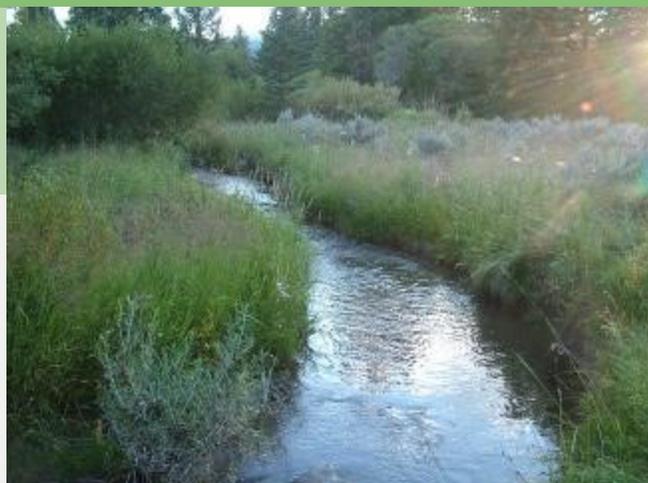
**Streamside vegetation conditions along upper Watkins Creek**

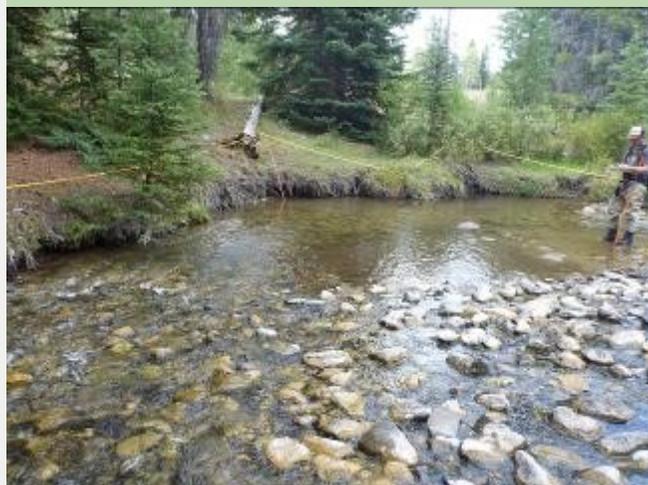
**An eroding streambank at monitoring site WATK 12-01**

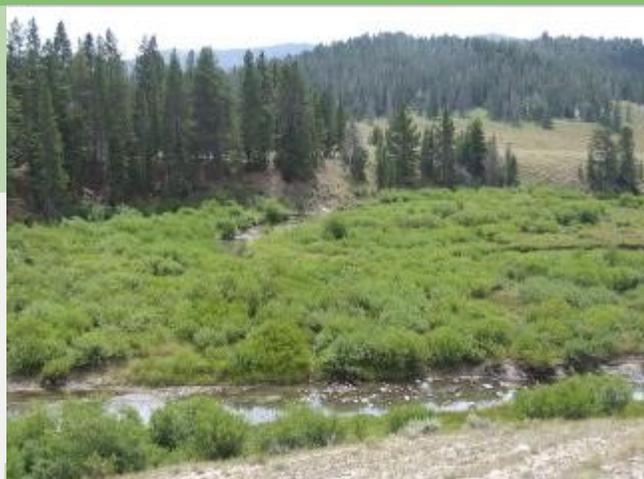
**Healthy streamside vegetation in the headwaters of the West Fork Madison River**

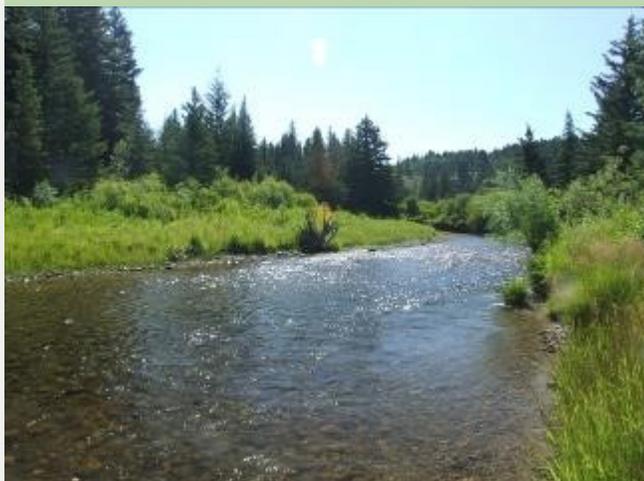
**Healthy streamside vegetation along the West Fork Madison River**

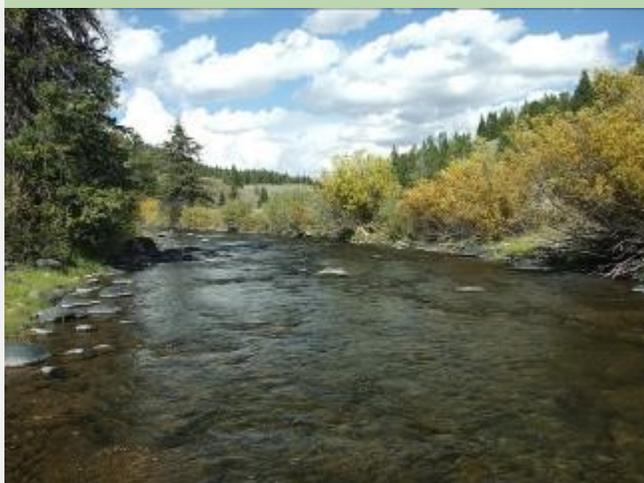
**Healthy streamside vegetation along the lower West Fork Madison River**

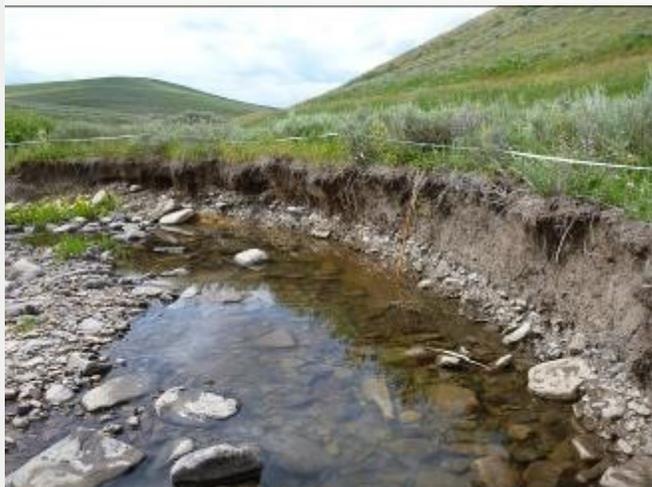
An eroding streambank along the upper West Fork Madison River, above Buford Creek

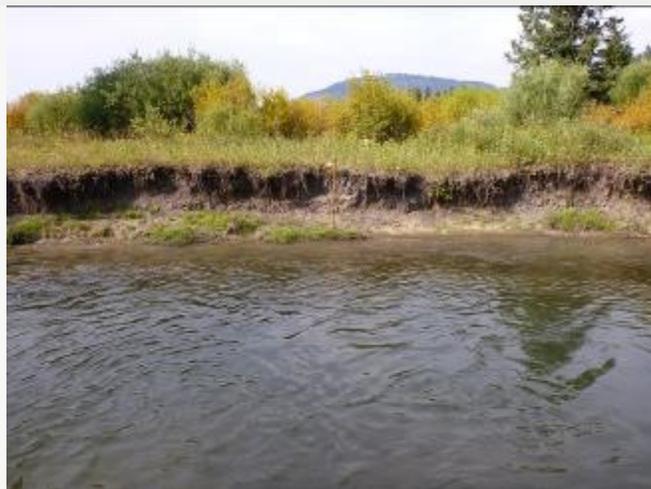
An eroding streambank along the West Fork Madison River at monitoring site WFMA 26-01

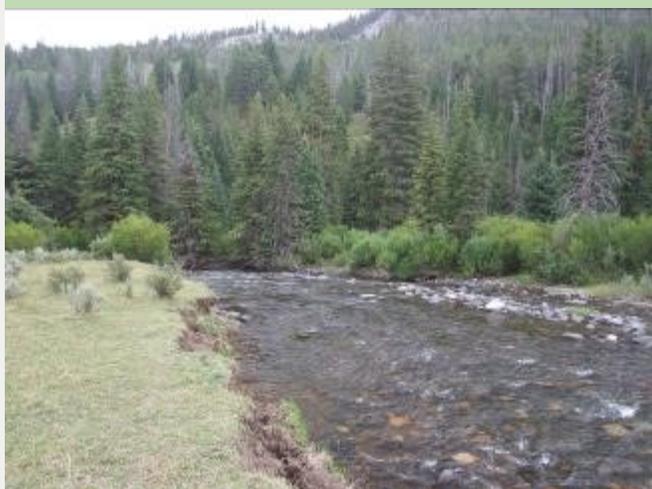
Unhealthy streamside vegetation along the lower West Fork Madison River due to livestock grazing

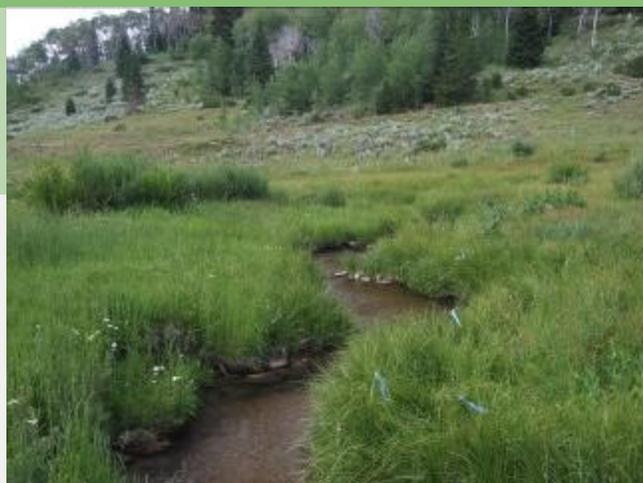
**Recovering vegetation along Wigwam Creek at monitoring site WGWM 08-01**
